2025 PHYSICAL CONDITION ROUTINE ELEMENT LEVEL INSPECTION REPORT

Bridge CUY-6-1456
SFN 1800930

Detroit-Superior/Veteran's Memorial over Cuyahoga River
Dates of Inspection: October 6-10, 2025

ODOT DISTRICT 12
5500 TRANSPORTATION BOULEVARD
GARFIELD HEIGHTS, OHIO 44125
DECEMBER 30, 2025

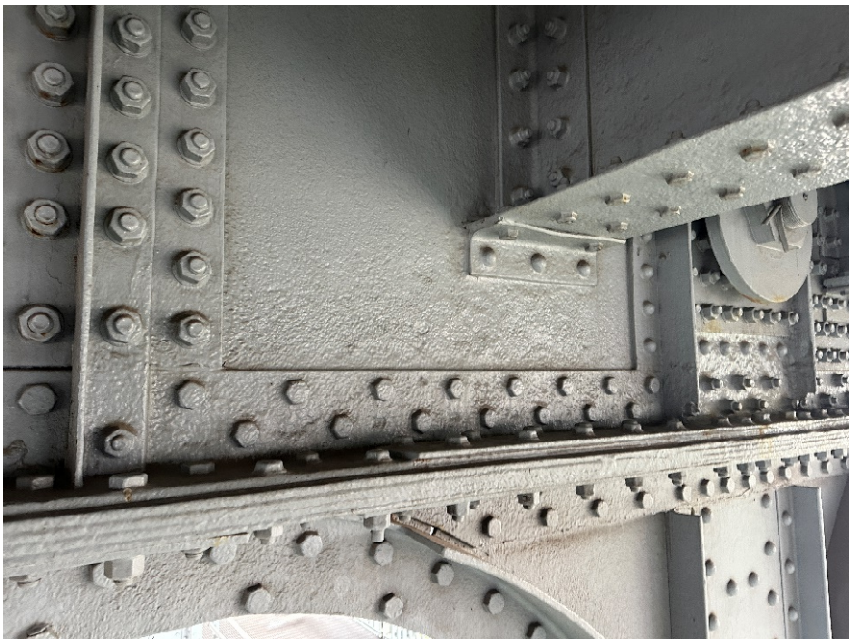
The steel floorbeams are in **Satisfactory** condition (Photos 18 & 19). The floorbeams typically have painted over pitting and section loss near the deck openings at the truss lines and deck joints. In these areas, there are some web perforations, with repair plates welded in place at some of the perforation locations. Floorbeams 0 and 0' have widespread painted over and active corrosion holes in transverse stiffeners and bottom flange due to joint leakage (Photo 20). Active surface corrosion is present due to ongoing water infiltration at the deck openings.

Photo 18: Typical Upper Floorbeam Condition – Looking East

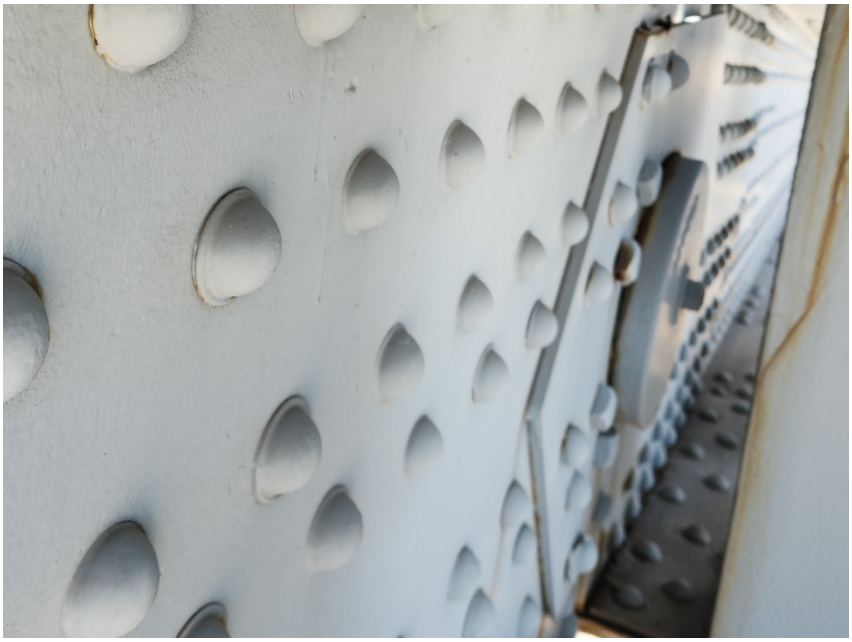
The arch is a 3-pinned arch with a pin at each bearing and a center pin at L12 (Photos **26** & **27**). The pin at L12 serves as both the center pin for the arch and the upper pin for the deck hanger. The pin and hangers are in good condition. There are longitudinal grooves in the upper hanger eye bar at L12 which is supported by the main hinge. These grooves appear to be fabrication marks. See photo below.

Photo 26: Center Arch Pin at L12R

Photo 27: Center Arch Pin and Deck Hanger at L12L, Looking Down. Lines in Top of Deck Hanger Eye Running Parallel with the Eye Appear to be Fabrication Defects.

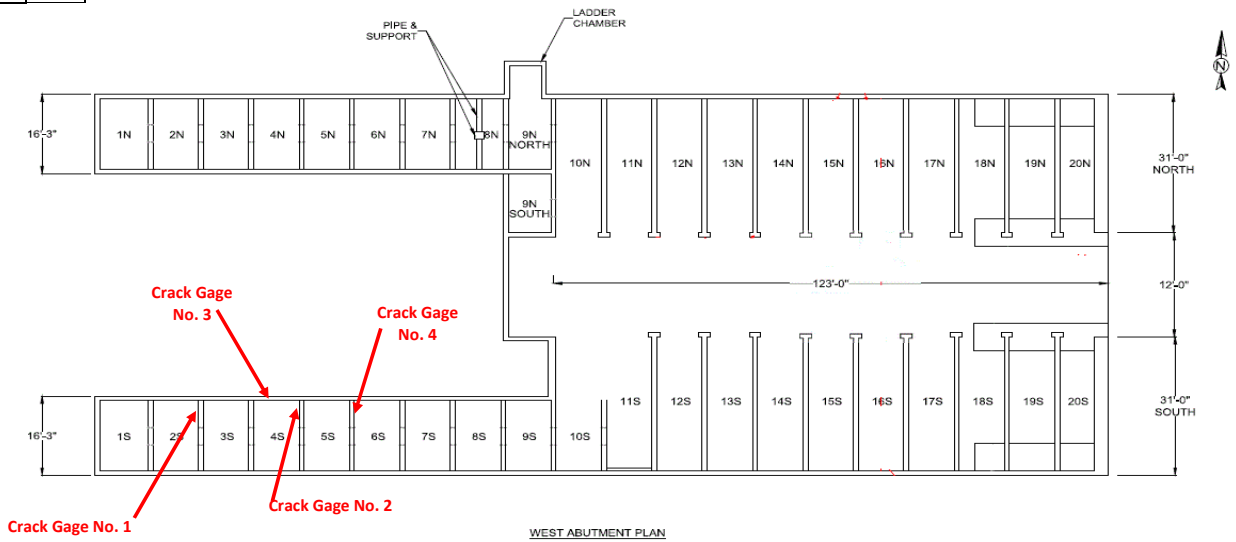
Table 7: West Station - Columns and Jack Arches				
Member Type	**Column Row**	**Column #**	**Face**	**Defect Description**
Column	A	2	E	Delaminated and spalled with exposed reinforcing (6 SF total). **Vertical cracking for 3' below corbel on the east corners.**
Jack Arch	A	2-3	N	Spalled with exposed reinforcing (**16** SF).
Column	A	3	E, W	Delamination on west face (1 SF). East face has 2 ft vertical crack near base.
Jack Arch	A	3-4	B	Heavy spalling with rust staining and efflorescence on bottom face around embedded mounting box (6 SF). **Wide, full height cracks from base up thru corbel.**
Column	A	4	N, W	Delamination on north and west faces (8 SF).
Column	A	6	NE	Northeast corner, east face delaminated / spalled with exposed reinforcing (10 SF total).
Jack Arch	A	6-7	N	Spalled with exposed reinforcing (4 SF).
Column	**A**	**7**	**N**	**Cracking around corbel for 5' H with spall and exposed reinforcing (1 SF)**

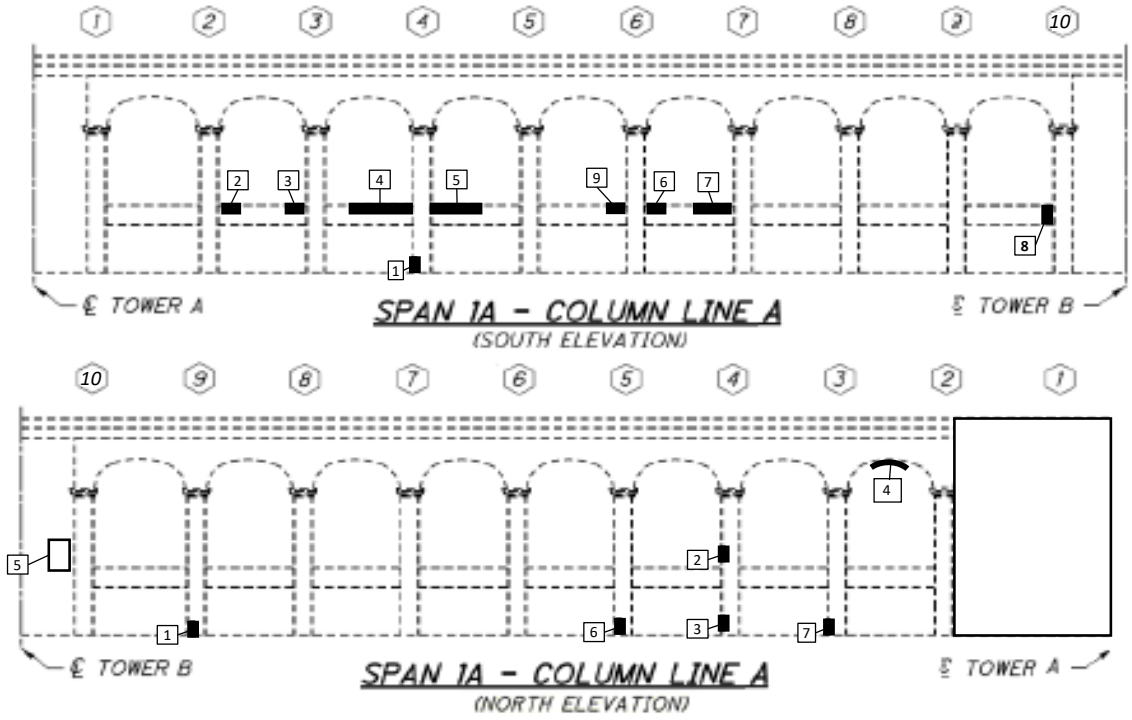
SPAN 1A - COLUMN LINE A (SOUTH ELEV.) DEFICIENCIES	
#	Defect
1	Spall w/ exp. Reinf., 2.5" D - 1 SF
2	Spall w/ exp. Reinf. - 1 SF
3	Delamination - 4 SF
4	Spall w/ exp. Reinf. - 7 SF
5	Delamination - 4 SF
6	Delamination - 1 SF
7	Delamination - 5 SF
8	Delamination - 1 SF
9	Spall w/ exp. Reinf.

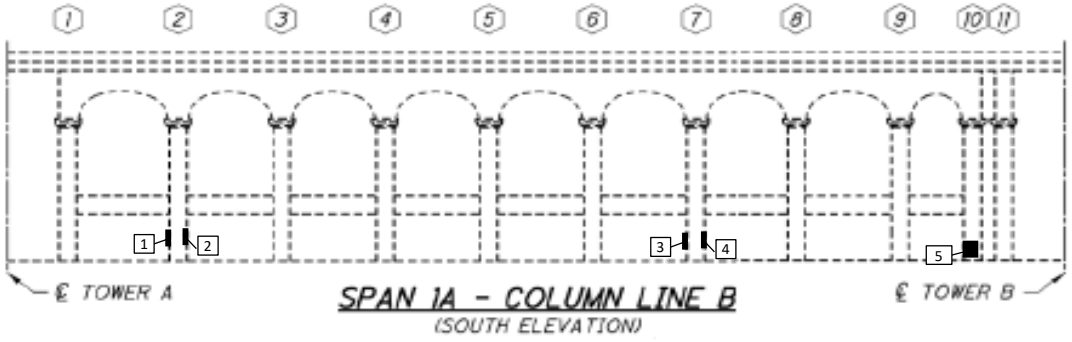
SPAN 1A - COLUMN LINE B (SOUTH ELEV.) DEFICIENCIES	
#	Defect
1	Delamination - 1 SF
2	Spall w/ exp. Reinf. - 1 SF
3	Spall w/ exp. Reinf., 1.5" D - 1 SF
4	Spall w/ exp. Reinf., 1.5" D - 1 SF
5	Delam./Spall w/ exp. Reinf., 1.5" D - 5 SF

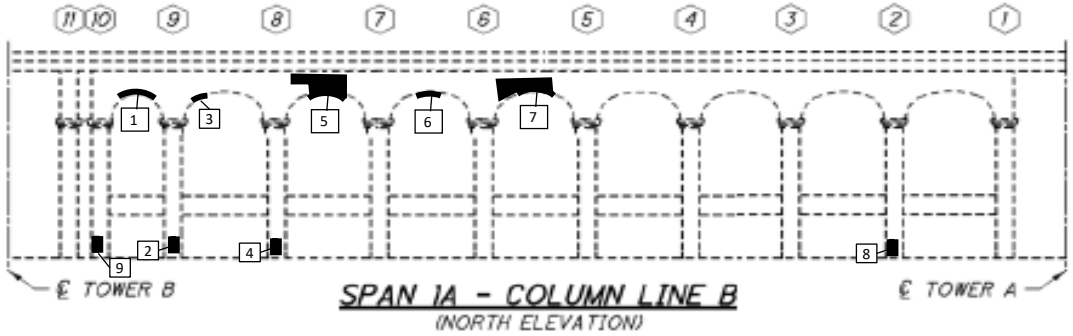
SPAN 1A - COLUMN LINE B (NORTH ELEV.) DEFICIENCIES	
#	Defect
1	Delamination - 2 SF
2	Delamination - 8 SF
3	Spall - 1 SF
4	Delamination - 2 SF
5	Spall w/ exp. Reinf. - 8 SF
6	Delamination - 1 SF
7	Delamination - 18 SF w/ Spall - 1 SF
8	Delamination - 2 SF
9	Delamination - 2 SF

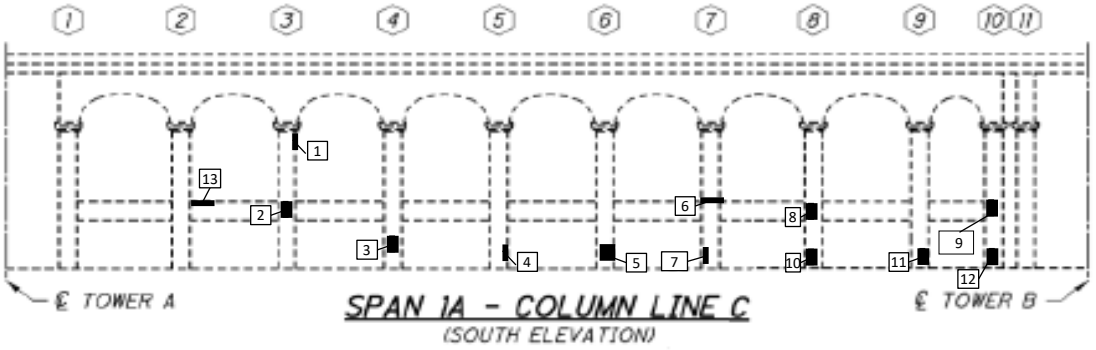
SPAN 1A - COLUMN LINE C
(SOUTH ELEVATION)

SPAN 1A - COLUMN LINE C (SOUTH ELEV.) DEFICIENCIES	
#	Defect
1	Spall w/ exp. Reinf. - 1 SF
2	Spall w/ exp. Reinf., 3" D - 1 SF
3	Delamination - 3 SF
4	Delam./Spall w/ exp. Reinf. - 6 SF
5	Delam./Spall w/ exp. Reinf., 2.5" D - 10 SF
6	Spall w/ exp. Reinf. - 1 SF
7	Delam/Spall, 1.5" D - 2 SF
8	Spall w/ exp. Reinf. - 1 SF
9	Spall w/ exp. Reinf. - 1 SF
10	Spall w/ exp. Reinf., 6" D - 4 SF
11	Delam./Spall w/ exp. Reinf. - 11 SF
12	Delamination - 10 SF
13	Spall w/ exp. Reinf., 2.5" D - 1 SF

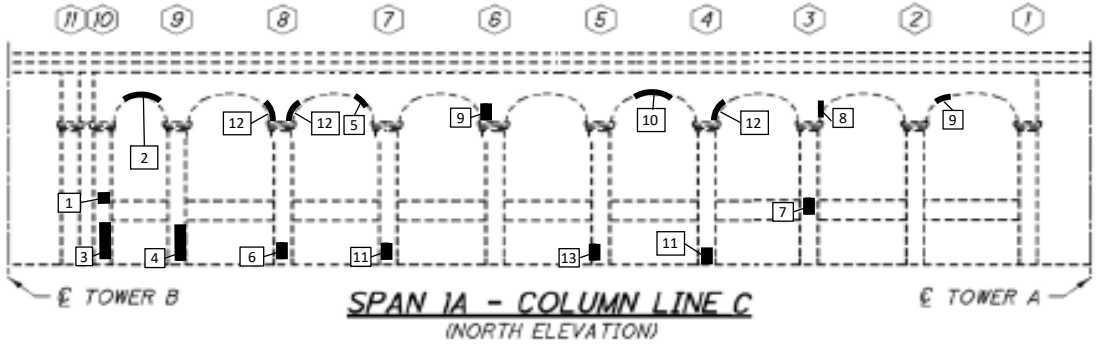
SPAN 1A - COLUMN LINE C
(NORTH ELEVATION)

SPAN 1A - COLUMN LINE C (NORTH ELEV.) DEFICIENCIES	
#	Defect
1	Spall w/ exp. Reinf. - 1 SF
2	Delam. and Spall w/ exp. Reinf. - 5 SF
3	Spall w/ exp. Reinf., 2" D - 2 SF
4	Delam./Spall w/ exp. Reinf. - 9 SF
5	Delamination - 2 SF
6	Spall w/ exp. Reinf., 2" D - 3 SF
7	Delam./Edge Spall with exp. Reinf. - 2 SF
8	Delamination - 2 SF
9	Delamination - 1 SF (2 locations)
10	Spall w/ exp. Reinf. - 1 SF
11	Delamination (2 Locations) - 2 SF each
12	Delamination (3 Locations) - 1 SF each
13	Spall w/ exp. Reinf., 3" D - 1 SF

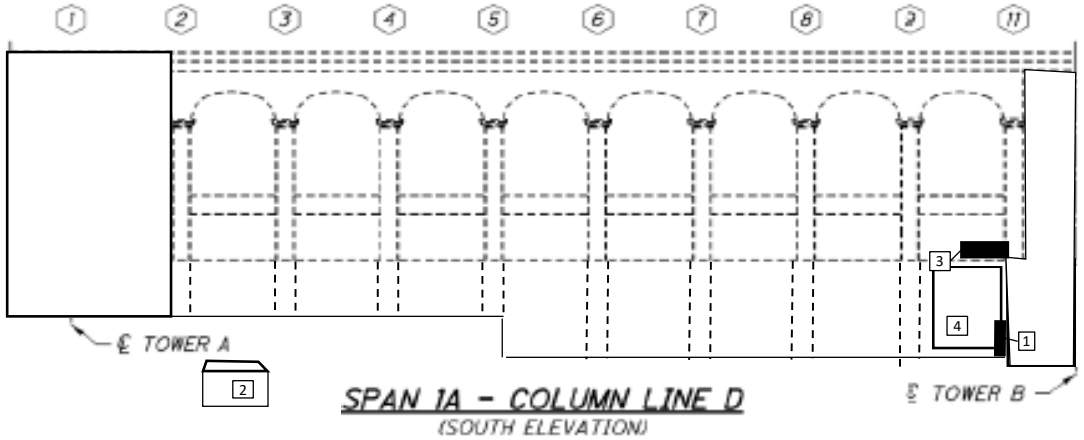
SPAN 1A - COLUMN LINE D
(SOUTH ELEVATION)

SPAN 1A - COLUMN LINE D (SOUTH ELV.) DEFICIENCIES	
#	Defect
1	Spall, 8" D - 5 SF
2	Embankment along the south side of Span 1A has signficant erosion for the full length. At the west end, there is a 15' Diameter x 4' D erosion ditch around the manhole. An erosion ditch extends from the manhole towards the east typ. 3' W x 2' D.
3	Spall w/ exp. Reinf. 1"D - 12 SF
4	Delamination - 40 SF

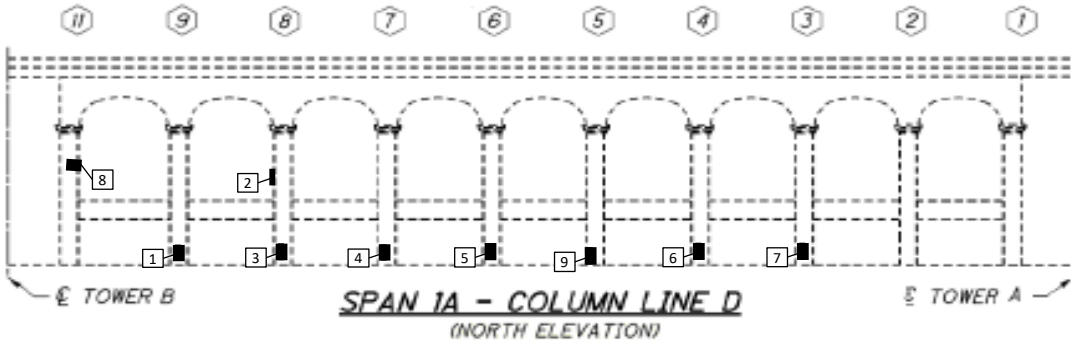
SPAN 1A - COLUMN LINE D
(NORTH ELEVATION)

SPAN 1A - COLUMN LINE D (NORTH ELV.) DEFICIENCIES	
#	Defect
1	Spall w/ exp. Reinf, 1.5" D - 7 SF
2	Delamination - 4 SF
3	Spall w/ exp. Reinf - 6 SF
4	Spall w/ exp. Reinf., 1.5" D - 6 SF
5	Delam. w/ Spall w/ exp. Reinf., 2.5" D - 4 SF
6	Delam. w/ Spall w/ exp. Reinf., 2.5" D - 8 SF
7	Delamination - 6 SF
8	Spall (corbel) - 1 SF
9	Delamination - 2 SF

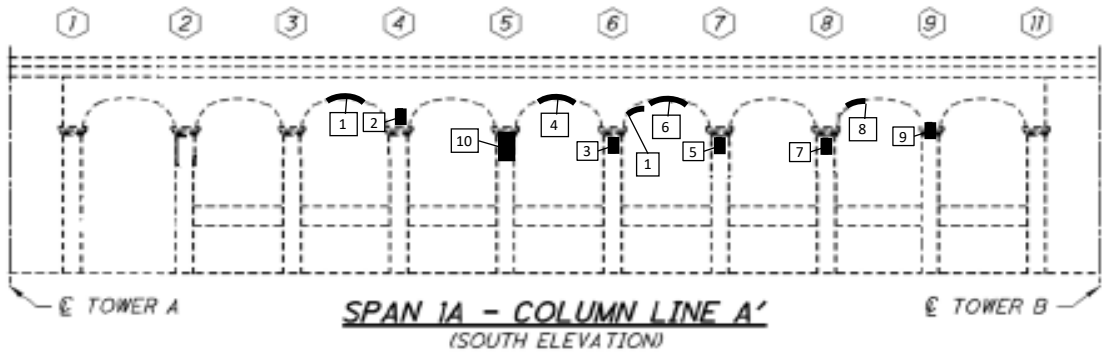
SPAN 1A - COLUMN LINE A' (SOUTH ELV.) DEFICIENCIES	
#	Defect
1	Delamination - 2 SF
2	Delamination - 4 SF
3	Spall w/ exp. Reinf., 3" D - 3 SF
4	Delam. w/ Spall w/ exp. Reinf. - 6 SF
5	Spall w/ exp. Reinf., 4" D - 8 SF
6	Spall w/ exp. Reinf. - 4 SF
7	Spall w/ exp. Reinf., 4" D - 6 SF
8	Delam. w/ edge spalls - 4 SF
9	Delamination - 2 SF
10	Spall w/ exp. Reinf., 3" D - 6 SF
11	Delamination - 1 SF

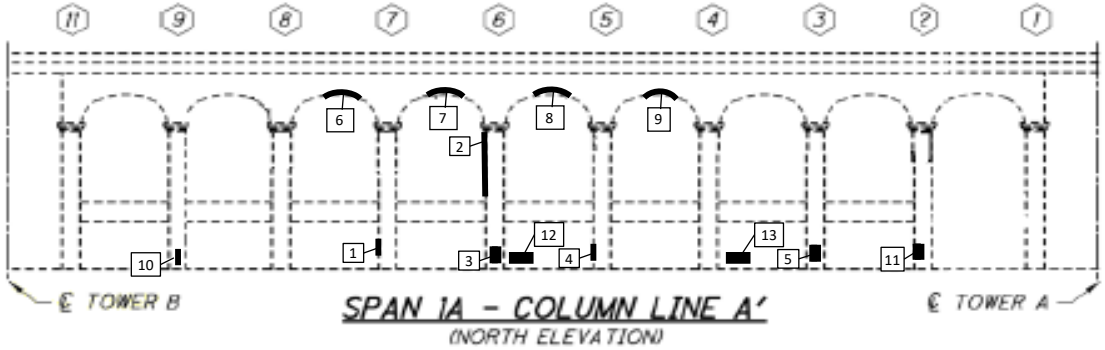
SPAN 1A - COLUMN LINE A' (NORTH ELV.) DEFICIENCIES	
#	Defect
1	Delamination - 6 SF
2	Delamination - 5 SF
3	Delaminaiton - 3 SF
4	Delam. w/ Spall w/ exp. Reinf. - 2 SF
5	Delamination - 1 SF
6	Spall w/ exp. Reinf. - 6 SF
7	Spall w/ exp. Reinf. - 3 SF
8	Spall w/ exp. Reinf. - 3 SF
9	Spall w/ exp. Reinf. - 6 SF
10	Delamination - 3 SF
11	Spall w/ exp. Reinf., 2" D - 2 SF
12	Delamination - 3 SF
13	Delamination - 2 SF

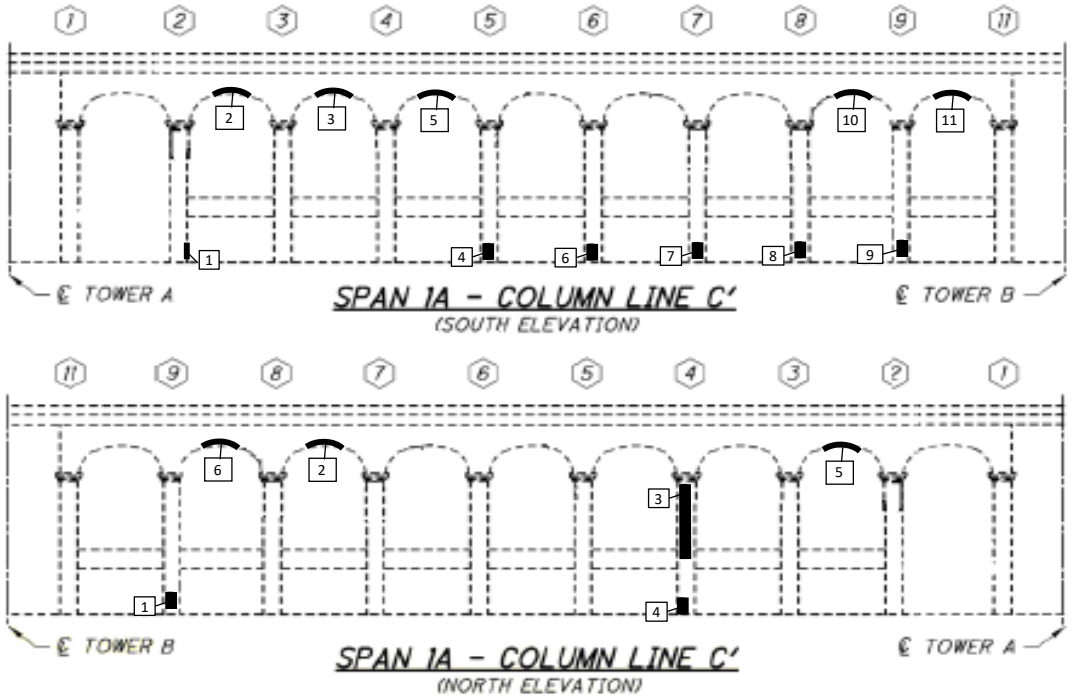
SPAN 1A - COLUMN LINE C' (SOUTH ELV.) DEFICIENCIES	
#	Defect
1	Spall w/ exp. Reinf., 2.5" D - 3 SF
2	Spall w/ exp. Reinf. - 6 SF
3	Spall w/ exp. Reinf. - 2 SF
4	Spall w/ exp. Reinf., 2" D - 4 SF
5	Spall w/ exp. Reinf. - 4 SF
6	Spall w/ exp. Reinf., 2" D - 3 SF
7	Spall w/ exp. Reinf., 3" D - 4 SF
8	Delamination - 4 SF
9	Delamination - 4 SF
10	Spall w/ exp. Reinf. - 3 SF
11	Spall w/ exp. Reinf. - 3 SF

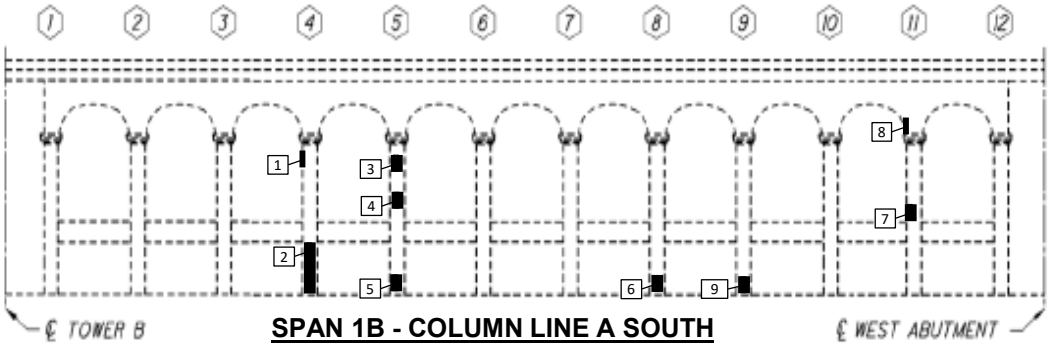
SPAN 1B - COLUMN LINE A SOUTH ELEVATION

SPAN 1B - COLUMN LINE A (SOUTH ELV.) DEFICIENCIES	
#	Defect
1	Delamination - 1 SF
2	Delam. w/ Spall w/ exp. Reinf. - 8 SF
3	Delamination - 4 SF
4	Delam. w/ Spall w/ exp. Reinf. - 2 SF
5	Delam. w/ Spall w/ exp. Reinf. - 8 SF
6	Delamination - 5 SF
7	Delam. w/ Spall w/ exp. Reinf. - 4 SF
8	Delamination - 2 SF
9	Delamination - 5 SF

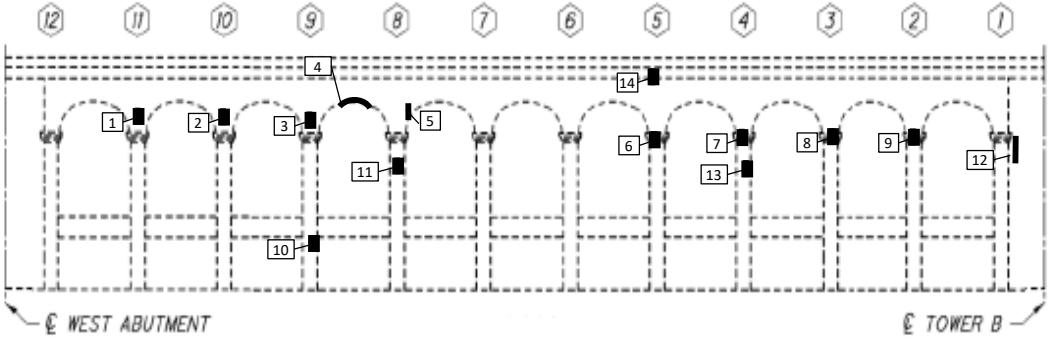
SPAN 1B - COLUMN LINE A NORTH ELEVATION

SPAN 1B - COLUMN LINE A (NORTH ELV.) DEFICIENCIES	
#	Defect
1	Delamination - 2 SF
2	Spall w/ exp. Reinf. - 1 SF (on bracket)
3	Delam. w/ Spall w/ exp. Reinf. - 2 SF (on bracket)
4	Delamination - 1 SF
5	Delam. w/ Spall w/ exp. Reinf. - 2 SF
6	Delamination - 2 SF
7	Spall w/ exp. Reinf. - 1 SF
8	Delam. - 2 SF (underside of bracket)
9	Spall w/ exp. Reinf. - 1 SF, 3" D
10	Spall w/ exp. Reinf. - 1 SF
11	Delamination - 1 SF
12	Spall w/exp. Reinf. 3 SF, 4" D
13	Delamination - 1 SF
14	Delamination - 1 SF (on bracket)

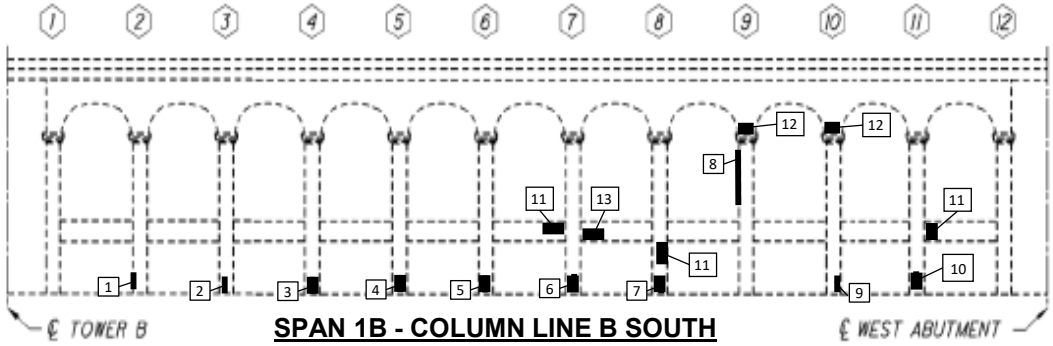
SPAN 1B - COLUMN LINE B SOUTH ELEVATION

SPAN 1B - COLUMN LINE B (SOUTH ELV.) DEFICIENCIES	
#	Defect
1	Delam. w/ Spall w/ exp. Reinf. - 4 SF
2	Delam. w/ Spall w/ exp. Reinf. - 4 SF
3	Delamination - 2 SF
4	Delamination - 4 SF
5	Spall w/ exp. Reinf., 2" D - 4 SF
6	Delam. w/ Spall w/ exp. Reinf. - 3 SF
7	Delamination - 6 SF
8	Delamination - 3 SF
9	Spall w/ exp. Reinf. - 2 SF
10	Delamination - 4 SF
11	Delamination (3 Locations) - 1 SF each
12	Delamination (2 Locations) - 2 SF each
13	Delamination - 3 SF

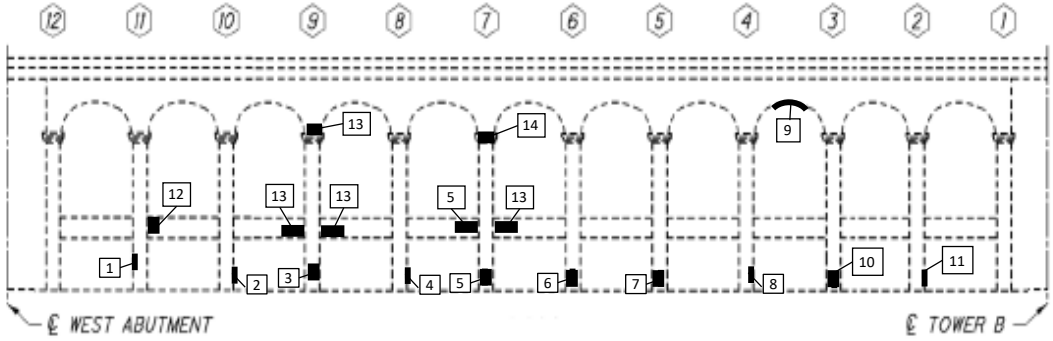
SPAN 1B - COLUMN LINE B NORTH ELEVATION

SPAN 1B - COLUMN LINE B (NORTH ELV.) DEFICIENCIES	
#	Defect
1	Spall w/ exp. Reinf. - 3 SF
2	Delam. w/ Spall w/ exp. Reinf. - 4 SF
3	Spall w/ exp. Reinf., 3" D - 5 SF
4	Delamination - 6 SF
5	Delamination (2 Locations) - 4 SF each
6	Spall w/ exp. Reinf., 2.5" D - 3 SF
7	Spall w/ exp. Reinf., 2" D - 4 SF
8	Delam. w/ Spall w/ exp. Reinf. - 4 SF
9	Delamination - 3 SF
10	Spall w/ exp. Reinf., 2.5" D - 6 SF
11	Spall w/ exp. Reinf., 4" D - 2 SF
12	Delamination - 1 SF
13	Delamination (4 Locations) - 2 SF each
14	Delamination - 5 SF

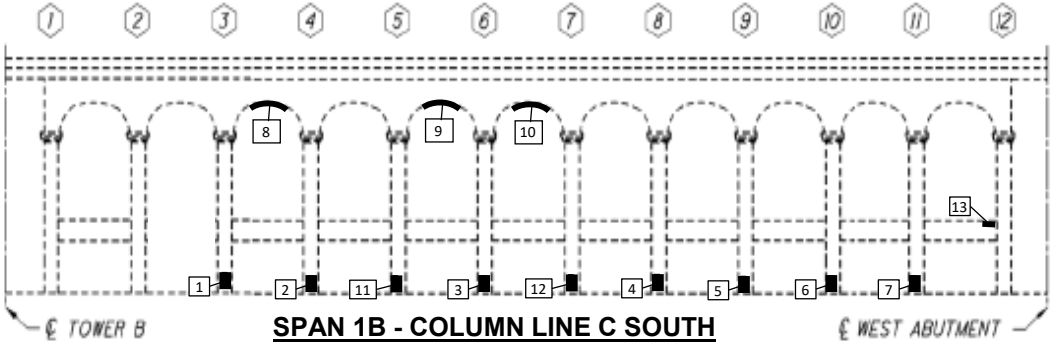
SPAN 1B - COLUMN LINE C SOUTH ELEVATION

SPAN 1B - COLUMN LINE C (SOUTH ELV.) DEFICIENCIES	
#	Defect
1	Spall w/ exp. Reinf. - 4 SF
2	Delam. w/ Spall w/ exp. Reinf. - 5 SF
3	Delam. w/ Spall w/ exp. Reinf. - 6 SF
4	Delamination - 4 SF
5	Delam. w/ Spall w/ exp. Reinf. - 6 SF
6	Delamination - 6 SF
7	Spall w/ exp. Reinf. - 2 SF
8	Delamination - 2 SF
9	Delam. w/ shallow cover reinf. - 2 SF
10	Delam. w/ Spall w/ exp. Reinf. - 4 SF
11	Delamination - 4 SF
12	Delam. & spall, 1" D - 2 SF
13	Spall w/ exp. Reinf. - 1 SF

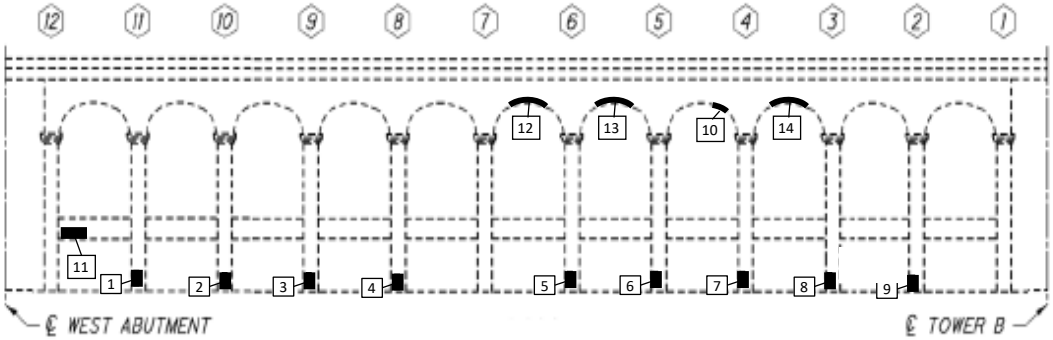
SPAN 1B - COLUMN LINE C NORTH ELEVATION

SPAN 1B - COLUMN LINE C (NORTH ELV.) DEFICIENCIES	
#	Defect
1	Delamination - 6 SF
2	Delamination - 4 SF
3	Delamination - 4 SF
4	Delamination - 4 SF
5	Delam. w/ Spall w/ exp. Reinf. - 4 SF
6	Delamination - 6 SF
7	Delamination - 2 SF
8	Delam. w/ Spall w/ exp. Reinf. - 4 SF
9	Delamination - 4 SF
10	Spall - 1 SF
11	Delamination - 4 SF
12	Delamination - 5 SF
13	Delamination - 3 SF
14	Delamination - 4 SF

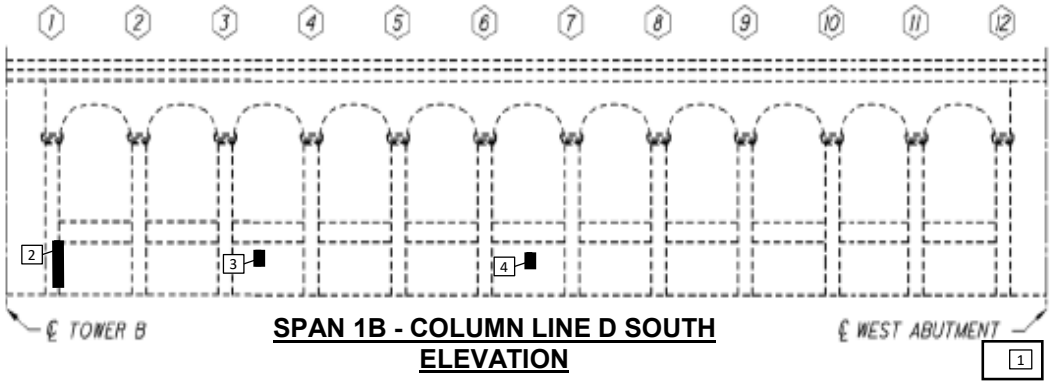
SPAN 1B - COLUMN LINE D SOUTH ELEVATION

SPAN 1B - COLUMN LINE D (SOUTH ELV.) DEFICIENCIES	
#	Defect
1	Delamination and spalling - 60 SF
2	Entire column is broken away from wall.
3	Delamination - 2 SF
4	Delamination - 1 SF

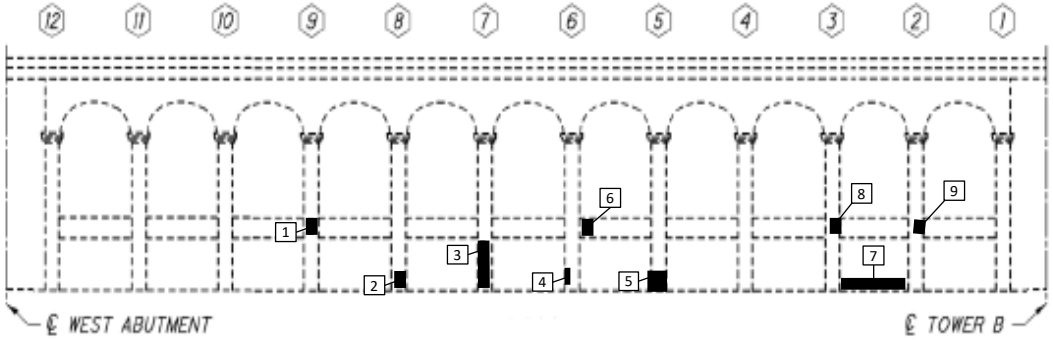
SPAN 1B - COLUMN LINE D NORTH ELEVATION

SPAN 1B - COLUMN LINE D (NORTH ELV.) DEFICIENCIES	
#	Defect
1	Spall w/ exp. Reinf. - 1 SF
2	Spall w/ exp. Reinf., 2" D - 4 SF
3	Spall w/ exp. Reinf. - 8 SF
4	Spall w/ exp. Reinf. - 2 SF
5	Delamination - 6 SF
6	Delamination - 1 SF
7	Delamination - 8 SF
8	Spall, 1" D - 1 SF
9	Delamination - 1 SF

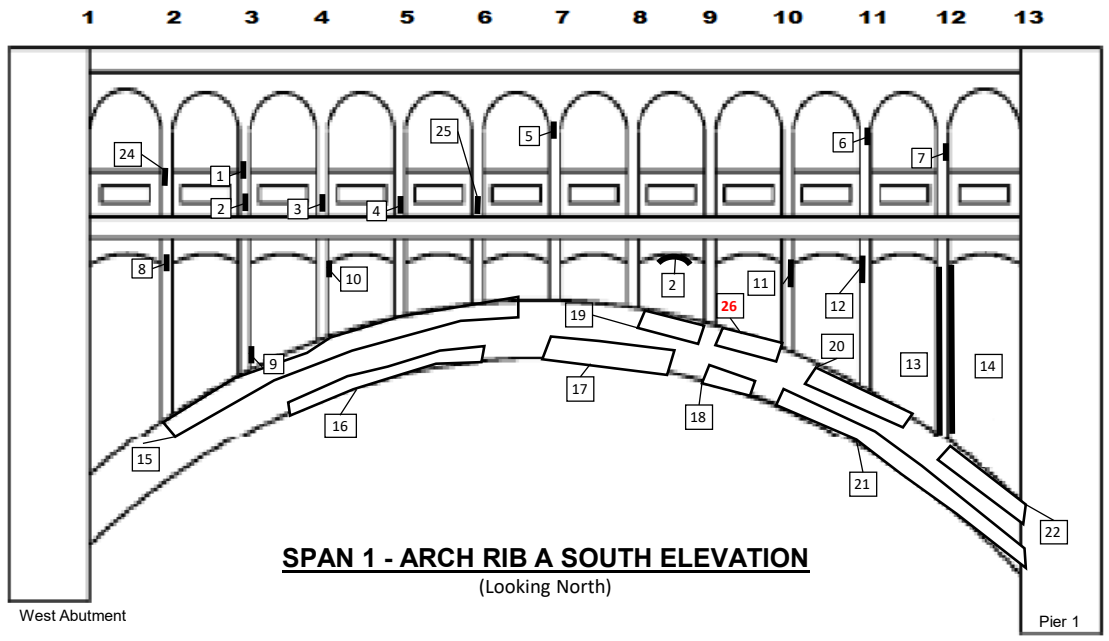
SPAN 1 - ARCH RIB A SOUTH ELEVATION
(Looking North)

SPAN 1 - ARCH RIB A SOUTH ELEVATION DEFICIENCIES	
#	Defect
1	Spall, 1.5" D - 1 SF
2	Delamination - 3 SF
3	Delam. w/ Spall w/ exp. Reinf., 1" D - 3 SF
4	Delamination - 2 SF
5	Spall w/ exp. Reinf., 1" D - 1 SF
6	Delamination - 1 SF
7	Delamination - 2 SF
8	Delamination - 8 SF
9	Delamination - 2 SF
10	Delamination - 3 SF
11	Delamination - 6 SF
12	Delamination - 3 SF
13	Delamination 1' W x FH - 15 SF
14	Delamination 1' W x FH - 15 SF
15	Delamination w/ map cracking - 43' L x 1.5' H
16	Delamination - 20' L x 1' H
17	Delamination - 18' L x 1.5' H
18	Delamination - 8' L x 1.5' H
19	Delamination - 8' L x 1.5' H
20	Delamination w/ map cracking - 8' L x 2' H
21	Delamination w/ map cracking - 40' L x 1.5' H
22	Delamination - 12' L x 2' H
23	Delamination - 4 SF
24	Spall, 1" D - 1 SF
25	Spall, 1" D - 1 SF
26	**Map Cracking - 4' L x 1' H**

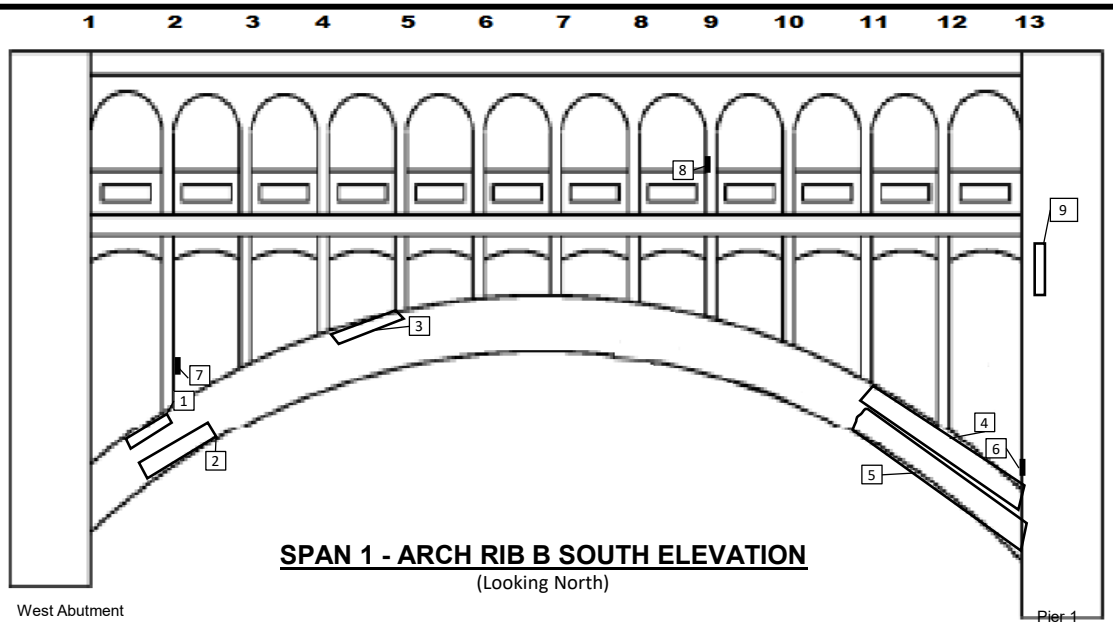
SPAN 1 - ARCH RIB B SOUTH ELEVATION
(Looking North)

SPAN 1 - ARCH RIB B SOUTH ELEVATION DEFICIENCIES	
#	Defect
1	Delamination - 1' L x 1' H
2	Delamination - 3' L x 2' H
3	Delamination - 4' L x 1' H
4	Delamination - 25' L x 1.5' H
5	Delamination - 20' L x 1.5' H
6	Delamination - 3 SF
7	Spall w/ exp. Reinf. - 1 SF
8	Spall - 1 SF
9	Delamination - 1' L x 5' H

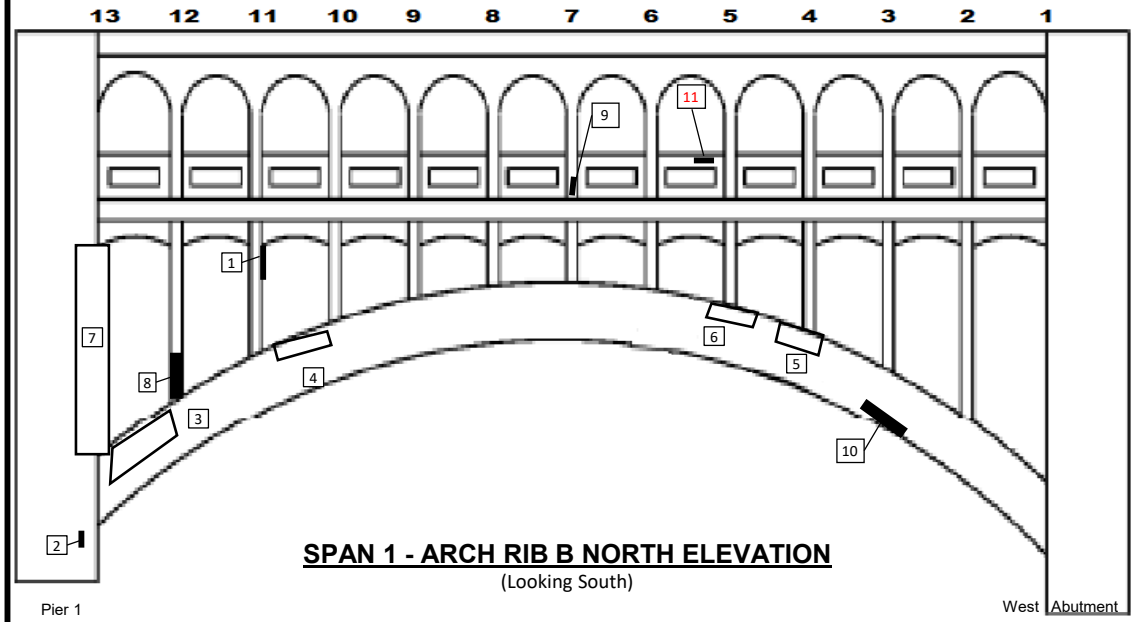
SPAN 1 - ARCH RIB B NORTH ELEVATION
(Looking South)

SPAN 1 - ARCH RIB B NORTH ELEVATION DEFICIENCIES	
#	Defect
1	Delamination - 3 SF
2	Delamination - 2 SF
3	Map Cracking - 10' L x 1' H
4	Delamination - 8 SF
5	Delamination - 5' L x 1' H
6	Delamination - 2' L x 1' H
7	Delam. - FH and extends 1' back each face - 40 SF
8	Delamination - 2 SF
9	Delamination - 2 SF
10	Delamination - 1' L x 5' H
11	**Spall w/ exp. Reinf. - 2 SF**

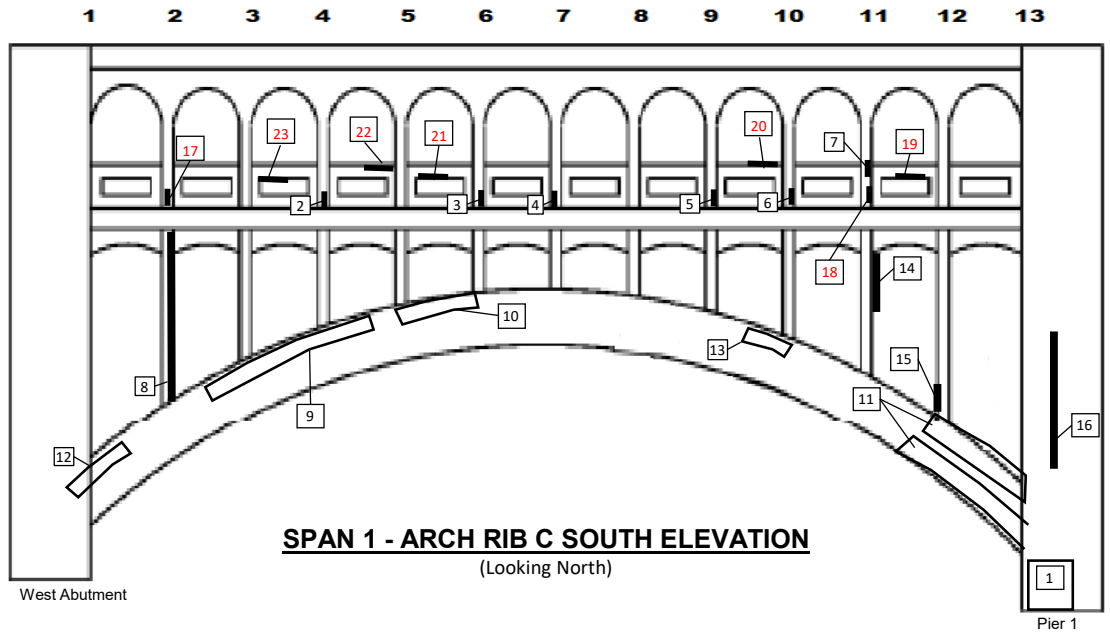
SPAN 1 - ARCH RIB C SOUTH ELEVATION DEFICIENCIES		
#	Defect	
1	Delamination - 12 SF	**17 | Delam 2 SF**
2	Delamination - 1 SF	**18 | Delam 3 SF**
3	Delam. w/ Spall w/ exp. Reinf. - 1 SF	
4	Delamination - 1 SF	**19 | Spall w/exp. Reinf. 3 SF**
5	Delamination - 1 SF	**20 | Delam 3 SF**
6	Delamination - 2 SF	**21 | Delam 4 SF**
7	Delamination - 2 SF	**22 | Delam 2 SF**
8	Delamination - 24 SF	**23 | Delam 1 SF**
9	Delam. and Spall w/ exp. Reinf - 25' L x 1' H	
10	Delamination - 10' L x 1' H	
11	Map cracking, top and bottom. - 15 LF	
12	Delamination - 5' L x 1' H	
13	Delamination - 4' L x 1' H	
14	Delamination - 3 SF	
15	Delamination - 2 SF	
16	Delamination - 10 SF

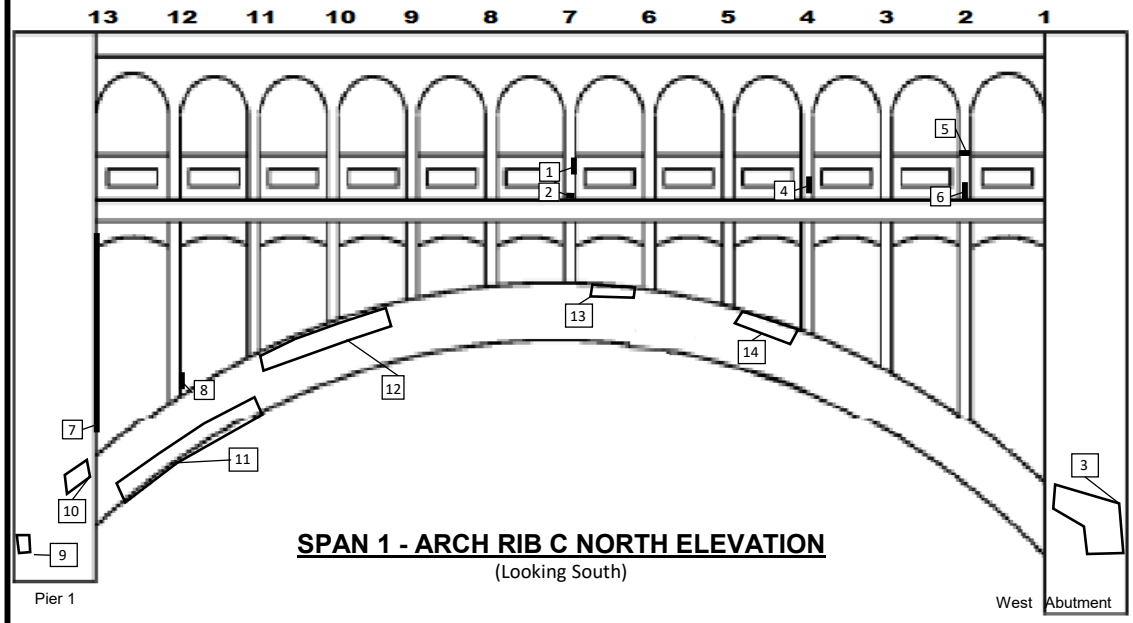
SPAN 1 - ARCH RIB C NORTH ELEVATION DEFICIENCIES	
#	Defect
1	**Delamination/Spall - 2 SF**
2	Delamination - 1 SF
3	Delamination - 6' L x 2' H
4	Delamination - 3 SF
5	Delamination - 4 SF
6	Delamination - 4 SF
7	Delamination - 20 SF
8	Delamination - 2 SF
9	Delamination - 3' L x 3' H
10	Delamination - 5' L x 1' H
11	Delamination - 14' L x 1' H
12	Delamination - 20' L x 1' H
13	Delamination - 4' L x 0.5' H
14	Delamination - 6' L x FW on top.

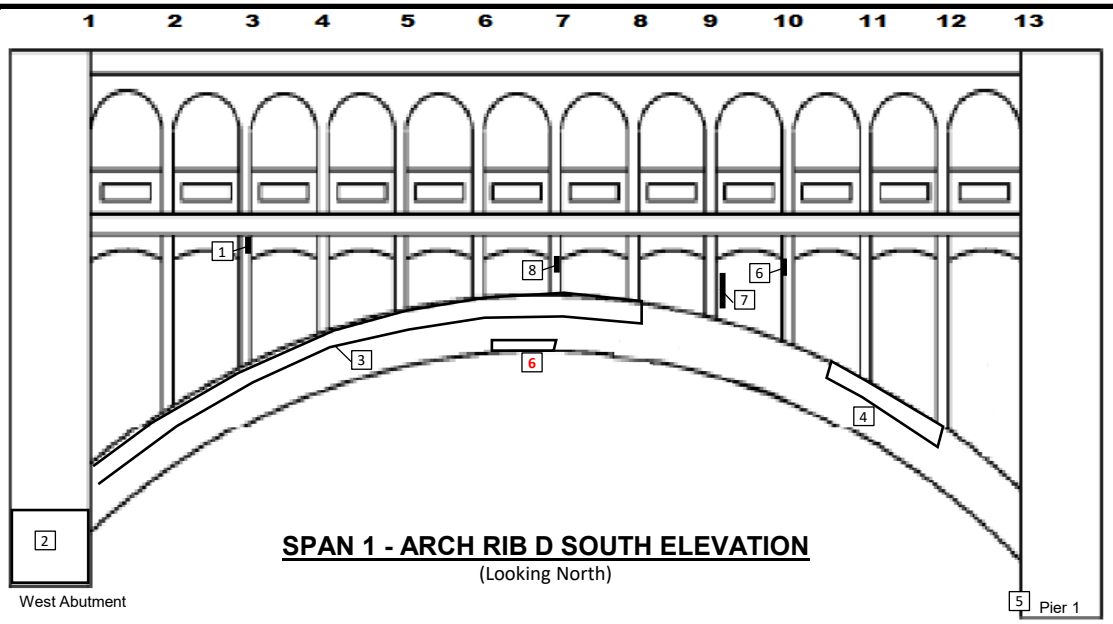
SPAN 1 - ARCH RIB D SOUTH ELEVATION DEFICIENCIES	
#	Defect
1	Delamination - 3 SF
2	Spall, 3" D @ base of abutment - 48 SF
3	Delamination - 80' L x 1' H
4	Delamination - 15' L x 1' H
5	Slope inclinometer 15' from pier column
6	**Map cracking - 4' L x 2' H**

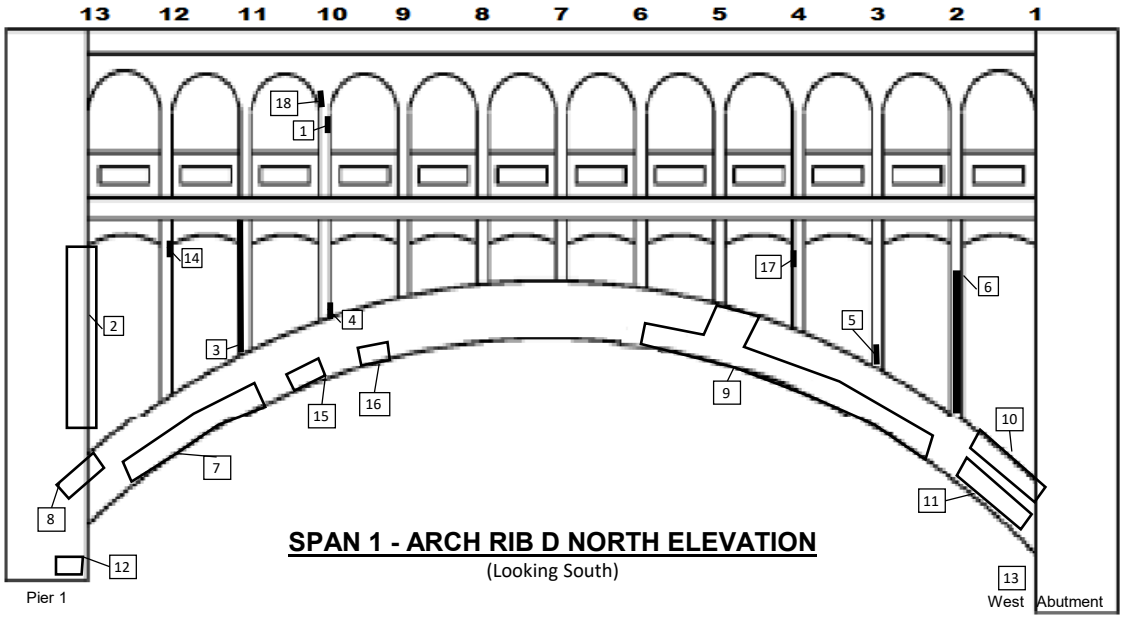
SPAN 1 - ARCH RIB D NORTH ELEVATION DEFICIENCIES	
#	Defect
1	Delamination - 1 SF
2	Delamination - 40 SF
3	Delamination - 8 SF
4	Delamination - 5 SF
5	Delamination - 1 SF
6	Delamination - 8 SF
7	Delamination w/ map cracking - 15' L x 1' H
8	Delamination - 4' L x 1' H
9	Delamination w/ map cracking - 30' L (80 SF)
10	Delamination w/ map cracking - 12' L x 2' H
11	Delamination - 8' L x 1' H
12	Delamination - 8 SF
13	Downspout and scupper 100% clogged
14	Delamination - 2 SF
15	Delamination - 4' L x 1' H
16	Delamination - 5' L x 1' H
17	Delamination - 2 SF
18	Spall, 2" deep, with exposed reinf.

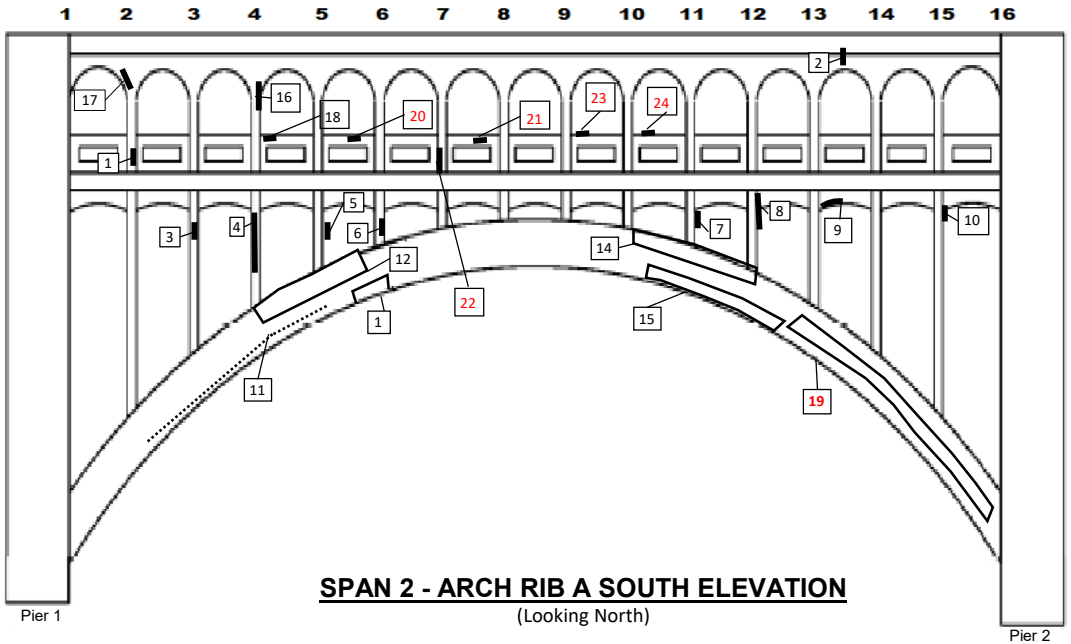
SPAN 2 - ARCH RIB A SOUTH ELEVATION
(Looking North)

SPAN 2 - ARCH RIB A SOUTH ELEV. DEFICIENCIES		
#	Defect	
1	Delamination - 3 SF	**20 | Delam - 4 SF**
2	Delamination - 5 SF	**21 | Spall w/exp.Reinf. 8 SF**
3	Spall w/ exp. Reinf. - 6 SF	
4	Spall w/ exp. Reinf. - 14 SF	
5	Delamination - 2 SF	**22 | Delam 1 SF**
6	Delamination - 6 SF	**23 | Spall - 2 SF**
7	Delamination - 1 SF	**24 | Spall - 3 SF**
8	Delam w/ Spall w/ exp. Reinf. - 8 SF	
9	Delamination w/ Spall w/ exp. Reinf. - 12 SF	
10	Delamination - 3 SF	
11	Up to 1/8" W crack, 25' L	
12	Delamination - 12' L x 1' W	
13	Delamination - 6' L x 1' W	
14	Delamination w/ Map Cracking - 15' L x 1' W	
15	Delamination w/ Map Cracking - 14' L x 2' H	
16	Delamination - 6 SF	
17	Spall w/ exp. Reinf - 1' L	
18	Spall w/ exp. Reinf. - 3 SF	
19	**Close Cracks ~1' Spa. - 20' L x 1' H**

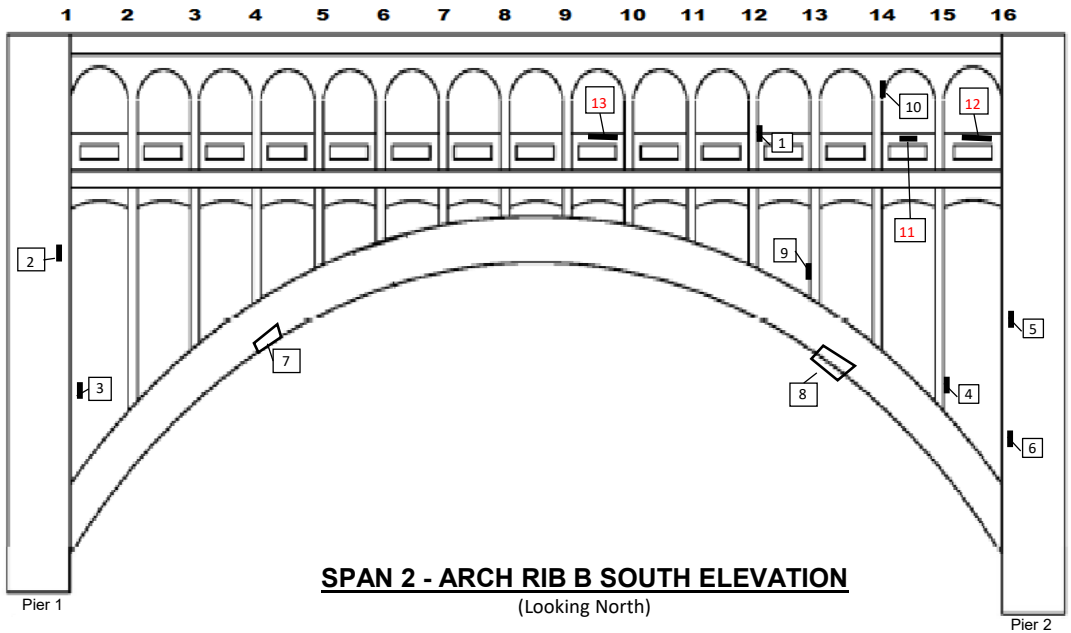
SPAN 2 - ARCH RIB B SOUTH ELEVATION
(Looking North)

SPAN 2 - ARCH RIB B SOUTH ELEV. DEFICIENCIES	
#	Defect
1	Spall, 1.5" D - 1 SF
2	Delamination - 6 SF
3	Delamination - 4 SF
4	Delamination - 2 SF
5	Delamination - 14 SF
6	Delamination - 2 SF
7	Spall w/ exp. Reinf. - 2 SF
8	Delamination - 8 SF
9	Spall w/ exp. Reinf. - 2 SF
10	Delamination - 1 SF
11	**Delamination - 2 SF**
12	**Spall - 1 SF**
13	**Delamination - 5 SF**

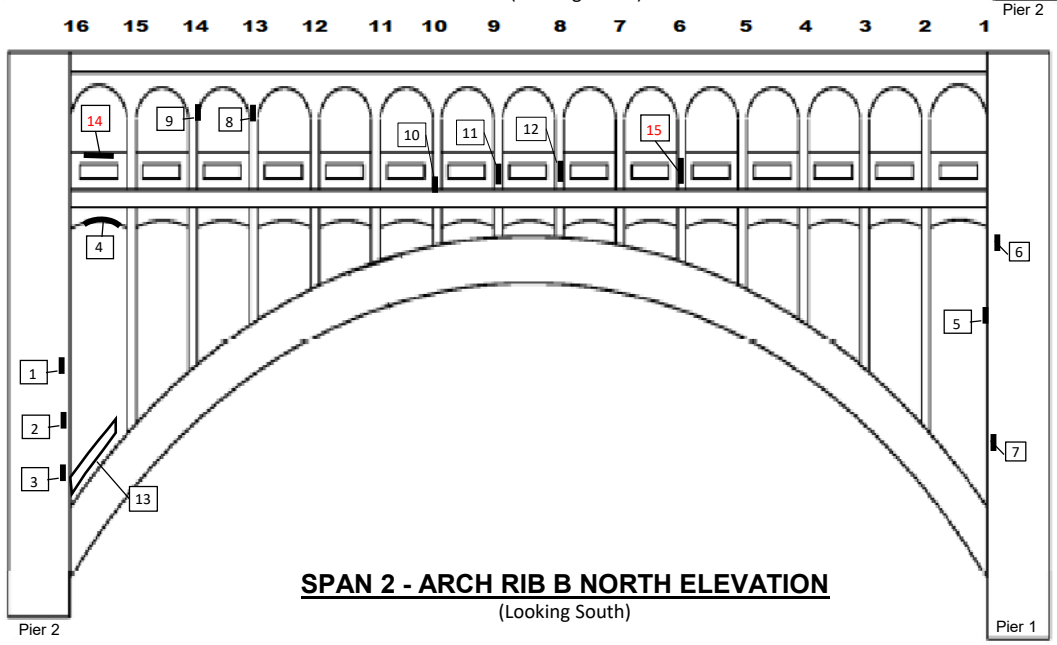
SPAN 2 - ARCH RIB B NORTH ELEVATION
(Looking South)

SPAN 2 - ARCH RIB B NORTH ELEV. DEFICIENCIES		
#	Defect	
1	Delamination - 4 SF	
2	Spall w/ exp. Reinf. - 4 SF	
3	Delamination - 12 SF	
4	Delamination - 2 SF	
5	Spall w/ exp. Reinf. - 5 SF	
6	Delamination - 6 SF	
7	Delamination - 3 SF	
8	Spall w/ exp. Reinf. - 1 SF	
9	Delamination - 6 SF	
10	Spall w/ exp. Reinf. - 1 SF	
11	Spall w/ exp. Reinf., 2" D - 1 SF	
12	Delamination - 1 SF	
13	Map cracking - 6' L x 1' H	
14	**Delamination - 4 SF**	**15 Delamination - 1 SF**

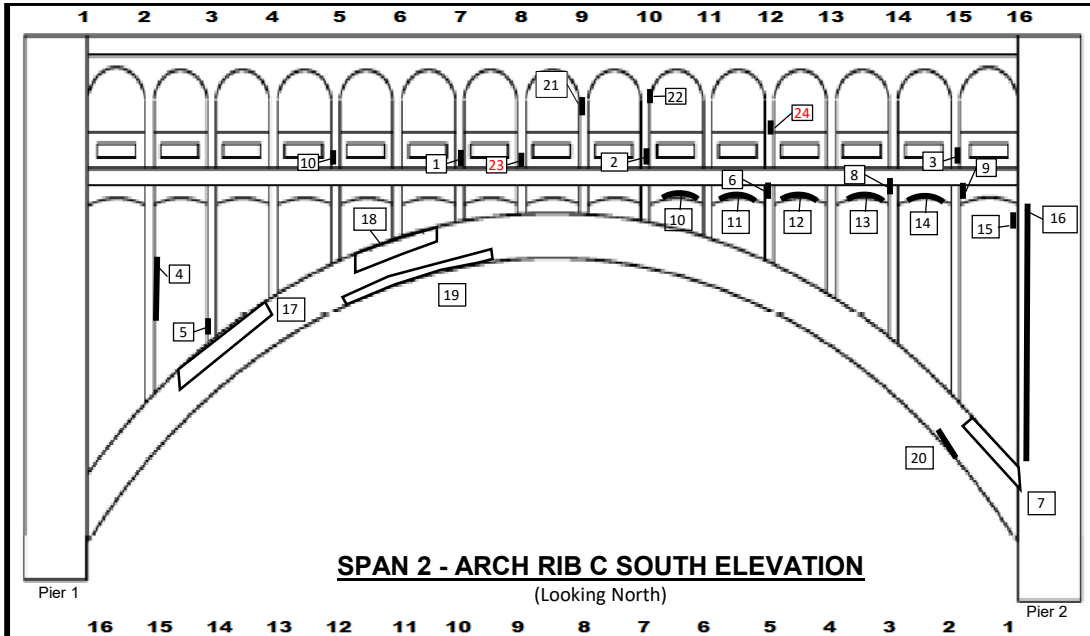
SPAN 2 - ARCH RIB C SOUTH ELEVATION
(Looking North)

SPAN 2 - ARCH RIB C SOUTH ELEV. DEFICIENCIES		
#	Defect	
1	Delamination - 4 SF	
2	Delam. w/ Spall w/ exp. Reinf. - 2 SF	
3	Delam. w/ edge spalls - 6 SF	
4	Delamination - 8 SF	
5	Delamination - 1 SF	
6	Spall w/ exp. Reinf. - 2 SF	
7	Delamination - 6 SF	
8	Delamination - 4 SF	
9	Delamination - 3 SF	
10	Delam. w/ Spall w/ exp. Reinf. - 2 SF	
11	Delamination - 3 SF	
12	Delamination (underside) - 5 SF	
13	Delamination - 2 SF	
14	Delamination - 4 SF	
15	Delamination - 5 SF	
16	Delamination - 30 SF	
17	Delamination - 15' L x 1' W	
18	Delamination - 14' L x 1' W	
19	Delamination w/ 1/8" W crack - 15' L x 1' W	
20	Delamination (underside of arch) - 2' L x 2' W	
21	Spall - 1 SF	
22	Cracking (corner of corbel)	
23	**Spall - 1 SF**	**24 | Spall - 2 SF**

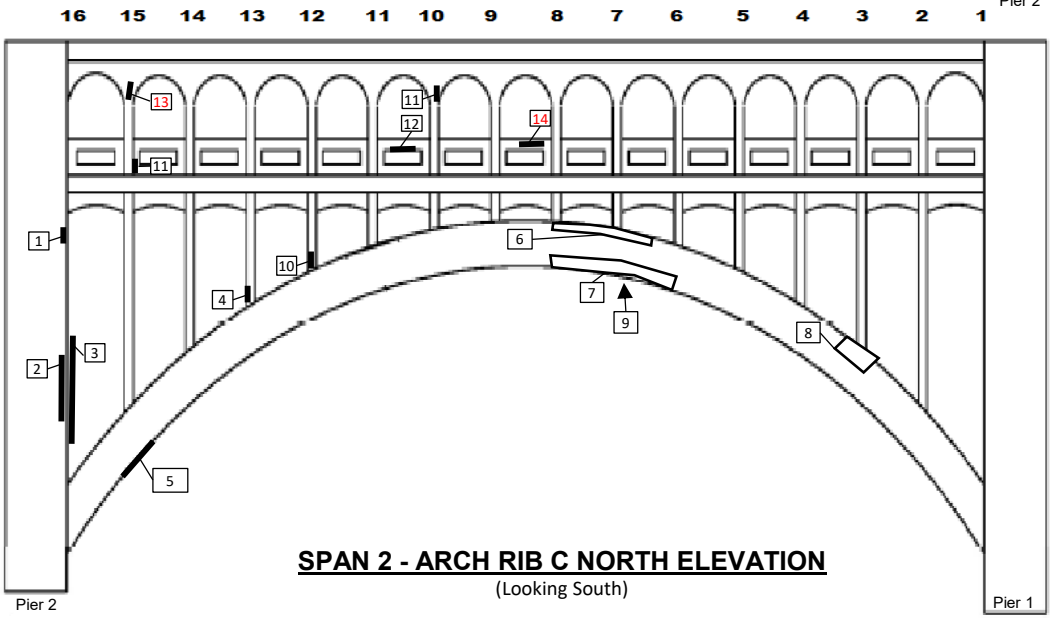
SPAN 2 - ARCH RIB C NORTH ELEVATION
(Looking South)

SPAN 2 - ARCH RIB C NORTH ELEV. DEFICIENCIES		
#	Defect	
1	Delamination - 12 SF	**13 | Spall - 1 SF**
2	Delamination - 20 SF	**14 | Delamination - 2 SF**
3	Delamination - 35 SF	
4	Spall w/ exp. Reinf. - 2 SF	
5	Delamination (underside of arch) - 4' L x 1' W	
6	Delamination - 10' L x 1' W	
7	Delamination - 6' L x 1' W	
8	Delamination - 4' L x 1' W	
9	Delamination (underside of arch) - 5' L x 1' W	
10	Spall w/ exp. Reinf. - 1 SF	
11	Spall/delam - 2 SF	
12	Spall - 5 LF
