2025 PHYSICAL CONDITION ROUTINE ELEMENT LEVEL INSPECTION REPORT

Bridge CUY-6-1456
SFN 1800930

Detroit-Superior/Veteran's Memorial over Cuyahoga River
Dates of Inspection: October 6-10, 2025

ODOT DISTRICT 12
5500 TRANSPORTATION BOULEVARD
GARFIELD HEIGHTS, OHIO 44125
DECEMBER 30, 2025

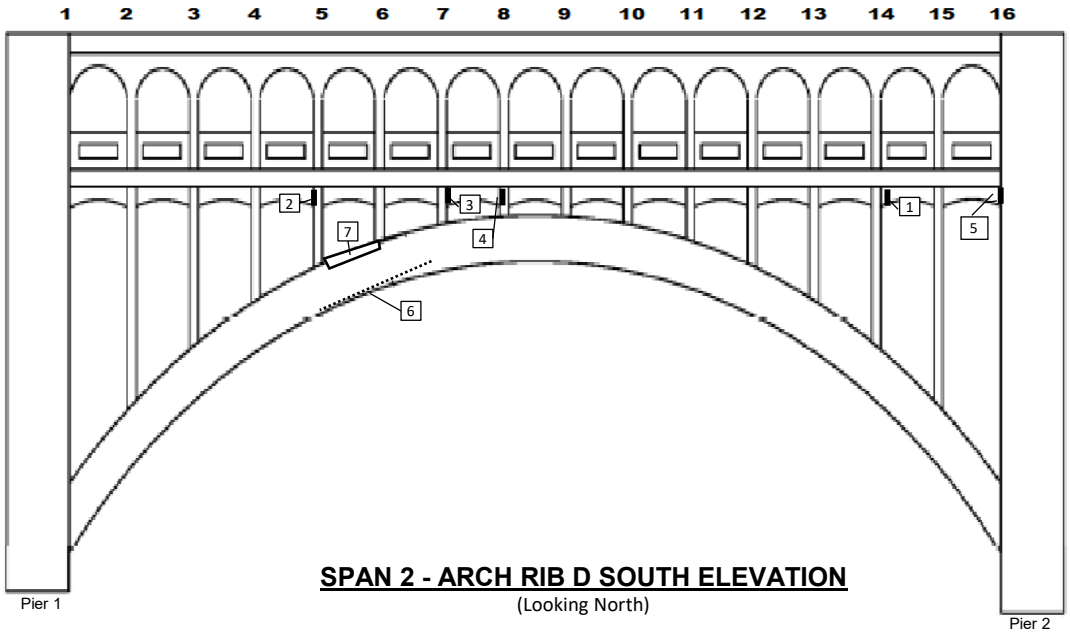
SPAN 2 - ARCH RIB D SOUTH ELEVATION
(Looking North)

SPAN 2 - ARCH RIB D SOUTH ELEVATION DEFICIENCIES	
#	Defect
1	Spall w/ exp. Reinf. - 1 SF
2	Delam. w/ Spall w/ exp. Reinf. - 2 SF
3	Delamination - 1 SF
4	Delamination - 1 SF
5	Delamination w/ Spall w/ exp. Reinf. - 9 SF
6	1/16" W Crack - 15 LF
7	Delamination - 5' L x 1' W

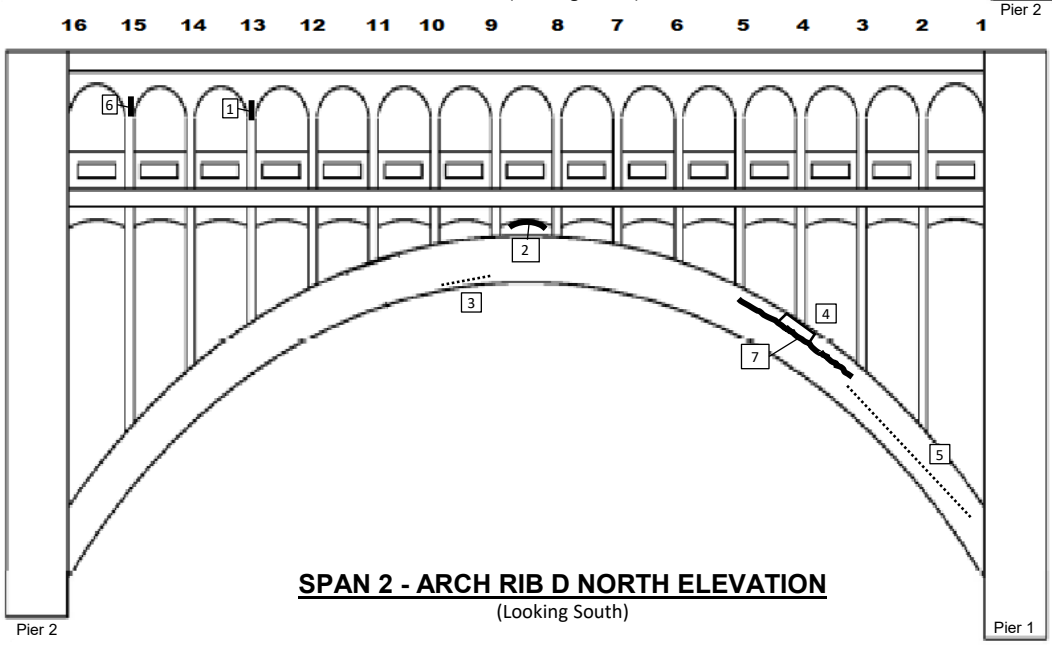
SPAN 2 - ARCH RIB D NORTH ELEVATION
(Looking South)

SPAN 2 - ARCH RIB D NORTH ELEVATION DEFICIENCIES	
#	Defect
1	Spall w/ exp. Reinf., 6" D - 1 SF
2	Delamination - 6 SF
3	1/16" W Crack - 6 LF
4	Delamination - 3' L x 1' W
5	1/16" W Crack - 25 LF
6	Delamination - 2 SF
7	Delamination - 30 SF

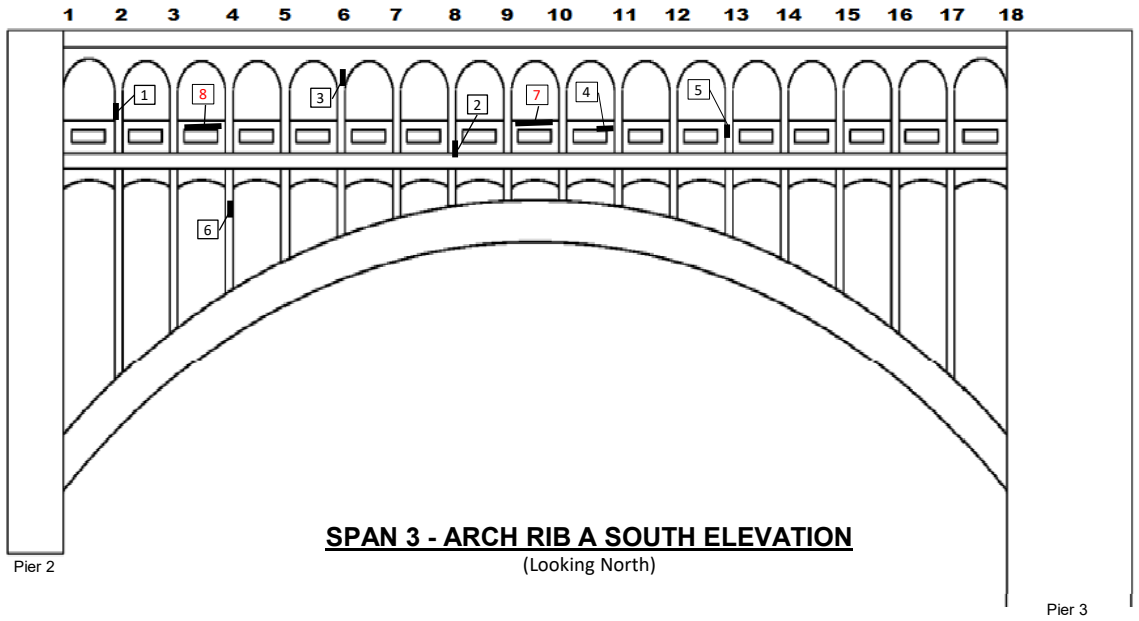
SPAN 3 - ARCH RIB A SOUTH ELEVATION
(Looking North)

SPAN 3 - ARCH RIB A SOUTH ELEVATION DEFICIENCIES	
#	Defect
1	Delamination - 2 SF
2	Delamination w/ exp. Reinf. - 6 SF
3	Delamination - 4 SF
4	Spall w/ exp. Reinf. - 4 LF
5	Spall - 2 SF
6	Crack - 4 LF
7	**Spall / Delamination - 7 SF**
8	**Spall w/ exp. Reinf. - 7 LF**

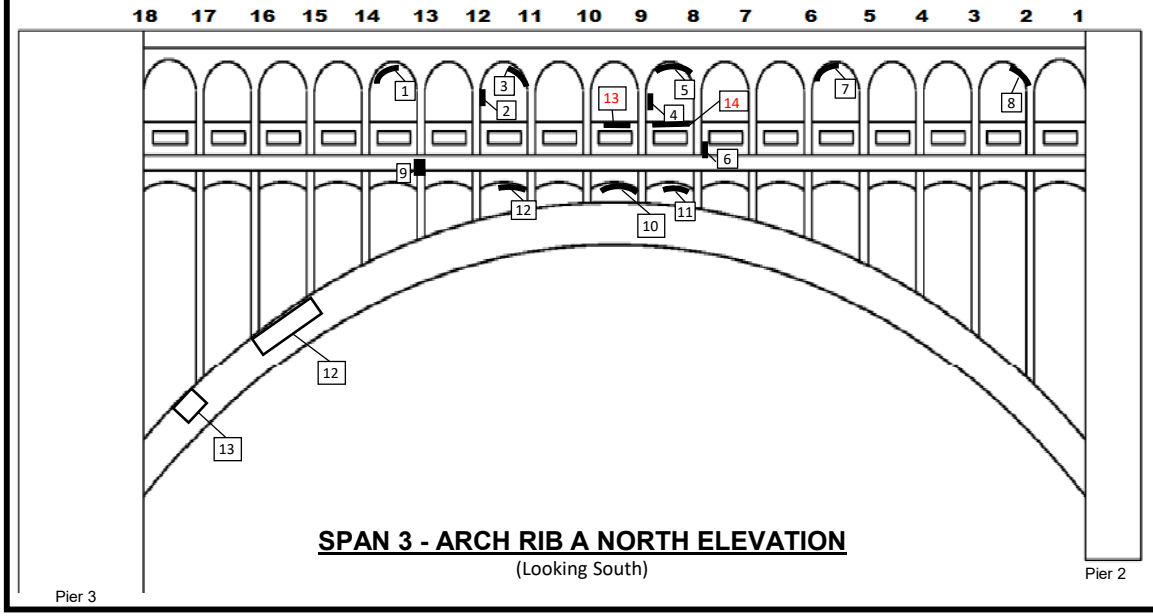
SPAN 3 - ARCH RIB A NORTH ELEVATION
(Looking South)

SPAN 3 - ARCH RIB A NORTH ELEVATION DEFICIENCIES		
#	Defect	
1	Delamination - 2 SF	
2	Delamination - 6 SF	
3	Delamination - 2 SF	
4	Delamination - 2 SF	
5	Delamination - 8 SF	
6	Delamination - 2 SF	
7	Delamination - 8 SF	
8	Delamination - 1 SF	
9	Broken lighting fixture	
10	Delamination - 4 SF	
11	Delamination - 4 SF	
12	Delamination - 2 SF	
12	**Map cracking - 6' L x 3' H**	
13	**Map cracking - 4' L x 4' H**	
14	**Spall w/ Exp. Rei - 7 SF**	**15 | Spall w/exp. - 6 SF**

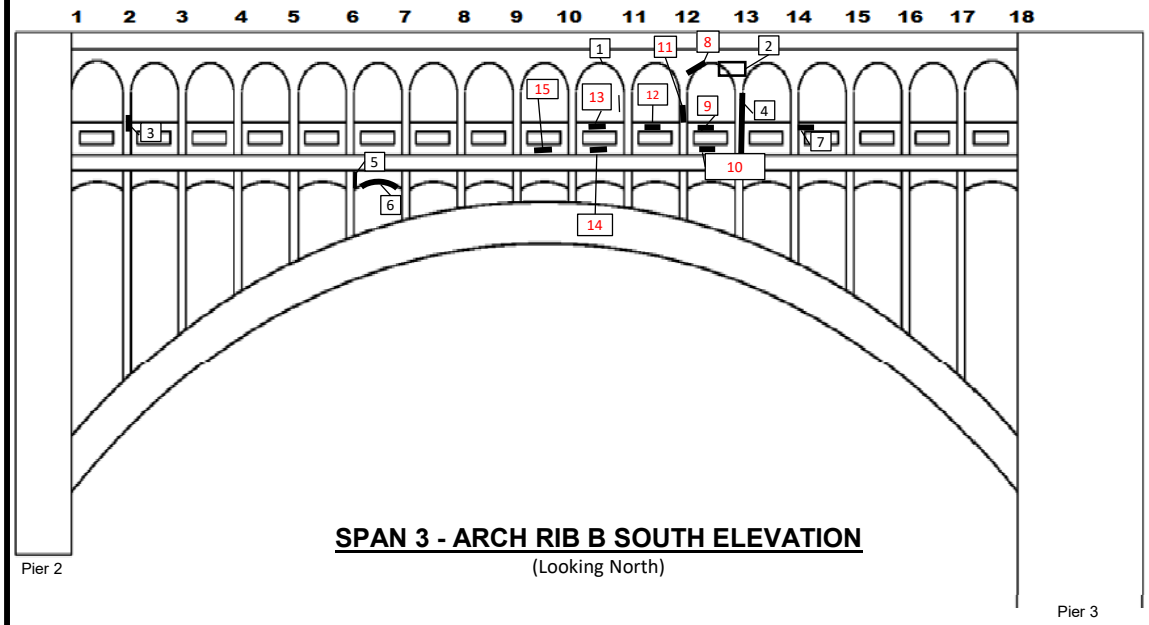
SPAN 3 - ARCH RIB B SOUTH ELEVATION
(Looking North)

SPAN 3 - ARCH RIB B SOUTH ELEVATION DEFICIENCIES		
#	Defect	
1	Jack arch is cracked w/efflorescence	
2	Delamination - 6 SF	
3	Delamination - 3 SF	
4	Delamination - 10 SF	
5	Spall - 1 SF	
6	Delamination - 2 SF	
7	Delamination - 3 SF	
8	**Delamination - 12 SF**	
9	**Delamination - 4 SF**	
10	**Spall - 1 SF**	
11	**Delamination - 3 SF**	
12	**Delamination - 2 SF**	**14 | Delam. - 3 SF**
13	**Delamination - 10 SF**	**15 | Spall w. exp. - 2 SF**

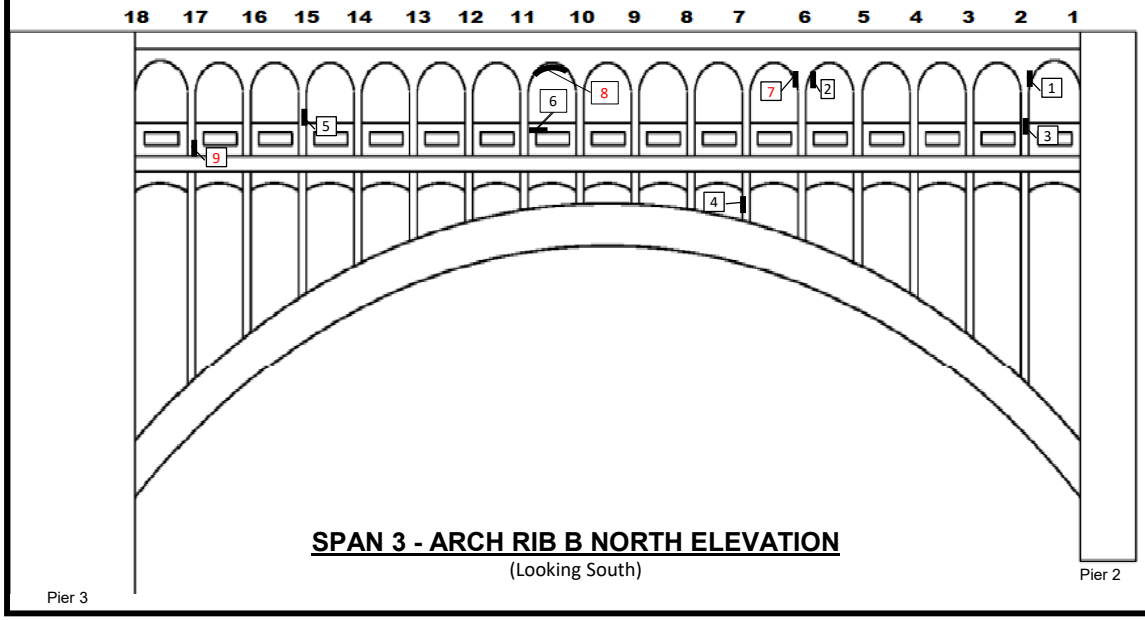
SPAN 3 - ARCH RIB B NORTH ELEVATION
(Looking South)

SPAN 3 - ARCH RIB B NORTH ELEVATION DEFICIENCIES	
#	Defect
1	Delamination - 1 SF
2	Delamination - 1 SF
3	Spall, 2" D - 1 SF
4	Delamination - 2 SF
5	Delamination - 2 SF
6	Spall w/ exp. Reinf. - 1 SF
7	**Spall - 1 SF**
8	**Delamination - 5 SF**
9	**Spall - 1 SF**

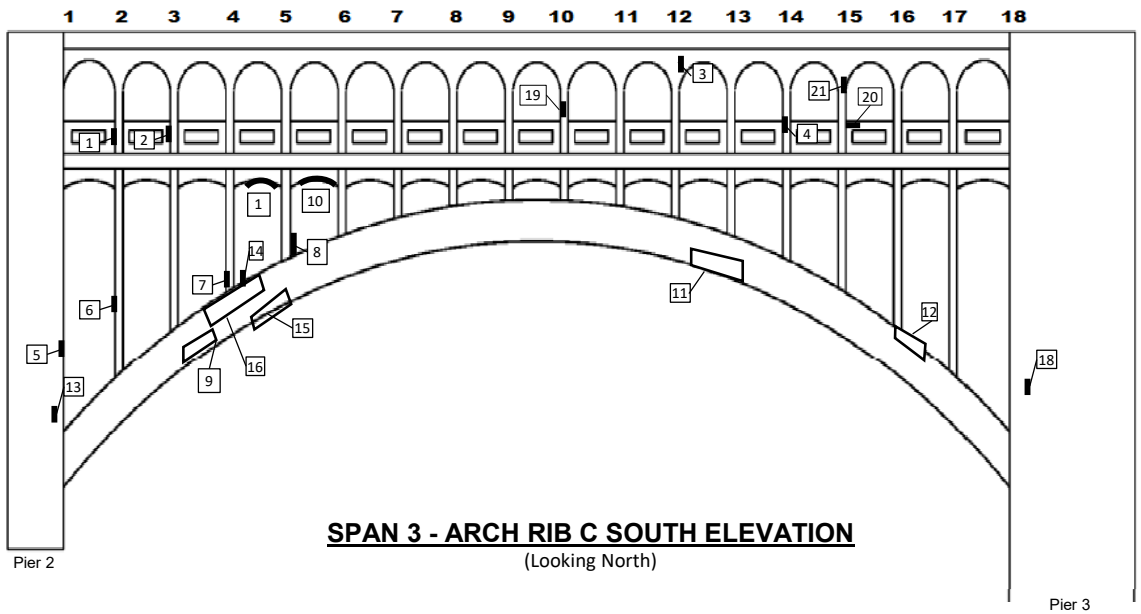
SPAN 3 - ARCH RIB C SOUTH ELEVATION
(Looking North)

SPAN 3 - ARCH RIB C SOUTH ELEVATION DEFICIENCIES	
#	Defect
1	Delam. w/ Spall, 3" D - 2 SF
2	Delamination - 4 SF
3	Spall w/ exp. Reinf., 3" D - 2 SF
4	Spall, 2.5" D - 1 SF
5	Delamination - 2 SF
6	Delamination - 4 SF
7	Delamination - 2 SF
8	Delamination - 2 SF
9	Delamination - 4' L x 1' W
10	Delamination - 4 SF
11	Delamination - 10' L x 1' W
12	Delamination - 4 SF
13	Delamination - 2 SF
14	Delamination - 1 SF
15	Delamination - 4' L x 1'W
16	Delamination - 10' L x 1'W
17	Delamination - 2 SF
18	Delamination - 2 SF
19	Spall w/ exp. Reinf., 2" D - 1 SF
20	Spall, 3" D - 1 SF
21	Cracking (corbel) - 1 SF

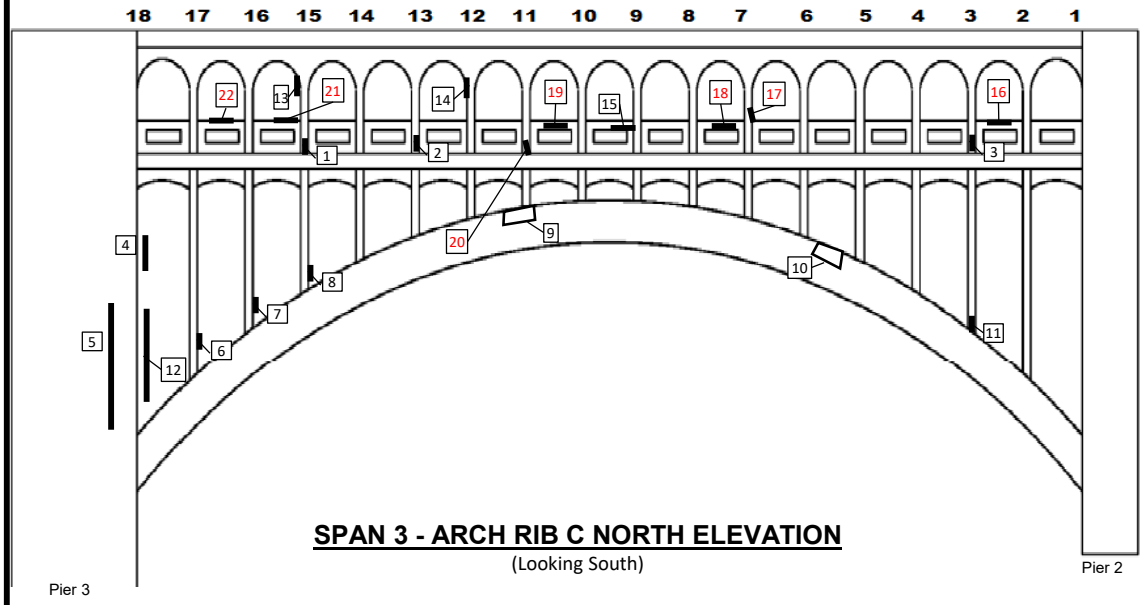
SPAN 3 - ARCH RIB C NORTH ELEVATION
(Looking South)

SPAN 3 - ARCH RIB C NORTH ELEVATION DEFICIENCIES		
#	Defect	
1	Delamination - 2 SF	**16 | Delam. - 7 SF**
2	Delamination - 3 SF	**17 | Spall - 2 SF**
3	Delamination - 3 SF	**18 | Delam. - 2 SF**
4	Corner delamination - 5 SF	**19 | Delam. - 2 SF**
5	Corner delamination - 20 SF	**20 | Delam. - 3 SF**
6	Delamination - 2 SF	**21 | Delam. - 3 SF**
7	Delamination - 1 SF	**22 | Delam. - 2 SF**
8	Delamination - 1 SF	
9	Spall w/ exp. Reinf. - 2 SF	
10	Delamination - 1 SF	
11	Delamination - 2 SF	
12	Corner delamination - 15 SF	
13	Delamination, cracking around corbel - 2 SF	
14	Delamination - 1 SF	
15	Delam./Cracking - 3 LF

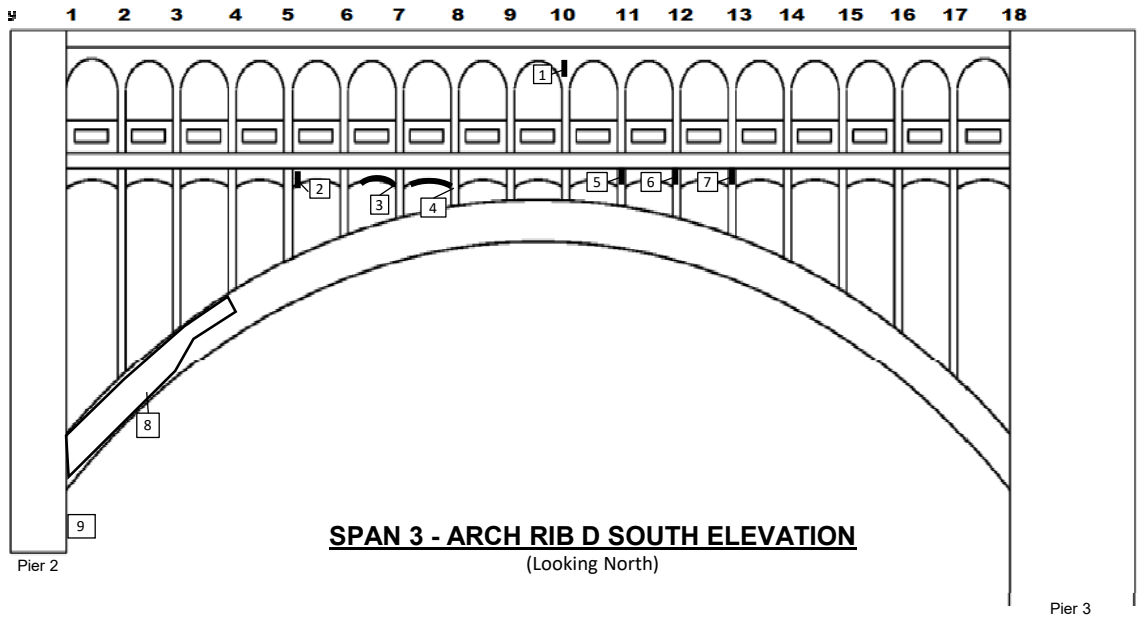
SPAN 3 - ARCH RIB D SOUTH ELEVATION
(Looking North)

SPAN 3 - ARCH RIB D SOUTH ELEVATION DEFICIENCIES	
#	Defect
1	Delamination - 3 SF
2	Delamination - 3 SF
3	Spall w/ exp. Reinf. - 8 SF
4	Delam. w/ Spall - 16 SF
5	Delamination - 4 SF
6	Delamination - 4 SF
7	Delamination - 6 SF
8	Delamination - 30' L x Var. H. (132 SF total)
9	10" diameter tree growing against bottomside of arch

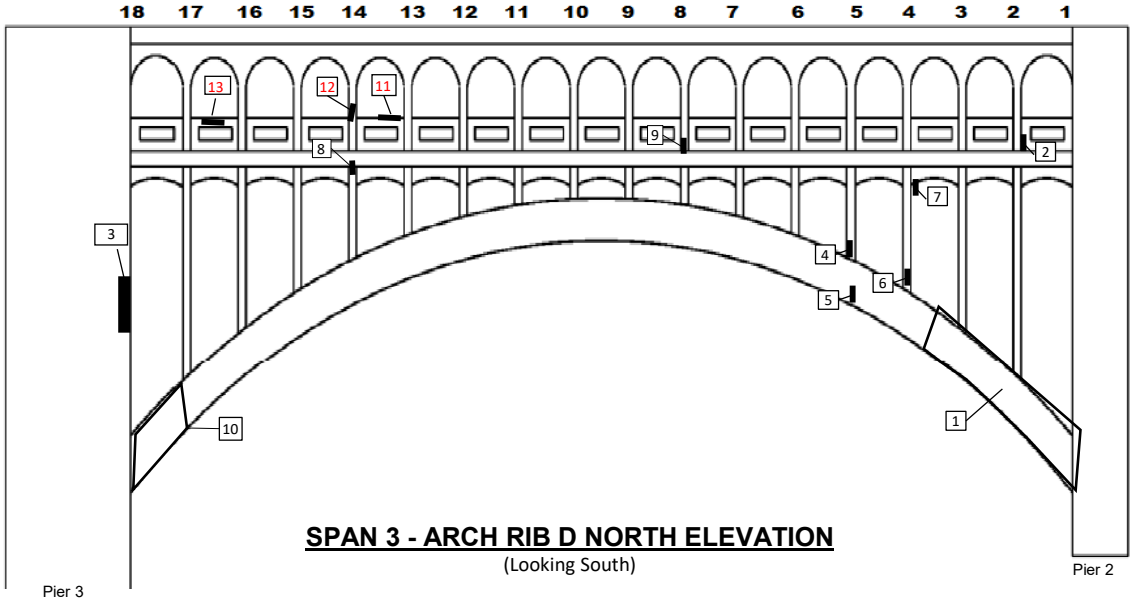
SPAN 3 - ARCH RIB D NORTH ELEVATION
(Looking South)

SPAN 3 - ARCH RIB D NORTH ELEVATION DEFICIENCIES	
#	Defect
1	Map Cracking w/ moisture staining and some delamination - 24' L
2	Delamination - 2 SF
3	Delamination - 5 SF
4	Delamination - 2 SF
5	Spall w/ exp. Reinf., 2" D - 3' L x 1' W
6	Delamination - 2 SF
7	Delamination - 6 SF
8	Spall w/ exp. Reinf. - 1 SF
9	Spall, 1" D - 1 SF
10	Map cracks - 5' L x 5' H
11	**Spall w/ exp. Reinf. - 8 SF**
12	**Spall w/ exp. Reinf. - 3 SF**
13	**Spall w/ exp. Reinf. - 10 SF**

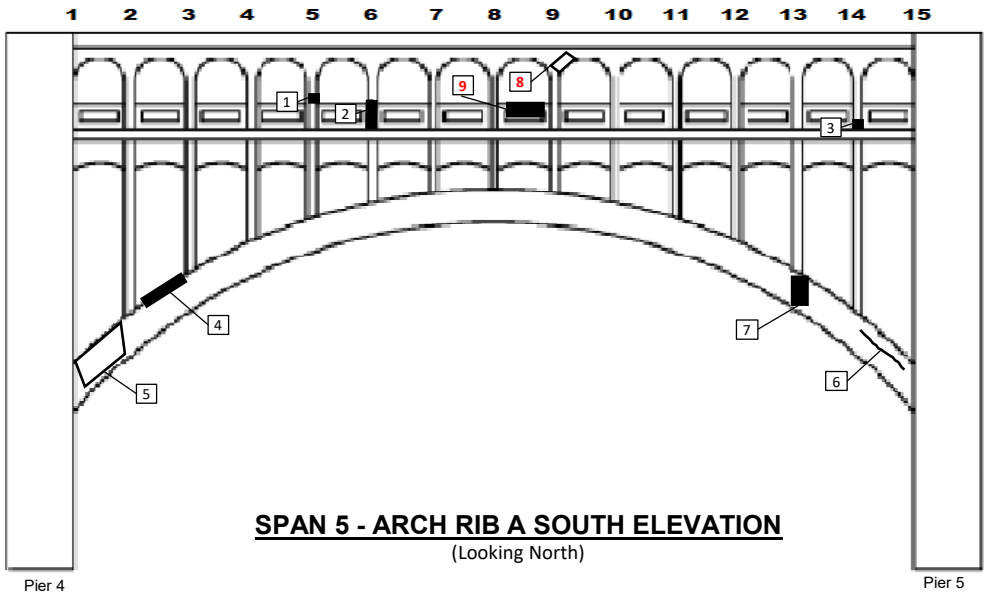
SPAN 5 - ARCH RIB A SOUTH ELEVATION
(Looking North)

SPAN 5 - ARCH RIB A SOUTH ELEVATION DEFICIENCIES	
#	Defect
1	Delamination - 1 SF
2	Delamination - 1 SF
3	Delamination - 2 SF
4	1/32" Crack on top of arch - 8 LF
5	Map cracking - 5' L x 2' H
6	Crack - 5 LF
7	Spall - 6 SF
8	**Delamination - 6 SF**

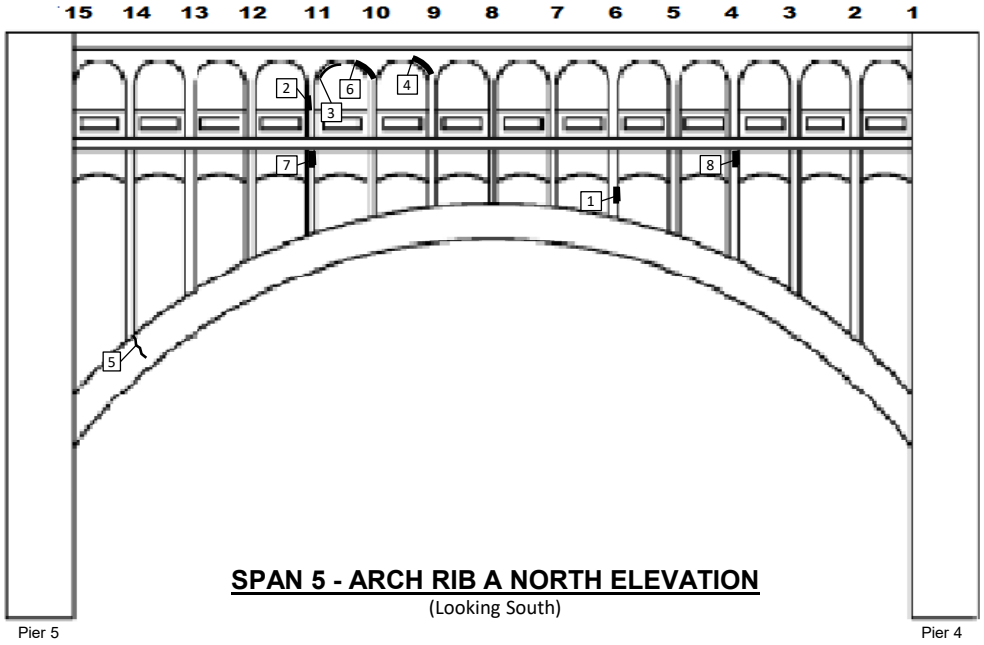
SPAN 5 - ARCH RIB A NORTH ELEVATION
(Looking South)

SPAN 5 - ARCH RIB A NORTH ELEVATION DEFICIENCIES	
#	Defect
1	Delamination - 1 SF
2	Spall w/ exp. Reinf. - 1 SF
3	Delamination - 3 SF
4	Delamination - 2 SF
5	Hairline crack - 2 LF
6	Delamination - 1 SF
7	Delamination - 1 SF
8	Delamination - 1 SF

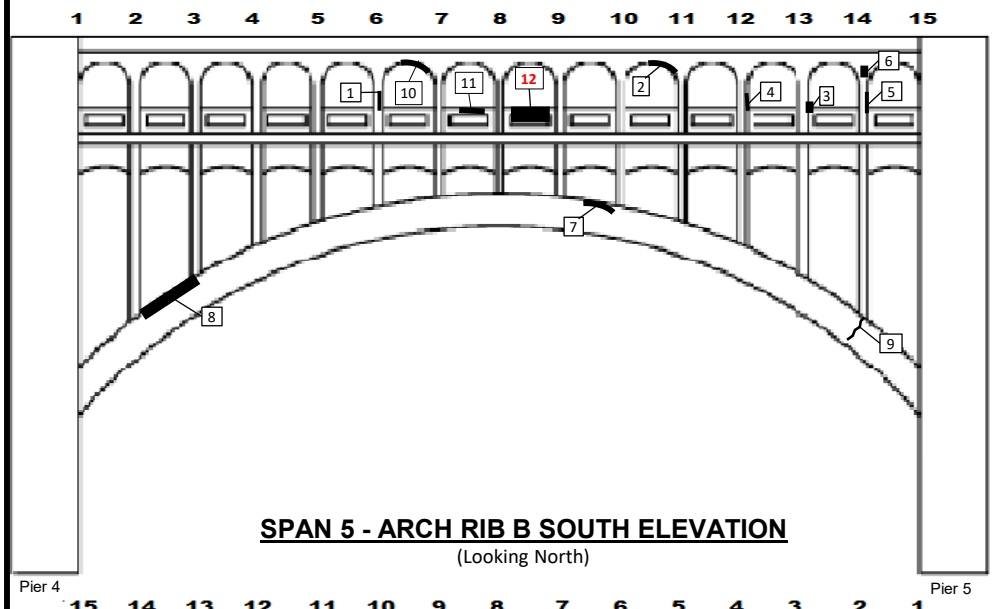
SPAN 5 - ARCH RIB B SOUTH ELEVATION
(Looking North)

SPAN 5 - ARCH RIB B SOUTH ELEVATION DEFICIENCIES	
#	Defect
1	Spall, 3" D - 1 SF
2	Delamination - 2 SF
3	Delamination - 1 SF
4	Delamination - 2 SF
5	Spall w/ exp. Reinf., 2" D - 3 SF
6	Delamination - 2 SF
7	Delamination - 5' L x 2.5' W
8	Hairline crack on top of arch - 8 LF
9	Hairline crack - 2 LF
10	Spall w/ exp. Reinf. - 1 SF
11	Spall w/ exp. Reinf. - 2 SF
12	**Spall - 3 SF**

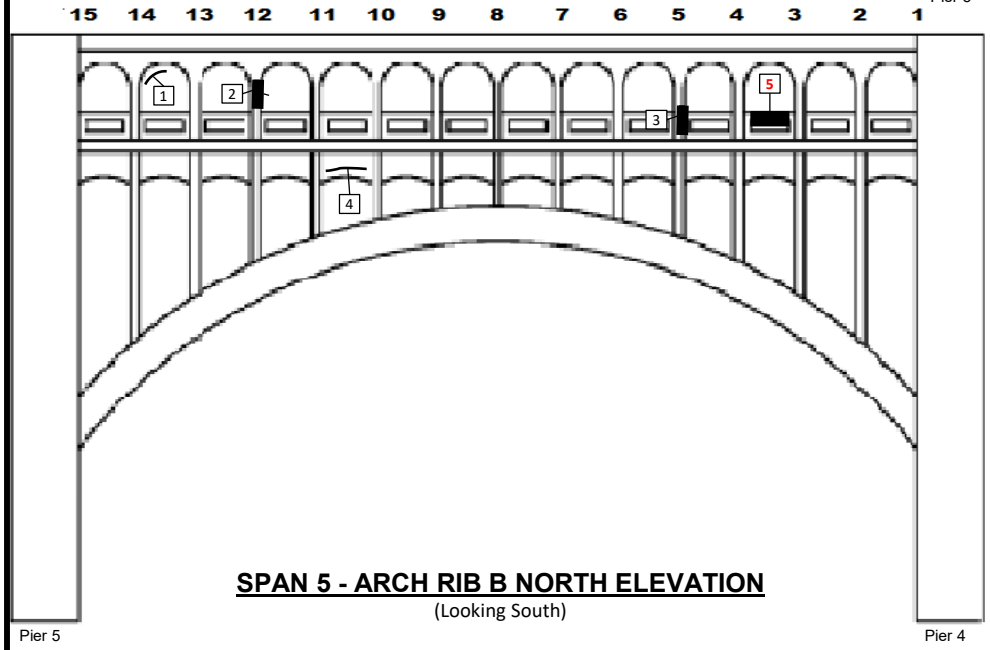
SPAN 5 - ARCH RIB B NORTH ELEVATION
(Looking South)

SPAN 5 - ARCH RIB B NORTH ELEVATION DEFICIENCIES	
#	Defect
1	Delamination - 3 SF
2	Spall w/ exp. Reinf. - 4 SF
3	Delamination - 3 SF
4	Crack - 5 LF

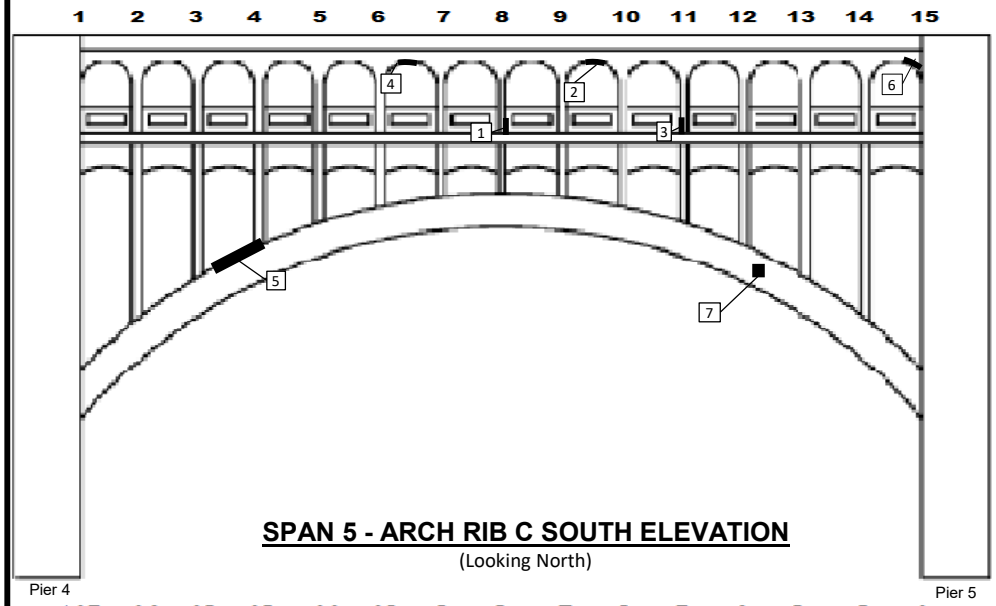
SPAN 5 - ARCH RIB C SOUTH ELEVATION
(Looking North)

SPAN 5 - ARCH RIB C SOUTH ELEVATION DEFICIENCIES	
#	Defect
1	Delamination w/ Spall w/ exp. Reinf. - 4 SF
2	Spall w/ exp. Reinf. - 1 SF
3	Delamination - 1 SF
4	Spall w/ exp. Reinf. - 1 SF
5	Delamination - 6' L x 1' H
6	Spall w/ exp. Reinf. - 1 SF
7	Spall - 1 SF

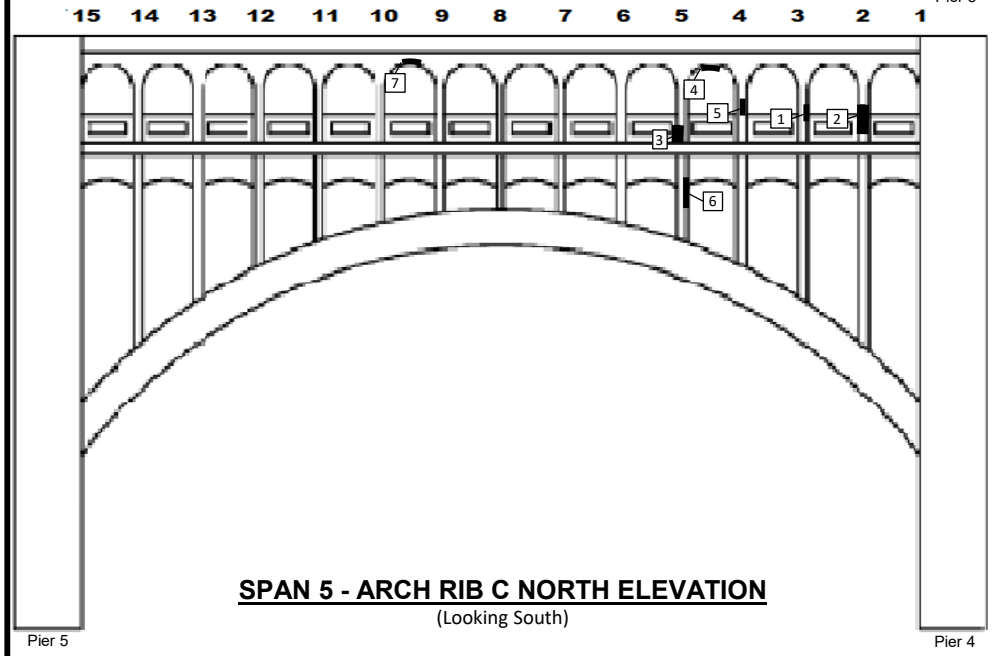
SPAN 5 - ARCH RIB C NORTH ELEVATION
(Looking South)

SPAN 5 - ARCH RIB C NORTH ELEVATION DEFICIENCIES	
#	Defect
1	Spall w/ exp. Reinf., 1" D - 2 SF
2	Spall w/ exp. Reinf., 1.5" D - 2 SF
3	Delamination - 2 SF
4	Delamination - 2 SF
5	Delamination - 2 SF
6	Two Spalls w/ exp. Reinf. - 1 SF total
7	Spall w/ exp. Reinf. - 2 SF

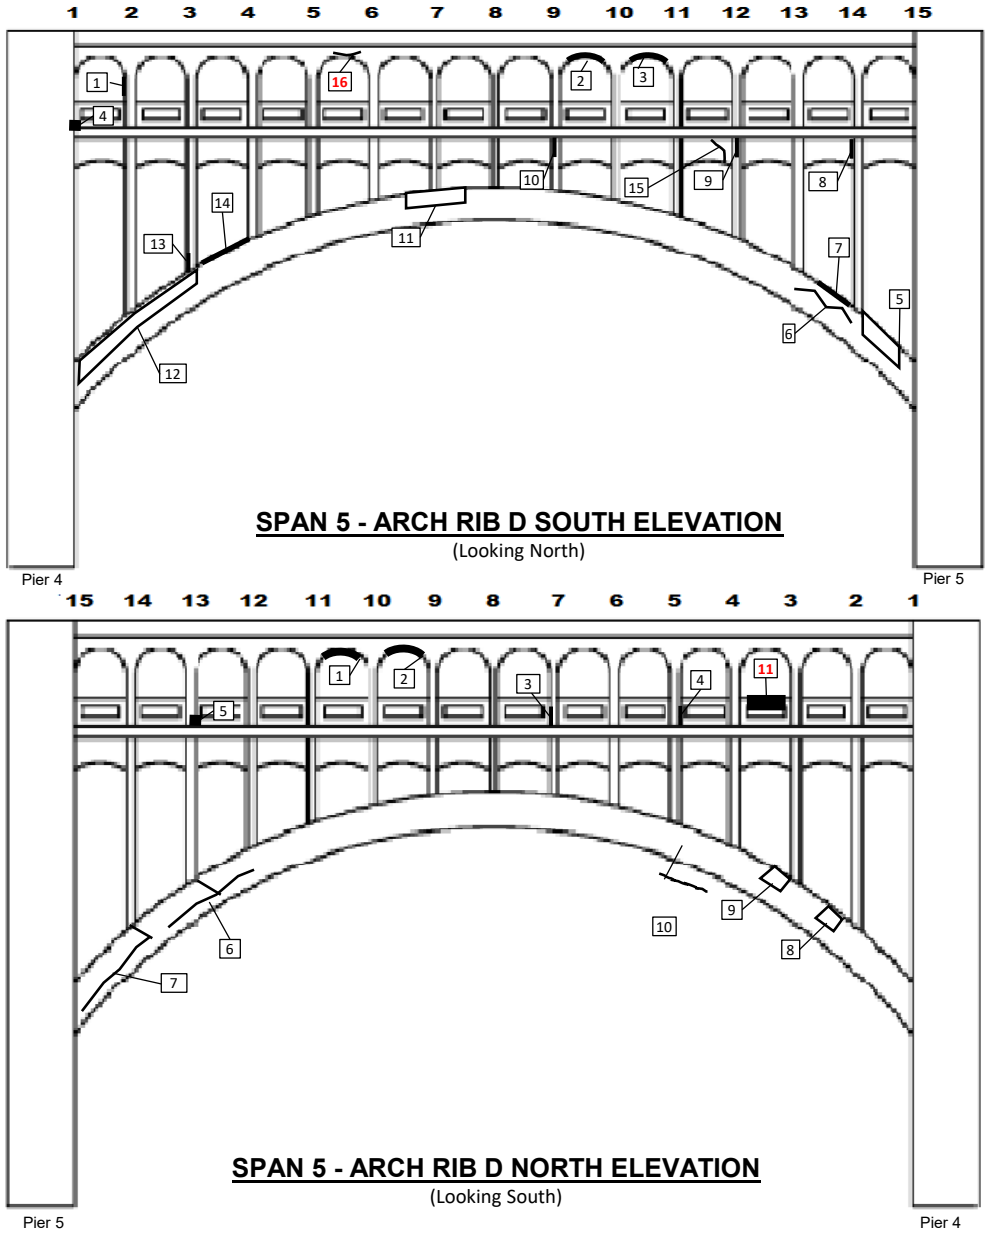
SPAN 5 - ARCH RIB D SOUTH ELEVATION DEFICIENCIES	
#	Defect
1	Delamination - 2 SF
2	Delamination - 2 SF
3	Delamination - 6 SF
4	Incomplete Repair - 3 SF
5	Map Cracking - 10' L x 3' H
6	1/16" Crack - 10 LF
7	Delamination - 8' L x 2' W
8	Delamination - 1 SF
9	Spalling - 3 SF
10	Delamination - 1 SF
11	Delamination - 6' L x 1' H
12	Vertical hairline cracking spa. @ 3' w/ some map cracking - 20 LF
13	Delamination - 2 SF
14	3/32" crack, appears to be partially filled - 8 LF
15	Cracking - 3 LF
16	**Cracking - 1 LF**

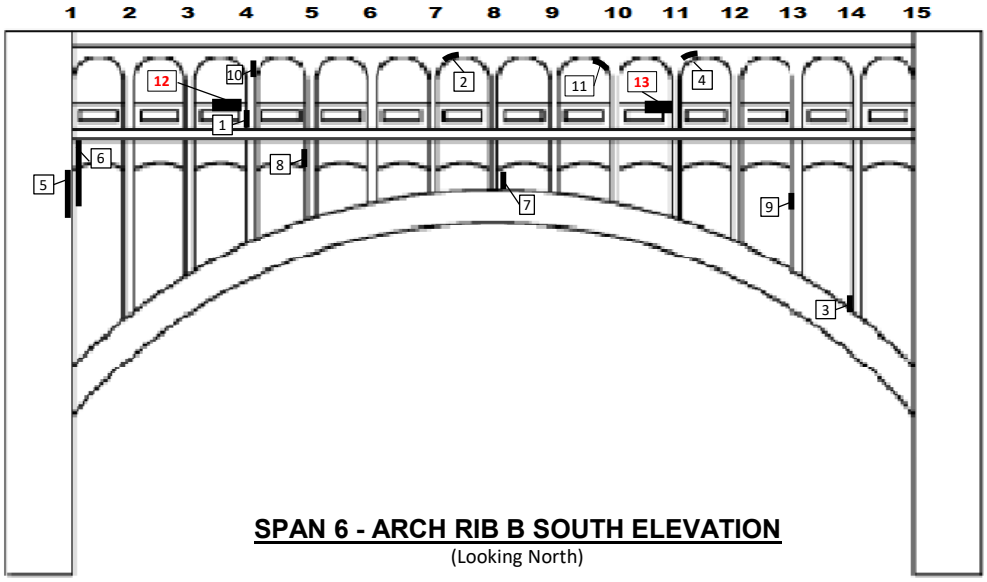
SPAN 6 - ARCH RIB B SOUTH ELEVATION
(Looking North)

SPAN 6 - ARCH RIB B SOUTH ELEVATION DEFICIENCIES	
#	Defect
1	Spall w/ exp. Reinf. - 2 SF
2	Delamination - 4 SF
3	Delamination - 1 SF
4	Spall w/ exp. Reinf., 4" D - 4 SF
5	Delamination - 16 SF
6	Delamination w/ Spall w/ exp. Reinf. - 20 SF
7	Delamination - 2 SF
8	Delamination - 4 SF
9	Spall w/ exp. Reinf. - 16 SF
10	Delamination - 3 SF
11	Spall w/ exp. Reinf. - 1 SF
12	**Delamination - 3 SF**
13	**Spall w/ exp. Reinf. - 4 SF**

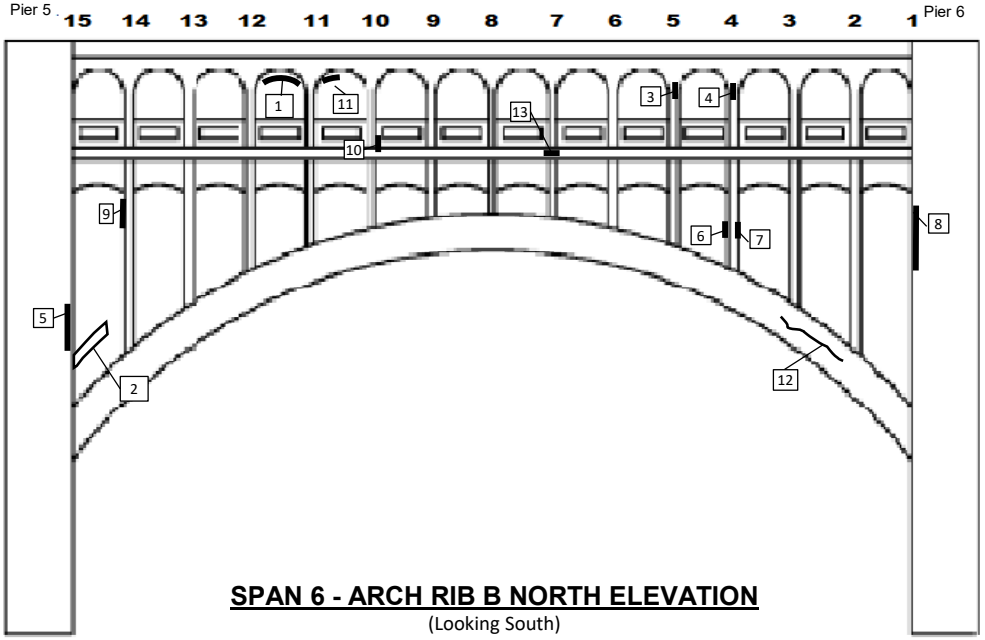
SPAN 6 - ARCH RIB B NORTH ELEVATION
(Looking South)

SPAN 6 - ARCH RIB B NORTH ELEVATION DEFICIENCIES	
#	Defect
1	Spall w/ exp. Reinf. - 24 SF
2	Map cracking - 8 SF
3	Delamination - 4 SF
4	Delamination - 2 SF
5	Delamination - 8 SF
6	Delamination - 1 SF
7	Delamination - 1 SF
8	Delamination - 8 SF
9	Spall w/ exp. Reinf. - 2 SF
10	Delamination - 1 SF
11	Delamination - 6 SF
12	Crack - 5 LF
13	Spall w/ exp. Reinf. - 3 SF

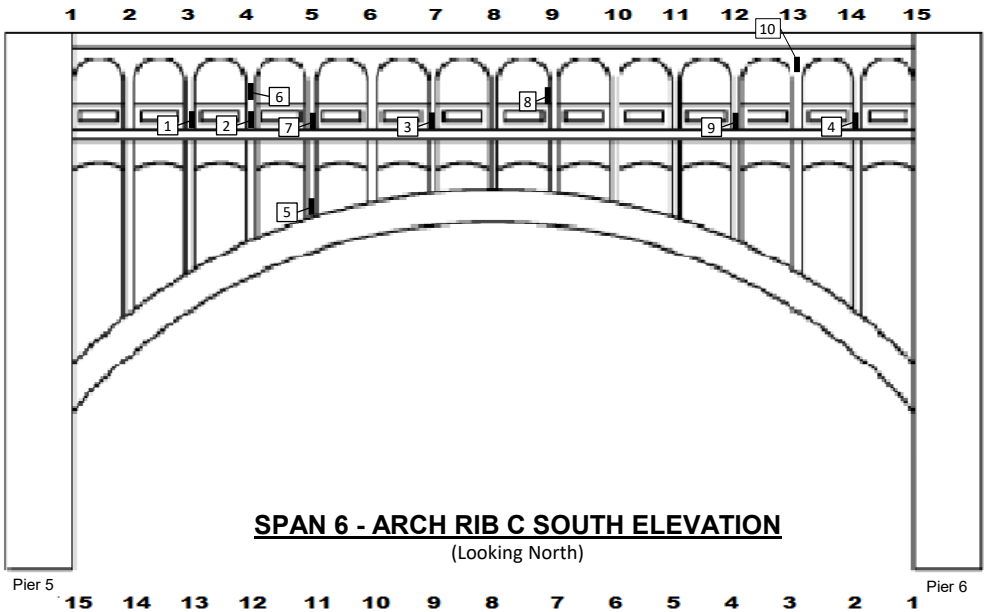
SPAN 6 - ARCH RIB C SOUTH ELEVATION
(Looking North)

SPAN 6 - ARCH RIB C SOUTH ELEVATION DEFICIENCIES	
#	Defect
1	Spall w/ exp. Reinf., 2" D - 2 SF
2	Spall w/ exp. Reinf., 3" D - 3 SF
	Delamination - 8 SF
3	Spall w/ exp. Reinf., 2" D - 1 SF
4	Delamination - 3 SF
5	Spall w/ exp. Reinf. - 1 SF
6	Delamination - 1 SF
7	Delamination - 4 SF
8	Delamination - 1 SF
9	Delamination - 2 SF
10	Spall w/ exp. Reinf. - 1 SF

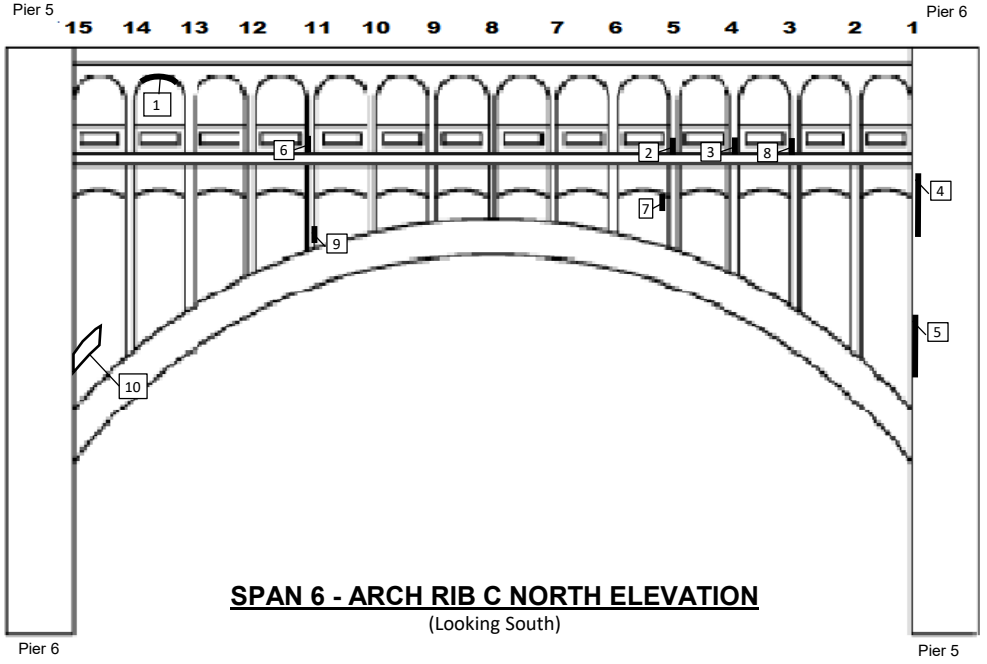
SPAN 6 - ARCH RIB C NORTH ELEVATION
(Looking South)

SPAN 6 - ARCH RIB C NORTH ELEVATION DEFICIENCIES	
#	Defect
1	Delamination - 2 SF
2	Spall w/ exp. Reinf. - 1 SF
3	Delamination - 4 SF
4	Spall w/ exp. Reinf. - 10 SF
5	Spall w/ exp. Reinf. - 15 SF
6	Spall w/ exp. Reinf - 2 SF
7	Delamination - 1 SF
8	Delamination - 4 SF
9	Delamination - 1 SF
10	Map cracking - 8 SF

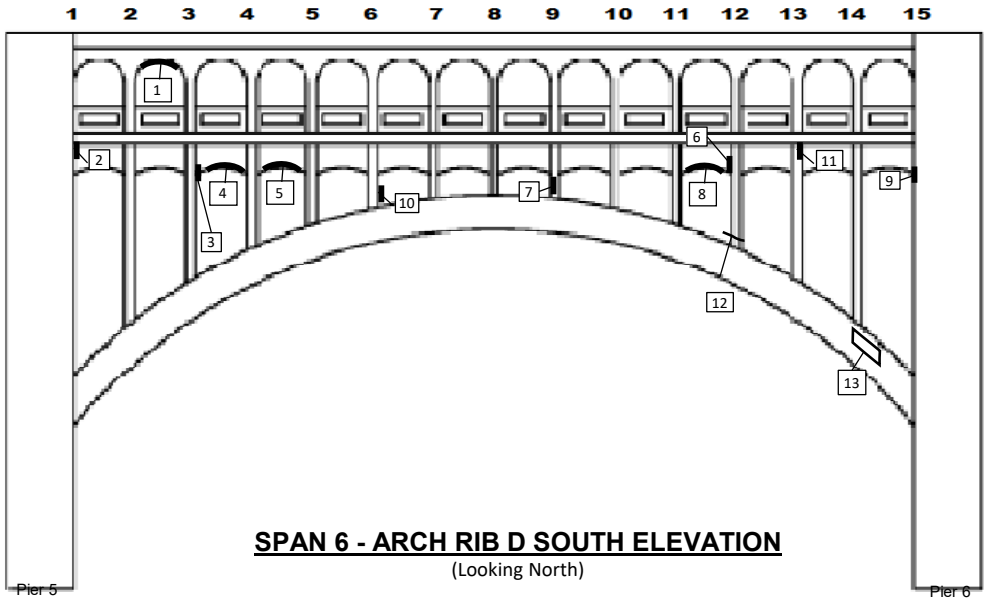
SPAN 6 - ARCH RIB D SOUTH ELEVATION
(Looking North)

SPAN 6 - ARCH RIB D SOUTH ELEVATION DEFICIENCIES	
#	Defect
1	Delamination - 2 SF
2	Delamination w/ Spall w/ exp. Reinf., 4" D - 5 SF
3	Spall w/ exp. Reinf. - 1 SF
4	Delamination - 4 SF
5	Delamination - 1 SF
6	Spall - 1 SF
7	Delamination - 1 SF
8	Delamination - 1 SF
9	Delamination - 6 SF
10	Delamination - 1 SF
11	Delamination - 1 SF
12	Crack - 2 LF
13	Map cracking - 4 SF

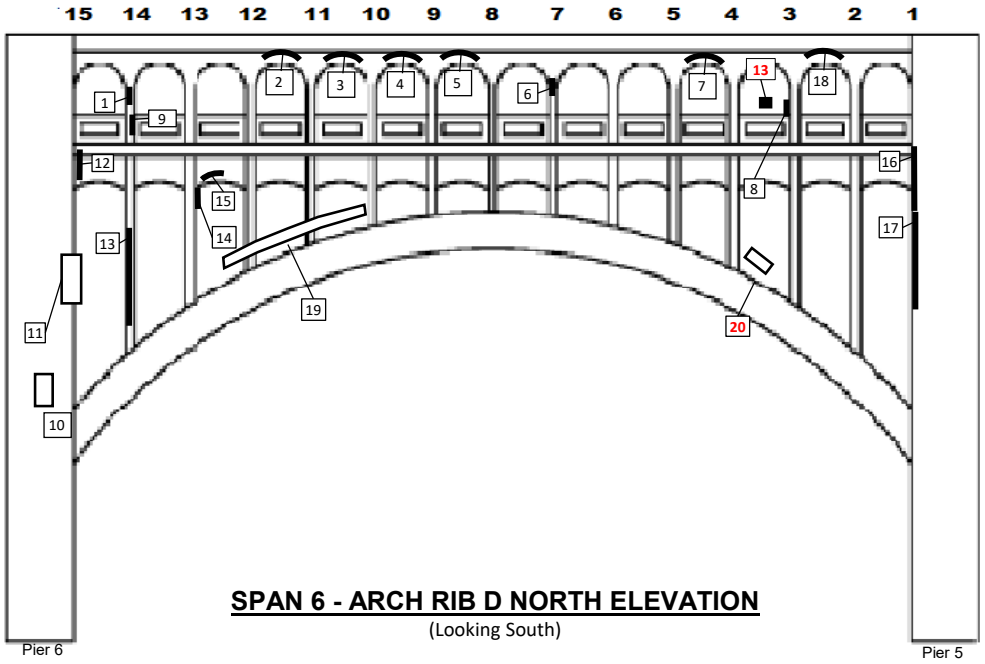
SPAN 6 - ARCH RIB D NORTH ELEVATION
(Looking South)

SPAN 6 - ARCH RIB D NORTH ELEVATION DEFICIENCIES	
#	Defect
1	Spall w/ exp. Reinf., 2.5" D - 5 SF
2	Delamination - 4 SF
3	Delamination - 10 SF
4	Delamination - 4 SF
5	Delamination - 4 SF
6	Delamination - 5 SF
7	Delamination - 2 SF
8	Delamination - 2 SF
9	Delamination - 1 SF
10	Spall, 4" D - 2 SF
11	Spall w/ exp. Reinf., 3" D - 6 SF
12	Delamination - 4 SF
13	Delamination w/ Spall w/ exp. Reinf. - 8 SF
14	Spall w/ exp. Reinf. - 1 SF
15	Spall w/ exp. Reinf. - 1 SF
16	Spall w/ exp. Reinf., 3" D - 5 SF
17	Delamination - 6 SF
18	Delamination - 6 SF
19	Map cracking - 20 SF
20	**Map cracking - 3 SF**
21	**Spall w/ exp. Reinf. - 1 SF**

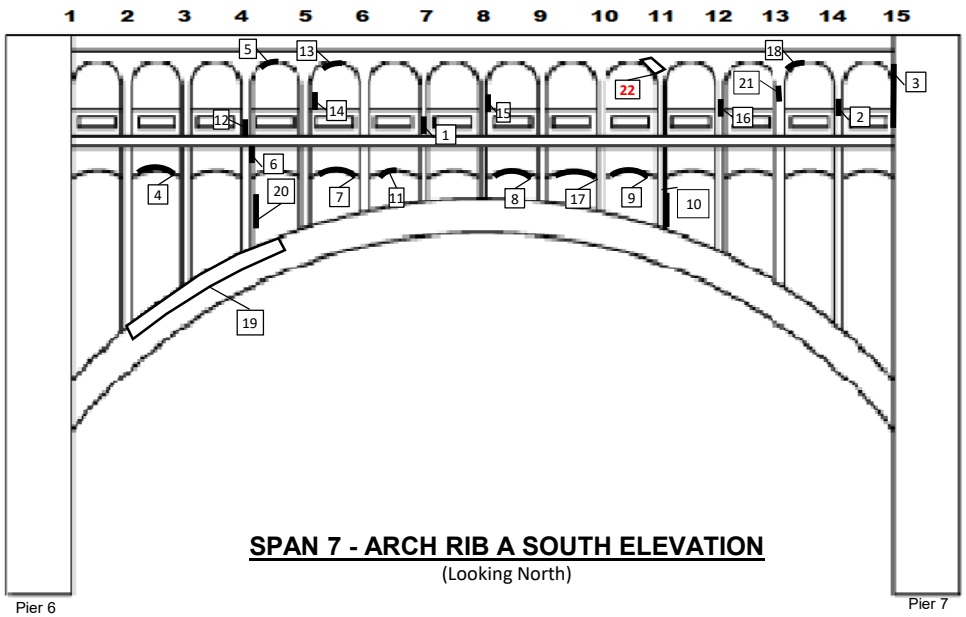
SPAN 7 - ARCH RIB A SOUTH ELEVATION
(Looking North)

SPAN 7 - ARCH RIB A SOUTH ELEVATION DEFICIENCIES	
#	Defect
1	Spall, 1" D - 1 SF
2	Delamination - 5 SF
3	Delamination w/ 1/4" W crack on edge of delamination (behind drain pipe) - 24 SF
4	Delamination - 4 SF
5	Delamination - 3 SF
6	Delamination - 5 SF
7	Delamination - 3 SF
8	Delamination - 8 SF
9	Delamination w/ Spall w/ exp. Reinf - 6 SF
10	Delamination - 2 SF
11	Delamination - 1 SF
12	Spall w/ exp. Reinf. - 1 SF
13	Spall w/ exp. Reinf. - 1 SF
14	Spall w/ exp. Reinf. - 1 SF
15	Delamination - 1 SF
16	Delamination - 1 SF
17	Delamination - 2 SF
18	Delamination - 1 SF
19	Map cracking - 66 SF
20	Delamination - 4 SF
21	Spall w/ exp. Reinf. - 1 SF
22	**Delamination - 3 SF**

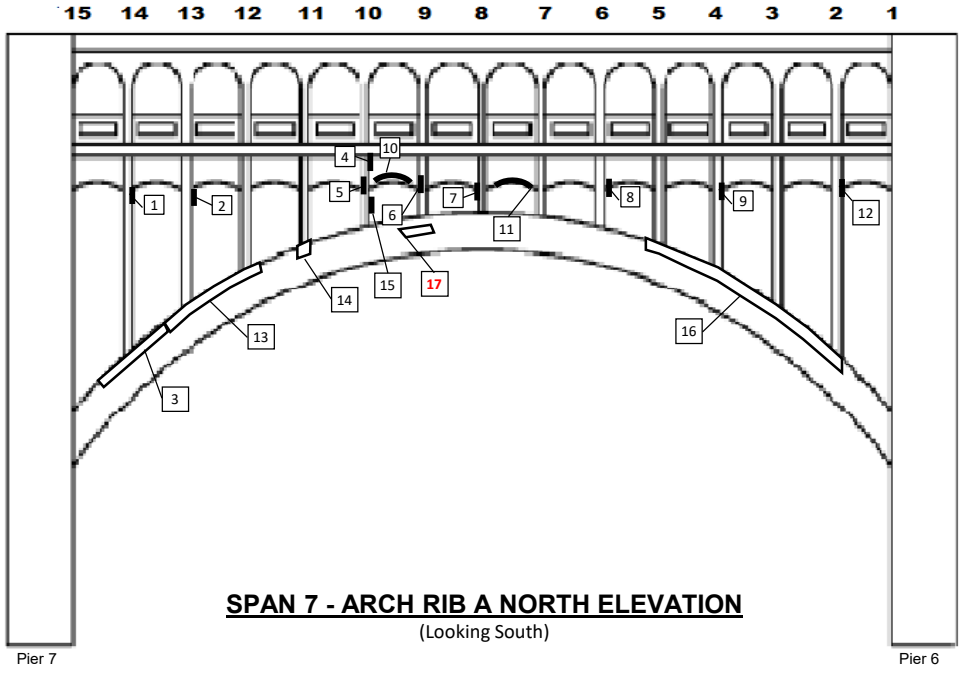
SPAN 7 - ARCH RIB A NORTH ELEVATION
(Looking South)

SPAN 7 - ARCH RIB A NORTH ELEVATION DEFICIENCIES	
#	Defect
1	Spall w/ exp. Reinf - 2 SF
2	Spall w/ exp. Reinf - 1 SF
3	1/8" W crack - 20 LF
4	Spall w/ exp. Reinf - 1 SF
5	Delamination - 1 SF
6	Spall w/ exp. Reinf - 1 SF
7	Spall w/ exp. Reinf - 1 SF
8	Spall w/ exp. Reinf - 1 SF
9	Delamination - 4 SF
10	Delamination - 6 SF
11	Delamination - 6 SF
12	Spall w/ exp. Reinf. - 1 SF
13	Map cracking - 30 SF
14	Spall w/ exp. Reinf - 1 SF
15	Spall w/ exp. Reinf - 1 SF
16	Map cracking - 30 SF
17	**Map cracking - 3 SF**

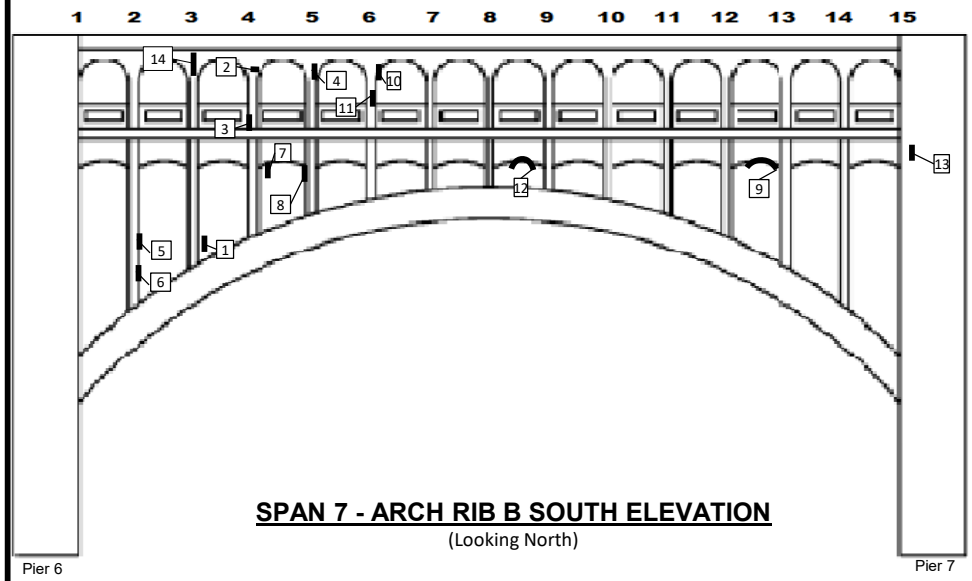
SPAN 7 - ARCH RIB B SOUTH ELEVATION
(Looking North)

SPAN 7 - ARCH RIB B SOUTH ELEVATION DEFICIENCIES	
#	Defect
1	Spall w/ exp. Reinf - 1 SF
2	Delamination - 2 SF
3	Delamination - 3 SF
4	Delamination - 2 SF
5	Spall w/ exp. Reinf - 3 SF
6	Delamination - 1 SF
7	Delamination w/ Spall w/ exp. Reinf - 4 SF
8	Spall w/ exp. Reinf - 2 SF
9	Spall w/ exp. Reinf - 1 SF
10	Delamination - 1 SF
11	Delamination - 1 SF
12	Delamination - 2 SF
13	Delamination - 2 SF
14	Spall w/ exp. Reinf. - 15 SF
15	**Delamination - 8 SF**

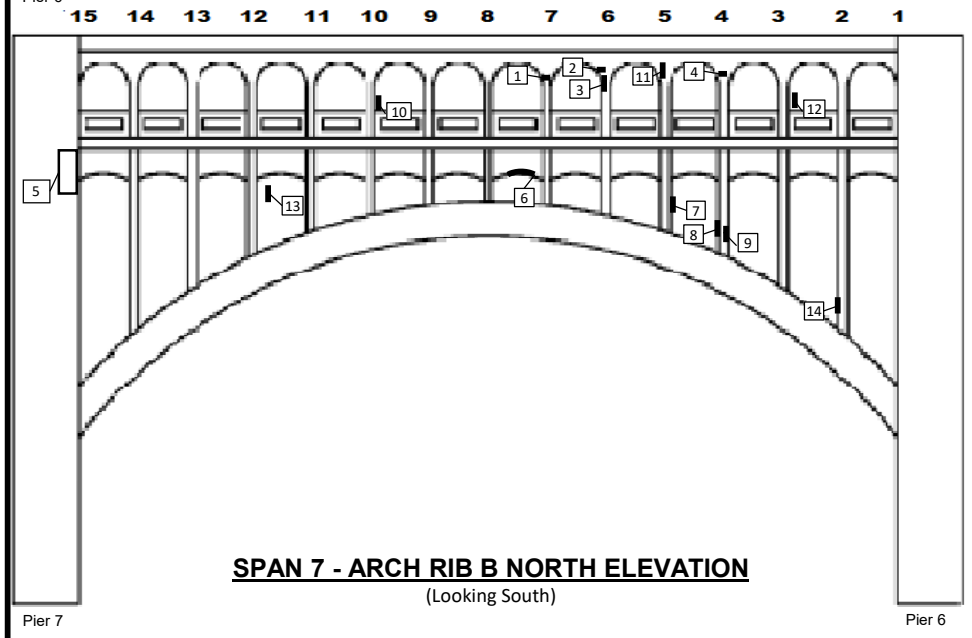
SPAN 7 - ARCH RIB B NORTH ELEVATION
(Looking South)

SPAN 7 - ARCH RIB B NORTH ELEVATION DEFICIENCIES	
#	Defect
1	Spall - 3 SF
2	Delamination - 4 SF
3	Delamination - 5 SF
4	Spall - 2 SF
5	Spall (inside face) - 6 SF
6	Spall w/ exp. Reinf - 3 SF
7	Spall w/ exp. Reinf - 3 SF
8	Delamination w/ Spall w/ exp. Reinf. - 5 SF
9	Delamination - 4 SF
10	Delamination - 2 SF
11	Delamination - 2 SF
12	Spall w/ exp. Reinf, 2" D - 6 SF
13	Spall w/ exp. Reinf - 1 SF
14	Spall w/ exp. Reinf - 2 SF

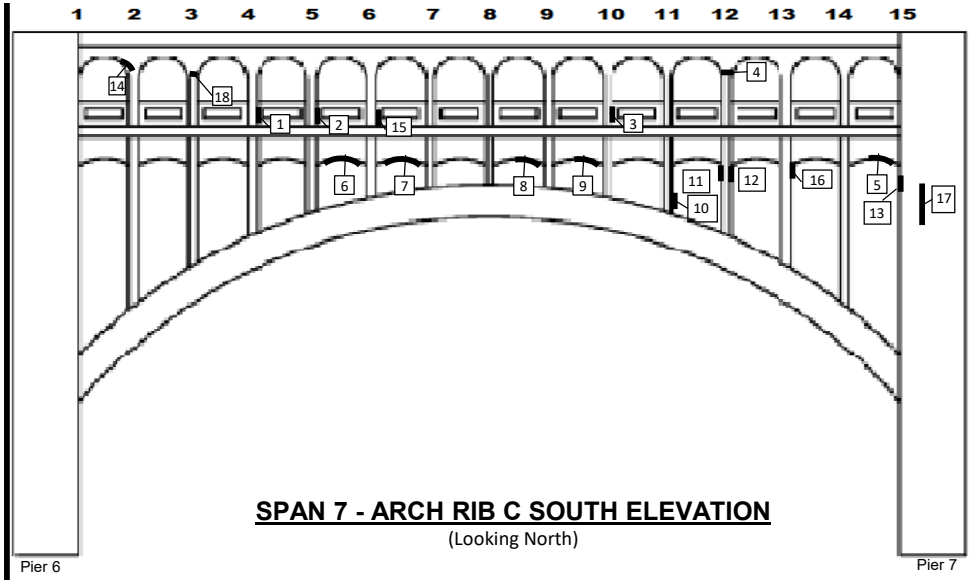
SPAN 7 - ARCH RIB C SOUTH ELEVATION
(Looking North)

SPAN 7 - ARCH RIB C SOUTH ELEVATION DEFICIENCIES	
#	Defect
1	Delamination - 2 SF
2	Delamination w/ Spall w/ exp. Reinf., 3" D - 5 SF
3	Delamination - 2 SF
4	Spall w/ exp. Reinf., 2" D - 2 SF
5	Delamination - 6 SF
6	Delamination - 6 SF
7	Delamination - 4 SF
8	Delamination - 4 SF
9	Delamination - 4 SF
10	Delamination - 1 SF
11	Delamination - 4 SF
12	Spall w/ exp. Reinf. - 1 SF
13	Delamination - 8 SF
14	Delamination - 2 SF
15	Delamination - 2 SF
16	Delamination - 1 SF
17	Delamination - 2 SF
18	Spall - 2 SF

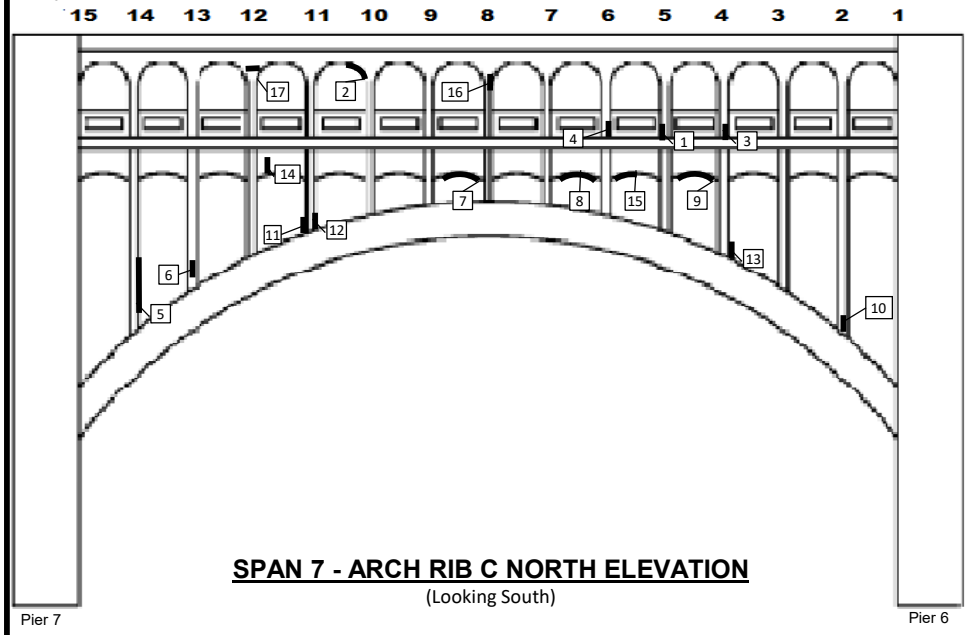
SPAN 7 - ARCH RIB C NORTH ELEVATION
(Looking South)

SPAN 7 - ARCH RIB C NORTH ELEVATION DEFICIENCIES	
#	Defect
1	Delamination - 2 SF
2	Spall, 3" D - 4 SF
3	Delamination - 2 SF
4	Delamination w/ Spall w/ exp. Reinf., 1.5" D - 2 SF
5	Delamination - 20 SF
6	Delamination - 2 SF
7	Delamination - 10 SF
8	Delamination - 2 SF
9	Delamination - 3 SF
10	Delamination - 3 SF
11	Delamination - 1 SF
12	Delamination - 1 SF
13	Spall w/ exp. Reinf. - 1 SF
14	Delamination - 10 SF
15	Delamination - 2 SF
16	Spall - 1 SF (corbel)
17	Spall - 1 SF (corbel)
