2025 PHYSICAL CONDITION ROUTINE ELEMENT LEVEL INSPECTION REPORT

Bridge CUY-6-1456
SFN 1800930

Detroit-Superior/Veteran's Memorial over Cuyahoga River
Dates of Inspection: October 6-10, 2025

ODOT DISTRICT 12
5500 TRANSPORTATION BOULEVARD
GARFIELD HEIGHTS, OHIO 44125
DECEMBER 30, 2025

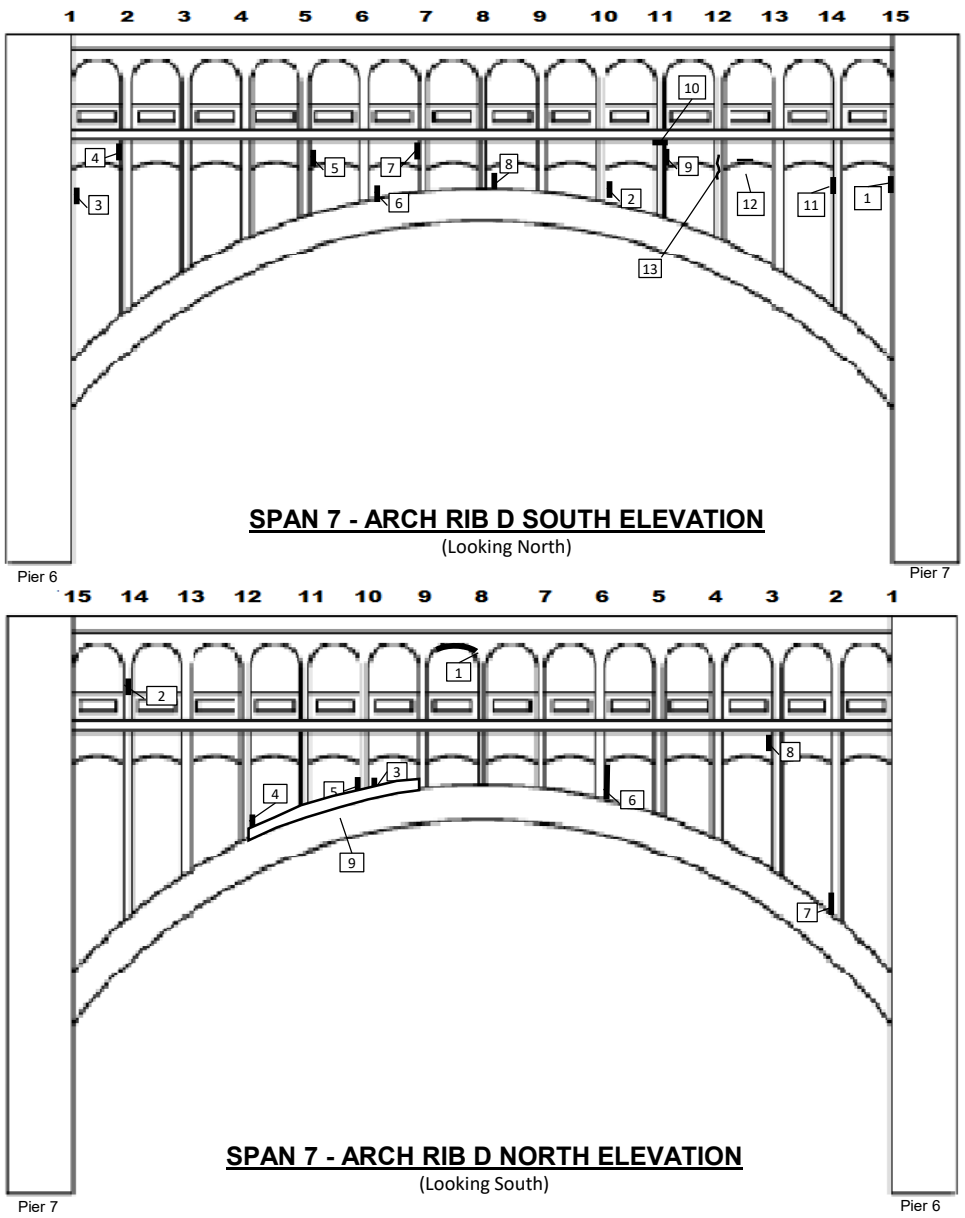
SPAN 7 - ARCH RIB D SOUTH ELEVATION DEFICIENCIES	
#	Defect
1	Delamination - 4 SF
2	Delamination - 1 SF
3	Delamination - 4 SF
4	Delamination w/ Spall w/ exp. Reinf. - 12 SF
5	Delamination - 3 SF
6	Delamination - 2 SF
7	Delamination - 3 SF
8	Spall w/ exp. Reinf - 1 SF
9	Delamination - 3 SF
10	Delamination - 6 SF
11	Delamination - 3 SF
12	Crack - 2 LF
13	Crack - 3 LF

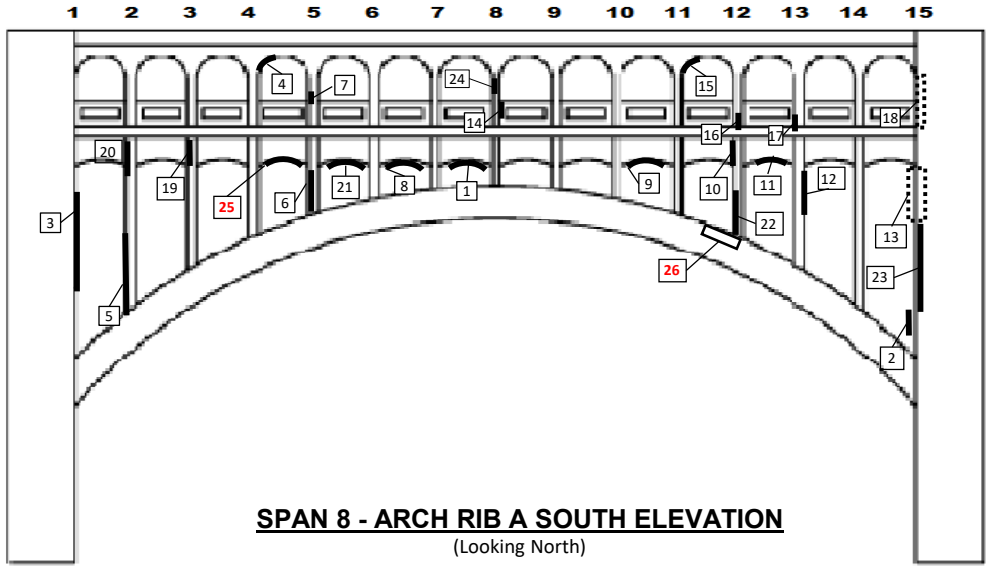
SPAN 8 - ARCH RIB A SOUTH ELEVATION
(Looking North)

SPAN 8 - RIB A SOUTH ELEVATION DEFICIENCIES			
#	Defect	#	Defect
1	Delamination - 3 SF	14	Delamination - 1 SF
2	Delamination - 4 SF	15	Delamination - 1 SF
3	Delamination w/ Spall w/ exp. Reinf. - 12 SF	16	Delamination - 1 SF
		17	Delamination - 1 SF
4	Delamination - 1 SF	18	Delam. (behind drain pipe) w/ 1/8" W crack on edge of delam. - 5 SF
5	Delamination w/ Spall w/ exp. Reinf. - 20 SF		
6	Delamination - 1 SF	19	Delamination - 1 SF
7	Spall, 2.5" D - 1 SF	20	Map Cracking - 8 SF
8	Delamination - 1 SF	21	Map Cracking - 5 SF
9	Delamination - 2 SF	22	Map Cracking - 2 SF
10	Delamination - 9 SF	23	Map Cracking - 20 SF
11	Delamination - 1 SF	24	Spall w/ reinf. - 1 SF
12	Delamination - 22 SF	23	Map Cracking - 20 SF
13	Delamination - 20 SF	24	Spall w/ reinf. - 1 SF
		25	**Map Cracking - 5 SF**
		26	**Map Cracking - 6 SF**

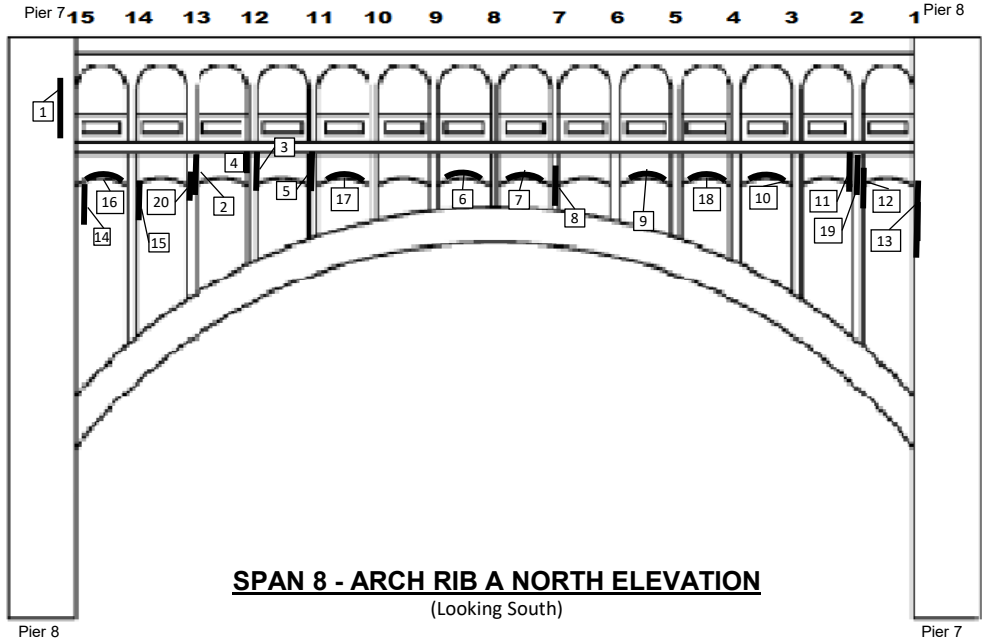
SPAN 8 - ARCH RIB A NORTH ELEVATION
(Looking South)

SPAN 8 - RIB A NORTH ELEVATION DEFICIENCIES			
#	Defect	#	Defect
1	Spall w/ exp. Reinf. - 6 SF	13	Delamination w/ Spall w/ exp. Reinf. - 8 SF
2	Delamination - 3 SF		
3	Delamination - 12 SF	14	Delamination w/ Spall w/ exp. Reinf. - 4 SF
4	Spall w/ exp. Reinf. - 1 SF	15	Delamination - 6 SF
5	Delamination - 8 SF	16	Delamination - 6 SF
6	Delamination - 4 SF	17	Delamination - 5 SF
7	Delamination - 6 SF	18	Delamination - 6 SF
8	Delamination - 4 SF	19	Crack - 4 LF
9	Delamination - 3 SF	20	Spall w/ exp. Reinf. - 5 SF
10	Delamination - 4 SF		
11	Delamination - 6 SF		
12	Delamination - 6 SF

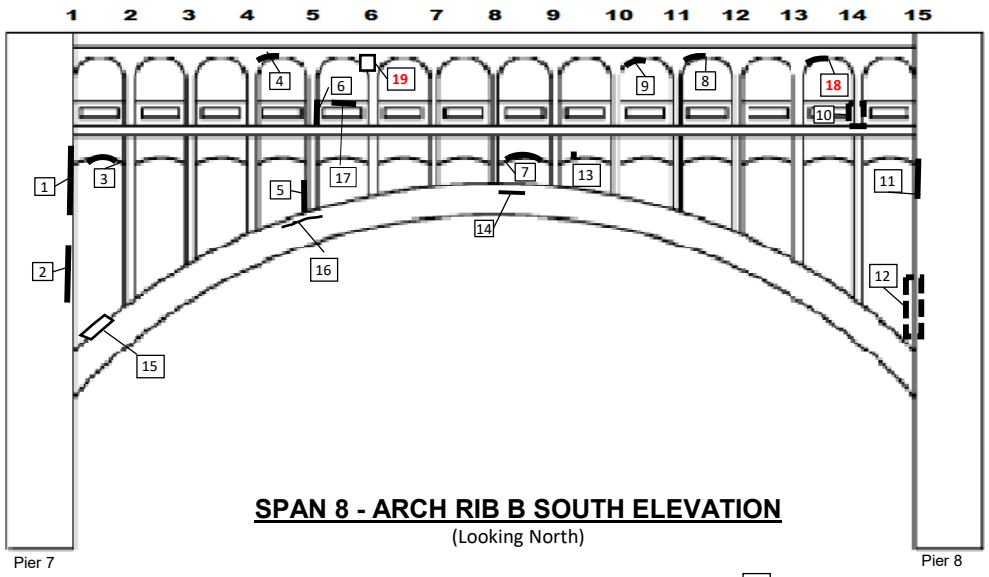
SPAN 8 - ARCH RIB B SOUTH ELEVATION
(Looking North)

SPAN 8 - RIB B SOUTH ELEVATION DEFICIENCIES			
#	Defect	#	Defect
1	Delamination - 9 SF	9	Spall w/ exp. Reinf. - 1 SF
2	Delamination - 8 SF		
3	Delamination - 4 SF	10	Delamination - 6 SF
4	Spall w/ exp. Reinf., 3" D - 1 SF	11	Delamination - 10 SF
		12	Delamination w/ Spall w/ exp. Reinf., 3" D - 15 SF
5	Spall w/ exp. Reinf. - 2 SF		
6	Delamination - 2 SF	13	Spall w/ exp. Reinf., 2" D - 2 SF
7	Spall w/ exp. Reinf. - 5 SF	14	Delamination - 4' L x 6" W
8	Spall w/ exp. Reinf., 1" D - 1 SF	15	Map cracking - 5 SF
		16	Crack - 5 LF
		17	Spall w/ exp. Reinf. - 1 SF
		18	**Delamination - 3 SF**
		19	**Delamination - 2 SF**

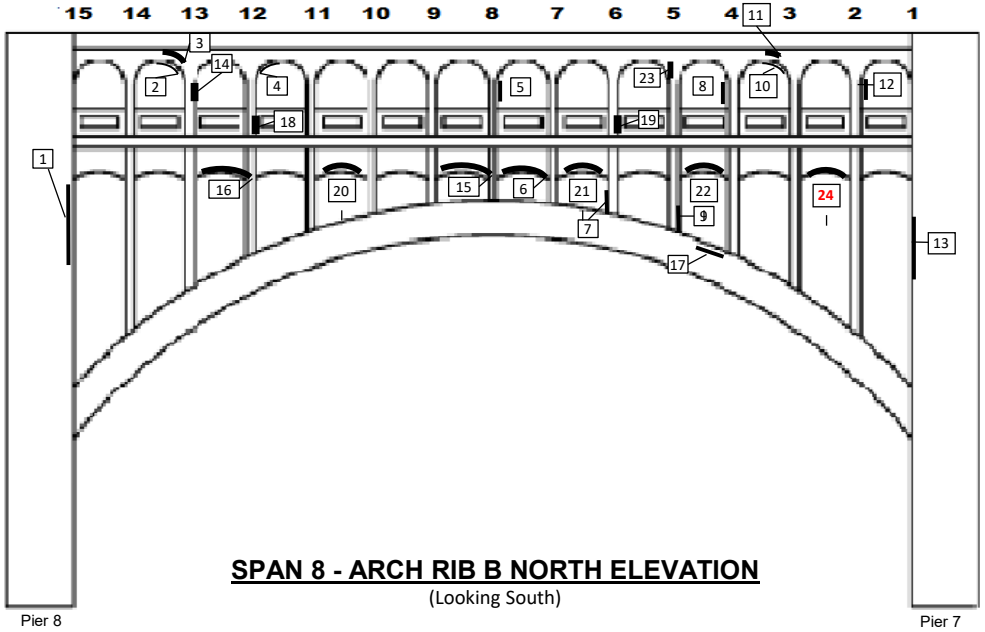
SPAN 8 - ARCH RIB B NORTH ELEVATION
(Looking South)

SPAN 8 - RIB B NORTH ELEVATION DEFICIENCIES			
#	Defect	#	Defect
1	Delamination - 16 SF	13	Delamination - 10 SF
2	Delamination - 2 SF	14	Delamination w/ Spall w/ exp. Reinf., 2" D - 4 SF
3	Delamination - 2 SF		
4	Spall w/ exp. Reinf., 5" D - 1 SF	15	Delamination - 6 SF
5	Delamination - 3 SF	16	Delamination - 1 SF
6	Delamination - 4 SF	17	Delamination - 3' L x 6" H
7	Delamination - 2 SF		
8	Delamination - 5 SF	18	Delamination - 1 SF
9	Delamination - 1 SF	19	Delamination - 2 SF
10	Delamination - 1 SF	20	Crack - 4 LF
11	Spall w/ exp. Reinf., 1.5" D - 1 SF	21	Crack - 4 LF
		22	Crack - 4 LF
12	Spall w/ exp. Reinf., 2" D - 5 SF	23	Delamination - 1 SF
		24	**Delamination - 2 SF**

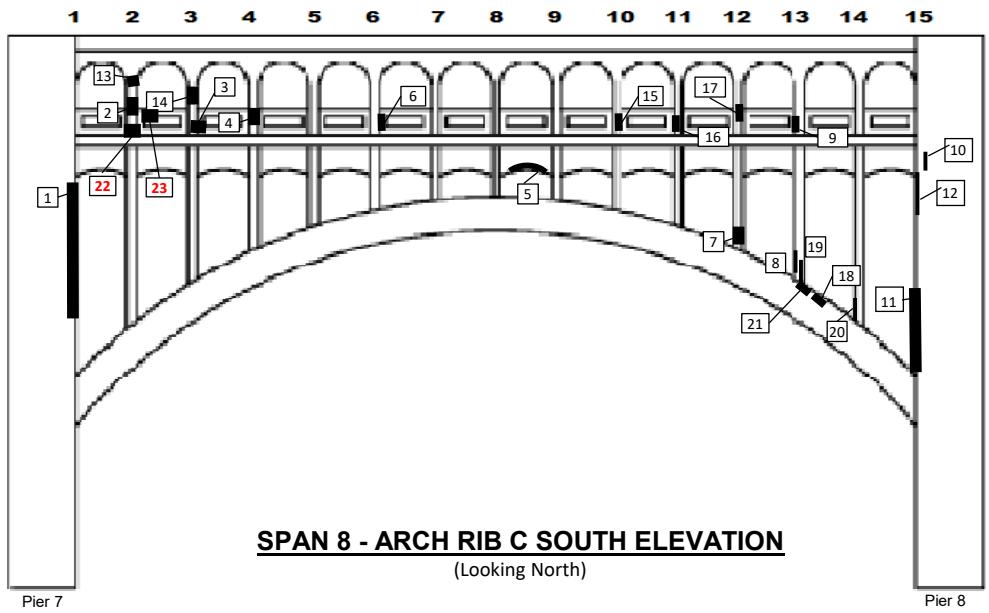
SPAN 8 - ARCH RIB C SOUTH ELEVATION
(Looking North)

SPAN 8 - RIB C SOUTH ELEVATION DEFICIENCIES			
#	Defect	#	Defect
1	Spall w/ exp. Reinf. 30% S.L. of bars at south end. 2 adj. shear stirrups w/ complete S.L. - 175 SF.	11	Delamination - 40 SF
		12	Delamination - 12 SF
		13	Spall, 1" D - 1 SF
		14	Spall w/ exp. Reinf. - 1 SF
2	Delamination w/ Spall w/ exp. Reinf. - 5 SF	15	Delamination - 2 SF
3	Delamination - 1 SF	16	Delamination - 2 SF
4	Delamination - 3 SF	17	Delamination w/ Spall w/ exp. Reinf. - 1 SF
5	Delamination - 6 SF		
6	Delamination w/ Spall w/ exp. Reinf. - 3 SF	18	Spall - 1' L x 1' H
		19	Delamination - 1 SF
7	Spall w/ exp. Reinf., 2" D - 1 SF	20	Delamination - 1 SF
		21	Spall - 1' L x 1' H
8	Delamination - 2 SF	**22**	**Spall - 1' L x 1' H**
9	Core sample location	**23**	**Spall - 1' L x 1' H**
10	Spall w/ exp. Reinf. - 1 SF

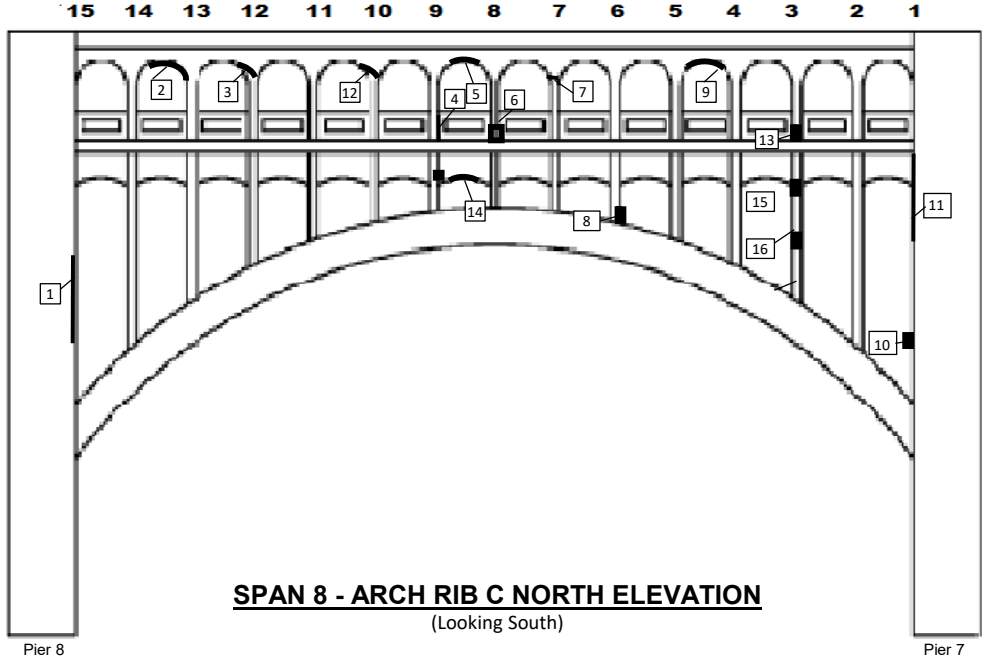
SPAN 8 - ARCH RIB C NORTH ELEVATION
(Looking South)

SPAN 8 - RIB C NORTH ELEVATION DEFICIENCIES			
#	Defect	#	Defect
1	Delamination - 15 SF	9	Delamination w/ Spall w/ exp. Reinf. - 2 SF
2	Delamination w/ Spall w/ exp. Reinf., 0.5" D - 4 SF	10	Delamination - 4 SF
		11	Delam. w/ Spall w/ exp. Reinf., 4" D - 20 SF. 1 exp. Tie w/ 50% S.L. (tie is broken on S face).
3	Spall w/ exp. Reinf., 4" D - 1 SF	12	Delamination w/ Spall - 1 SF
4	Spall w/ exp. Reinf., 1" D - 1 SF	13	Delamination - 1 SF
5	Spall w/ exp. Reinf., 1.5" D - 1 SF	14	Delamination - 1 SF
6	Spall - 1 SF	15	Delamination - 1 SF
7	Delamination w/ Spall - 2 SF (corbel)	16	Delamination - 1 SF
8	Spall w/ exp. Reinf. - 1 SF

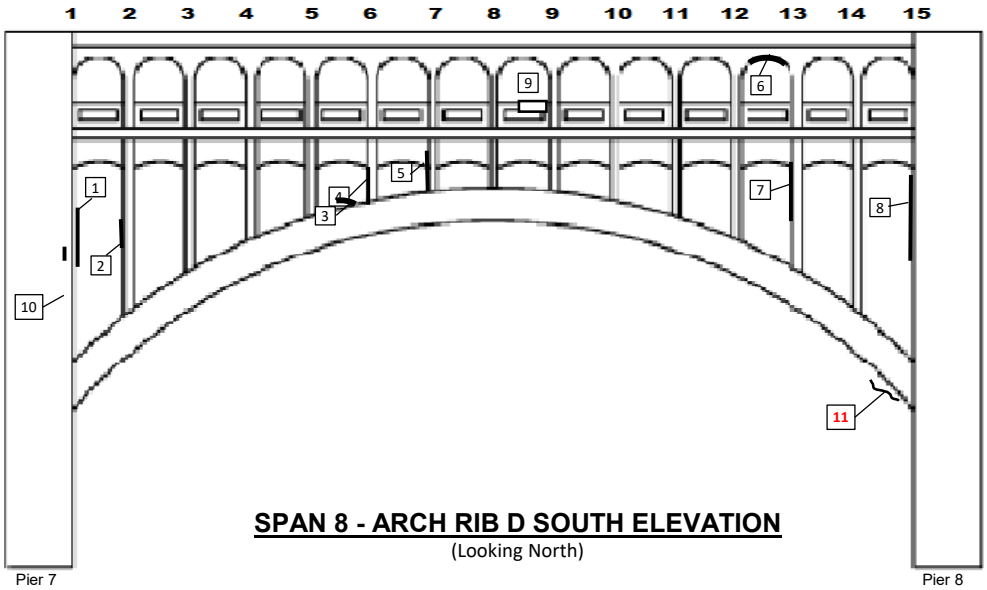
SPAN 8 - ARCH RIB D SOUTH ELEVATION
(Looking North)

SPAN 8 - RIB D SOUTH ELEVATION DEFICIENCIES			
#	Defect	#	Defect
1	Delamination - 12 SF	6	Delamination - 6 SF
2	Spall w/ exp. Reinf. - 1 SF	7	Delamination w/ Spall w/ exp. Reinf - 20 SF
3	Spall w/ exp. Reinf. - 4 SF	8	Delamination w/ some Spalling - 23 SF
4	Delamination - 12 SF	9	Spall w/ exp. Reinf. - 1 SF
5	Delamination - 12 SF		
		10	Spall - 2 SF
		11	**Crack - 5 LF**

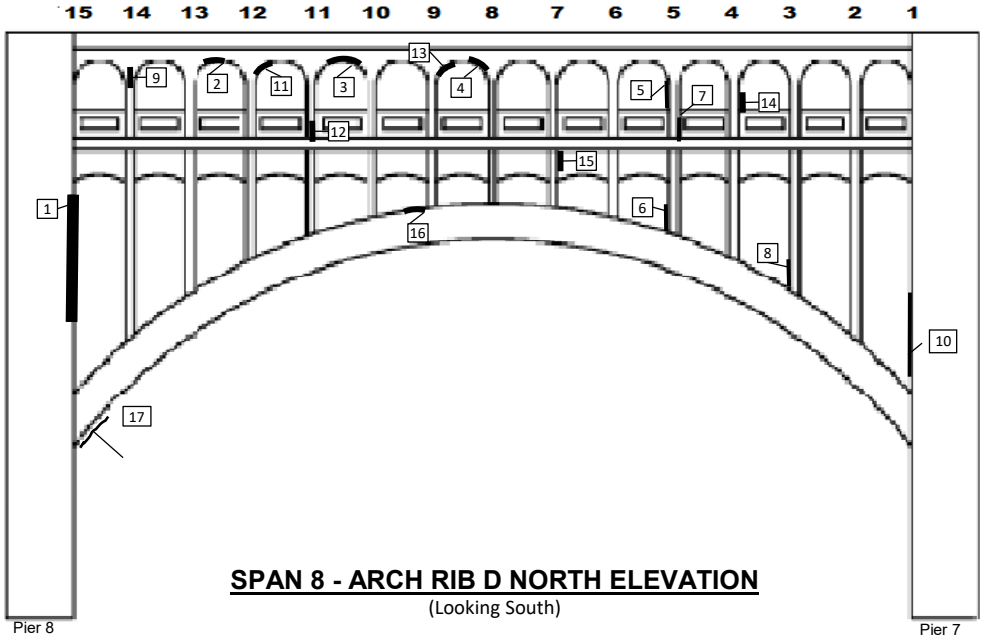
SPAN 8 - ARCH RIB D NORTH ELEVATION
(Looking South)

SPAN 8 - RIB D NORTH ELEVATION DEFICIENCIES			
#	Defect	#	Defect
1	Delam. w/ Spall w/ exp. Reinf. w/ minor S.L. - 60 SF	9	Delamination - 2 SF
		10	Delamination - 4 SF
		11	Spall - 1 SF
2	Delamination - 3 SF	12	Delamination - 4 SF
3	Delamination - 4 SF	13	Delamination - 1 SF
4	Delamination - 4 SF	14	Delamination - 2 SF
5	Spall w/ exp. Reinf., 1" D - 1 SF	15	Delamination - 1 SF
		16	Delamination - 2' L x 6" W
6	Delamination - 1 SF		
7	Delamination - 3 SF	17	Crack - 5 LF
8	Delamination - 1 SF

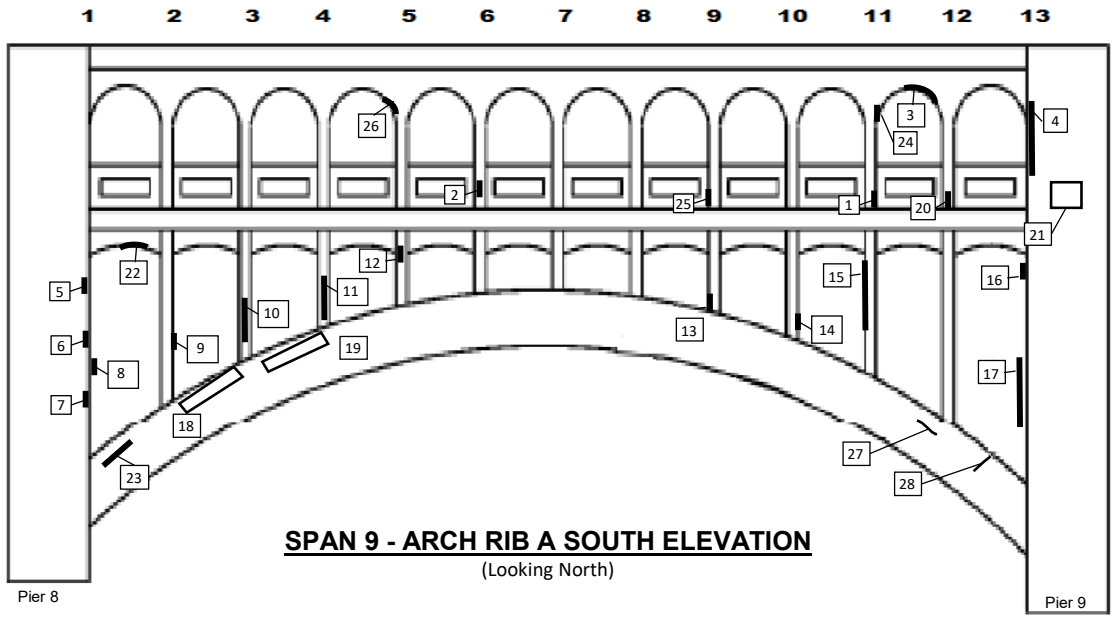
SPAN 9 - ARCH RIB A SOUTH ELEVATION
(Looking North)

SPAN 9 - RIB A SOUTH ELEVATION DEFICIENCIES			
#	Defect	#	Defect
1	Delamination - 1 SF	14	Delamination - 2 SF
2	Spall w/ exp. Reinf., 1" D - 1 SF	15	Delamination - 10 SF
3	Delamination - 8 SF	16	Delamination - 4 SF
4	Delam. (behind drain pipe) w/ up to 1/8" W crack on edge of delam. - 12 SF	17	Delamination - 30 SF
		18	Delamination - 8' L x 2' W
5	Delamination - 14 SF	19	Delaminaiton - 6' L x 2' W
6	Delamination - 5 SF	20	Delamination - 4 SF
7	Delamination - 10 SF	21	Delamination - 4 SF
8	Delamination - 5 SF	22	Delamination - 4 SF
9	Delam. w/ Spall - 4 SF	23	Delamination - 3' L x 1' W
10	Spall w/ rebar - 50 SF	24	Delamination - 1 SF
11	Delam. w/ Spall w/ exp. Reinf. - 9 SF	25	Delamination - 1 SF
12	Delamination - 2 SF	26	Delamination - 1 SF
13	Delamination - 1 SF	27	Crack - 3 LF
		28	Crack - 3 LF

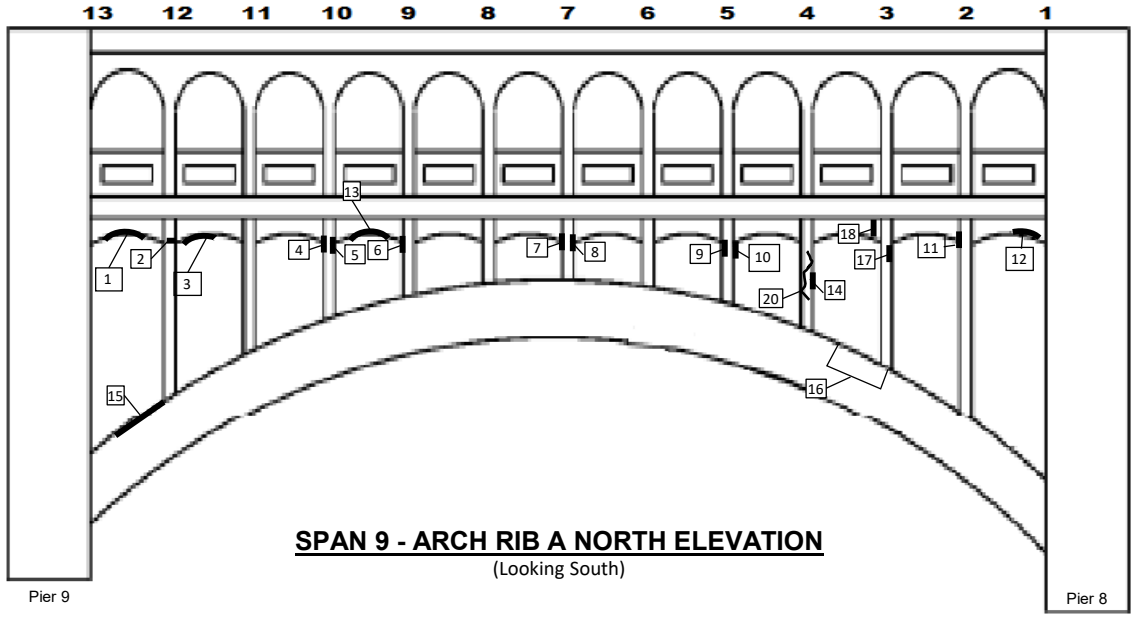
SPAN 9 - ARCH RIB A NORTH ELEVATION
(Looking South)

SPAN 9 - RIB A NORTH ELEVATION DEFICIENCIES			
#	Defect	#	Defect
1	Delam. w/ Spall w/ exp. Reinf. - 4 SF	13	Delamination - 1 SF
2	Delam. w/ Spall w/ exp. Reinf. - 4 SF	14	Delamination - 9 SF
3	Delam. w/ Spall - 2 SF	15	Delamination - 5' L x 3' W
4	Delam. w/ Spall w/ exp. Reinf. - 2 SF	16	Delamination - 2' L x 6" W
5	Delamination - 1 SF	17	Delamination - 1 SF
6	Spall - 2 SF	18	Delam. w/ Spall w/ exp. Reinf. - 1 SF
7	Delam. w/ Spall w/ exp. Reinf. - 3 SF	19	Delamination - 3 SF
8	Delam. w/ Spall w/ exp. Reinf. - 2 SF	20	Crack - 7 LF
9	Delamination - 3 SF		
10	Delamination - 4 SF		
11	Delamination - 4 SF		
12	Delam. w/ Spall w/ exp. Reinf. - 5 SF

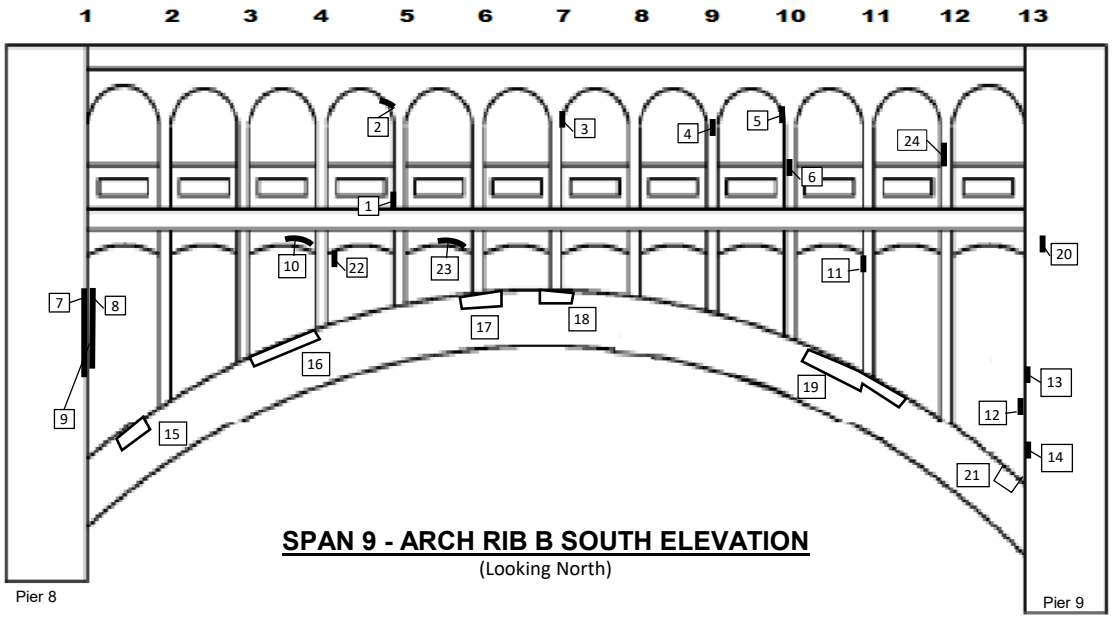
SPAN 9 - ARCH RIB B SOUTH ELEVATION
(Looking North)

SPAN 9 - RIB B SOUTH ELEVATION DEFICIENCIES			
#	Defect	#	Defect
1	Spall w/ exp. Reinf., 1" D - 1 SF	11	Delamination - 3 SF
2	Spall w/ exp. Reinf., 4" D - 2 SF	12	Delam. w/ Spall w/ exp. Reinf - 4 SF
3	Delam. w/ Spall - 2 SF		
4	Delam. w/ Spall , 3" D & 1/4" crack - 6 SF	13	Delamination - 12 SF
		14	Delamination - 10 SF
5	Delamination - 2 SF	15	Delamination - 2' L x 1' H
6	Delamination - 1 SF	16	Delamination - 8' L x 6" W
7	Delamination - 40 SF (west face of column)	17	Delamination - 3' L x 6" W
		18	Spall w/ exp. Reinf. - 3' L x 6" W
8	Delamination - 28 SF (east face of column)	19	Delamination - 10' L x 1' W
		20	Delamination - 4 SF
9	Delamination - 30 SF (south face of column)	21	Delamination - 3' L x 6" H
		22	Delamination - 1 SF
10	Delam. w/ Spall w/ exp. Reinf. - 3 SF	23	Spall - 3 SF
		24	Spall - 1 SF

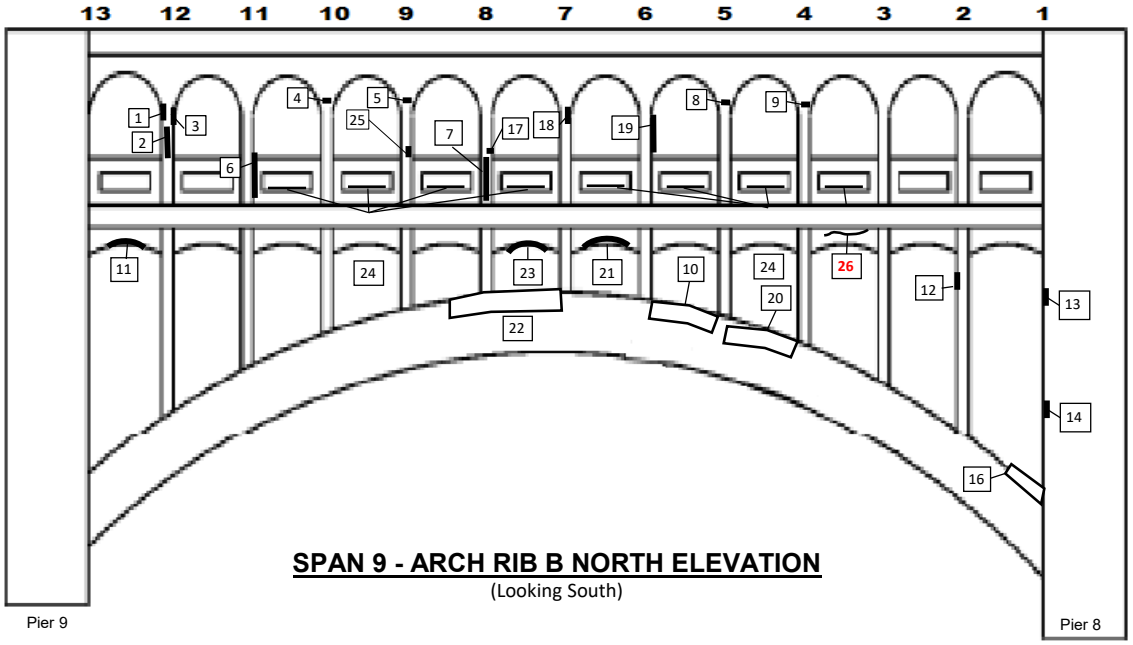
SPAN 9 - ARCH RIB B NORTH ELEVATION
(Looking South)

SPAN 9 - RIB B NORTH ELEVATION DEFICIENCIES			
#	Defect	#	Defect
1	Spall w/ exp. Reinf., 1.5" D - 4 SF	13	Delamination - 6 SF
2	Delamination - 4 SF	14	Delamination - 12 SF
3	Delamination - 5 SF	15	Delamination - 2 SF
4	Delamination - 4 SF	16	Delamination - 2' L x 1' W
5	Delamination - 3 SF	17	Spall w/ exp. Reinf., 1" D - 2 SF
6	Delamination - 8 SF	18	Spall w/ exp. Reinf., 1" D - 2 SF
7	Delamination - 8 SF	19	Delamination - 4 SF
8	Delamination - 4 SF	20	Delamination - 5' L x 6" W
9	Delamination - 3 SF	21	Delamination - 2 SF
10	Delamination - 8' L x 1' W	22	Delamination - 10' L x 6" W
11	Delamination - 4 SF	23	Delamination - 4 SF
12	Delamination - 5 SF	24	Crack - 5 LF (7 Loc.)
		25	Delamination - 2 SF
		26	**Crack - 8 LF**

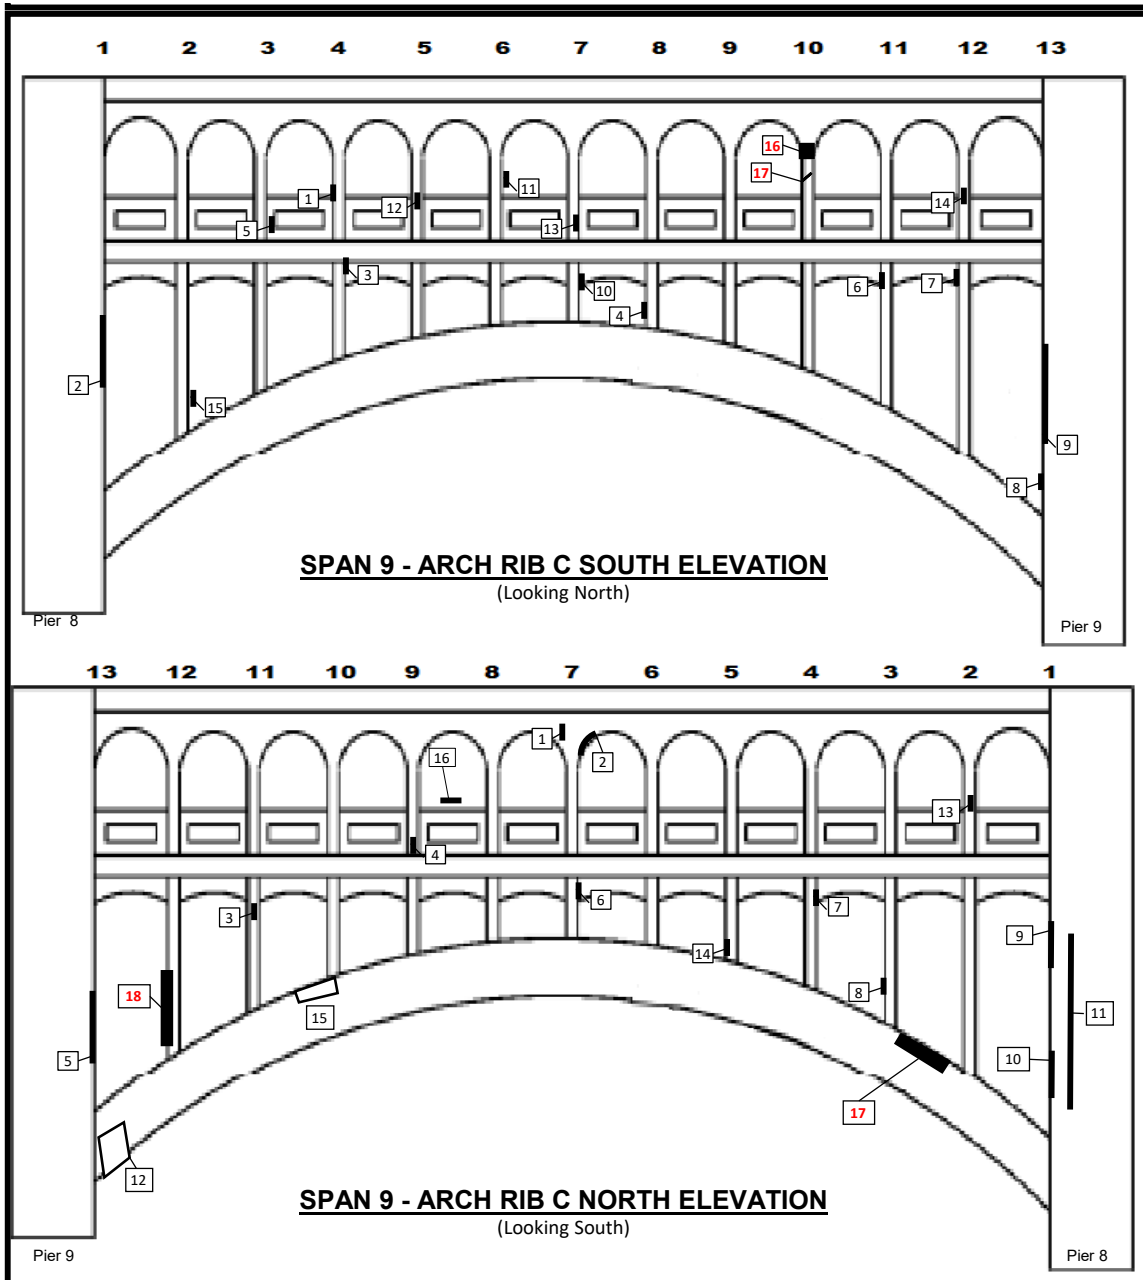
SPAN 9 - RIB C SOUTH ELEVATION DEFICIENCIES			
#	Defect	#	Defect
1	Spall - 1 SF	13	Delamination - 2 SF
2	Delamination - 24 SF	14	Delamination - 2 SF
3	Spall w/ exp. Reinf. - 2 SF	15	Delamination - 2 SF
4	Delamination - 1 SF	**16**	**Spall w/ exp. Reinf. - 1 SF**
5	Delamination - 1 SF	**17**	**Crack - 1 LF**
6	Delam. w/ Spall - 3 SF		
7	Delamination - 1 SF		
8	Delamination - 1 SF		
9	Delamination - 20 SF		
10	Delamination - 1 SF		
11	Delamination - 1 SF		
12	Delamination - 1 SF

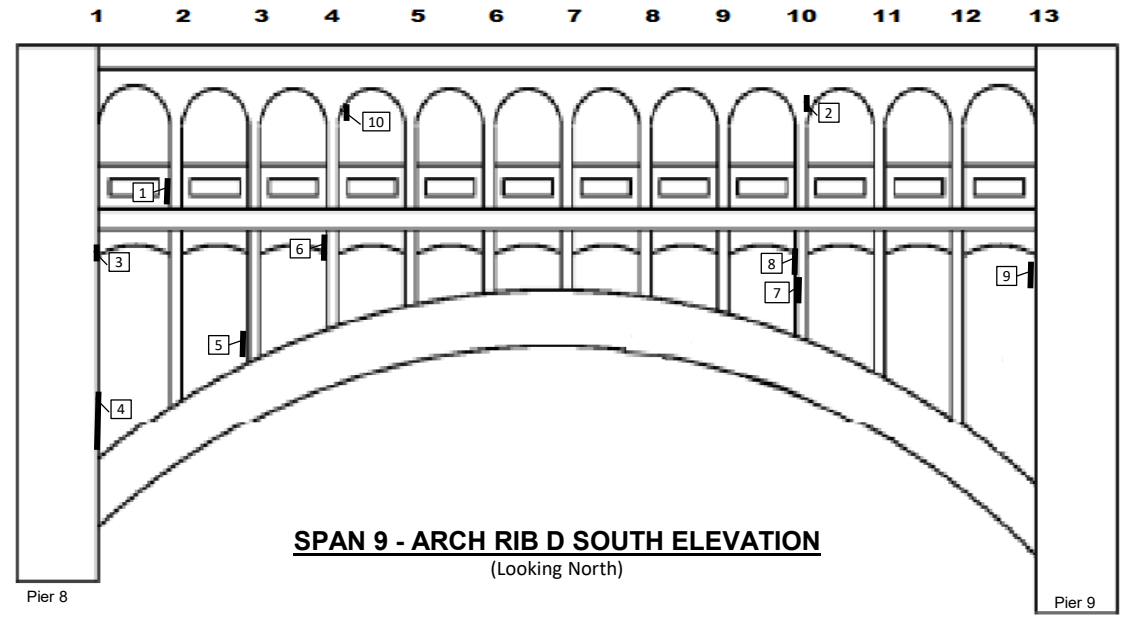
SPAN 9 - ARCH RIB D SOUTH ELEVATION
(Looking North)

SPAN 9 - RIB D SOUTH ELEVATION DEFICIENCIES	
#	Defect
1	Delamination - 2 SF
2	Spall w/ exp. Reinf. - 1 SF
3	Spall w/ exp. Reinf. - 4 SF
4	Spall w/ exp. Reinf. - 28 SF
5	Delamination - 1 SF
6	Delamination - 5 SF
7	Spall w/ exp. Reinf. (South face) - 1 SF
8	Delamination (West face) - 1 SF
9	Delamination - 6 SF
10	Delamination - 1 SF

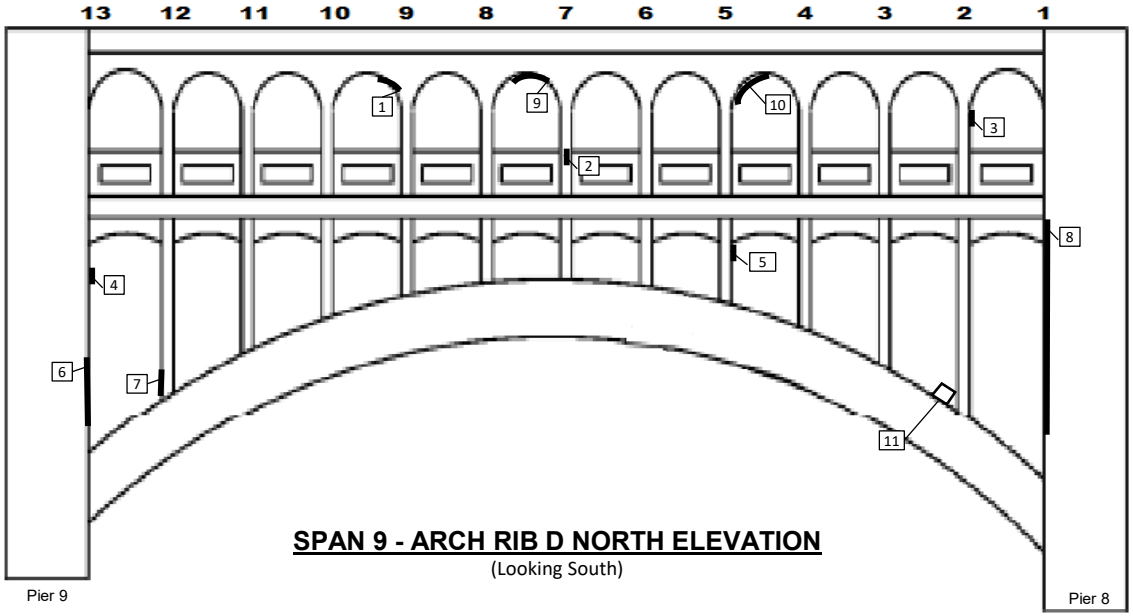
SPAN 9 - ARCH RIB D NORTH ELEVATION
(Looking South)

SPAN 9 - RIB D NORTH ELEVATION DEFICIENCIES	
#	Defect
1	Delamination - 4 SF
2	Delamination - 4 SF
3	Delamination - 3 SF
4	Delamination (North face) - 2 SF
5	Delamination - 1 SF
6	Delamination w/ Spall w/ exp. Reinf. - 15 SF
7	Delamination - 2 SF
8	Delamination - 50 SF
9	Delamination - 1 SF
10	1/16" W through-crack
11	Spall - 2 SF

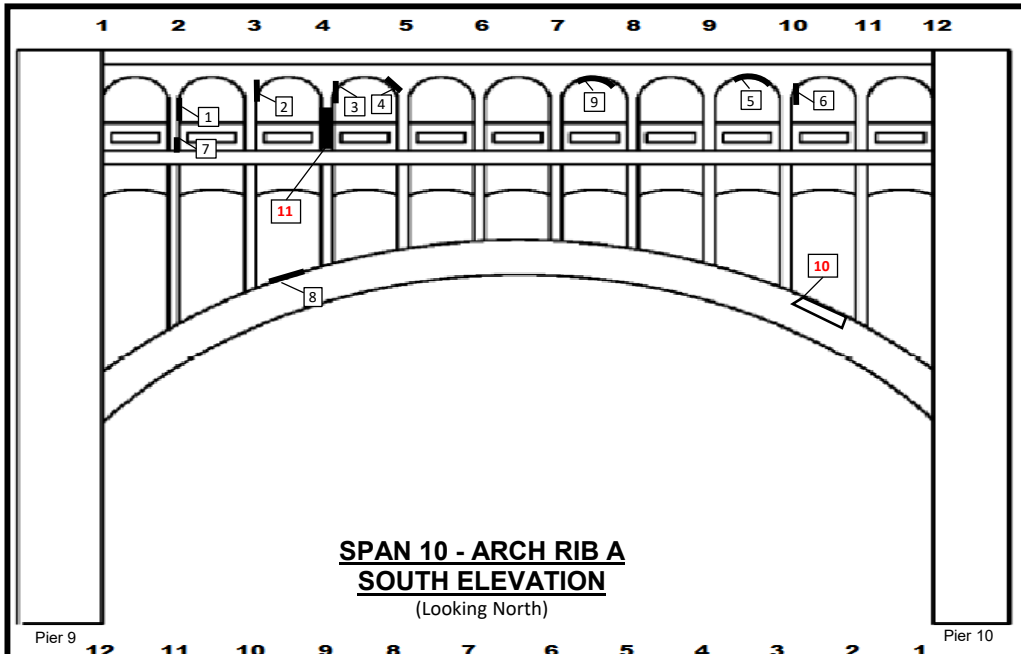
SPAN 10 - ARCH RIB A SOUTH ELEVATION
(Looking North)

SPAN 10 - ARCH RIB A SOUTH ELEVATION DEFICIENCIES	
#	Defect
1	Delamination (Behind Utility Conduit) - 3 SF
2	Delamination - 2 SF
3	Delamination - 20 SF
4	Delamination - 1 SF
5	Delamination - 2 SF
6	Delamination - 3 SF
7	Delamination - 2 SF
8	Delamination - 6' L x 3' W
9	Delamination - 1 SF
10	**Map Cracking - 5' L x 1' W**
11	**Delamination - 14 SF**

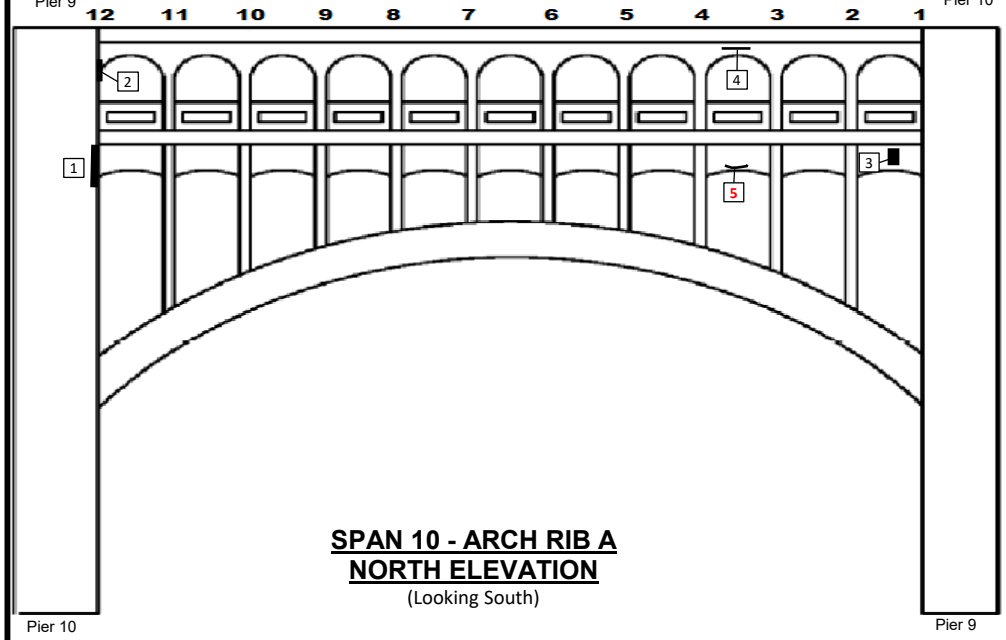
SPAN 10 - ARCH RIB A NORTH ELEVATION
(Looking South)

SPAN 10 - ARCH RIB A NORTH ELEVATION DEFICIENCIES	
#	Defect
1	Spall w/ exp. Reinf. - 4 SF
2	Delamination - 3 SF
3	Delamination - 1 SF
4	Crack - 5 LF
5	**Crack - 1 LF**

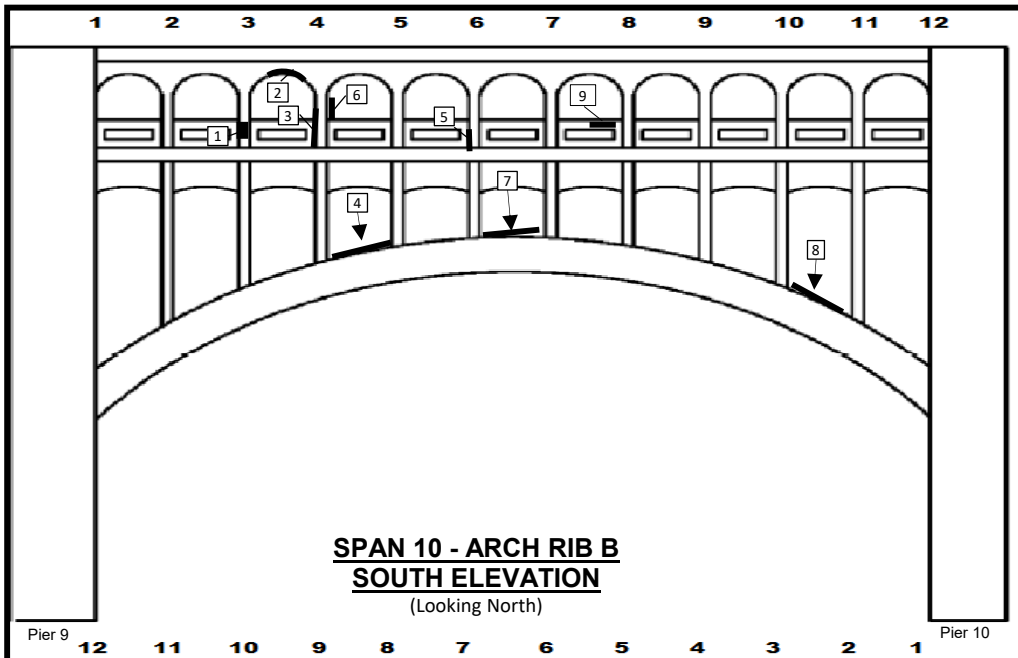
SPAN 10 - ARCH RIB B SOUTH ELEVATION
(Looking North)

SPAN 10 - ARCH RIB B SOUTH ELEVATION DEFICIENCIES	
#	Defect
1	Delamination - 1 SF
2	Delamination - 1 SF
3	Delamination - 1 SF
4	Delamination - 4' L x 1.5' W
5	Delamination - 2 SF
6	Delamination - 1 SF
7	Spall - 20 SF
8	Delamination - 3' L x 4' W
9	Spall - 2 SF

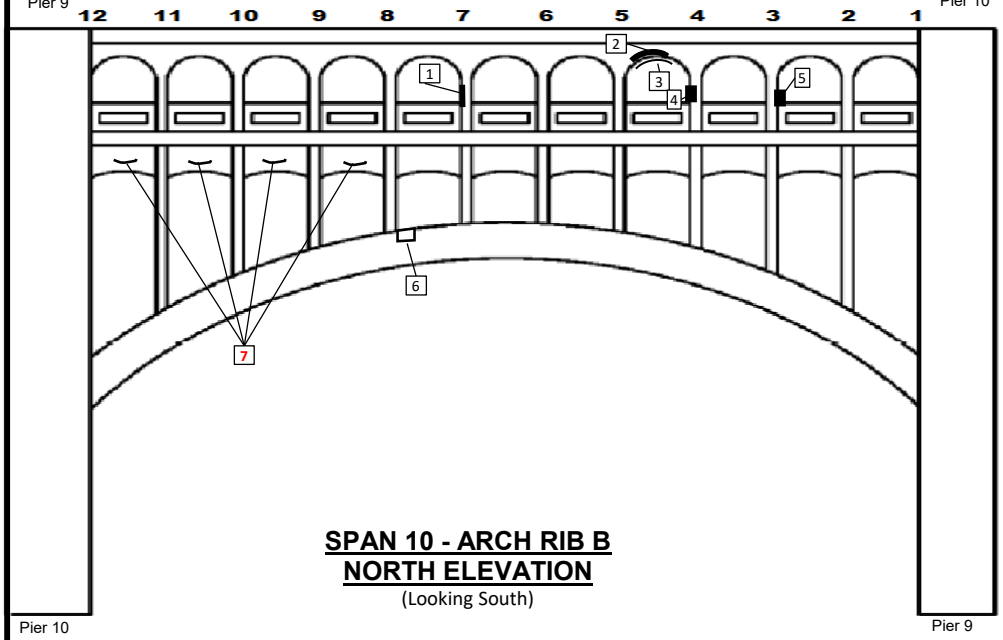
SPAN 10 - ARCH RIB B NORTH ELEVATION
(Looking South)

SPAN 10 - ARCH RIB B NORTH ELEVATION DEFICIENCIES	
#	Defect
1	Delamination - 2 SF
2	Delamination - 6 SF
3	Delamination - 3 SF
4	Delamination - 2 SF
5	Delamination - 3 SF
6	Map cracking - 2 SF
7	**Cracks - 25 LF**

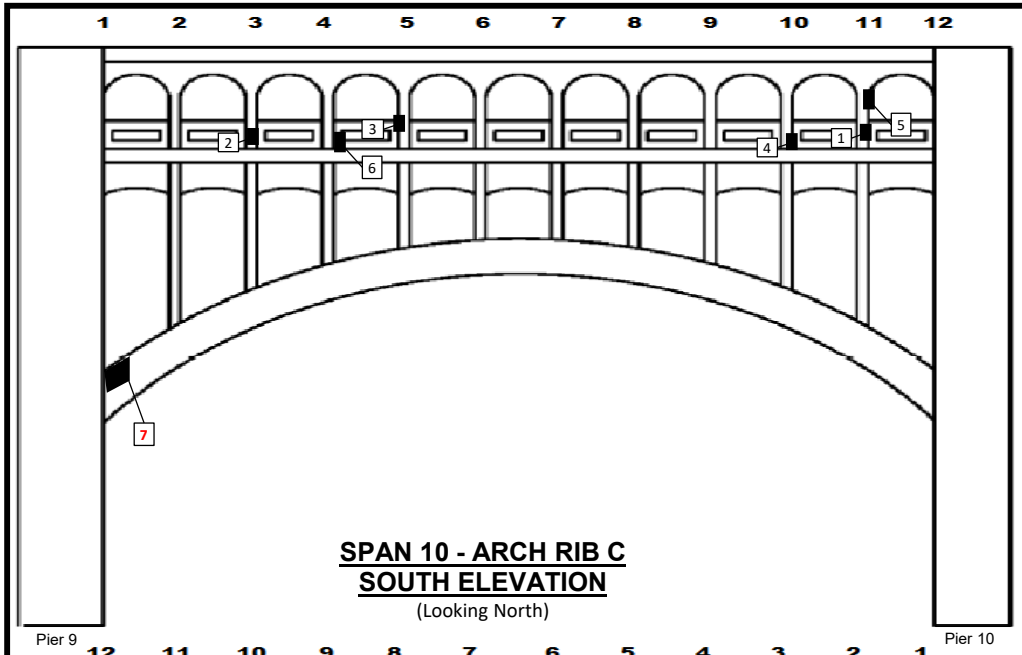
SPAN 10 - ARCH RIB C SOUTH ELEVATION
(Looking North)

SPAN 10 - ARCH RIB C SOUTH ELEVATION DEFICIENCIES	
#	Defect
1	Delamination - 3 SF
2	Delamination w/ Spall w/ exp. Reinf. - 6 SF
3	Delamination - 1 SF
4	Delamination - 2 SF
5	Delamination - 1 SF
6	Delamination - 3 SF
7	**Delamination - 10 SF**

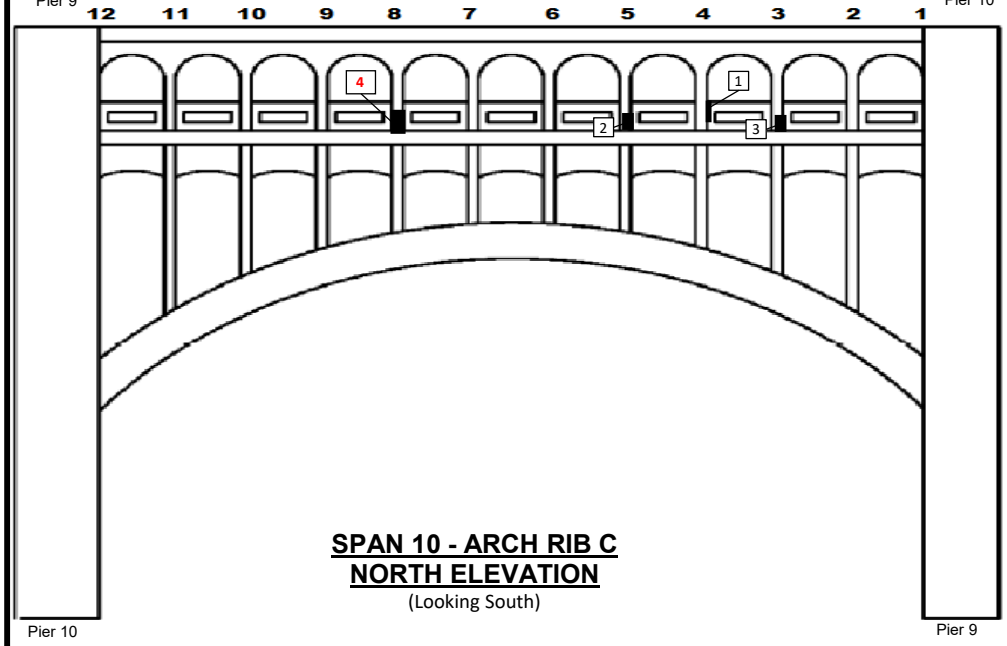
SPAN 10 - ARCH RIB C NORTH ELEVATION
(Looking South)

SPAN 10 - ARCH RIB C NORTH ELEVATION DEFICIENCIES	
#	Defect
1	Delamination - 1 SF
2	Spall w/ exp. Reinf. - 3 SF
3	Delamination - 2 SF
4	**Delamination - 2 SF**

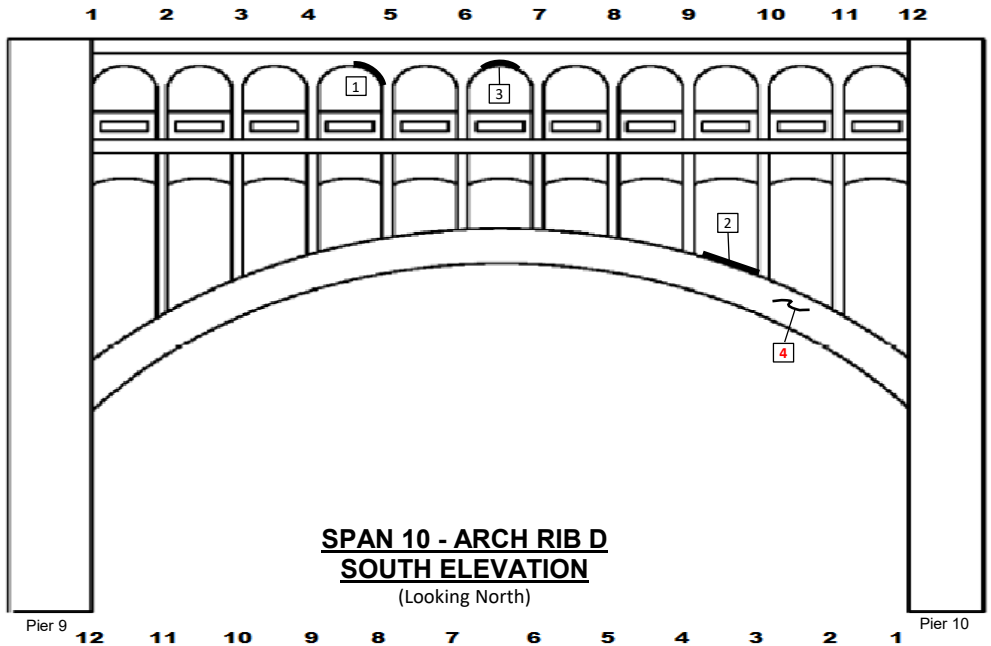
SPAN 10 - ARCH RIB D SOUTH ELEVATION
(Looking North)

SPAN 10 - ARCH RIB D SOUTH ELEVATION DEFICIENCIES	
#	Defect
1	Delamination - 6 SF
2	Delamination - 4' L x 3' W
3	Delamination - 6 SF
4	**Crack - 3 LF**

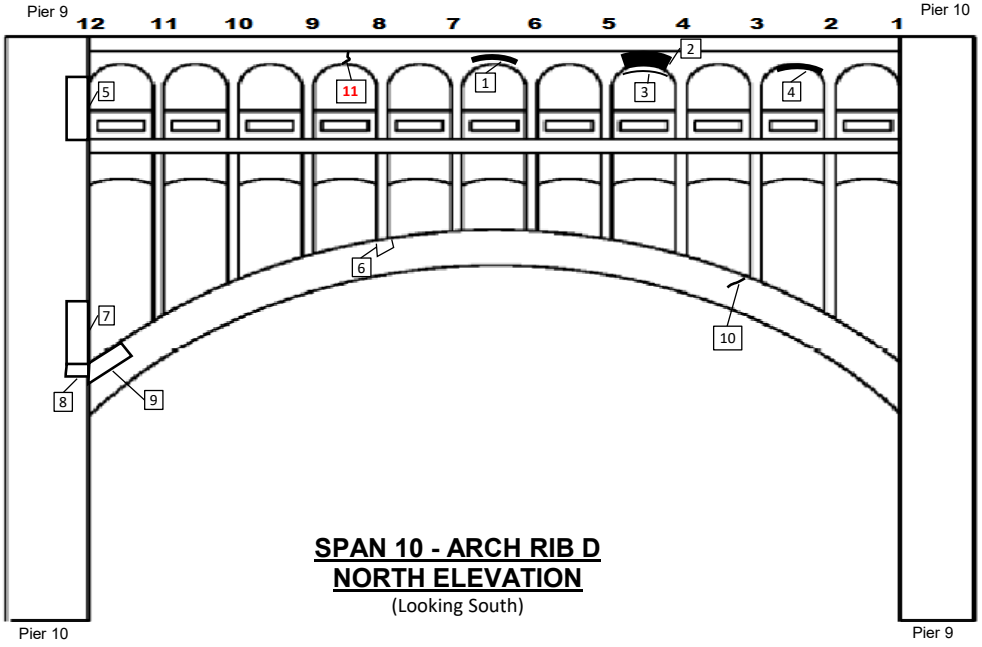
SPAN 10 - ARCH RIB D NORTH ELEVATION
(Looking South)

SPAN 10 - ARCH RIB D NORTH ELEVATION DEFICIENCIES	
#	Defect
1	Delamination - 5 SF
2	Delamination - 24 SF
3	Delamination - 18 SF
4	Delamination - 3 SF
5	Delamination (On tower behind drain pipe) - 45 SF
6	Delamination - 1.5' L x 6" W
7	Delamination - 1 SF
8	Spall - 1 SF
9	Map cracking - 10 SF
10	Crack - 1 LF
11	**Crack - 1 LF**

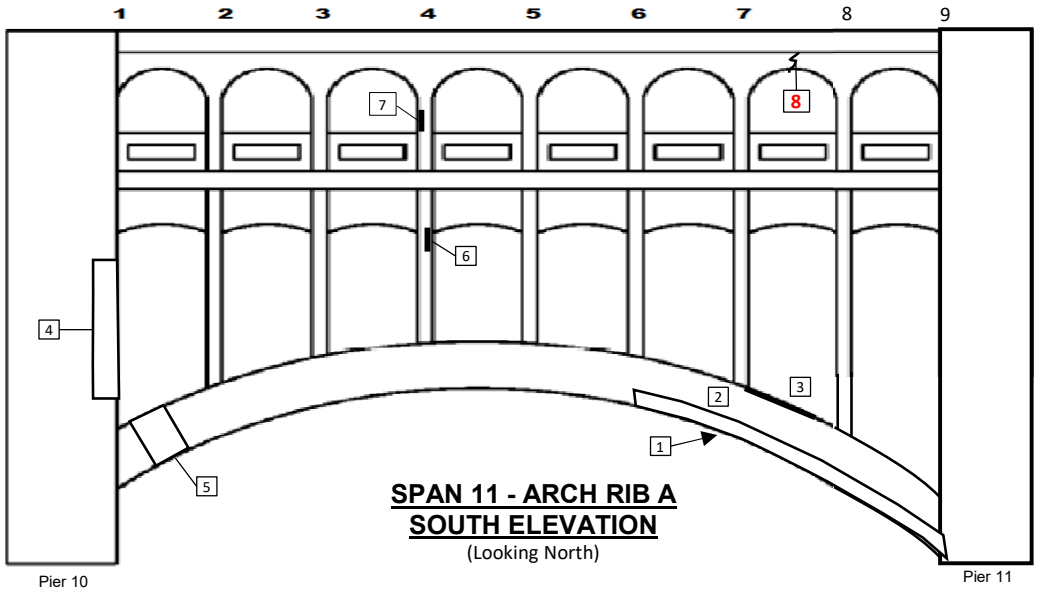
SPAN 11 - ARCH RIB A SOUTH ELEVATION
(Looking North)

SPAN 11 - ARCH RIB A SOUTH ELEVATION DEFICIENCIES	
#	Defect
1	Crack on south face extending from pier 11 to column 5
2	Delamination with cracking - 60 SF
3	Delamination - 6' L x 1' W
4	Delamination - 6' L x 2' W
5	Map cracking - 16 SF
6	Spall - 6" L x 3" W
7	Spall w/ exp. Reinf. - 1 SF
8	**Crack - 2 LF**

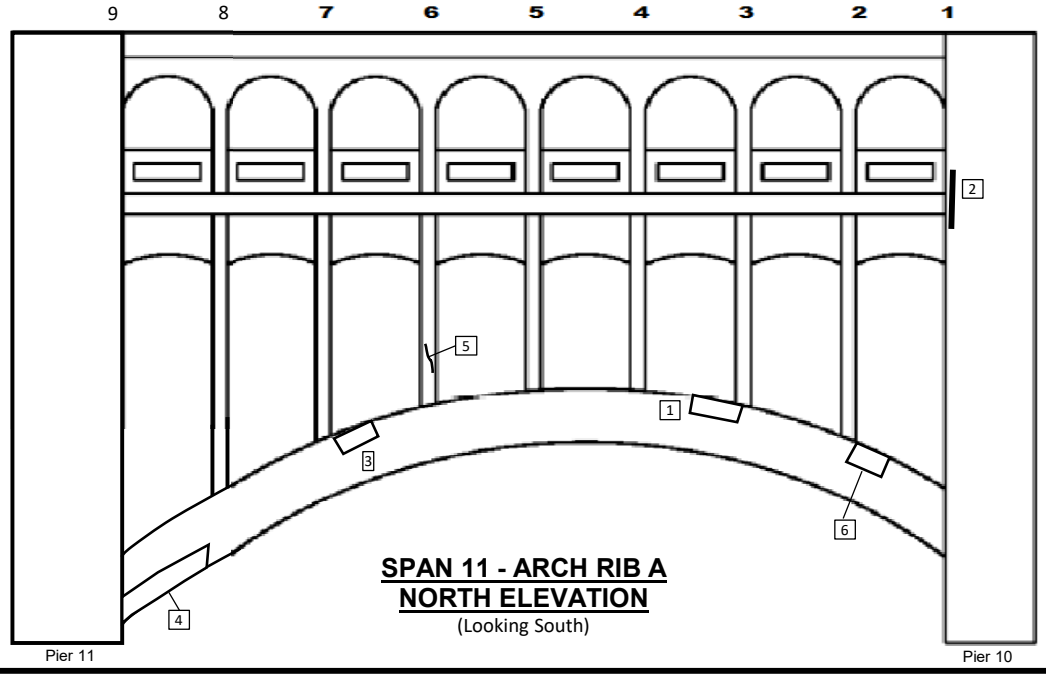
SPAN 11 - ARCH RIB A NORTH ELEVATION
(Looking South)

SPAN 11 - ARCH RIB A NORTH ELEVATION DEFICIENCIES	
#	Defect
1	Delamination - 6' L x 1' W
2	Delamination - 8' L x 1.5' W
3	Delamination - 3' L x 6" H
4	Map cracking - 8' L x 1.5' H
5	Crack - 2 LF
6	Map cracking - 3' L x 2' H

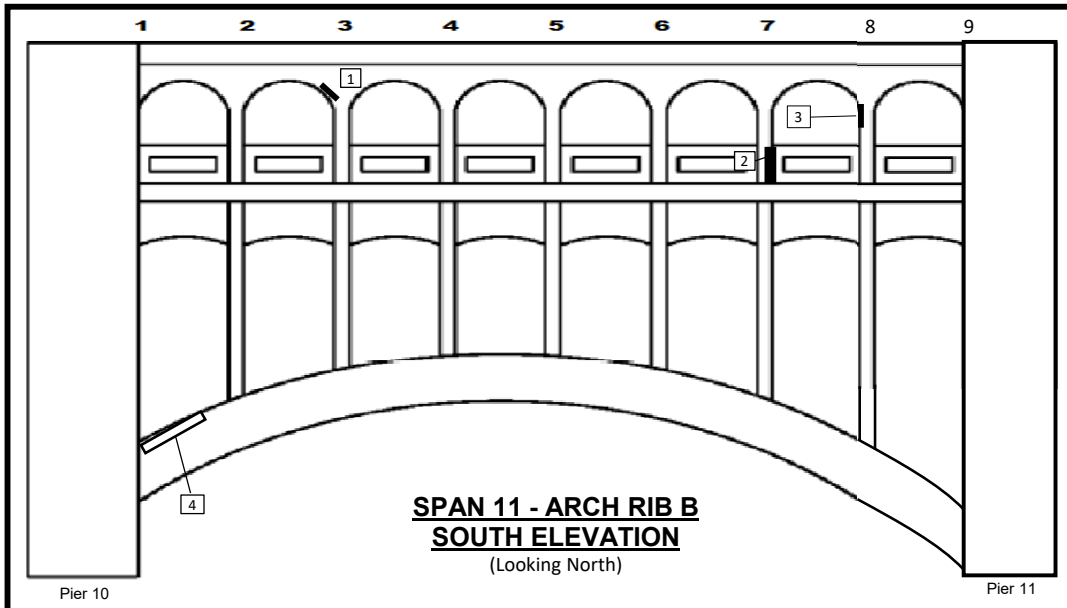
SPAN 11 - ARCH RIB B SOUTH ELEVATION
(Looking North)

SPAN 11 - ARCH RIB B SOUTH ELEVATION DEFICIENCIES	
#	Defect
1	Delamination - 1 SF
2	Spall w/ exp. Reinf., 3" D - 1 SF
3	Delamination - 1 SF
4	Map Cracking - 5 SF
