2025 PHYSICAL CONDITION ROUTINE ELEMENT LEVEL INSPECTION REPORT

Bridge CUY-6-1456
SFN 1800930

Detroit-Superior/Veteran's Memorial over Cuyahoga River
Dates of Inspection: October 6-10, 2025

ODOT DISTRICT 12
5500 TRANSPORTATION BOULEVARD
GARFIELD HEIGHTS, OHIO 44125
DECEMBER 30, 2025

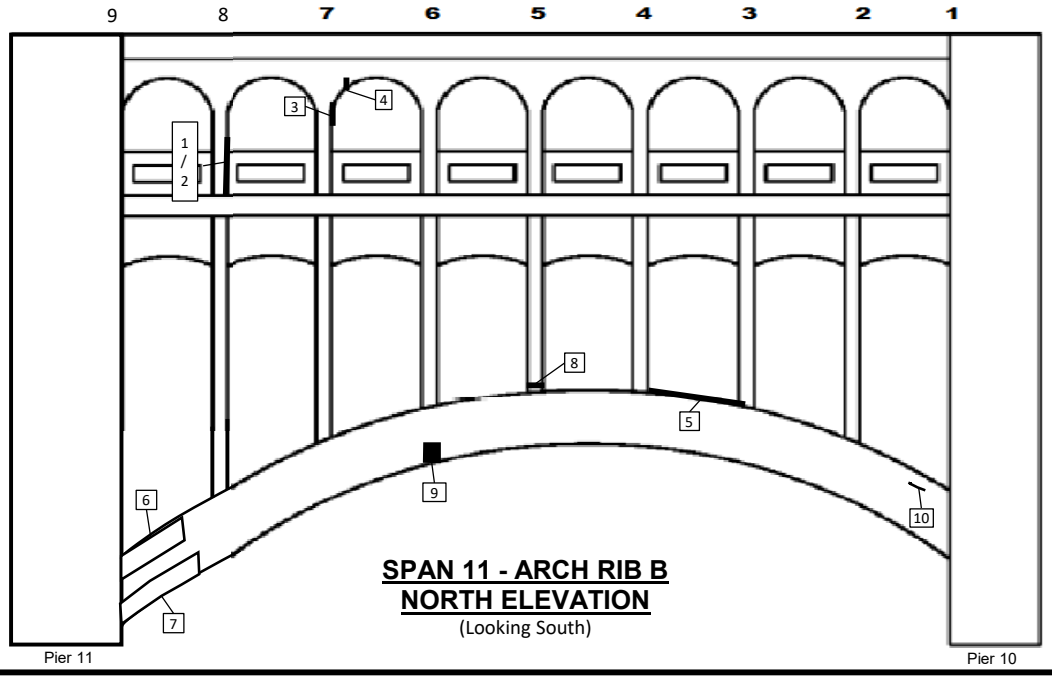
SPAN 11 - ARCH RIB B NORTH ELEVATION
(Looking South)

SPAN 11 - ARCH RIB B NORTH ELEVATION DEFICIENCIES	
#	Defect
1	Spall w/ exp Reinf., 3" D - 1 SF
2	Delamination - 35 SF
3	Delamination - 3 SF
4	Delam. w/ Spall w/ exp. Reinf., 3" D - 3 SF
5	Delamination - 6' L x 1' W
6	Delamination - 4' L x 1' W
7	Delamination - 6' L x 1' W
8	Crack - 2 LF
9	Spall - 1 SF
10	Crack - 1 LF

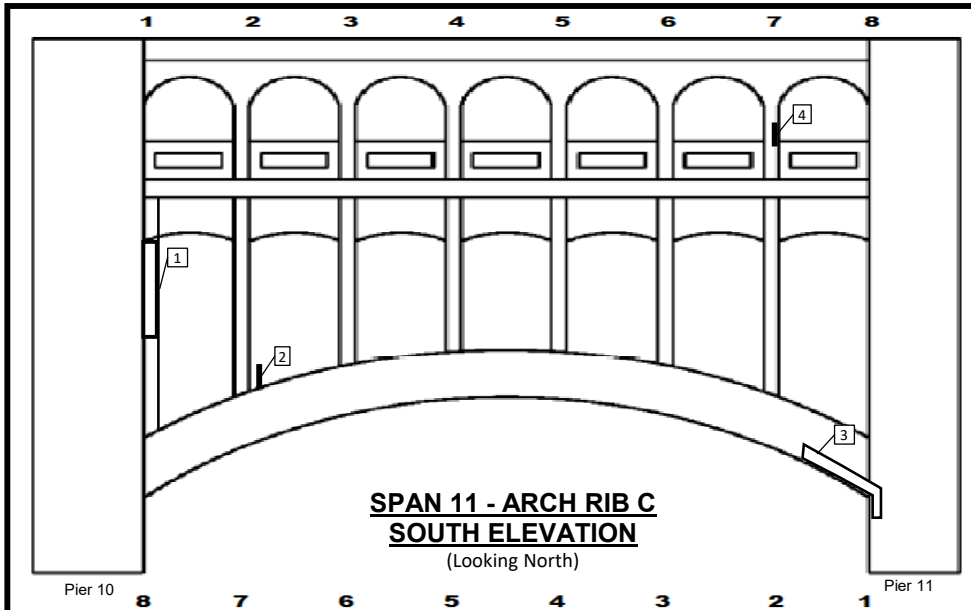
SPAN 11 - ARCH RIB C SOUTH ELEVATION DEFICIENCIES	
#	Defect
1	Delamination - 8 SF
2	Delamination - 1 SF
3	Delam. w/ rust staining - 6' L x 1' W
4	Delamination - 1 SF

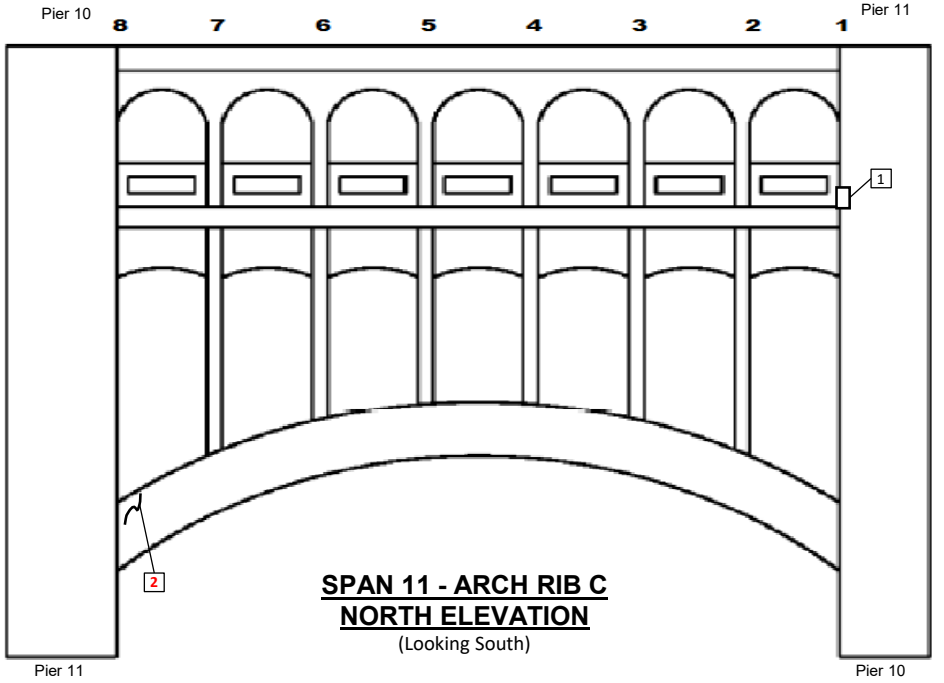
SPAN 11 - ARCH RIB C NORTH ELEVATION DEFICIENCIES	
#	Defect
1	Incomplete repair location (no reinf. exp.) - 1 SF
2	**Crack - 3 LF**

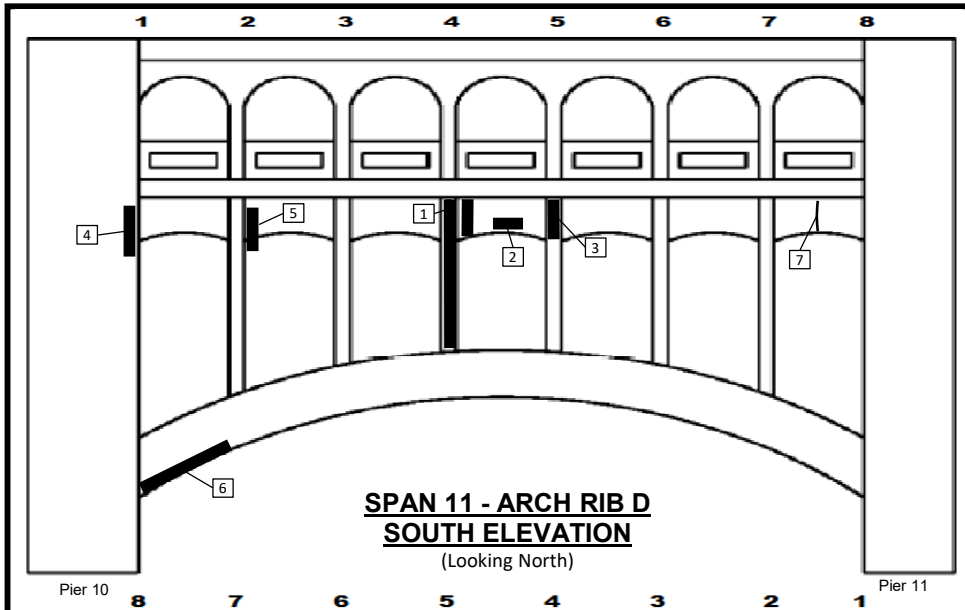
SPAN 11 - ARCH RIB D SOUTH ELEVATION
(Looking North)

SPAN 11 - ARCH RIB D SOUTH ELEVATION DEFICIENCIES	
#	Defect
1	Spall w/ exp. Reinf., 6" D - 1.5' W x Full H
2	Spall w/ exp. Reinf. - 2 SF
3	Delamination - 2 SF
4	Spall - 1 SF
5	Delamination - 1 SF
6	Map cracking - 10 SF
7	Crack - 3 LF

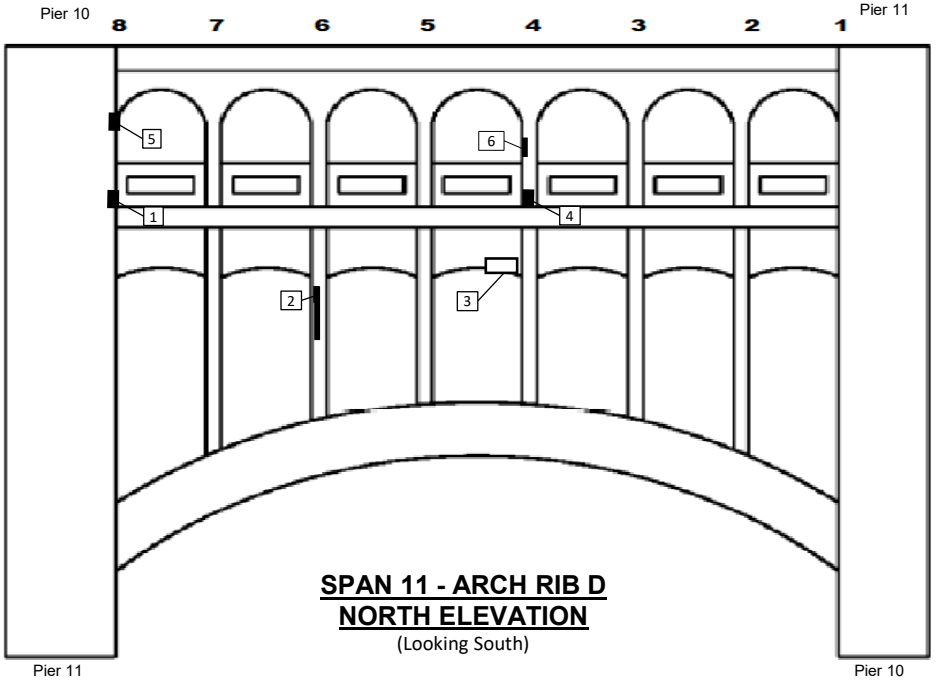
SPAN 11 - ARCH RIB D NORTH ELEVATION
(Looking South)

SPAN 11 - ARCH RIB D NORTH ELEVATION DEFICIENCIES	
#	Defect
1	Delamination - 2 SF
2	Delamination - 2 SF
3	Delamination - 4 SF
4	Delamination - 2 SF
5	Spall (corbel) - 2 SF
6	Spall w/ exp. Reinf. - 1 SF

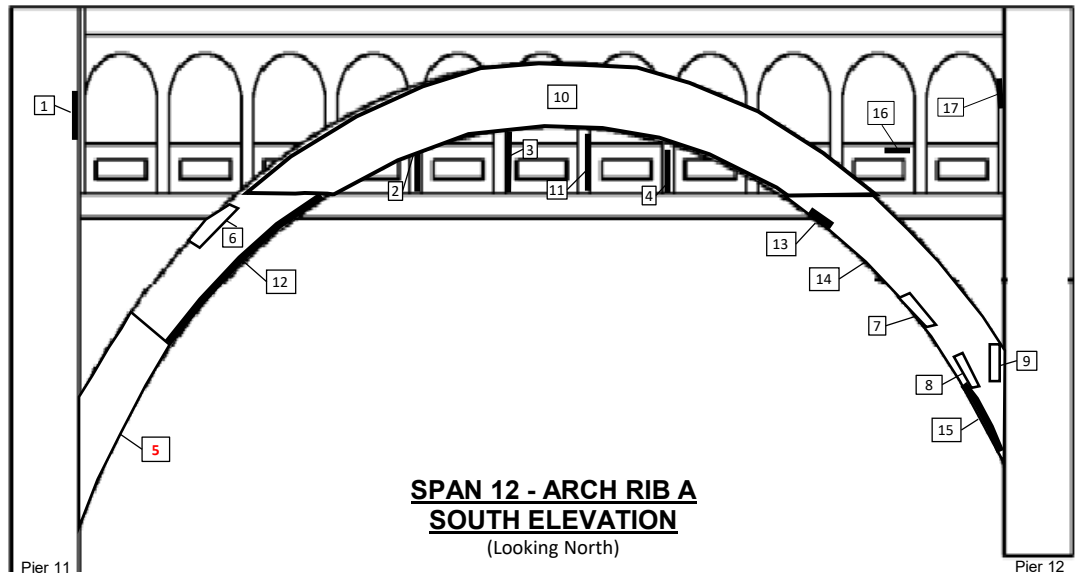
SPAN 12 - ARCH RIB A
SOUTH ELEVATION
(Looking North)

Note: All concrete encased steel hangers sound delaminted due to only 4"± cover between steel hanger and outside face of concrete.

SPAN 12 - RIB A SOUTH ELEVATION DEFICIENCIES			
#	Defect	#	Defect
1	Spall w/ exp. Reinf., 4" D - 3 SF	10	S. face of arch delam. (90%) w/ widespread cracking near the bases. 1/2" W crack in delam. surface.
2	Delam. w/ 1/8" W Crack - 12 SF		
3	Delam. w/ 1/2" W Crack - 15 SF		
4	Delamination - 8 SF	11	Delamination - 12 SF
5	Delamination - 56 SF	12	Map cracking - 120 SF
6	Delamination - 6' L x 1' W	13	Incomplete Sawcut Repair (I.S.R.) Location - 4 SF
7	Delamination - 2' L x 1' W		
8	Delamination - 3' L x 1' W	14	Map cracking - 80 SF
9	Delamination - 1' L x 1' W	15	Map cracking - 48 SF
		16	Spall w/ exp. Reinf. - 2 SF
		17	Spall w/ exp. Reinf. - 8 SF

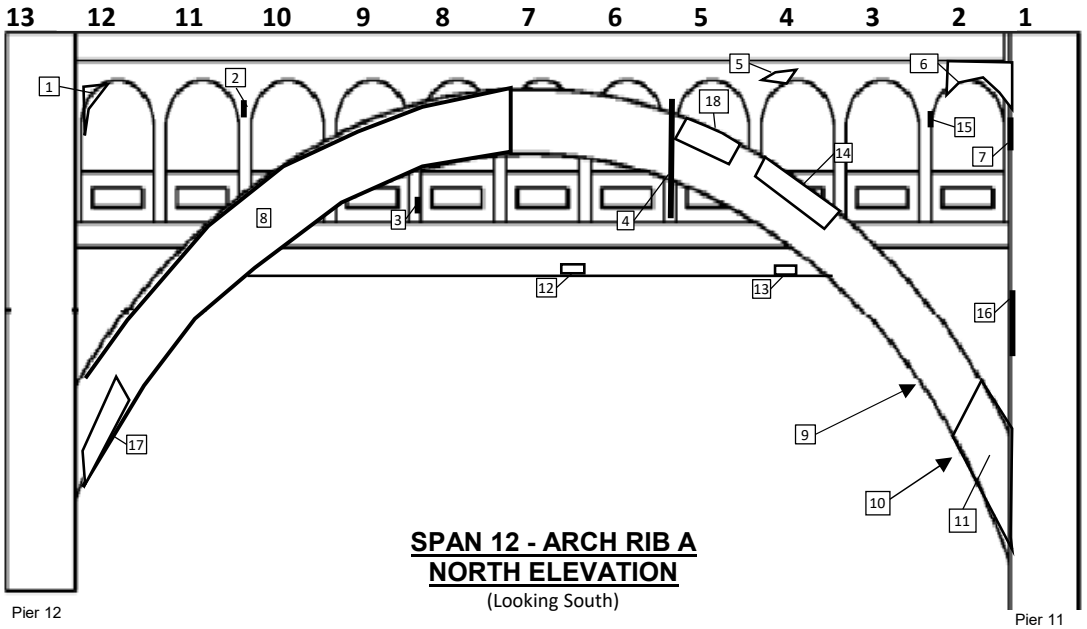
SPAN 12 - ARCH RIB A
NORTH ELEVATION
(Looking South)

SPAN 12 - RIB A NORTH ELEVATION DEFICIENCIES			
#	Defect	#	Defect
1	Spall w/ exp. Reinf., 6" D - 12 SF	12	Spall - 1 SF
2	Spall w/ exp. Reinf., 2" D - 1 SF	13	Spall - 1 SF
3	Spall w/ exp. Reinf., 2" D - 1 SF	14	Delamination - 15 SF (8 LF)
4	Delamination - 8 SF	15	Spall w/ exp. Reinf. - 1 SF
5	Spall w/ exp. Reinf., 2" D - 1 SF	16	Delam. w/ Spall w/ exp. Reinf. (on pier) - 4 SF
6	Entire face of arch is spalling and delaminated, up to 3" D	17	Spall, 1" D - 3' L x 1' W
7	Spall, 4" D (on pier) - 8 SF	18	Delamination - 8 SF
8	Delam. w/ map cracking & poor patching - 120 SF (40 LF)		
9	Delam. (U.o.A) - 5' L x 1' W		
10	Delam. (U.o.A) - 18' L x 1' W		
11	Delam. w/ Spall - 18 LF

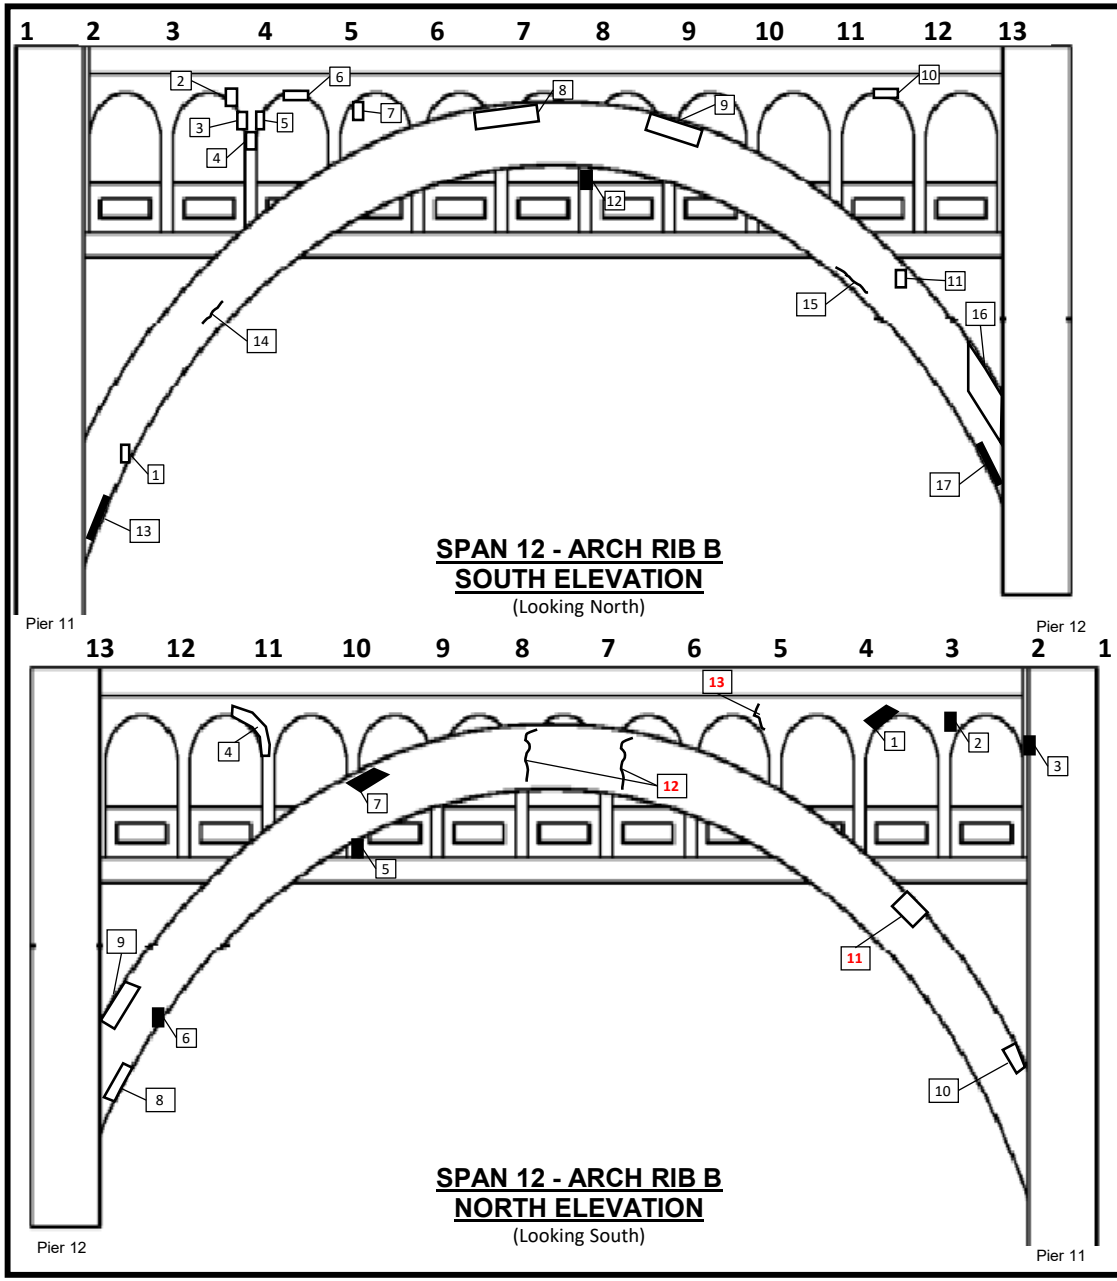
Note: All concrete encased steel hangers sound delaminted due to only 4"± cover between steel hanger and outside face of concrete.

SPAN 12 - ARCH RIB B SOUTH ELEV. DEFICIENCIES			
#	Defect	#	Defect
1	Delam. - 1' L x 1' W	9	I.S.R. - 3 SF
2	Incomplete Sawcut Repair (I.S.R.) Location - 1 SF	10	I.S.R. - 4 SF
		11	Delamination - 1 SF
3	I.S.R. - 1 SF	12	Delamination - 6 SF
4	I.S.R. - 1 SF	13	Map cracking - 4 SF
5	I.S.R. - 1 SF	14	Crack - 1 LF
6	I.S.R. - 1 SF	15	Crack - 3 LF
7	I.S.R. - 1 SF	16	Map cracking - 12 SF
8	I.S.R. - 4 SF	17	Map cracking - 4 SF

SPAN 12 - ARCH RIB B NORTH ELEV. DEFICIENCIES			
#	Defect	#	Defect
1	Delamination - 2 SF	5	Delamination - 9 SF
2	Delamination - 1 SF	6	Delamination - 6 SF
3	Delamination - 1 SF	7	Delam. - 2 SF
4	Delamination - 1 SF	8	Map cracking - 4 SF
		9	Map cracking - 8 SF
		10	Map cracking - 2 SF
		11	**Map cracking - 2 SF**
		12	**Crack - 8 LF**
		13	**Crack - 3 LF**

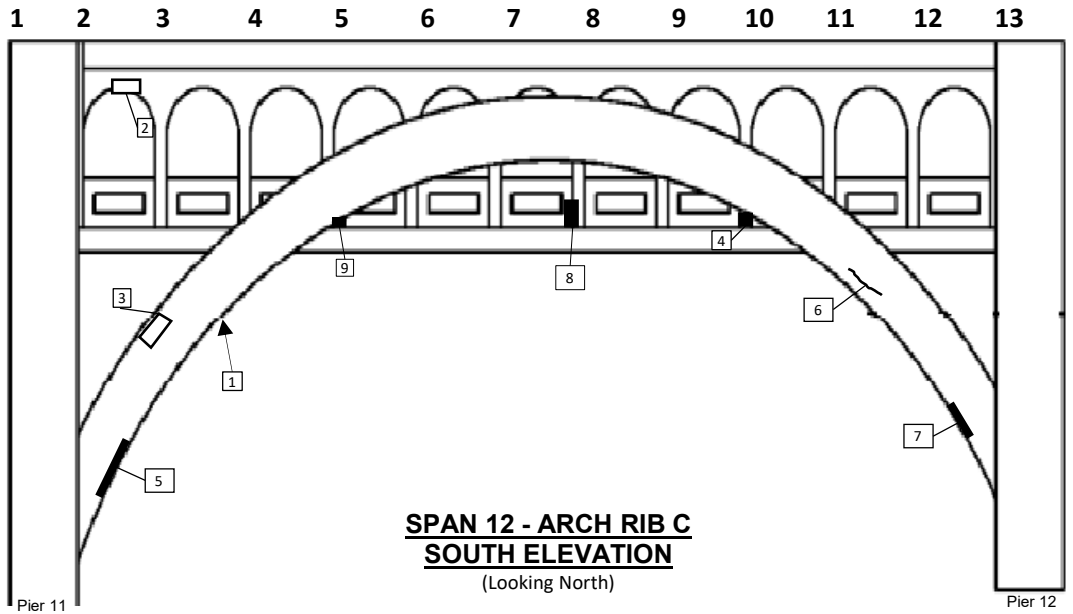
SPAN 12 - ARCH RIB C
SOUTH ELEVATION
(Looking North)

Note: All concrete encased steel hangers sound delaminted due to only 4"± cover between steel hanger and outside face of concrete. Map cracking typical.

SPAN 12 - ARCH RIB C SOUTH ELEVATION DEFICIENCIES			
#	Defect	#	Defect
1	Delam. (underside) - 5 SF	5	Crack - 5 LF
2	Incomplete Sawcut Repair Location (I.S.R.) w/ exp. Reinf. - 3 SF	6	Map cracking - 5 SF
		7	Map cracking - 2 SF
		8	Spall w/ exp. Reinf. - 3 SF
3	Delamination - 2 SF		
4	I.S.R. w/ exp. Reinf. (entire face is exposed) - 10 SF	9	Spall w/ exp. Reinf. - 1 SF

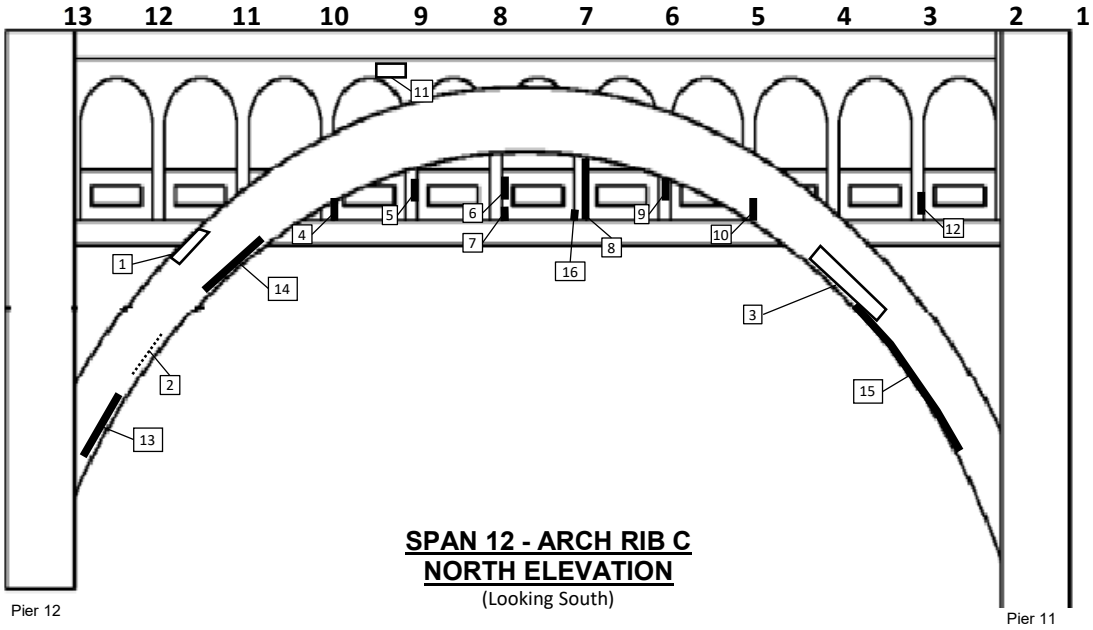
SPAN 12 - ARCH RIB C
NORTH ELEVATION
(Looking South)

SPAN 12 - ARCH RIB C NORTH ELEVATION DEFICIENCIES			
#	Defect	#	Defect
1	Delamination - 2 SF	7	I.S.R. w/ exp. Reinf. - 3 SF
2	1/16" Crack w/ Delam. - 5 LF	8	Delamination - 10 SF
3	Delaminations - 5' L x 1' W & 1' L x 1' W	9	Delamination - 6 SF
		10	Delamination - 5 SF
4	Delamination - 8 SF	11	I.S.R. w/ exp. Reinf. - 10 SF
5	Delamination - 4 SF	12	Delamination - 1 SF
6	Delamination - 4 SF	13	Map cracking - 6 SF
		14	Map cracking - 6 SF
		15	Map cracking - 20 SF
		16	Spall w/ exp. Reinf. - 1 SF

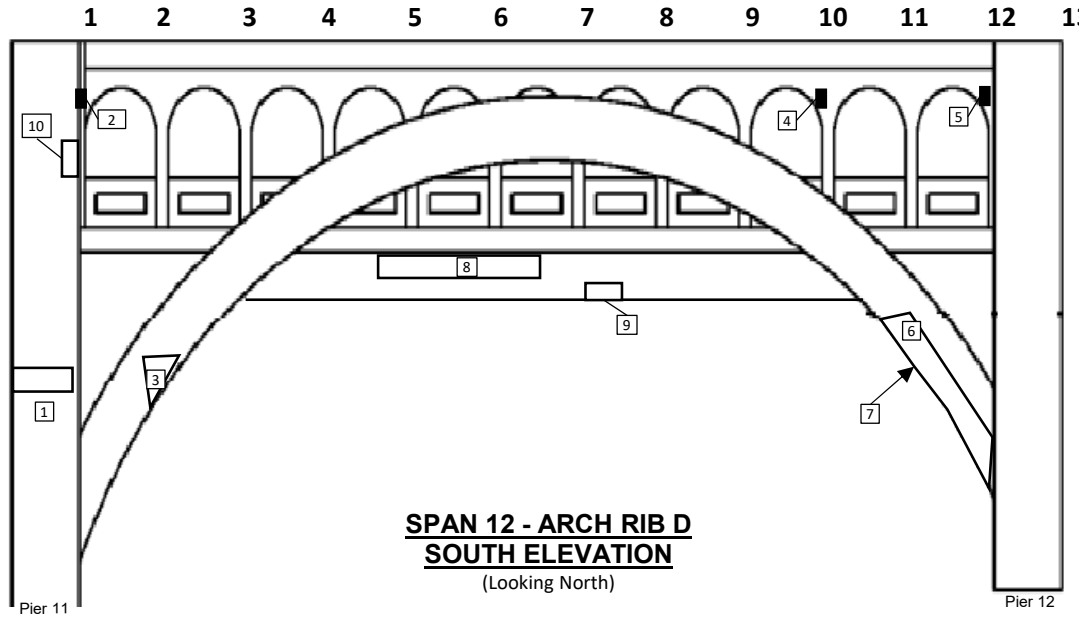
SPAN 12 - ARCH RIB D
SOUTH ELEVATION
(Looking North)

Note: All concrete encased steel hangers sound delaminted due to only 4"± cover between steel hanger and outside face of concrete. Map cracking typical.

SPAN 12 - ARCH RIB D SOUTH ELEVATION DEFICIENCIES			
#	Defect	#	Defect
1	Map Cracking - 4' H x FW	7	Map Cracking (underside) - 20' L x FW
2	Delamination - 2 SF		
3	Map Cracking - 18 SF	8	Delamination - 8' L x 1' W
4	Spall w/ exp. Reinf., 1" D - 1 SF	9	Spall - 2' L x 1' H
5	Spall w/ exp. Reinf., 6" D - 1 SF	10	Map cracking - 4 SF
6	Map Cracking w/ Delamination - 29' L x 2' H

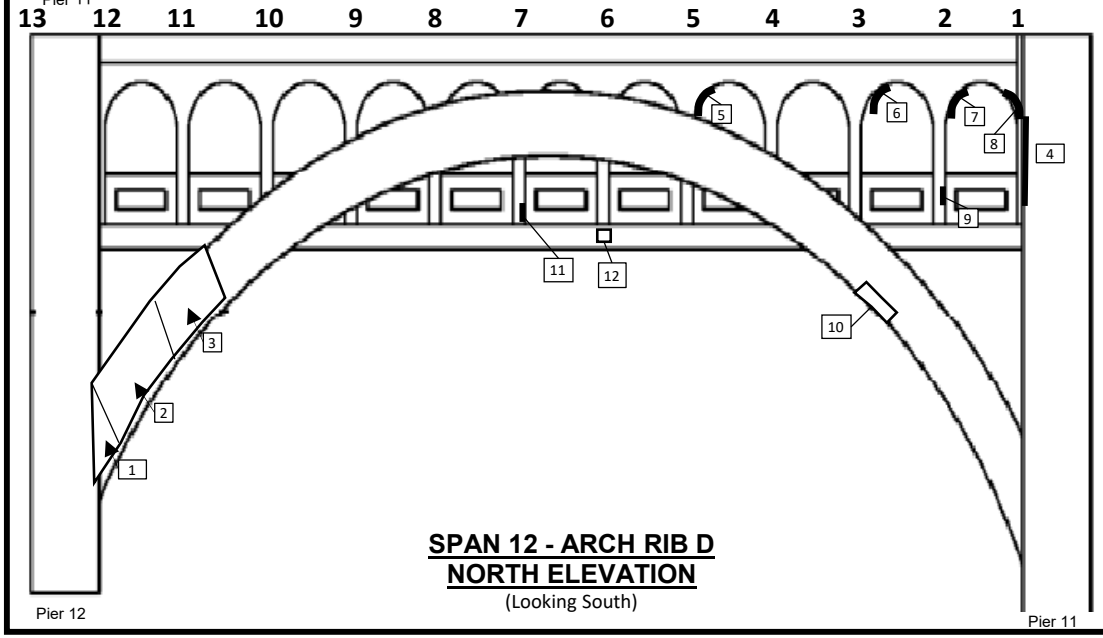
SPAN 12 - ARCH RIB D
NORTH ELEVATION
(Looking South)

SPAN 12 - ARCH RIB D NORTH ELEVATION DEFICIENCIES			
#	Defect	#	Defect
1	Delamination - 3' L x 1' L	5	Delamination - 3 SF
2	Map Cracking - 5' L x 4' H	6	Delamination - 1 SF
3	Delamination - 6' L x 5' H	7	Delamination - 1 SF
4	Spall w/ exp. Reinf. (On tower) - 6 SF	8	Delamination - 2 SF
		9	Spall w/ exp. Reinf. - 1 SF
		10	Map cracking - 4 SF
		11	Delamination - 3 SF
		12	Spall - 3 SF

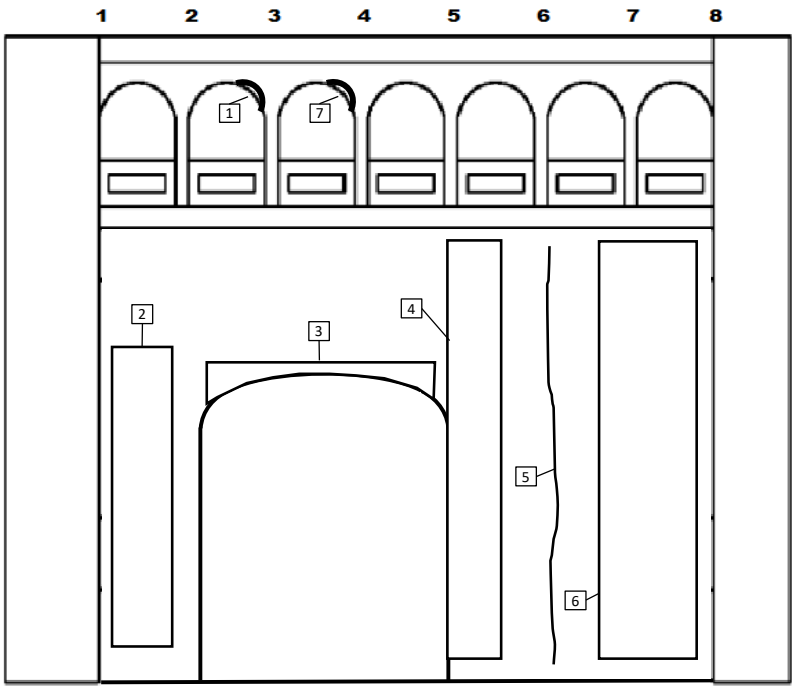
SPAN 13 - ARCH RIB A SOUTH ELEVATION (Looking North)

SPAN 13 - ARCH RIB A SOUTH ELEVATION DEFICIENCIES	
#	Defect
1	Delamination - 1 SF
2	Map cracking - 20 SF
3	Map cracking - 15 SF
4	Map cracking - 15 SF
5	Crack - 15 LF
6	Map cracking - 30 SF
7	Delamination - 3 SF

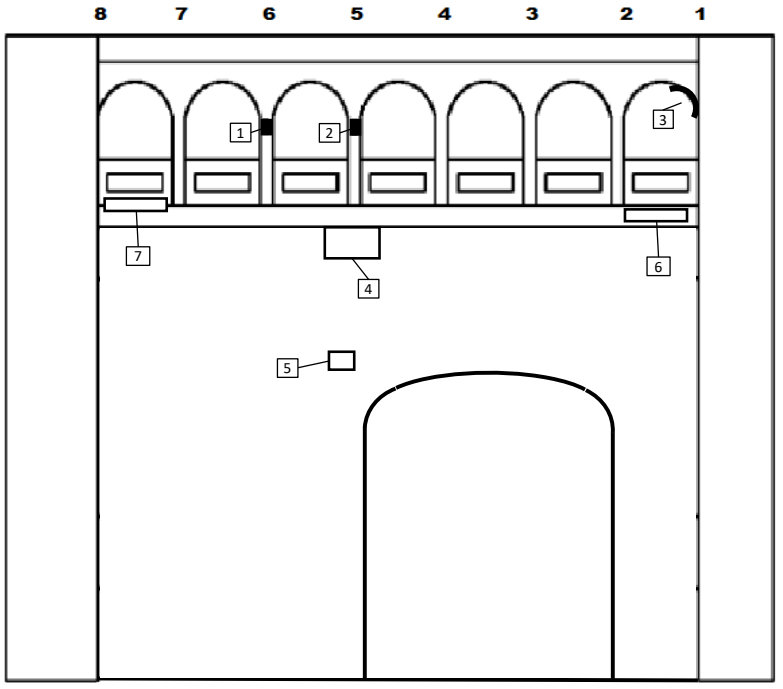
SPAN 13 - ARCH RIB A NORTH ELEVATION (Looking South)

SPAN 13 - ARCH RIB A NORTH ELEVATION DEFICIENCIES	
#	Defect
1	Delamination - 2 SF
2	Delamination - 1 SF
3	Half Width 1/16" crack
4	Map cracking - 4 SF
5	Spall - 1 SF
6	Map cracking - 10 SF
7	Map cracking - 10 SF

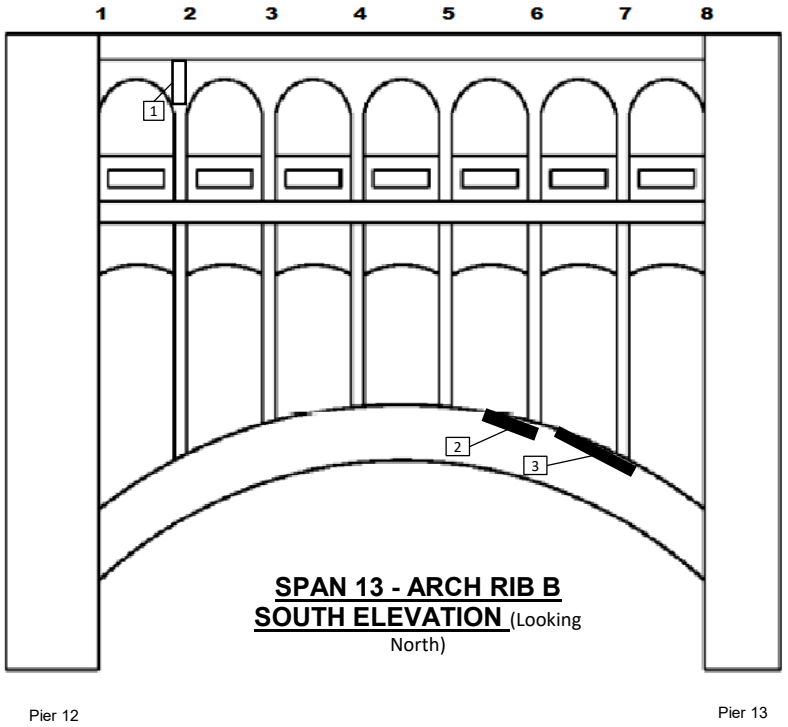
SPAN 13 - ARCH RIB B SOUTH ELEVATION DEFICIENCIES	
#	Defect
1	Incomplete Sawcut Repair Location w/ exp. Reinf. (I.S.R.) - 2 SF
2	Spall - 3 SF
3	Spall - 4 SF

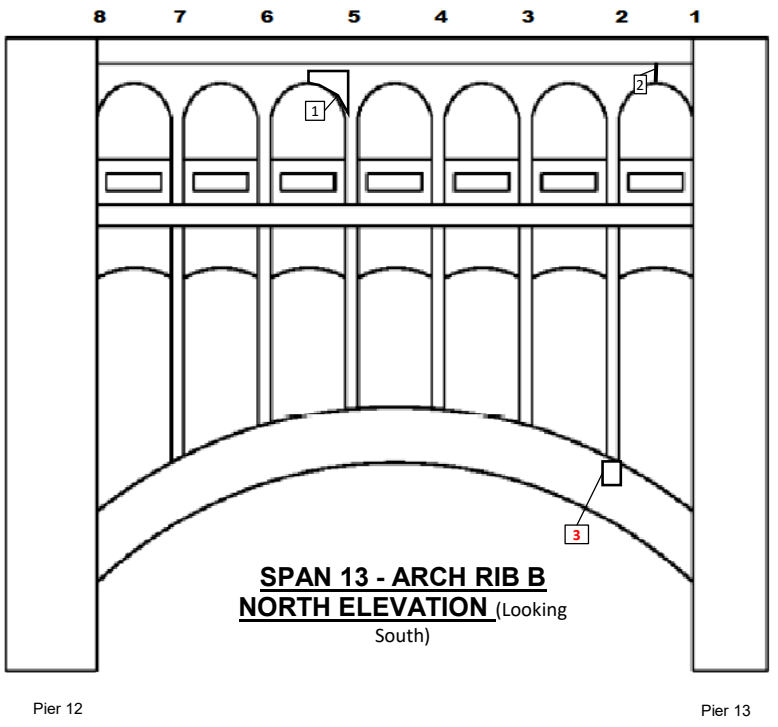
SPAN 13 - ARCH RIB B NORTH ELEVATION DEFICIENCIES	
#	Defect
1	I.S.R. - 8 SF
2	Full Height 1/8" W crack
3	**Delamination - 2 SF**

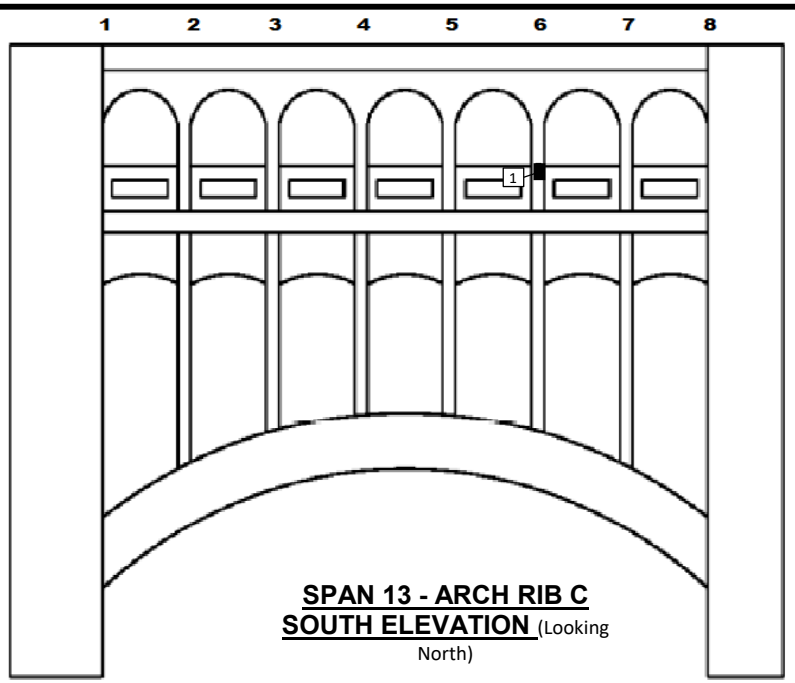
SPAN 13 - ARCH RIB C SOUTH ELEVATION DEFICIENCIES	
#	Defect
1	Spall, 1" D - 1 SF

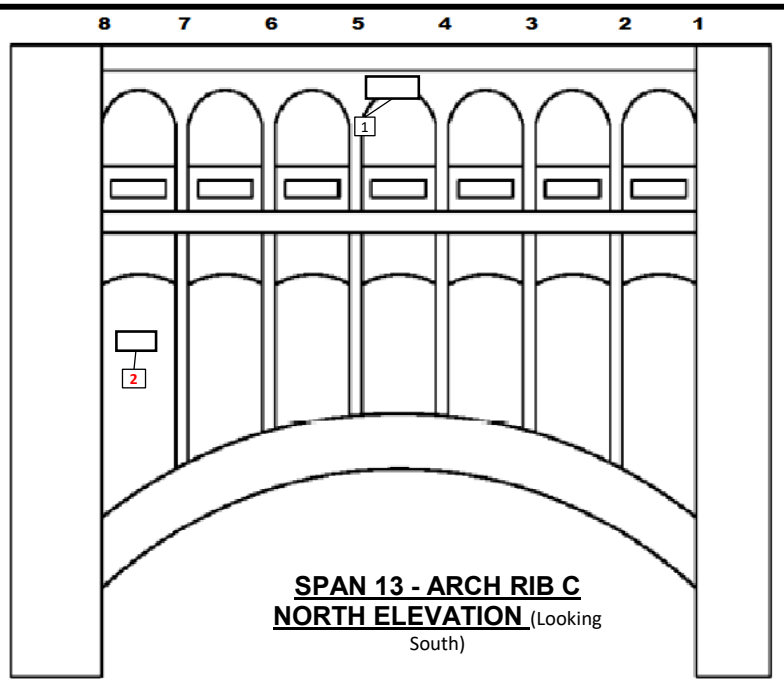
SPAN 13 - ARCH RIB C NORTH ELEVATION DEFICIENCIES	
#	Defect
1	Incomplete Sawcut Repair Location w/ exp. Reinf. (I.S.R.) - 4 SF
2	**Delamination - 2 SF**

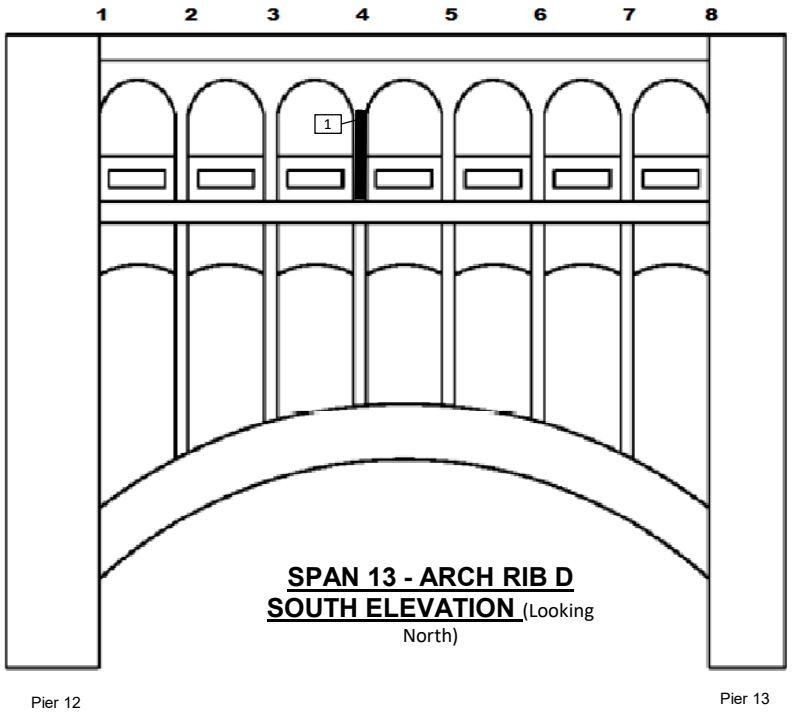
SPAN 13 - ARCH RIB D SOUTH ELEVATION (Looking North)

SPAN 13 - ARCH RIB D SOUTH ELEVATION DEFICIENCIES	
#	Defect
1	Delamination - 12 SF

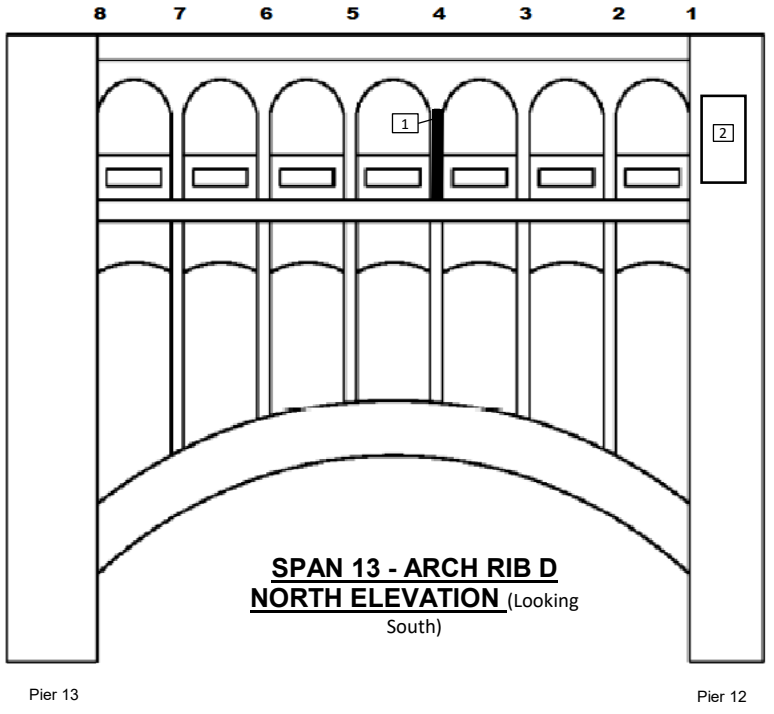
SPAN 13 - ARCH RIB D NORTH ELEVATION (Looking South)

SPAN 13 - ARCH RIB D NORTH ELEVATION DEFICIENCIES	
#	Defect
1	Spall w/ exp. Reinf., 2.5" D - 8 SF
2	Delamination w/ up to 1/8" crack near column 1 (In tower) - 45 SF

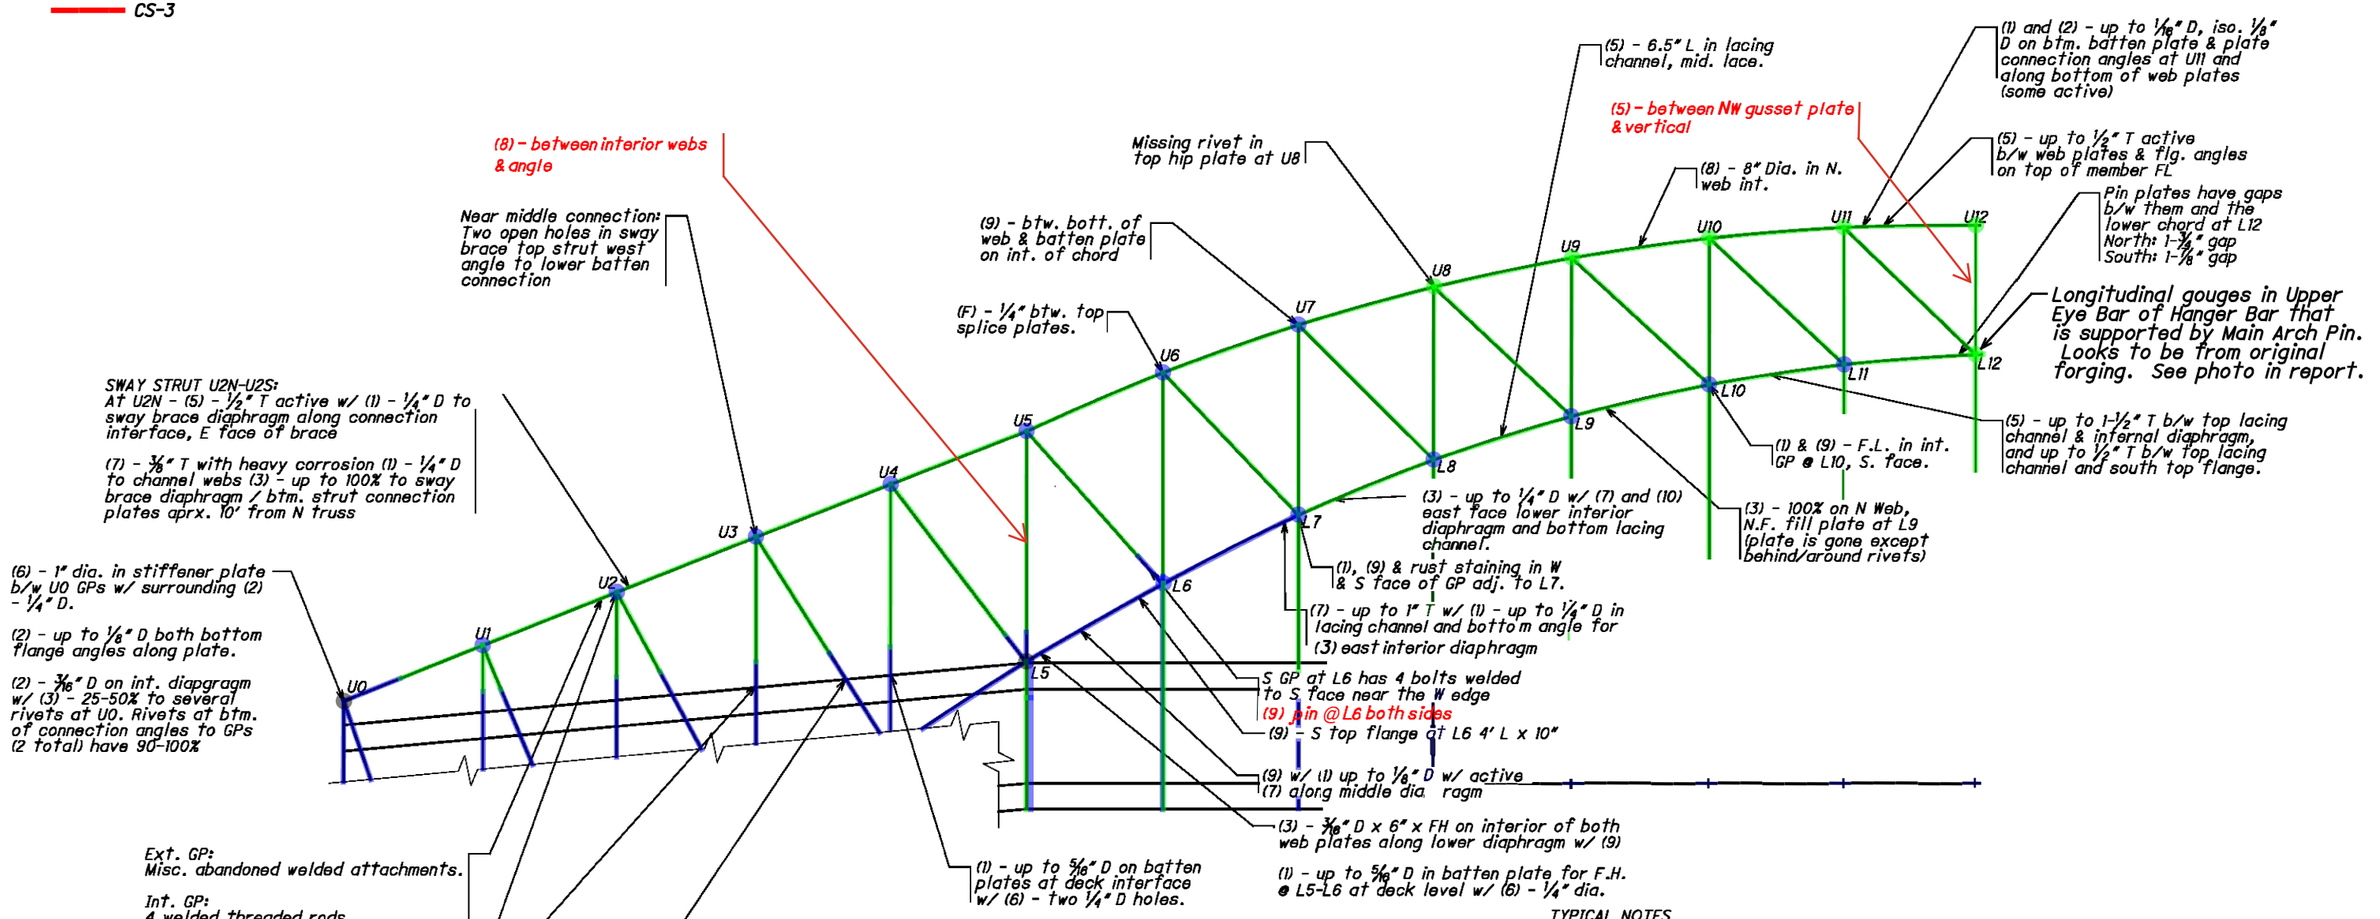
NORTH TRUSS ELEVATION

(A) - Bottom sway strut angles and connection plates typ. have areas of paint failure with (9). Worst for typ. 6' - 8' L near middle of strut.

(B) - Small areas of (9) and paint failure typ. on truss.

(9) - reactivating over a full length along lacing bars webs due to leaking joint w/ (1) moderate to lacing bars w/ (6) - 2" dia. on E face of lacing bar and (5) - up to 3/4" T active b/w lacing bars & flg. angles

(8) - moderate on vert t/o from leaking deck joint above.

broken rivet @ bot. of deck S face

(8) - moderate at E end of L.C. below the deck with rust staining due to water leakage from above the deck
(7) - at top of bottom flange angle both sides.

N face of pin end cover completely broken off & laying on BRG casting below. Exposed pin end exhibits (7/8).

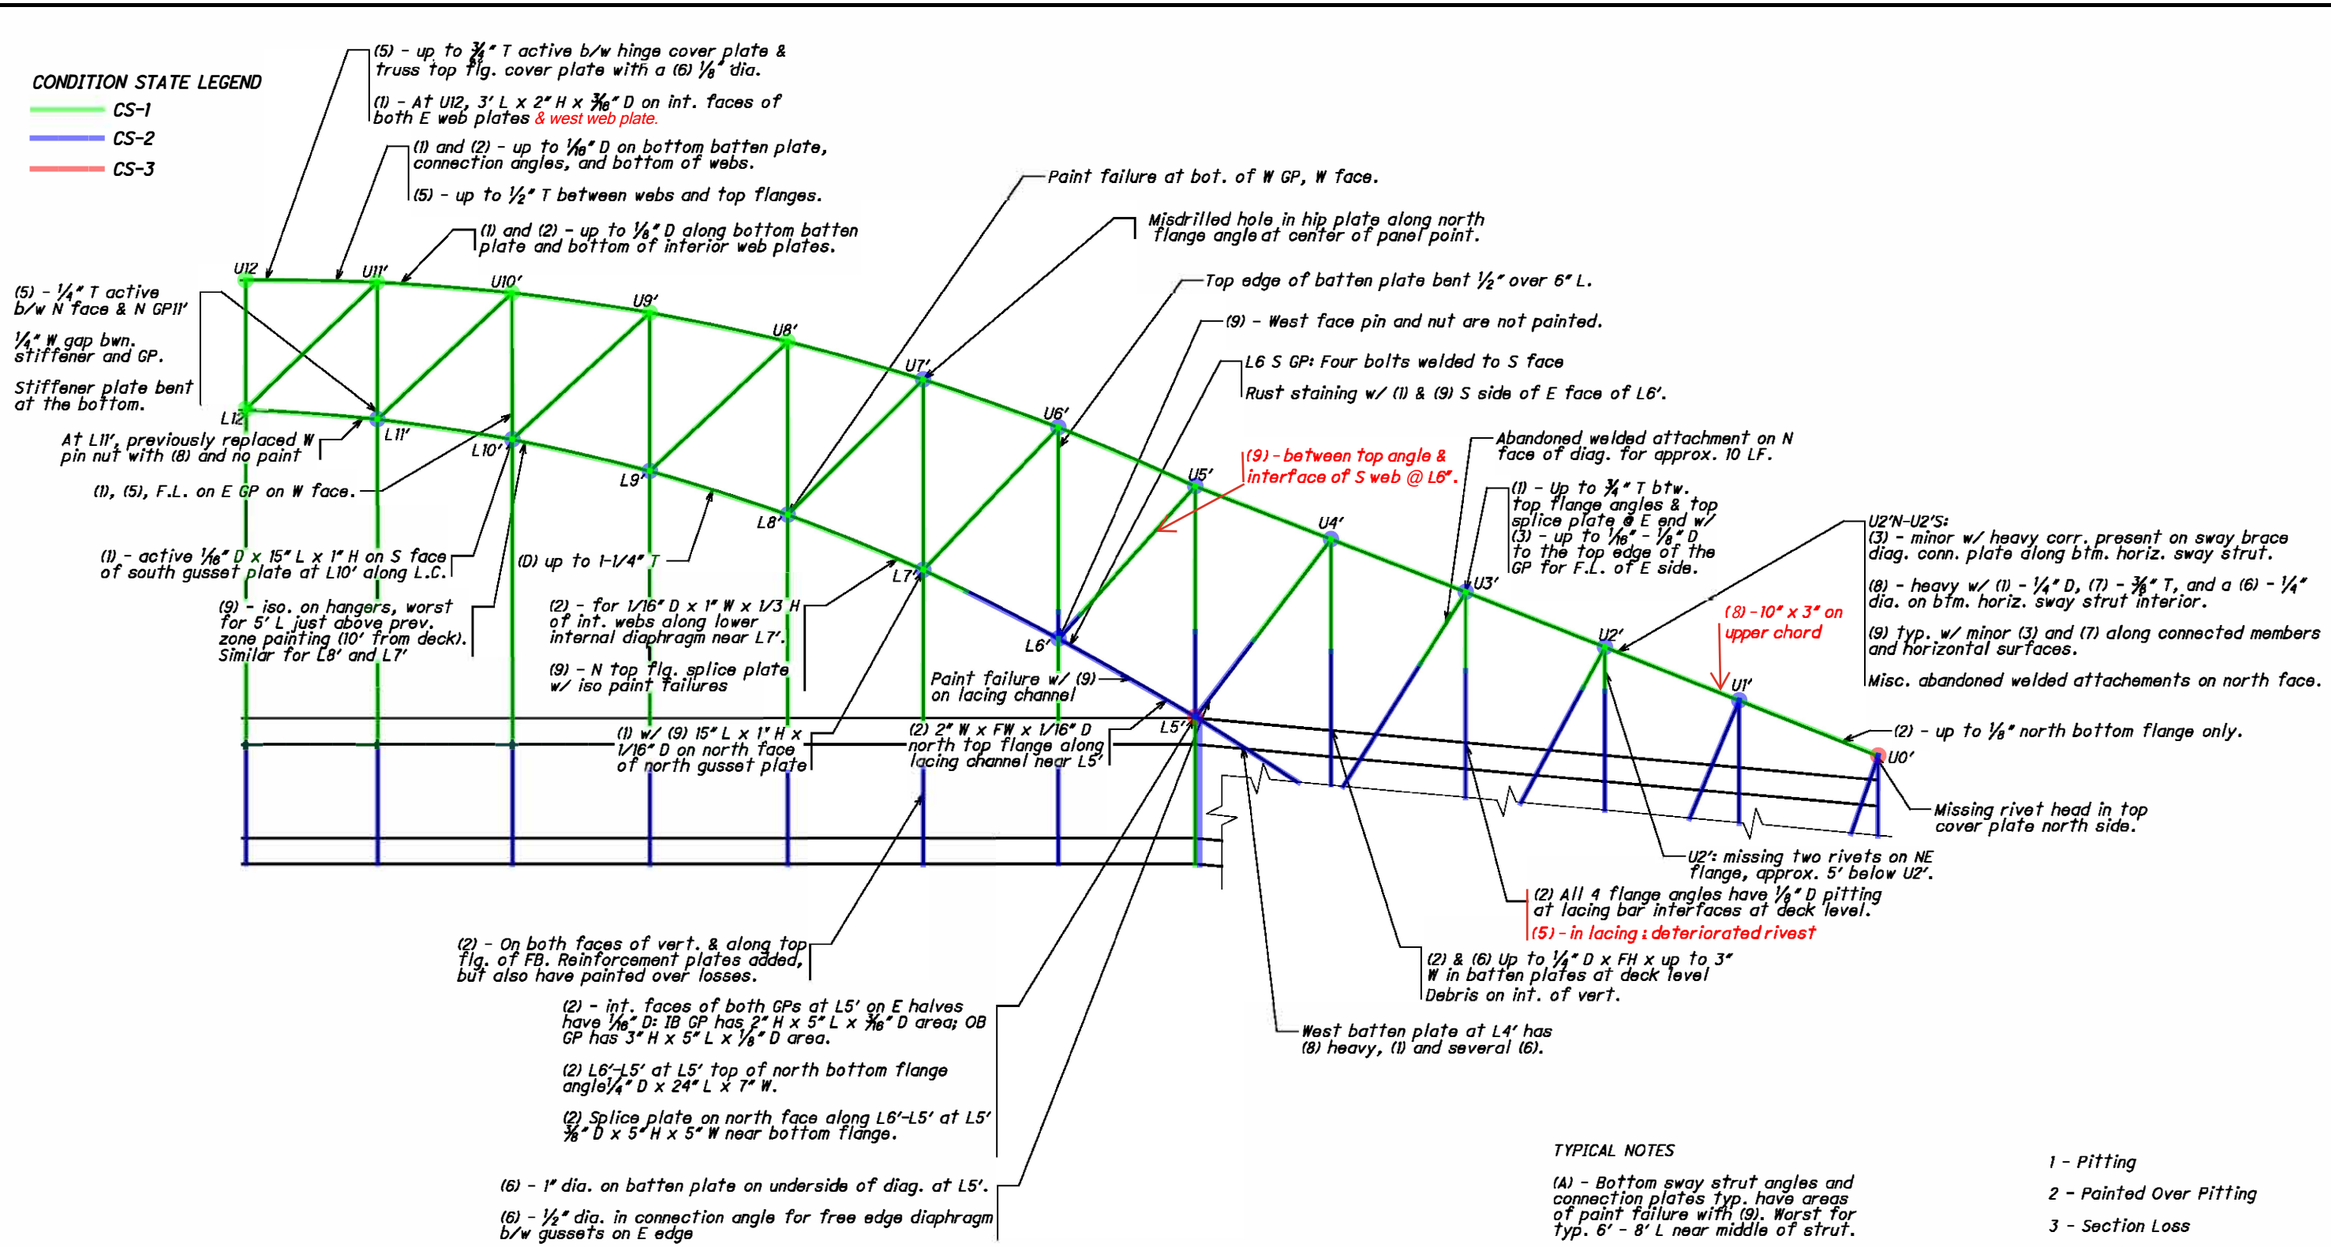
NORTH TRUSS ELEVATION
(ABOVE DECK)

(A) - Bottom sway strut angles and connection plates typ. have areas of paint failure with (9). Worst for typ. 6' - 8' L near middle of strut.

(B) - Small areas of (9) and paint failure typ. on truss.

L2'-L1' at L2':
(1) - 5/16" D in top batten plate w/ welded repair plate. One lacing channel has (6) - 2" dia., and another has 1" dia.

(3) - two lacing bars missing and/or broken due to s.l. at L2'.

L1'S - L1'N: Moderate (9) and paint failure on W bottom flange angle over length.

On L0' OB pin cover plate:
6-¾" L crack in OB face & 1-¼" L crack on top.

On L0' IB pin cover plate:
6-¾" L crack in IB face & 1-½" L crack on top

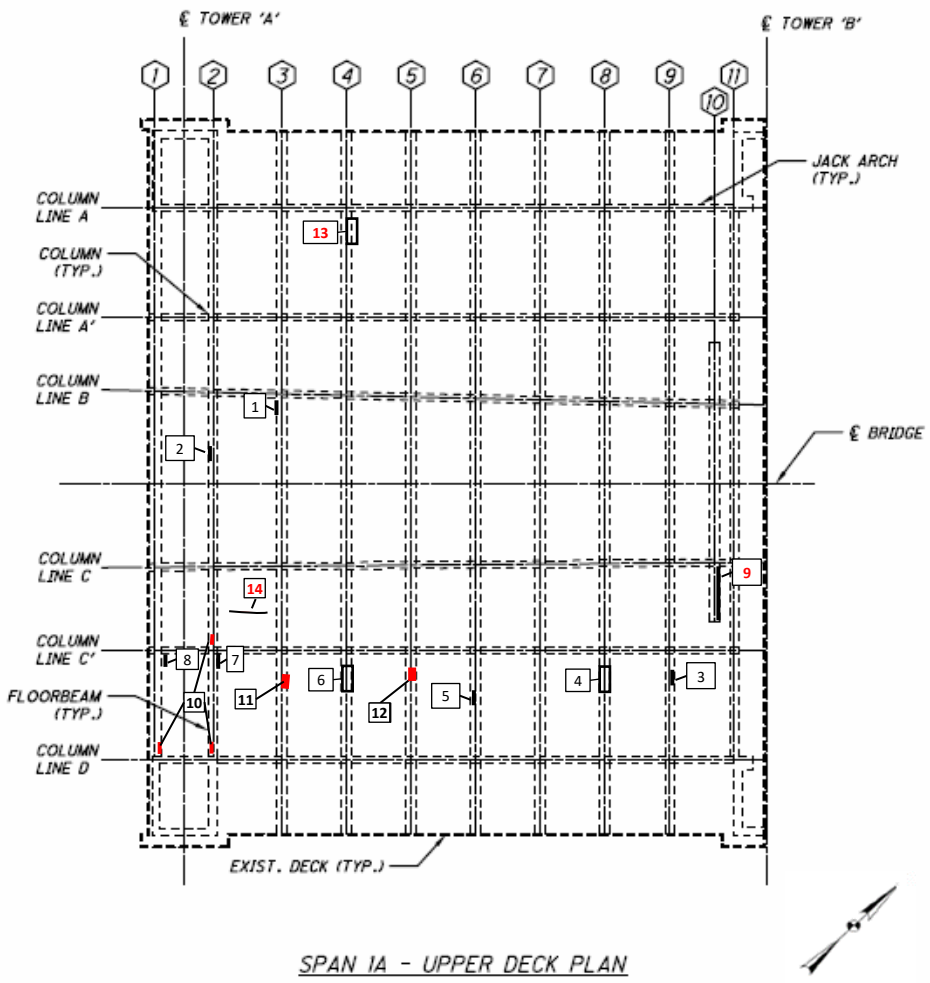
SPAN 1A - UPPER DECK PLAN

SPAN 1A, UPPER DECK DEFICIENCIES	
#	DEFECT
1	Delamination w/ shallow Spall - 3 SF (2 LF)
2	Spall w/ exp. Reinf. - 2 SF (1 LF)
3	Spall w/ exp. Reinf. - 2 SF (2 LF)
4	Shallow Spall w/ exp. Reinf. - 20 SF (4 LF)
5	Spall w/ exp. Reinf. - 2 SF (1 LF) Delamination - 4 SF (2 LF)
6	Spall w/ exp. Reinf. - 20 SF (5 LF)
7	Delamination w/ shallow Spall - 6 SF (2 LF)
8	Delamination w/ shallow Spall - 6 SF (2 LF)
9	Spall w/ exp. Reinf. - 10 LF
10	Transverse cracking - 1 LF
11	Spall w/ exp. Reinf. - 5 LF
12	Spall w/ exp. Reinf. - 5 LF
13	**Delamination - 2 SF (1 LF)**
14	**Crack w/Effloresence (4 LF)**

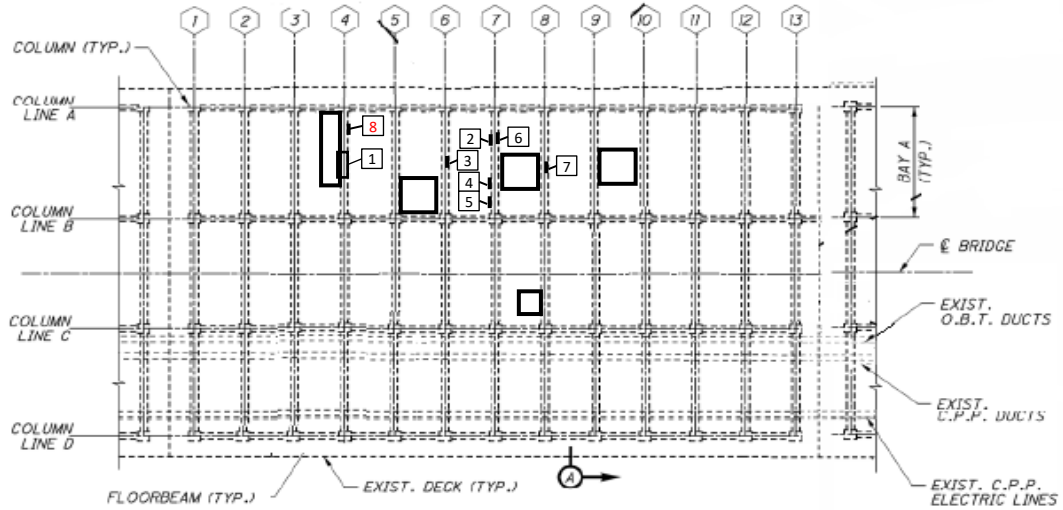
SPAN 1 – UPPER DECK PLAN

SPAN 1, UPPER DECK DEFICIENCIES			
#	DEFECT	#	DEFECT
1	Delamination - 2 SF (2 LF)	5	Delamination - 3 SF (1 LF)
2	Two delams., 3 SF (3 LF)	6	2-Spalls w/ exp. Reinf., 2" D - 2 SF (2 LF)
3	Spall w/ exp. Reinf., 2" D - 1 SF (1 LF)	7	Spall w/ exp. Reinf., 2" D - 1 SF (1 LF)
4	Spall w/ exp. Reinf., 2" D - 1 SF (1 LF)	**8**	**Delamination - 4 SF (4 LF)**
