2025 PHYSICAL CONDITION ROUTINE ELEMENT LEVEL INSPECTION REPORT

Bridge CUY-6-1456
SFN 1800930

Detroit-Superior/Veteran's Memorial over Cuyahoga River
Dates of Inspection: October 6-10, 2025

ODOT DISTRICT 12
5500 TRANSPORTATION BOULEVARD
GARFIELD HEIGHTS, OHIO 44125
DECEMBER 30, 2025

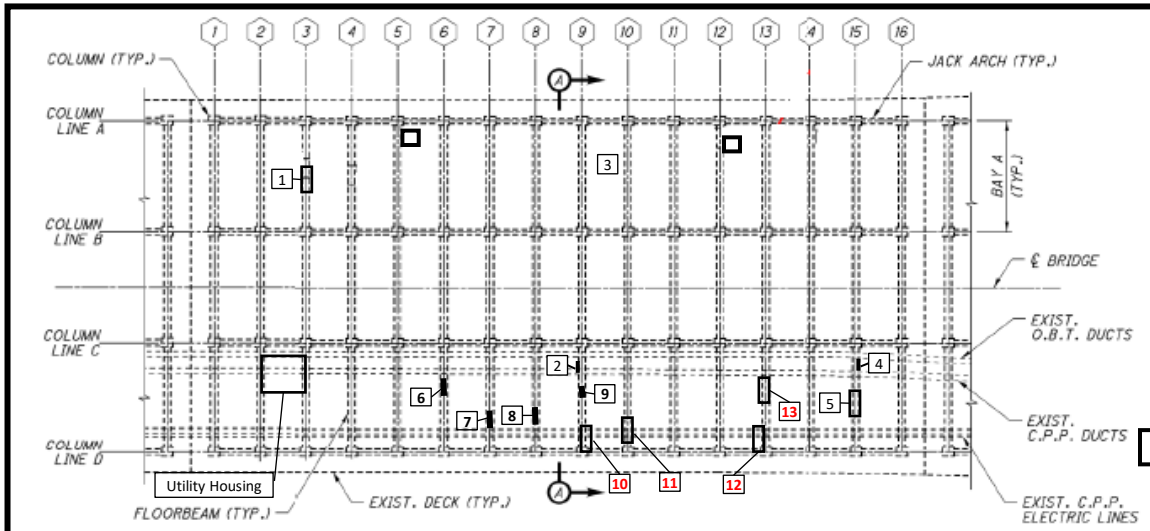
SPAN 2 – UPPER DECK PLAN

SPAN 2, UPPER DECK DEFICIENCIES			
#	DEFECT	#	DEFECT
1	Spall w/ exp. Reinf. - 2 SF (1 LF)	7	Transverse cracking - 15 LF
2	Cracking (10 LF)	8	Transverse cracking - 15 LF
3	Spall, 1" D - 1 SF	9	Longitudinal crack - 3 LF
4	Delamination - 6' L x 1' H	**10**	**Spall w/ exp. Reinf. - 2 SF (1 LF)**
5	Delamination With Spall - **4** SF (**4** LF)	**11**	**Transverse cracking - 10 LF**
		12	**Spall w/ exp. Reinf. - 1 SF (1 LF)**
6	Cracking w/ leakage - 5 LF	**13**	**Transverse cracking - 13 LF**

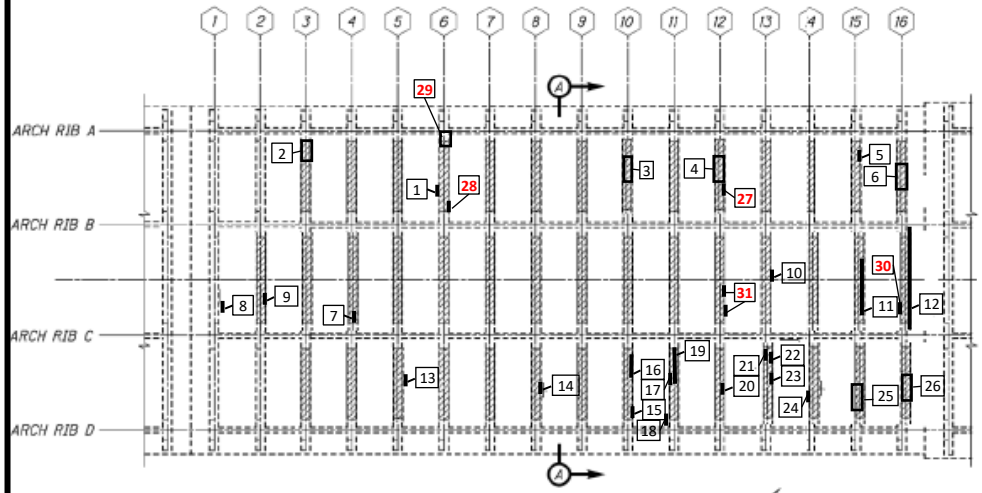
SPAN 2 – LOWER DECK PLAN

SPAN 2, LOWER DECK DEFICIENCIES			
#	DEFECT	#	DEFECT
1	Delamination - 2' L x 2' H	18	Delamination - 4' L x 3' H
2	Delamination - 2' L x 2' H	19	Delamination w/ Spall w/ exp. Reinf. - 6' L x 4' H
3	Delamination w/ Spall w/ exp. Reinf. - 6 SF		
4	Delamination - 4' L x 1' H	20	Delamination - 10' L x 3' H & Spall w/ exp. Reinf - 2' L x 2' H
5	Delamination - 9' L x 3' H		
6	Delamination w/ Spall w/ exp. Reinf - 4' L x 2' H	21	Delamination - 6' L x 3' H
7	Delamination - 2' L x 1' H	22	Delamination - 7' L x 2' H
8	Delamination w/ Spall w/ exp. Reinf - 2' L x 2' H	23	Delamination - 2' L x 4' H
9	Spall w/ exp. Reinf - 1' L x 1' H	24	Delamination - 9' L x Variable Width
10	Spall w/ exp. Reinf - 1' L x 1' H		
11	Delamination - 6' L x 4' H	25	Delamination - 6' L x 1' H
12	Delamination - 20' L x 4' H	26	Delamination - 13' L x 2' H
13	Delamination - 6' L x 3' H	**27**	**Delamination - 6' L x 6' H**
14	Delamination w/ Spall w/ exp. Reinf. - 4' L x 2' H	**28**	**Delamination - 2' L x 1' H**

15	Delamination - 4' L x 3' H	**29**	**Delamination - 6' L x 2' H**
16	Delamination w/ Spall w/ exp. Reinf - 5' L x 3' H	**30**	**Spall w/ exp. Reinf - 6 SF (3 LF)**
17	Delamination w/ Spall w/ exp. Reinf - **7**' L x 3' H	**31**	**Spall w/ exp. Reinf - 1' L x 1' H**

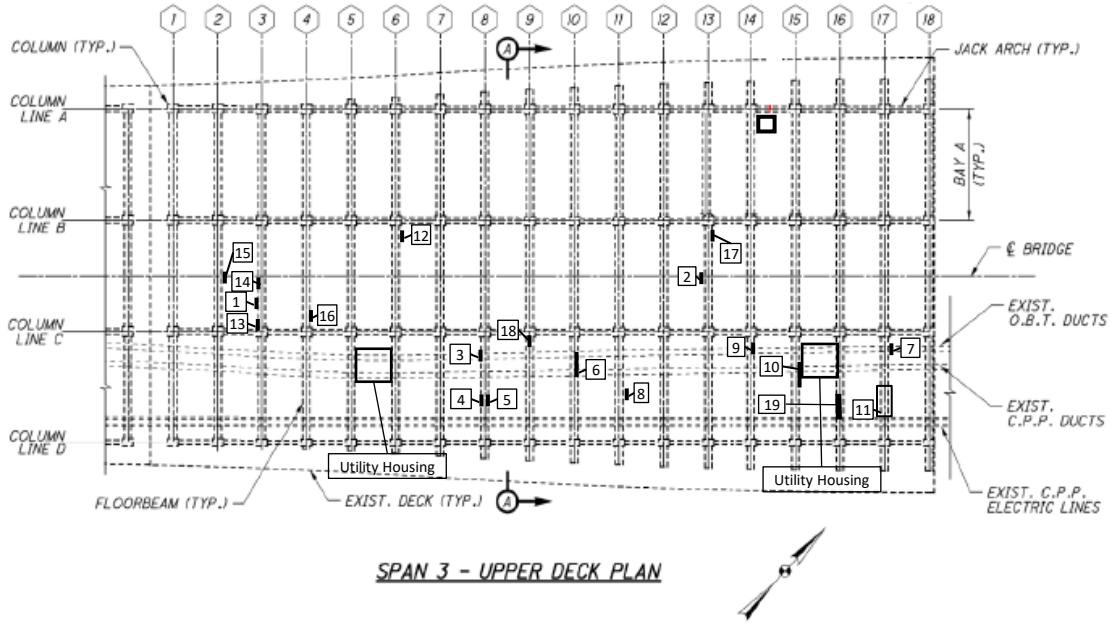
SPAN 3 – UPPER DECK PLAN

SPAN 3, UPPER DECK DEFICIENCIES			
#	DEFECT	#	DEFECT
1	Spall w/ exp. Reinf. w/ minor S.L., 3" D - **12** SF (3 LF)	9	Delam. and cracking (**4** LF)
2	Delam. - 2 SF (2 LF)	10	Delam. - 20 SF (**10** LF)
3	Spall w/ exp. Reinf., 1.5" D - 0.5 SF (1 LF)	11	Spall w/ exp. Reinf - 3 SF (2 LF) & Delam. 16 SF (8 LF)
4	Delam. - 4 SF (2 LF)	12	Delam. - 1 SF (1 LF)
5	Delam. w/ small spall - 12 SF (4 LF)	13	Delam. - 3 SF (2 LF)
		14	Delam. - 2 SF (1 LF)
6	Delam. w/ small spall - 10 SF (5 LF)	15	Delam. - 1 SF (1 LF)
		16	Delam. - 1 SF (1 LF)
7	Spall w/ exp. Reinf. - 4 SF (2 LF)	**17**	**Delam. - 1 SF (1 LF)**
8	Spall w/ exp. Reinf., 3" D - 20 SF (5 LF)	18	Spall w/ exp. Reinf., 2" D - 3 SF (2 LF)
		19	Cracking - 12 LF

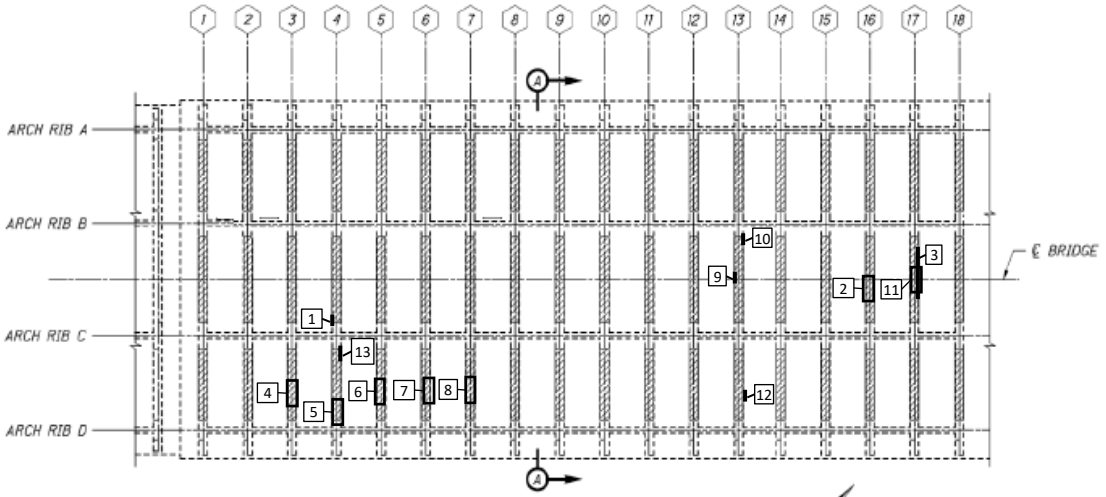
SPAN 3 – LOWER DECK PLAN

SPAN 3, LOWER DECK DEFICIENCIES			
#	DEFECT	#	DEFECT
1	Spall w/ exp. Reinf - 1' L x 1' H	7	Spall w/ exp. Reinf. - 12' L x 2' H
2	Delam. - **4**' L x 2' H	8	Delam. - 3' L x 1' H
3	Delam. **w/ Spall w/ exp. Reinf.** - 12' L x **2**' H	9	Delam. - 2' L x 2' H
4	Delam. - 10' L x 1' H	10	Delam. - 2' L x 2' H
5	Delam. - 6' L x 1.5' H	11	Delam. - 4' L x 2' H
6	Delam. - 10' L x 2' H & Spall w/ exp. Reinf. - 4' L x 1' H	12	Delam. - 4' L x 1' H
		13	Delam. - 2' L x 0.5' H

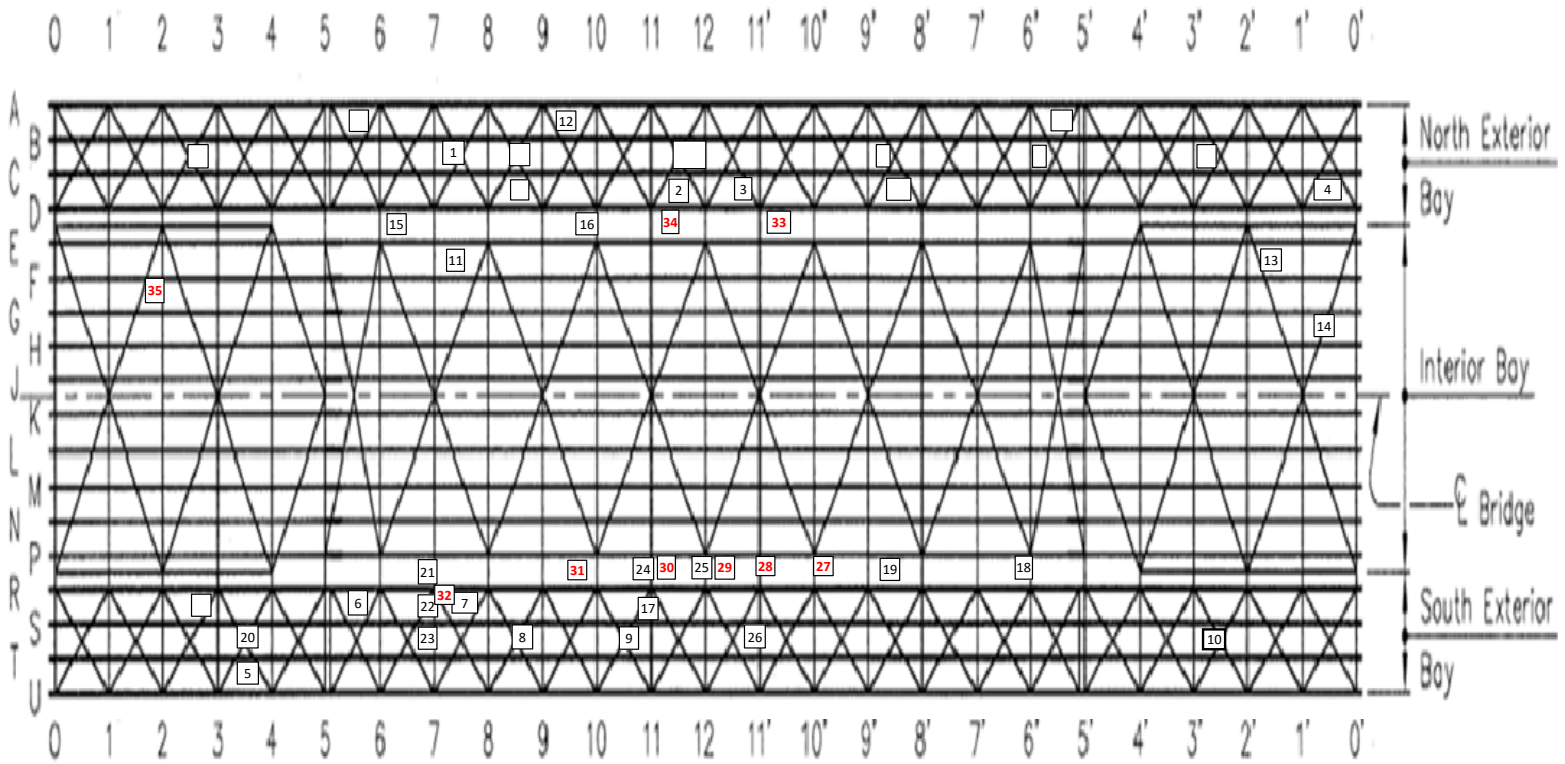
SPAN 4, UPPER DECK DEFICIENCIES

#	DEFECT	#	DEFECT	#	DEFECT
1	Spall w/ exposed Reinforcement - 1	14	Spall w/ exposed Reinforcement - 2 SF	27	Spall - 1 SF
2	Spall w/ exposed Reinforcement - 1	15	Spall w/ exposed Reinforcement - 2 SF	28	Delamination - 2 SF
3	Spall - 1 SF	16	Spall w / exposed Reinforcement - 1 SF	29	Spall w/ exposed Reinforcement - 1 SF
4	Spall - 4 SF	17	Spall w/ exposed Reinforcement - 1 SF	30	Spall w/ exposed Reinforcement - 1 SF
5	Delamination - 4 SF	18	Spall - 1 SF	31	Spall - 1 SF
6	Delamination - 1 SF	19	Spall w/ exposed Reinforcement - 2 SF	32	Delamination - 1 SF
7	Delamination - 1 SF	20	Spall - 1 SF	33	Spall w/ exposed Reinforcement - 1 SF
8	Spall, 1/2" D - 1 SF	21	Spall w/ exposed reinforcement - 2 SF	34	Spall w/ exposed Reinforcement - 1 SF
9	Delamination - 9 SF	22	Spall w/ exposed reinforcement - 4 SF	35	Delamination - 2 SF

#	Spall w/ exp. Reinf. - 3" D - 6 SF	23	Spall w/ exposed reinforcement - 1 SF		
#	Spall w/ exposed Reinforcement - 2	24	Spall w/ exposed reinforcement - 2 SF

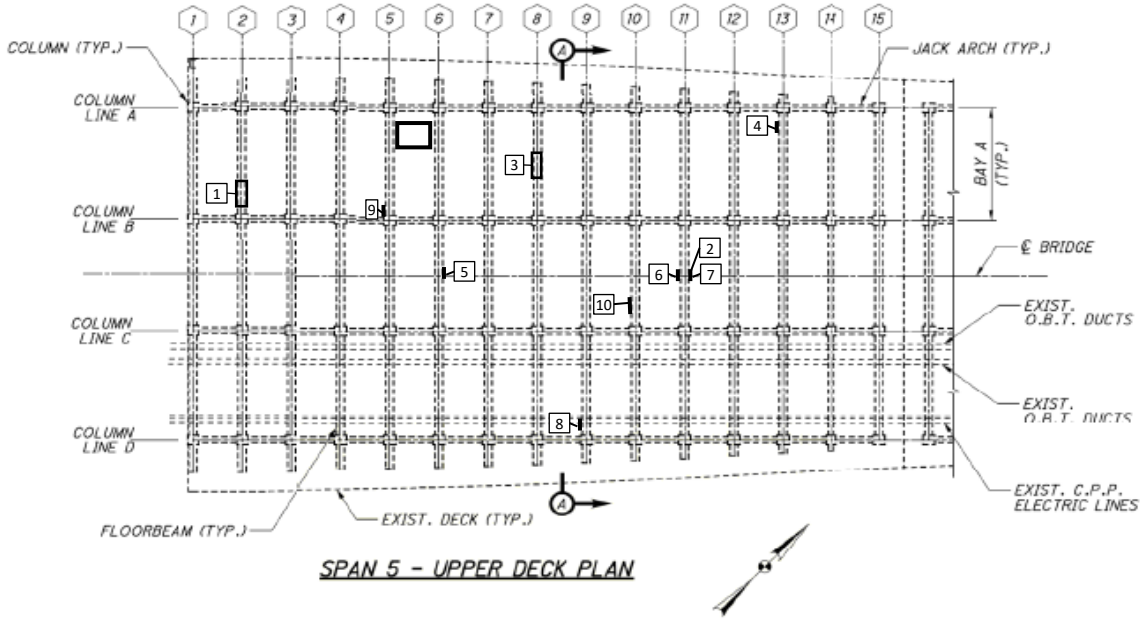
SPAN 5 – UPPER DECK PLAN

SPAN 5, UPPER DECK DEFICIENCIES	
#	DEFECT
1	Spall w/ exp. Reinf. - 3 SF (2 LF)
2	Delamination (Bottom of Beam) - 2 SF (2 LF)
3	Spall - 1 SF (1 LF)
4	Delamination - 9 SF (3 LF)
5	Spall w/ exp. Reinf., 2" D - 6 SF (2 LF)
6	Spall w/ exp. Reinf. w/ minor S.L., 3" D - 9 SF (3 LF)
7	Spall (failed patch) - 6 SF (3 LF)
8	Spall w/ exp. Reinf., 1" D - 1 SF (1 LF)
9	Delamination - 3 SF (1 LF)
10	**Delamination - 2 SF (2 LF)**

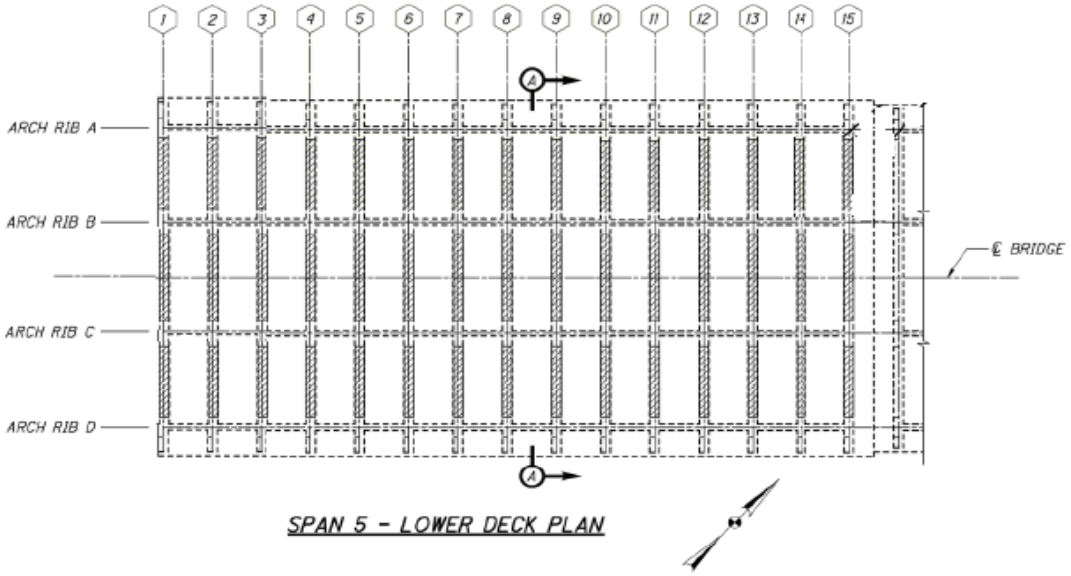
SPAN 5 – LOWER DECK PLAN

In Bay B, there are numerous vertical hairline cracks wih efflorescence. Some cracks have been epoxy injected with 3-ft to 5-ft spacing.

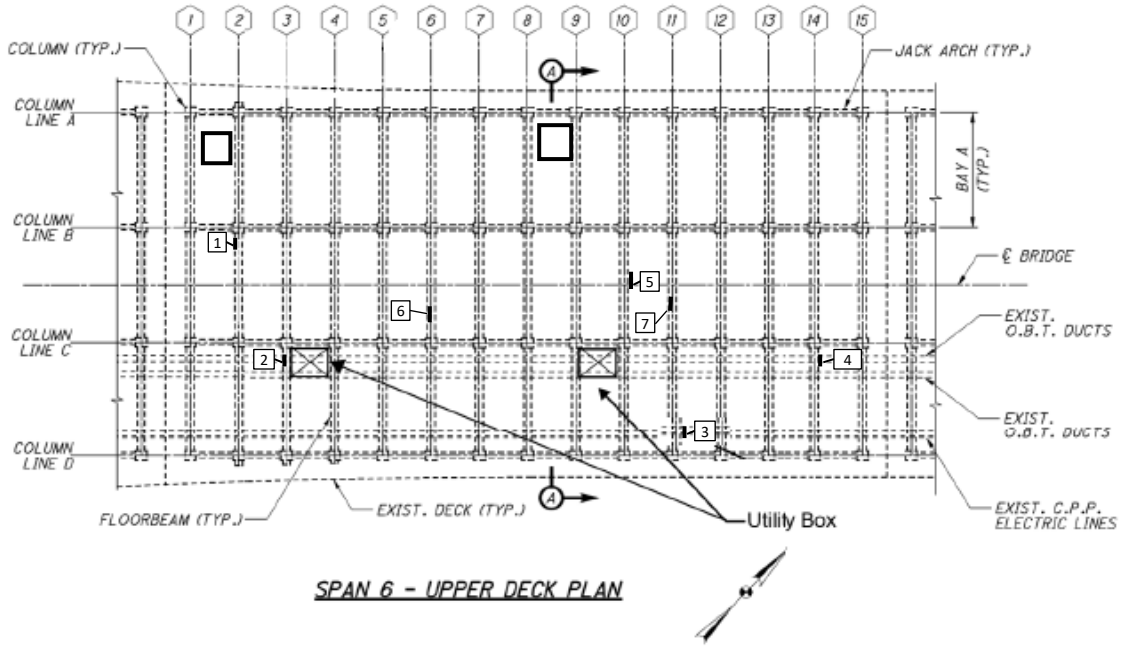
SPAN 6 - UPPER DECK PLAN

SPAN 6, UPPER DECK DEFICIENCIES	
#	DEFECT
1	Spall w/ exp. Reinf., 4" D - 6 SF (2 LF)
2	Spall w/ exp. Reinf., 1" D - 1 SF (1 LF)
3	Delamination - 6 SF (3 LF)
4	Spall w/ exp. Reinf., 1" D - 1 SF (1 LF)
5	Spall w/ exp. Reinf., 1.75" D - 3 SF (2 LF)
6	**Spall - 1 SF (1 LF)**
7	**Spall - 1 SF (1 LF)**

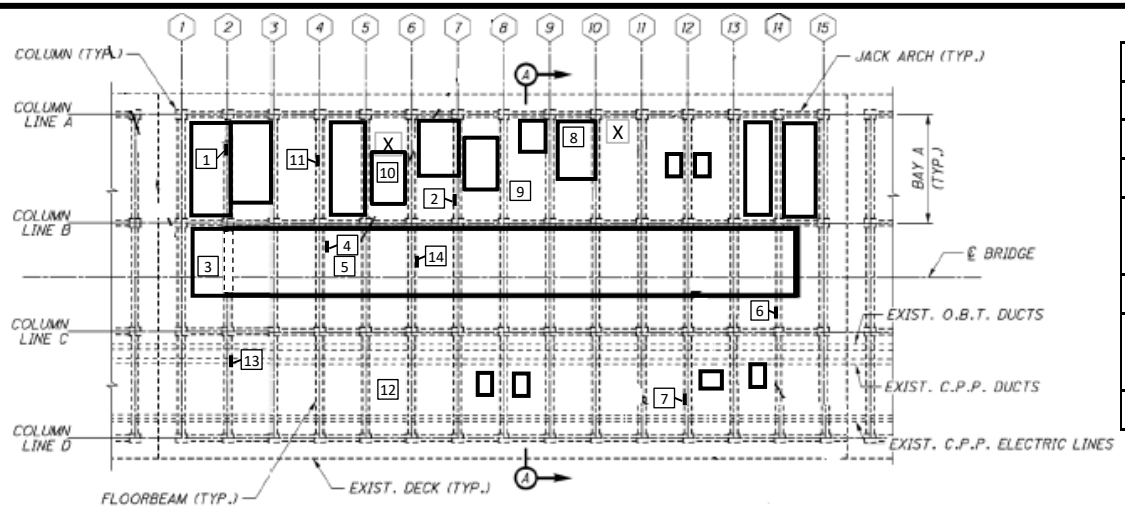
SPAN 7 – UPPER DECK PLAN

SPAN 7, UPPER DECK DEFICIENCIES			
#	DEFECT	#	DEFECT
1	Delam. - 1 SF (1 LF)	7	Delam. - 5 SF (5 LF)
2	Delam. - 1 SF (1 LF)	8	Delamination - 18 SF
3	Hairline crack w/ eff. and moisture staining - 4 LF	9	Delamination - 8 SF
		10	Delamination - 30 SF
4	Spall w/ exp. Reinf. - 1 SF (1 LF)	11	Spall - 1 SF (1 LF)
5	Hairline cracking w/ eff. & active leakage - 9 SF	12	Delamination - 4 SF
		13	Delamination - 1 SF (1 LF)
6	Spall, 1" D - 4 SF (2 LF)	14	**Delamination - 2 SF (1 LF)**

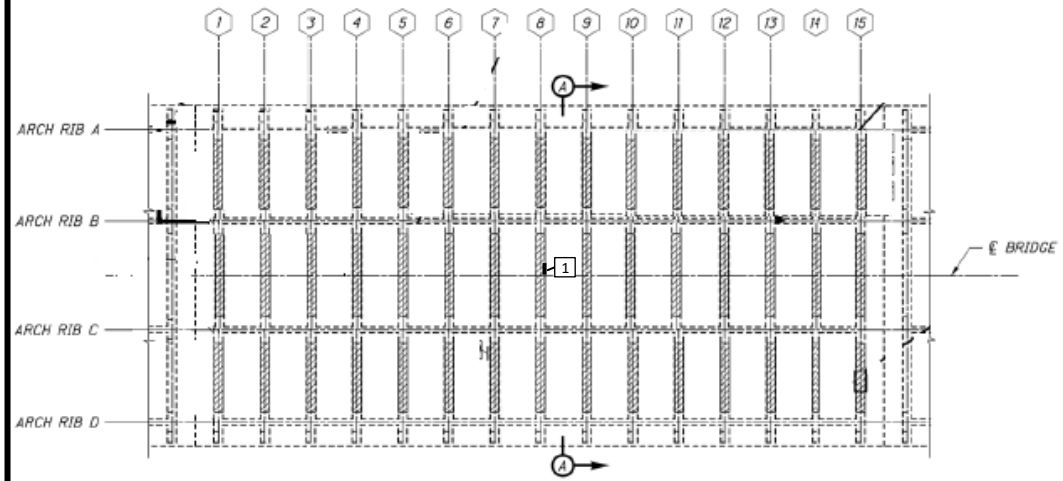
SPAN 7 – LOWER DECK PLAN

SPAN 7, UPPER DECK DEFICIENCIES	
#	DEFECT
1	Delamination - 1 SF (1 LF)

Bay B floorbeams have hairline vertical cracks spaced about 3' apart. Some have light efflorescence.

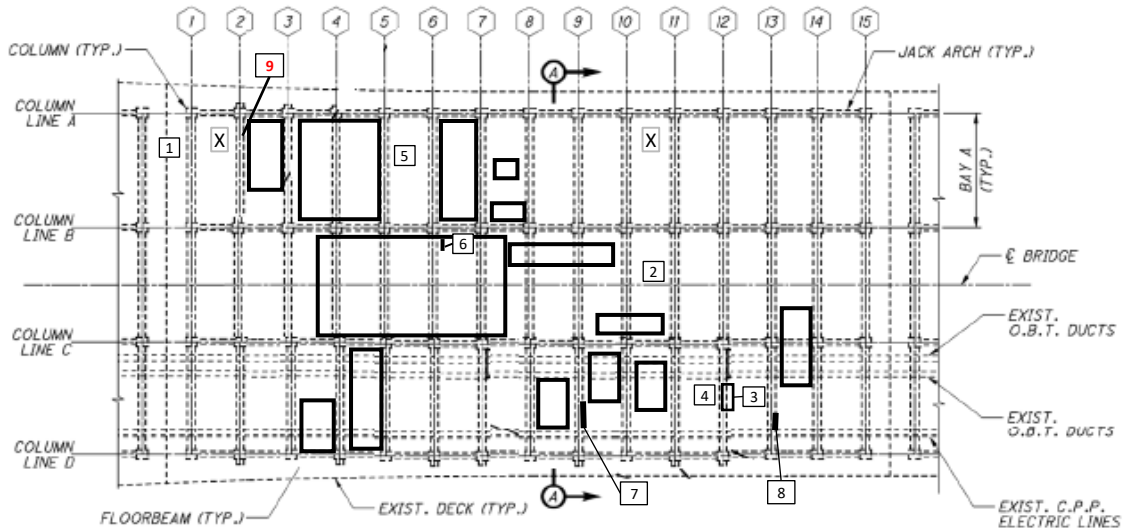
SPAN 8 – UPPER DECK PLAN

SPAN 8, UPPER DECK DEFICIENCIES	
#	DEFECT
1	Leaking at the deck joint - 1 LF
2	Spall w. exp. Reinf., 2" D - 1 SF
3	Delam. with Efflorescence - 4 SF (4 LF)
4	Spall w. exp. Reinf. - 9 SF
5	Delamination - 20 SF
6	**Spall** - **2** SF (1 LF)
7	Delam./cracking - 8 LF
8	Cracking - **3** LF
9	**Delam. - 2 SF (2 LF)**

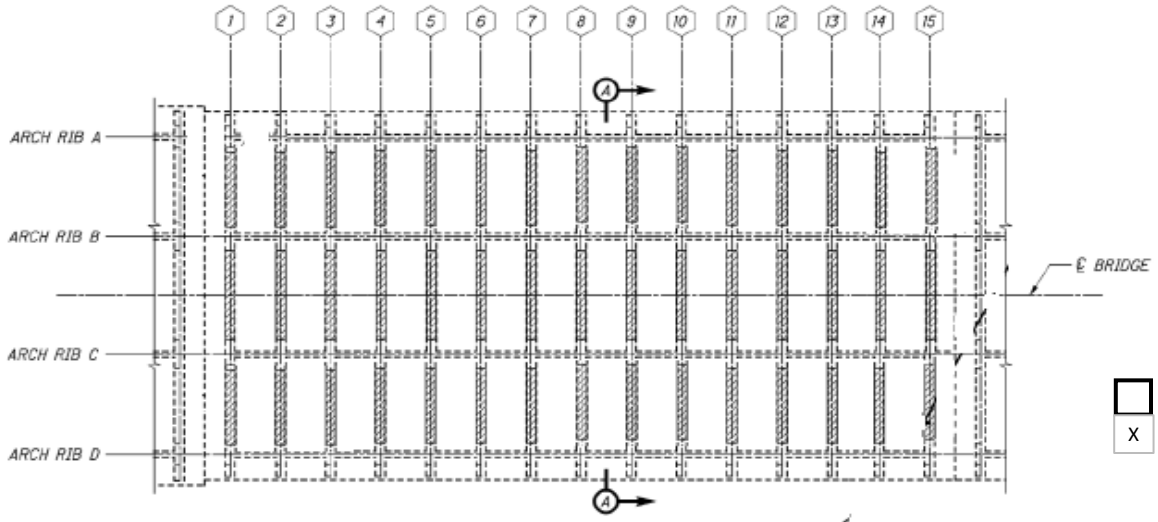
SPAN 8 – LOWER DECK PLAN

* Bay B floorbeams have hairline vertical cracks spaced about 3' apart. Some have light efflorescence.

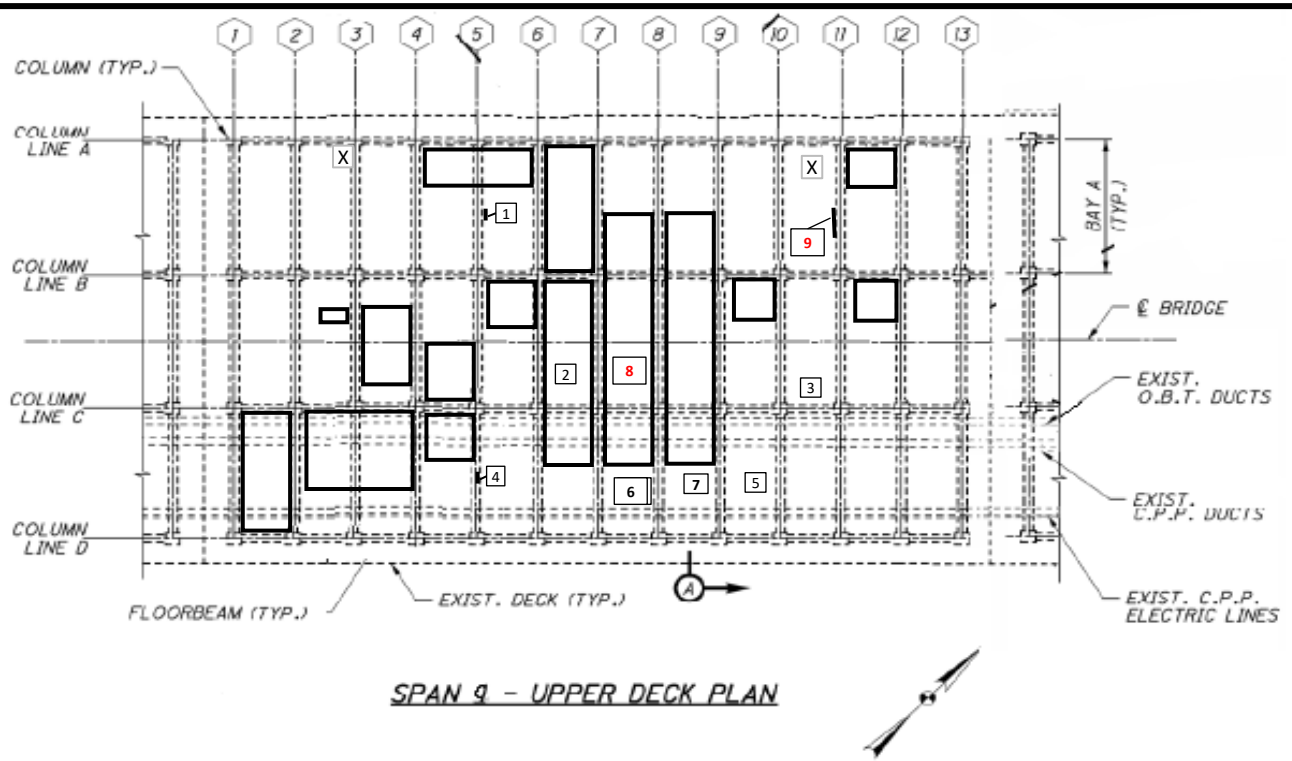
SPAN 9 – UPPER DECK PLAN

SPAN 9, UPPER DECK DEFICIENCIES	
#	DEFECT
1	Delamination - 1 SF (1 LF)
2	Spall w/ exp. Reinf., 2.5" D - 4 SF
3	Spall w/ exp. Reinf., 1.5" D - 1 SF
4	Delamination - 4 SF (4 LF)
5	Delamination - 3 SF
6	Delamination - 12 SF
7	Delamination - 1 SF
8	**Spall w/ exp. Reinf., 6" D - 4 SF**
9	**Spall - 1 SF (1 LF)**

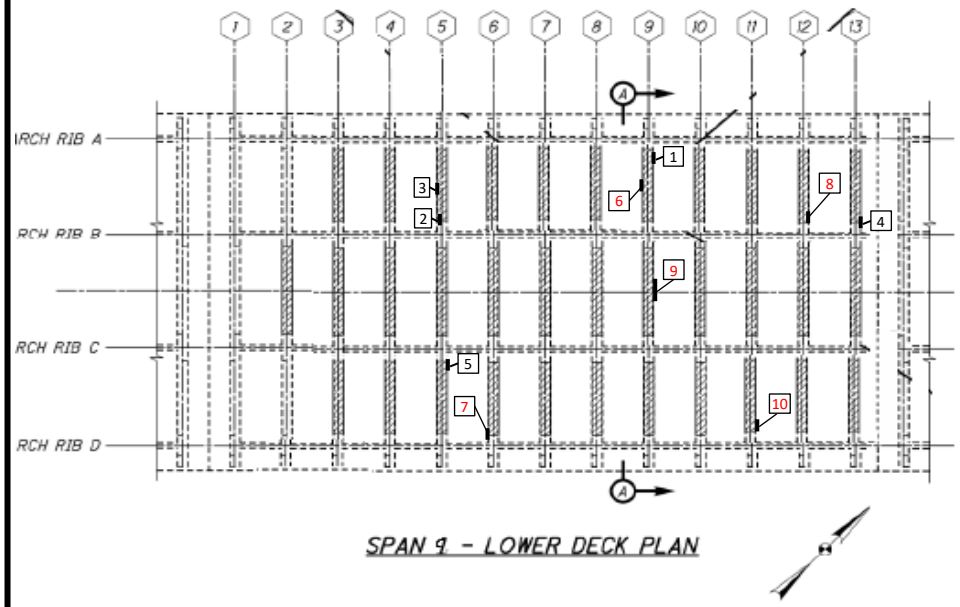
SPAN 9 - LOWER DECK PLAN

SPAN 9, LOWER DECK DEFICIENCIES	
#	Defect
1	**Spall w/ exp. Reinf.** - 1' L x 1' H
2	Delamination - 1' L x 2' H
3	Delamination - 2' L x 2' H
4	Delamination - 4' L x 2' H
5	Delamination - 1' L x 1' H
6	**Delamination - 3' L x 1' H**
7	**Spall - 1' L x 1' H**
8	**Delamination - 2' L x 1' H**
9	**Delamination - 6' L x 1' H**
10	**Delamination - 1' L x 1' H**

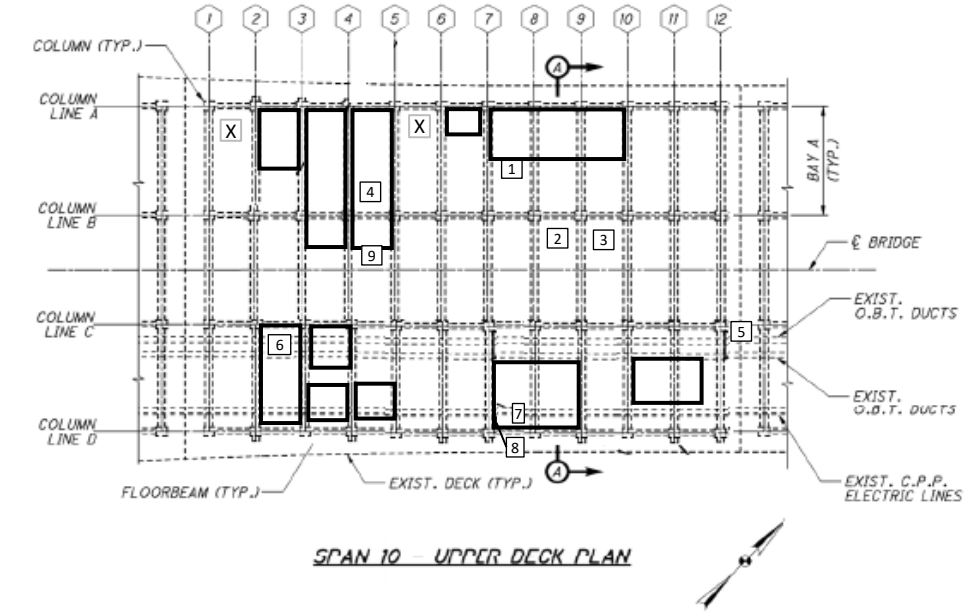
SPAN 10 – UPPER DECK PLAN

SPAN 10 - UPPER DECK DEFICIENCIES	
#	DEFECT
1	Spall w/ exp. Reinf., 2" D - 1 SF
2	Spall w/ exp. Reinf., 2" D - 3 SF
3	Spall w/ exp. Reinf., 2" D - 1 SF
4	Delamination w/ Efflorescence - 12 SF
5	Leaking from hole in Joint 3 - 3 LF
6	Delamination w/ Efflorescence - 1 SF
7	Crack w/ Efflorescence for Half Span
8	Spall w/ exp. Reinf. - 1 SF (1 LF)
9	**Delamination - 2 SF**

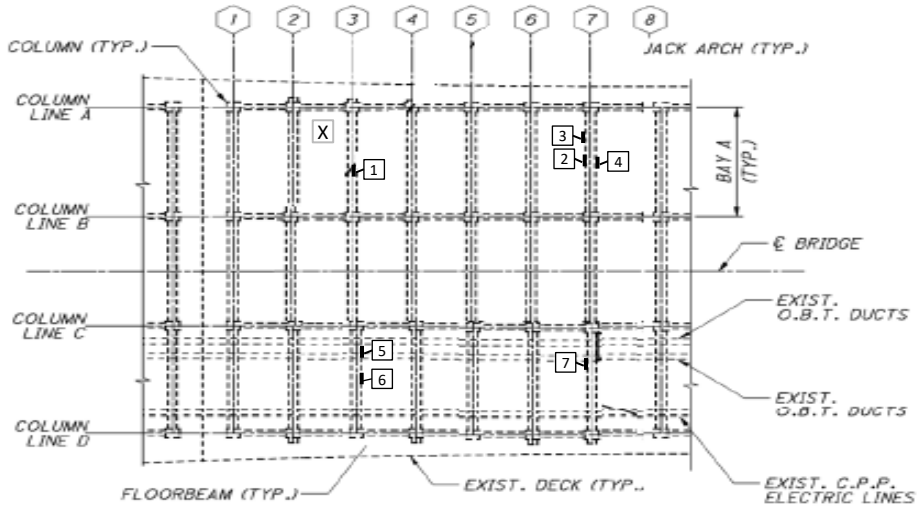
SPAN 11 -- UPPER DECK PLAN

SPAN 11, UPPER DECK DEFICIENCIES	
#	DEFECT
1	Spall w/ exp. Reinf., 1" D - 8 SF (6 LF)
2	Spall w/ exp. Reinf., 1" D - 2 SF (1 LF)
3	Spall w/ exp. Reinf. - 1 SF (1 LF)
4	Spall w/ exp. Reinf., 1" D - 2 SF (1 LF)
5	Delamination - 1 SF
6	Delamination - 2 SF
7	Delamination - 2 SF (2 LF)

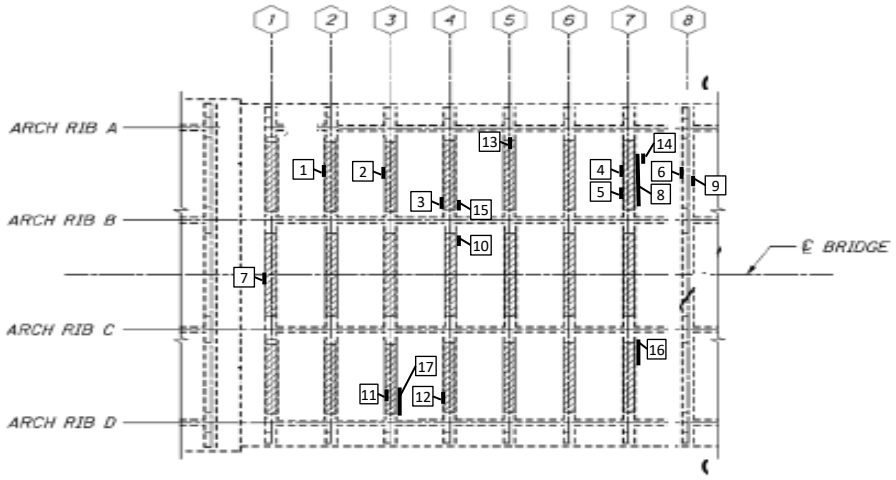
SPAN 11 - LOWER DECK PLAN

SPAN 11, LOWER DECK DEFICIENCIES			
#	DEFECT	#	DEFECT
1	Delamination w/ Spalling - 1' W x 4' H	8	Crack - 8 LF
		9	Delamination - 6" W x 3' H
2	Delamination - 2' W x 2' H	10	Delamination - 6" W x 2' H
3	Delamination - 6" W x 3' H	11	Delamination - 6' W x 1' H
4	Spall w/ exp. Reinf. - 6" W x 1.5' H	12	Delamination - 4' W x 1' H
		13	Delam. w/ Spall w/ exp. Reinf. - 1' W x 1' H
5	Spall w/ exp. Reinf. - 6" W x 1.5' H	14	Delamination - 6" W x 1' H
6	Delamination - 2' W x 3' H	15	Delamination - 6" W x 1' H
7	Spall w/ exp. Reinf., 2" D - 1.5' W x 1.5' H	16	Delamination - 1' W x 2' H
		17	Delamination - 5' W x 1' H

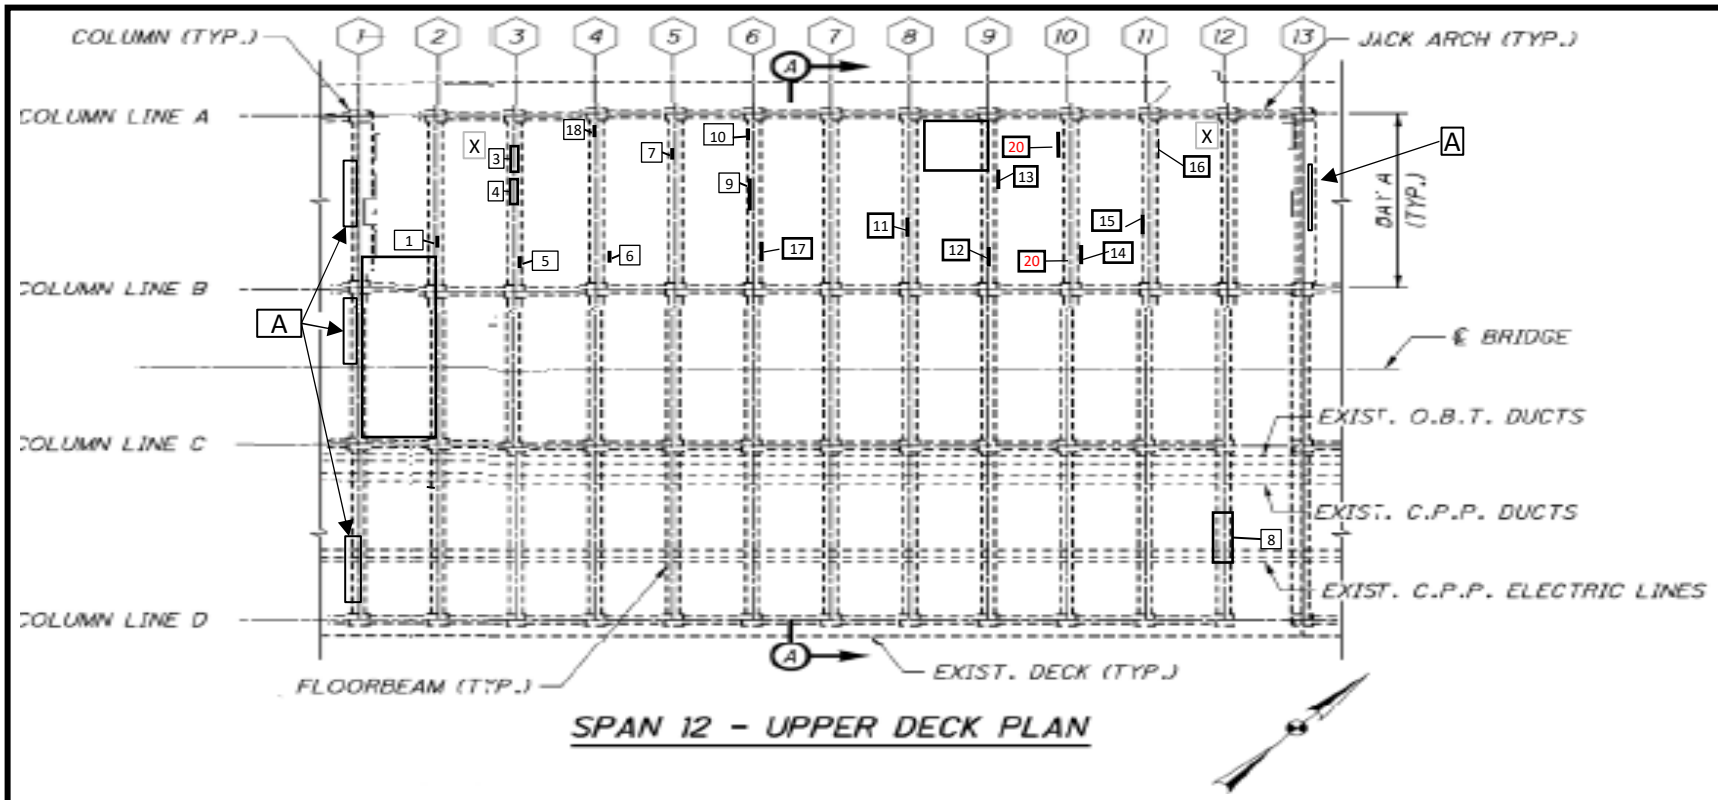
SPAN 12 - UPPER DECK PLAN

SPAN 12 - UPPER DECK DEFICIENCIES			
#	DEFECT	#	DEFECT
1	Delamination - 1 SF (1 LF)	12	Spall w/ exp. Reinf., 1" D - 2 SF (2 LF)
2	Spall w/ exp. Reinf. - 1 SF (1 LF)	13	Delam. w/ Spall w/ exp. Reinf., 1" D - 3 SF (3 LF)
3	Delamination - 4 SF (2 LF)		
4	Delamination - 3 SF (3 LF)	14	Spall w/ exp. Reinf. - 1 SF (1 LF)
5	Delamination - 3 SF (3 LF)	15	Delamination - 6 SF
6	Spall w/ exp. Reinf. - 1 SF (1 LF)	16	Delamination - 1 SF
7	Spall w/ exp. Reinf. - 3 SF (3 LF)	17	Delamination - 1 SF (1 LF)
8	Delamination - 2 SF (2 LF)	18	Spall w/ exp. Reinf. - 1 SF (1 LF)
9	Delamination - 27 SF (9 LF)		
10	Spall w/ exp. Reinf. - 1 SF (1 LF)	**19**	**Spall w/ exp. Reinf., 1 SF (1 LF)**
11	Spall w/ exp. Reinf. - 1 SF (1 LF)	**20**	**Spall w/ exp. Reinf. - 1 SF (1 LF)**

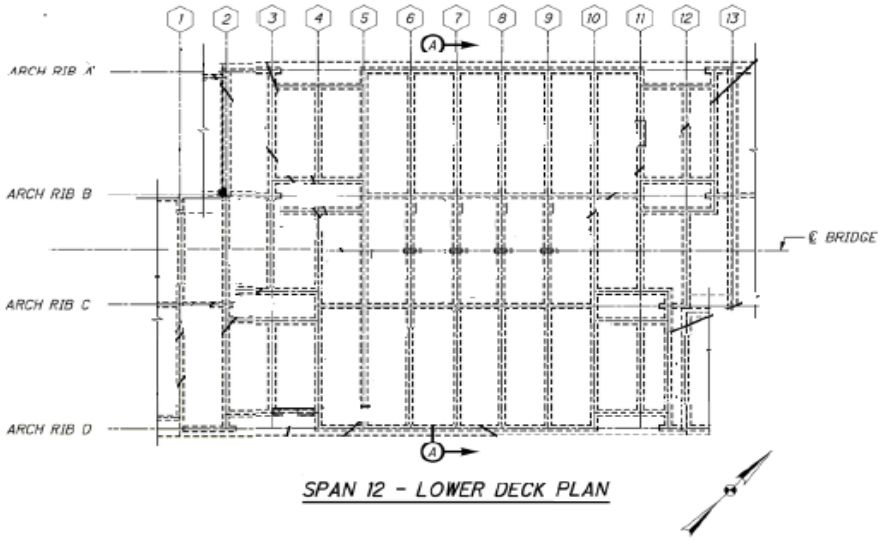
SPAN 12 - LOWER DECK PLAN

SPAN 12, LOWER DECK DEFICIENCIES				
FB #	Defect	Bay A (sf)	Bay B (sf)	Bay C (sf)
1	Delamination		**6 (3)**	0
	Spall w/ exp. Reinf.		**16 (6)**	0
2	Delamination	4 (4)	19 (8)	13 (5)
	Spall w/ exp. Reinf.	5 (5)	14 (6)	5 (3)
3	Delamination	1 (1)	3 (3)	**22 (10)**
	Spall w/ exp. Reinf.	**6 (3)**	0	0
4	Delamination	**10 (10)**	6 (6)	33 (12)
	Spall w/ exp. Reinf.	6 (3)	4 (3)	16 (6)
5	Delamination	**10 (10)**	6 (3)	17 (9)
	Spall w/ exp. Reinf.	16 (7)	**3 (3)**	6 (4)
6	Delamination	94 (30)	**66 (22)**	12 (8)
	Spall w/ exp. Reinf.	0	1 (1)	1 (1)
7	Delamination	2 (2)	**8 (3)**	0
	Spall w/ exp. Reinf.	0	0	**2 (1)**
8	Delamination	**5 (5)**	11 (6)	4 (2)
	Spall w/ exp. Reinf.	2 (2)	2 (2)	1 (1)
9	Delamination	22 (10)	19 (7)	45 (15)
	Spall w/ exp. Reinf.	0	0	2 (2)
10	Delamination	14 (7)	0	8 (4)
	Spall w/ exp. Reinf.	32 (8)	0	0
11	Delamination	4 (2)	0	8 (4)
	Spall w/ exp. Reinf.	7 (4)	2 (4)	0
12	Delamination	10 (5)	4 (2)	20 (10)

Note A: Between the deck underside and the top of the transverse floorbeam overs Piers 11 and 12, there are 3" H concrete pedastals with galvanized steel plates sitting on top and between each pedestal. In several locations these plates are missing and no longer support the deck underside, or have displaced from the bearing pedestal. See Table below for locations and description of displaced plates.

Joint	Location	Description
Pier 11	Ribs A-B	One plate missing and one displaced 3.5" east
	Ribs B-C	Two plates missing and one plate displaced up to 1.5" west
	Ribs C-D	Six plates displaced up to 6.5" west
Pier 12	Ribs A-B	One plate missing and three displaced up to 1" east

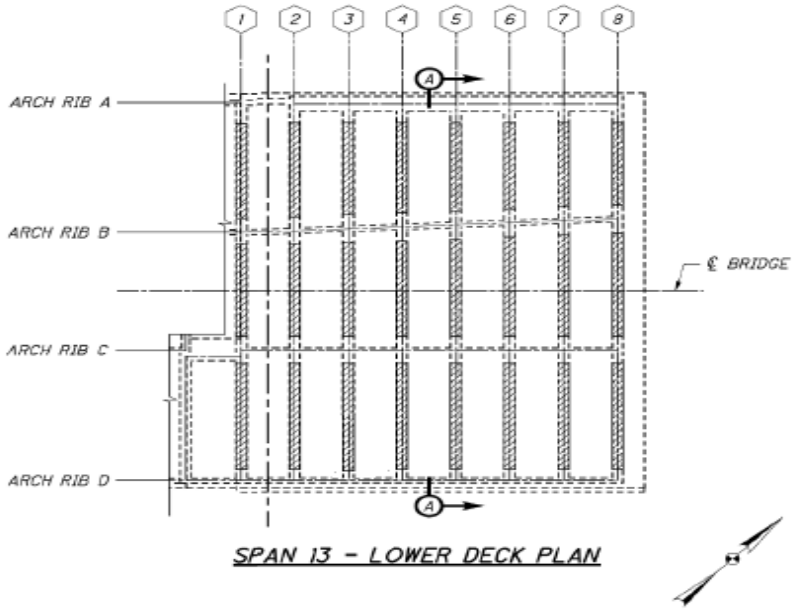
SPAN 13 – LOWER DECK PLAN

SPAN 13, UPPER DECK DEFICIENCIES	
#	DEFECT
1	Delam. w/ Spalling w/ exp. Reinf. - 24 SF, 4" D (8 LF)
2	Incomplete Sawcut Repair Location w/ exp. Reinf. (I.S.R.) - 4 SF (2 LF)
3	I.S.R. - 9 SF (6 LF)
4	I.S.R. - 4 SF (4 LF)
5	I.S.R. - 12 SF (4 LF)
6	I.S.R. - 2 SF (2 LF)
7	I.S.R. - 1 SF (1 LF)
8	Area of deck leakage - 2 LF
9	I.S.R. - 1 SF (1 LF)
10	Delamination - 12 SF (6 LF)
11	**Spall w/ exp. Reinf. - 2 SF (2 LF)**

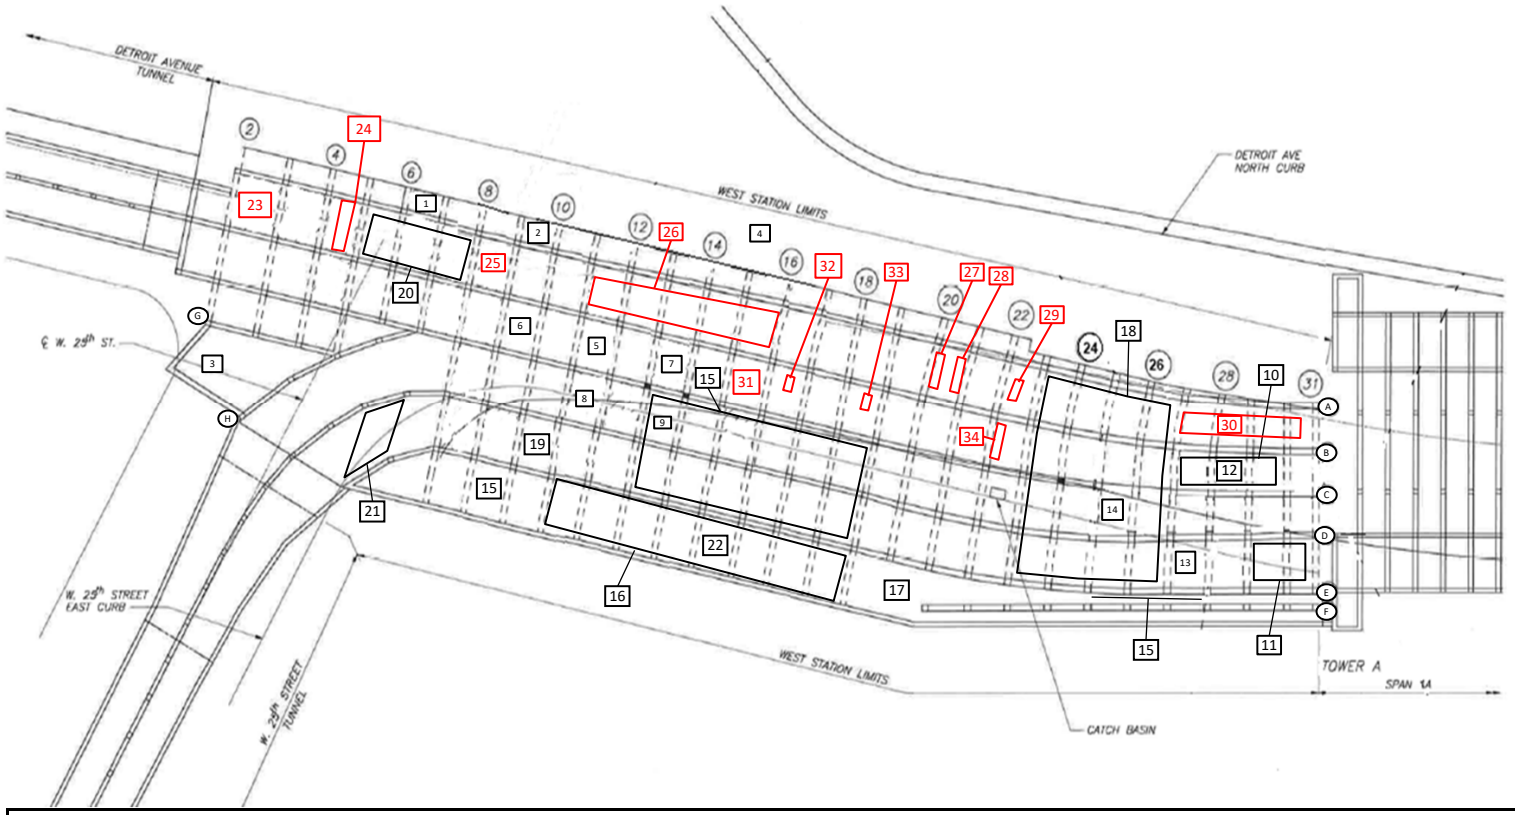
West Station Ceiling Deficiencies					
#	Defect	#	Defect	#	Defect
1	Spall w/ exp. Reinf. - 1 bar w/ 100% section loss; Adjacent bars have advanced section loss.	8	Spall w/ exp. Reinf. - 1 completely exposed bar, not broken; Adjacent bars have advanced section loss.	16	Leakage near wires
				17	Spall w/ exp. Reinf. (40 SF)
2	Spall w/ exp. Reinf. - 1 bar w/ 100% section loss; Adjacent bars have advanced section loss.	9	Spall w/ exp. Reinf. - 1 completely exposed bar, not broken.	18	Area typically has spalling with exposed rebar/**effl.** throughout
3	Spall w/ exp. Reinf. - 2 completely exposed bars, no broken; Adjacent bars have heavy advanced section loss.	10	Area typ. has numerous transverse and longitudinal cracking w/ heavy efflorescence and delam.	19	Spall w/ exp. Reinf. - 2 adjacent transverse bars w/ section loss
		11	Spall w/ exp. Reinf. - Bars have advanced section loss.	20	Transverse cracks with efflorescence and exposed transverse reinforcing bars

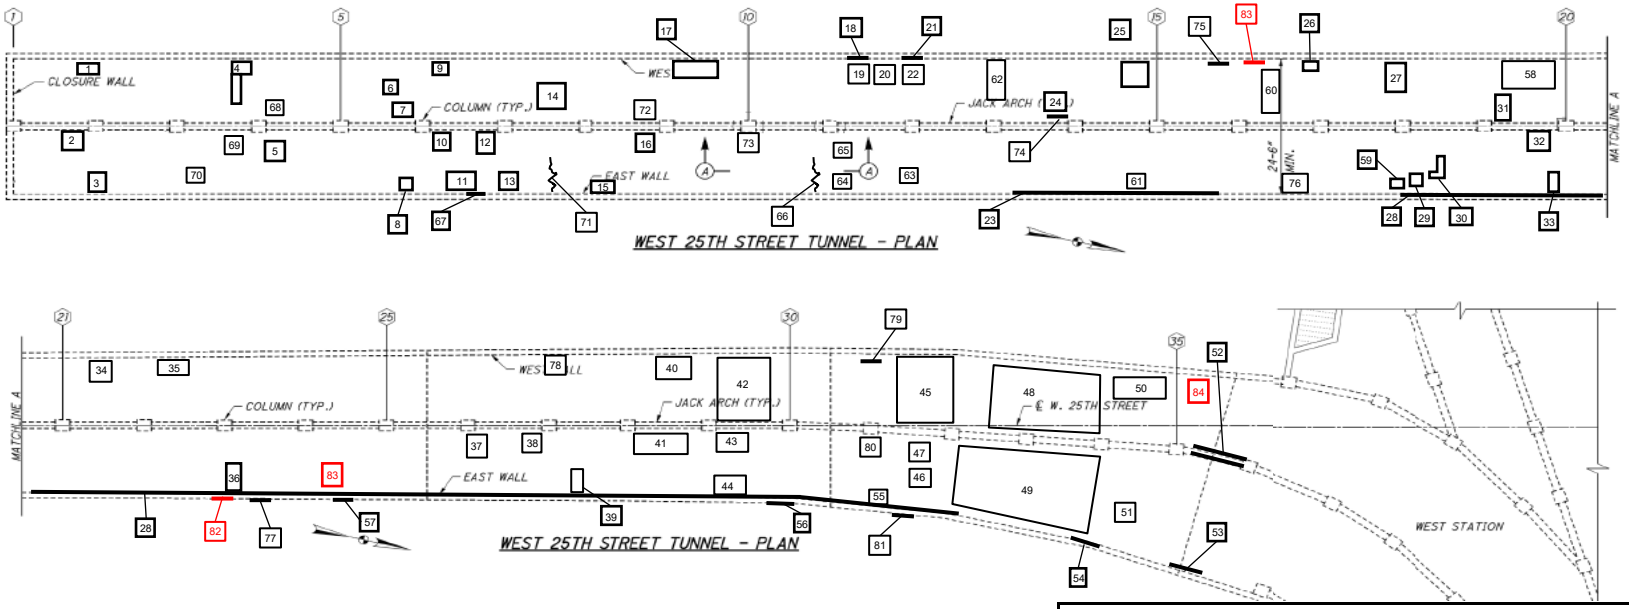
W 25TH STREET TUNNEL CEILING DEFICIENCIES
(QUANTITIES ARE CS3 UNLESS OTHERWISE NOTED)

#	SF	#	SF	#	SF	#	SF	#	SF
1	**12**	*15*	**4**	*33*	**15**	*47*	**4**	66	**15**
2	**20**	*16*	**5**	*34*	**1**	*48*	**50**	68	**3**
3	**30**	*17*	**24**	*35*	**2**	*49*	**300**	69	**1**
4	**40**	*19*	**4**	*36*	**15**	*50*	**28**	70	**1**
5	**6**	*20*	**1**	*37*	**15**	*51*	**16**	71	**2 (CS2)**
6	**2**	*22*	**15**	*38*	**2**	*55*	**16**	72	**4**
7	**1**	*24*	**12**	*39*	**9**	58	**30**	73	**6 (CS2)**
8	**4**	*25*	**10**	*40*	**54**	59	**2**	76	**4**
9	**20**	*26*	**2**	*41*	**45**	60	**10 (CS2)**	78	**1**
10	**24**	*27*	**6**	*42*	**77**	61	**5 (CS2)**	80	**2**
11	**16**	*29*	**4**	*43*	**9**	62	**14 (CS2)**	83	**4**
12	**5**	*30*	**8**	*44*	**9**	63	**2**	84	**3**
13	**16**	*31*	**5**	*45*	**40**	64	**2**		
14	**10**	*32*	**5**	*46*	**3**	65	**9 (CS2)**

W 25TH STREET TUNNEL DEFICIENCIES

#	Comments
18	Bottom of wall - 2 SF
21	Bottom of wall - 18 SF
23	Bottom of wall - 60 SF
28	Bottom of wall - 2.5' high spalling from columns 18-32
52	Top of arch - 75% of length, both faces
53	Wall - Full Ht x 4' Spall w/ exp. Reinf. + 10 SF spall area
54	Top of Wall - 12 SF
56	Top of wall - **15** SF Spall w/ exp. Reinf.
57	Top of wall - 1 SF Spall w/ exp. Reinf.
67	Top of wall - 4 SF Spall w/ exp. Reinf.
74	Jack Arch - N face - 2 SF Spall w/ exp. Reinf.
75	Bottom of wall - 4 SF Spall w/ exp. Reinf.
77	Top of wall - 1 SF Spall w/ exp. Reinf.
79	Bottom of wall - 5 SF Spall w/ efflo. & exp. Reinf.
81	Full height crack & 18 SF delam (spalling imminent)
82	**Top of wall - 1 SF Spall w/ exp. Reinf.**
83	**Top of wall - 4 SF Spall w/ exp. Reinf.**

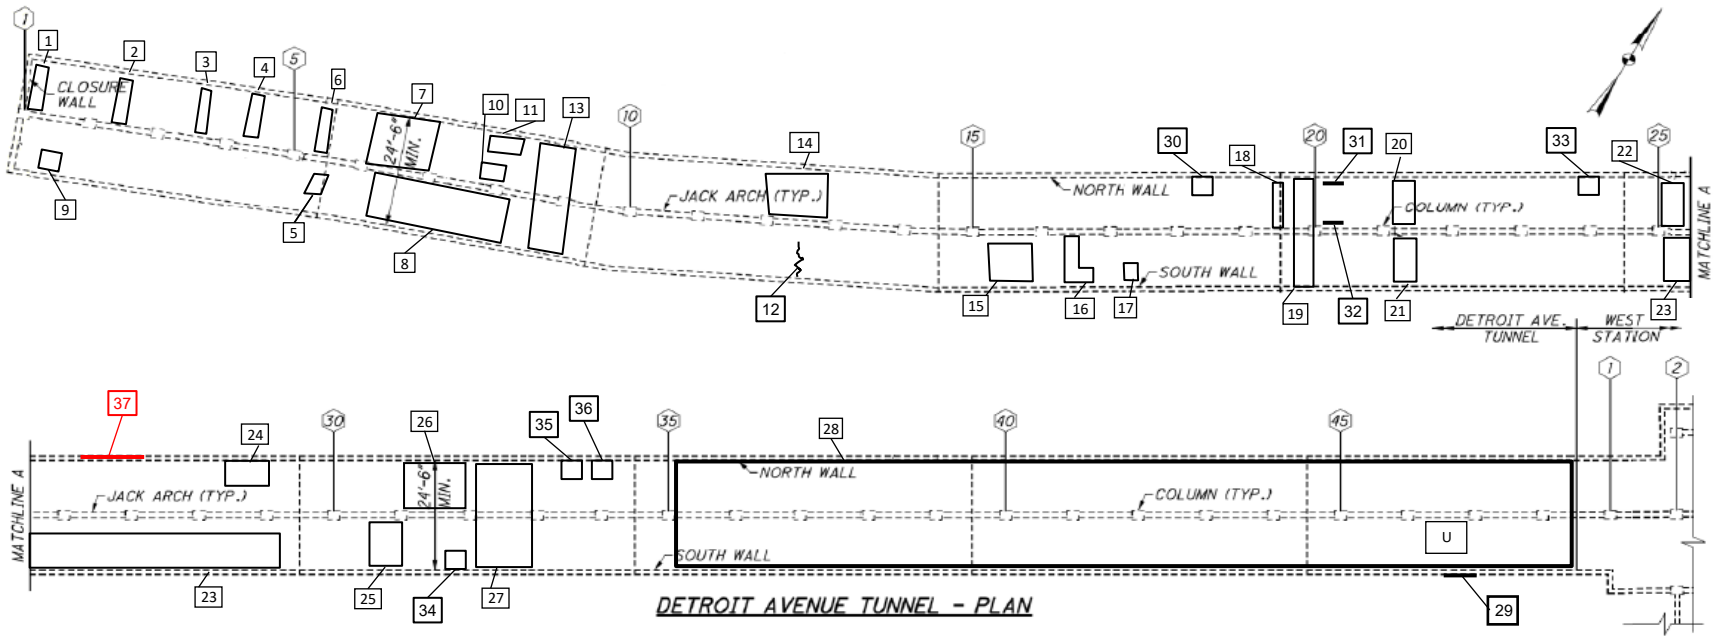
Detroit Avenue Tunnel Ceiling Deficiencies					
#	Defect	15	Spall w/ efflorescence & heavy rust staining - 96 SF	27	Spall w/ exp. Rebar - 196 SF
1	Spall w/ exp. Rebar - 50 SF			28	From C35-48, app. 55% of the ceiling is Spall w/ exp. Rebar (2630 SF) and 20% is cracking w/ seepage (956 SF).
2	Cracking w/ efflorescence & stalagtites & seepage - 66 SF	16	Spall w/ exp. Rebar - 36 SF		
		17	Spall w/ exp. Rebar - 5 SF		
3	Spall w/ exp. Rebar - 44 SF	18	Transverse & longitudinal cracks in the joint header. Joint is leaking.	29	Spall w/ exp. Rebar. - 150 SF
4	Cracking w/ efflorescence & stalagtites & seepage - 30 SF			30	Spall w/ exp. Rebar. - 1 SF
		19	Area of cracking, spalling, delamination w/ eff. & exp. Rebar - 150 SF	31	Spall w/ exp. Rebar. - 2 SF, top wall
5	Spall w/ exp. Rebar & efflo. - 6 SF			32	Spall w/ exp. Rebar. - 1 SF, jack arch, N face
6	Cracking w/ efflorescence - 30 SF	20	Spall w/ exp. Rebar - 96 SF

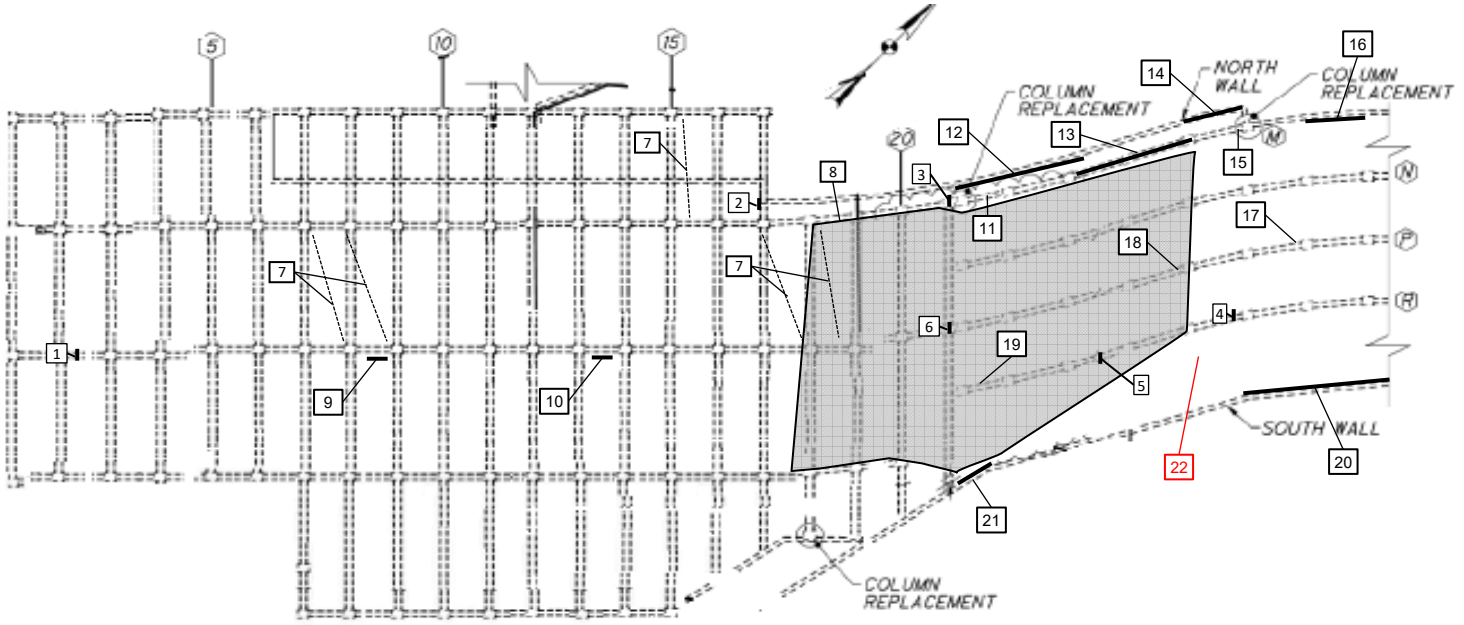
EAST STATION & SUBWAY - PLAN

EAST STATION & SUBWAY DEFICIENCIES			
#	DEFECT	#	DEFECT
1	Spall w/ exp. Reinf. - 1 SF, 1" D (underside of arch)	12	Spall w/ exp. Reinf - 25 SF (on N wall near top)
2	Spall w/ exp. Reinf. - 24 SF (in wall) and Spall - 6 SF (in btm of FB)	13	Cracks w/ efflorescence (jack arch M24-M25 & M25-M26 bot. face)
3	Spall w/ exp. Reinf. - 8 SF (top of Col. 22)	14	Spall w/ exp. Reinf - 8 SF (on N wall near top)
4	Spall w/ exp. Reinf. (N. side of jack arch 26-27) - 1 SF (1 LF)	15	Spall w/ exp. Reinf - 6 SF (on Col. M26)
5	Spall w/ exp. Reinf. (S. side of jack arch 24-25) - 1 SF (1 LF)	16	Spall w/ exp. Reinf - 6 SF (on N wall, various spalls)
6	Delamination (Both sides of Col. 22) - 2 SF	17	Spall w/ exp. Reinf - 1 SF (on jack arch P26-P27 bottom face)
7	Leaking slab cracks **with efflorescence**	18	Spall w/ exp. Reinf - 1 SF (on jack arch P24-P25 bottom face)
8	Standing water - depth varies 3"(W) to 12"(±)(E)	19	Spall w/ exp. Reinf - 1 SF (on jack arch R21-R22 bottom face)

9	Spall w/ exp. Reinf - 1 SF (on jack arch P8-P9 S. face)	20	Spall w/ exp. Reinf - 30 SF (on S wall, various spalls along top and bottom of wall, column line 27 to abutment)
10	Spall w/ exp. Reinf - 2 SF (on jack arch P13-P14 S. face)		
11	Spall w/ exp. Reinf - 1 SF (on jack arch M21-M22 S. and bottom face)	21	Spall w/ exp. Reinf - 10 SF (on S wall near bottom)
		22	**Utility hanger broken**

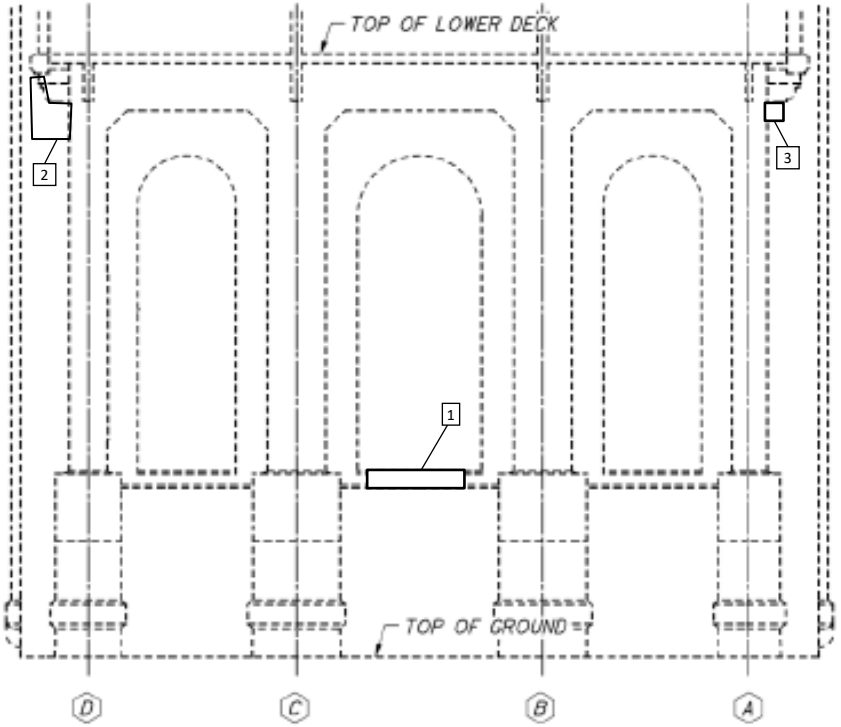
PIER 1 – EAST ELEVATION

Pier 1 - East Elevation Deficiencies	
#	Deficiency
1	Delamination - 8 SF
2	Spall w/ exp. Reinf., 8" D - 9 SF
3	Spall w/ exp. Reinf. - 4 SF
