2025 PHYSICAL CONDITION ROUTINE ELEMENT LEVEL INSPECTION REPORT

Bridge CUY-6-1456
SFN 1800930

Detroit-Superior/Veteran's Memorial over Cuyahoga River
Dates of Inspection: October 6-10, 2025

ODOT DISTRICT 12
5500 TRANSPORTATION BOULEVARD
GARFIELD HEIGHTS, OHIO 44125
DECEMBER 30, 2025

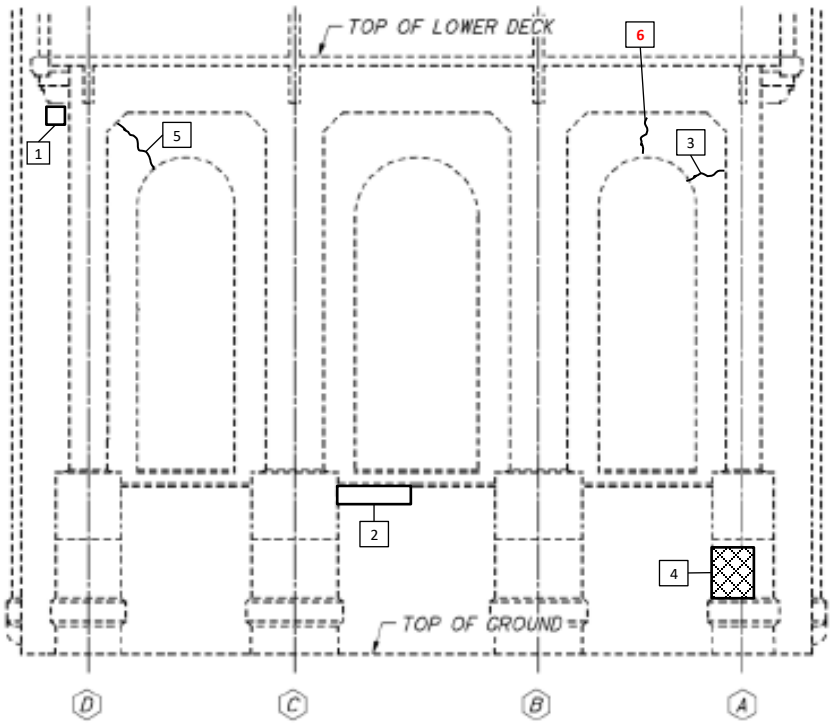
PIER 1 - WEST ELEVATION

Pier 1 - West Elevation Deficiencies	
#	Deficiency
1	Delamination - 2 SF
2	Delamination - 10 SF
3	Crack - 6 LF
4	Map Cracking - 8 SF
5	Crack - 8 LF
6	**Crack - 6 LF**

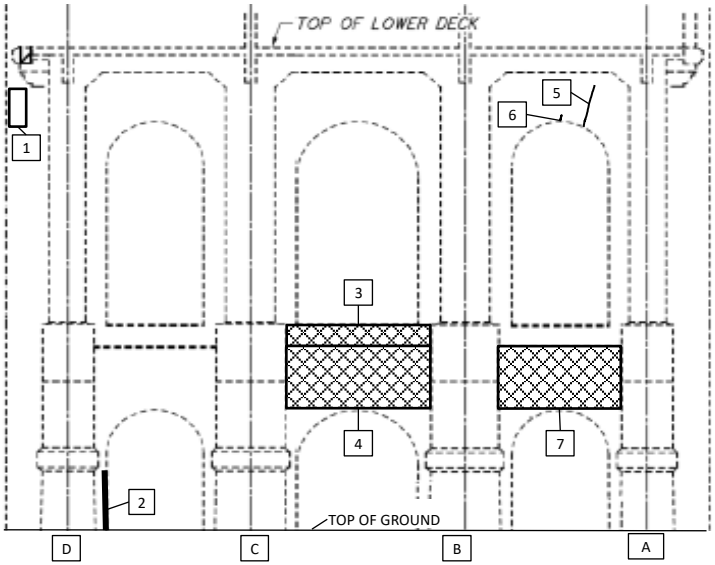
PIER 2 - EAST ELEVATION

Pier 2 - East Elevation Deficiencies	
#	Deficiency
1	Spall w/ exp. Reinf. - 6 SF
2	Map Cracking (inside face) - 15 SF
3	Map Cracking - 45 SF
4	Map Cracking - 75 SF
5	Crack - 10 LF
6	Crack - 1 LF
7	Map Cracking - 75 SF

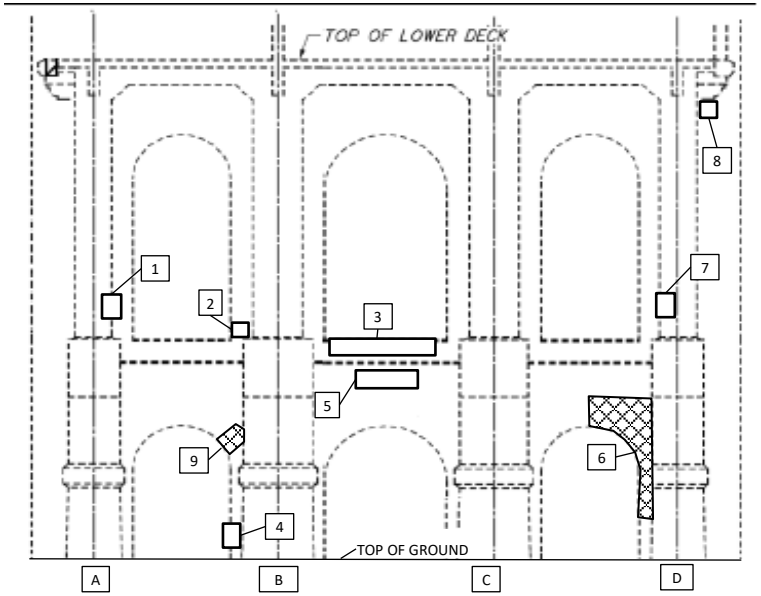
PIER 2 - WEST ELEVATION

Pier 2 - West Elevation Deficiencies	
#	Deficiency
1	Delamination (south inner face) - 4 SF
2	Delamination - 1 SF
3	Delamination - 20 SF
4	Delam. w/ Spall - 4 SF
5	Delamination - 10 SF
6	Map Cracking - 45 SF
7	Delamination (north inner face) - 9 SF
8	Spall w/ exp. Reinf., 4" D - 4 SF
9	Map Cracking - 10 SF

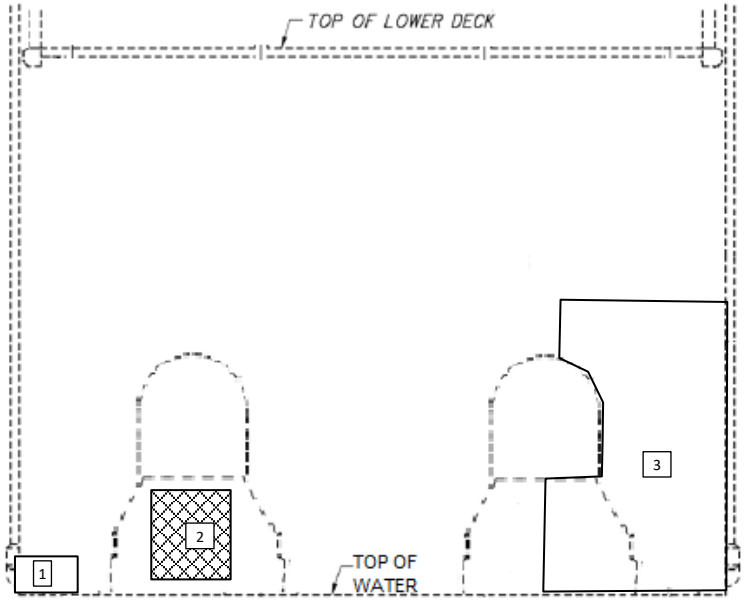
PIER 3 – EAST ELEVATION

Pier 3 - East Elevation Deficiencies	
#	Deficiency
1	Corner Spall
2	Map Cracking - 144 SF
3	Vine growth covering concrete

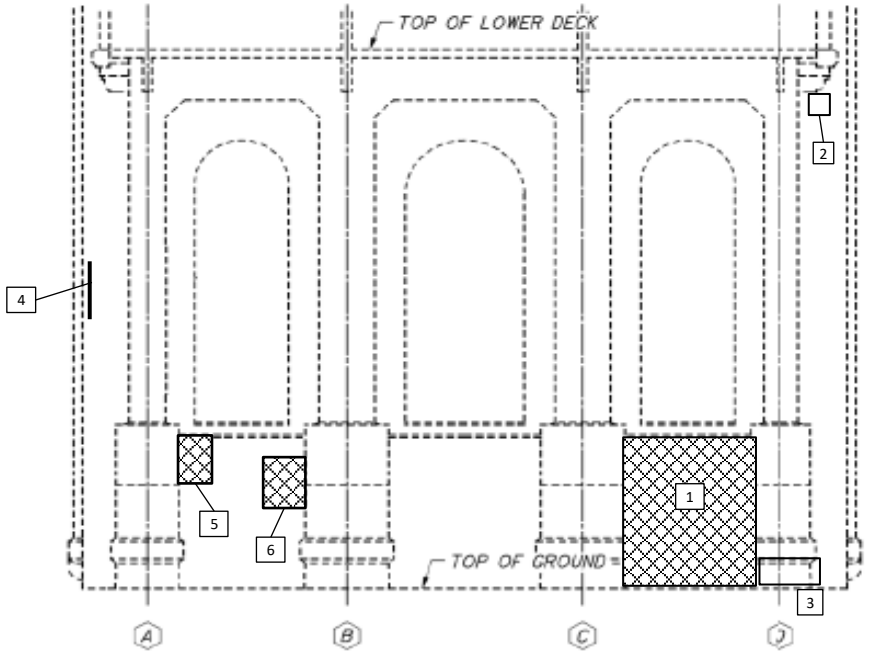
PIER 3 – WEST ELEVATION

Pier 3 - West Elevation Deficiencies	
#	Deficiency
1	Map Cracking - 80 SF
2	Spall - 1 SF
3	Base of pier has 1" D abrasion for 1' above the waterline. Embankment is steep and erodible despite placement of rubble rip rap.
4	Spall w/ exp. Reinf., 1.5" D - 5 SF
5	Map Cracking - 8 SF
6	Map Cracking - 12 SF

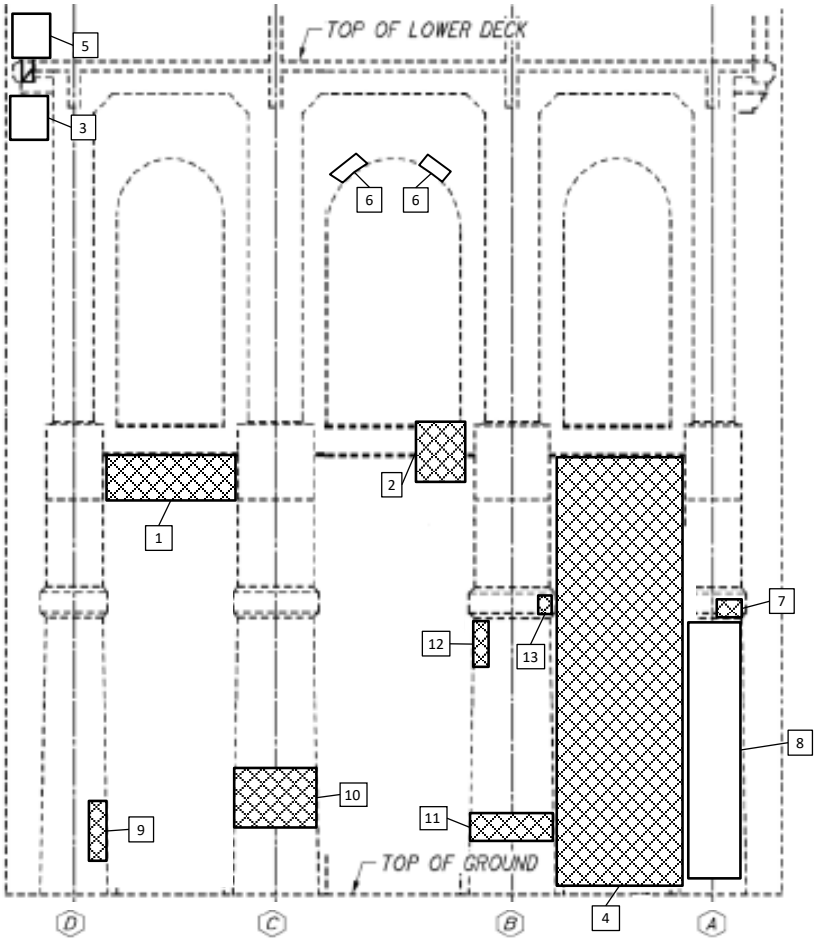
PIER 4 – EAST ELEVATION

Pier 4 - East Elevation Deficiencies			
#	Deficiency	#	Deficiency
1	Map Cracking - 32 SF	8	**Map Cracking - 75 SF**
2	Map Cracking - 16 SF	9	Map Cracking - 16 SF
3	Spalling - 1 SF	10	Map Cracking - 80 SF
4	Map Crack./Delam. - 600 SF	11	Map Cracking - 48 SF
5	Incomp. Repair - 2 SF	12	Map Cracking - **24** SF
6	Spall w/ Det. Rebar - 4 SF	13	Map Cracking - 3 SF
7	Map Cracking - 10 SF

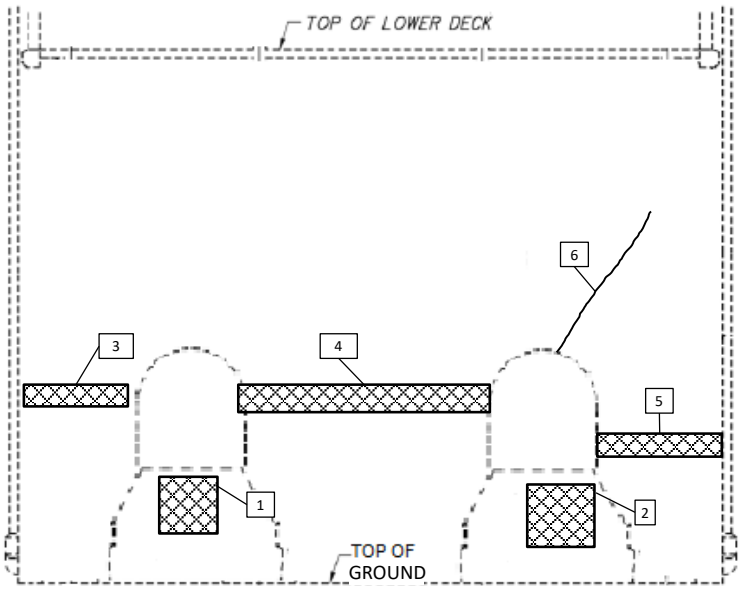
PIER 4 – WEST ELEVATION

Pier 4 - West Elevation Deficiencies	
#	Deficiency
1	Map Cracking - 144 SF
2	Map Cracking - 144 SF
3	Map Cracking - 20 SF
4	Map Cracking and Delamination - 170 SF
5	Map Cracking and Delamination - 20 SF
6	Crack - 15 LF

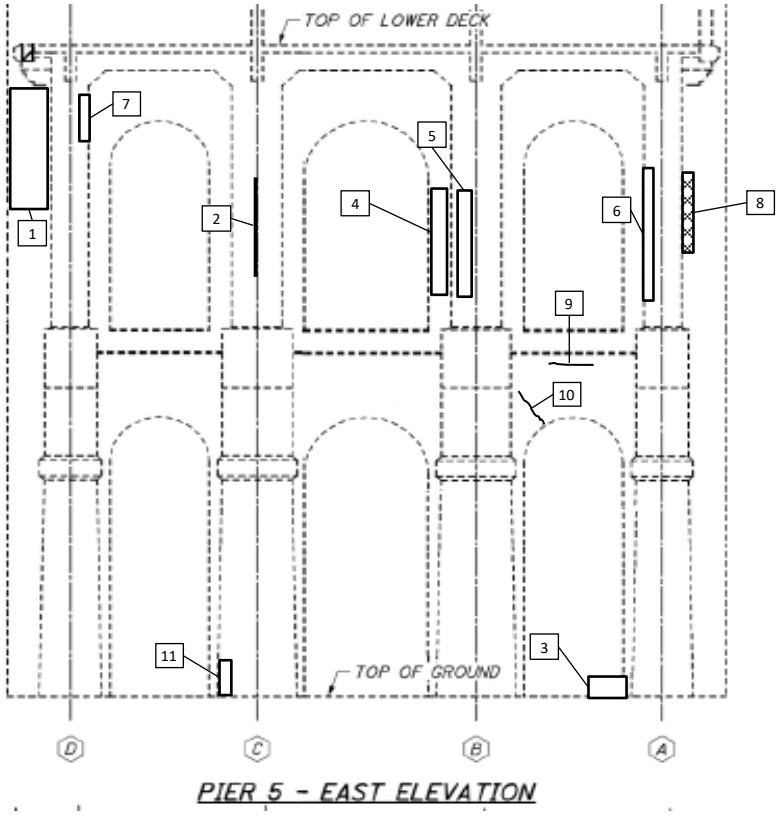
PIER 5 – EAST ELEVATION

Pier 5 - East Elevation Deficiencies			
#	Deficiency	#	Deficiency
1	Delam. - 40 SF & Spall w/ exp. Reinf. - 10 SF, 8" D	6	Delamination - 20 SF
		7	Spalling - 6 SF
2	Delam. w/ map cracks - 40 SF	8	Map Cracking - 40 SF
		9	Crack - 4 LF
3	Catch basin shifted and spalled w/ exp. Reinf.	10	Crack - 6 LF
		11	Spalling - 4 SF
4	Delamination - 70 SF		
5	Delamination - 35 SF

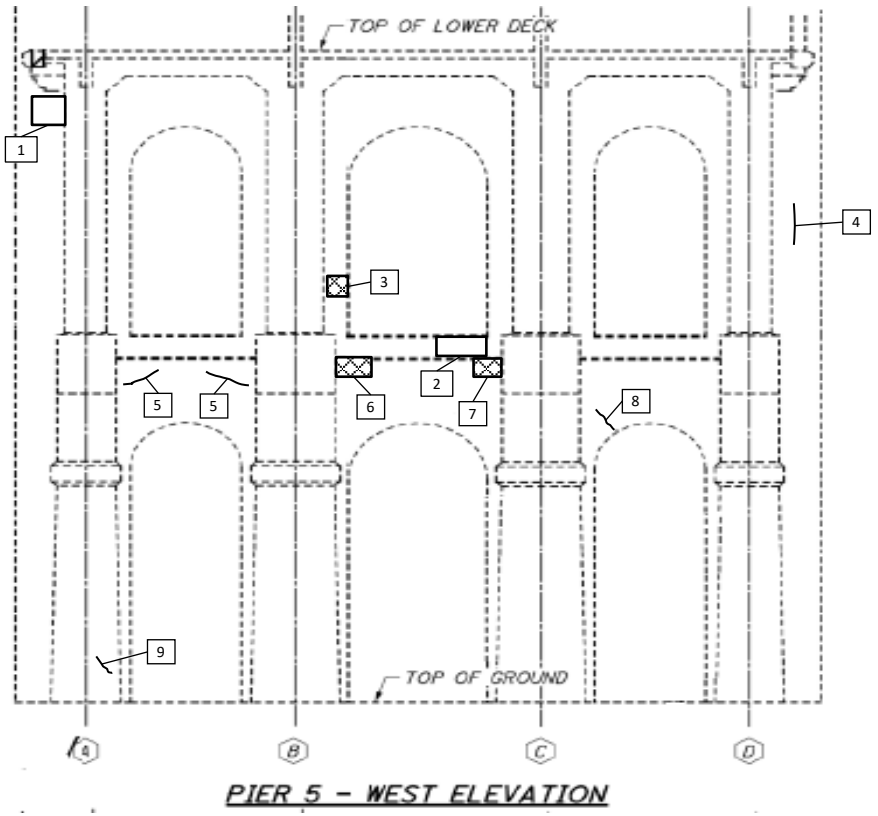
PIER 5 – WEST ELEVATION

Pier 5 - East Elevation Deficiencies			
#	Deficiency	#	Deficiency
1	Delamination - 10 SF	6	Map Cracking - 24 SF
2	Delamination - 6 SF	7	Map Cracking - 16 SF
3	Map Cracking - 25 SF	8	Crack - 4 LF
4	Crack - 10 LF	9	Crack - 3 LF
5	Crack - 8 LF

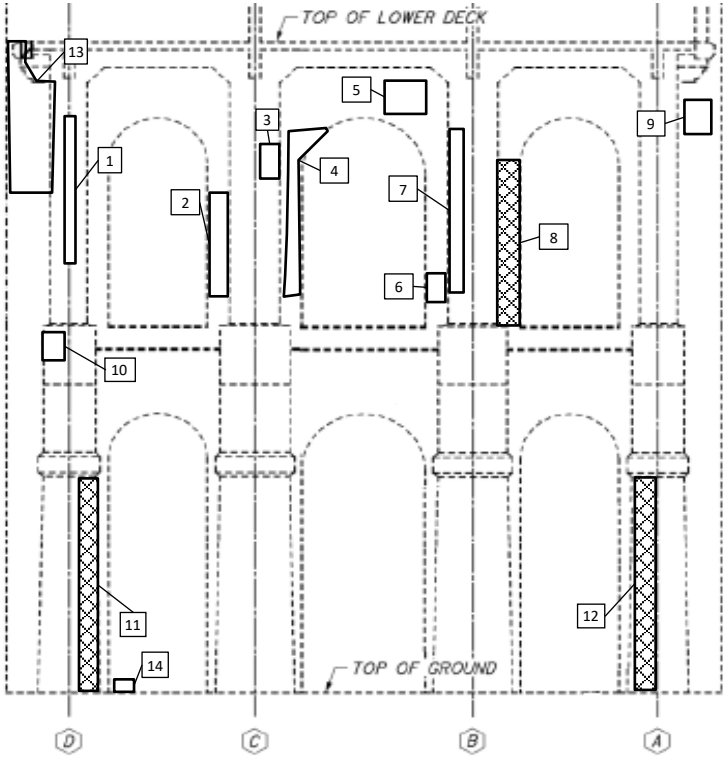
PIER 6 – EAST ELEVATION

Pier 6 - East Elevation Deficiencies			
#	Deficiency	#	Deficiency
1	Delamination - 30 SF	10	Spall, 6" D - 15 SF
2	Delamination - 80 SF	11	Map Cracking (inside face) - 60 SF
3	Delamination - 5 SF		
4	Delamination - 20 SF	12	Map Cracking - 60 SF
5	Delamination - 10 SF	13	Delam. w/ Spall w/ exp. Reinf. - 40 SF
6	Delamination - 20 SF		
7	Delamination - 35 SF	14	Catch basin cover has shifted.
8	Map Cracking - 30 SF		
9	Delamination- 20 SF Spall - 5 SF

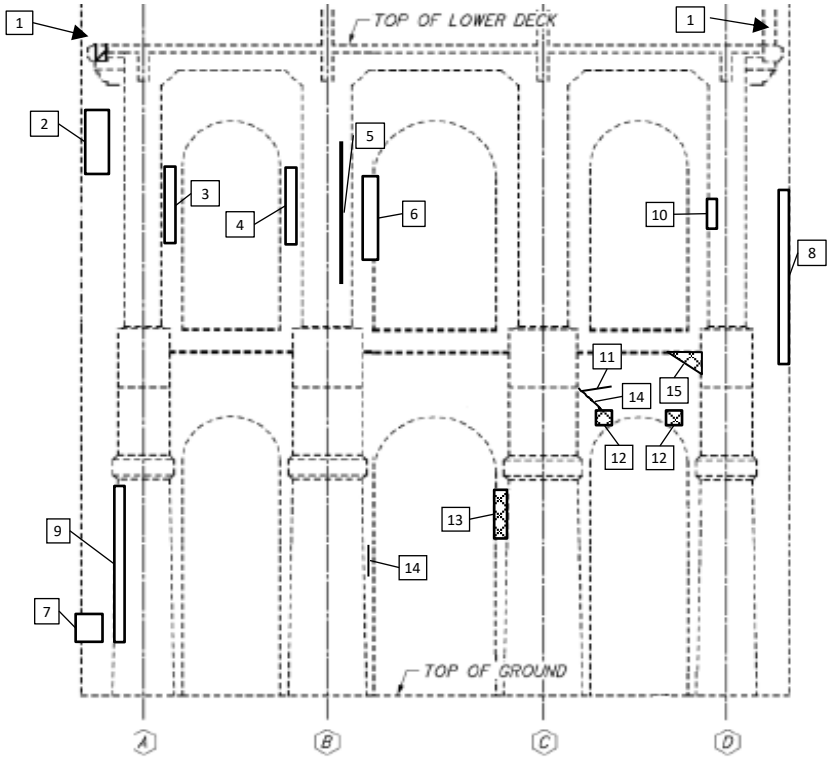
PIER 6 – WEST ELEVATION

Pier 6 - West Elevation Deficiencies			
#	Deficiency	#	Deficiency
1	The top North Pylon is pulling away 3/4". The top South Pylon is pulling away 2-1/4".	7	Spall - 3 SF
		8	Delam. w/ Spall (outside face) - 210 SF
		9	Close Cracks - 20 LF
2	Spall - 5 SF, 7" D	10	Spall - 2 SF
3	Delamination - 15 SF	11	Crack - 5 LF
4	Delamination - 15 SF	12	Map Cracking - 50 SF
5	Delamination - 30 SF (south face)	13	Map Cracking - 8 SF
		14	Crack - 3 LF
6	Map Cracking - 50 SF	15	Map Cracking - 8 SF

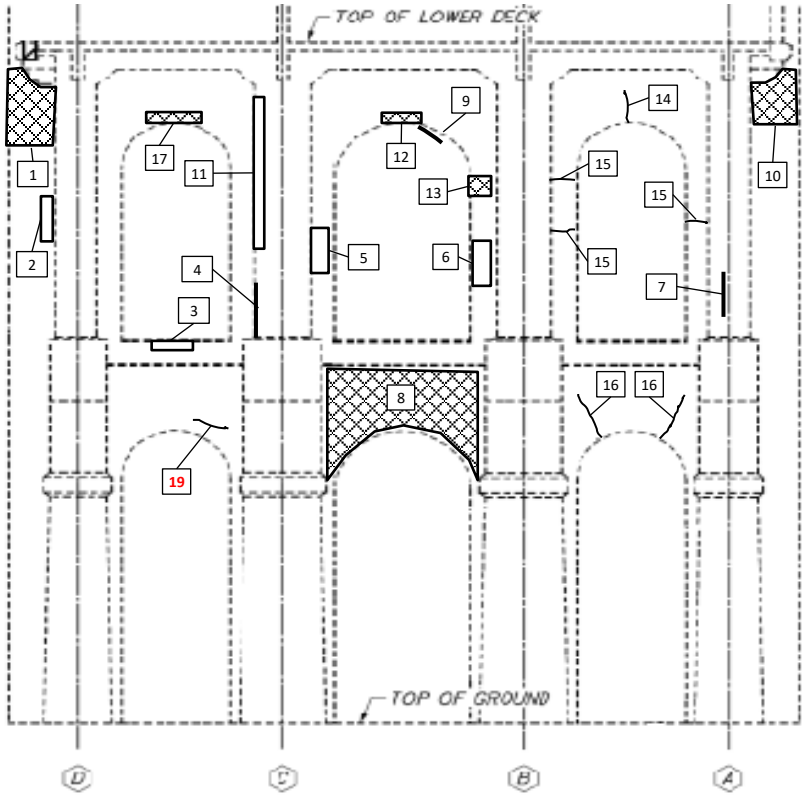
PIER 7 – EAST ELEVATION

Pier 7 - East Elevation Deficiencies			
#	Deficiency	#	Deficiency
1	Map Cracking - 30 SF	10	Delamination - 24 SF
2	Delam. w/ spalling - 7 SF	11	Spall w/ Det. Rebar - 45 SF
3	Delamination - 8 SF	12	Map Cracking - 5 SF
4	Spall w/ exp. Reinf. (South face) - 3 SF	13	Map Cracking - 4 SF
		14	Crack - 3 LF
5	Delamination - 4 SF	15	Crack - 2 LF
6	Delamination - 15 SF	16	Crack - 5 LF
7	Spall w/ exp. Reinf. - 6 SF	17	Map Cracking - 16 SF
8	Map Crack/Delam. - 30 SF	**18**	**Crack - 3 LF**
9	Delamination - 2 SF

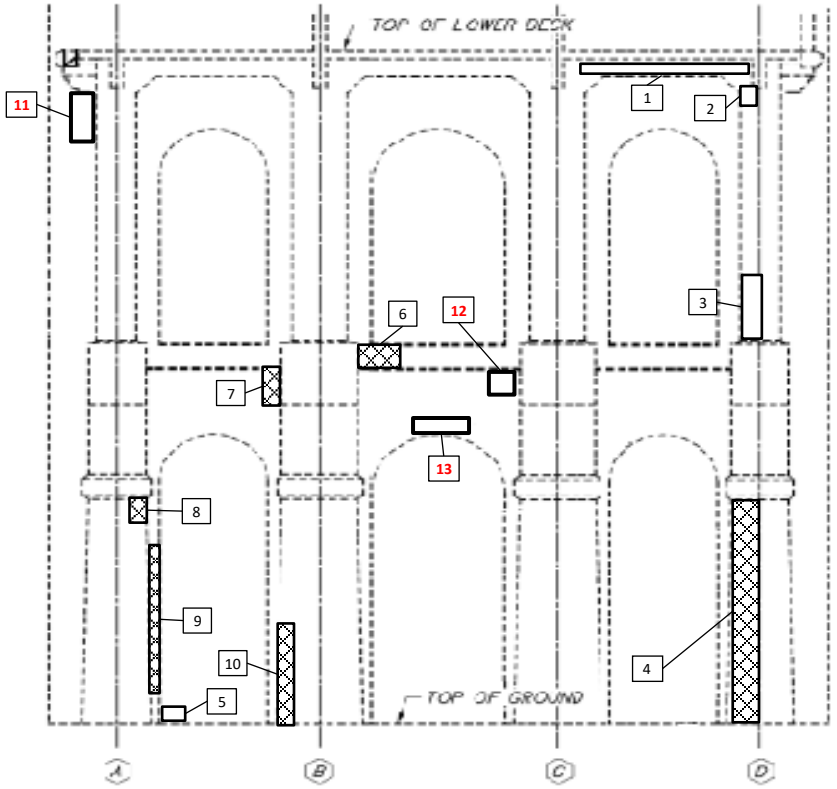
PIER 7 – WEST ELEVATION

Pier 7 - West Elevation Deficiencies			
#	Deficiency	#	Deficiency
1	Delamination - 20 SF	8	Close Cracks - 2 SF
2	Delamination - 15 SF	9	Close Cracks - 15 SF
3	Delamination - 10 SF	10	Map Cracking - 10 SF
4	Map Crack/Delam. - 60 SF	**11**	**Spall w/ exp. Reinf. - 4 SF**
5	Catch basin cover rotated. **Corner spalls.**	**12**	**Delamination - 2 SF**
6	Map Cracking - 18 SF	**13**	**Delamination - 5 SF**
7	Map Cracking - 12 SF

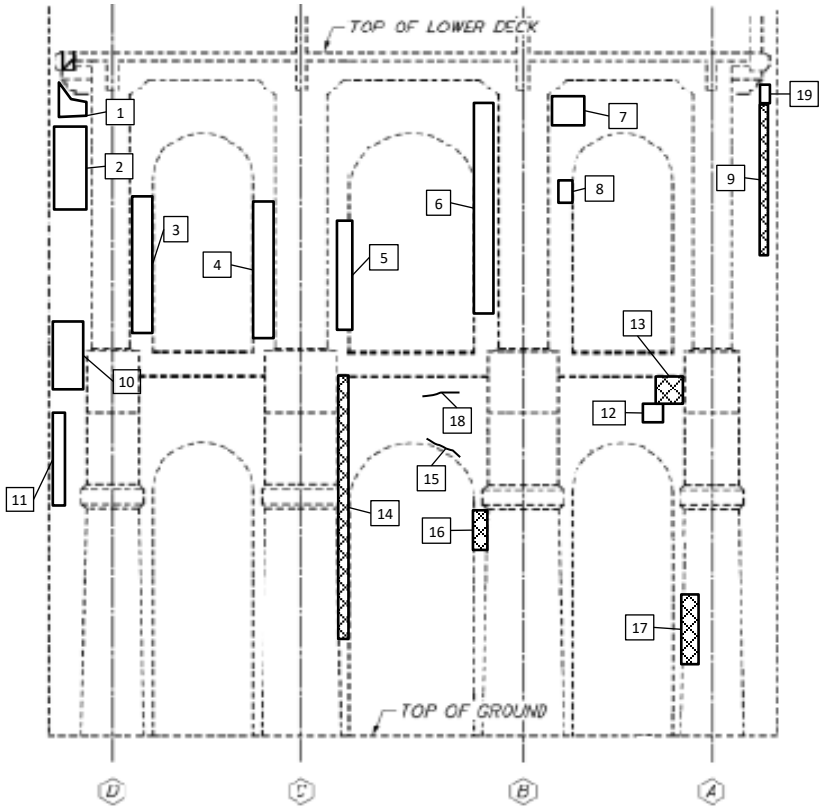
PIER 8 – EAST ELEVATION

Pier 8 - East Elevation Deficiencies			
#	Deficiency	#	Deficiency
1	Spall w/ det. Reinf. - 9 SF	11	Delam. w/ some spalling - 10 SF
2	Delamination - 42 SF		
3	Delamination - 75 SF	12	Delamination - 4 SF
4	Delamination - 100 SF	13	Map Cracking - 9 SF
5	Delamination - 40 SF	14	Map Cracking - 20 SF
6	Delamination - 50 SF	15	Crack - 5 LF
7	Delamination - 9 SF	16	Map Cracking - 3 SF
8	Delamination - 2 SF	17	Map Cracking - 12 SF
9	Map Cracking - 30 SF	18	Crack - 2 LF
10	Delamination - 21 SF	19	Spall w/ det. Reinf. - 3 SF

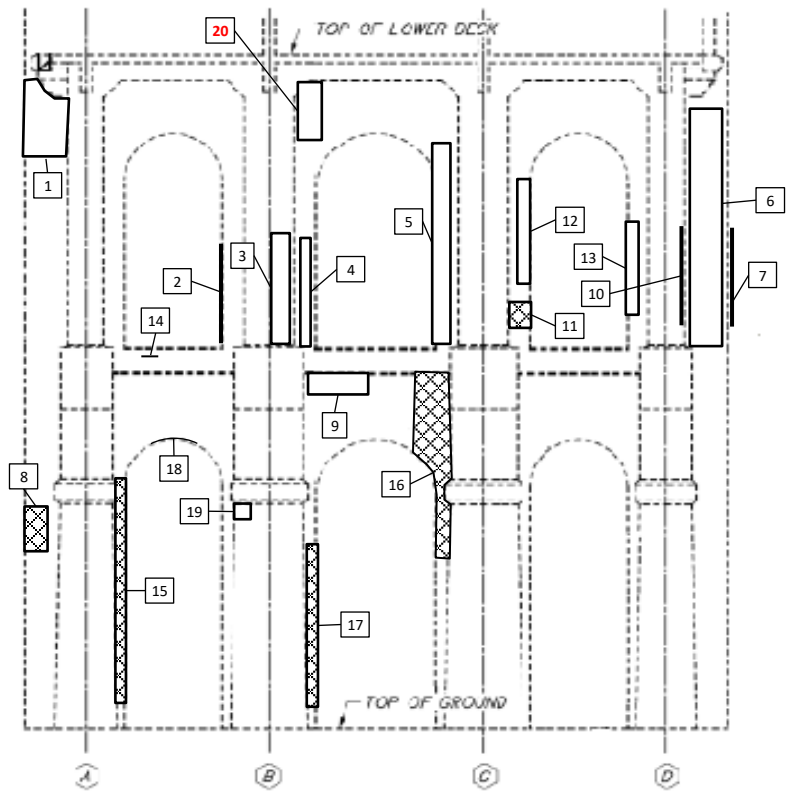
PIER 8 – WEST ELEVATION

Pier 8 - West Elevation Deficiencies			
#	Deficiency	#	Deficiency
1	Delam. w/ spalling - 32 SF	11	Delamination - 3 SF
2	Delamination - 15 SF	12	Spall w/ Crack - 10 SF
3	Delamination - 30 SF	13	Spall w/ Crack - 10 SF
4	Delamination - 35 SF	14	Crack - 1 LF
5	Delamination - 60 SF	15	Close Cracks - 15 SF
6	Delam. w/ spalling - 68 SF	16	Map Cracking - 30 SF
7	Delamination - 9 SF	17	Map Cracking - 10 SF
8	Map Cracking - 10 SF	18	Crack (bot. face) - 10 LF
9	Delamination - 4 SF	19	Spall - 1 SF
10	Delamination - 10 SF	**20**	**Delamination - 15 SF**

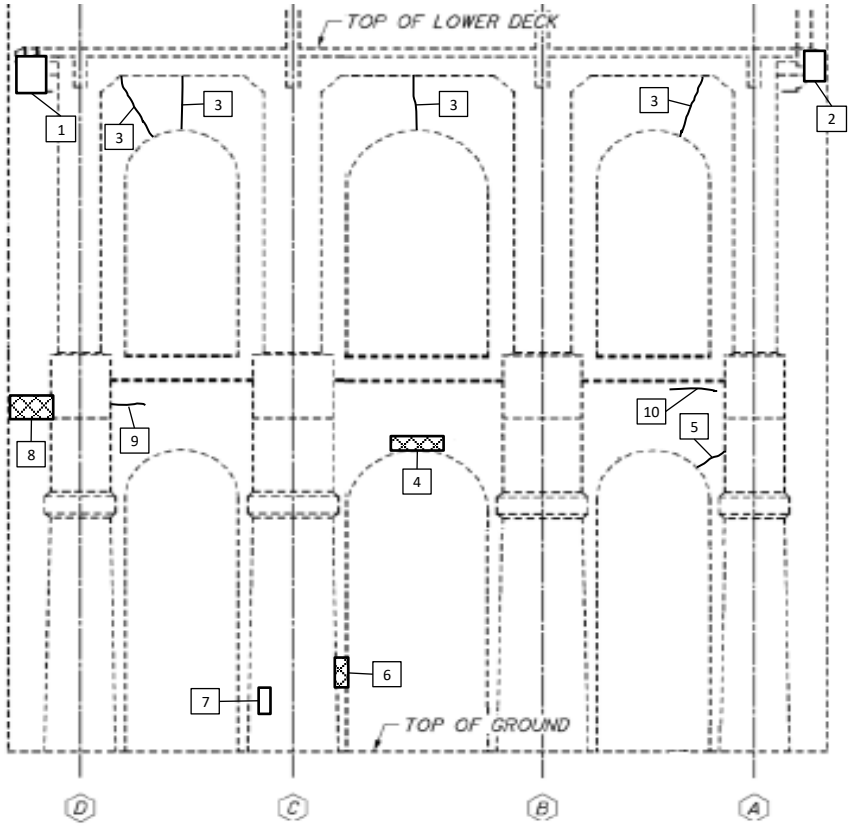
PIER 9 – EAST ELEVATION

Pier 9 - East Elevation Deficiencies			
#	Deficiency	#	Deficiency
1	Delamination - 2 SF	6	Map Cracking - 2 SF
2	Delamination - 3 SF	7	Spall - 2 SF
3	Crack - 8 LF	8	Map Cracking - 6 SF
4	Map Cracking - 4 SF	9	Crack - 3 LF
5	Crack - 3 LF	10	Crack - 6 LF

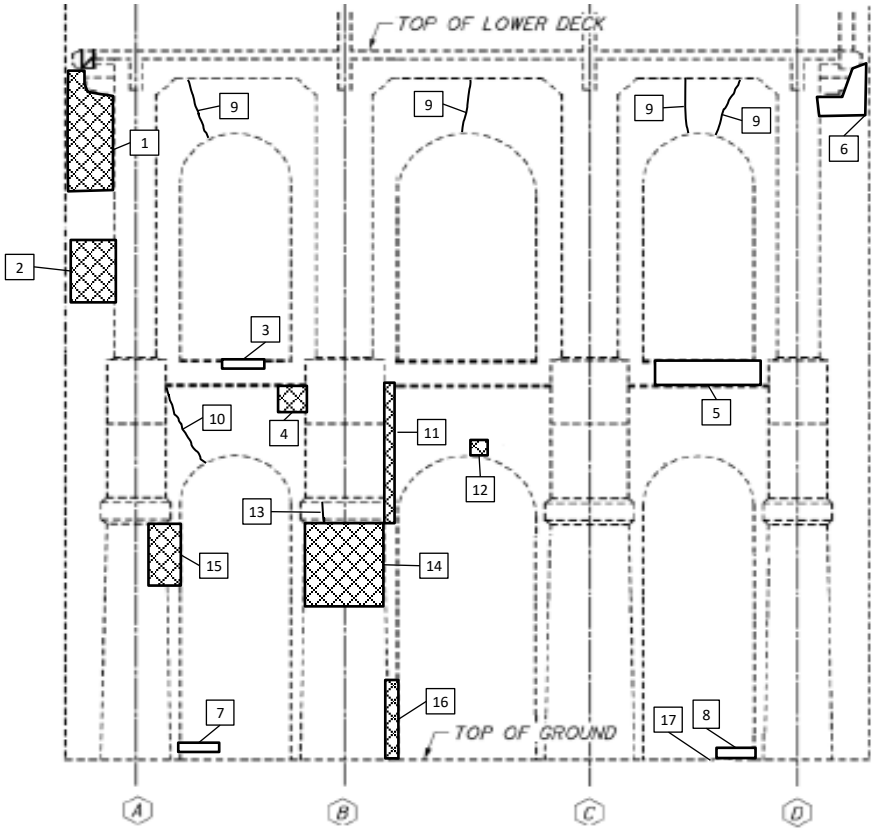
PIER 9 – WEST ELEVATION

Pier 9 - West Elevation Deficiencies			
#	Deficiency	#	Deficiency
1	Map Cracking - 34 SF	10	Crack - 7 LF
2	Spall w/ Det. Rebar - 8 SF	11	Map Cracking - 20 SF
3	Delamination - 1 SF	12	Map Cracking - 1 SF
4	Map Cracking - 9 SF	13	Crack - 2 LF
5	Delamination - 20 SF	14	Map Cracking - 36 SF
6	Delam. w/ Spalling - 20 SF	15	Close Cracks - 20 SF
7	Catch basin frame shifted. **Corner spalls**	16	Map Cracking - 12 SF
8	Catch basin frame shifted. **Corner spalls**	17	Significant rutting at CB
9	Crack - 8 LF

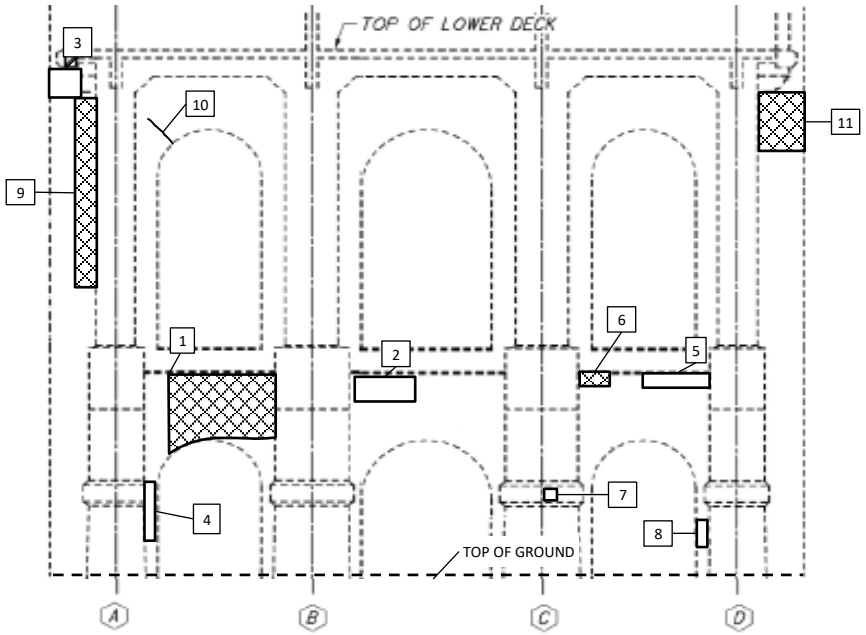
PIER 10 – EAST ELEVATION

Pier 10 - East Elevation Deficiencies	
#	Deficiency
1	Map Cracking - 30 SF
2	Delamination - 3 SF
3	Spall - 2 SF
4	Map Cracking - 15 SF
5	Poor Patching / Delamination - 8 SF
6	Map Cracking - 2 SF
7	Spall - 1 SF
8	Spall - 2 SF
9	Map Cracking - 15 SF
10	Crack - 6 LF
11	Map Cracking - 20 SF

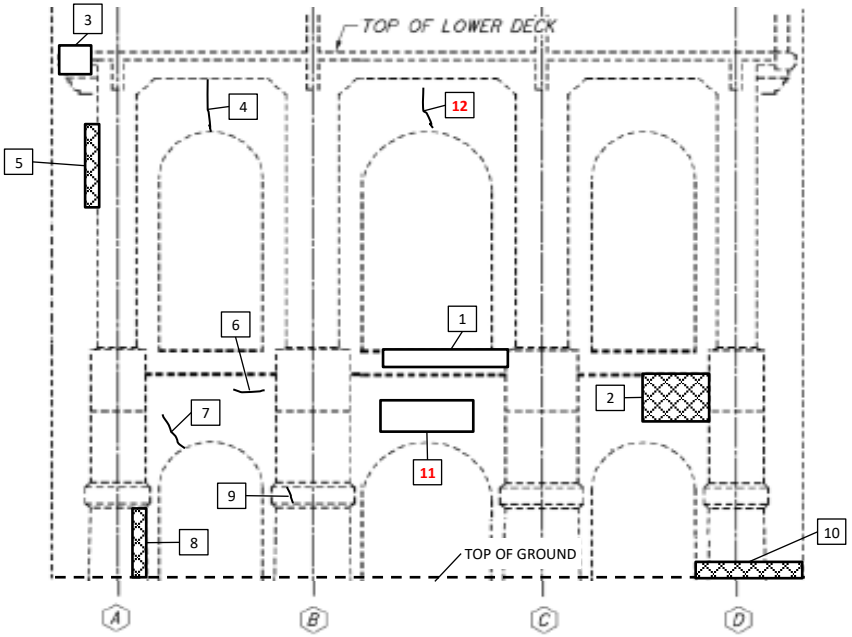
PIER 10 – WEST ELEVATION

Pier 10 - West Elevation Deficiencies	
#	Deficiency
1	Delamination - 10 SF
2	Map Cracking - 24 SF
3	Spall - 5 SF
4	Crack - 8 LF
5	Map Cracking - 20 SF
6	Crack - 4 LF
7	Crack - 5 LF
8	Map Cracking - 24 SF
9	Crack - 5 LF
10	Delamination - 10 SF
11	**Delamination - 6 SF**
12	**Crack - 6 LF**

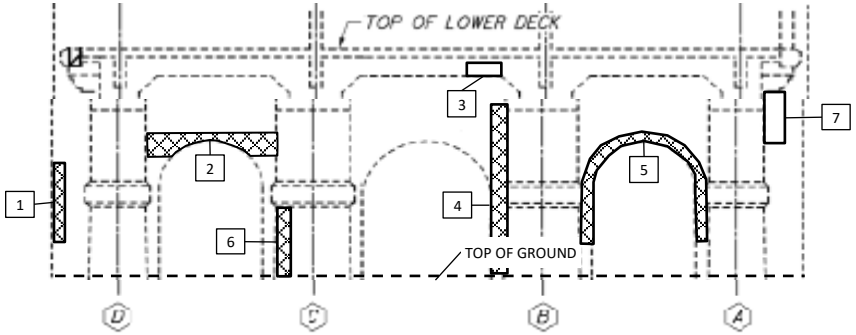
PIER 11 - EAST ELEVATION

Pier 11 - East Elevation Deficiencies	
#	Deficiency
1	Map Cracking - 11 SF
2	Map Cracking - 90 SF
3	Incomp. Repair - 12 SF
4	Map Cracking - 40 SF
5	Map Cracking - 42 SF
6	Map Cracking - 6 SF
7	Spall w/ Det. Rebar - 8 SF

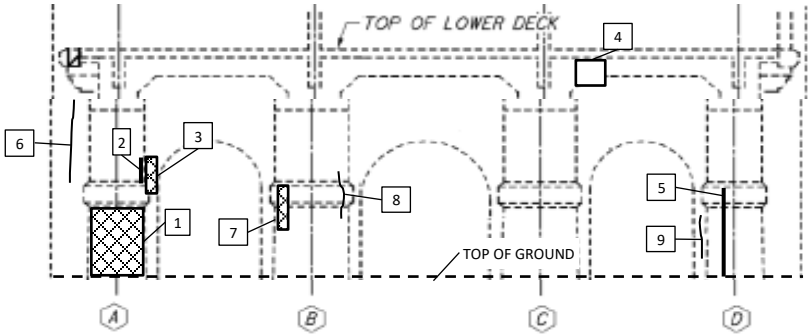
PIER 11 - WEST ELEVATION

Pier 11 - West Elevation Deficiencies	
#	Deficiency
1	Map Cracking - 30 SF
2	Map Cracking - 6 SF
3	Delamination and Map Cracking - 10 SF
4	Delamination - 2 SF
5	Delamination (Inside face) - 4 SF
6	Crack - 15 LF
7	Map Cracking - 4 SF
8	Crack - 8 LF
9	Crack - 6 LF

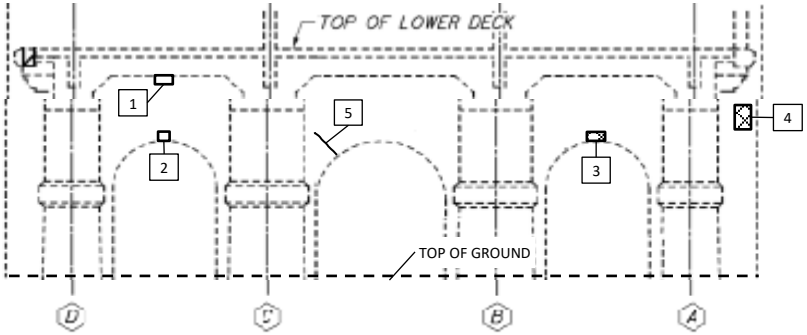
PIER 12 - EAST ELEVATION

Pier 12 - East Elevation Deficiencies	
#	Deficiency
1	Spall - 3 SF
2	Spall w/ Det. Rebar - 1 SF
3	Close Cracks - 1 SF
4	Map Cracking - 8 SF
5	Crack - 5 LF

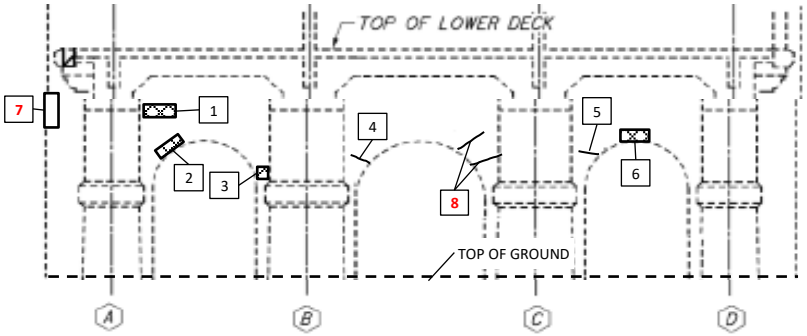
PIER 12 - WEST ELEVATION

Pier 12 - West Elevation Deficiencies	
#	Deficiency
1	Map Cracking - 8 SF
2	Map Cracking - 3 SF
3	Map Cracking - 1 SF
4	Crack - 2 LF
5	Crack - 2 LF
6	Map Cracking - 2 SF
7	**Delamination - 2 SF**
8	**Crack - 8 LF**

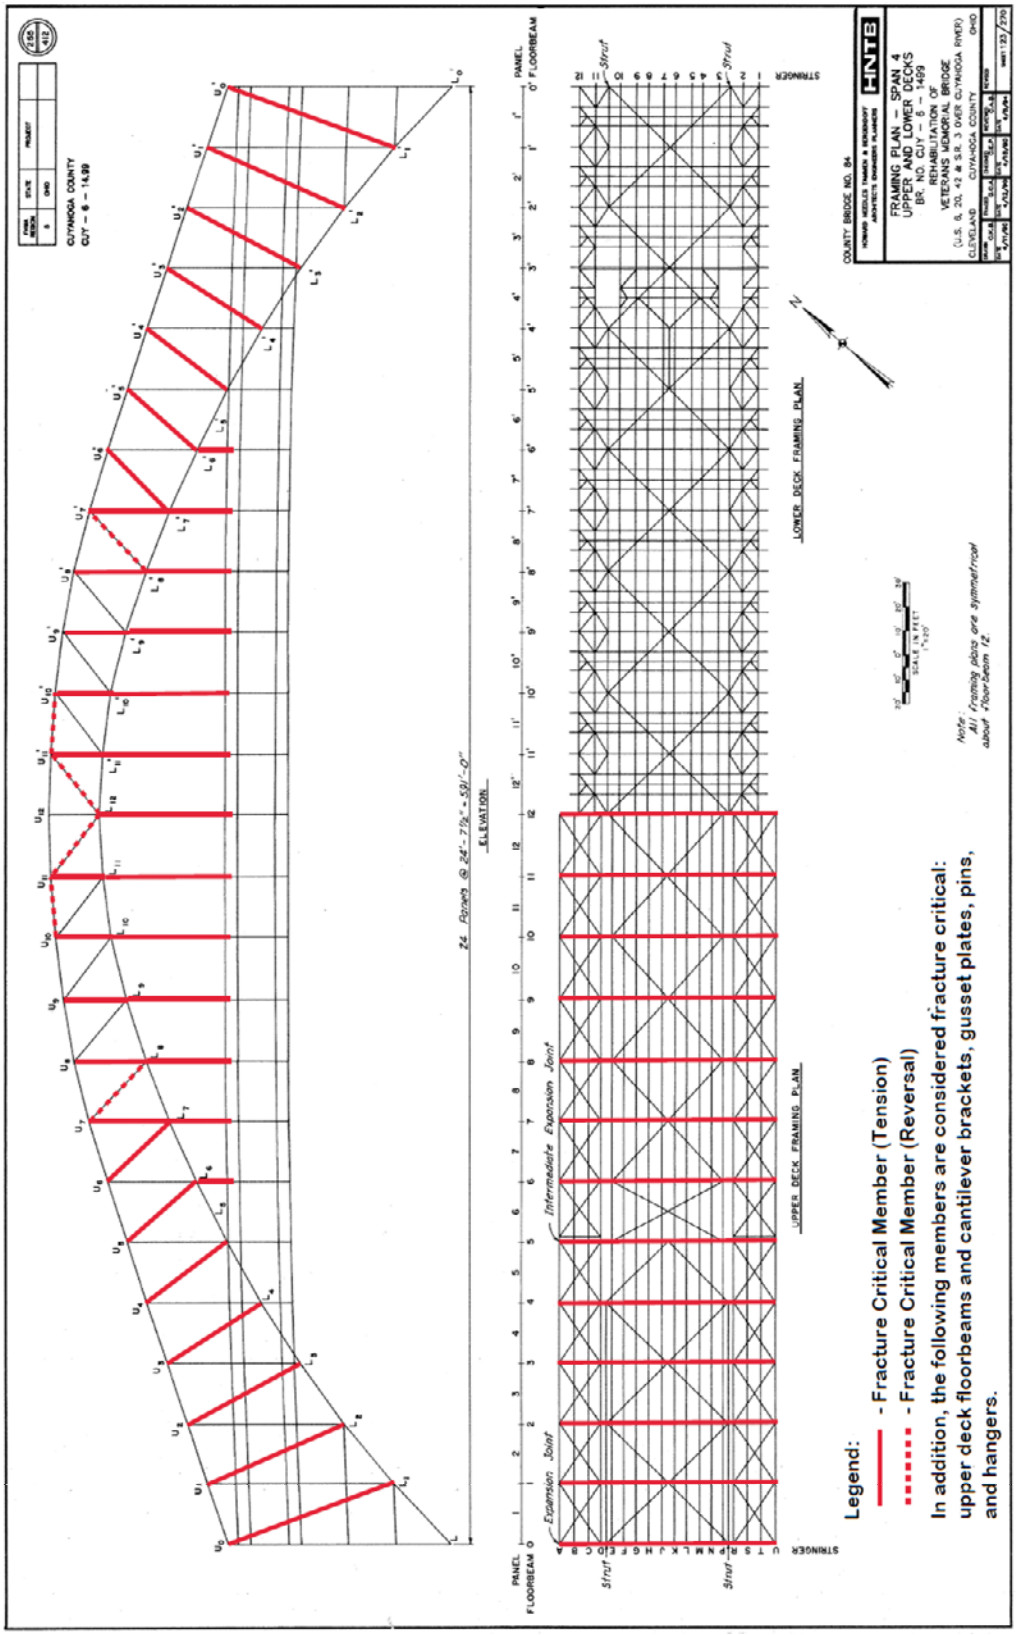
Description: The bridge is approximately 2,880 feet long, including 1,673 feet of subway tunnel that is linked by the lower deck. The bridge was constructed from 1912 to 1917. The majority of the main spans are reinforced concrete deck arches. Span 4 is a 591-foot long, three-hinged steel half through arch truss in a Pratt configuration. In this steel arch span, portions of the arch truss, pins, hangers, upper deck floorbeams and upper deck overhang brackets are considered fracture critical (see *Figures 3 & 4*).

Figure 3: Fracture Critical Member Locations (Highlighted Red)

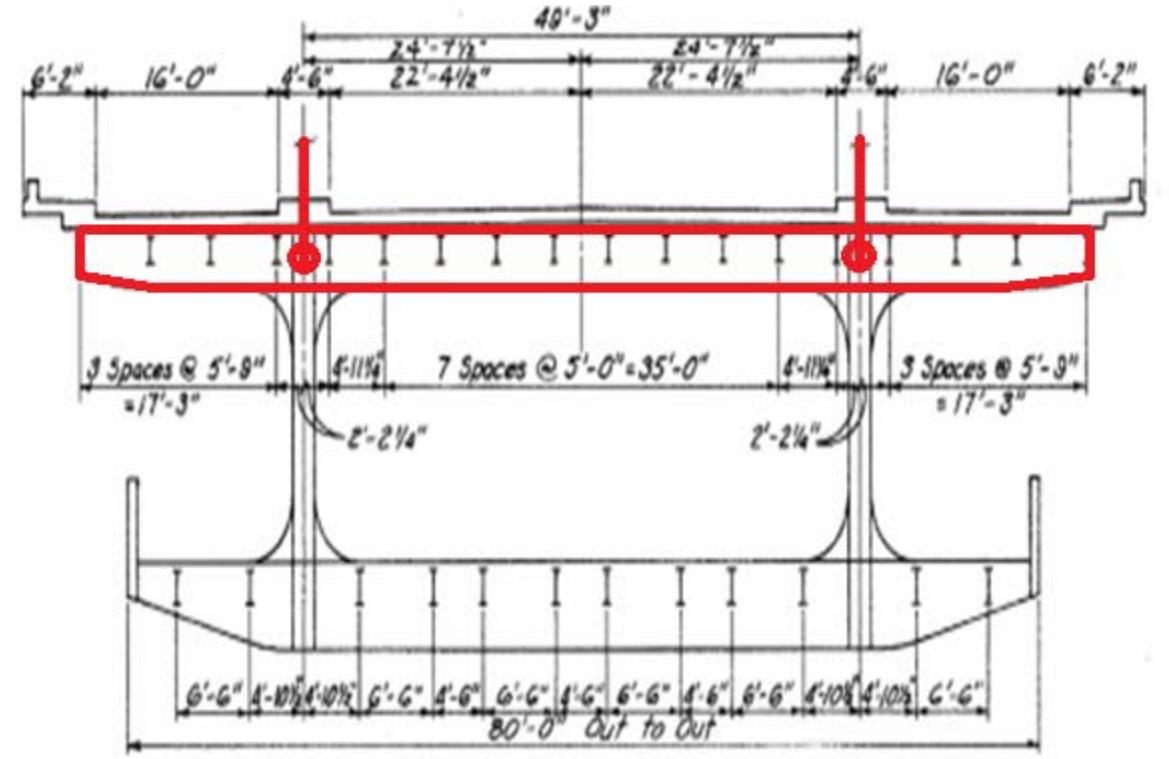
Figure 4: Fracture Critical Member Locations (Highlighted Red)

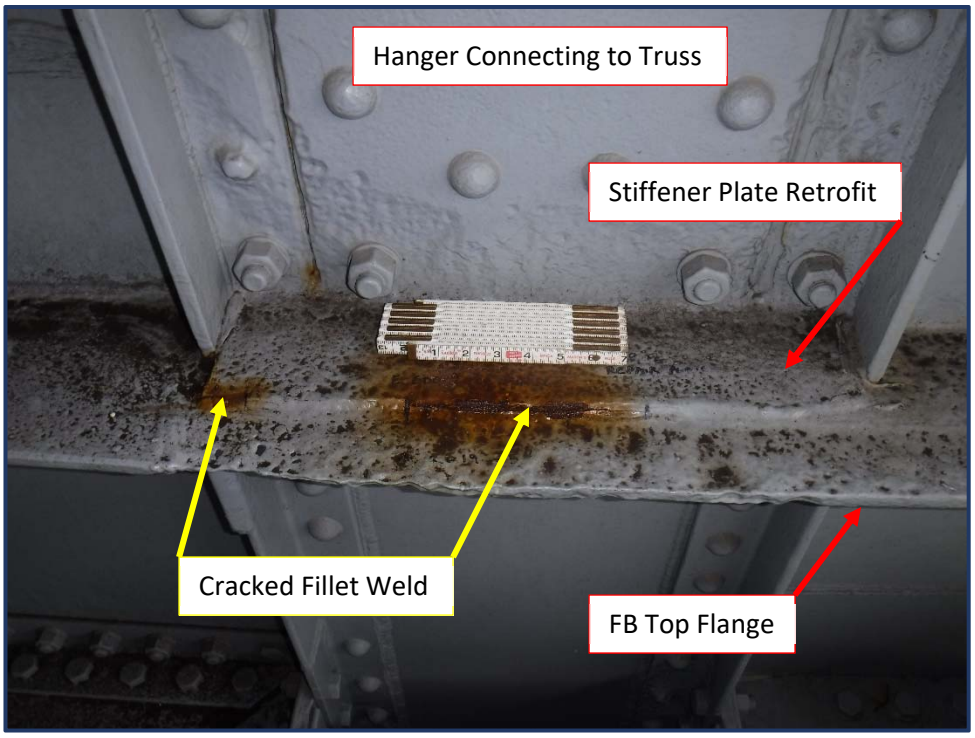
7. Cracks in the fillet welds are present at several of the stiffening retrofit plates welded to the top flange of the lower deck floorbeams at the truss lines.

Photo 1a – Cracking at Lower Deck Floorbeam Stiffener Plate Retrofit

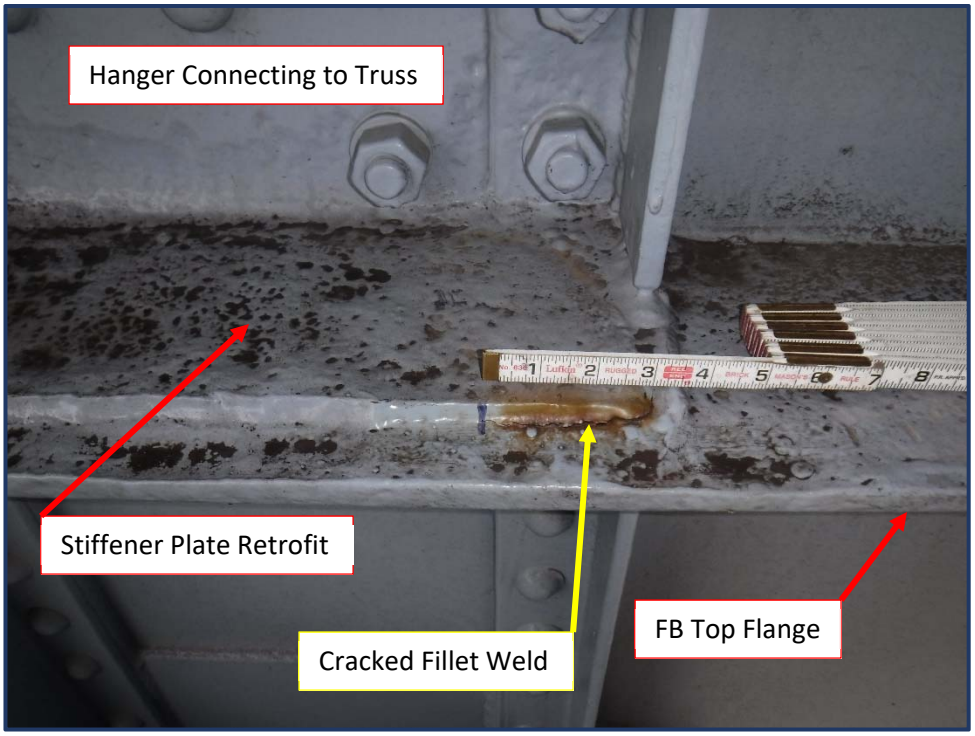
Photo 1b – Cracking at Lower Deck Floorbeam Stiffener Plate Retrofit
