April 29, 2024

Subject: Asbestos Inspection of CUY 00077 15460 I-77 Bridge over US-422WB (SFN #1806815 / PID #119380) in Cleveland, Ohio 44115
L&A Project No: 23-0495

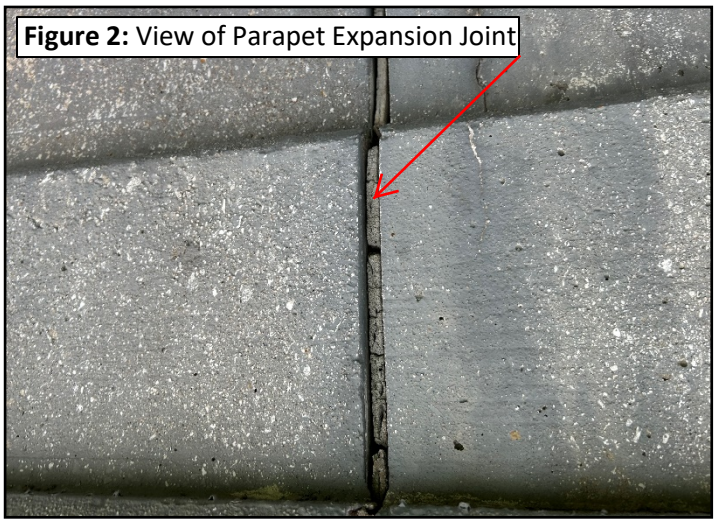
Sample #	Sample Description and Location	Asbestos %
1	Parapet Expansion Joint – South Side, West End	No Asbestos Detected
2	Parapet Expansion Joint – South Side, Middle	No Asbestos Detected
3	Parapet Expansion Joint – South Side, East End	No Asbestos Detected
4	Bolt Caulking – South Side, West End	No Asbestos Detected
5	Bolt Caulking – South Side, Middle	No Asbestos Detected
6	Bolt Caulking – South Side, East End	No Asbestos Detected
7	Paint on Concrete – South Side, East End, Below Deck	No Asbestos Detected
8	Paint on Concrete – North Side, East End, Below Deck	No Asbestos Detected
9	Paint on Concrete – South Side, West End, Below Deck	No Asbestos Detected
10	Paint on Steel – South Side, East End, Below Deck	No Asbestos Detected
11	Paint on Steel – North Side, East End, Below Deck	No Asbestos Detected
12	Paint on Steel – South Side, West End, Below Deck	No Asbestos Detected

Under the current EPA/NESHAP regulations, materials that contain greater than 1% asbestos are considered to be an asbestos-containing material (ACM). None of the materials sampled were found to be Asbestos Containing Material as defined by U.S EPA/NESHAP regulations.

Figure 2: View of Parapet Expansion Joint

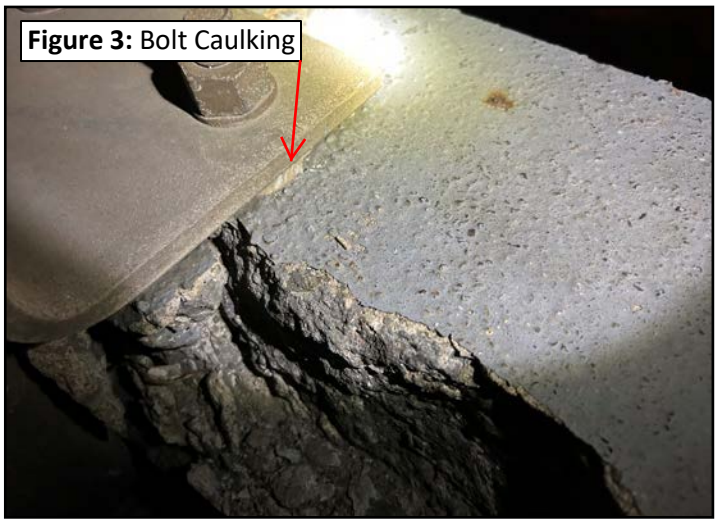
Figure 3: Bolt Caulking

Figure 4: Paint on Concrete & Steel
