**Baker Slope Stability Study Report
(Reference Document)**

**Innerbelt Bridge
Construction Contract Group 1 (CCG1)**

Slope Stability Evaluation Report of the West Bank

CUY-90-14.92
PID 77332

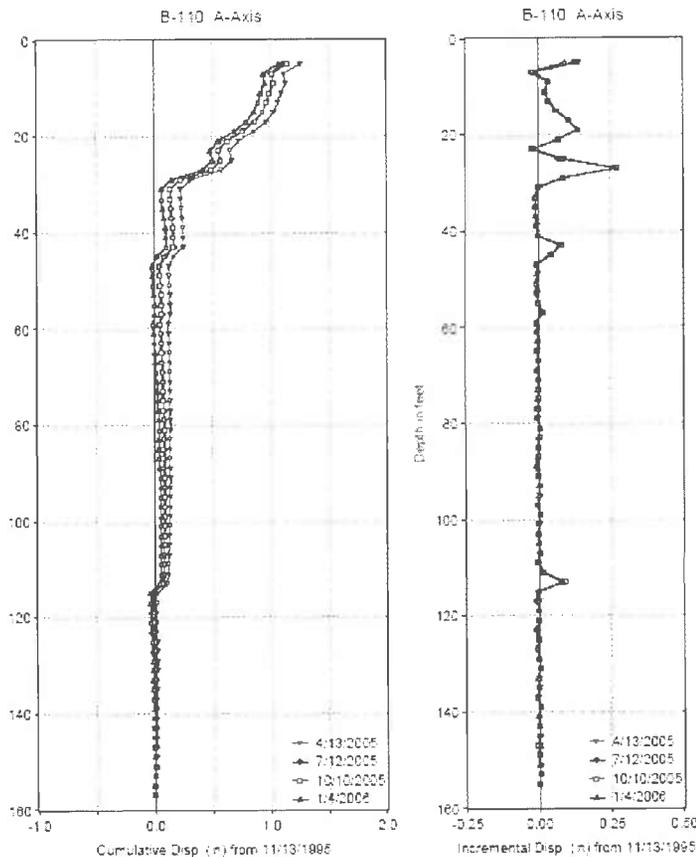
Response: The rate of movement (0.15 in/yr) provided in the BBC&M report, page 39, was taken from Table 1a of the 2005-2006 annual monitoring report. The value of 0.15 in/yr was determined by summing the displacement from 7 to 25 feet, 25 to 31 feet and 43 to 47 feet (see displacement time history plot for B-110 of the 2005-2006 annual monitoring report). This was done to quantify the total displacement as is shown in the B-110 displacement figure below.

Stating the rate of movement of 0.15 in/yr may be misleading as it includes displacement along at least two slip planes and indicates cantilever deflection. However, it was done in an attempt to quantify the total relative shallow movement observed in inclinometer B-110. Presenting the relative displacement between the ground surface and a depth of 47 feet is more relevant than simply presenting the displacement along one slip plane as all of this shallow movement would be transferred to a pier if it were placed in the vicinity of inclinometer B-110.

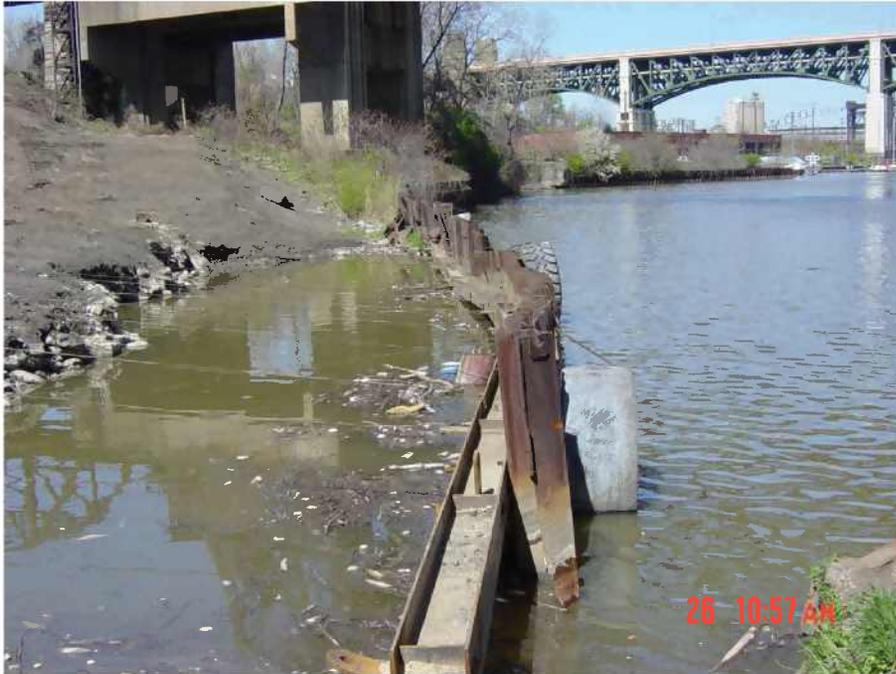
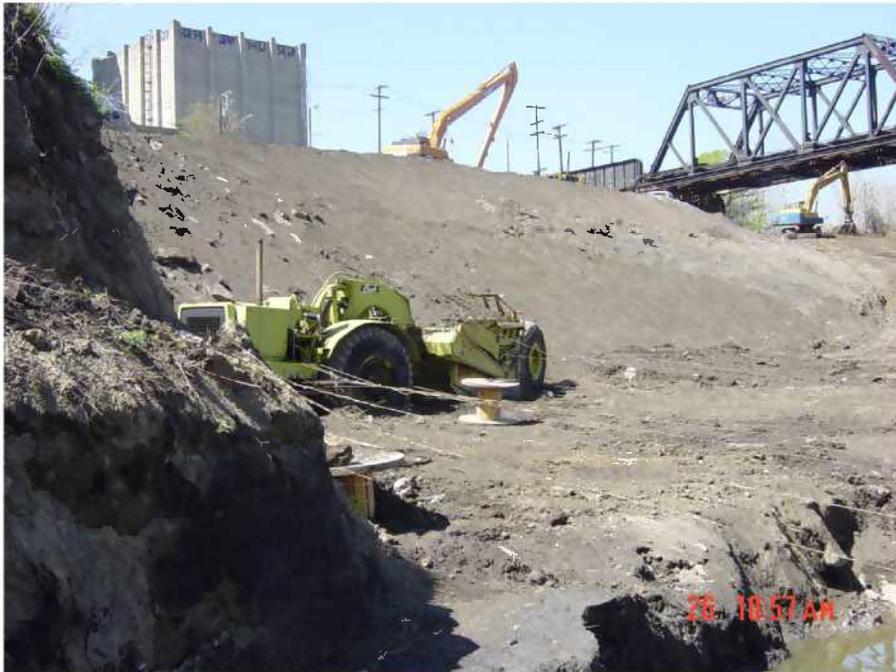
A sheet pile revetment wall exists at the toe of the slope. It is required by the US Army Corps of Engineers to help maintain a navigable water way. The sheets are 65 feet long. Horizontal steel rods spaced at 8 ft intervals extend from the top of the sheeting to anchor located approximately 40 ft behind the sheeting. These tiebacks failed over time with the consequence that soil and water pressures acting on the back of the sheeting caused the sheeting to displace outward by several feet as shown in the pictures in Figure 3.1. The current owner has excavated soil from behind the sheeting with the hope that the sheeting can be pulled back into place, new tiebacks placed and the slope backfilled. This operation has reduced the overall factor of safety of the existing slope approximately 0.13. This revetment wall should be replaced with a strong, reliable revetment. A new pier should be located to avoid the sheet pile wall tie-backs.

Figure 3.1: Pictures showing the failed sheet pile wall.

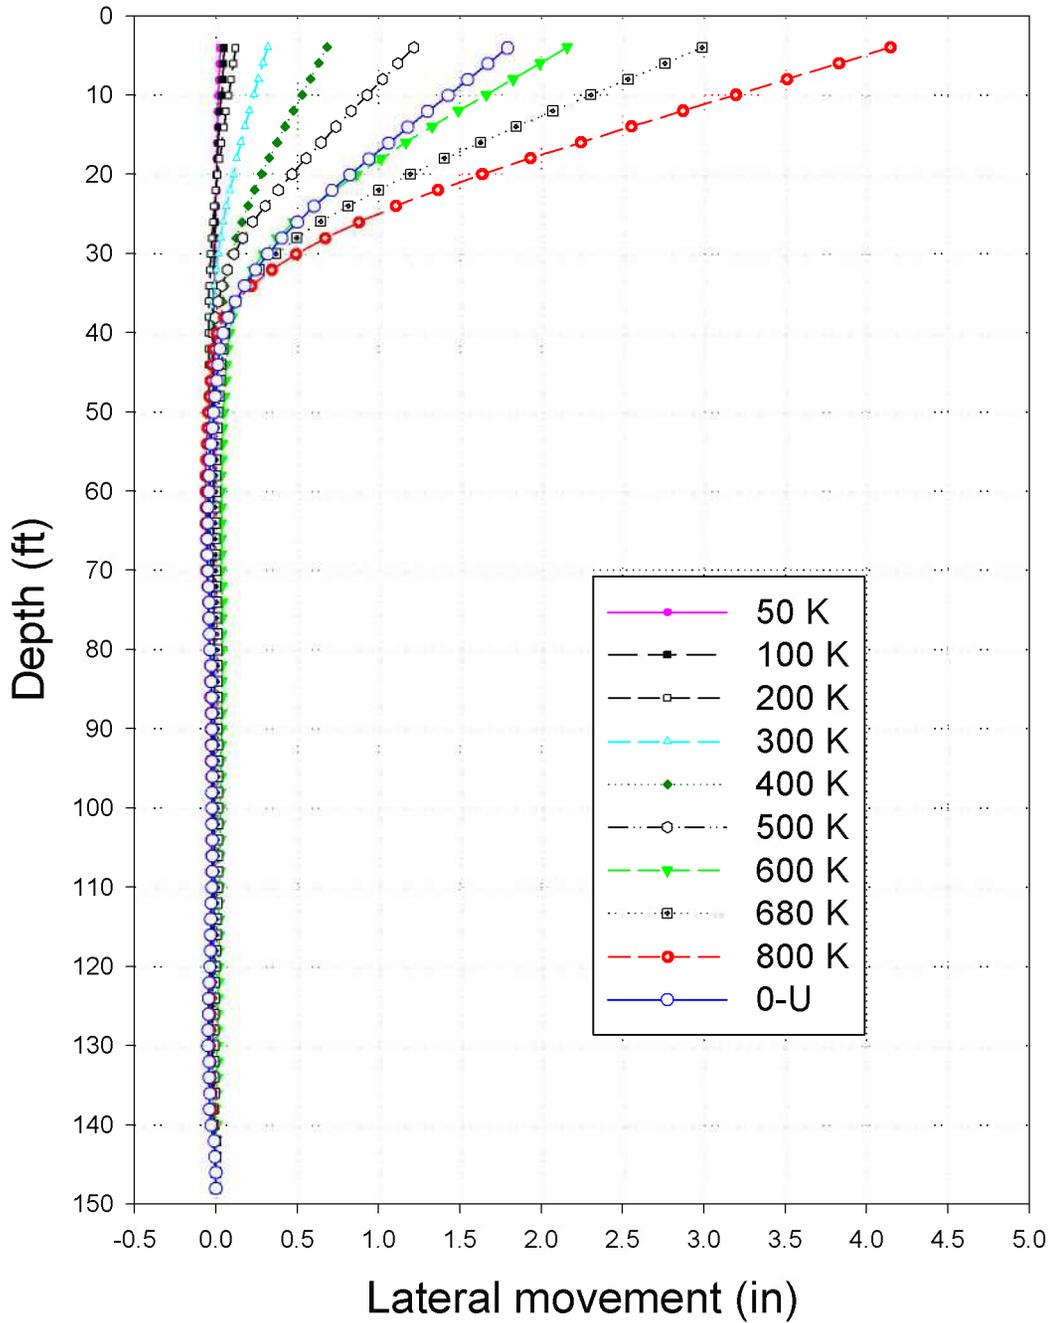
Figure 5.15 Deflection vs. Depth from Shaft #1 during the lateral load test.

During construction of the drilled shafts for the stabilization structure, a lateral load test was conducted between shafts #1 and #3. The maximum applied lateral load was 800 kips. The deflection associated with a lateral load of 800 kips was 5 inches as shown in Figure 5.15. The maximum bending strain along the depth of shaft #1 associated with the 800 kips lateral load was 1614 micro strains as shown in Table 5.2. From long term monitoring data obtained from instrumentation installed in drilled shaft #9, measurements indicated a maximum bending strain located at a depth of 95 feet to have a magnitude equal to 151 micro strains. This value is 10% of the 1614 value measured during the lateral load test.

Based on the findings from the lateral load test, the drilled shafts have the ability to move up to 5 inches elastically (which was the maximum movement reported in the lateral load test). The rate of movement in drilled shaft #17 was the highest (i.e. 0.12 inch/yr). Assuming a constant rate of 0.12 inch/yr, it will take 15 years to reach a total movement of 3.5 inches (1.7 + 1.8). Assuming a constant rate of 0.12 inch/yr, it will take 28 years to reach a total movement of 5 inches (1.7 + 3.3). This indicates that the safe life of the stabilization shafts is approximately 30 years before getting beyond the condition as tested in 1998. From the long term monitoring data, the rate of increase in the moment and axial force in shaft #9 at a depth of 95 feet appears to have decreased as shown in Figures 5.17 and 5.18. The recently collected data from the July 2006 readings show minimal increase in the strain in the shaft.

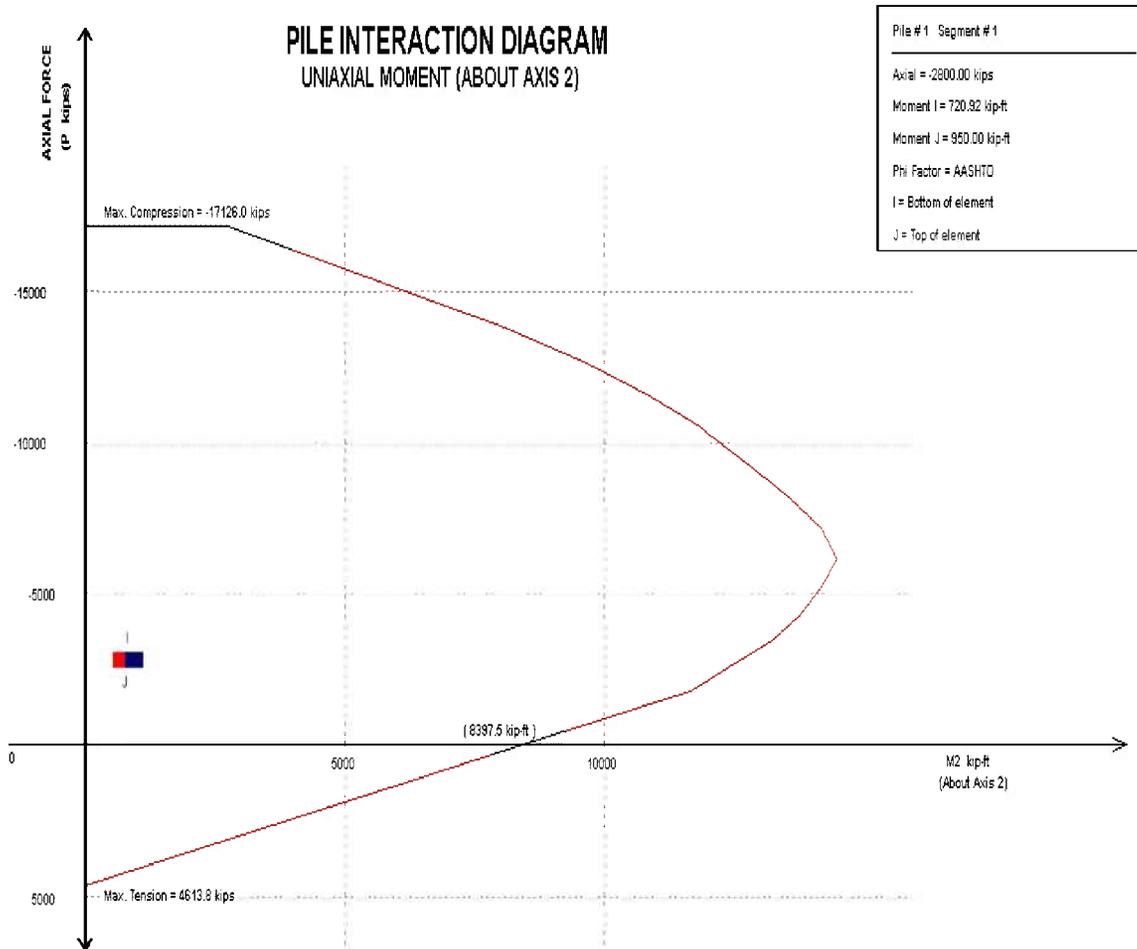
Figure 5.16 Interaction Diagram for Drilled shafts in the stabilization structure.

For shaft #17, which experienced a maximum movement of 1.7 inches, the strain equivalent to this value from the lateral load test is equal to 231 micro strains. Figure 5.16 shows the interaction diagram for the stabilization drilled shafts. The concrete strength used was 6000 psi, which was taken from the drilled shaft inspection record attached at the end of this chapter.

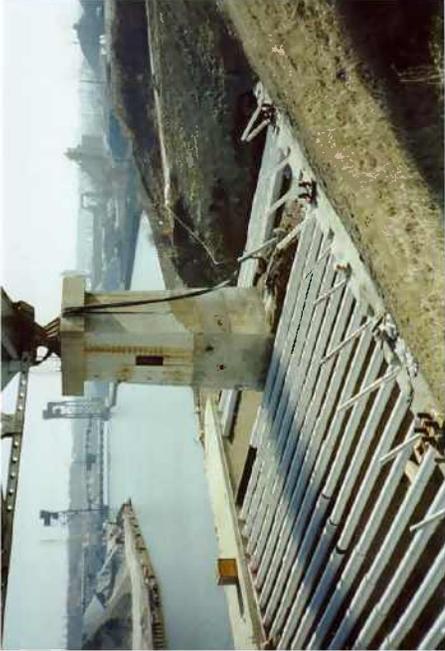
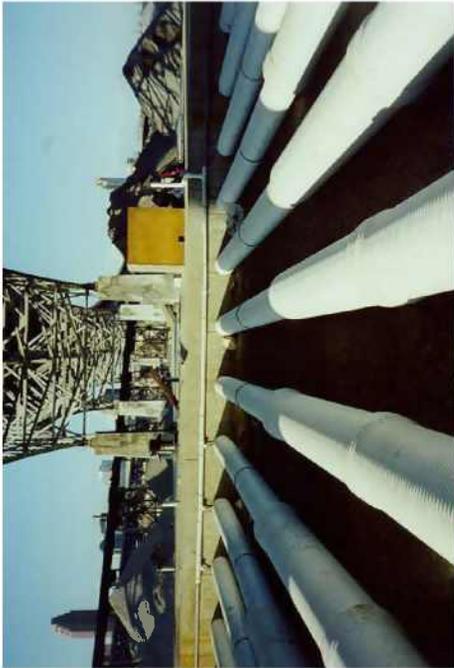
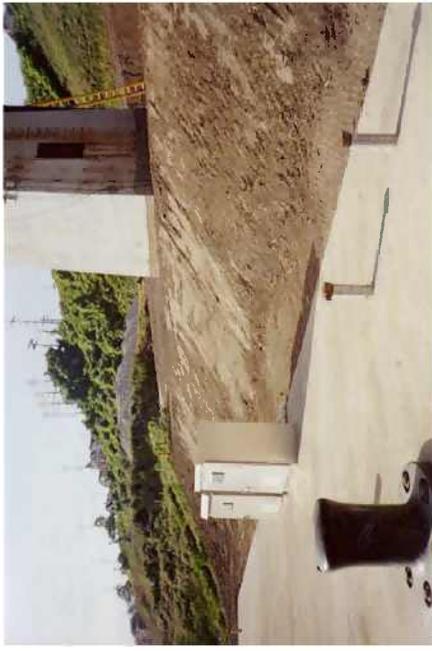
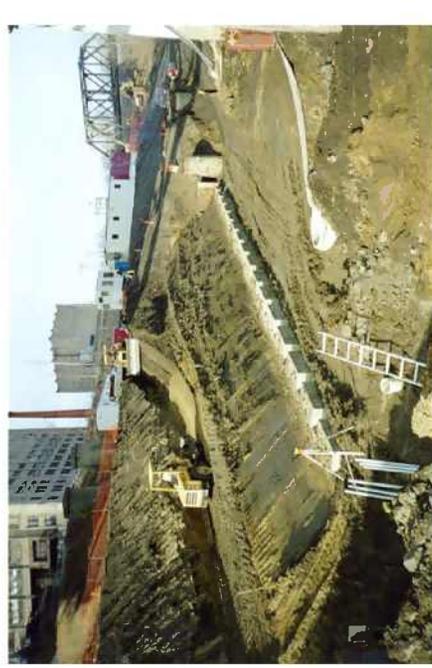
Tie beam measurements are experiencing a steady state condition with no indication of any trend to vary with time except for slight stress changes which are most likely a result of changes in temperature. Note that there is a relatively high frictional resistance from the soil around and on top of the beams. The tie beams were insulated in a 24" diameter corrugated PVC, which was filled with concrete after tensioning of the anchors. Due to the corrugated pipe and the concrete filling, the tie beams are acting as a composite 24" diameter corrugated section. The steel beam inside the section is not indicating any increase in stress in response to the movement of the caps. The force transmitted through the PVC composite sections has to overcome the friction of the surrounding soil. It appears that the drilled shaft cap and the pile cap are moving similar distances laterally, which allows the tie beams to remain in a constant state of stress. Pictures in Figure 5.19 show the construction of the tie beams and the

Figure 5.19 Photo showing the construction of the tie beams and the buildup of fill on top

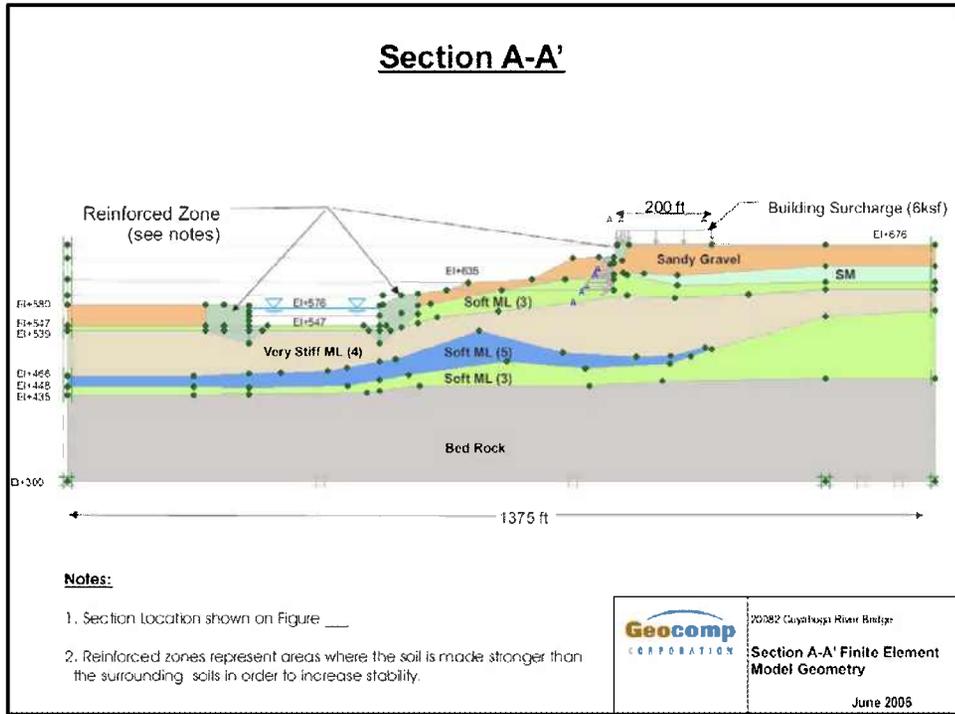
The geometry and soil properties used to analyze section A-A along the new bridge alignment were the same for GSTABL7, UTEXAS4 and PLAXIS. Figure 7B.1 shows the geometry in the PLAXIS analysis.

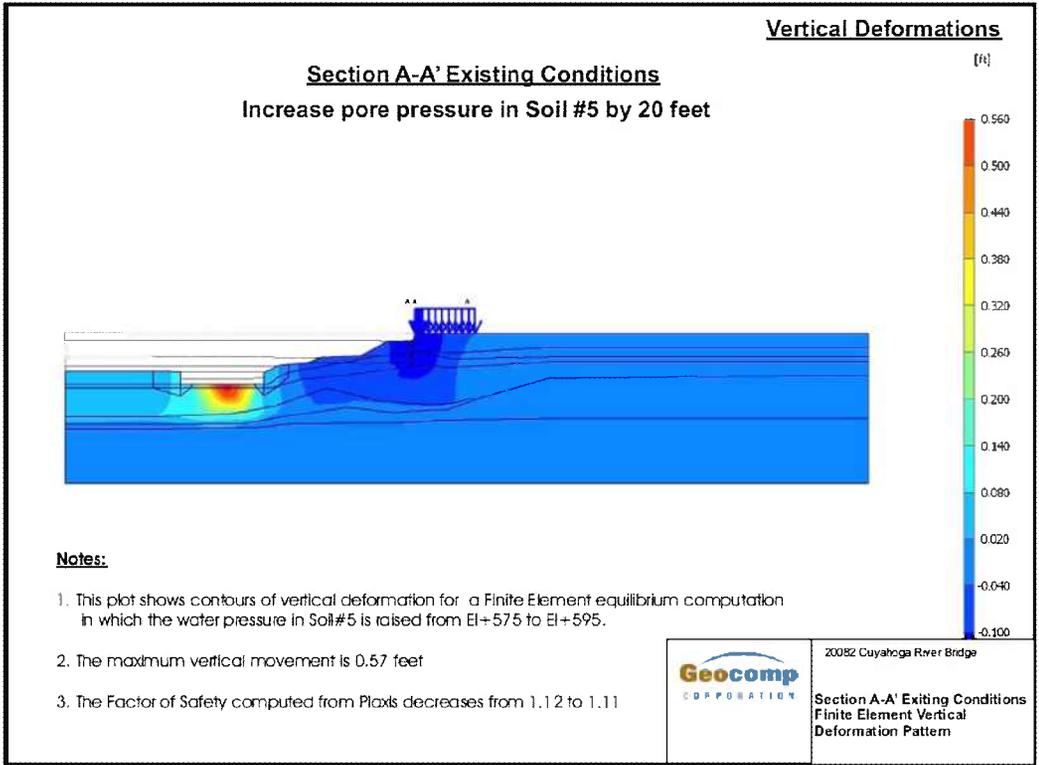
Figure 7B.3: Horizontal Movements in Existing Slope from Increasing Pore Pressure in Soil #5 by 20 ft

Figure 7B.4: Vertical Movement in Existing Slope from Increasing Pore Pressure in Soil #5 by 20 ft.

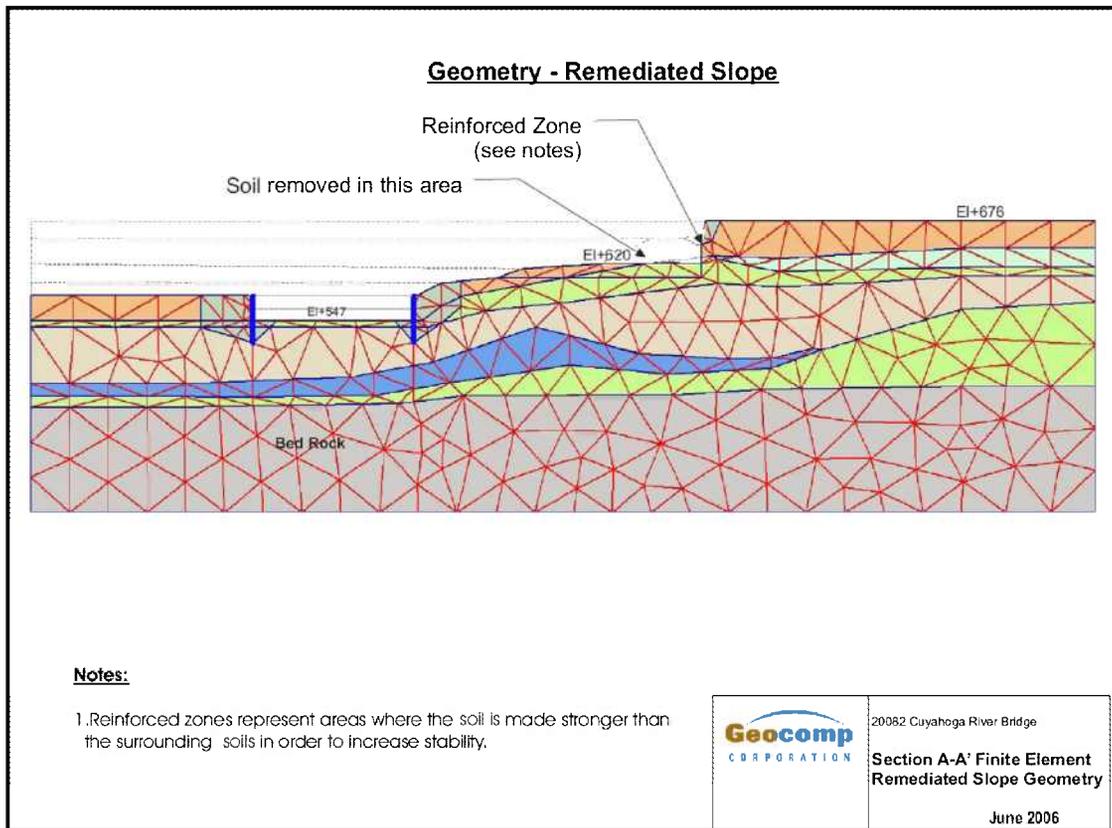
Figure 7B.5: PLAXIS Geometry for Unloaded Slope

We also used PLAXIS to evaluate the benefits of unloading the slope. Figure 7B 5 shows the analyzed geometry. It includes removal of the warehouse building and unloading of the slope to El +620 back to University Ave. The analysis assumes some type of retaining wall would be used to support University Ave.

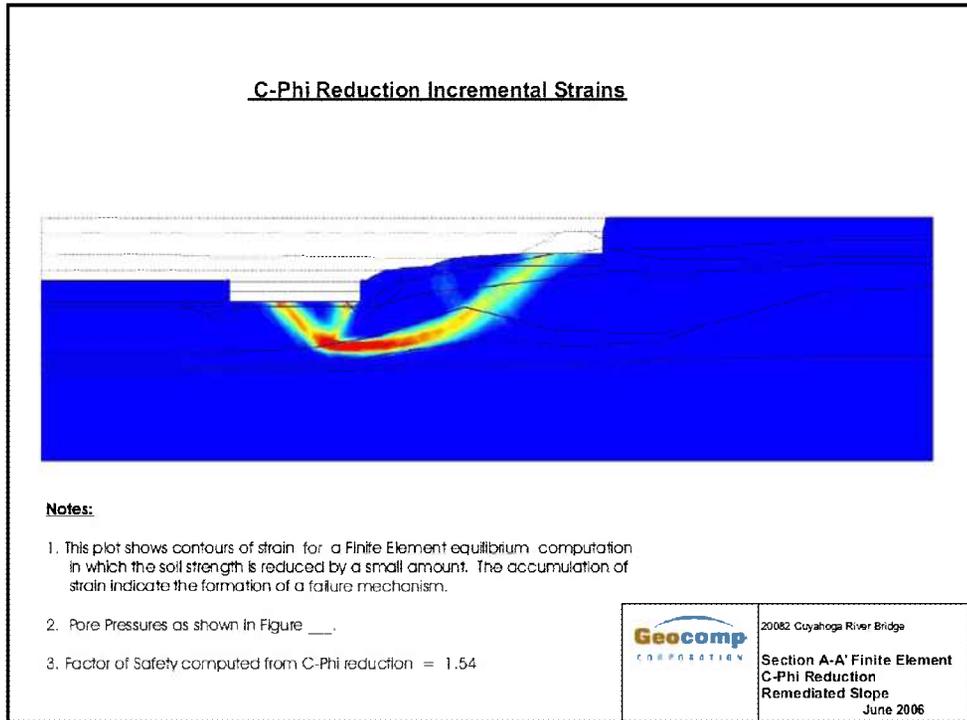
Figure 7B.6: Stability Analysis with PLAXIS for Unloaded Slope

Figure 7B.6 shows the PLAXIS strength reduction analysis for the slope upgraded by unloading. Removing the building and soil up to University Ave. increases the factor of safety determined with PLAXIS from 1.12 to 1.54. The critical failure surface also moves more towards the river. This should result in smaller horizontal movements behind the slope from the FOS decreasing.

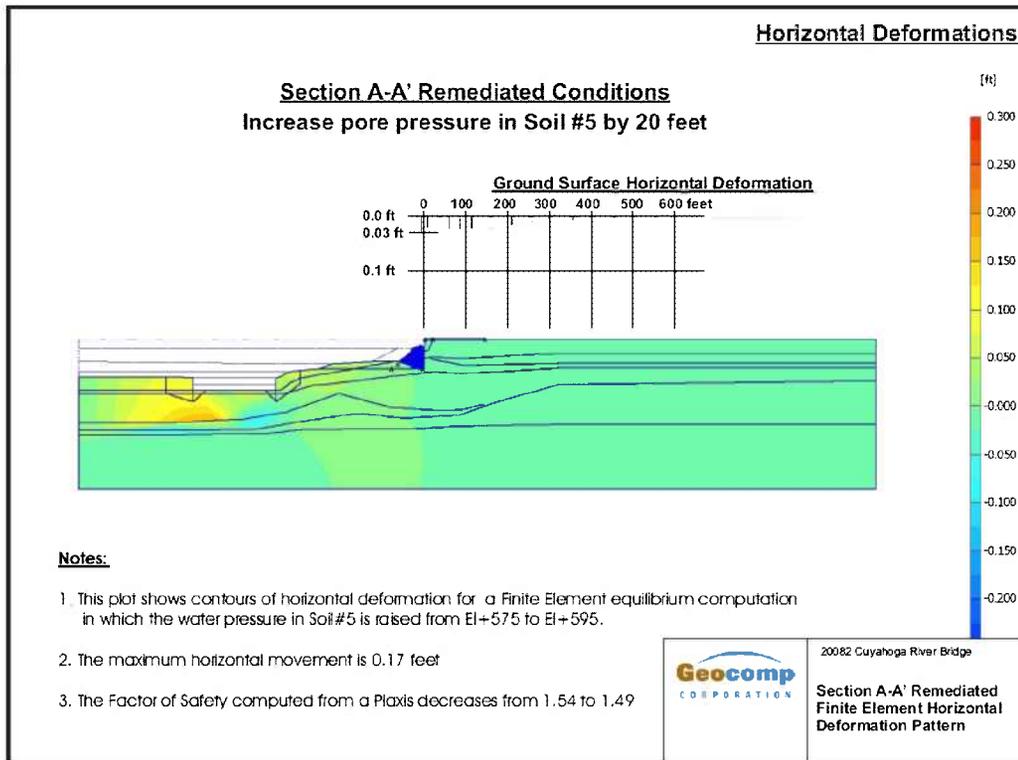
Figure 7B.7: Horizontal Displacements of Unloaded Slope from an Increase in Pore Pressure of 20 ft in Soil #5

Figure 7B.7 shows the horizontal displacements that result from the unloaded slope if the pore pressure in Soil #5 is increased by 20 ft. Figure 7B.8 shows the vertical displacements for the same condition. The Factor of Safety is reduced from 1.54 to 1.49. Horizontal movement at the edge of University Avenue is less than ½ inch. Vertical displacement at the edge of University Avenue is about 1 inch at the edge of University Avenue but quickly decreases away from the slope to small values.

These results show that by unloading the slope a factor of safety greater than 1.5 can be obtained. With careful consideration to the final slope geometry, a bridge foundation could be located any where on the slope and back of the slope, except within about 100 ft of the existing river revetment.

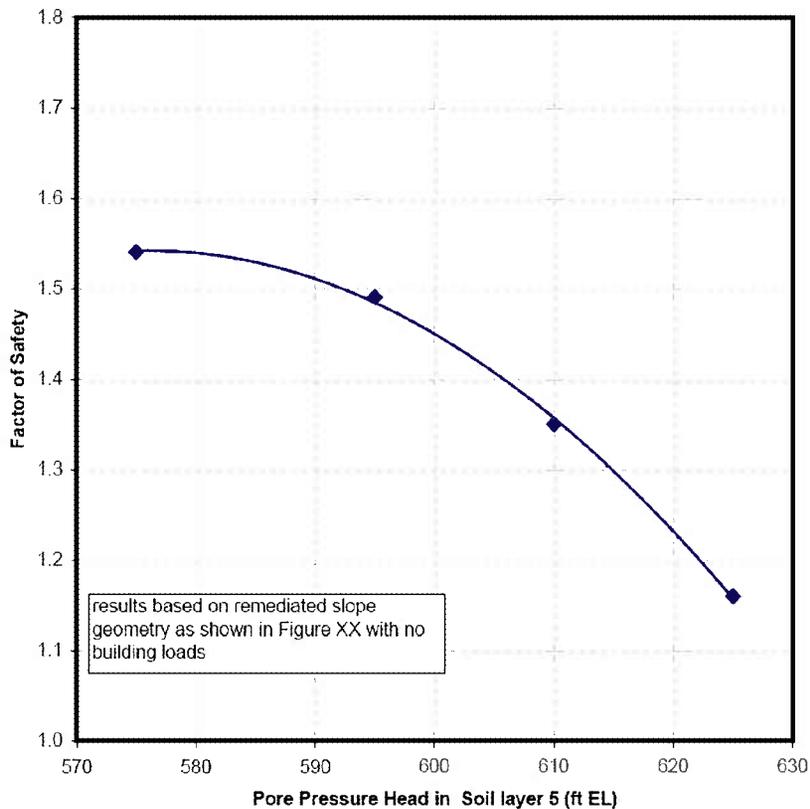
Figure 7B.9 Effect of Increasing Pore Pressure on Stability of Unloaded Slope

The above results were for an arbitrary increase in pore pressure of 20 ft in Soil #5. Figure 7B.9 shows the effect on Factor of Safety of increasing pore pressure in the slope as determined by PLAXIS. Once the piezometric elevation in Soil #5 increases above about 600 ft, the effect of rising pore pressure on factor of safety becomes more pronounced. Using the results from the above deformation analysis, we can conclude that horizontal movements behind the slope will be less than 1 inch for the unloaded slope as long as pore pressures in the slope are prevented from rising above elev. 600 ft. This should be easily accomplished with horizontal drains.

4. The analyses show that removing the warehouse building and soil to unload the slope are very effective in improving the factor of safety to greater than 1.5.
5. PLAXIS analyses show that displacements resulting from increases in pore pressure in Soil #5 are acceptably small as long as no pore pressure exceeds elevation 600 ft. Measures must be included in the final design to control pore pressures from water and gas so that they do not exceed elevation 600 ft.

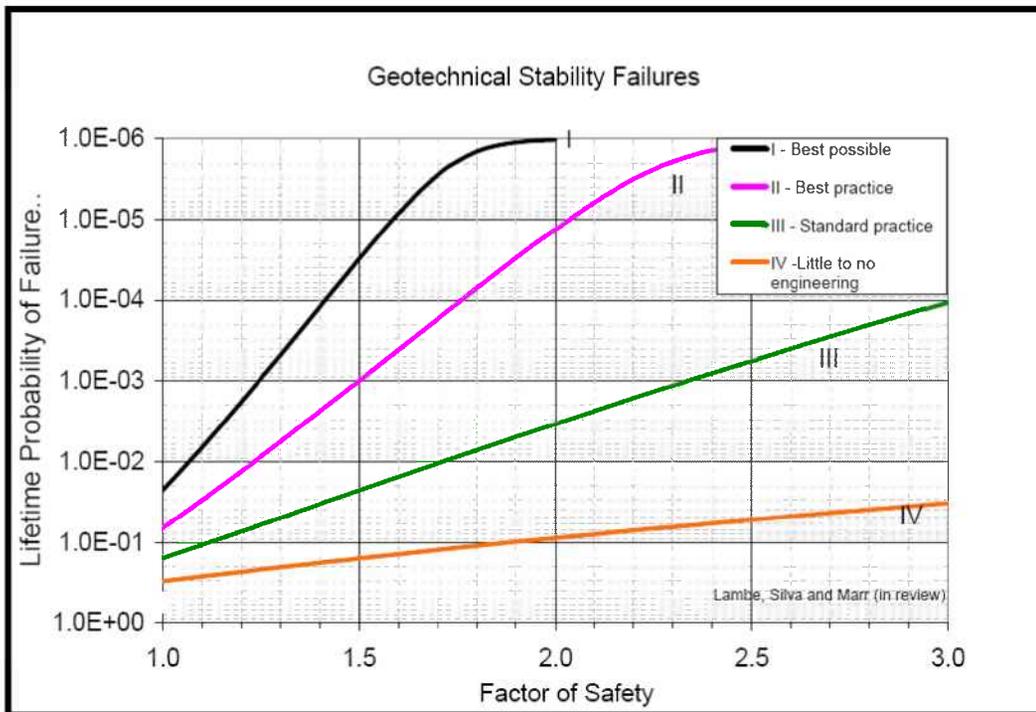
Figure 7B.11: Current version of Factor of Safety/Probability of Failure Curves (Lambe, Marr, Silva - in review)

As an example of how to use Figure 7B.11, consider a deep failure in the section A-A' slope for the new bridge. We concluded from stability analyses that in its present condition it has a Factor of Safety in the vicinity of 1.15. The slope did not previously receive much engineering attention nor was it monitored very closely, except as peripheral to the monitoring of the slope for the existing bridge; therefore, its classification is between I and II. From Figure 7B.11 we can see that the probability of a failure of this slope over time is in the vicinity of 10 to 25% (1 in 10 to 1 in 4). The slope in its present condition is not where one would position a large bridge pier.

In summary, the slope in its present condition has a probability of failure over time in the vicinity of 10 to 25% (1 in 10 to 1 in 4). By unloading the slope and controlling pore pressures within the slope, this value can be lowered to the vicinity of 0.01% (1 in 10,000). At this level, geotechnical risks from slope failure are well below other risks to the project and a further reduction in factor of safety and probability of failure would probably not be justifiable.

Additional analyses in this report show that by flattening the slope and controlling pore pressures in the soil within the slope, the factor of safety can be improved to above 1.5. Considering the importance of this structure, its design and construction should follow the attributes of a Level II facility in Table 7B.3. The lifetime probability of failure becomes less than 0.1% (1 in 1,000). This value decreases to less than 0.01% (1 in 10,000) if the factor of safety is increased above 1.75. At this level, geotechnical risks from slope failure are well below other risks to the bridge and a further reduction in factor of safety and probability of failure would not be justifiable.

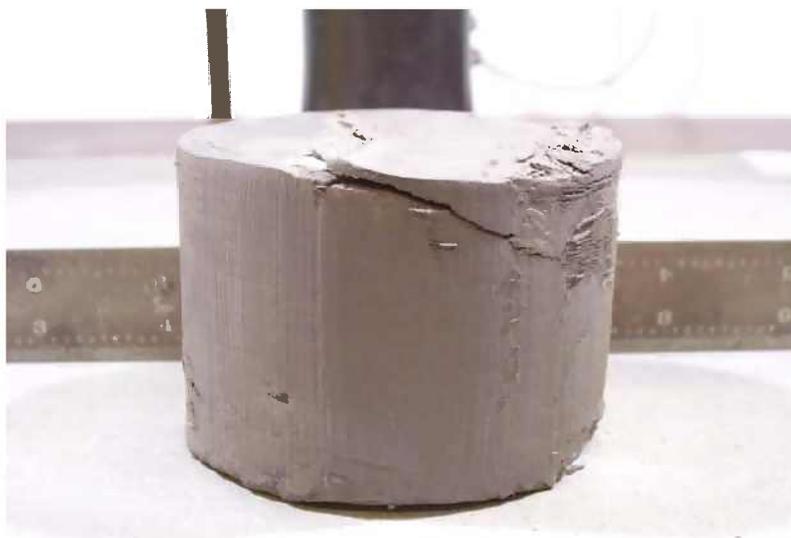
Extruded sample showing in-situ shear plane. Side view.
Direct Simple Shear test, DSS-2 was trimmed from this piece.

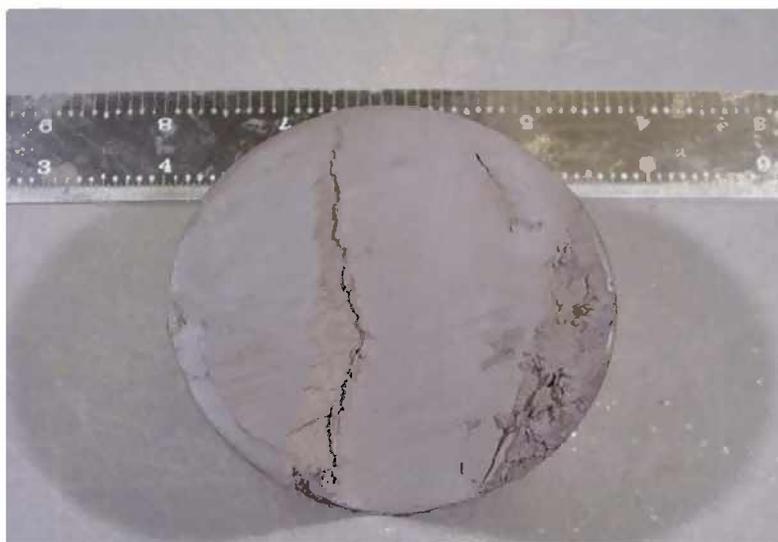
Same extruded sample showing in-situ shear plane. Top view.

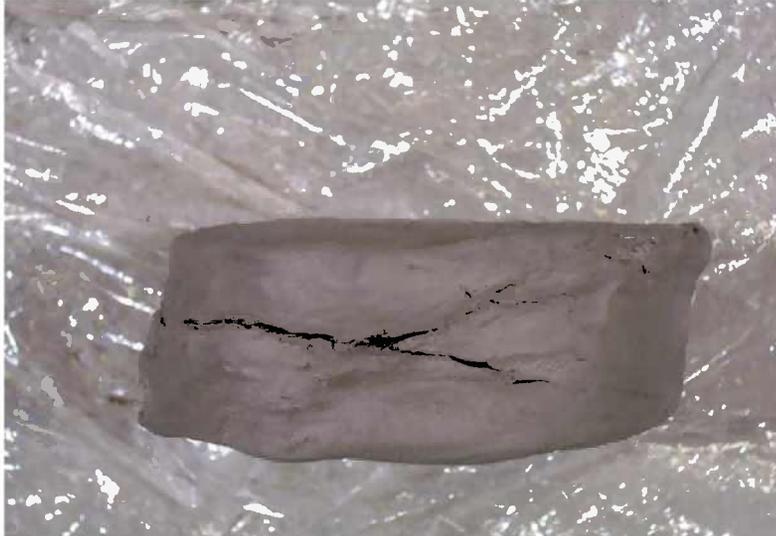
Post test picture, after pulling apart and putting back together. Shows development of an angular shear plane. Direct Simple Shear (DSS-2) test sample.

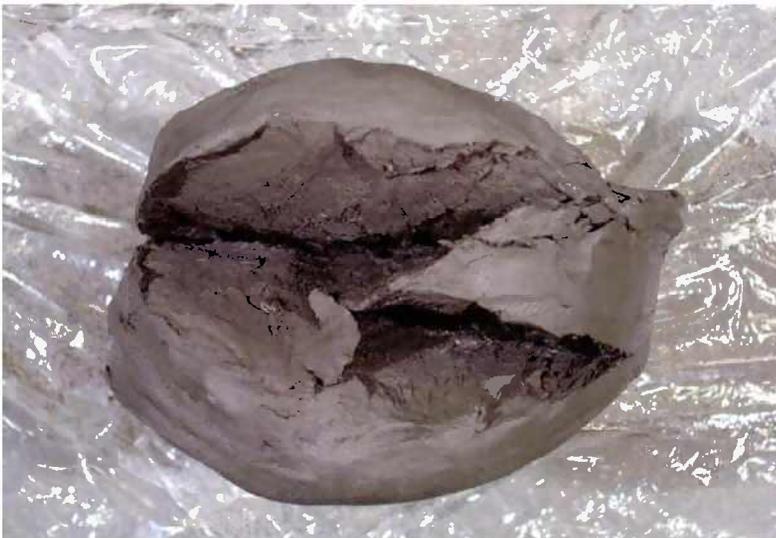
Same sample, pulled apart view of the internal structure along horizontal planes. The material appeared rough. There were no visible polished surfaces.

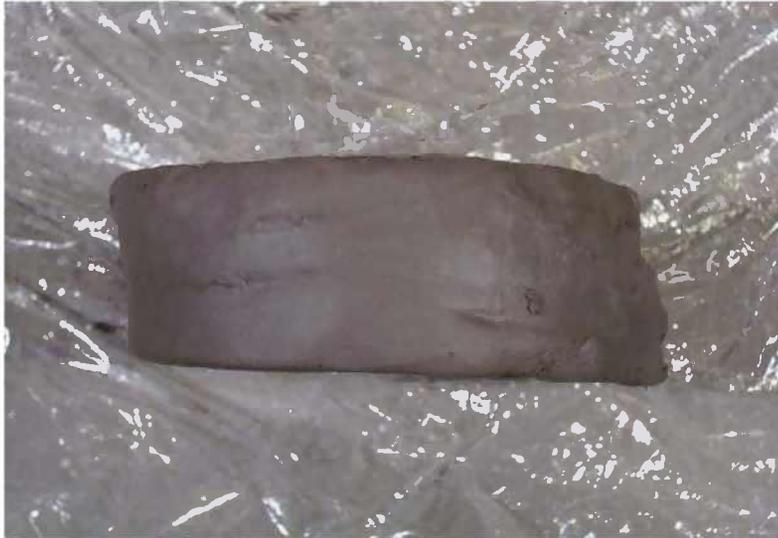
Post test showing failure lean to the left. Slight shear plane developing angling back. Direct Simple Shear (DSS-2) test specimen.

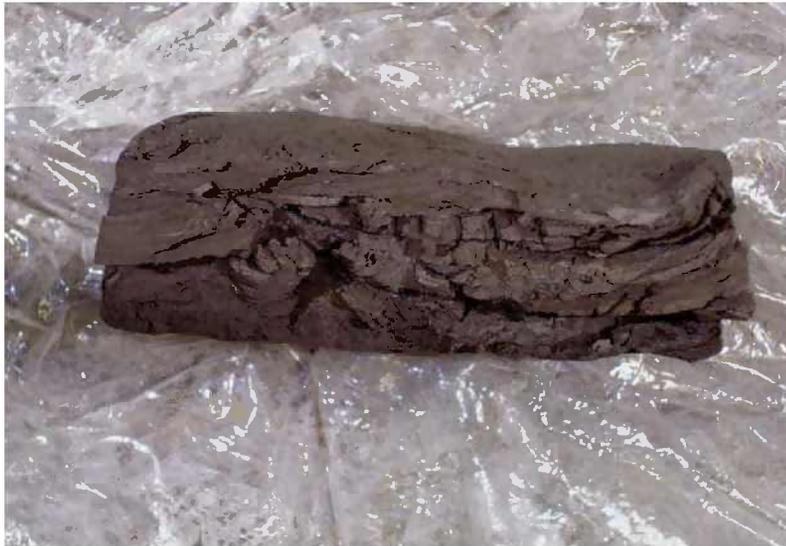
Same sample, broken to show the cross section through the middle of specimen. Shows horizontal layers, some with an almost blocky structure at a very small scale.

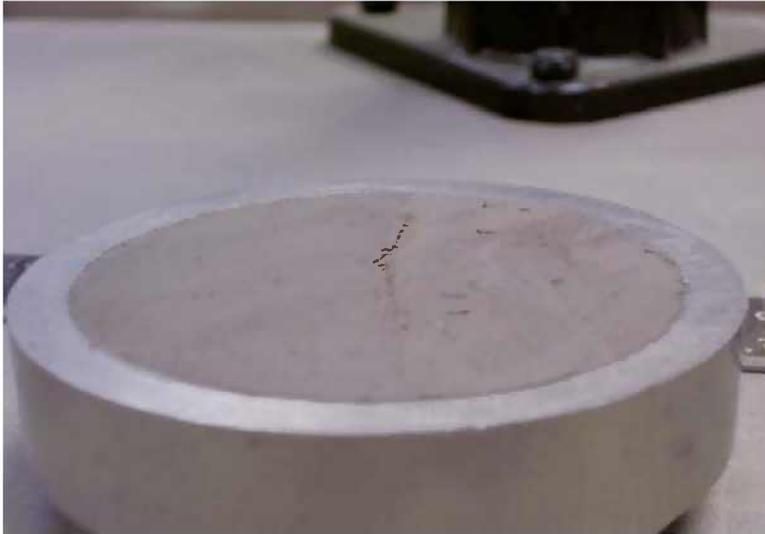
Sample in trimming ring showing an in-situ shear plane in the material as received. Residual Shear test (RS-2), angled view.

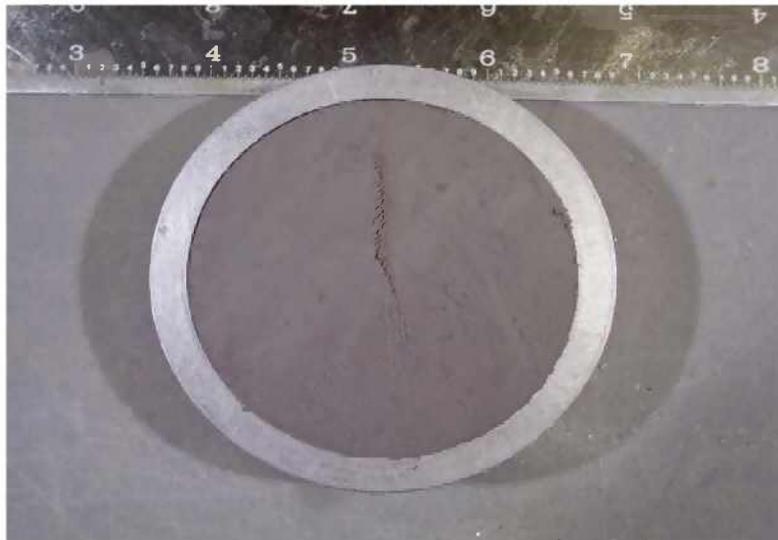
Same sample, in trimming ring showing an in-situ shear plane in the material as received. Residual Shear test (RS-2), top view.

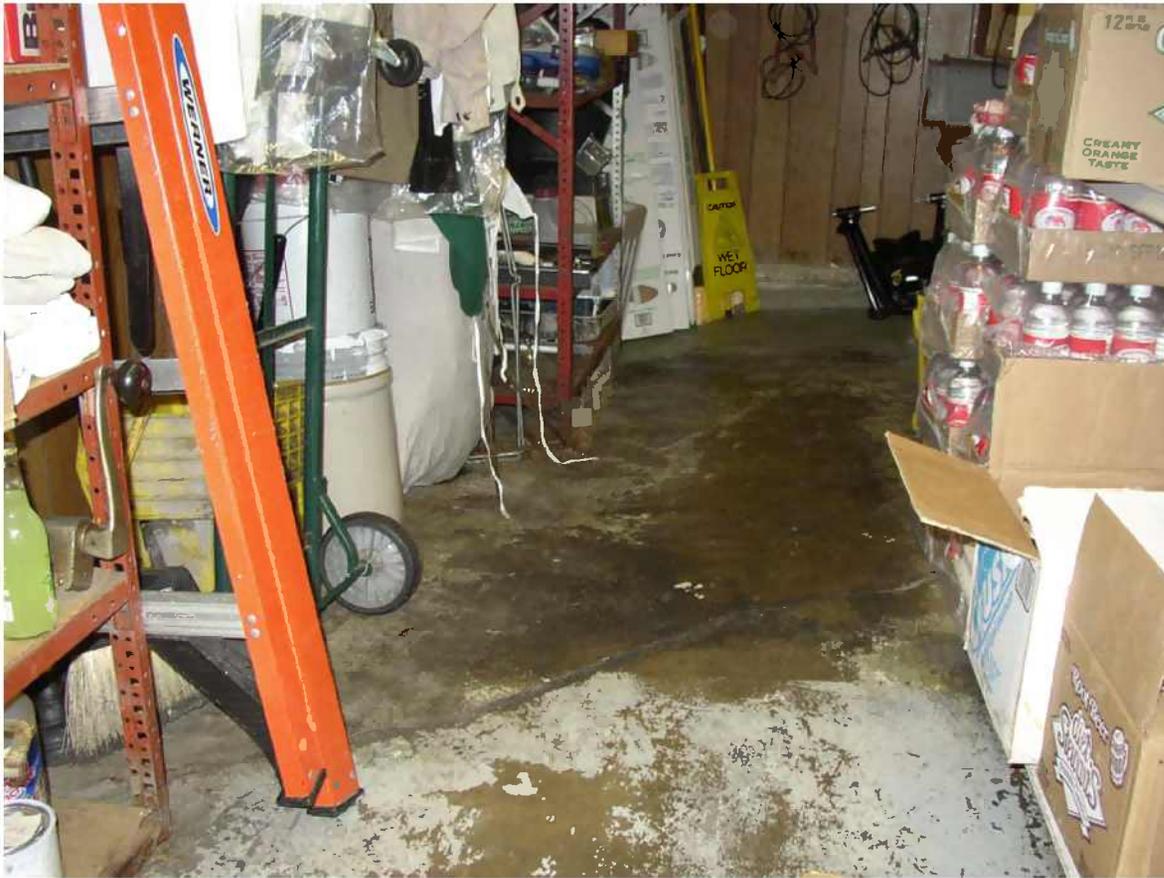
Figure 8: 1201 University Avenue (Sokolowski's University Inn). Photo is taken from inside looking at the north-west corner of the building. This photo illustrates settlement that occurred approximately 5 years ago. The maximum vertical displacement is at least 9-inches (BBCM, 2005b).

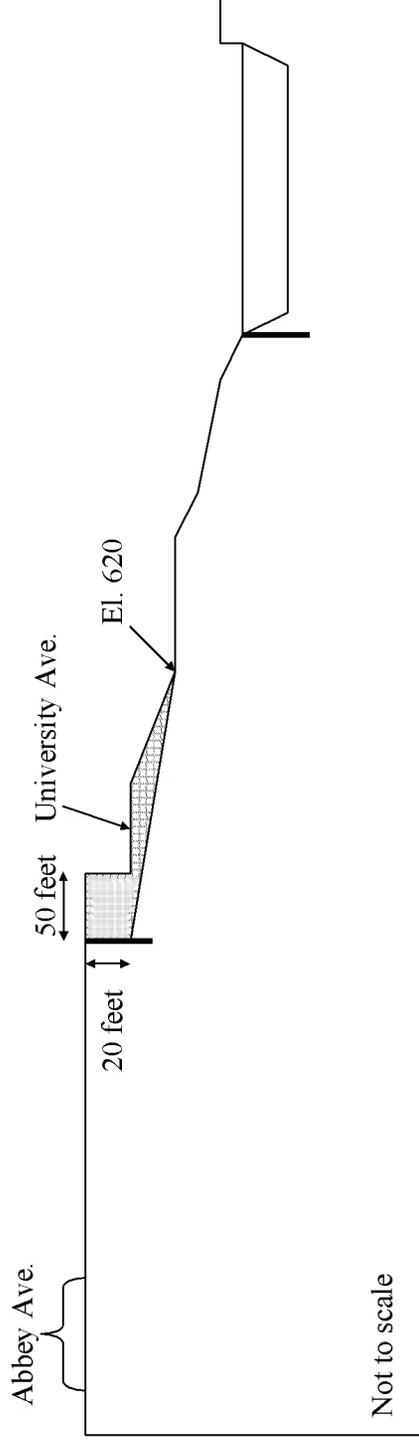
20-foot vertical excavation located approximately 50 feet south of University Avenue as shown in Figure 15a and Plate 13 of Appendix F;

a) Alternative 1. 20-foot vertical excavation located 50 feet behind University Avenue.

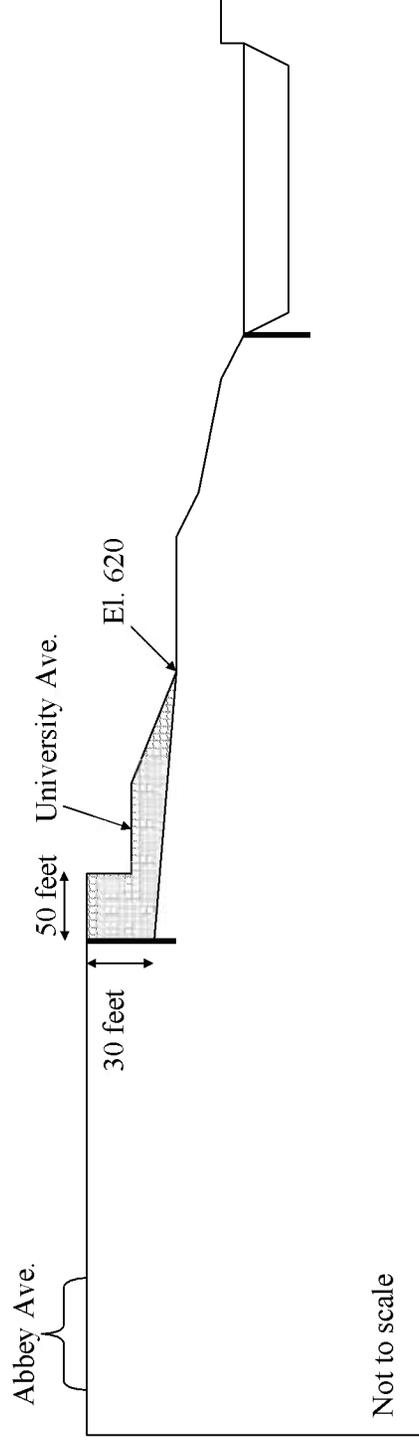
30-foot vertical excavation located approximately 50 feet south of University Avenue as shown in Figure 15b and Plate 14 of Appendix F;

b) Alternative 2. 30-foot vertical excavation located 50 feet behind University Avenue.

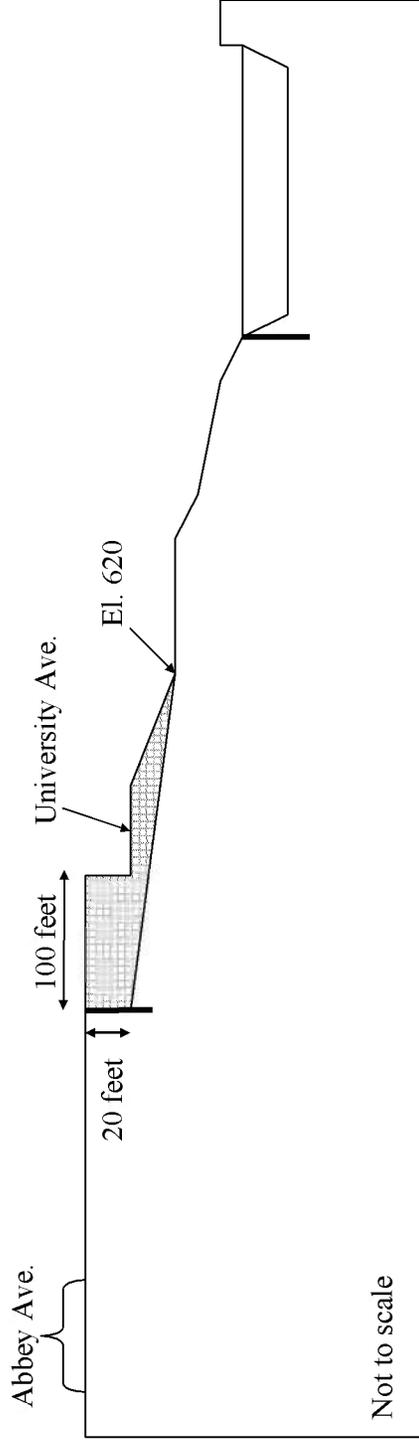
20-foot vertical excavation located approximately 100 feet south of University Avenue as shown in Figure 16a and Plate 15 of Appendix F;

a) Alternative 3: 20-foot vertical excavation located 100 feet behind University Avenue.

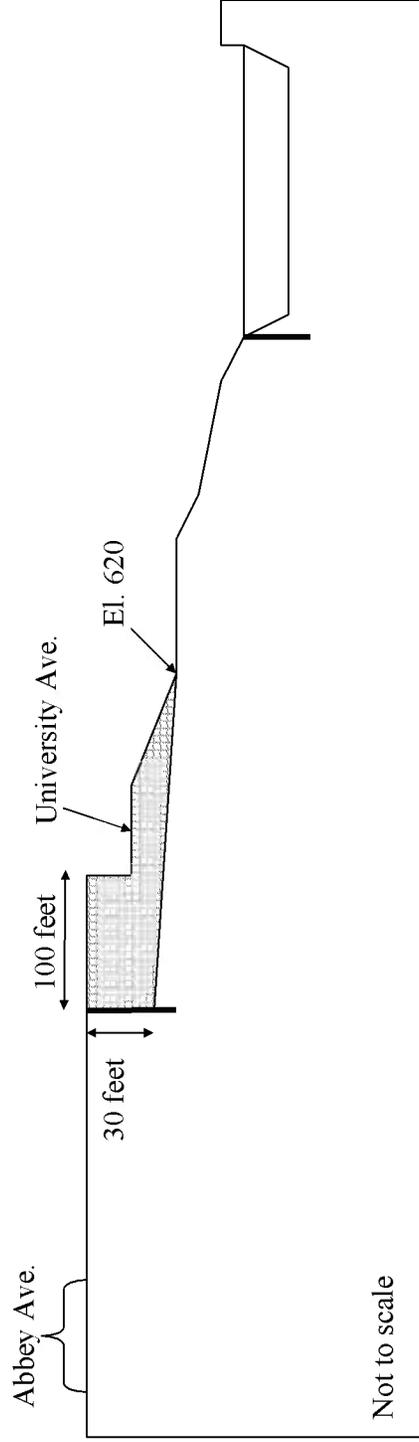
30-foot vertical excavation located approximately 100 feet south of University Avenue as shown in Figure 16b and Plate 16 of Appendix F;

b) Alternative 4: 30-foot vertical excavation located 100 feet behind University Avenue.

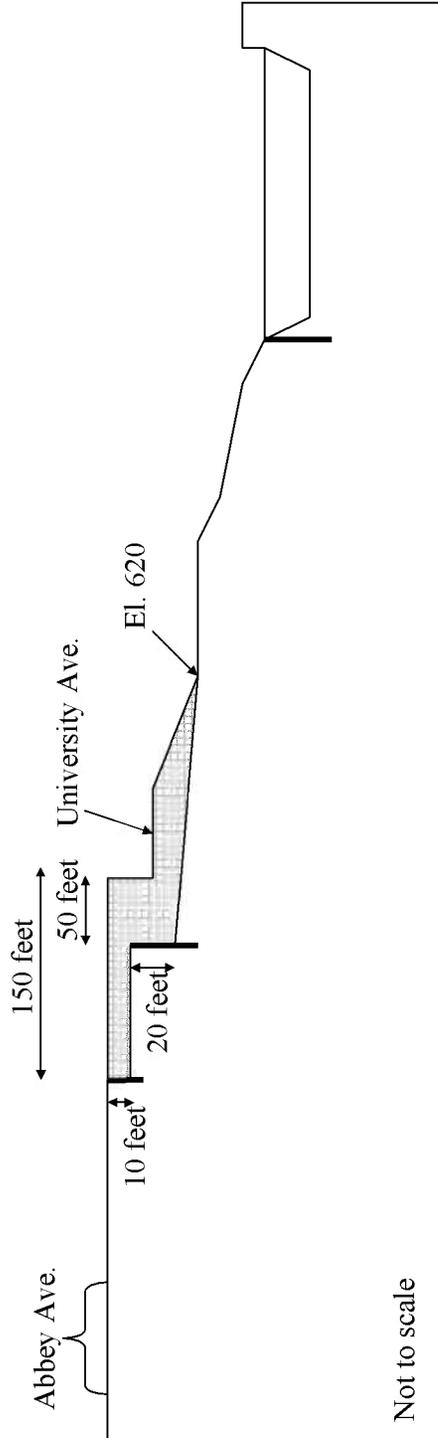
Terraced excavation with a 10-foot vertical excavation located approximately 150 feet south of University Avenue and a 20-foot vertical excavation located approximately 50 feet south of University Avenue as shown in Figure 17a and Plate 17 of Appendix F;

a) Alternative 5: 10-foot vertical excavation located 150 feet behind University Avenue and a 20-foot vertical excavation located 50 feet behind University Avenue.

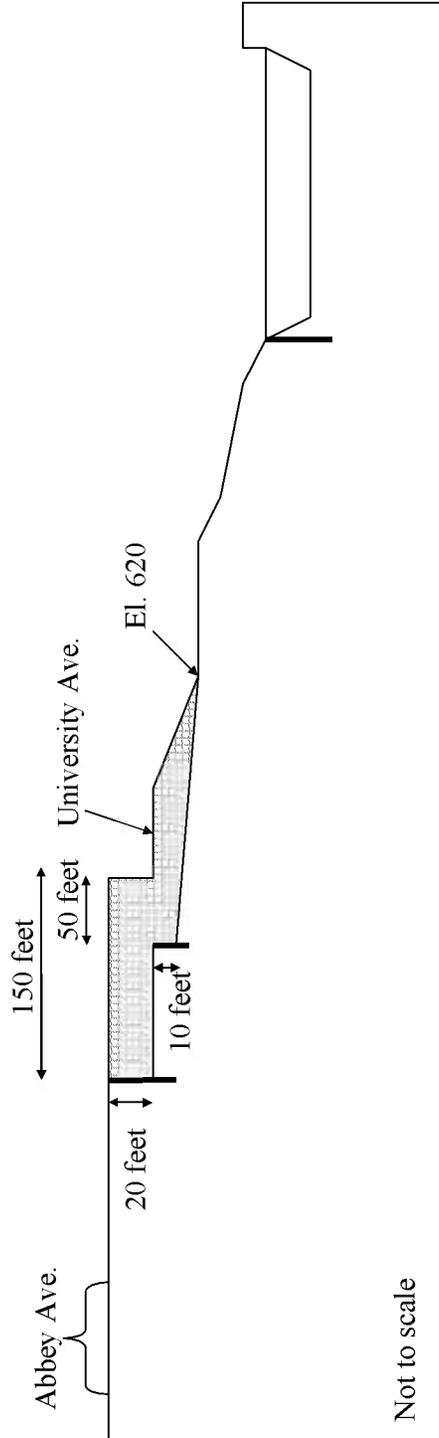
Terraced excavation with a 20-foot vertical excavation located approximately 150 feet south of University Avenue and a 10-foot vertical excavation located approximately 50 feet south of University Avenue, as shown in Figure 17b and Plate 18 of Appendix F;

b) Alternative 6: 20-foot vertical excavation located 150 feet behind University Avenue and a 10-foot vertical excavation located 50 feet behind University Avenue.
