**Baker Slope Stability Study Report
(Reference Document)**

**Innerbelt Bridge
Construction Contract Group 1 (CCG1)**

Slope Stability Evaluation Report of the West Bank

CUY-90-14.92
PID 77332

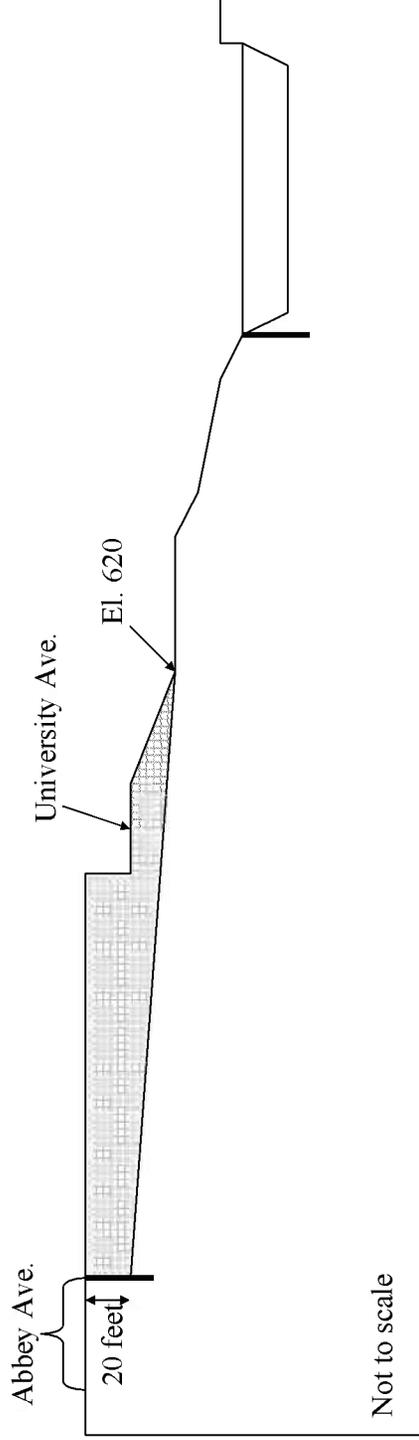
20-foot vertical excavation located on the north side of Abbey Avenue as shown in Figure 18a and Plate 19 of Appendix F;

a) Alternative 7: 20-foot vertical excavation north of Abbey Avenue.

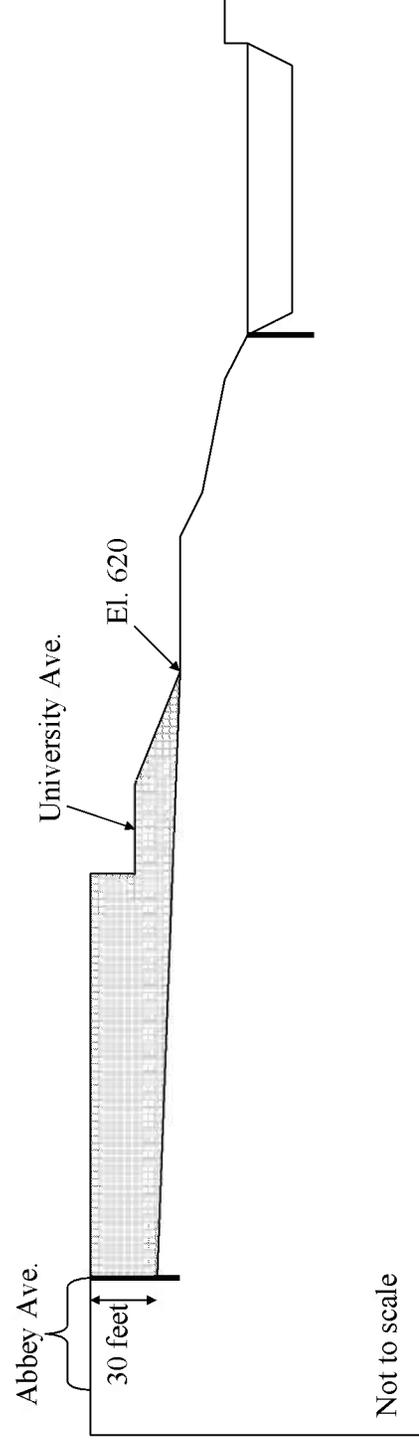
30-foot vertical excavation located on the north side of Abbey Avenue as shown in Figure 18b and Plate 20 of Appendix F;

b) Alternative 8: 30-foot vertical excavation north of Abbey Avenue.

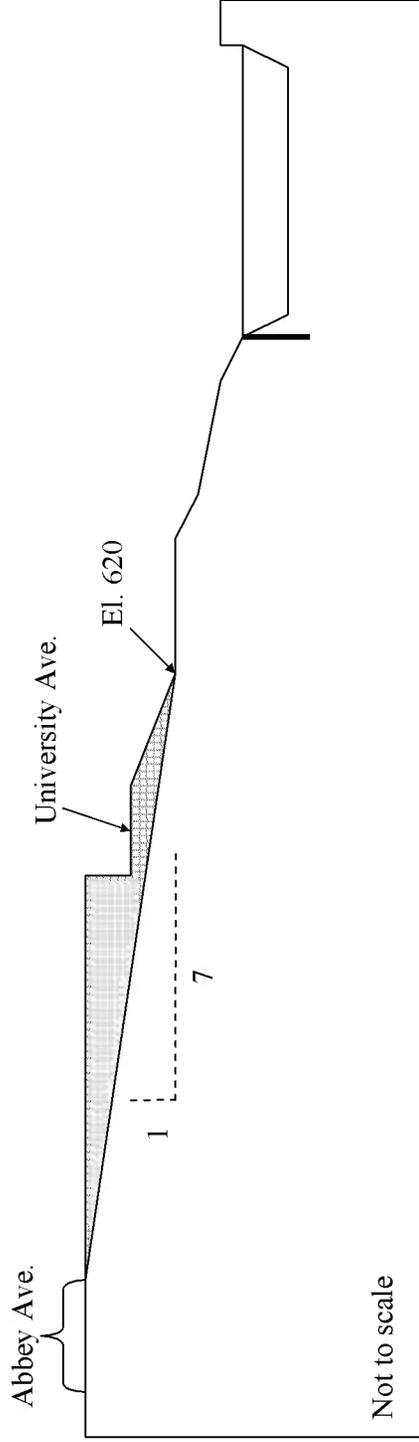
7(H):1(V) slope beginning north of Abbey Avenue extending down to El. 620 feet, as shown in Figure 19a and Plate 21 of Appendix F; and,

a) Alternative 9: 9(H):1(V) slope beginning north of Abbey Avenue.

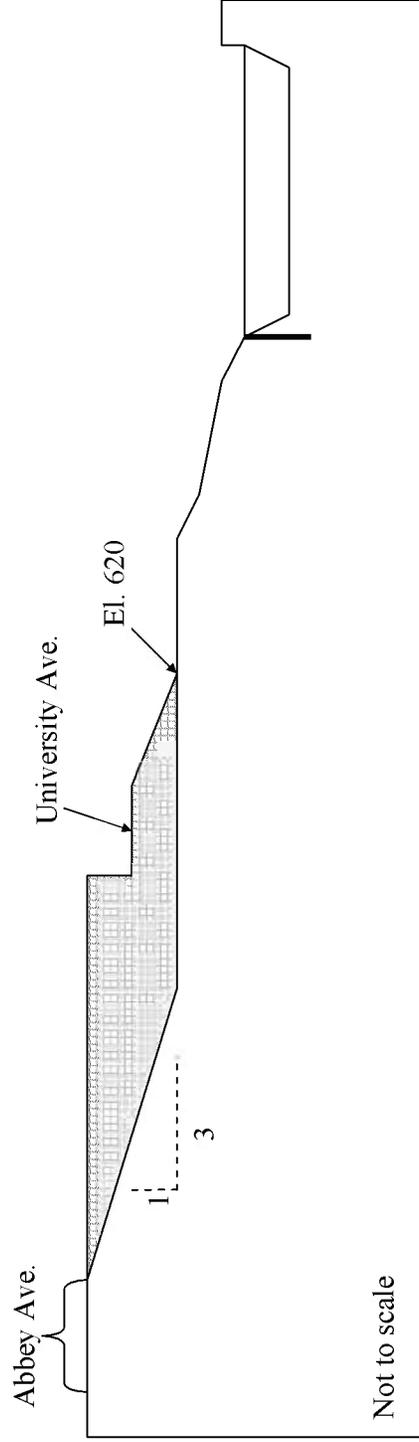
3(H):1(V) slope beginning north of Abbey Avenue extending down to El. 620 feet, as shown in Figure 19b and Plate 22 of Appendix F.

b) Alternative 10: 3(H):1(V) slope beginning at Abbey Avenue extending to El. 620 feet.

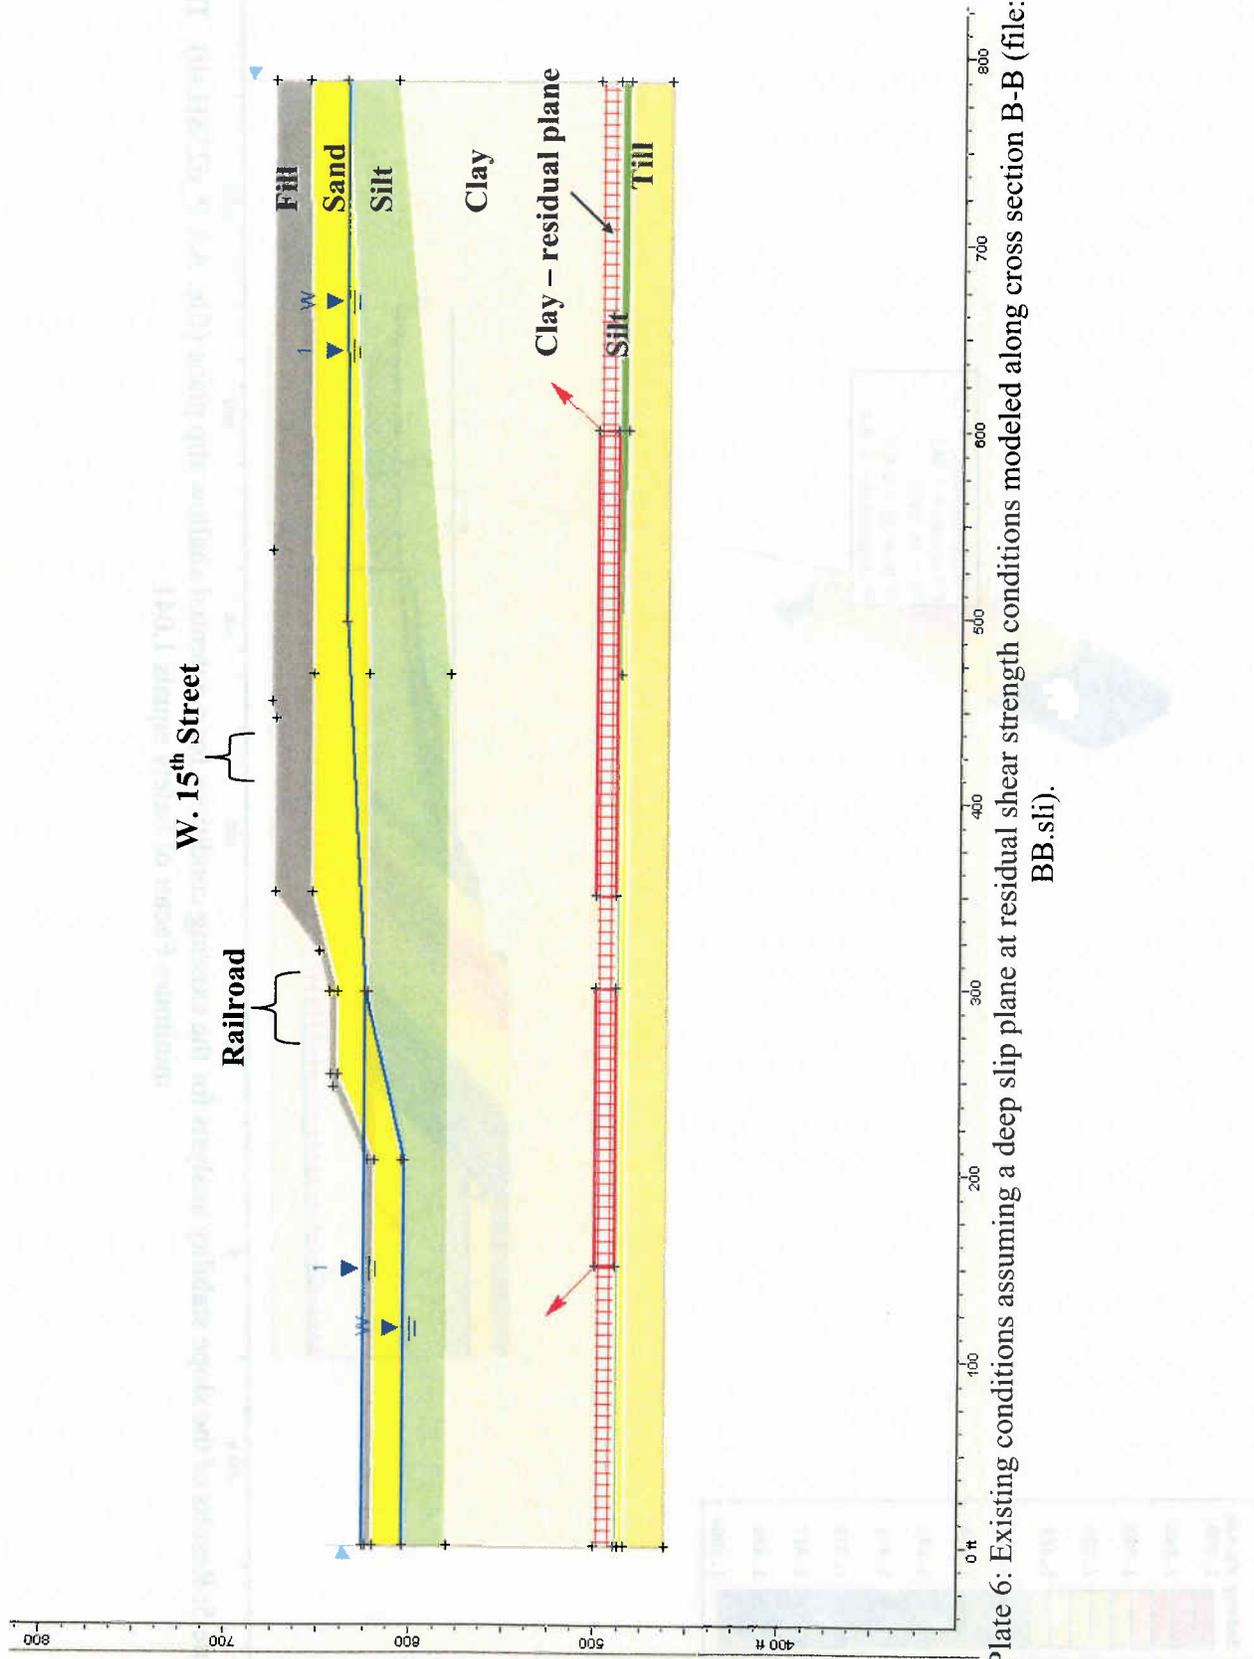
Plate 6: Existing conditions assuming a deep slip plane at residual shear strength conditions modeled along cross section B-B (file: BB.sli).

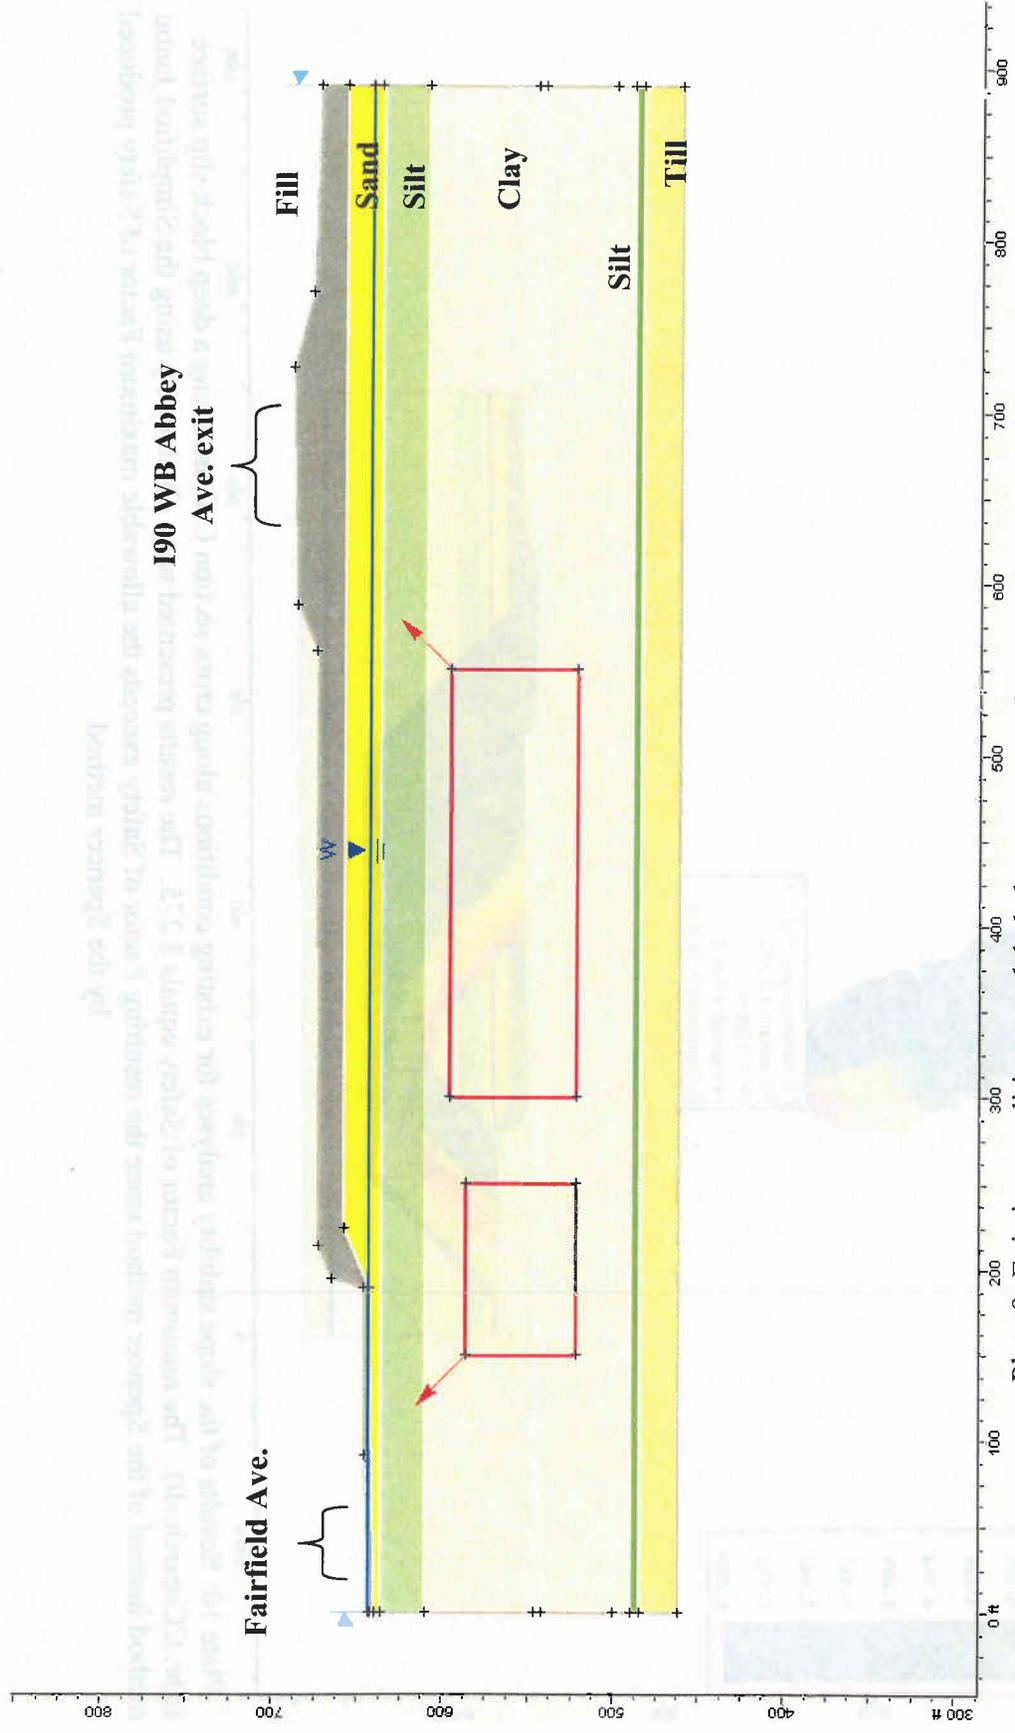
Plate 9: Existing conditions modeled along cross section C-C (file: CCsearch.sli).

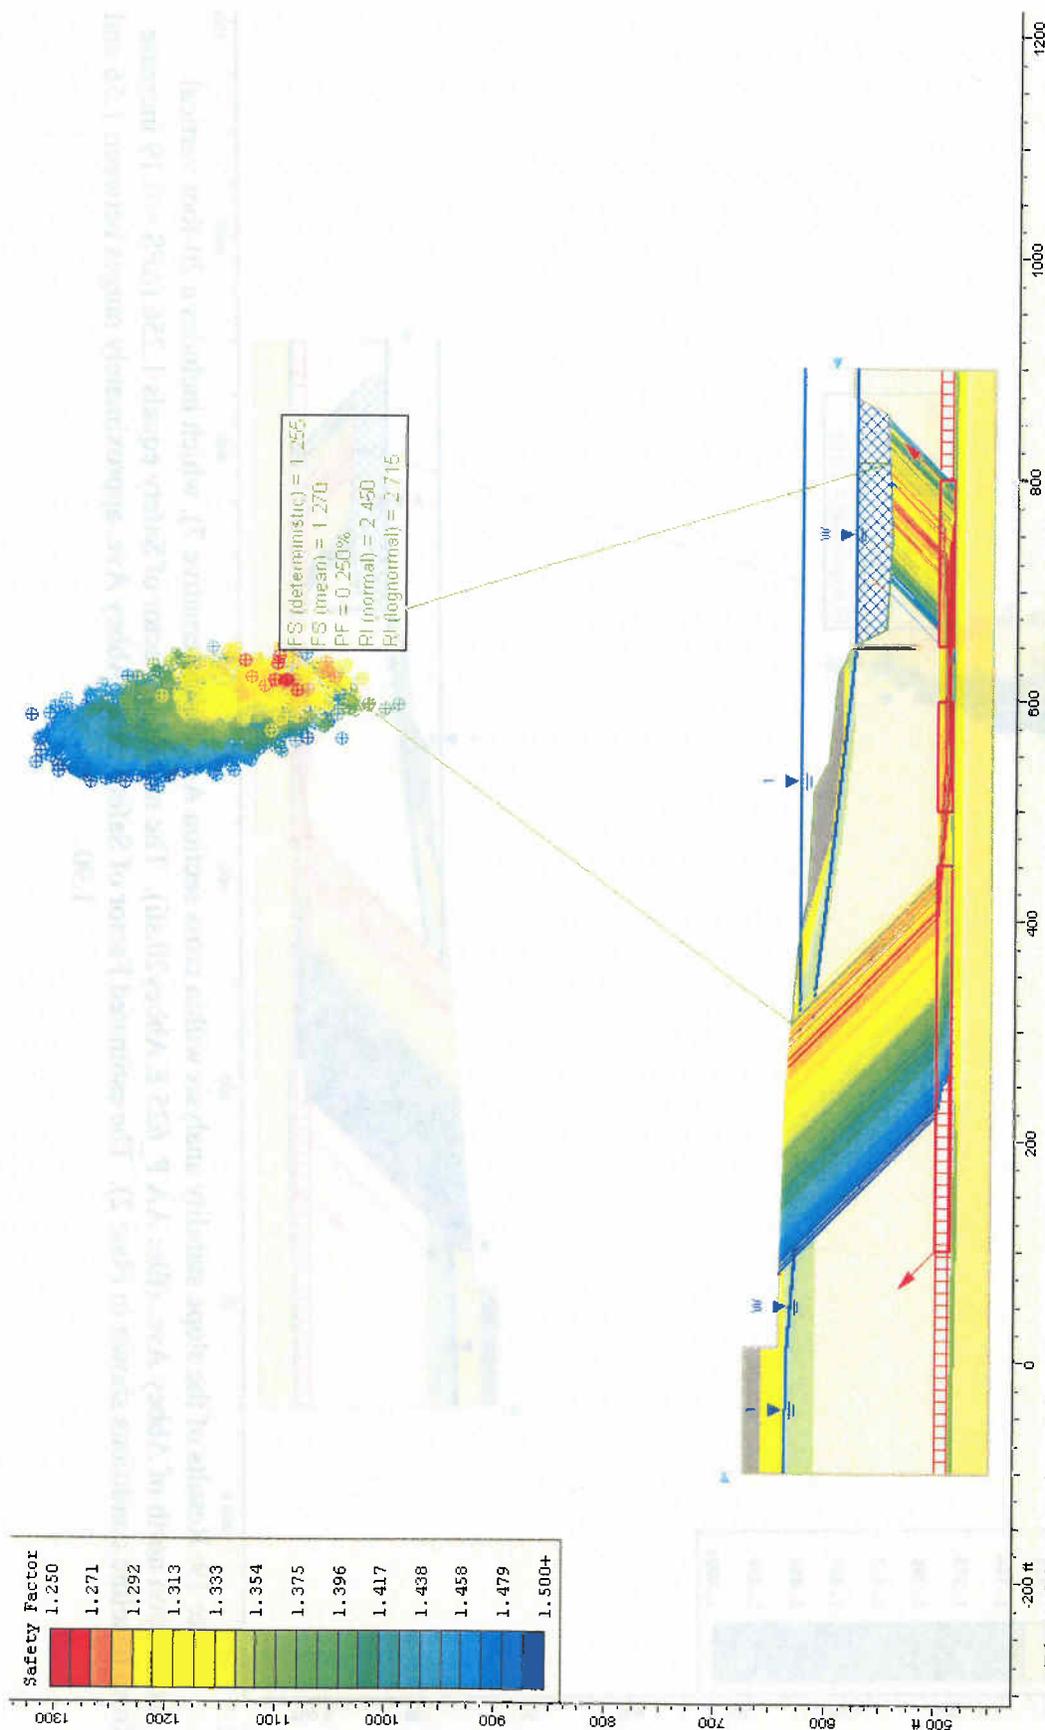
Plate 20: Results of the slope stability analysis within cross section A-A for (alternative 8), which includes a 30-foot vertical excavation north of Abbey Ave. (file: AA P_625 E Abbey30.sli). The minimum Factor of Safety equals 1.256 (Δ FS = 0.19 increase from baseline conditions shown in Plate 2). The estimated Factor of Safety along Abbey Ave. approximately ranges between 1.62 and 1.64.

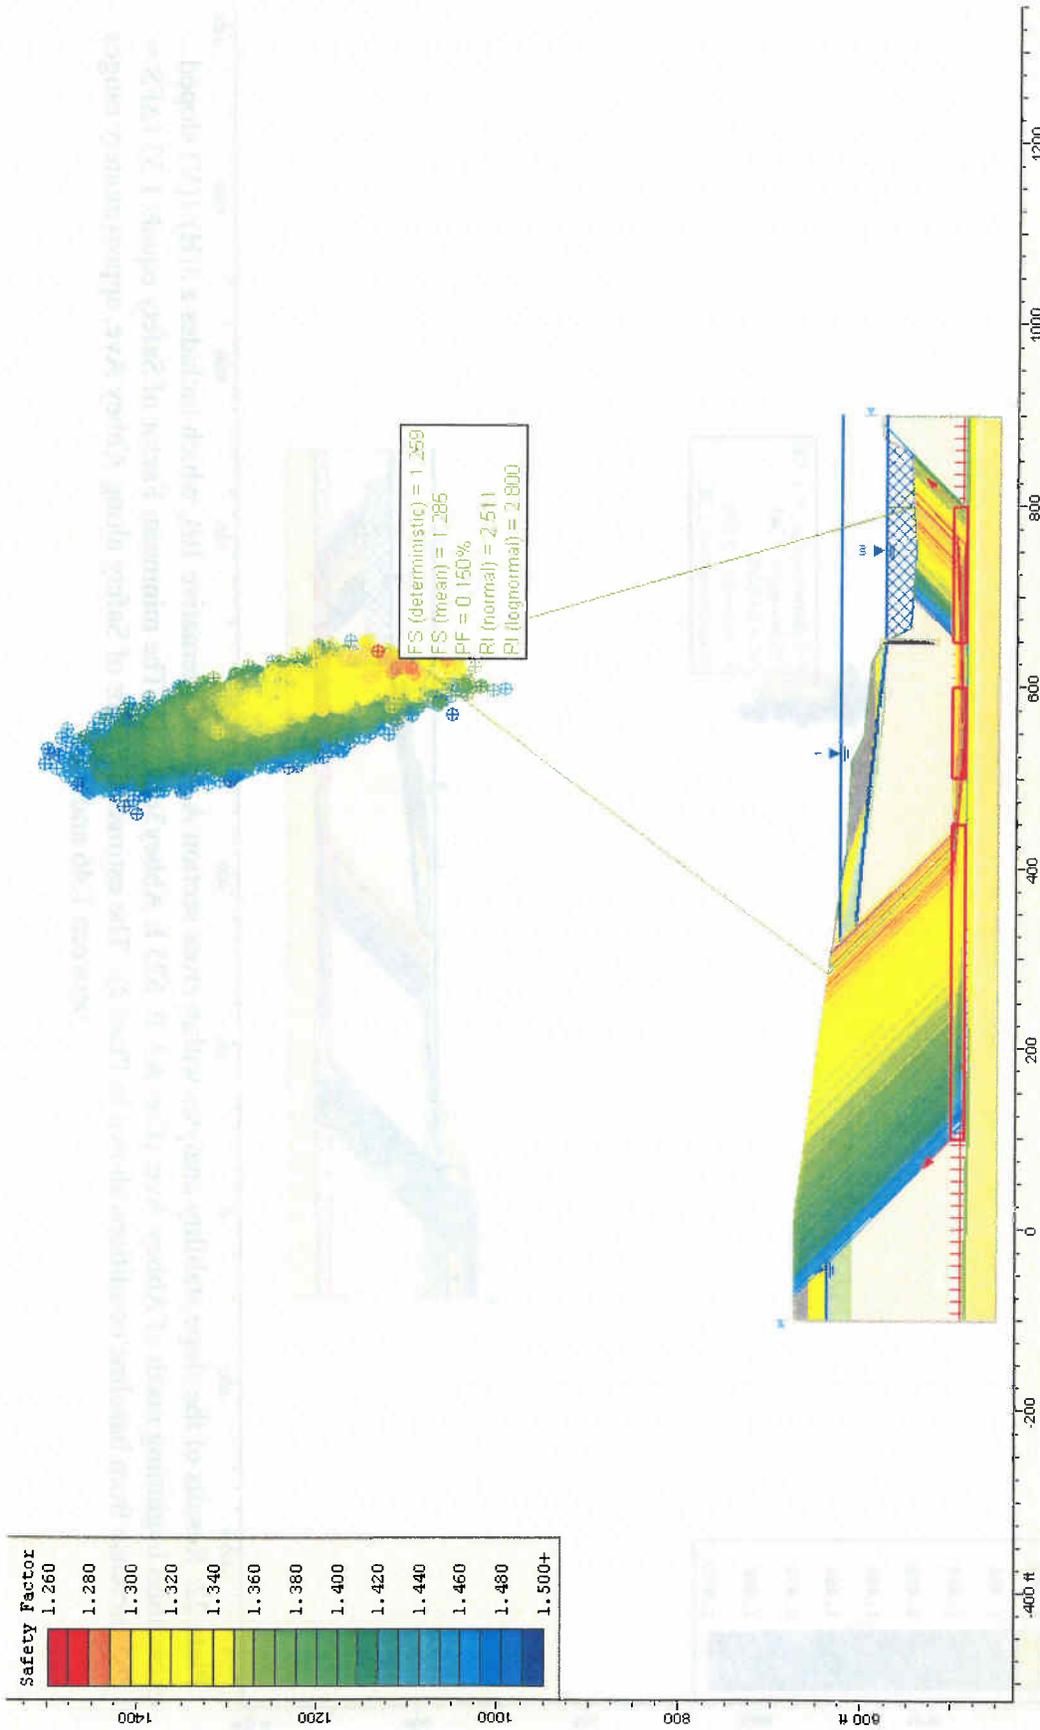
Plate 21: Results of the slope stability analysis within cross section A-A for (alternative 9), which includes a 7(H):1(V) sloped excavation beginning north of Abbey Ave. (file: AA_P_625 E Abbey7on1.sli). The minimum Factor of Safety equals 1.256 (Δ FS = 0.19 increase from baseline conditions shown in Plate 2). The estimated Factor of Safety along Abbey Ave. approximately ranges between 1.40 and 1.47.

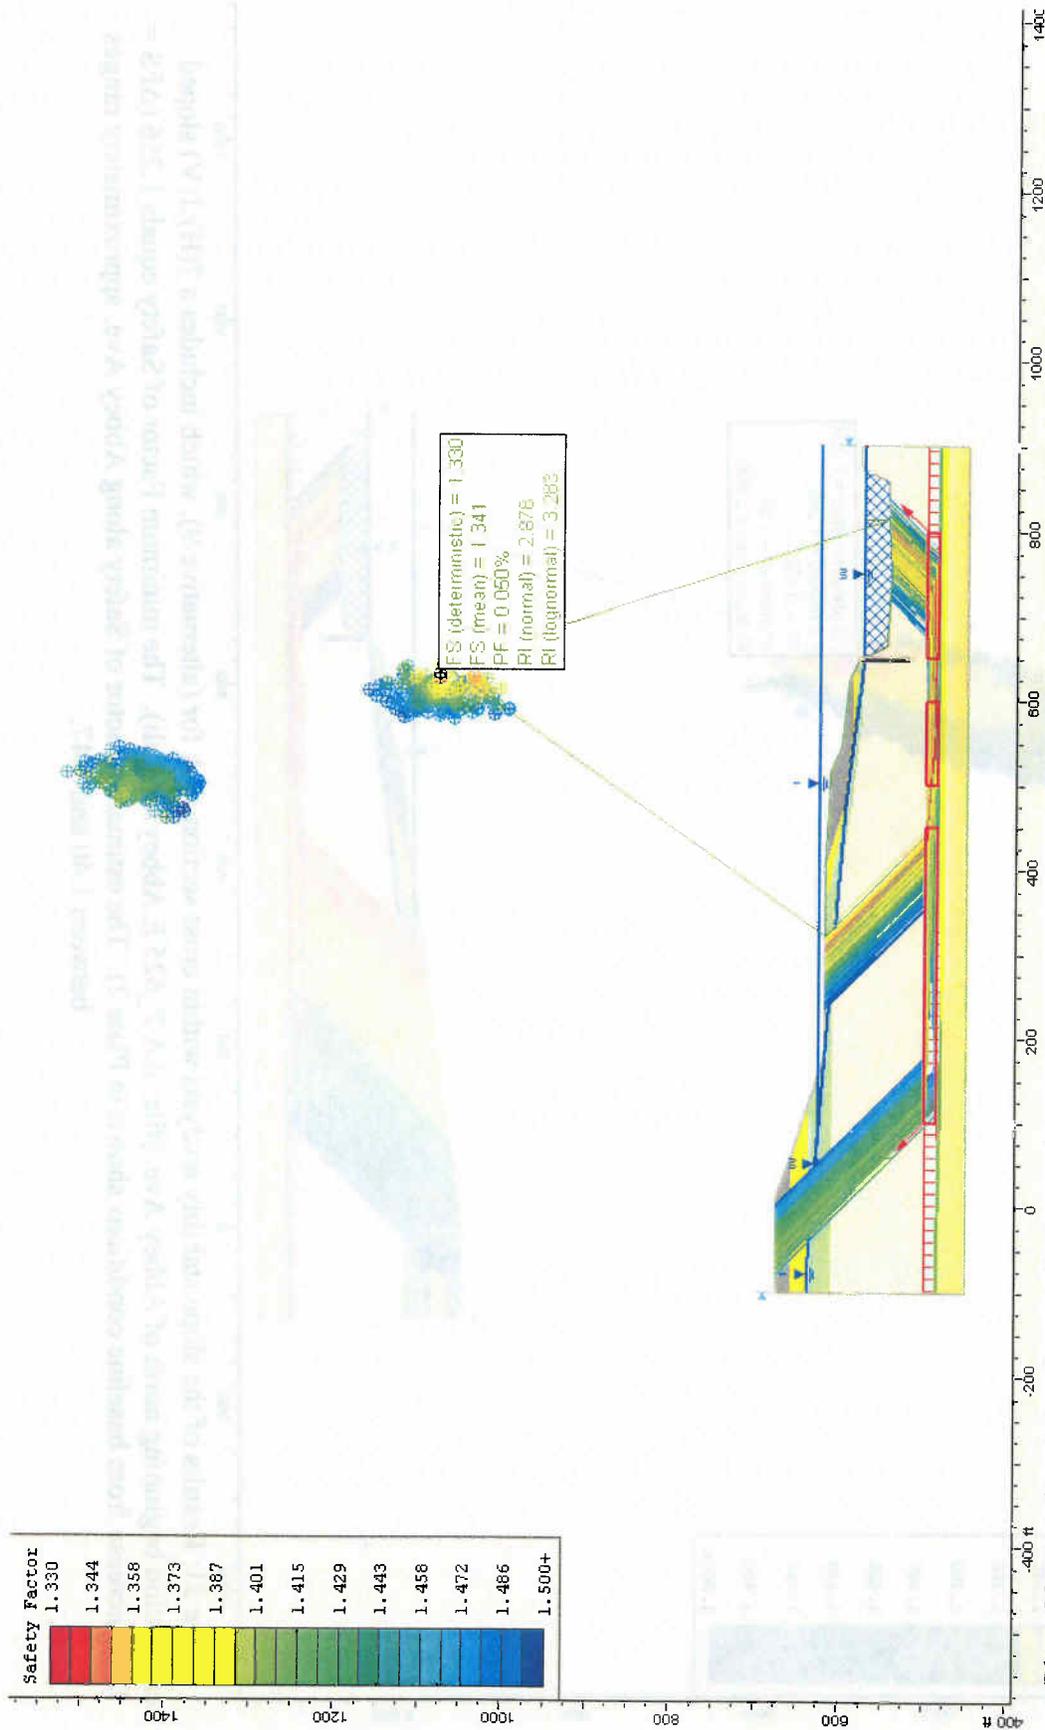
Plate 22: Results of the slope stability analysis within cross section A-A for (alternative 10), which includes a 3(H):1(V) sloped excavation beginning north of Abbey Ave. (file: AA_P_625 E_Abbey3on1.sli). The minimum Factor of Safety equals 1.33 (Δ FS = 0.265 increase from baseline conditions shown in Plate 2). The estimated Factor of Safety along Abbey Ave. approximately ranges between 1.46 and 1.61.

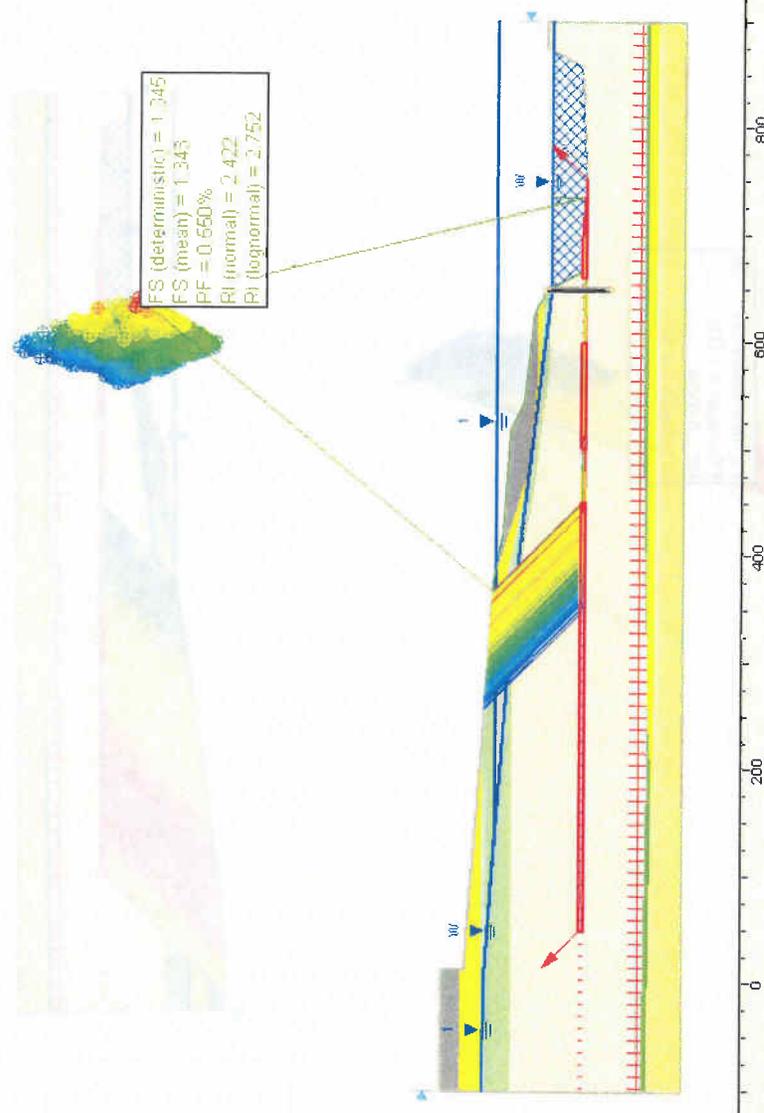
Plate 23: Results of the slope stability analysis within cross section A-A for (alternative 7), which includes a 20-foot vertical excavation north of Abbey Ave. (file: AA_P_625 E Abbey20SH.sli) for a potential shallow slip plane. The minimum Factor of Safety equals 1.345 ($\Delta FS = 0.30$ increase from baseline conditions shown in Plate 15). The estimated Factor of Safety along Abbey Ave. approximately ranges between 1.73 and 1.85.

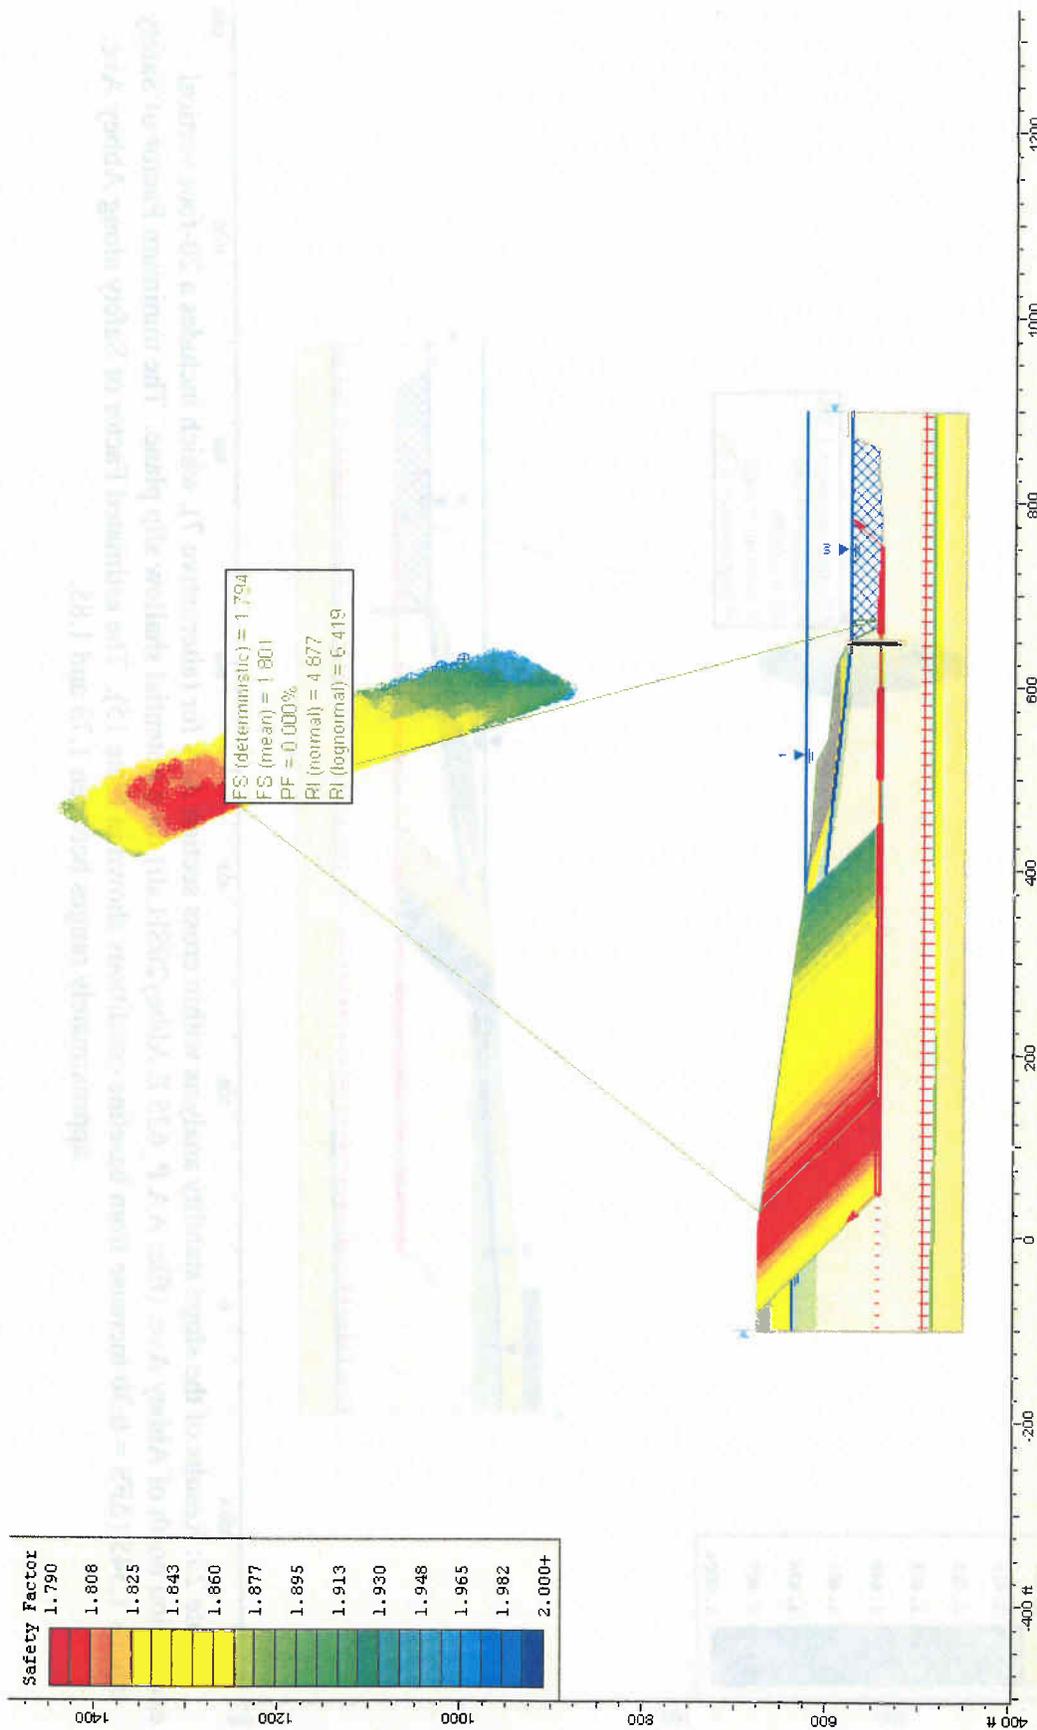
Plate 24: Results of the slope stability analysis within cross section A-A for (alternative 9), which includes a 7(H):1(V) sloped excavation beginning north of Abbey Ave. (file: AA_P_625 E_Abbey7on1SH.sli) for a potential shall slip plane. The minimum Factor of Safety equals 1.794 (Δ FS = 0.75 increase from baseline conditions shown in Plate 15). The estimated Factor of Safety along Abbey Ave. approximately ranges between 1.81 and 1.85.

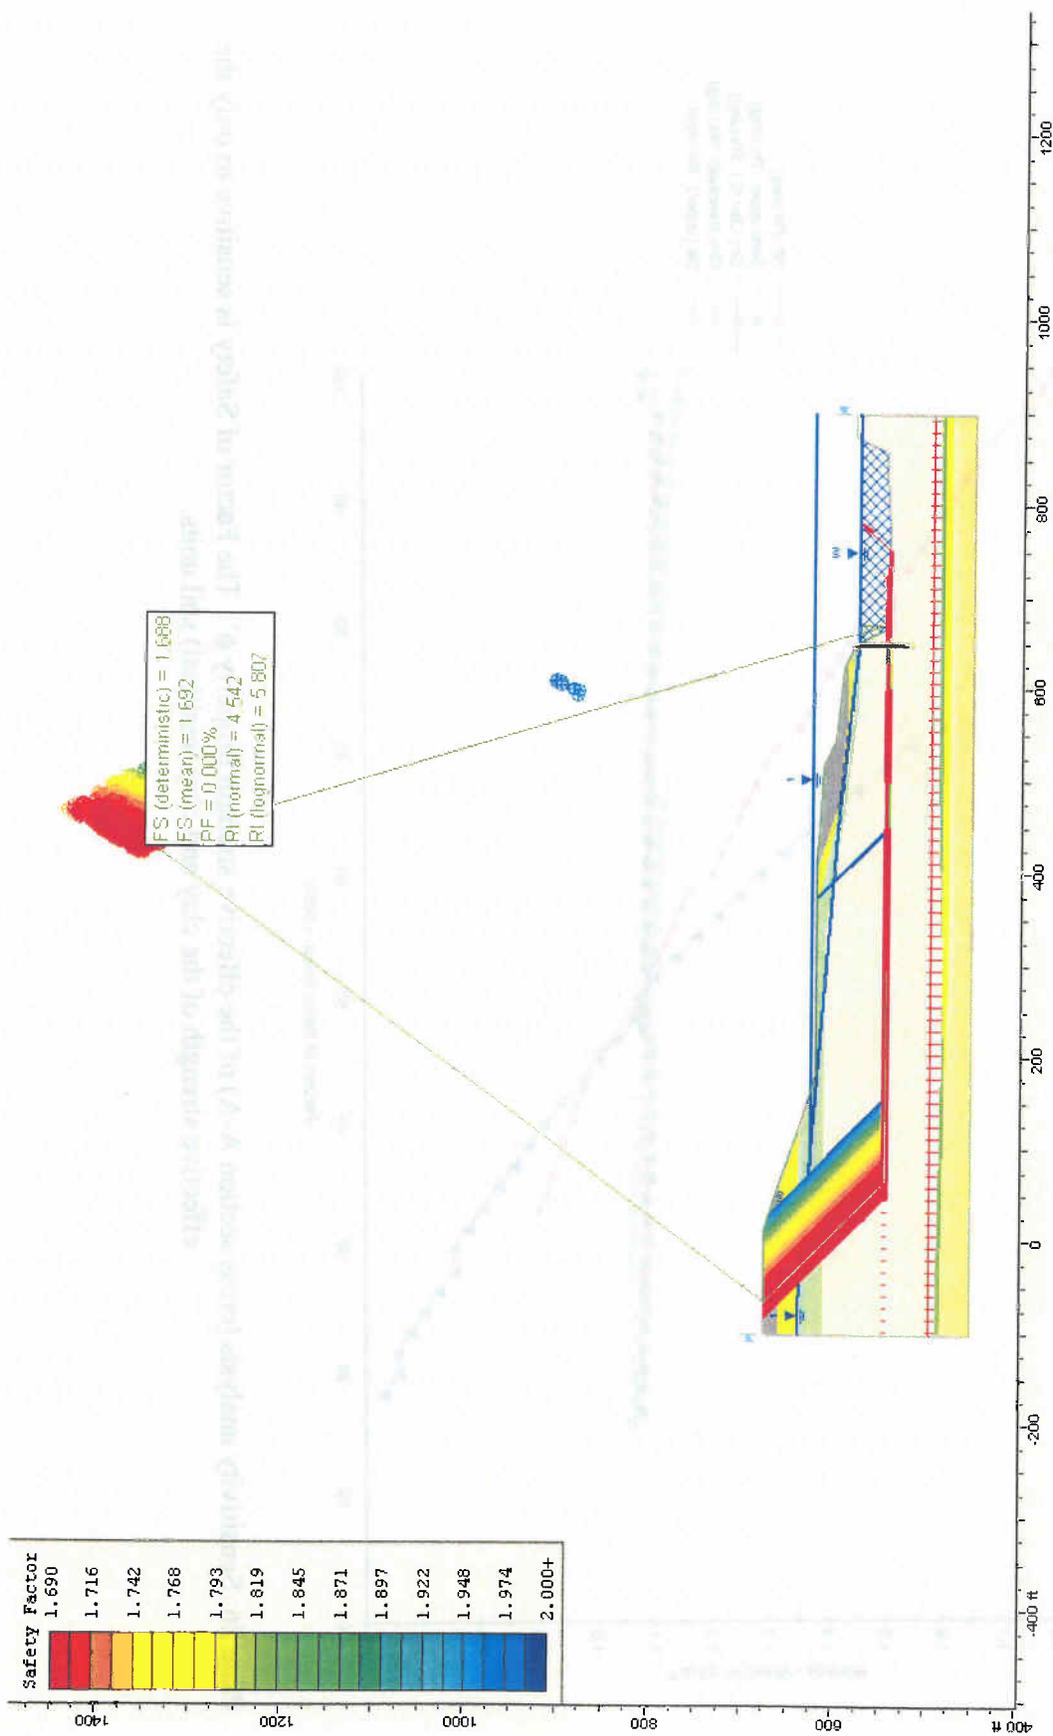
Plate 25: Results of the slope stability analysis within cross section A-A for (alternative 10), which includes a 3(H):1(V) sloped excavation beginning north of Abbey Ave. (file: AA_P_625 E Abbey3on1SH.sli) for a potential shallow slip plane. The minimum Factor of Safety equals 1.688 (Δ FS = 0.64 increase from baseline conditions shown in Plate 15). The estimated Factor of Safety along Abbey Ave. approximately ranges between 1.69 and 1.70.

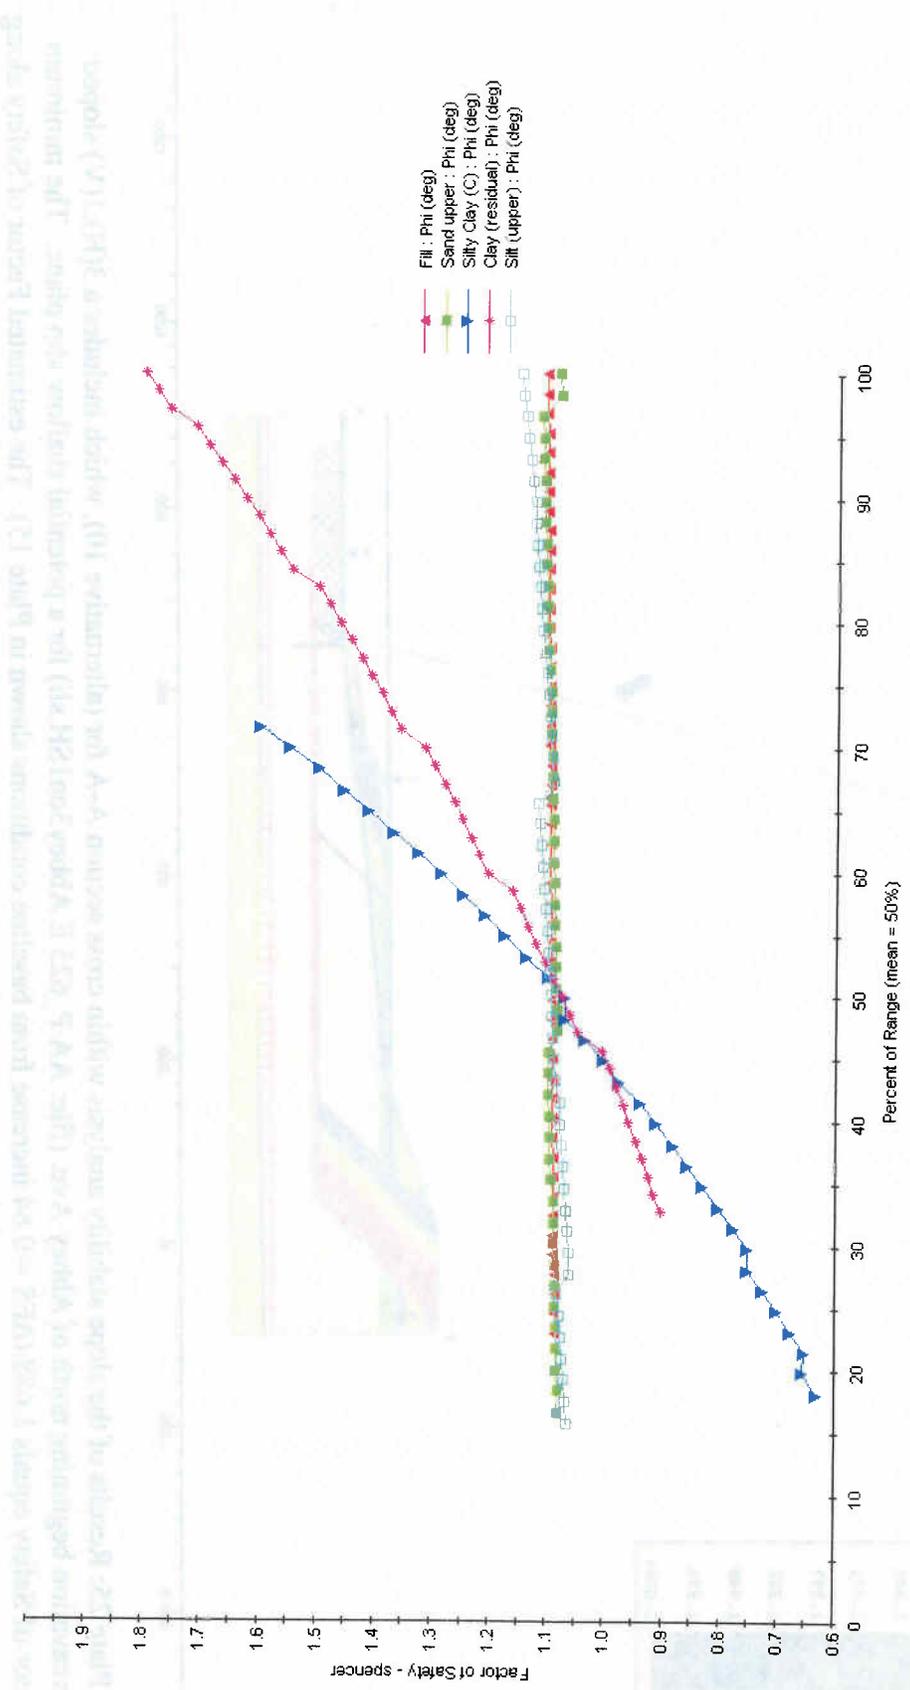
Plate 26: Sensitivity analysis (cross section A-A) of the effective strength property ϕ' . The Factor of Safety is sensitive to only the effective strength of the clay and clay (residual) soil units.

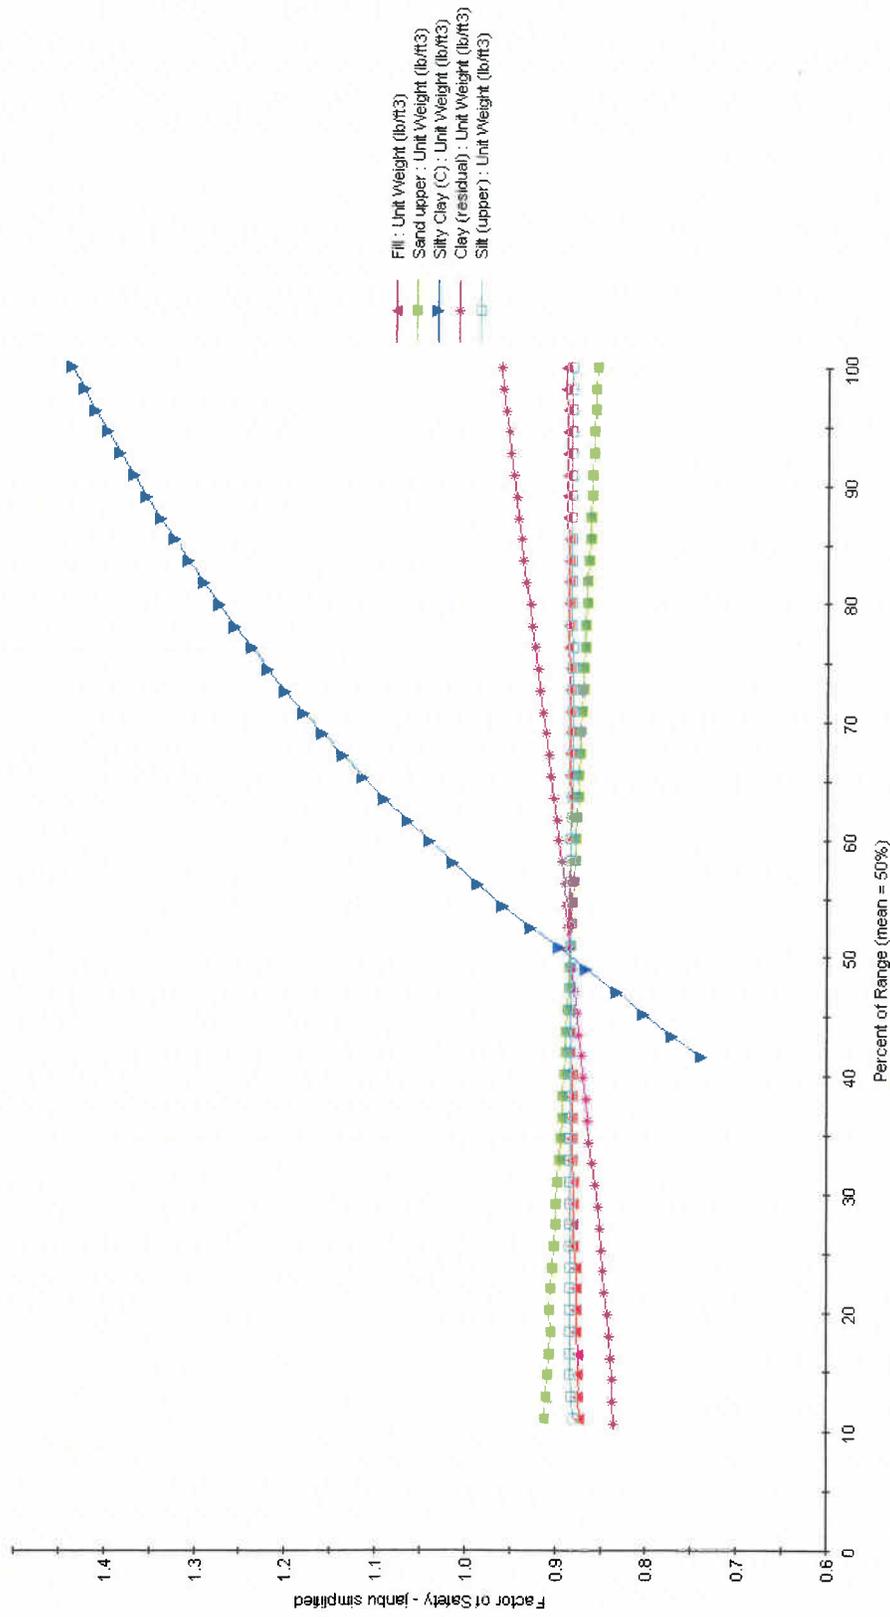
Plate 27: Sensitivity analysis (cross section A-A) of soil unit weight. The Factor of Safety is sensitive to only the unit weight of the clay.

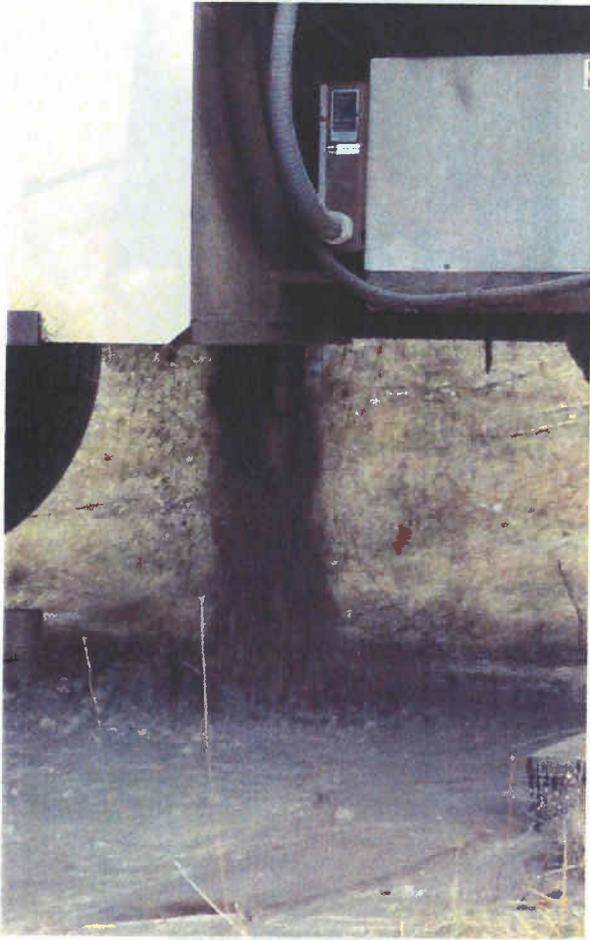
a) Water/gas erupting beneath the CPT rig at C-05-02.

Figure 5: Examples of artesian gas pressures that were encountered during field operations.

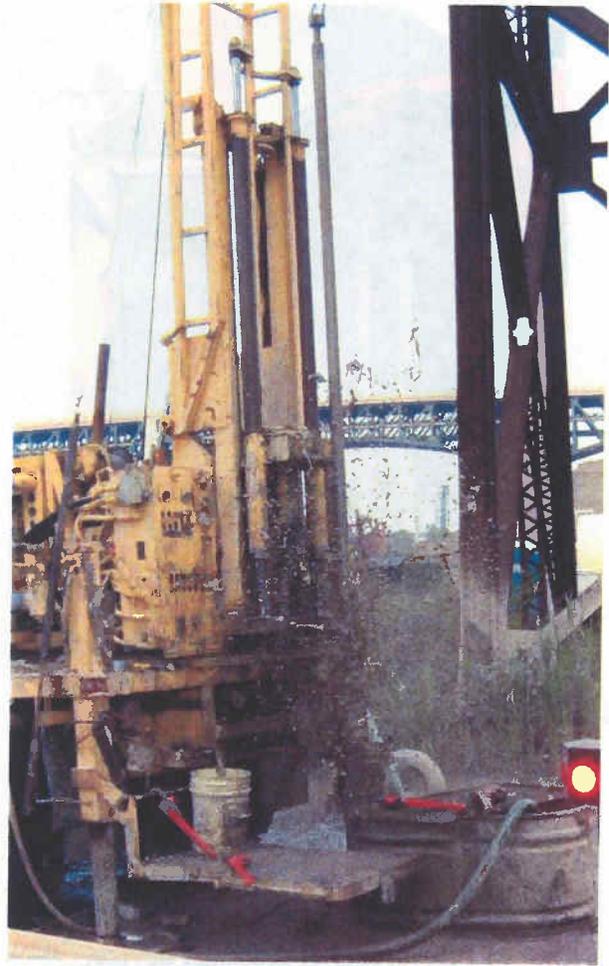
b) Water/gas erupting during drilling operations at B-05-15.
