Geohazard Exploration Report (Final)
CUY-480-16.56 Landslide
Brooklyn Heights, Cuyahoga County, Ohio
S&ME Project No. 24170140E

Geohazard Exploration Report – Final (Task Order No. D12-04)

CUY-480-16.56 Landslide (PID 124096)
Brooklyn Heights, Cuyahoga County, Ohio
S&ME Project No. 24170140E

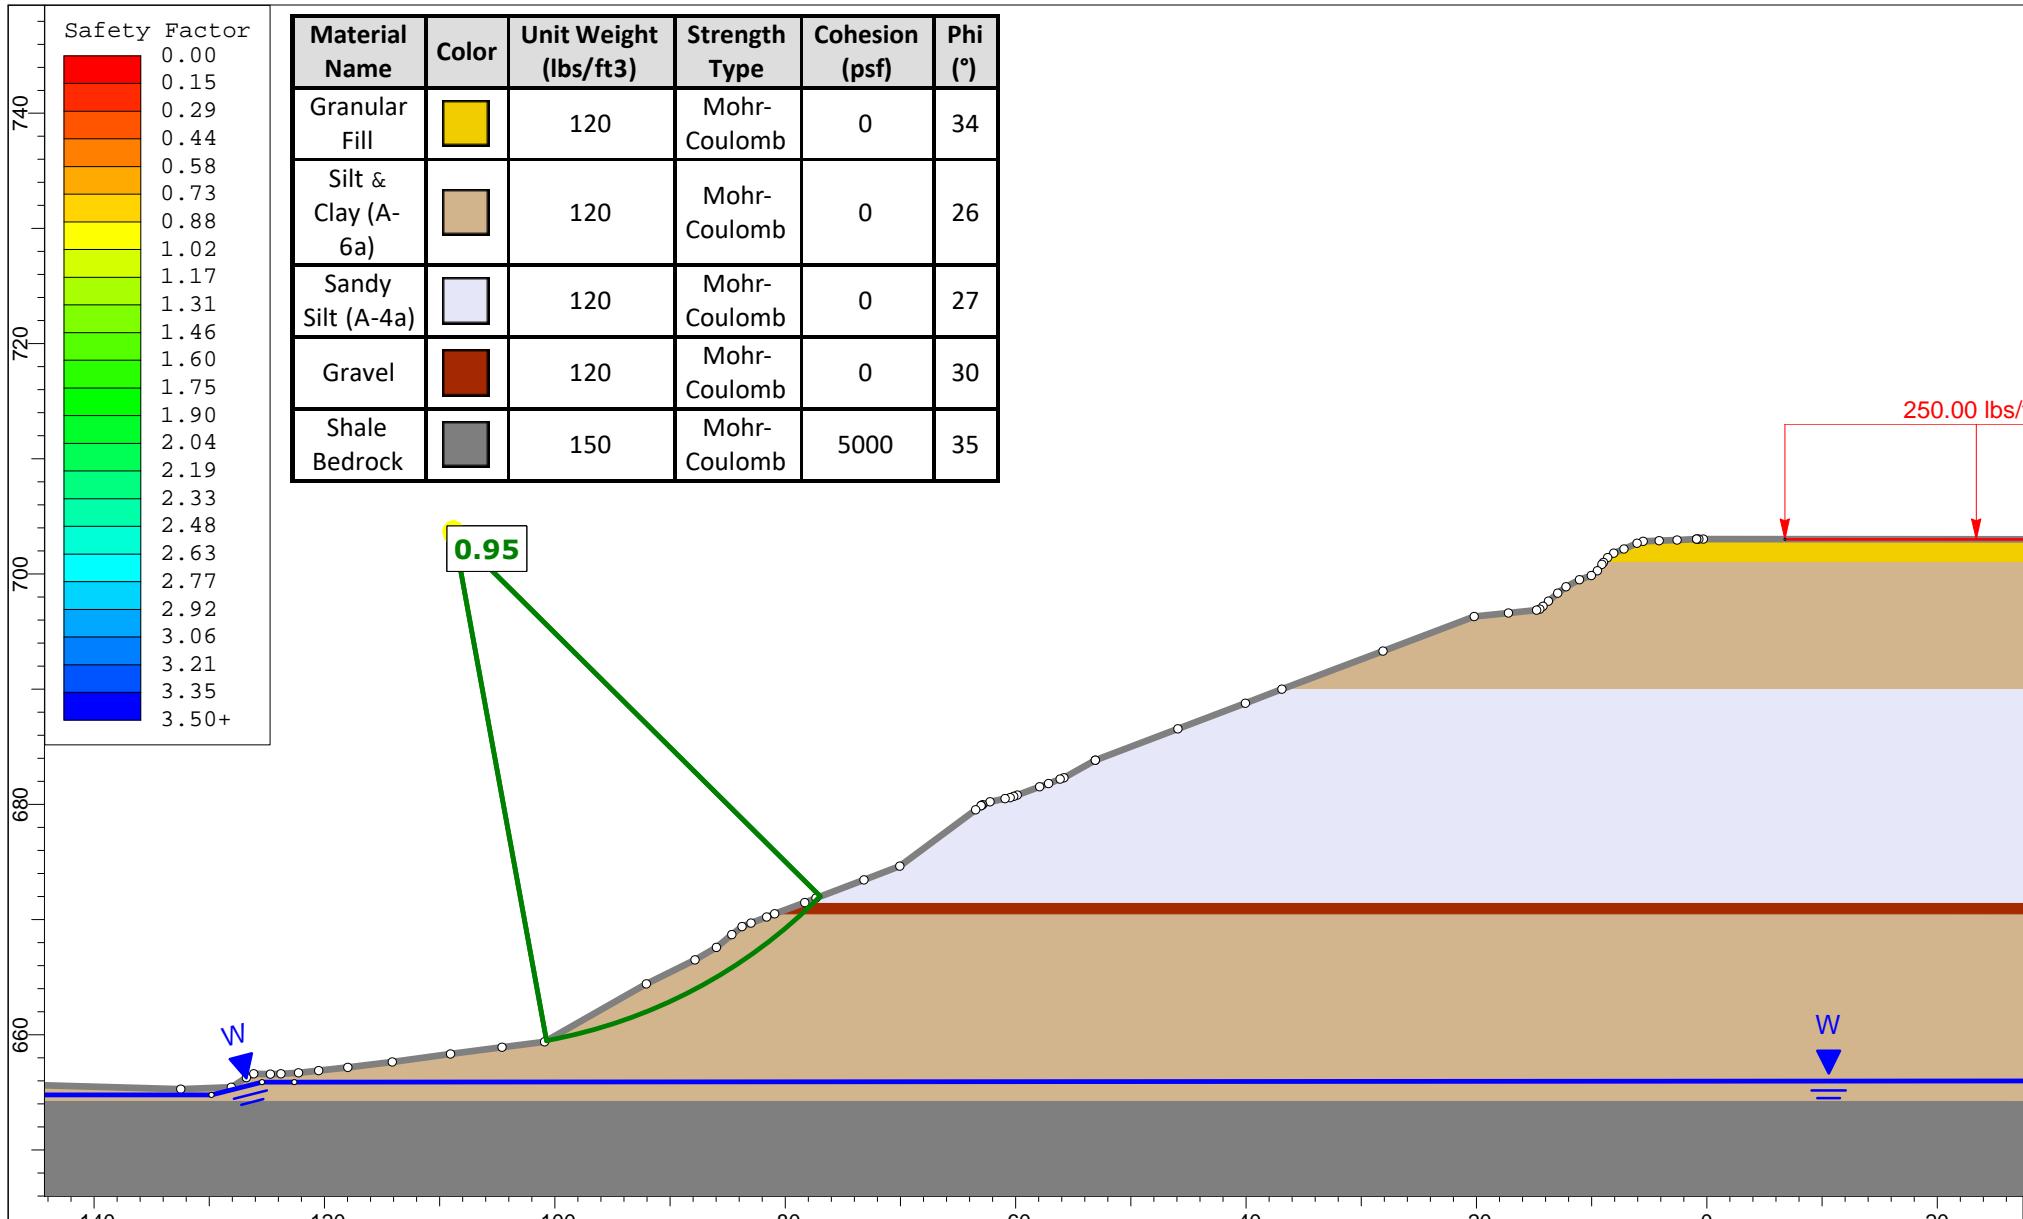
S&ME evaluated the stability of the failed existing embankment at Sta. 896+25, Sta. 897+50, and Sta. 899+00. Using cross sections at these 3 locations provided by ODOT and CVE and the results of the field exploration and laboratory testing programs, S&ME back-analyzed the cross section models to develop a failure model which roughly reproduced the observed slope failure. For the purposes of our analyses, slope failure was considered to have occurred when the factor of safety calculated was approximately 1.0. We note that back-analyses performed at Sta. 896+25 resulted in a factor of safety near 1.2 due to the slightly flatter existing slope at that location.

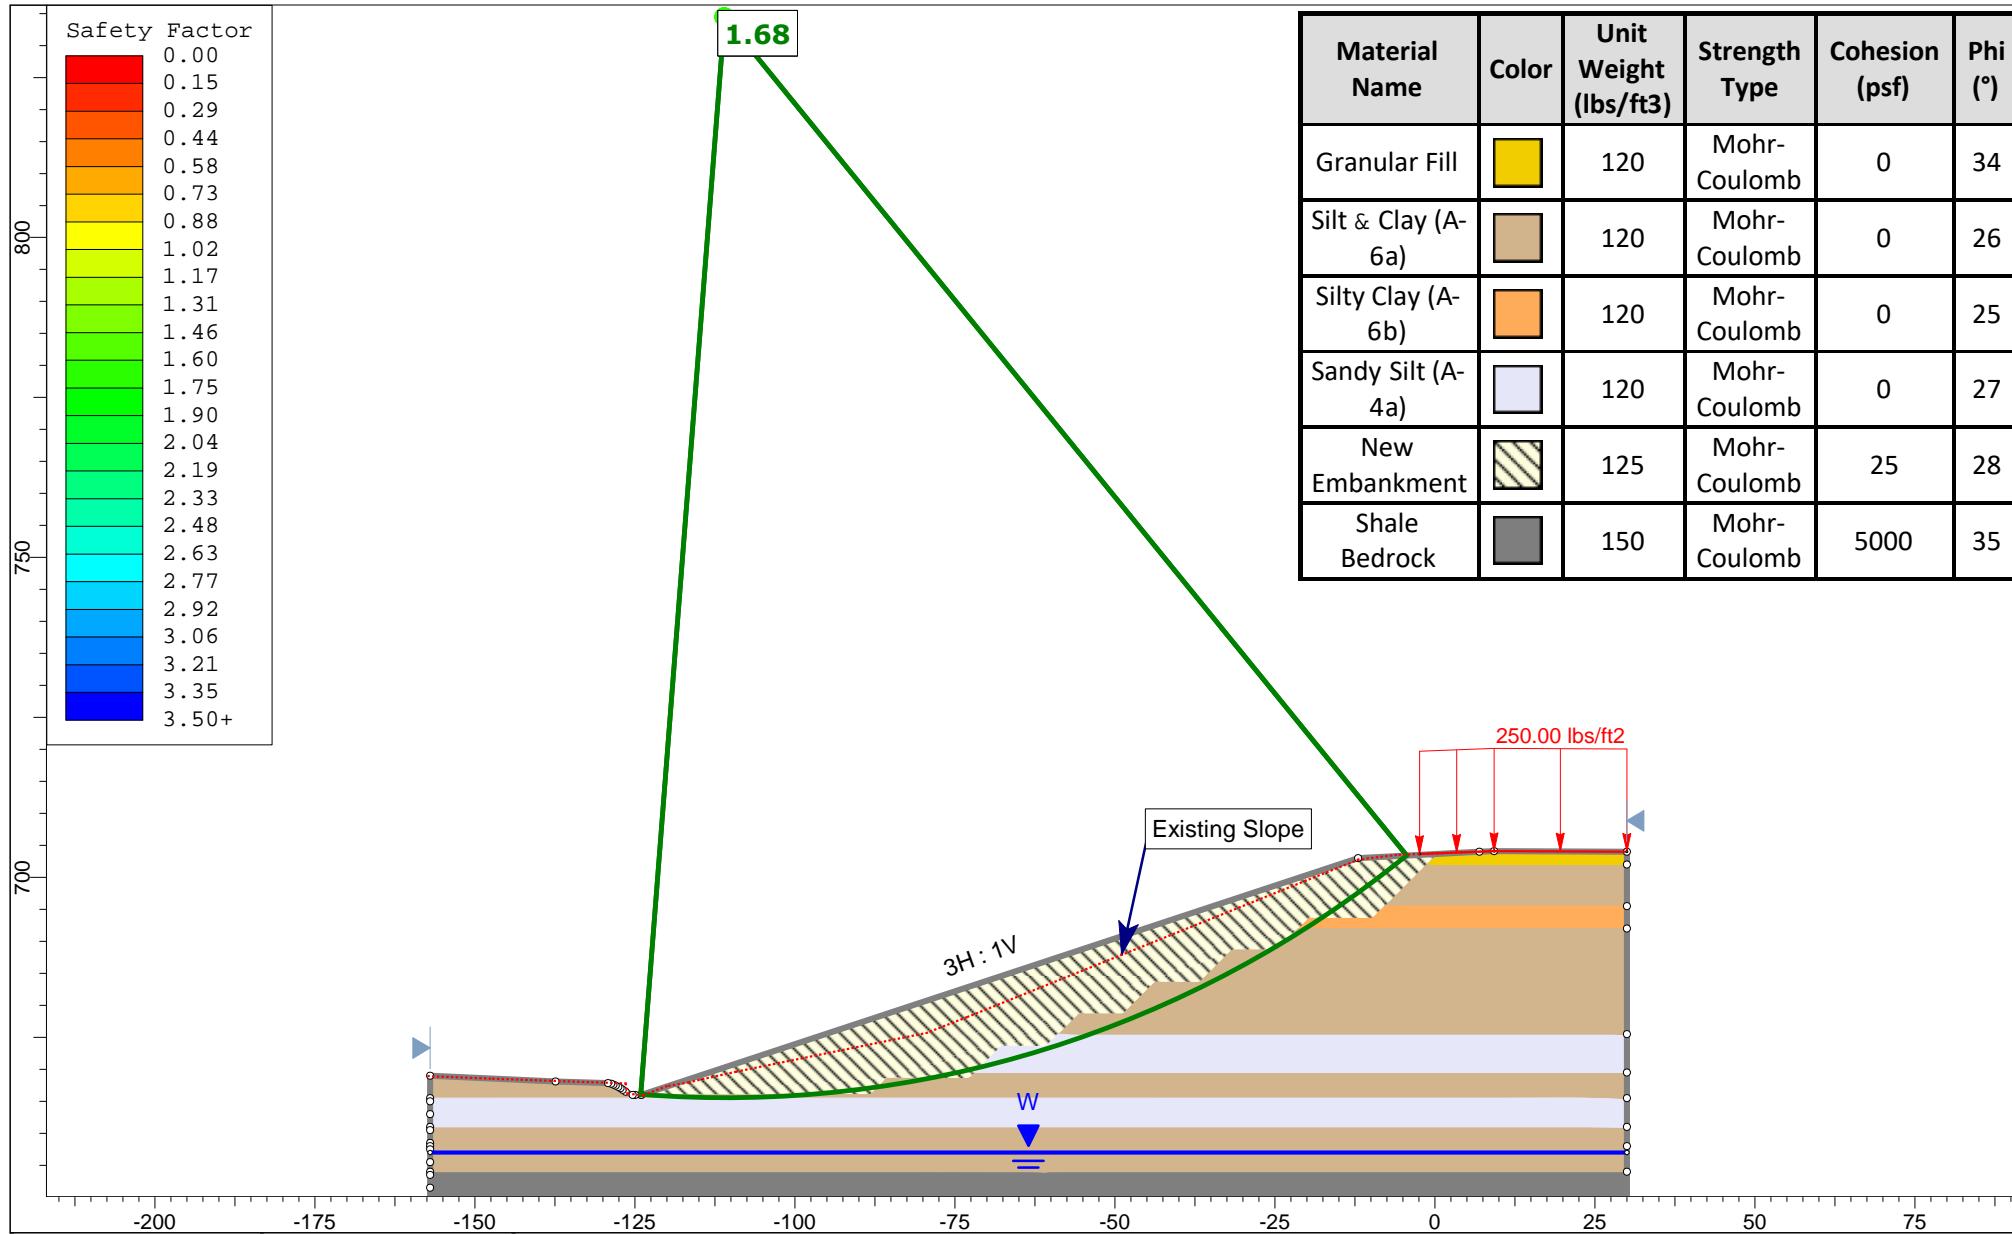
PLATE 6

Following the back-analyses at each of these cross sections, S&ME performed stability analyses at the same stations assuming that the failed surface material was completely removed using an "excavate and replace" benching approach as described in Section 800 of the ODOT *Geotechnical Design Manual (GDM)*. The SLIDE output for these repair analyses is also provided in Appendix II.

- In the paved IR 480 shoulder, begin benching repairs at the existing baseline of the existing IR 480 westbound exit ramp to Granger Road, defined on the plans as "BL CONST. W.B.O.L.".
- The embankment repairs should extend from Sta. 896+25 to Sta. 899+00 with a transition zone on both ends of the full depth benching repair area beginning at the surface of the existing embankment slope and then cutting into the embankment to attain the full bench heights as discussed below. We recommend this transition zone be a minimum of 25 feet long at each end of the repair limits (896+00 on the west and Sta. 899+25 on the east).
- Construct an upper bench 10 feet high and intermediate benches approximately 5 feet high, depending on the best configuration to maintain a constant number of benches throughout the entire repair area. A

constant bench elevation is not required, but the bench should be flatter than 8H:1V, but still sloped sufficiently to drain from the back of each bench to the front. Additionally, the benches should also be sloped to drain longitudinally. Conceptual “excavate and replace” benching sequences at each cross section analyzed are presented on Plates 5, 10 and 15 of Appendix II.
