Pavement Core Summary

S&ME Project No.: 217525

Project Name: LOR-90-10.76

Client: ODOT District 3

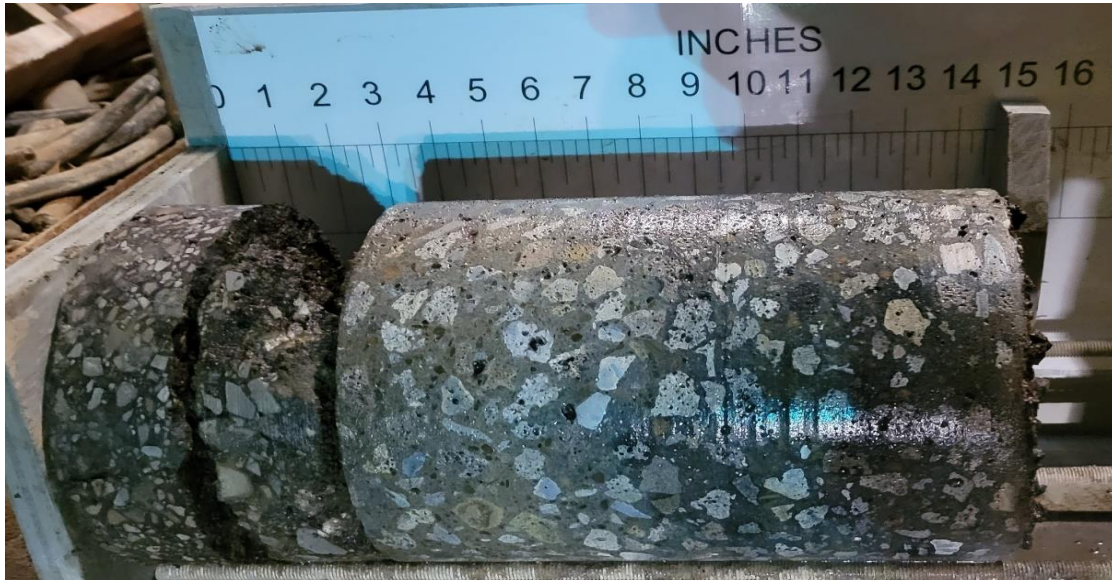
10	Core Number / Thickness	B-010-0-22 / Asphalt = 4½" Concrete = 9¼"
	Remarks	Reinforcing steel observed ¾" and 4" below the top of concrete. A color change was observed in the concrete about ½" from the top of concrete

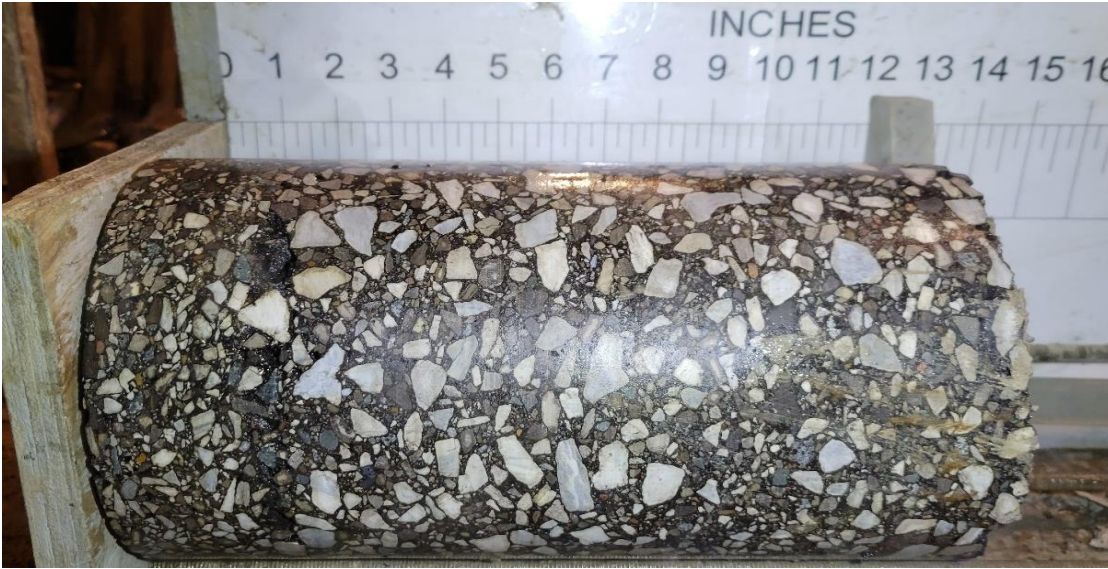
Core length ranged from 15¾" to 17¼".

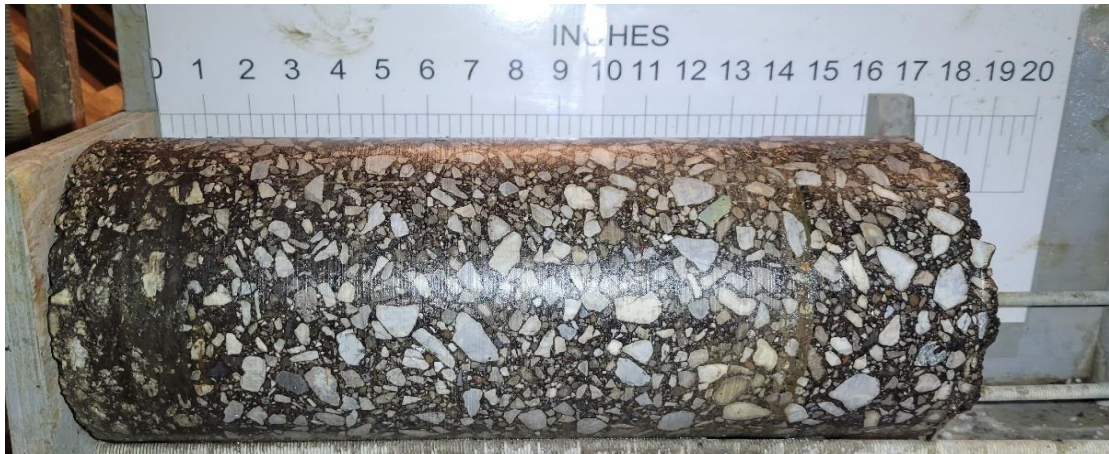
Reinforcing steel observed 3¼" below the top of concrete.

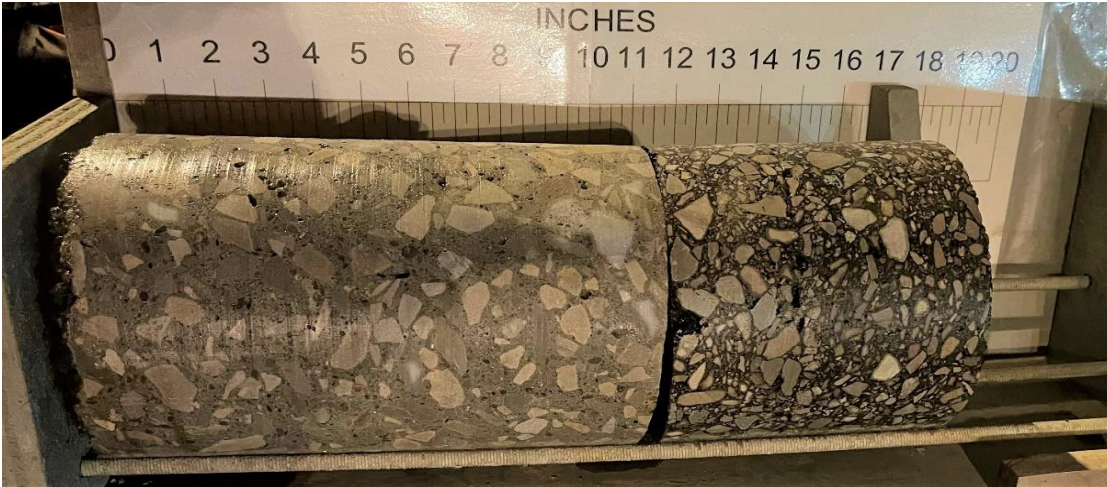
30	Core Number / Thickness	B-026-0-22 / Asphalt = 7¾" Concrete = 9¼"
	Remarks	Reinforcing steel observed 3½" below the top of concrete.

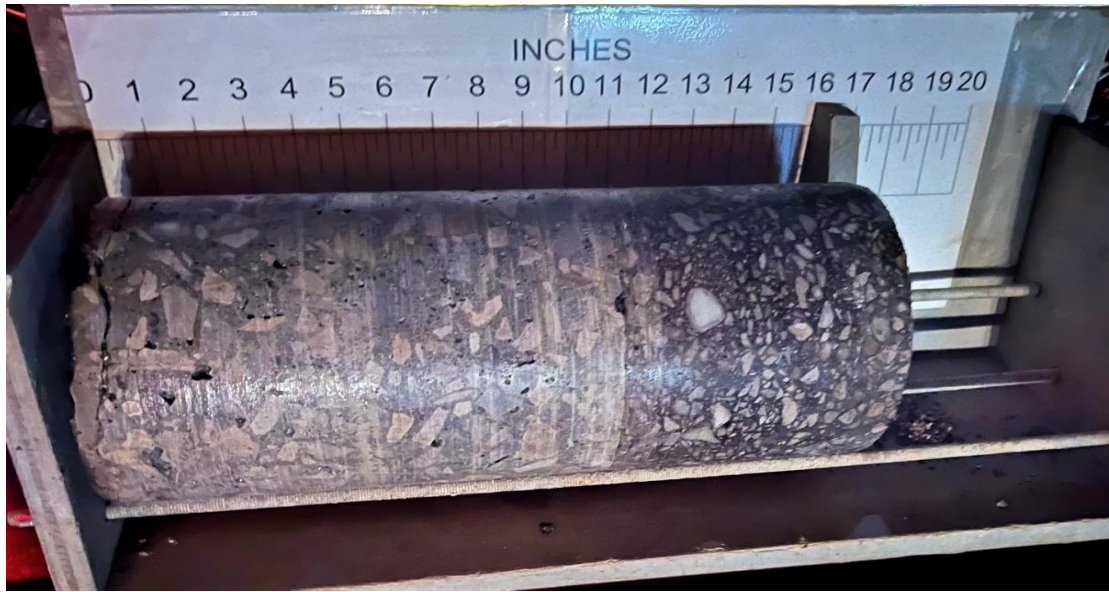
32	Core Number / Thickness	B-036-0-22 / Asphalt = 5½" Concrete = 10½"
	Remarks	Reinforcing steel was observed 3½" and 4" from the top of concrete.

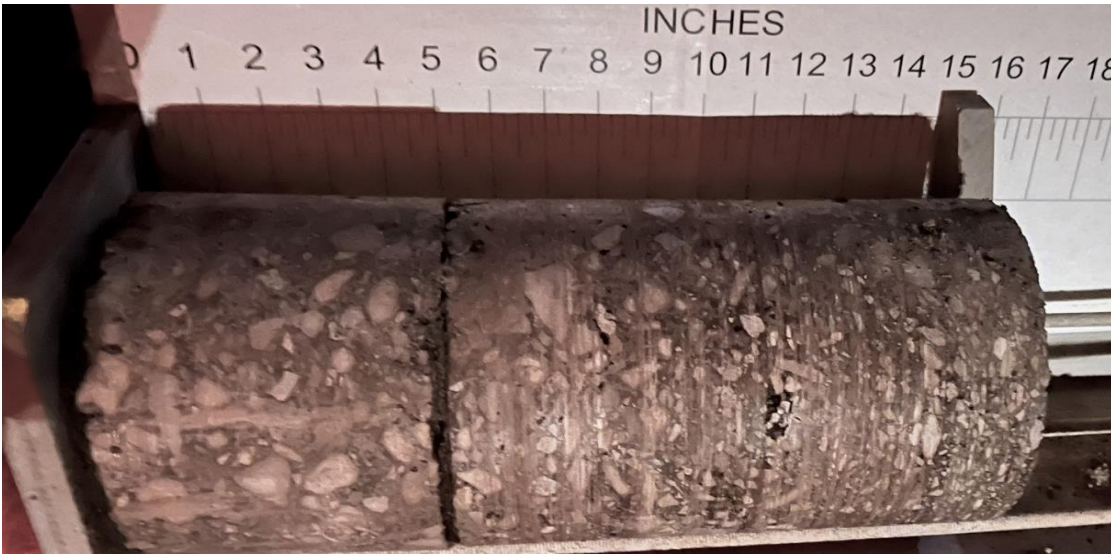
Reinforcing steel was observed 4¼" from the top of concrete.
Deterioration was observed in the lower ½" of the concrete.

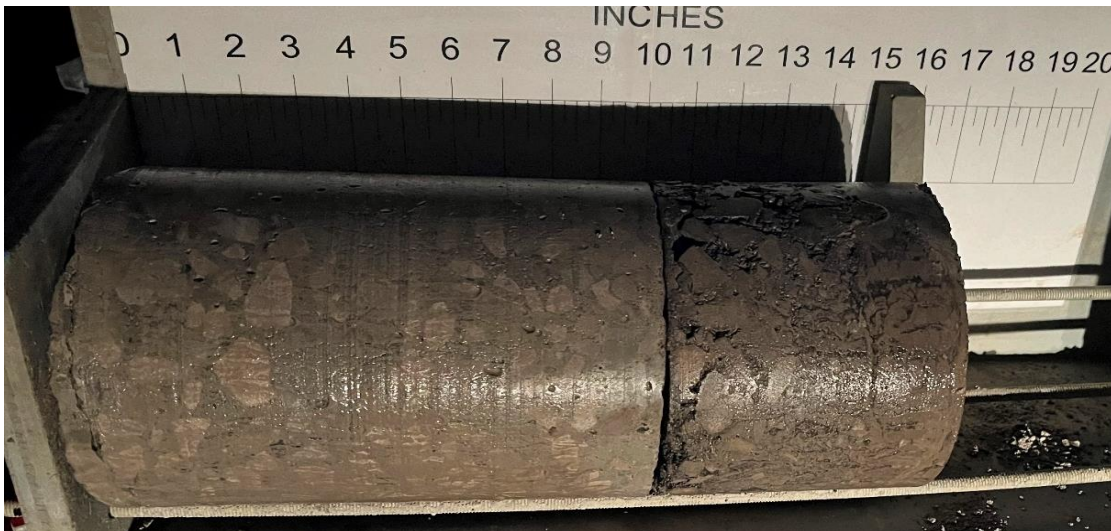
Reinforcing steel was observed 3³/₄" from the top of concrete. A portion of the lower 3" of the concrete split away during coring.

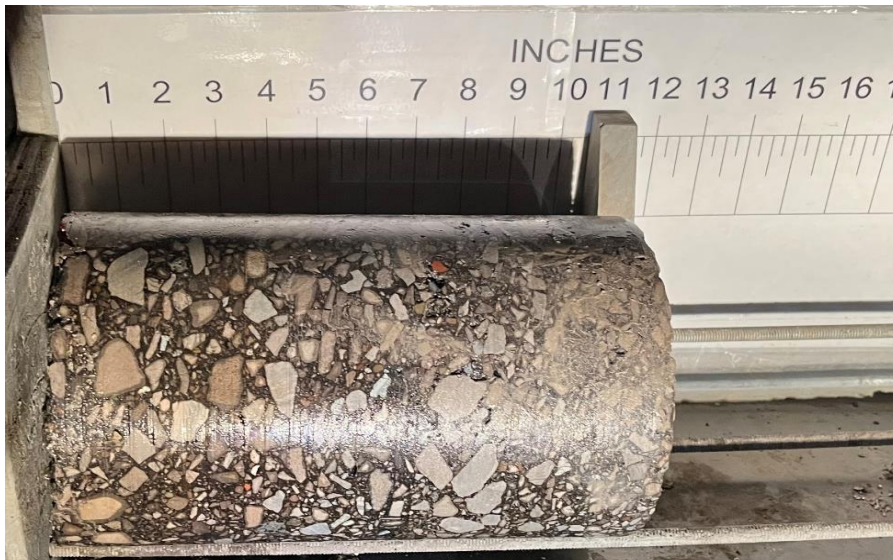
Cemented slag/base (4") based partially recovered below asphalt.

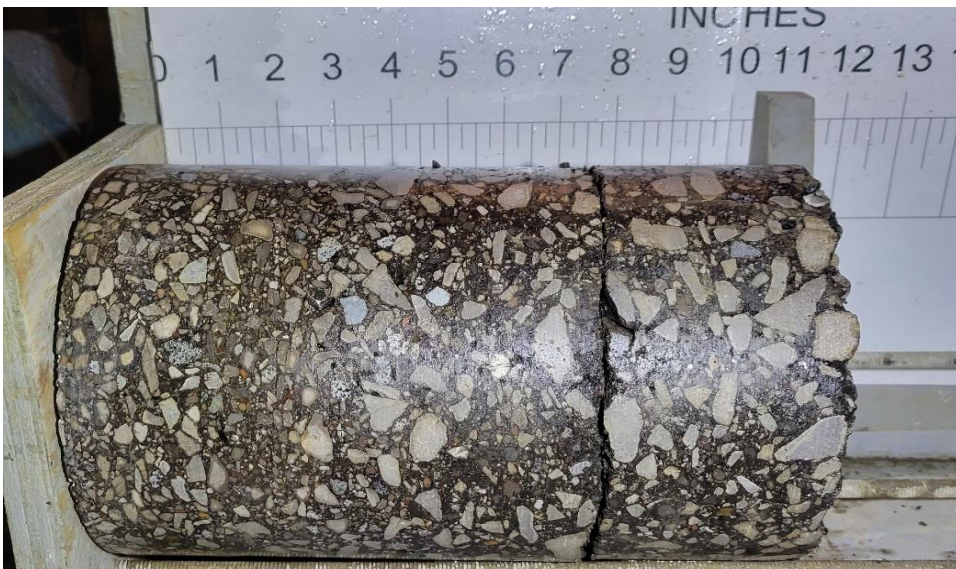
45	Core Number / Thickness	B-058-0-22 / Asphalt = 5" Concrete = 10¼"
	Remarks	An expansion joint, was observed in the upper 2½ of the concrete. A vertical crack, filled with a bituminous compound was observed in the upper 5¾" of the concrete. Horizontal cracks were observed in the lower 1" of the concrete.

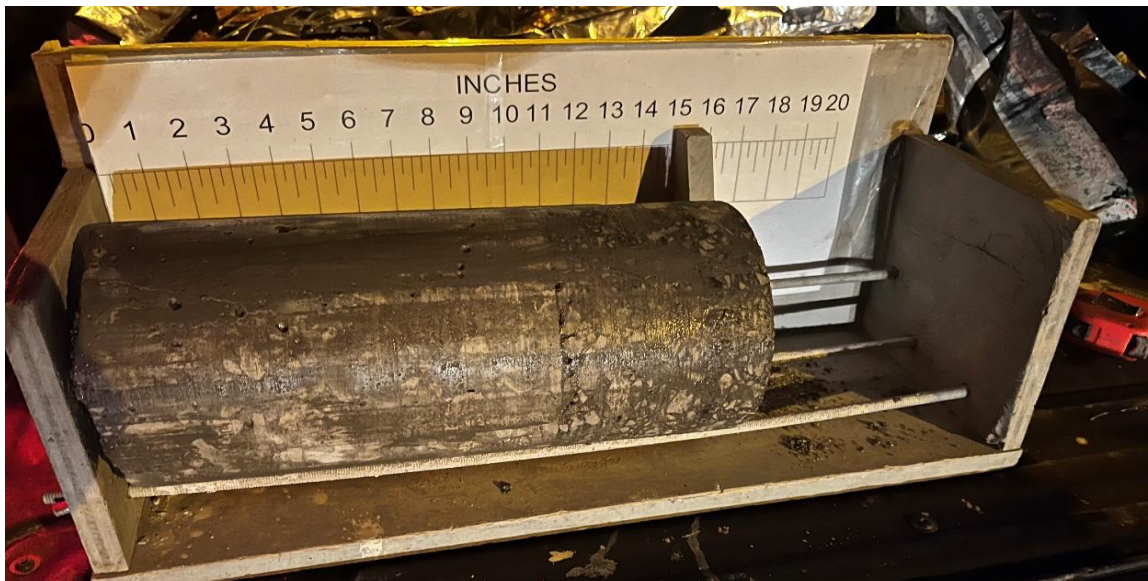
53	Core Number / Thickness	B-062-0-22 / Asphalt = 6 " Concrete = 9¼"
	Remarks	Reinforcing steel observed 4¾" below the top of concrete.

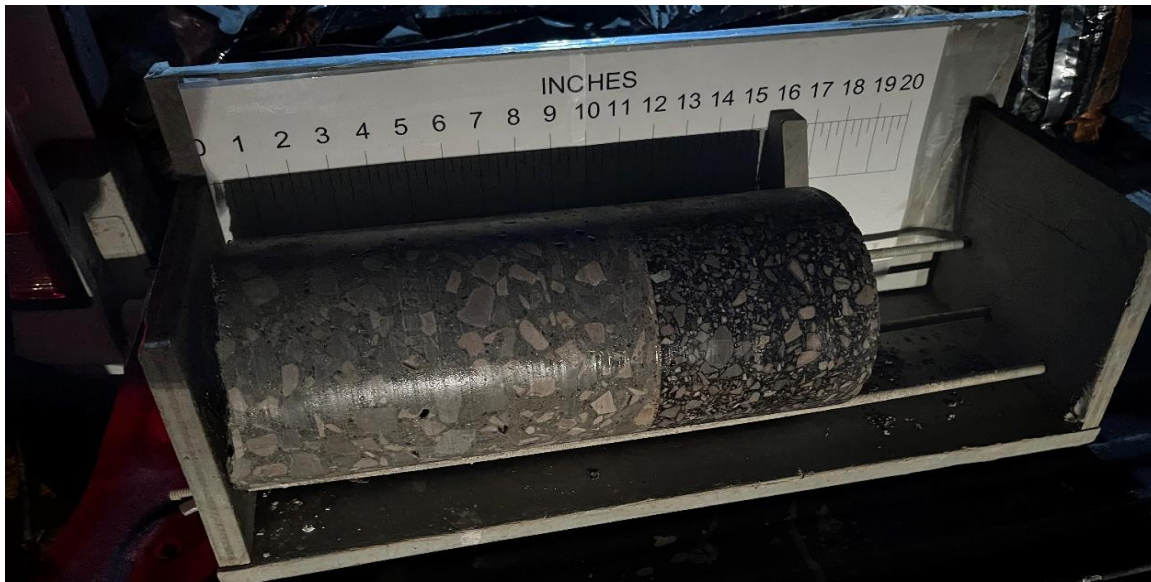
57	Core Number / Thickness	B-070-0-22 / Asphalt = 5 " Concrete = 10 "
	Remarks	Reinforcing steel observed 4¼" and 4½" below the top of concrete.

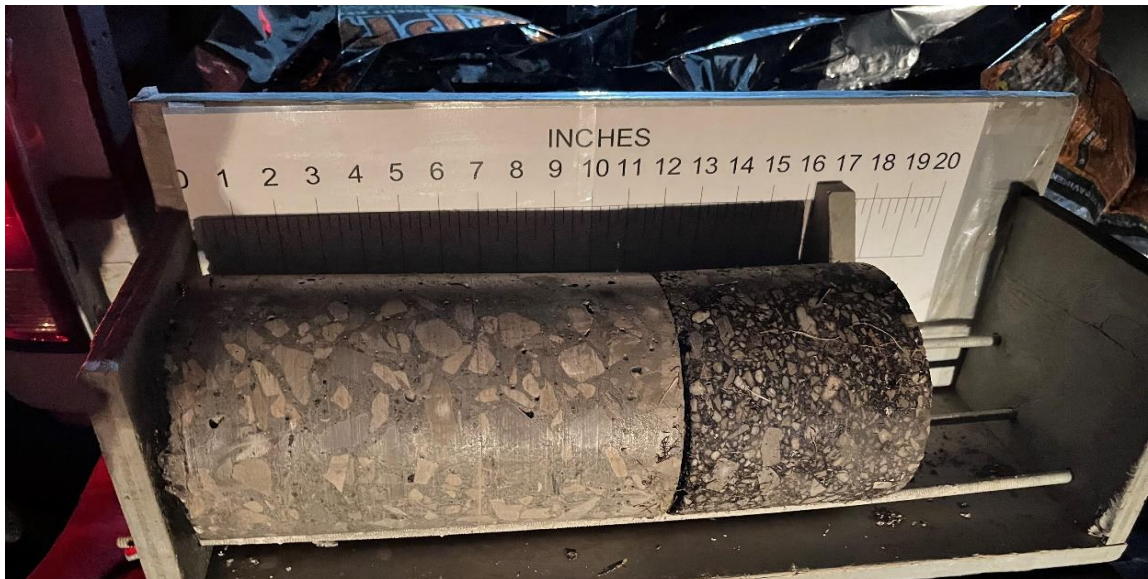
59	Core Number / Thickness	B-074-0-22 / Asphalt = 5¾" Concrete = 10¼"
	Remarks	Reinforcing steel observed 4¼" below the top of concrete. Horizontal cracks observed in the lower ½" of the concrete.

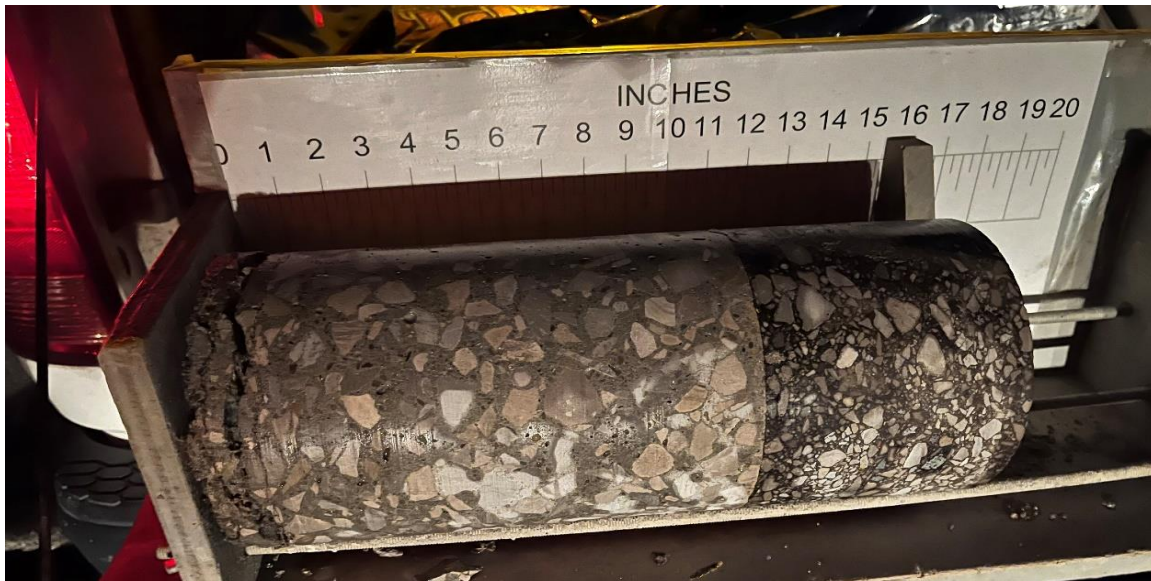
61	Core Number / Thickness	B-078-0-22 / Asphalt = 5¾" Concrete = 10¼"
	Remarks	Reinforcing steel observed 4½" below the top of concrete. Deterioration observed in the asphalt and concrete layers at their interface.

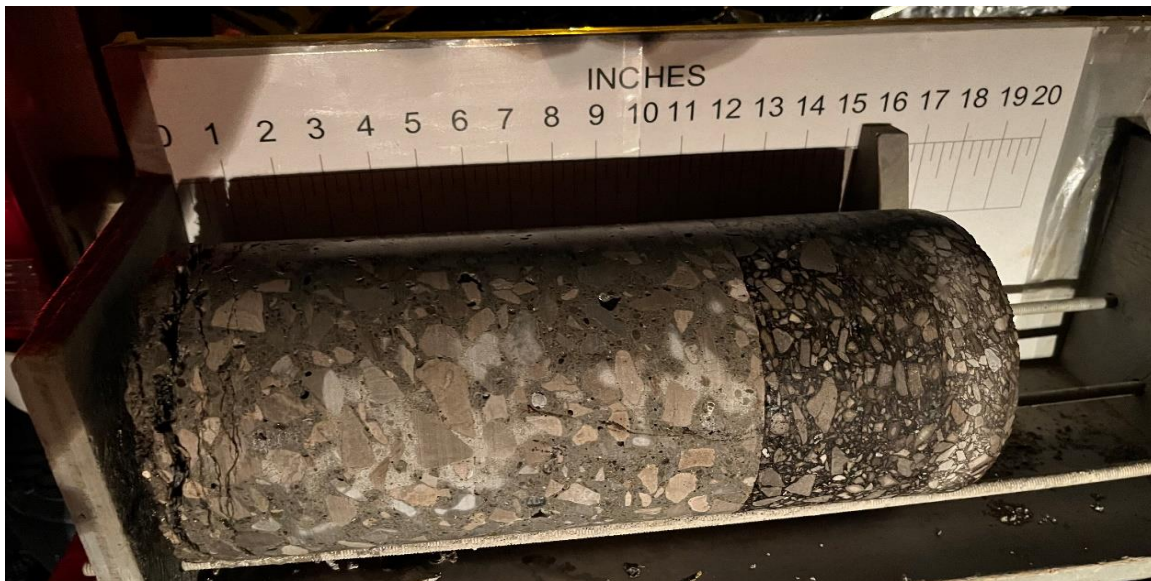
Reinforcing steel observed 4" and 4¼" below the top of concrete.

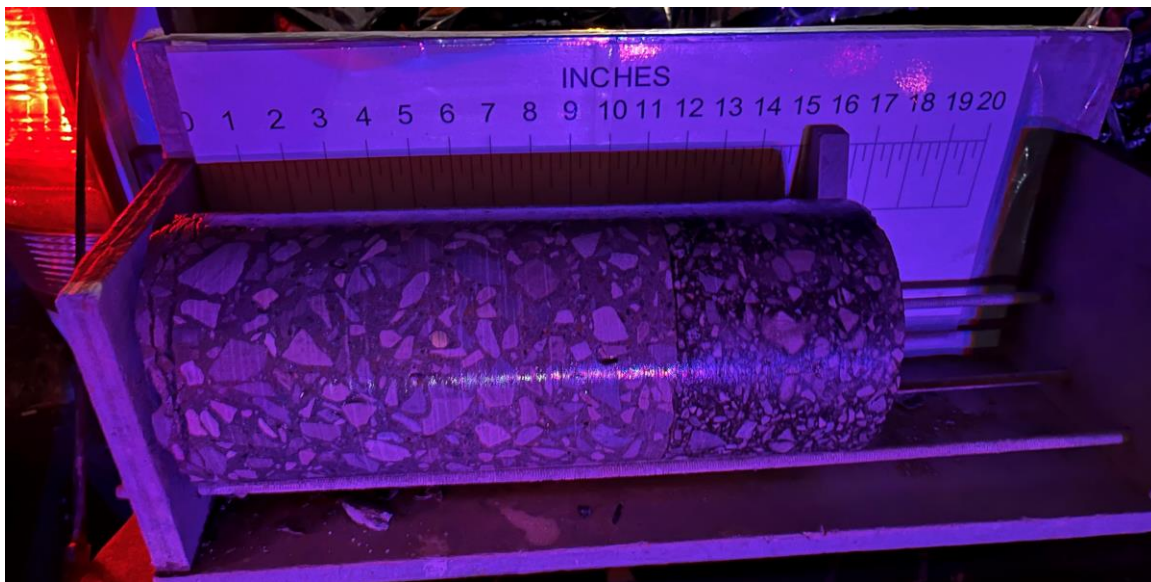
Reinforcing steel observed 4½" below the top of concrete.
