**THE ANTHONY WAYNE BRIDGE**

Over the Maumee River

**2013 CABLE STRENGTH EVALUATION  
REPORT**

**MODJESKI AND MASTERS, INC.**  
**CONSULTING ENGINEERS**  
**MECHANICSBURG, PENNSYLVANIA**

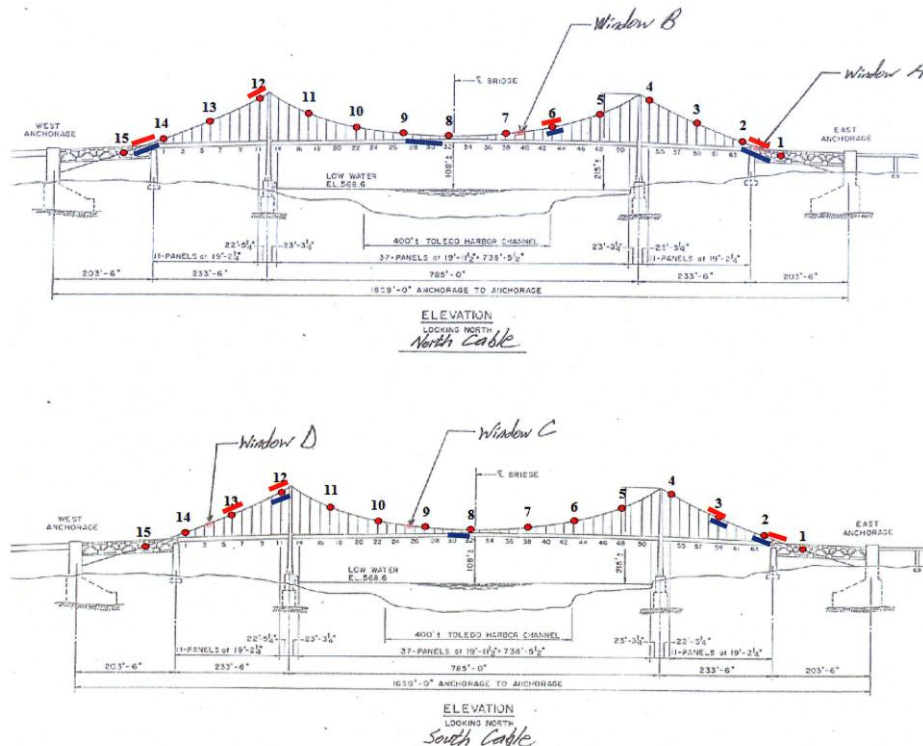
**Figure 3.2- MISTRAS Figure of Areas of Potential Interest for Future Inspection**

*As of Thursday, July 14, 2011 – the systems and sensors on both the North and South cables have been continuously recording and monitoring the cable. As of September 10, 2011, no potential wire breaks have been recorded. However, there are several sections on both the North and South cable that have an AE signature that is different from the surrounding panels and are potential locations for future inspection. On the North cable, the section of cable between Sensors 7, 8 and 9 show a high amount of activity, with higher trending of activity between Sensors 8 & 9 (mostly frictional). Additionally, a small cluster between Sensors 14 & 15 has been observed. For the south cable, a similar trend of AE activity is located between Sensors 7 & 8 and is about three times higher than the average observed for the same section on the North cable. Additionally, a small cluster of AE activity was observed between Sensors 1 & 2.*

MISTRAS also summarized this information on elevations of the bridge as shown in Figure 3.2.

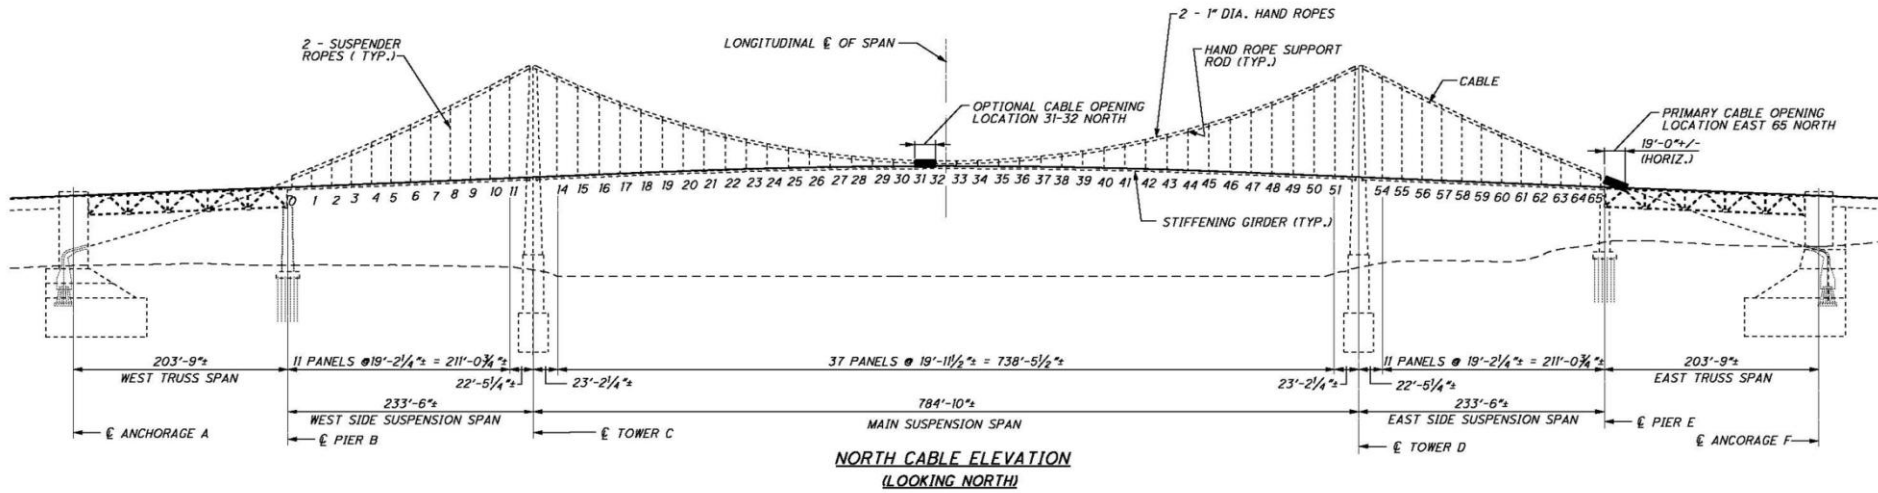
**Figure 3.3 - North Cable Inspection Locations**

Based on all of the available information, MM recommended that the primary cable locations should be located between PP 3 – PP 4 on the south cable and the area east of PP 65 on the north cable. The recommended optional locations were located between PP 58 – PP 59 on the south cable and PP 31 – PP 32 on the north cable. ODOT concurred with these recommendations.

The chosen locations are shown in Figure 3.3 for the north cable and Figure 3.4 for the south cable.

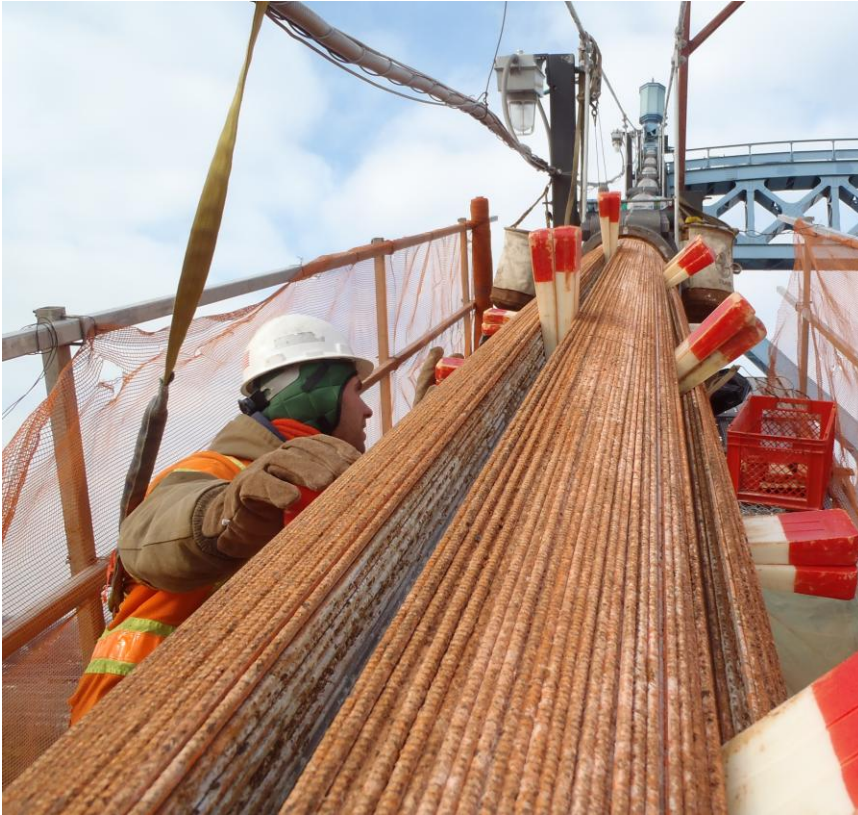
**Figure 4.4– Cable Wedged for Inspection**

At most of the locations, the cables were wedged over a full 20-foot (+/-) panel length. However, due to the large cable band spacing of the backstays, this was not practical at location East PP 65, North. Here the cables were opened over an approximate length of 20 ft. between the cable hold-down band and the cable hood where the cable passes through the sidewalk. A photograph of the cable wedged for inspection is shown in Figure 4.4.

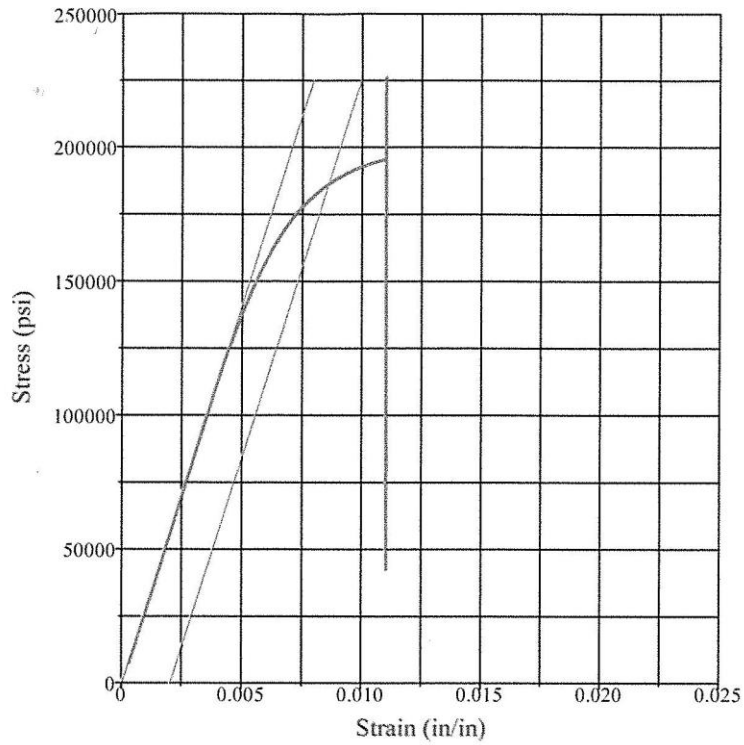
**Figure 5.2– Uncracked Wire Stress-Strain Curve**

The tensile tests were also used to determine the number of specimens with pre-existing cracks. Uncracked wires fail in a ductile manner, achieving strains of about 4%. A typical stress-strain curve for an uncracked wire is shown in Figure 5.2. Their failure surface shows a reduction in the wire diameter at the failure location (necking) along with a "cup and cone" failure surface, as shown in Figure 5.3. Wires with cracks were identified by both their sudden failure at relatively low strains and their ragged failure surface, shown in Figure 5.5. Since the stress-strain curves were not generated to failure, the lower strains associated with cracked wires are not apparent in Figure 5.4. The low elongation in a 10-inch length combined with the lower ultimate tensile strength, as displayed in the information adjacent to the graphs, point to the possibility that the wire was cracked.

Test Results	
Specimen Gage Length:	10.0000 in
Diameter:	0.1920 in
After Test Diameter:	0.1500 in
Area:	0.0290 in <sup>2</sup>
After Test Area:	0.0177 in <sup>2</sup>
Correlation Coefficient:	0.9999
Tangent Modulus:	28187 ksi
Tensile Strength:	226 ksi
Total Elongation:	4 %
Pretest Punch Length:	10 in
Posttest Punch Length:	10.378 in
Reduction of Area:	39 %
Peak Load:	6551.2000 lbf
Load at Offset:	5398 lbf
Stress at Offset:	186 ksi
Proportional Limit:	4242.1000 lbf
