2020 In-Depth, Element Level Bridge Inspection Report

LUC-2-1862 **In-Depth, Element Level Bridge Inspection Report**

PID: 108045

October 2020

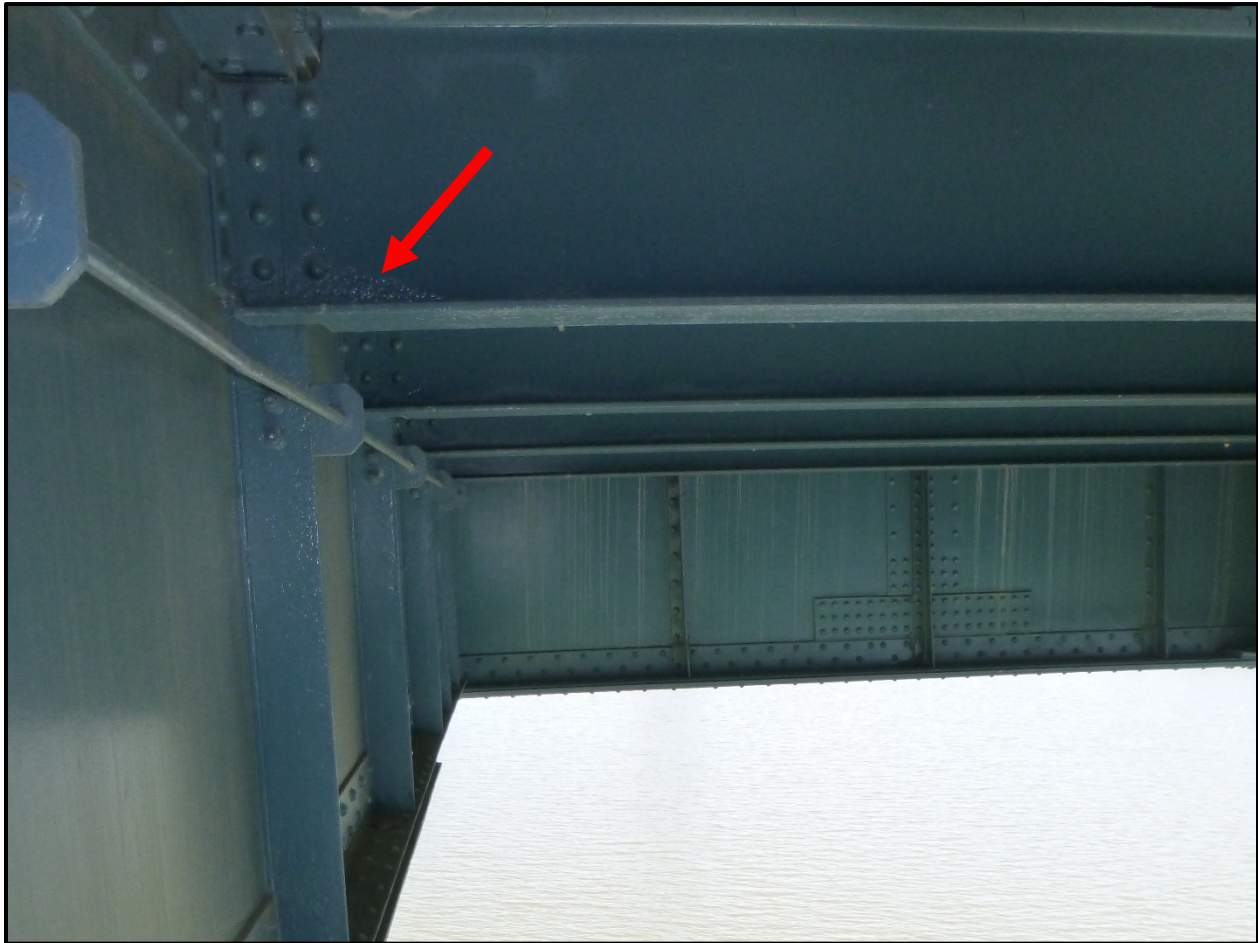
Section loss greater than 1/16" at floor beam/stringer connections and sidewalk connections was typical in approach and suspension spans.

Photo 18 – Typical Painted Over Section Loss at Floor Beam Connection

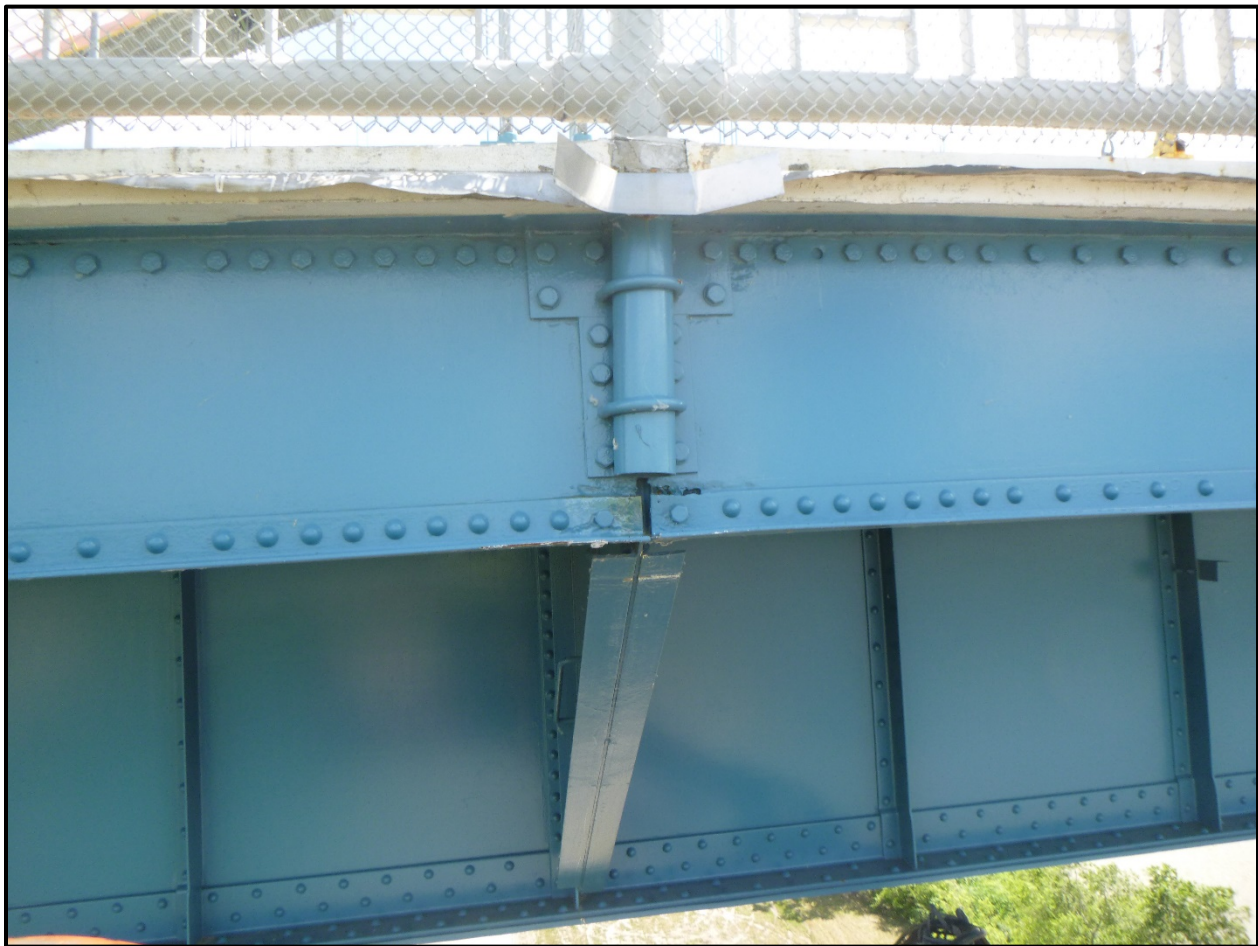
Photo 19 – Typical Painted Over Section Loss at Sidewalk Stringer Connections

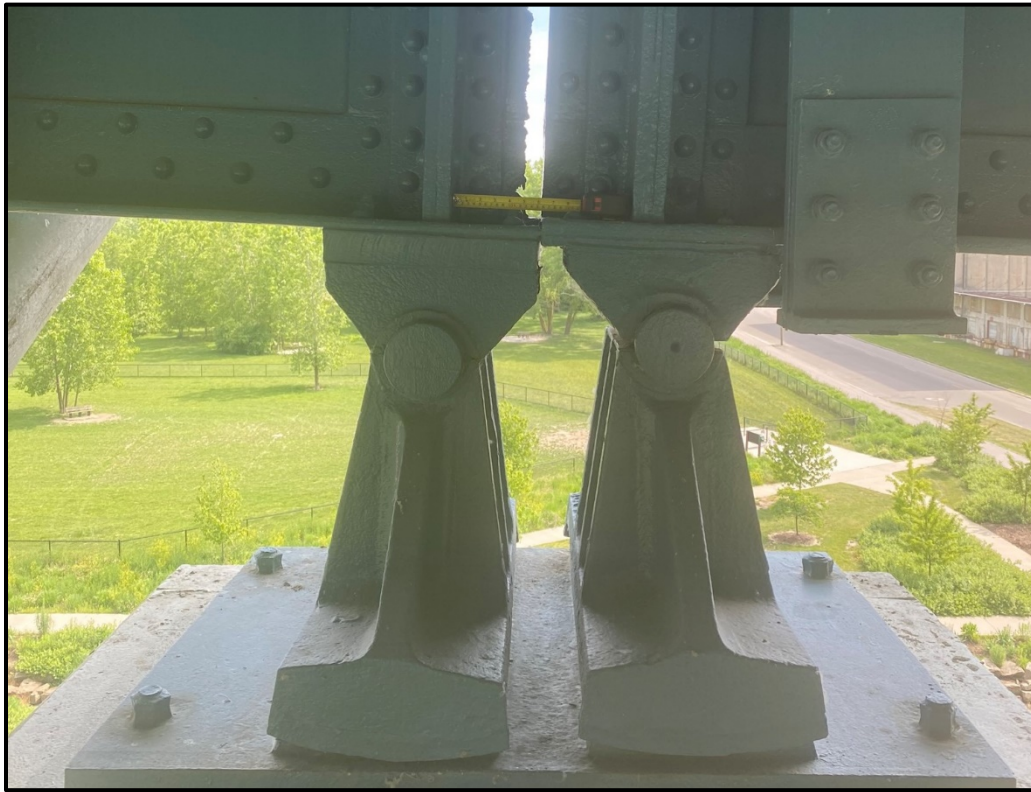
Photo 25 - LG Bearings at Pier 2W are both Tilted approximately 10 Degrees Towards Each Other, Resulting in Girder Contact and Restricted Movement

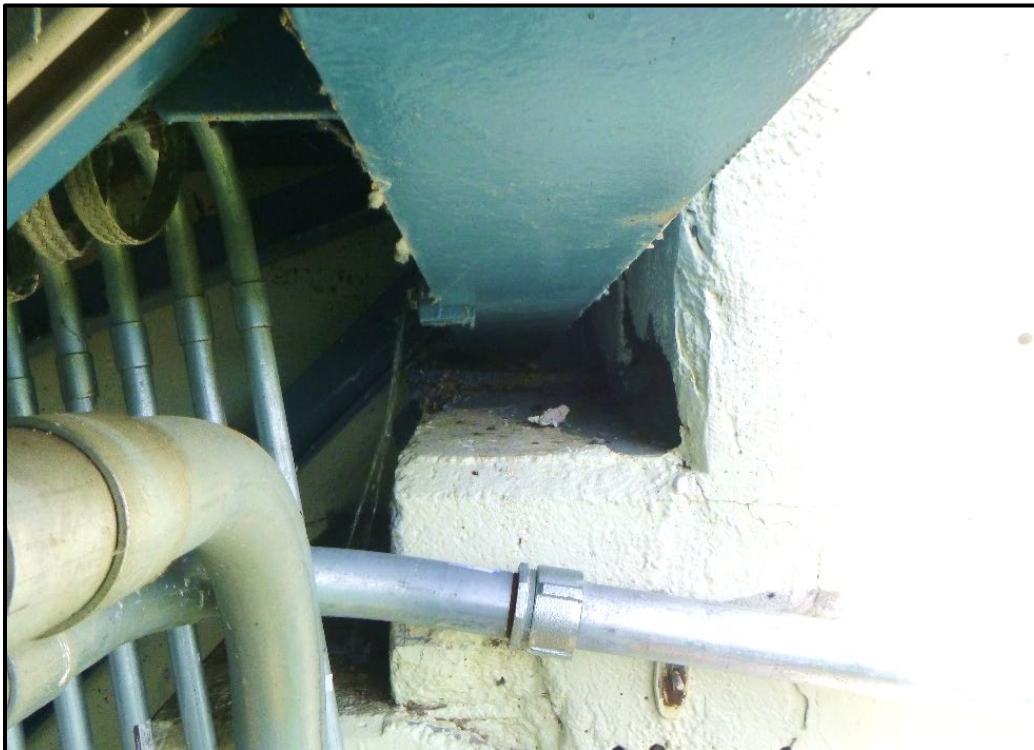
Photo 26 - S1 Bearing Plate at Anchorage A Overhangs Beam Seat by 1/2"

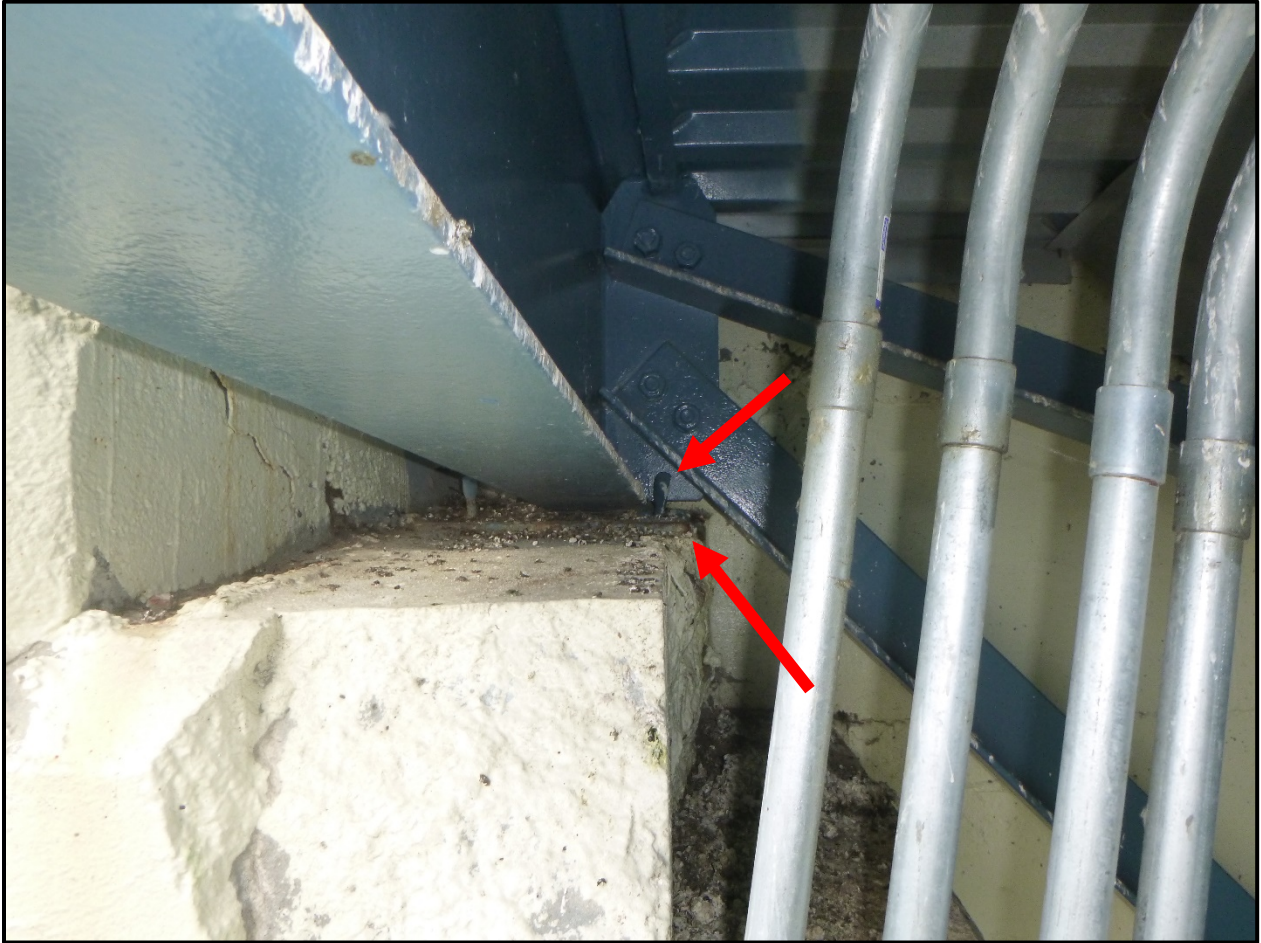
Photo 27 - S2 Bearing Plate at Anchorage A Beginning to Undermine. Also note Section Loss to Bearing Anchor Bolts

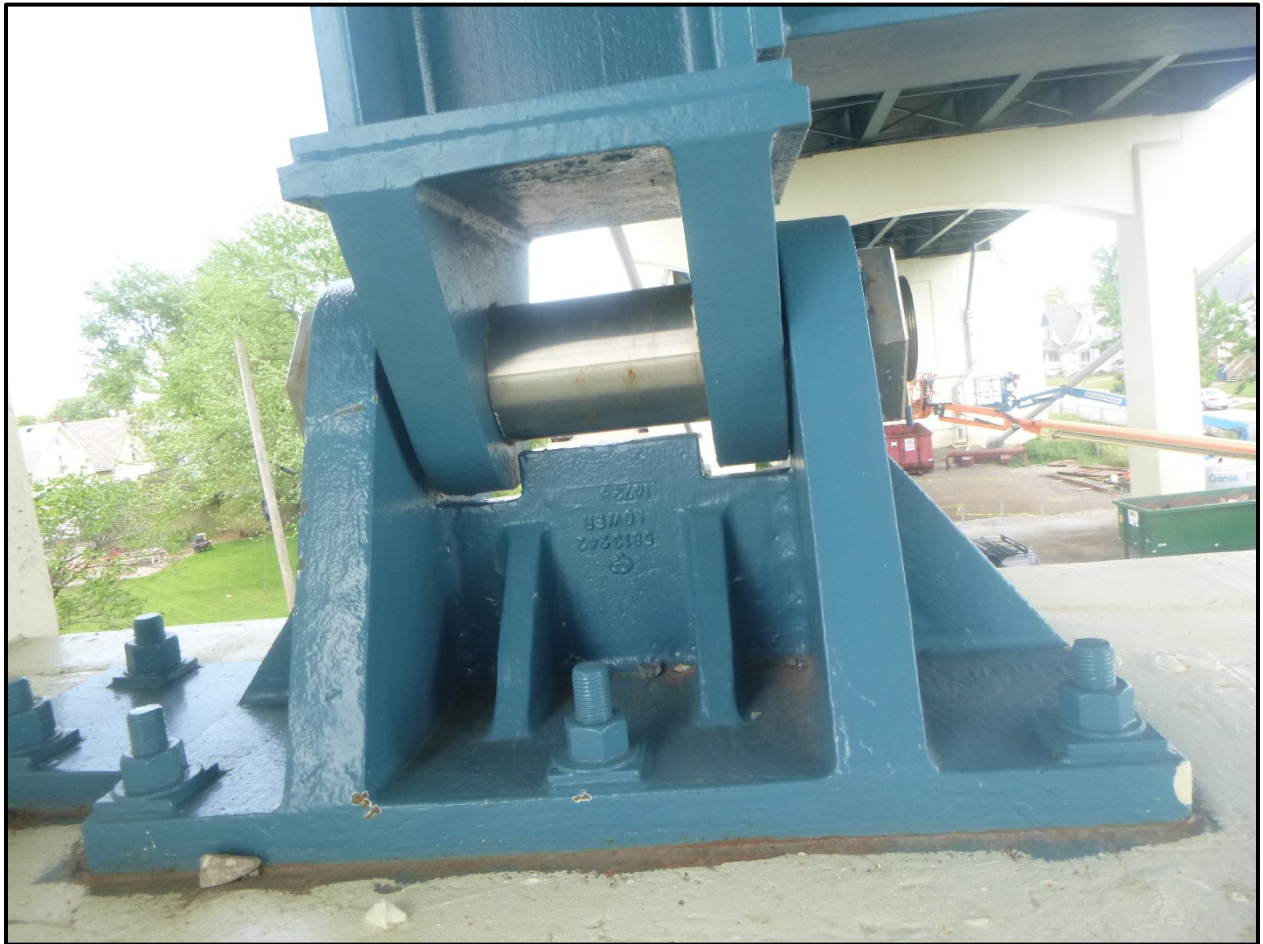
Photo 33 - Unpainted Bearing Pin at Pier E (South Bearing shown, North similar)

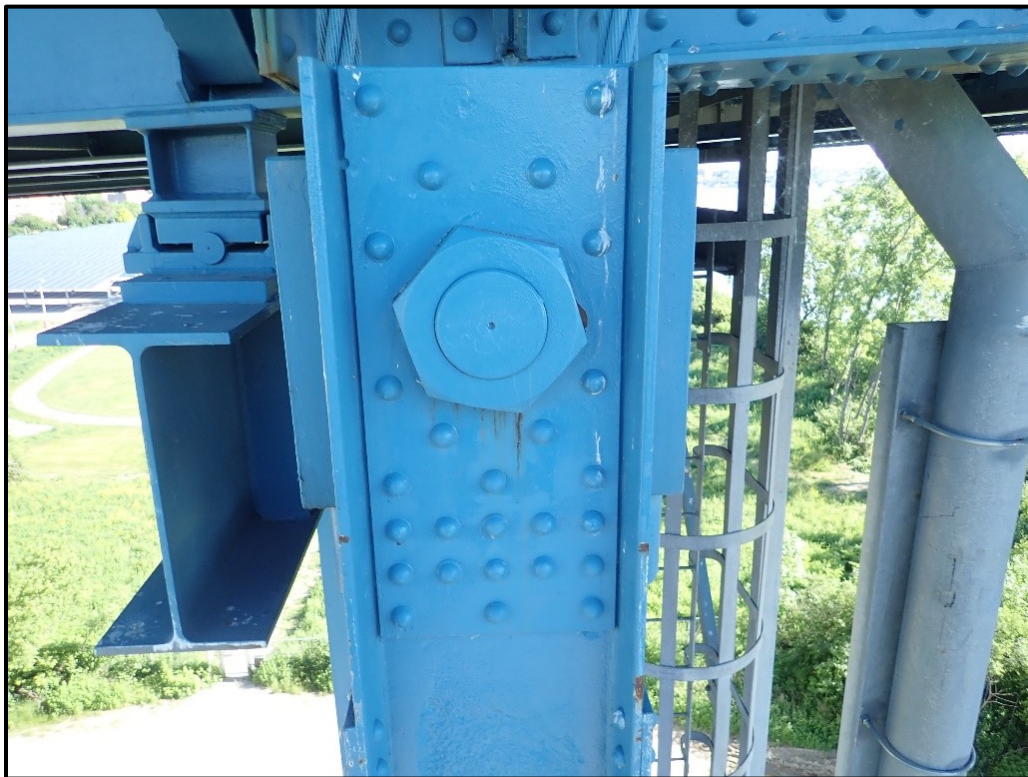
Photo 48 - Typical Connection for Hold-Down Suspender Ropes below Roadway. East Cable Bent, South Link Upper Pin shown

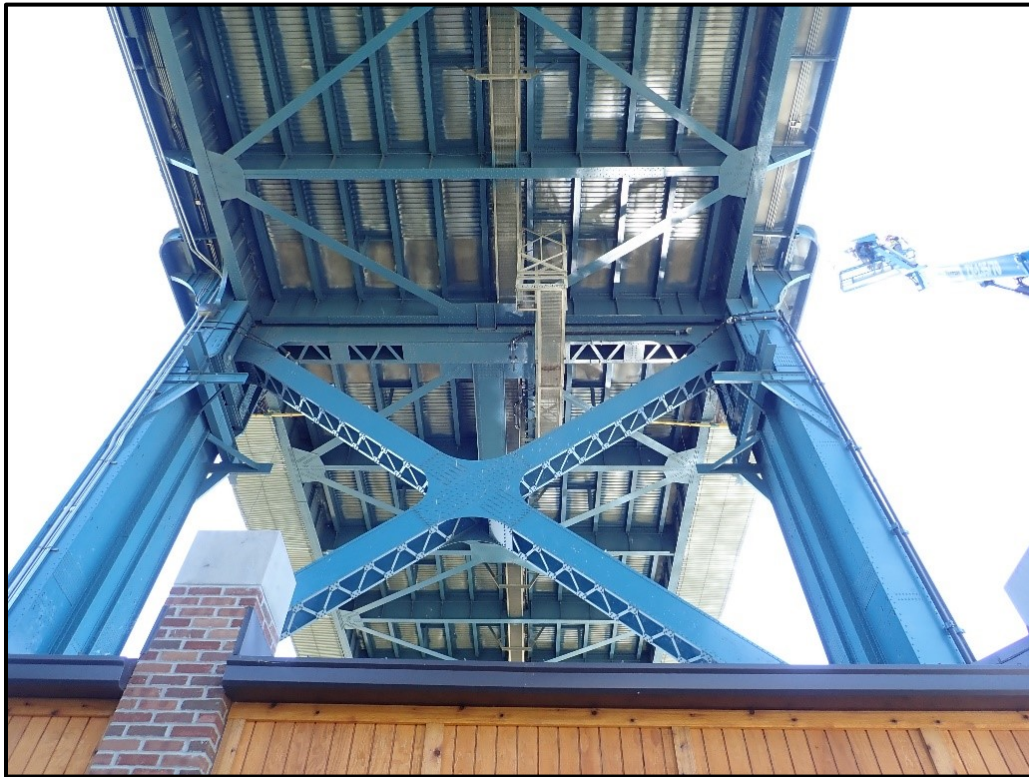
The steel towers are in good condition overall. The exterior paint is in very good condition with a few isolated areas with minor paint chipping with no corrosion of the underlying tower metalwork. The tower struts and cross-braces exhibit more significant deterioration which has been painted over, with large corrosion holes in batten plates, lacing angles, and other horizontal surfaces where debris and moisture accumulate. There are widespread areas of pitting section loss up to 3/16" in the exterior of the web plates of the tower struts below the roadway with several small corrosion holes. There are areas with significant crevice corrosion remaining between faying surfaces at connections, particularly at the centerline connection plates for the cross-bracing where there is up to 1-1/2" of crevice corrosion, however, the crevice corrosion appears to be arrested by paint cover at the majority of locations. Many of the tower anchor bolts exhibit section loss ranging from 10% to 40% in the lower 6" just above the embedment surface, with adjacent anchor bolt stiffeners exhibiting section loss and corrosion holes. At the tower tops, the previously reported cracked welds between the cable saddles and the sole plates have been repaired at all four corners of all four saddles.

Photo 56 - Tower C Bracing

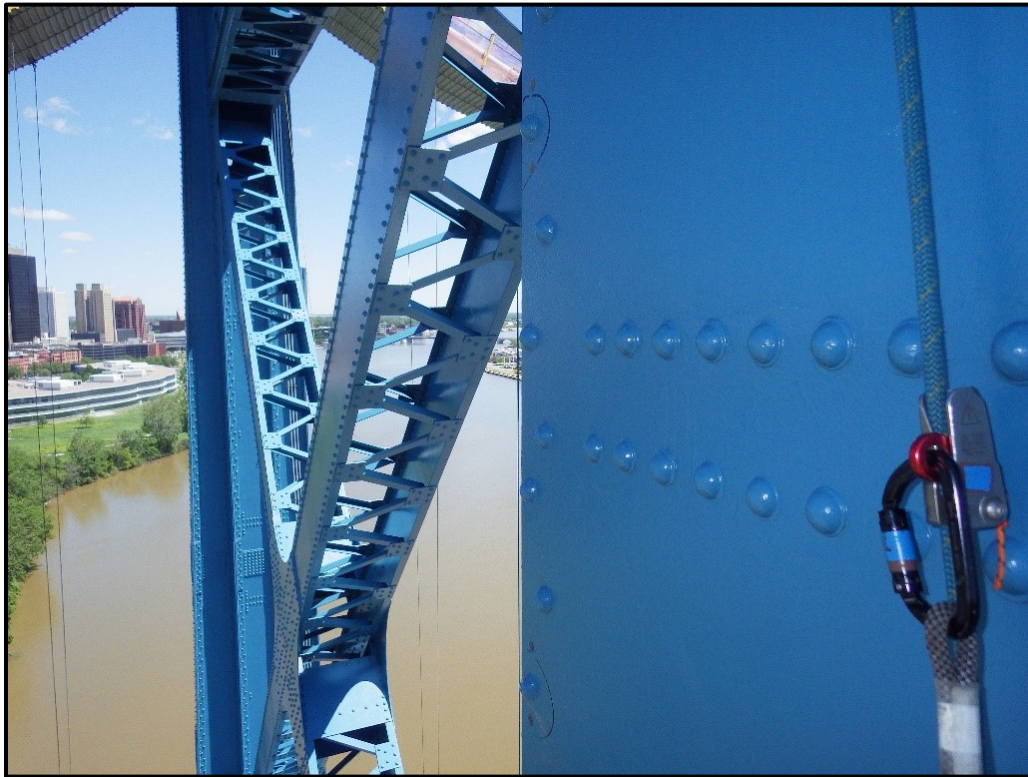
Photo 58 - Tower C Bracing above Roadway

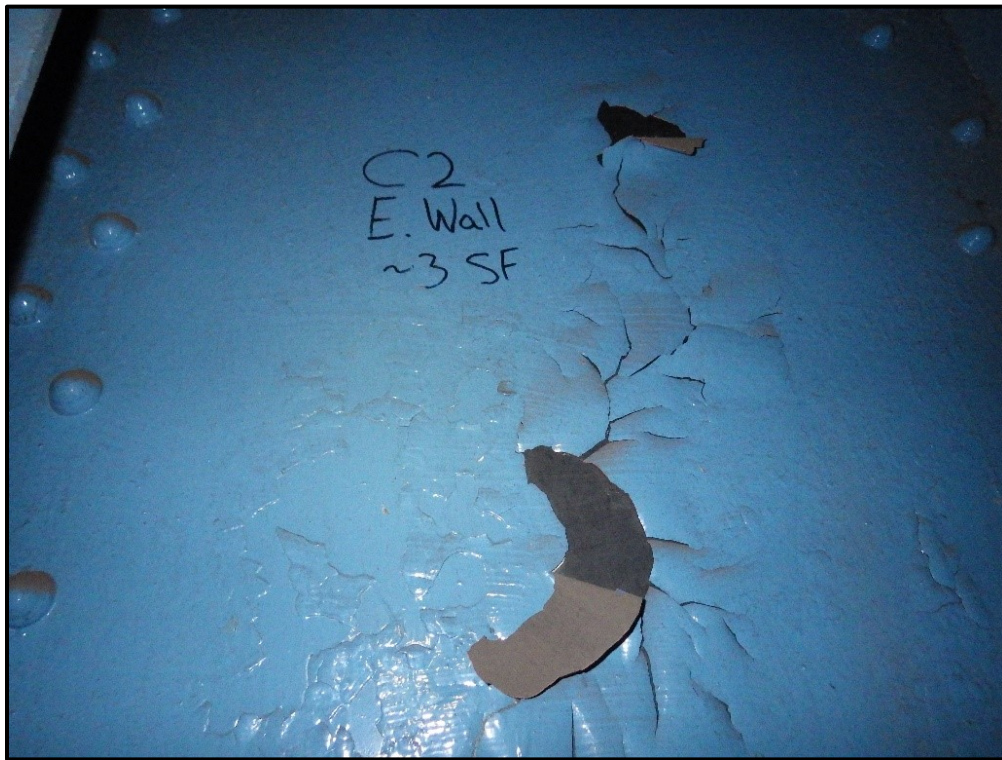
The interior paint of the steel towers is in fair condition overall. Each tower leg cross-section has 3 chambers that run the full height of the tower. These chambers are designated as the East, West and Center chambers corresponding with the bridge orientation. Regularly spaced horizontal diaphragms are placed throughout the height of each of the chambers, dividing the towers into numerous cells. The east and west chambers of each tower have only an original orange primer coat of paint (red lead paint). The center chamber of each tower leg also has an original coat of blue finish paint throughout their height. Furthermore, at roadway level, all chambers were recently painted. Due to the presence of lead paint, only the west tower, south leg received a full inspection to minimize exposure to inspectors. The original primer and finish paints are generally in fair condition with peeling and flaking paint. The underlying steel generally does not have any corrosion or measurable section loss except for minor section loss at the bottom of the base chambers.

Photo 62 - Typical Paint Peeling in Tower Interior Chambers. Center Chamber at 2nd Cell above Roadway Level in South Leg of Tower C shown.

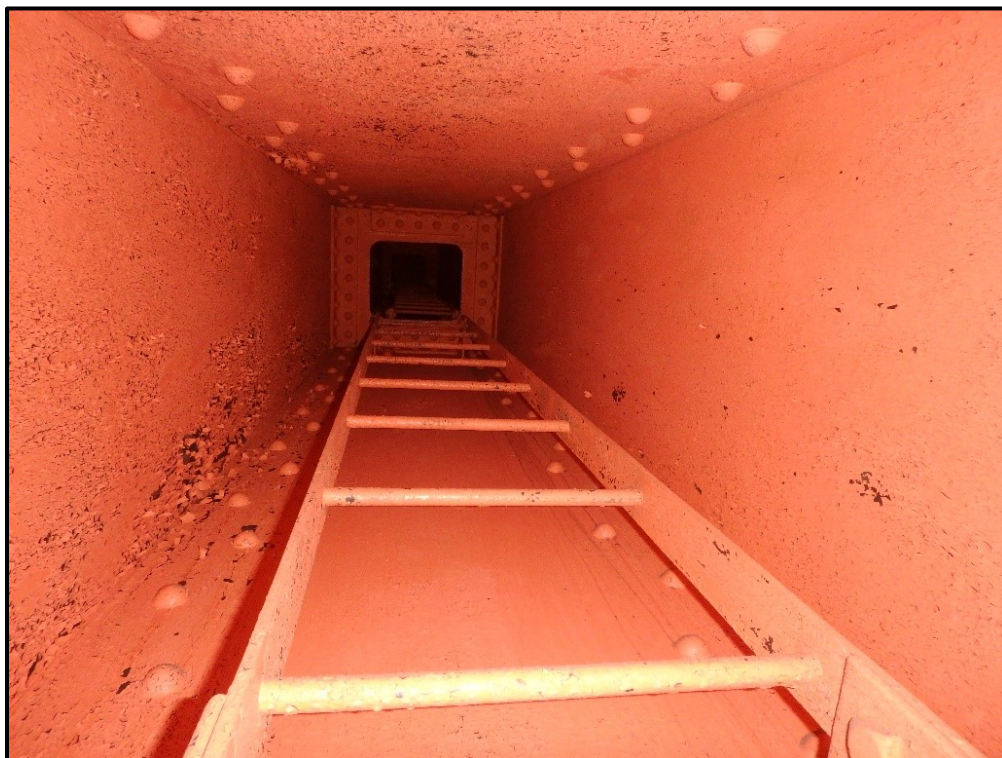
Photo 63 - Typical Brittle and Peeling Orange Primer Paint in Tower Side Chambers. West Chamber at 7th Cell above Roadway Level in South Leg of Tower C shown.

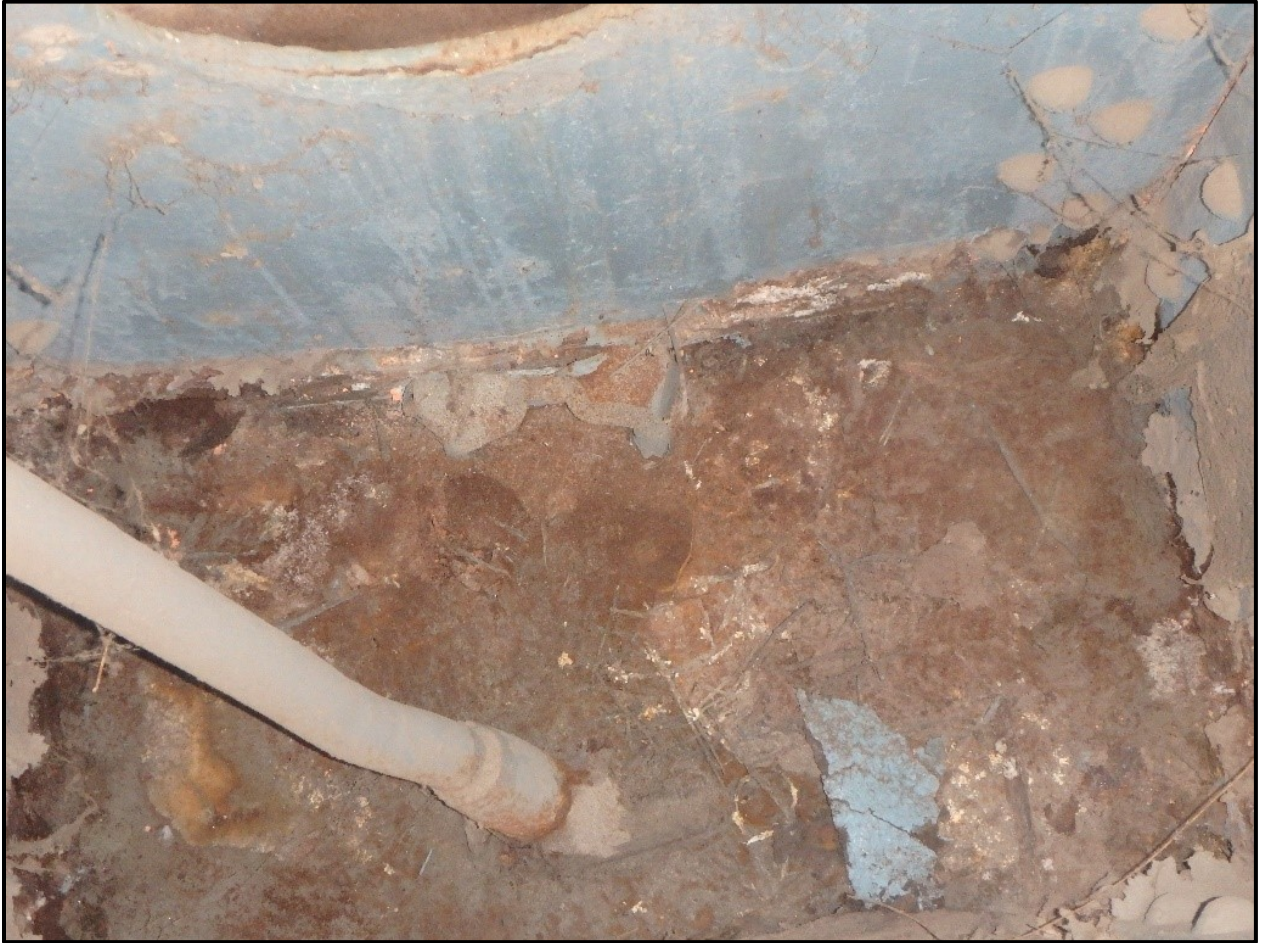
Photo 64 - Typical Minor Section Loss to the Lower 2" of Chamber Walls. Center Chamber at Base of Tower C shown.

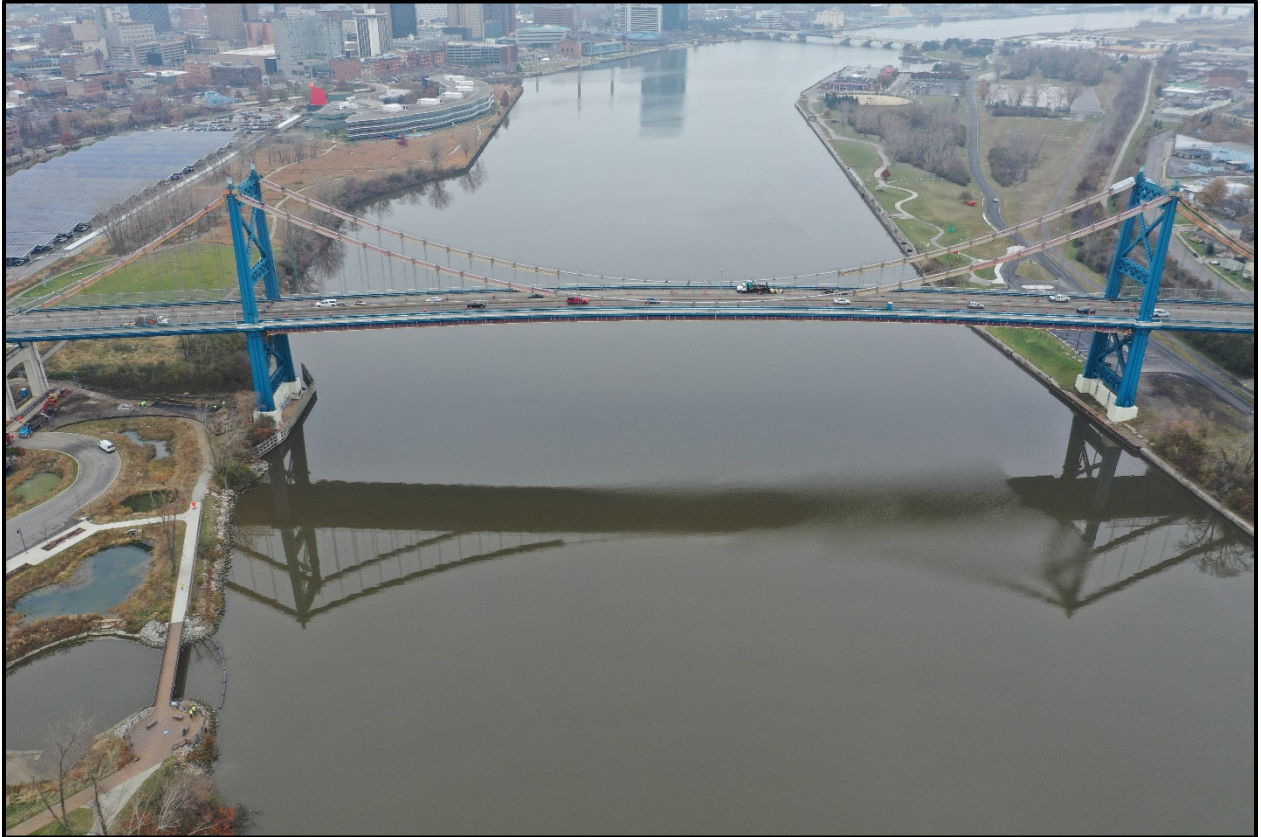
Channel is in good condition with a National Bridge Inventory Rating of 7. No signs of obstructions or erosion. New navigation lights were being installed during the 2020 element level inspection.

Photo 65 – Channel from Above, Looking North

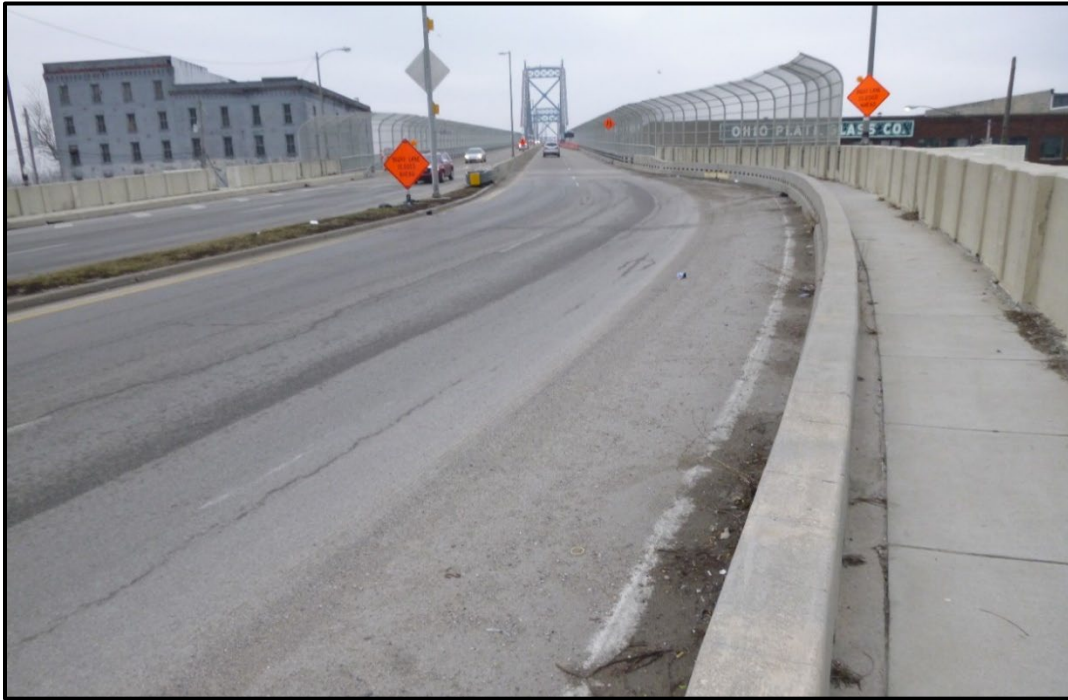
Overall, the approach roadway is in satisfactory condition. All lanes on the west and east approaches exhibit map, transverse and longitudinal cracks. The approach slabs and approach slab terminations are in good condition and show no signs of distress.

Photo 66 - West Approach

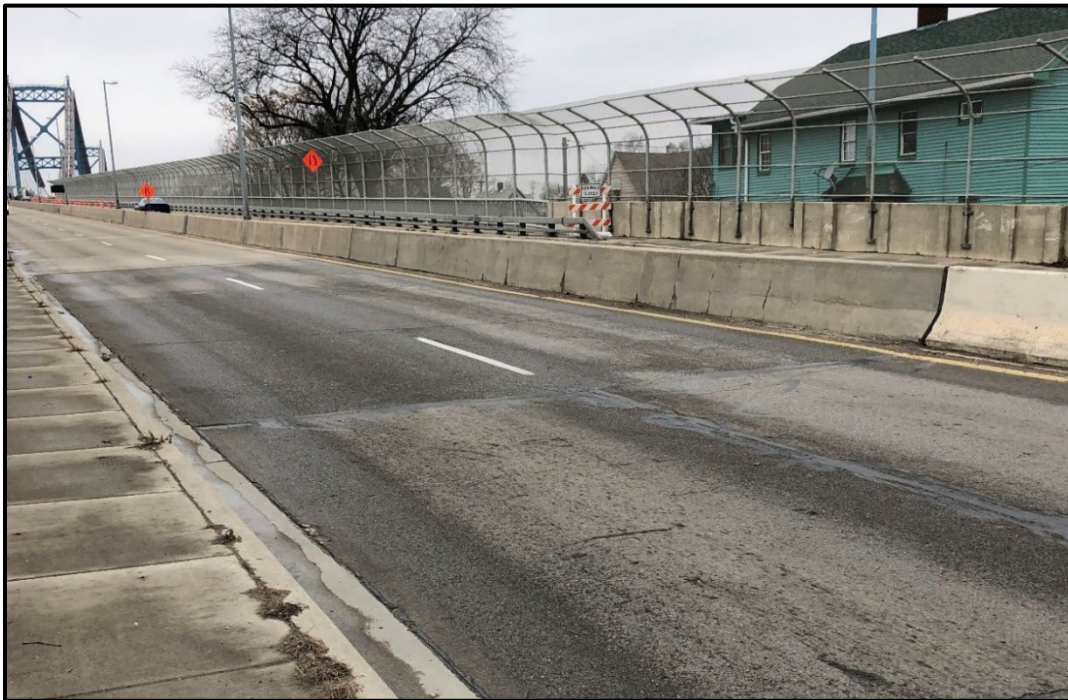
Photo 67 - East Approach

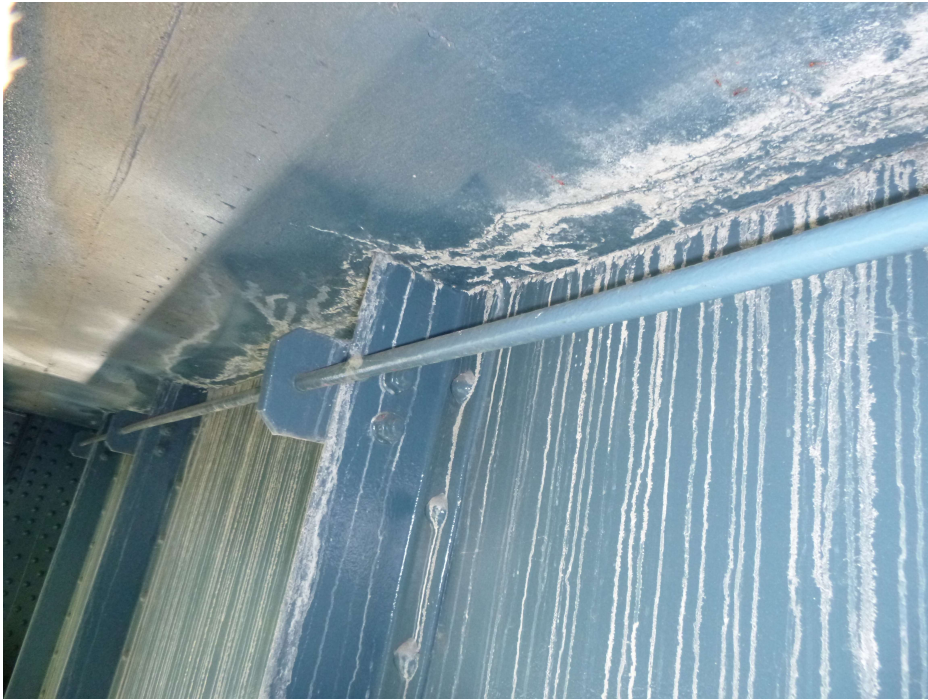
PHOTO 5 Condition

Description Typical condition on underside of deck at girder interface in the suspension spans

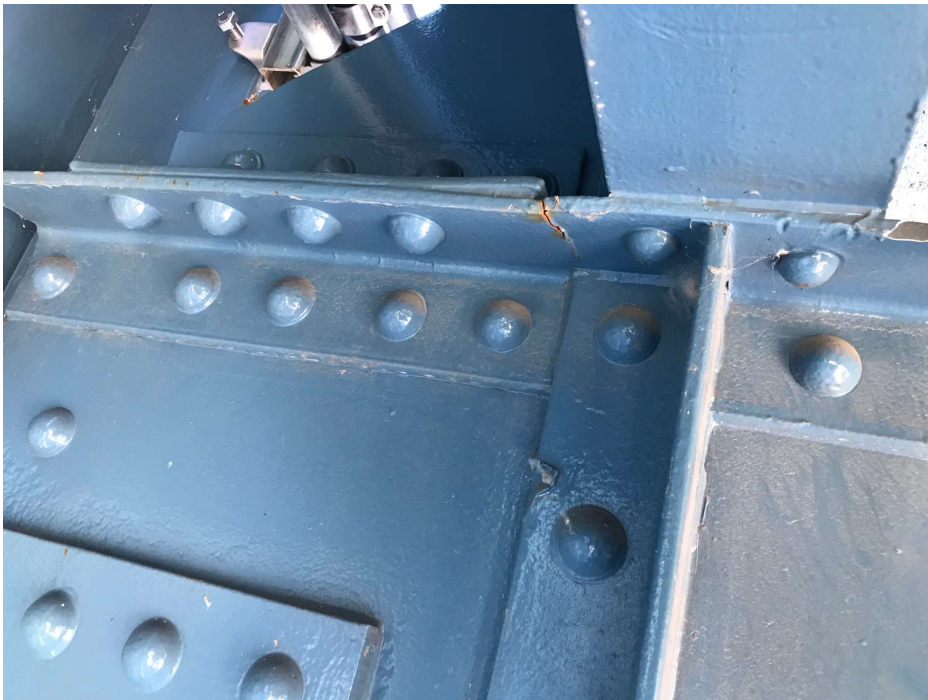
PHOTO 6 Condition

Description Crack in top flange of floor beam cantilever (in suspension span near towers)

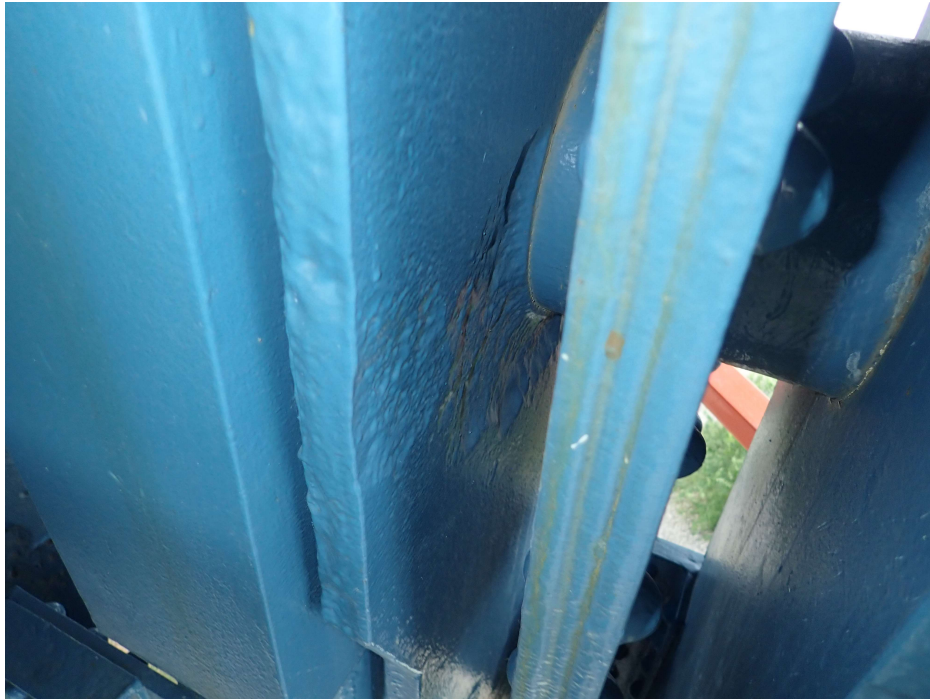
PHOTO 7 Condition

Description East Cable Bent, North Column, Outboard Face of the Inboard Link Plate at the Top Pin

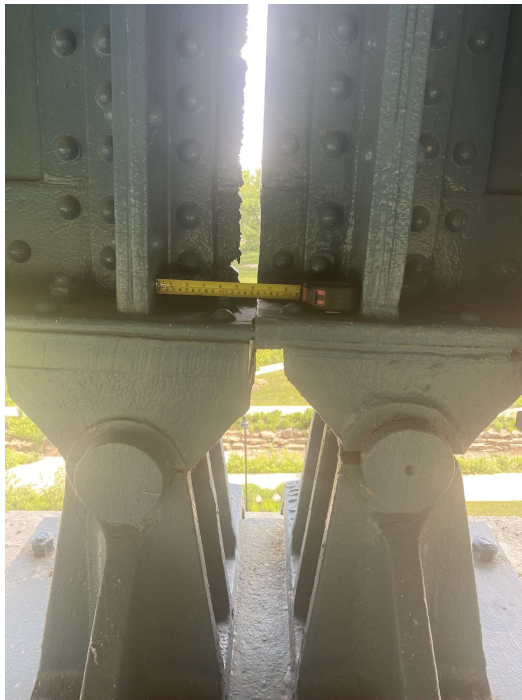
PHOTO 8 Condition

Description Ends of bottom flanges of the left girders at Pier 2W are in contact and restricting movement

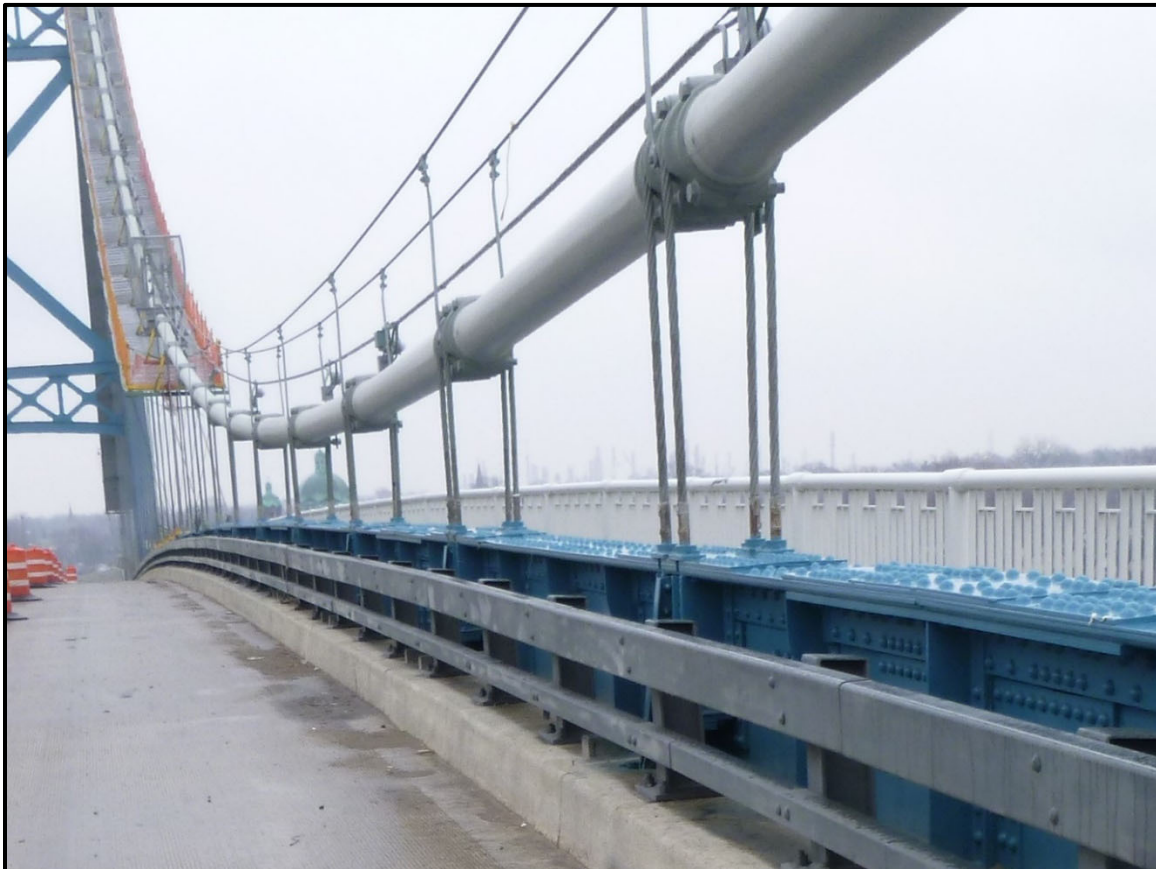
Photo 2 - Main Suspension Cables near Midspan

Main Suspension Cables: The main cables of the Anthony Wayne Bridge are made up of 19 strands of 186 galvanized steel wires each. The tension cables run from the anchorage houses at each end through the backstays, side spans, and the main suspension span.

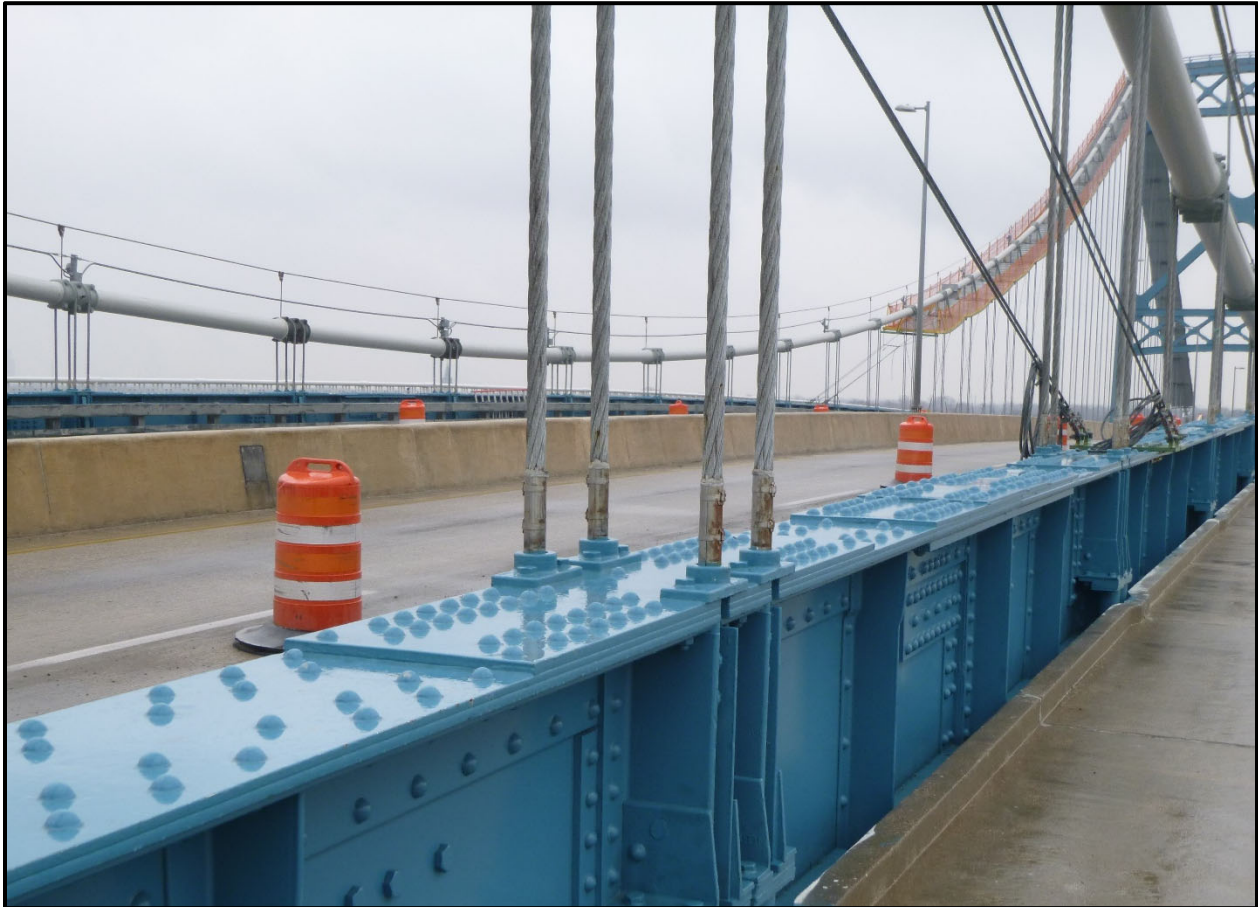
Photo 3 - Hanger Cable - Suspension Girder Connection

Secondary Hanger Cables: The suspenders consist of two wire ropes, or suspender cables, looped over the main cables, providing four components to carry each panel load. Special attention should be given to the hanger-girder connection to ensure load transfer.

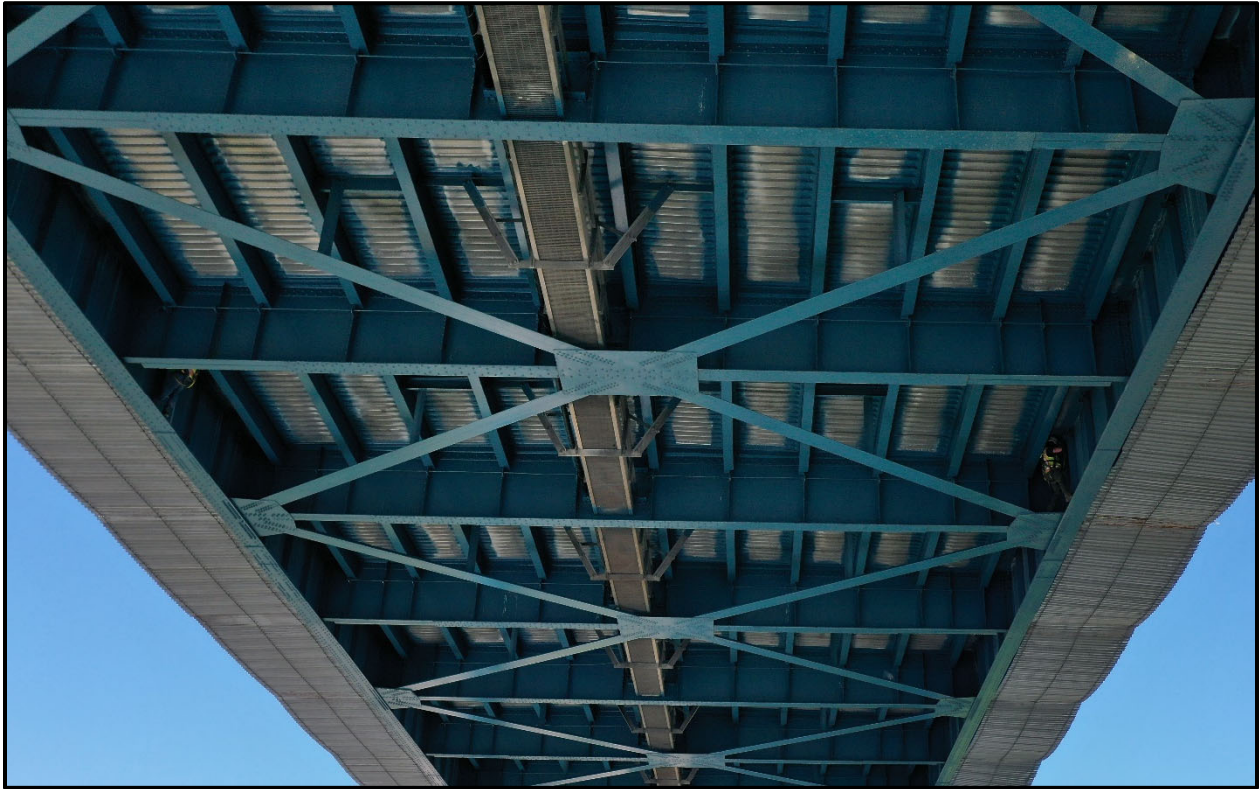
Photo 4 - Suspension Span Girders

2-Girder System Girders – Suspension Span: Located in all 3 Suspension Spans, the riveted, built-up girders support a floor beam/stringer floor system. Special attention should be given to the bottom flange tension zones and hanger-top flange connections.

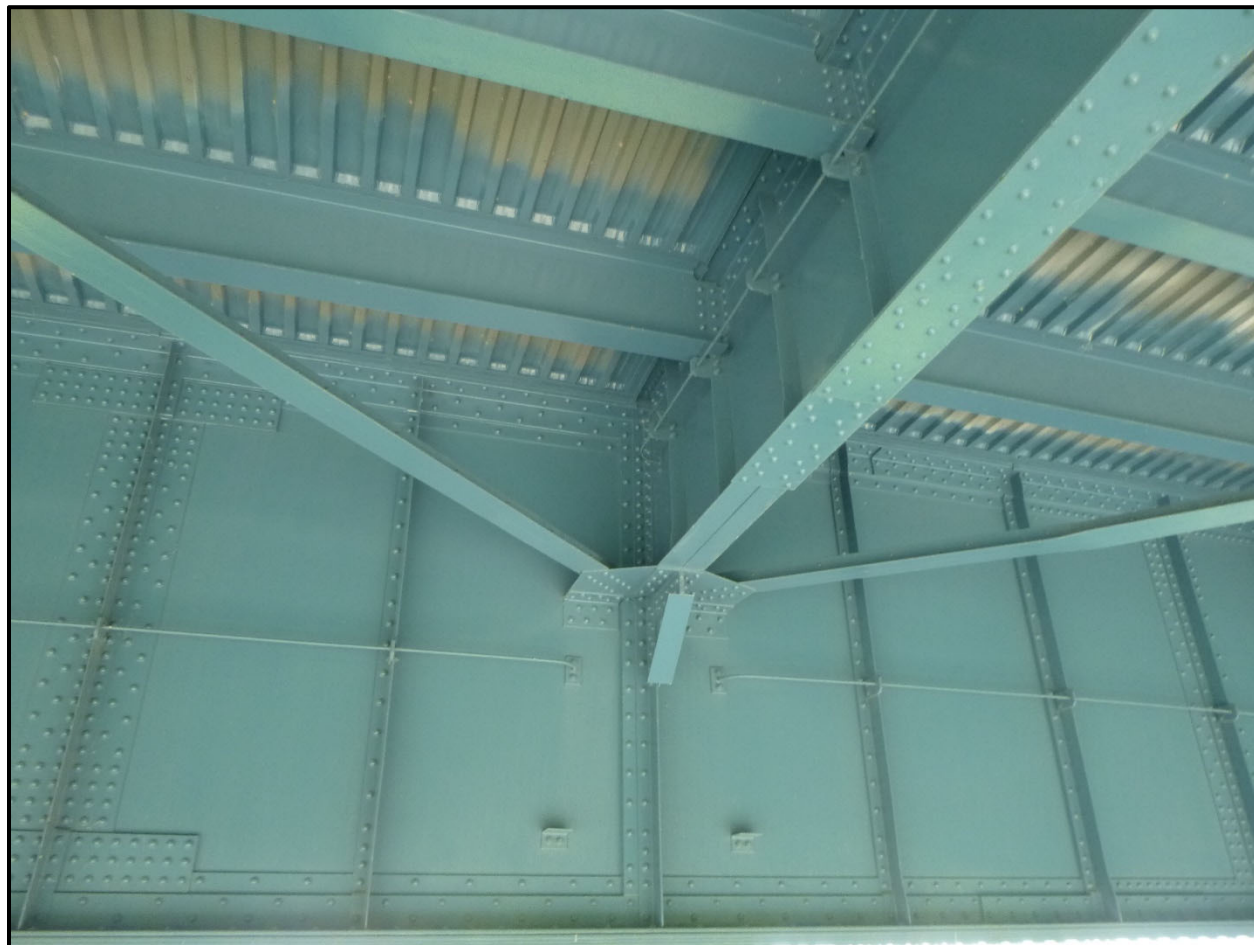
Photo 5 - Approach Span Girder

2-Girder System Girders – Approach Spans: Located in Spans 7W through 1W and Spans 1E through 7E, the single-span riveted, built-up girders support a floor beam/stringer floor system. Special attention should be given to the bottom flange tension zones near midspan.

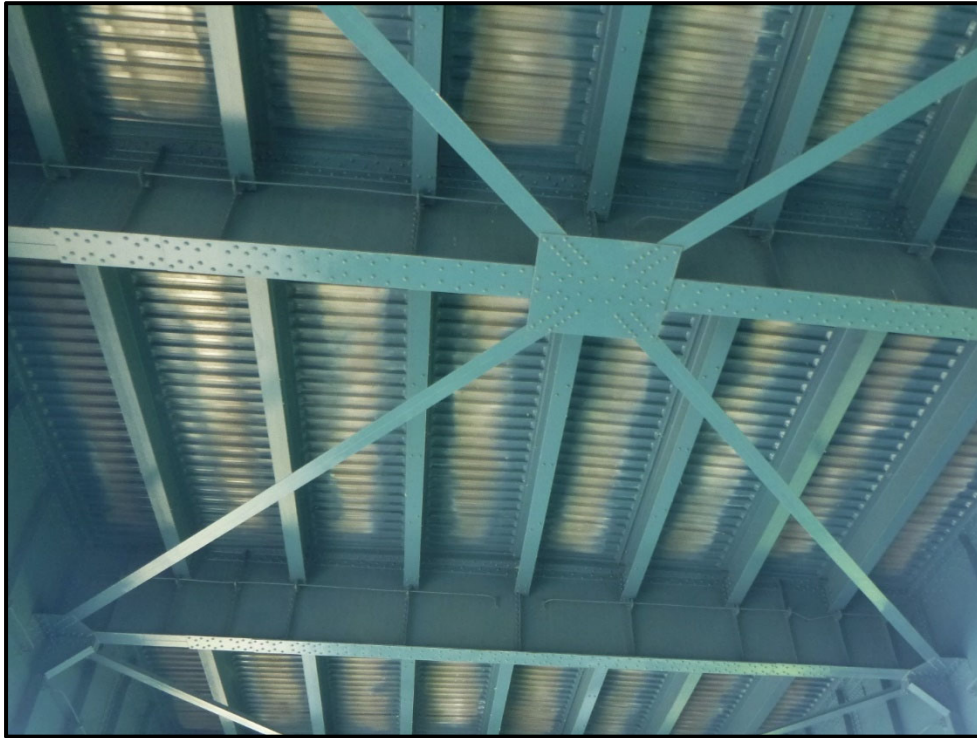
Photo 6 - Floor Beams in 2-Girder Approach Span

Floor Beams: The riveted, built-up girders frame into the girder webs and cantilever beyond the girders to support the sidewalks. Tension zones include the bottom flange between girders and the top flange cantilever supporting the sidewalks.
