2020 In-Depth, Element Level Bridge Inspection Report

LUC-2-1862 **In-Depth, Element Level Bridge Inspection Report**

PID: 108045

October 2020

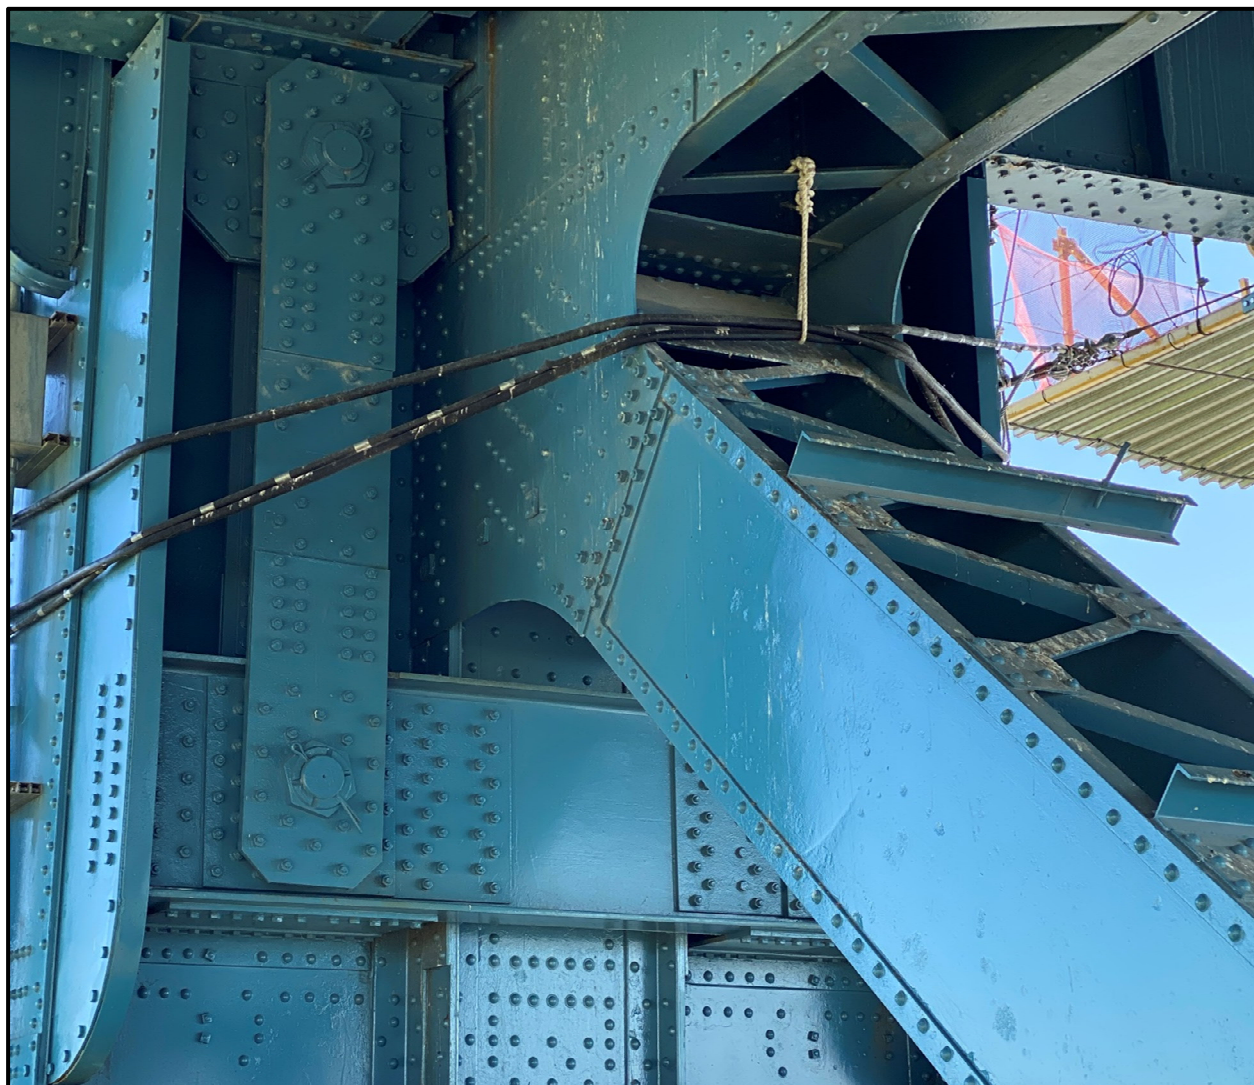
Photo 8 - Link Pins and Hangers at Tower C (Tower D similar)

Pins/Hangers at Towers: Located at Towers C and D, the link pins and hangers prevent uplift of the stiffening girders.

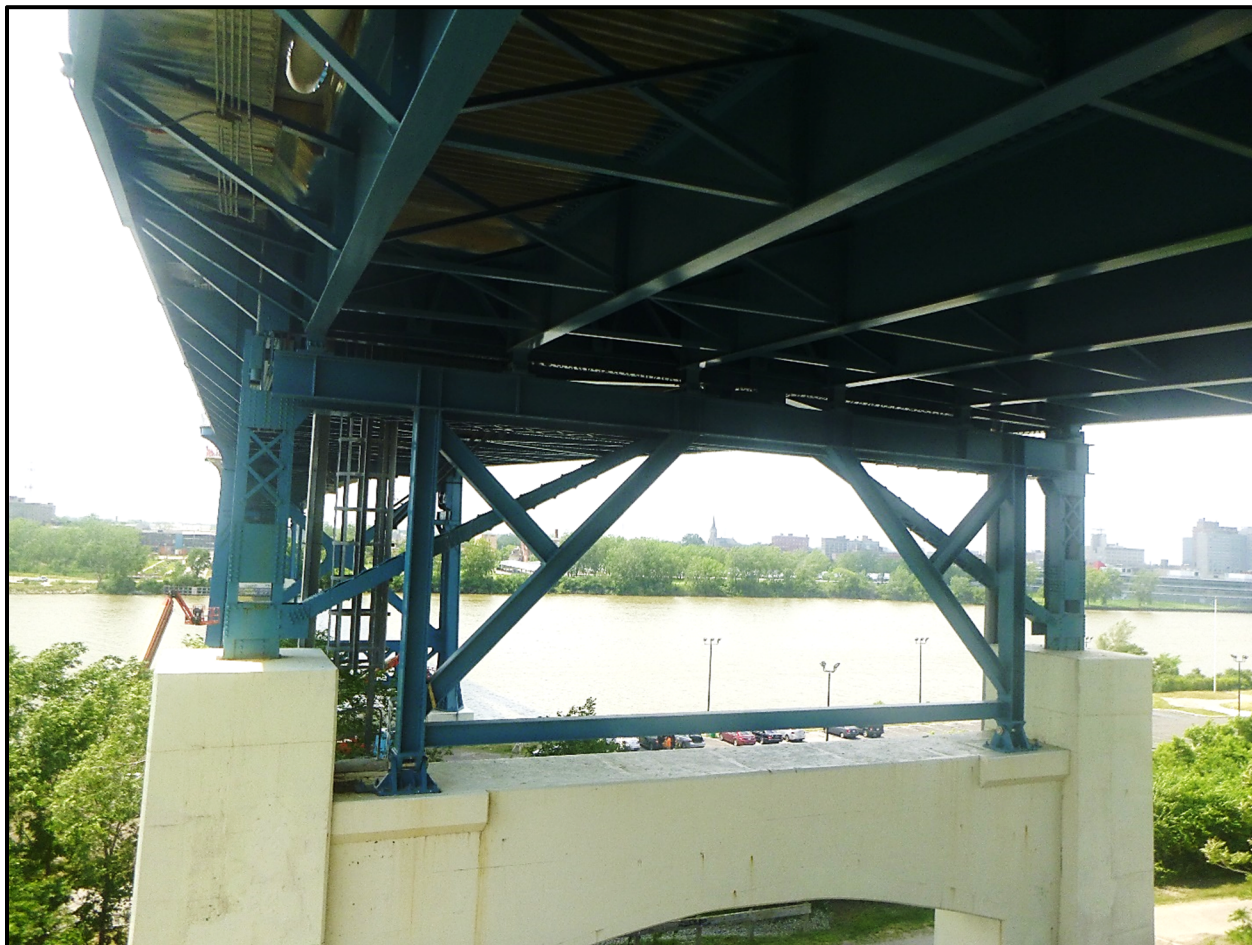
Photo 9 - Steel Frame Supporting New Replacement Span at Pier E (Frame at Pier B similar)

Steel Frames: Located at Piers B and E, these frames were installed during the recent rehabilitation to support the new replacement spans. Special attention should be given to the fracture critical cap and the pin bearings, which control span movement.

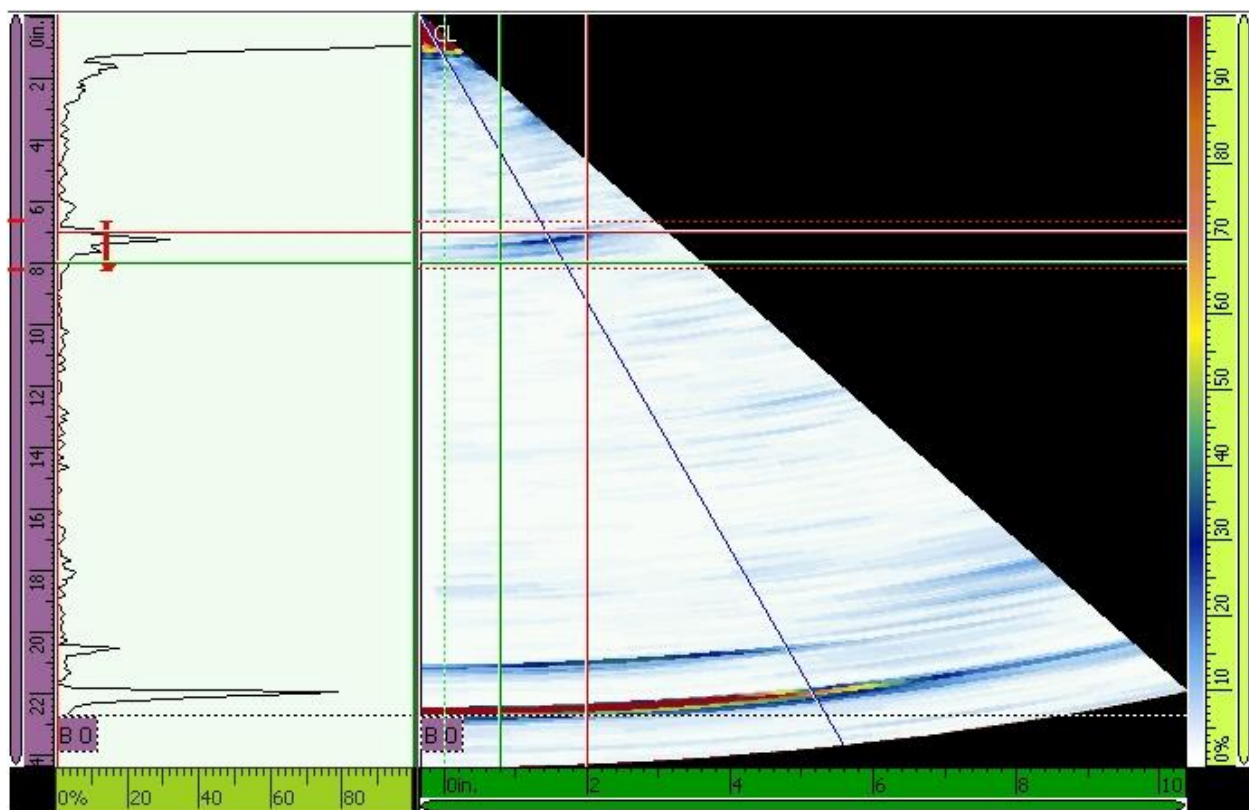
Ref.	Indication #	Scan	Index	Group	Channel	A%	DA ^	PA ^	SA ^	U(m-r)	I(m-r)	I•U(m-r)	S(m-r)
-	1	0.000 in	0.000 in	PA 1	14.00°	32.3 %	7.263 in	1.499 in	7.485 in	0.994 in	1.220 in	1.574 in	--- in

Rounded Simulated Corrosion 14 degree focal law selection with an amplitude of 32% of FSH.

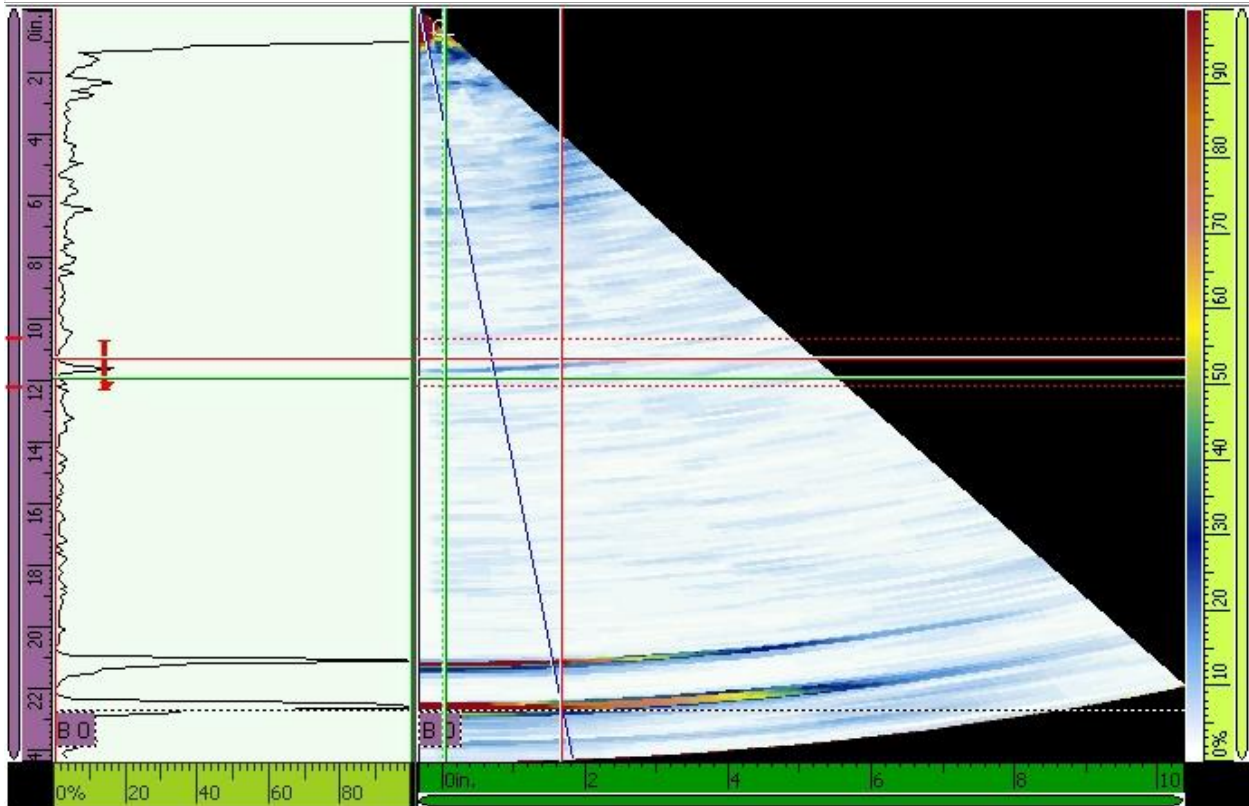
Ref. #	Indication	Scan	Index	Group	Channel	A%	DA^	PA^	SA^	U(m-r)	I(m-r)	I•U(m-r)	S(m-r)
-	2	0.000 in	0.000 in	PA 1	5.00°	17.6 %	11.652 in	0.708 in	11.697 in	0.659 in	1.610 in	1.740 in	--- in

Linear Notch analyzed with the 5-degree focal law. Amplitude of 18% FSH.

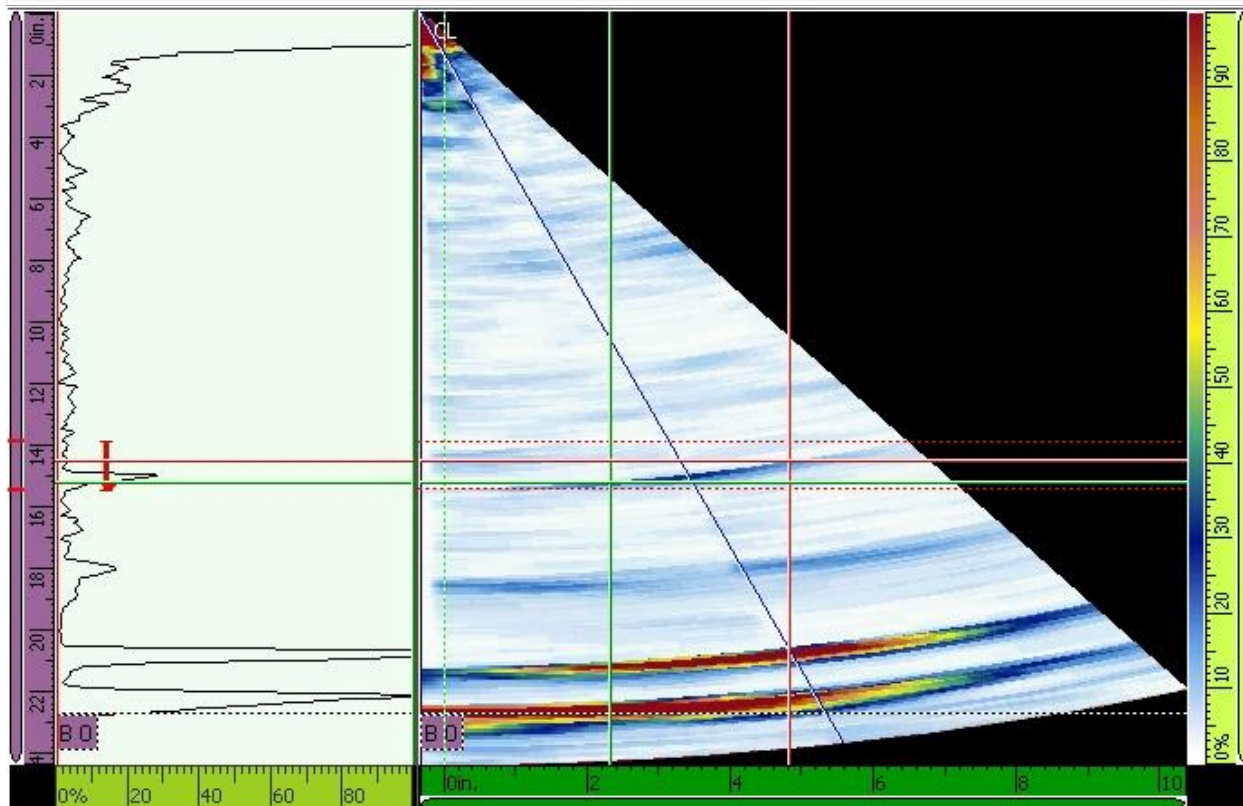
Ref. #	Indication	Scan	Index	Group	Channel	A%	DA^	PA^	SA^	U(m-r)	I(m-r)	I•U(m-r)	S(m-r)
- 3		0.000 in	0.000 in	PA 1	14.00°	28.4 %	15.003 in	3.429 in	15.462 in	0.744 in	2.500 in	2.608 in	--- in

Linear Notch viewed with the 14 degree focal law and showing 28% FSH.

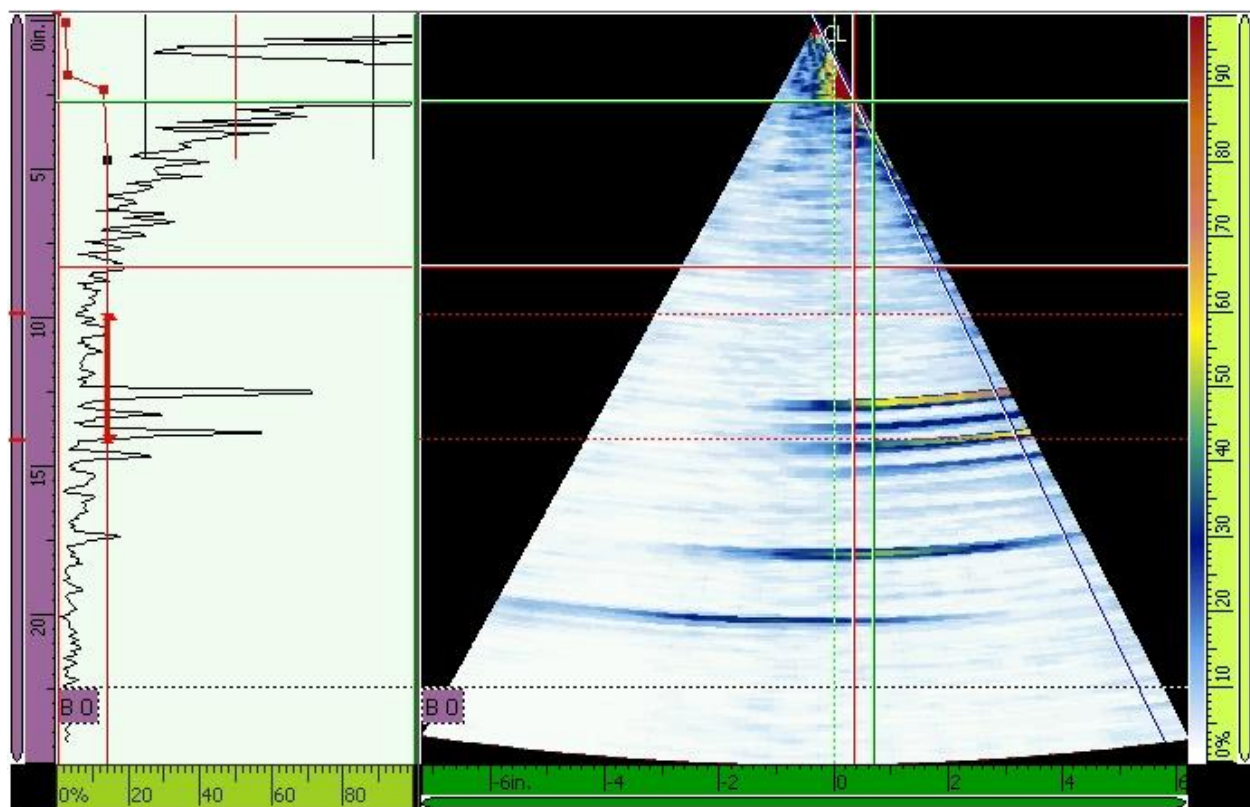
Indication One is the same indication as indication two but viewed from a different focal law. View One is viewed at 14 degrees while View Two is viewed at 15 degree. This indication is located from the 1 o'clock to 5 o'clock positions and the amplitude is above the SSL but below the ARL.

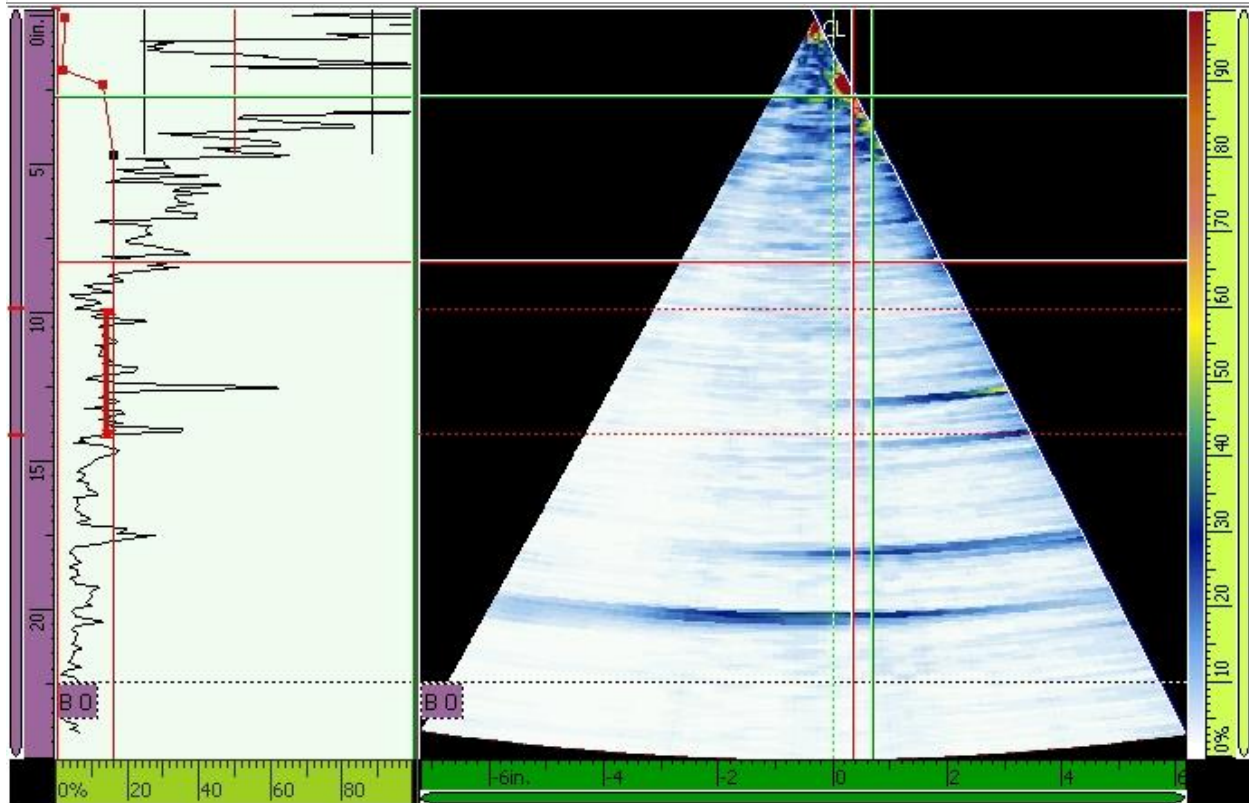
Ref. #	Indication	Scan	Index	Group	Channel	A%	DA^	PA^	SA^	U(m-r)	I(m-r)	I•U(m-r)	S(m-r)
-	2	0.000 in	0.000 in	PA 1	15.00°	62.6 %	12.546 in	3.050 in	12.988 in	5.571 in	0.333 in	5.581 in	--- in

Indication Two is the same indication as indication one but viewed from a different focal law. View One is viewed at 14 degrees while View Two is viewed at 15 degree. This indication is located from the 1 o'clock to 5 o'clock positions and the amplitude is above the SSL but below the ARL.

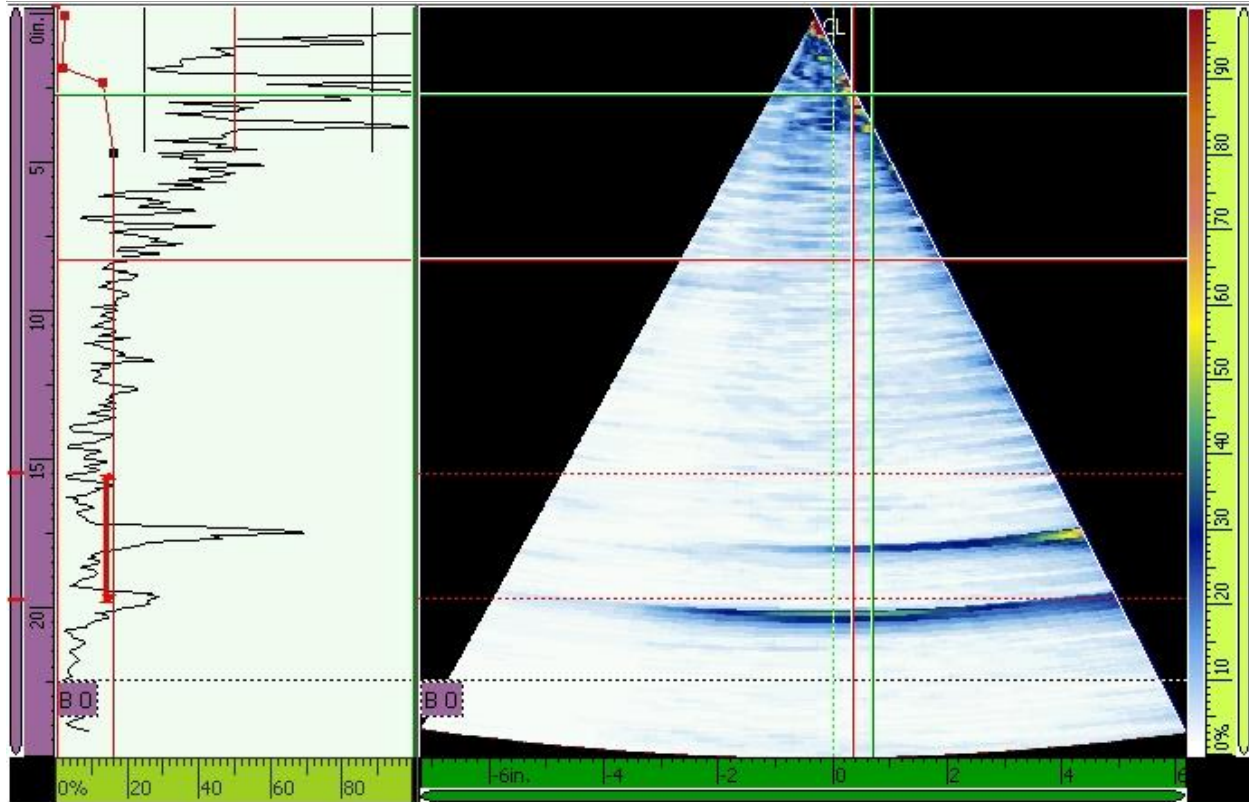
Ref. #	Indication	Scan	Index	Group	Channel	A%	DA^	PA^	SA^	U(m-r)	I(m-r)	I•U(m-r)	S(m-r)
- 3		0.000 in	0.000 in	PA 1	15.00°	69.5 %	17.486 in	4.374 in	18.103 in	5.571 in	0.333 in	5.581 in	--- in

Indication Three is reference to show a clear backwall reflection.

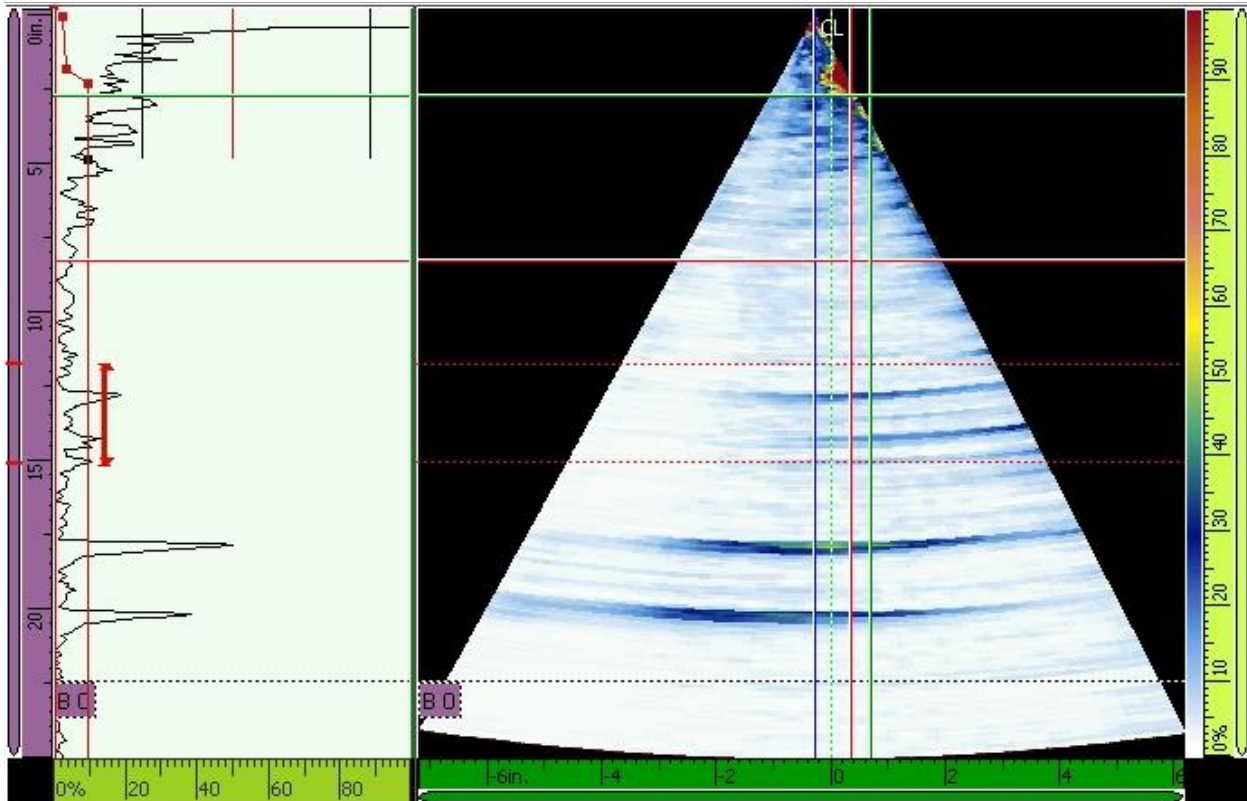
Ref. #	Indication	Scan	Index	Group	Channel	A%	DA^	PA^	SA^	U(m-r)	I(m-r)	I•U(m-r)	S(m-r)
- 4		0.000 in	0.000 in	PA 1	0.00°	19.6 %	12.839 in	-0.311 in	12.839 in	5.571 in	0.333 in	5.581 in	--- in

Indication four is below the DRL line and viewed compliant. The indication is a discontinuity internally in the pin at the 9 o'clock position.

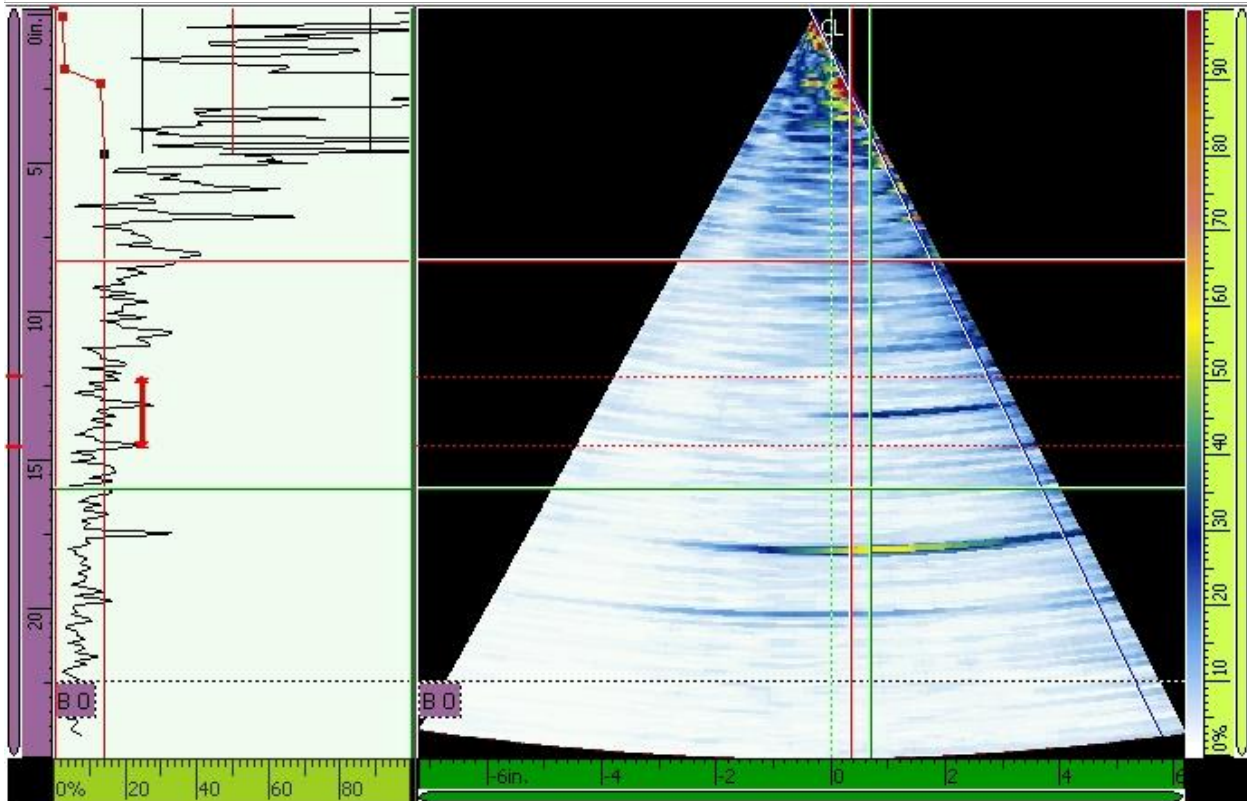
Ref. #	Indication	Scan	Index	Group	Channel	A%	DA^	PA^	SA^	U(m-r)	I(m-r)	I•U(m-r)	S(m-r)
- 2		0.000 in	0.000 in	PA 1	14.00°	28.4 %	13.149 in	2.967 in	13.552 in	7.744 in	0.333 in	7.751 in	--- in

Indication Two is a compliant indication with a screen height above the DRL but below the SSL. The indication shows wear of the pin barrel face at the 9 o'clock position.

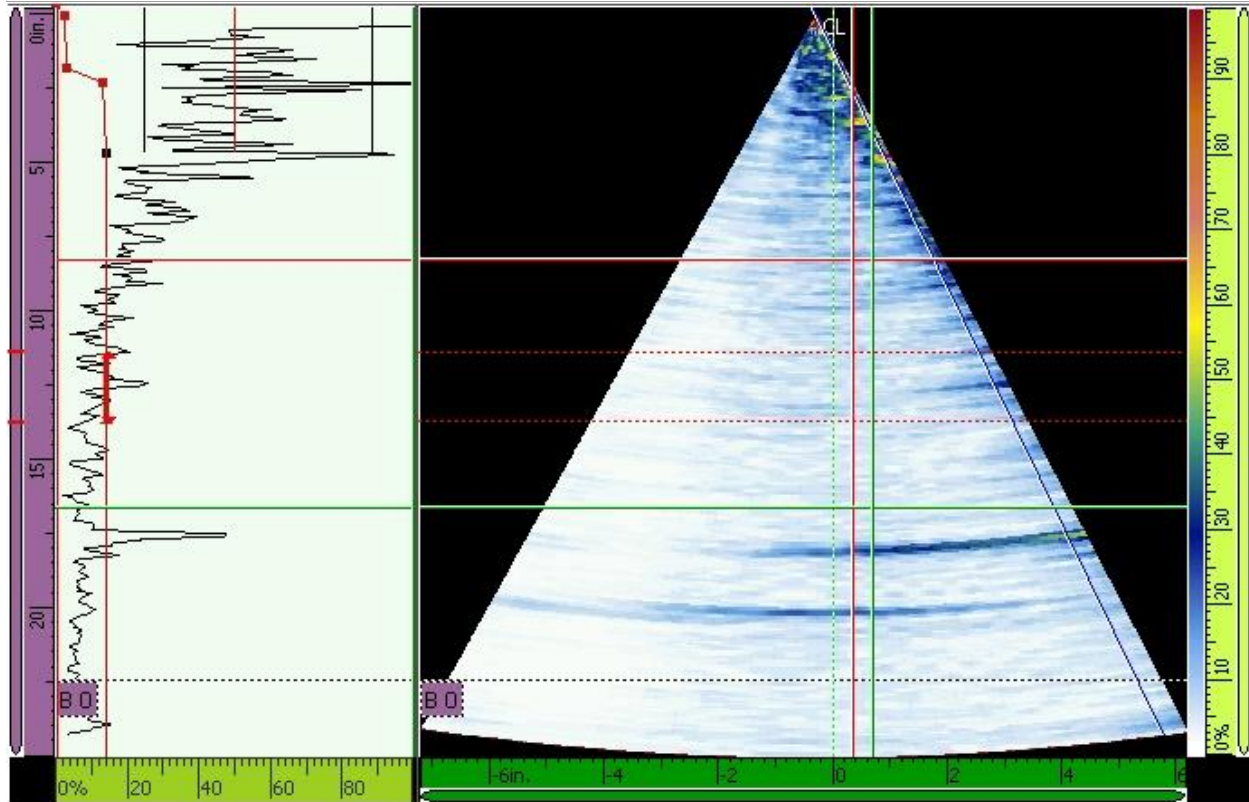
Ref. #	Indication	Scan	Index	Group	Channel	A%	DA^	PA^	SA^	U(m-r)	I(m-r)	I•U(m-r)	S(m-r)
- 2		0.000 in	0.000 in	PA 1	14.00°	26.4 %	12.461 in	2.795 in	12.842 in	8.429 in	0.333 in	8.435 in	--- in

Indication two exceeds the DRL but is below the SSL. The indication is located at the 9 o'clock position.

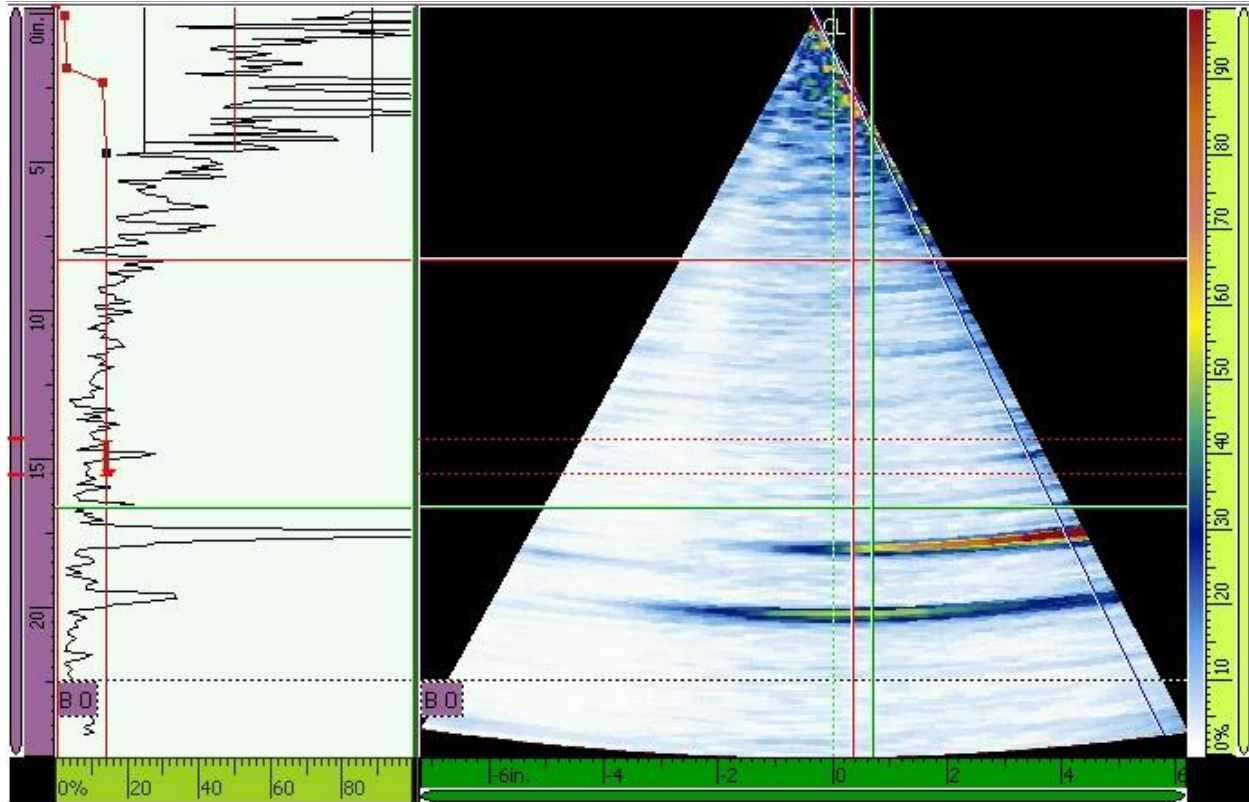
Ref. #	Indication	Scan	Index	Group	Channel	A%	DA^	PA^	SA^	U(m-r)	I(m-r)	I•U(m-r)	S(m-r)
- 3		0.000 in	0.000 in	PA 1	14.00°	28.4 %	14.844 in	3.390 in	15.299 in	8.429 in	0.333 in	8.435 in	--- in
Comments													
The indication exceeds the DRL but is below the SSL. The indication is located at the 6 o'clock position.

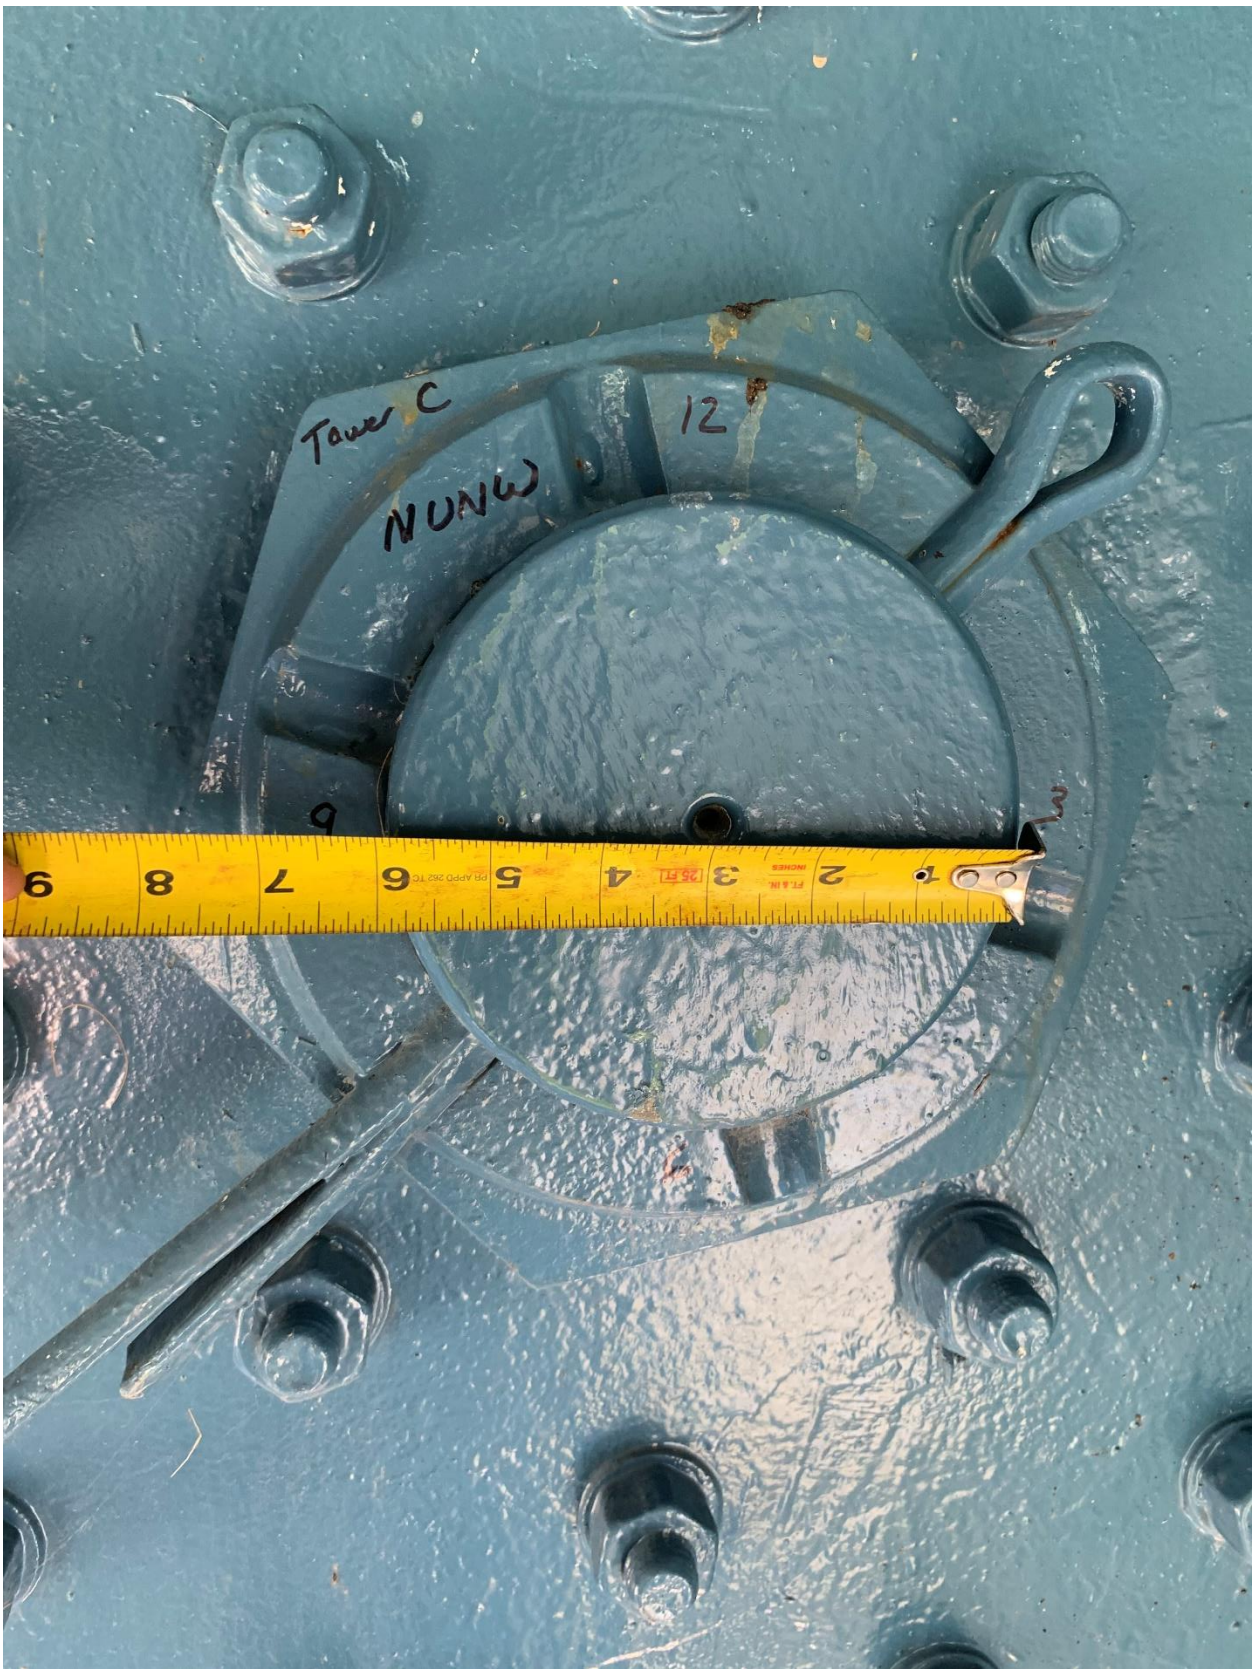
Ref. #	Indication #	Scan	Index	Group	Channel	A%	DA^	PA^	SA^	U(m-r)	I(m-r)	I•U(m-r)	S(m-r)
-	2	0.000 in	0.000 in	PA 1	14.00°	28.4 %	13.149 in	2.967 in	13.552 in	7.744 in	0.333 in	7.751 in	--- in

Indication 2 is in excess of the SSL for the 15 degree position along the barrel wall. Indication was located with a depth of 13.149 inches and is located from the 3 o'clock position down to 4 o'clock position. This indication measured to a depth which physically corresponded with the backside of the hanger assembly in a known wear area. It should be noted that the cotter pin is located across the face of the pin from 2 o'clock to 8 o'clock positions.

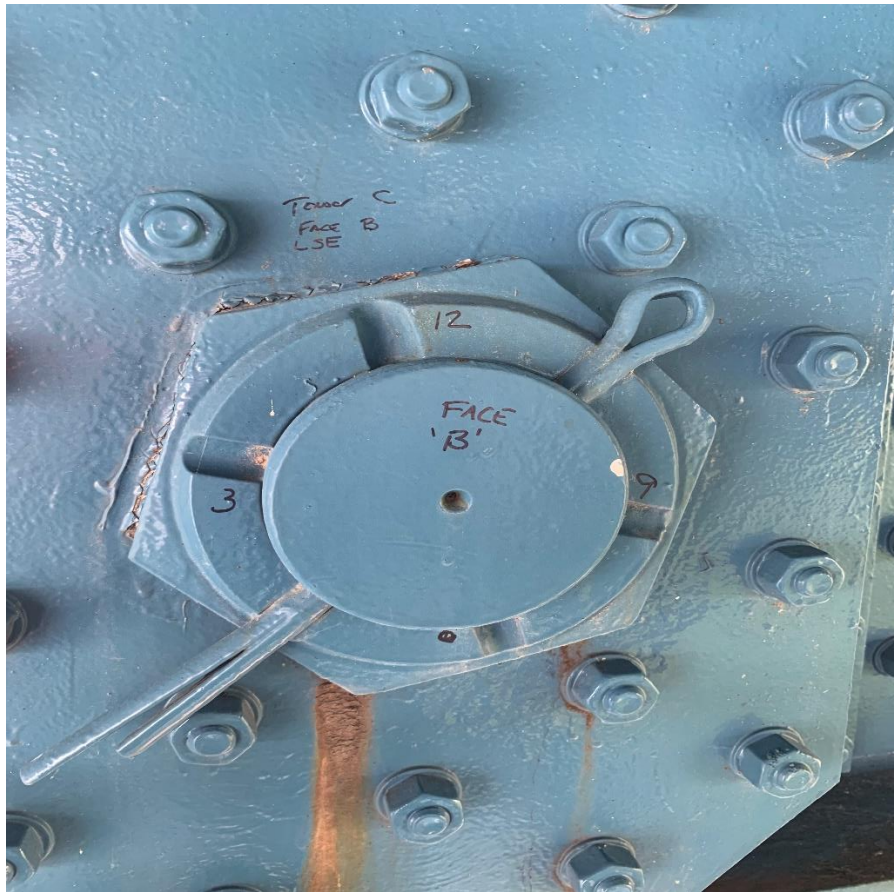
Picture supplied to illustrate the rolling or movement of the connection. The cracks in the coating system show that this pin location has moved since the coating operation took place. Also note the rust bleed out from the bottom of the connection.

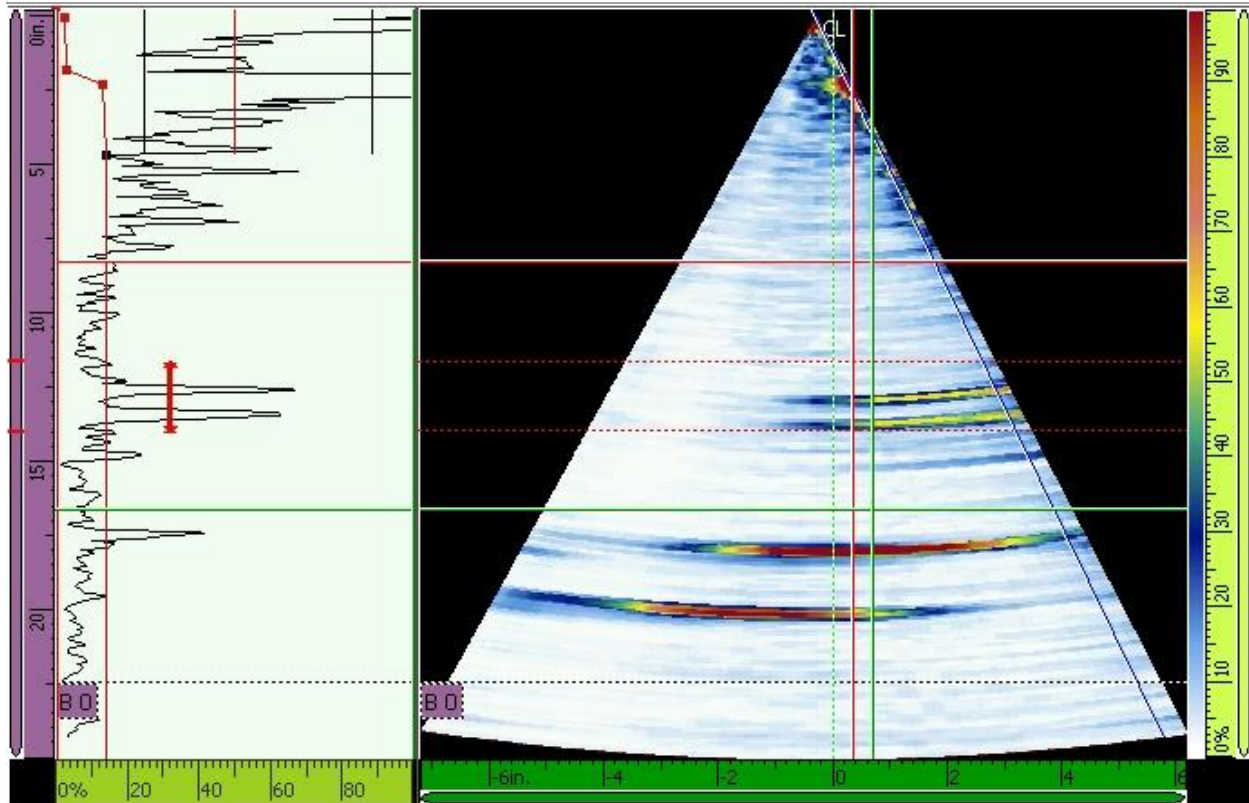
Indication Two is showing wear along the barrel face of the pin. This indication is the same indication as indication three, this view was the initial screenshot of the discontinuity. Please see the comments on Indication Three.

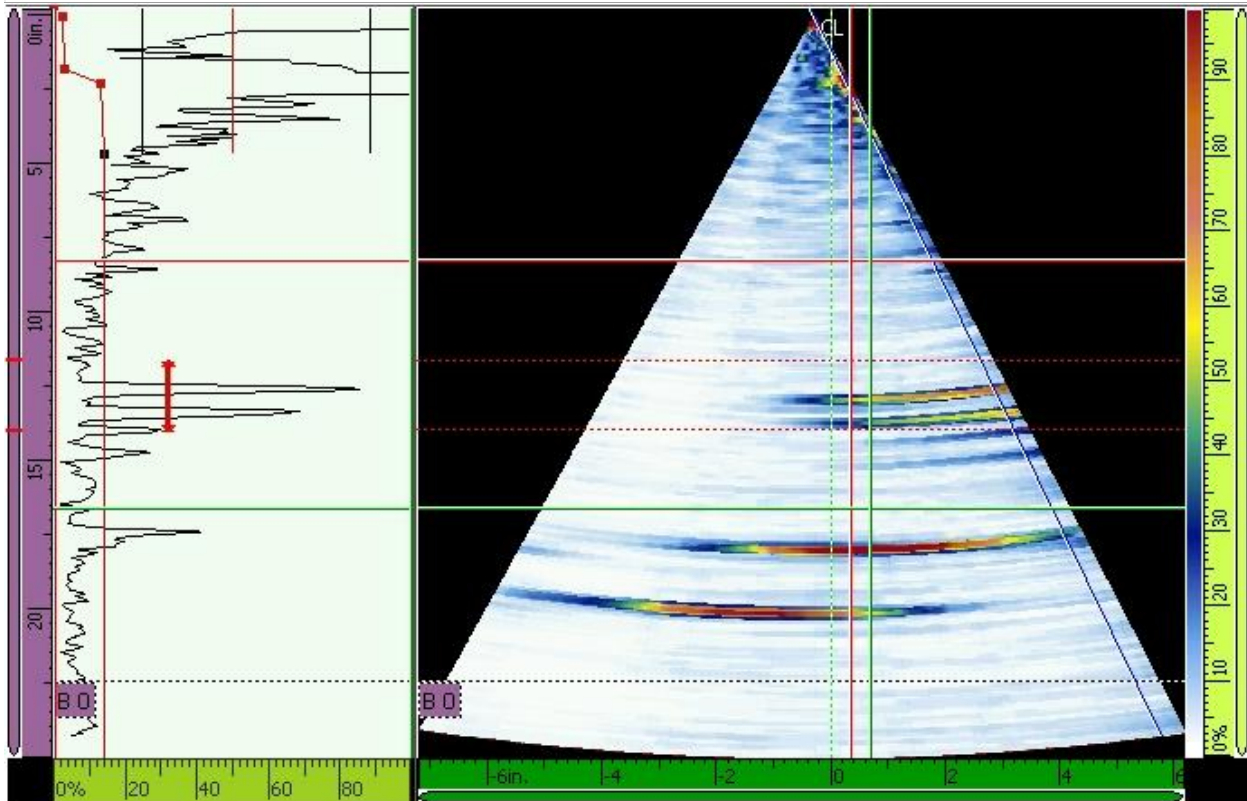
Indication Three is located at the 7 o'clock to 9 o'clock position and is nearing the ARL. The indication is showing wear along the barrel face of the pin.

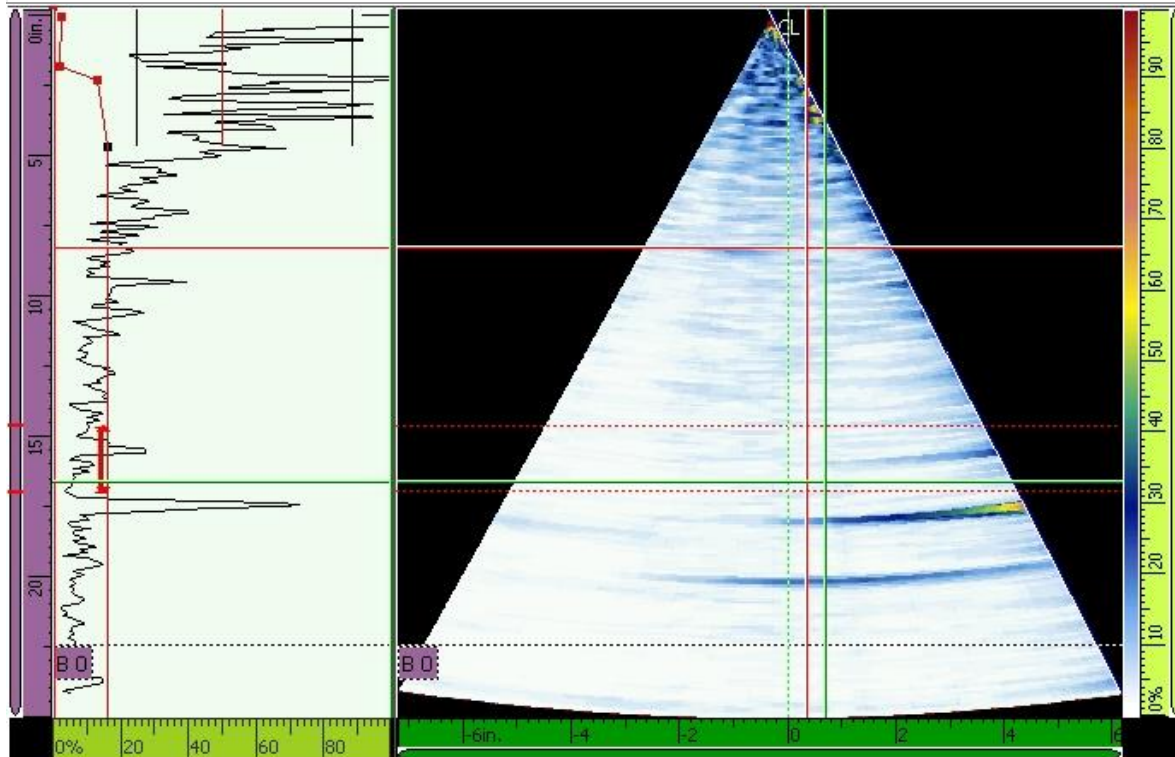
Indication Two represents a linear indication showing wear at approximately the 6 o'clock to 9 o'clock position. The reference level is just breaking the DRL but not exceeding the SSL. Indication is noted for reference and future evaluation.

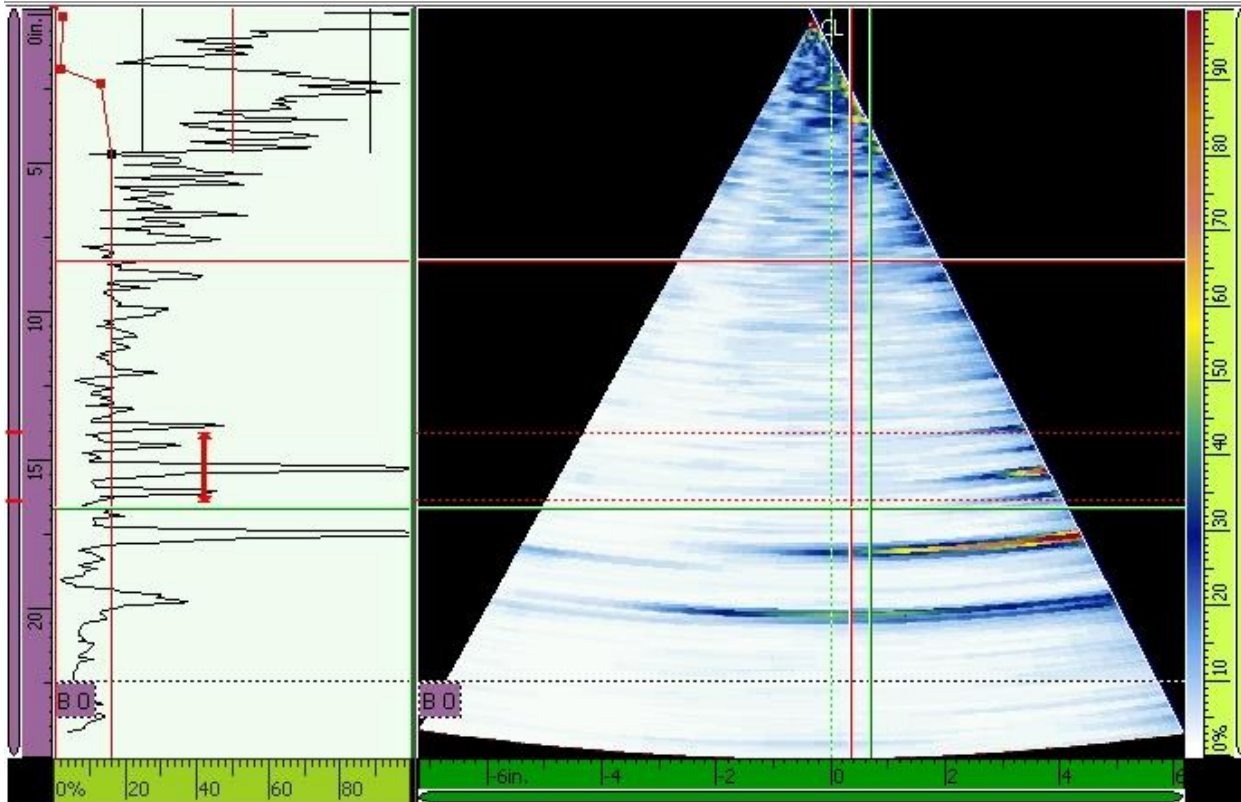
Indication two is located at 11 o'clock to 12 o'clock position, is in excess of ARL and is showing wear along the barrel face of the pin.

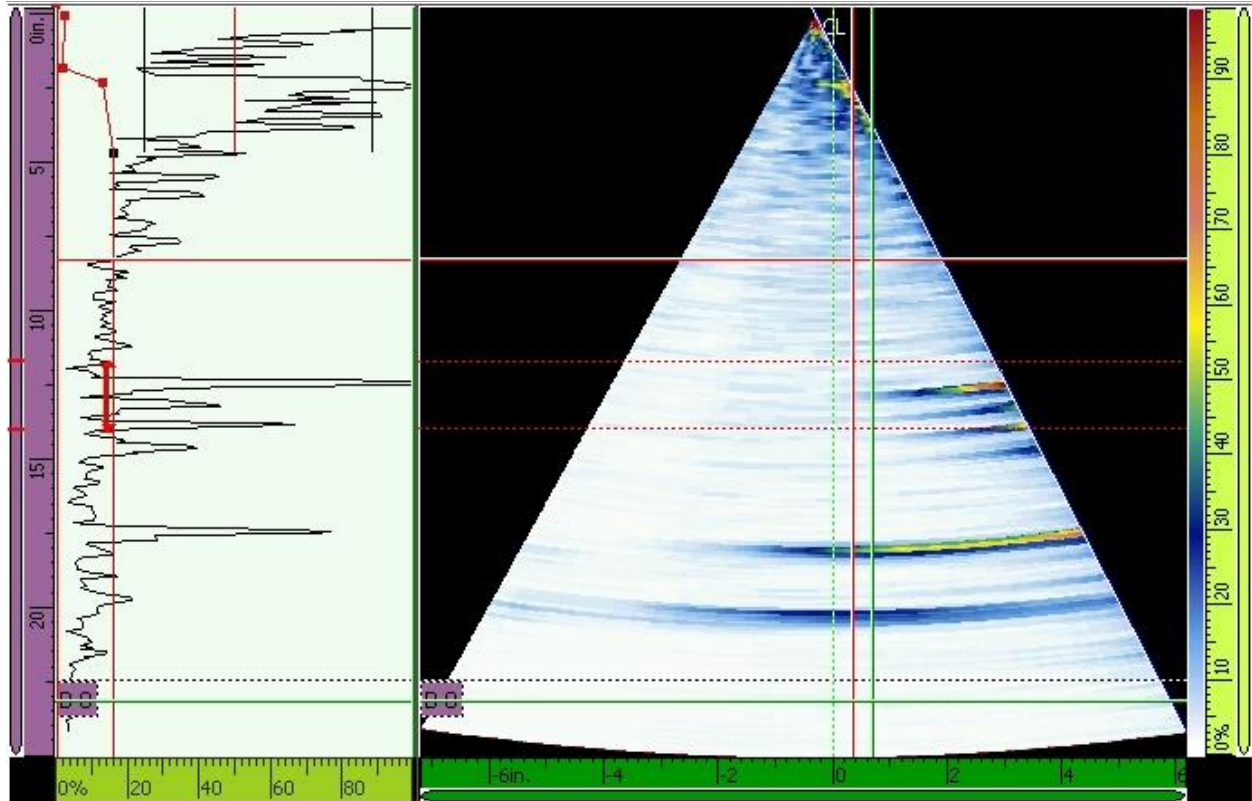
Ref.	Indication #	Scan	Index	Group	Channel	A%	DA^	PA^	SA^	U(m-r)	I(m-r)	I•U(m-r)	S(m-r)
-	2	0.00 mm	0.00 mm	PA 1	15.00°	111.6 %	316.04 mm	76.77 mm	327.19 mm	379.20 mm	8.47 mm	379.30 mm	--- mm
Comments													
Indication two is a discontinuity indication is along the barrel face of the pin. The amplitude exceeds the ARL. The indication is located from the 2 o'clock to the 4 o'clock position.

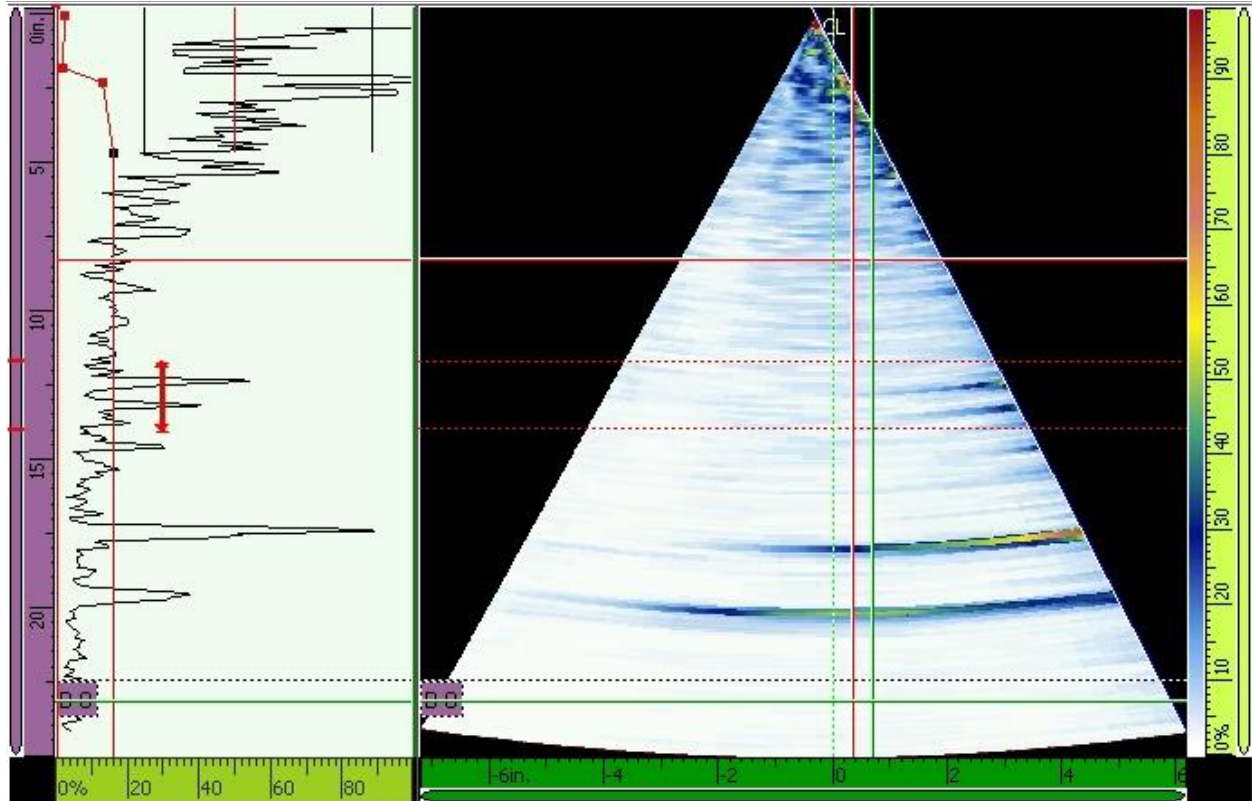
Ref.	Indication #	Scan	Index	Group	Channel	A%	DA ^	PA ^	SA ^	U(m-r)	I(m-r)	I•U(m-r)	S(m-r)
-	3	0.00 mm	0.00 mm	PA 1	15.00°	54.8 %	315.16 mm	76.54 mm	326.28 mm	379.20 mm	8.47 mm	379.30 mm	--- mm
Comments Indication three shows a discontinuity along the barrel face of the pin. The amplitude exceeds the SSL. The indication is located from the 6 o'clock to the 7 o'clock position.
