2020 In-Depth, Element Level Bridge Inspection Report

LUC-2-1862 **In-Depth, Element Level Bridge Inspection Report**

PID: 108045

October 2020

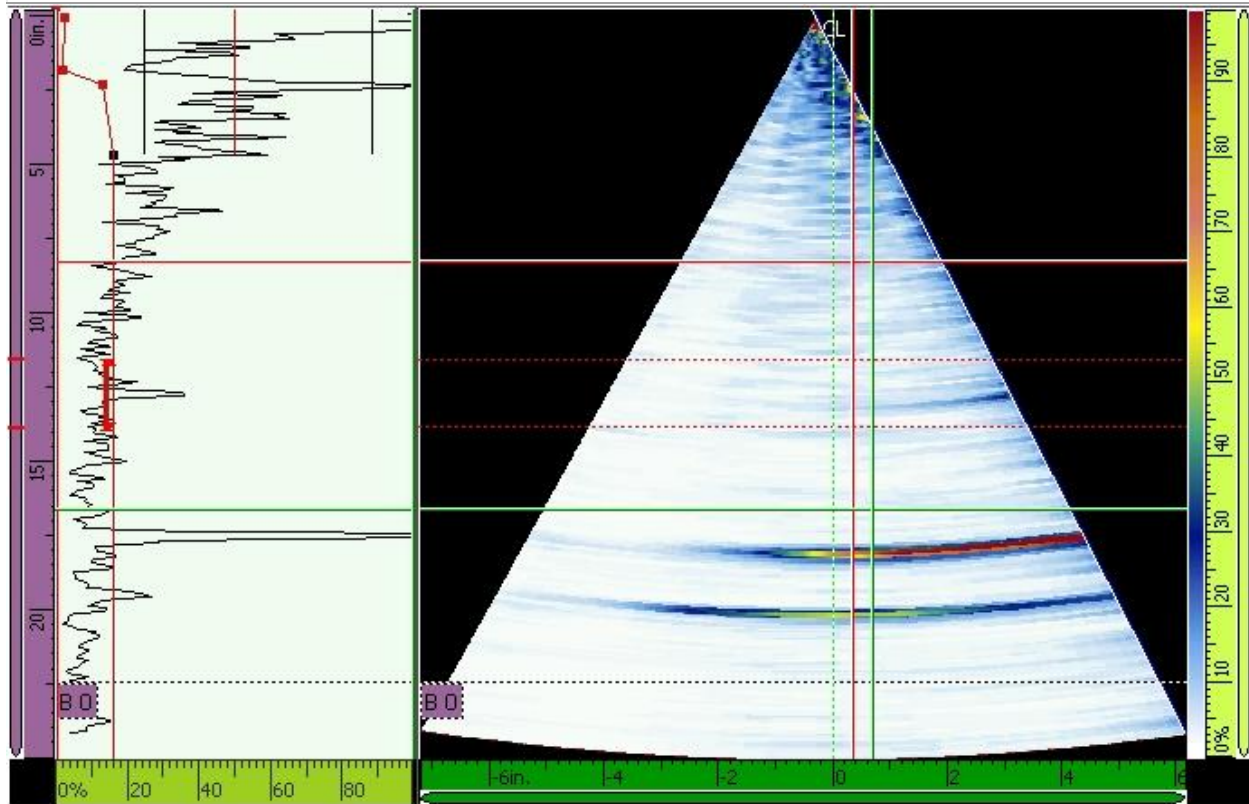
Indication two is above the DRL and below the SSL. The indication is located from the 6 o'clock to 7 o'clock position.

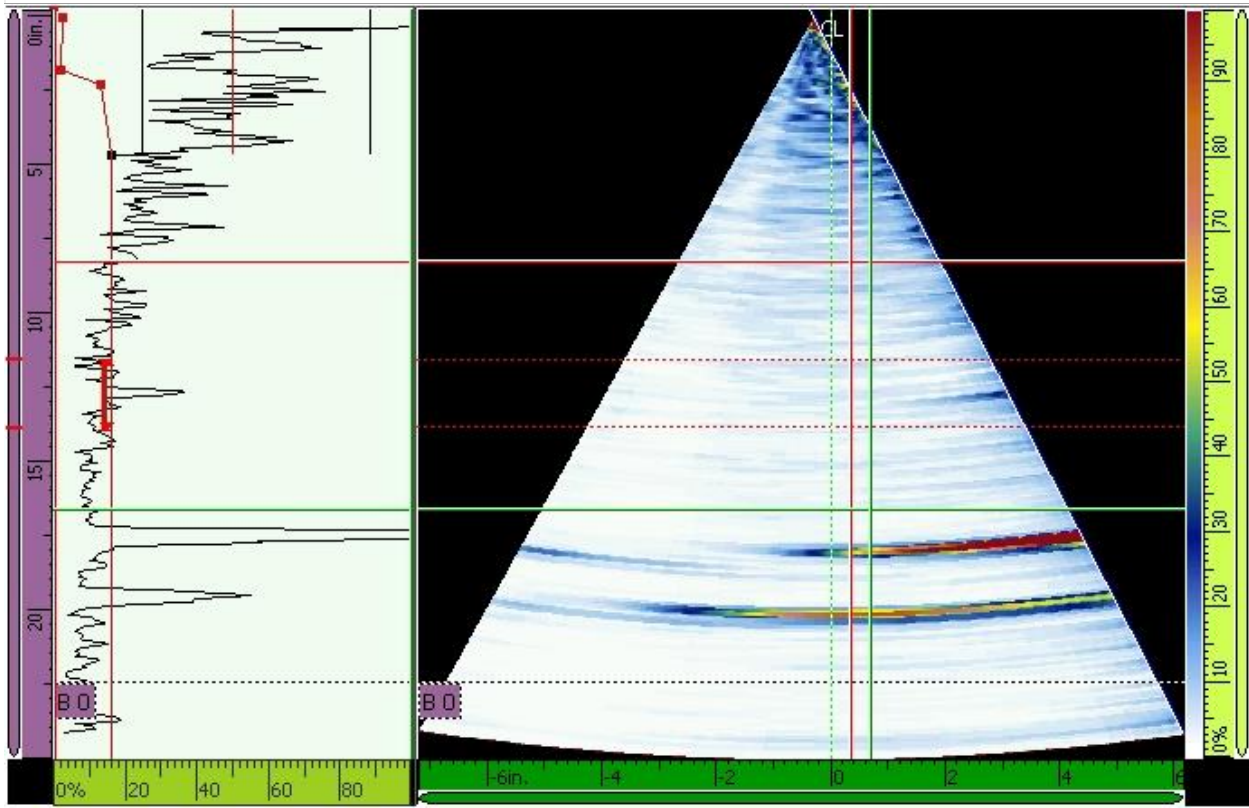
Indication three is above the DRL and below the SSL. The indication is located at the 2 o'clock position.

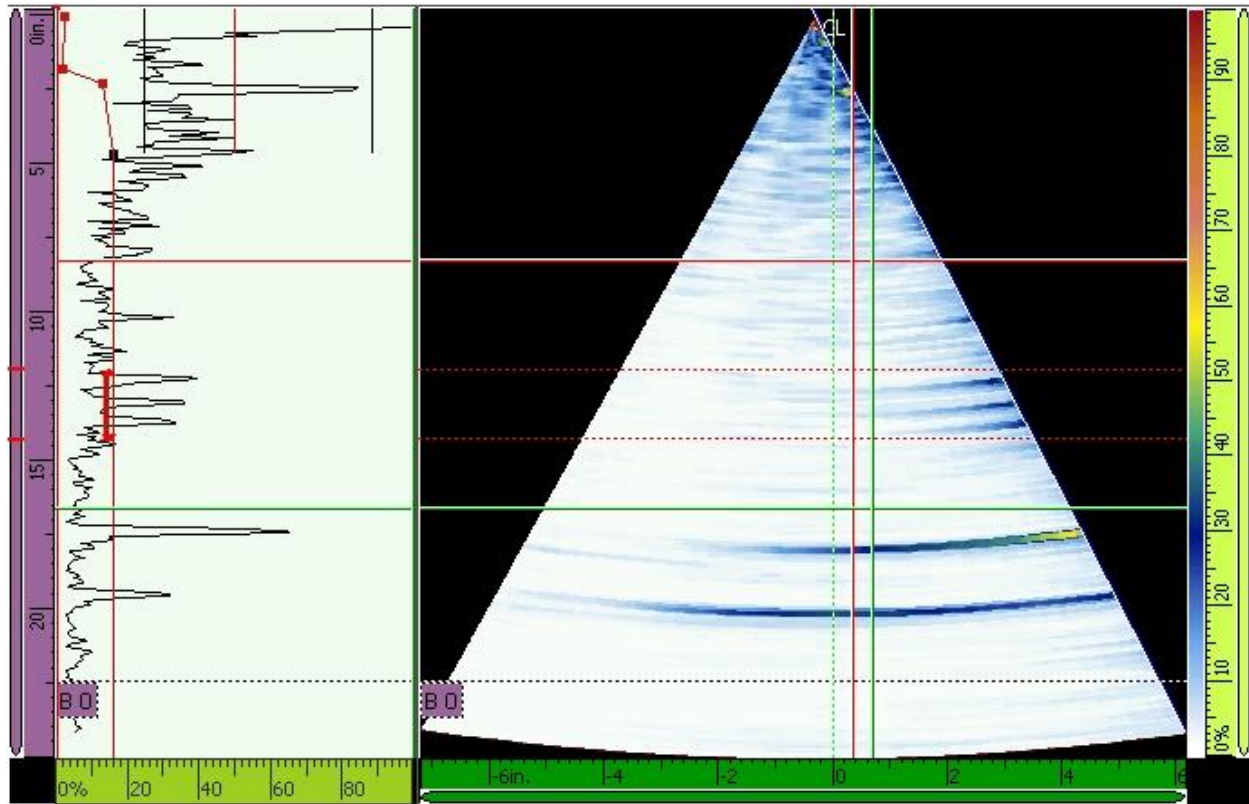
Indication Two is between the DRL and SSL. The indication is located from the 3 o'clock to 5 o'clock position.

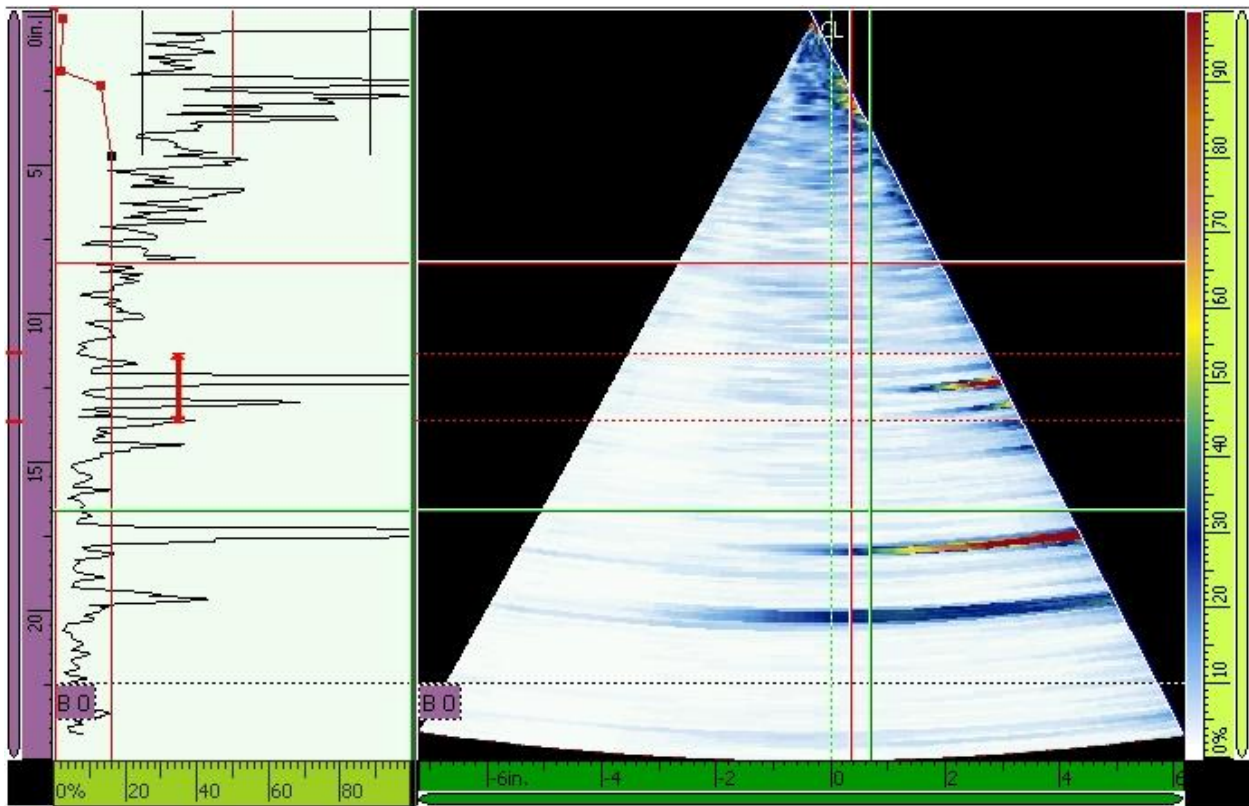
Indication Three 248% of Full Screen Height. The indication is located from the 8 o'clock to 11 o'clock position.

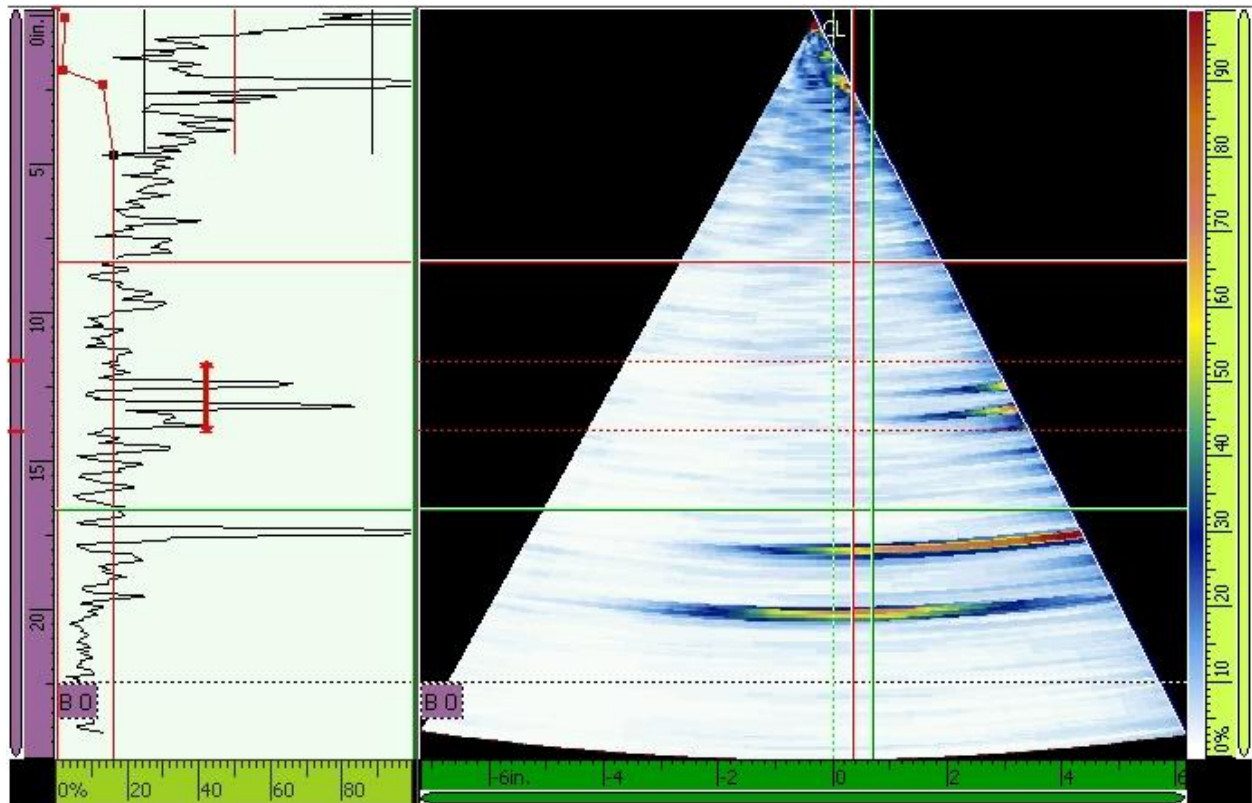
Ref.	Indication #	Scan	Index	Group	Channel	A%	DA ^	PA ^	SA ^	U(m-r)	I(m-r)	I•U(m-r)	S(m-r)
-	2	0.000 in	0.000 in	PA 1	15.00°	84.2 %	13.159 in	3.214 in	13.623 in	8.429 in	0.333 in	8.435 in	--- in
Comments													
Indication Two is between the SSL and ARL. This indication is located from the 9 o'clock to 6 o'clock position.

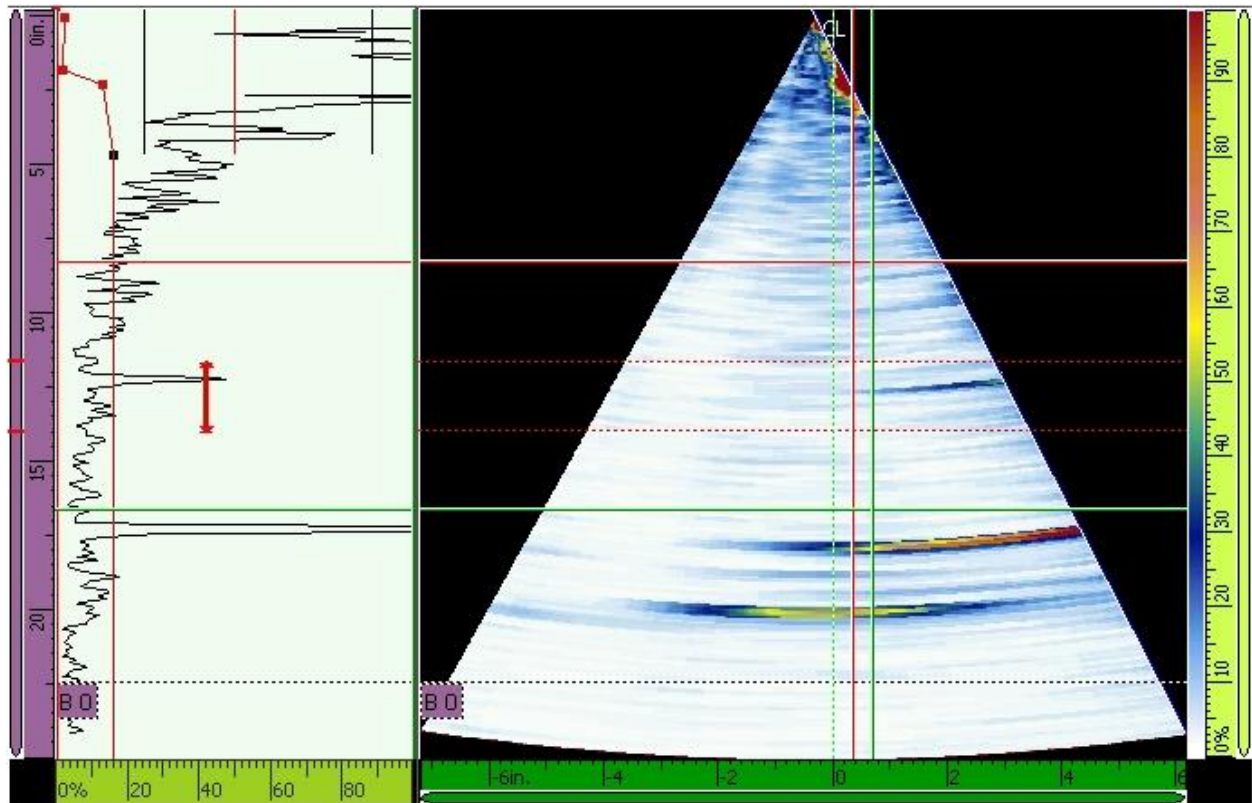
Ref.	Indication #	Scan	Index	Group	Channel	A%	DA ^	PA ^	SA ^	U(m-r)	I(m-r)	I•U(m-r)	S(m-r)
-	3	0.000 in	0.000 in	PA 1	15.00°	48.0 %	12.246 in	2.970 in	12.678 in	8.429 in	0.333 in	8.435 in	--- in
Comments													
Indication Three is between the SSL and the DRL. The indication is located at the 3 o'clock position on the pin.

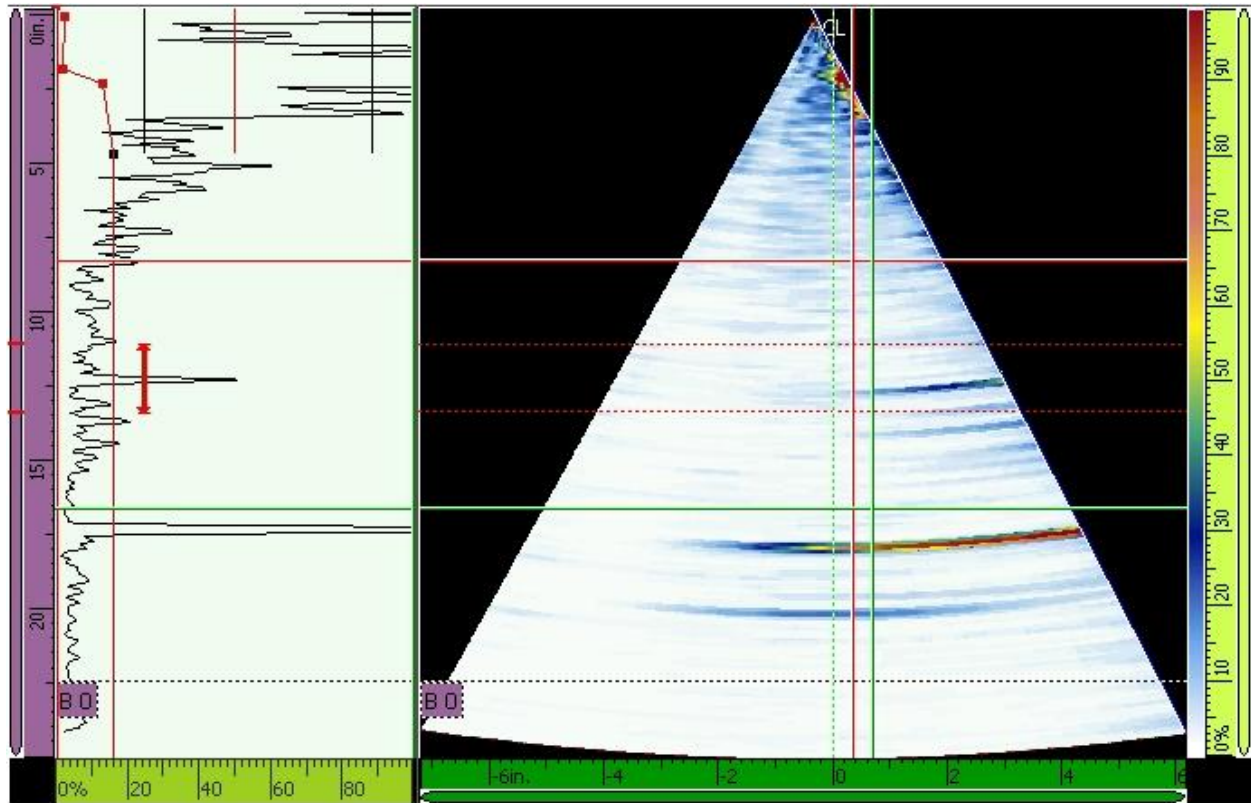
This indication is breaking the SSL by 0.9%, placing it between the SSL and the ARL. The indication is located from the 8 o'clock to 9 o'clock position.

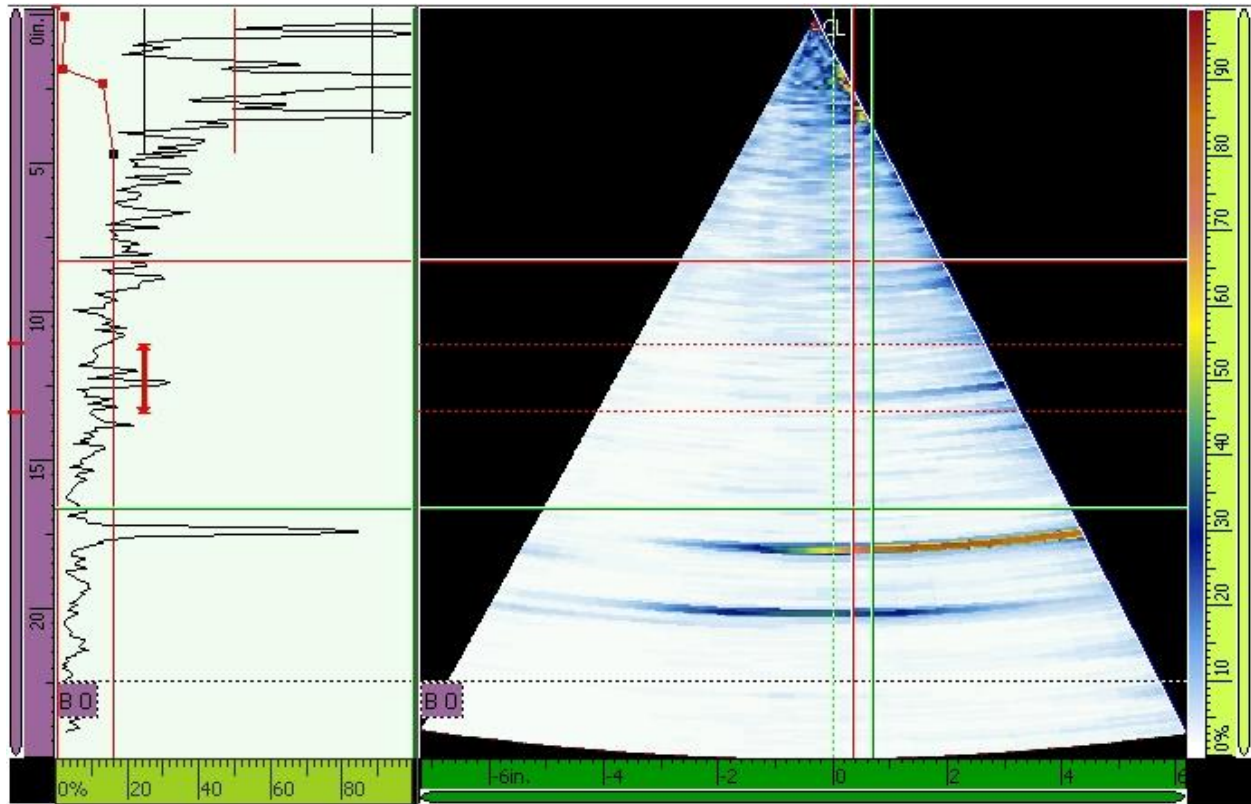
This indication is in excess of the DRL but below the SSL. This indication is located from the 3 o'clock to 1 o'clock position.

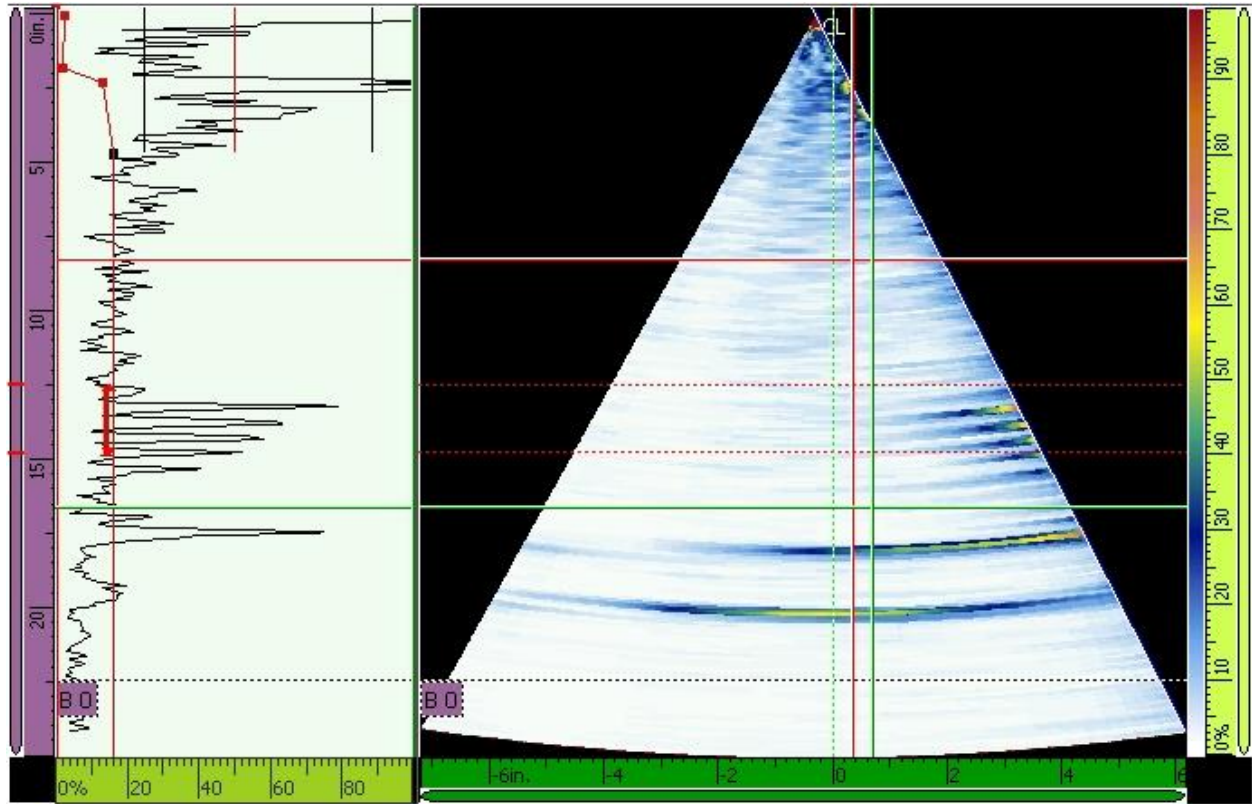
Ref.	Indication #	Scan	Index	Group	Channel	A%	DA ^	PA ^	SA ^	U(m-r)	I(m-r)	I•U(m-r)	S(m-r)
-	2	0.000 in	0.000 in	PA 1	15.00°	79.3 %	13.244 in	3.237 in	13.711 in	8.429 in	0.333 in	8.435 in	--- in
Comments													
Indication Two is higher than the SSL but below the ARL. This indication is located at the 9 o'clock position.

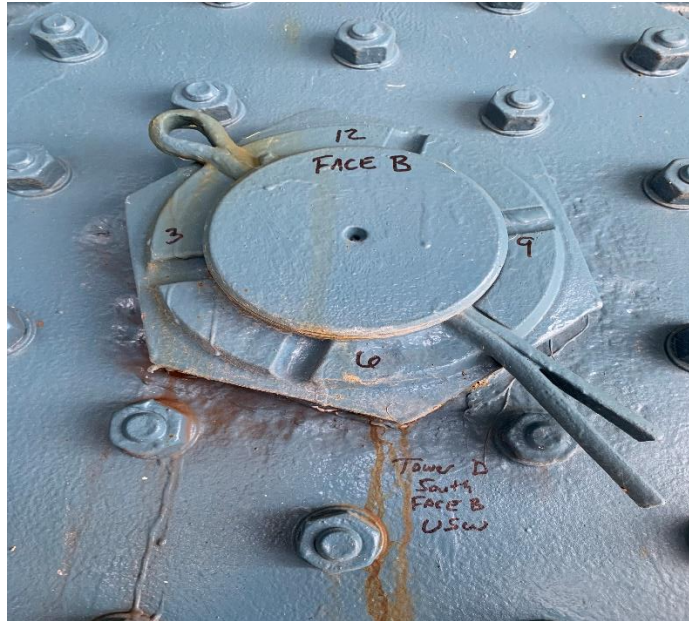
Indication two is located at 11 o'clock to 12 o'clock position, is in excess of ARL and is showing wear along the barrel face of the pin.

Indication 3 is located at 9 o'clock to 10 o'clock position, is in excess of ARL and is showing wear along the barrel face.
