FRACTURE CRITICAL INSPECTION REPORT

SFN4400038 (LAW-07-0240)
SR-7 OVER SYMMES CREEK
LAWRENCE COUNTY, OH
DISTRICT 9

September 2024

Project: Symmes Creek Truss NSTM Inspection (PID No. 105476)

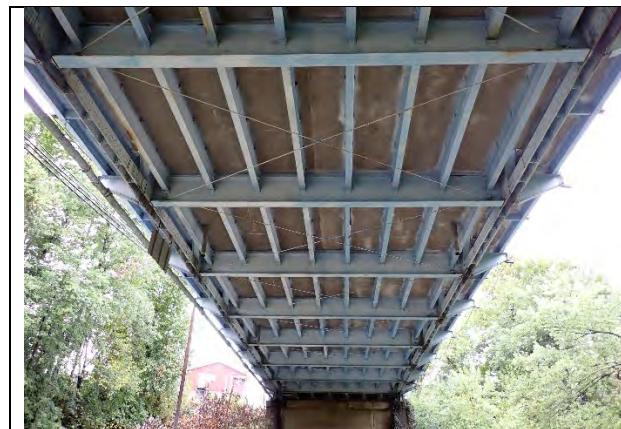
Generally, the floor beams exhibited up to 1/4" deep pitting (1/8" deep typical) on the webs adjacent to floor beam connection angles (Photos 40 to 43). This is a high shear zone where most the load is carried by the floor beam web. Typically, floor beam pitting is painted over but isolated areas are reactivating. Floor Beam 0 has a 12' long by 6" high area of 1/4" deep pitting on the rear web that starts 5' from the right truss. This section was caused by joint leakage at the Rear Abutment. A plug weld was observed on Floor Beam 8, forward (east) face just above Stringer 1 (Photo 44). No defects or cracks were observed. The bottom flange of Floor beam 9 has isolated 3/8" deep pitting on the forward bottom flange edge adjacent to the left truss and isolated 1/4" deep pitting to the forward bottom flange edge and underside at the right truss. Specific details of floor beam pitting and section loss are listed in Exhibit 3.

Photograph 39: Overall view of the configuration and condition of floor beams, looking west.

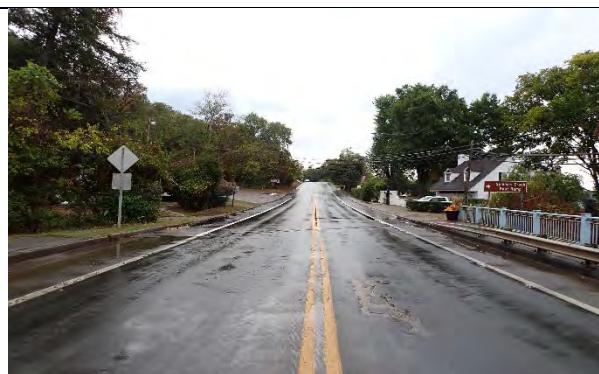
The approaches are in good condition overall (Photos 58 and 59). A new overlay was installed on both approaches since the prior inspection. The scaling and cracks previously mentioned are now not visible. The east approach transition is smooth. The west approach transition is smooth overall though settlement of 1/8" is present at the end of the west approach slab.

Photograph 58: View of the forward (east) approach looking east.

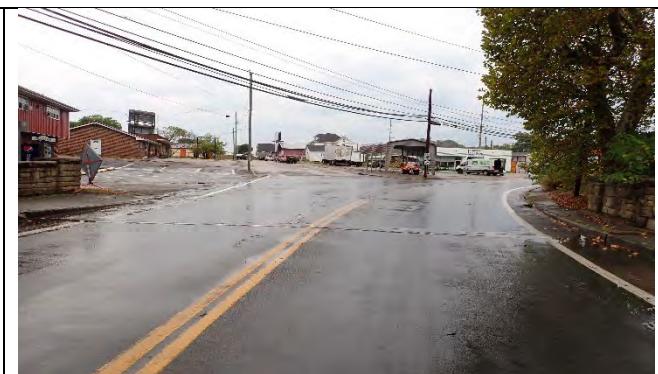
Photograph 59: View of the rear (west) approach looking west.

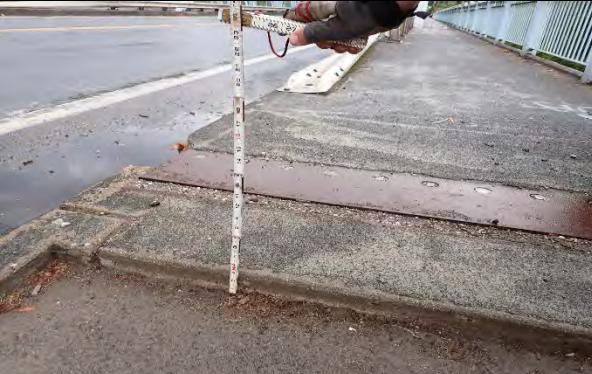
Both rear approach sidewalks have settled (Photos 60 and 61). These measured 2 1/2" at the northwest corner and 2 1/4" at the southwest corner (relative to the Span 1 sidewalk). This is an old comment that has not appreciably changed for this inspection.

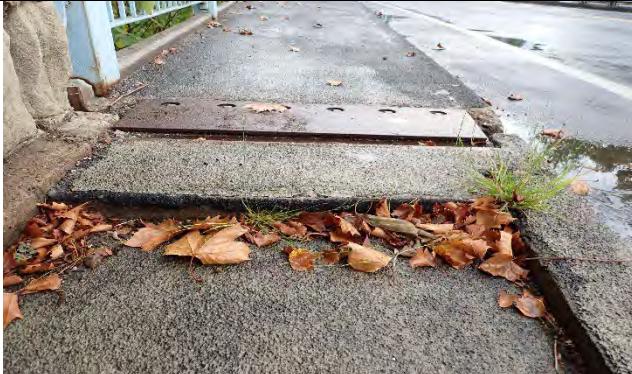
A photograph showing a concrete sidewalk that has settled. The sidewalk is dark grey and shows significant vertical cracks. There are fallen leaves scattered on the sidewalk near a metal drain cover.
Photograph 60: View of the settlement to the rear right (southwest) approach sidewalk.	Photograph 61: View of the settlement to the rear left (northwest) approach sidewalk.

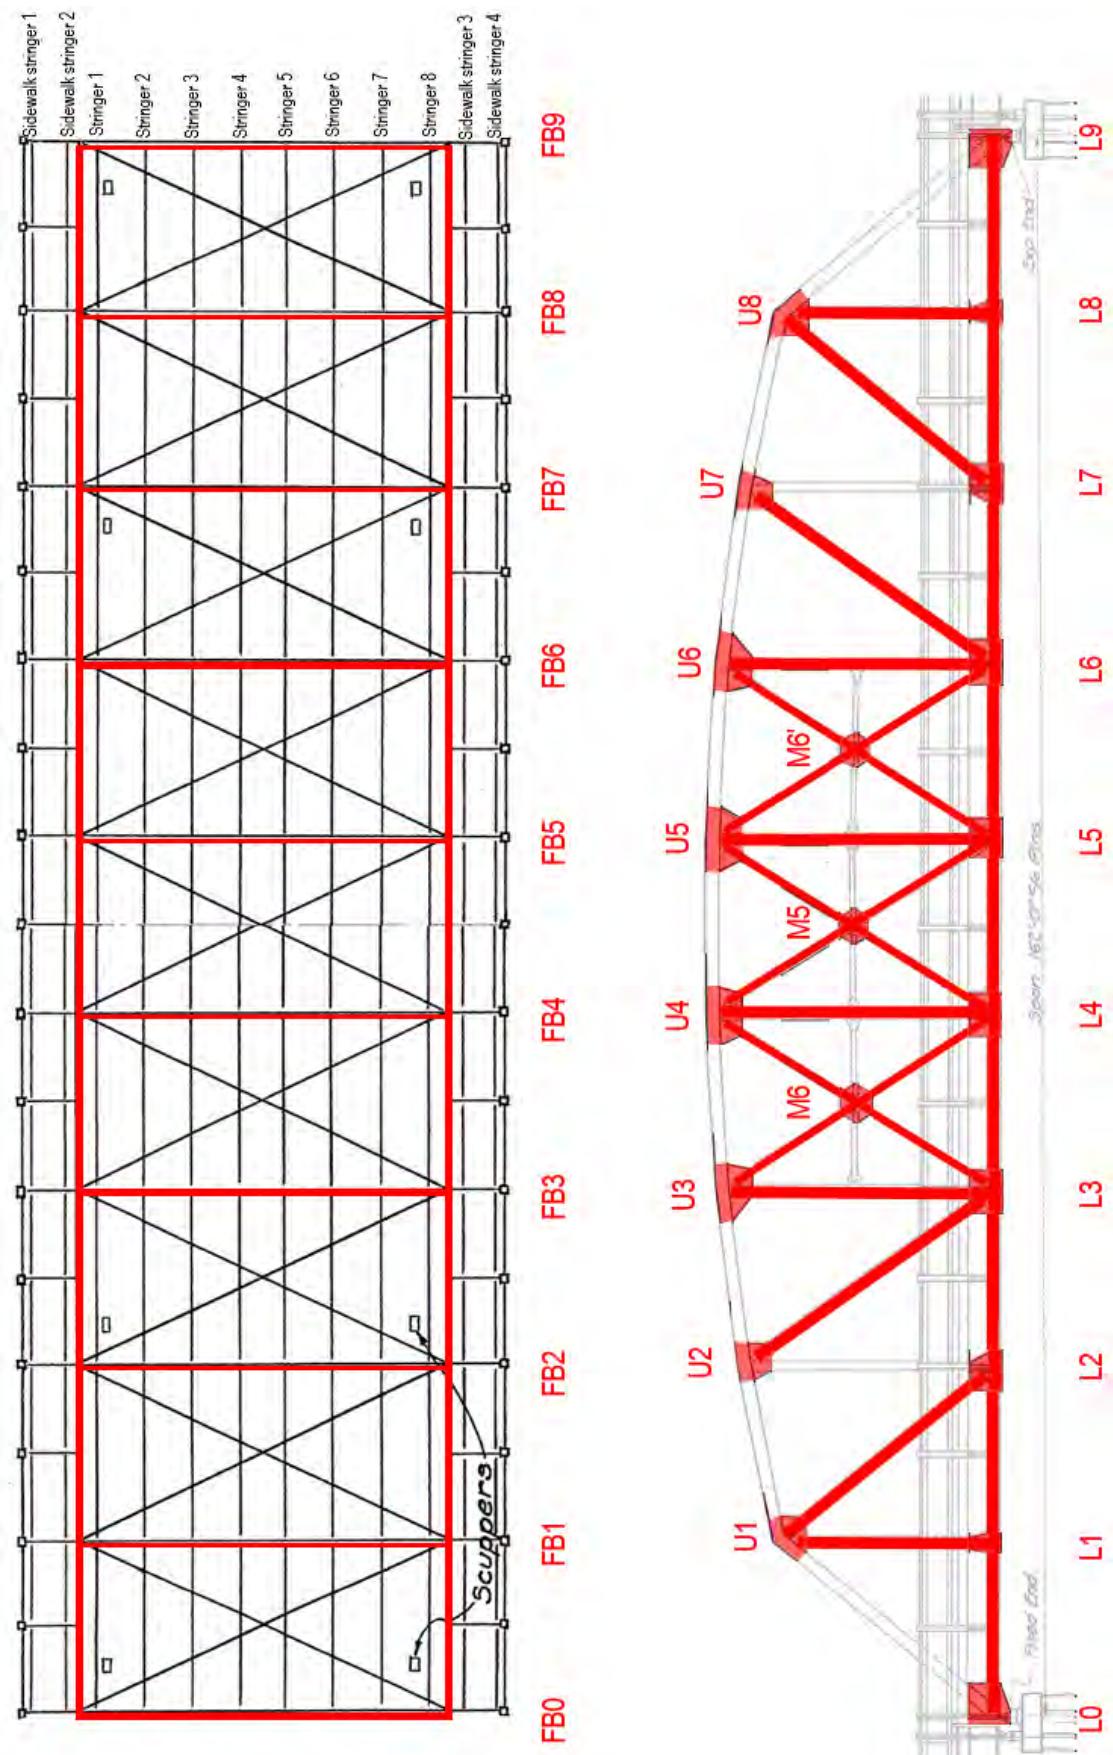
Figure 3 – Span 2 framing plan and truss south elevation (images taken from the 1932 design drawings).
Lower chord members, diagonals, verticals (except U2-L2 & U7-L7), gusset plates, and floorbeams are fracture critical members.
