**PHYSICAL CONDITION REPORT  
FOR THE 2020 SPECIAL TOWER HEAD INSPECTION**

**SR 93 OVER THE OHIO RIVER**

BR#: LAW-93-0.00  
SFN: 4401263

**OHIO DEPARTMENT OF TRANSPORTATION  
DISTRICT 9  
PID #102917**

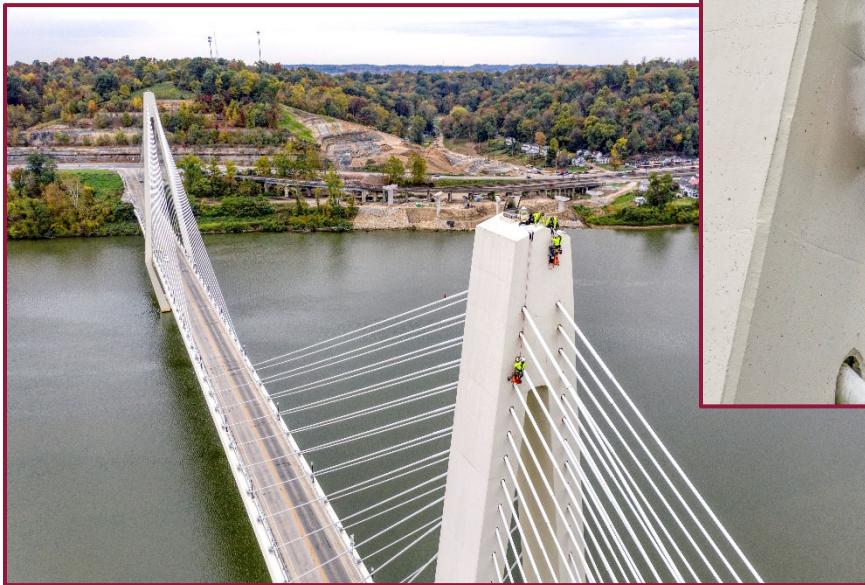
Overall the exterior faces of the towers are in good condition. Vertical and diagonal hairline cracking on the exterior faces of the towers at the cable anchorages is typical (see Photo 1). Cracking with rust staining from the guide tube on the exterior faces around the full circumference of the lowest anchorages in Segment 12 of the towers is also typical (see Photo 1). Poor construction/consolidation has resulted in minor to moderate voids up to 1" in diameter and up to 1/2" deep throughout the tower exterior vertical faces and roof with many of these voids not having the sealant penetrated inside (see Photo 3). Isolated areas with very minor rust staining were noted on the exterior faces (see Photo 2).

Photo 1 - Typical hairline crack above the anchor and cracking with rust staining around the guide tube (looking north at the south face of Tower 3 at Cable M16E in Segment 12).

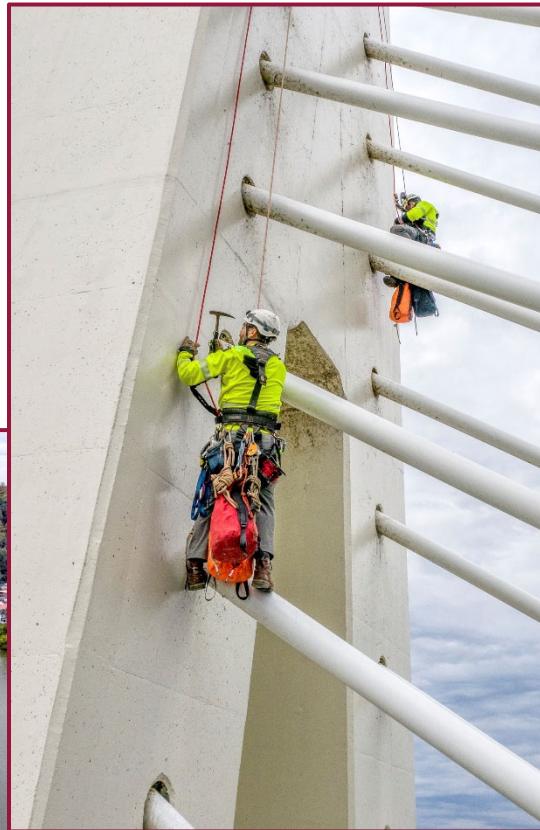
Photo 2 - Typical isolated area of minor rust staining (looking north at the south face of Tower 3 above Cable M19W).
