Re: April 2016 Quarterly Report
CUY-90-15.24 Slope Monitoring
PID 96504
EDP Project No. 069032.00

APRIL 2016 QUARTERLY REPORT

CUY-90-15.24 SLOPE MONITORING
PID 96504
CLEVELAND, OHIO
SME PROJECT NO. 069032.00

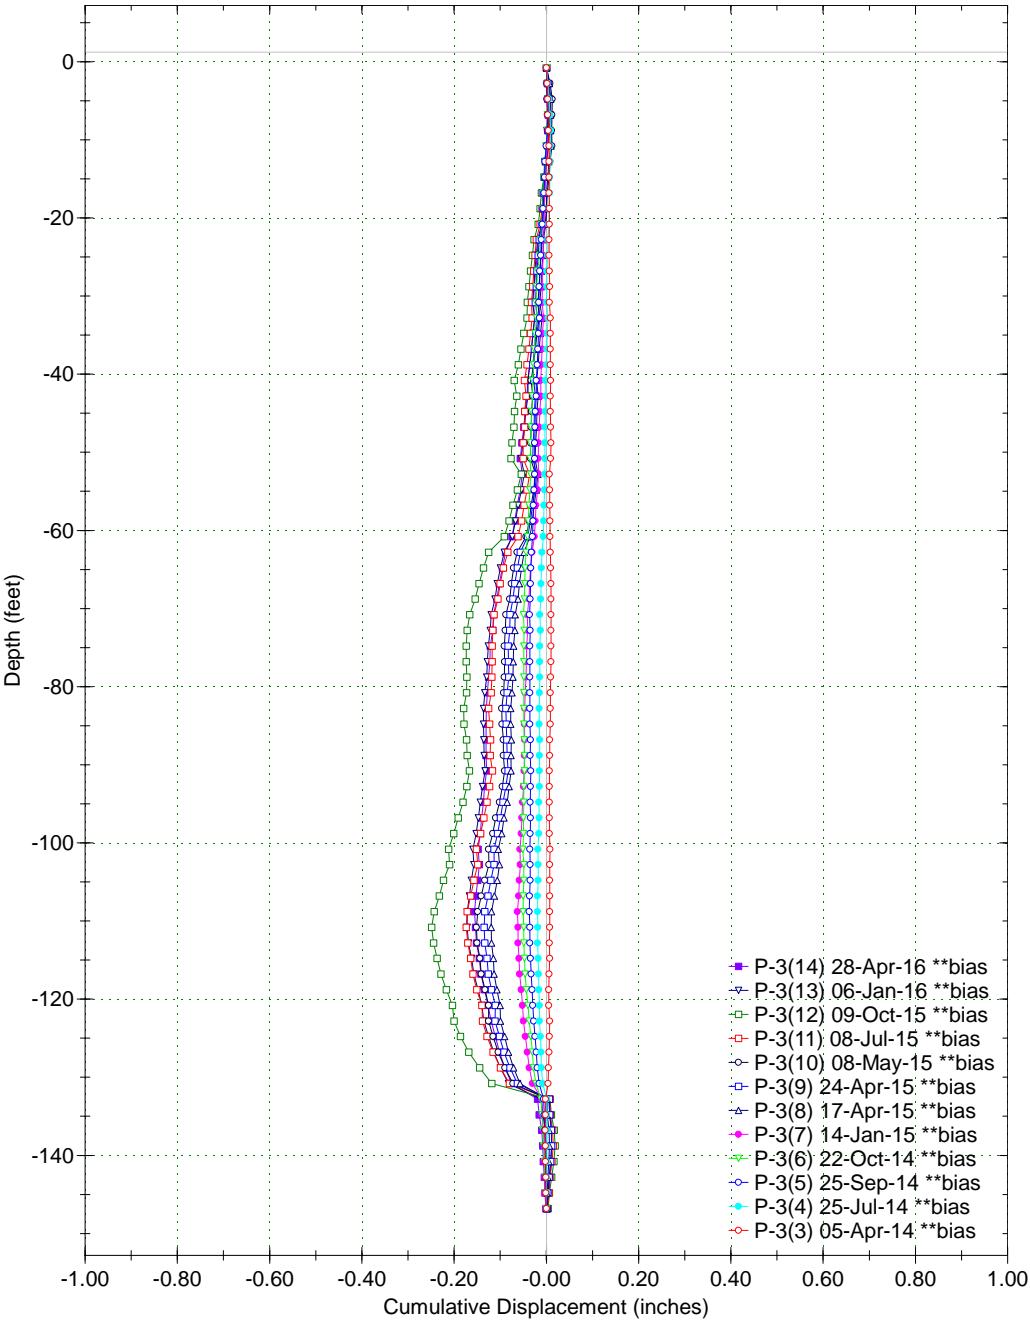
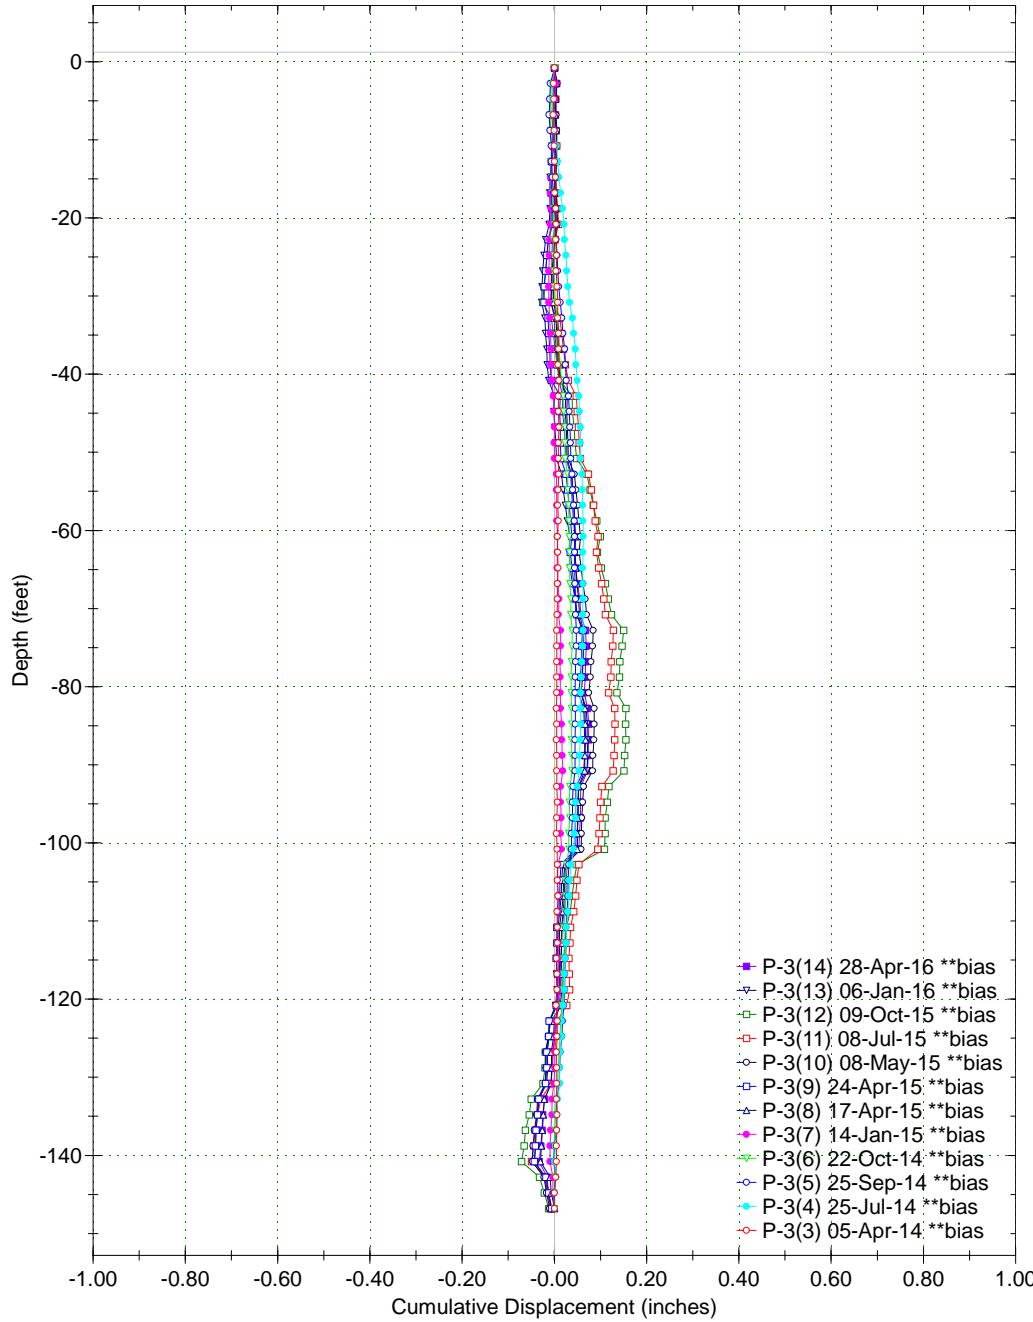
Borehole : P-3
 Project : CUY-90-15-24
 Location : Cleveland, Ohio
 Northing :
 Easting :
 Collar :

TGR P-3. On December 23, 2015, total head increases of 3 to 5 feet are shown in all three piezometers. This increase was caused by the placement of fill in the area which we observed during our biweekly visit. The pore pressures then began to decrease with the rate of decrease slowing with depth. Through most of this quarter, the total head in the two deep piezometers continued to decrease with a change of about 2 feet. Total head in the shallowest piezometer increased by about 1 foot.
