Re: June 16, 17, and 20, 2016 Bi-Weekly Readings
CUY-90-15.24 Slope Monitoring
PID 96504
SME Project No. 069032.00

Bi-weekly instrument readings for the I-90 west slope taken on June 16, 17, and 20, 2016, are presented in this report. Bi-weekly readings currently include instruments at I/P-001-13, I/P-002-13, I/P-003-10, I/P-004-13, I/P-009-13, B-101, B-102, B-105A, B-05-02, B-05-A-03, B-05-04, B-05-A-11, P-1, P-9N, TGR I-2, and TGR I-4. Changes reported for the individual instruments are for the previous two-week period unless noted otherwise.

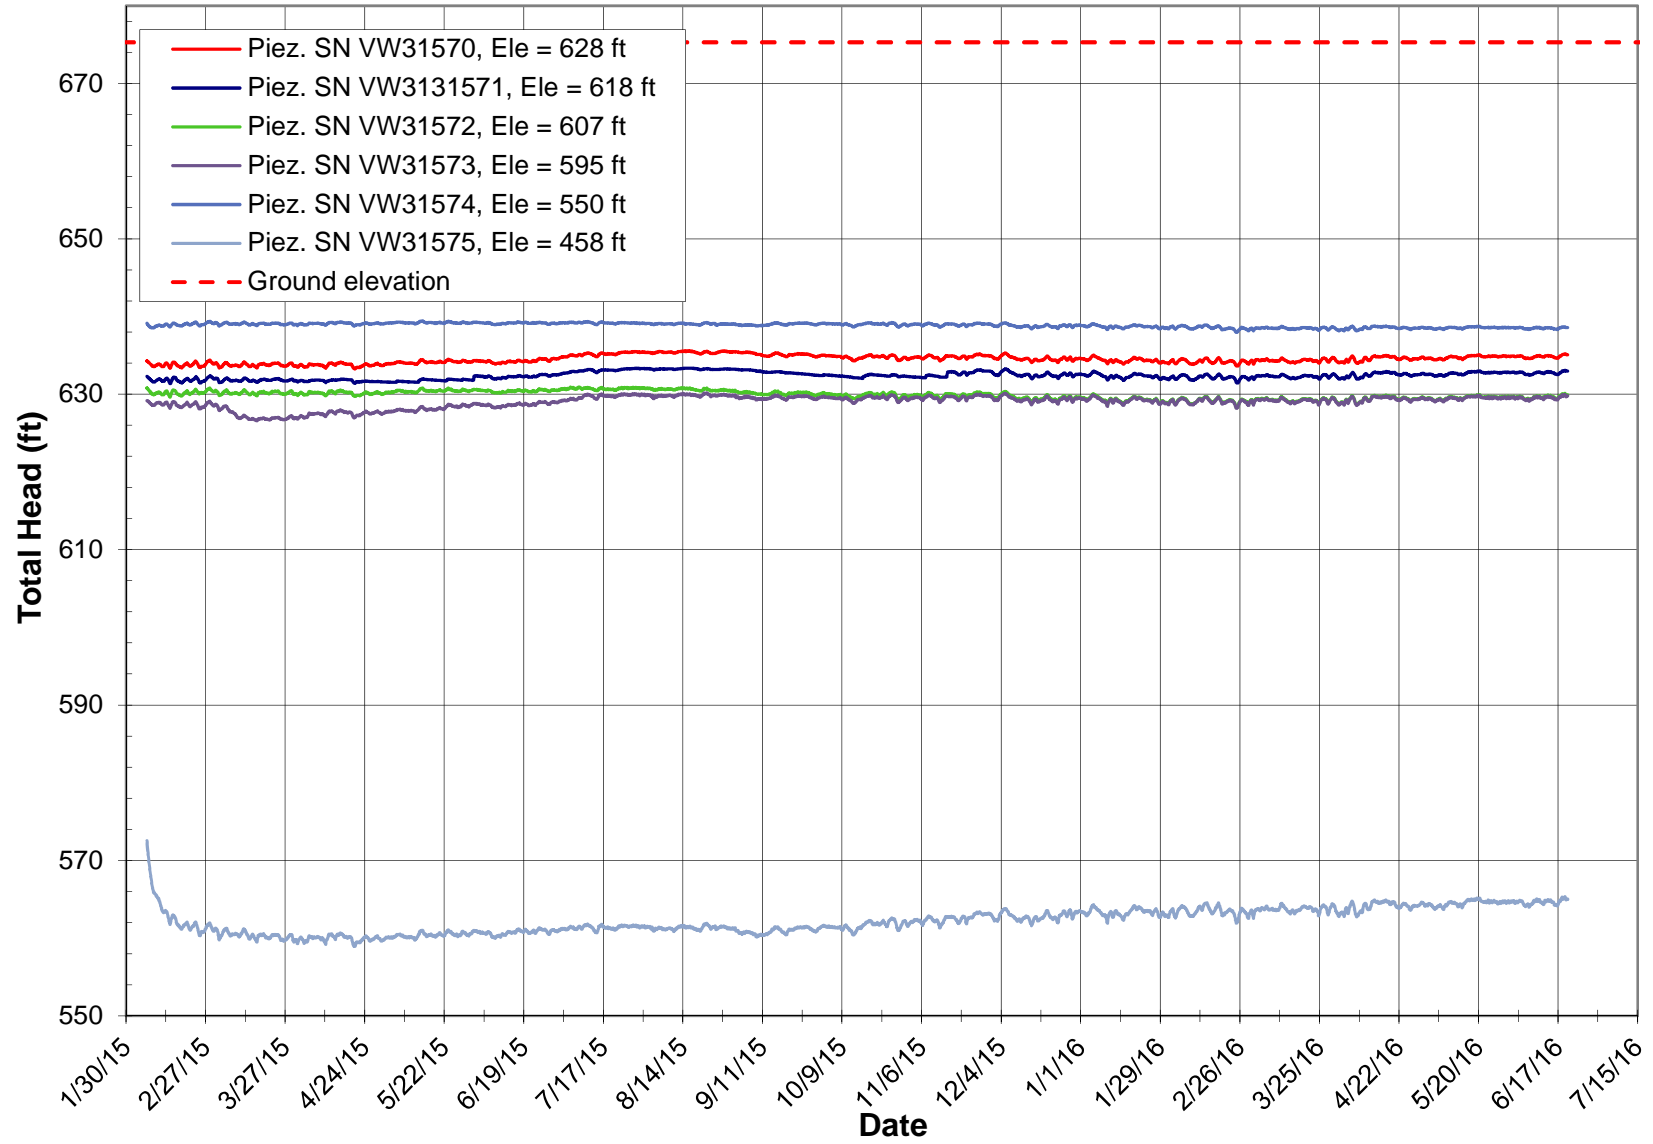
P-002-13 VW Piezometer Readings

P-002-13, P-003-10, P-009-13, B-105-A, B-05-A-03, B-05-04 – Pore pressure readings at these locations fluctuated by less than 0.5 feet, but show virtually no net change in total head.
