Re: August 29 and 30, 2016 Bi-Weekly Readings  
CUY-90-15.24 Slope Monitoring  
PID 96504  
SME Project No. 069032.00

Bi-weekly instrument readings for the I-90 west slope taken on August 29 and 30, 2016, are presented in this report. Bi-weekly readings currently include instruments at I/P-001-13, I/P-002-13, I/P-003-10, I/P-004-13, I/P-009-13, B-101, B-102, B-105A, B-05-02, B-05-A-03, B-05-04, B-05-A-11, P-1, P-9N, TGR I-2, and TGR I-4. Changes reported for the individual instruments are for the previous two-week period unless noted otherwise.

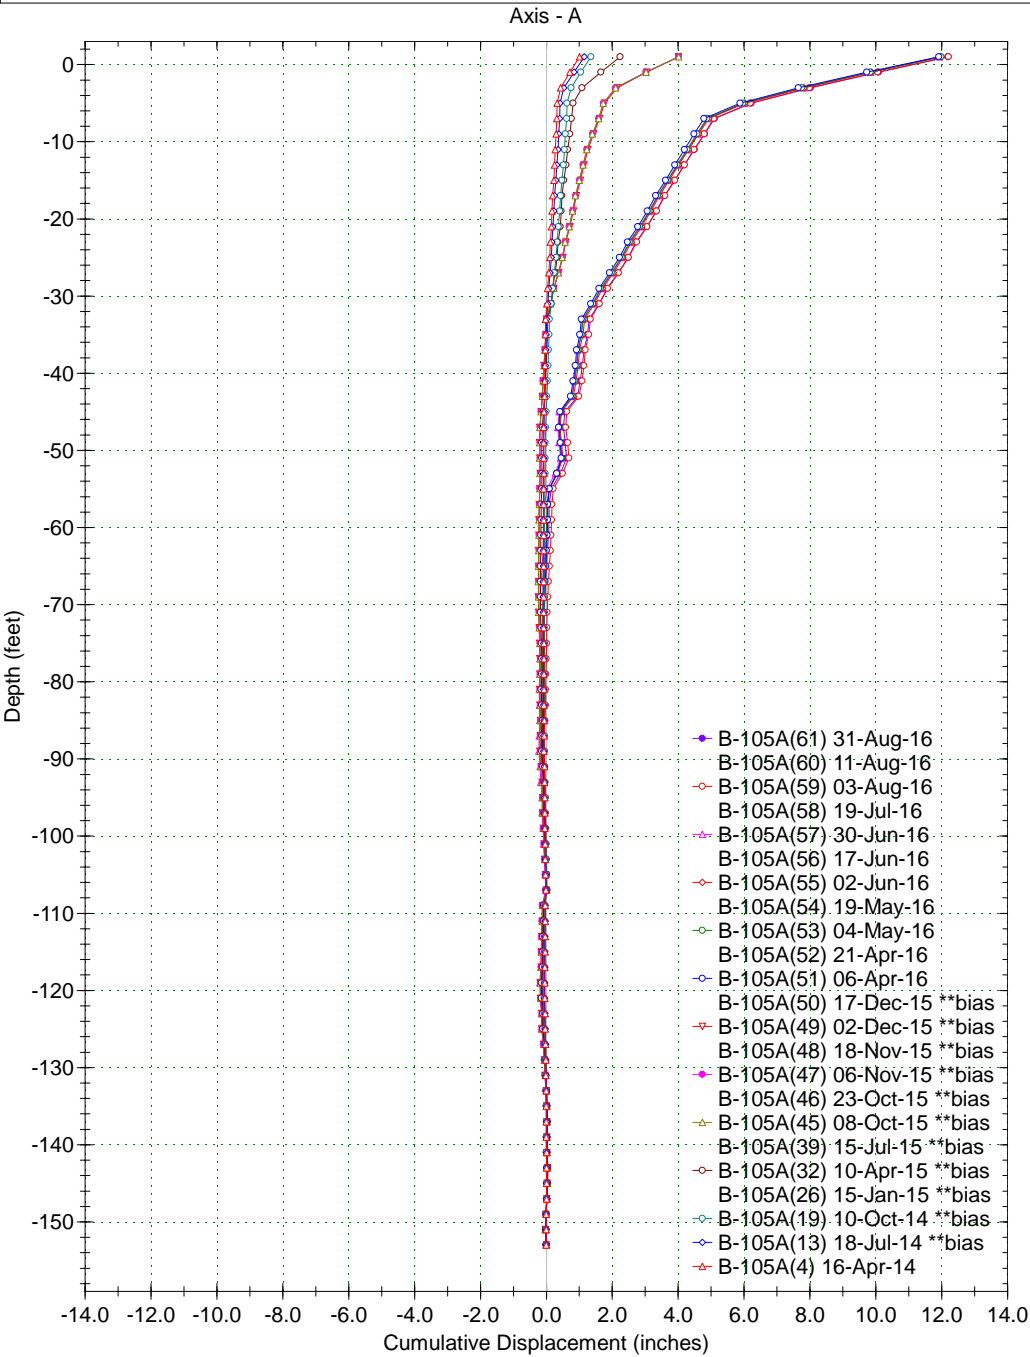
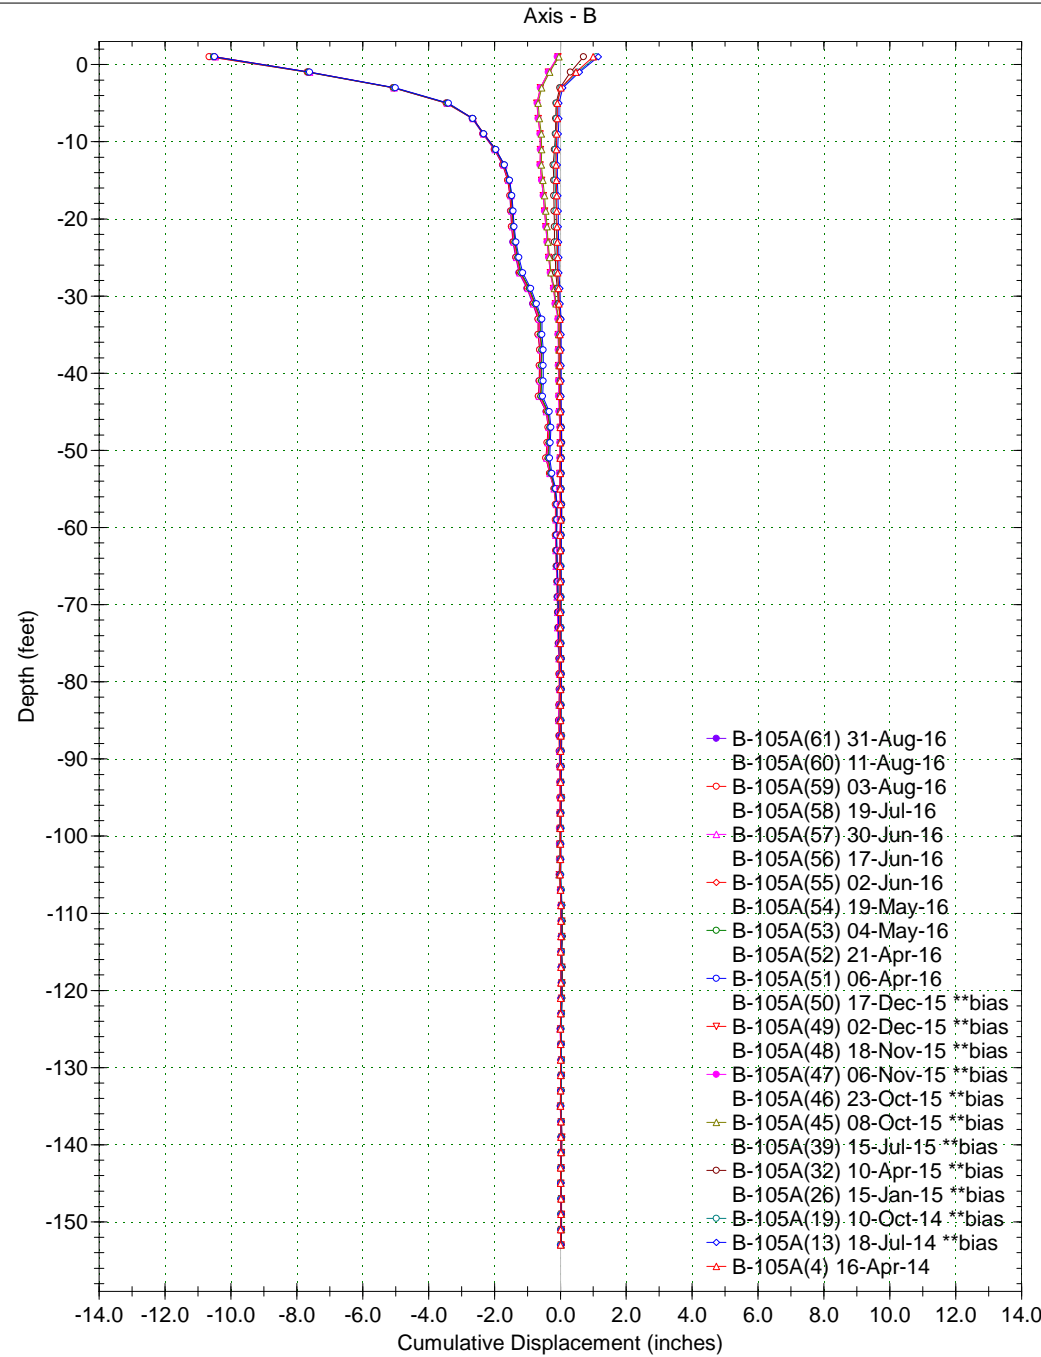
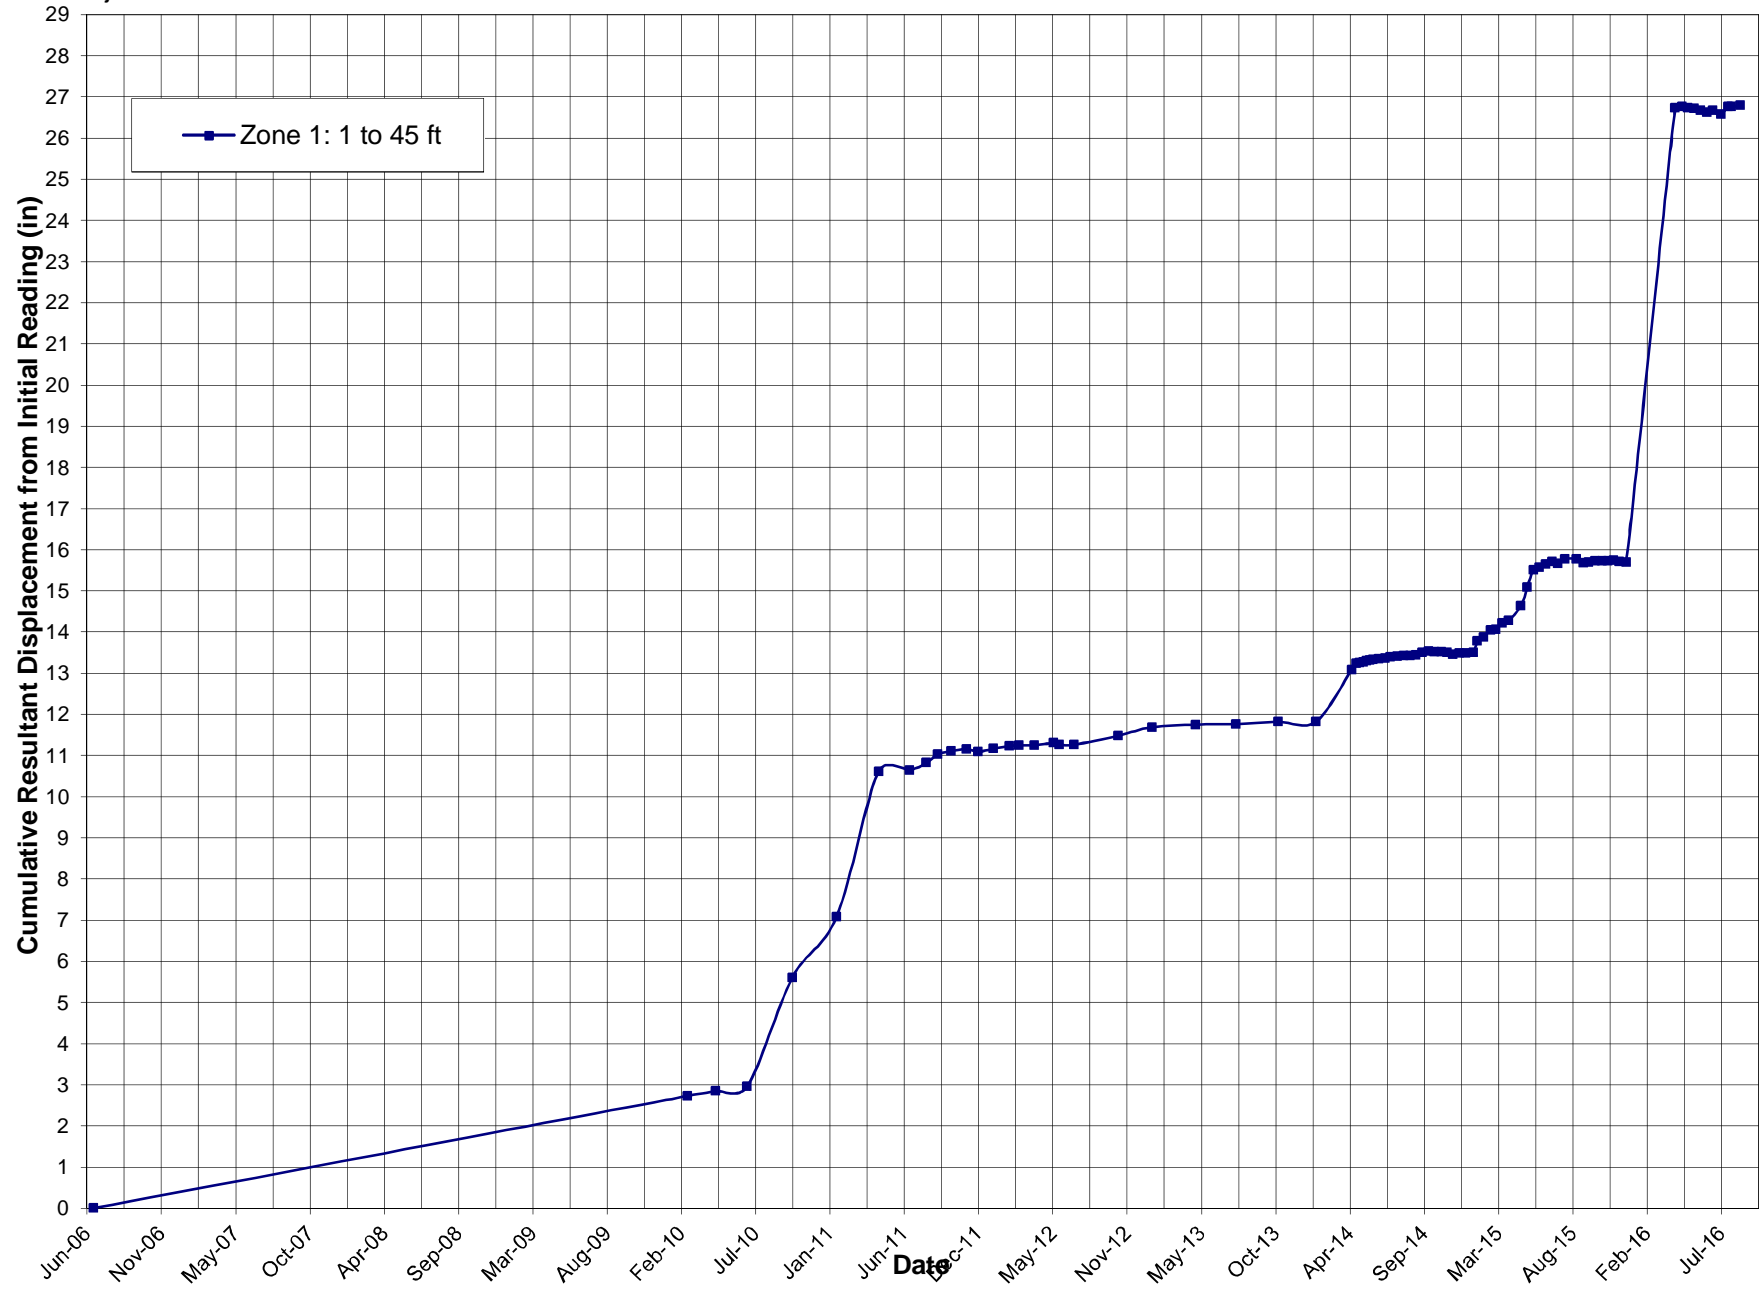
### B-105A

P-001-13, P-002-13, P-009-13, B-105A, B-05-02, B-05-04 – Pore pressure readings at these locations fluctuated by less than 0.5 feet, but show virtually no net change in total head.

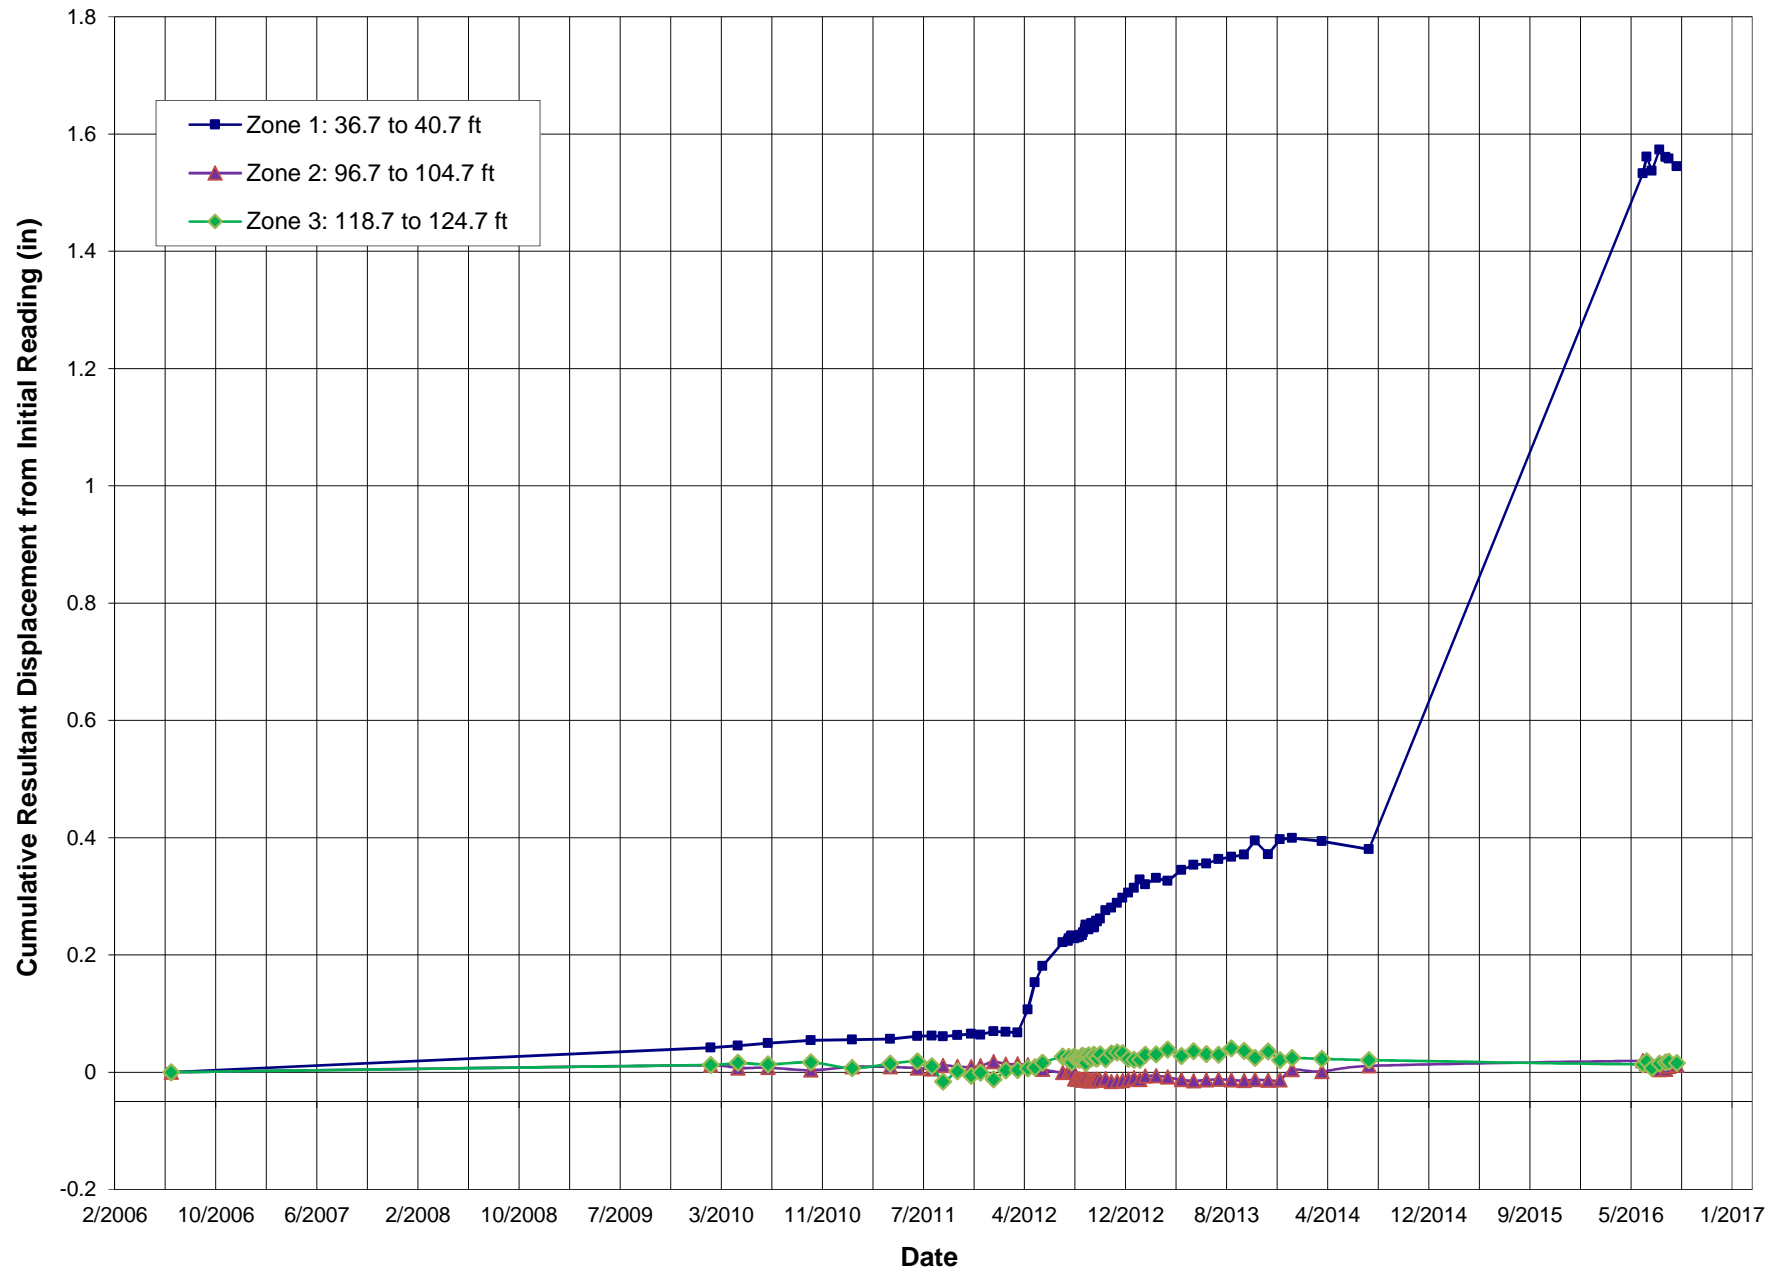
### B-05-02

**B-05-02** – Total head in both piezometers at this location increased by about 0.5 feet.
