Re: December 1 and 2, 2016 Bi-Weekly Readings
CUY-90-15.24 Slope Monitoring
PID 96504
SME Project No. 069032.00

Bi-weekly instrument readings for the I-90 west slope taken on December 1 and 2, 2016, are presented in this report. Bi-weekly readings currently include instruments at I/P-001-13, I/P-002-13, I/P-003-10, I/P-004-13, I/P-009-13, B-101, B-102, B-105A, B-05-02, B-05-A-03, B-05-04, B-05-A-11, P-1, P-9N, and TGR I-4. Changes reported for the individual instruments are for the previous two-week period unless noted otherwise.

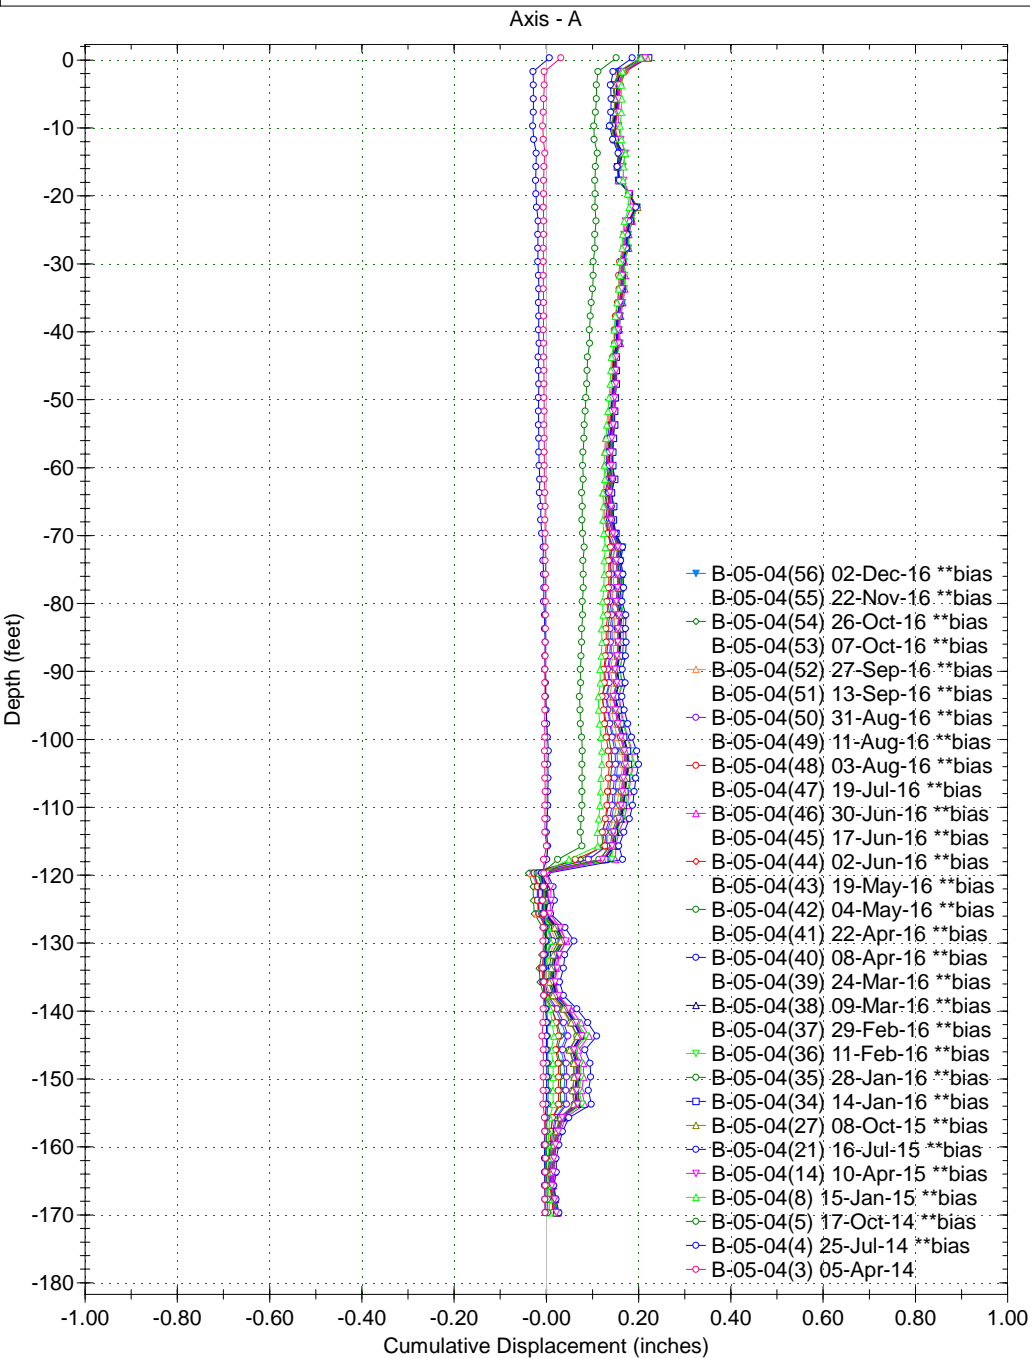
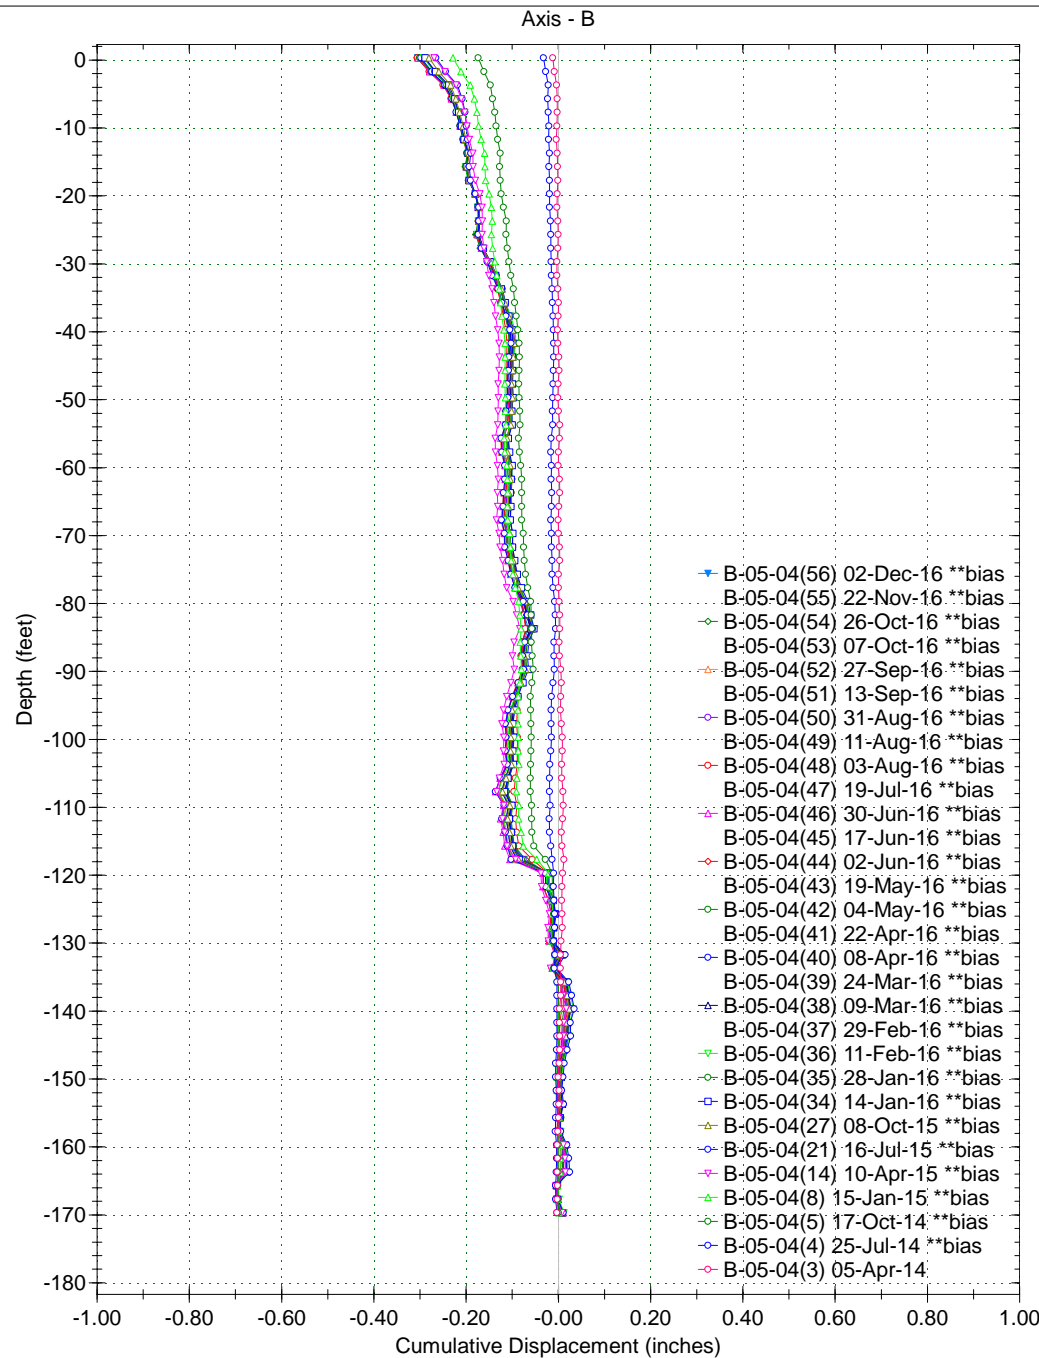
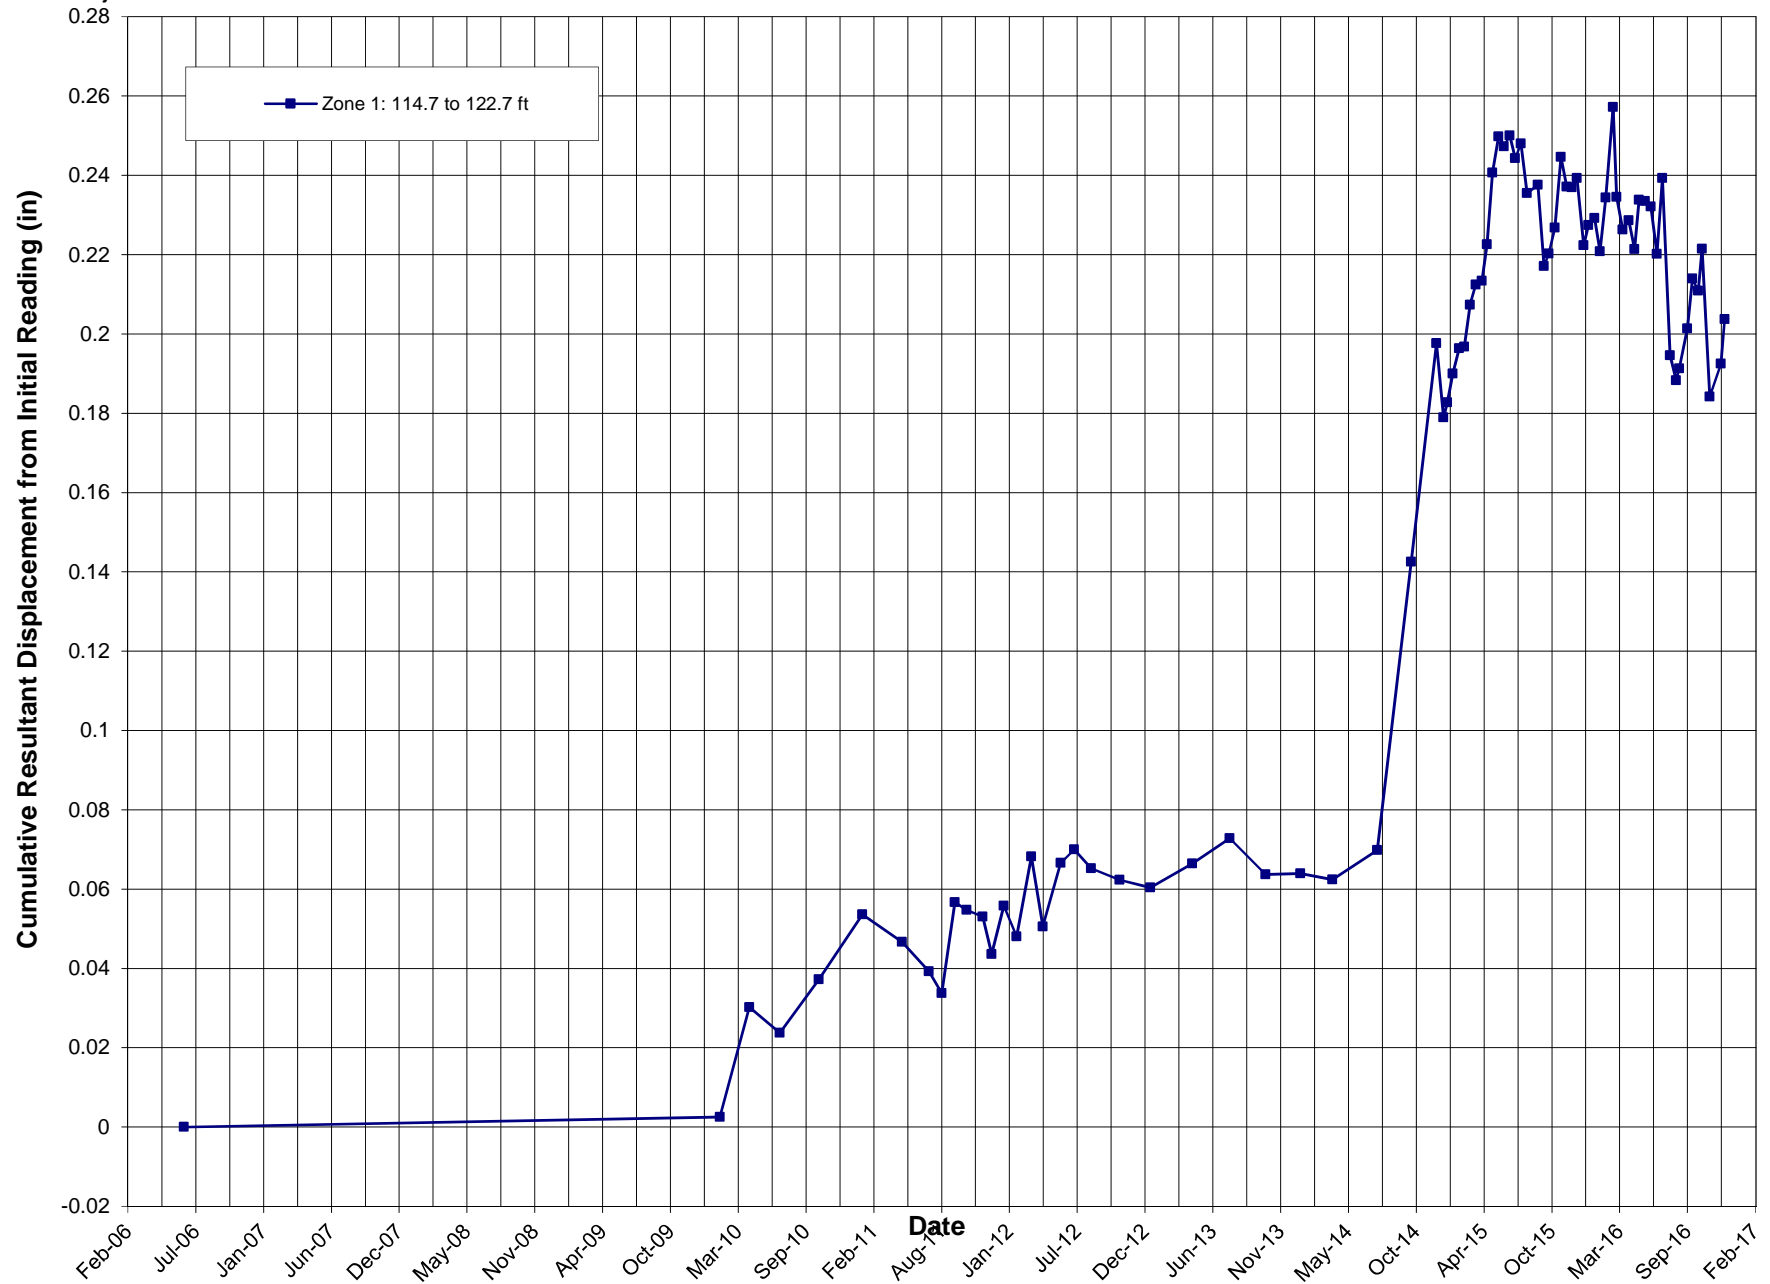
B-05-04 – The most recent pore pressure readings for the shallow piezometer at this location are not shown on the attached plot because they flat-lined at an unrealistically high value. We think this is due to a connection issue within the data logger since the temperature readings for this piezometer look good. We repaired the connection and will check the status again prior to the next readings. Pore pressure readings in the deep piezometer show virtually no change.

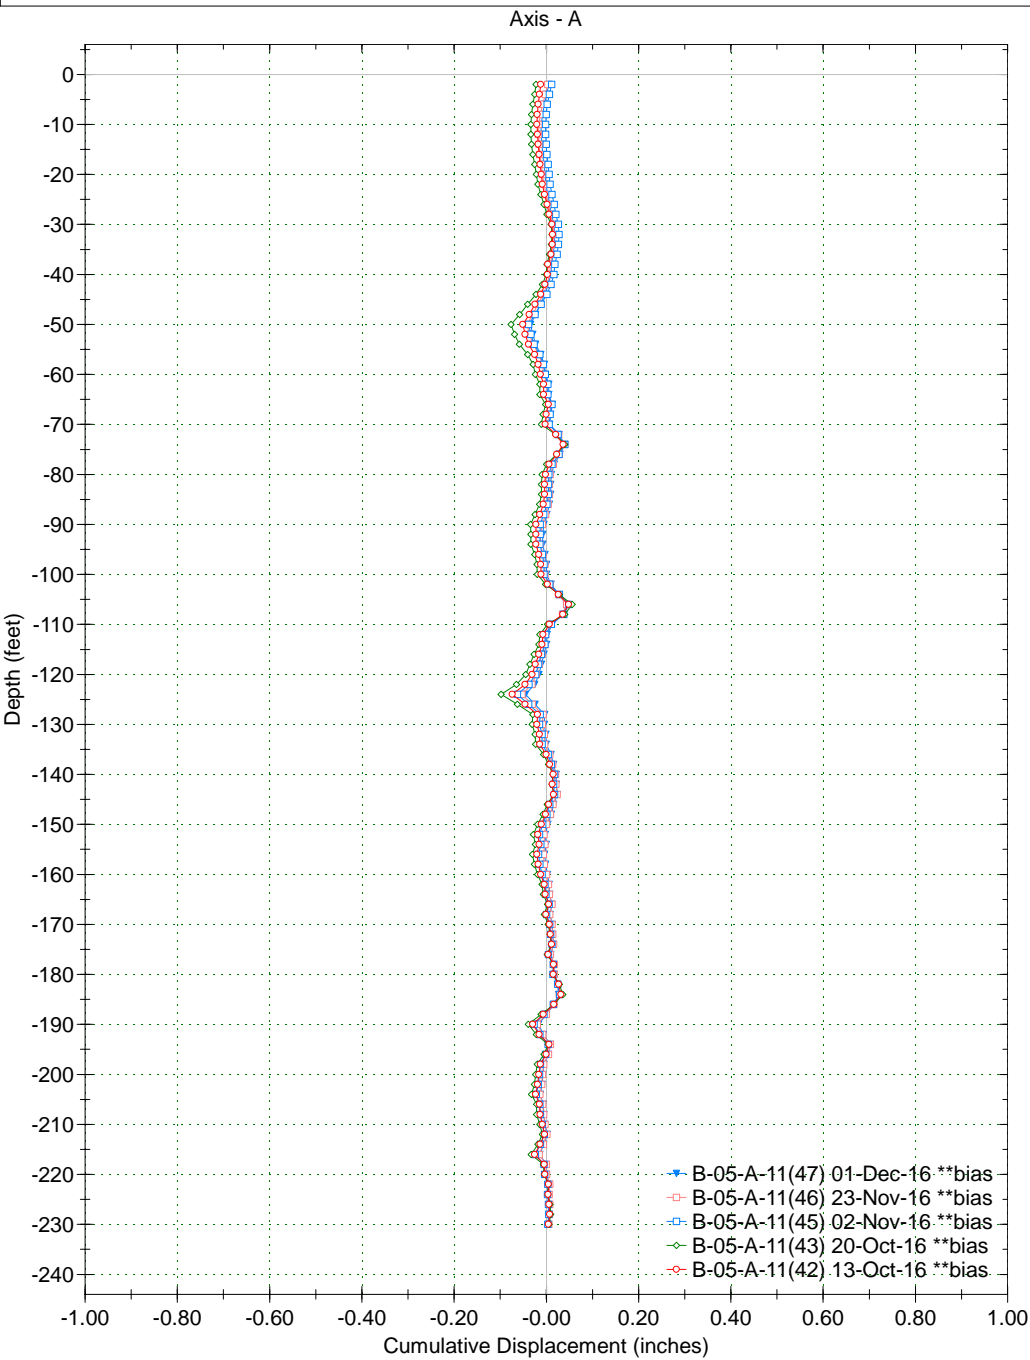
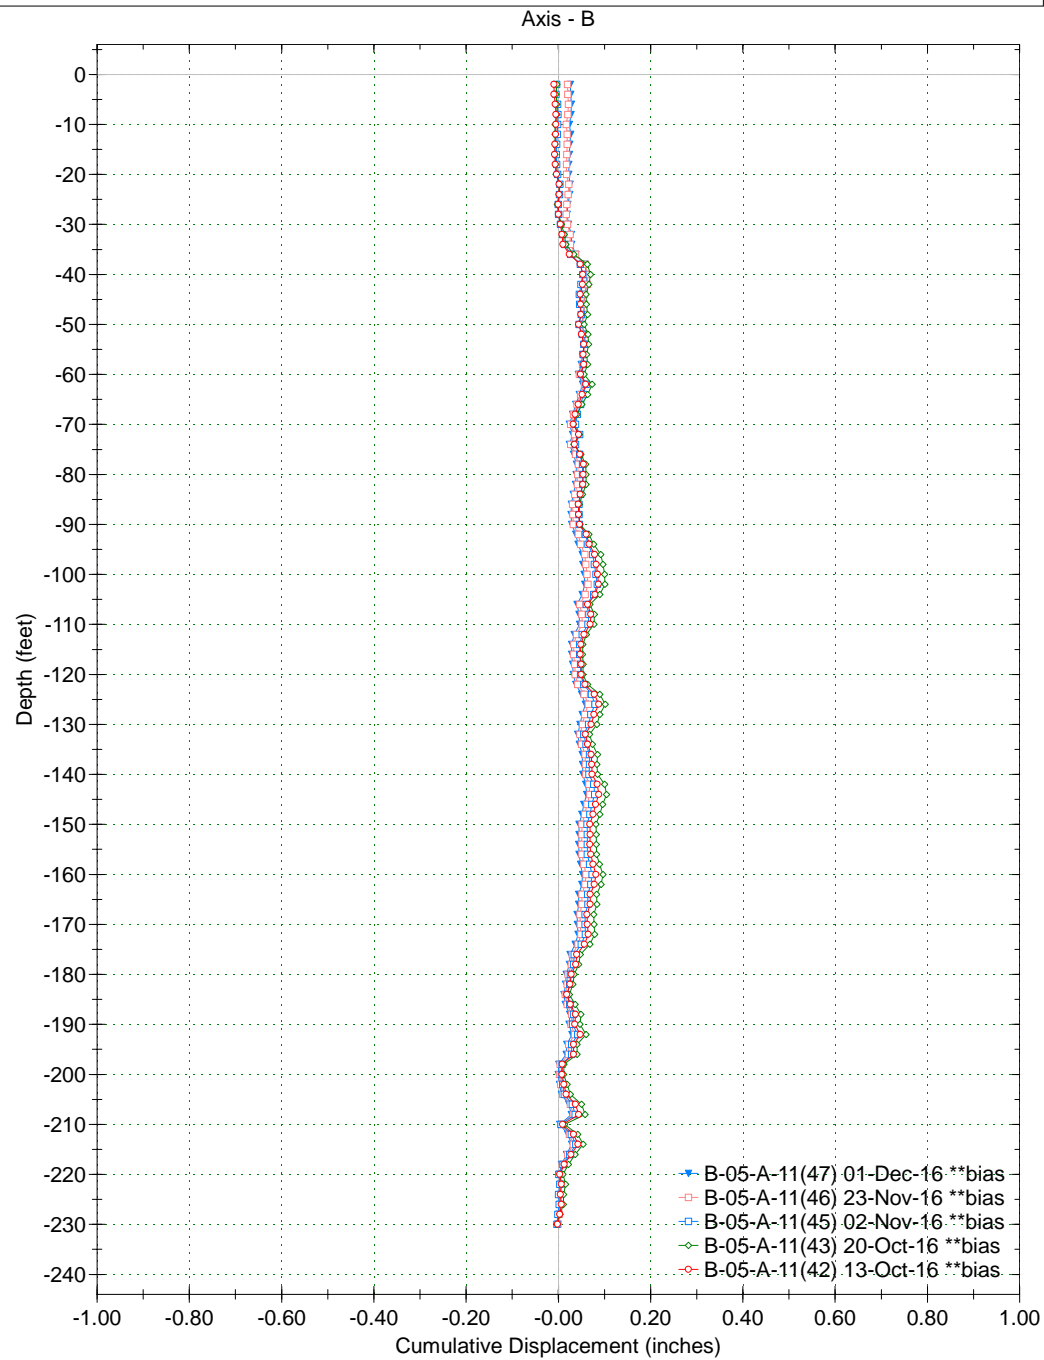
Borehole : B-05-A-11 230 ft
Project : CUY-90-15-24
Location :
Northing :
Easting :
Collar :

B-05-A-11 – Pore pressure in the deep piezometer at this location continued to decrease. Since September 23, 2016, the pore pressure has decreased by 1.5 feet. The data logger for the shallow piezometer stopped working about halfway through this reading cycle. Prior to that, the pore pressure readings showed virtually no change. We are working with the manufacturer to determine why this and other data loggers are failing.
