January 12, 2017

Re: December 19, 20, and 21, 2016 Bi-Weekly Readings
CUY-90-15.24 Slope Monitoring
PID 96504
SME Project No. 069032.00

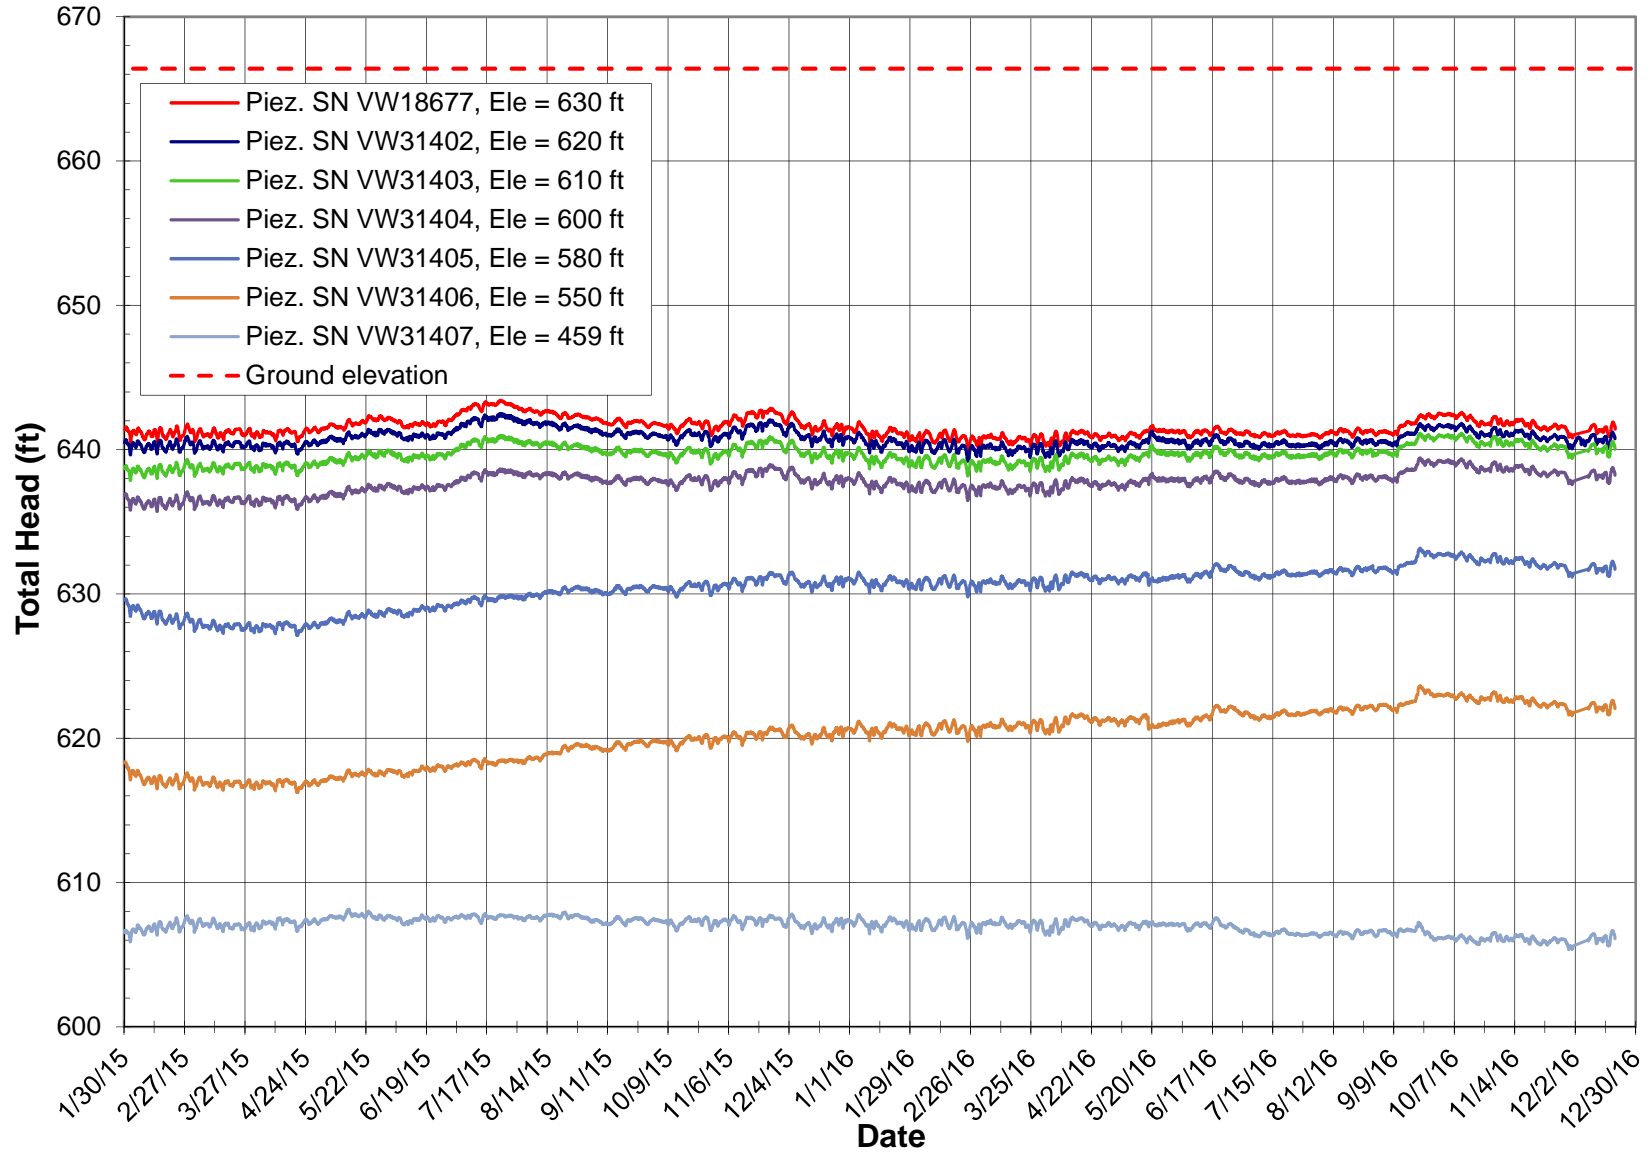
P-001-13 VW Piezometer Readings

Pore pressure readings at P-001-13, P-002-13, P-003-10, P-004-13, P-009-13, B-105A, and B-05-04 fluctuated by less than 1 foot and show virtually no net change in total head for the period.
