Re: January 3, 4, 5, and 6, 2017 Bi-Weekly Readings  
CUY-90-15.24 Slope Monitoring  
PID 96504  
SME Project No. 069032.00

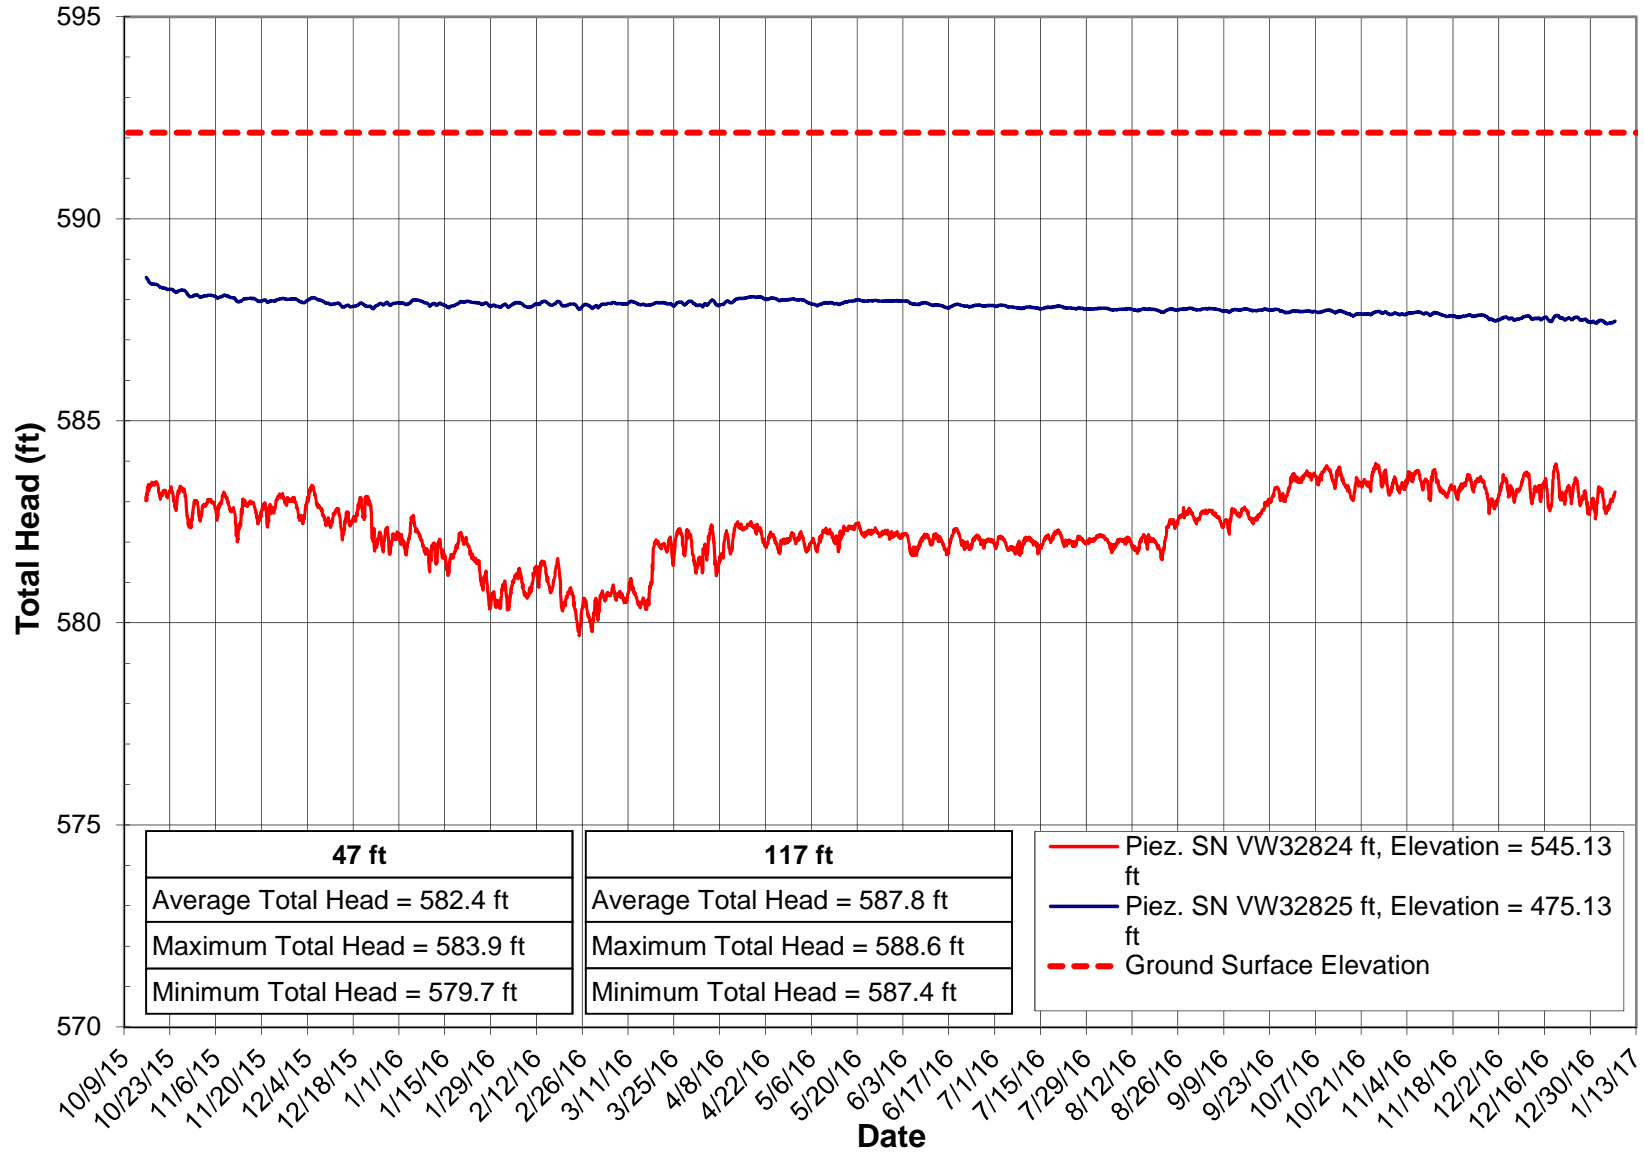
# P-004-13 VW Piezometer Readings

Pore pressure readings at P-004-13, P-009-13, and B-05-A-03 show changes in total head of less than 0.5 feet for the period.
