February 17, 2017

Re: January 18, 19, and 20, 2017 Bi-Weekly Readings
CUY-90-15.24 Slope Monitoring
PID 96504
SME Project No. 069032.00

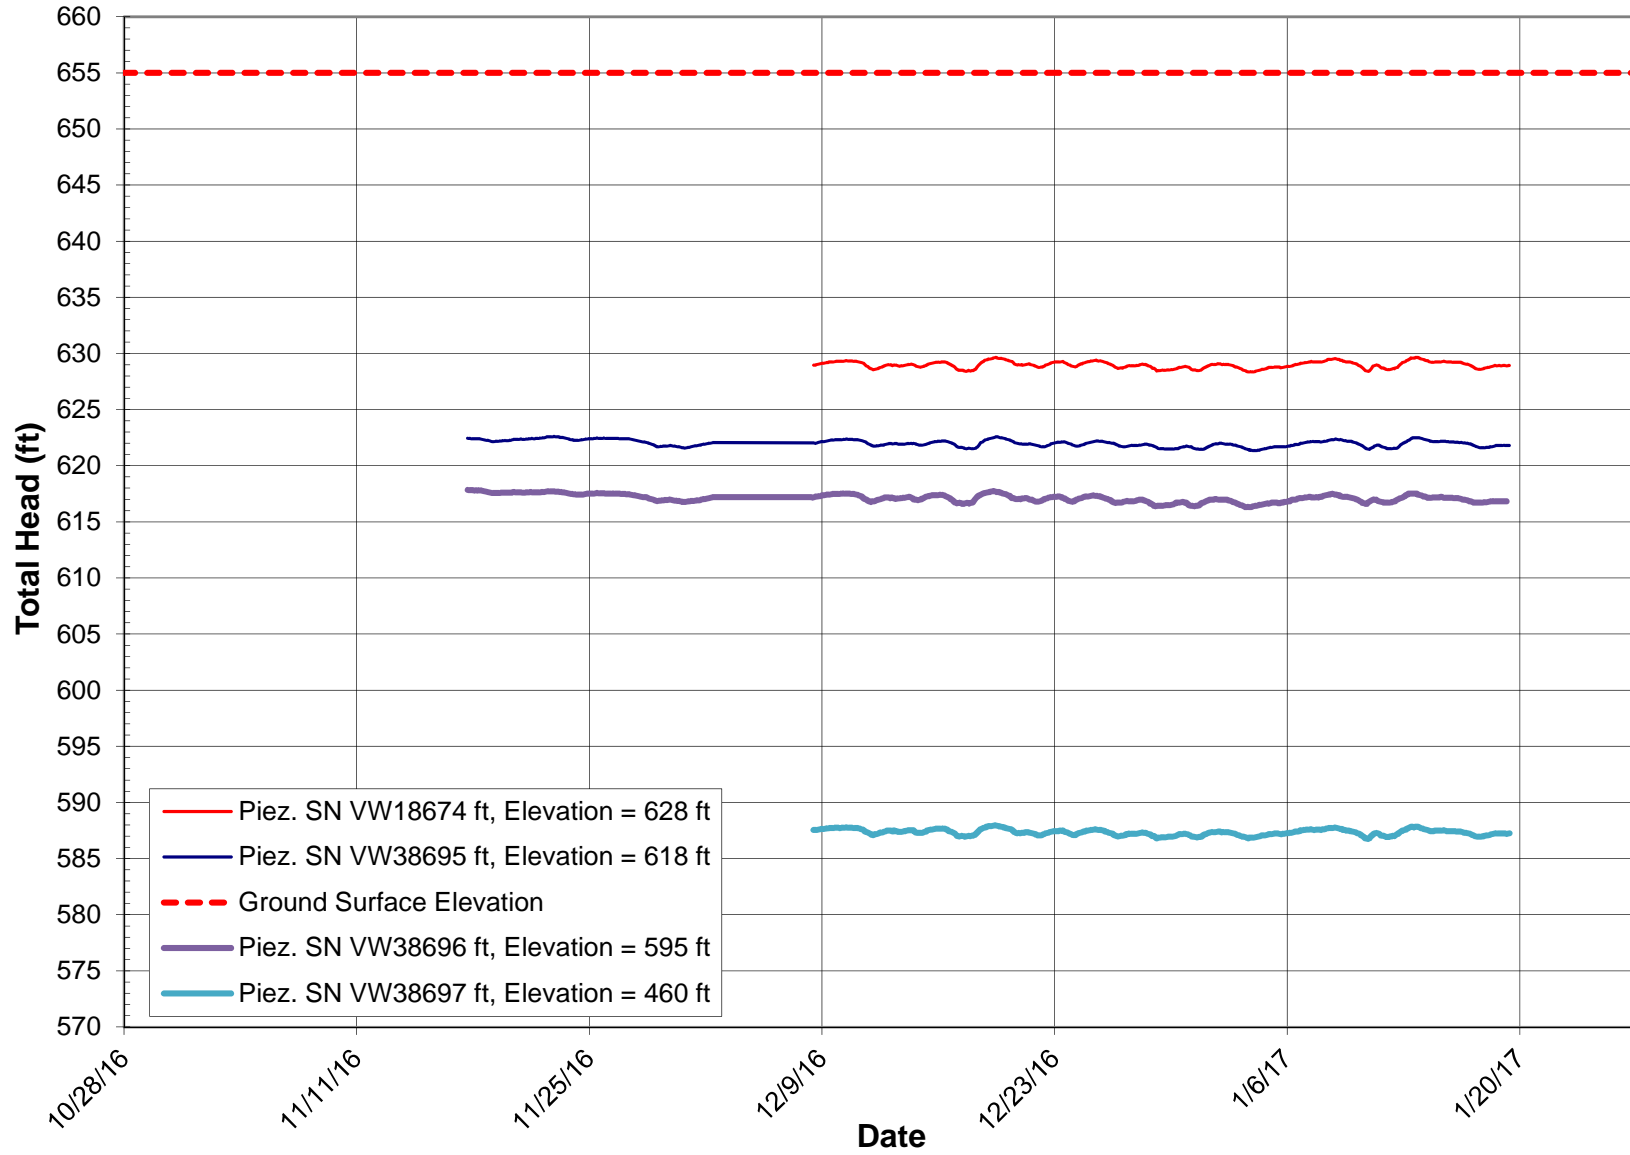
P-003-13 VW Piezometer Readings

Pore pressure readings at P-003-13, P-004-13, B-105A, B-05-A-03, B-05-04, and B-05-A-11 show changes in total head of less than 0.5 feet for the period.
