Re: January 2017 Quarterly Report  
CUY-90-15.24 Slope Monitoring  
PID 96504  
EDP Project No. 069032.00

# JANUARY 2017 QUARTERLY REPORT

CUY-90-15.24 SLOPE MONITORING  
PID 96504  
CLEVELAND, OHIO  
SME PROJECT NO. 069032.00

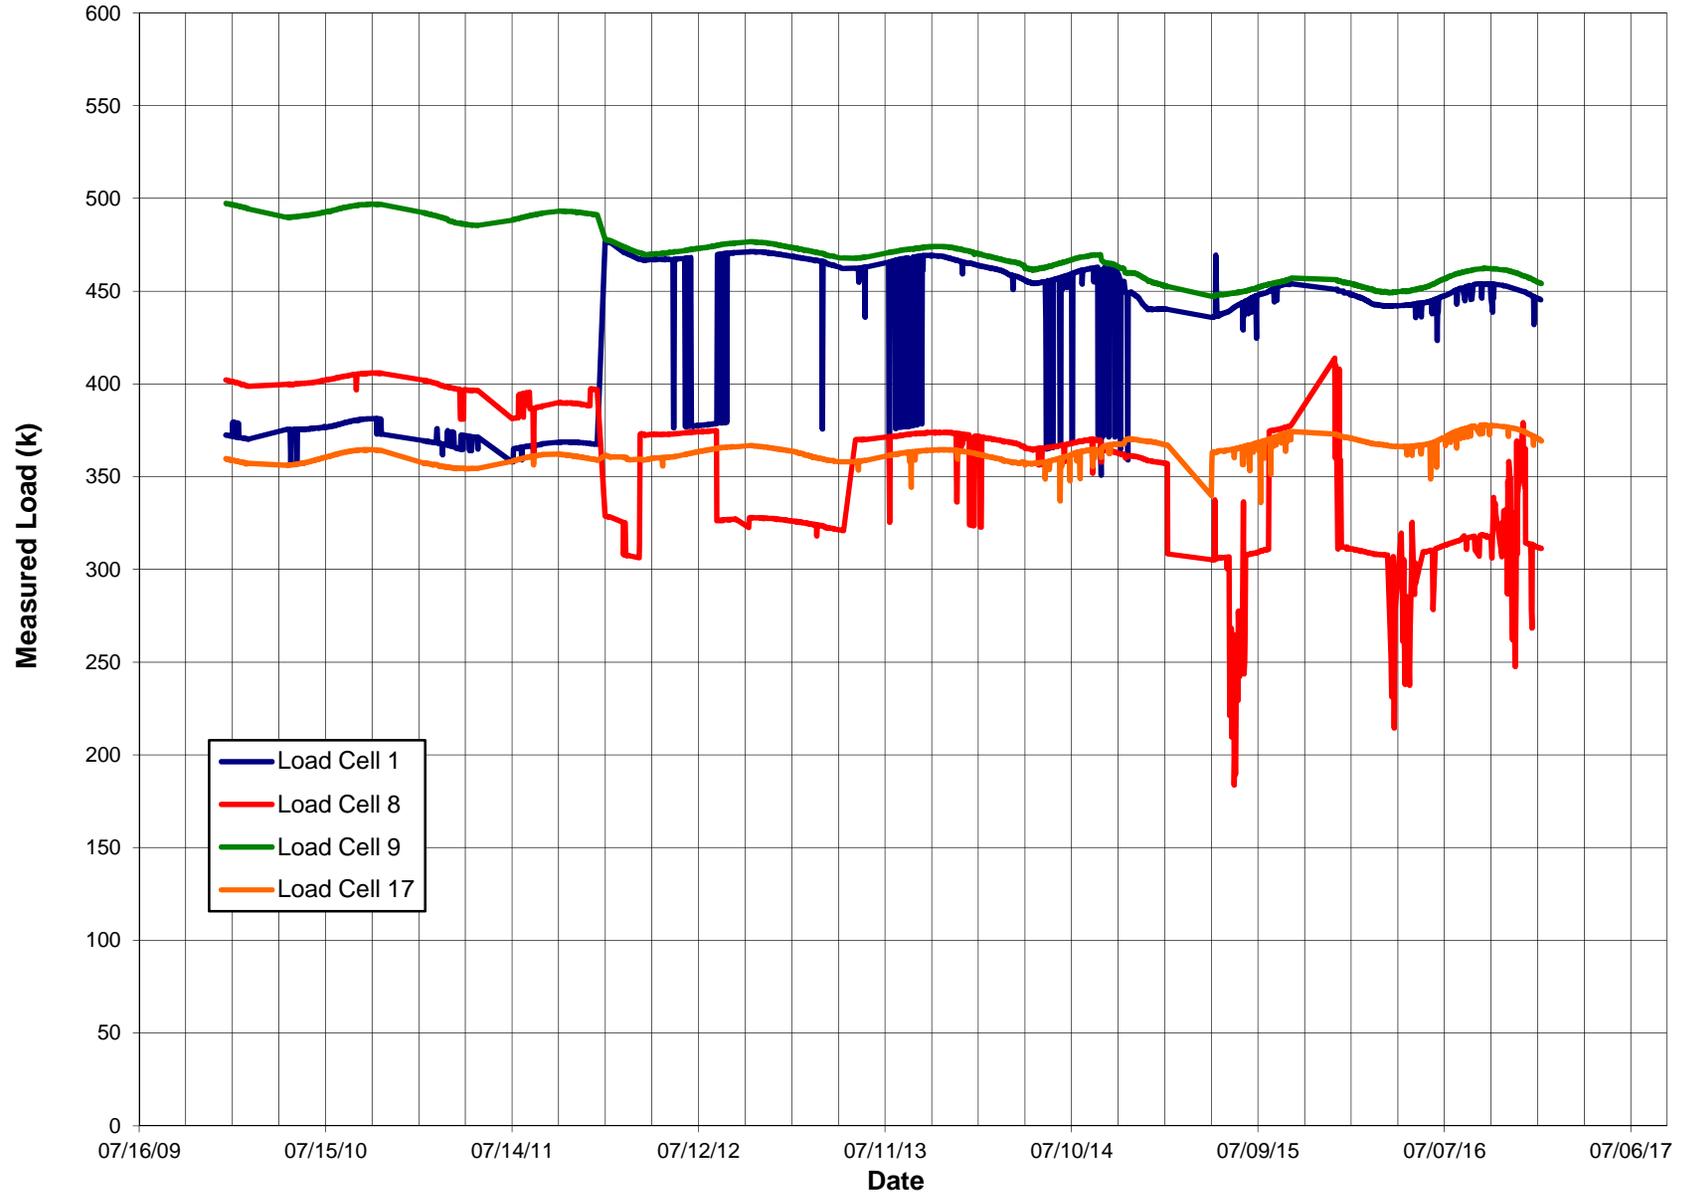
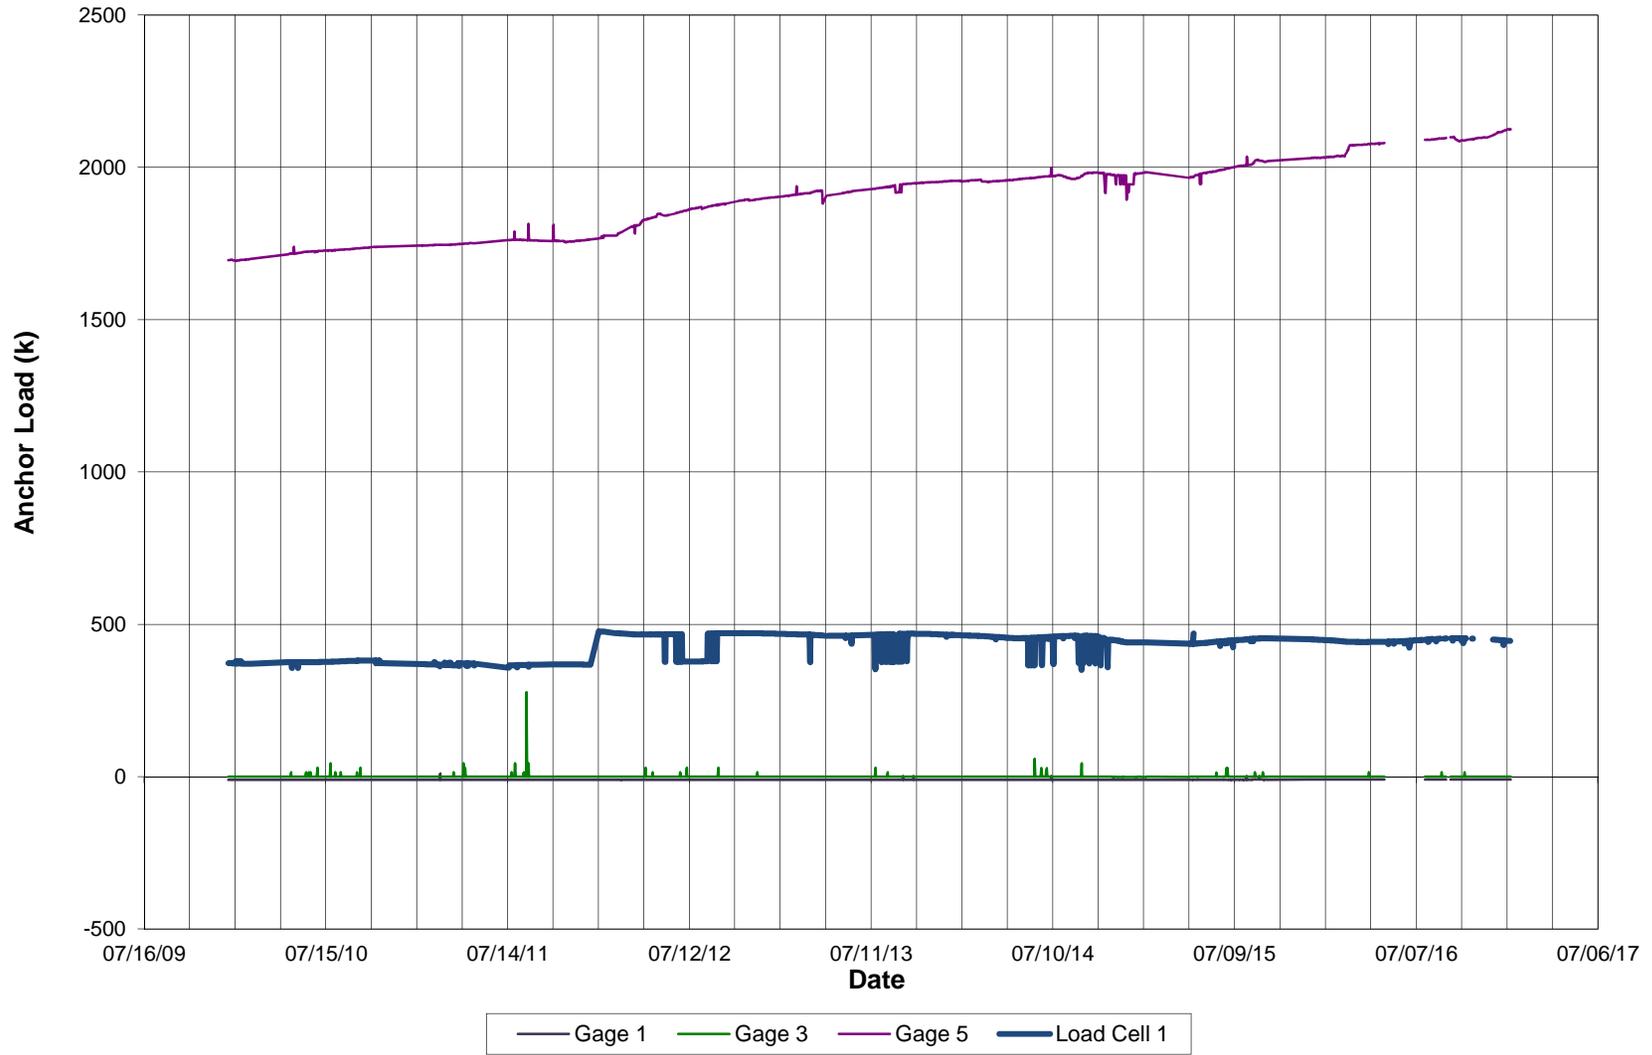
### Anchor #1 - Load Cell #1

Seasonal variations are apparent in the plots for all the load cells with the usual decrease in load occurring during the winter months. The plots for all load cells indicate a slight upward trend throughout 2016. The many spikes shown in the plot for Load Cell 8 occur when one or more of the gages in the load cell fail to record. These spikes are occurring in all load cells with the exception of Load Cell 9. Table 2 shows which gages were active in each of the load cells this quarter. A plot of the load cell data is included in Appendix B.
