Re: April 25, 26, 27, and 28, 2017 Monthly Readings  
CUY-90-15.24 Slope Monitoring  
PID 96504  
SME Project No. 069032.00

Monthly instrument readings at the I-90 west slope taken on April 25, 26, 27, and 28, 2017 are presented in this report. Monthly readings currently include instruments at I/P-001-13, I/P-002-13, I/P-003-10, P-003-13, I/P-004-13, I-008-10, I/P-009-13, B-101, B-102, B-105A, B-05-02, B-05-04, B-05-A-11, P-1, P-9N. Changes reported for the individual instruments are for the previous four-week period unless noted otherwise.

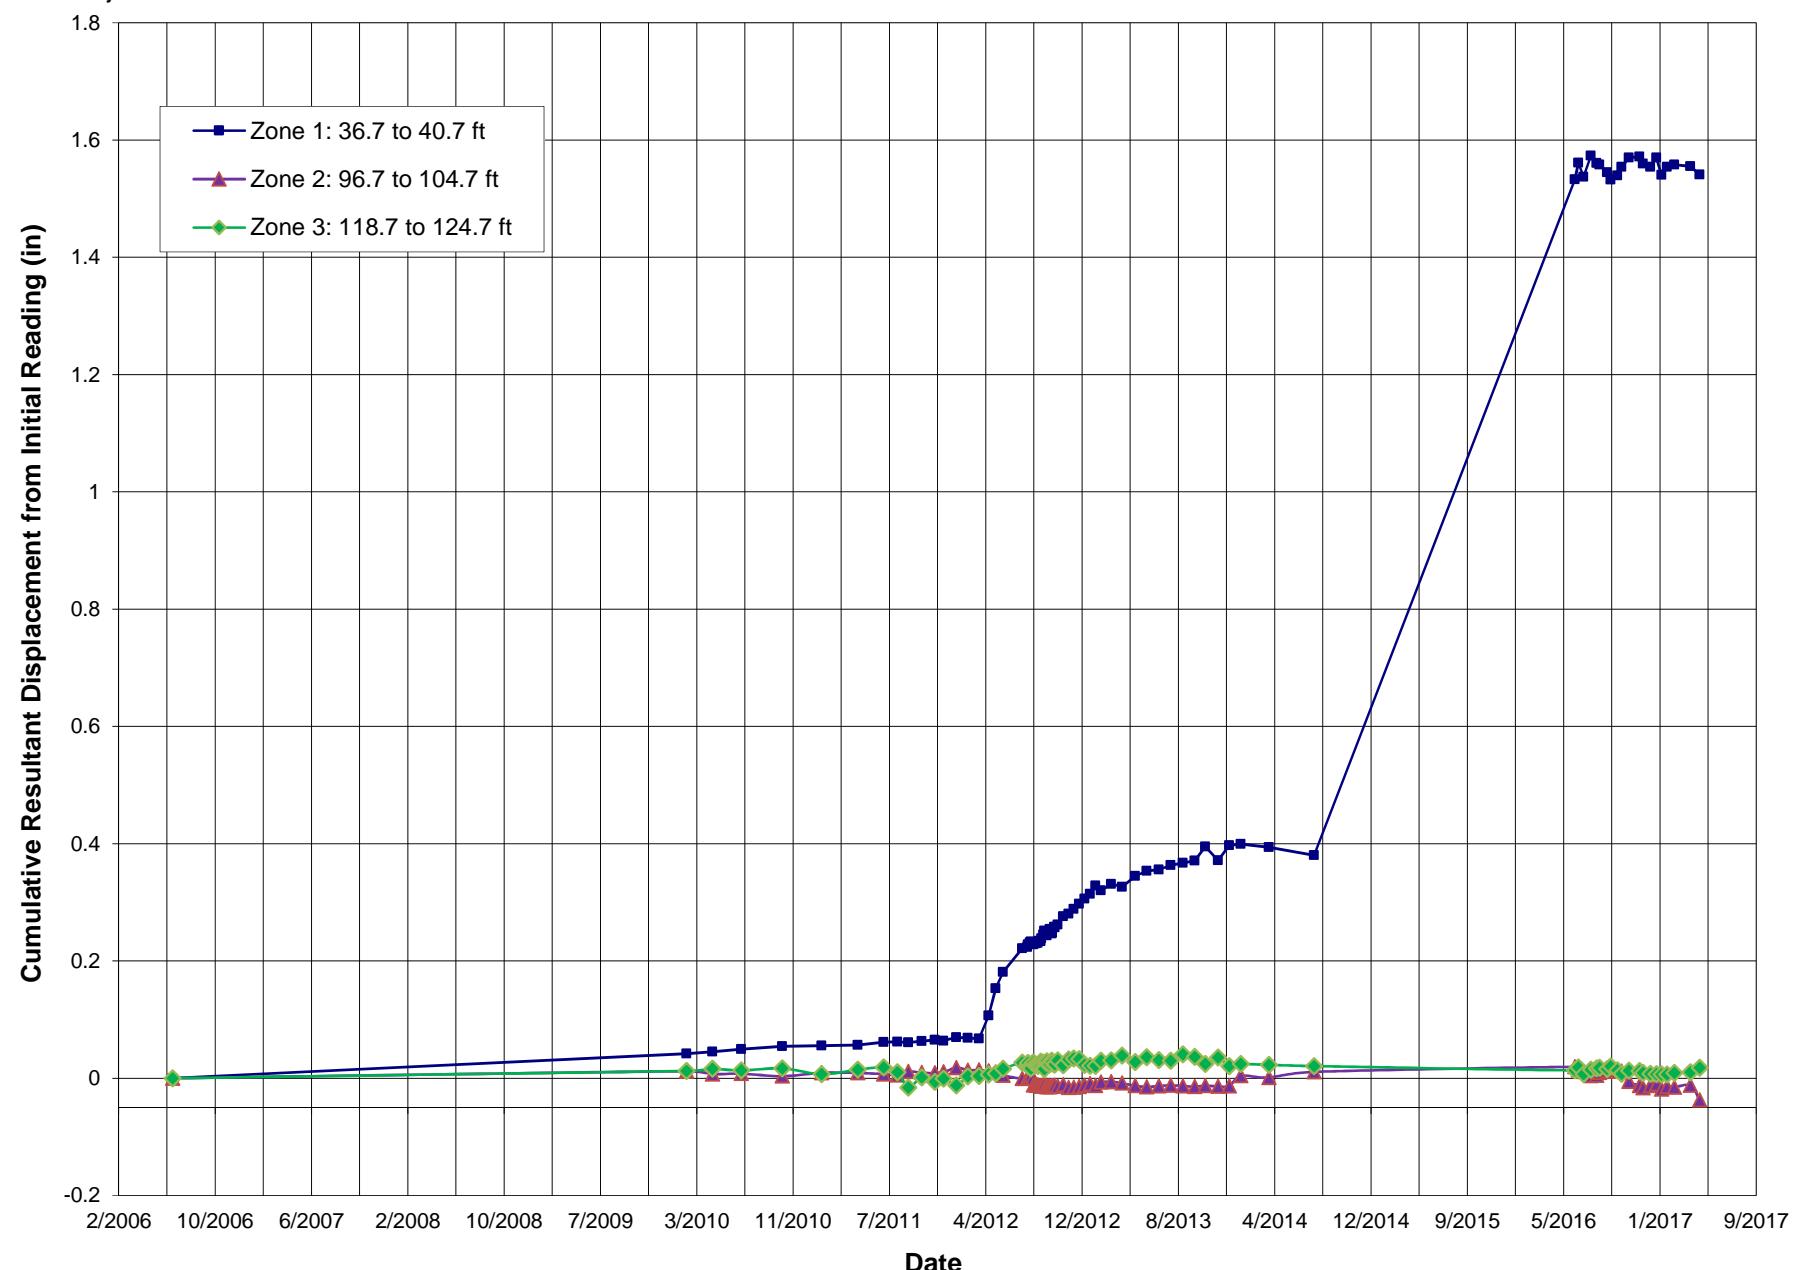
**B-05-02** – The top four readings at this location are fictitious. This is being done to preserve the ability to track current movement with the historic data. The ground surface at this location is actually at -8 feet relative to the top of casing in the plots. The current plot indicates movement of the top 8 feet of casing below the ground surface (16 feet below the 0 point in the plots). Rip rap was placed around this instrument which may be the cause of this movement.
