2019 PHYSICAL CONDITION FRACTURE CRITICAL INSPECTION REPORT

Bridge CUY-10-0869

SFN 1801325

S.R. 10 (Lorain Road) Bridge over the Rocky River Valley
Dates of Inspection September 9 to September 12, 2019

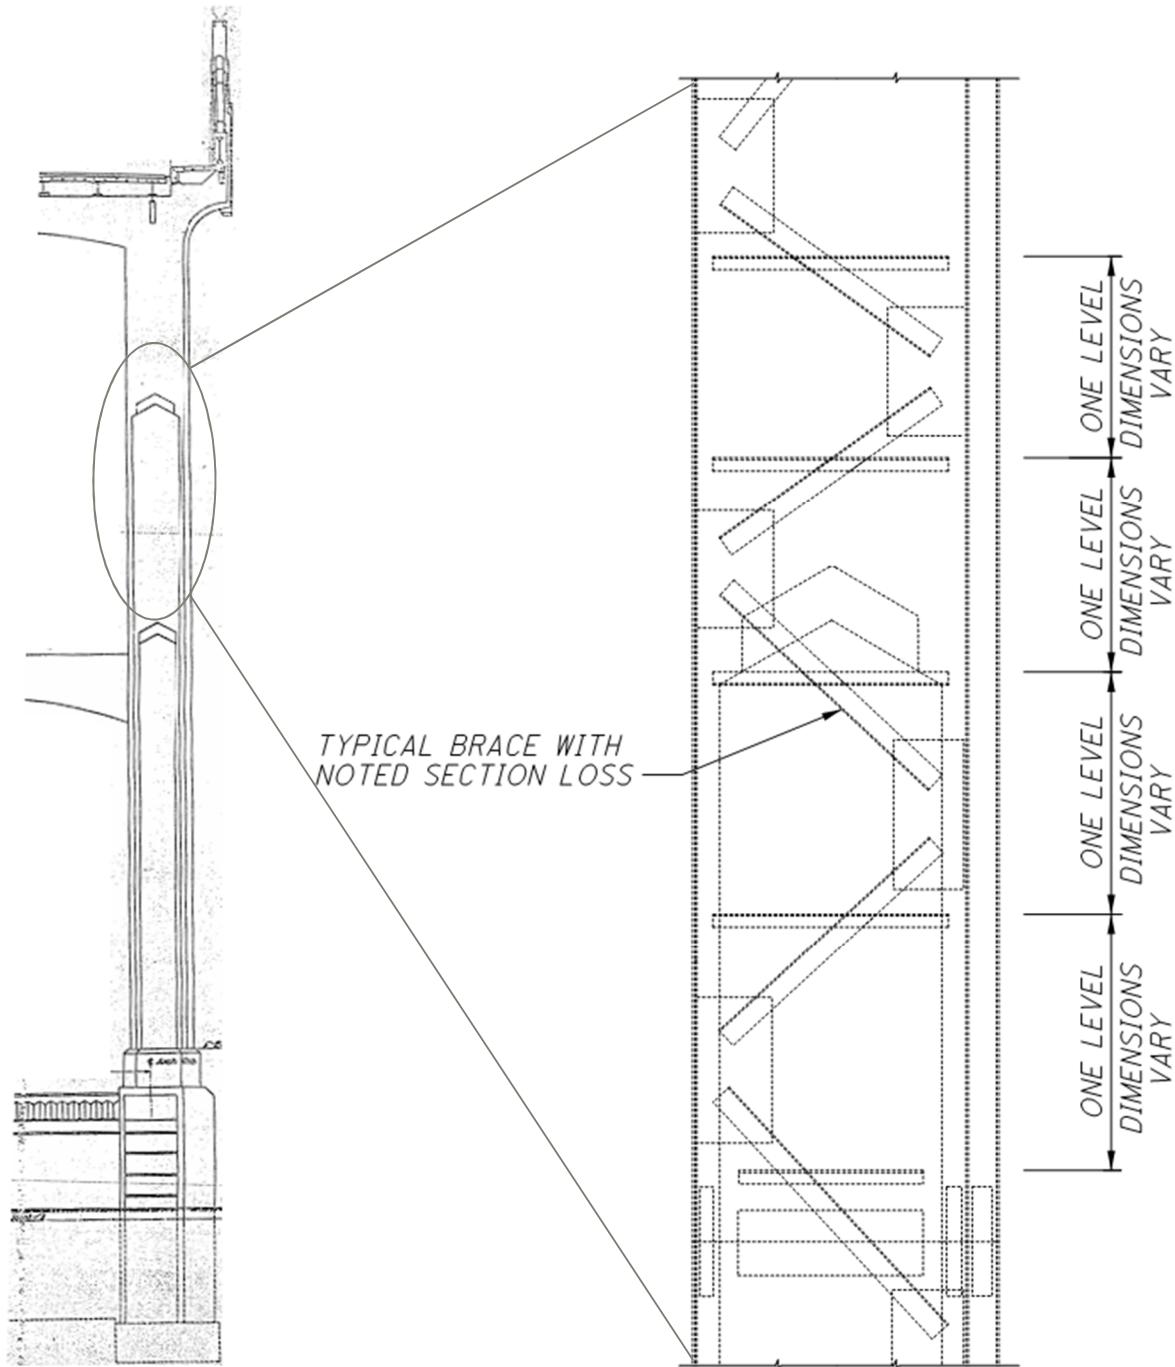
Partial Pier Elevation
Pier Column Interior Detail

The following table of deficiencies were also noted (levels are numbered between internal horizontal bracings starting from 1 at the bottom of the pier column):

PIER	TOWER	COMMENTS
2	North	Broken access door latch, closed by $\frac{3}{4}$ " bolt only
4	South	Broken access door hinges
5	Both	Broken access door latch
5	North	Missing rivet in between levels 2-3, 6-7, and 11-12
6	Both	Broken access door hinges
6	North	Missing rivet at top level
7	North	Up to 12" deep piles of flaking rust along the base of the interior of the tower, access ladder attachment plates show severe section loss, plate to center cross brace exhibits section loss reducing width by 4" or more
7	South	Missing rivet on level 3, 4, 5, 8 and the top level
8	South	Missing rivet on level 4
8	North	Missing rivets on level 4, 5, 7 and 11
8	South	Broken access door hinges and latch
