2020 PHYSICAL CONDITION ELEMENT LEVEL INSPECTION REPORT

Bridge CUY-176-1334

SFN 1805436

S.R. 176 NB (Jennings Freeway) under I-71 NB

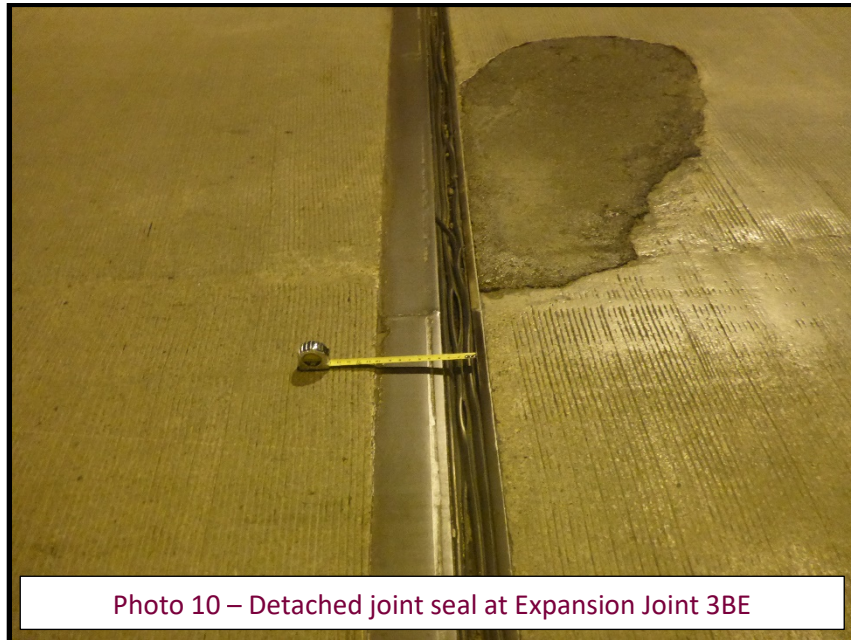
At Expansion Joint 1B, the joint seal is broken and coming out of the joint on the left shoulder. At Expansion Joint 2BW, the seal is coming out of the joint on both shoulders and **cars driving in the right lane make a sound when driving over the joint that seem to indicate a portion of the joint was loose**. At Expansion Joint 2BE, the joint seal is broken and coming out of the joint on the left side (Photo 9) and **the joint metal is sticking above the wearing surface on the left side**. At Expansion Joint 3BE, the entire joint seal is becoming detached and appears wavy (Photo 10).

Photo 10 – Detached joint seal at Expansion Joint 3BE

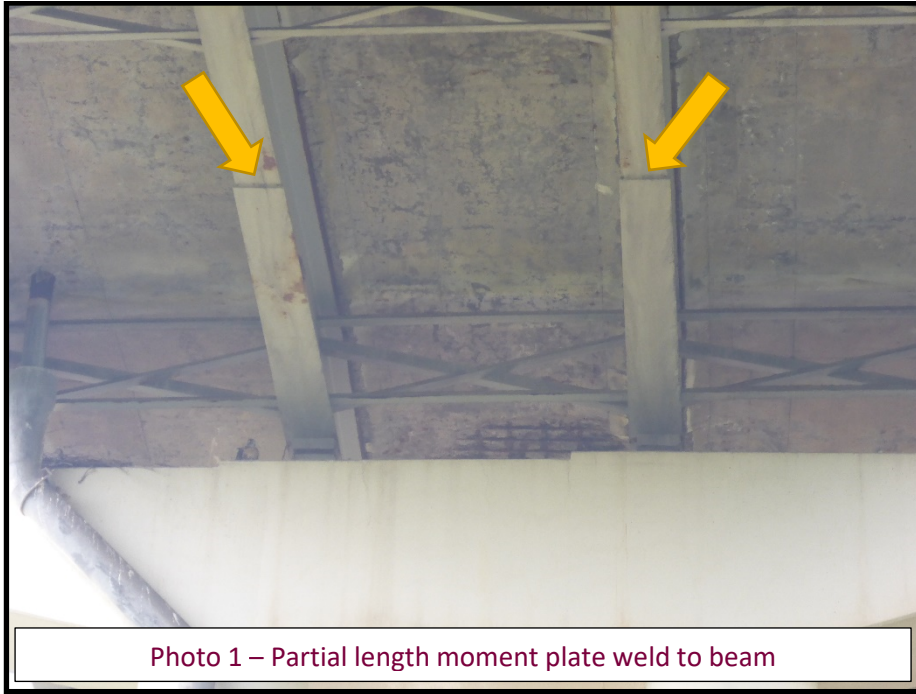
Photo 1 – Partial length moment plate weld to beam
