2025 PHYSICAL CONDITION ROUTINE ELEMENT LEVEL INSPECTION REPORT

Bridge CUY-10-1613

SFN 1801503

Hope Memorial/Lorain Carnegie over Cuyahoga River

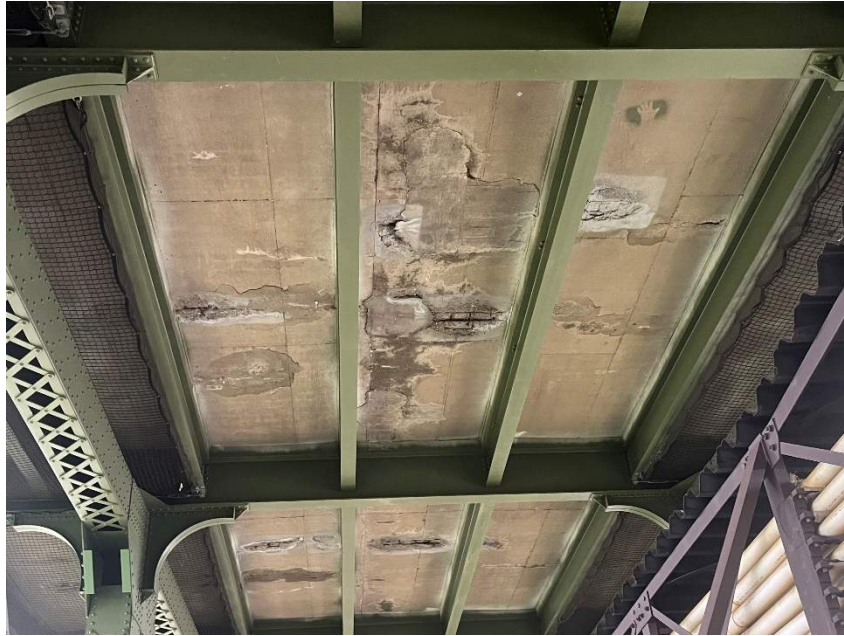
The deck is in **Satisfactory** condition. The underside of the deck has areas of spalling with exposed rebar, delaminations, cracking with efflorescence, and failing patches noted throughout (Photos 1 & 2). Heavier concrete deterioration is noted near the joints and scuppers. Many of the previous spalls have been coated with a spray-on cathodic protection, but corrosion is reactivating at some of these locations. The newer spalls that do not have the cathodic protection applied exhibit minor section loss on the reinforcing. Netting and/or wood falsework are in place over the roadways and parking lots to prevent loose concrete from falling into traffic (Photo 3). There was spalled concrete caught in the netting, and it should be removed before more spalls fall off and overload the netting. There is a paved parking lot between Pier 3 and 4, and there is no netting on the underside of the maintenance deck in this area.

Photo 1: Typical Spalls with Exposed Rebar, Delaminations, Cracks with Efflorescence, and Failing Patches on the Deck

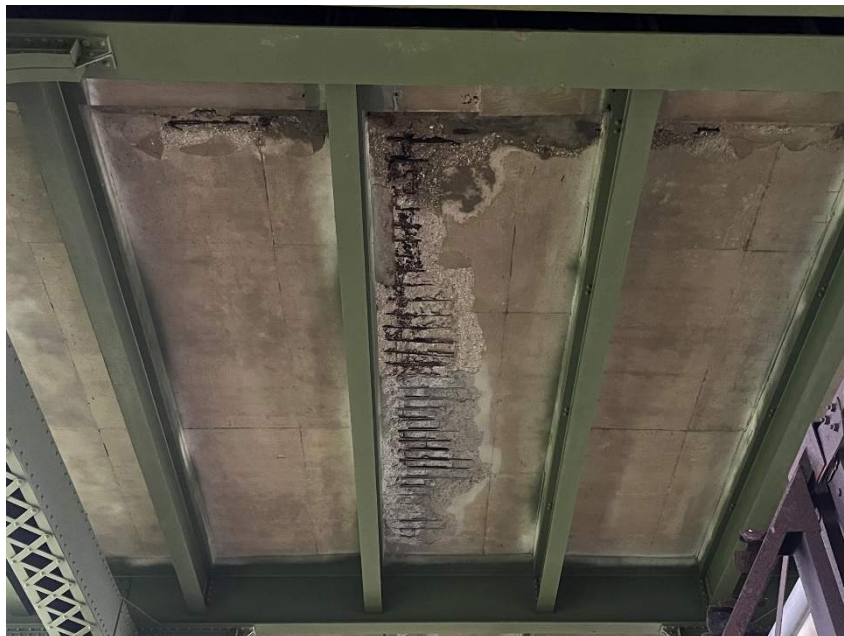
Photo 2: Large Spall with Deteriorated Rebar on the Deck in Span 12

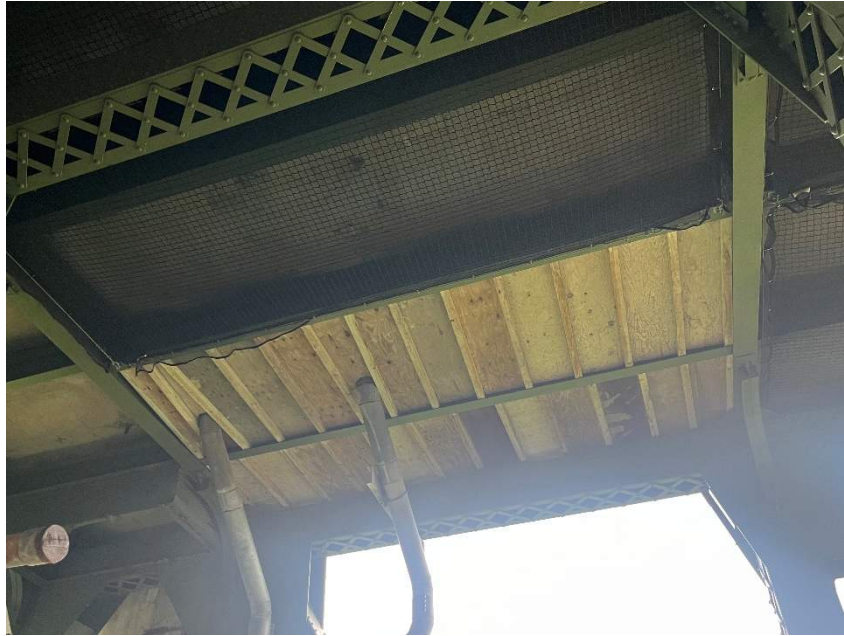
Photo 3: Typical Netting and Falsework Below the Deck

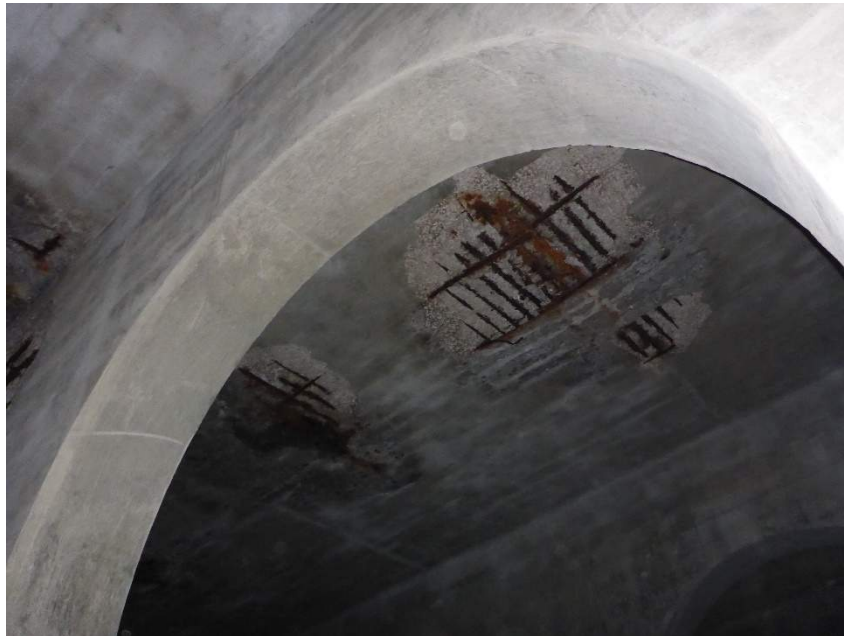
The deck in east approach spans between Column 6A and the east end exhibits areas of cracking, saturation, delamination, and spalling with exposed reinforcing, with section loss ranging from minor to complete (Photo 4). The deck in the west approach unit has areas of spalling with exposed rebar, delamination, and cracking with efflorescence. For specific deck deficiencies and locations, see Table 1 and Approach Span Drawings in Appendix C.

**Photo 4: Typical Spalls with Deteriorated Rebar on the Deck in the East Approach Spans
(2024 Inspection Photo)**

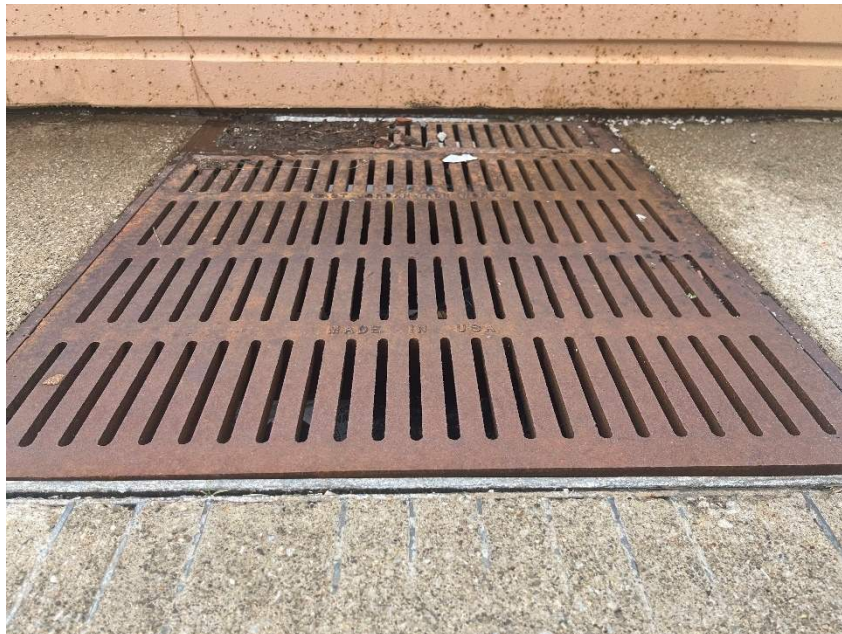
The deck drainage is in **Poor** condition. The drainage recesses covered by grates in the north sidewalk are clogged with significant debris (Photo 5). Otherwise, there is minor debris in the deck scuppers and recesses, and some isolated surface corrosion below the deck in the drainage downspouts. At Pier 6, two of the manhole covers at the base of the pier are missing.

Photo 5: Typical Clogged Drainage Recesses Covered by Grates in the North Sidewalk

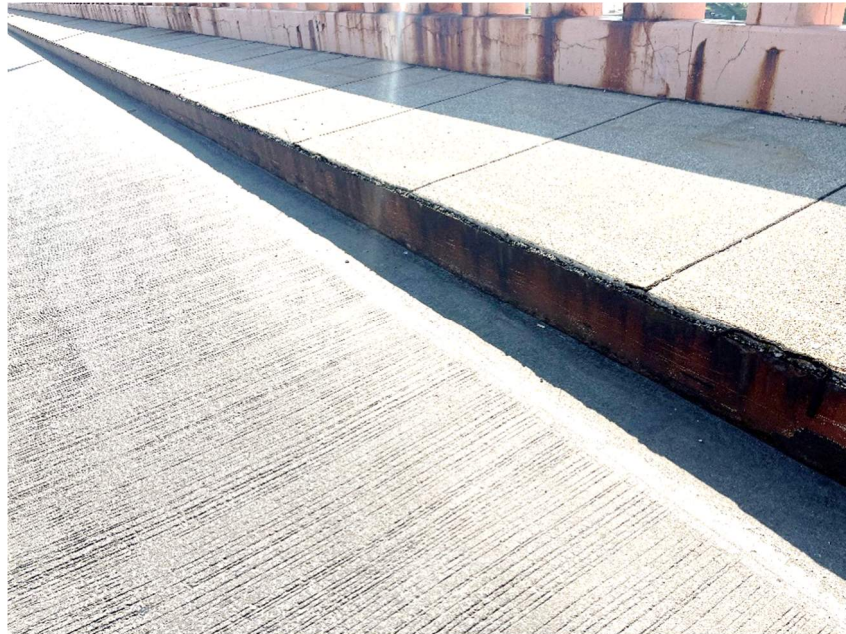
The concrete and steel plate curbs and concrete sidewalk are in **Fair** condition. The steel plate curb on the south sidewalk exhibits rust (Photo 6). Both sidewalks have isolated areas of delamination and light cracking with efflorescence (Photo 7). The south sidewalk shows more deterioration with some areas of spalling and the seal between the top of the steel curb plate and the concrete is deteriorating with vegetation growing in many of the cracked areas adjacent to the curb. On the south sidewalk in Span 7, there is a 9'x4'x1" spall with deteriorated reinforcing on the sidewalk (Photo 8). For specific sidewalk deficiencies and locations, see Table 1 in Appendix C.

Photo 6: Typical Rusting Steel Curb Plate on South Sidewalk

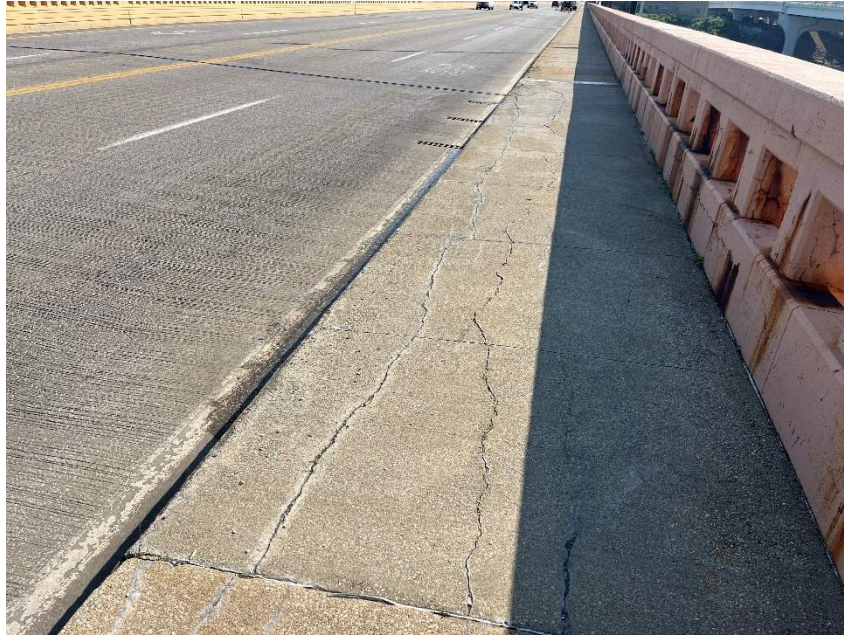
Photo 7: Typical Cracks on Sidewalks

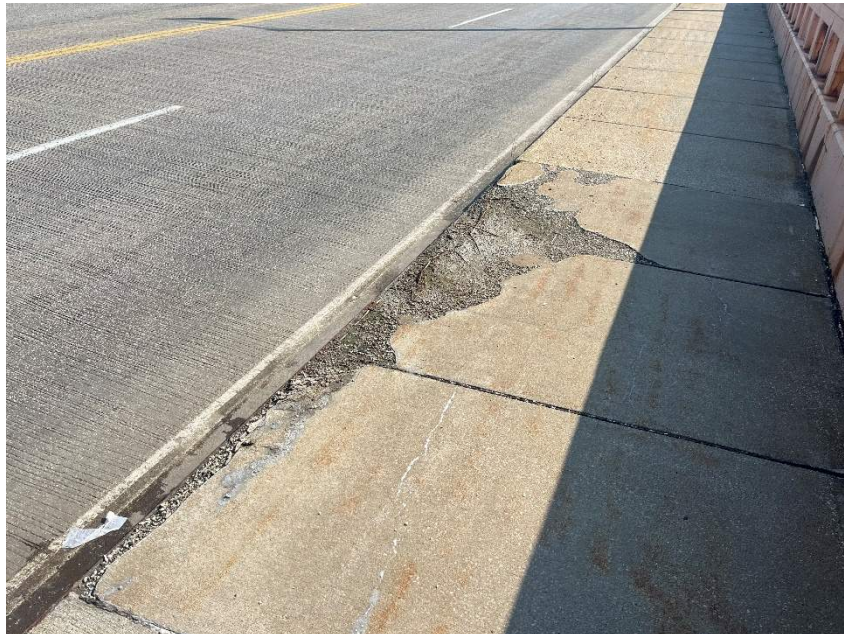
Photo 8: Spall with Deteriorated Reinforcing in Span 7 of South Sidewalk

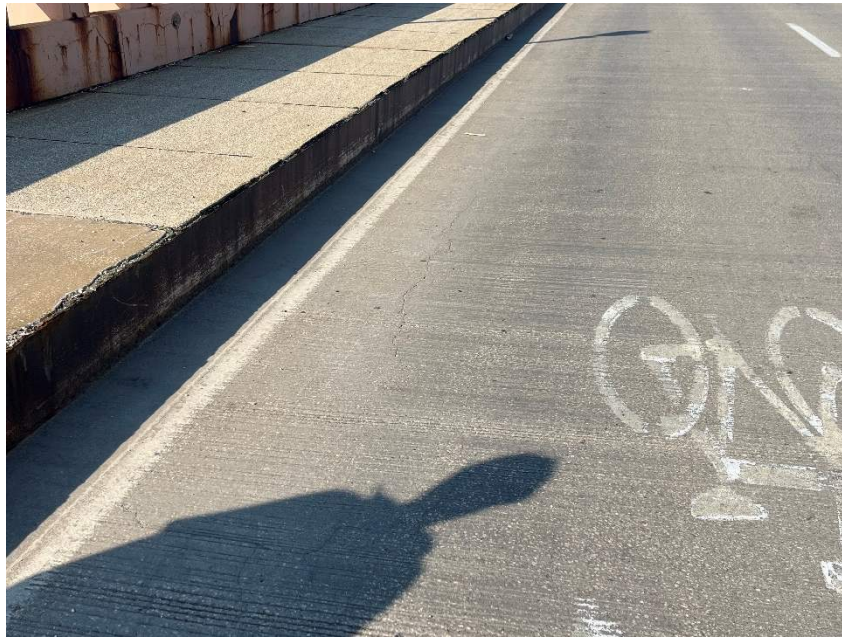
The microsilica concrete wearing surface rating is a **7**, indicating that it is in **Good** condition. There are isolated longitudinal, transverse, and map cracks up to 1/16" wide throughout the deck (Photo 9), and several areas with shallow potholes, some of which have been patched with asphalt. For specific wearing surface deficiencies and locations, see Table 1 in Appendix C.

Photo 9: Typical Minor Cracks in Wearing Surface

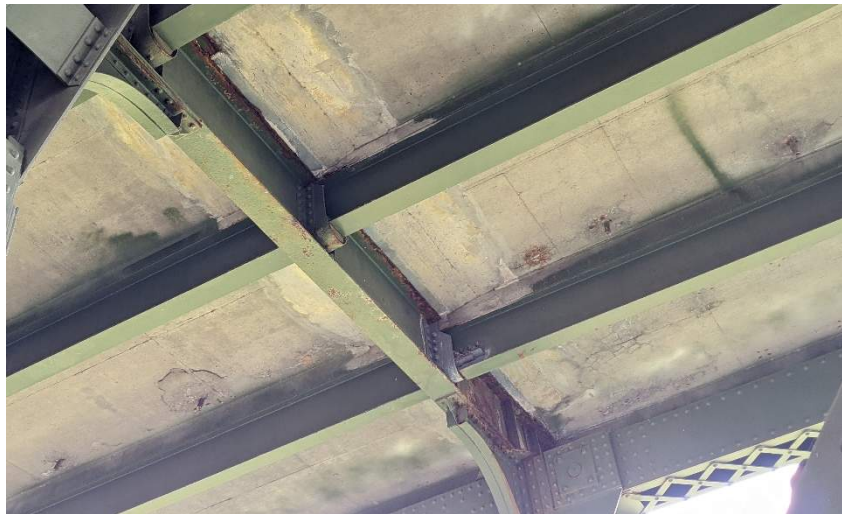
The stringers are in **Satisfactory** condition. There are isolated areas of active corrosion at the floorbeam connections and fascia stringers, with some minor section loss. There are isolated locations of corrosion holes which were previously cleaned and painted, and in some locations, repaired (Photo 10). For specific stringer deficiencies and locations, see Truss Drawings in Appendix C.

Photo 10: Stringer-Floorbeam Connection Repair

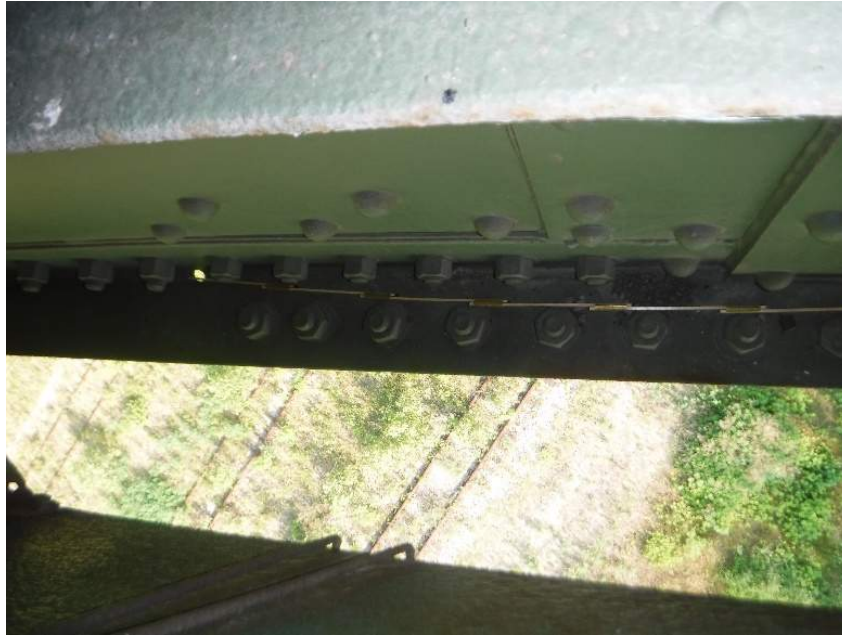
The lower chords have varying degrees of section loss and pack rust located between the flange angles and the web plates. This pack rust measures up to 2" thick, causing significant distortion of the web plates and flange angles. Portions of the flange angles and webs of the lower chords have pockets of deep pitting or corrosion holes. The greatest section loss is typically located in Spans 11 and 13. In these spans, twelve (12) lower chord members had section loss measurements between 5% and 22%, as previously reported by the 2014 Inspection Report with no notable progression since that inspection. Bolted plates have been placed in some areas to repair areas with corrosion holes and advanced section loss. The lower chords, mainly in Span 12, have some cracks in the flange angles. The cracks typically run longitudinally along the fillet welds between the legs of the flange angle. Crack arrest holes have been drilled at some of the crack locations (Photo 11).

Photo 11: Crack Arrest Hole at Bottom Flange L3-L4 5" West of the West end of the Crack in the South Lower Flange angle at L4 of North Interior Truss

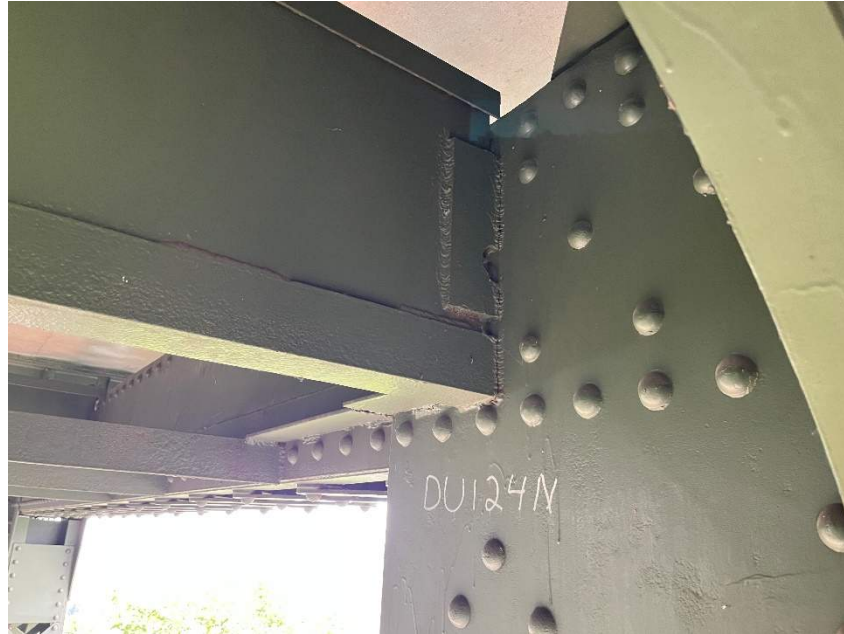
The upper chords are in overall good condition, with some areas of painted over pitting and minor section loss. There are a couple locations with active pack rust between the upper chord member and gusset plate. At deck joints and junction box drains, leakage is causing active corrosion to upper chord members. There is dirt and construction debris present below the expansion joints inside some upper chord connections with the verticals. At several locations, abandoned drainage or utility brackets are welded to the webs. At U0-U1 of the Span 8-9-10 South Exterior Truss, the welds to one of these brackets is cracked. At U4-U5 of the Span 6-7-8 South Exterior Truss, there are five (5) cracked welds at the inboard web and at the U4 inboard gusset plate (Photo 12). At U6-U7 of the Span 2-3-4 South Exterior Truss, there are several cracked welds around the abandoned utility support.

Photo 12: Cracked Weld of the Abandoned Utility Attachment at U4-U5 of the Span 6-7-8 South Exterior Truss

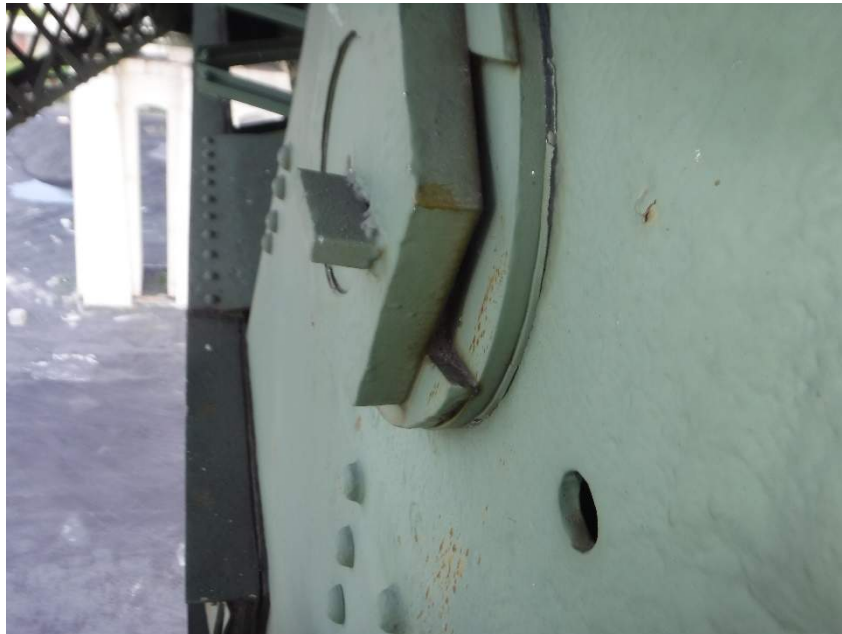
The pins, hangers, and hinges are in **Fair** condition. Minor to moderate section loss and pack rust were noted on the pins and the adjacent plates. At some locations, minor misalignments of the pins were noted (Photo 13). More severe defects of pins and adjacent plates noted previously were repaired as part of the most recent rehabilitation. For specific pin, hanger, and hinge deficiencies and locations, see Truss Drawings in Appendix C.

Photo 13: Recessed Pin at L17 in **Span 9** of North Interior Truss

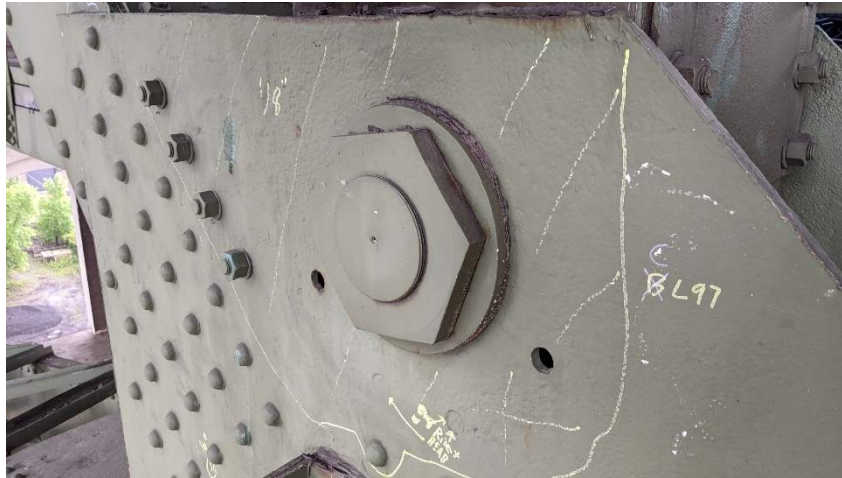
edges and at ends of the diagonal connections. Rivet head loss is also common at these locations. At pin locations, the gusset plates typically have section loss and pitting around the pins (Photo 14). Minor bows were noted along the free edges of the gusset plates due to pack rust buildup. The upper chord gusset plates are in good condition with little corrosion and pitting observed, except at locations of deck joint leakage where some section loss and pack rust are present. The free edges of many of the gusset plates have been stiffened during the most recent rehabilitation. For specific gusset plate deficiencies and locations, see Truss Drawings in Appendix C.

Photo 14: Gusset Plate at L0 in Span 4 of South Interior Truss

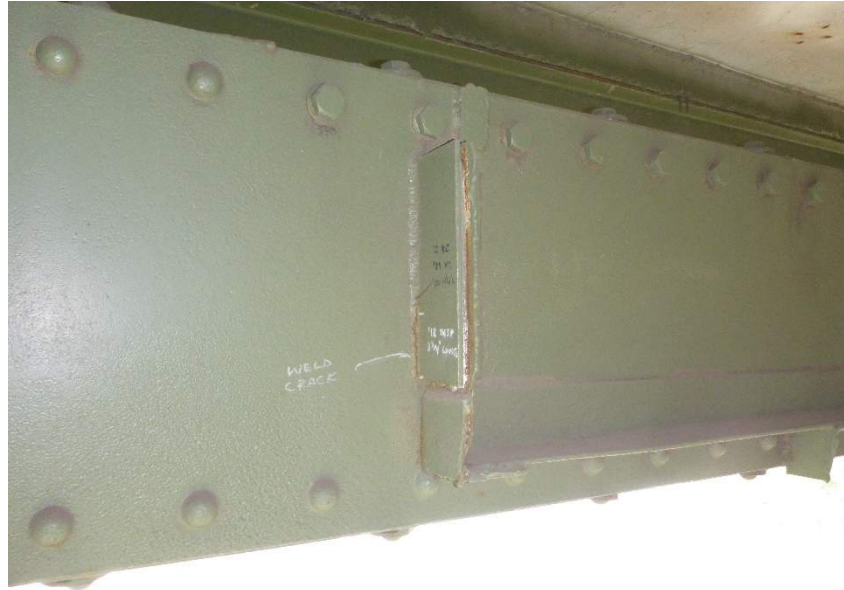
The Fatigue Prone Details are in **Satisfactory** condition. Fatigue prone details are present on the abandoned drainage and utility brackets, which are welded to the upper chords and diagonals. At U0-U1 in Span 10 of the Span 8-9-10 South Exterior Truss, the welds to one of these brackets is cracked, but the crack does not propagate into the base metal (Photo 15).

Photo 15: Weld Crack at U0-U1 in Span 10 of South Exterior Truss (2024 Inspection Photo)

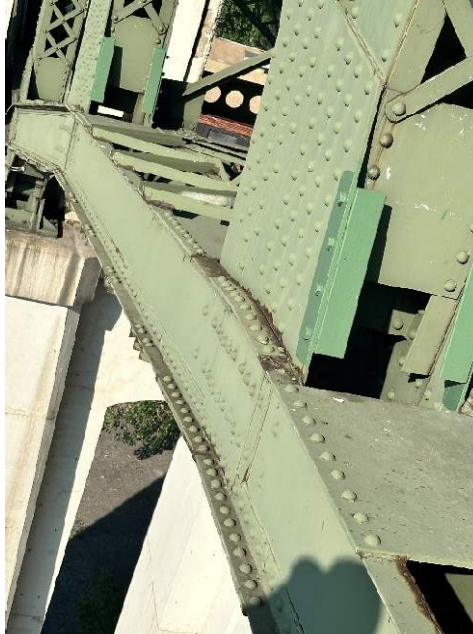
The protective coating system (PCS) rating is a **6**, indicating that it is in **Satisfactory** condition. There are areas of peeling and bubbling paint and surface corrosion, especially at expansion joints where water infiltration and active corrosion is occurring. At some locations, corrosion is reinitiating where pack rust was previously cleaned and sealed. There is widespread fading and loss of pigment (Photo 16), particularly on the portions of the truss where sun exposure is the highest. At scattered locations the top coat of paint is peeling, revealing the epoxy intermediate coat.

Photo 16: Typical Fading and Loss of Pigment of Paint

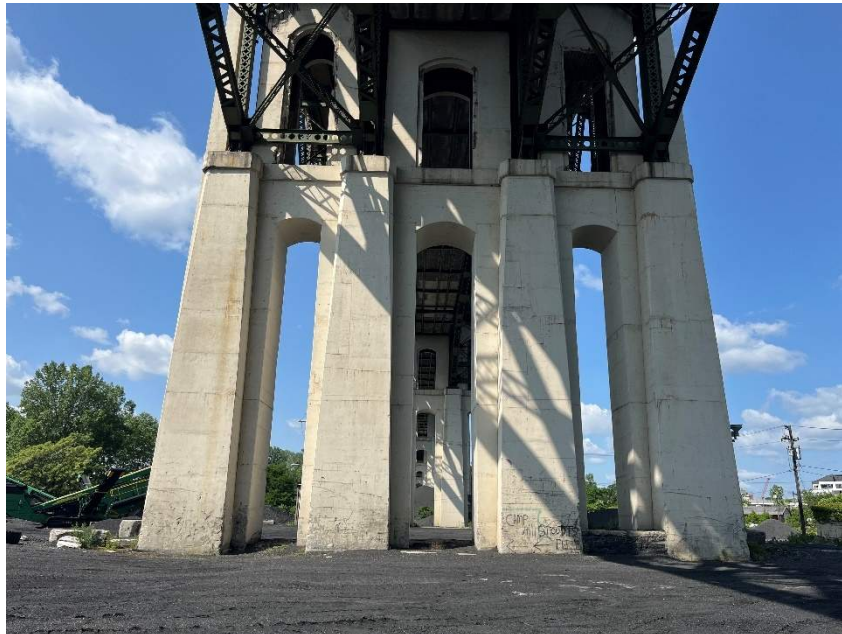
The reinforced concrete pier columns are in **Satisfactory** condition. Pier columns have areas of cracking, staining, delamination, or spalling concentrated around previously patched areas. On Pier 7, there is damage where the south and east faces of the southern columns were scraped by vehicle/equipment (Photo 17). For specific pier column deficiencies and locations, see Pier and West Approach Drawings in Appendix C.

Photo 17: Scraping Damage of **East Faces of Columns** of Pier 7

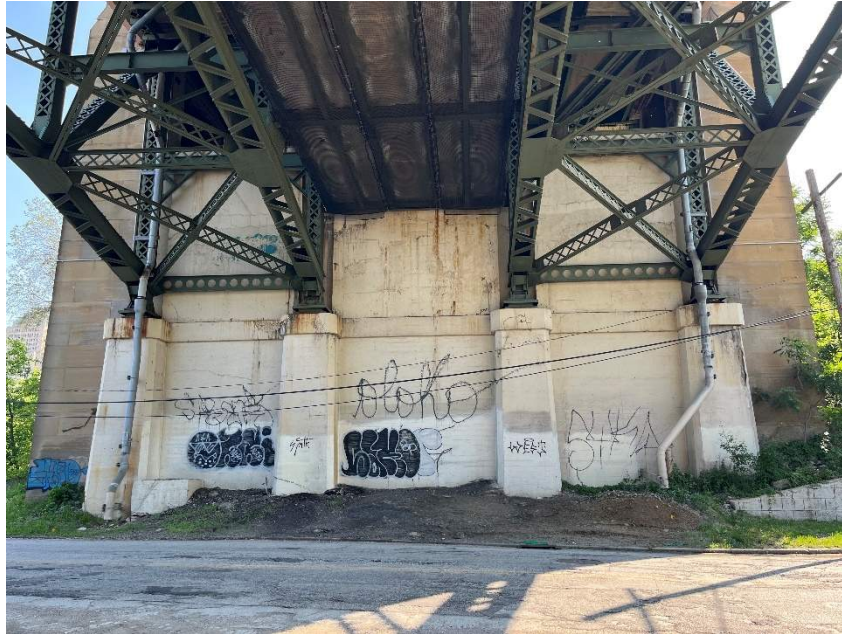
Photo 18: East Pylon

The pier walls are in **Satisfactory** condition. Pier walls are present at the East and West Pylons. Minor cracking, staining, patched areas, and some minor spalling were noted throughout (Photo 18). For specific pier wall deficiencies and locations, see Pier Drawings in Appendix C.

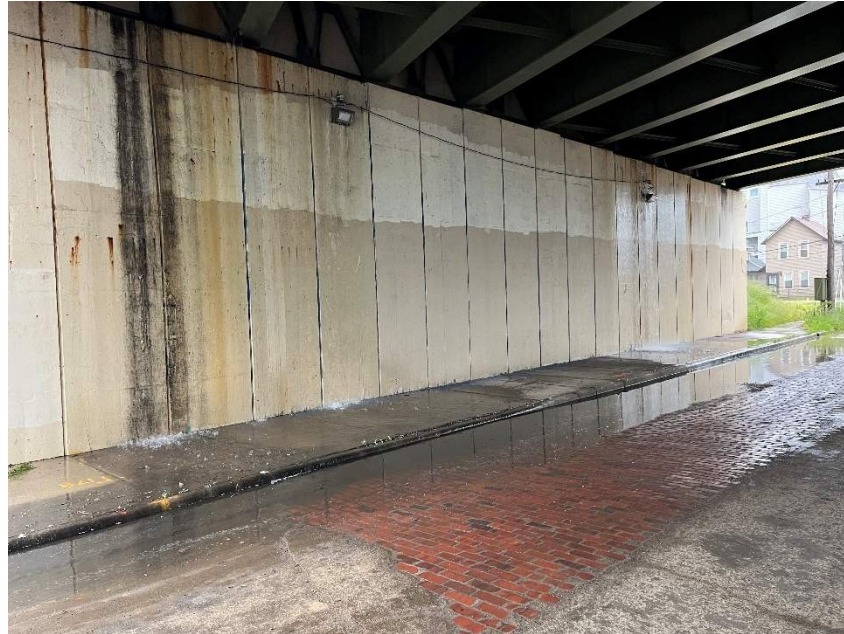
Photo 19: South Half of West Abutment

The abutment walls are in **Satisfactory** condition. There are cracks, areas of patching, rust staining, and some delaminations (Photo 19). For specific abutment deficiencies and locations, see Abutment Drawings in Appendix C.

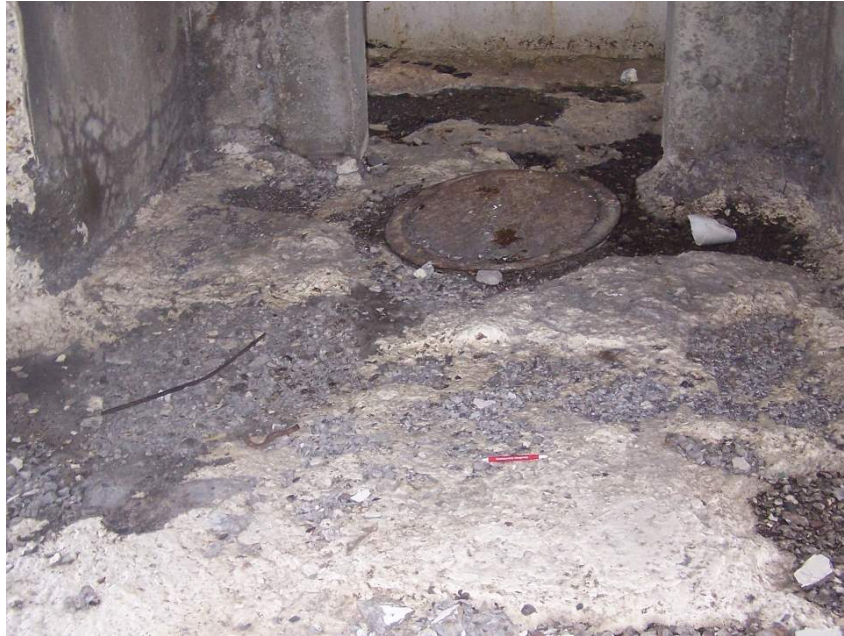
The pier caps are in **Satisfactory** condition. There are areas of cracking, delamination, and patching on the caps. The inspection manholes in the pier caps are in poor condition. There is insufficient surface bearing area to support the covers and care should be taken when walking near them or opening them (Photo 20). There is standing water at several places on top of the pier caps, including around some bearings (Photo 21).

Photo 20: Top of Pier Cap Around Manhole (2024 Inspection Photo)

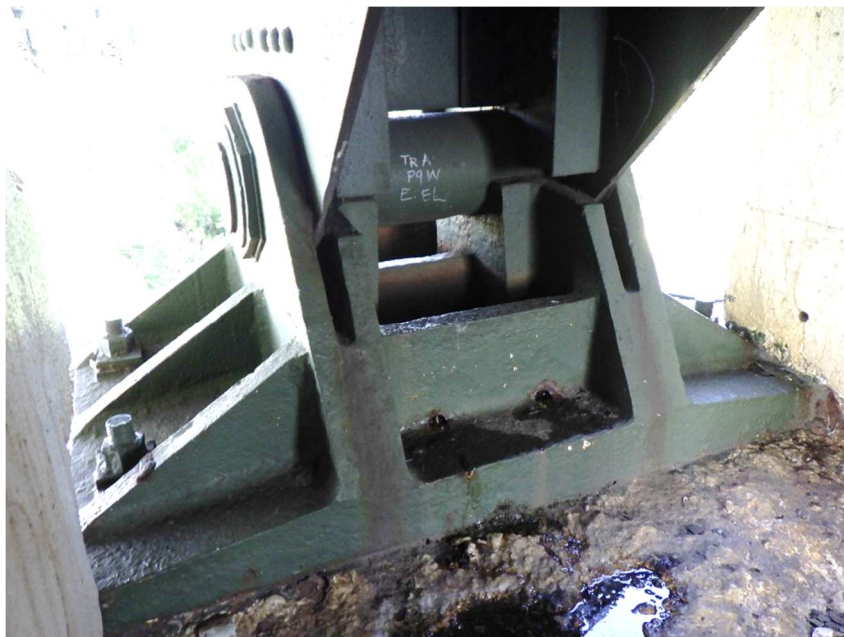
Photo 21: Standing Water Around Bearing at L14 North Exterior Truss

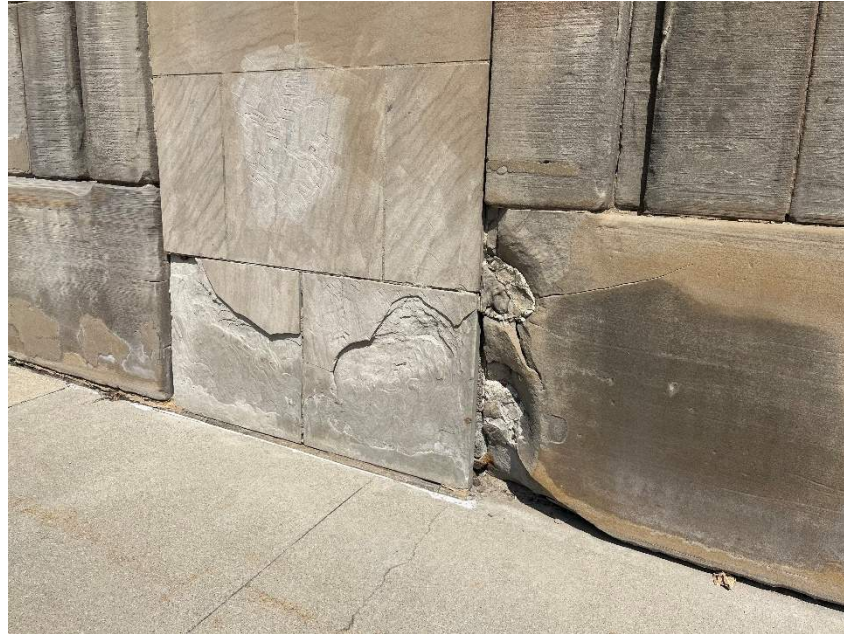
The decorative sandstone pylons are in **Satisfactory** condition. The sandstone units exhibit some areas of spalling and deterioration (Photo 22). For specific pylon deficiencies and locations, see Table 1 and Pier Drawings in Appendix C.

Photo 22: Typical Spalls on Northeast Decorative Pylon

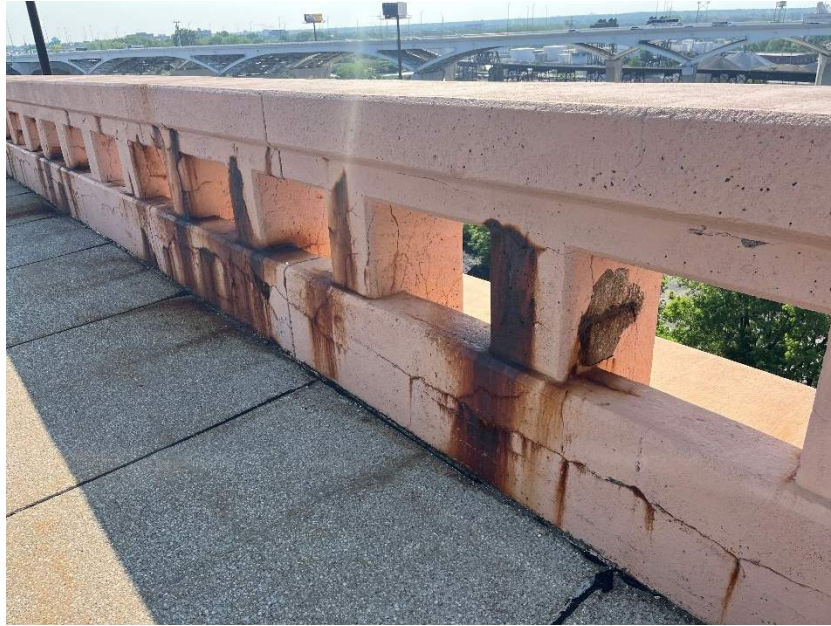
The reinforced concrete bridge railings rating is a **5**, indicating that they are in **Fair** condition. The exterior railings have widespread cracking with rust staining and some areas of delamination and spalls with exposed reinforcing (Photo 23). The bikeway railing, located between the roadway and north sidewalk, is in good condition with a few minor deteriorated areas. For specific railing deficiencies and locations, see Table 1 in Appendix C.

Photo 23: Typical Deteriorated Exterior Railing

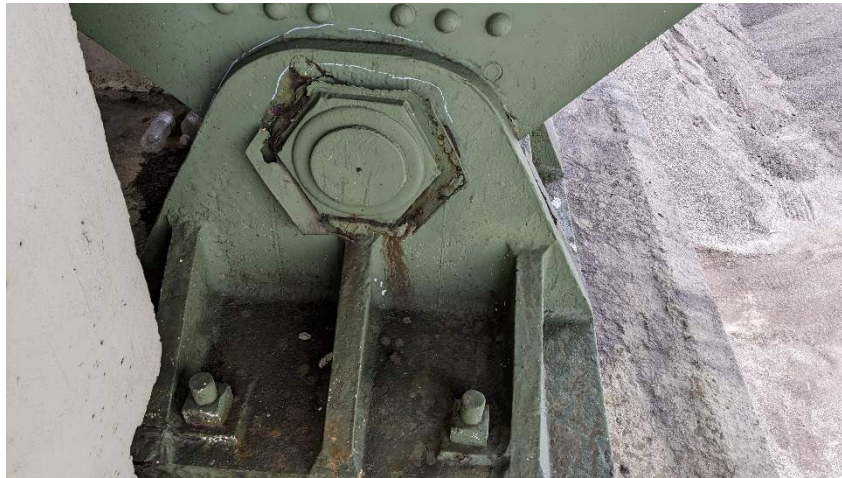
The fixed bearings are in **Satisfactory** condition. Moderate surface corrosion with areas of section loss was noted on the pins and adjacent plates (Photo 24). There is debris and water accumulation in several of the truss bearings. For specific fixed bearing deficiencies and locations, see Truss Drawings in Appendix C.

Photo 24: Typical Section Loss on Pin and Surface Corrosion on Bearing

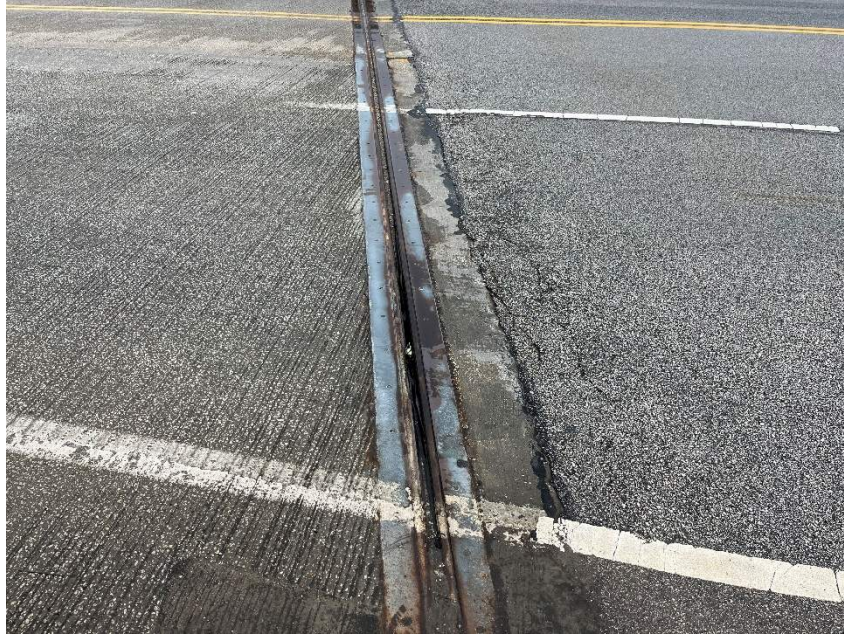
is debris accumulation through most of the length of the joints. At Joint 17, there is a 6' long missing length of joint material in the westbound lanes (Photo 25). At Joint 18, there are two areas where the seal is tearing or has come out of the retainer (Photo 26). The Strip Seal in Joint 2 at the north railing has a hole which is leaking onto the end vertical of Truss A and the West Face of the East Pylon.

Photo 25: Missing Length of Joint Material in Expansion Joint 17

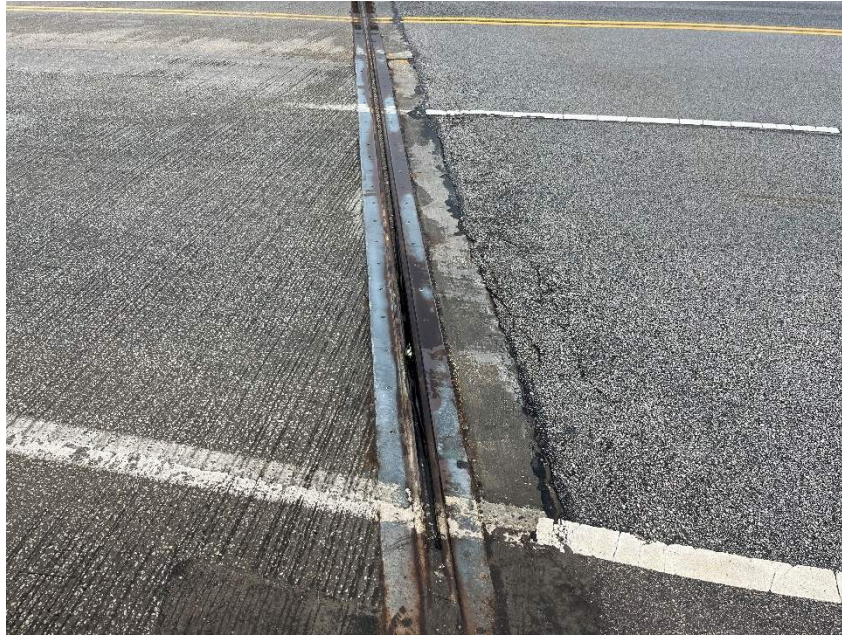
Photo 26: Damaged Seal and Debris in Expansion Joint 18

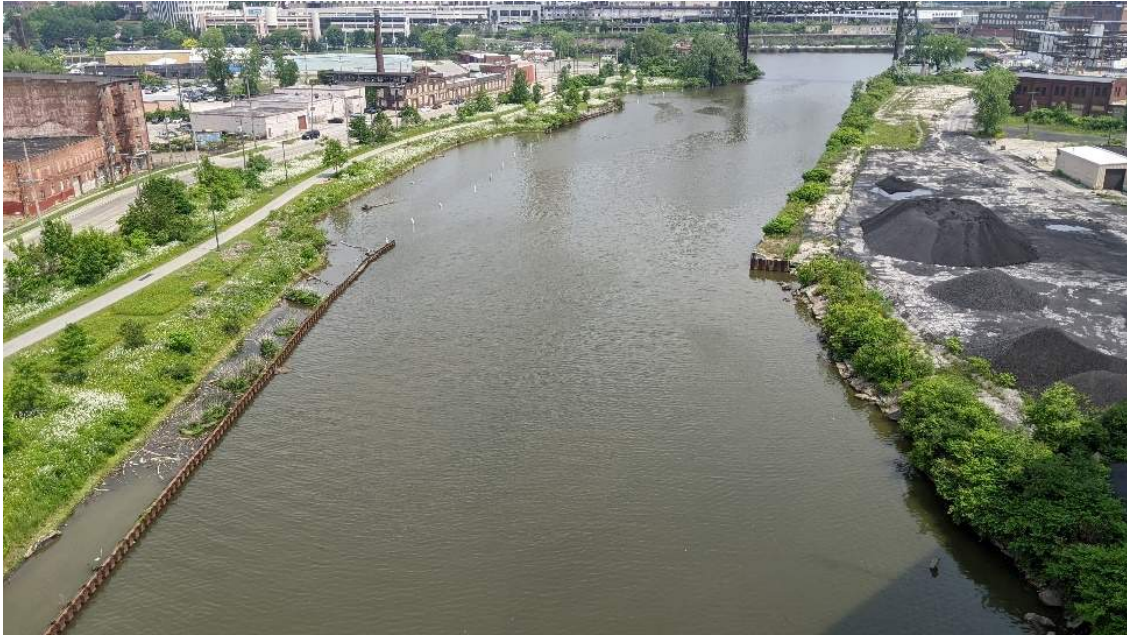
The alignment is in **Satisfactory** condition. The channel is skewed with respect to the piers, but this is an as-built condition (Photos 27 & 28).

Photo 27: Bridge Channel, Looking North (Downstream)

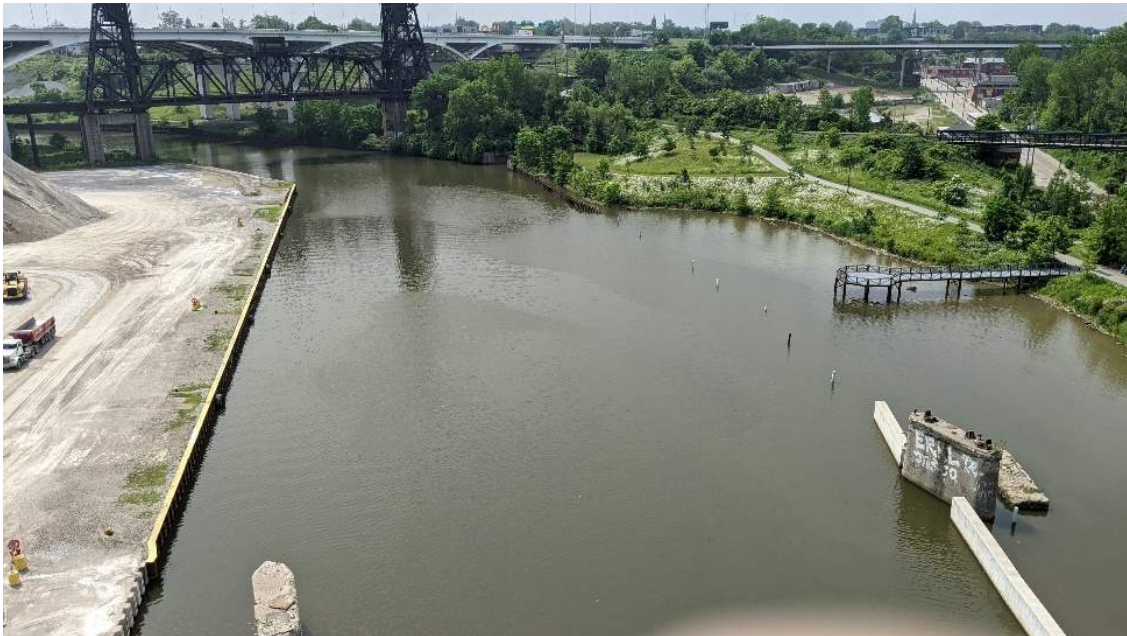
Photo 28: Bridge Channel, Looking South (Upstream)

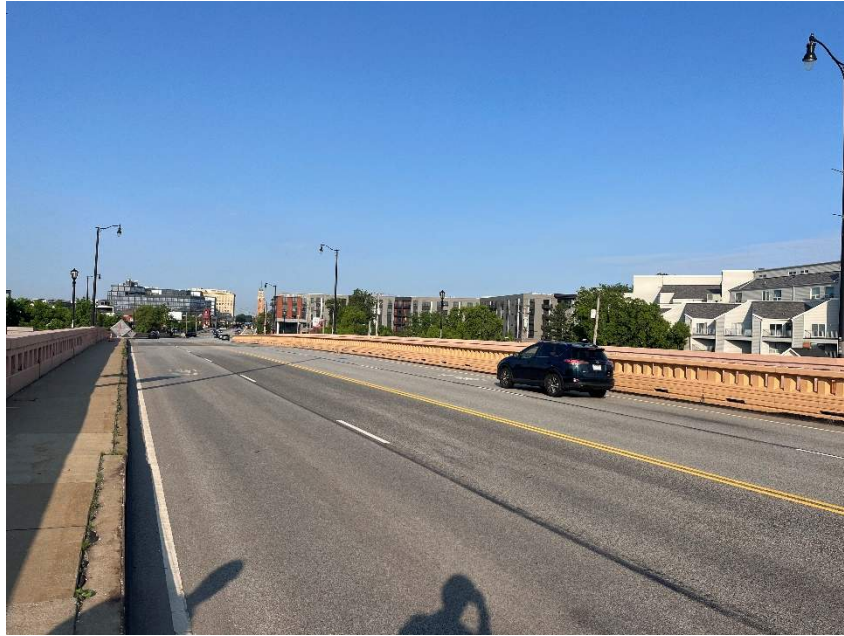
The approach wearing surfaces are in overall **Good** condition. The west approach was repaved in 2022 (Photo 29). **There is a 3'Lx9"Wx3½"D pothole in the outside eastbound lane along the joint between the east approach slab and approach pavement (Photo 30).**

Photo 29: Repaved West Approach Wearing Surface

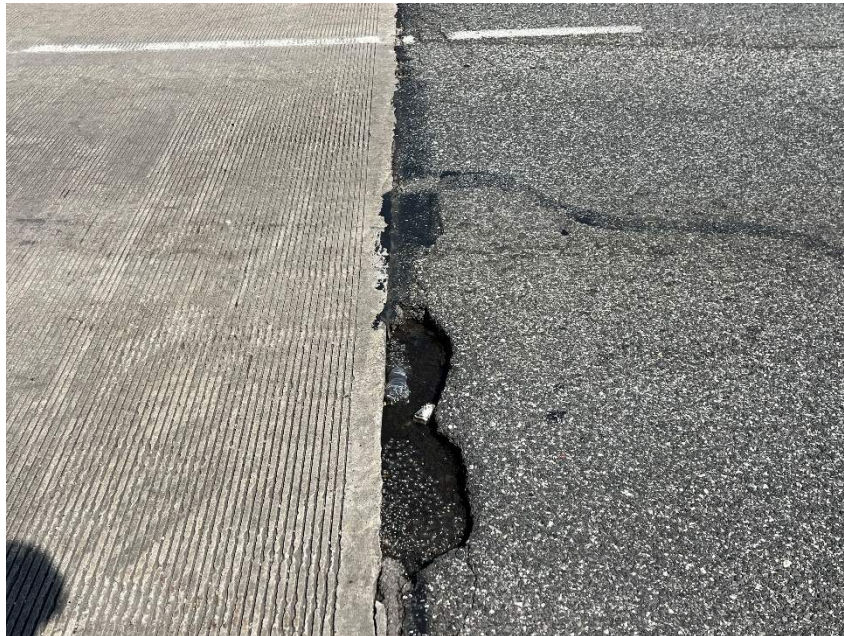
Photo 30: Large Pothole at Joint Between East Approach Slab and Approach Pavement

10. Repair or replace the street light poles on the north side that are **removed** in Span 3 and missing in Span 6. **Replace the missing globe on the street light pole on the south side in Span 7.**
11. **Repair large pothole in the eastbound lane along the joint between the east approach slab and approach pavement.**
12. **Repair the electrical conduit that is detached from the utility box in Span 7 at Pier 6 on the north maintenance deck rail.**

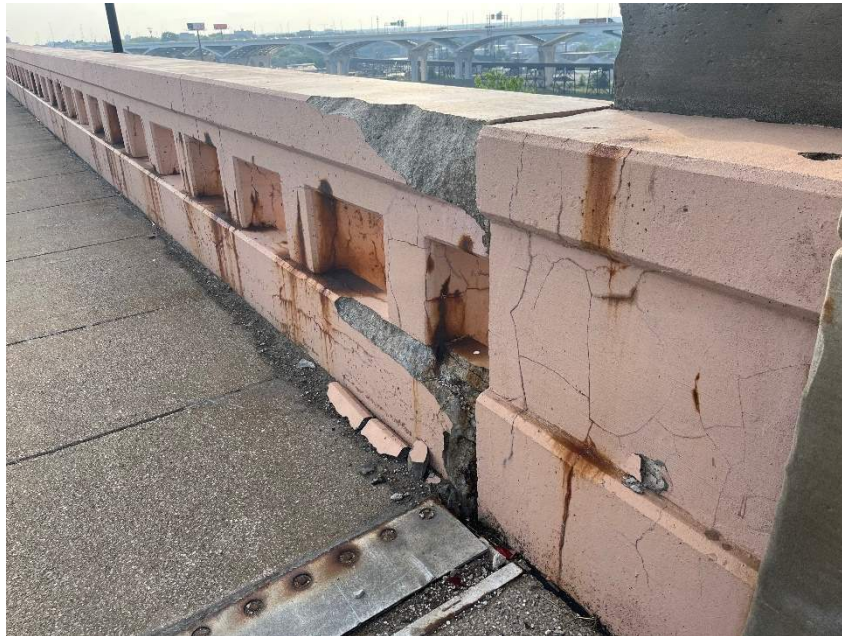
The approach guardrails are in **Fair** condition. The approach guardrail is an extension of the concrete rail on the bridge. It exhibits cracking, minor surface spalling, and rust staining (Photo 31).

Photo 31: Typical Cracks, Spalls, and Rusting Staining on Approach Railing

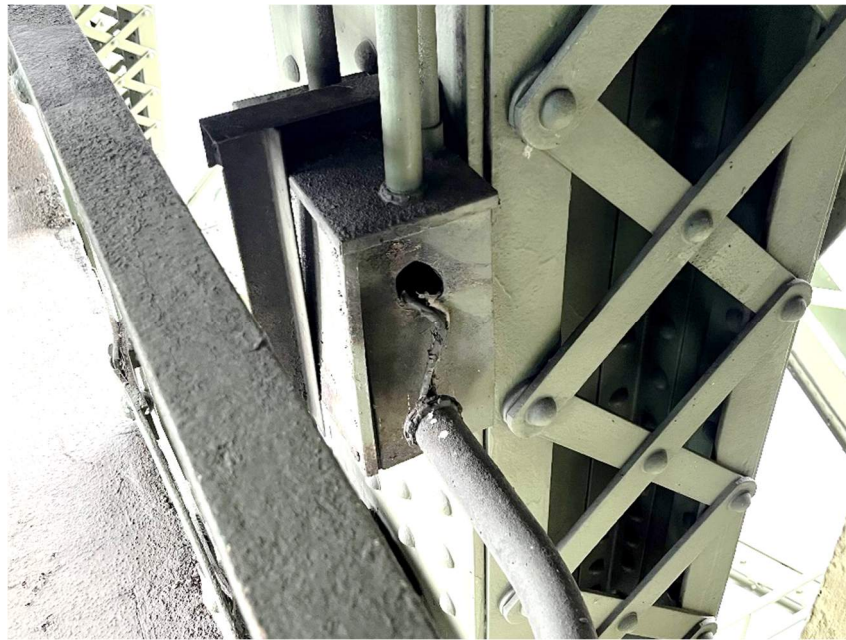
The utilities are in **Poor** condition. On the south side above the maintenance deck, there is a large group of PVC conduits supported by a truss, mounted to the unused overhead floorbeam. Under these conduits there is a large diameter natural gas line supported on the maintenance deck. An electrical conduit is mounted to the north maintenance deck rail. **The electrical conduit is detached from the utility box in Span 7 at Pier 6 (Photo 32).** For utility deficiency locations and descriptions, see Table 6 in Appendix C.

Photo 32: Electrical Conduit Detached From Utility Box in Span 7

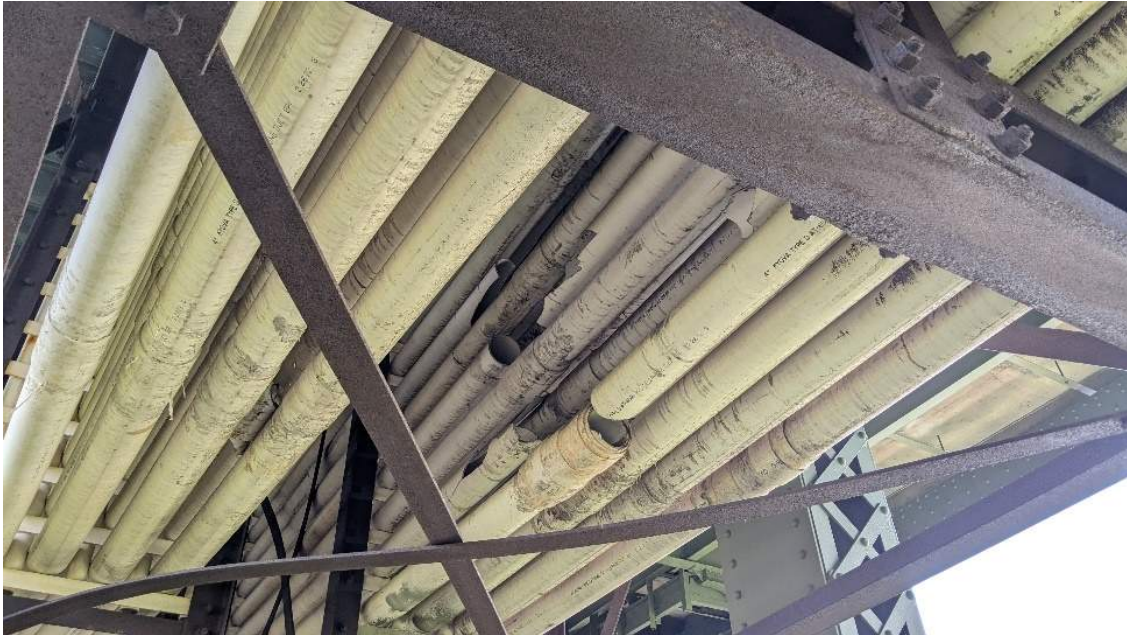
The PVC telecom conduits are damaged, and cables are exposed in many locations (Photo 33). The telecom truss support, sheds, and corrugated roofs/walls have widespread heavy deterioration (Photo 34). At several truss locations, the lower chords have 100% section loss at supports, the lateral bracing is detached or bent, and gusset plates are warped. The corrugated roofs under the deck joints have completely deteriorated at

Photo 33: Typical Damaged PVC Conduits

1. Remove areas of loose and deteriorating concrete on the deck fascia over Canal Road, the parking lot between Piers 3 and 4, W. 3rd Street, Scranton Road, and the Lake Link Trail.
2. Repair spalls on the wearing surface with a rigid patching material.
3. Replace and/or repair the non-functioning navigation lights.
4. Repair the access manholes in the pier caps and replace the missing manhole covers at Pier 6.
5. Fix the areas of broken and deteriorated utility supports.
6. Install deck netting to protect the new paved parking lot between Piers 3 and 4 from spalling concrete.
7. Repair security fence at south end of West Pylon.
8. Clean out the drainage recesses covered by grates in the north sidewalk that are clogged with significant debris.
9. Repair or replace the deteriorated truss that is above the maintenance deck and supports the PVC telecom conduits.

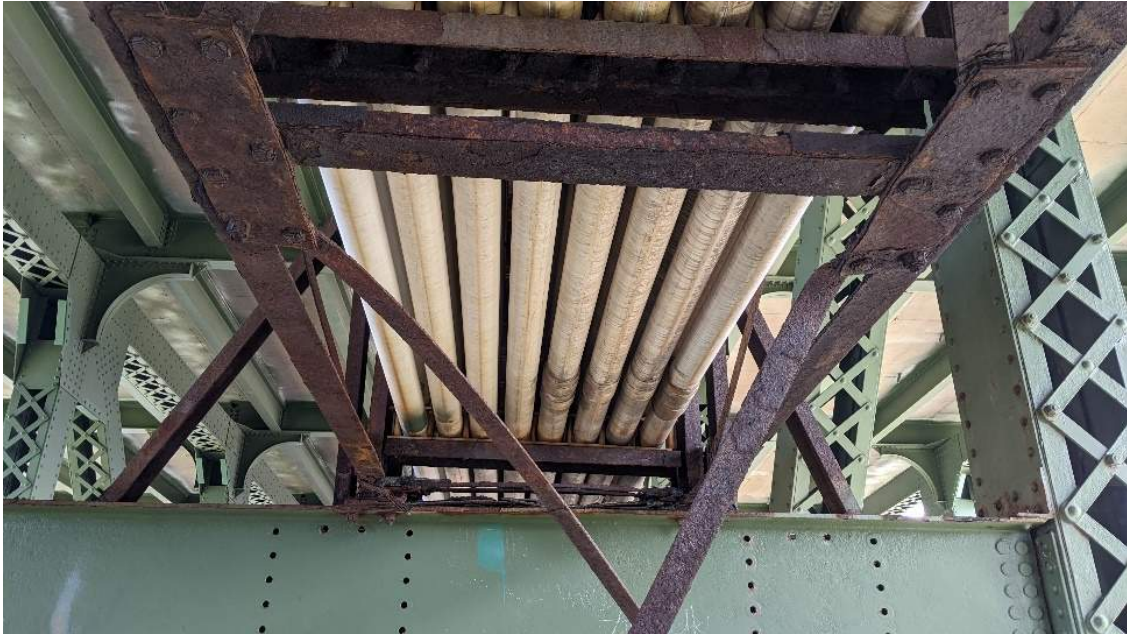
Photo 34: Typical Deteriorated PVC Conduit Truss with Broken and Warped Gusset Plates
