2025 PHYSICAL CONDITION ROUTINE ELEMENT LEVEL INSPECTION REPORT

Bridge CUY-10-1613

SFN 1801503

Hope Memorial/Lorain Carnegie over Cuyahoga River

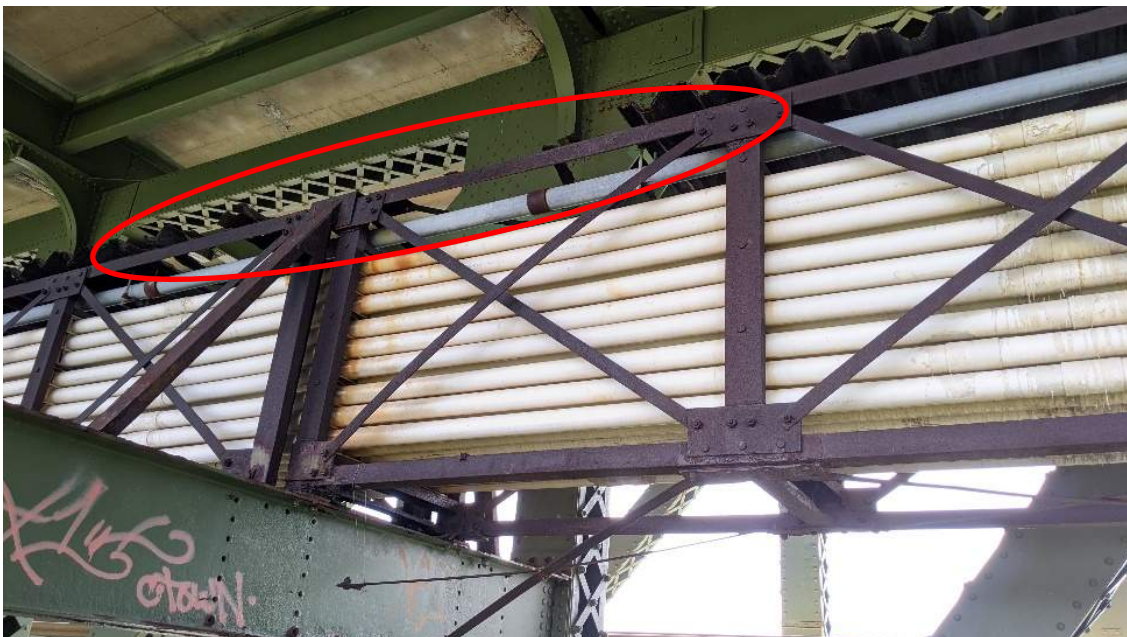
The PVC telecom conduits are damaged, and cables are exposed in many locations (Photo 33). The telecom truss support, sheds, and corrugated roofs/walls have widespread heavy deterioration (Photo 34). At several truss locations, the lower chords have 100% section loss at supports, the lateral bracing is detached or bent, and gusset plates are warped. The corrugated roofs under the deck joints have completely deteriorated at

most deck joint locations (Photo 35). At the utility access hatches in the deck, there is widespread corrosion of the supports and evidence of leakage.

Photo 35: Typical Deteriorated Corrugated Roof For PVC Conduits Under Deck Joints

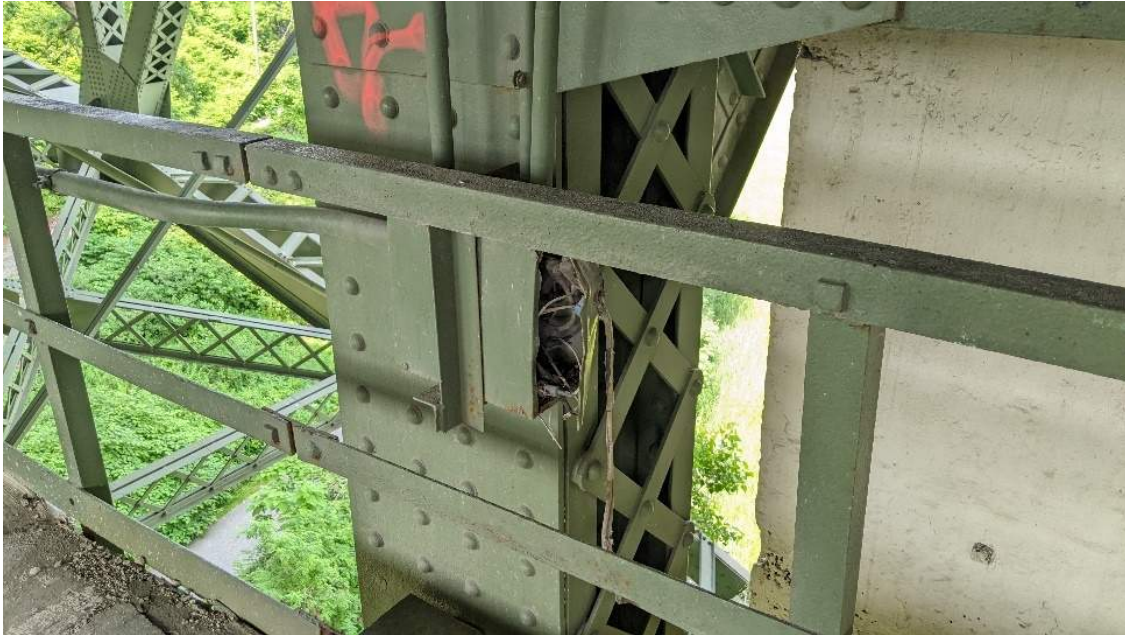
In spans 6, 11, 12, and 13, the electrical conduit is detached from the railing and is laying on the maintenance deck floorbeams. In span 11, a junction box for the electrical conduit is deformed and missing its cover plate **and in span 13, a junction box has a deformed cover plate** (Photo 36).

Photo 36: Deformed Junction Box For Electrical Conduit with Deformed Cover Plate in Span 13

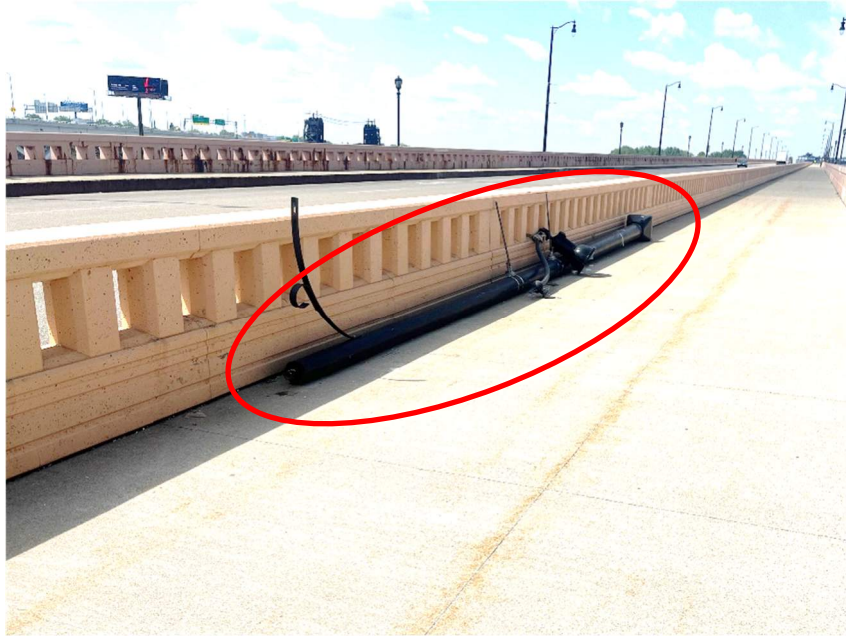
Several of the street lights are non-operational, but no damage was detected on **most of** these street lights. Street light poles on the north side are **removed and laying against the interior railing** in Span 3 (Photo 37) and missing in Span 6 (Photo 38). **A street light pole on the south side is missing the globe at the top of the pole in Span 7 (Photo 39).**

Photo 37: Removed Street Light Pole Laying Against North Interior Railing in Span 3

10. Repair or replace the street light poles on the north side that are **removed** in Span 3 and missing in Span 6. **Replace the missing globe on the street light pole on the south side in Span 7.**
11. **Repair large pothole in the eastbound lane along the joint between the east approach slab and approach pavement.**
12. **Repair the electrical conduit that is detached from the utility box in Span 7 at Pier 6 on the north maintenance deck rail.**

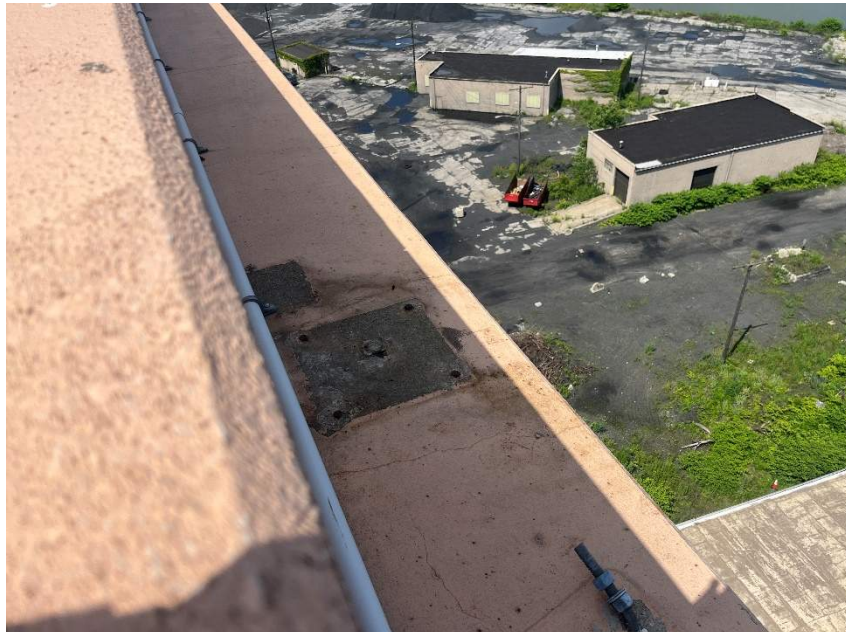
Photo 38: Missing Street Light Pole Outside of North Railing in Span 6

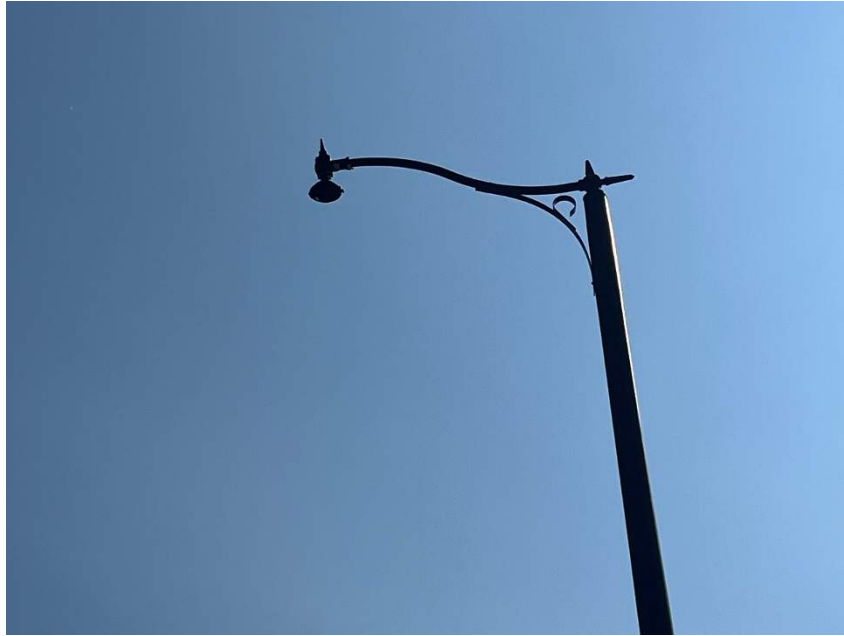
Photo 39: Street Light Missing Globe Outside of South Railing in Span 7

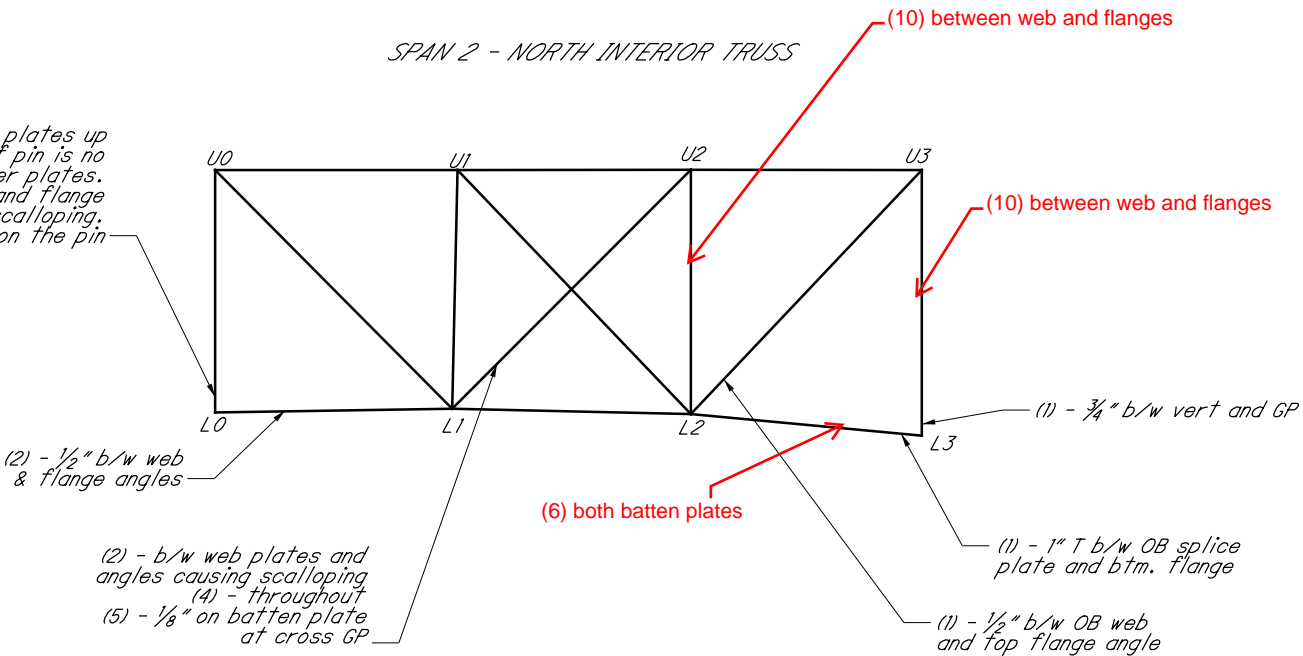
(1) - b/w IB and OB L.C. plates up to 1-3/4", OB end of pin is no longer flush with cover plates.
(2) - 1/8" b/w web and flange angles causing scalloping.
(5) - 1/4" on the pin

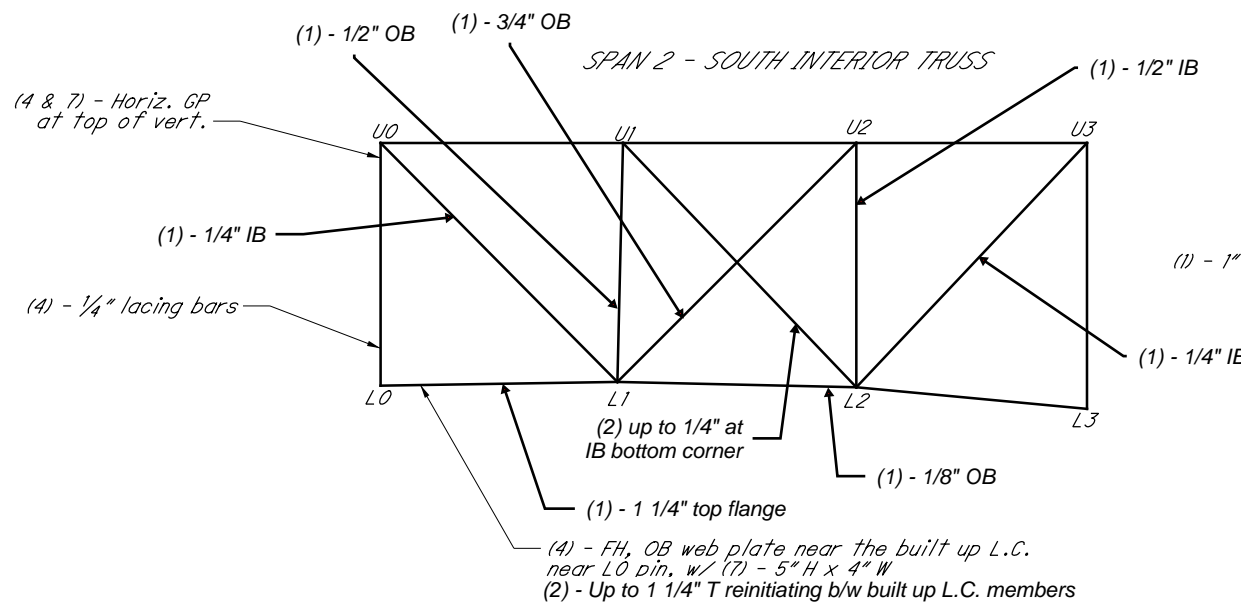
SPAN 2 - TRUSS ELEVATIONS

SOUTH INTERIOR GUSSET PLATE DEFICIENCIES
L0, BOTH - (6) - heavy up to 1/4" around 8" pin
(2) - Reactivated 1-1/4"

SOUTH EXTERIOR GUSSET PLATE DEFICIENCIES
L0, BOTH - (4) - 3/16" along LC around pin.
L1, IB GP - (4) - 3/8" on IB face along top of lower chord. OB GP - (3) - 3/16" ALONG L.C.
L2, IB GP - (4) - 3/16" along IB face on both sides of the connection. OB GP - (3) - 3/16" ALONG L.C.
L3, BOTH - (3) - up to 1/8" with (1) reactivated up to 5/8" b/w GPs & vertical.
U3, BOTH - (3) - up to 1/8" full perimeter of the upper pins.

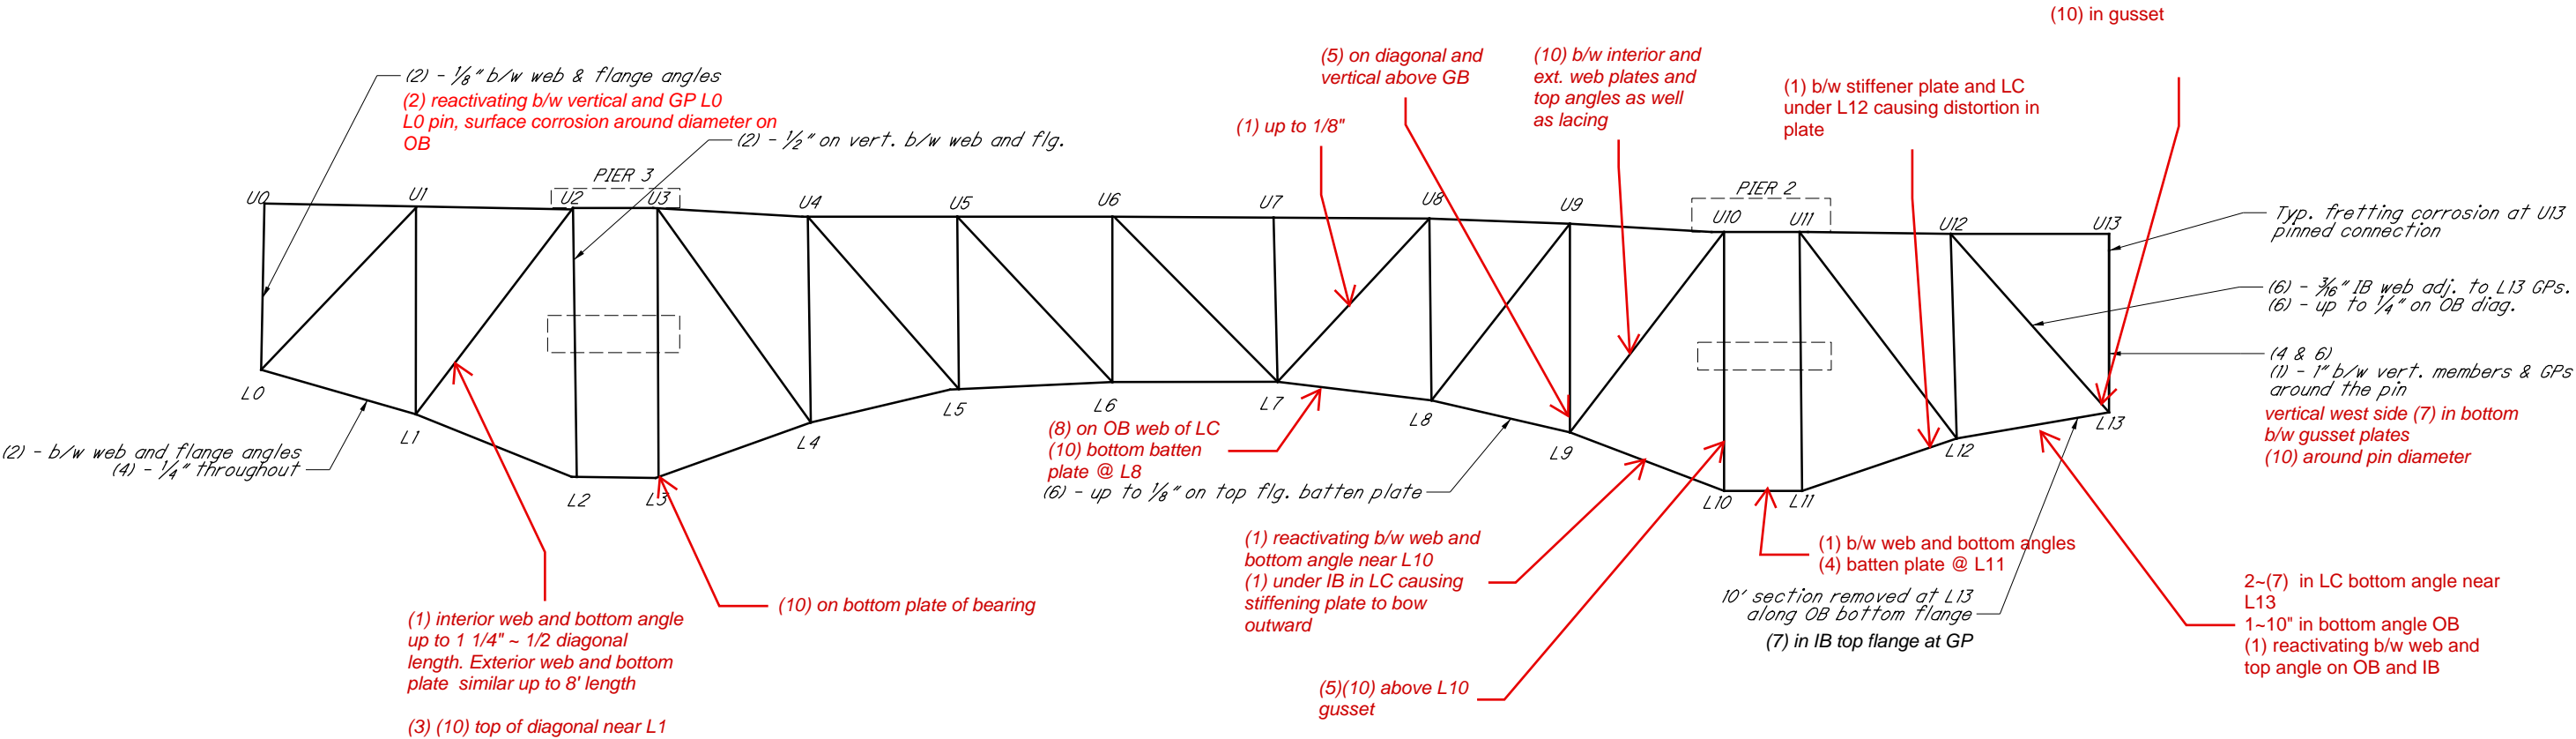
SPAN 3 - NORTH INTERIOR TRUSS ELEVATION

SPAN 3 NORTH INTERIOR - GUSSET PLATE DEFICIENCIES

- L0, Both GPs - (1) $\frac{3}{4}$ " at vertical member.
(10) along bottom edges
- U0 Both GPs - fretting corrosion from upper chord at both GPs
- L2 - (5) ALONG LC OUTSIDE FACES

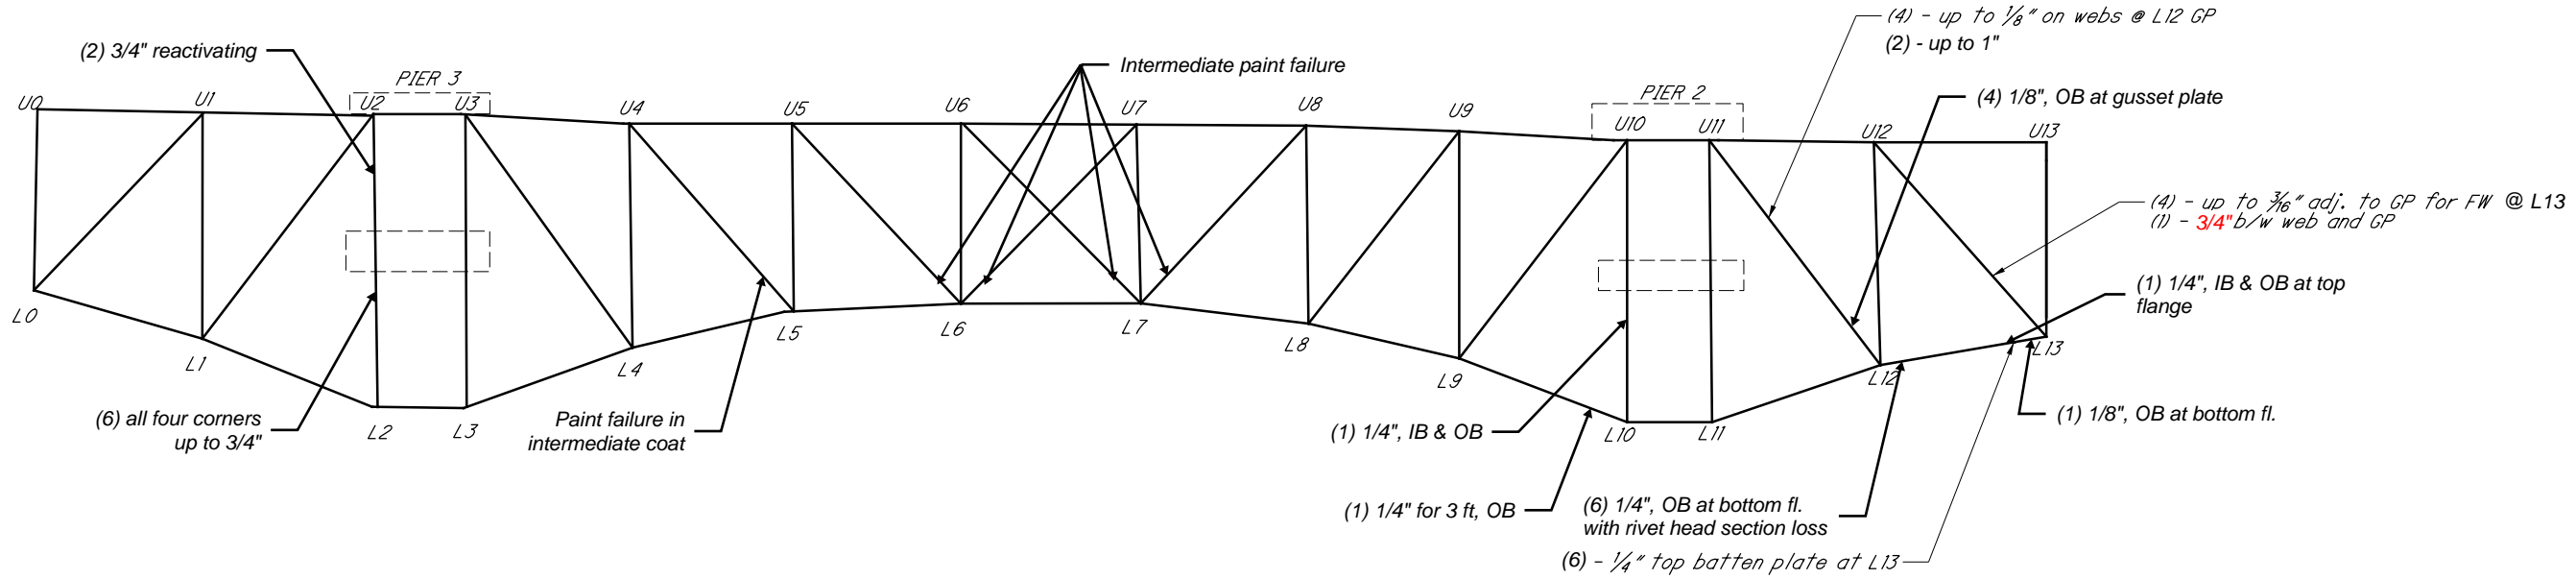
SPAN 3 - SOUTH INTERIOR TRUSS ELEVATION

SOUTH INTERIOR - GUSSET PLATE DEFICIENCIES

- L2, IB GP - (4) up to 1/4" on IB face around bearing pin.
OB GP - (4) 1/16" along LC.
- L12, OB GP - (1) 1-1/2" T x 20" L between south diagonal.
- U12, BOTH - (6) 1/8" around vertical pin.
- L13, OB GP - (1) 3/4" at diagonal connection

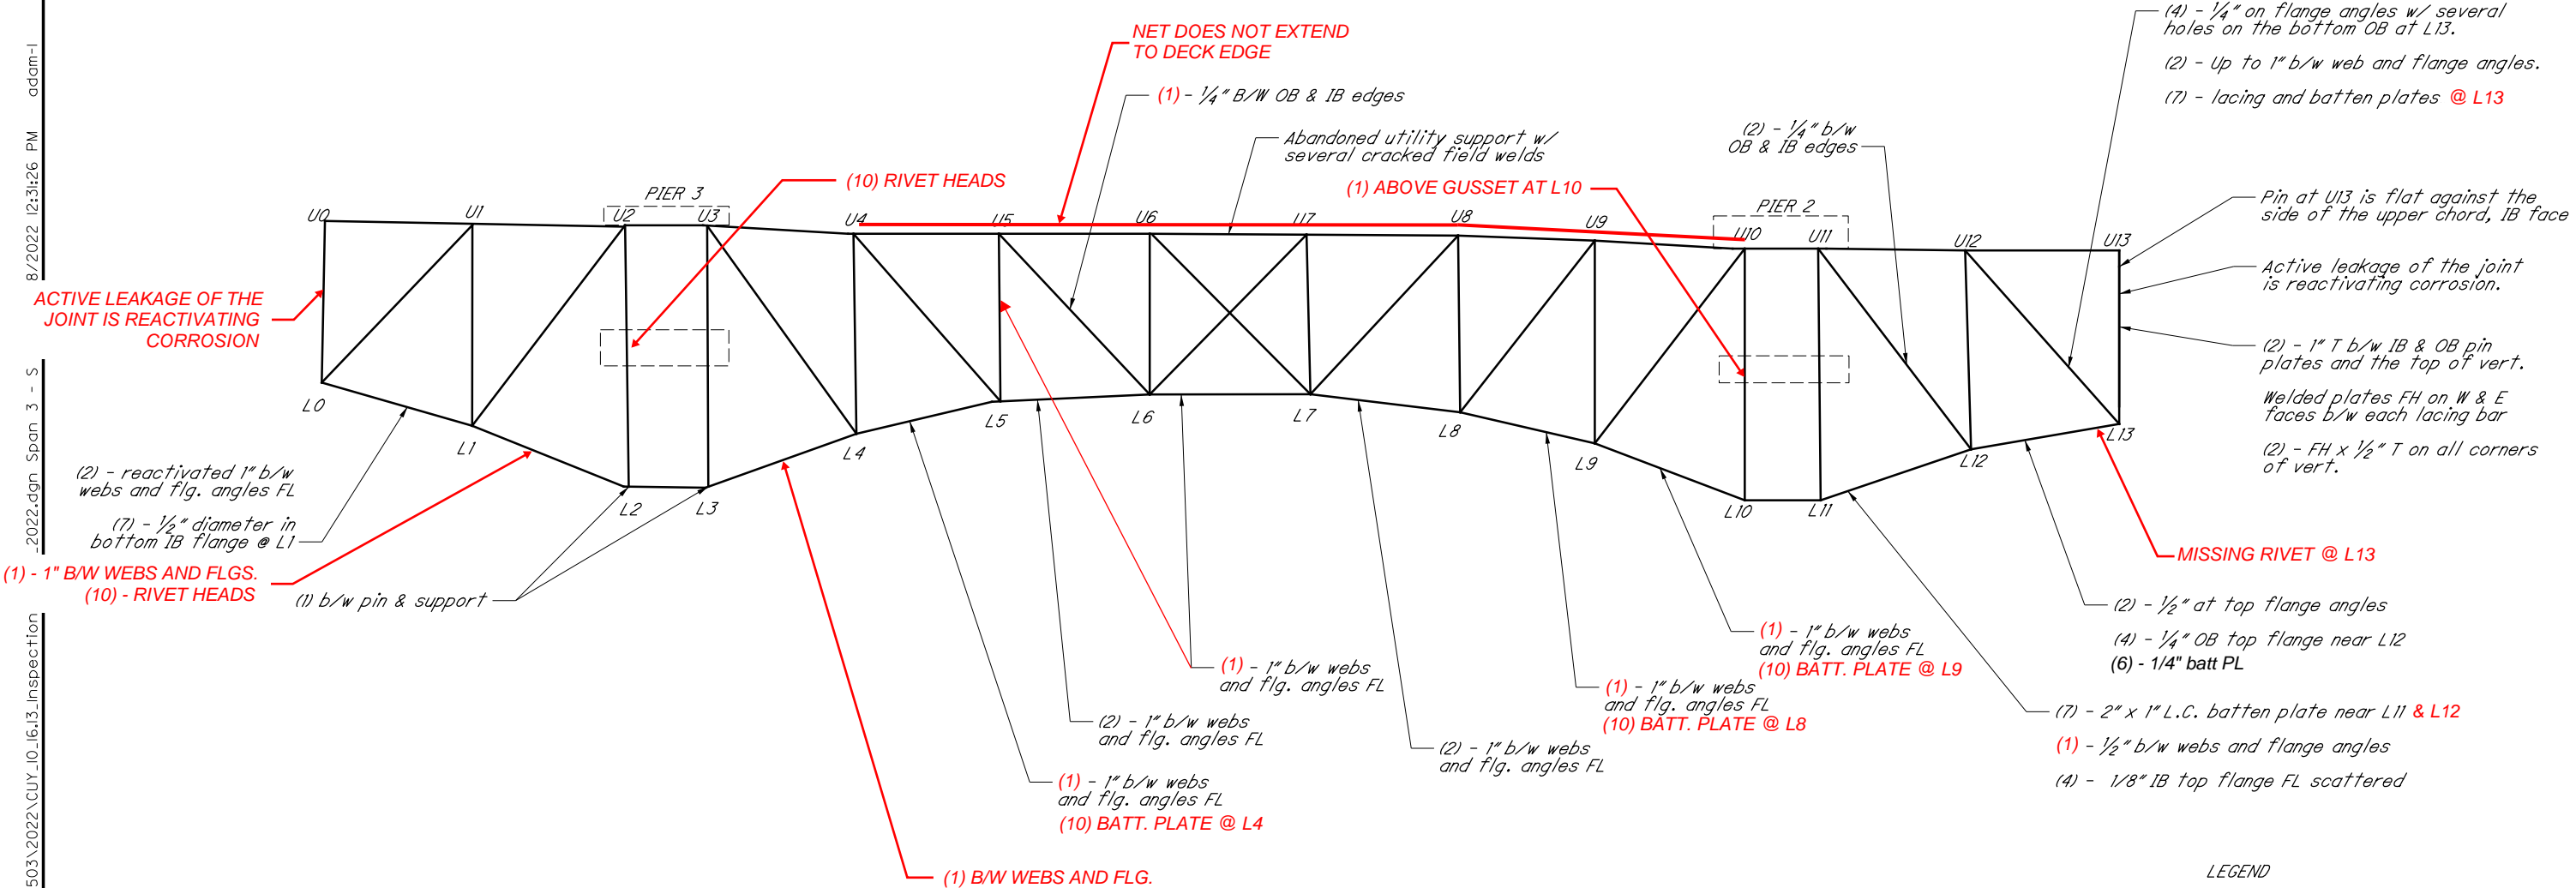
SPAN 3 - SOUTH EXTERIOR TRUSS ELEVATION

SPAN 3 SOUTH EXTERIOR - GUSSET PLATE DEFICIENCIES

- L2, IB GP - (3) 1/16" with active (1) along top of lower chord.
- L4, BOTH - (3) - 1/8" IB face above LC.
- L5, OB GP - (3) 1/8" ALONG L.C.
- L6, IB GP - (3) - 1/8" ALONG LC
- L8, BOTH - (3) - active above lower chord connection, east side of IB face, 18" L x 7" H x 3/16" D
- L9, BOTH - (4) - west side of IB face, area 13" x 13" x 3/16" D
- L11, Both GPs - (3) 1/16" along LC.
- L12, BOTH - (3) 1/8" along LC and scattered.
- U12, IB GP - (5) 1/16" on SW face.
- L13, Both GPs - (3) up to 3/16" with (2) on all faces.
- L13, Both GPs - (2) - 1" between the GP and vertical and diagonal.
- U13, Both GPs - (3) - 3/16" full perimeter of upper pins.
(1) - 1" at vertical reactivated

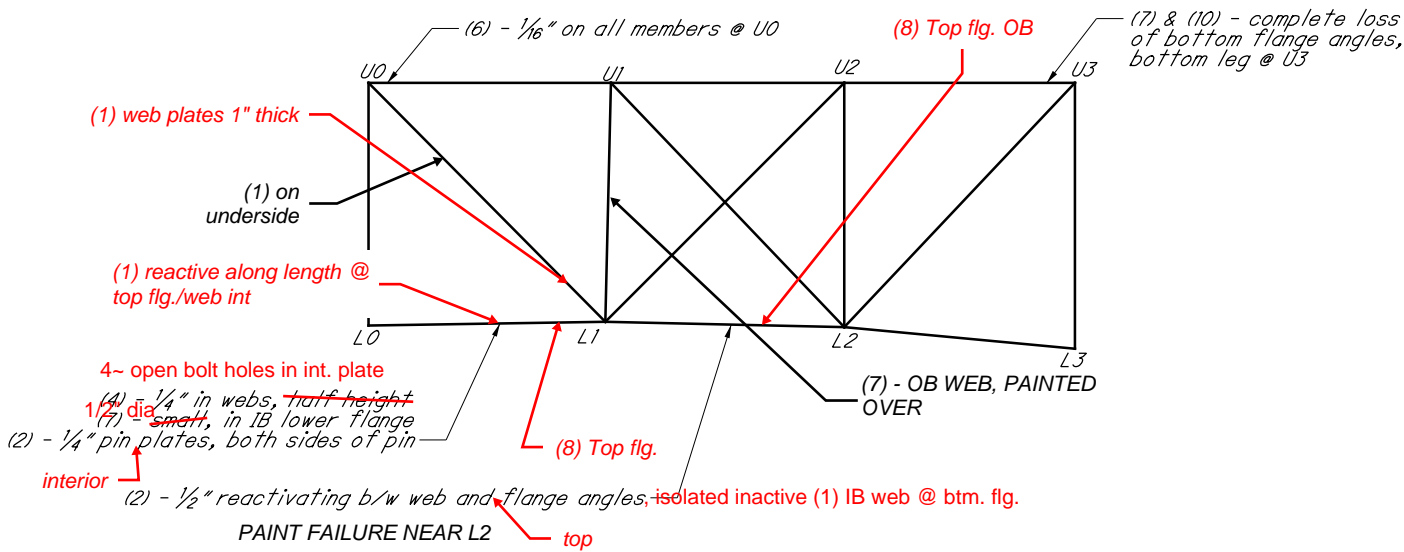
SPAN 4 - NORTH EXTERIOR TRUSS

NORTH EXTERIOR GUSSET PLATE DEFICIENCIES

L1, IB GP - (6) 1/4" IB face above LC; (10) (6) scattered
L1, BOTH GPs- PAINT FAILURE

L2, - OB GP - (2) Painted over packed rust at lower bracing gusset plate.
L2, - IB GP - (2)(10) Painted over pitting and activated corrosion on bottom of gussets and top flange plate.

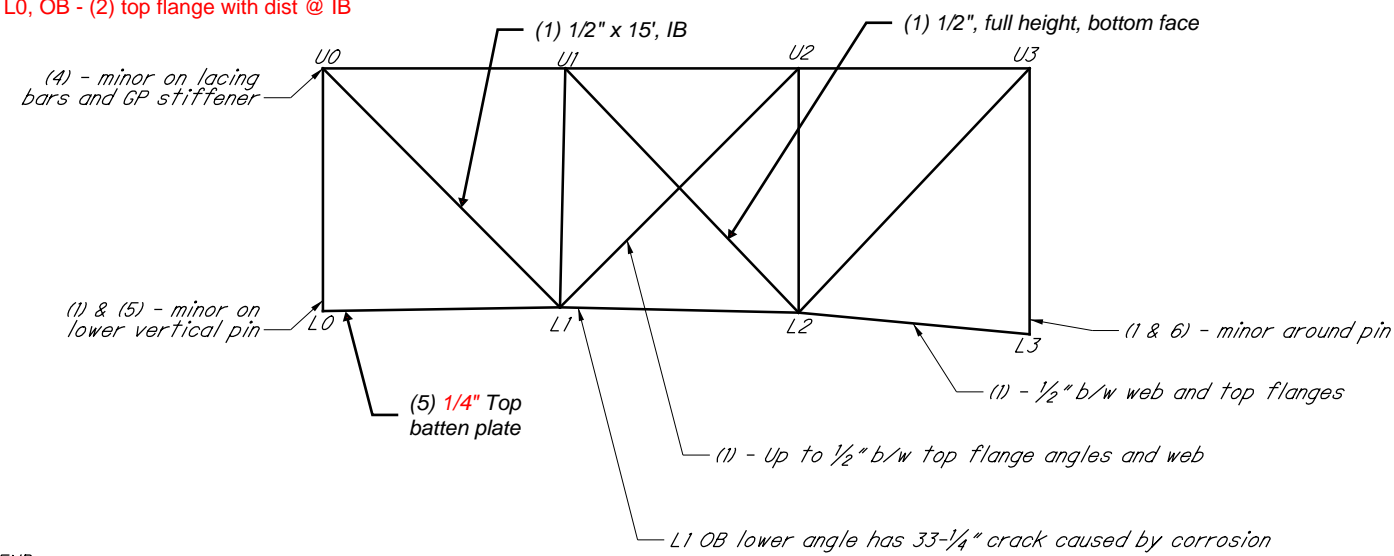
SPAN 4 - SOUTH INTERIOR TRUSS

L0, IB and OB - (6) 1/8" around pin and LC connection

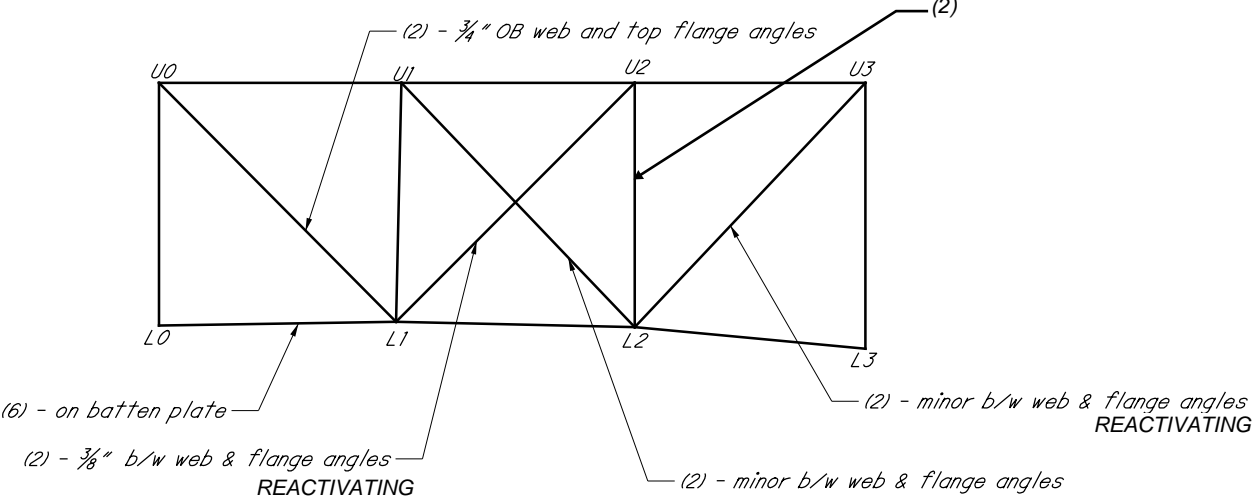
SPAN 4 - NORTH INTERIOR TRUSS

NORTH INTERIOR GUSSET PLATE DEFICIENCIES

L0, (7) - in GP internal stiffening plate

L1 BOTH GP - Paint failure at bottom of gusset plates and flange plates at lower chord w/ activated corrosion

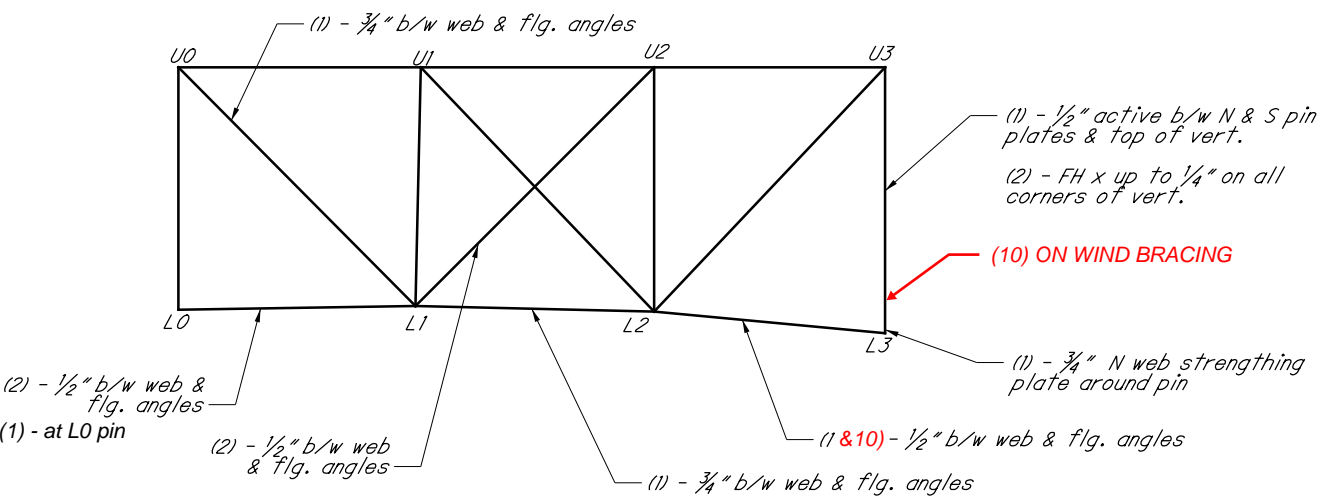
SPAN 4 - SOUTH EXTERIOR TRUSS

SOUTH EXTERIOR GUSSET PLATE DEFICIENCIES

L1, IB GP - (6) 1/8" IB face above LC reactivating.

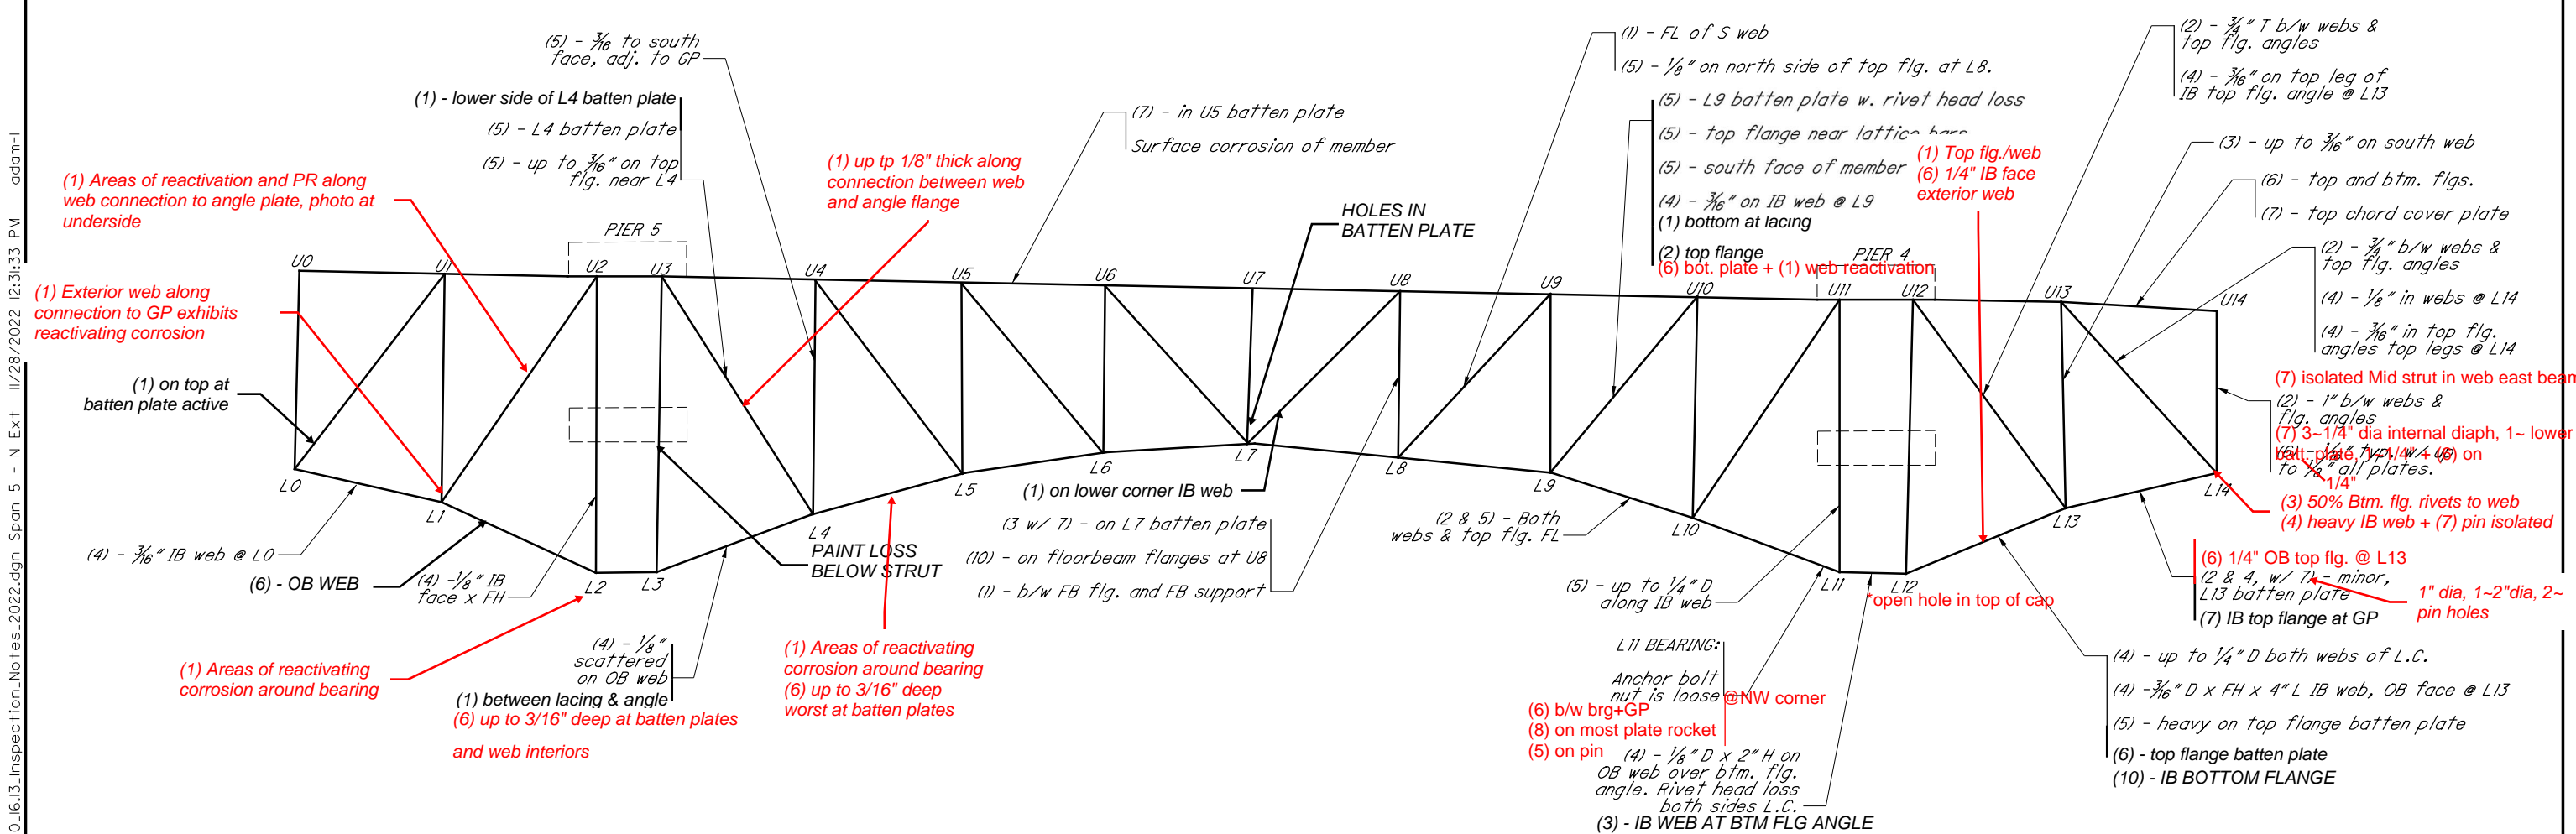
SPAN 5 - NORTH EXTERIOR TRUSS ELEVATION

SPAN 5 NORTH EXTERIOR - GUSSET PLATE DEFICIENCIES

- L0, Both GPs - (1) - at vert. and diag. active
- L1, BOTH - (5) - 3/16" IB face along lower chord w/ (10)
- L2, Both GPs - (6) - 1/4" inside faces; (10) AT LC

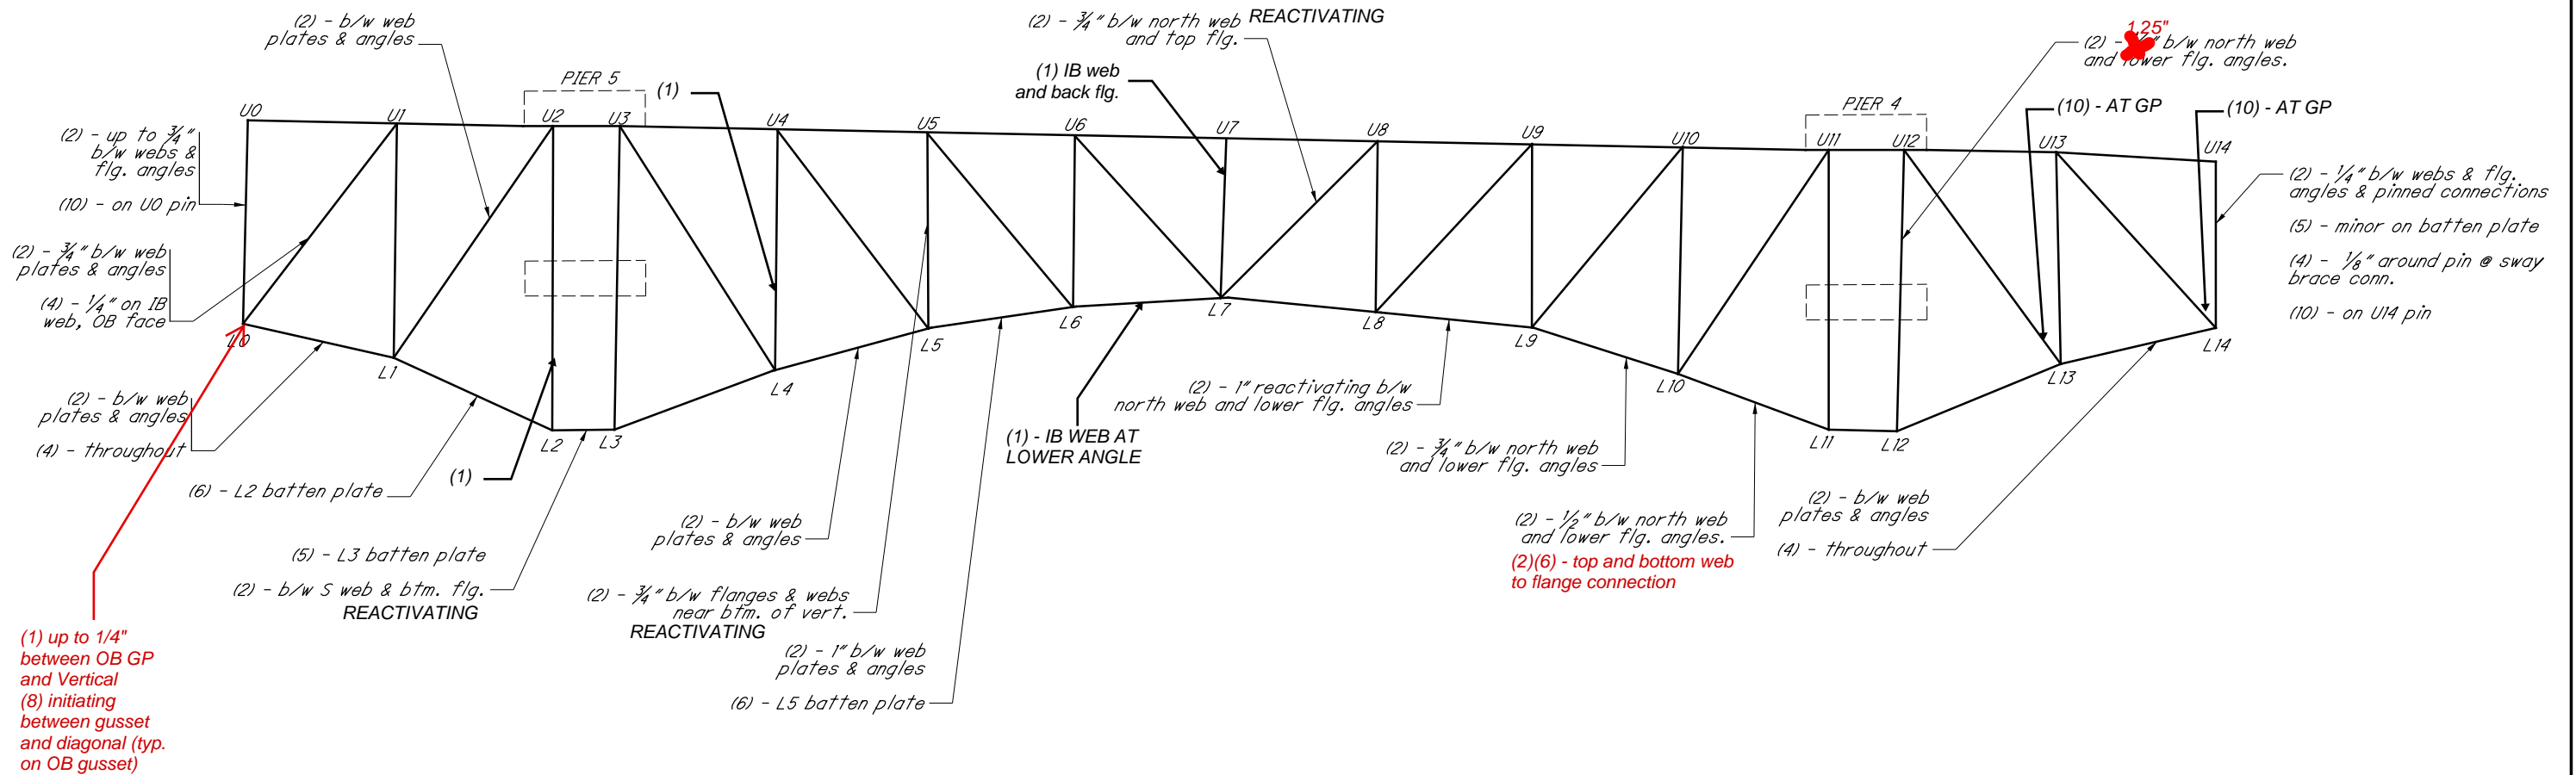
SPAN 5 - NORTH INTERIOR TRUSS ELEVATION

SPAN 5 NORTH INTERIOR - GUSSET PLATE DEFICIENCIES

U0, BOTH - FRETTING CORROSION ON INTERIOR
(2) - UP TO 5/8" B/W GPs & VERT.

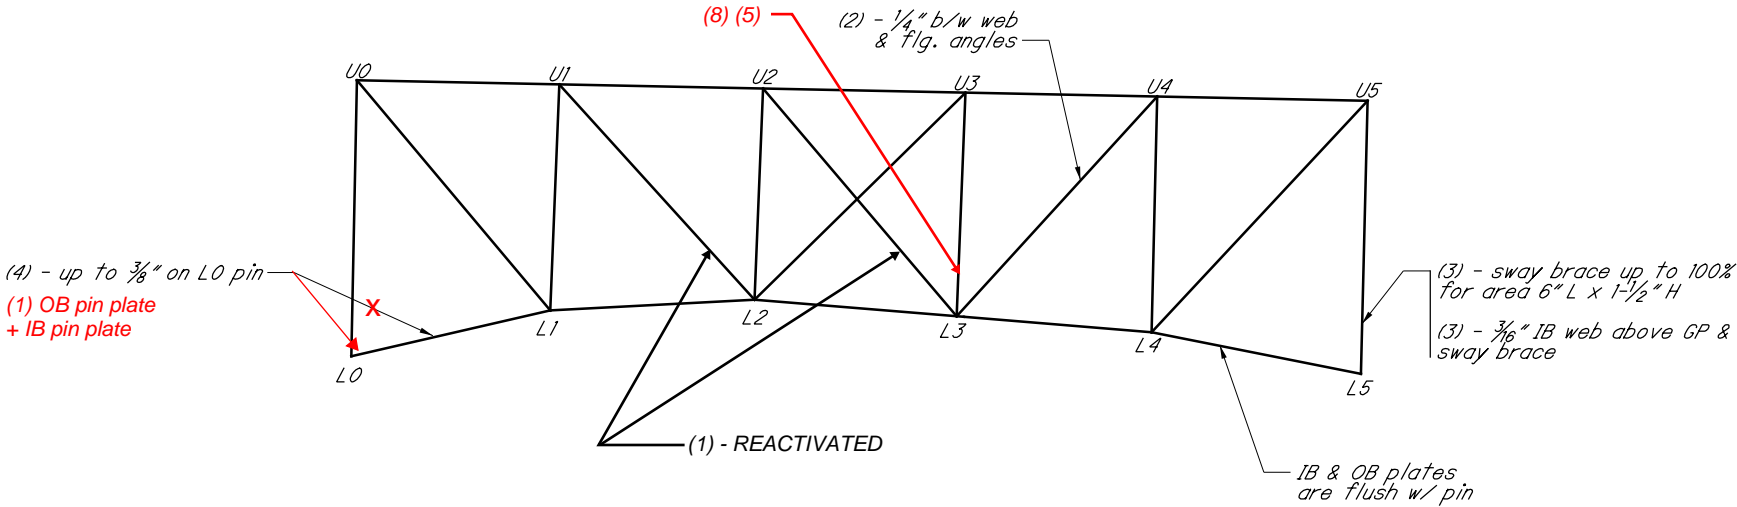
SPAN 6 - NORTH EXTERIOR TRUSS

NORTH EXTERIOR GUSSET PLATE DEFICIENCIES

- L0, BOTH - (3) - @ stiffening strut & minor reactivation
L1, IB GP - (5) - up to 1/8" D along L.C.
L2, IB GP - (6) - up to 1/8" along L.C. reactivated
L2, OB GP - (1) - above LC active
L3, IB GP - (6) - 1/16" D along L.C.
(1) - along L.C.
L3, OB GP - (6) - iso. 1/8" D along L.C.
L4, IB GP - (5) - iso. 1/8" D along L.C., some active
L4, BOTH - (1) - reactivated along L.C.
L5, BOTH - (2) - up to 1" b/w vert.
L5, IB GP - (6) - 1/8" widespread REACTIVATED
(2) - 1/2" @ diag.
(1) between stiffening strut and GP
U5, BOTH - (4) - up to 1/8" D full perimeter of upper pins
(2) - up to 1" b/w vert.
U5, OB GP - 5 partially filled-in holes (misdrilled or corrosion?)

- L5, - IB GP - (10) Interior face east of vertical exhibits active corrosion
L5, - OB GP - (6) Exterior face exhibits laminating corrosion along connection to LC
L5, - IB GP - (6) Interior face along connections to members exhibits heavy laminating corrosion
L5, - IB GP - (1) PR up to 1" wide between pin area/vertical and GP
Pin @ L5, GP
(6) Inboard exterior face of pin with areas of laminating corrosion
L5, - IB GP - (1) Exterior face exhibits active PR around bracing connections to GP
L5, - IB GP - (1) Exterior face between LC pin connection areas exhibits potential plug welds
Pin @ L5, LC
Inboard exterior face of pin
Pin @ L5, GP
(6) Interior of pin between GPs exhibits heavy laminating corrosion
Pin @ L5, LC
Outboard exterior face of pin
Pin @ L5, GP
(10) Outboard exterior face of pin with areas of corrosion

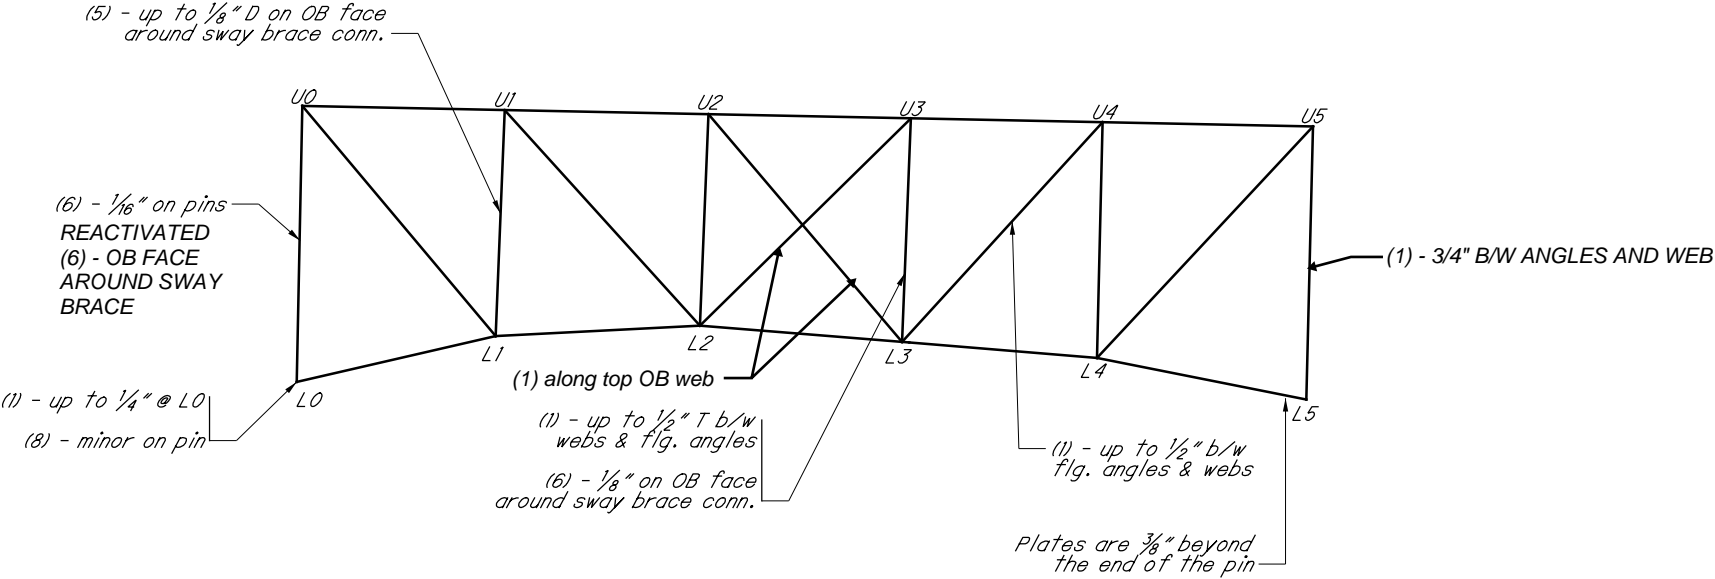
SPAN 6 - NORTH INTERIOR TRUSS

NORTH INTERIOR GUSSET PLATE DEFICIENCIES

- L0, Both GPs - (3) - @ stiffening strut
L0, IB GP - (1) - 1 1/2"+ @ pin
L1, OB GP - (6) ABOVE LC (UP TO 1/4")
L1, IB GP - (4) - 1/8" above L.C.
L2, BOTH - (6) - isolated, along lower chord up to 1/8"
L2 - IB GP - (10) at bottom
L3, BOTH - (6) - isolated, along lower chord up to 1/8"
L5, BOTH - (2) - up to 5/8" between GPs & vertical.

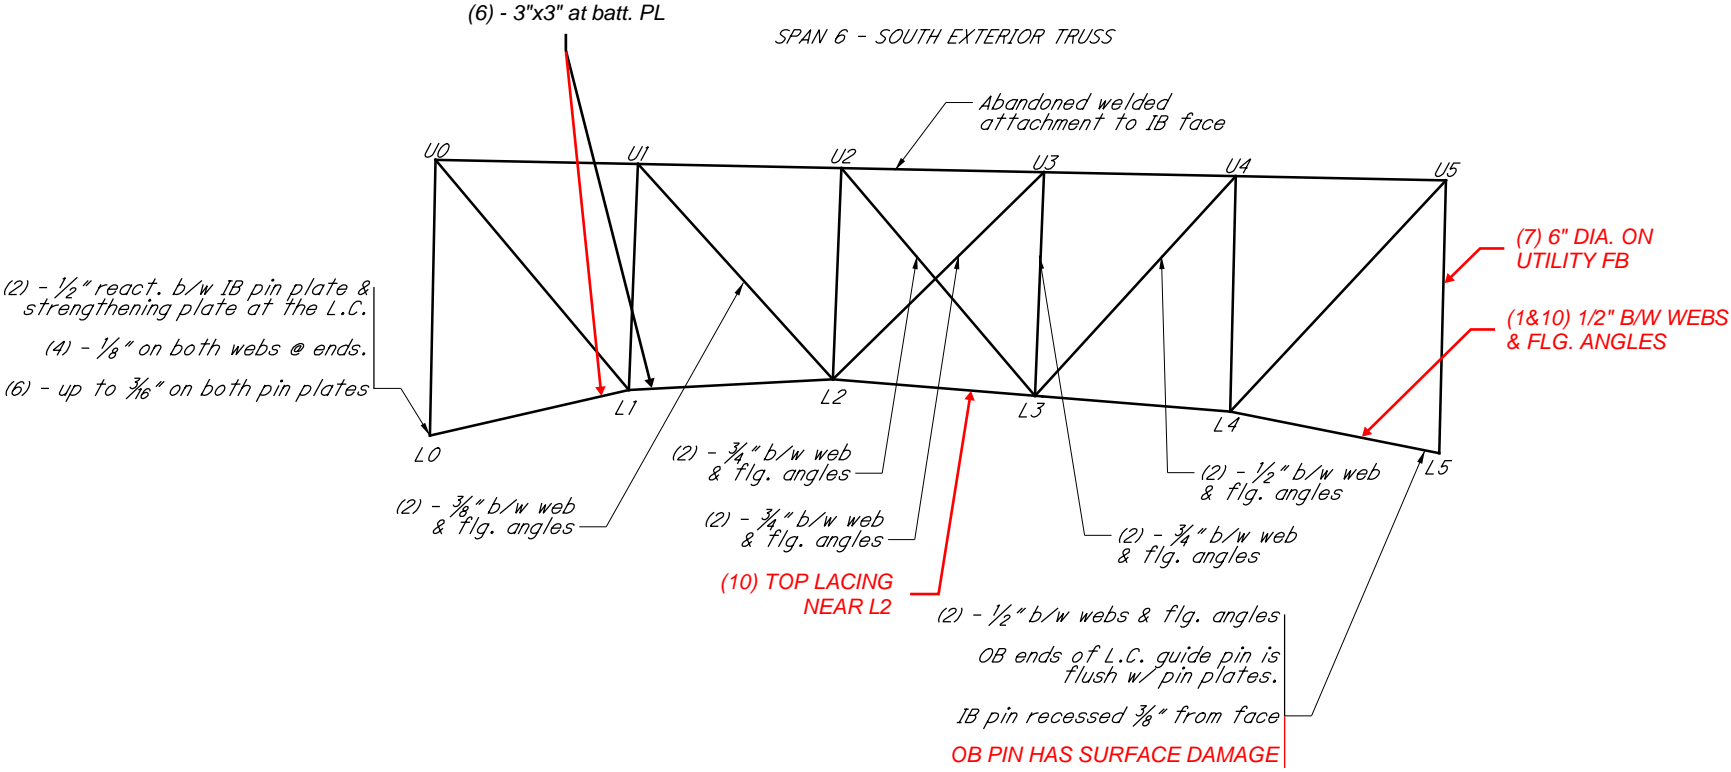
SOUTH EXTERIOR GUSSET PLATE DEFICIENCIES

- L0, BOTH - (4) - 1/8" along L.C.
- L1, IB GP - (4) - 3/16" above L.C.
- L2, IB GP - (4) - 1/8" along L.C.
- (6) - 2"x4"x3/16" at L2-U3
- L3, IB GP - (6) - widespread 1/16"
- L5 & U5, BOTH - (2) - react. up to 1" T b/w GP, vert., diag., and pin.
- (6) - up to 1/4" D.
- U5, BOTH - (2) - 1/2" @ vert. reactivated
- (4) - 1/8" around pin
