2025 PHYSICAL CONDITION ROUTINE ELEMENT LEVEL INSPECTION REPORT

Bridge CUY-10-1613

SFN 1801503

Hope Memorial/Lorain Carnegie over Cuyahoga River

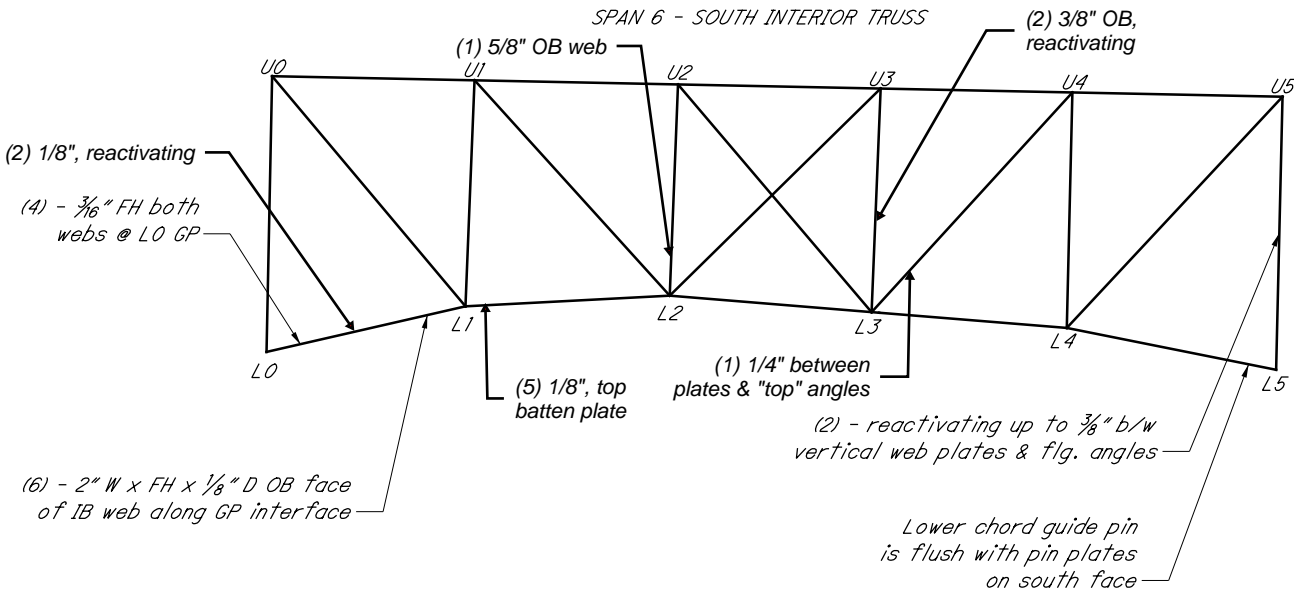
SOUTH INTERIOR GUSSET PLATE DEFICIENCIES

- L0, BOTH - (1) - 1-3/4" b/w both GPs and vertical & OB/lower chord connection
- (4) - exterior faces up to 3/16" around pin
- (5) - interior faces up to 1/8" D
- U0, BOTH - (1) - 1" b/w GPs and the verticals
- (6) - up to 1/8" D around pin
- L1, OB - (6) 1/8" x 1" x 2", OB face at top of lower chord connection

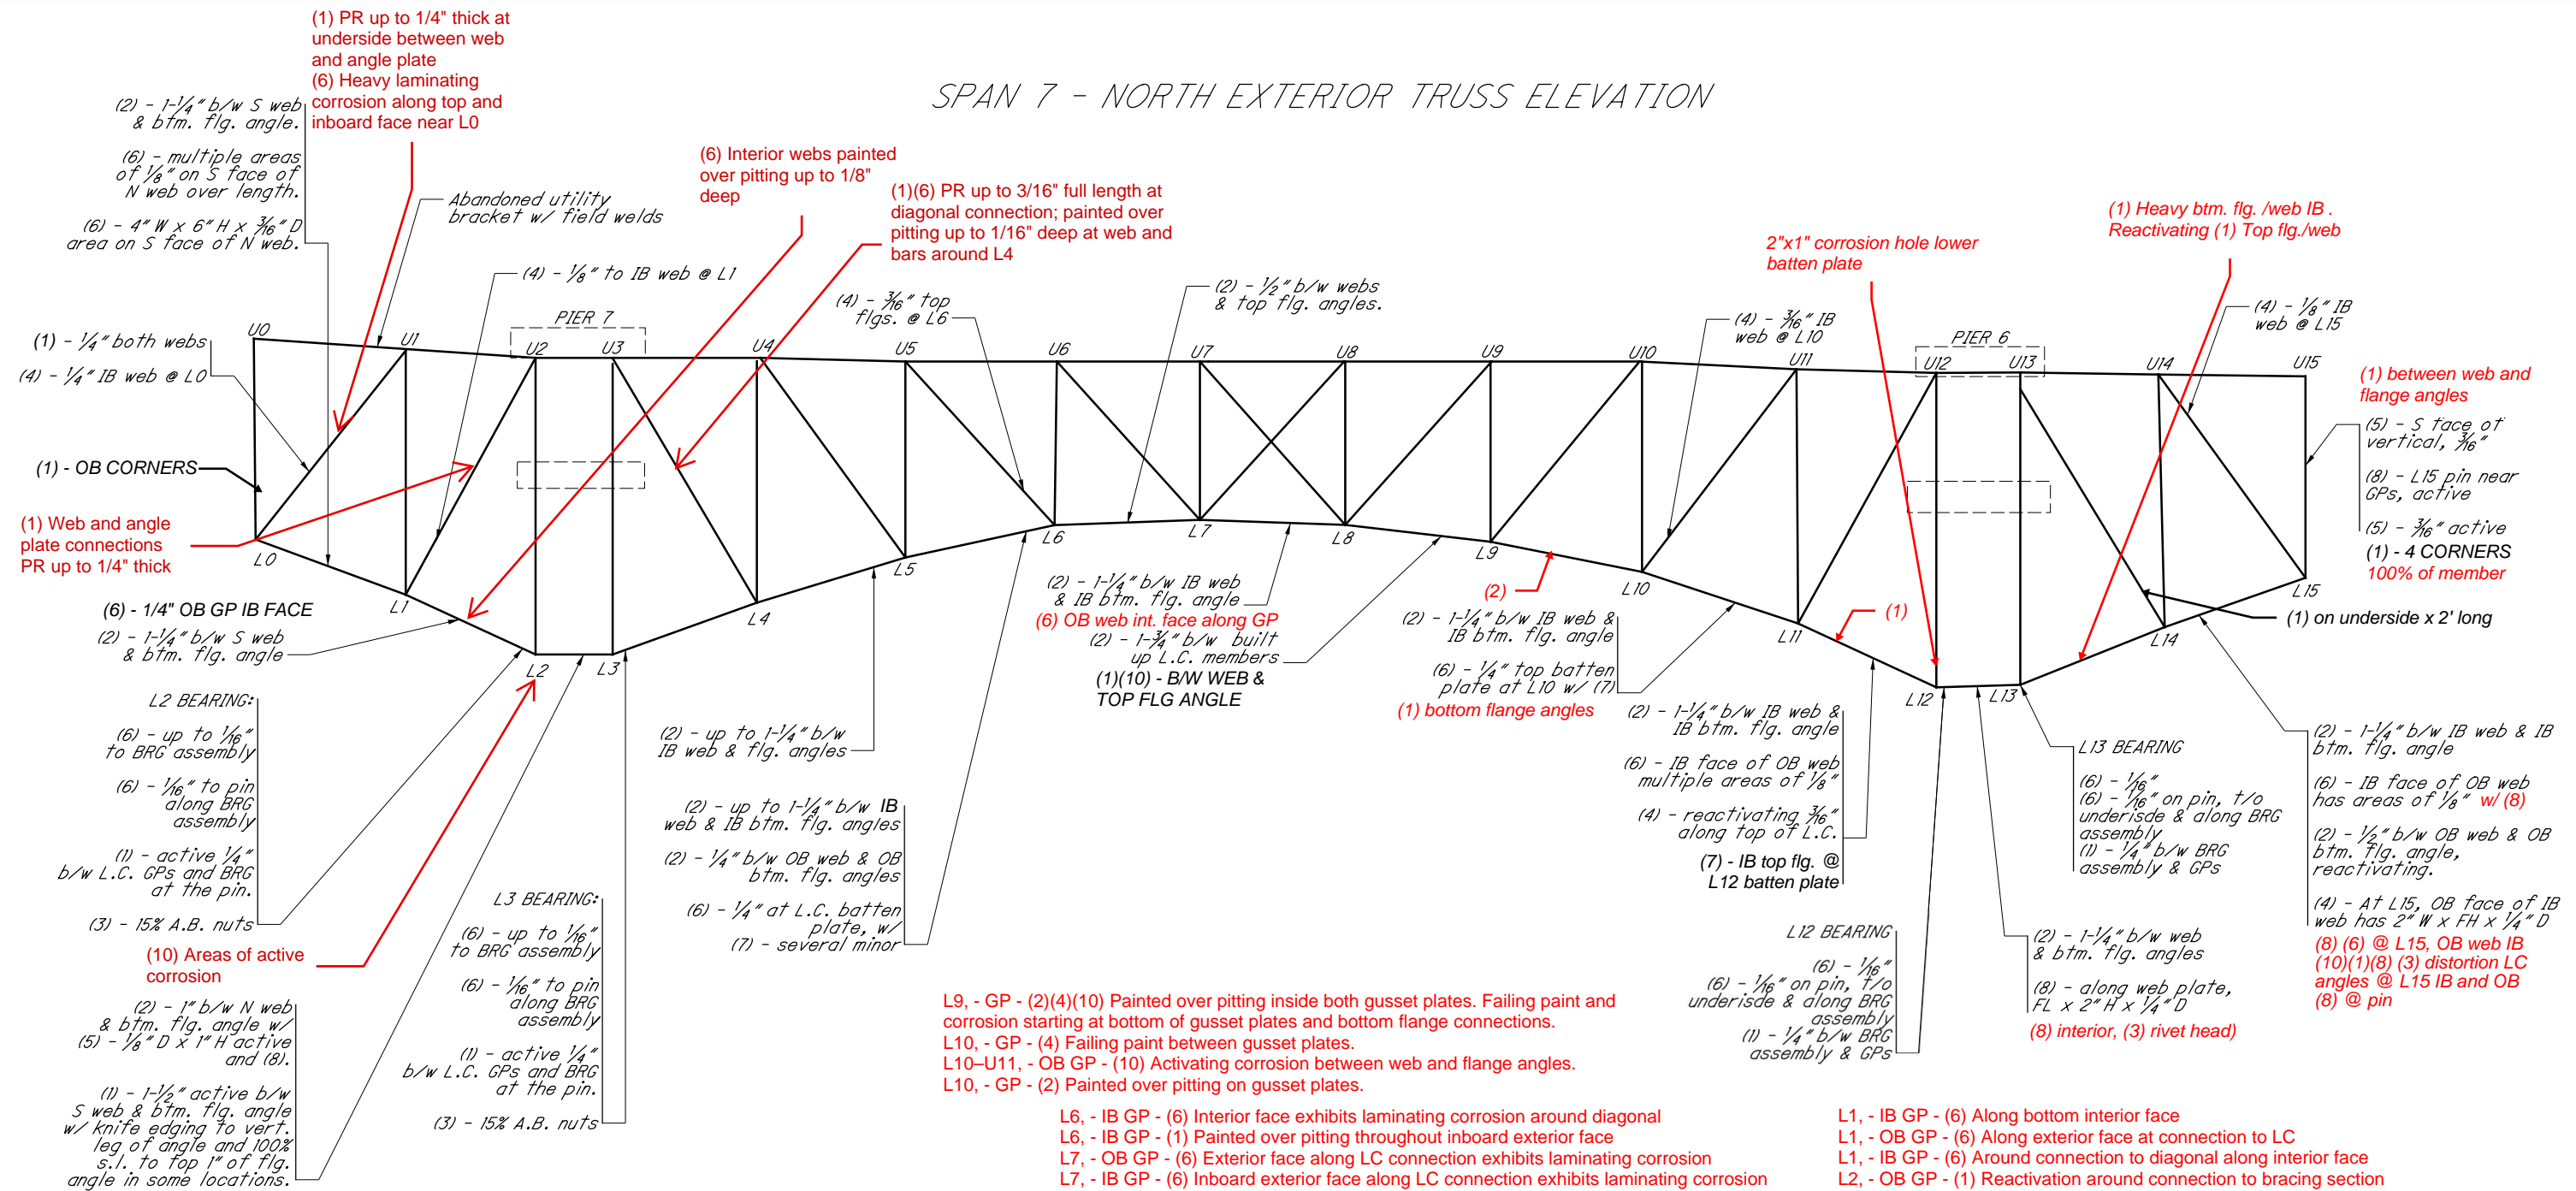
SPAN 7 - NORTH EXTERIOR TRUSS ELEVATION

SPAN 7 NORTH EXTERIOR - GUSSET PLATE DEFICIENCIES

- L0, BOTH GPs - (4) AROUND PIN
- L1, BOTH - (6) - 1/8" D ON INTERIOR FACES, IB UP TO 3/16"
(2) - 1/2" REACT. BETWEEN GP AND DIAGONAL.
- L2, OB GP - (6) - 3/16" D ON INTERIOR FACES
- L2, IB GP - (6) - 1/8" WIDESPREAD BOTH FACES
- L3, IB GP - (6) - 3/16" TO BOTH FACES AT W. END
- L4, OB GP - (1) 1/2" AT DIAGONAL (ACTIVE)
- L4, BOTH GPs - (5) ALONG LC (ACTIVE)
- L6, IB GP - (6) - 3/16" ON IB FACE
- L6, OB GP - (5) AROUND DIAGONAL
- L7, IB GP - (6) 1/8" ALONG L.C.
- L7, OB GP - (1) ALONG LC REACTIVATED
- L8, IB GP - (6) - 3/16" D on IB face (6) reactivating
- L8, OB GP - (1) between GP and lower chord.
- L9, IB GP - (6) - 1/16" D on IB face
- L10, IB GP - (2) - 1" t reactivating between GP and diagonal.
(6) - 1/8" near diag.

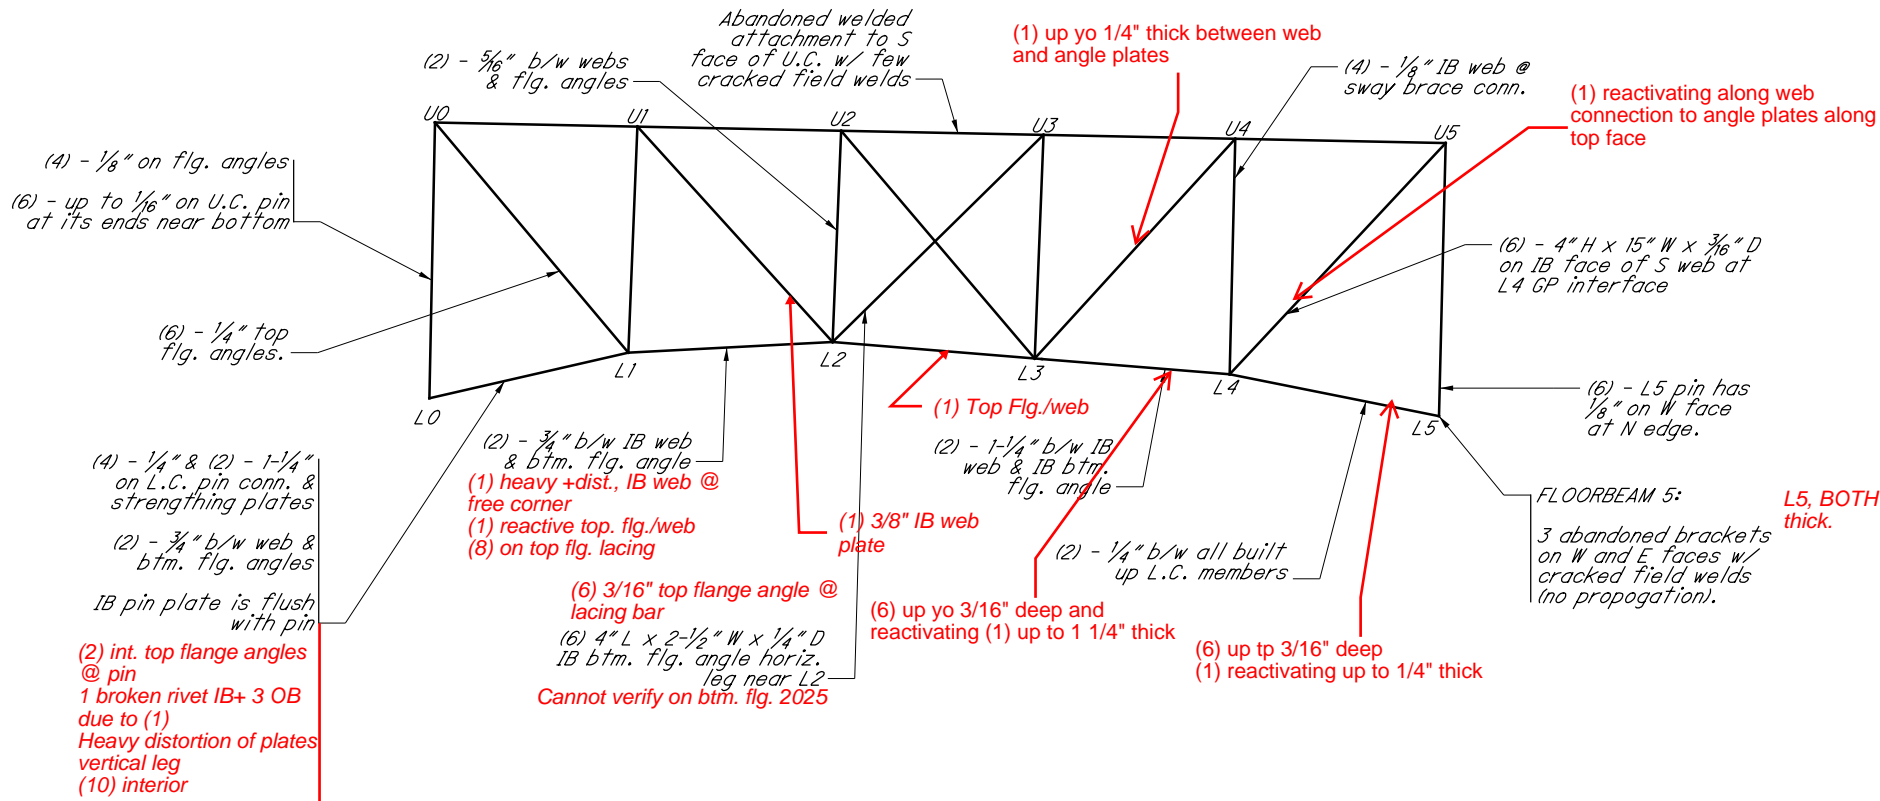
SPAN 8 - NORTH EXTERIOR TRUSS

NORTH EXTERIOR GUSSET PLATE DEFICIENCIES

- L0, BOTH - (2) - up to 1" T between the verticals
(6) - exterior faces around pin, up to 1/8"
- L0, IB GP - (6) - 1/4" along its west end.
- L1, OB GP - (10) AT LC (6)

- L4, IB GP - (6) - up to 1/4", reactivating, IB face along lower chord
(8) - with minor surface corrosion(1)
- L5, BOTH - (2) - up to 3/4" @ vert. & diag.
L5, IB GP - (4) - up to 1/4" D on IB face around pin & scattered (8) (10), exterior face thick.

- L5, OB GP - (4) - 1/8" around pin.
- U5, BOTH - (2) - 1" T between the vertical webs
- Pin @ L5 @ GP
(8) Interior pin exhibits areas of laminating corrosion.

- Pin @ L5 @ GP
(10) IB pin face exhibits areas of active corrosion
- Pin @ L5, @ GP
(10) OB pin face exhibits areas of corrosion
- Pin @ U5
(8) OB pin face exhibits areas of active corrosion. FB and stringers at this location exhibits laminating corrosion.

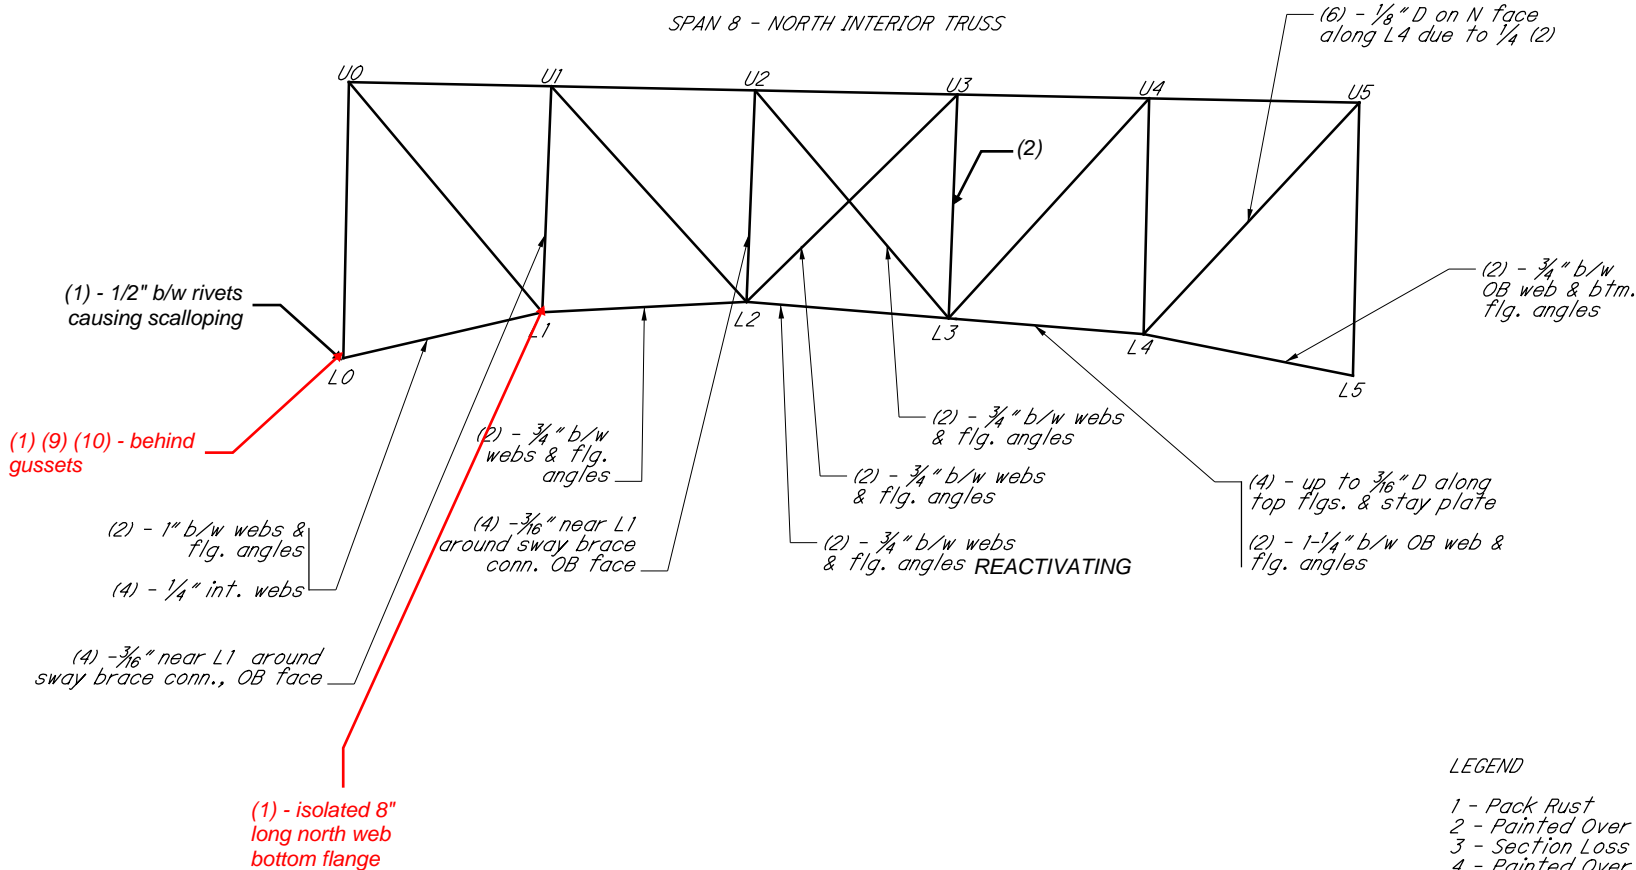
SPAN 8 - NORTH INTERIOR TRUSS

NORTH INTERIOR GUSSET PLATE DEFICIENCIES

- L1, OB GP - (4) - 1/4" scattered.
- L2, OB GP - (10) AT LC AND DIAGONAL
- L3, OB GP - (8) AT LC
- L4, OB GP - (4) - 1/4" OB face along E free edge. (8) interior face around diagonal connections
- L5, - IB GP - (6) East of vertical along interior face exhibits heavy laminating corrosion
- L0, - GP - (1) Both gusset plates distorted up to 1-3/4" due to pack rust
- L2-U2, - OB GP - (1) Isolated areas of pack rust causing web distortion
- L2, - OB GP - (10) At LC and diagonal
- L3, - OB GP - (8) At LC
- L4, - OB GP - (4) 1/4" OB face along east free edge
- L1, - BW GP - (1)(6) Pack rust and pitting at bottom of gusset.
- L3, - BW GP - (1)(6)(10) Active corrosion, pack rust, and pitting at bottom of gusset.
- L3, - OB GP - (4) Failing paint on gusset.

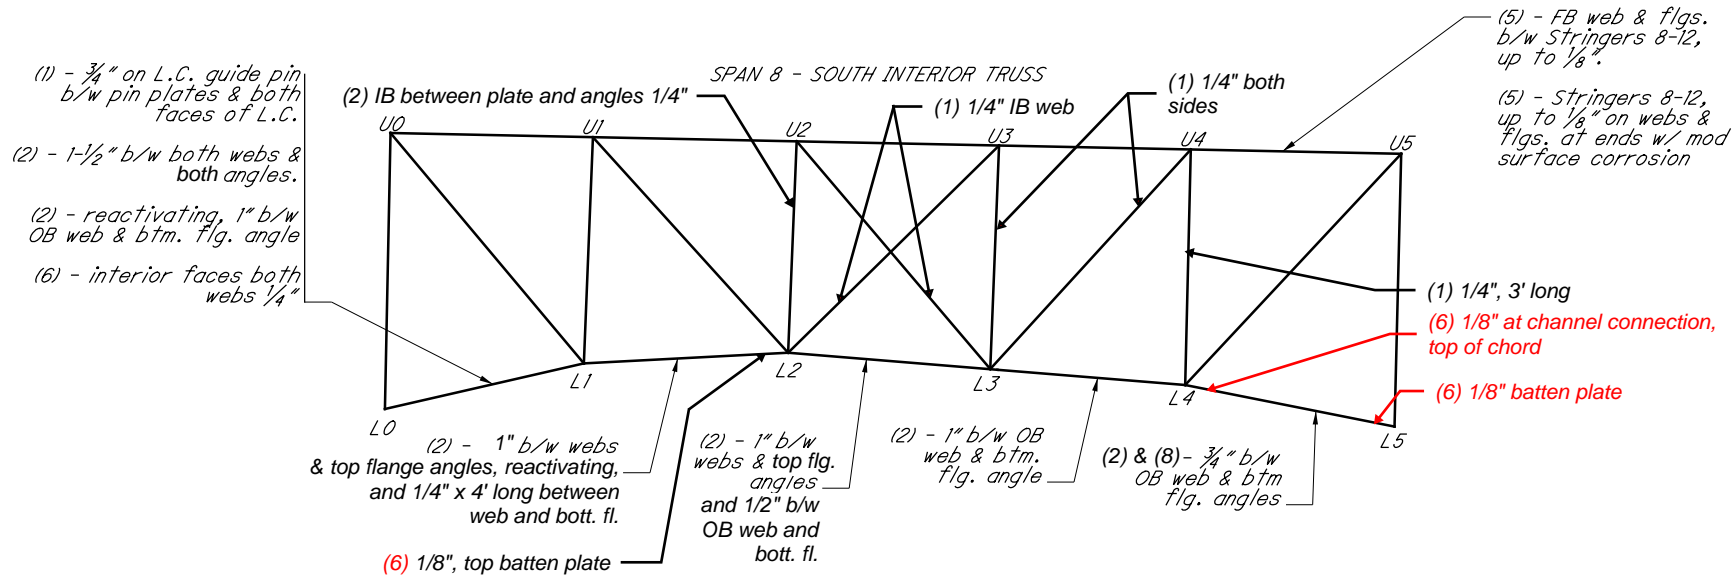
SPAN 8 - SOUTH TRUSS ELEVATIONS

SOUTH INTERIOR GUSSET PLATE DEFICIENCIES

- L0, BOTH - (4) - up to $\frac{3}{8}$ " around pin w/
(1) - 2" T, active
(1) - 2- $\frac{1}{4}$ " T, active, between plates and vertical web plates
- L1, IB GP - (6) - $\frac{1}{4}$ " x 2- $\frac{1}{2}$ " H area along lower chord interface.
- L2, IB GP - (6) - $\frac{1}{4}$ " D x 1" H x 3' L along top of lower chord and pack rust/deformation of top of lower chord at GP connection
- L4, IB GP - (5) along LC interface
- L5, BOTH - (2) - reactivating, 1- $\frac{1}{2}$ " T between top of plates and vertical.
- L5, BOTH - (1) - $\frac{1}{2}$ " T above lower chord guide pin. *
(5) - $\frac{1}{8}$ " around L.C. guide pin.
- U5, IB GP - (2) - $\frac{1}{2}$ " t between IB GP and vertical.

* Pack rust at guide pin plate is causing plate to bow and its outer face is flush with the guide pin

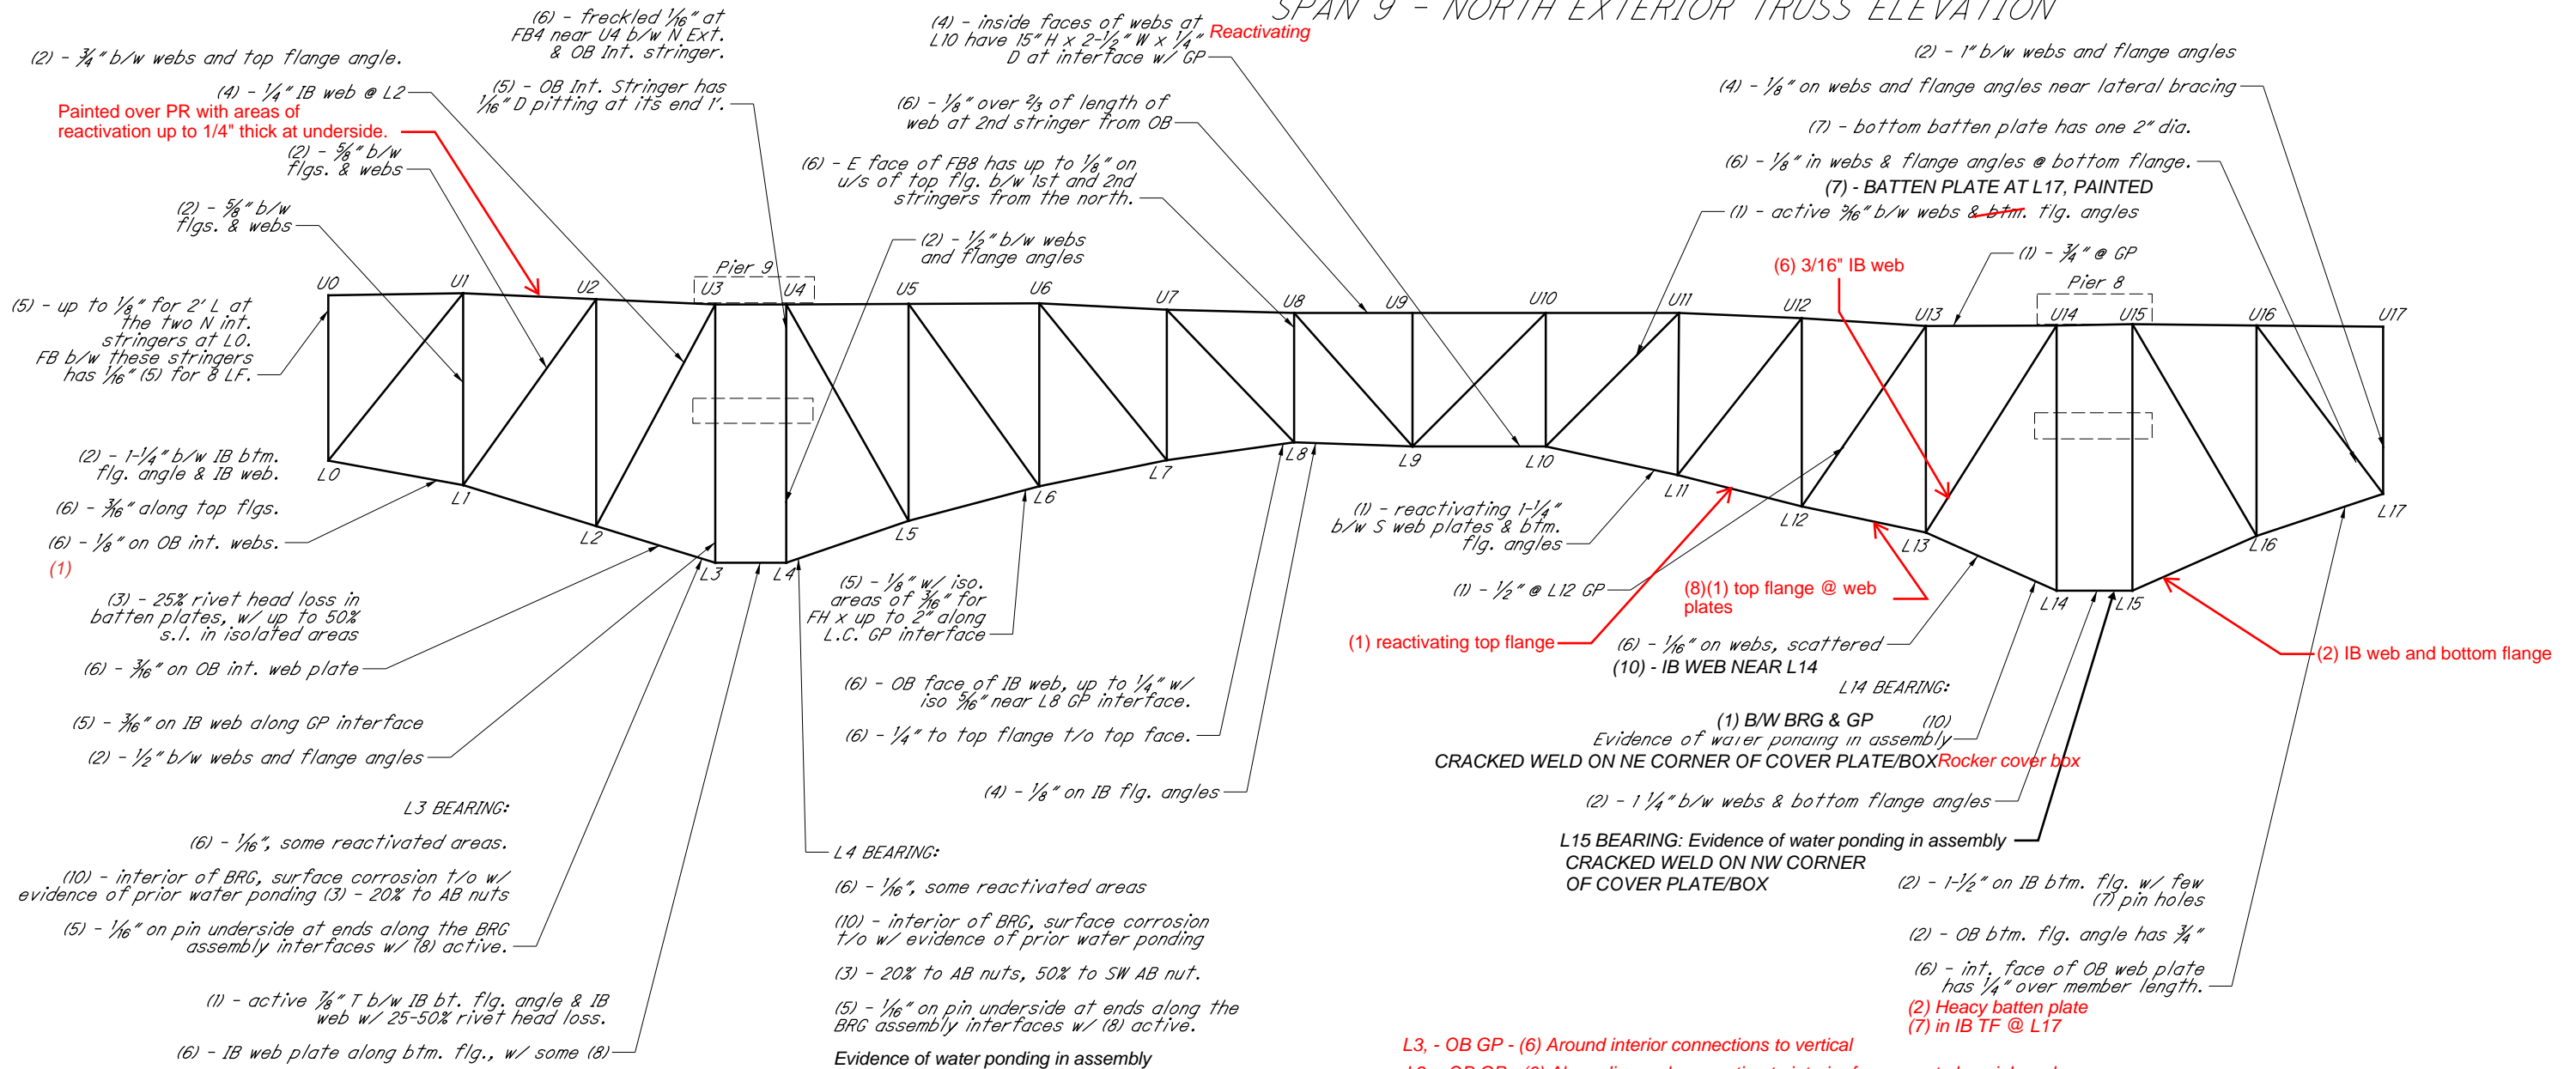
SPAN 9 - NORTH EXTERIOR TRUSS ELEVATION

SPAN 9 NORTH EXTERIOR GUSSET PLATE DEFICIENCIES

- L1, IB GP - (6) - areas of $\frac{1}{4}$ " above LC IB face
L1, BOTH GPs - (10) INTERIOR AT DIAGONAL
L1, OB GP - (10) AT VERTICAL
L2, IB GP - (6) - areas of reactivating $\frac{3}{8}$ " near interface
with lower chord and around sway brace connection.

SPAN 9 NORTH EXTERIOR GUSSET PLATE DEFICIENCIES (CONT'D)

- L10, OB GP - (10) AT LC
L10, IB GP - (4) - 3#16" along LC.
- L11, BOTH GPs - (10) AT LC
L12, IB GP - (6) - up to 1#4" reactivating, worst on IB face
with isolated areas up to 5#16" at east end along lower chord.
- L12, OB GP - (6) - isolated areas up to 3#16" on IB face.
L12, BOTH GPs - (10) AT LC
- L13, IB GP - (6) - areas up to 1#4".
- L13, BOTH - (1) between GP and diagonal.
- L13, BOTH - (8) active along bottom + rust along LC OB
- L14, OB GP - (10) AT LC
L14, BOTH - (6) - UP TO 1#4" THROUGHOUT
- L15, OB GP - (10) AT LC
L15, BOTH - (6) - ISOLATED AREAS UP TO 1#4"
- L16, IB GP - (6) - AREAS UP TO 1#4"
L16, BOTH GPs - (10) AT LC
- L17, BOTH - (6) - 3#16" widespread around pins. IB everywhere
(1) - 5/8"
- U17, BOTH - (2) - 1-1#8" and (6) - 1#4" widespread.

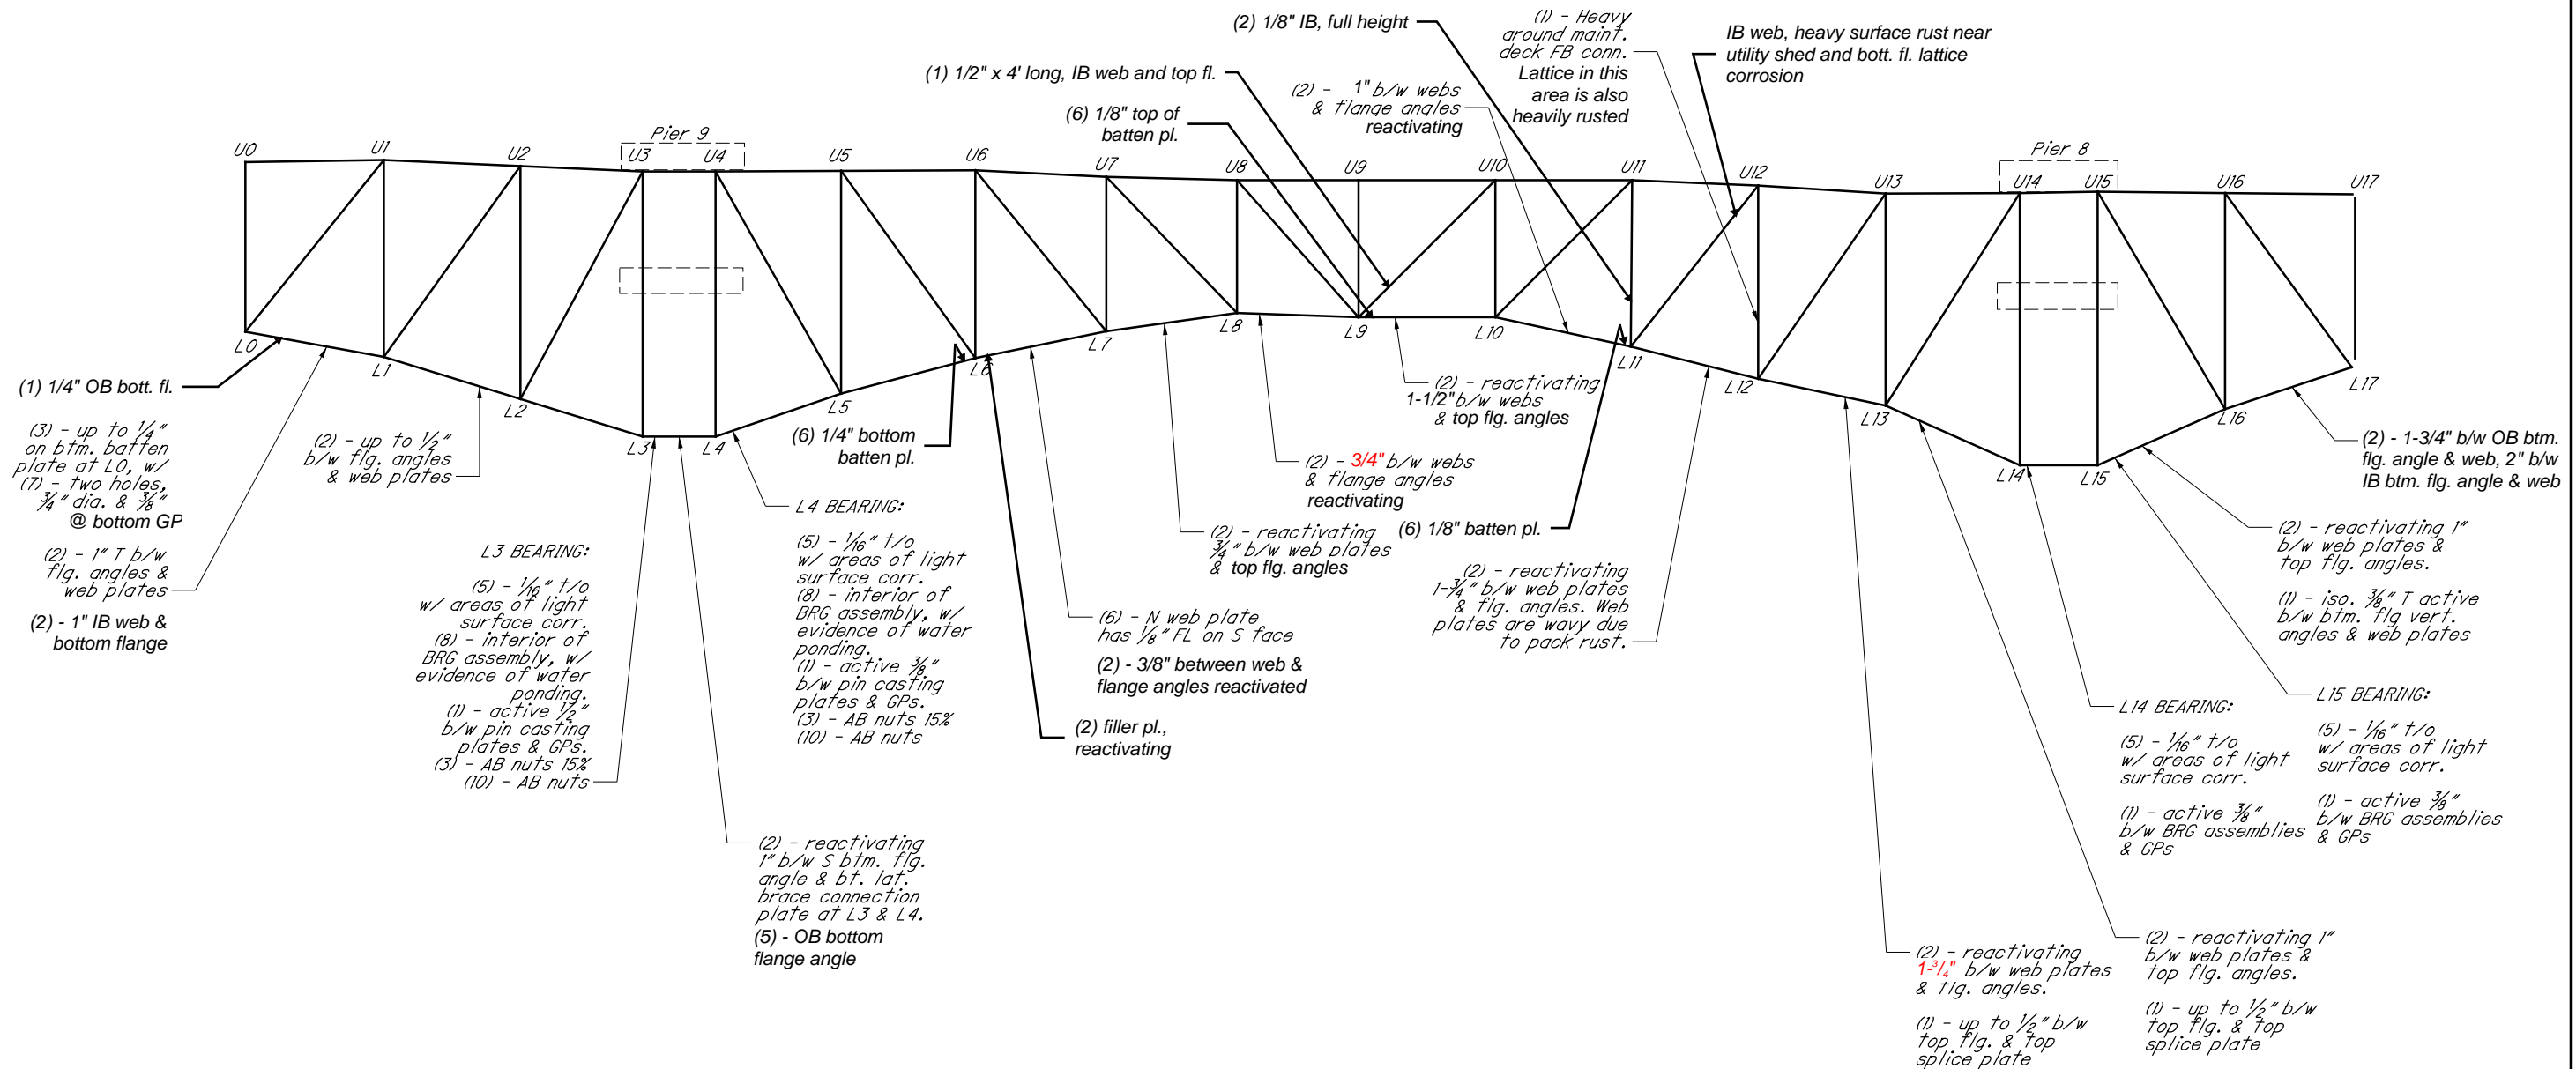
SPAN 9 - SOUTH INTERIOR TRUSS ELEVATION

SPAN 9 SOUTH INTERIOR GUSSET PLATE DEFICIENCIES

L0, BOTH - (6) - exterior faces have up to 1/16".

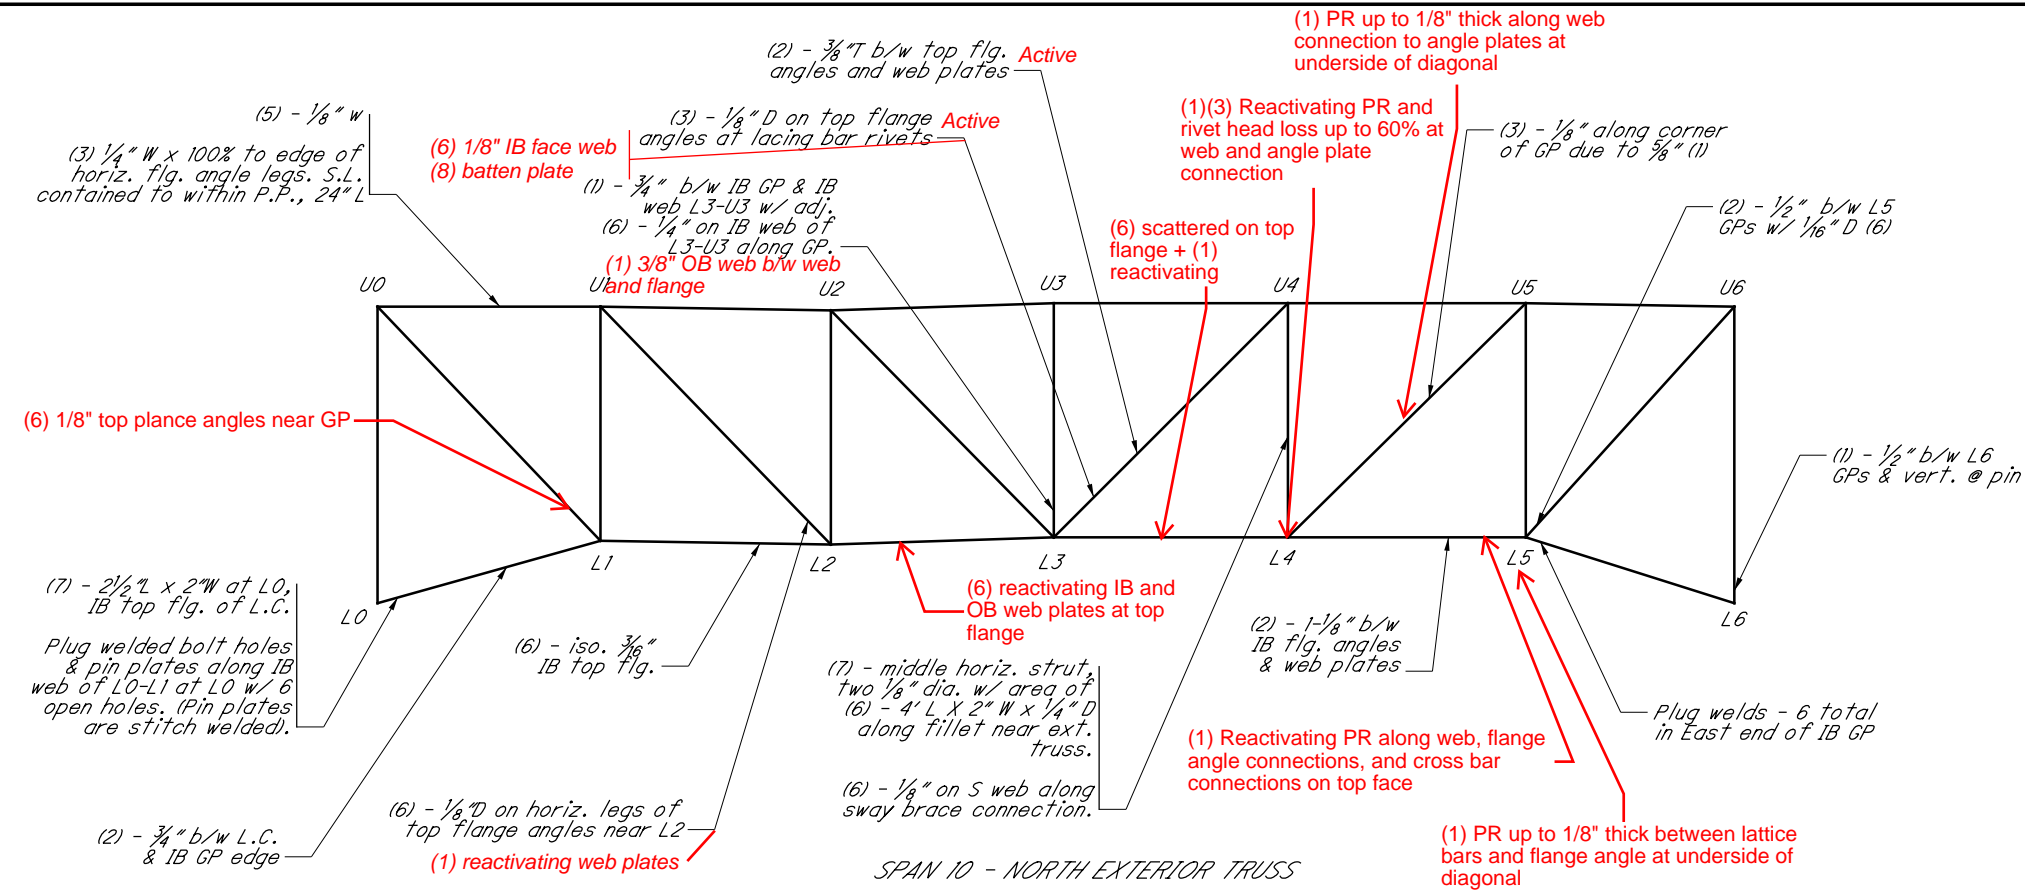
SPAN 10 - NORTH EXTERIOR TRUSS

NORTH EXTERIOR GUSSET PLATE DEFICIENCIES

Pin @ L6, @ GP
(10) Inboard pin exhibits areas of active corrosion.

Pin @ U6
(10) Outboard pin exhibits areas of active corrosion.(6) The stringer and FB at this location also exhibit laminating corrosion.

Pin @ L6, @ LC
(6)(10) Interior pin exhibits areas of heavy laminating corrosion at the ends.

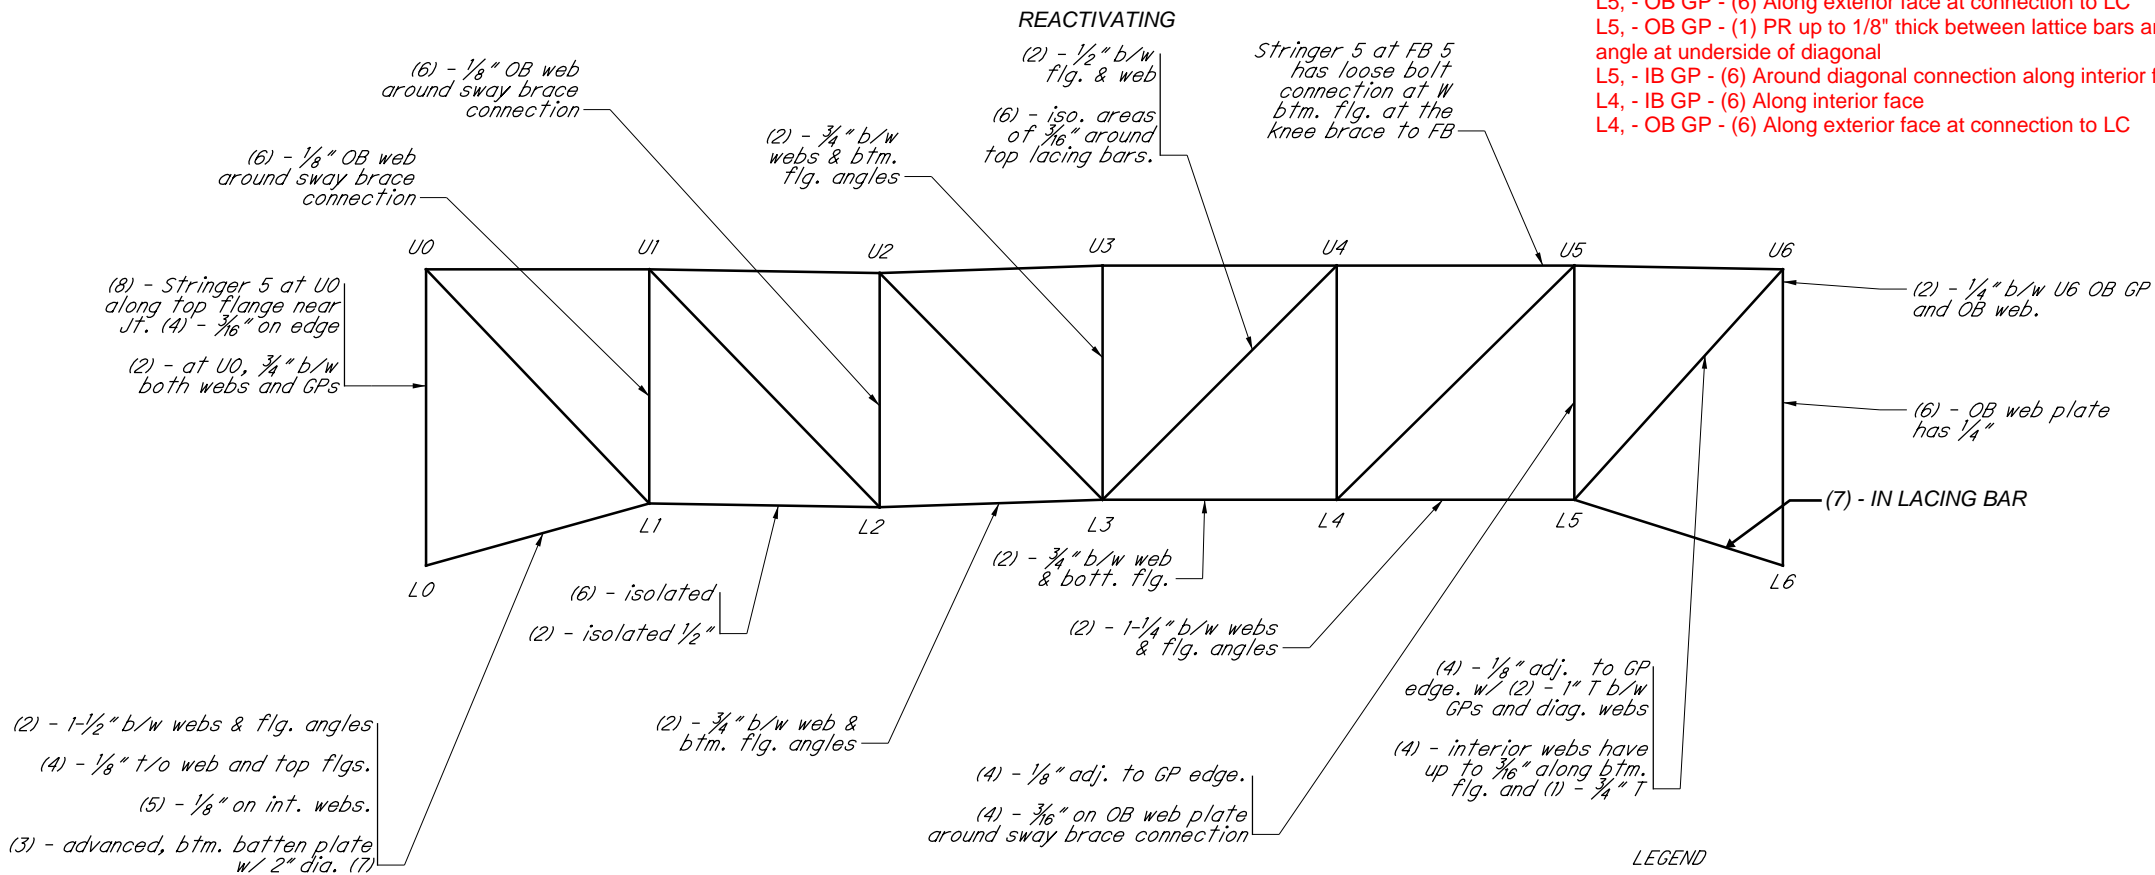
SPAN 10 - NORTH INTERIOR TRUSS

L0-L1, - Expansion Pin - (1) Pack rust behind expansion pin and pin plate; corrosion at north web channel at expansion pin location
L0-L1, - OB GP - (1) Pack rust behind gusset plates causing top flange angle distortion
L0-L1, - OB GP - (7)(3) Corrosion holes and section loss at top flange
L1, - IB GP - (6) Pitting up to 9/32" deep at northwest end of north gusset plate
L1, - OB GP - (3)(6) Pitting section loss on gusset plate and connection bolts, up to 7/32" deep
L0, - OB GP - (7)(3)(6) Corrosion holes and section loss at top flange plate near L0, with pitting

NORTH INTERIOR GUSSET PLATE DEFICIENCIES

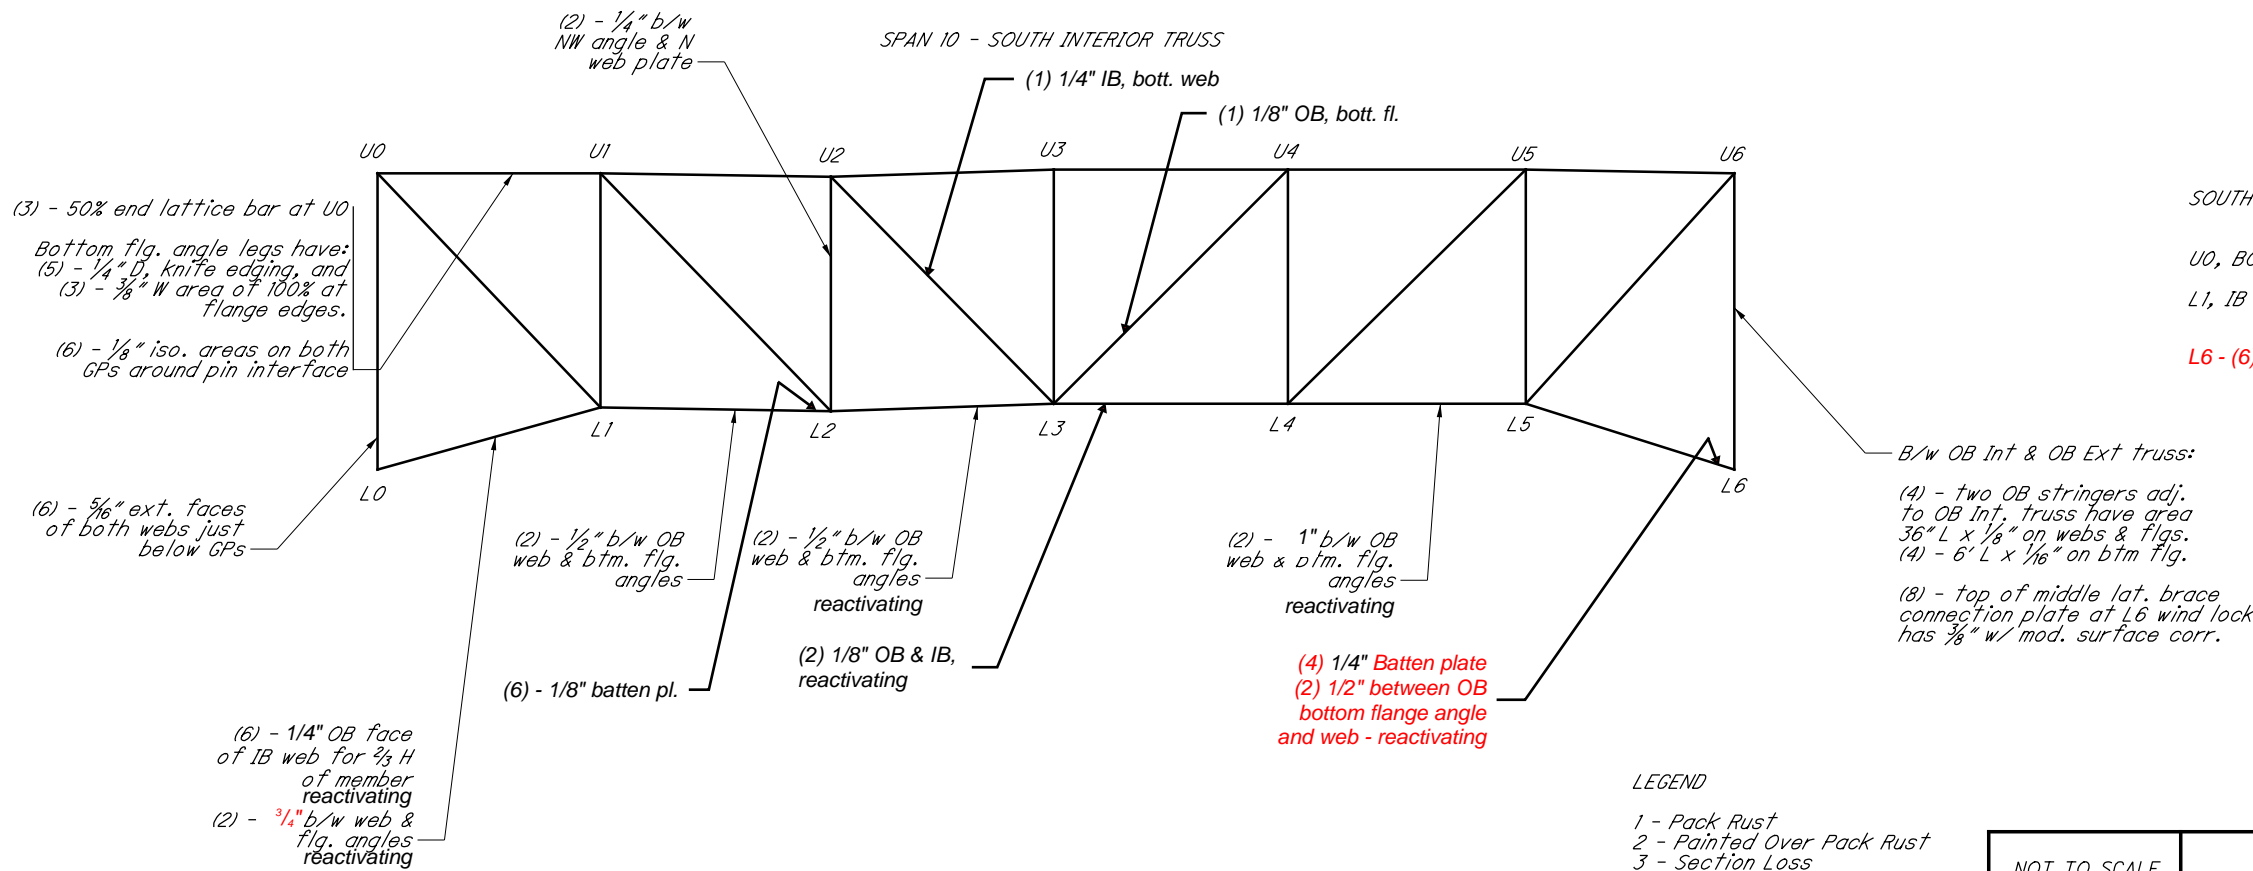
SOUTH INTERIOR GUSSET PLATE DEFICIENCIES

- U0, BOTH - (6) - $\frac{1}{8}$ " reactivating, around pin interface.
- L1, IB GP - (6) $\frac{1}{8}$ " along the lower chord.
- Reactivating around diagonal riveted connections.
- L6 - (6) $\frac{1}{8}$ " at LC connection, reactivating
