2025 PHYSICAL CONDITION ROUTINE ELEMENT LEVEL INSPECTION REPORT

Bridge CUY-10-1613

SFN 1801503

Hope Memorial/Lorain Carnegie over Cuyahoga River

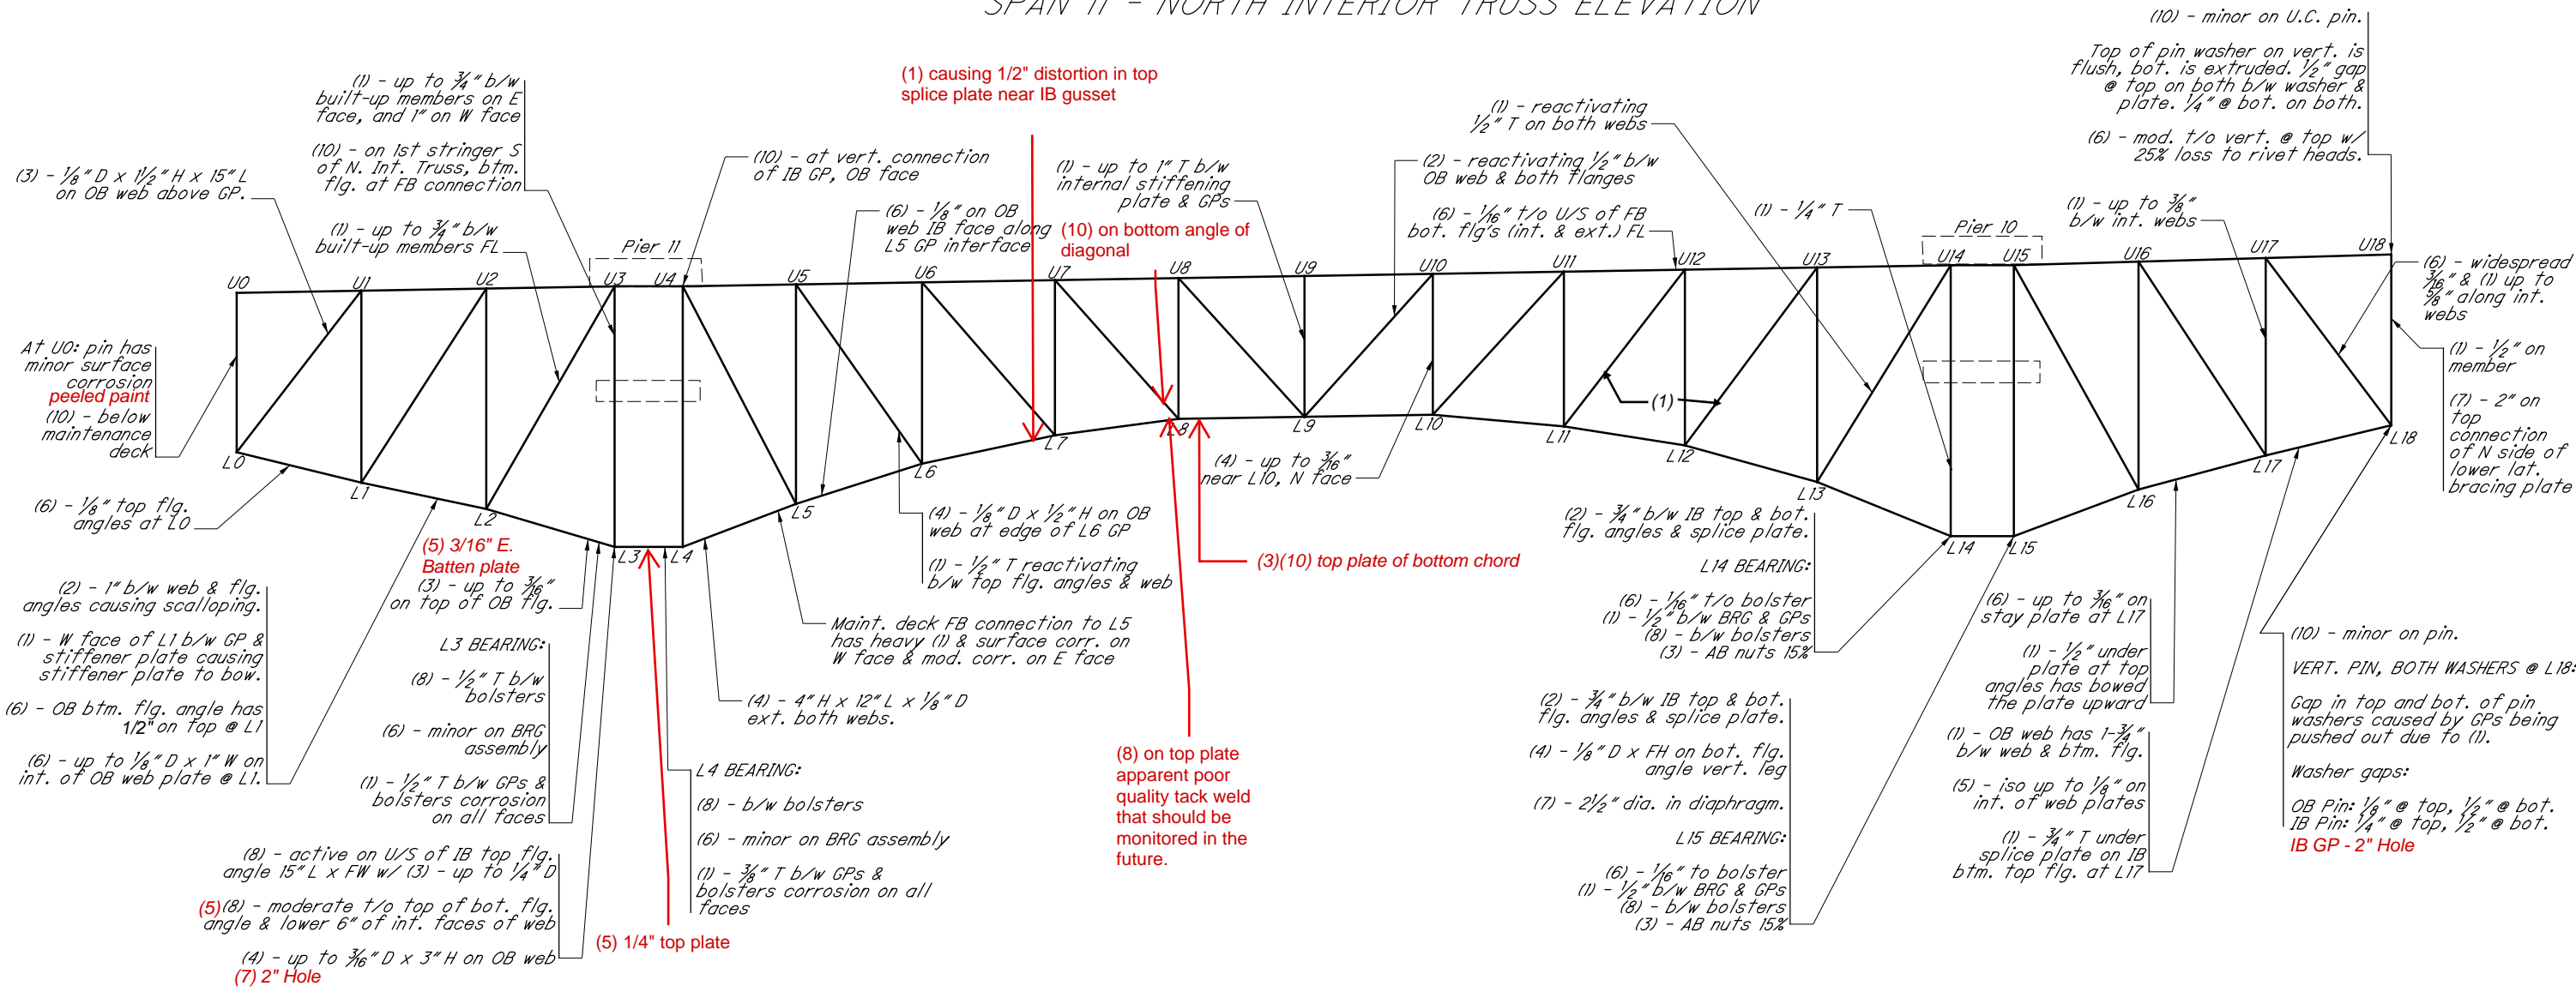
SPAN 11 - NORTH INTERIOR TRUSS ELEVATION

SPAN 11 NORTH INTERIOR GUSSET PLATE DEFICIENCIES

L0, BOTH - (4) - OB face has up to $\frac{1}{4}$ " above the diagonal conn. angle.

L18, IB GP - paint failure, heavy surface corrosion and (4).

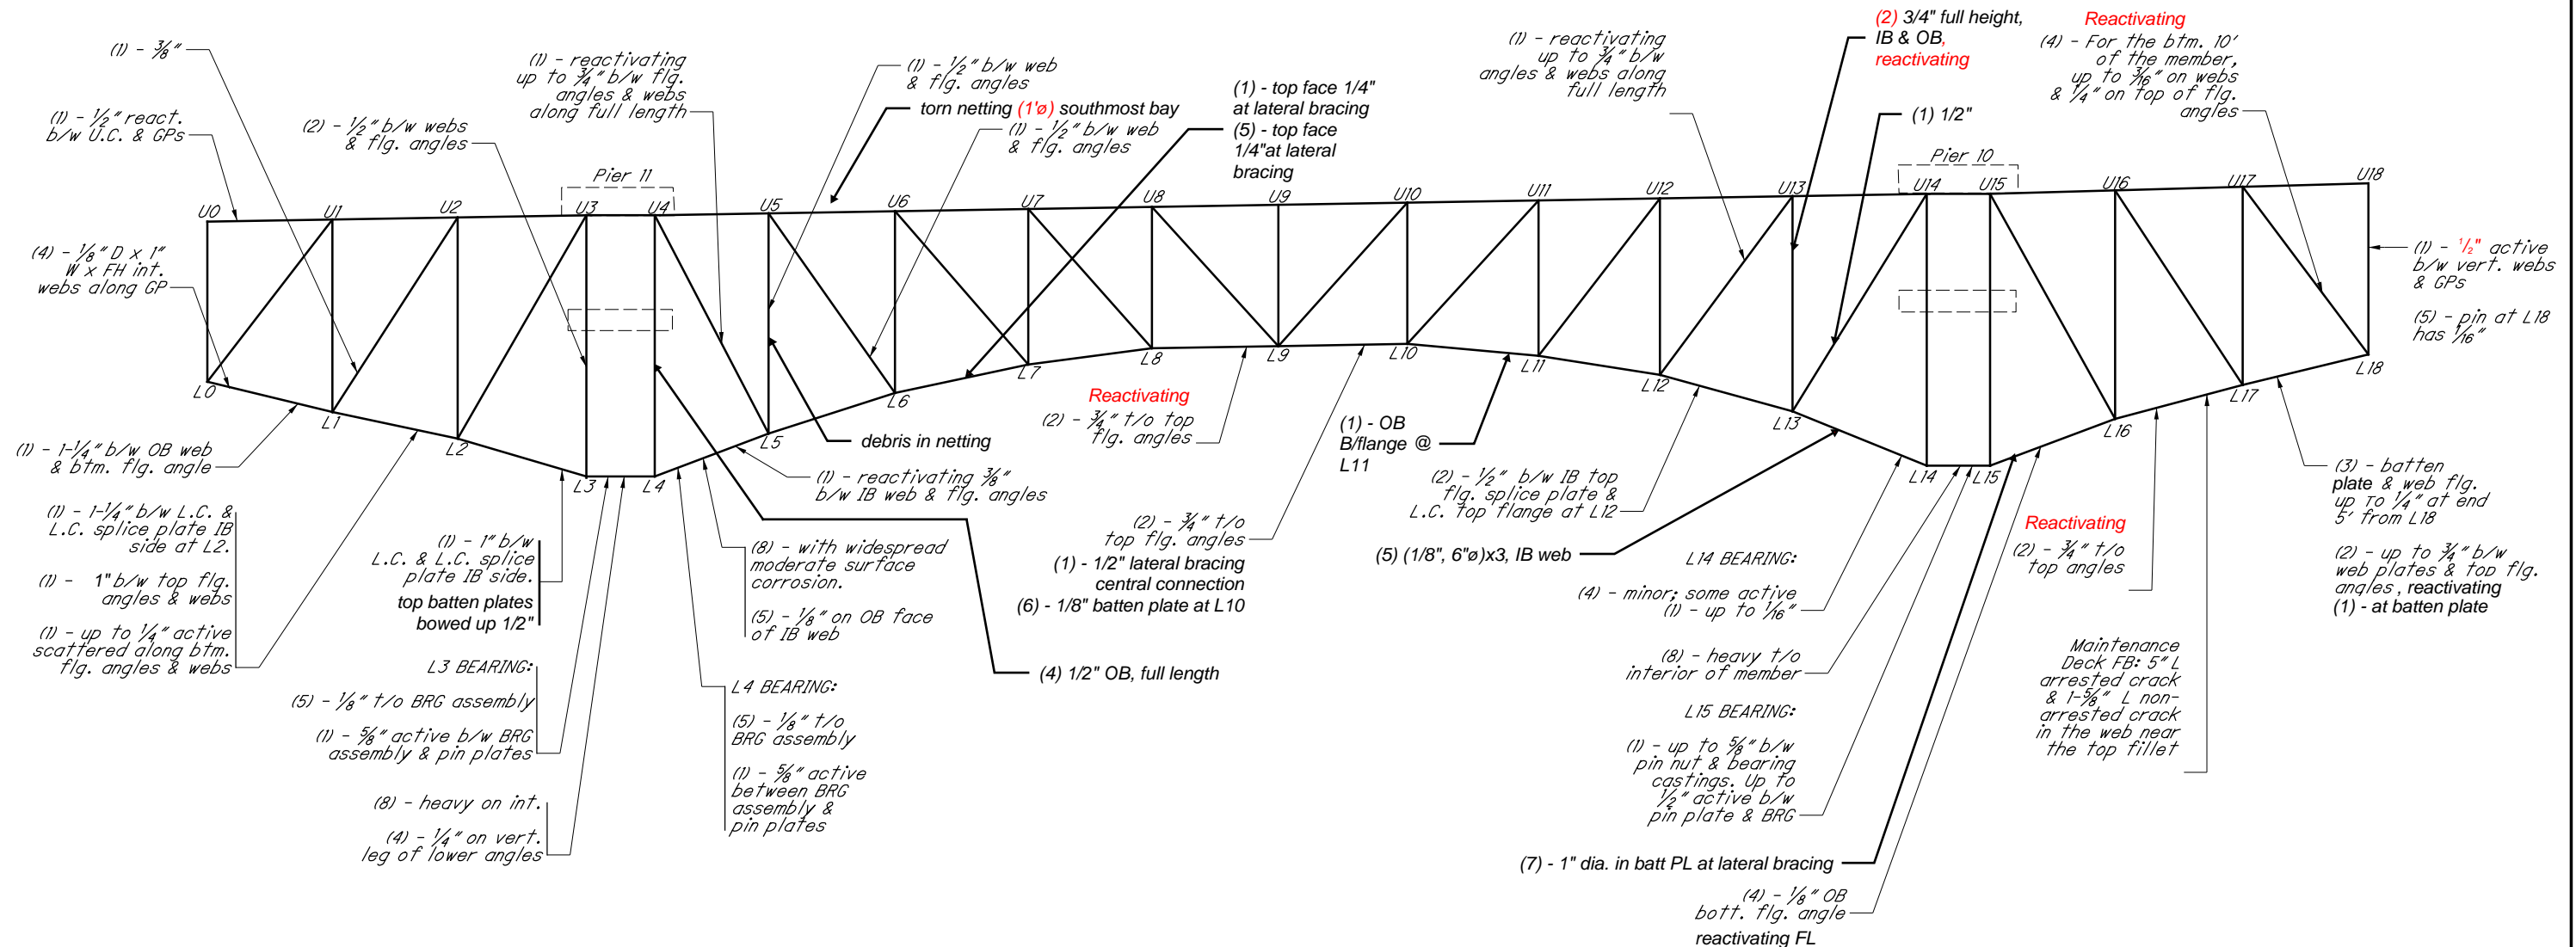
SPAN 11 - SOUTH INTERIOR TRUSS ELEVATION

SPAN 11 SOUTH INTERIOR GUSSET PLATE DEFICIENCIES

- L0, BOTH - (4) - $\frac{1}{16}$ " T/O with isolated up to $\frac{3}{16}$ "
(1) - reactivating between vertical & GPs
- U0, IB GP - (1) $\frac{1}{2}$ " reactivating between GP & vertical

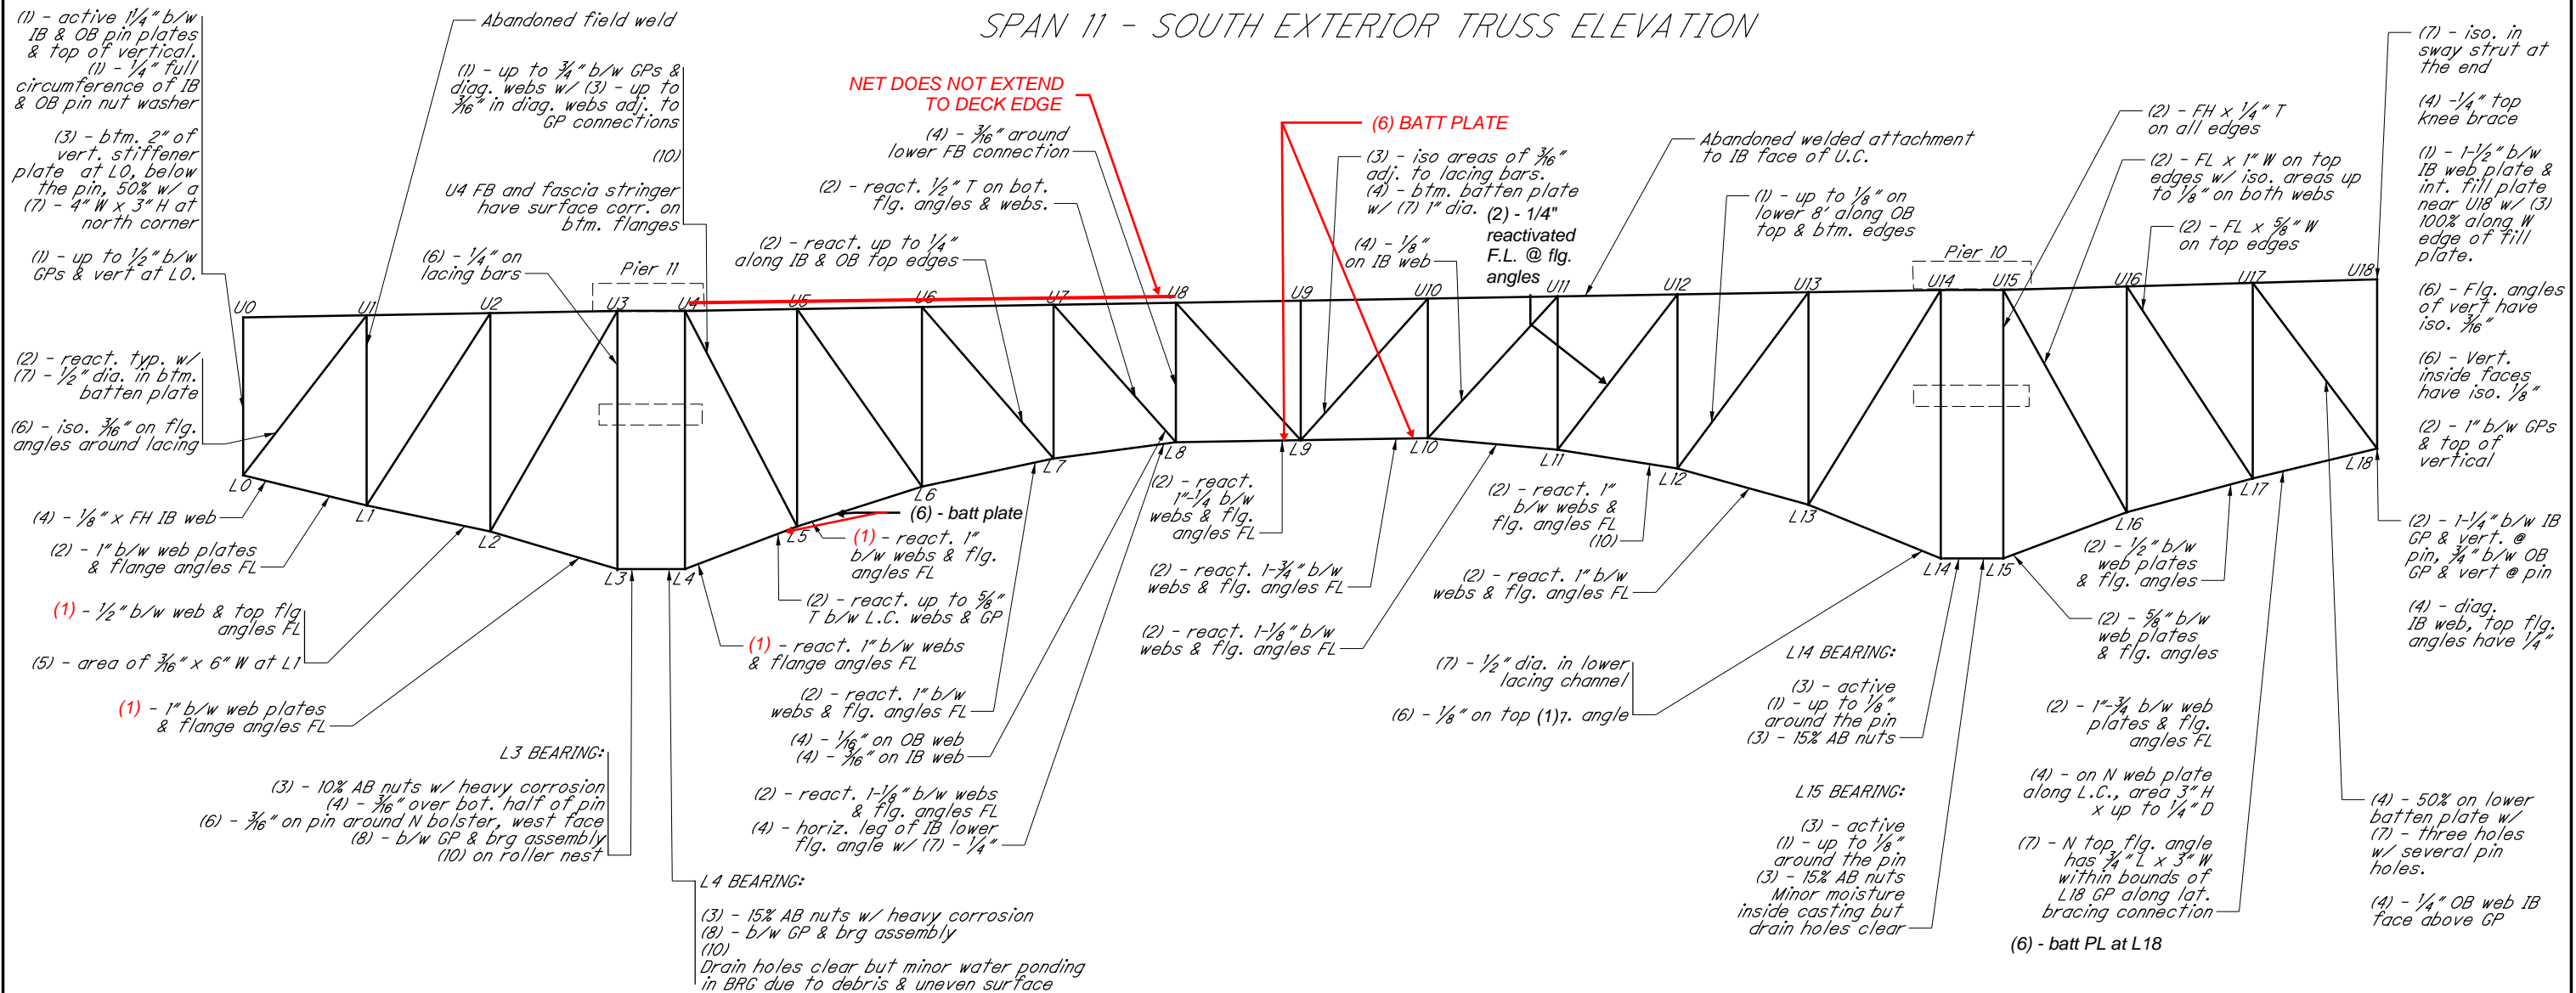
SPAN 11 - SOUTH EXTERIOR TRUSS ELEVATION

SPAN 11 SOUTH EXTERIOR GUSSET PLATE DEFICIENCIES

L0, BOTH - (6) - widespread, worst on IB plate around pin (avg. $\frac{3}{16}$ ")

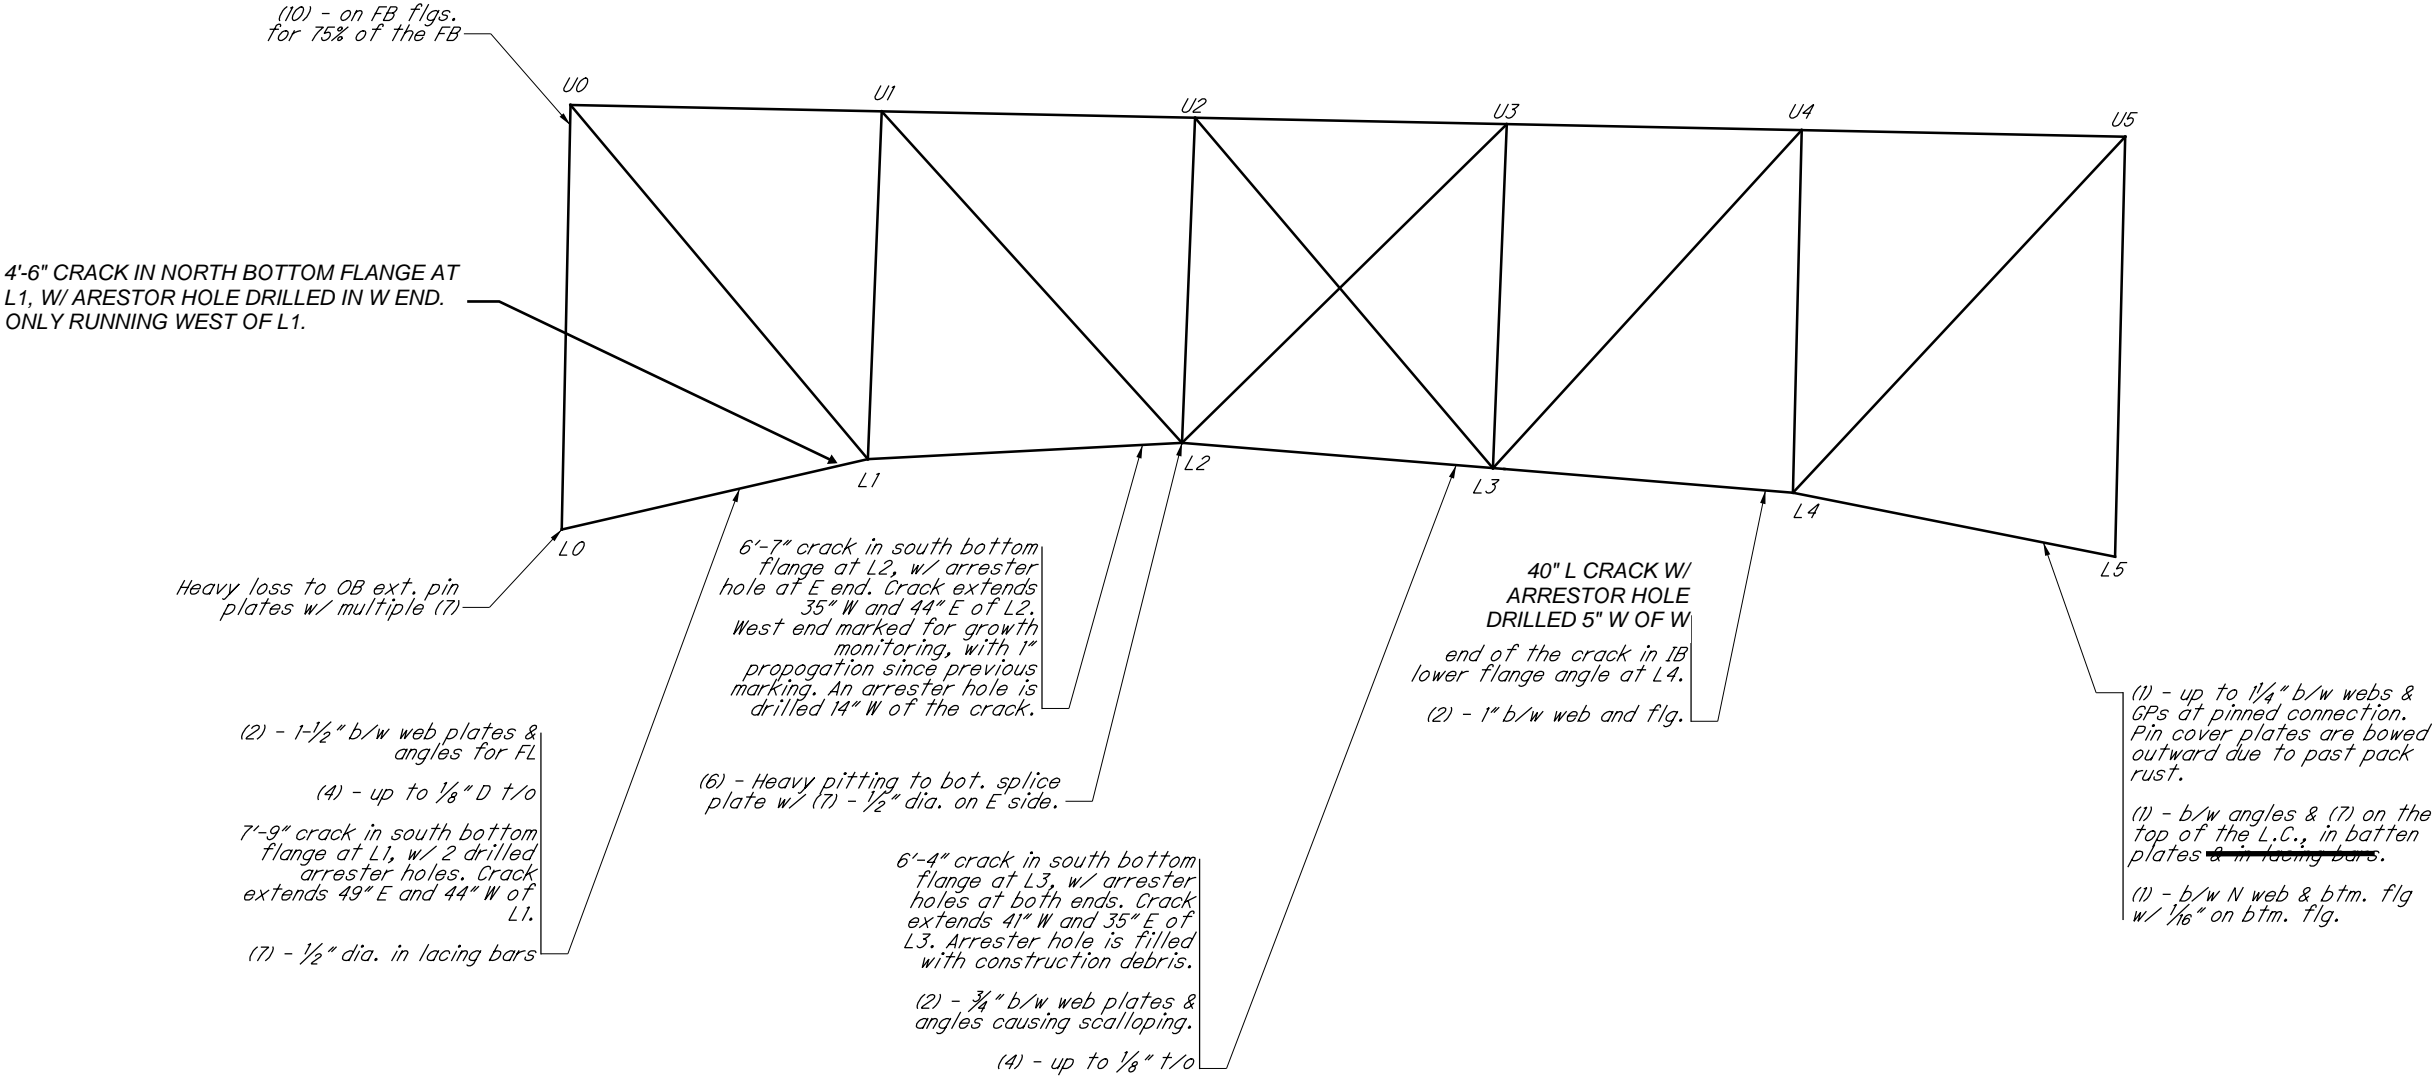
SPAN 12 - NORTH INTERIOR TRUSS ELEVATION

NORTH INTERIOR GUSSET PLATE DEFICIENCIES

- L0, BOTH - (10) - on GPs and interior stiffener plate.
- L0, IB GP - (6) - 1/8" t/o on IB face.
- L0, OB GP - (6) - 1/4" t/o on OB face
- L1, OB GP - (6) - 3/16" along top of the lower chord.
- L2, BOTH - (8) - 1/4" T x 4" H on int. faces.
- L4, BOTH - (4) - 1/4" D x 4" L x 4" H on int. faces @ top of diag. top flg. angle.
- L4, OB GP - (4) - 55" L x 3" H x up to 1/4" D on OB face.
- L5, OB GP - (6) - 3/16" along top of the lower chord.
- (1) 3/4" T b/w GP & lower strut connection angles.

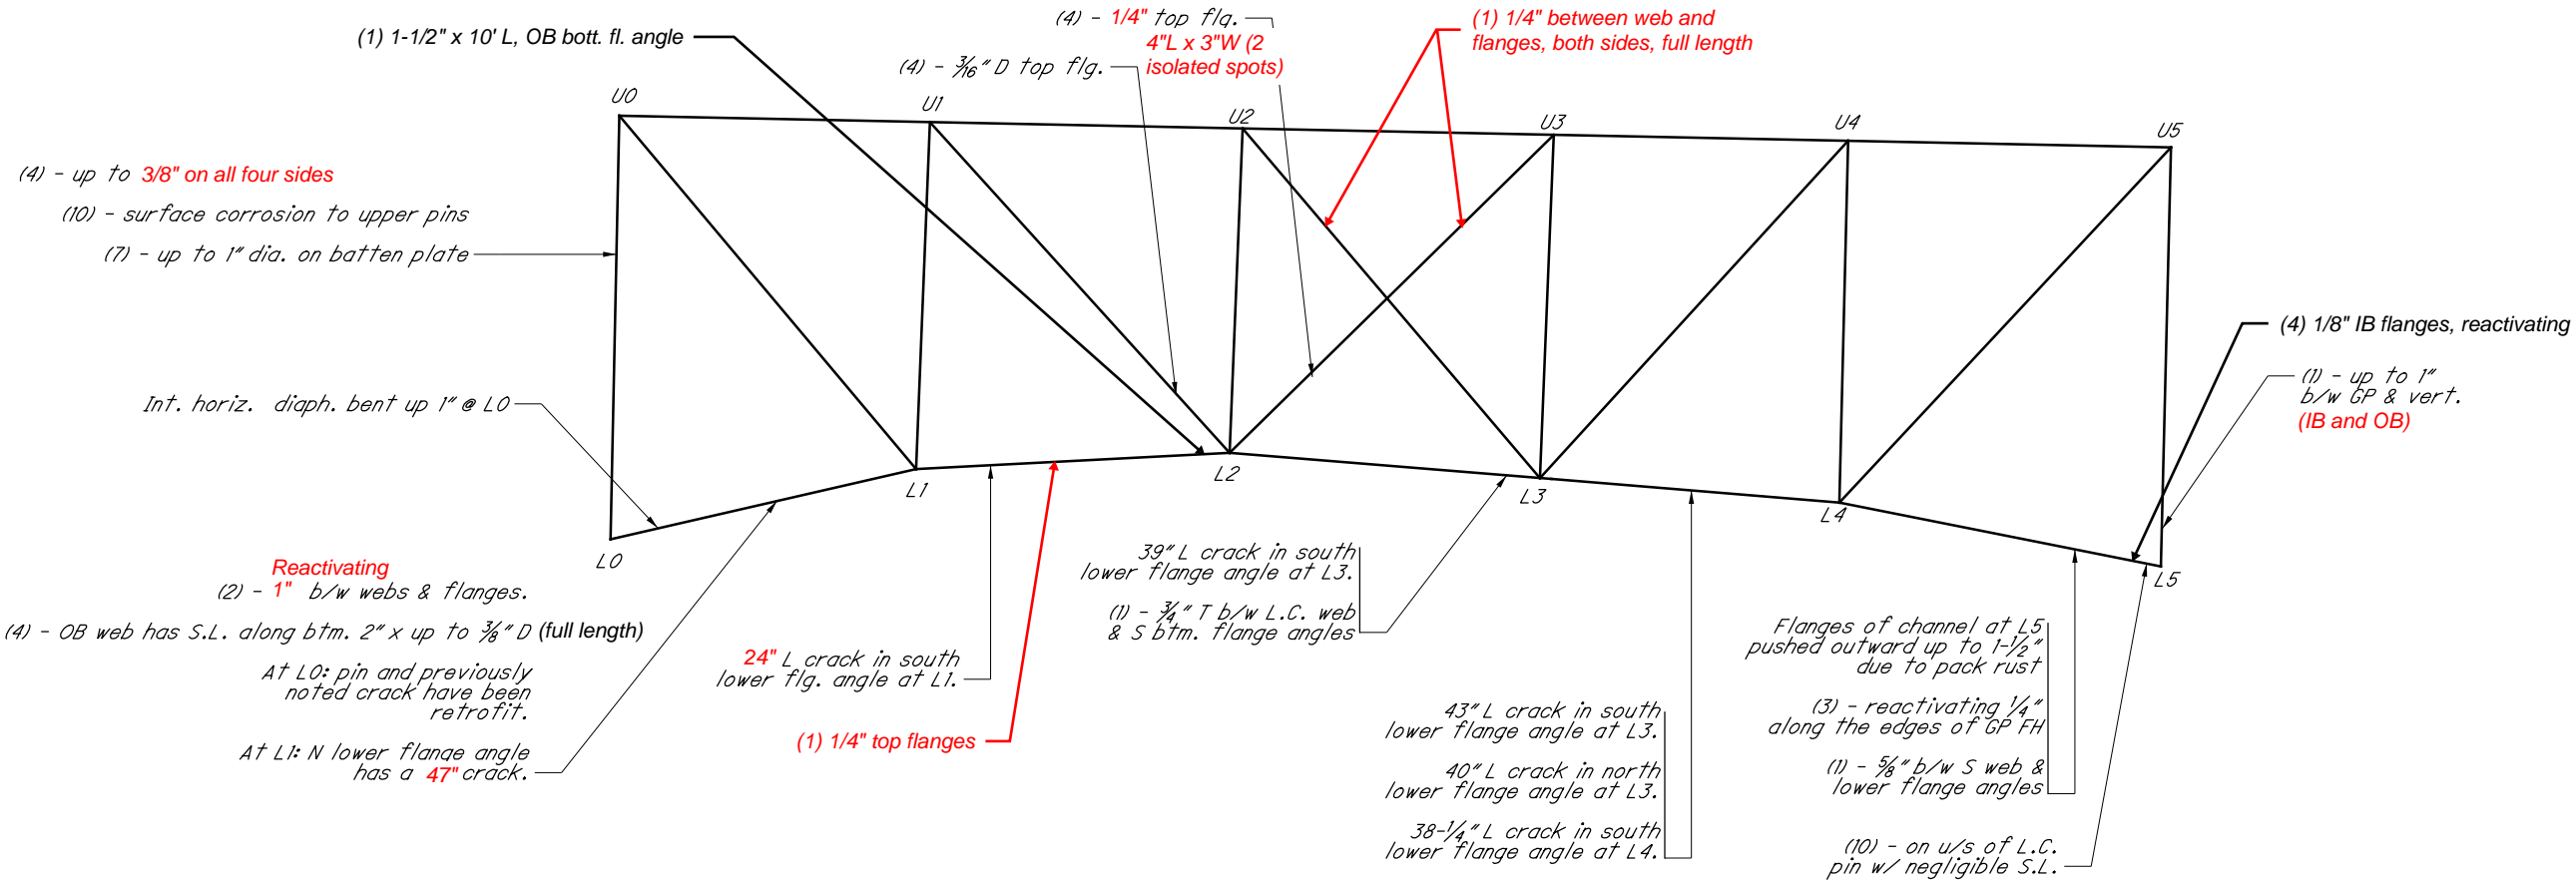
SPAN 12 - SOUTH INTERIOR TRUSS ELEVATION

SOUTH INTERIOR GUSSET PLATE DEFICIENCIES

U0, BOTH - GPs are bowing up to 1-1/4\"/>
L1, IB GP - (4) - iso. small areas up to 3/16\"/>
L2, IB GP - (4) 3/8\" deep above U1L2 (6\"L x 2\"H)
L4, IB GP - (4) - 1/8\" D x 5\" x L x 2\" H over diag.
L4, IB GP - (4) - 1/4\" D x 6\" L x 2\" H IB face at lower chord
L5, BOTH - (6) 1/8\" deep, top half

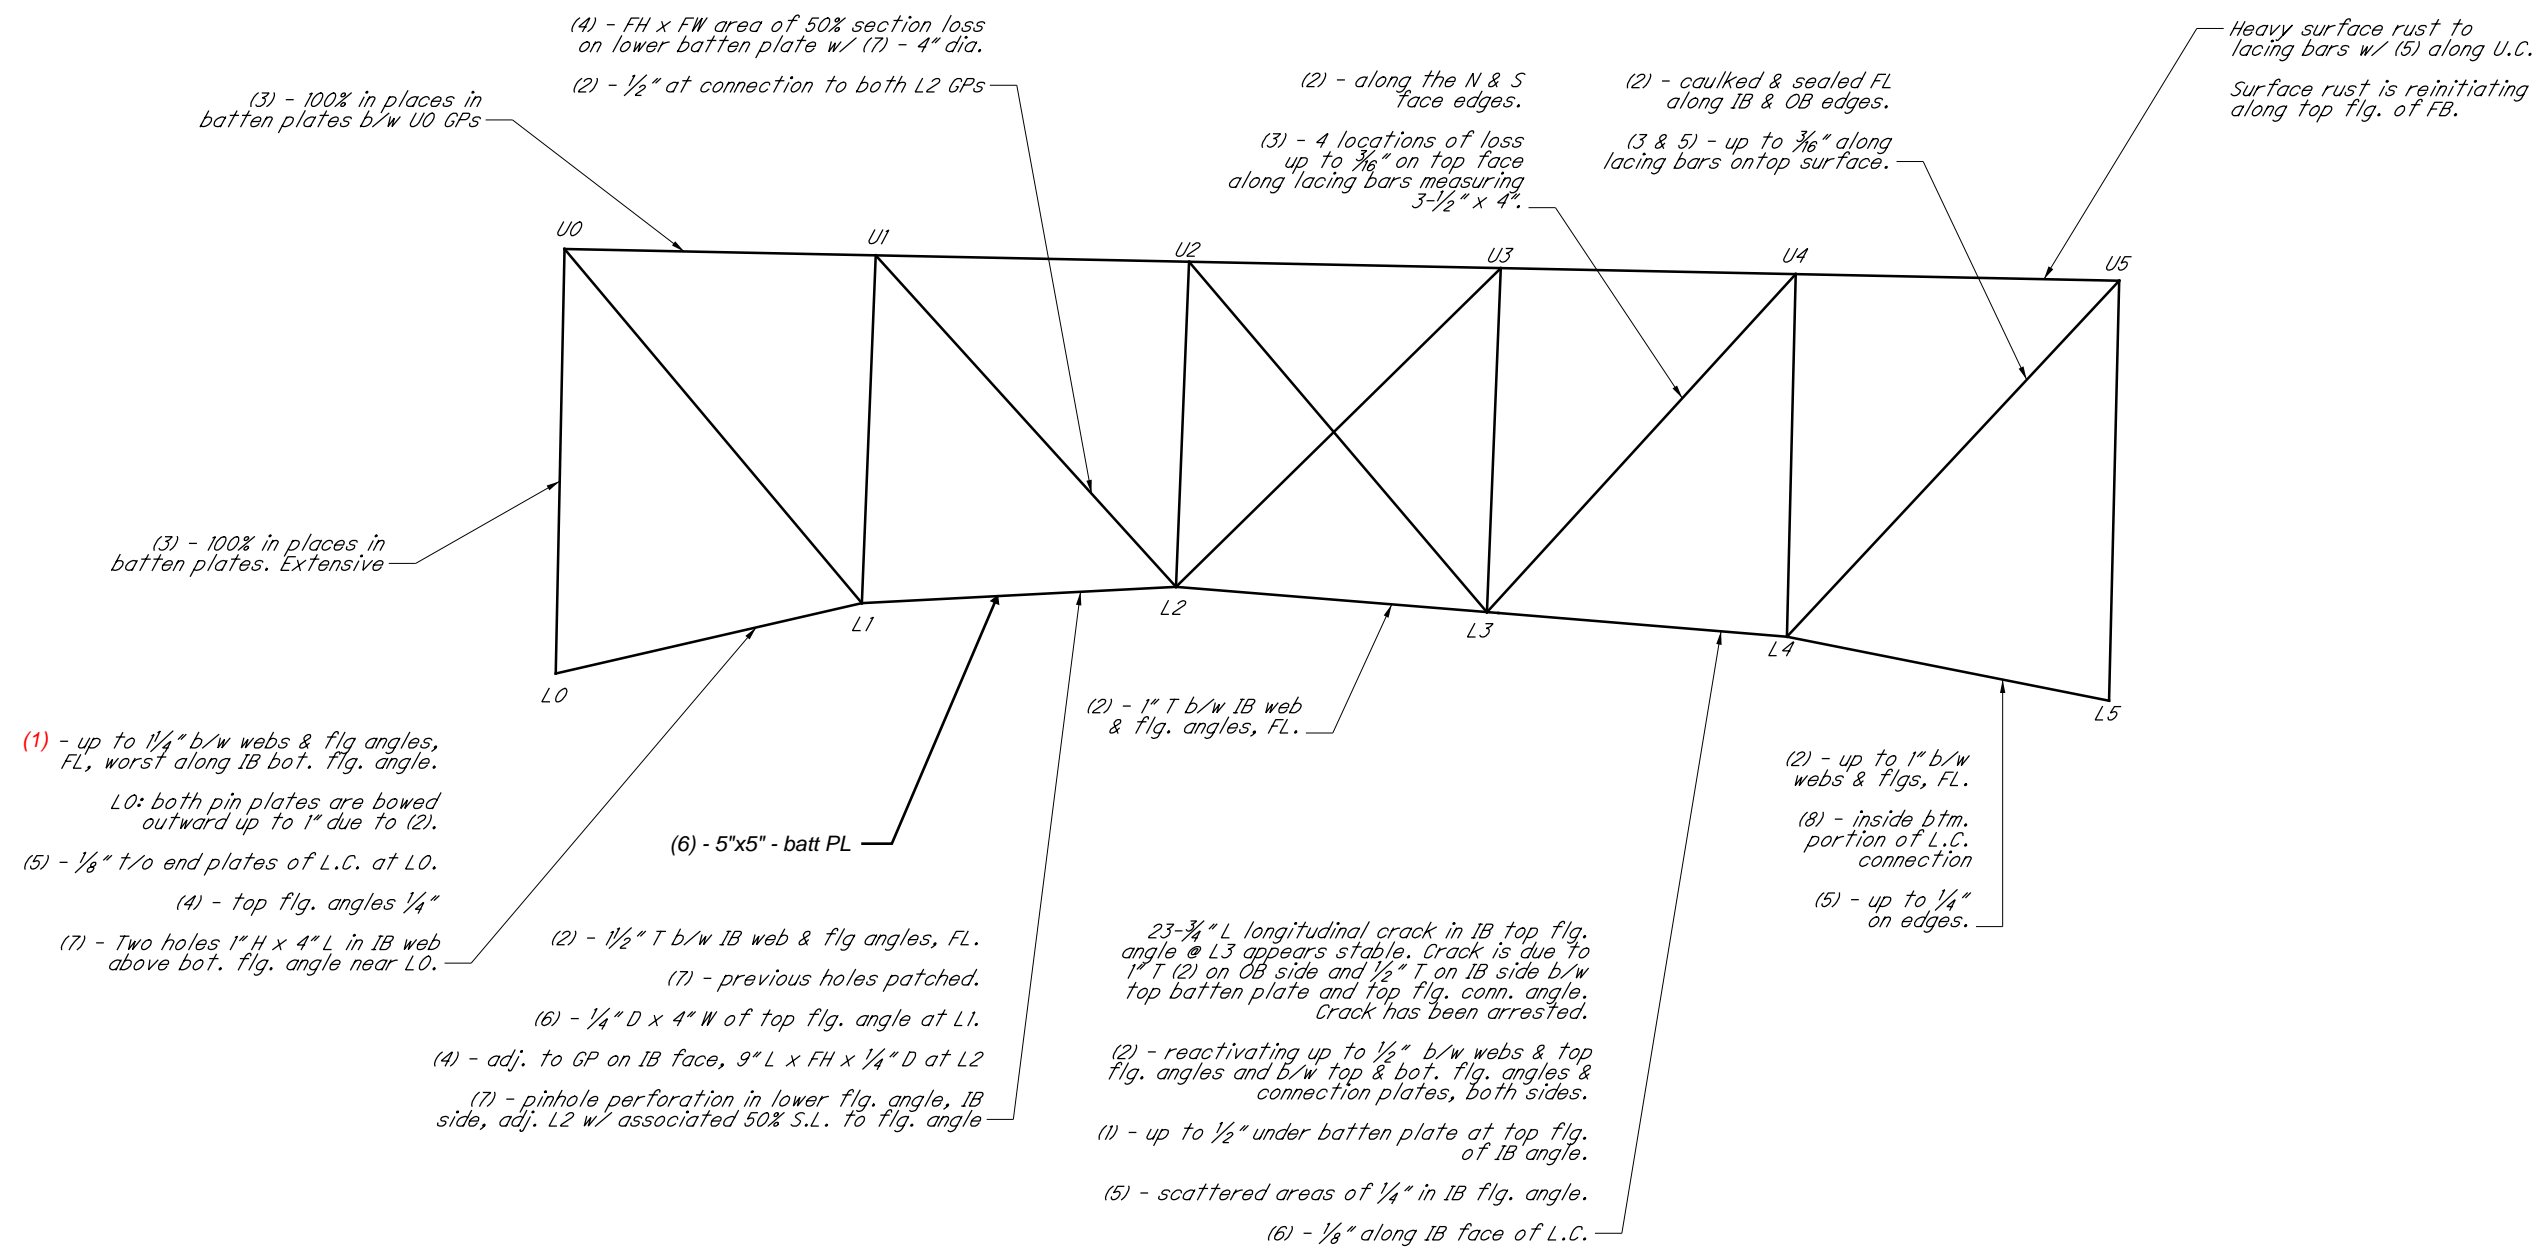
SPAN 12 - SOUTH EXTERIOR TRUSS ELEVATION

SOUTH EXTERIOR GUSSET PLATE DEFICIENCIES

- L1, IB GP - (3) - 1/4" D x 9" x 6" in area just above L.C.
L2, IB GP - (3) - widespread reactivating 5/16" on IB face
L2, OB GP - Retrofit
L3, IB GP - (6) - 1/8" above bottom flange.
(3) - 1/8" on IB face along sway brace connection.
L4, BOTH - (5) - 1/4" along top of diagonal, 9" x 4".
L5, BOTH - (3) - up to 3/16" along a 6-8" perimeter of the pin.
Sporadic areas t/o rest of GPs w/ 3/16" typ.
(1) - 1/2" T typ. b/w north & south GPs and vertical

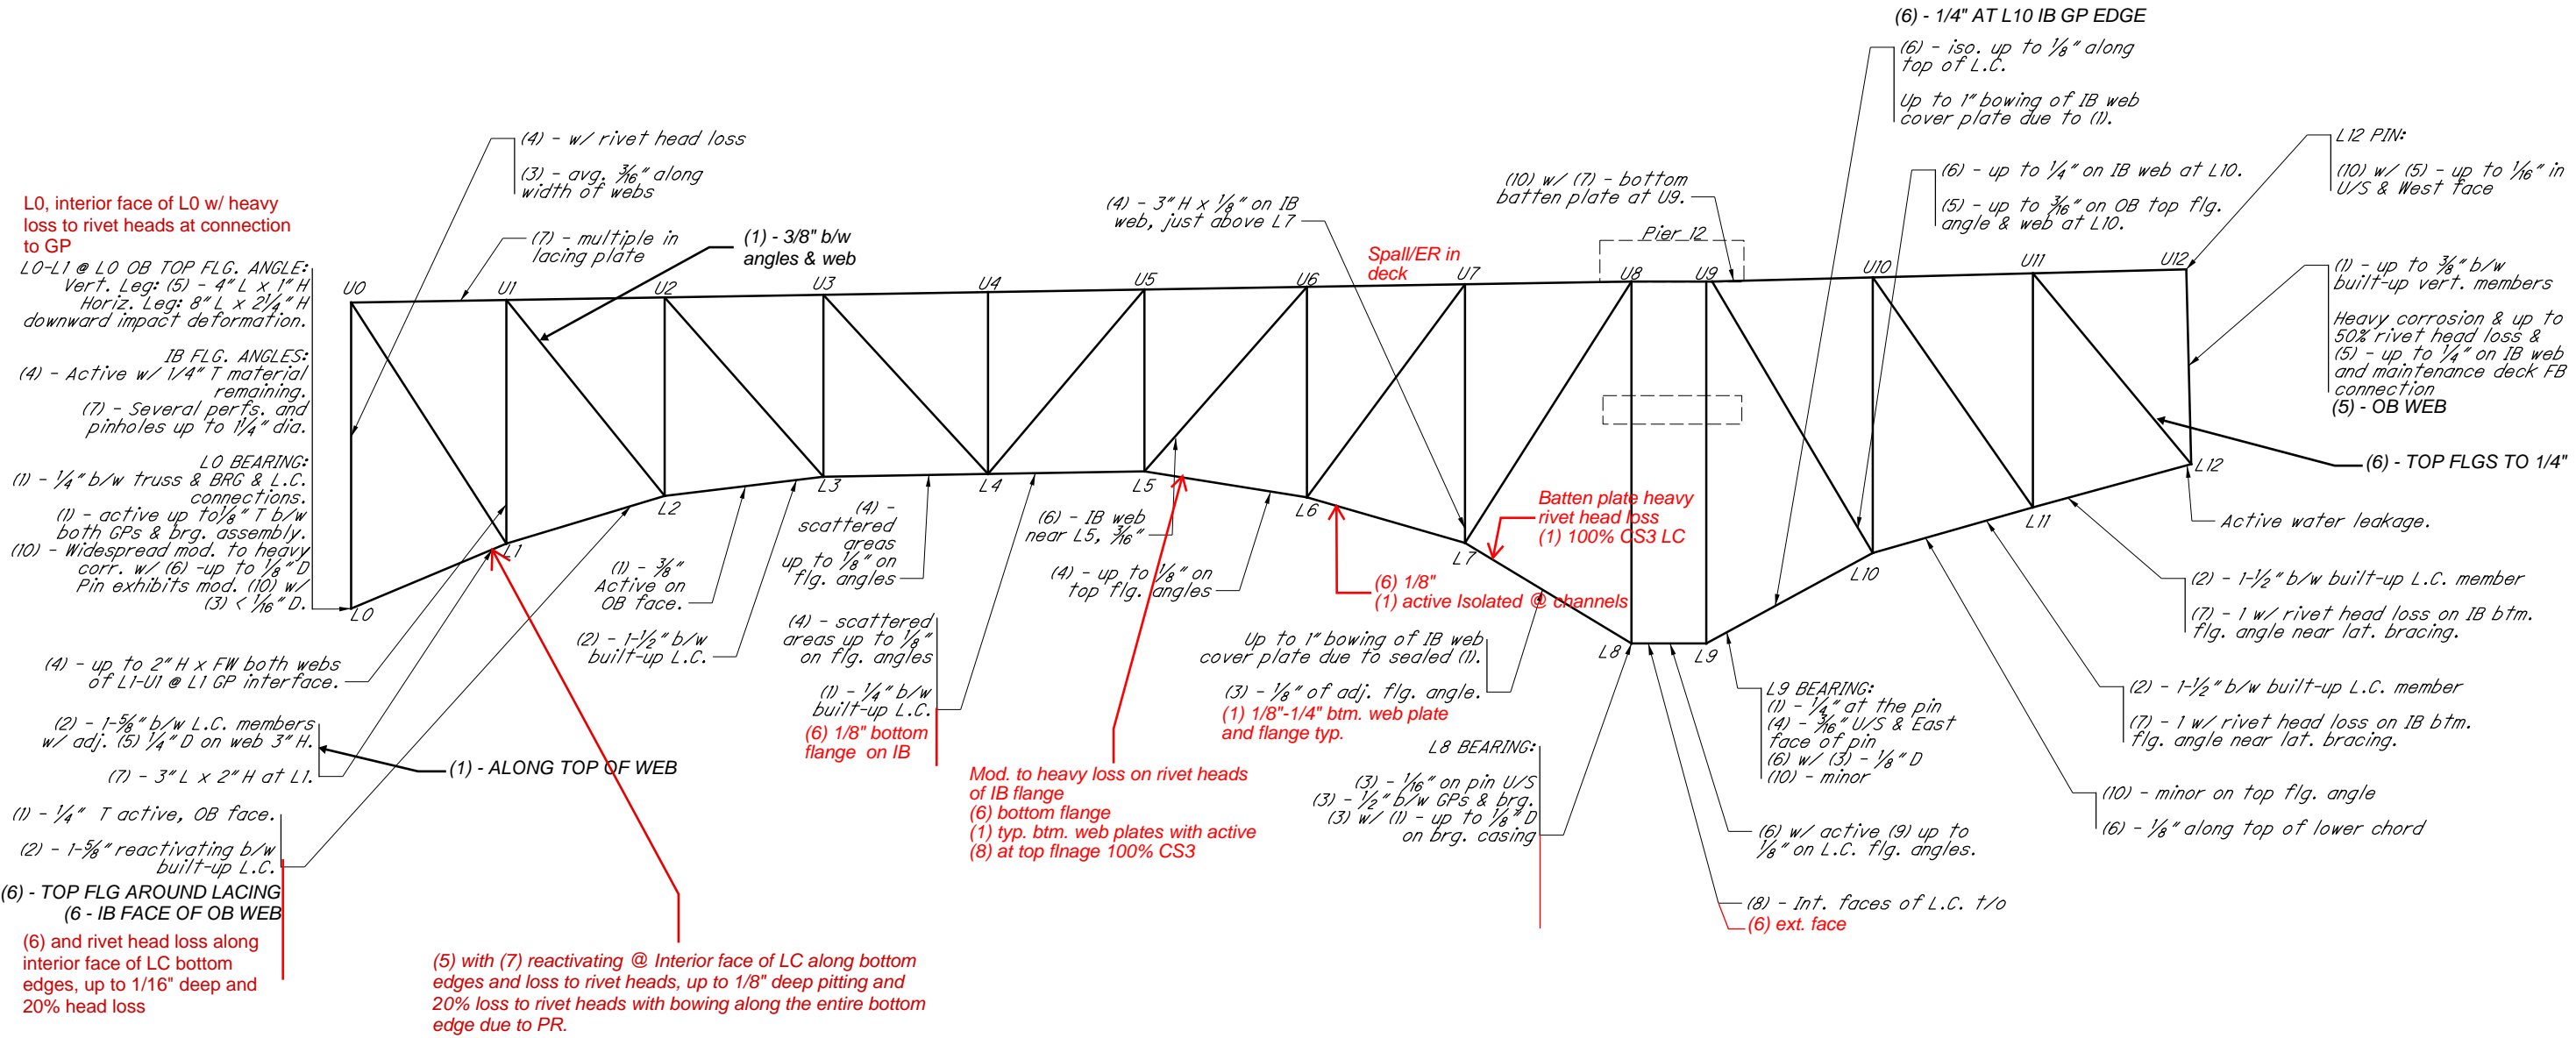
SPAN 13 - NORTH EXTERIOR TRUSS ELEVATION

L0, interior face of L0 w/ heavy loss to rivet heads at connection to GP
L0-L1 @ L0 OB TOP FLG. ANGLE:
Vert. Leg: (5) - 4" L x 1" H
Horiz. Leg: 8" L x 2 1/4" H
downward impact deformation.
IB FLG. ANGLES:
(4) - Active w/ 1/4" T material remaining.
(7) - Several perfs. and pinholes up to 1/4" dia.
L0 BEARING:
(1) - 1/4" b/w truss & BRG & L.C. connections.
(1) - active up to 1/8" T b/w both GPs & brg. assembly.
(10) - Widespread mod. to heavy corr. w/ (6) - up to 1/8" D Pin exhibits mod. (10) w/ (3) < 1/16" D.
(4) - up to 2" H x FW both webs of L1-U1 @ L1 GP interface.
(2) - 1-5/8" b/w L.C. members w/ adj. (5) 1/4" D on web 3" H.
(7) - 3" L x 2" H at L1.
(1) - 1/4" T active, OB face.
(2) - 1-5/8" reactivating b/w built-up L.C.
(6) - TOP FLG AROUND LACING
(6) - IB FACE OF OB WEB
(6) and rivet head loss along interior face of LC bottom edges, up to 1/16" deep and 20% head loss

(5) with (7) reactivating @ Interior face of LC along bottom edges and loss to rivet heads, up to 1/8" deep pitting and 20% loss to rivet heads with bowing along the entire bottom edge due to PR.

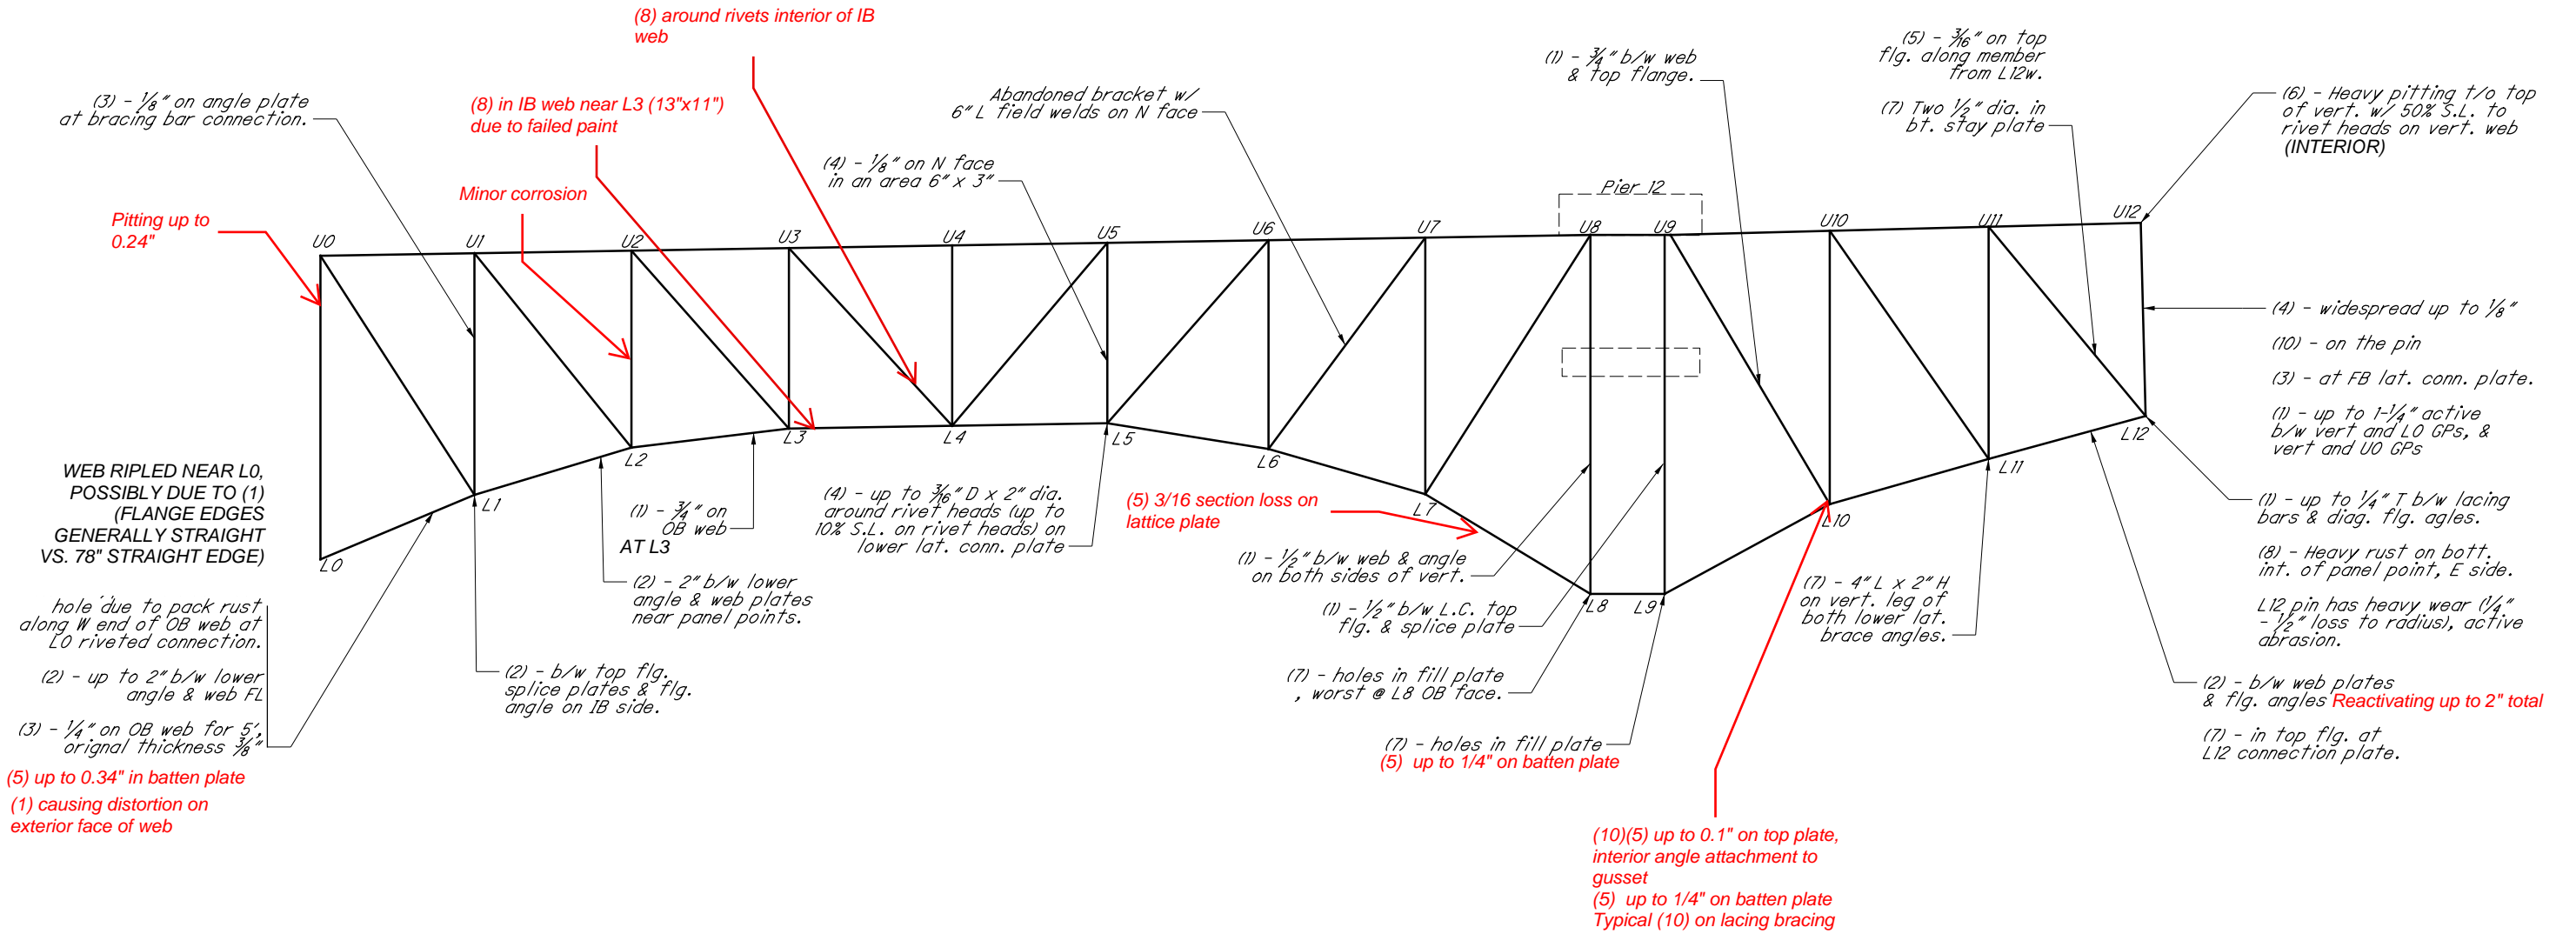
SPAN 13 - NORTH INTERIOR TRUSS ELEVATION

SPAN 13 NORTH INTERIOR GUSSET PLATE DEFICIENCIES

L0, BOTH - (6) - $\frac{1}{8}$ " on ext. faces and $\frac{1}{16}$ " full height throughout.
