2025 PHYSICAL CONDITION ROUTINE ELEMENT LEVEL INSPECTION REPORT

Bridge CUY-10-1613

SFN 1801503

Hope Memorial/Lorain Carnegie over Cuyahoga River

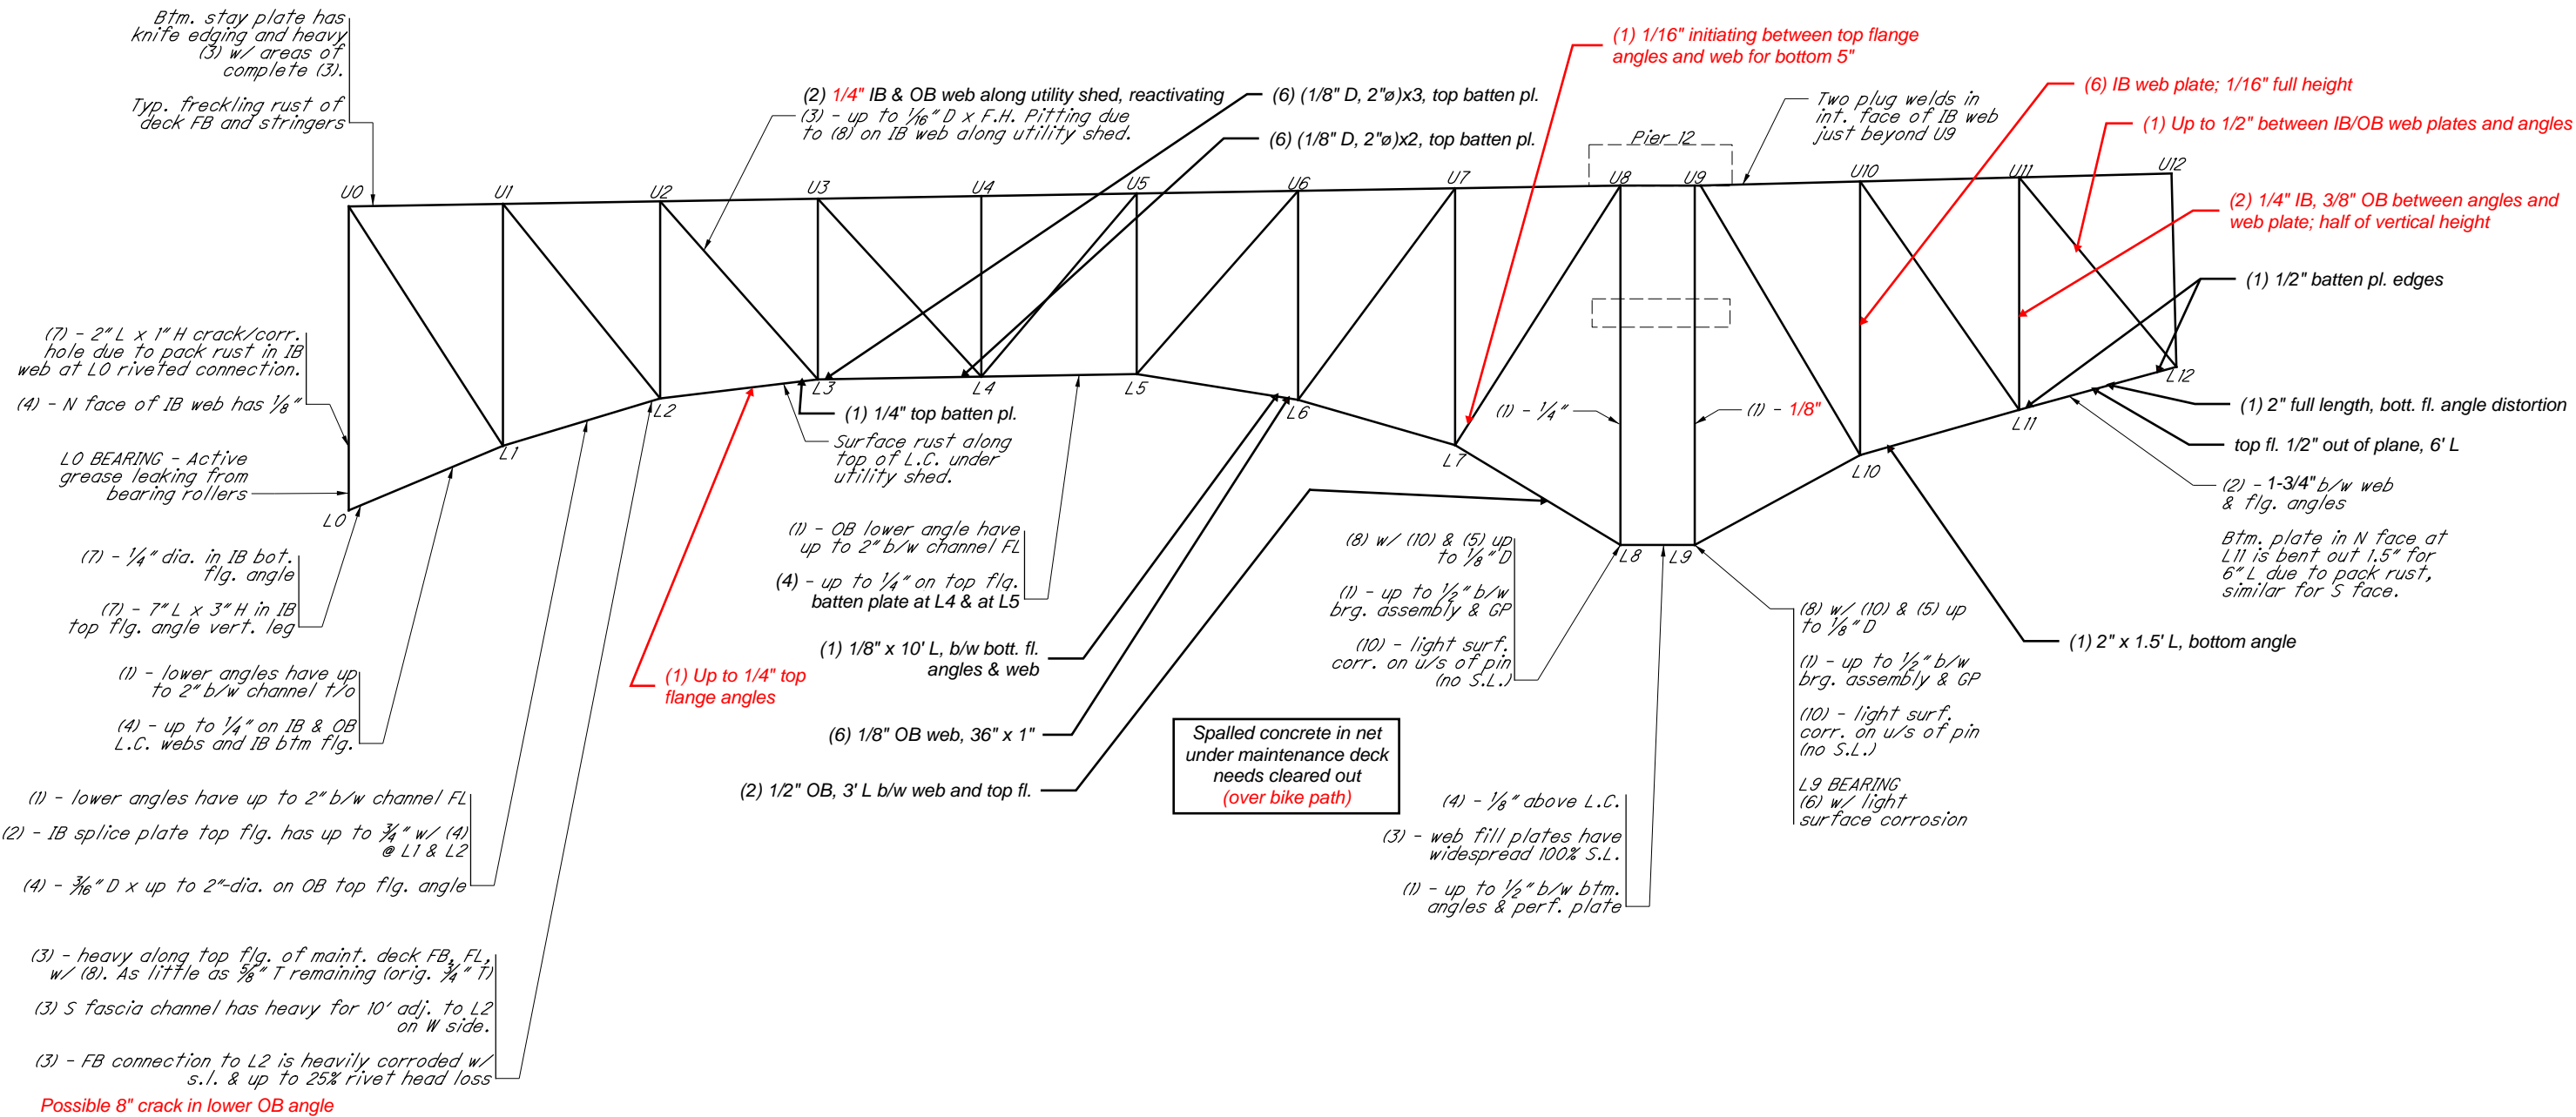
SPAN 13 - SOUTH INTERIOR TRUSS ELEVATION

SPAN 13 SOUTH INTERIOR GUSSET PLATE DEFICIENCIES

- L0, IB GP - (4) - isolated up to $\frac{3}{8}$ " D x $\frac{1}{2}$ " dia.
L0, BOTH - (4) - interior faces have $\frac{3}{8}$ " D
L1, IB GP - (4) - $\frac{1}{8}$ " in a 2' L x 2" H area, OB face
L6, BOTH - (4) - $\frac{1}{4}$ " on interior faces, reactivating
L6, IB GP - (1) - $\frac{3}{4}$ " between lower chord top flange and splice plate 33" L.
L7, IB GP - (6) - $\frac{1}{8}$ " D x 6" H x 3" W over diag.
(4) - $\frac{1}{8}$ " D over diag.
L7, OB GP - (3) - $\frac{1}{8}$ " D over diag.
(5) w/ (8) - $\frac{1}{8}$ " D x 6" H x 3" W over diag.
L8, BOTH - (8) w/ (3) - $\frac{1}{16}$ " D on int. faces
L9, IB GP - (8) w/ (3) - $\frac{1}{8}$ " D x 2" H x 38" L, IB face along L.C.
L10, BOTH - (4) - $\frac{1}{8}$ " w/ (8) 36" L x 2" H

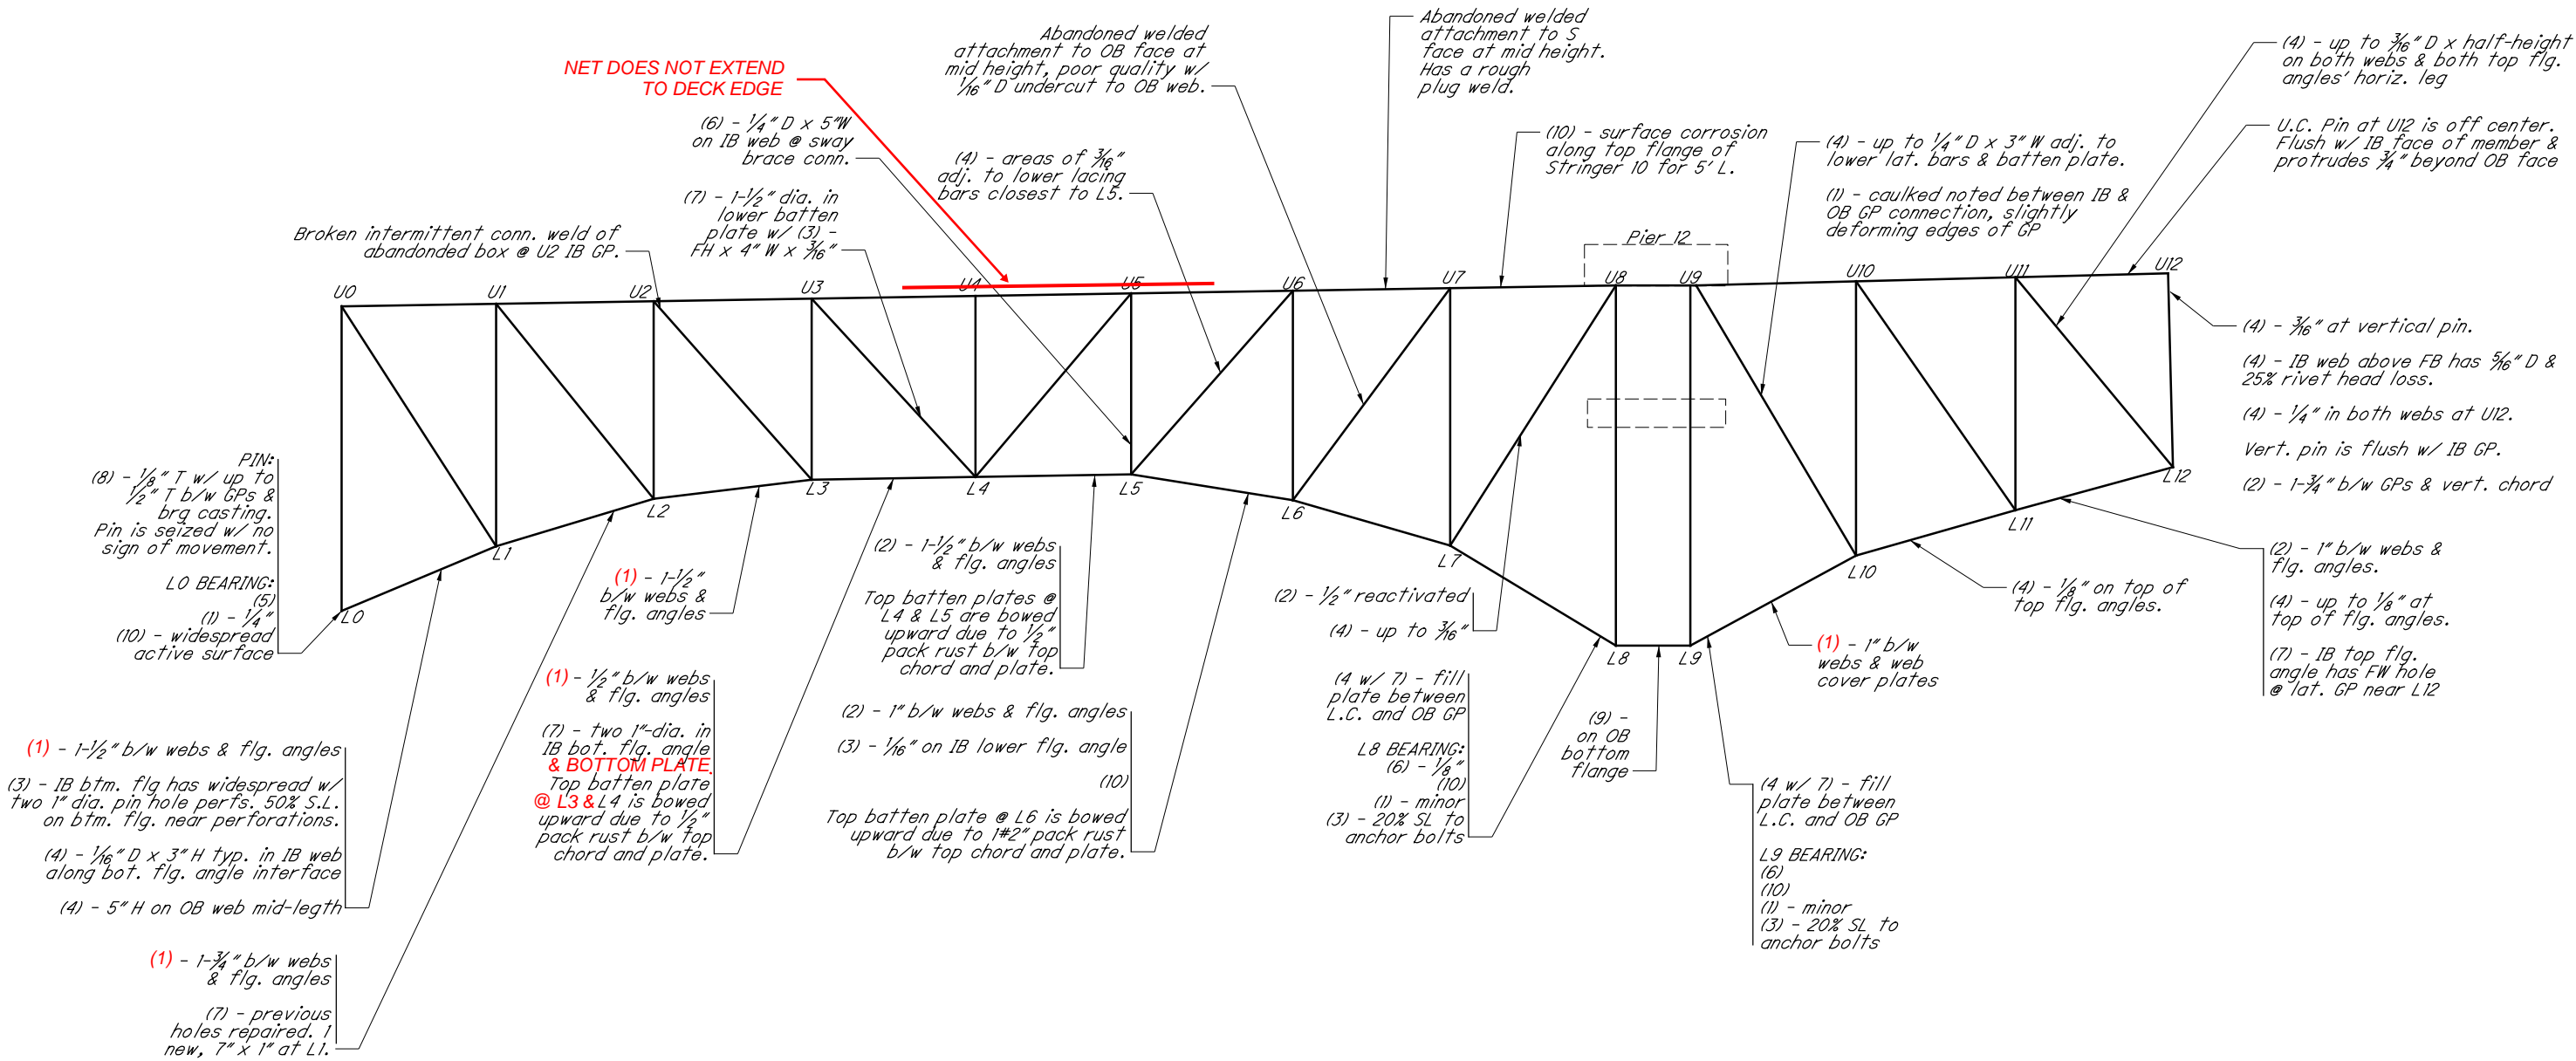
SPAN 13 - SOUTH EXTERIOR TRUSS ELEVATION

SPAN 13 SOUTH EXTERIOR GUSSET PLATE DEFICIENCIES

- L0, BOTH - (4) - $\frac{1}{8}$ " along back edge of vertical, & along top of L.C. and inside faces.
- L1, IB GP - (4) - scattered up to $\frac{3}{16}$ "

- L10, IB GP - (4) - $\frac{3}{16}$ " along top of L.C.
- L12, BOTH - (4) - $\frac{1}{4}$ " around pin & in scattered locations throughout.
Up to $\frac{1}{2}$ " bowing due to arrested pack rust.

- U12, BOTH - Up to $1\frac{3}{4}$ " localized bowing along bot. free edge due to arrested pack rust.
(3) - $\frac{3}{8}$ " around vertical pin.

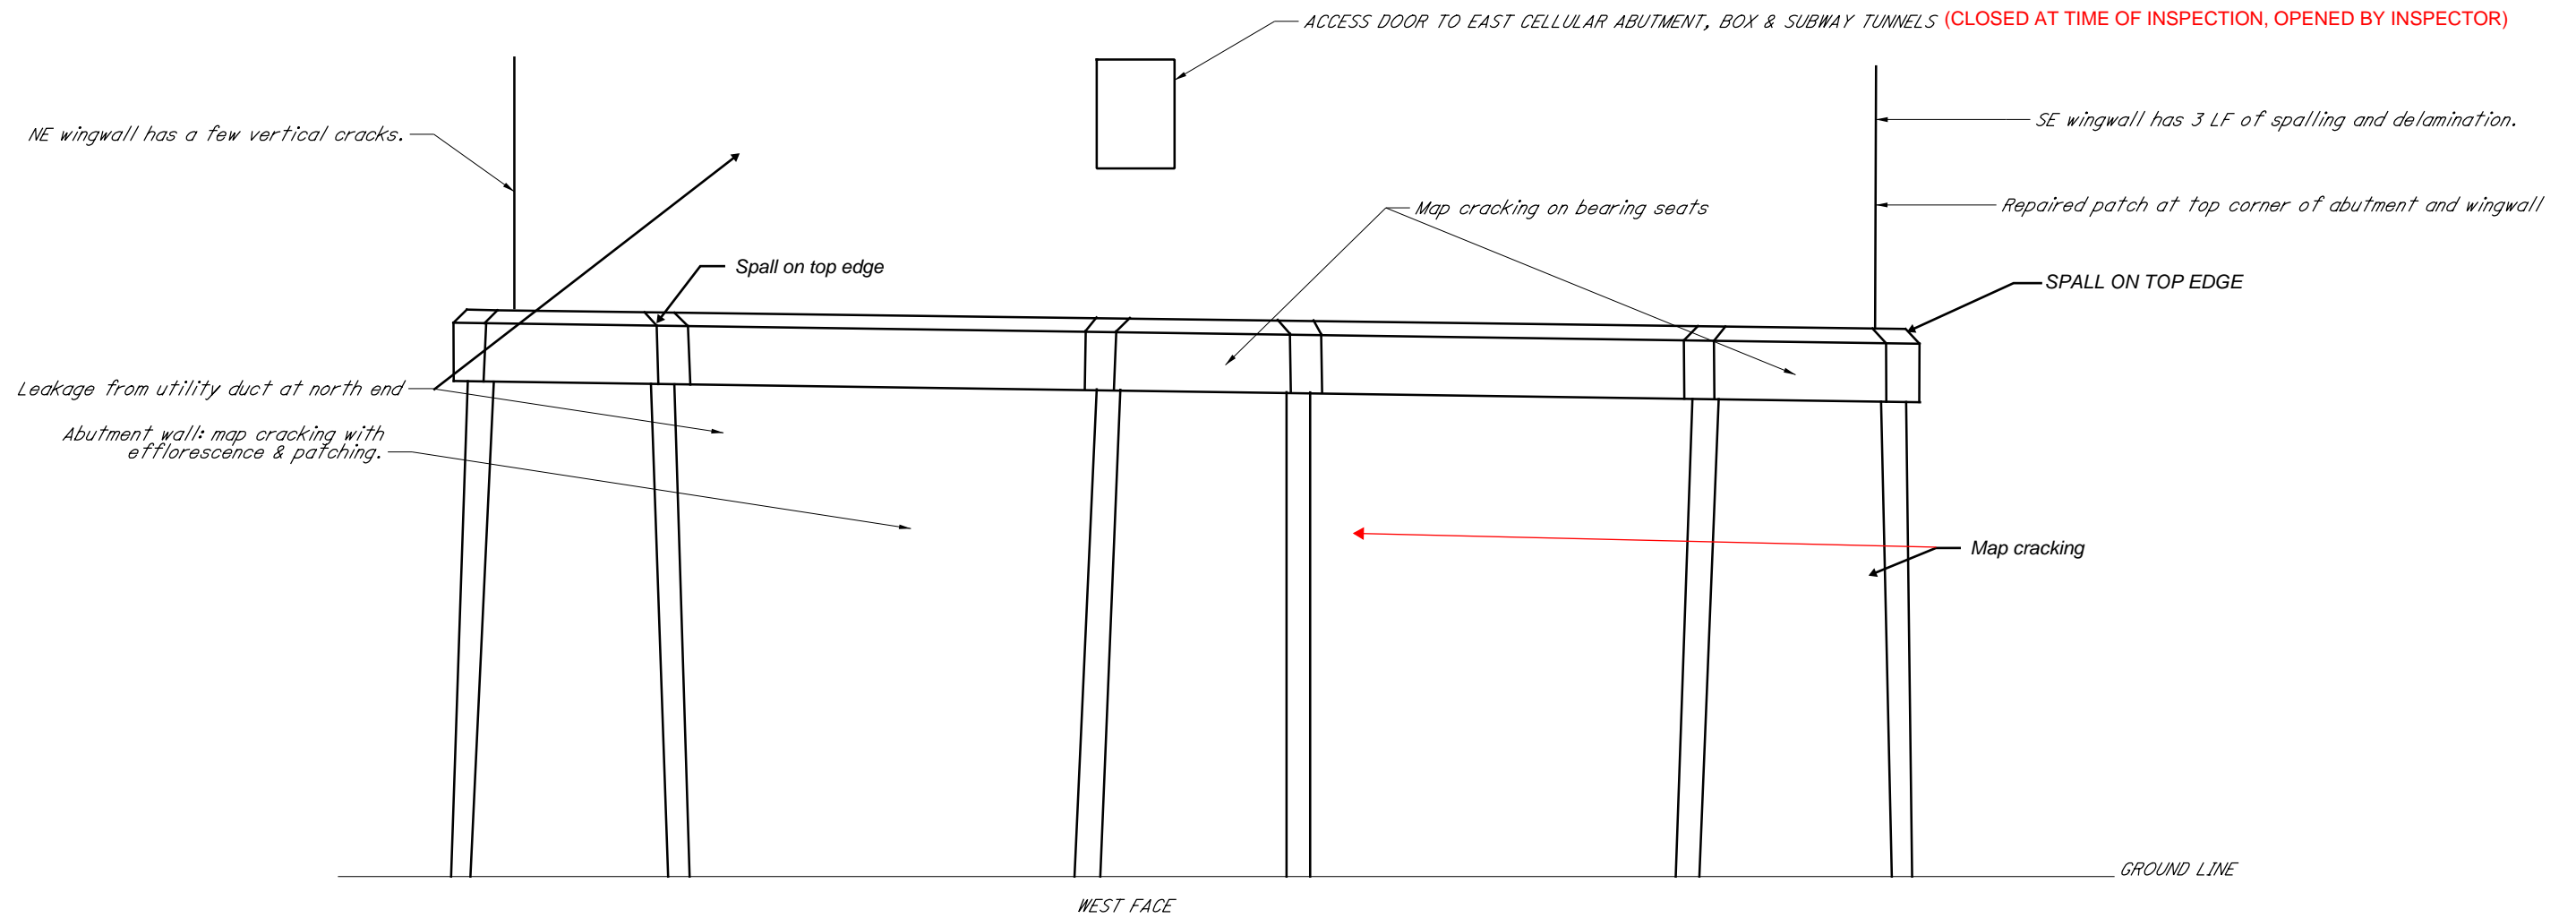
There are cracks, areas of patching, rust staining and some delaminations on the abutment walls.
Scattered areas of crack, delamination and minor spalling on wingwalls.

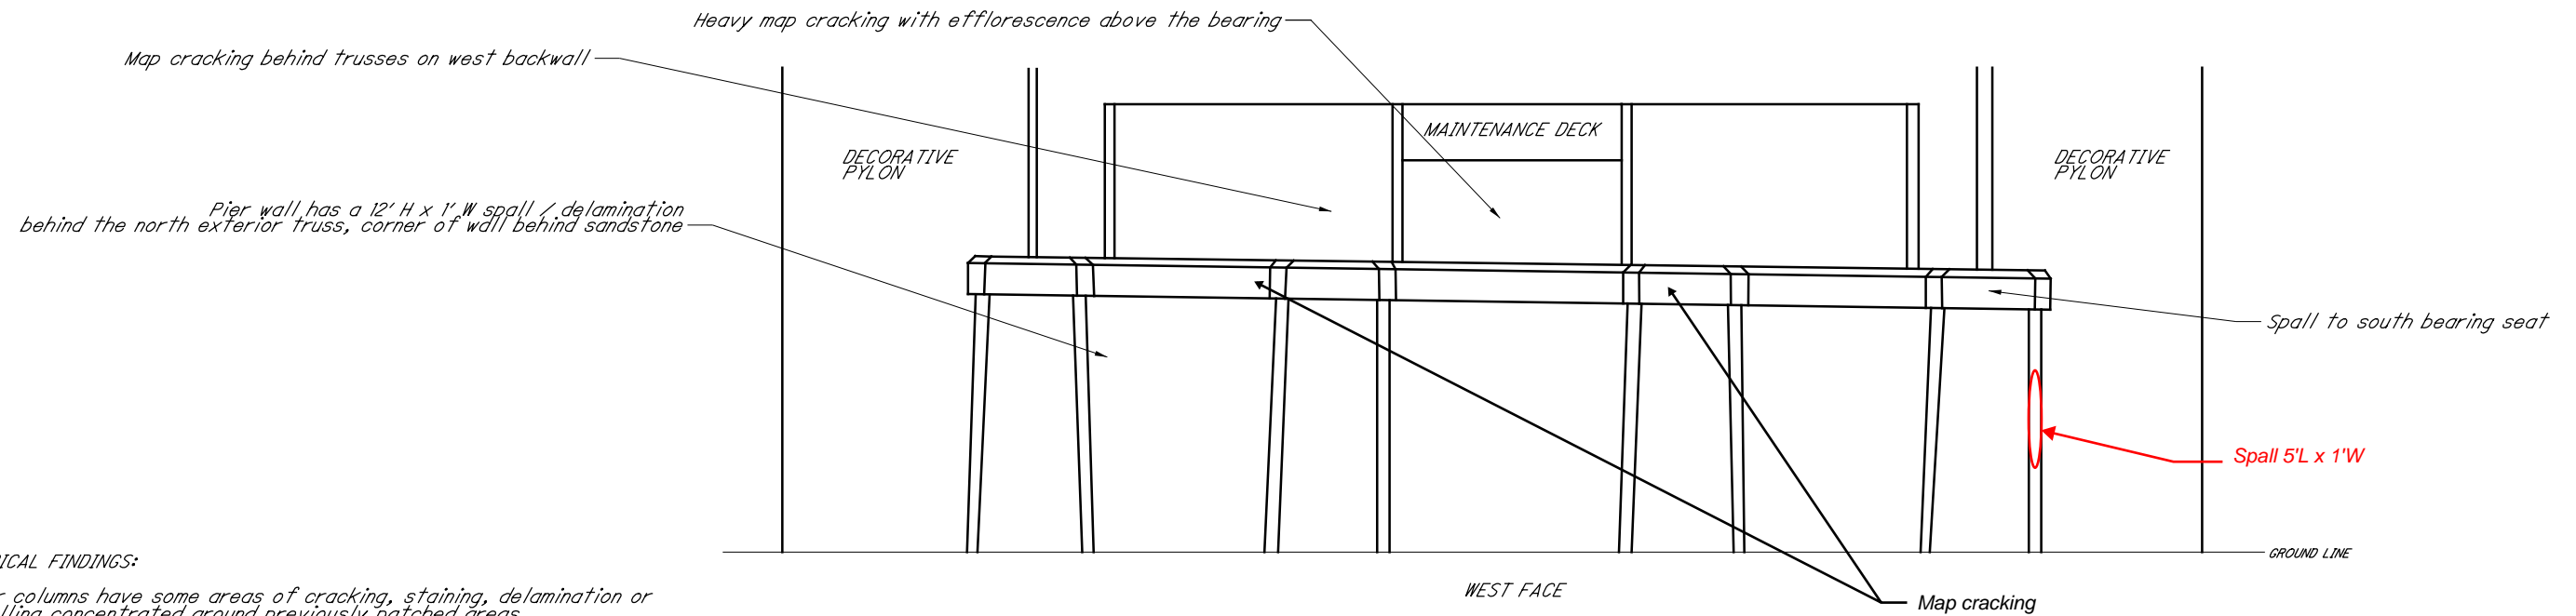
Pier columns have some areas of cracking, staining, delamination or spalling concentrated around previously patched areas.

Pier Walls have minor cracking, staining, patched areas and some minor spalling throughout.

Cracking at the bearing seats.

The underside of the pier towers are deteriorated with cracks, spalls, delaminations and spalls. The majority of the spalling has exposed reinforcing.

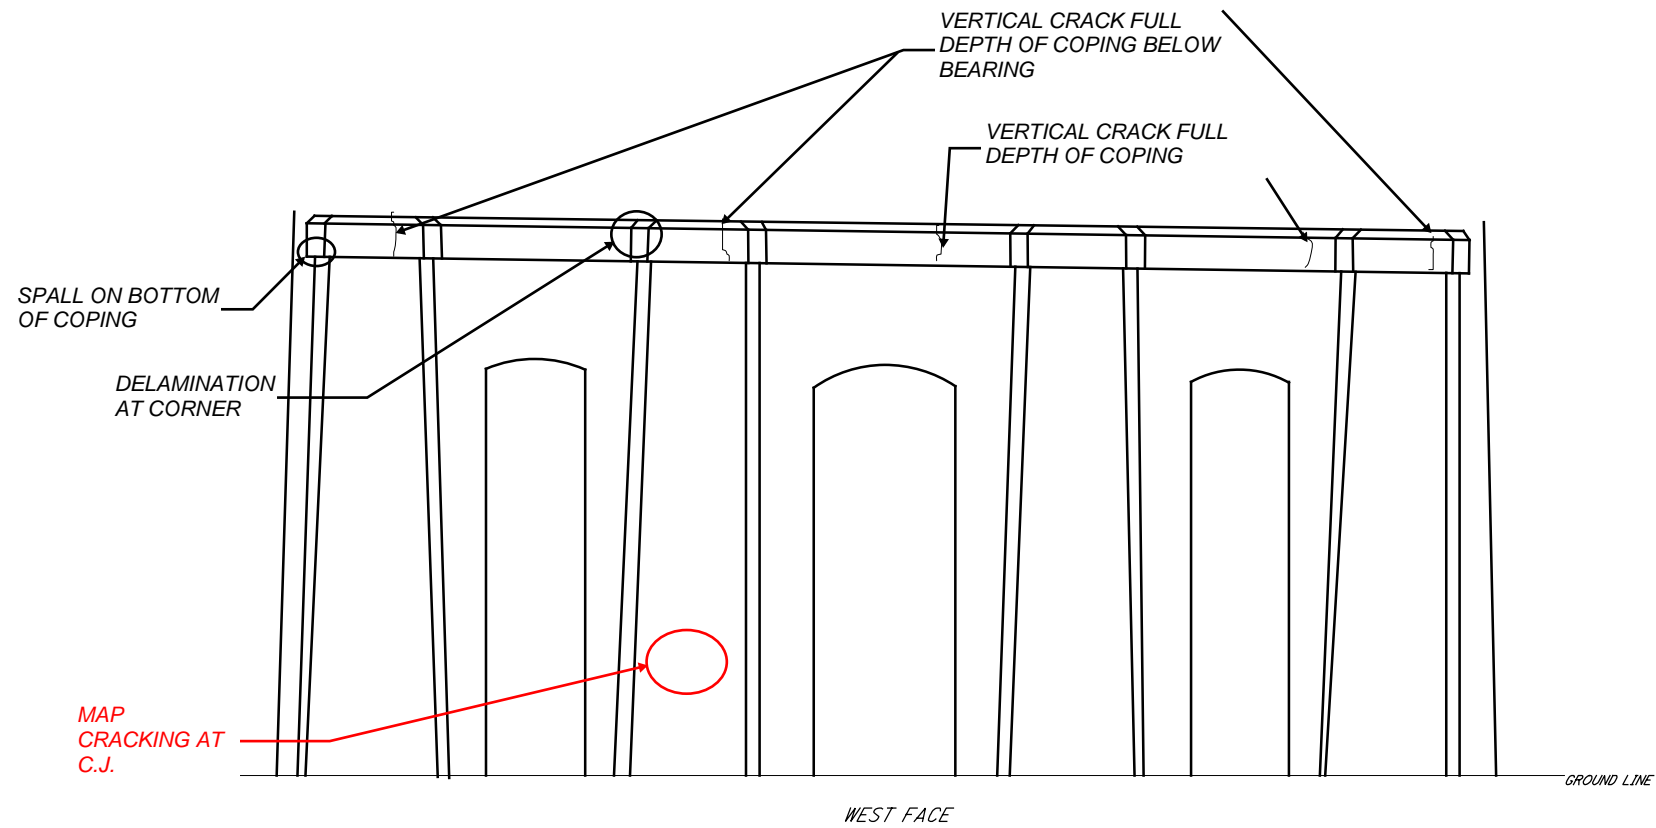
Pier columns have some areas of cracking, staining, delamination or spalling concentrated around previously patched areas.

The underside of the pier towers are deteriorated with cracks, spalls, delaminations and spalls. The majority of the spalling has exposed reinforcing.

The access manholes in the pier caps are in poor condition with the lips heavily deteriorated.

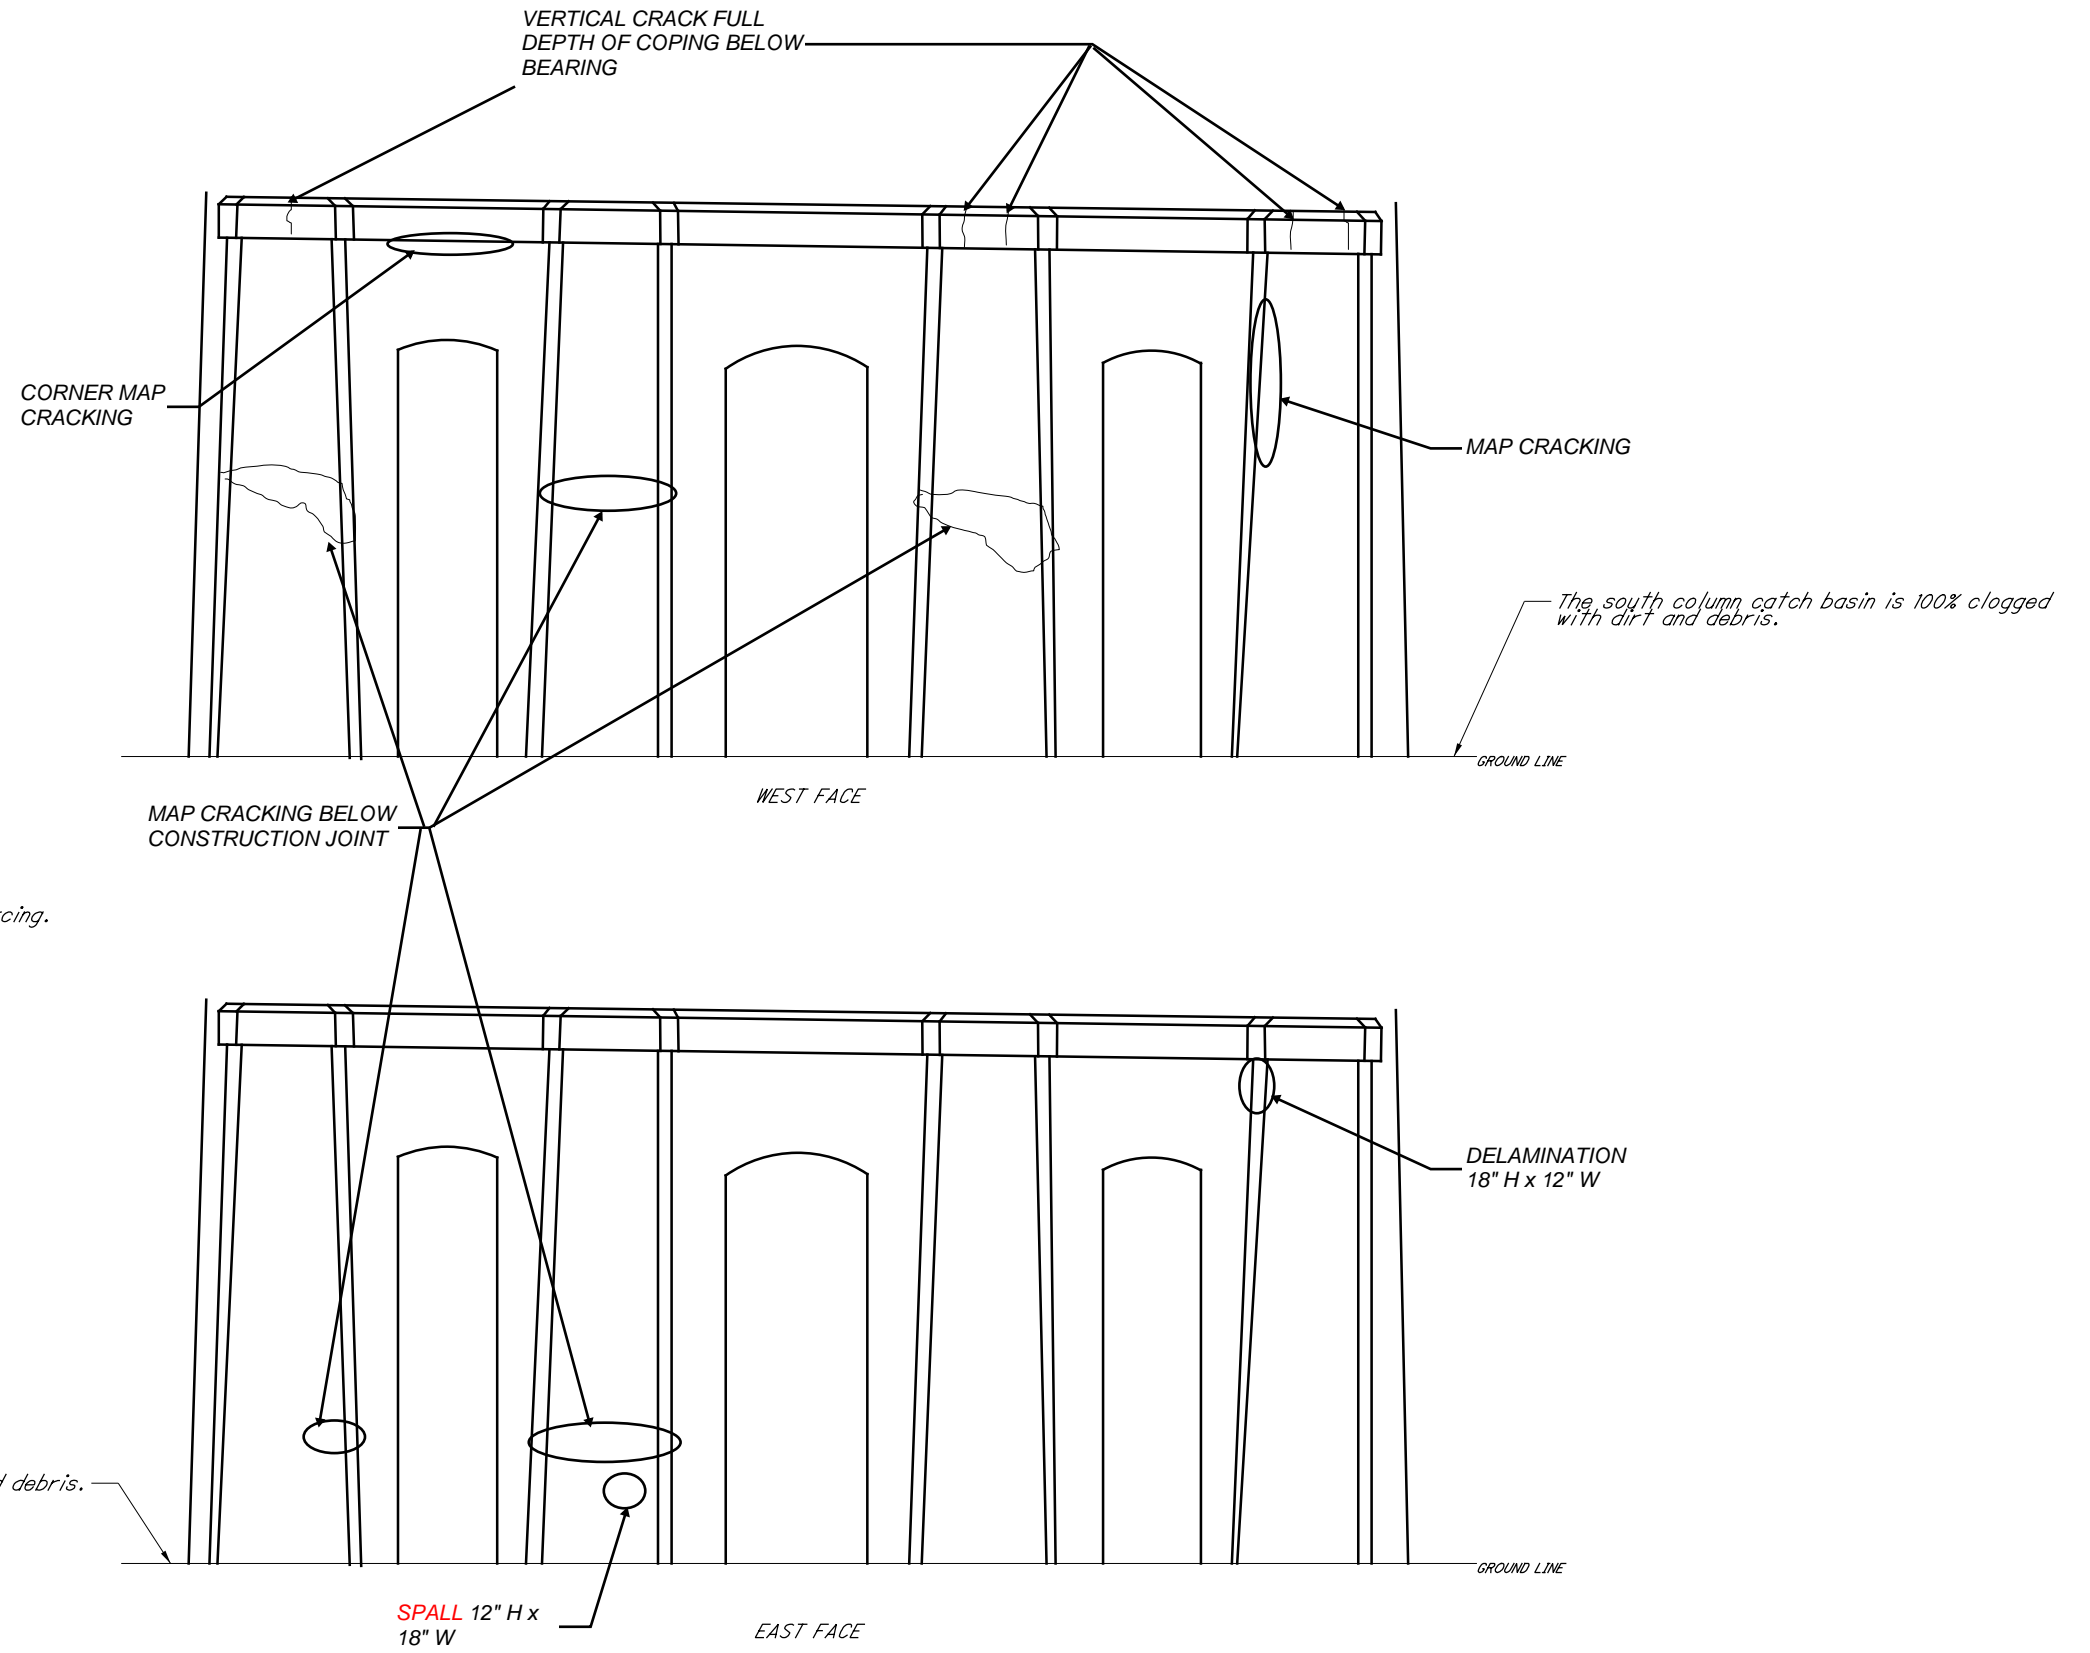
The underside of the pier towers are deteriorated with cracks, spalls, delaminations and spalls. The majority of the spalling has exposed reinforcing.

The access manholes in the pier caps are in poor condition with the lips heavily deteriorated.

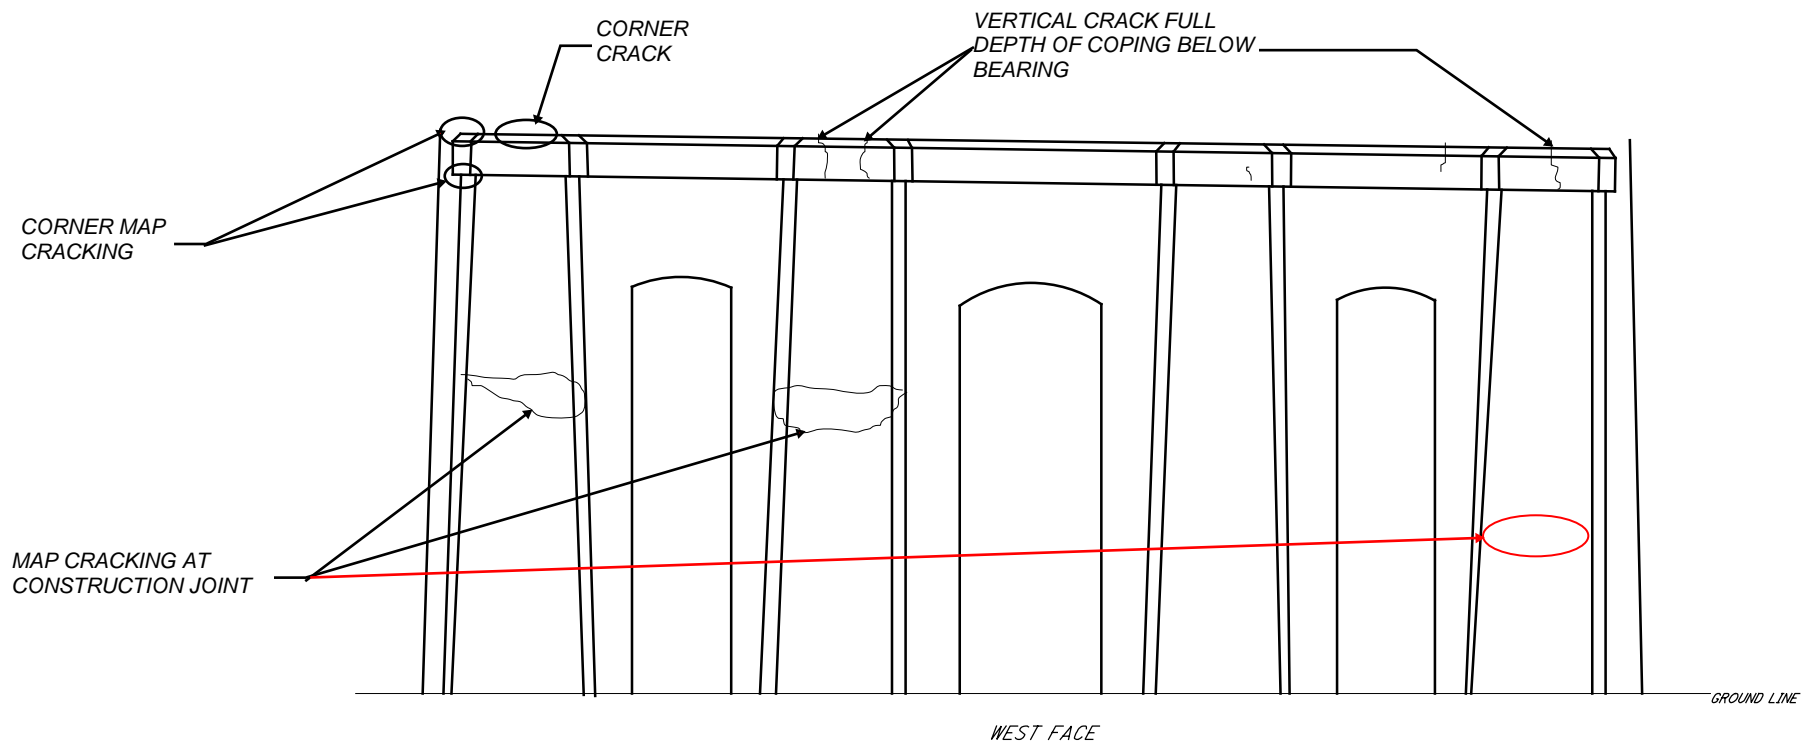
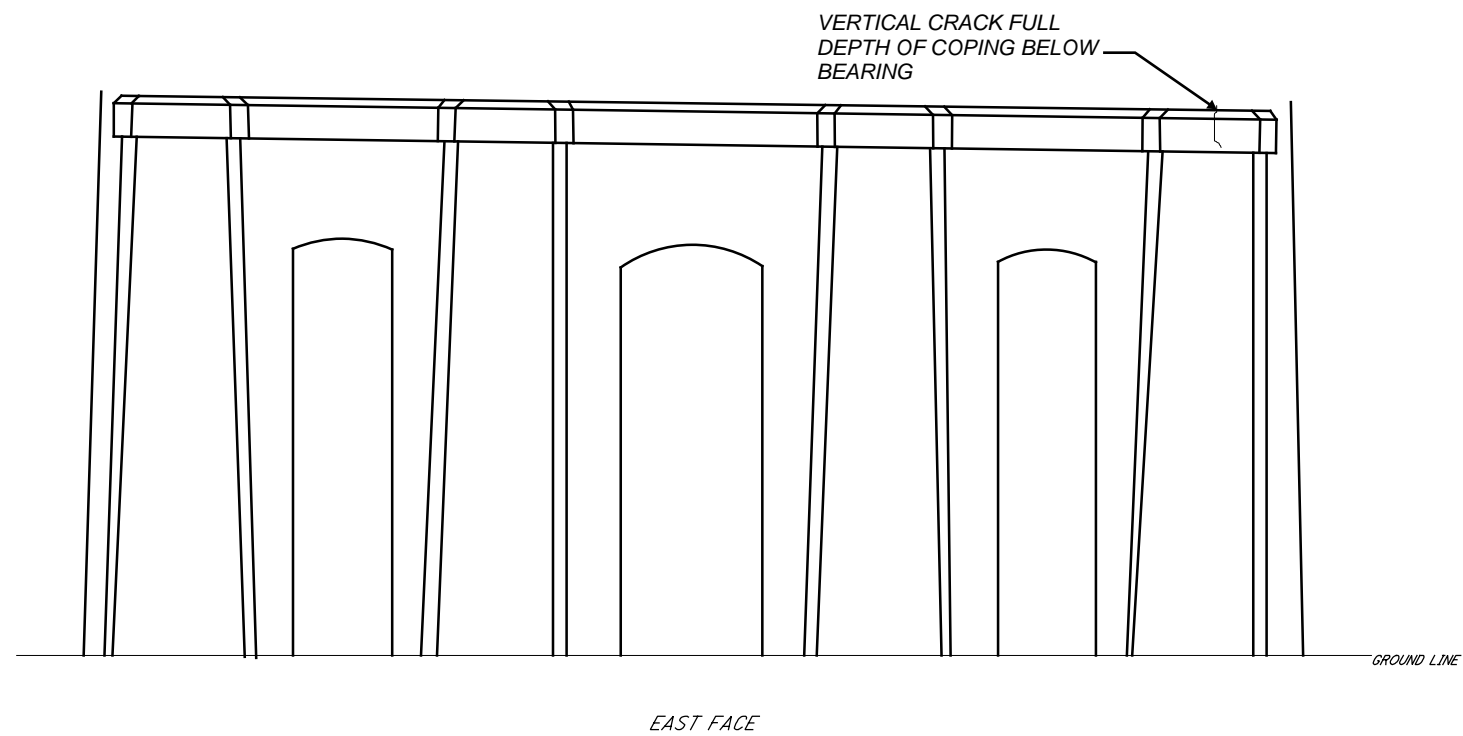
LORAIN-CARNEGIE BRIDGE	
		CUY-10-16.13	
DATE JUNE 2025		PIER 5 ELEVATION	PAGE 51/61

Pier columns have some areas of cracking, staining, delamination or spalling concentrated around previously patched areas.

The underside of the pier towers are deteriorated with cracks, spalls, delaminations and spalls. The majority of the spalling has exposed reinforcing.

The access manholes in the pier caps are in poor condition with the lips heavily deteriorated.

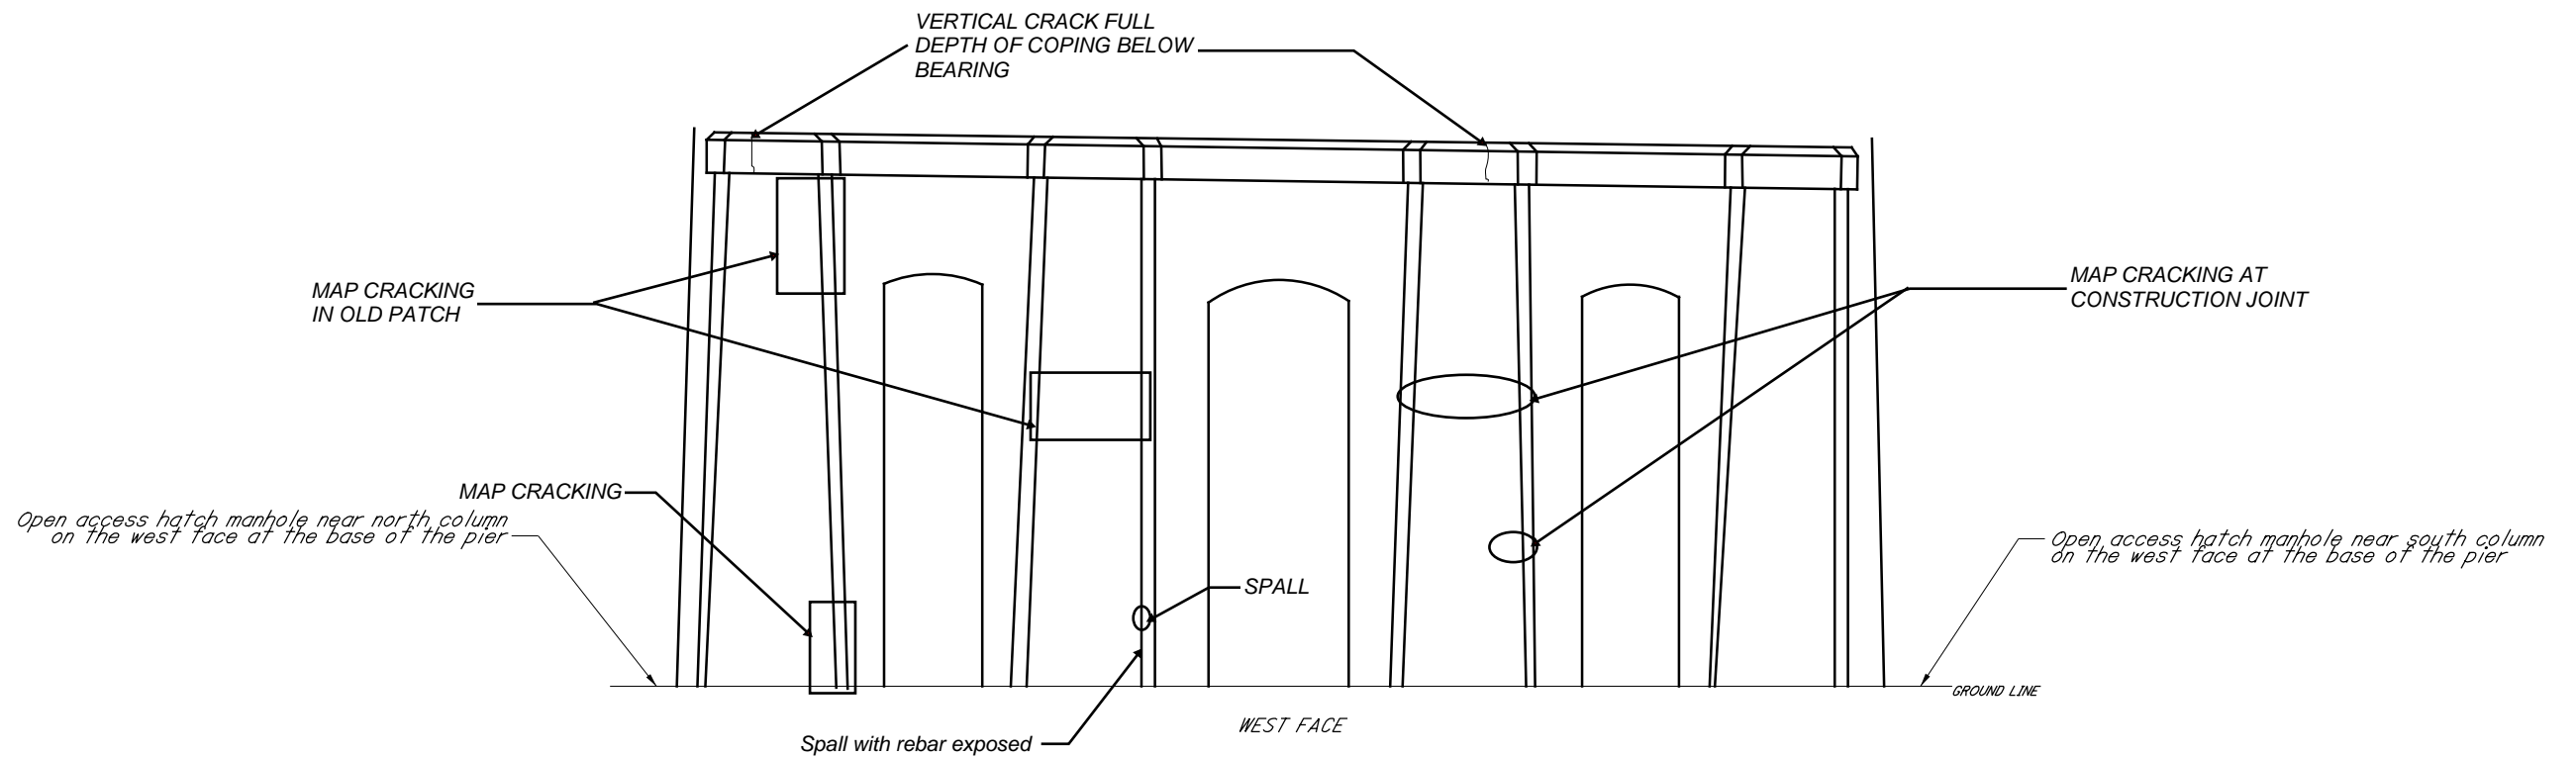
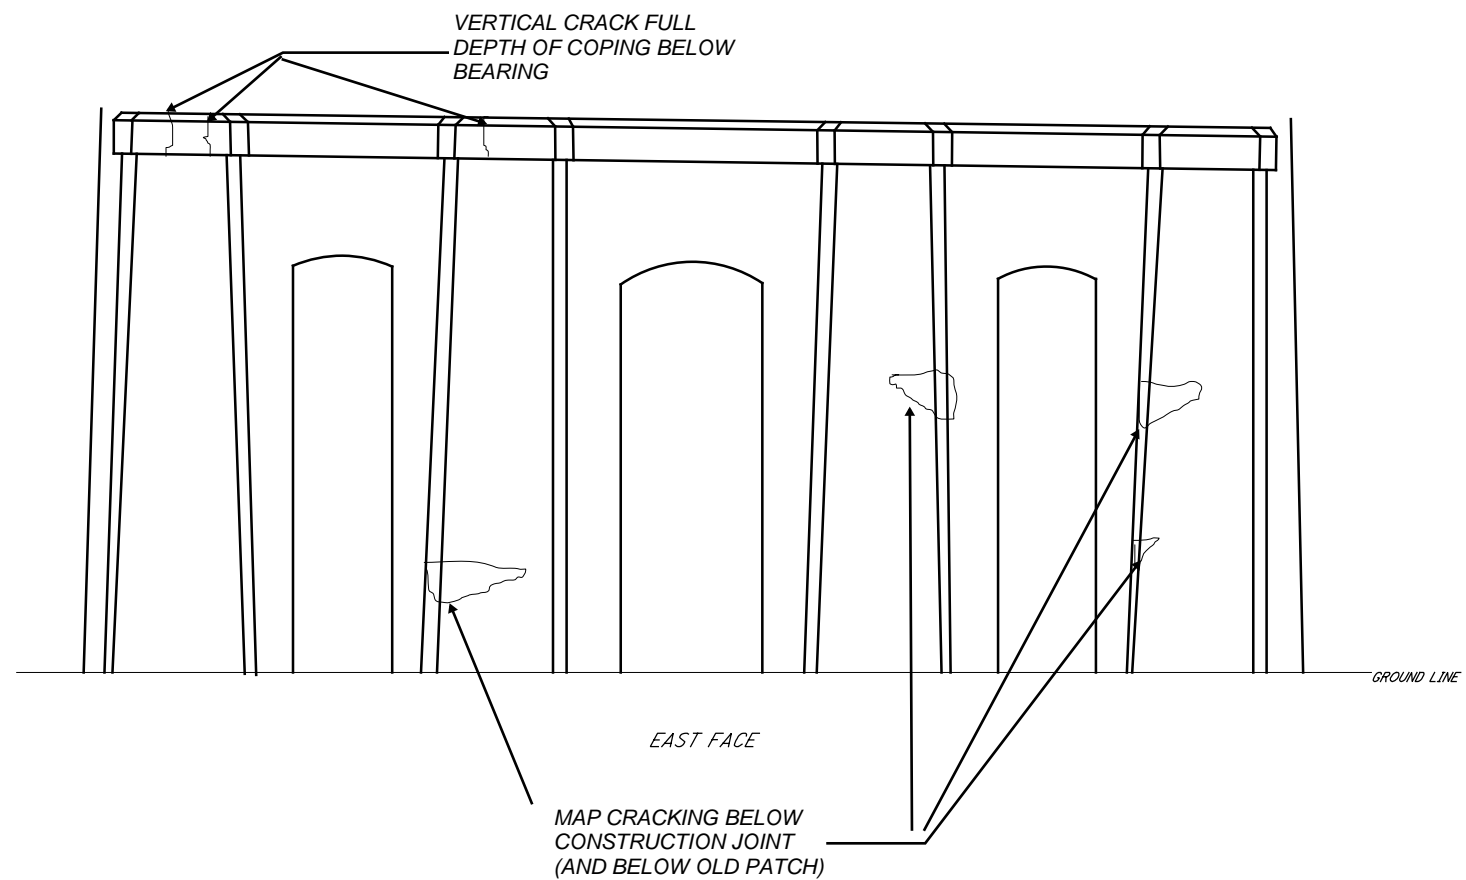
NOT TO SCALE	 	LORAIN-CARNEGIE BRIDGE	
		CUY-10-16.13	
DATE JUNE 2025		PIER 6 ELEVATION	PAGE 52/61

Pier columns have some areas of cracking, staining, delamination or spalling concentrated around previously patched areas.

The underside of the pier towers are deteriorated with cracks, spalls, delaminations and spalls. The majority of the spalling has exposed reinforcing.

The access manholes in the pier caps are in poor condition with the lips heavily deteriorated.
