2025 PHYSICAL CONDITION ROUTINE ELEMENT LEVEL INSPECTION REPORT

Bridge CUY-10-1613

SFN 1801503

Hope Memorial/Lorain Carnegie over Cuyahoga River

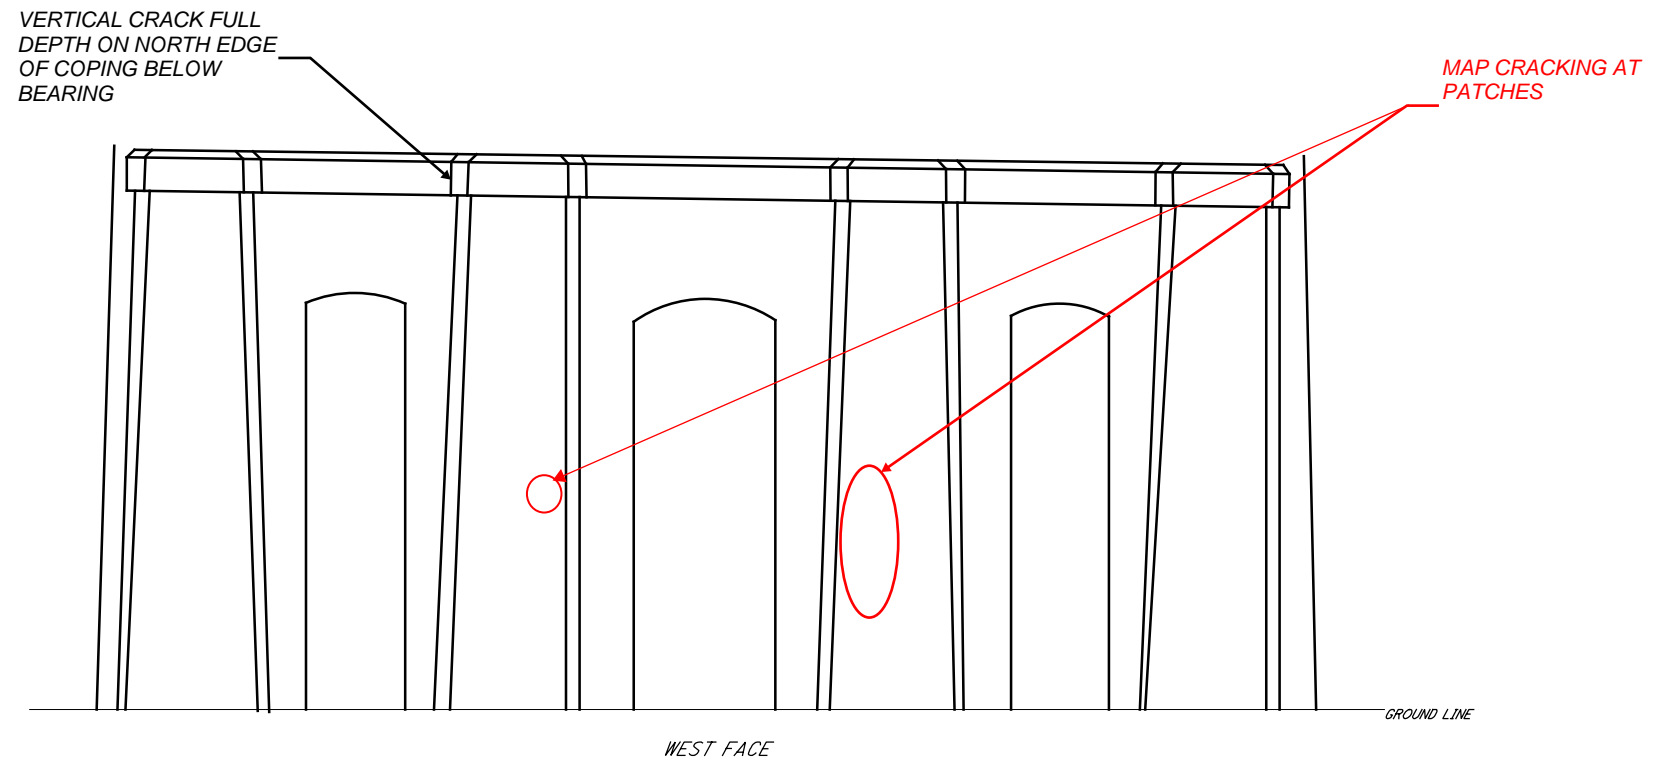
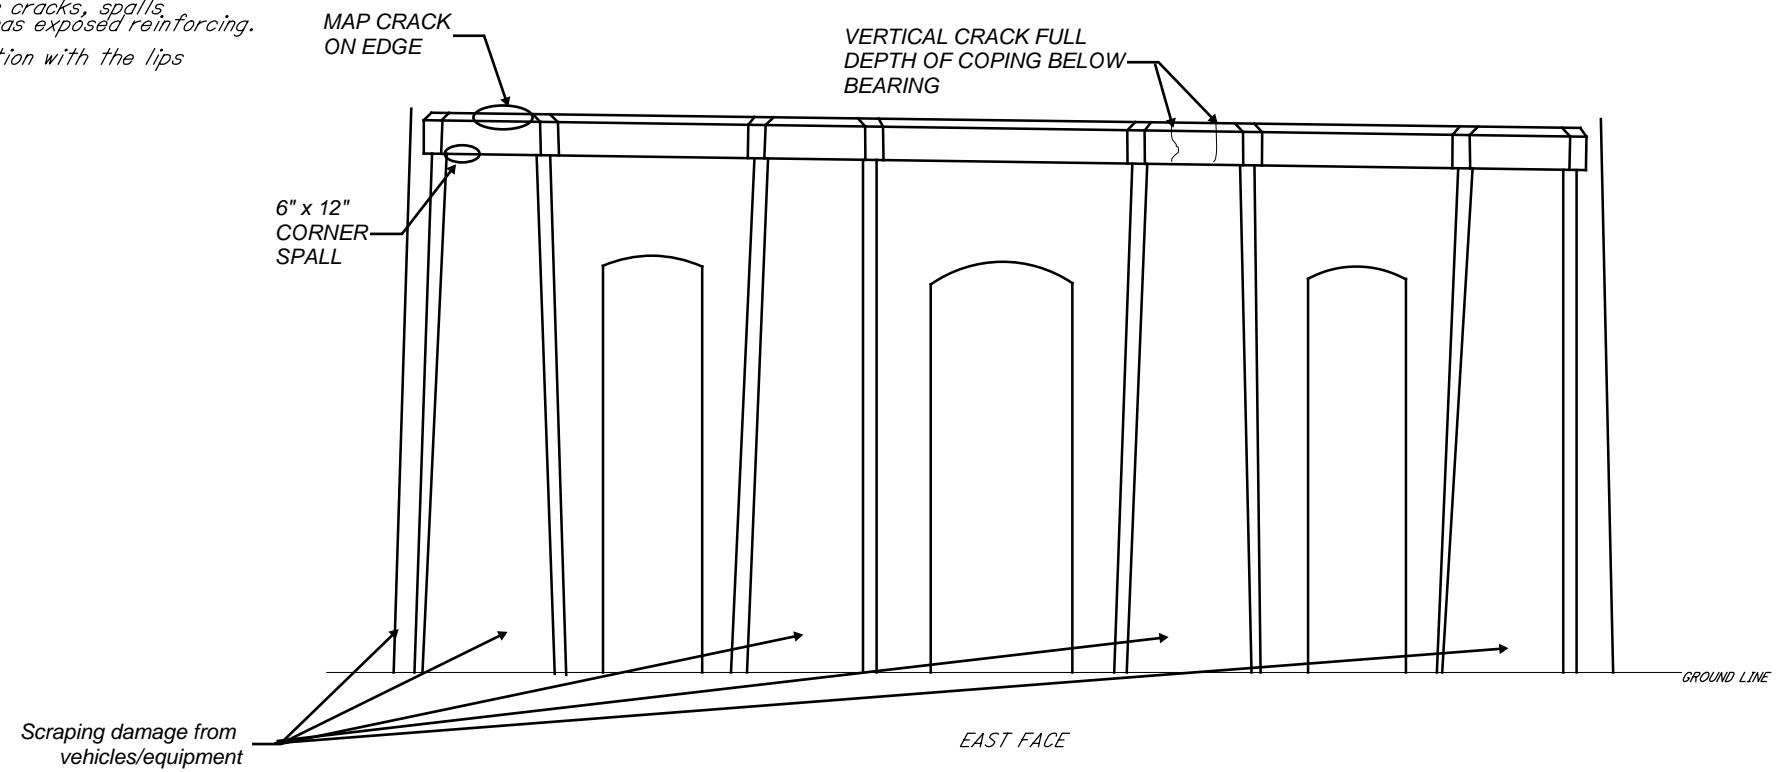
NOT TO SCALE	 	LORAIN-CARNEGIE BRIDGE	
		CUY-10-16.13	
DATE JUNE 2025		PIER 7 ELEVATION	PAGE 53/61

Pier columns have some areas of cracking, staining, delamination or spalling concentrated around previously patched areas.

The underside of the pier towers are deteriorated with cracks, spalls, delaminations and spalls. The majority of the spalling has exposed reinforcing.

The access manholes in the pier caps are in poor condition with the lips heavily deteriorated.

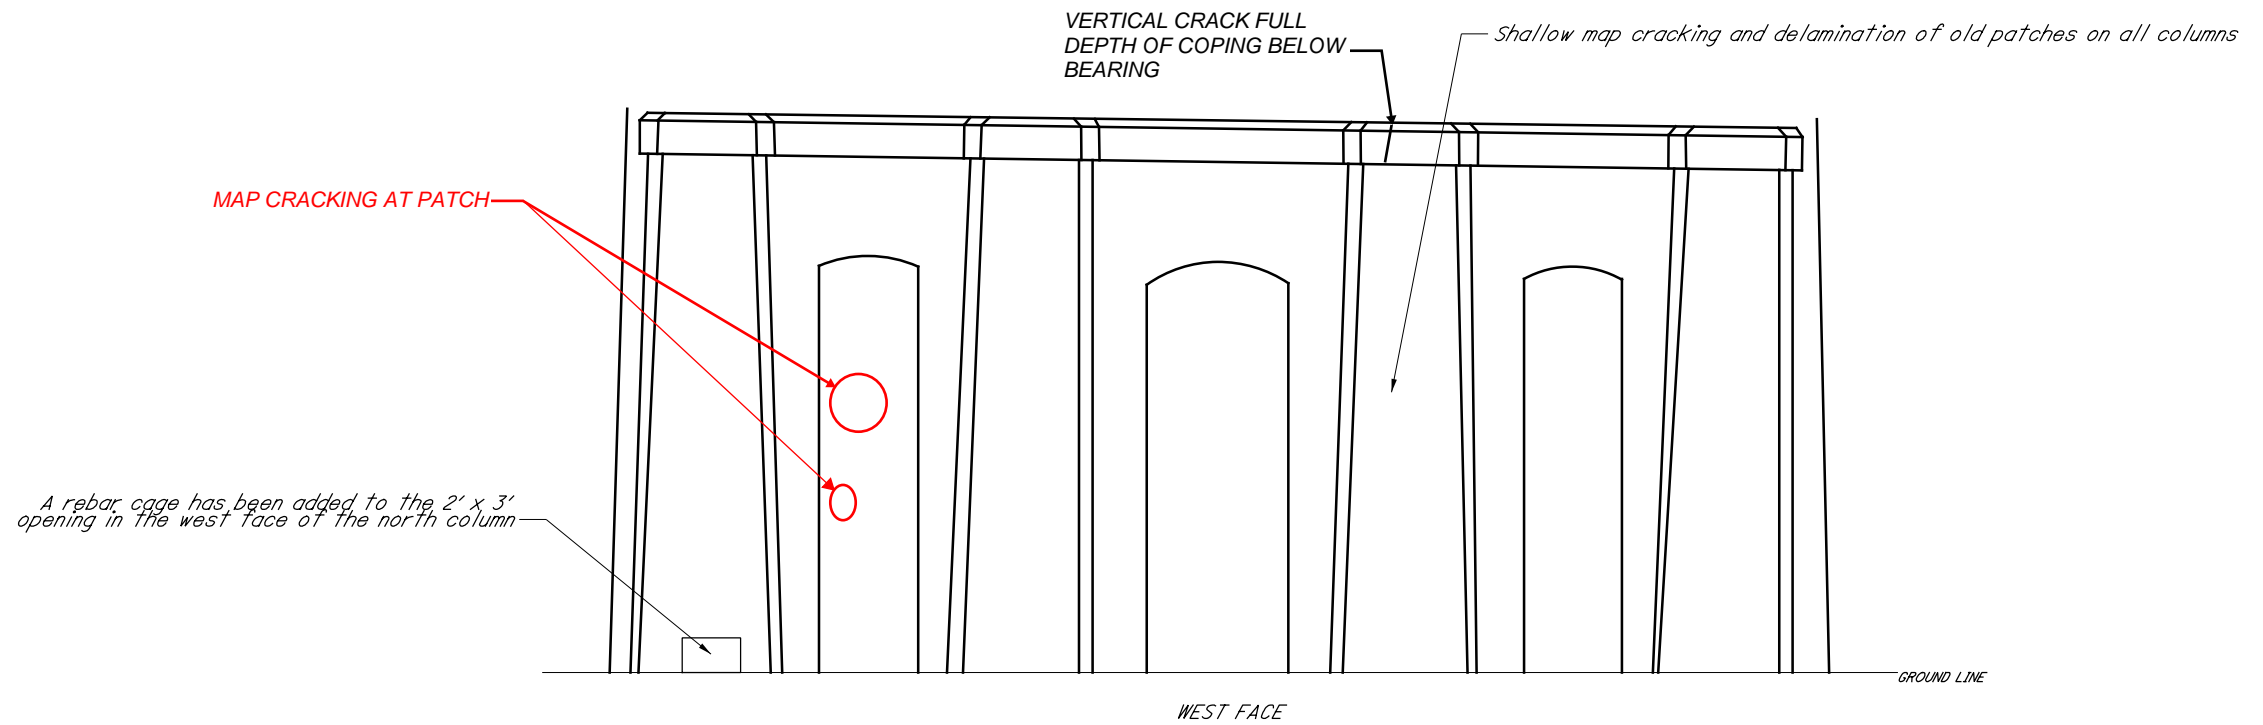
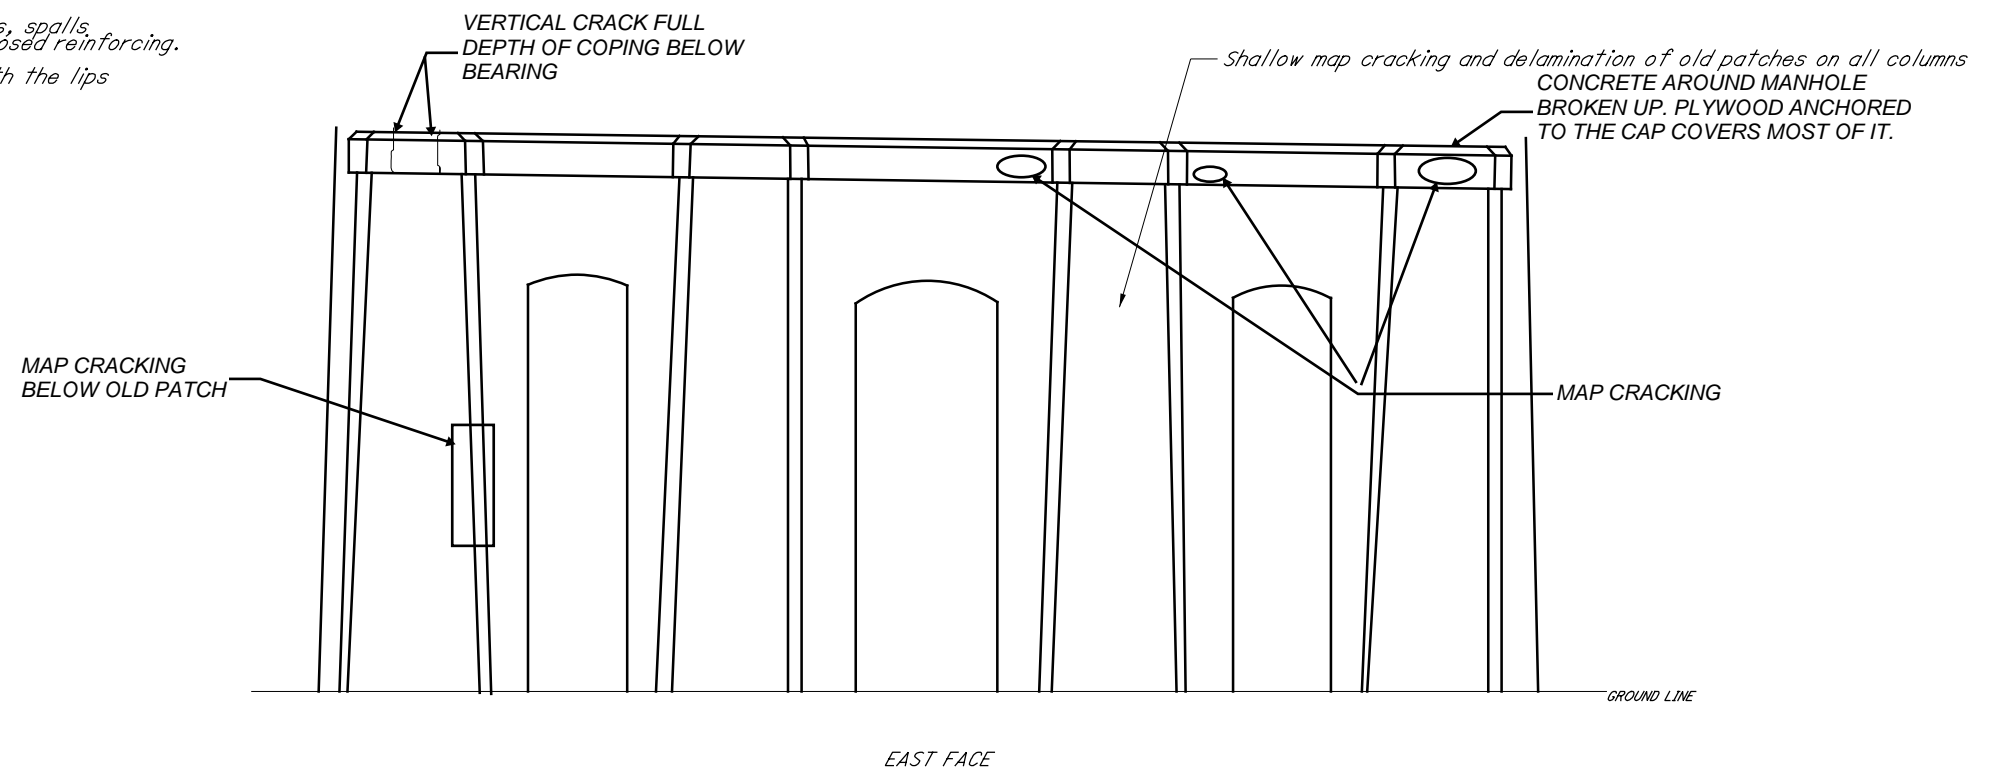
NOT TO SCALE	 	LORAIN-CARNEGIE BRIDGE CUY-10-16.13	
DATE JUNE 2025		PIER 8 ELEVATION	PAGE 54/61

Pier columns have some areas of cracking, staining, delamination or spalling concentrated around previously patched areas.

The underside of the pier towers are deteriorated with cracks, spalls, delaminations and spalls. The majority of the spalling has exposed reinforcing.

The access manholes in the pier caps are in poor condition with the lips heavily deteriorated.

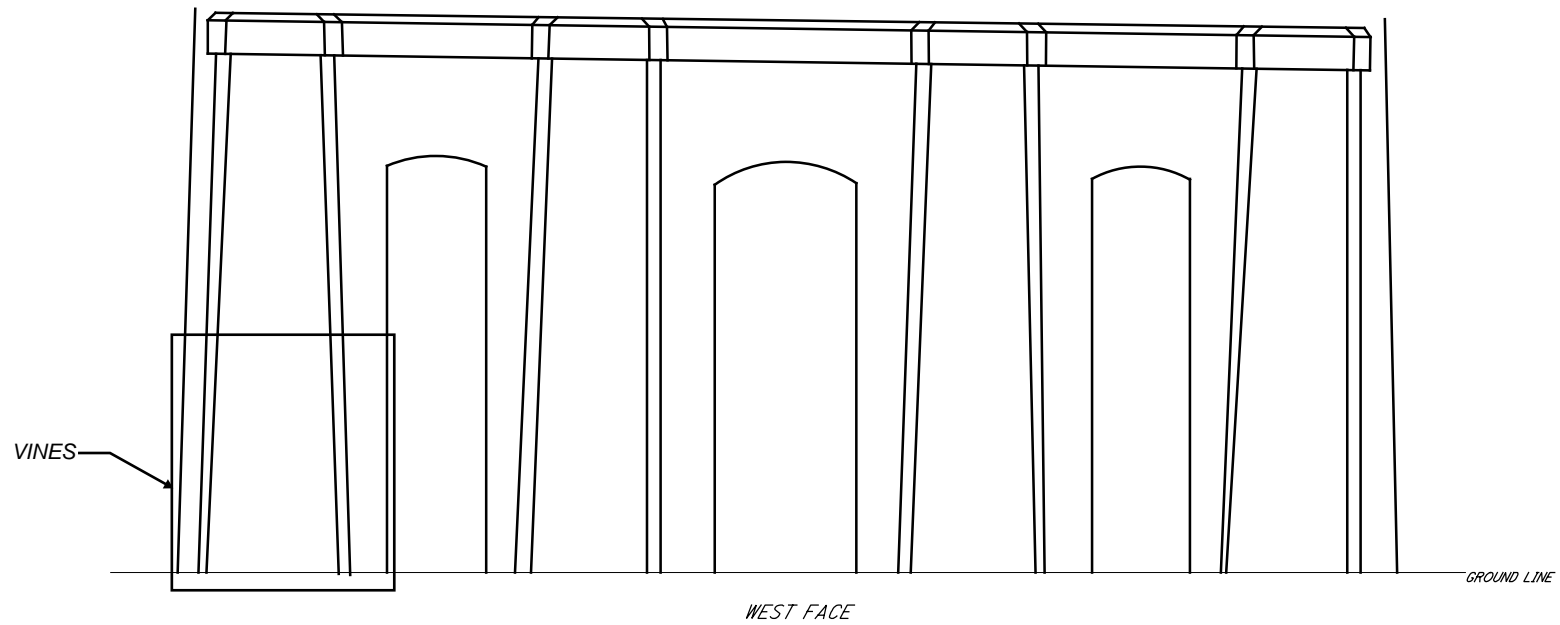
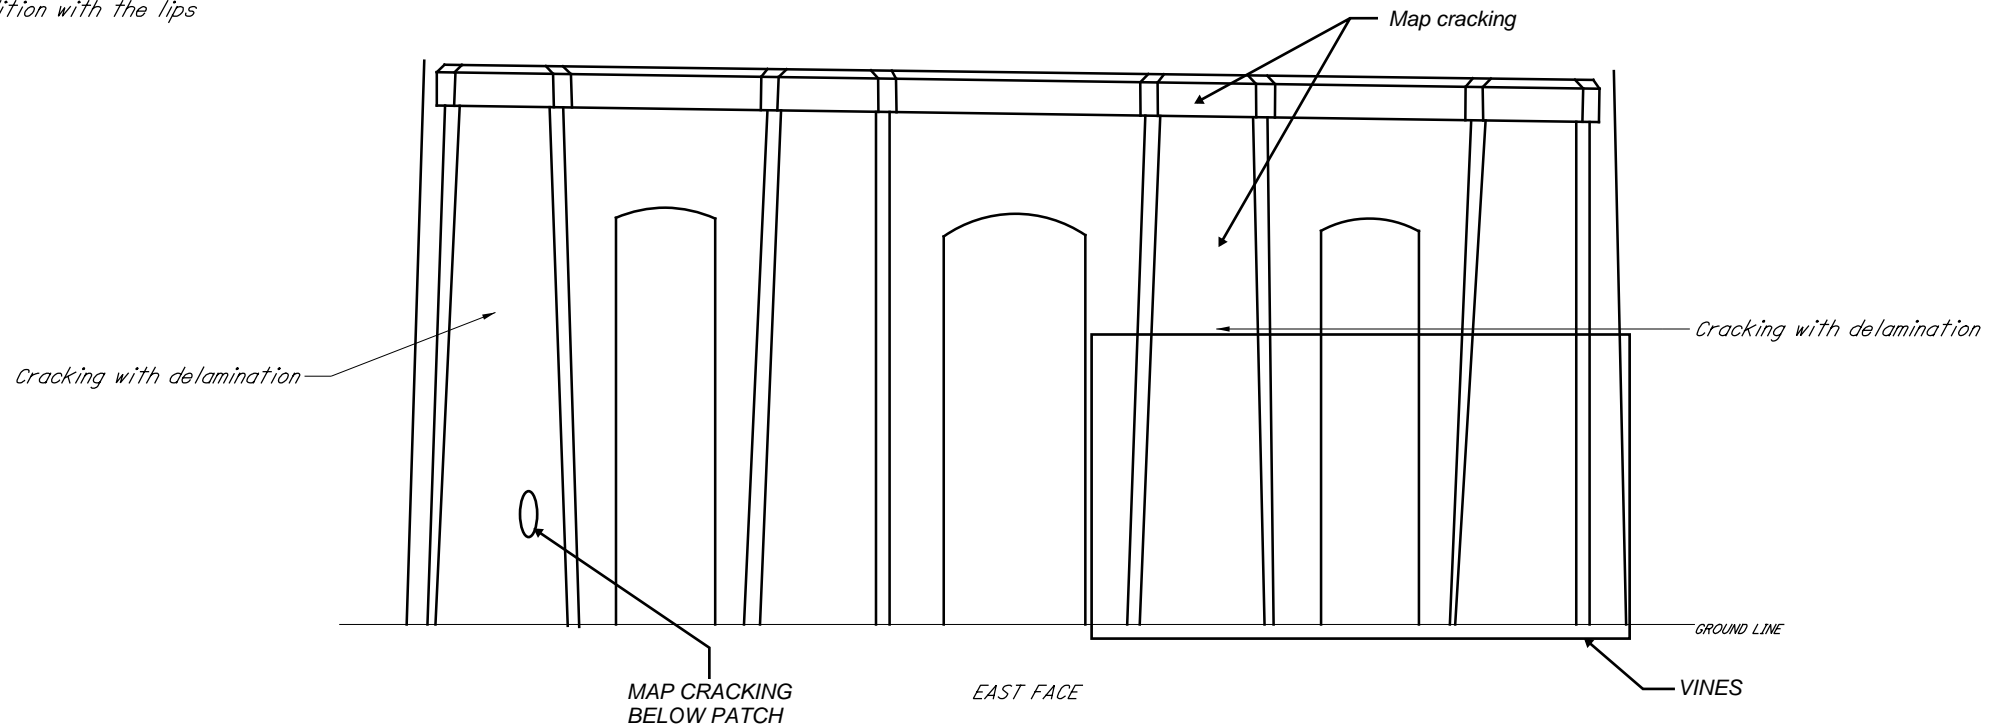
NOT TO SCALE	 	LORAIN-CARNEGIE BRIDGE	
		CUY-10-16.13	
DATE JUNE 2025		PIER 9 ELEVATION	PAGE 55/61

Pier columns have some areas of cracking, staining, delamination or spalling concentrated around previously patched areas.

The underside of the pier towers are deteriorated with cracks, spalls, delaminations and spalls. The majority of the spalling has exposed reinforcing.

The access manholes in the pier caps are in poor condition with the lips heavily deteriorated.

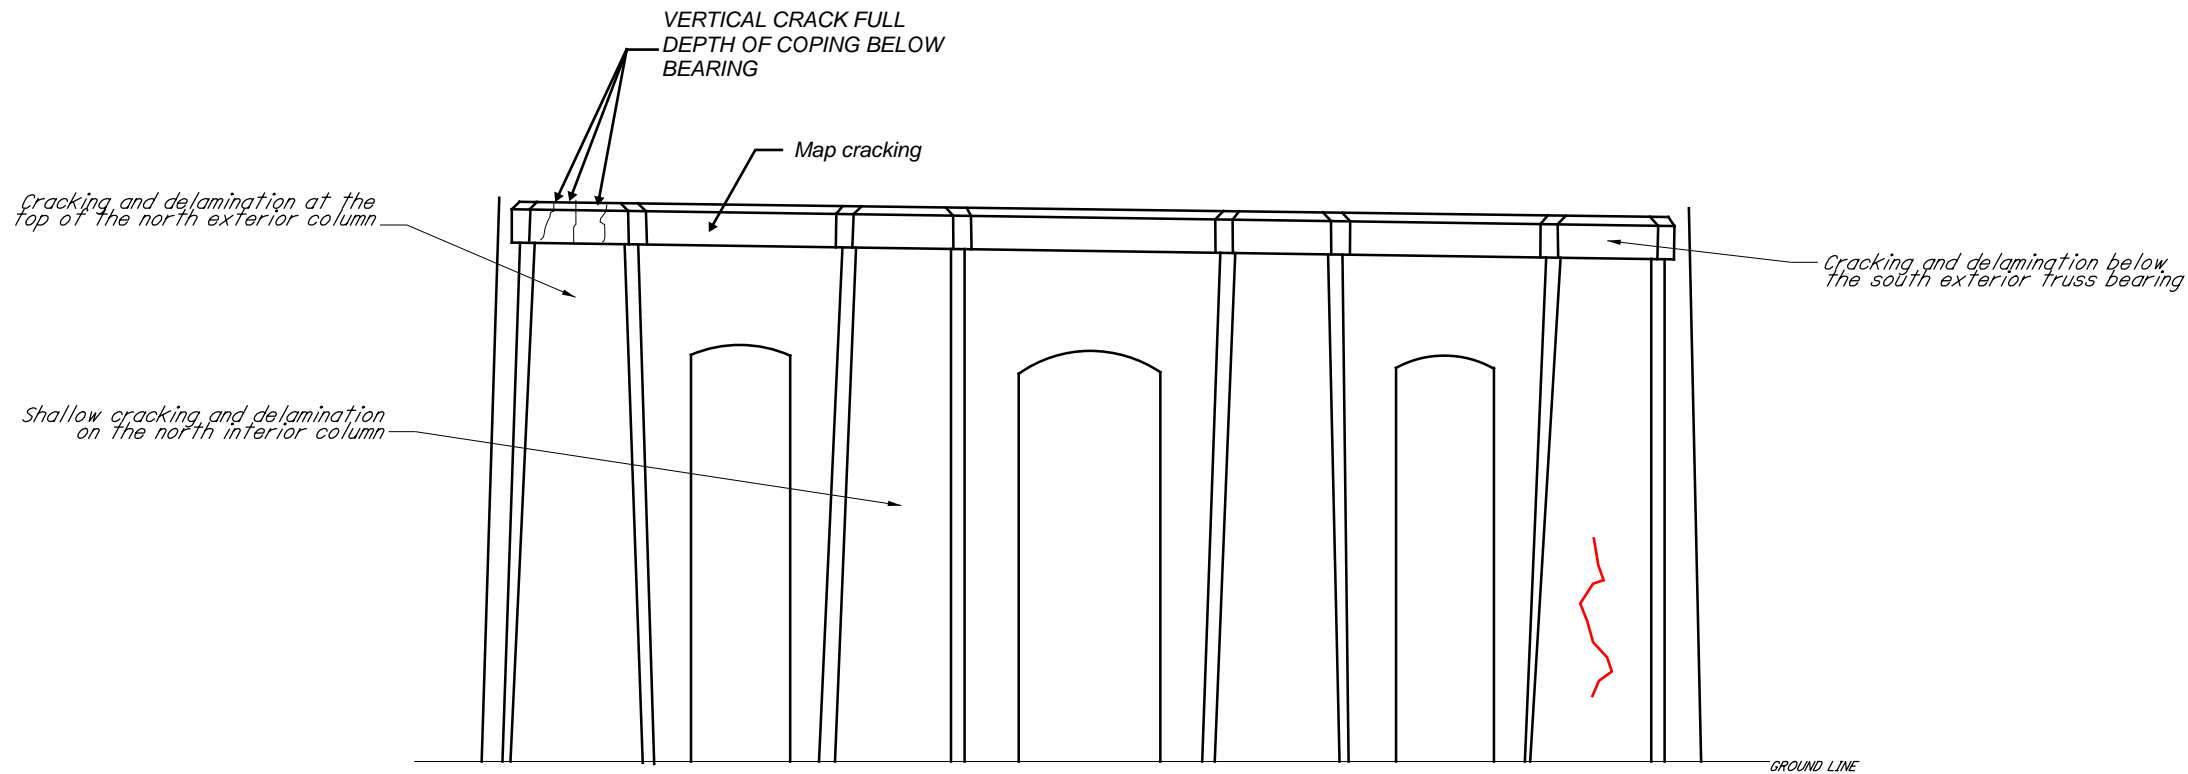
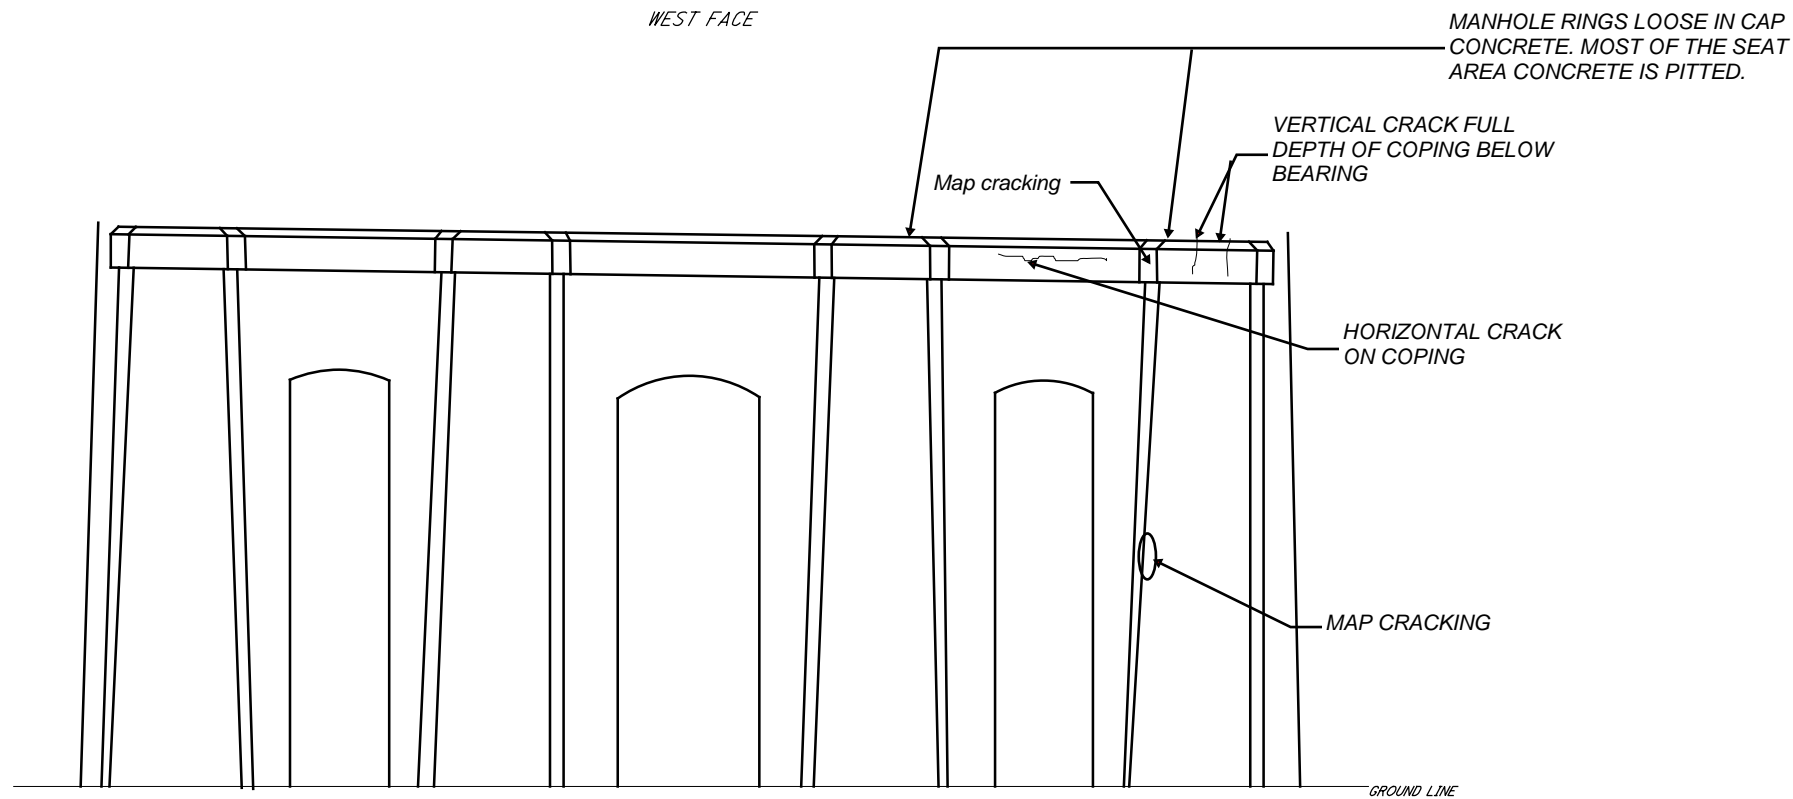
Pier columns have some areas of cracking, staining, delamination or spalling concentrated around previously patched areas.

The underside of the pier towers are deteriorated with cracks, spalls, delaminations and spalls. The majority of the spalling has exposed reinforcing.

The access manholes in the pier caps are in poor condition with the lips heavily deteriorated.

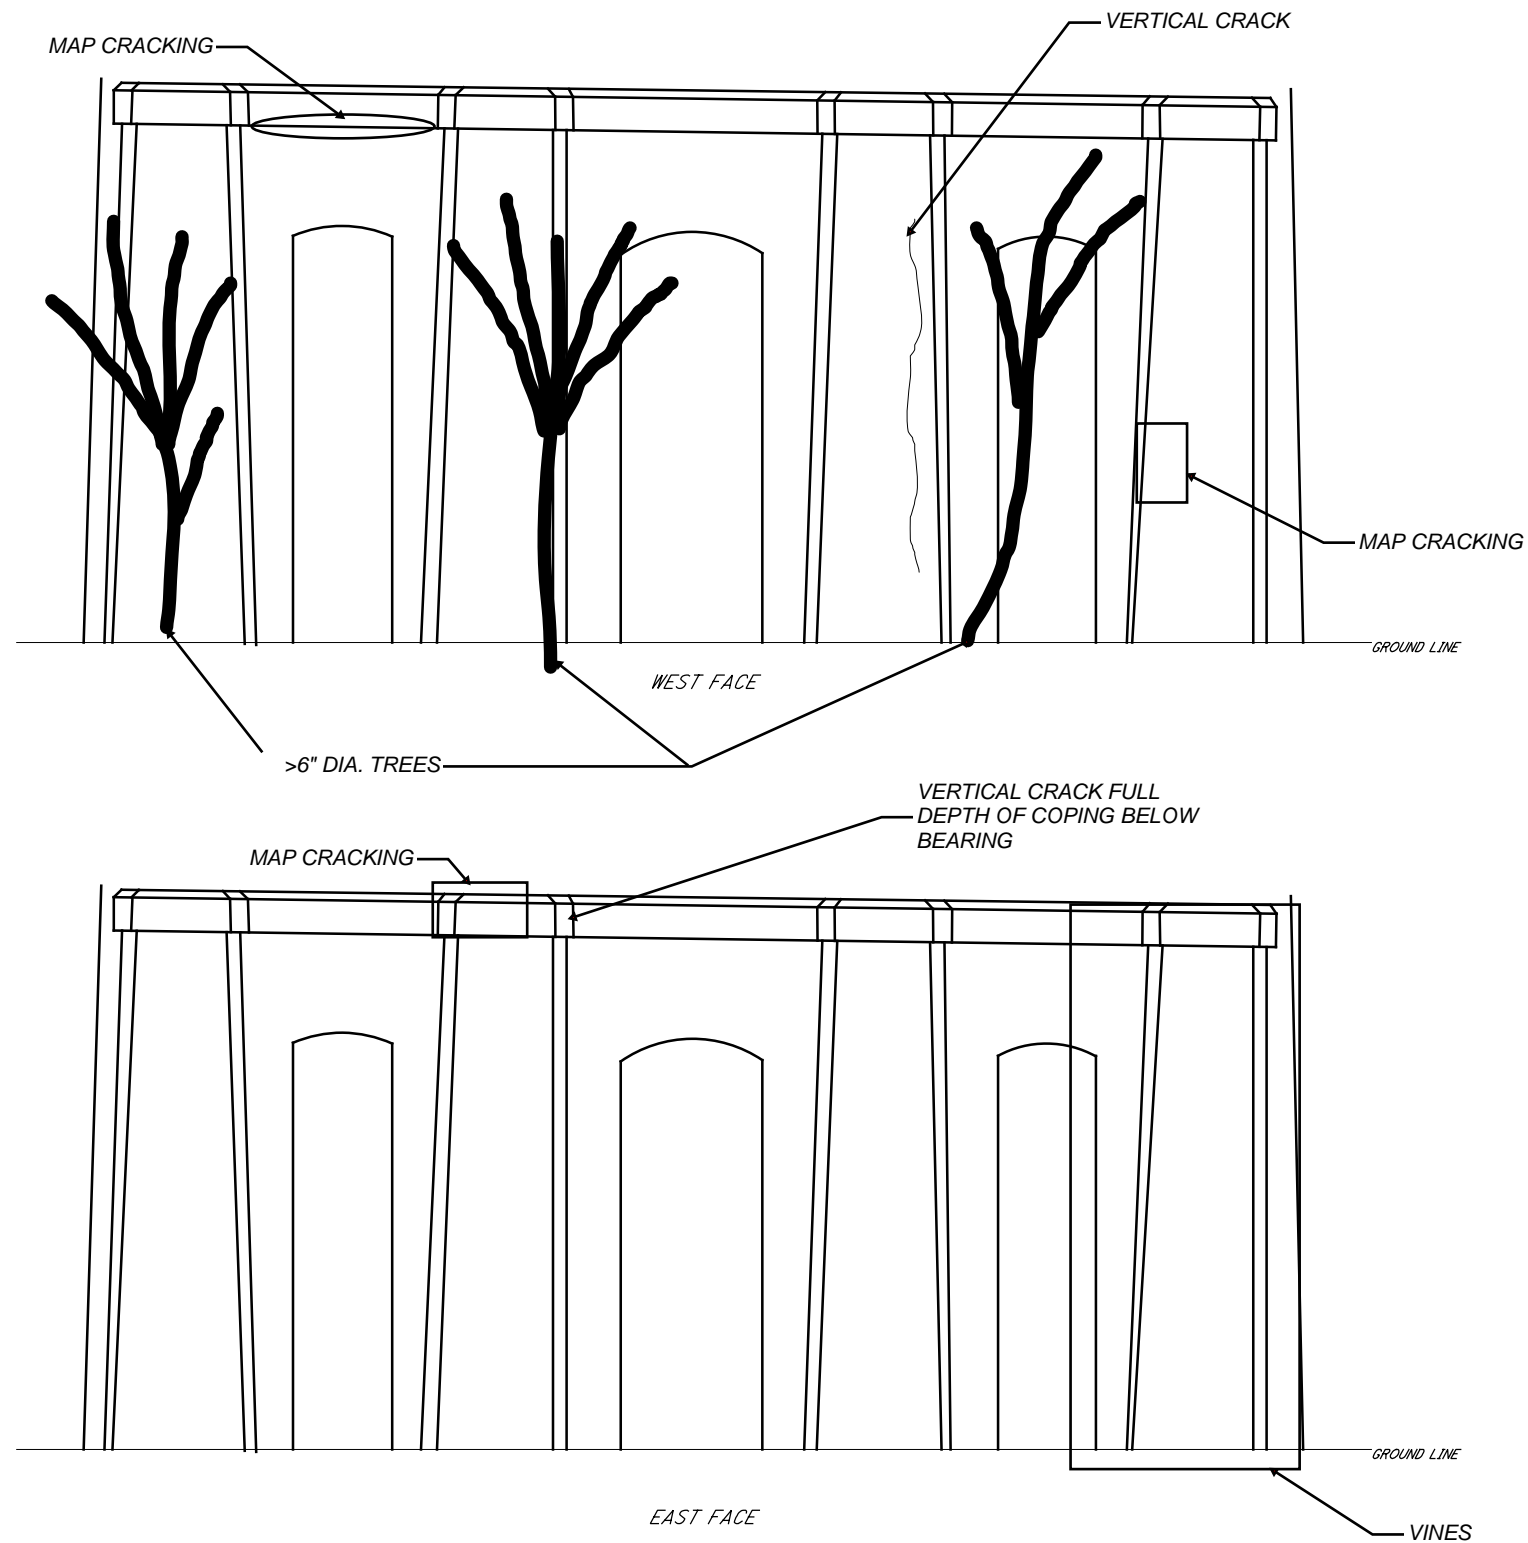
LORAIN-CARNEGIE BRIDGE	
		CUY-10-16.13	
DATE JUNE 2025		PIER 11 ELEVATION	PAGE 57/61

Pier columns have some areas of cracking, staining, delamination or spalling concentrated around previously patched areas.

The underside of the pier towers are deteriorated with cracks, spalls, delaminations and spalls. The majority of the spalling has exposed reinforcing.

The access manholes in the pier caps are in poor condition with the lips heavily deteriorated.

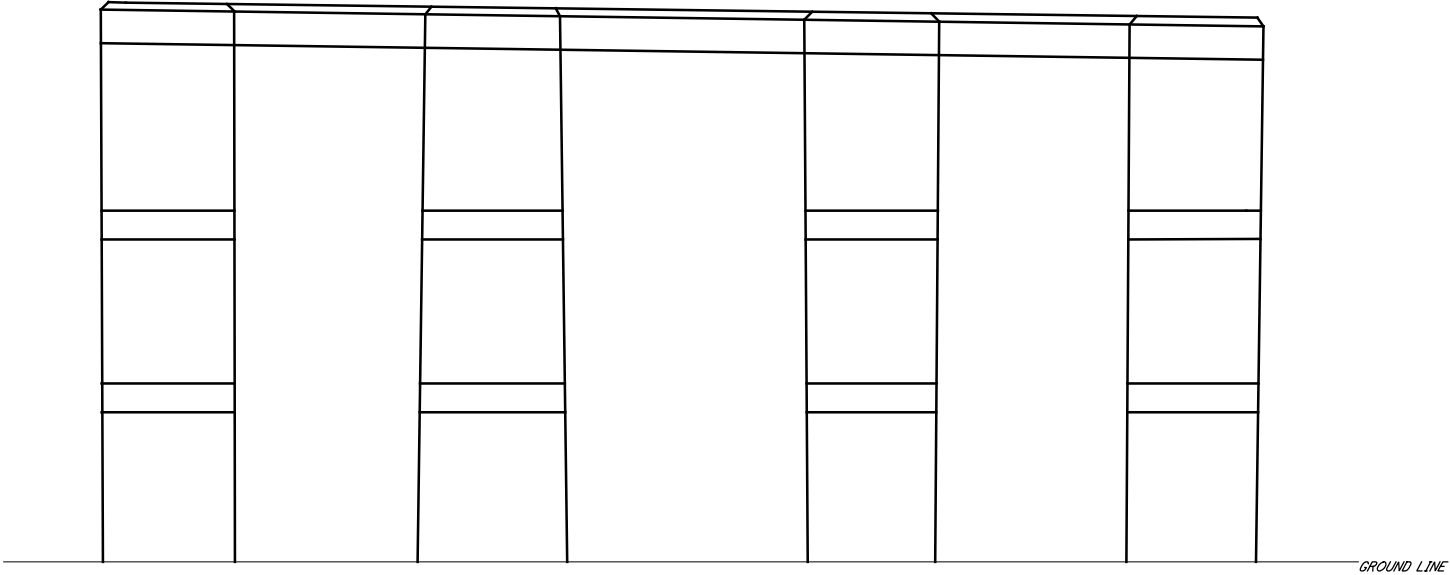
- Pier columns have some areas of cracking, staining, delamination or spalling concentrated around previously patched areas.
- The underside of the pier towers are deteriorated with cracks, spalls, delaminations and spalls. The majority of the spalling has exposed reinforcing.
- The access manholes in the pier caps are in poor condition with the lips heavily deteriorated.
- Spalls with exposed rebar at corbels on pier legs.

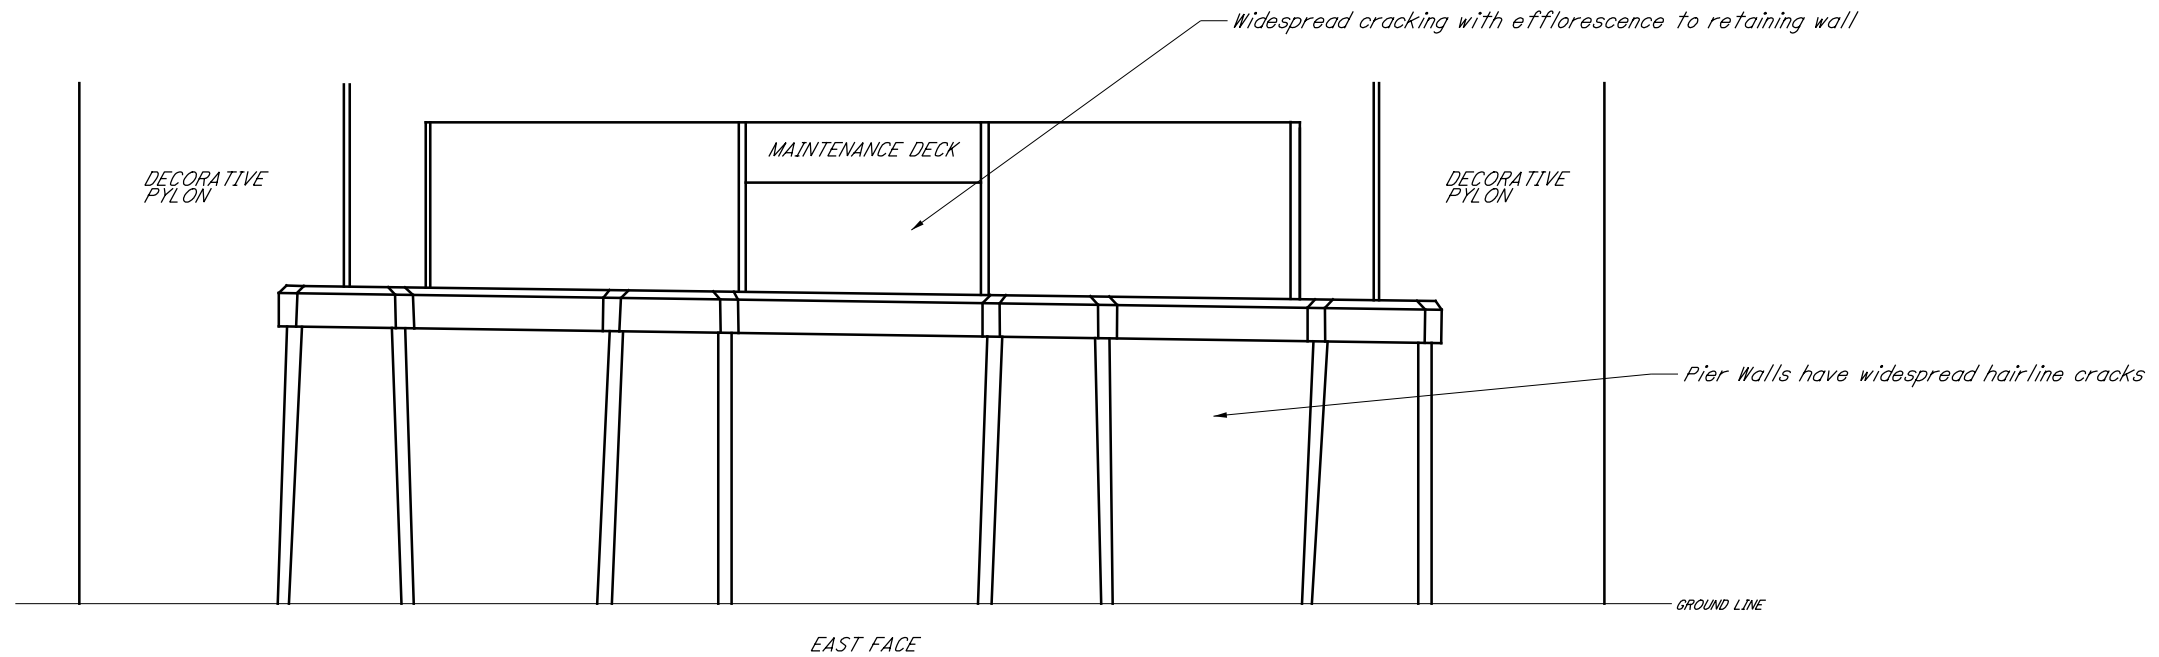
NOT TO SCALE	 	LORAIN-CARNEGIE BRIDGE CUY-10-16.13	
DATE JUNE 2025		WEST PYLON ELEVATION	PAGE 59/61

Pier columns have some areas of cracking, staining, delamination or spalling concentrated around previously patched areas.

Pier Walls have minor cracking, staining, patched areas and some minor spalling throughout.

The underside of the pier towers are deteriorated with cracks, delaminations and spalls. The majority of the spalling has exposed reinforcing.

The access manholes in the pier caps are in poor condition with the lips heavily deteriorated.

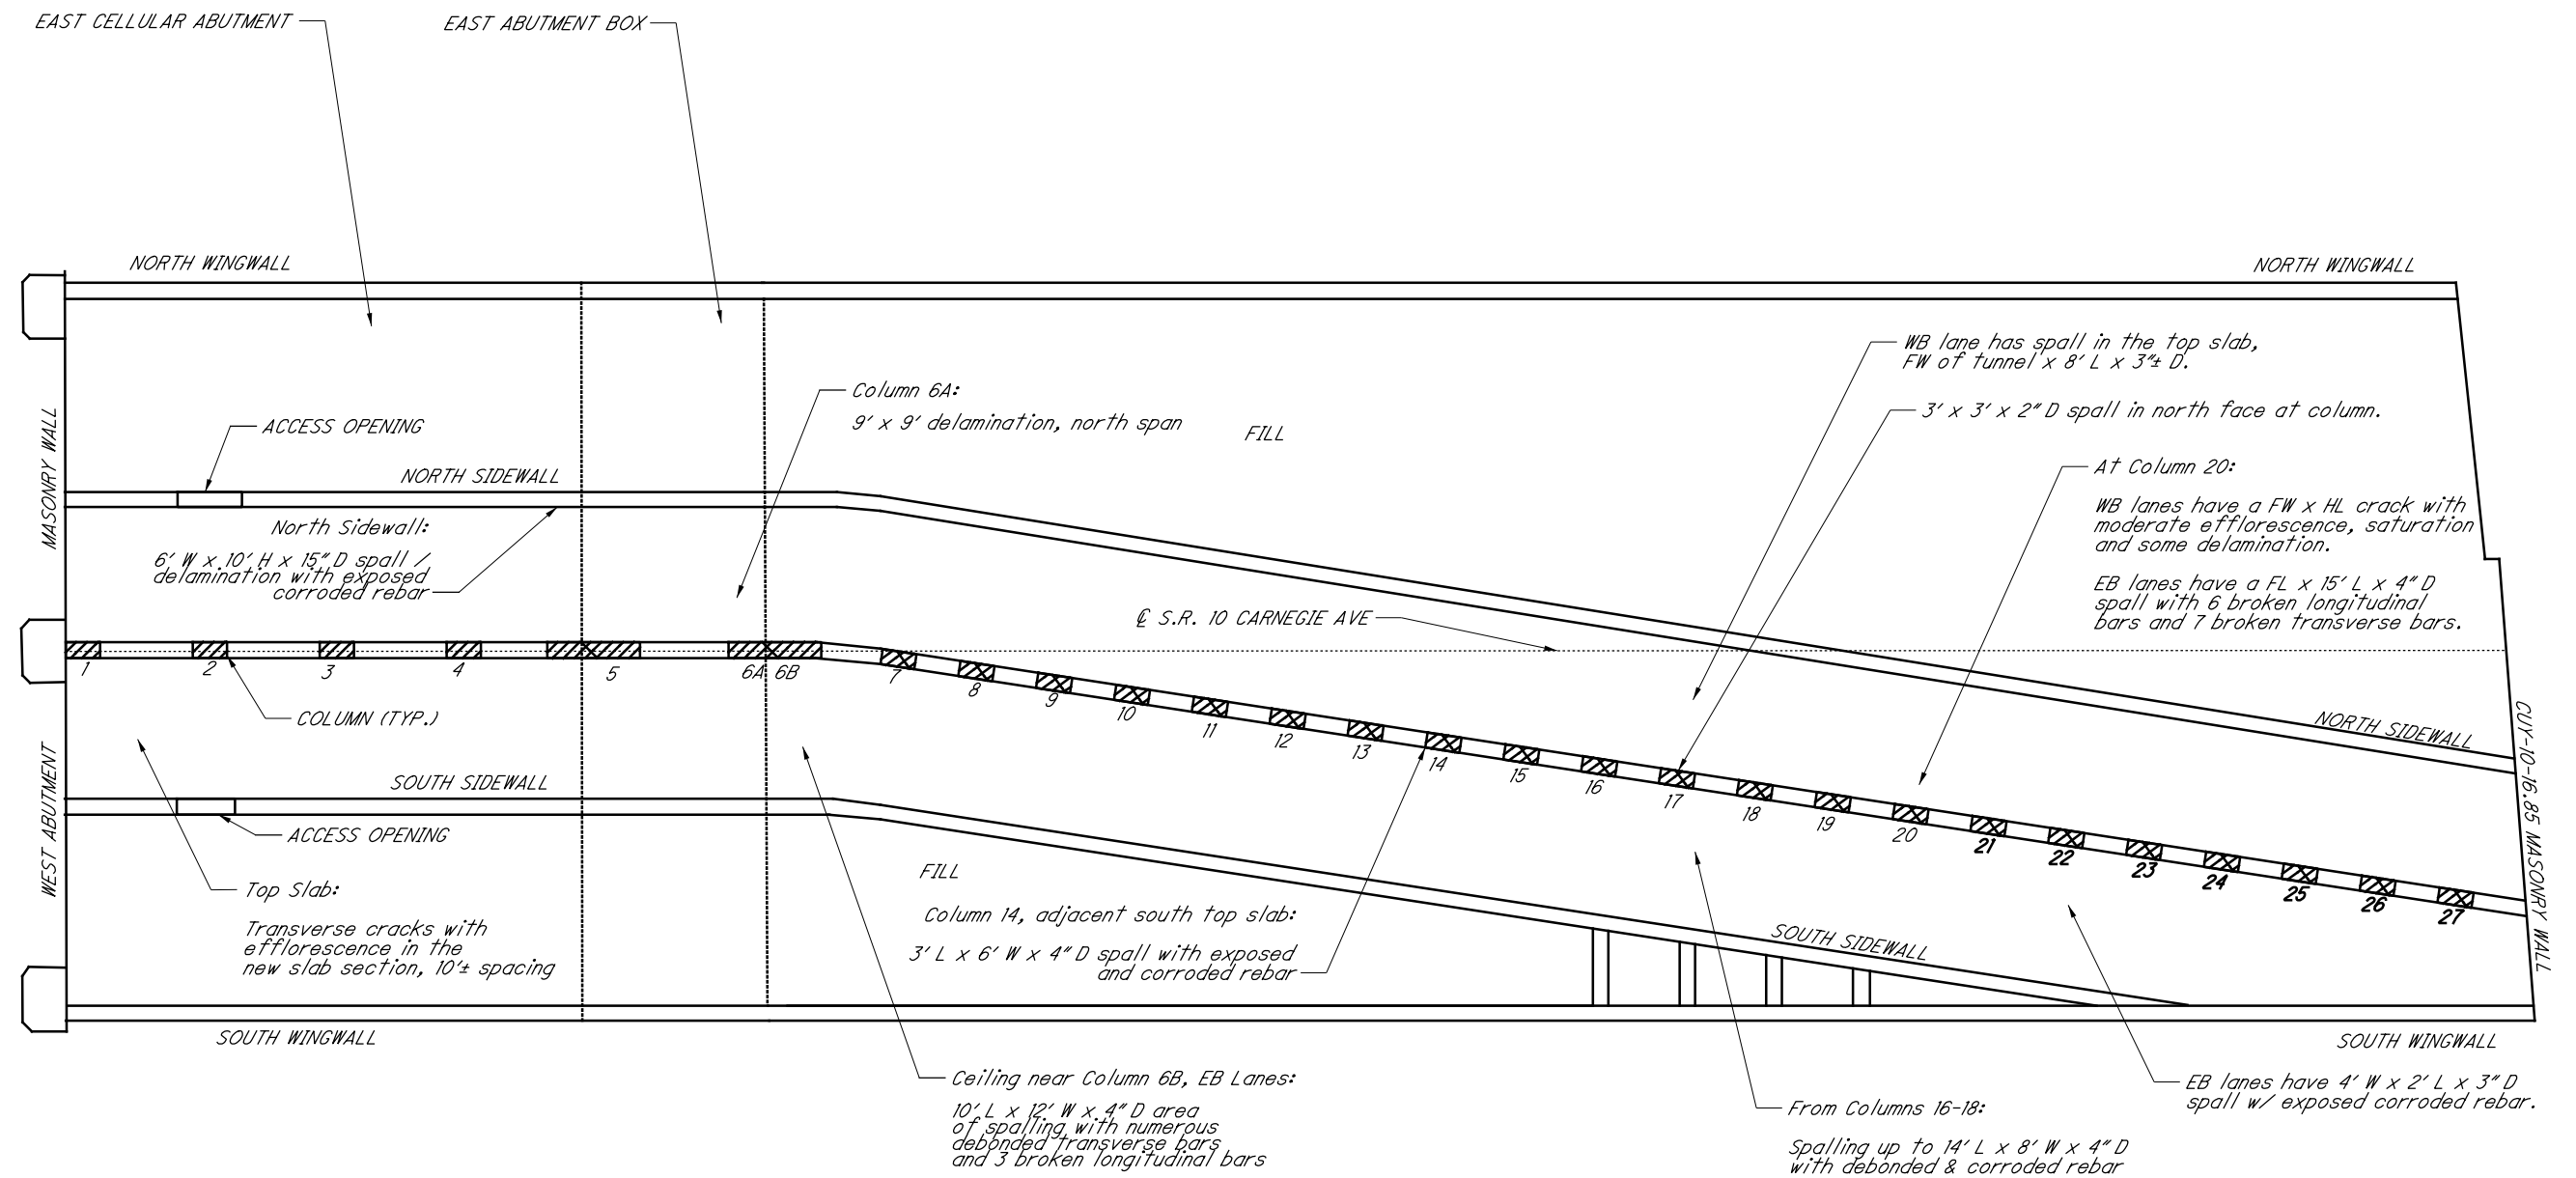
EAST CELLULAR ABUTMENT, ABUTMENT BOX & SUBWAY TUNNEL DEFICIENCIES

Columns typically have a FH x 1/4" W crack at jack arches

Typical vertical cracks in sidewalls up to 3/8" L. A few diagonal cracks are also present

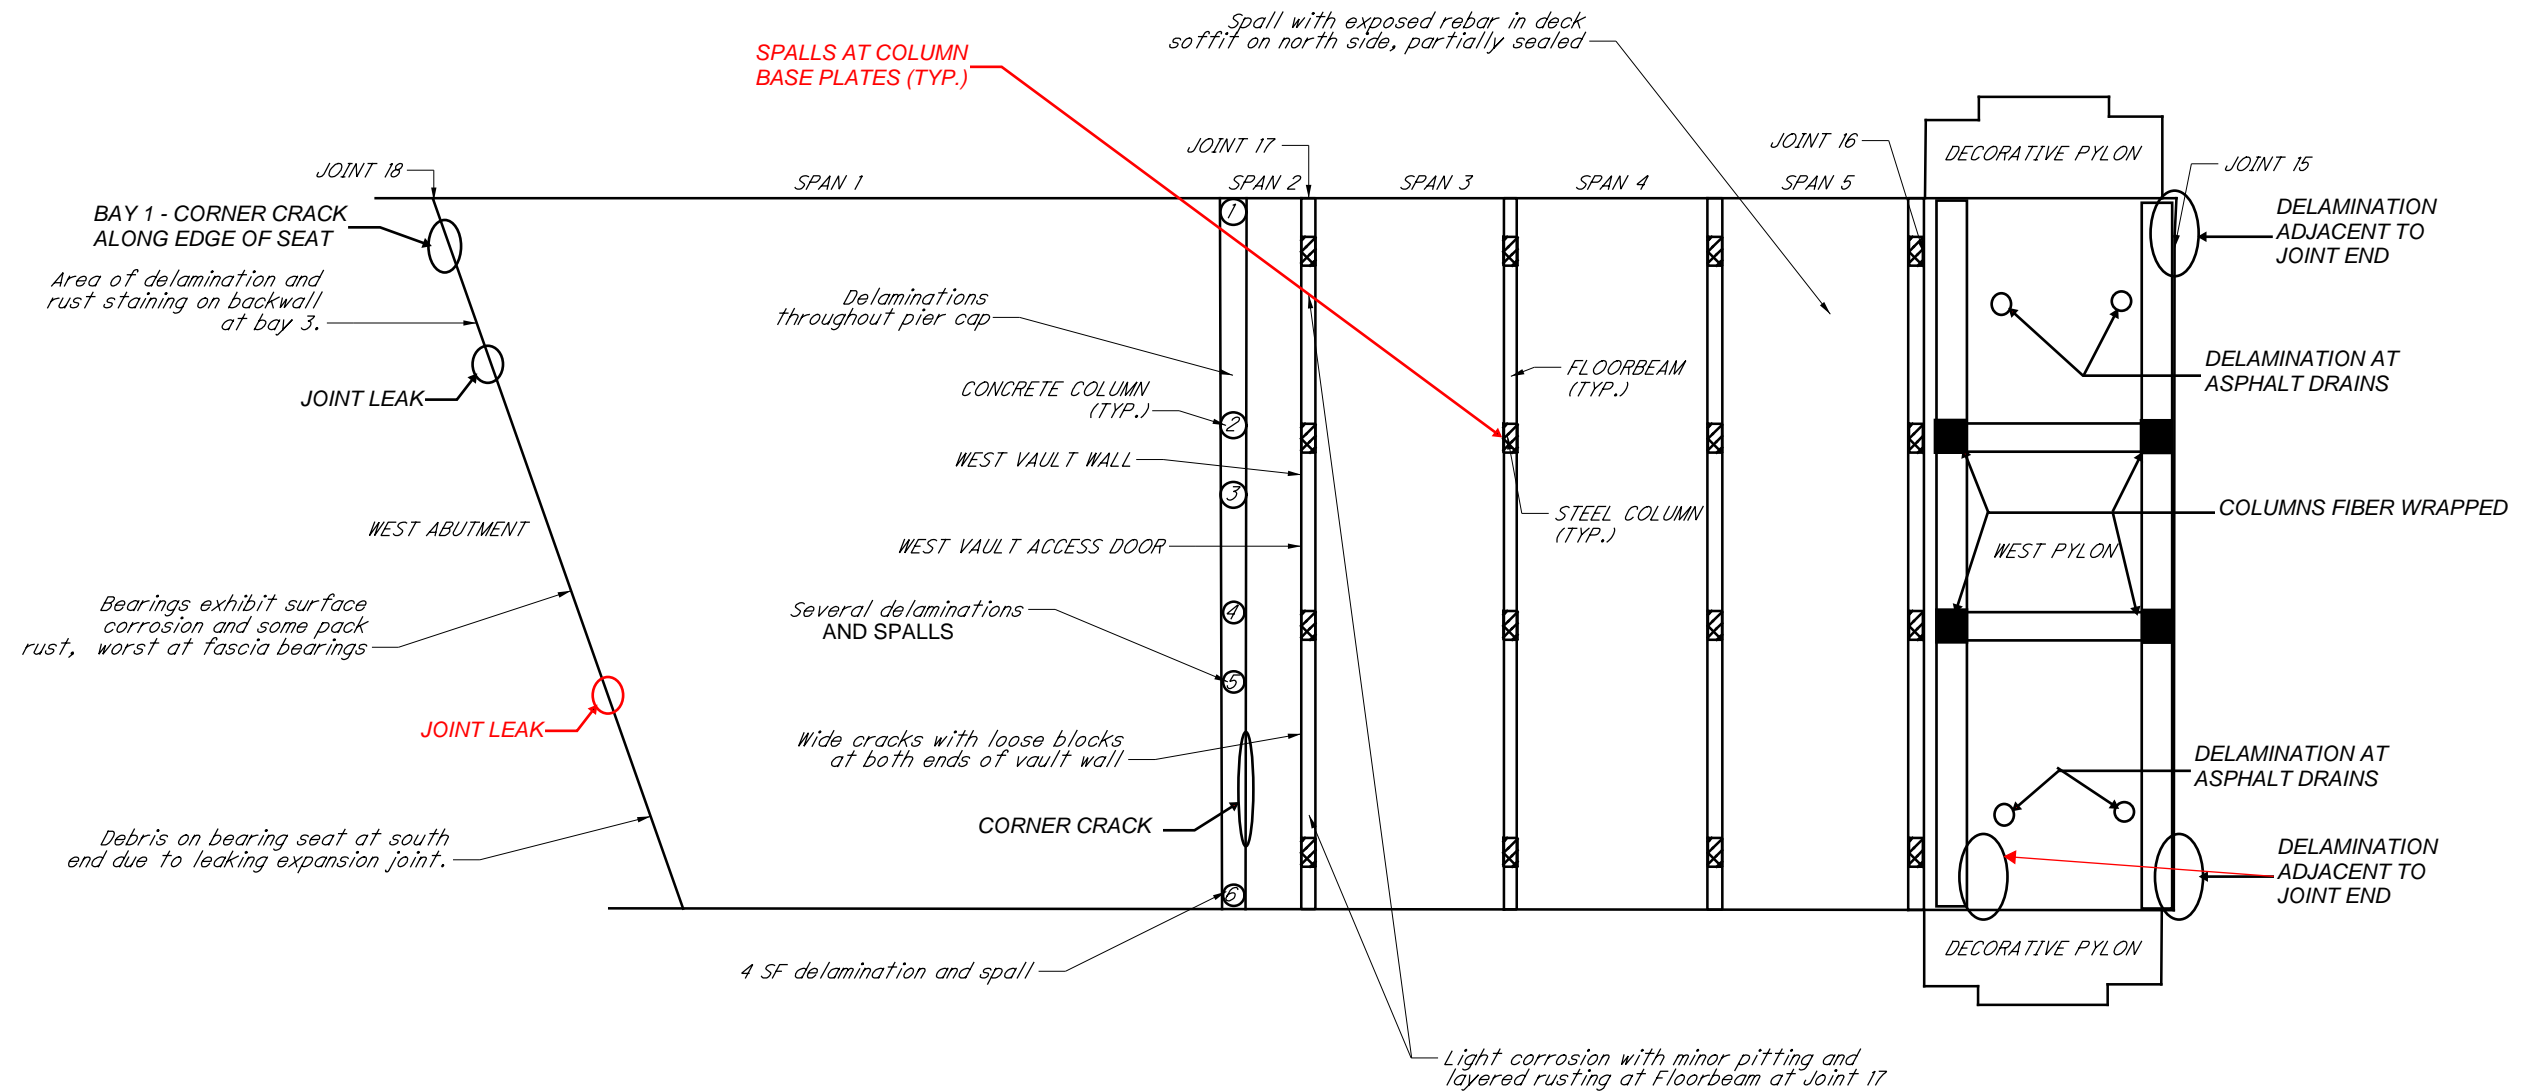
WEST APPROACH PLAN VIEW

ABUTMENTS: There are cracks, areas of patching, rust staining and some delaminations.

BACKWALLS: Cracking and delamination were noted in some of the backwalls.

WINGWALLS: Scattered areas of cracking, delamination and minor spalling.

DECORATIVE PYLONS: Exhibit some areas of spalling and deterioration.
