2025 PHYSICAL CONDITION ROUTINE ELEMENT LEVEL INSPECTION REPORT

Bridge CUY-10-1613

SFN 1801503

Hope Memorial/Lorain Carnegie over Cuyahoga River

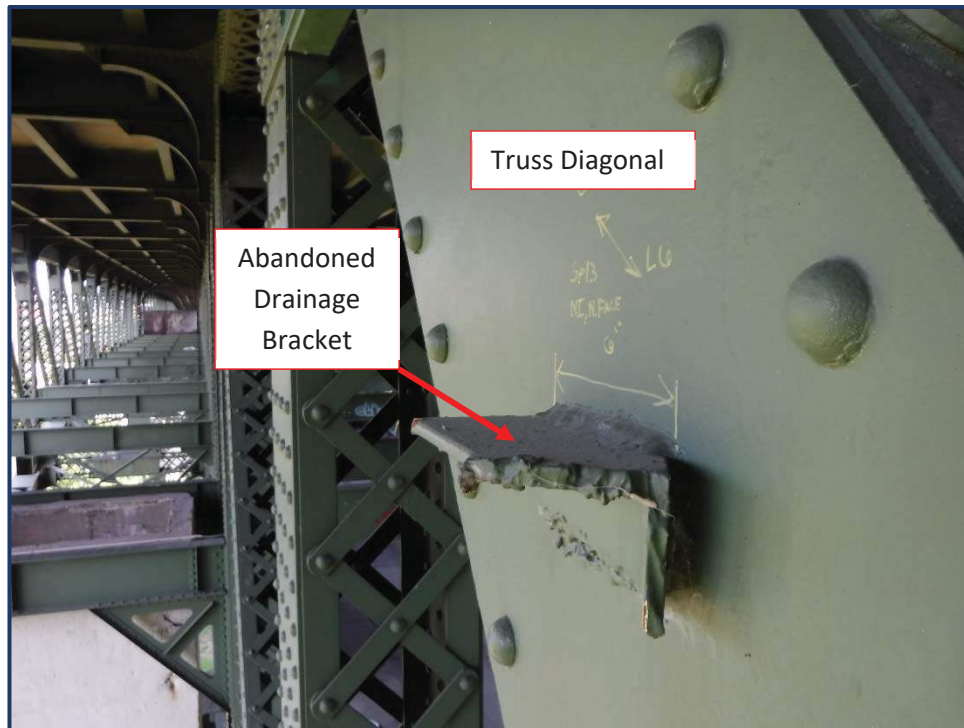
Known Structural Risk Factors & Fatigue Prone Details <i>Category reference: AASHTO LRFD Bridge Design Specs, 9th Ed. Table 6.6.1.2.3-1</i>			
Photo Reference	Label / Fatigue Category	Where?	Description
1	Abandoned Drainage Brackets, Fatigue Category E	Span 13 Truss Diagonals	Fillet welds connecting abandoned drainage brackets to truss diagonals (NI L6-U7, SI L6-U7, SE L6-U7)
2	Abandoned Utility Brackets, Fatigue Category E	South Exterior Truss Upper Chords	Fillet welds connecting abandoned utility brackets to truss upper chords (S5 U10-U11, S7 U4-U5, S9 U0-U1, S9 U12-U13, S11 U11-U12, S13 U6-U7). Crack present in vertical fillet weld at S9 U0-U1.
3	Cracks in Flange Angles	Lower Chords	Cracks in fillet of lower flange angles at gusset plates (S6 SI L1-L2, S12 NI L1-L2, S12 NI L2-L3, S12 NI L2-L4, S12 SI L0-L1, S12 SI L2-L3, S12 SI L3-L4, S12 SE L3-L4). Some locations have been arrested with drilled holes.

Photo 1 – Abandoned Drainage Bracket on Truss Diagonal
