District 2 Planning & Engineering

W00-64-5.40 Safety Study

SR-64 at Bishop Road (Township Road 208)

12/15/2023

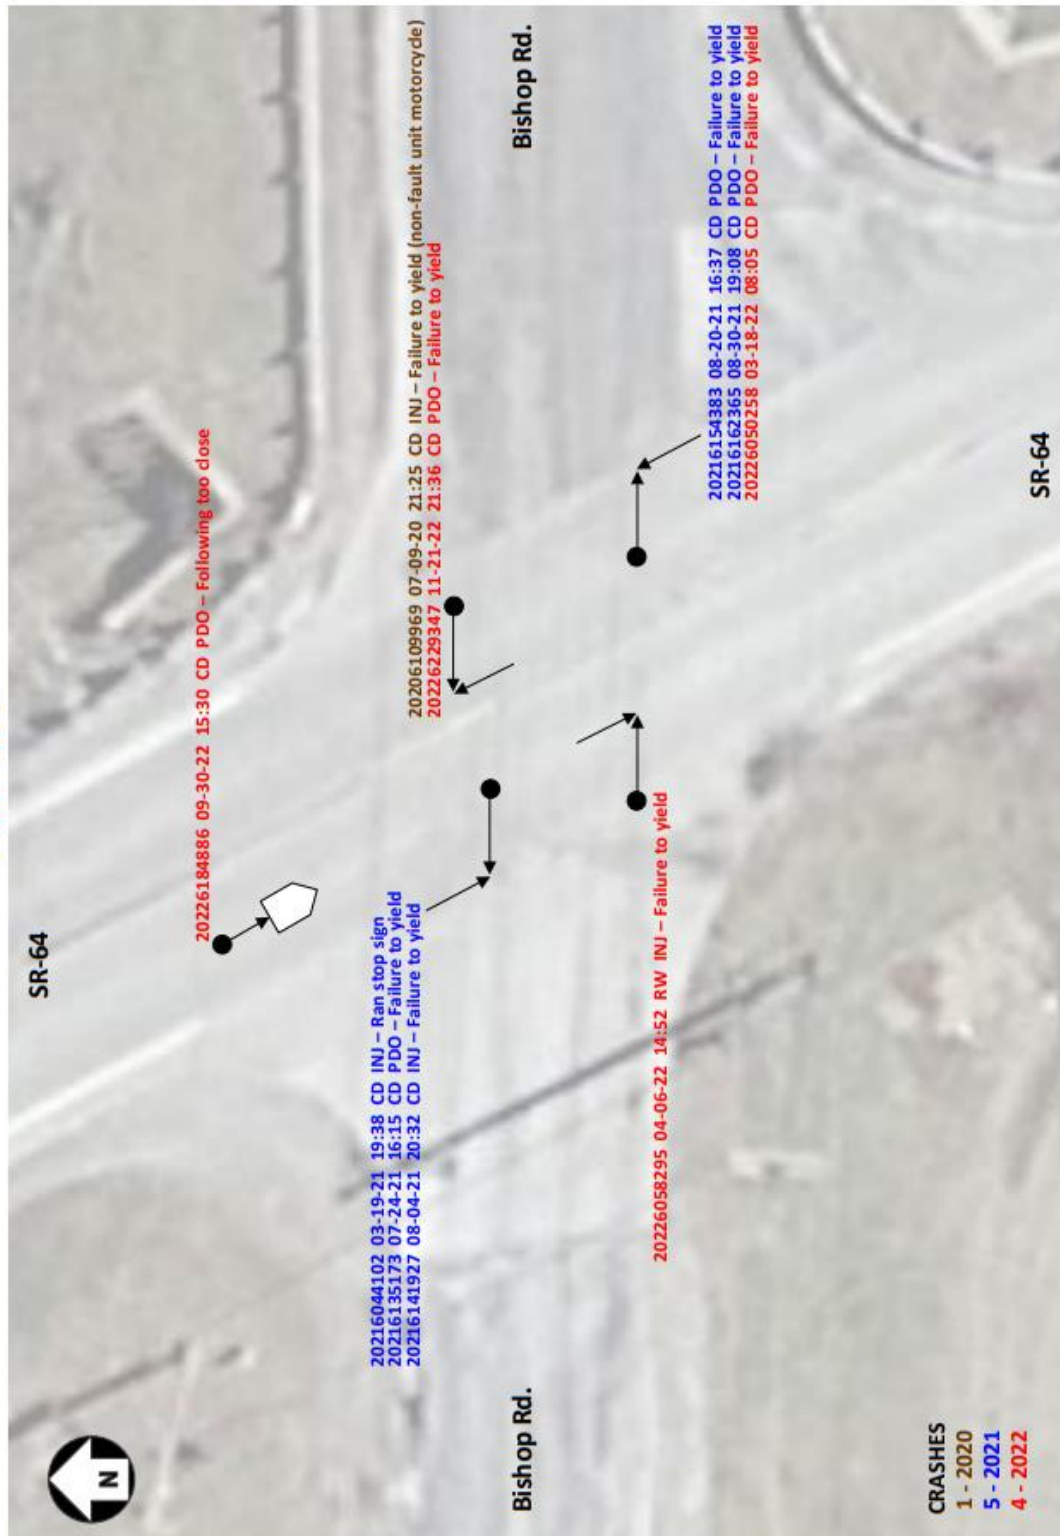
E. COLLISION DIAGRAM

WOO-64-5.40
2020-2022

The majority of crashes are angle crashes. These may be attributed to a mix of the intersection skew, sight distance constraints, and traffic delay. Each of these factors are described in further detail below.

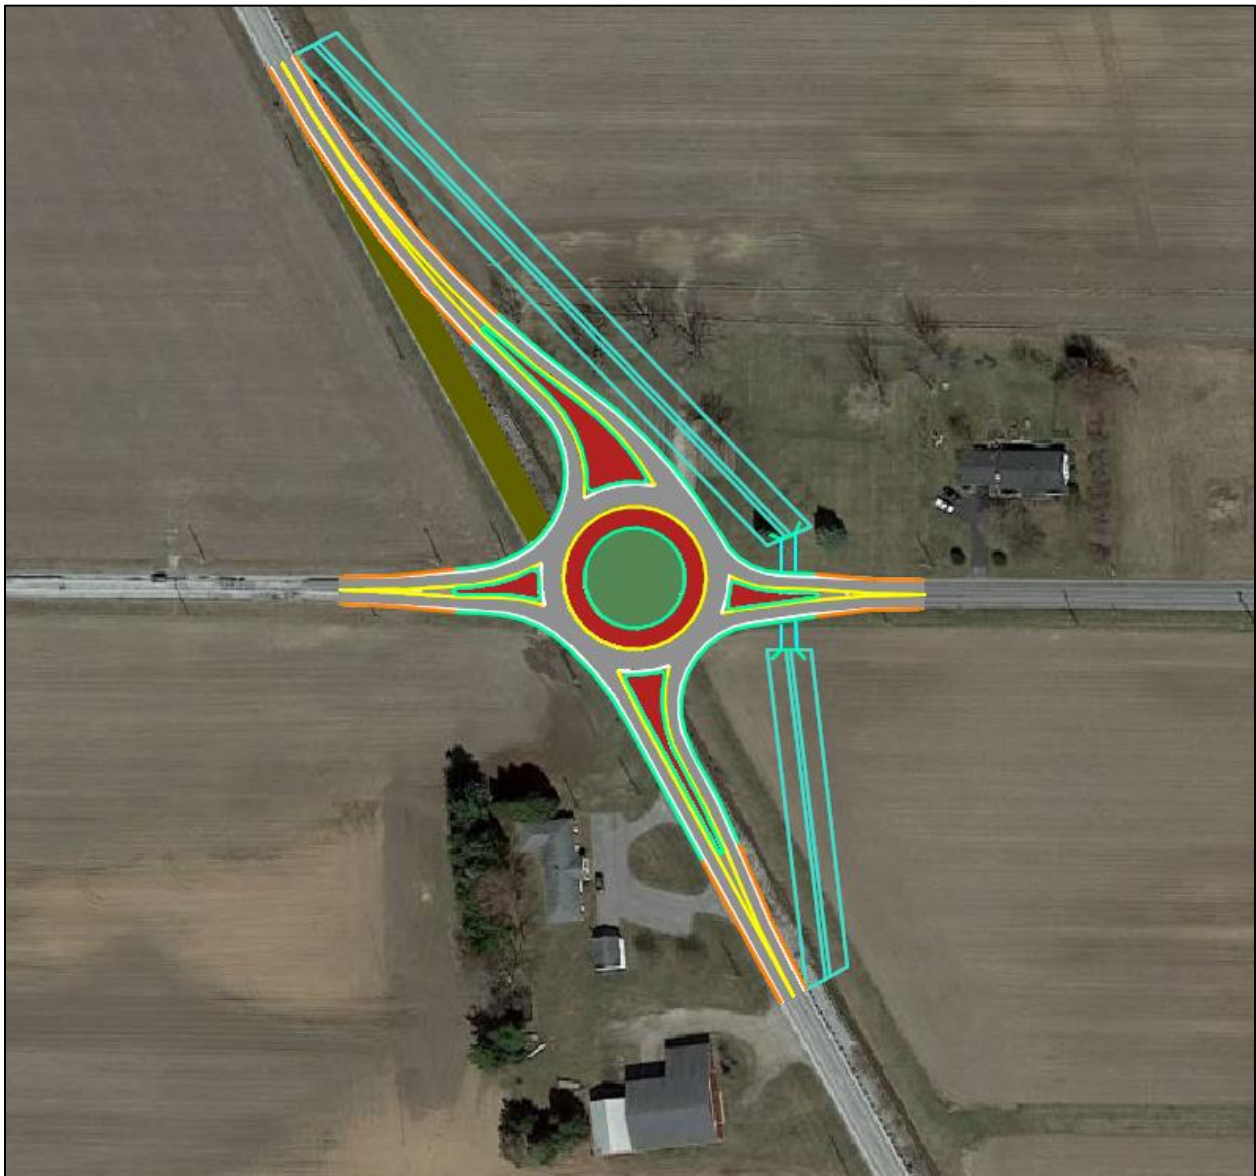
Conceptual drawing of Layout #1, Offset Roundabout, showing rerouted ditch to the east

Layout #1, Offset Roundabout, has the center of the roundabout shifted to the northeast to avoid impacts to the property on the south leg. It is a fairly typical layout for a single lane roundabout, with approach angles slightly under 90°. Two different options are provided for routing the ditch through the project limits. The first option reroutes the ditch east of its current alignment, with a new culvert located under the east leg of Bishop Rd. The second option “snakes” the ditch more-or-less along the existing alignment of the ditch & SR-64 through a series of alternating new ditches & culverts.

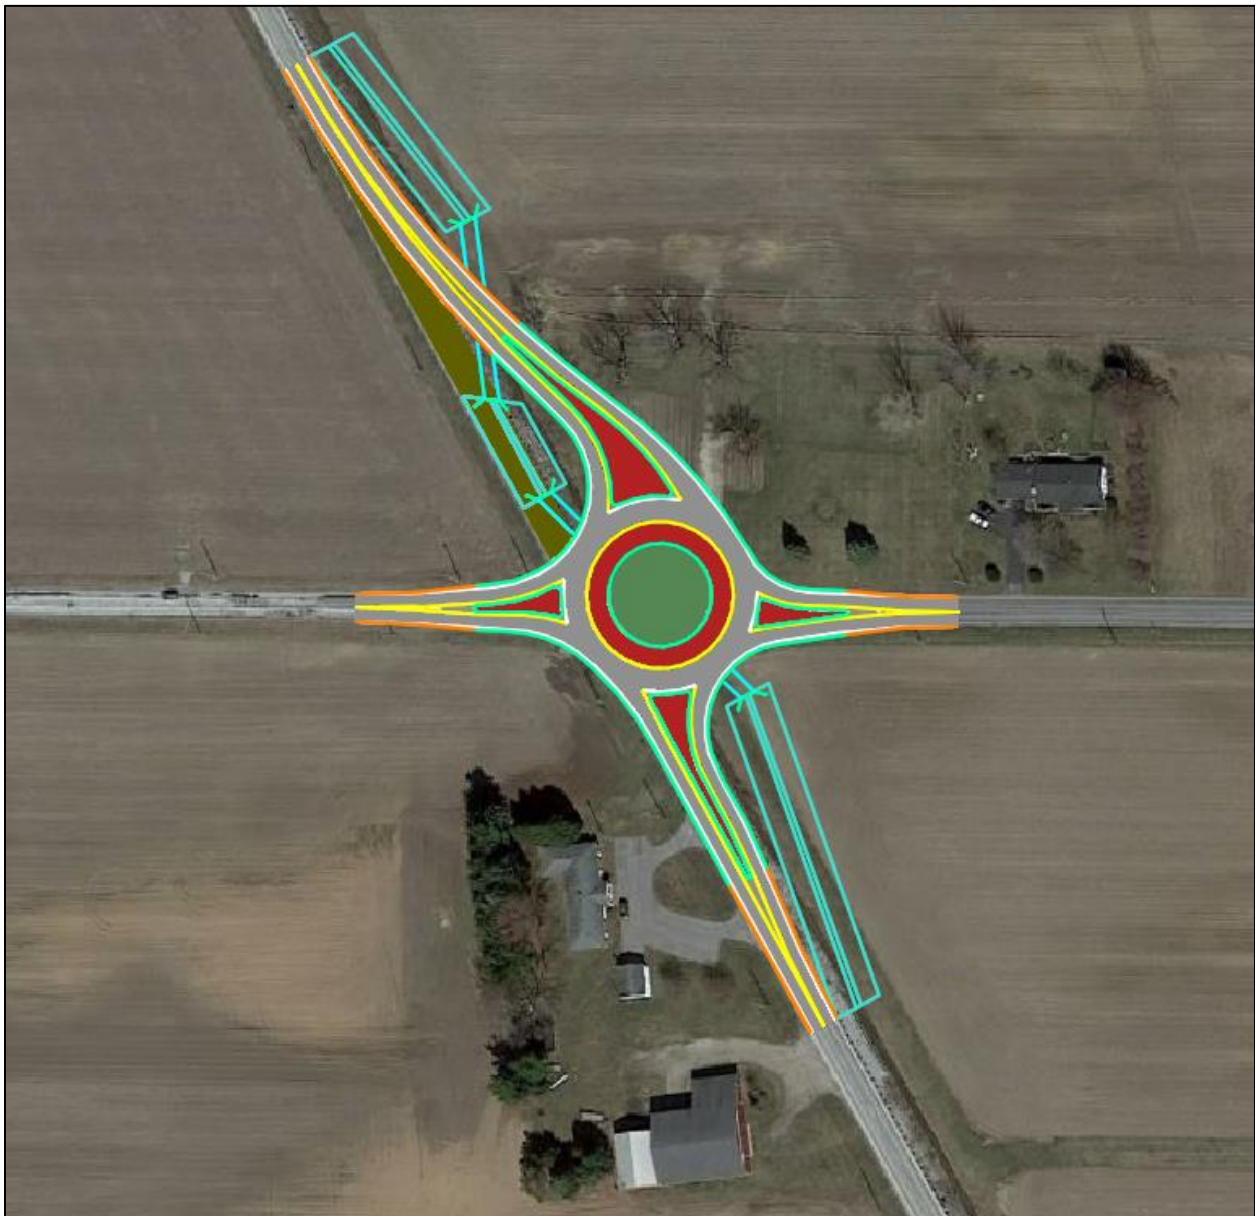
Conceptual drawing of Layout #1, Offset Roundabout, showing rereouted ditch "snaking" though middle of project limits

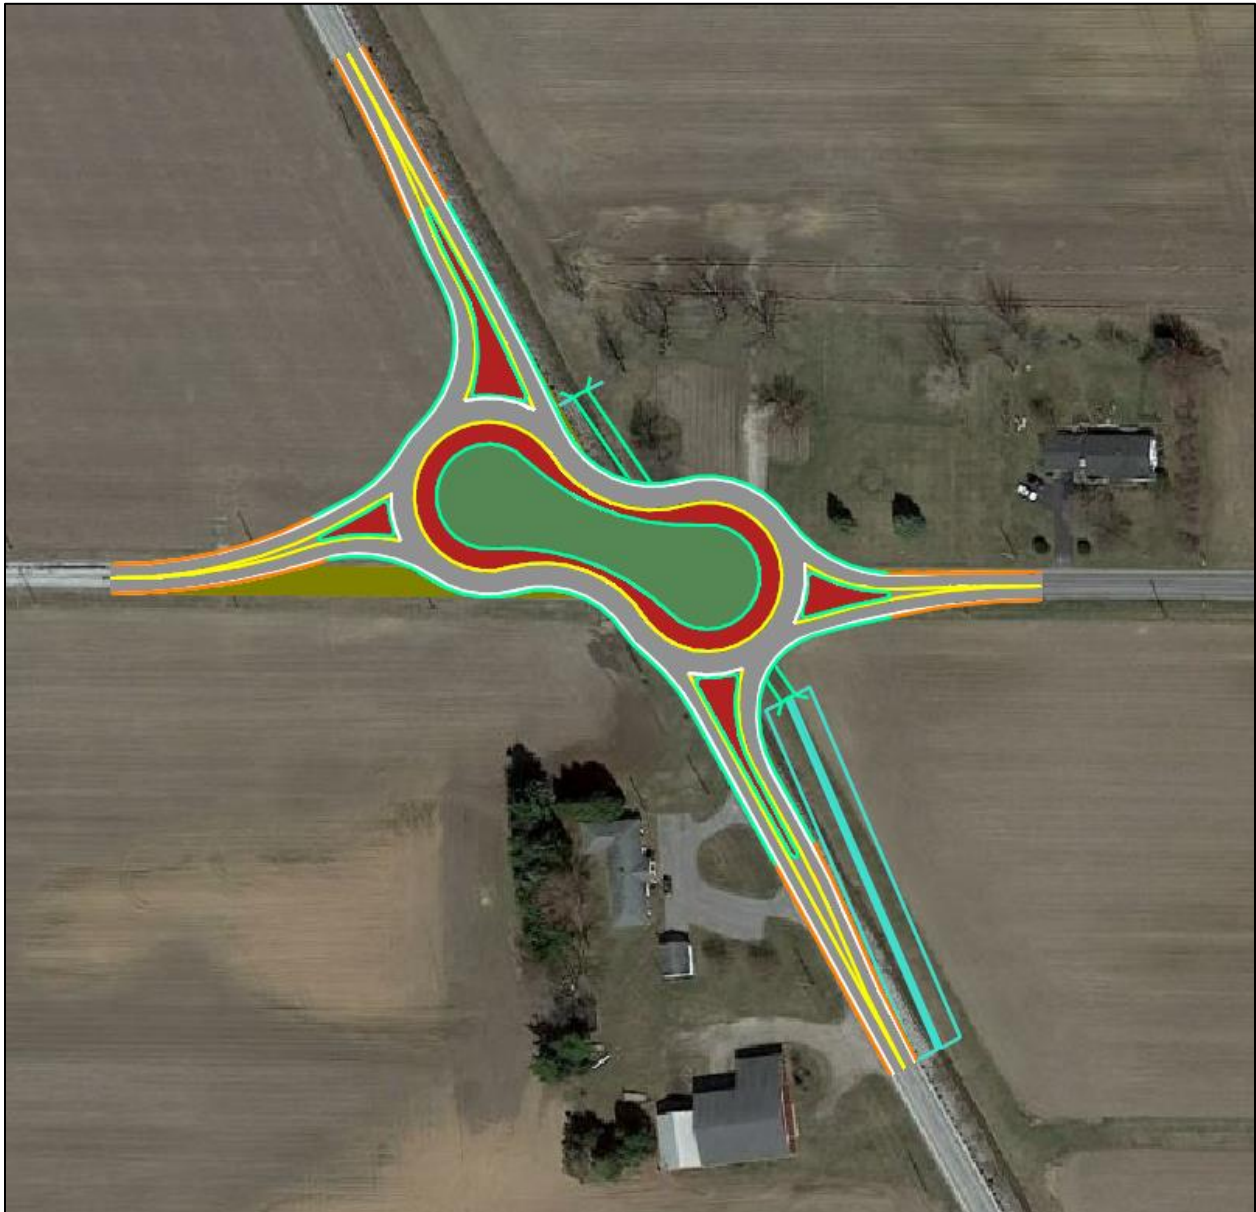
Conceptual drawing of Layout #2, Peanut Roundabout

Layout #2, Peanut Roundabout, would be an unusual layout locally, as no peanut-shaped roundabouts are found in northwest Ohio. The Peanut Roundabout has slightly wider approach angles than the Offset Roundabout. The Peanut Roundabout also lessens impacts to the ditch. A culvert is provided through the middle of the roundabout so that the ditch alignment can stay mostly intact north of Bishop Rd.

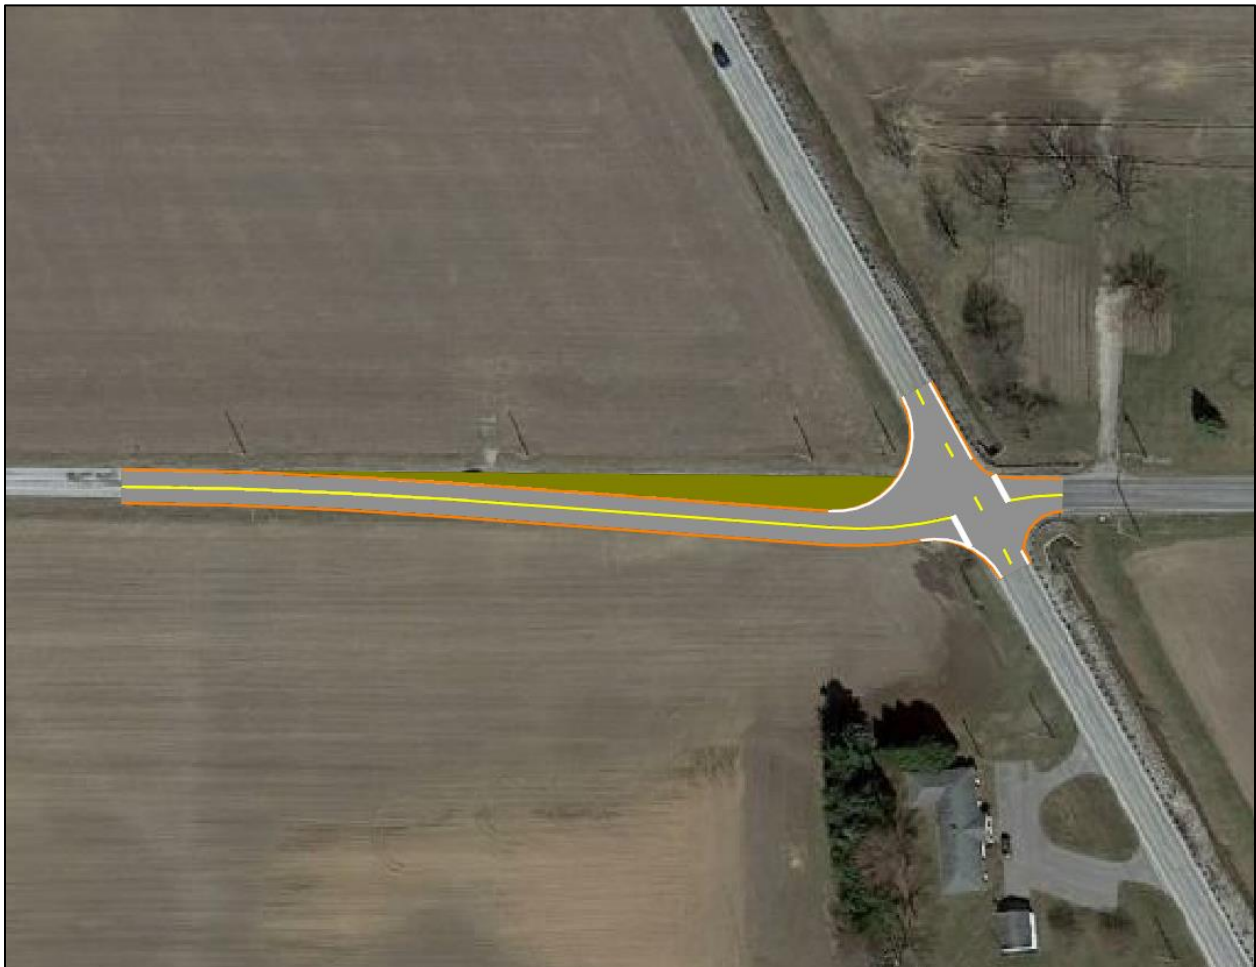
Conceptual drawing of Bishop Rd. realignment

Realigning the approaches of Bishop Rd. would address the skew angle & vehicle frame obstruction issues which are occurring with the current intersection configuration. By aligning the Bishop Rd. approaches at closer to a 90° angle with SR-64, stopped motorists should be able to see oncoming traffic more clearly & directly out of their vehicle windows. For some corners of the intersection, it would also be possible to provide wider radii to facilitate turning vehicles.

L&D Figure 401-1 was used as the primary guide for realigning Bishop Rd. according to ODOT specifications. For this countermeasure, curvature was introduced on the east leg of Bishop Rd., with the idea of this being accomplished through pavement markings and not roadway realignment to preserve the ditch & culvert. This reduced the skew angle to around 12°. Next, the west leg of Bishop Rd. was realigned directly across from the east leg and at the same skew angle. Wider corner radii were provided on the west side of SR-64.

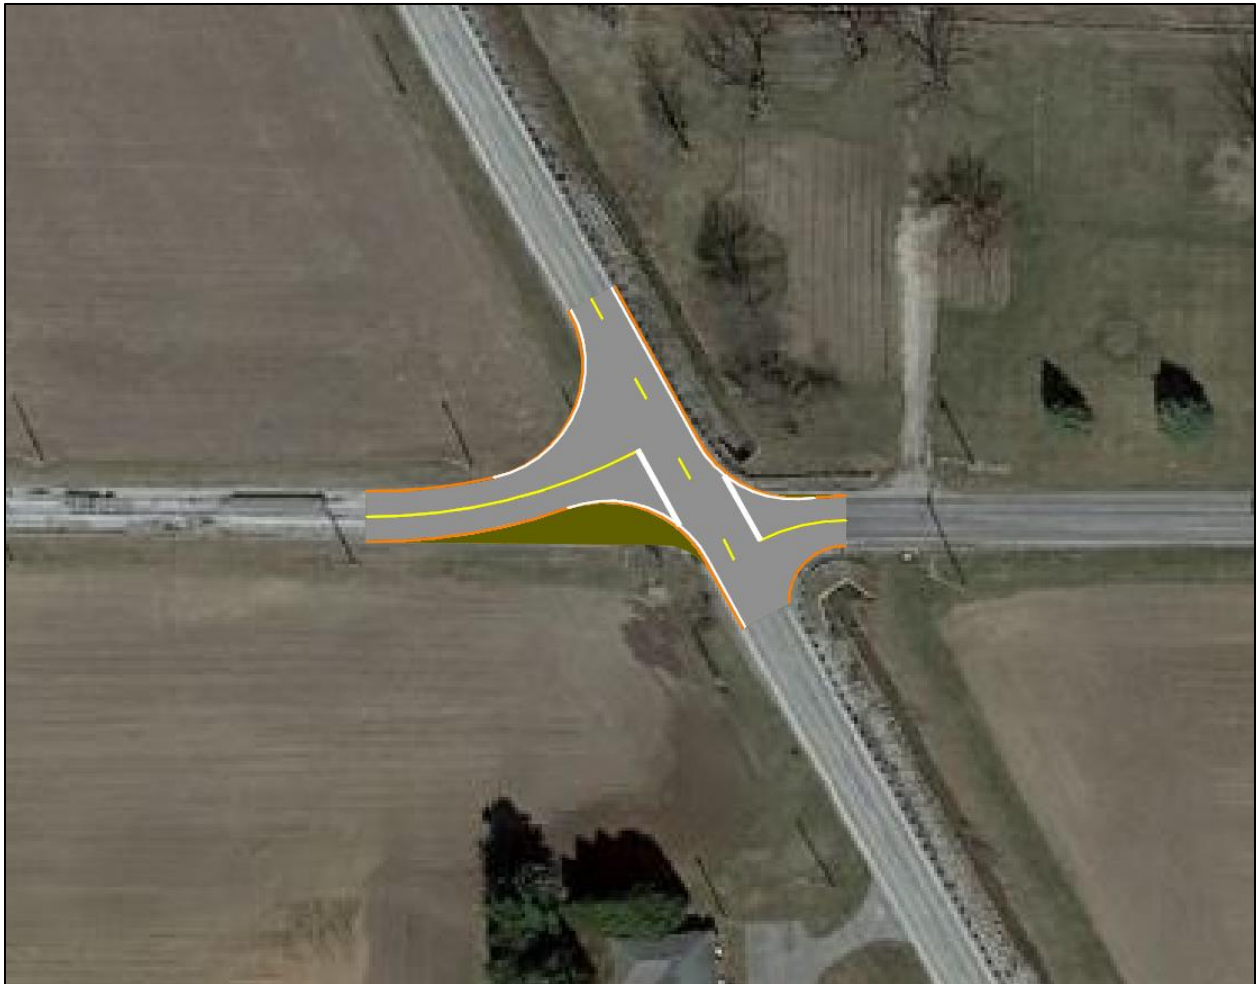
Conceptual drawing of offset intersection countermeasure

For this countermeasure, the alignment of the east leg of Bishop Rd. remained the same as with the Bishop Rd. realignment. However, the west leg of Bishop Rd. was realigned to the north to create an offset intersection. The west leg of Bishop Rd. was able to be realigned perpendicular to SR-64. Wider corner radii were also provided on the west side of SR-64. This option significantly reduces the limits of the impacted roadway.

While it becomes more difficult for Bishop Rd. through traffic to cross SR-64, safety benefits are associated with creating this more complex crossing maneuver. If an angle crash were to occur, it is less likely that both vehicles would be perpendicular to one another, reducing the overall potential severity. Having the west leg of Bishop Rd. align at a right angle with SR-64 also reduces the intersection skew CMF and enhances the intersection sight distance.

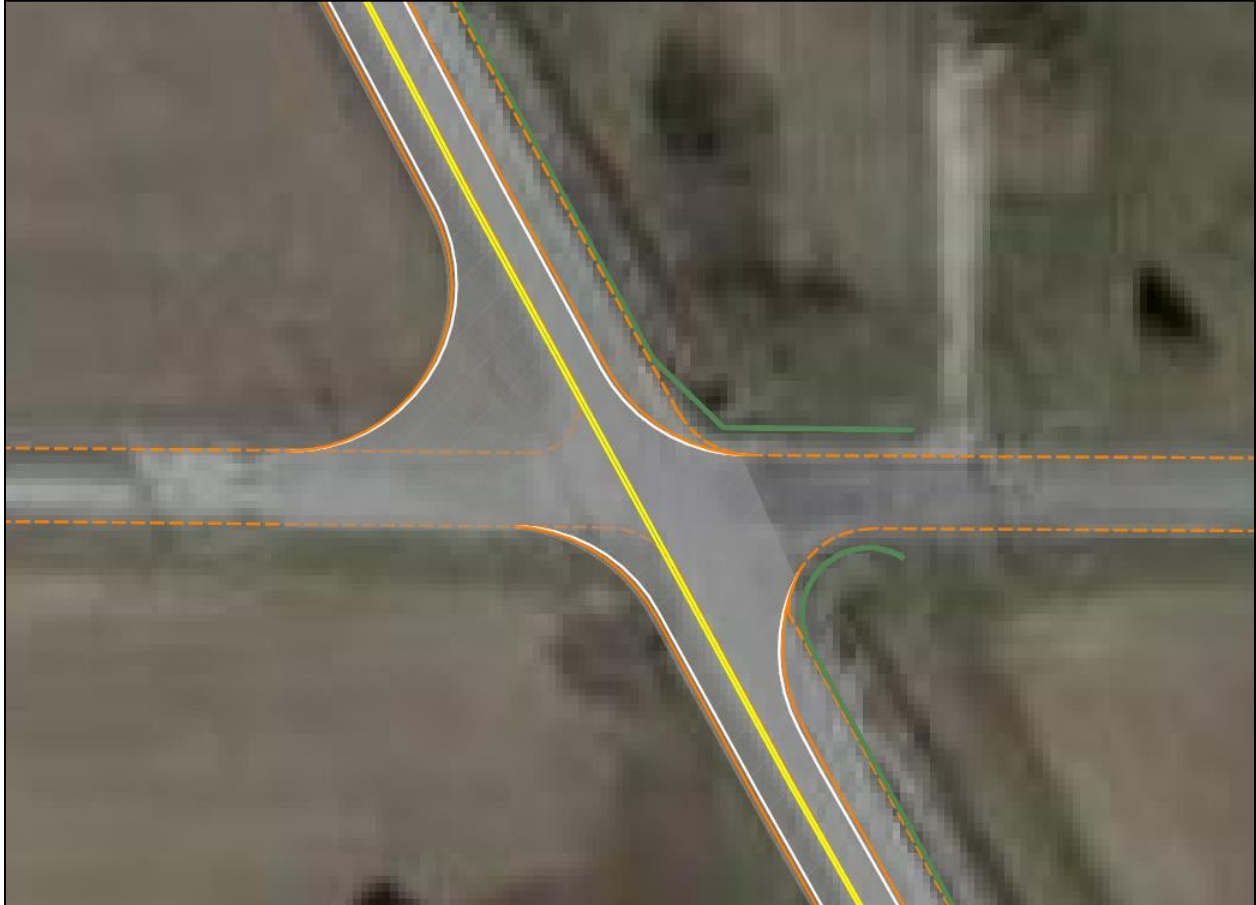
Close-up of conceptual drawing of SR-64 realignment. The new alignment is shown in solid lines and shaded in gray. The current roadway is shown with orange dashed lines. The guardrail runs are shown with green lines.

It is possible to shift SR-64 slightly to the west so that traffic on the east leg of Bishop Rd. stops past the line of guardrail. With the guardrail no longer obstructing the view of oncoming traffic, the overall sight distance would increase substantially.

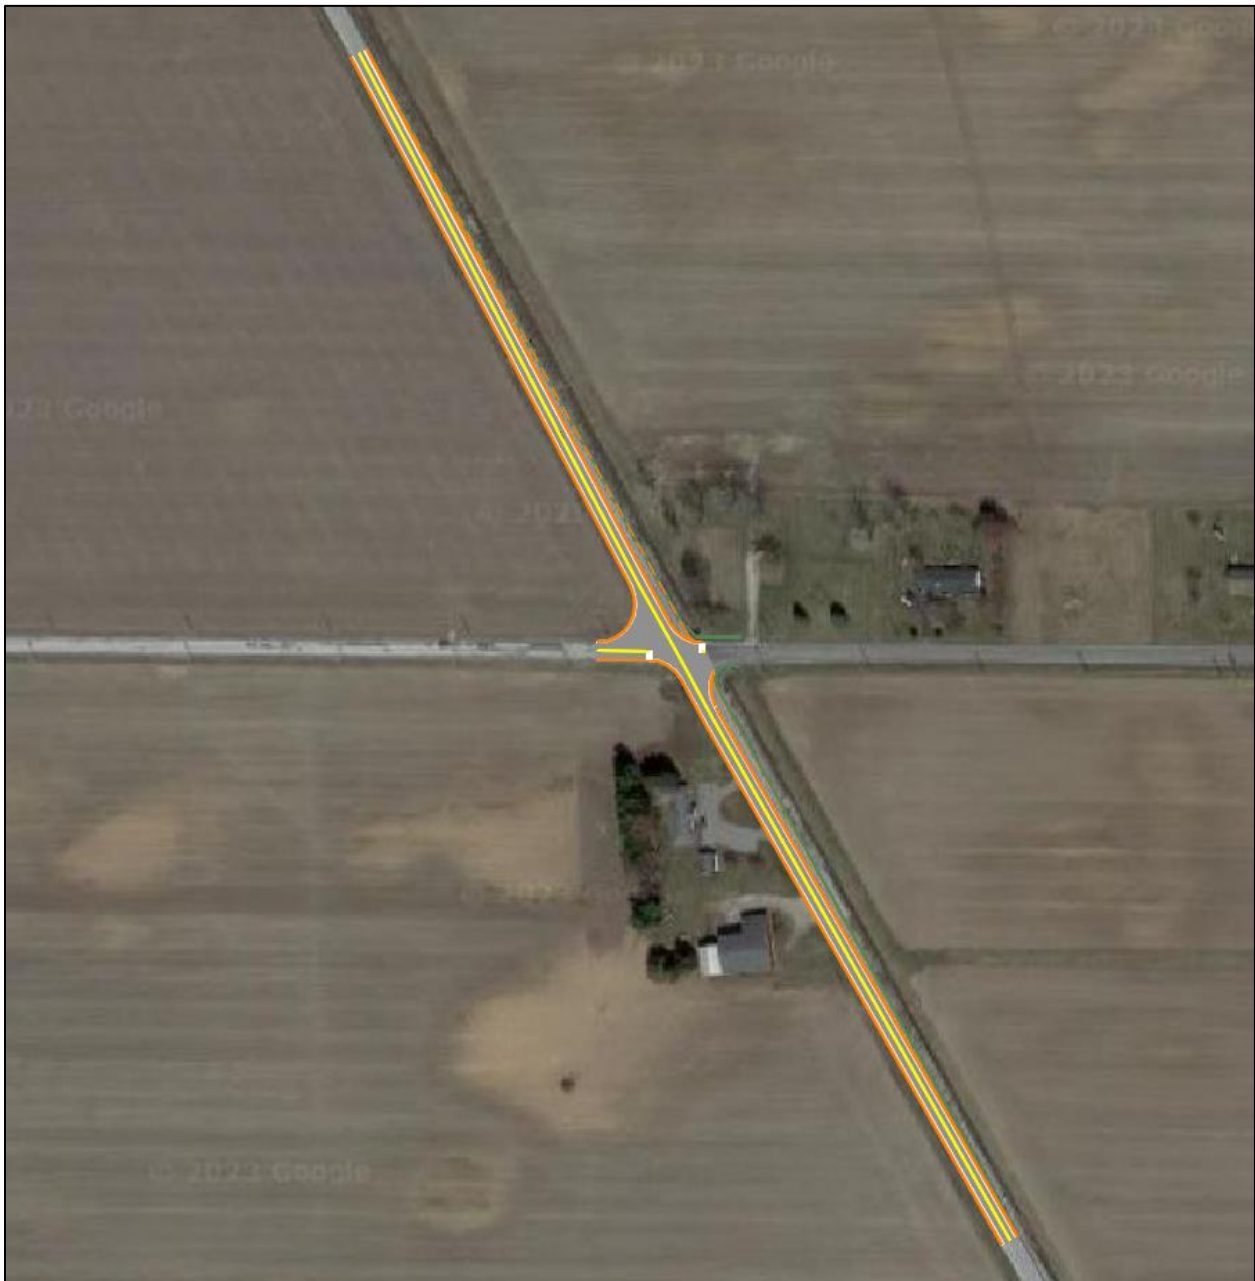
Zoomed-out conceptual drawing of SR-64 realignment, showing approximate project limits.

Besides improved sight distance, shifting SR-64 west has the added benefits of increasing the radii on all corners of the intersection to facilitate turning vehicles, and creates separation from the guardrail, allowing for more forgiveness with drivers who may inadvertently veer off the road.

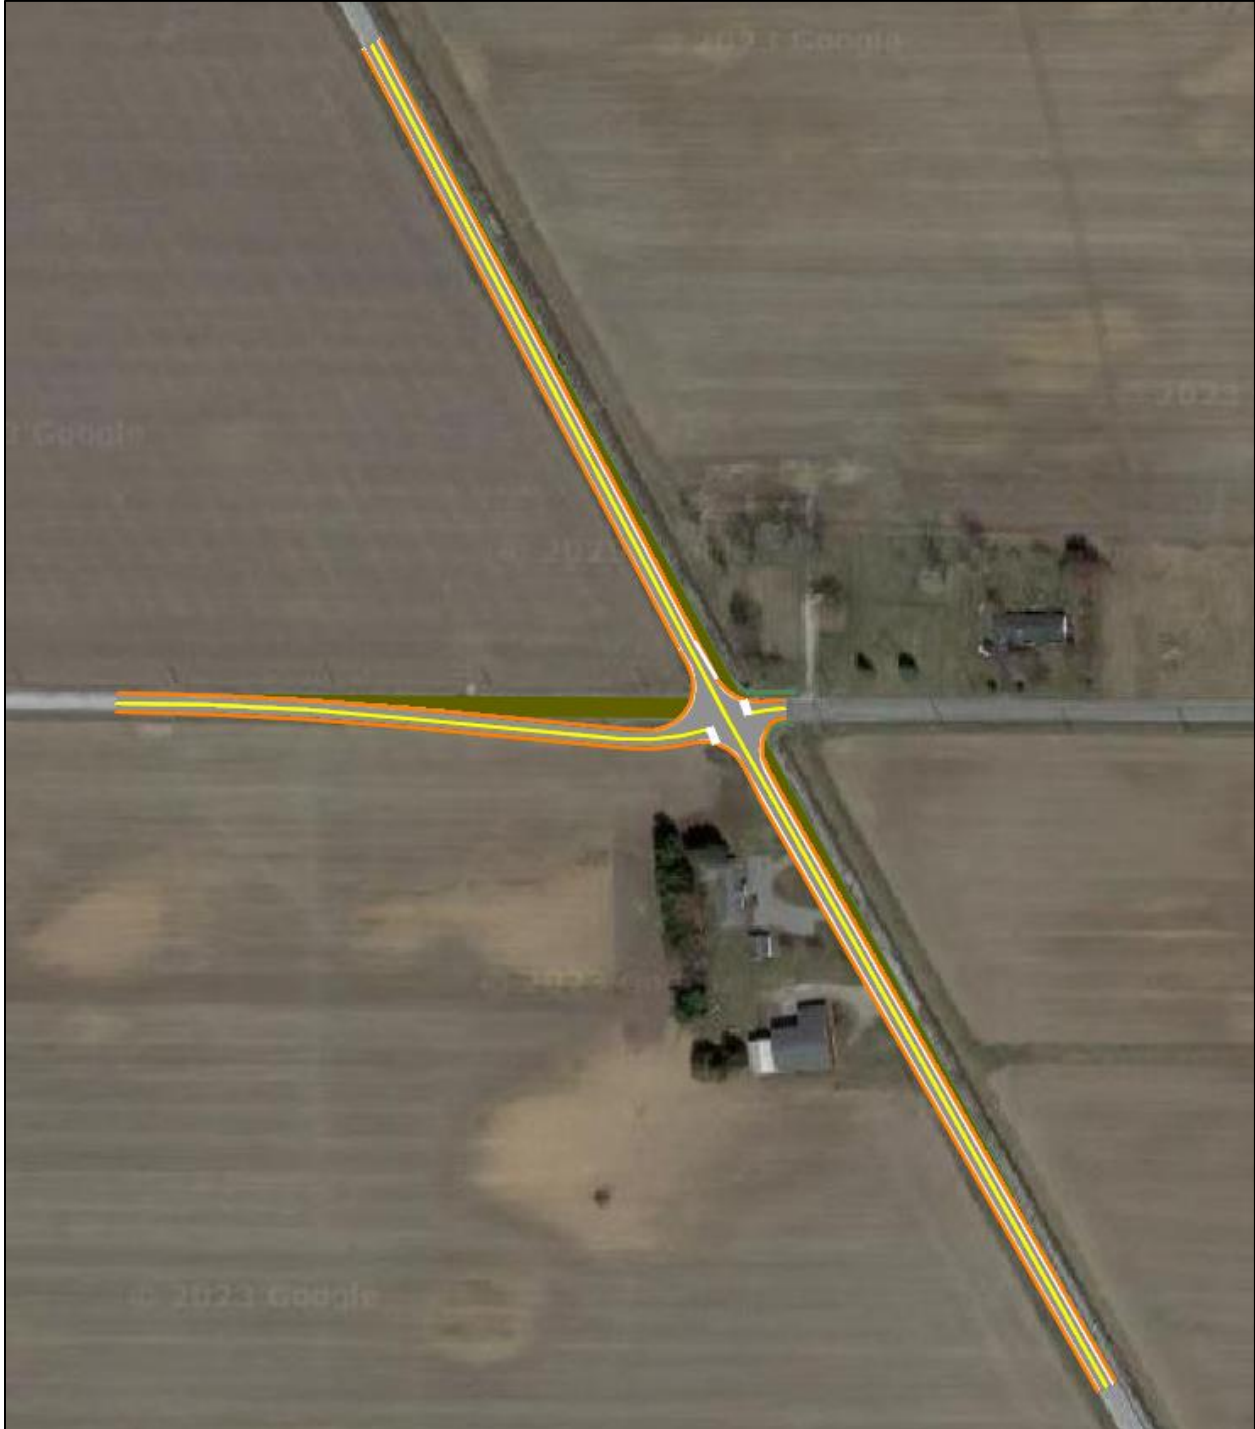
Conceptual drawing showing realignment of both SR-64 and Bishop Rd.

The realignment of SR-64 can also be combined with the realignment of Bishop Rd. In this instance, the shifting of SR-64 to the west also allows for the east leg of Bishop Rd. to be curved greater to align with SR-64 more perpendicular. For the conceptual below, the skew angle has been reduced to around 8°.

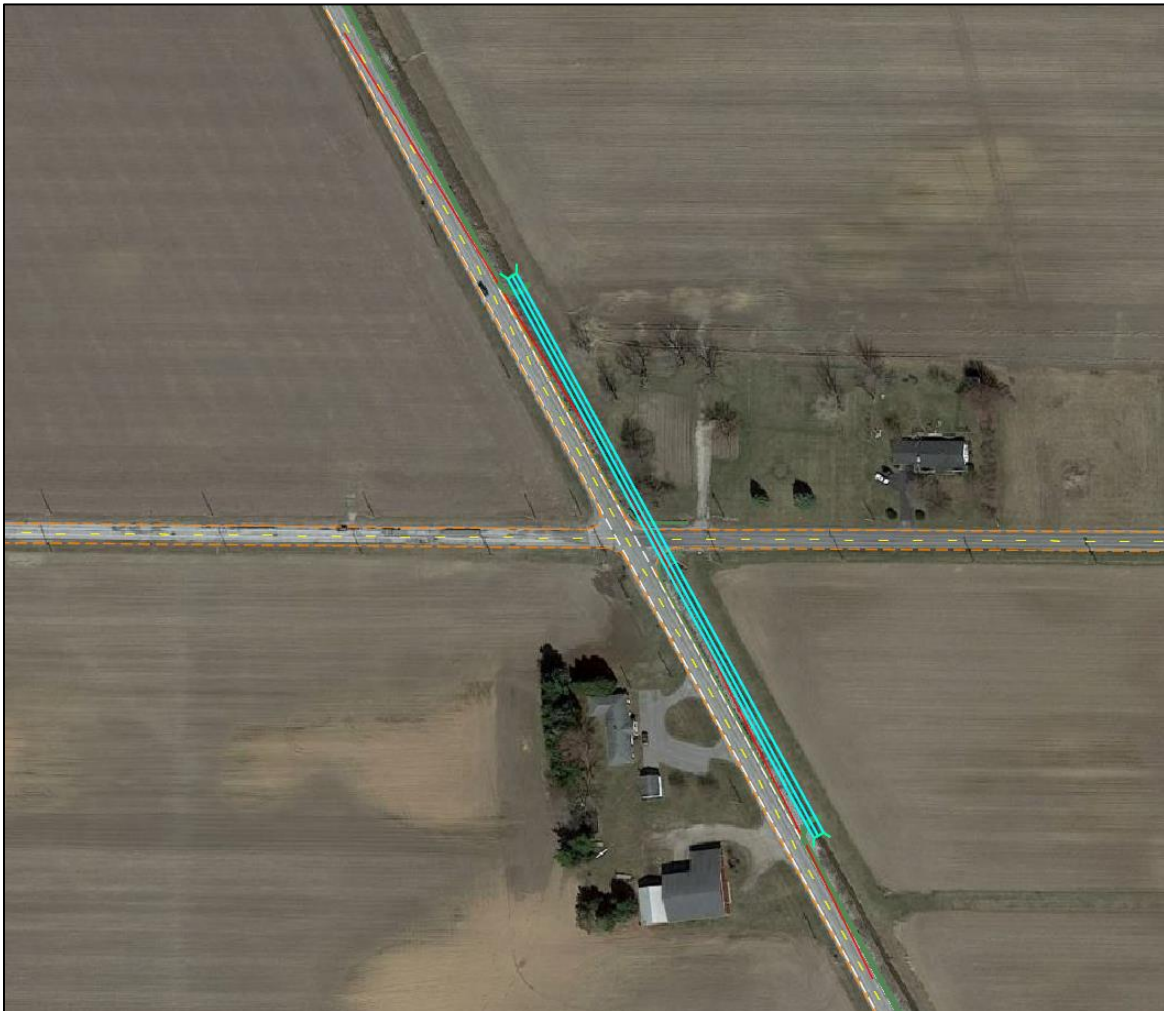
Conceptual of ditch enclosure option. The culvert extension is represented by the light blue lines. The new guardrail alignment is shown with green lines. The necessary sight distance lines are shown in red.

Another option to increase the sight distance is by filling-in the ditch and shortening the guardrail runs to the point necessary to create sufficient intersection sight distance per current L&D standards. The total length of the necessary ditch enclosure to achieve sufficient intersection sight distance is estimated to be about 740 feet. The roadway alignments would stay intact. The culvert would either need to be extended or replaced, depending on what is deemed most practical based on constructability & the condition/remaining life cycle of the existing culvert. There would also likely be environmental concerns which would need to be addressed since the ditch would be impacted.
