UNDERWATER BRIDGE INSPECTION REPORT

STRUCTURE NO. 3502392 (HEN-109-1820)
SR 109 OVER MAUMEE RIVER
HENRY COUNTY, OH
DISTRICT 2

April 2020

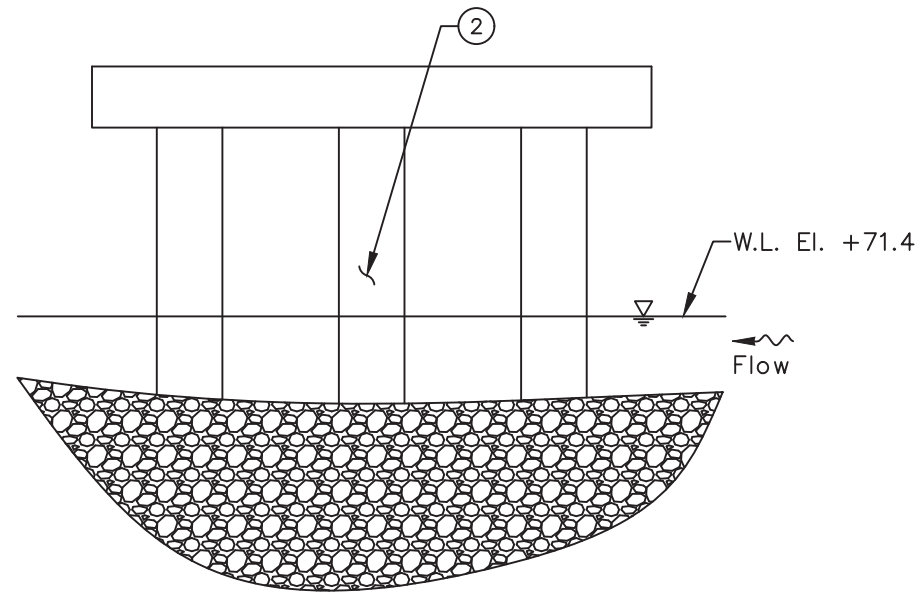
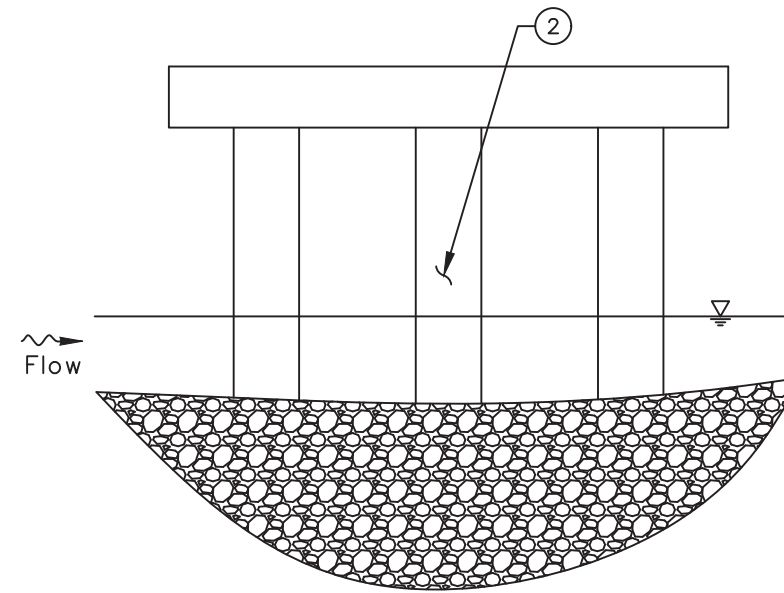
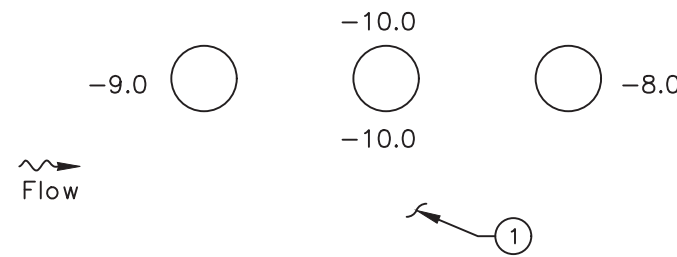
SR-109 OVER MAUMEE RIVER
 STRUCTURE NO. HEN-109-1820
 BENT 5
 HENRY COUNTY, OHIO

The channel bottom material consisted of riprap up to 18 in diameter with no probe rod penetration. The steel typically exhibited light surface corrosion with no pitting observed. One tree measuring approximately 9 in. diameter was observed on the channel bottom extending up to 6 ft from the north and south faces. Refer to Figure 11 in Exhibit 1 for detailed inspection notes of Bent 5. Refer to Photographs 17 and 18 in Exhibit 2 for views of Bent 5.

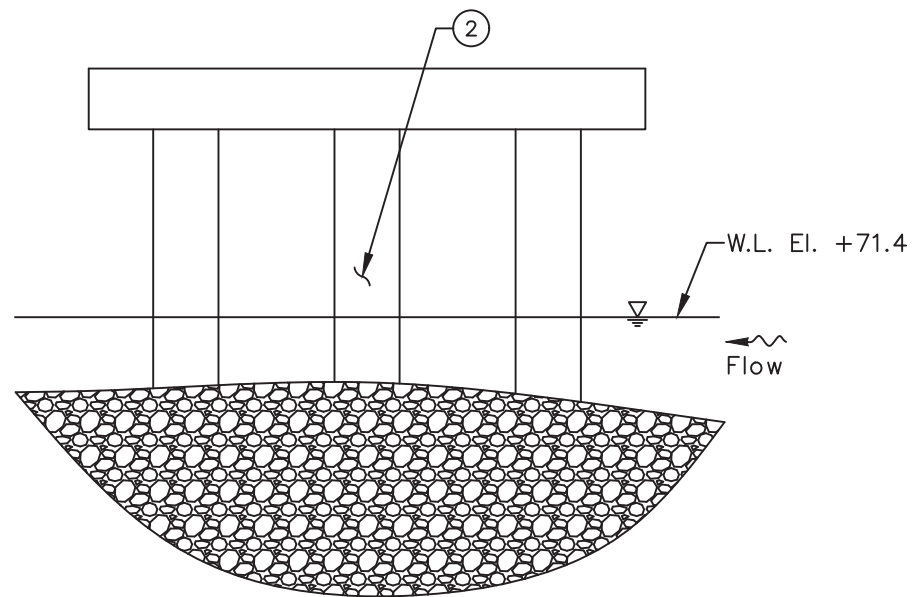
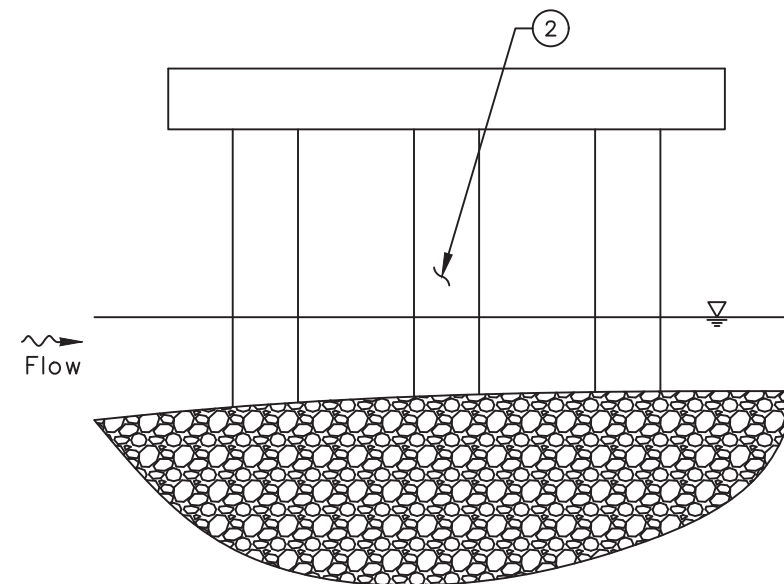
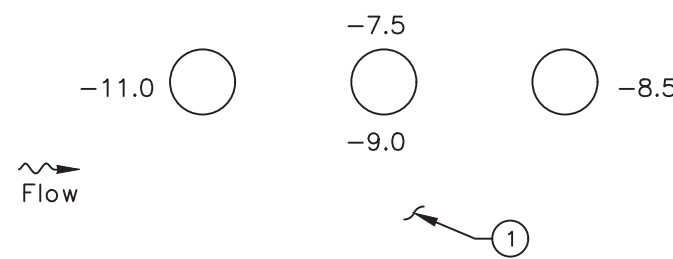
SR-109 OVER MAUMEE RIVER
STRUCTURE NO. HEN-109-1820
BENT 9
HENRY COUNTY, OHIO

The channel bottom material consisted of riprap up to 18 in. diameter with no probe rod penetration. The steel typically exhibited light surface corrosion with no pitting observed. Refer to Figure 15 in Exhibit 1 for detailed inspection notes of Bent 9. Refer to Photographs 25 and 26 in Exhibit 2 for views of Bent 9.

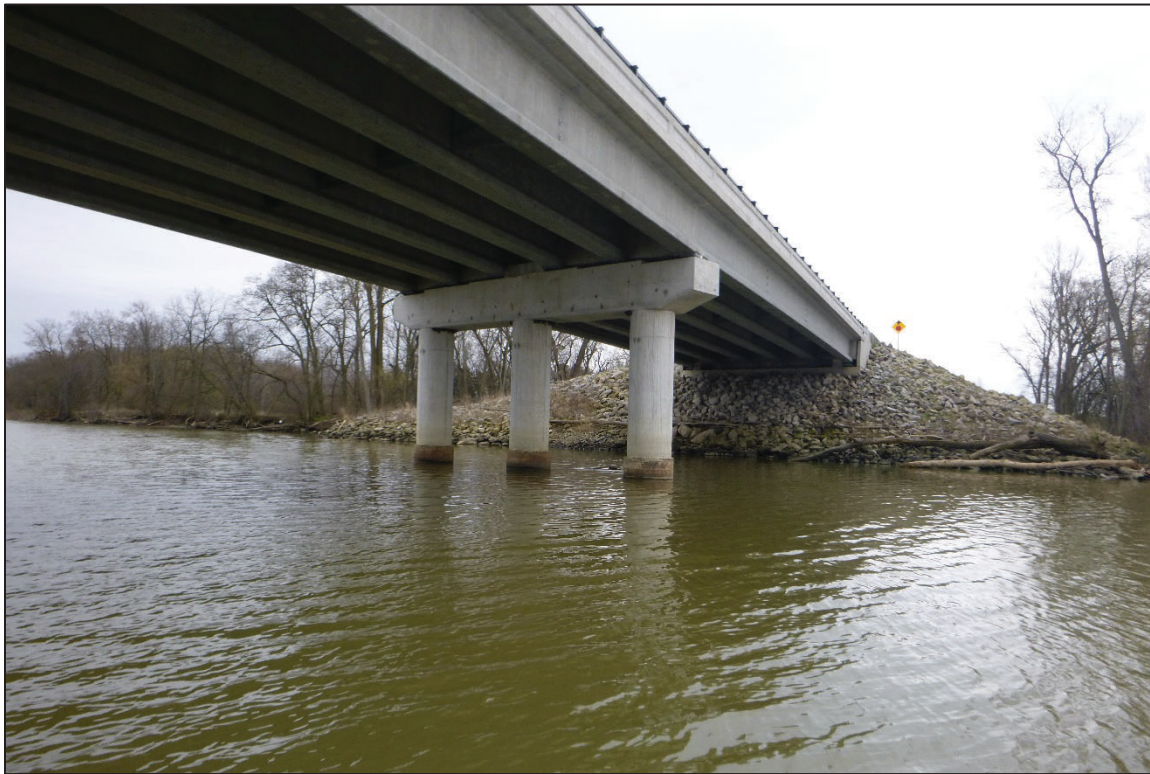
Photograph No. 9: View of the North Face of Bent 1, Looking Southeast.

The channel bottom material consisted of riprap up to 18 in. diameter with no probe rod penetration. The steel typically exhibited light surface corrosion with no pitting observed. Refer to Figure 7 in Exhibit 1 for detailed inspection notes of Bent 1. Refer to Photographs 9 and 10 in Exhibit 2 for views of Bent 1.

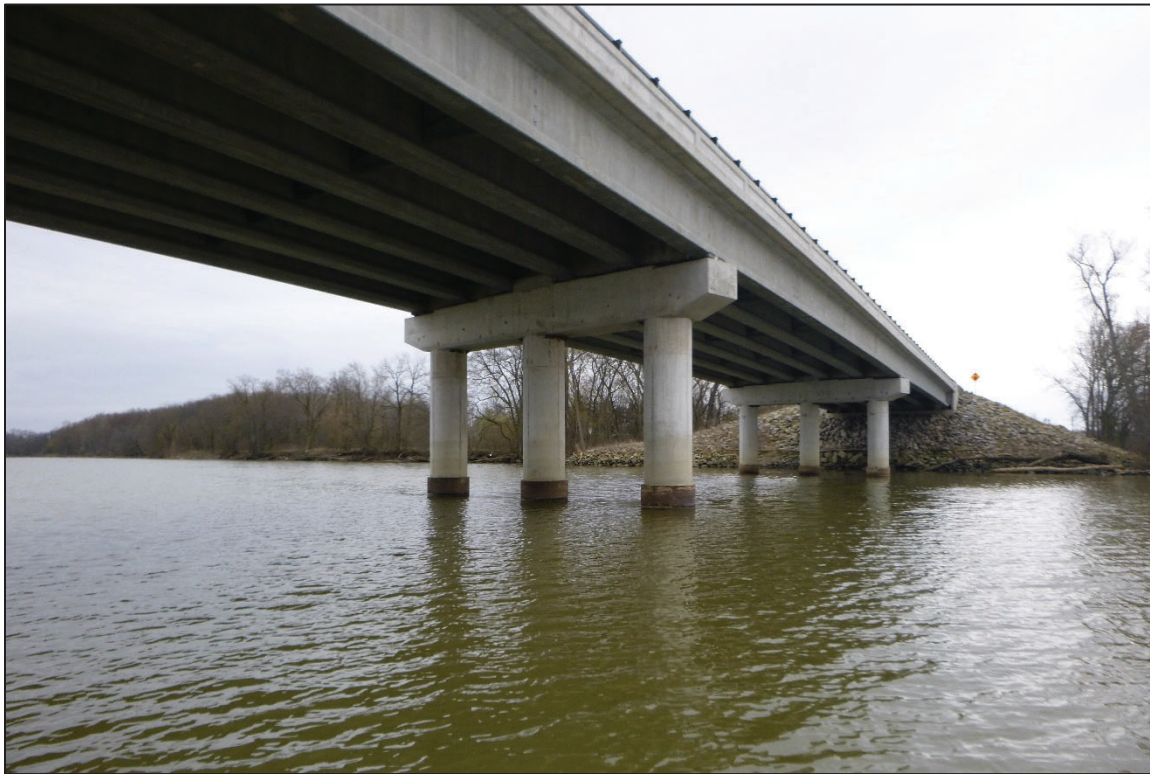
Photograph No. 11: View of the North Face of Bent 2, Looking Southeast.

The channel bottom material consisted of riprap up to 18 in. diameter with no probe rod penetration. The steel typically exhibited light surface corrosion with no pitting observed. Refer to Figure 8 in Exhibit 1 for detailed inspection notes of Bent 2. Refer to Photographs 11 and 12 in Exhibit 2 for views of Bent 2.

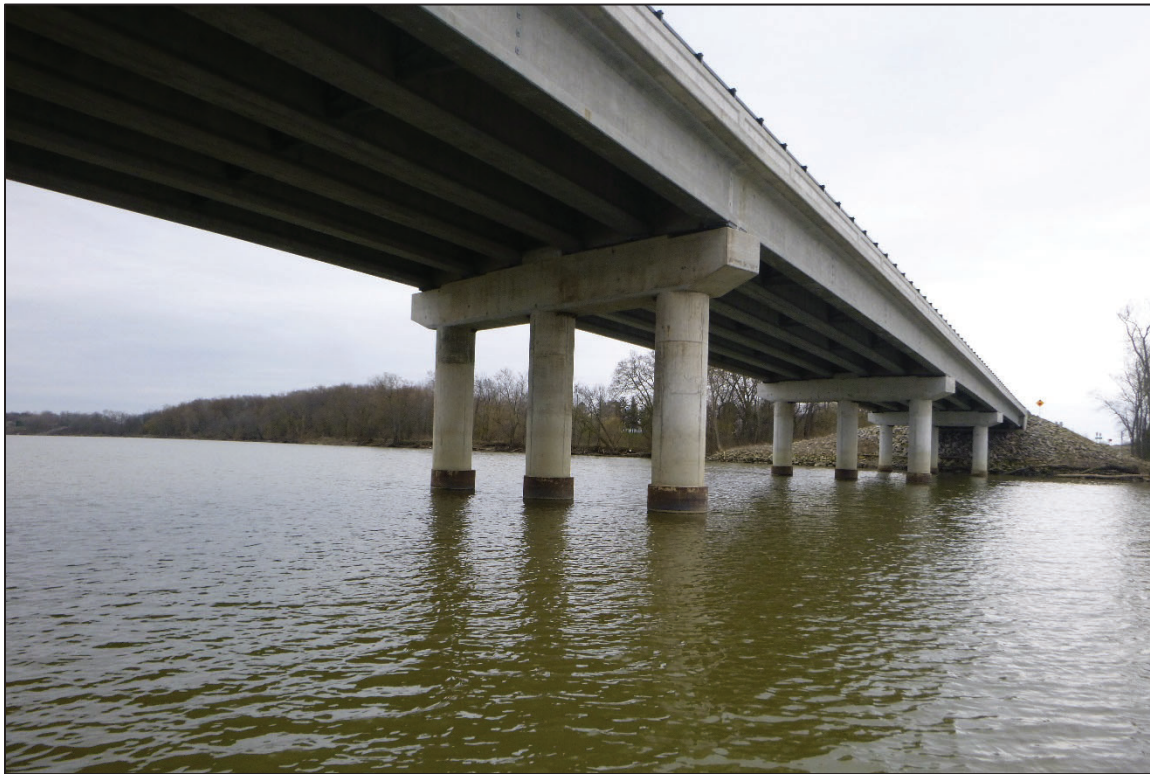
Photograph No. 13: View of the North Face of Bent 3, Looking Southeast.

The channel bottom material consisted of riprap up to 18 in. diameter with no probe rod penetration. The steel typically exhibited light surface corrosion with no pitting observed. Light timber debris, consisting of branches up to 6 in. diameter, was observed on the upstream nose extending up to a 10 ft radius off the pier. Refer to Figure 9 in Exhibit 1 for detailed inspection notes of Bent 3. Refer to Photographs 13 and 14 in Exhibit 2 for views of Bent 3.

- Monitor timber debris accumulation at Piers 3, 5, and 7.
- Monitor steel condition at the waterline.

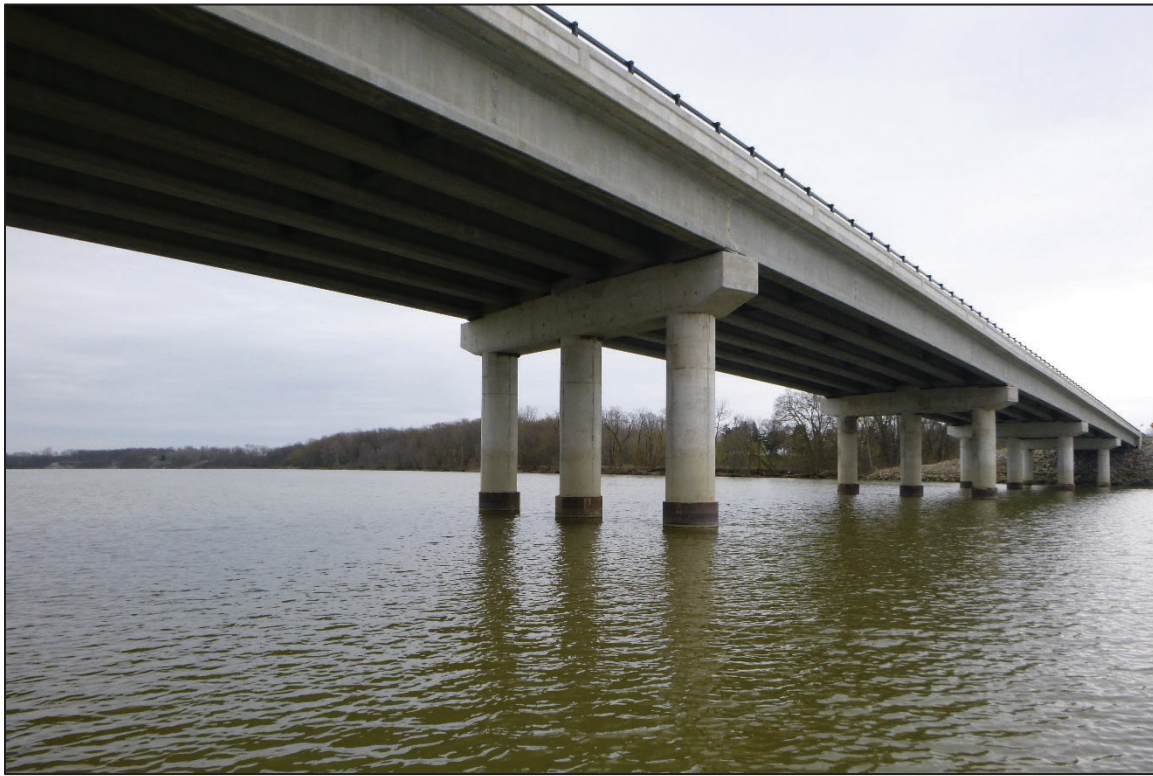
Photograph No. 15: View of the North Face of Bent 4, Looking Southeast.

The channel bottom material consisted of riprap up to 18 in. diameter with no probe rod penetration. The steel typically exhibited light surface corrosion with no pitting observed. Light timber debris, consisting of branches up to 4 in. diameter, was observed on the channel bottom extending from Column B to Column C. Refer to Figure 10 in Exhibit 1 for detailed inspection notes of Bent 4. Refer to Photographs 15 and 16 in Exhibit 2 for views of Bent 4.

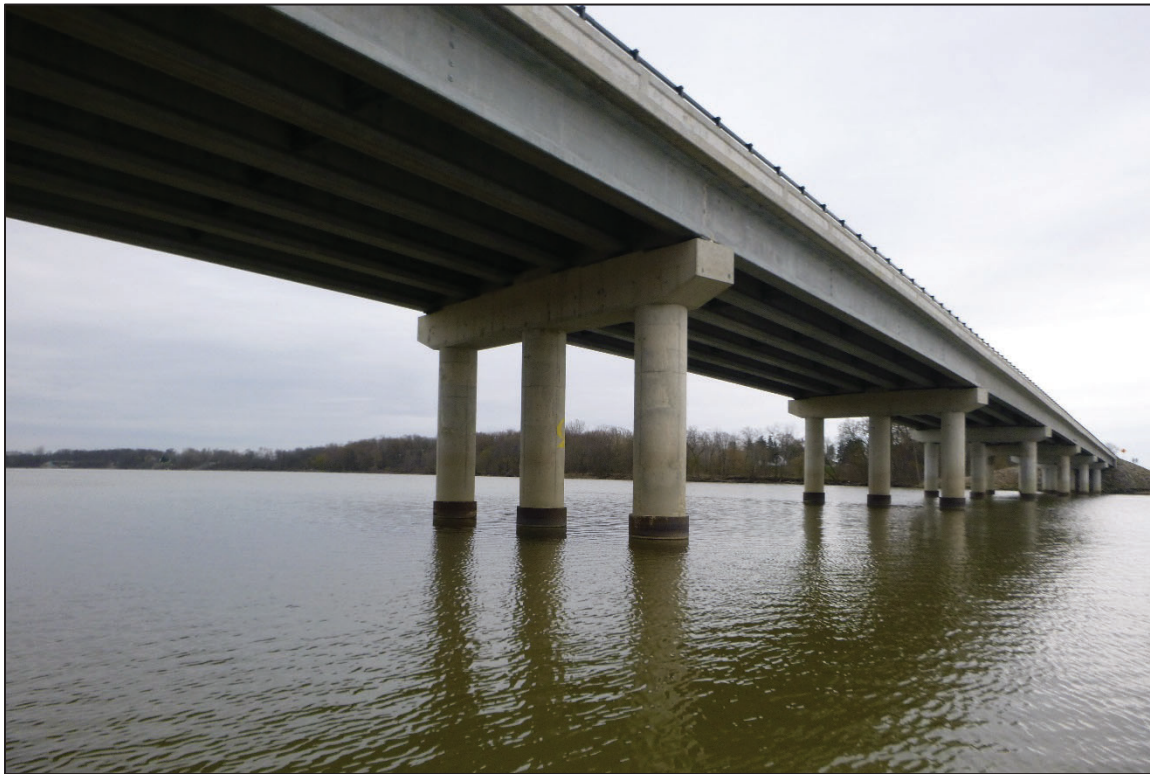
Photograph No. 19: View of the North Face of Bent 6, Looking Southeast.

The channel bottom material consisted of riprap up to 18 in. diameter with no probe rod penetration. The steel typically exhibited light surface corrosion with no pitting. Refer to Figure 12 in Exhibit 1 for detailed inspection notes of Bent 6. Refer to Photographs 19 and 20 in Exhibit 2 for views of Bent 6.

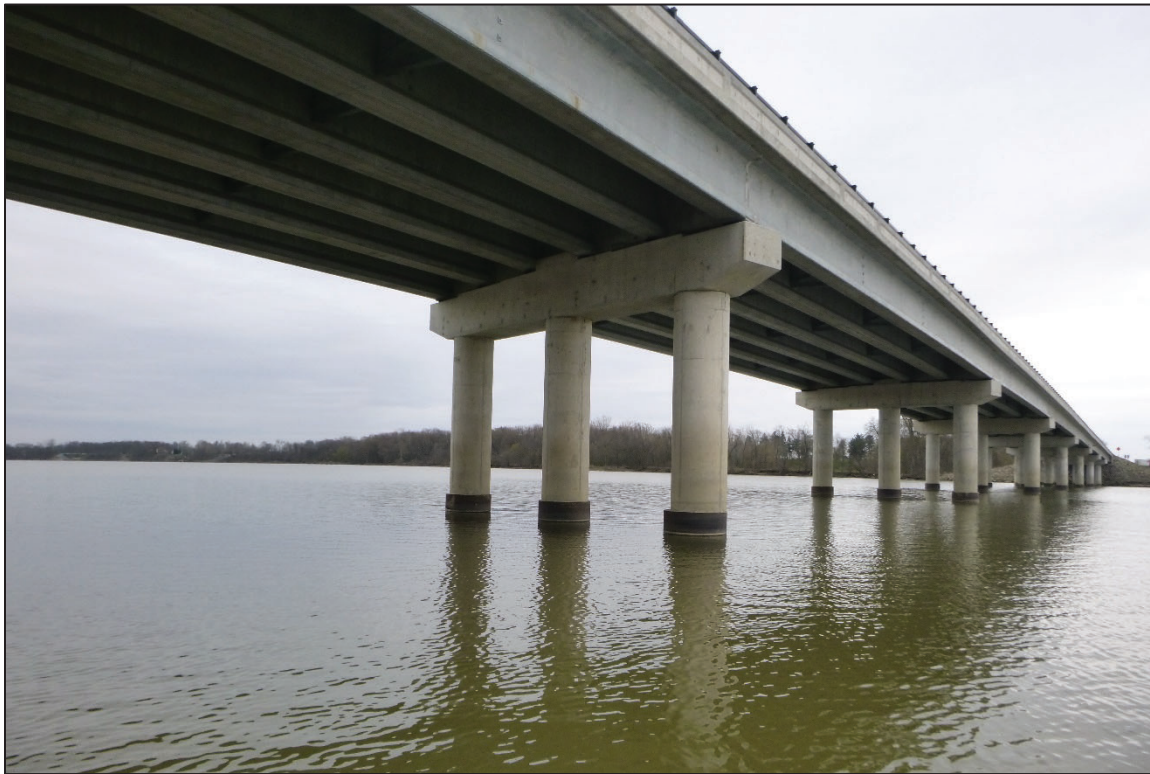
Photograph No. 21: View of the North Face of Bent 7, Looking Southeast.

The channel bottom material consisted of riprap up to 18 in. diameter with no probe rod penetration. The steel typically exhibited light surface corrosion with no pitting observed. Light timber debris, consisting of branches up to 6 in. diameter, was observed on the upstream nose extending up to a 10 ft radius off the pier. Refer to Figure 13 in Exhibit 1 for detailed inspection notes of Bent 7. Refer to Photographs 21 and 22 in Exhibit 2 for views of Bent 7.

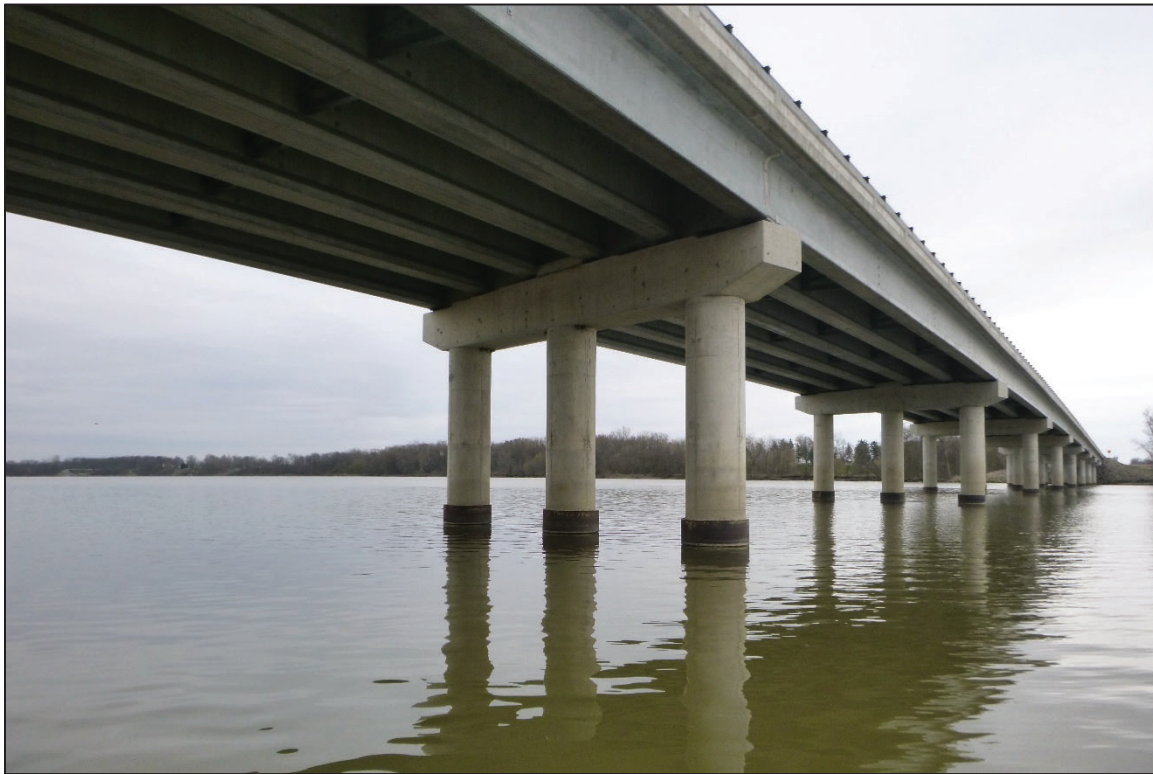
Photograph No. 23: View of the North Face of Bent 8, Looking Southeast.

The channel bottom material consisted of riprap up to 18 in. diameter with no probe rod penetration. The steel typically exhibited light surface corrosion with no pitting observed. Refer to Figure 14 in Exhibit 1 for detailed inspection notes of Bent 8. Refer to Photographs 23 and 24 in Exhibit 2 for views of Bent 8.

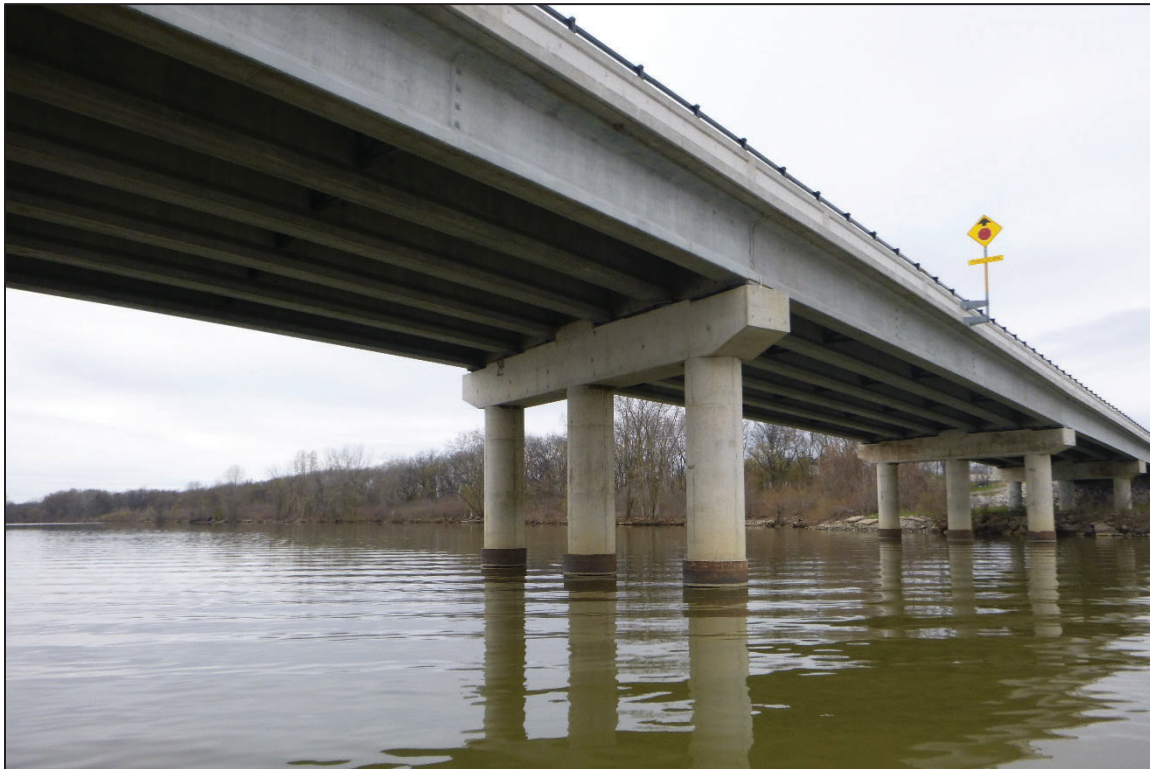
Photograph No. 26: View of the South Face of Bent 9, Looking Northwest.

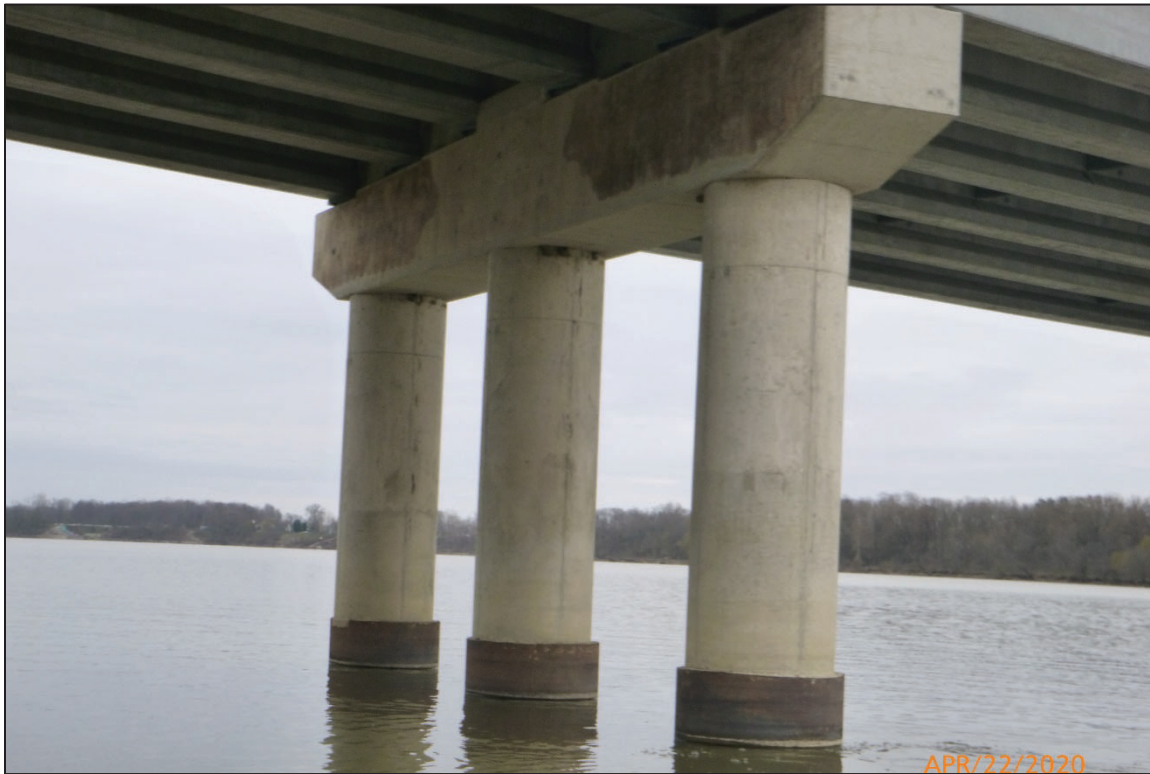
The channel bottom material consisted of riprap up to 18 in. diameter with no probe rod penetration. The steel typically exhibited light surface corrosion with no pitting observed. Refer to Figure 16 in Exhibit 1 for detailed inspection notes of Bent 10. Refer to Photographs 27 through 29 in Exhibit 2 for views of Bent 10 and typical steel condition at the waterline.

Photograph No. 27: View of the North Face of Bent 10, Looking Southeast.

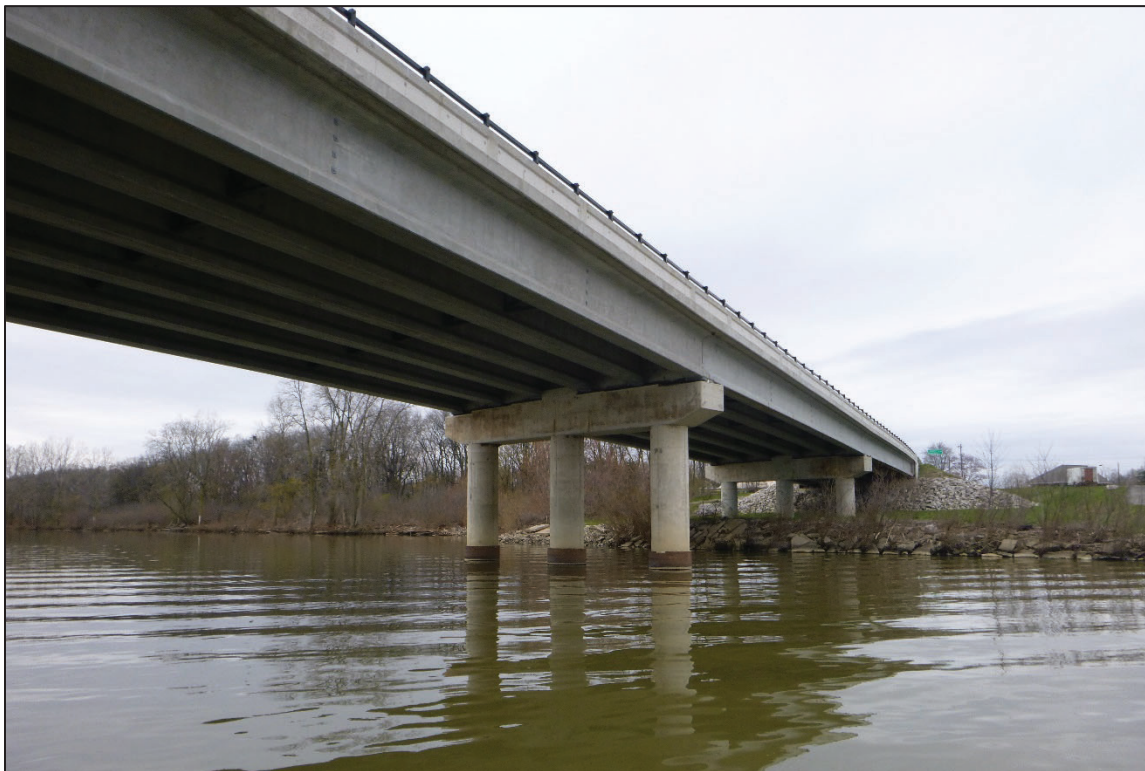
Photograph No. 28: View of the South Face of Bent 10, Looking Northwest.
