UNDERWATER BRIDGE INSPECTION REPORT

STRUCTURE NO. 4805909 (LUC-280-0346)
I-280 OVER MAUMEE RIVER
LUCAS COUNTY, OH
DISTRICT 2

May 2020

COLLINS
ENGINEERS INC.

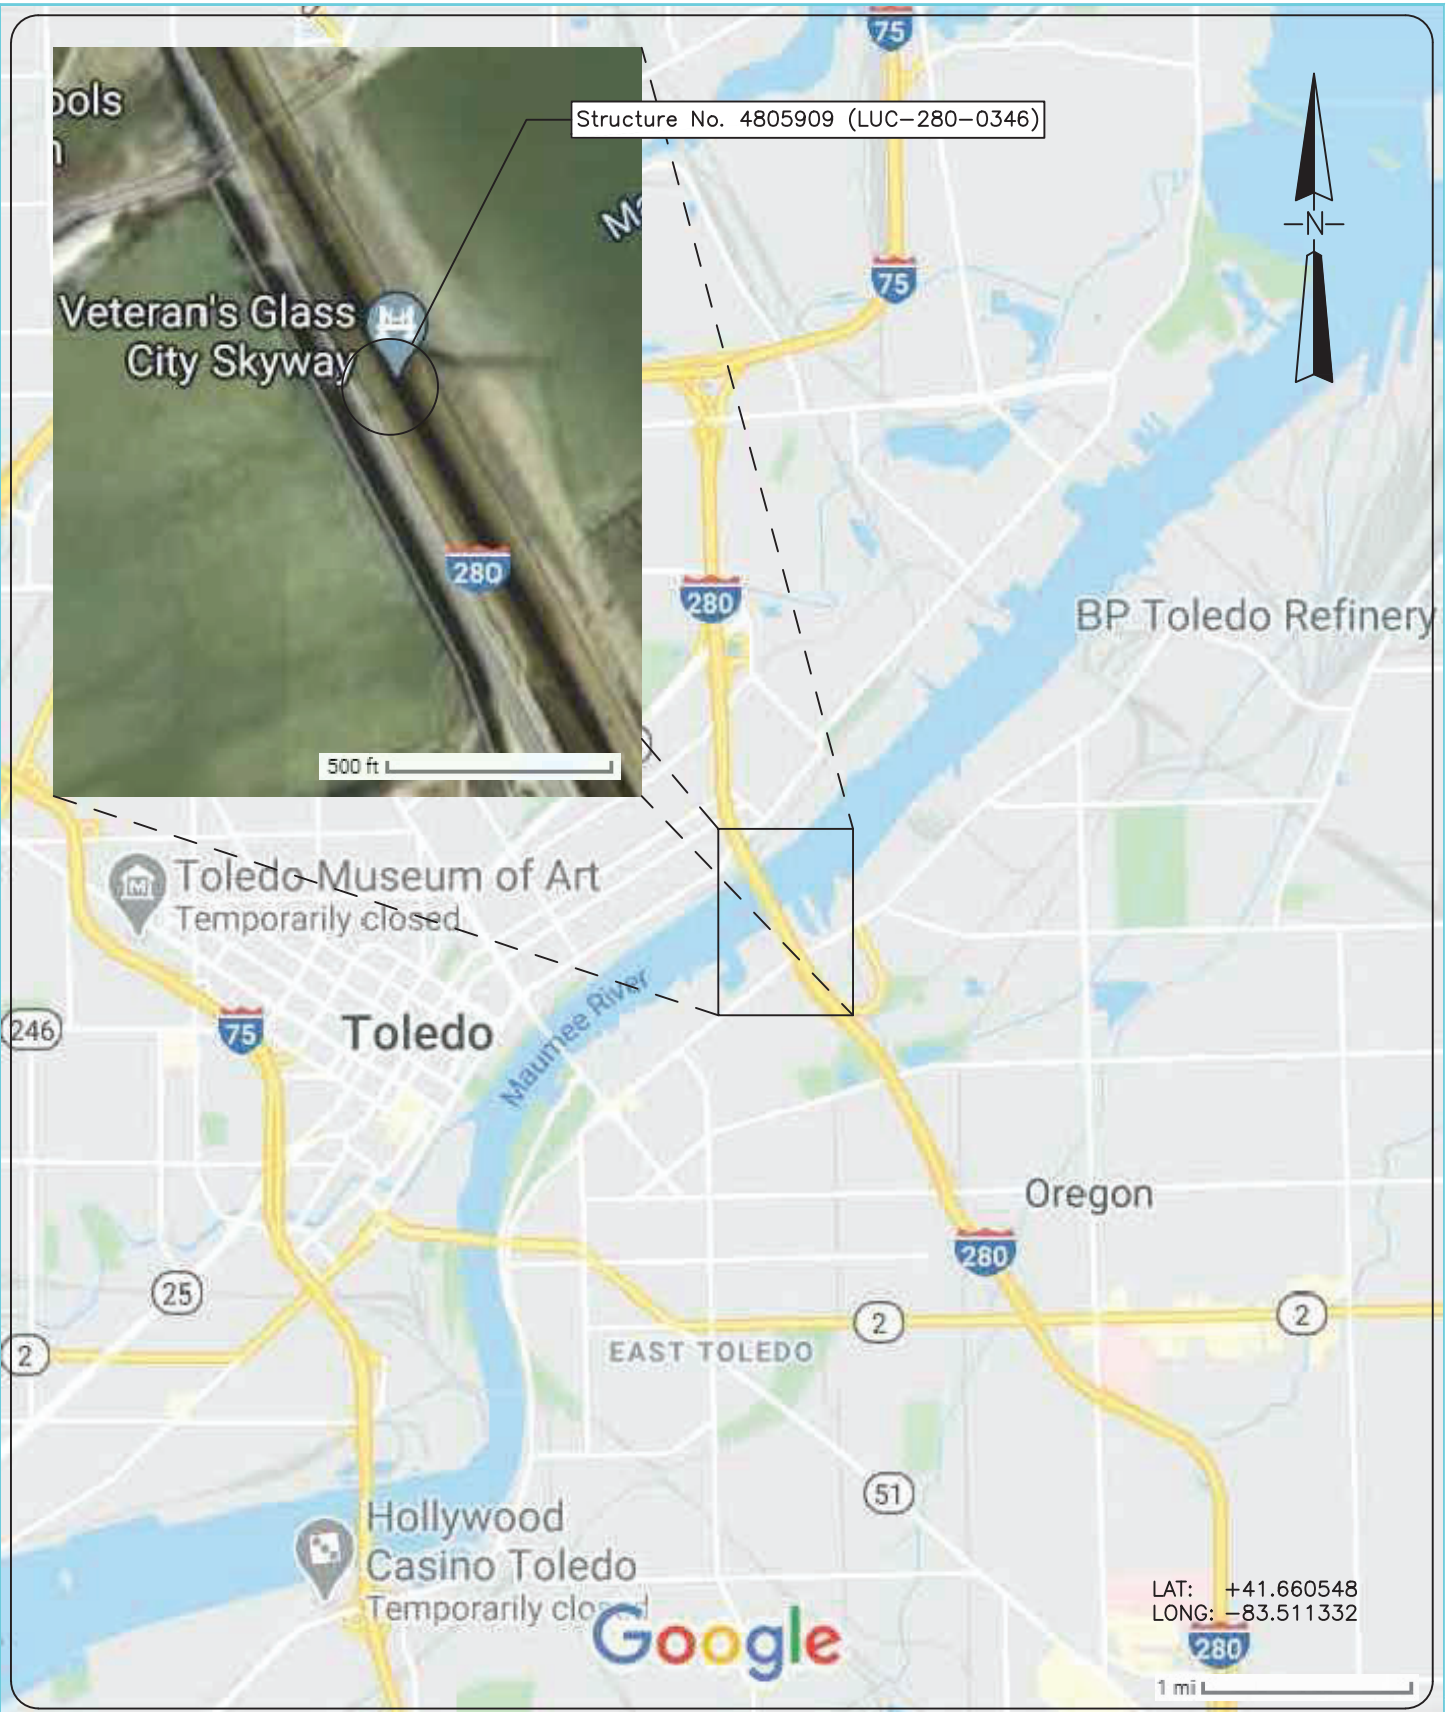
I-280 OVER MAUMEE RIVER
 STRUCTURE NO. 4805909 (LUC-280-0346)
 SOUNDING PLAN
 LUCAS COUNTY, OHIO

Channel bottom soundings were performed utilizing a digital fathometer and pneumofathometer. Soundings were collected at quarter points along the bridge centerline as well as at quarter points along the upstream and downstream fascias and 50 ft fascias. Additional soundings were collected adjacent to Pier 28 and at 10 foot intervals in-line with the piers, upstream and downstream, and the waterline was referenced to a known elevation on the bridge. A sounding plan was developed using the soundings and approximate location of the shorelines. Refer to Figures 2 through 5 in Exhibit 1 for the sounding plan and channel cross sections that show the channel limits and water depths around the structure.

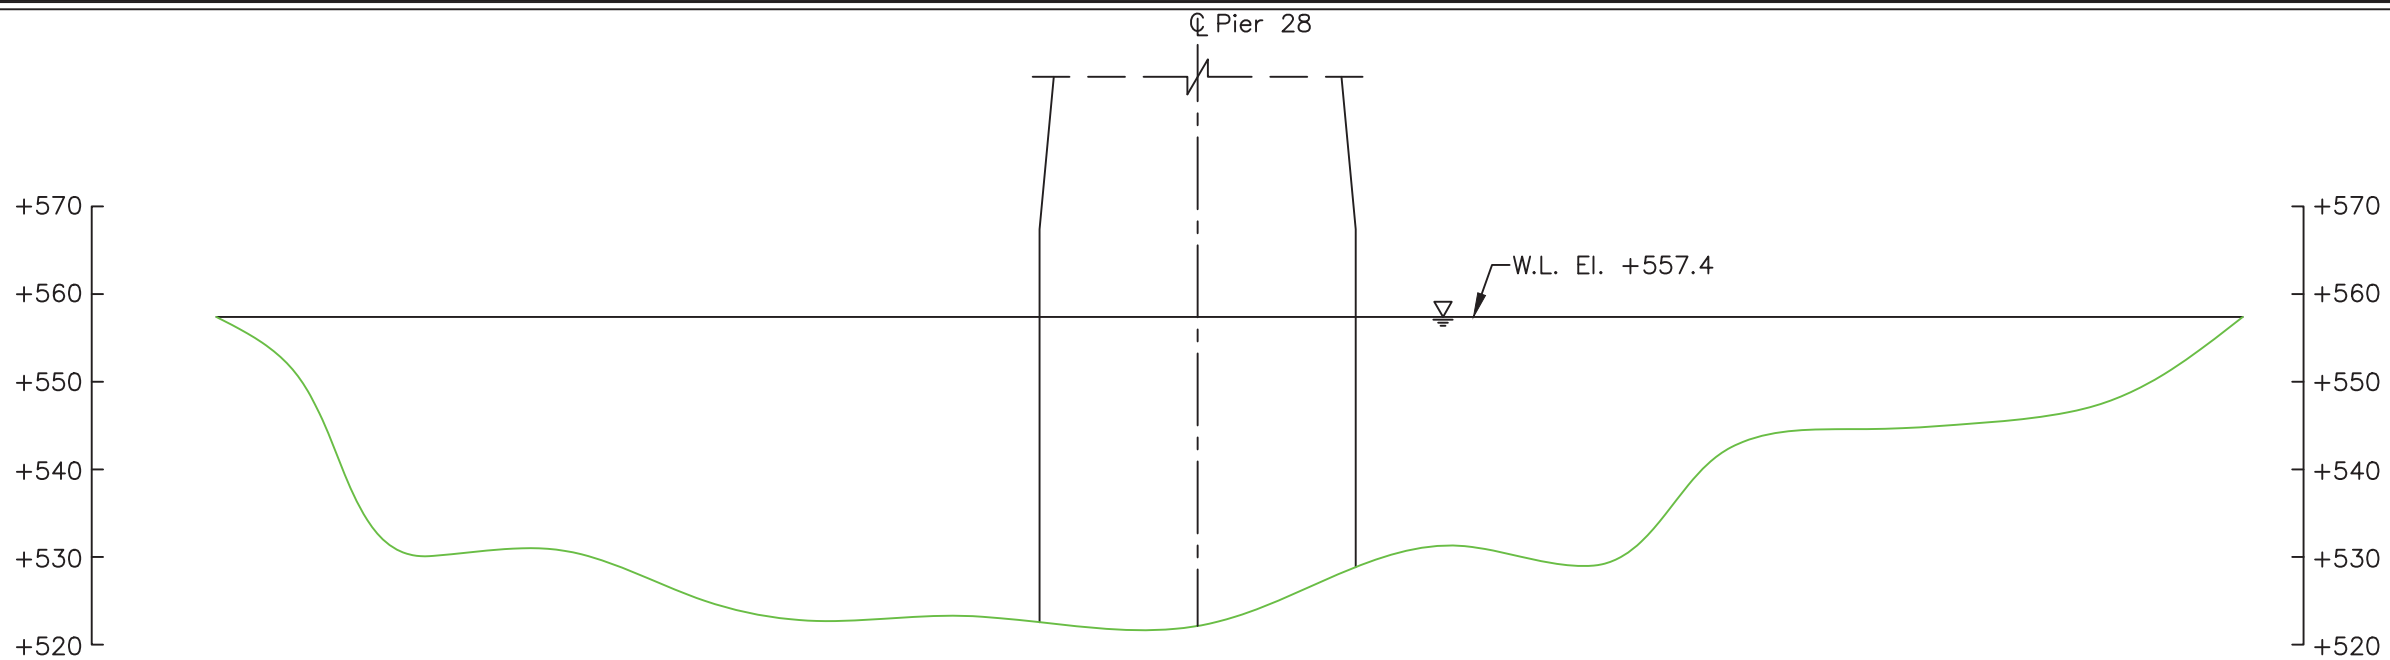
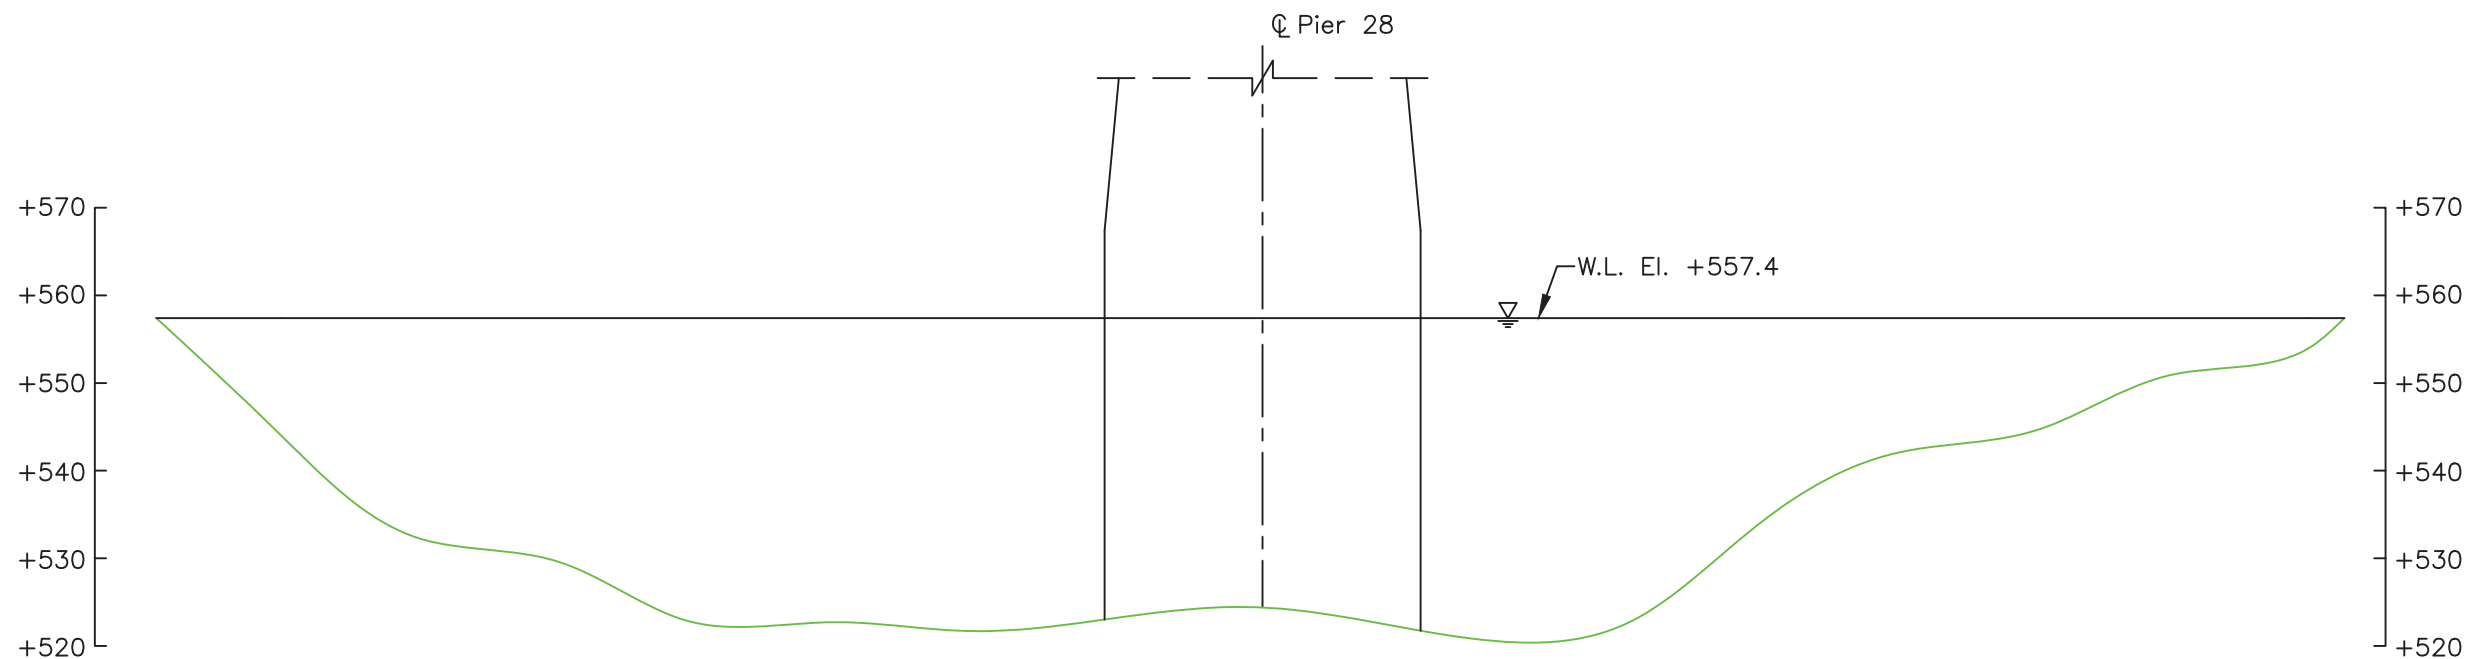
I-280 OVER MAUMEE RIVER
STRUCTURE NO. 4805909 (LUC-280-0346)
CROSS SECTIONS - UPSTREAM
LUCAS COUNTY, OHIO

CHANNEL CROSS SECTION
UPSTREAM FASCIA
(LOOKING DOWNSTREAM)

CHANNEL CROSS SECTION
50 FT UPSTREAM
(LOOKING DOWNSTREAM)

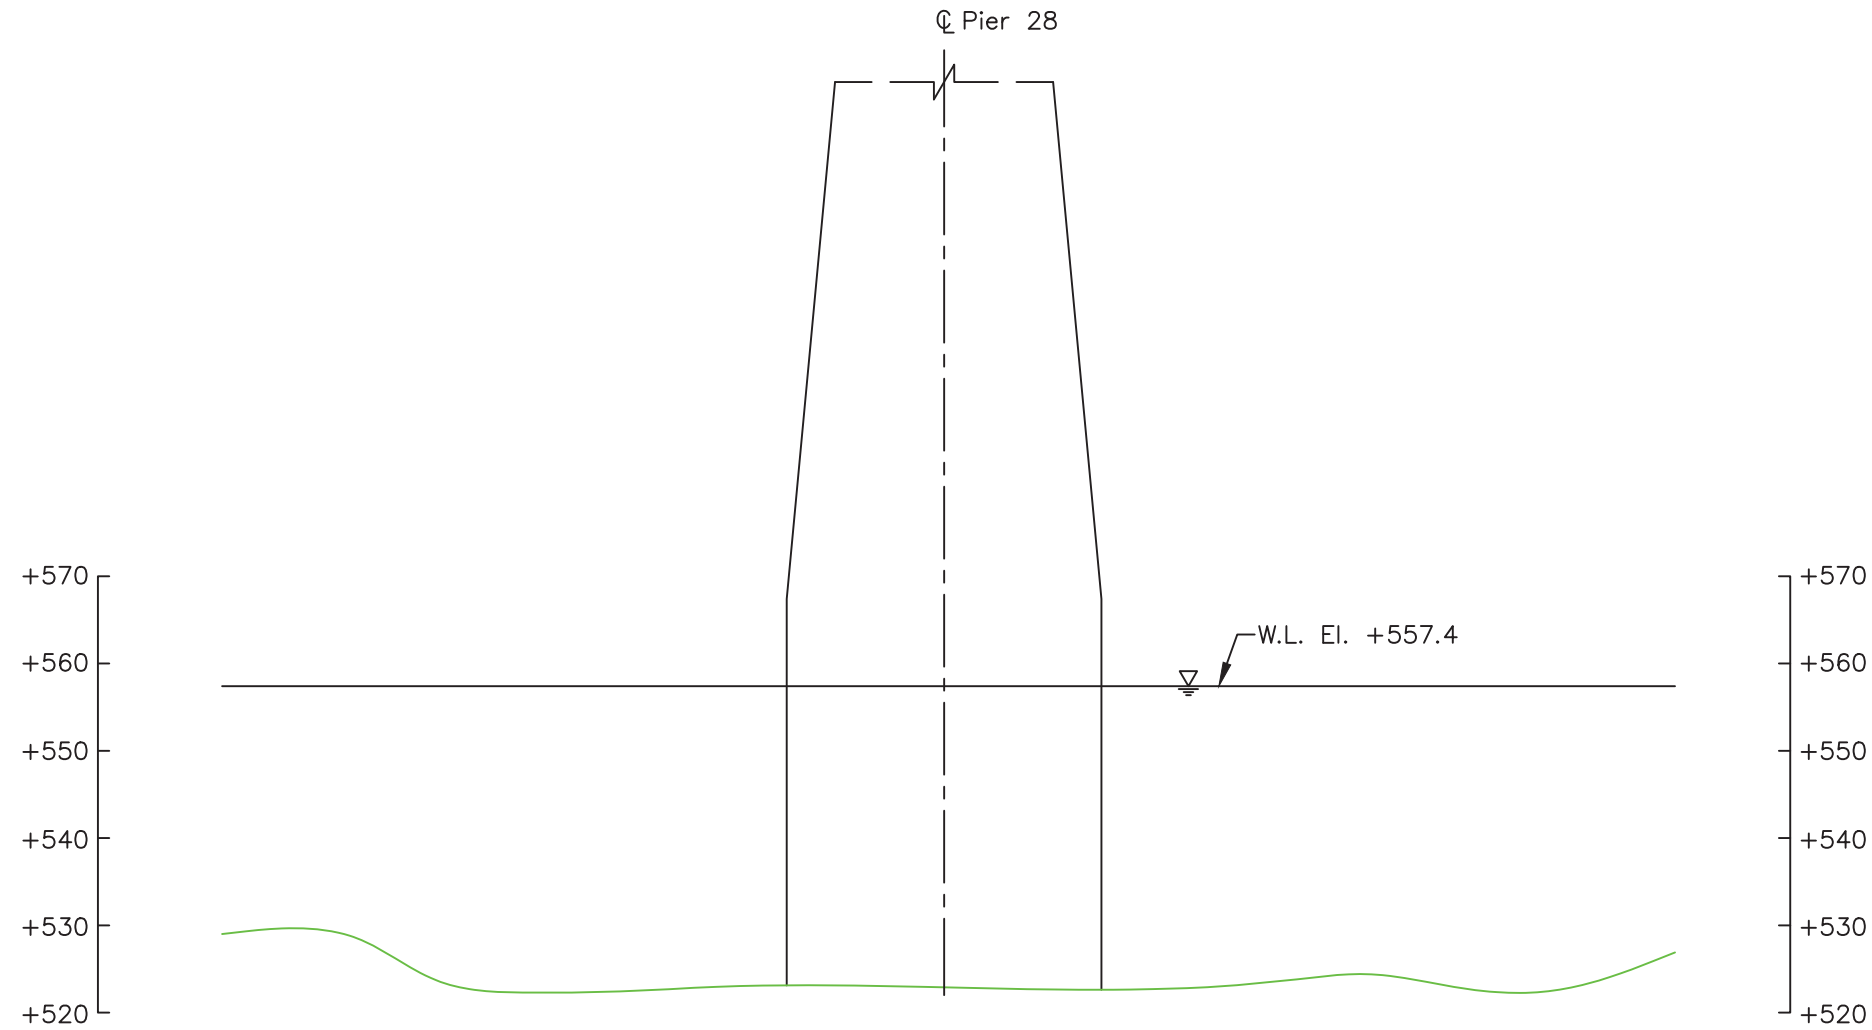
I-280 OVER MAUMEE RIVER
STRUCTURE NO. 4805909 (LUC-280-0346)
CROSS SECTIONS - CENTERLINE
LUCAS COUNTY, OHIO

CHANNEL CROSS SECTION
STRUCTURE CENTERLINE
(LOOKING DOWNSTREAM)

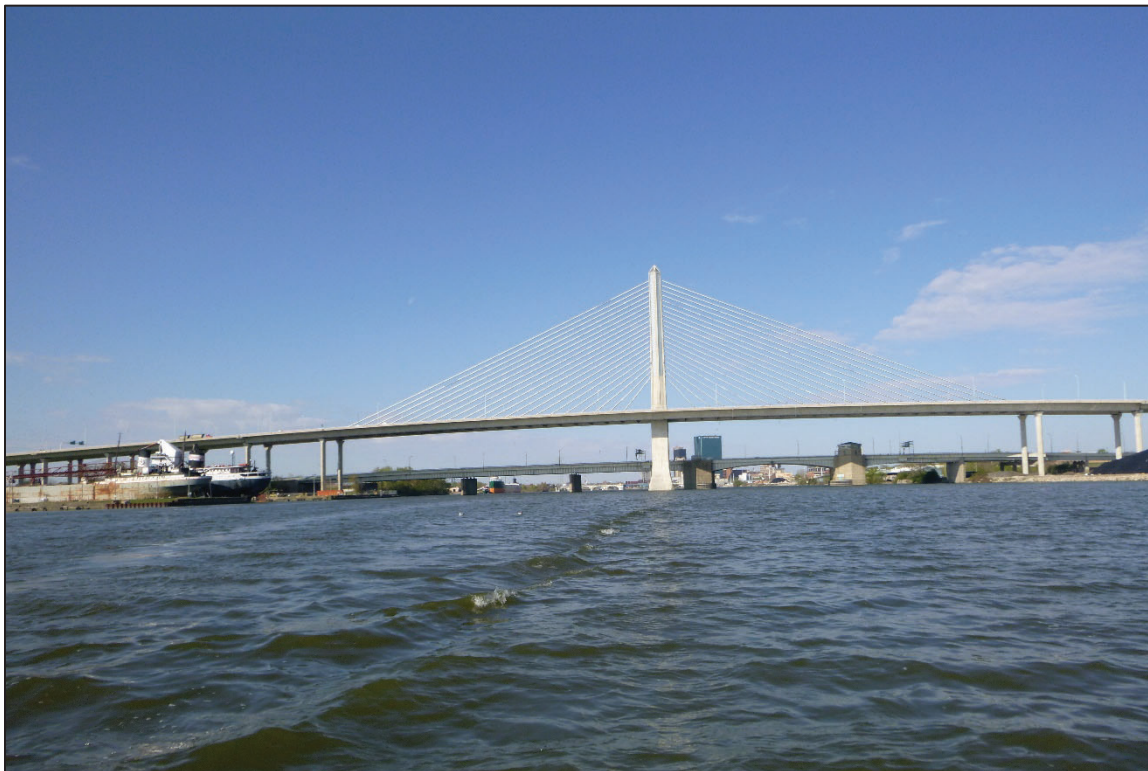
Photograph No. 2: Overall View of Structure No. 4805909 (LUC-280-0346), Looking Southwest.
