# UNDERWATER BRIDGE INSPECTION REPORT

STRUCTURE NO. 6200184 (OTT-2-1312)  
SR 2 OVER RUSHA CREEK  
OTTAWA COUNTY, OH  
DISTRICT 2

April 2020

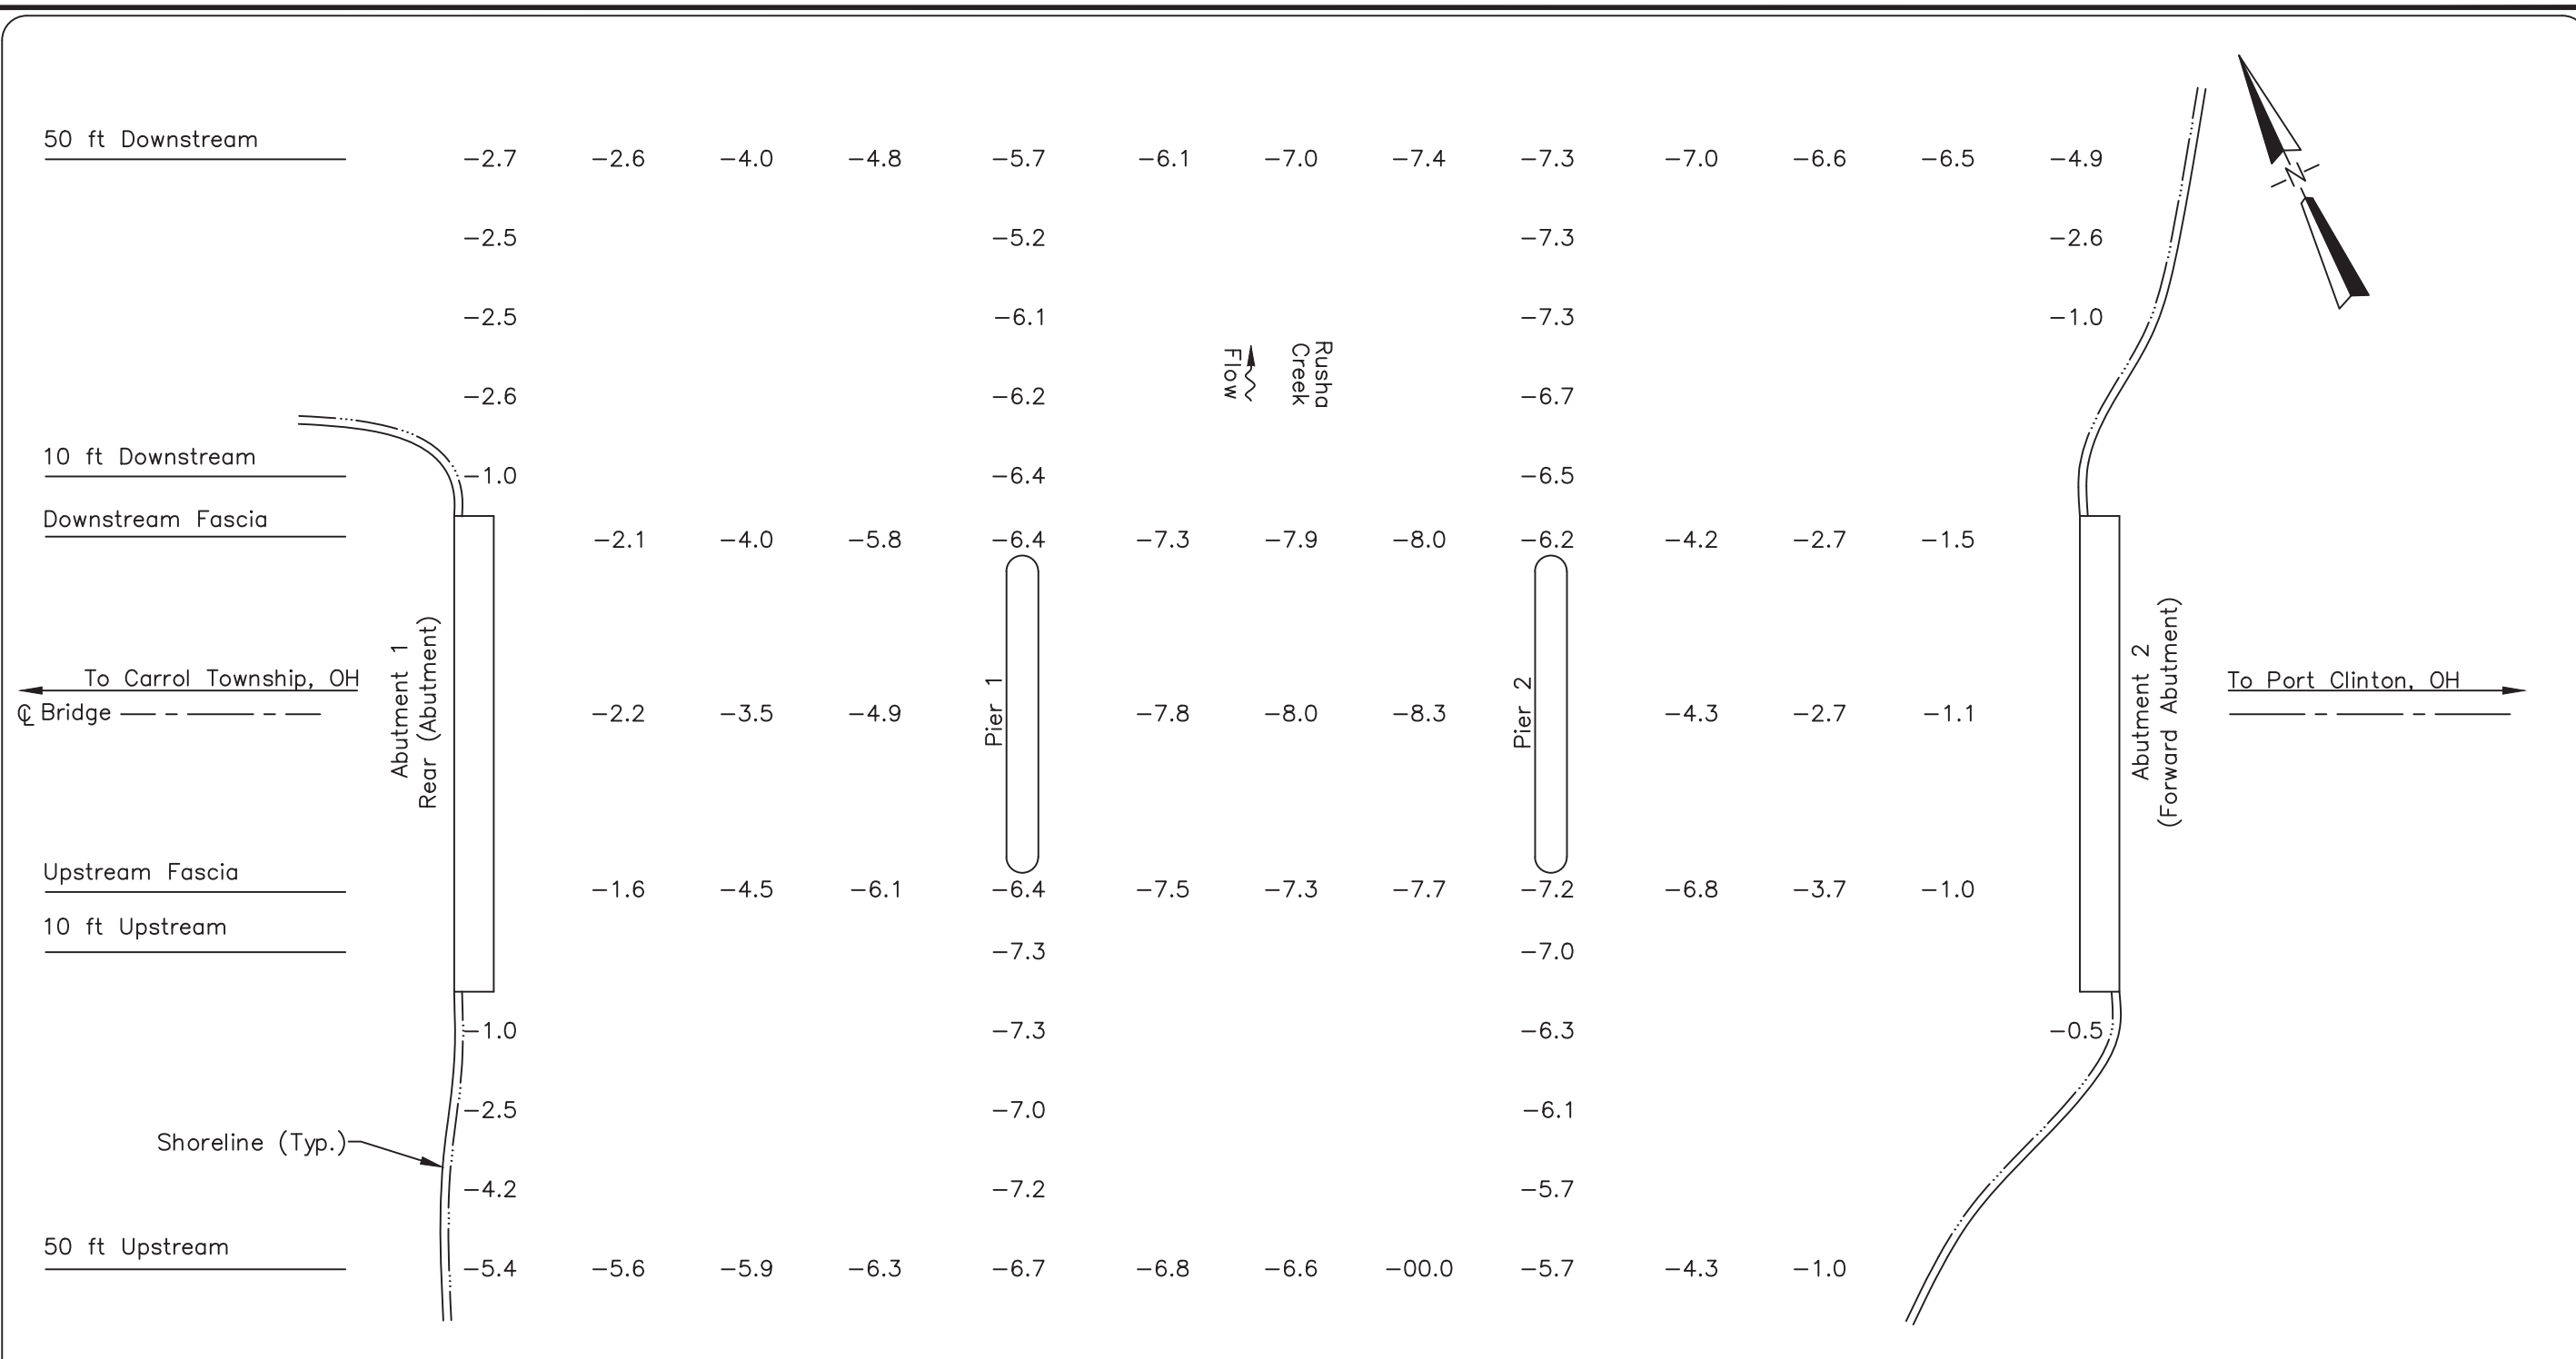
SOUNDING PLAN

<b>Maximum Depth at SSU:</b>	8.6 ft – Midpoint on North Face of Pier 2		
<b>Shoreline Conditions:</b>	The east and west shorelines consisted of well-protected, well-vegetated, mild slopes with no signs of erosion.

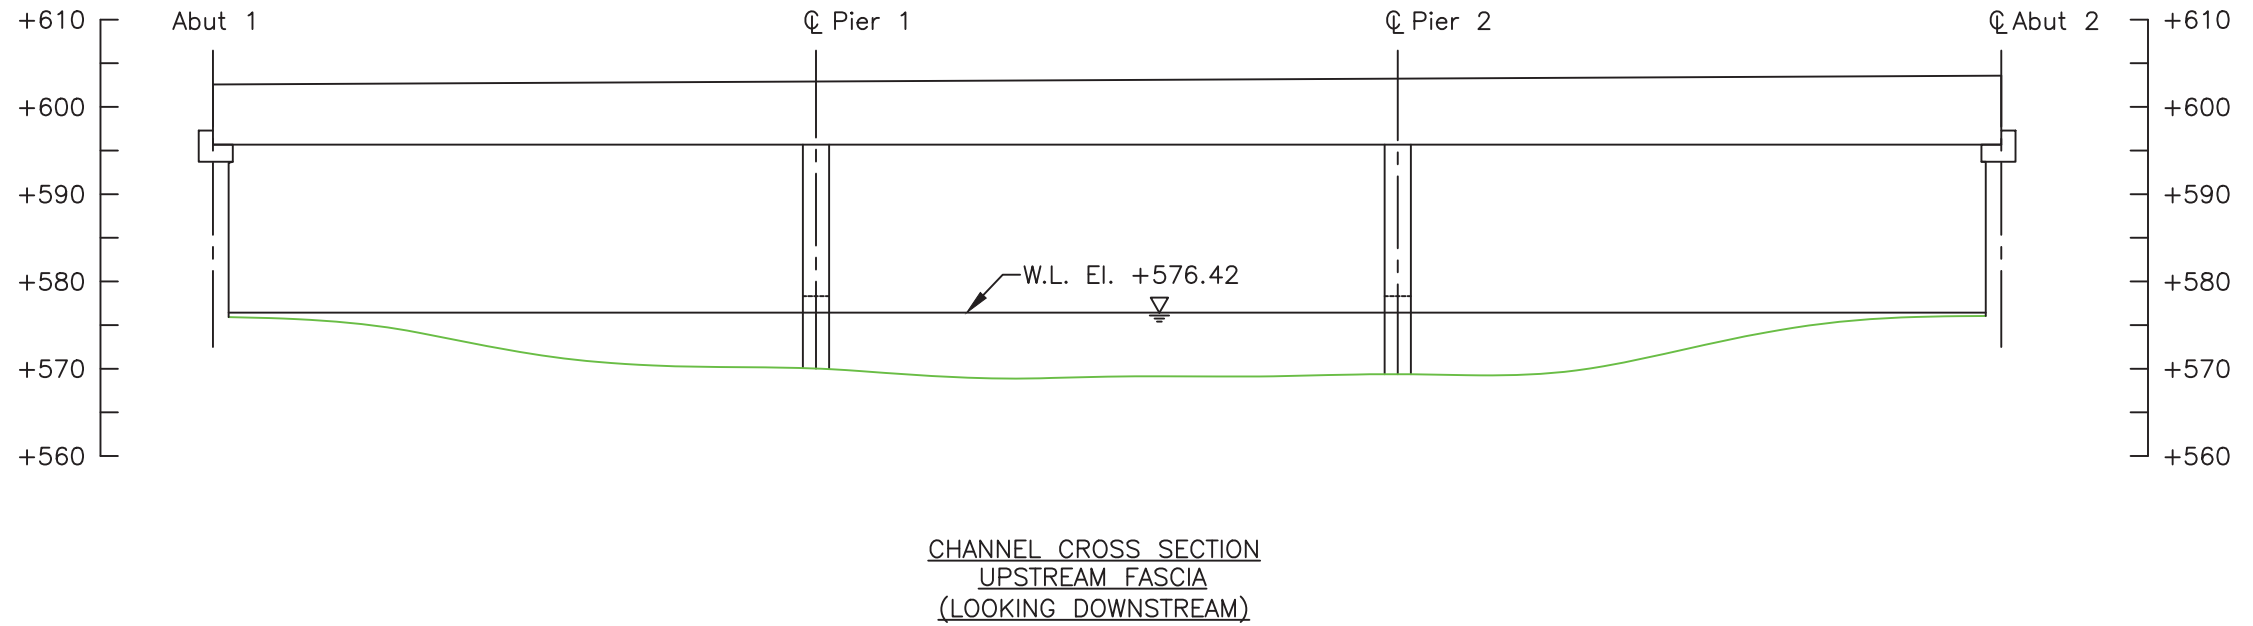
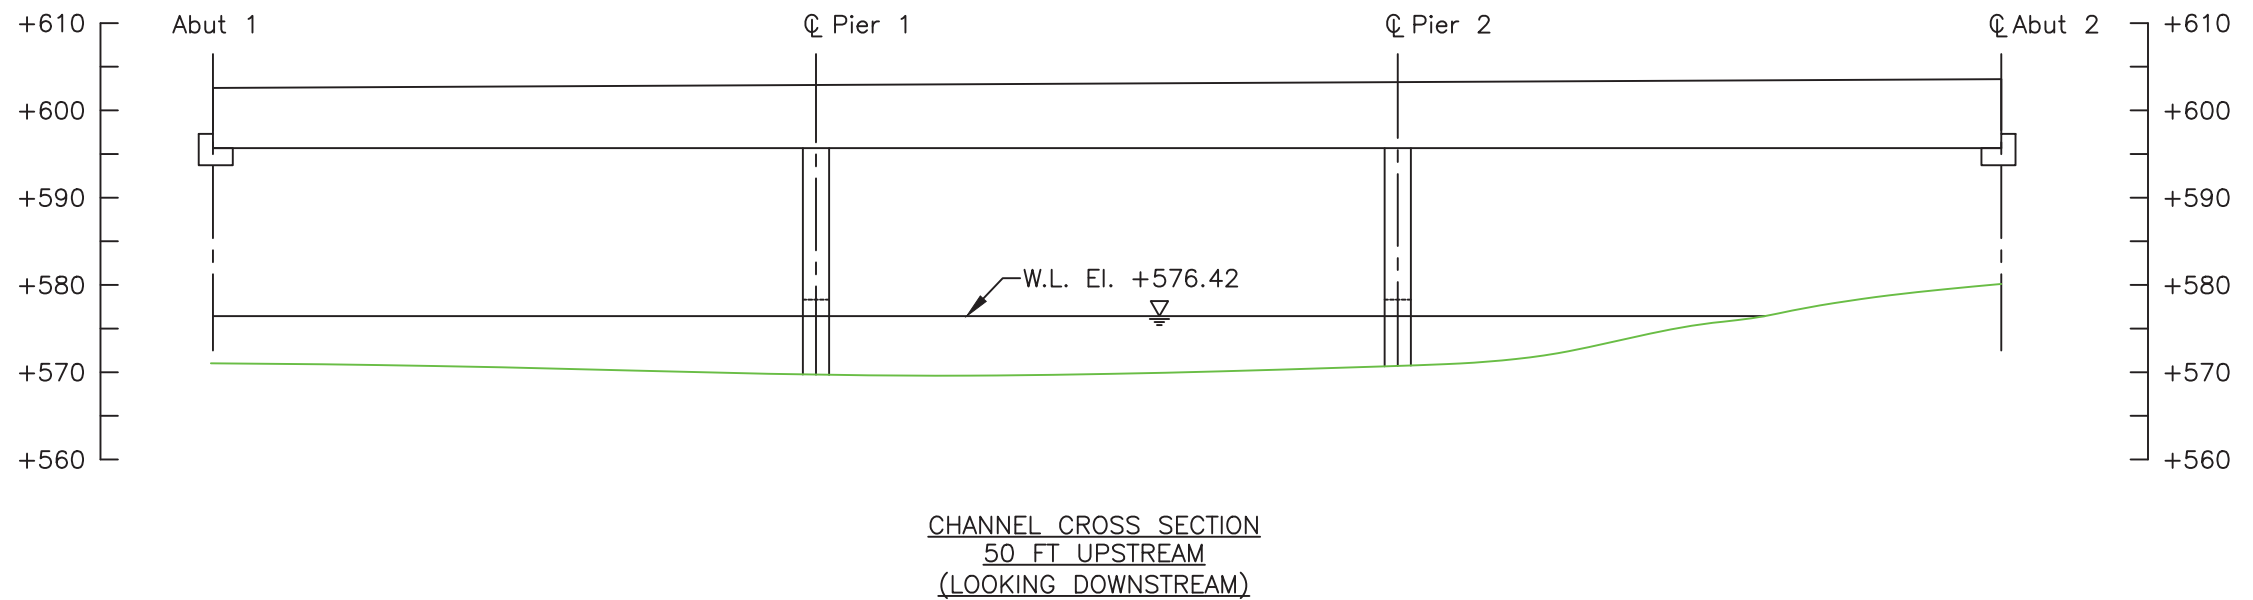
**SR-2 OVER RUSHA CREEK  
STRUCTURE NO. 6200184 (OTT-2-1312)  
CROSS SECTIONS - UPSTREAM  
OTTAWA COUNTY, OHIO**

UPSTREAM FASCIA LOOKING DOWNSTREAM	
Location	Y(ft)*
A1	7.9
1/4	8.5
1/2	11.5
3/4	13.1
B1	13.6
1/4	14.8
1/2	14.7
3/4	15.2
B2	14.8
1/4	14.5
1/2	11.5
3/4	8.9
A2	8.4

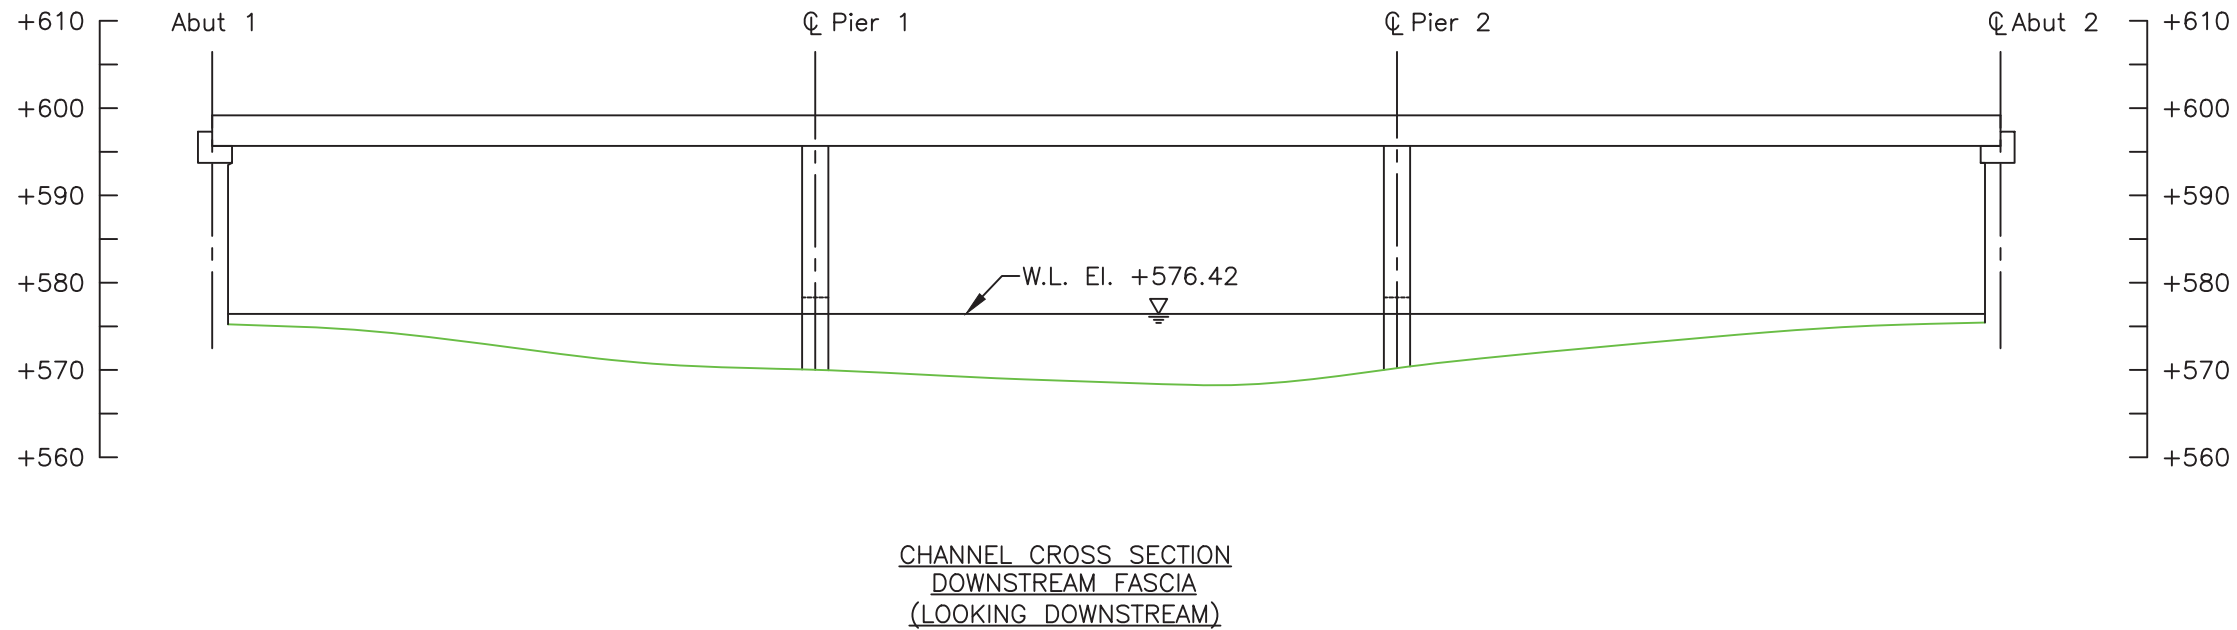
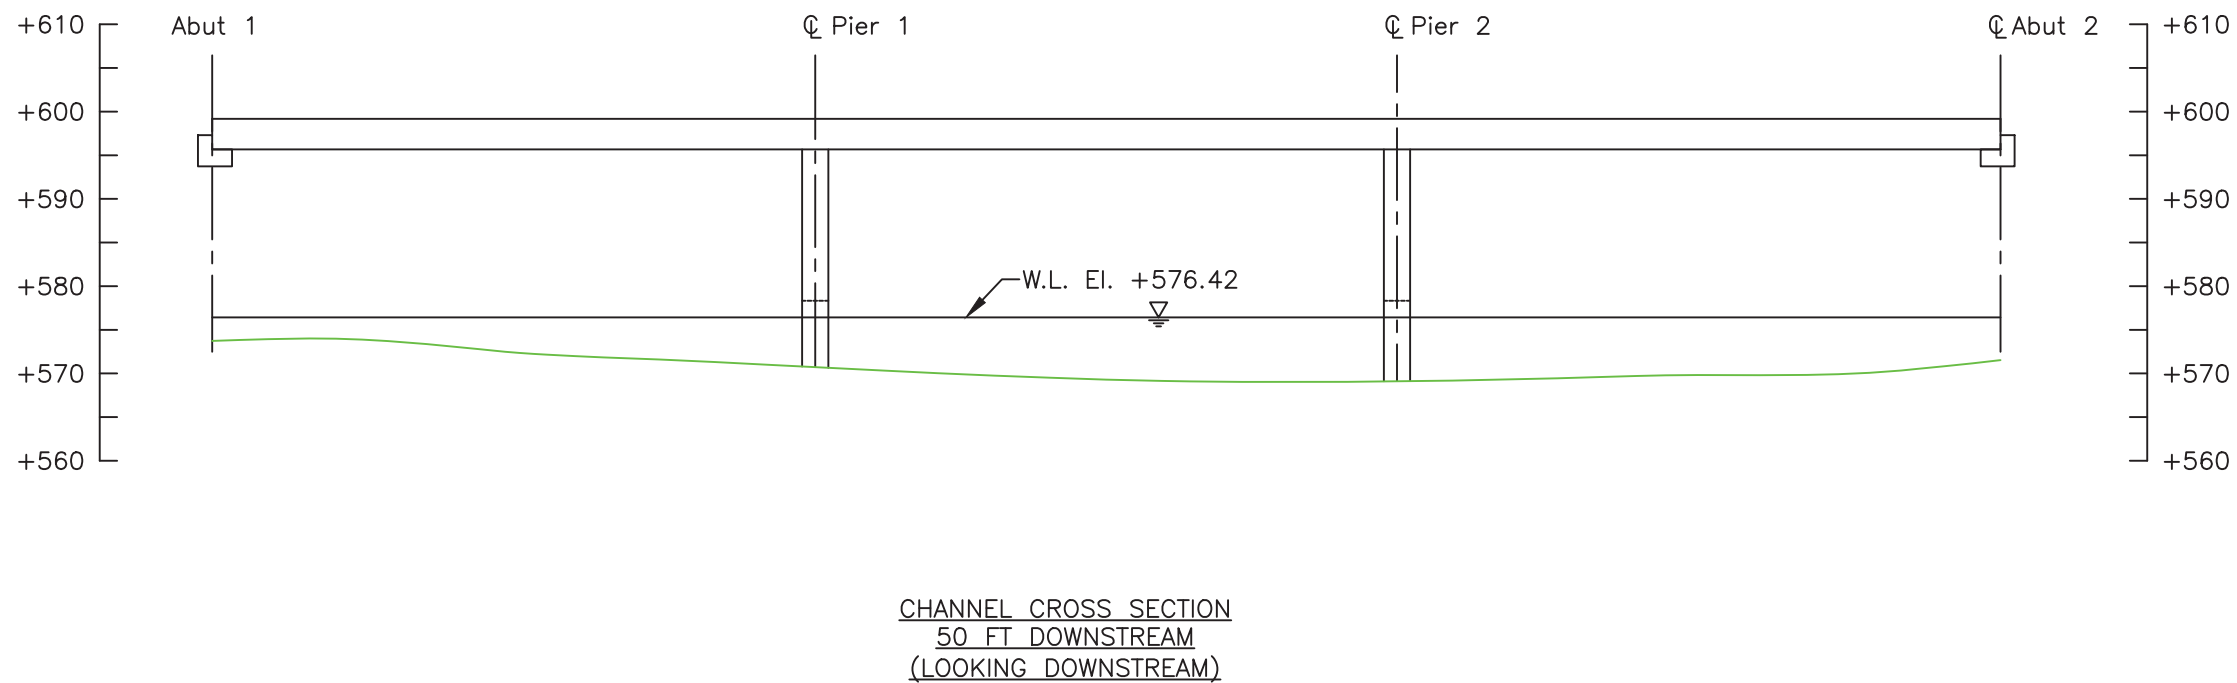
DOWNSTREAM FASCIA LOOKING DOWNSTREAM	
Location	Y(ft)*
A1	4.5
1/4	5.6
1/2	7.5
3/4	9.3
B1	9.9
1/4	10.8
1/2	11.4
3/4	11.5
B2	9.7
1/4	7.7
1/2	6.2
3/4	5.0
A2	3.5

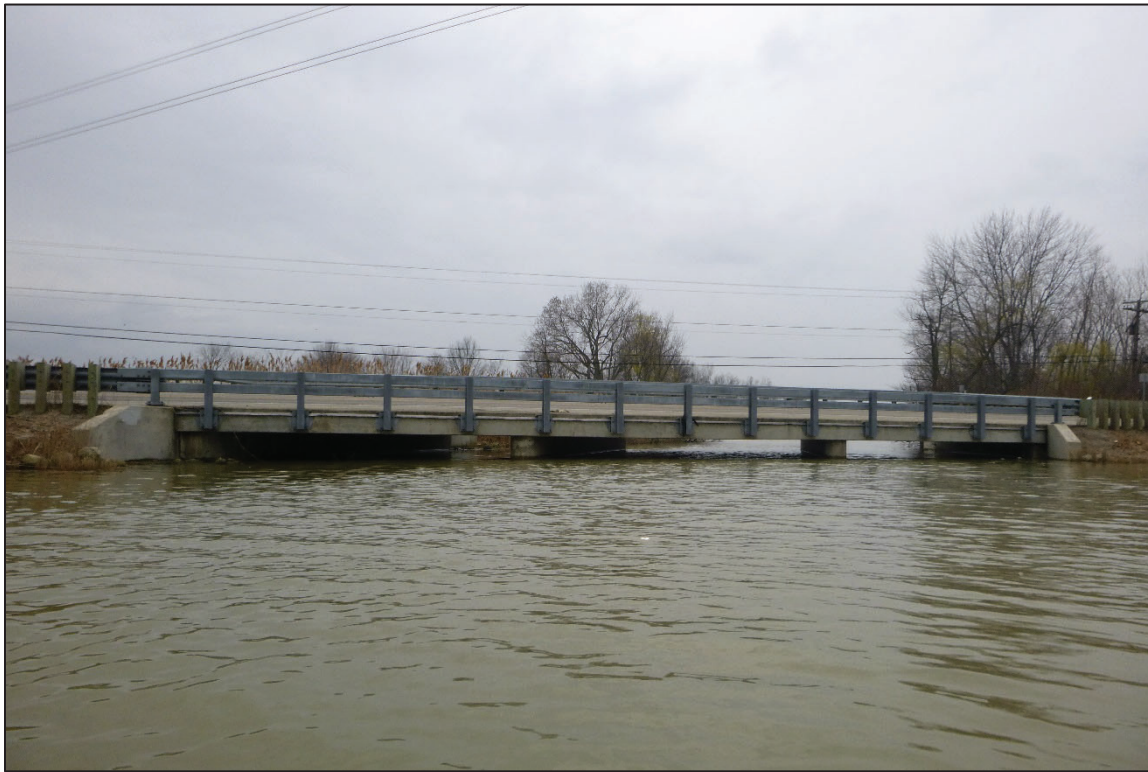
Photograph No. 1: Overall View of Structure No. 6200184 (OTT-2-1312), Looking Southwest.

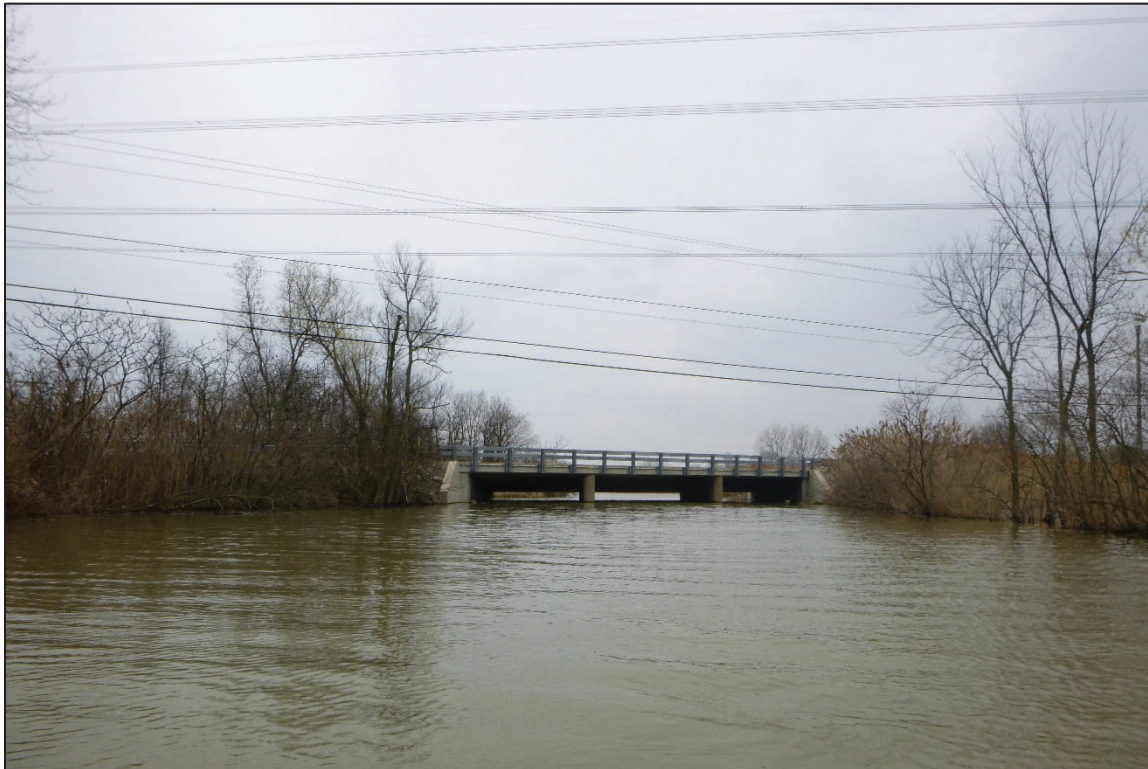
Photograph No. 2: Overall View of Structure No. 6200184 (OTT-2-1312), Looking Northeast.

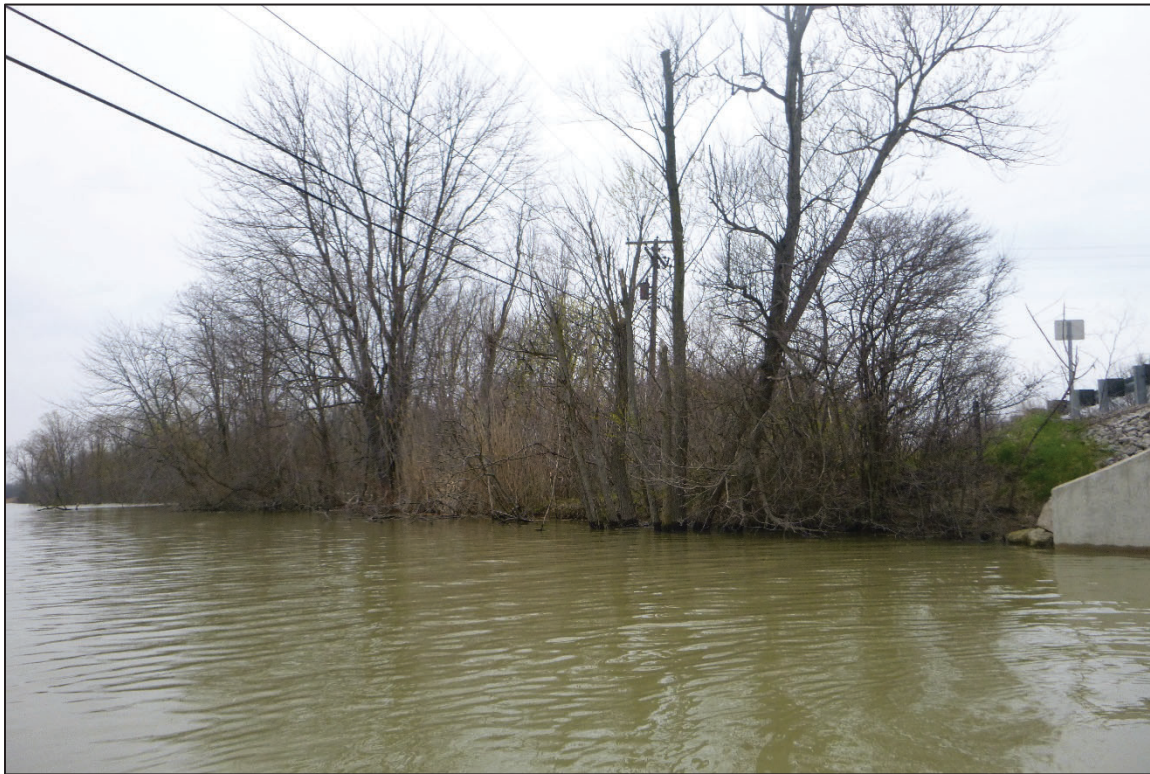
At the time of the inspection, the waterline of 6200184 (OTT-2-1312) was located approximately 1.9 ft below the top of pier at the downstream nose at Pier 2, which corresponds to a waterline elevation of 576.42 ft. During the inspection, the waterway was flowing at approximately 0 ft per second. The bridge pier skew was consistent with the channel alignment and does not require attention at this time. The east and west shorelines consisted of well-protected, well-vegetated, mild slopes with no erosion. Refer to Photographs 3 through 8 in Exhibit 2 for views of the shorelines near the structure.

Photograph No. 3: View of the West Embankment Upstream of the Structure, Looking West.

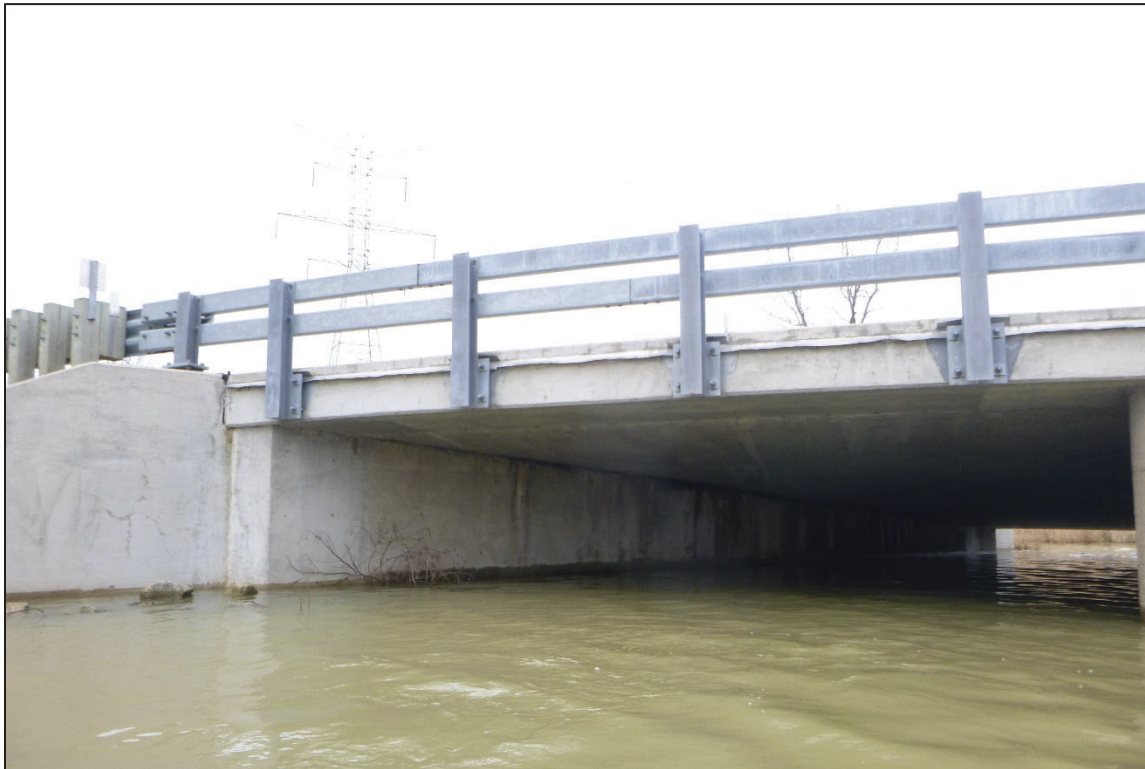
The channel bottom material consisted of riprap and silt with approximately 6 in. probe rod penetration. Refer to Figure 6 in Exhibit 1 for detailed inspection notes of Abutment 1. Refer to Photographs 4 and 5 in Exhibit 2 for views of Abutment 1.

Photograph No. 4: View of the West Embankment at the Structure, Looking North.

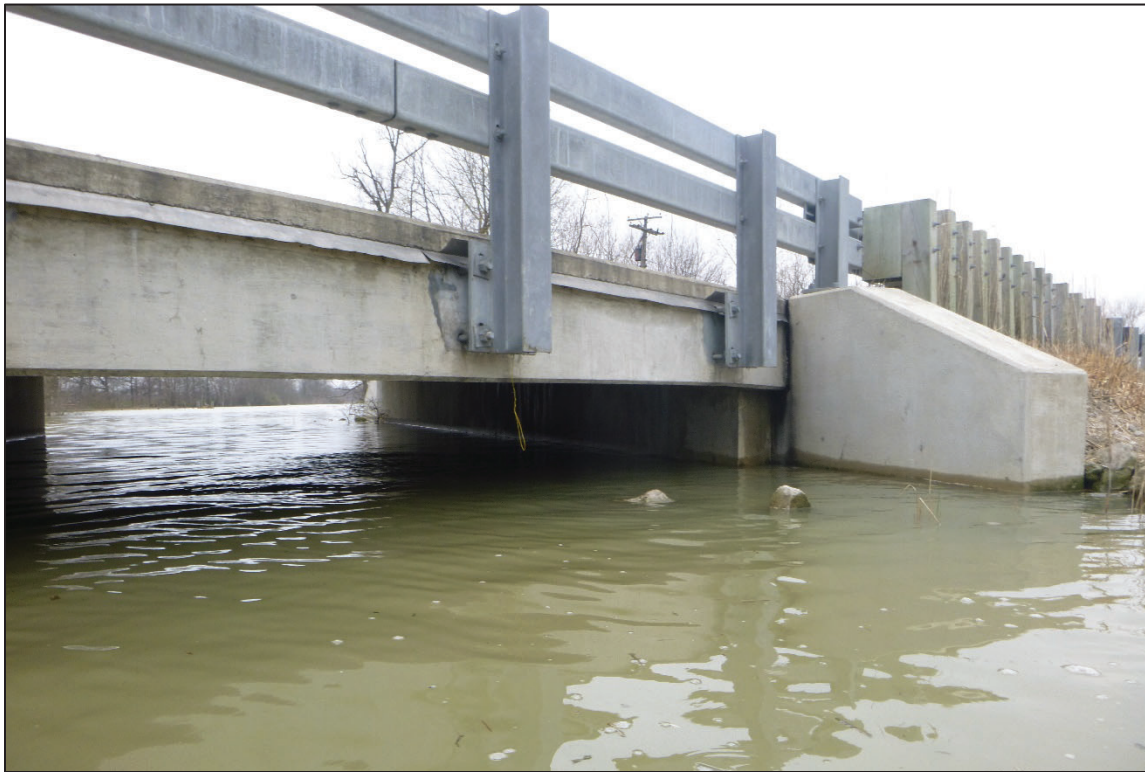
Photograph No. 5: View of the West Embankment at the Structure, Looking North.

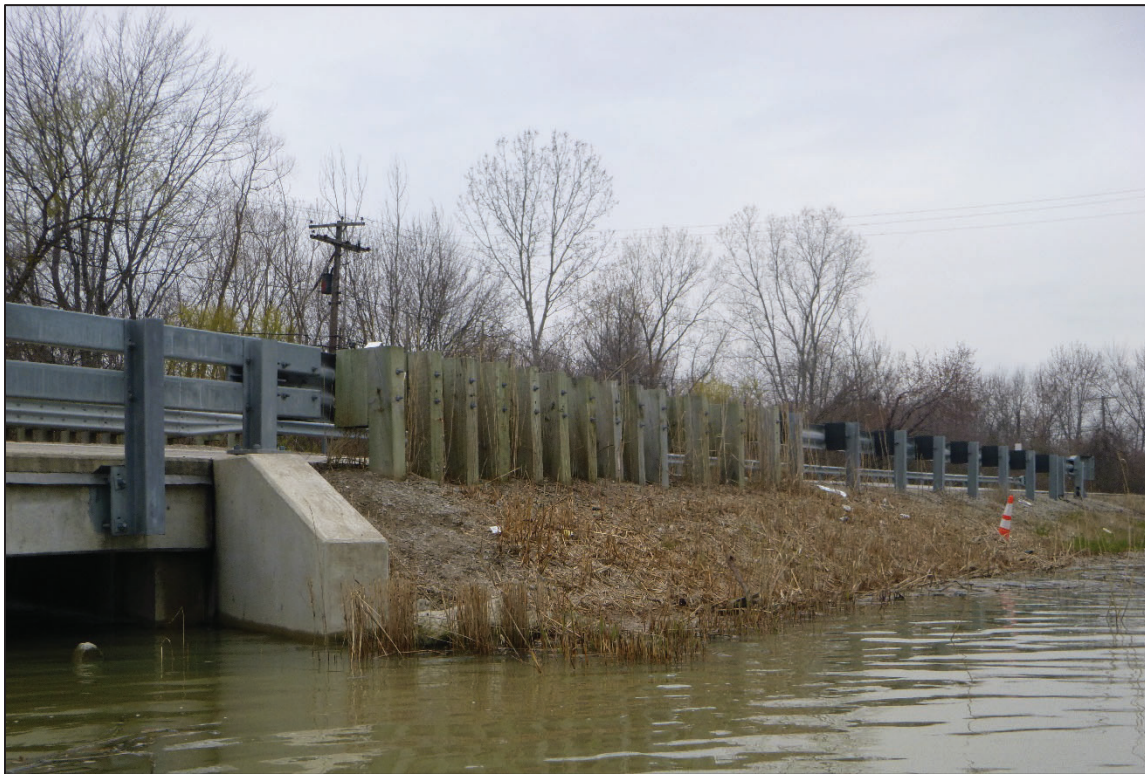
The channel bottom material consisted of riprap and silt with approximately 6 in. probe rod penetration. The submerged portions of the pier were sound and smooth with no defects observed. Hairline cracking with efflorescence observed on 30 percent of the abutment face. Refer to Figure 10 in Exhibit 1 for detailed inspection notes of Abutment 2. Refer to Photographs 6 and 7 in Exhibit 2 for views of Abutment 2.

Photograph No. 6: View of the West Embankment Downstream of the Structure, Looking West.

- Monitor concrete cracking in pier and abutment faces for further propagation.

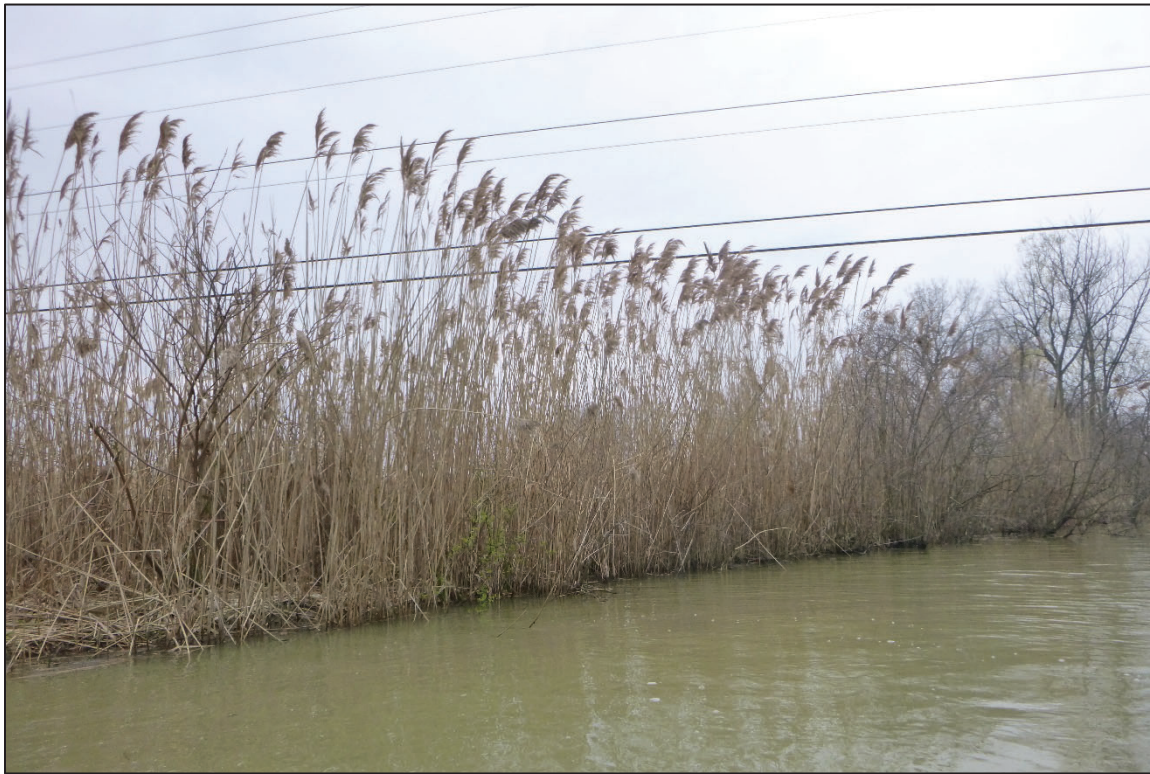
Photograph No. 7: View of the East Embankment Upstream of the Structure, Looking South.

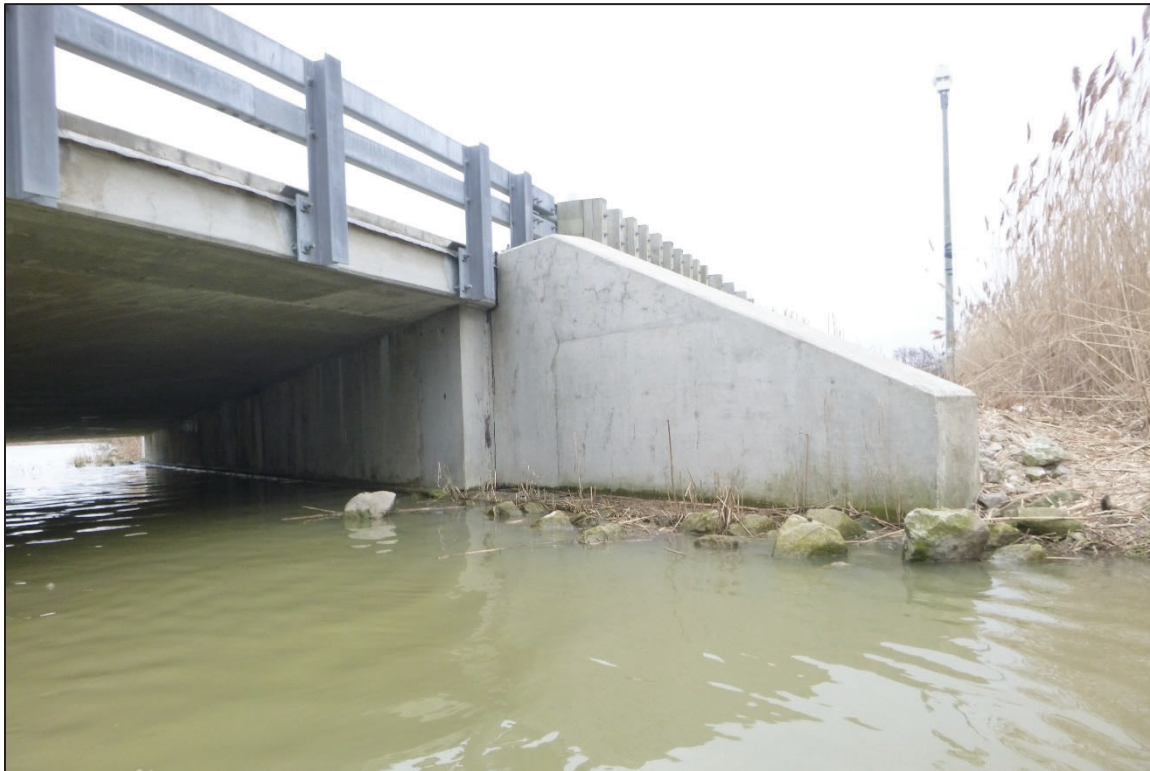
Photograph No. 8: View of the East Embankment at the Structure, Looking East.

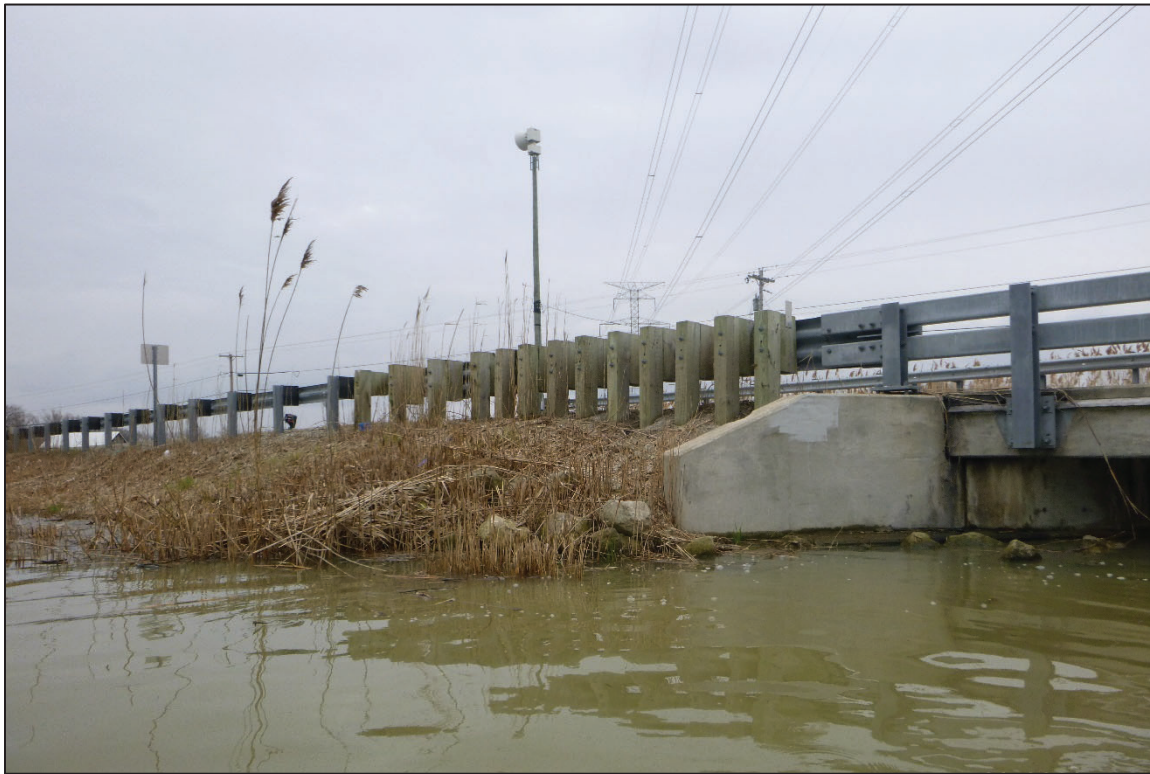
Photograph No. 9: View of the East Embankment Downstream of the Structure, Looking South.
