UNDERWATER BRIDGE INSPECTION REPORT

STRUCTURE NO. 6200788 (OTT-2-2839)
SR 2 OVER SANDUSKY BAY
OTTAWA COUNTY, OH
DISTRICT 2

May 2020

COLLINS
ENGINEERS INC.

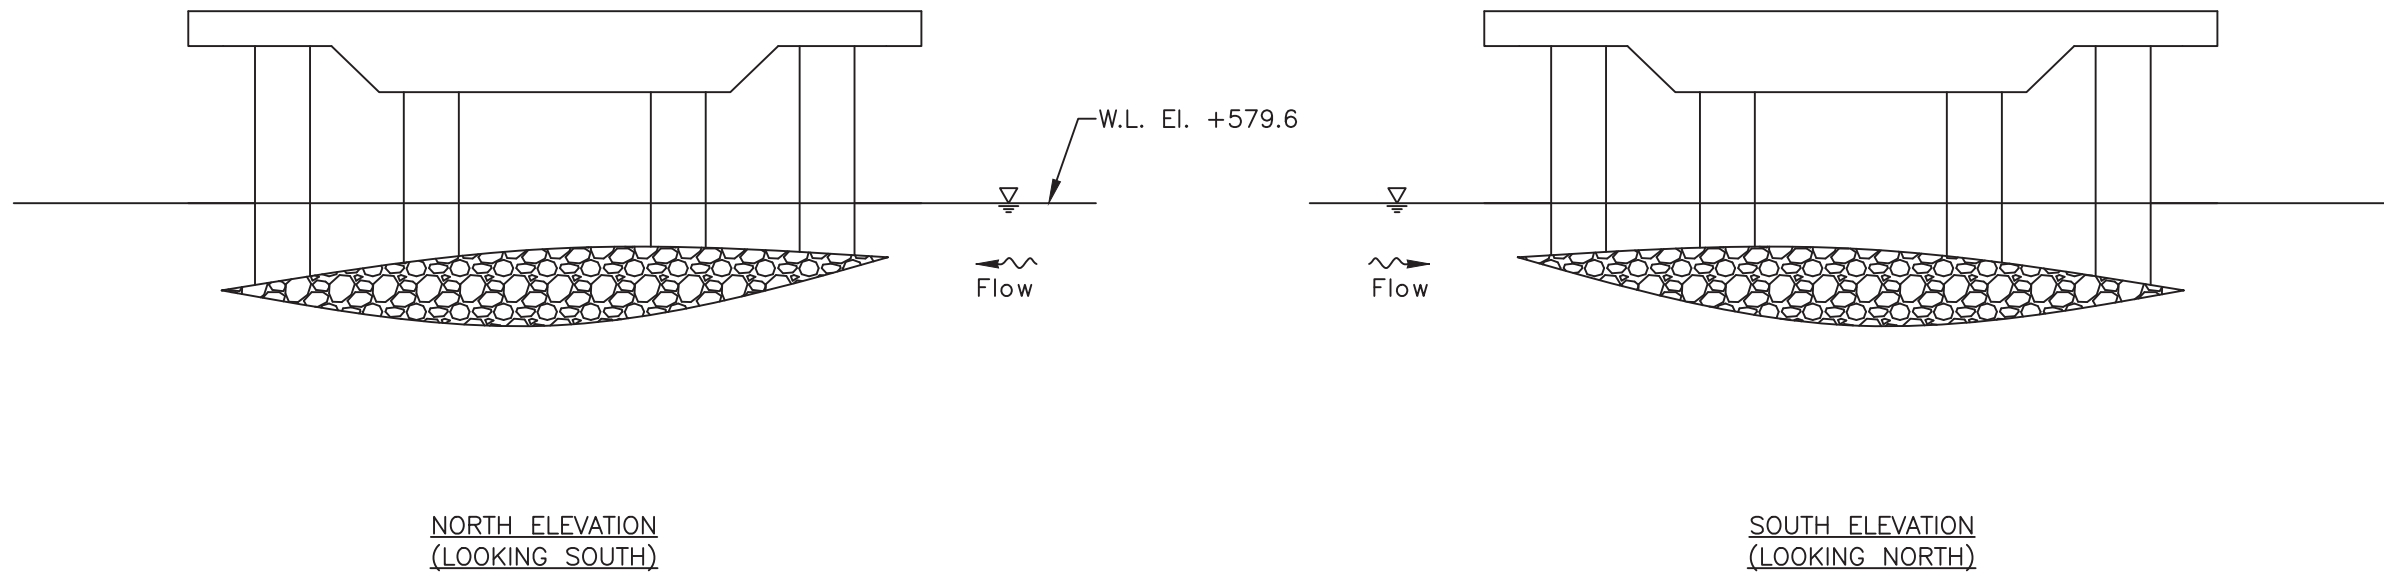
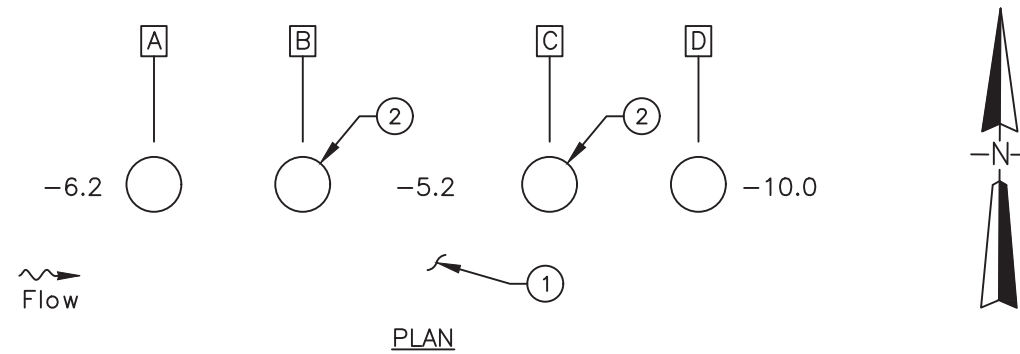
- **Bent 1:**
 - The channel bottom material consisted of riprap and sand infill with no probe rod penetration.
 - The typical steel caisson on typical Columns B and C exhibited moderate corrosion and rust nodules up to 1 in. diameter with pitting up to 1/8 in.

- ① The channel bottom material consisted of riprap and sand infill with no probe rod penetration.
- ② Columns B and C typically exhibited moderate corrosion and rust nodules up to 1 in diameter with pitting up to $\frac{1}{8}$ in.

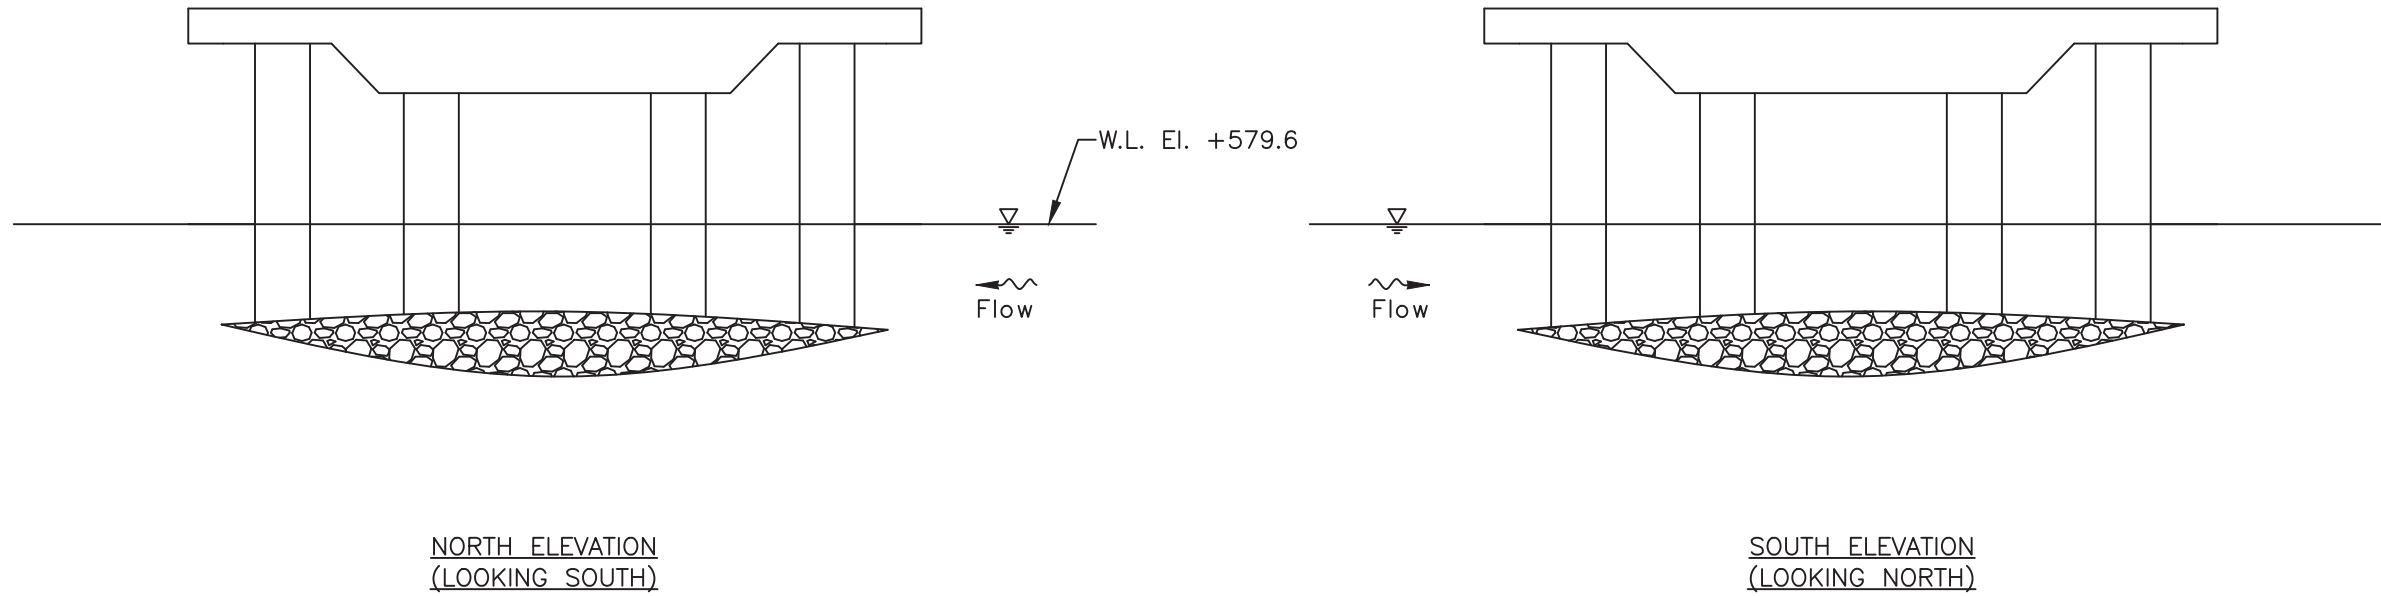
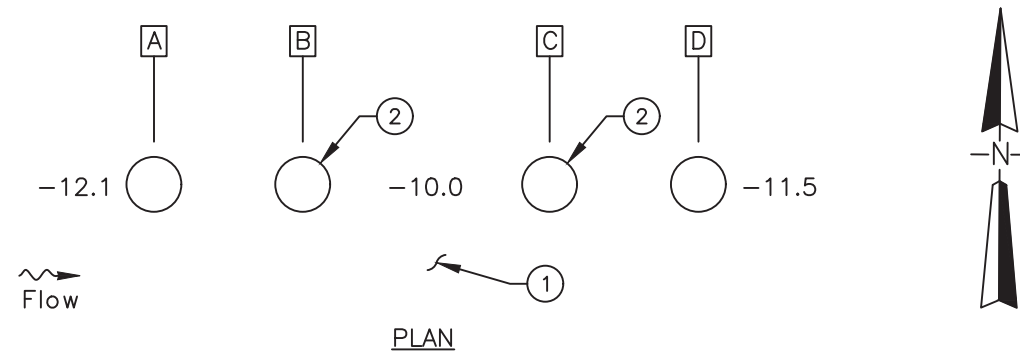
- **Bent 2:**
 - The channel bottom material consisted of riprap and sand infill with no probe rod penetration.
 - The typical steel caisson on typical Columns B and C exhibited moderate corrosion and rust nodules up to 1 in. diameter with pitting up to 1/8 in.

- ① The channel bottom material consisted of riprap and sand infill with no probe rod penetration.
- ② Columns B and C typically exhibited moderate corrosion and rust nodules up to 1 in diameter with pitting up to $\frac{1}{8}$ in.

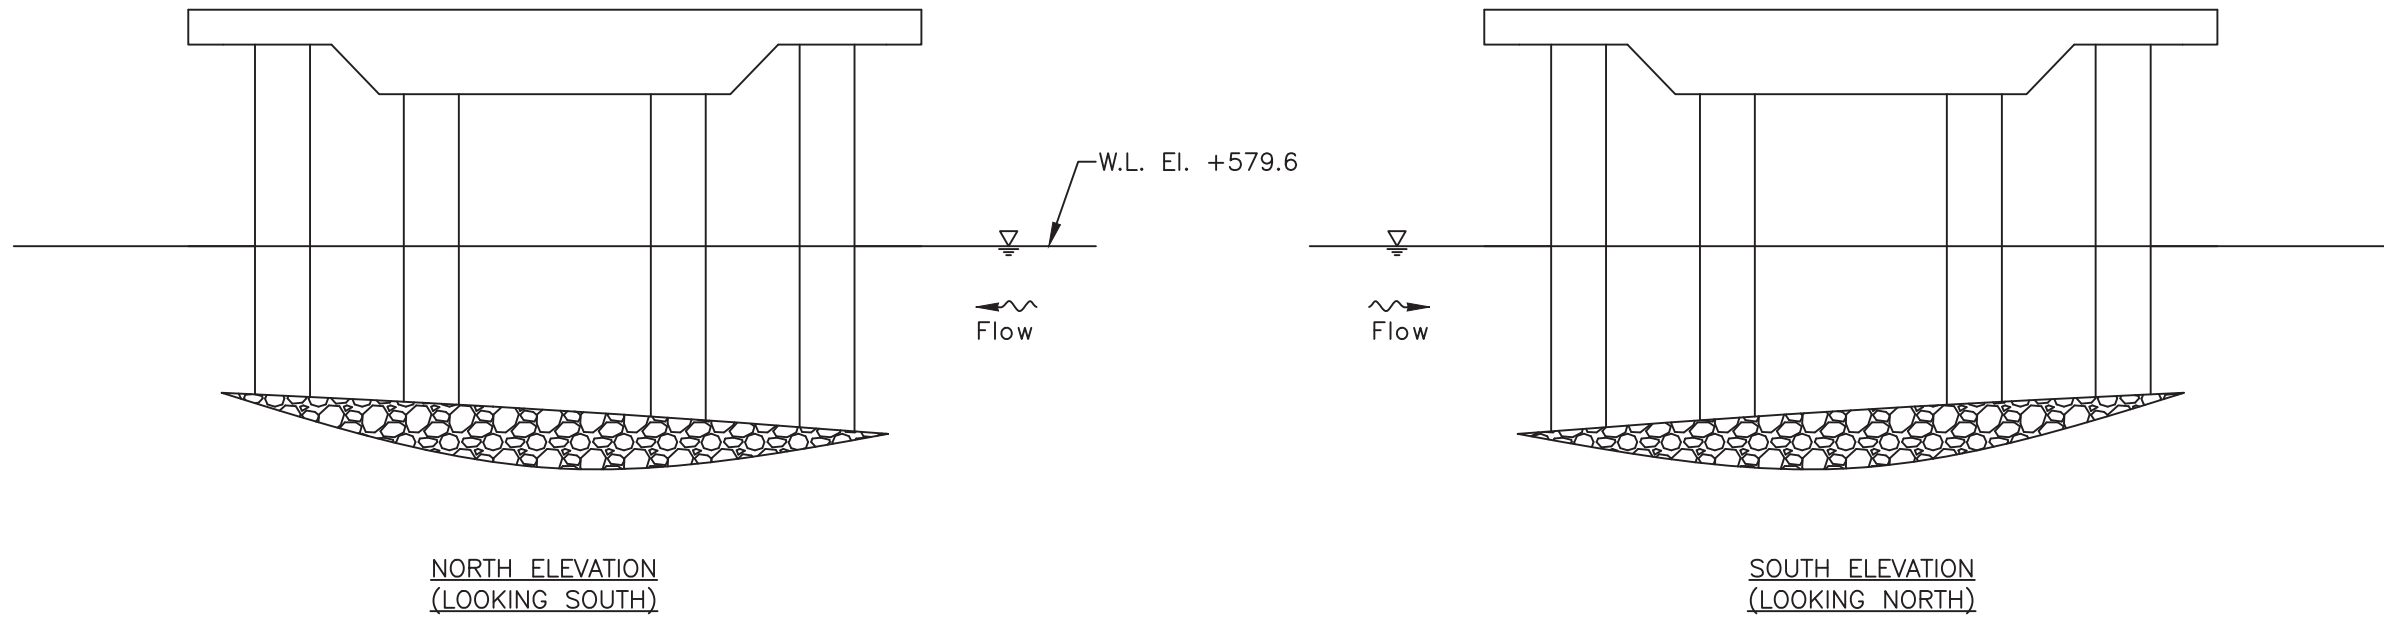
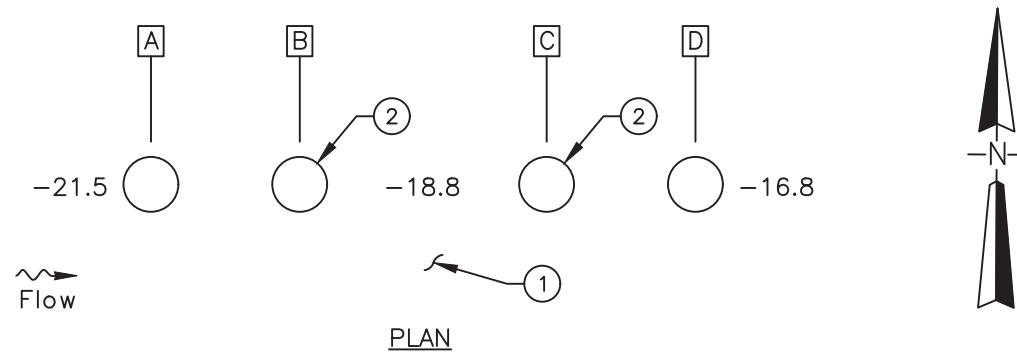
- **Bent 3:**
 - The channel bottom material consisted of riprap and sand infill with no probe rod penetration.
 - The typical steel caisson on typical Columns B and C exhibited moderate corrosion and rust nodules up to 1 in. diameter with pitting up to 1/8 in.

- ① The channel bottom material consisted of riprap and sand infill with no probe rod penetration.
- ② Columns B and C typically exhibited moderate corrosion and rust nodules up to 1 in diameter with pitting up to 1/8 in.

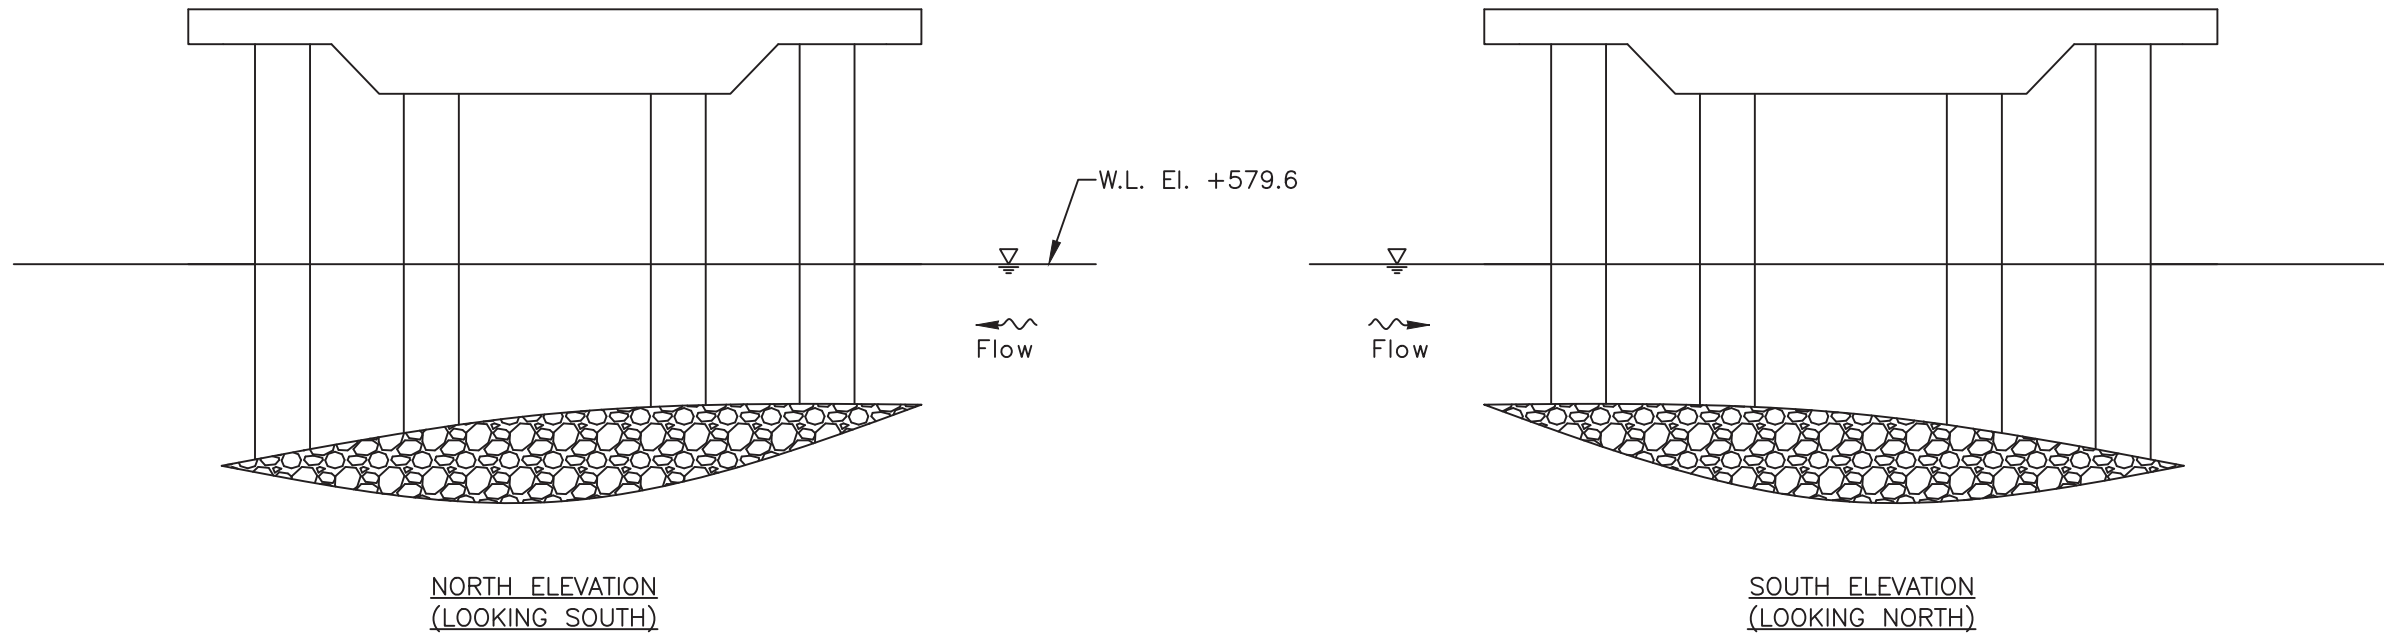
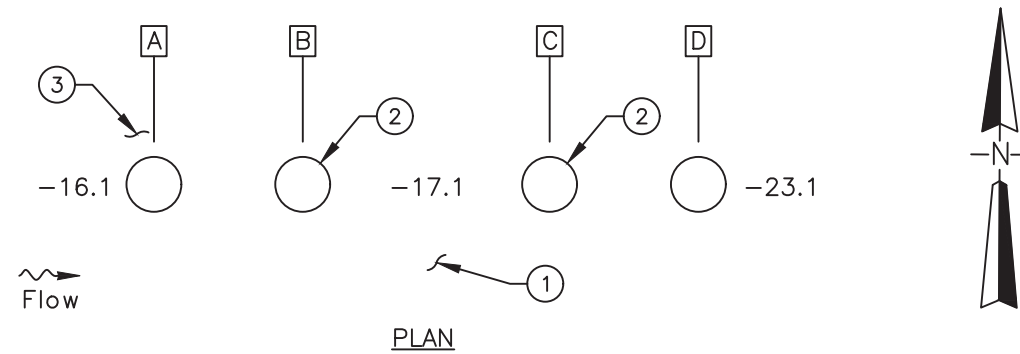
- **Bent 4:**
 - The channel bottom material consisted of riprap and sand infill with no probe rod penetration.
 - The typical steel caisson on typical Columns B and C exhibited moderate corrosion and rust nodules up to 1 in. diameter with pitting up to 1/8 in.

- A scour hole 5 ft diameter by 5 ft deep was observed around the North and South faces of the upstream nose at Column A.

- ① The channel bottom material consisted of riprap and sand infill with no probe rod penetration.
- ② Columns B and C typically exhibited moderate corrosion and rust nodules up to 1 in diameter with pitting up to $\frac{1}{8}$ in.
- ③ A scour hole 5 ft diameter by 5 ft deep was observed around the North and South faces of the upstream nose at Column A.

- Monitor timber debris accumulation at Bents 6 and 17.
- Monitor typical corrosion and rust nodules on steel caissons.
- Monitor scour pockets on Bents 4, 5, and 7.
- Monitor timber piles in fender system

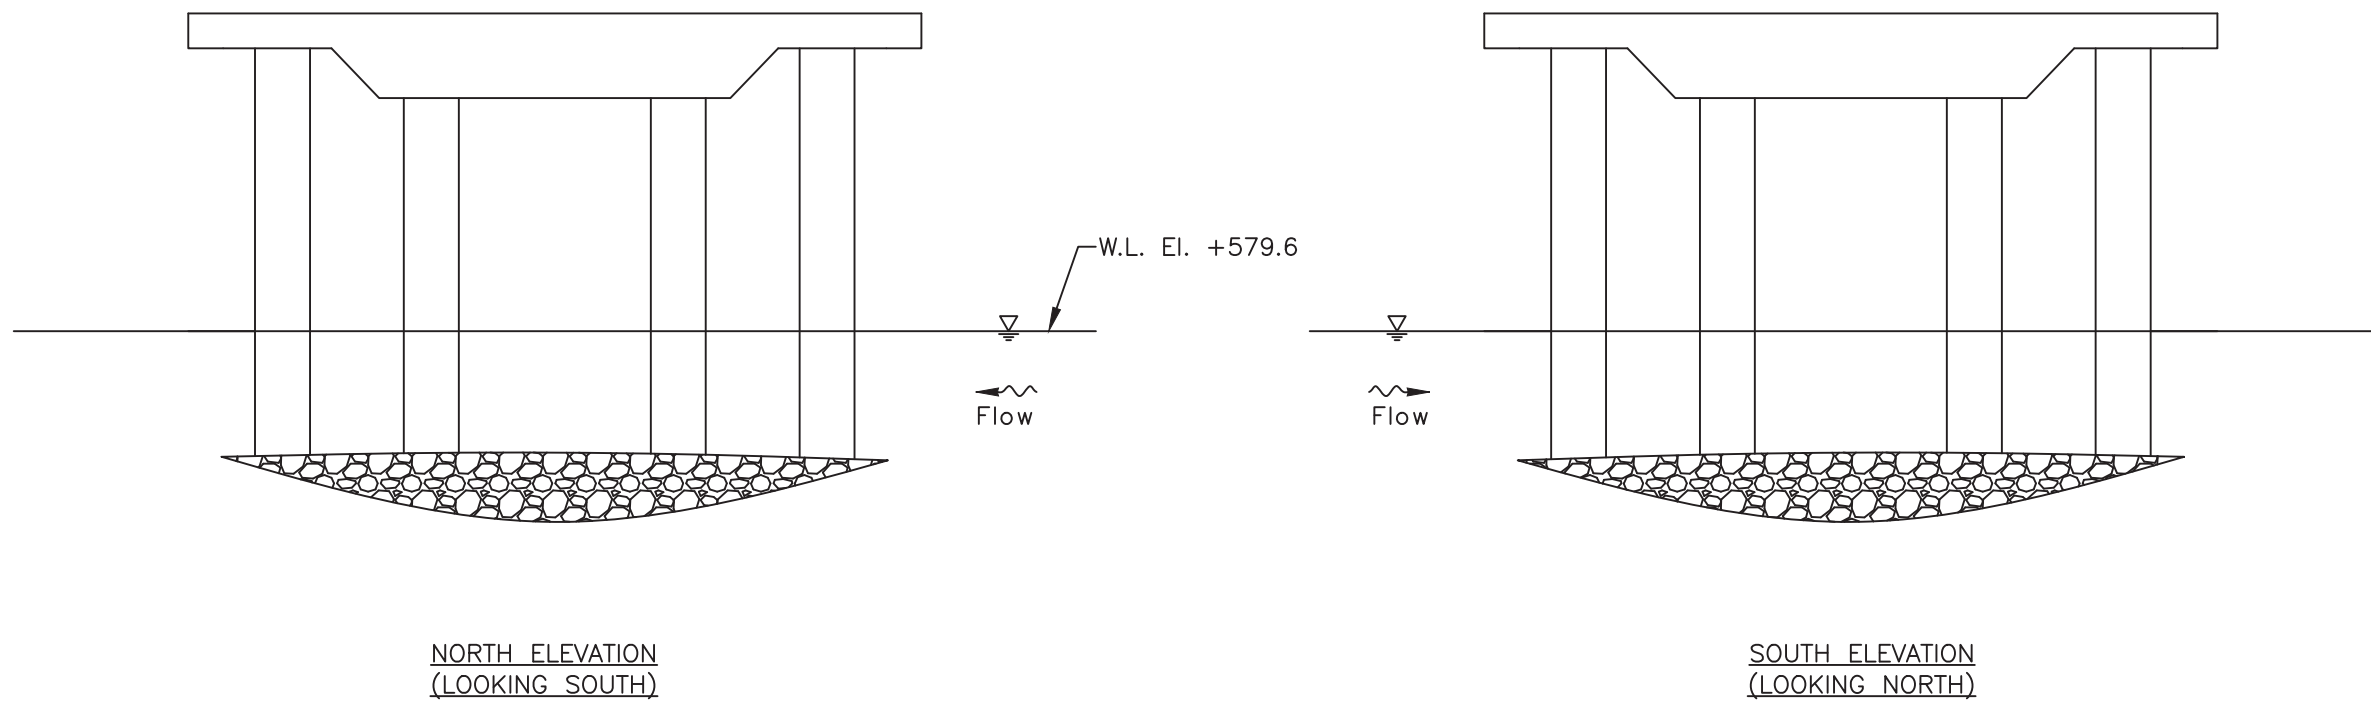
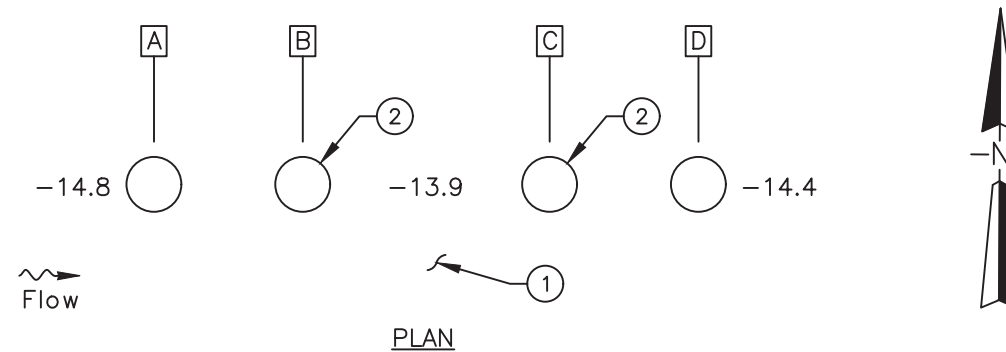
SR-2 OVER SANDUSKY BAY
 STRUCTURE NO. 6200788 (OTT-2-2839)
 BENT 13
 OTTAWA COUNTY, OHIO

-
- **Bent 13:**
 - The channel bottom material consisted of riprap and sand infill with no probe rod penetration.
 - The typical steel caisson on typical Columns B and C exhibited moderate corrosion and rust nodules up to 1 in. diameter with pitting up to 1/8 in.

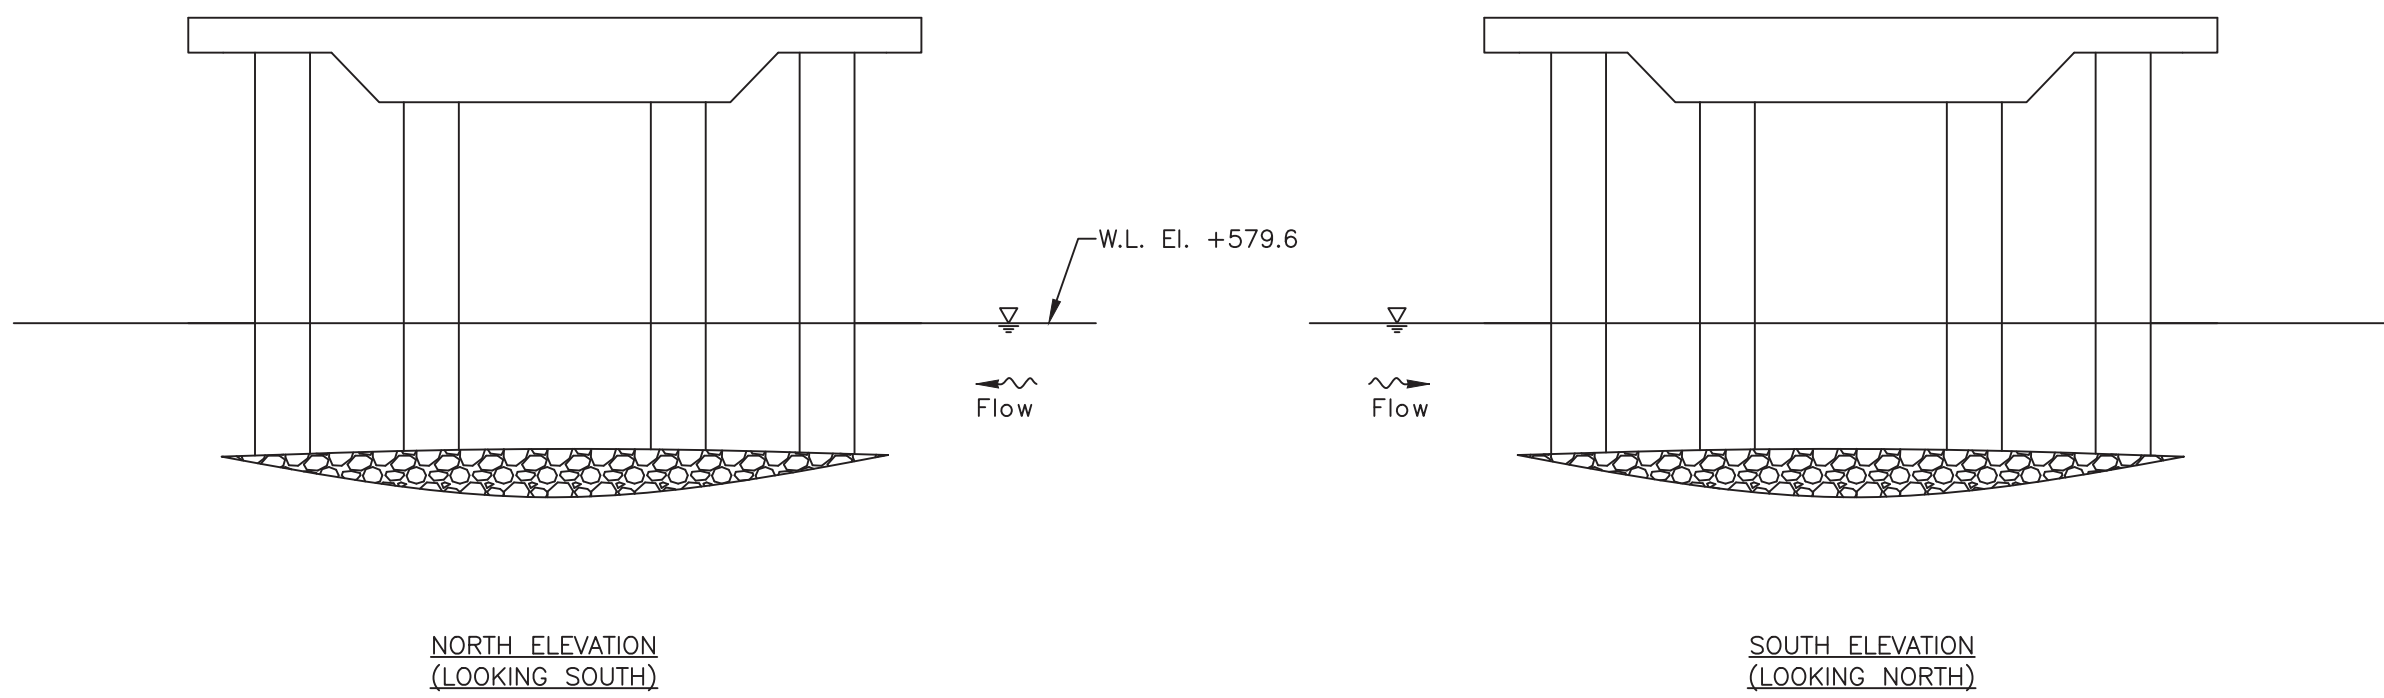
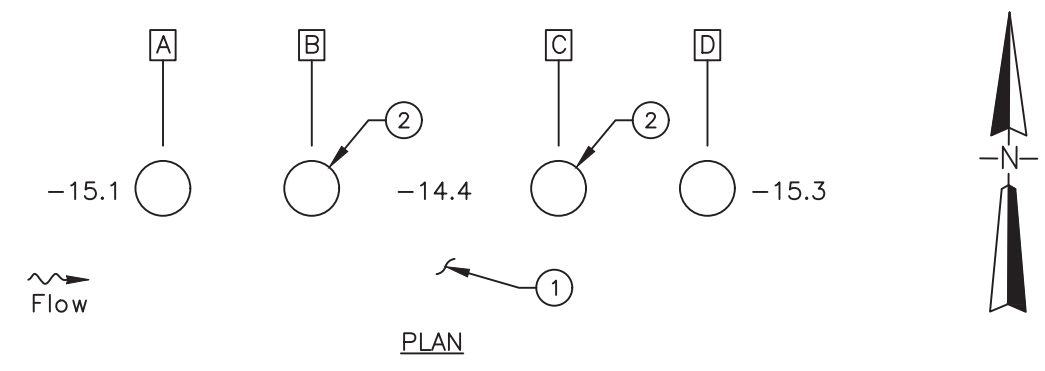
- ① The channel bottom material consisted of riprap and sand infill with no probe rod penetration.
- ② Columns B and C typically exhibited moderate corrosion and rust nodules up to 1 in diameter with pitting up to 1/8 in.

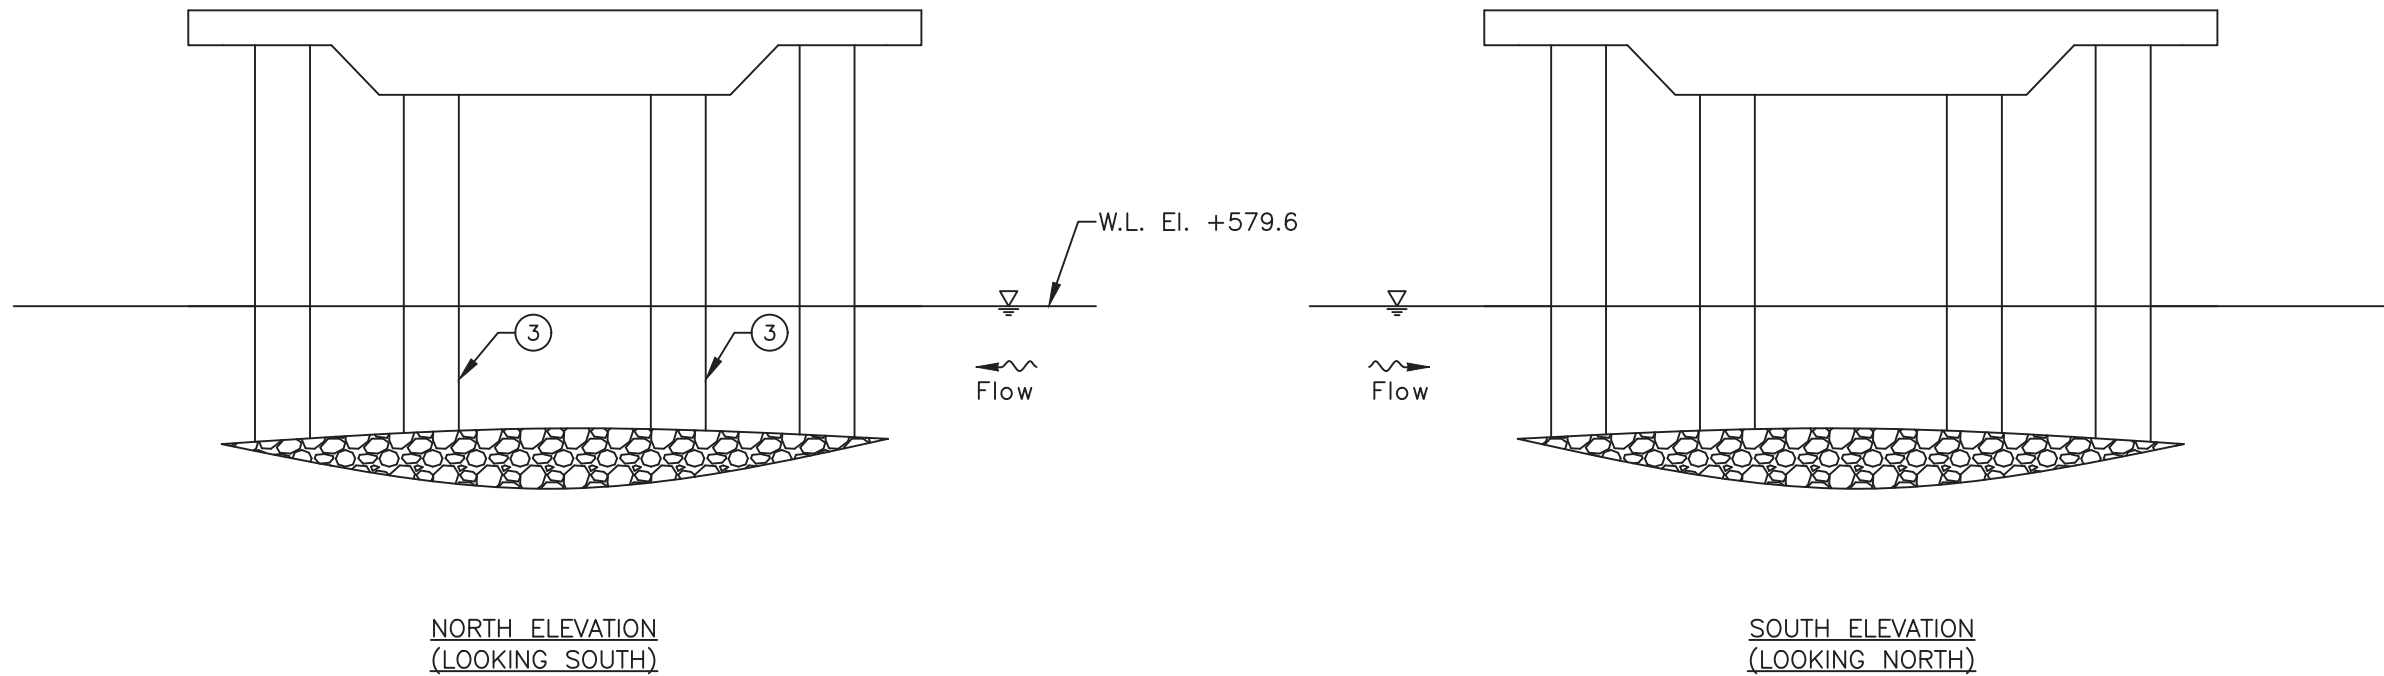
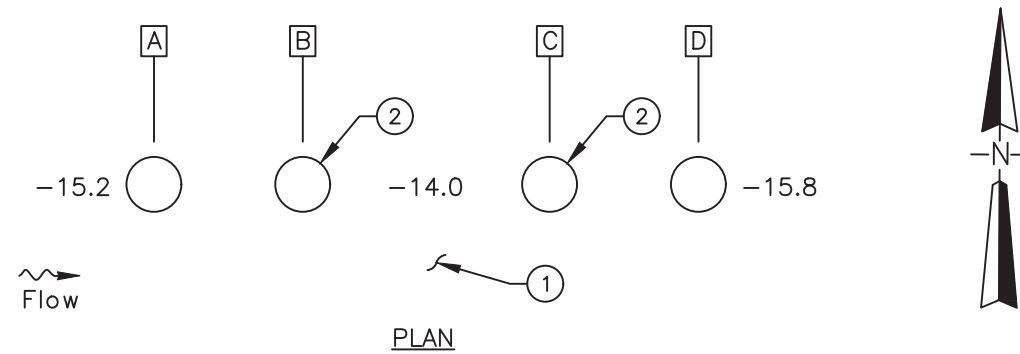
SR-2 OVER SANDUSKY BAY
 STRUCTURE NO. 6200788 (OTT-2-2839)
 BENT 15
 OTTAWA COUNTY, OHIO

- ① The channel bottom material consisted of riprap and sand infill with no probe rod penetration.
- ② Columns B and C typically exhibited moderate corrosion and rust nodules up to 1 in diameter with pitting up to $\frac{1}{8}$ in.
- ③ A 2 ft vertical concrete jacket was observed around Columns B and C beginning at 10.5 ft below waterline and was observed to be in good condition.

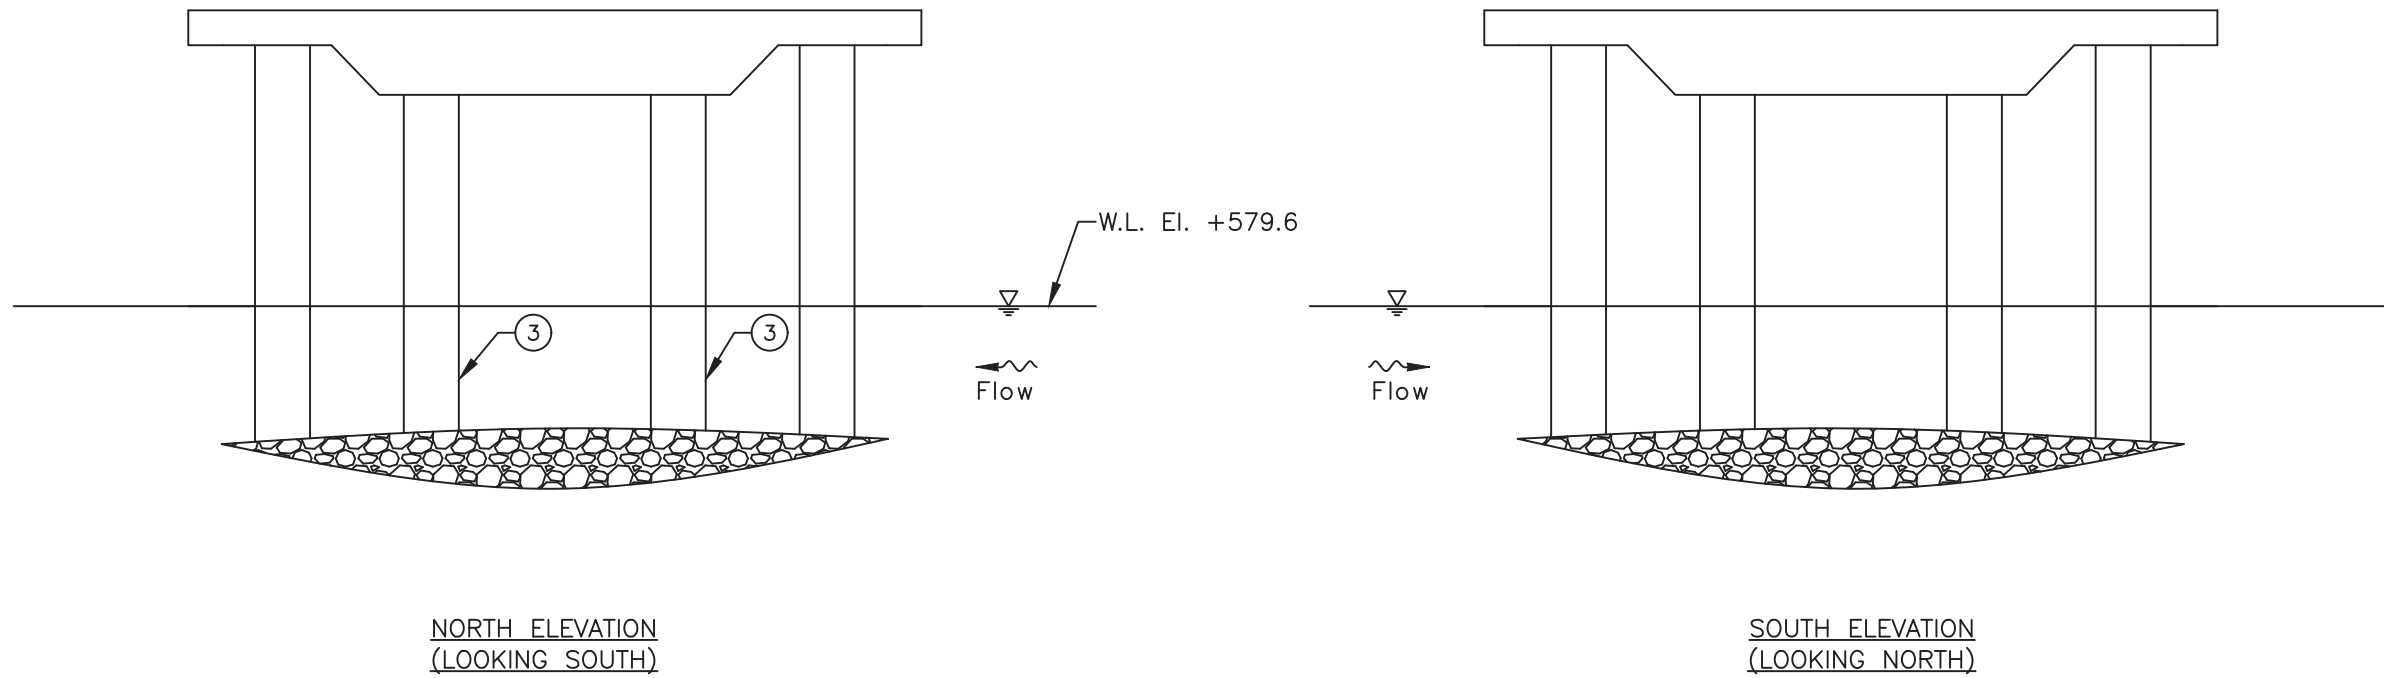
- ① The channel bottom material consisted of riprap and sand infill with no probe rod penetration.
- ② Columns B and C typically exhibited moderate corrosion and rust nodules up to 1 in diameter with pitting up to $\frac{1}{8}$ in.
- ③ A 2 ft vertical concrete jacket was observed around Columns B and C beginning at 10.5 ft below waterline and was observed to be in good condition.

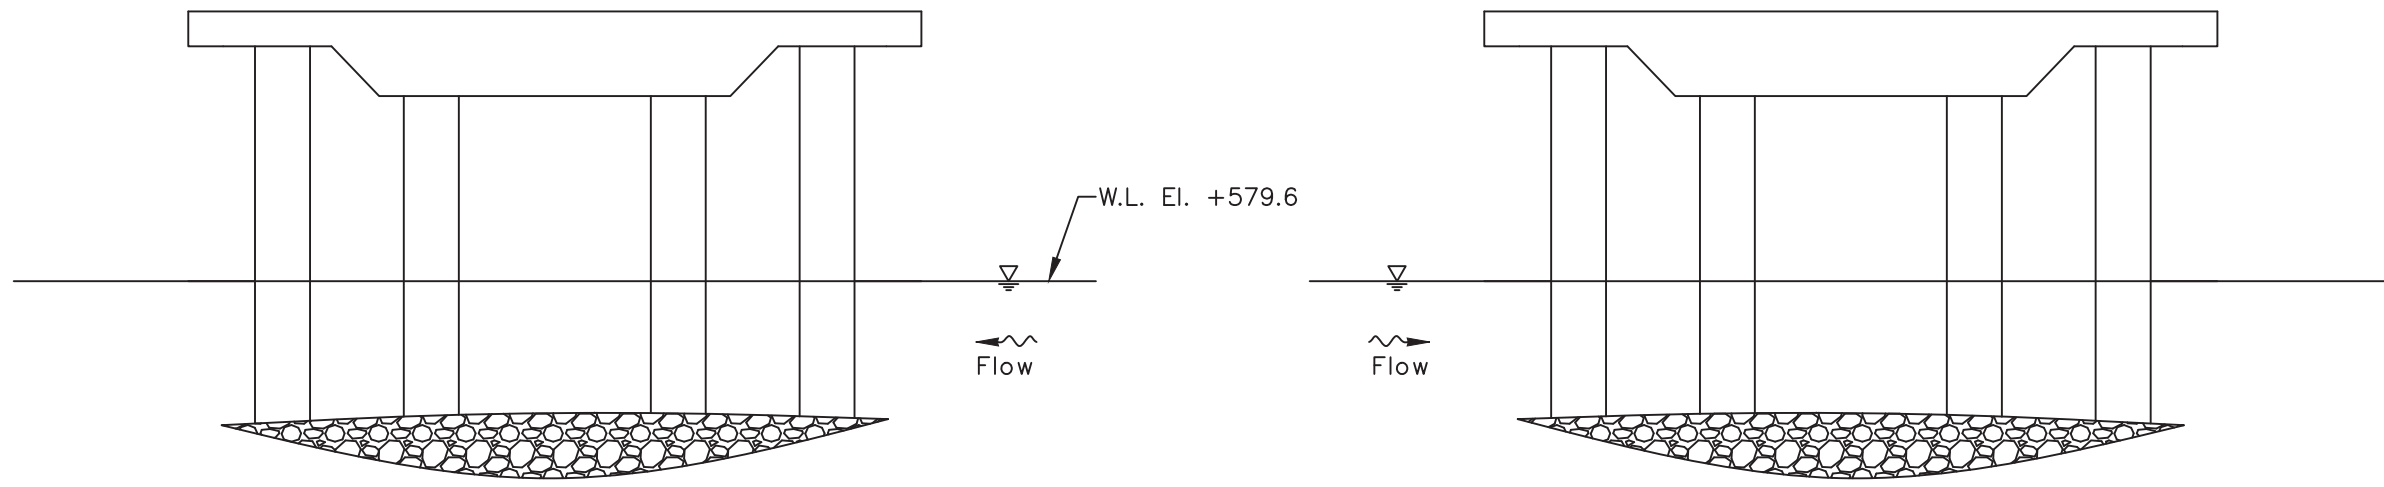
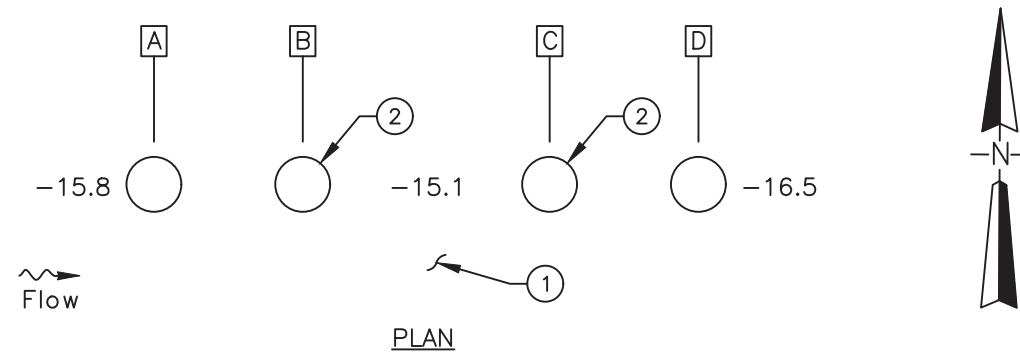
- ① The channel bottom material consisted of riprap and sand infill with no probe rod penetration.
- ② Columns B and C typically exhibited moderate corrosion and rust nodules up to 1 in diameter with pitting up to 1/8 in.

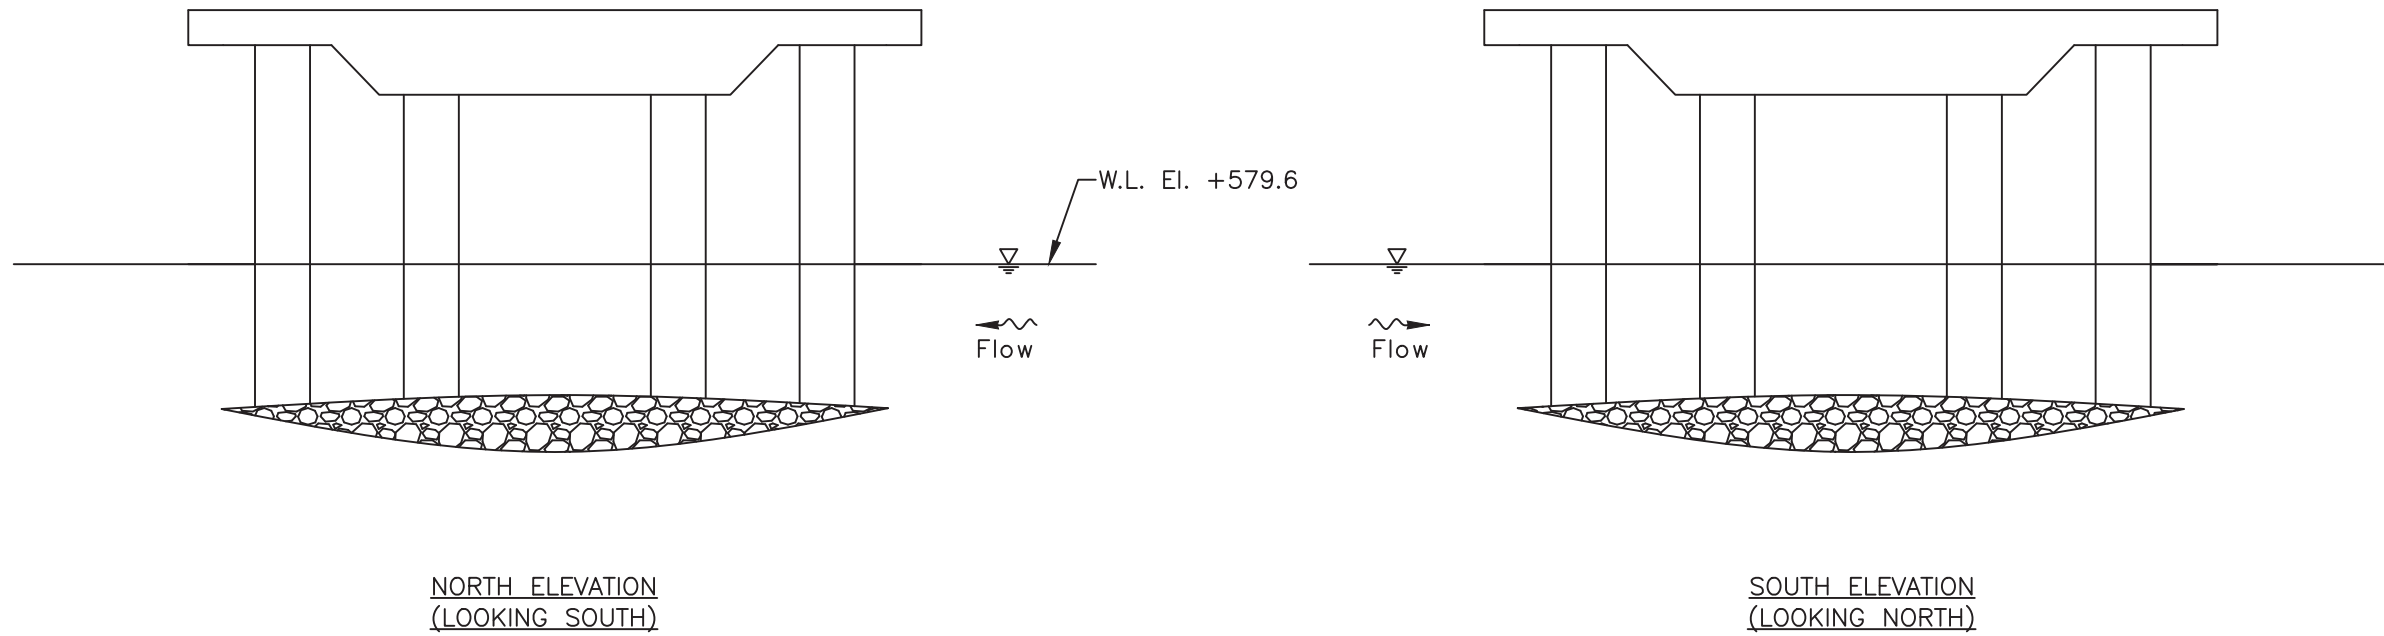
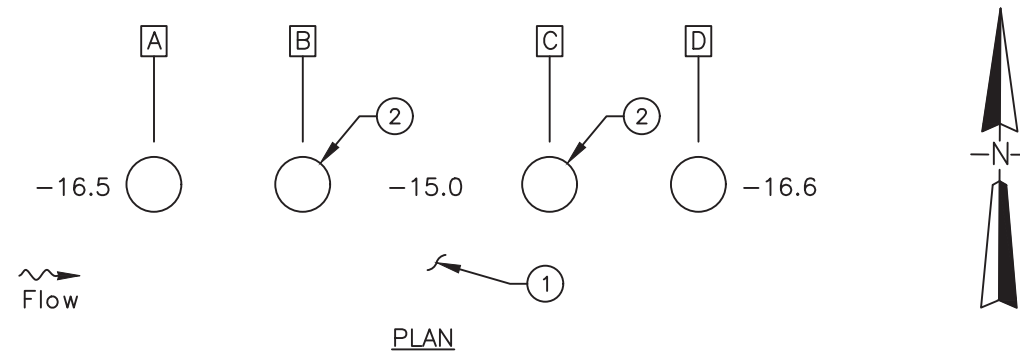
- ① The channel bottom material consisted of riprap and sand infill with no probe rod penetration.
- ② Columns B and C typically exhibited moderate corrosion and rust nodules up to 1 in diameter with pitting up to 1/8 in.

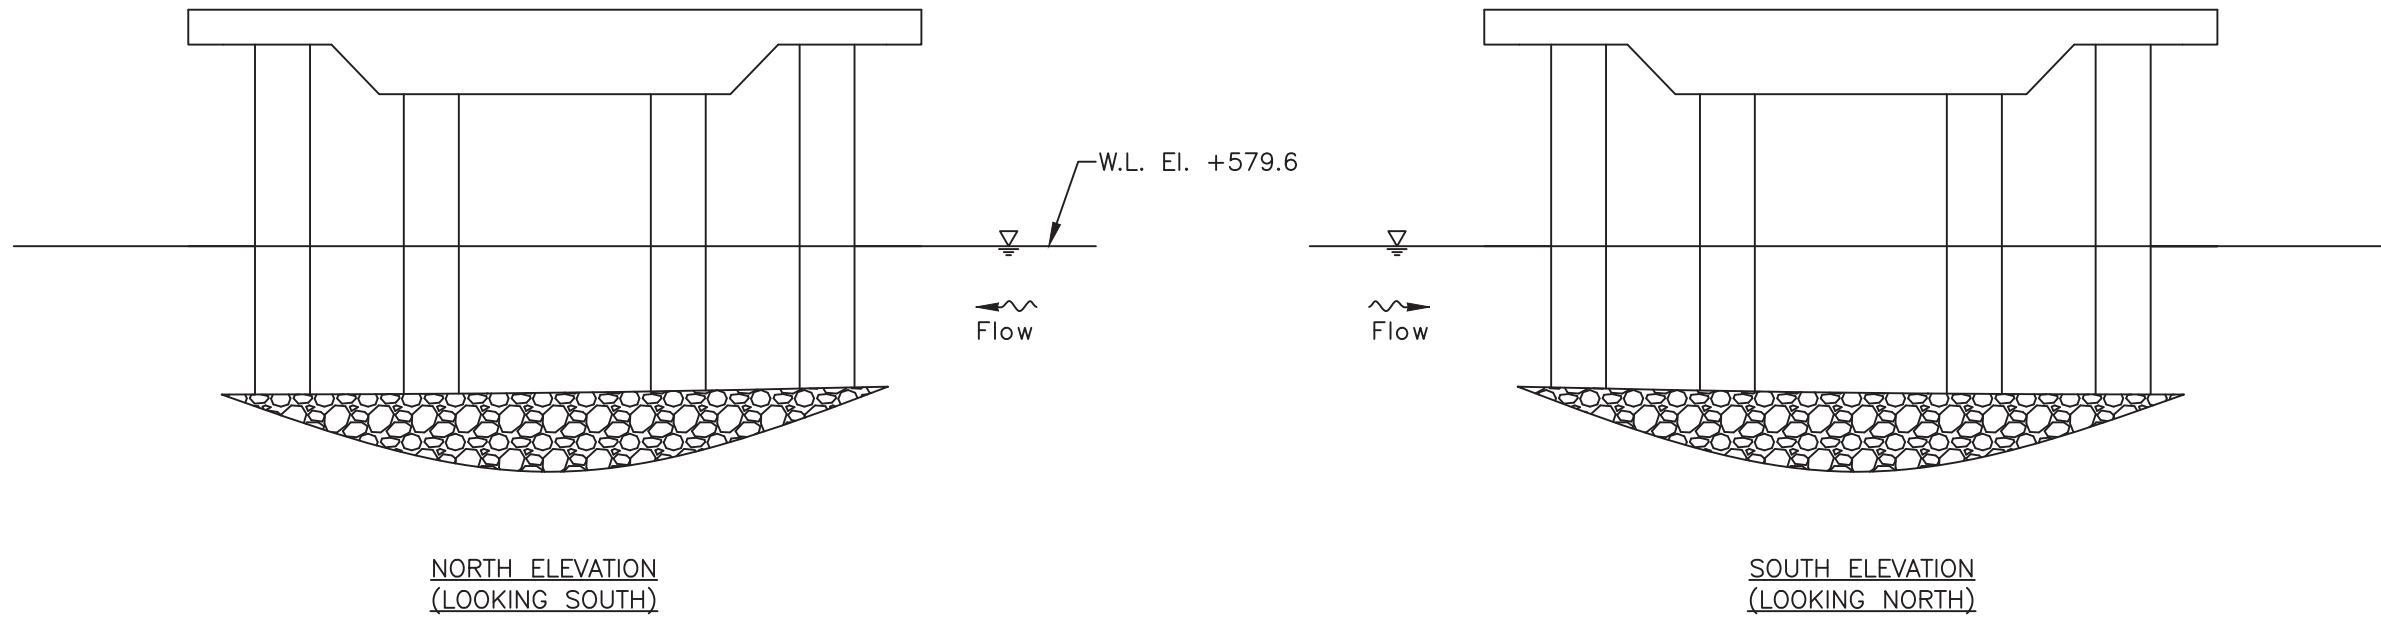
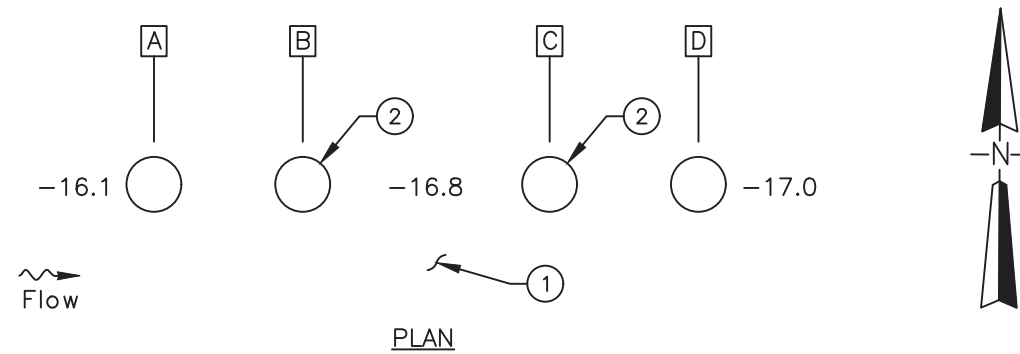
- ① The channel bottom material consisted of riprap and sand infill with no probe rod penetration.
- ② Columns B and C typically exhibited moderate corrosion and rust nodules up to 1 in diameter with pitting up to $\frac{1}{8}$ in.

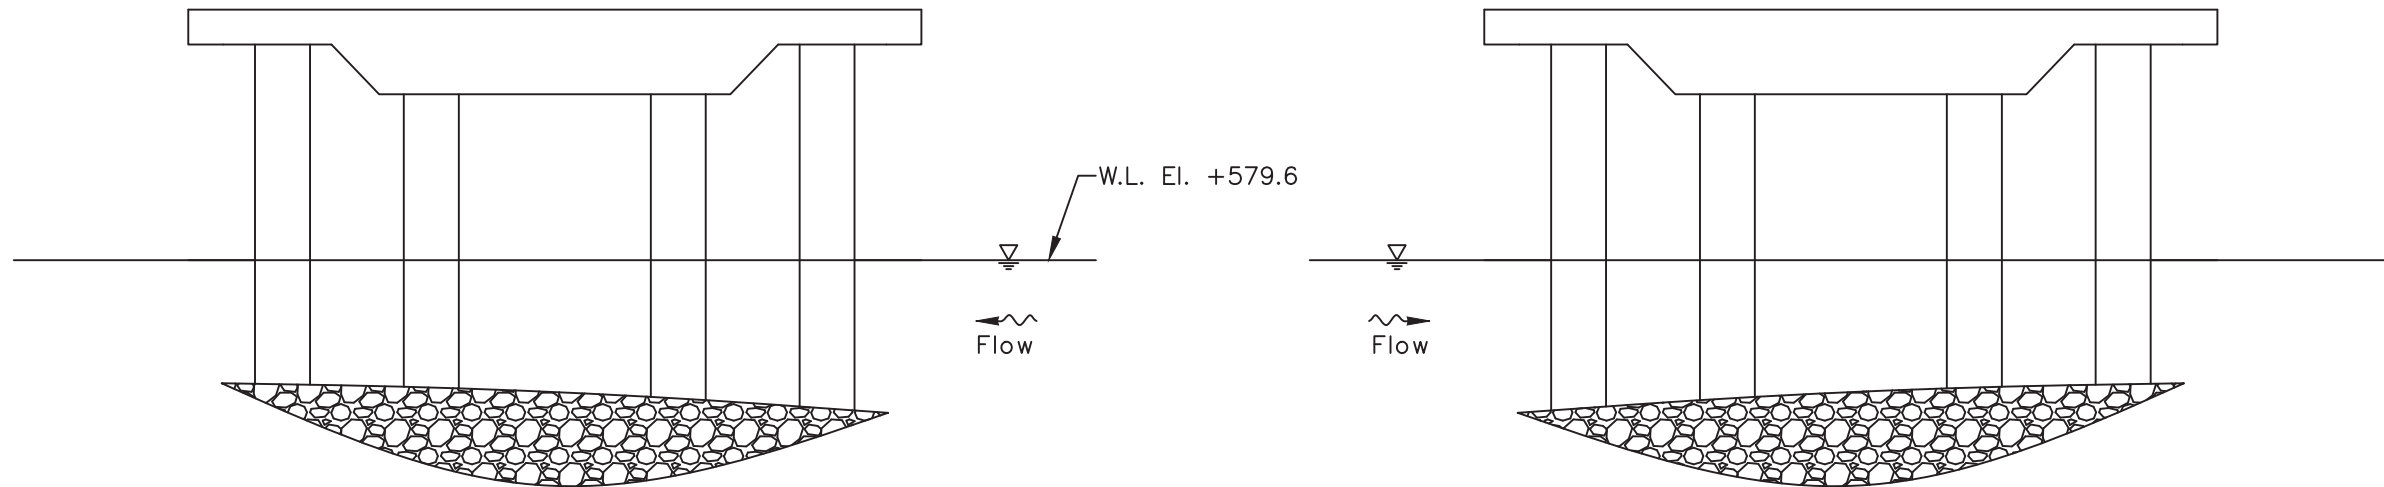
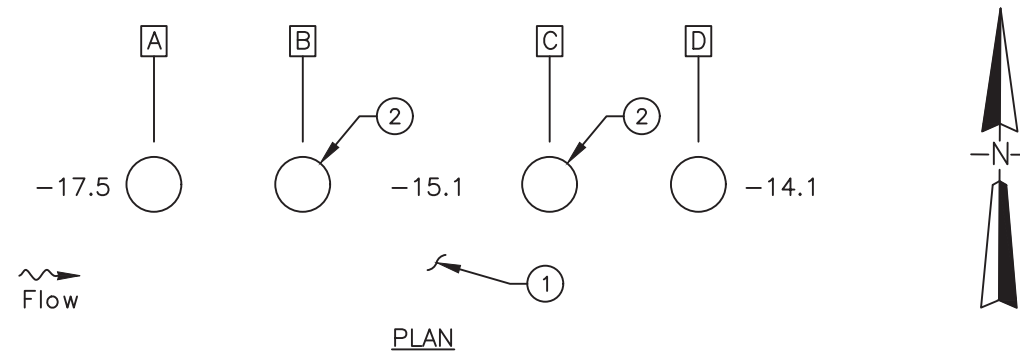
- ① The channel bottom material consisted of riprap and sand infill with no probe rod penetration.
- ② Columns B and C typically exhibited moderate corrosion and rust nodules up to 1 in diameter with pitting up to 1/8 in.
