UNDERWATER BRIDGE INSPECTION REPORT

STRUCTURE NO. 6200788 (OTT-2-2839)
SR 2 OVER SANDUSKY BAY
OTTAWA COUNTY, OH
DISTRICT 2

May 2020

COLLINS
ENGINEERS INC.

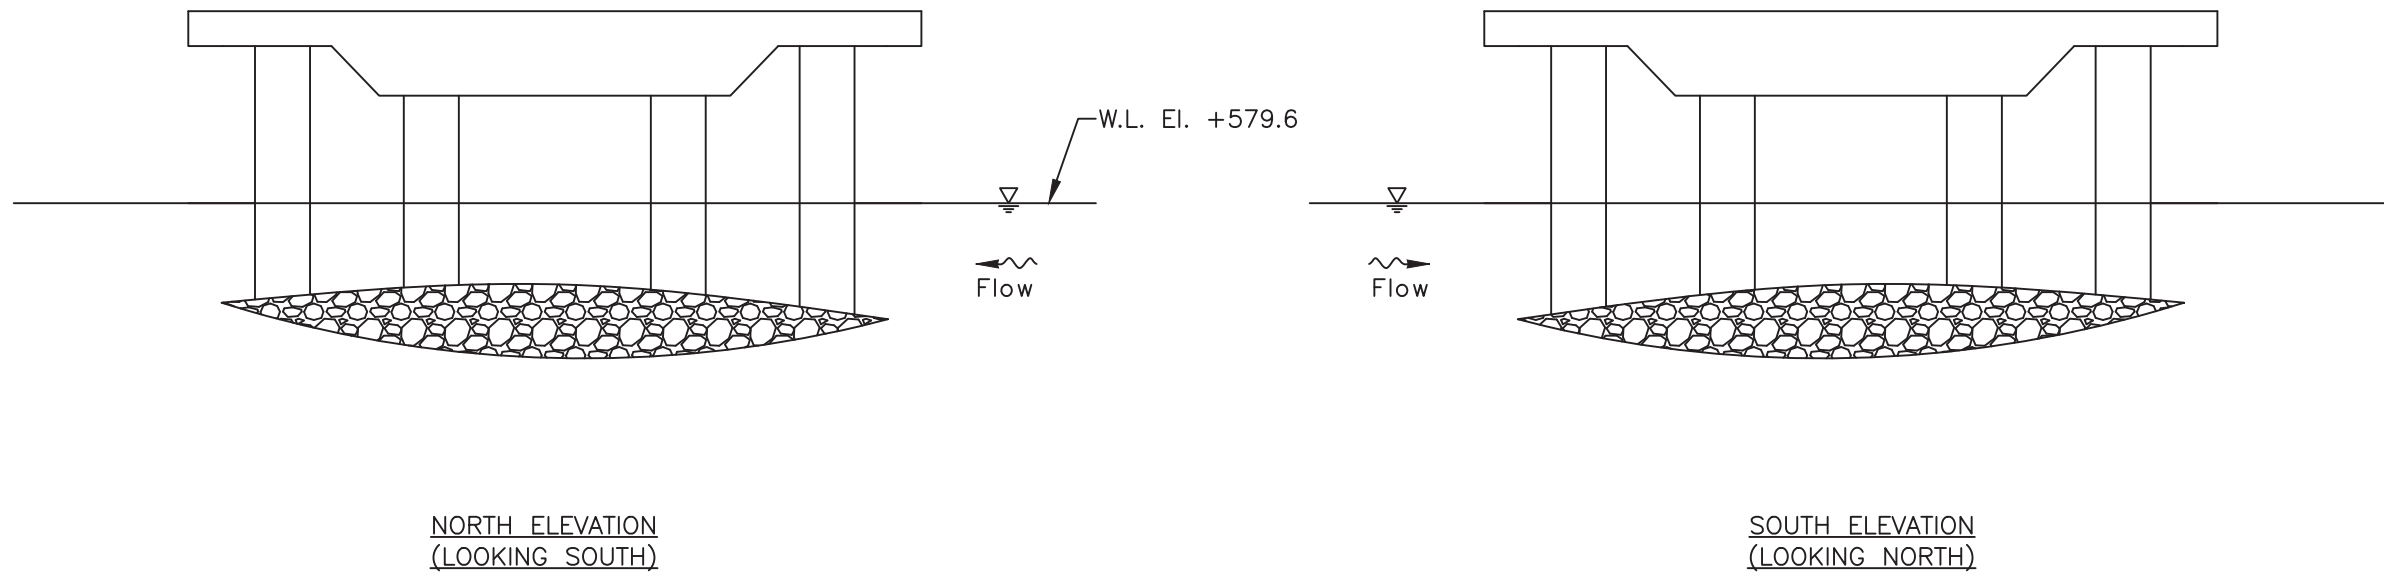
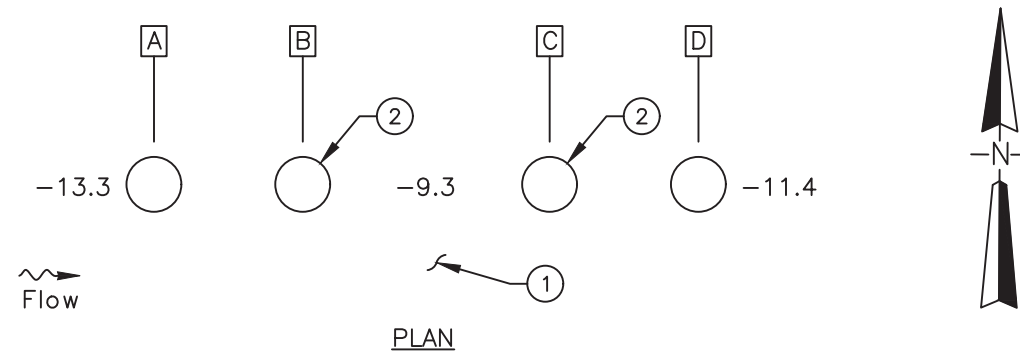
- ① The channel bottom material consisted of riprap and sand infill with no probe rod penetration.
- ② Columns B and C typically exhibited moderate corrosion and rust nodules up to 1 in diameter with pitting up to $\frac{1}{8}$ in.

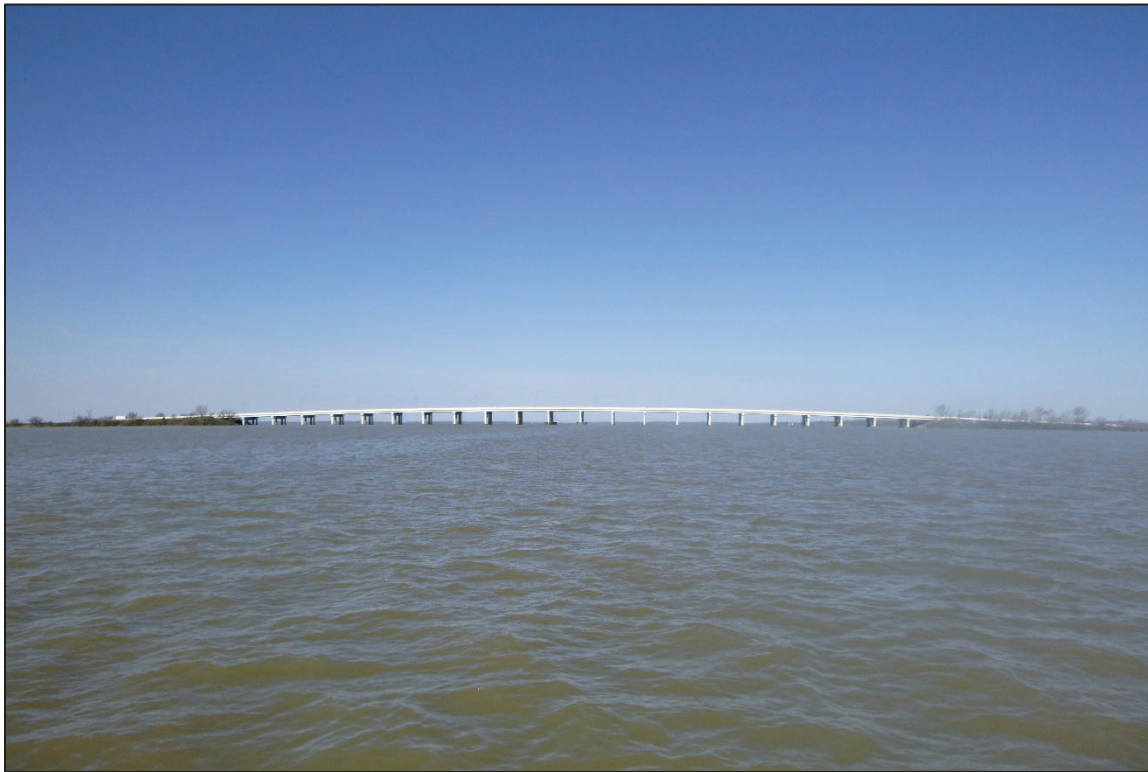
Photograph No. 1: Overall View of Structure No. 6200788 (OTT-2-2839), Looking West.

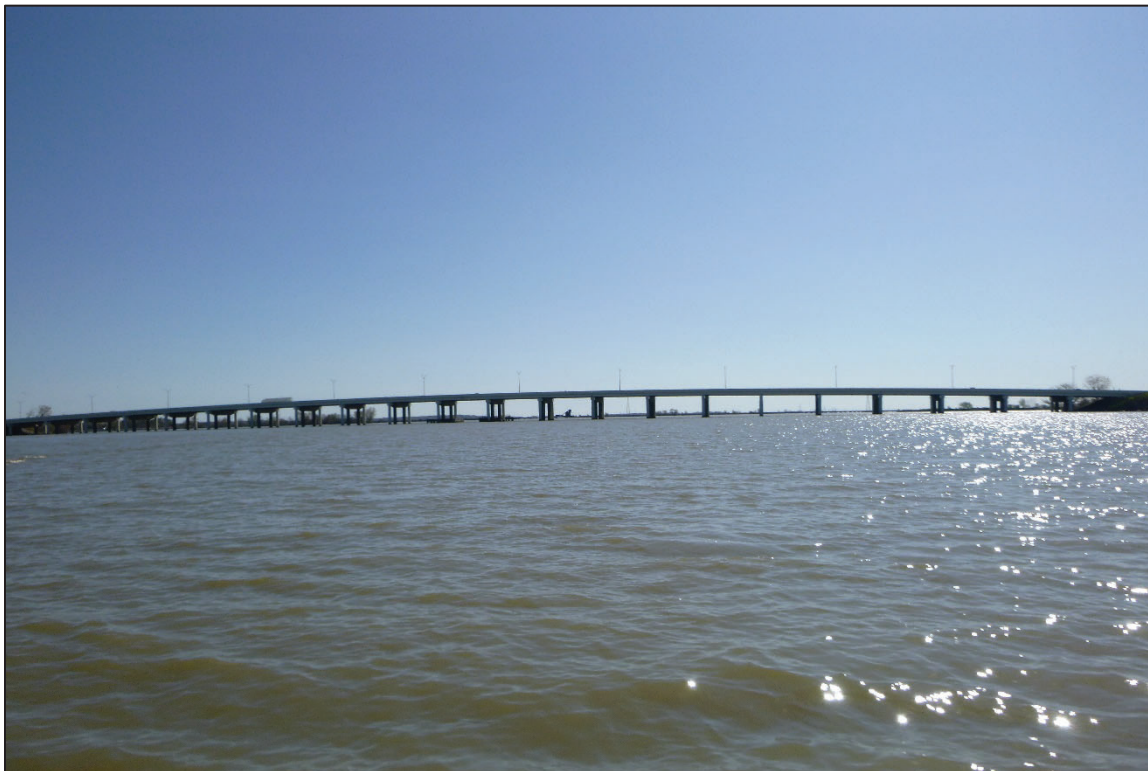
Photograph No. 2: Overall View of Structure No. 6200788 (OTT-2-2839), Looking East.

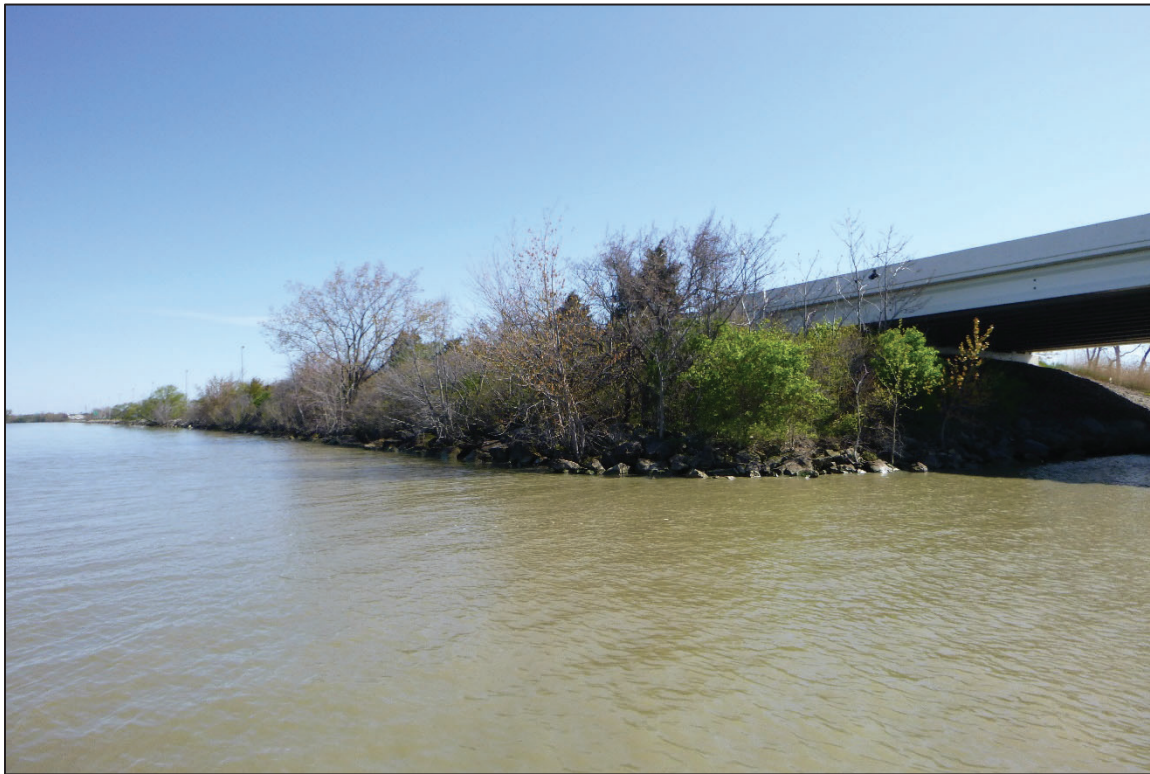
skew was consistent with the channel alignment and does not require attention at this time. The north and south shorelines consisted of sparsely vegetated moderate slopes with no signs of erosion. Refer to Photographs 3 through 8 in Exhibit 2 for views of the shorelines near the structure.

Photograph No. 3: View of the North Embankment Upstream of the Structure, Looking Northeast.

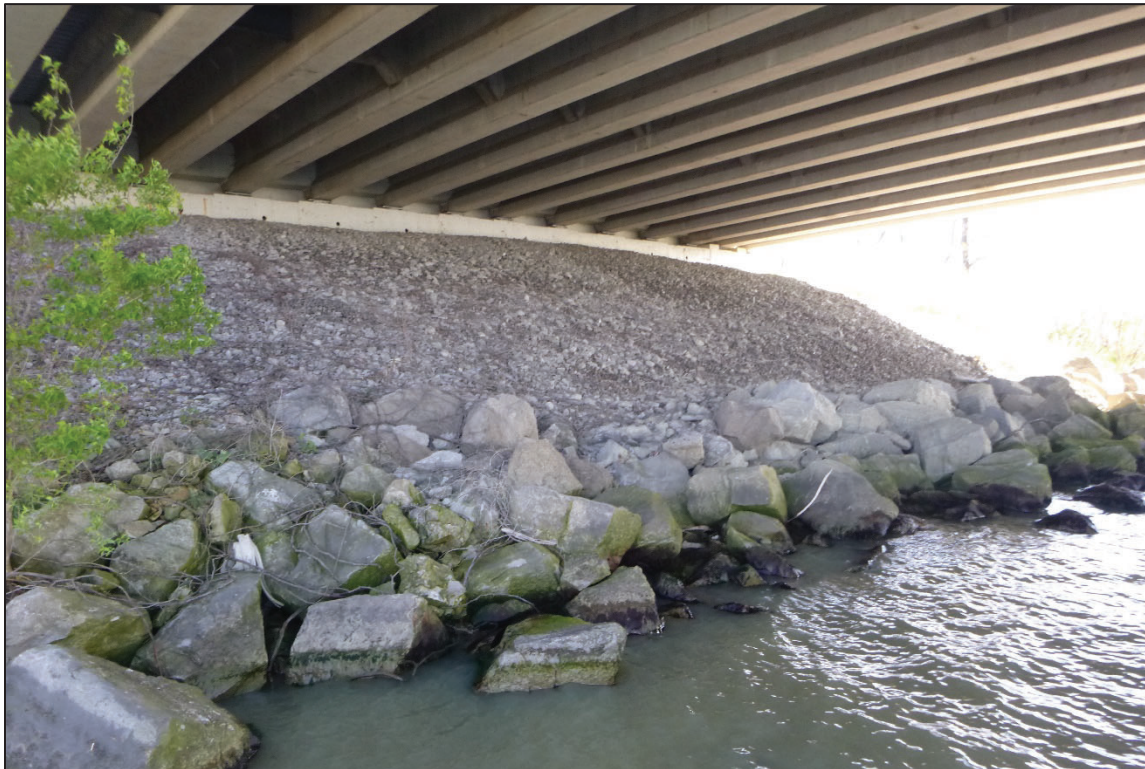
Photograph No. 4: View of the North Embankment at the Structure, Looking Northeast.

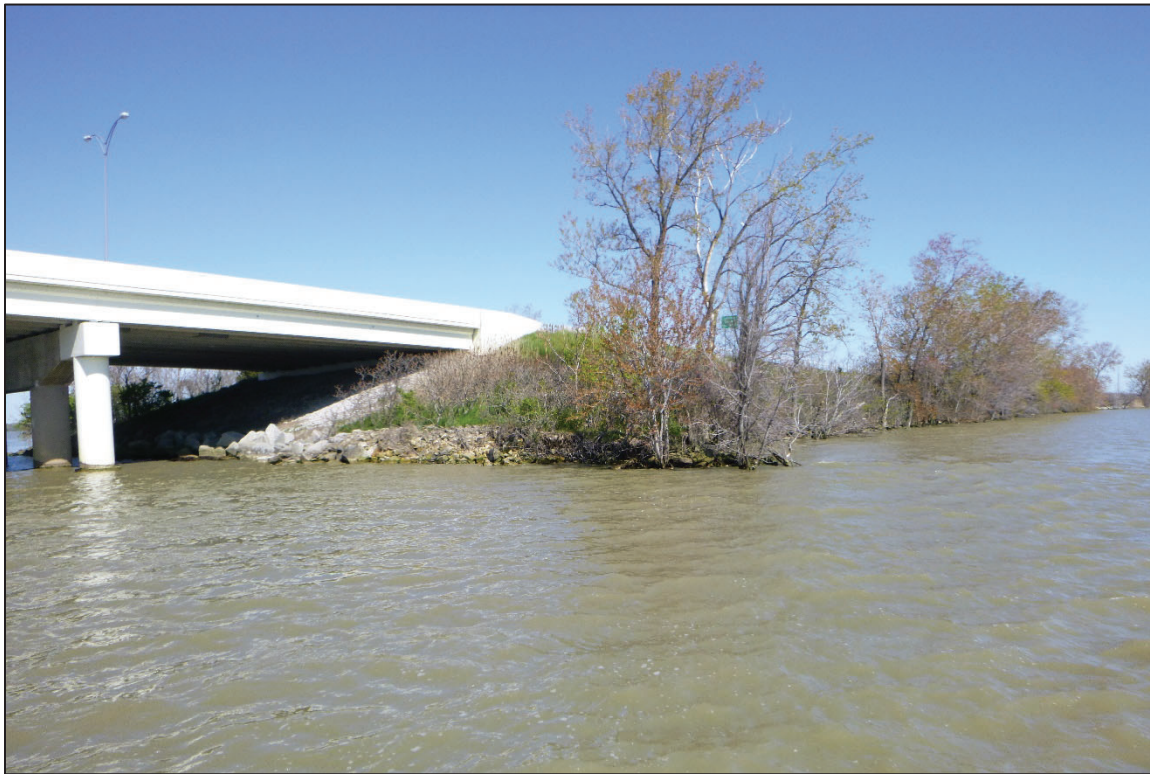
Photograph No. 5: View of the North Embankment Downstream of the Structure, Looking Northwest.

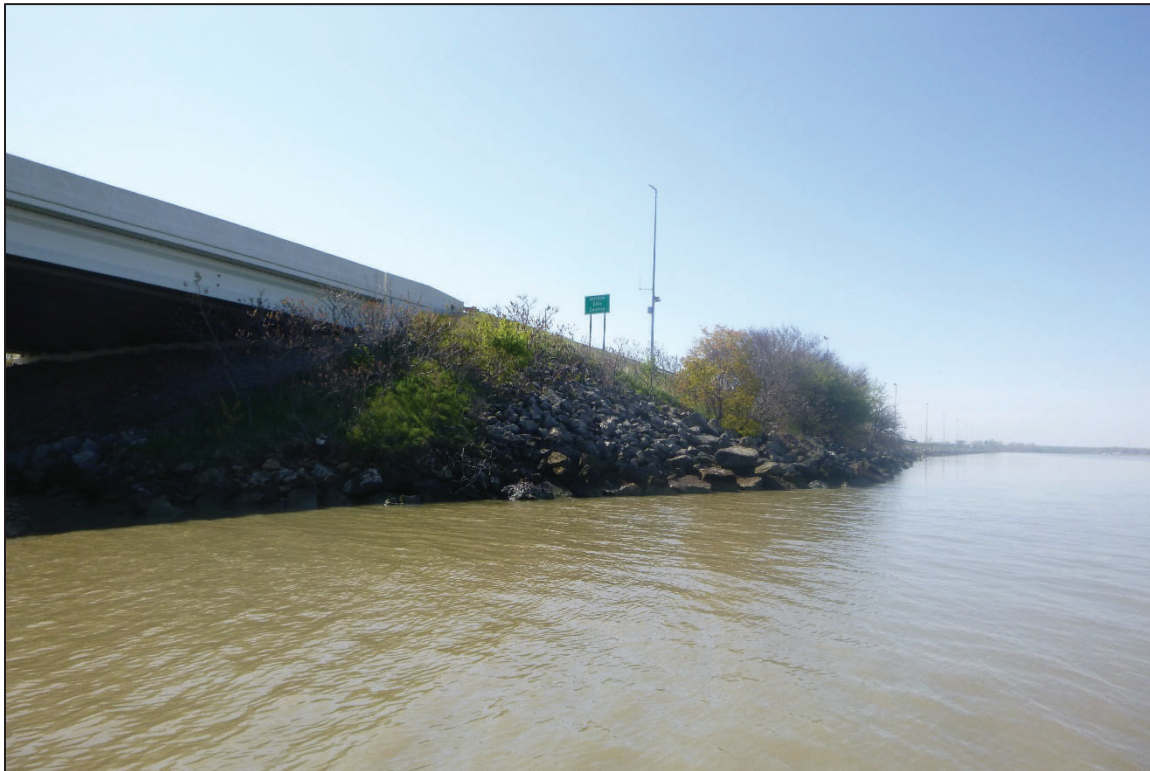
Photograph No. 6: View of the South Embankment Upstream of the Structure, Looking Southeast.

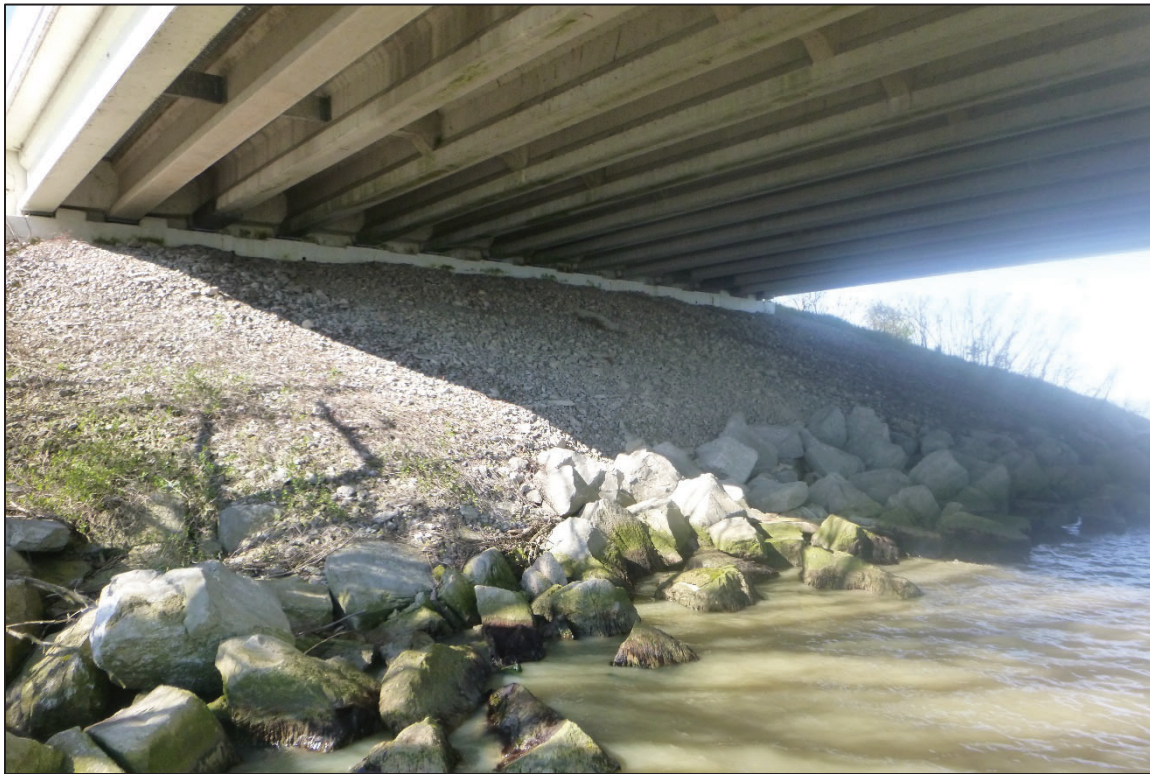
Photograph No. 7: View of the South Embankment at the Structure, Looking Southwest.

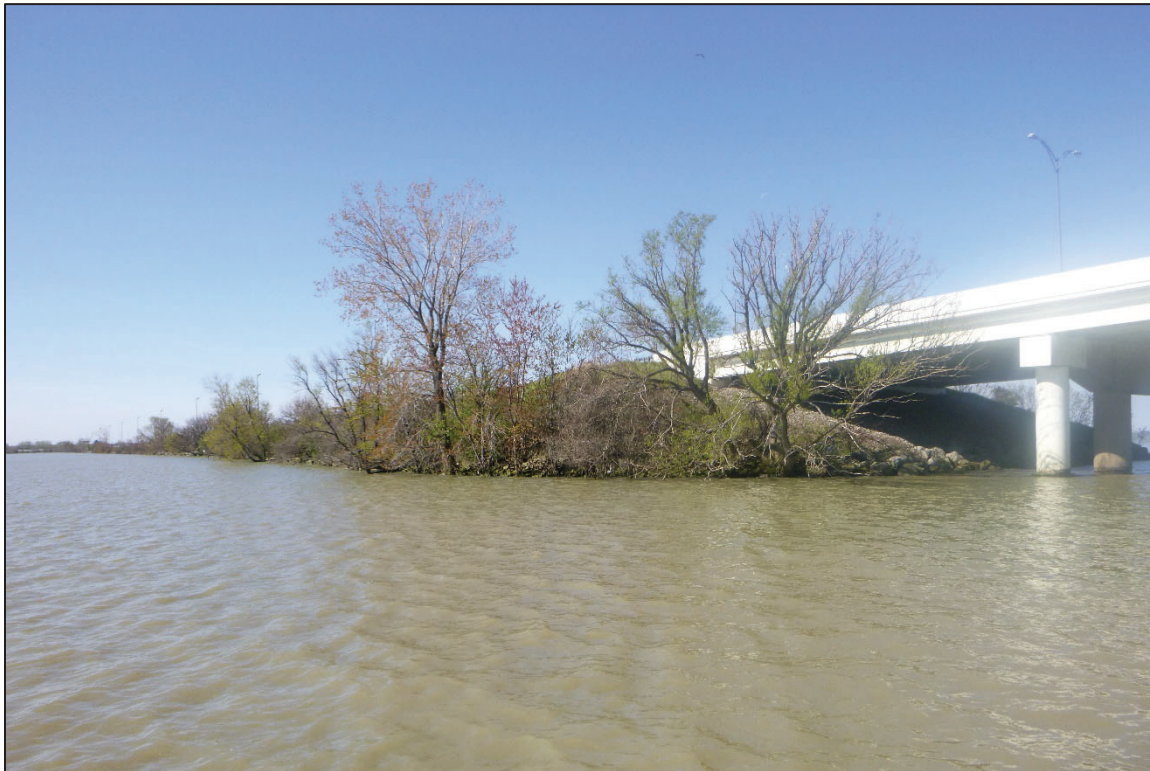
Photograph No. 8: View of the South Embankment Downstream of the Structure, Looking Southwest.

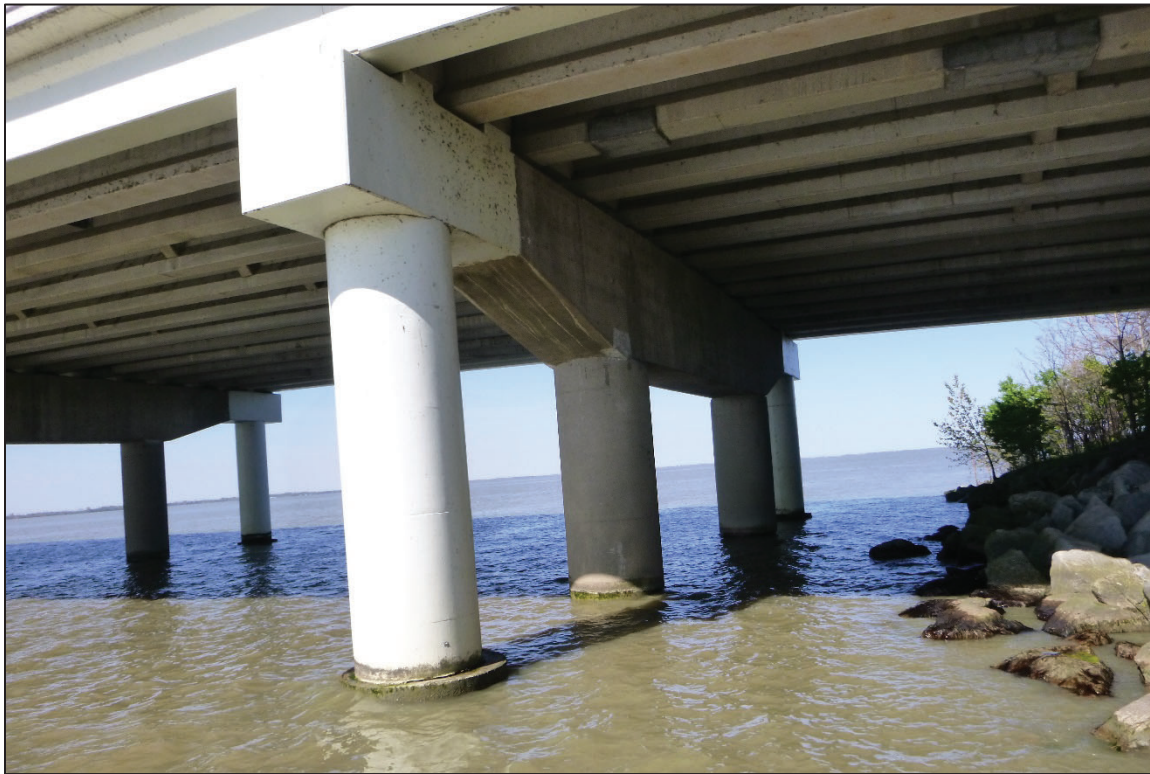
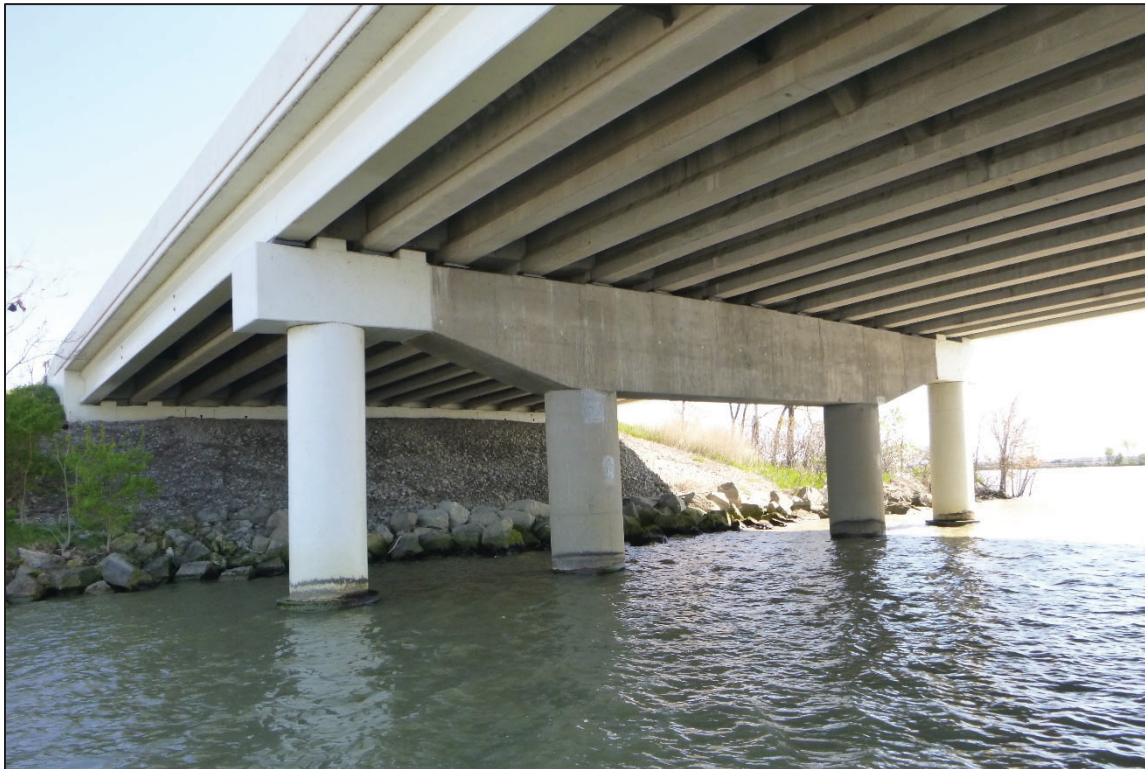
The channel bottom material around Bent 1 consisted of riprap and sand infill with no probe rod penetration. The typical steel caisson on typical Columns B and C exhibited moderate corrosion and rust nodules up to 1 in. diameter with pitting up to 1/8 in. Refer to Figure 20 in Exhibit 1 for detailed inspection notes of Bent 1. Refer to Photographs 9 and 10 in Exhibit 2 for views of Bent 1.

Photograph No. 9: View of the North Face of Bent 1, Looking Southwest.

Photograph No. 10: View of the South Face of Bent 1, Looking Northeast.

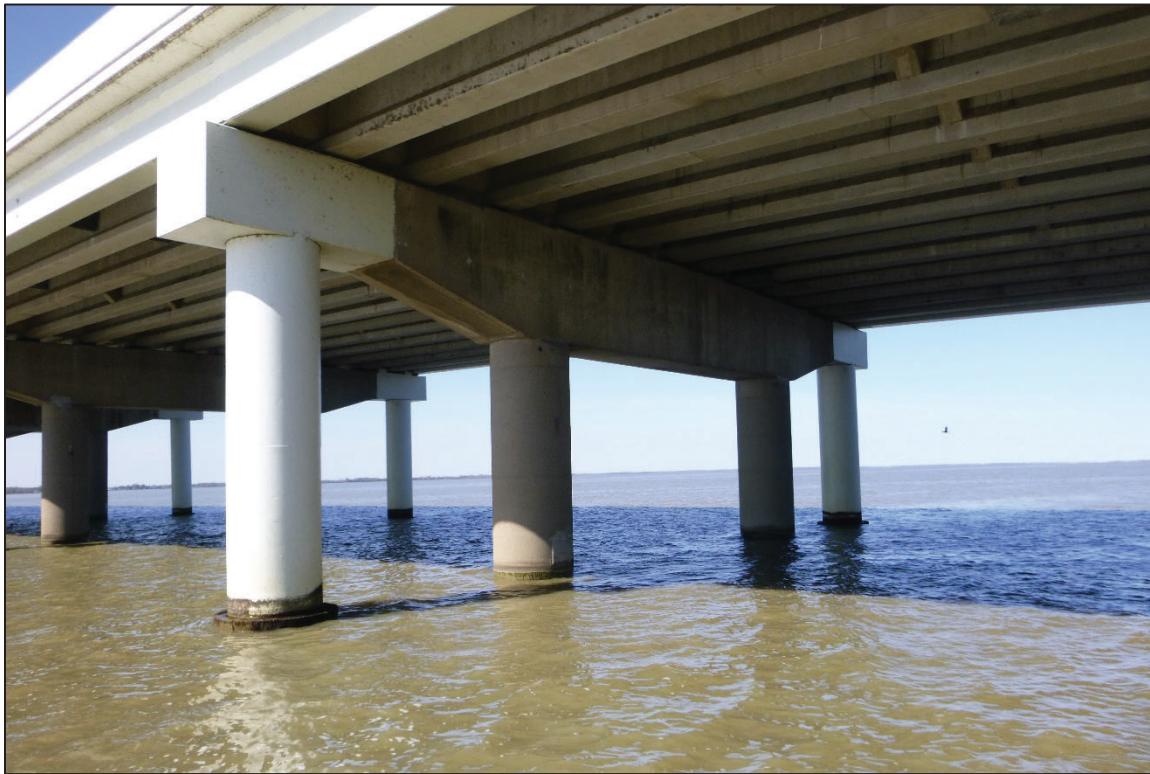
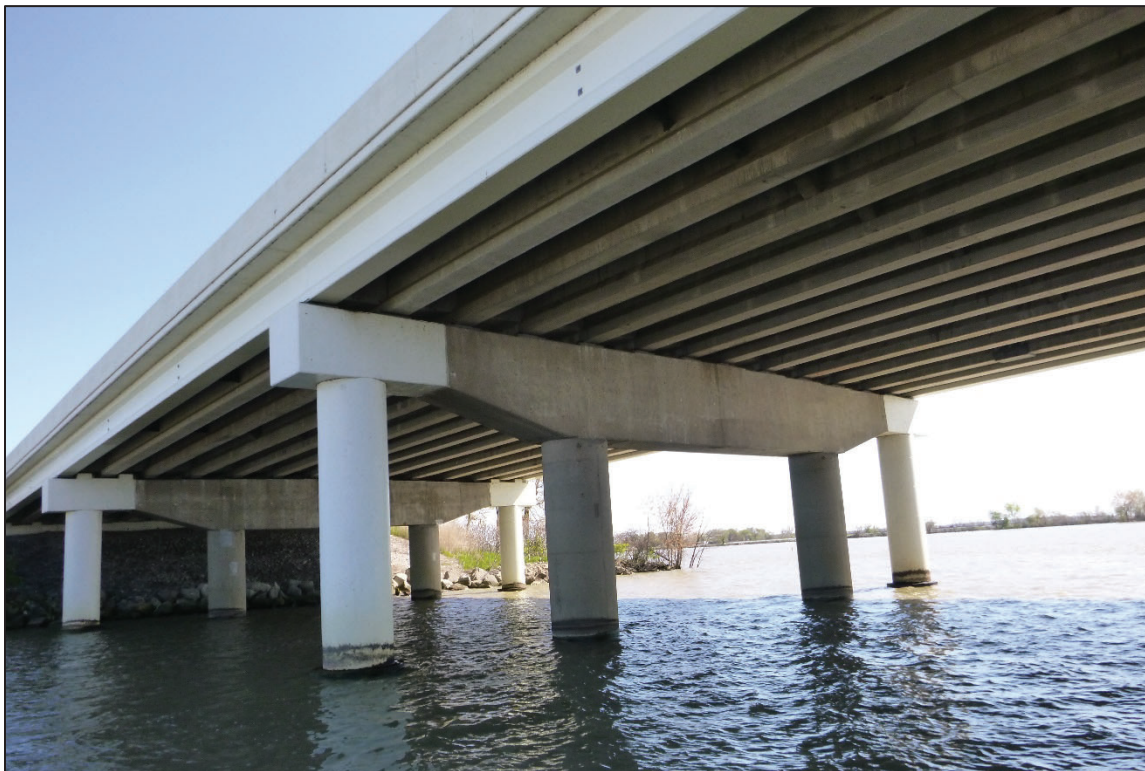
The channel bottom material around Bent 2 consisted of riprap and sand infill with no probe rod penetration. The typical steel caisson on typical Columns B and C exhibited moderate corrosion and rust nodules up to 1 in. diameter with pitting up to 1/8 in. Refer to Figure 21 in Exhibit 1 for detailed inspection notes of Bent 2. Refer to Photographs 11 and 12 in Exhibit 2 for views of Bent 2.

Photograph No. 11: View of the North Face of Bent 2, Looking Southwest.

Photograph No. 12: View of the South Face of Bent 2, Looking Northeast.

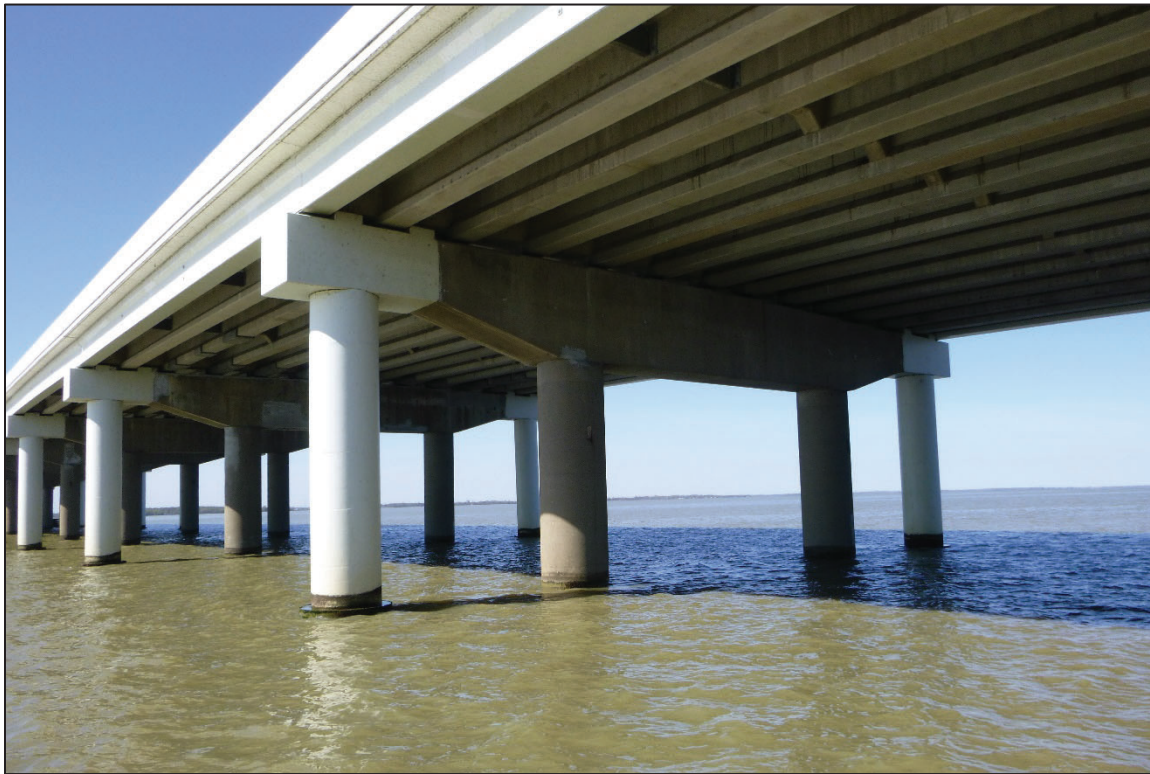
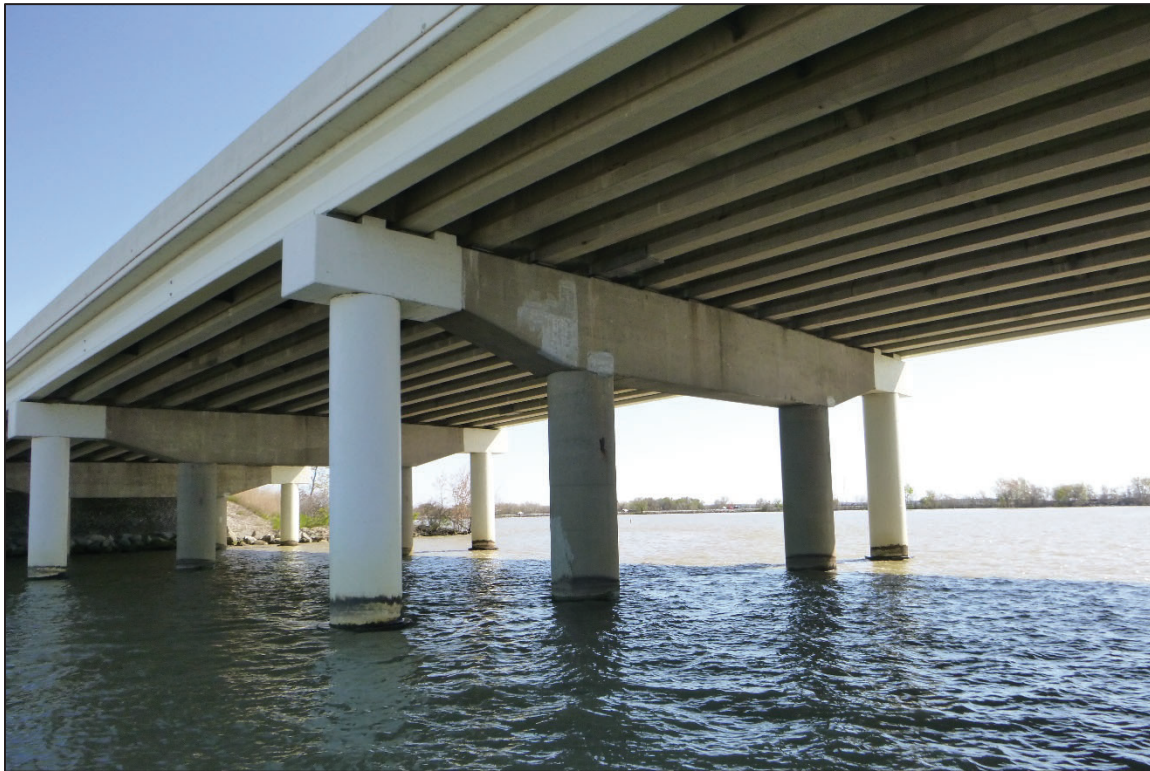
The channel bottom material around Bent 3 consisted of riprap and sand infill with no probe rod penetration. The typical steel caisson on typical Columns B and C exhibited moderate corrosion and rust nodules up to 1 in. diameter with pitting up to 1/8 in. Refer to Figure 22 in Exhibit 1 for detailed inspection notes of Bent 3. Refer to Photographs 13 and 14 in Exhibit 2 for views of Bent 3.

Photograph No. 13: View of the North Face of Bent 3, Looking Southwest.

Photograph No. 14: View of the South Face of Bent 3, Looking Northeast.

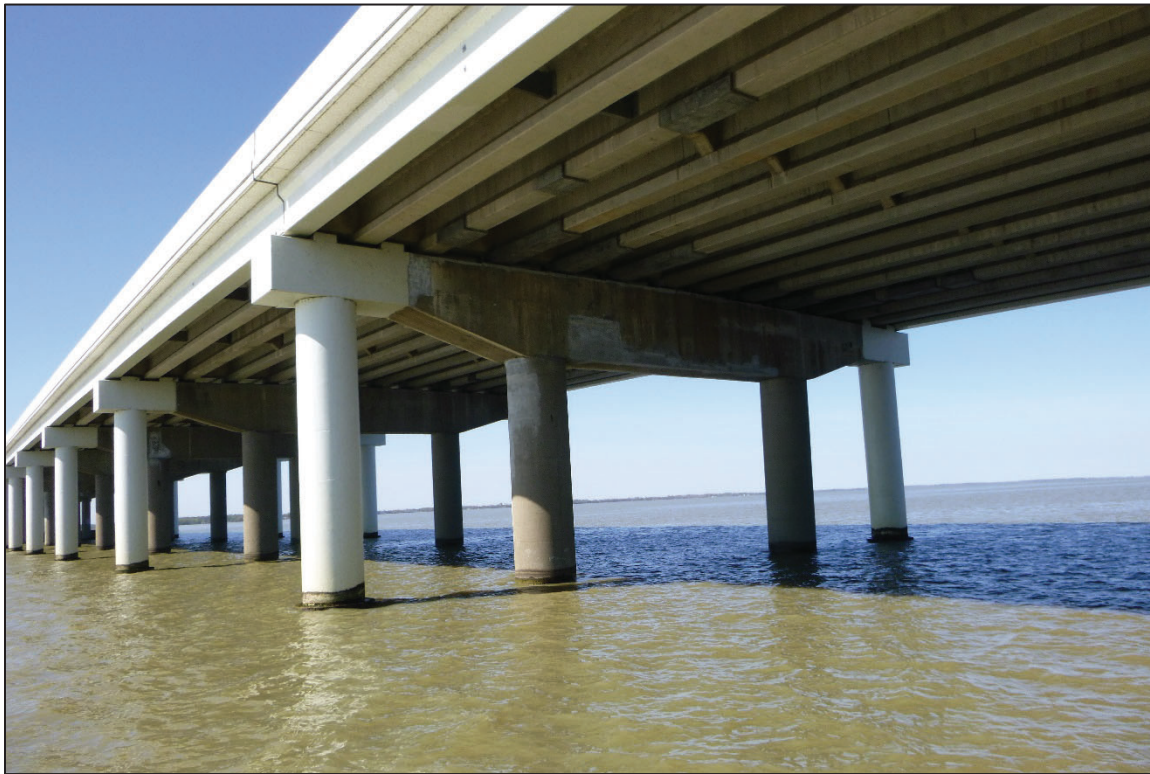
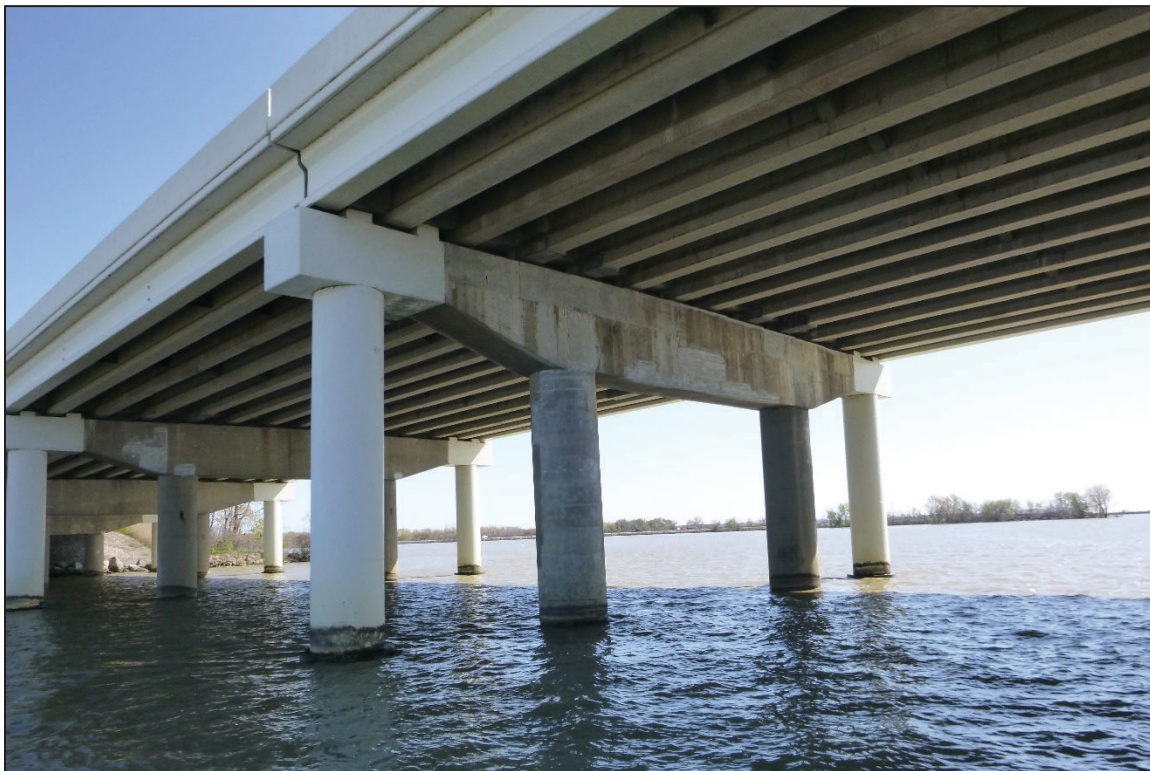
The channel bottom material around Bent 4 consisted of riprap and sand infill with no probe rod penetration. The typical steel caisson on typical Columns B and C exhibited moderate corrosion and rust nodules up to 1 in. diameter with pitting up to 1/8 in. A scour hole 5 ft deep by 5 ft diameter was found around the North and South faces of the upstream nose of Column A. Refer to Figure 23 in Exhibit 1 for detailed inspection notes of Bent 4. Refer to Photographs 15 and 16 in Exhibit 2 for views of Bent 4.

Photograph No. 15: View of the North Face of Bent 4, Looking Southwest.

Photograph No. 16: View of the South Face of Bent 4, Looking Northeast.

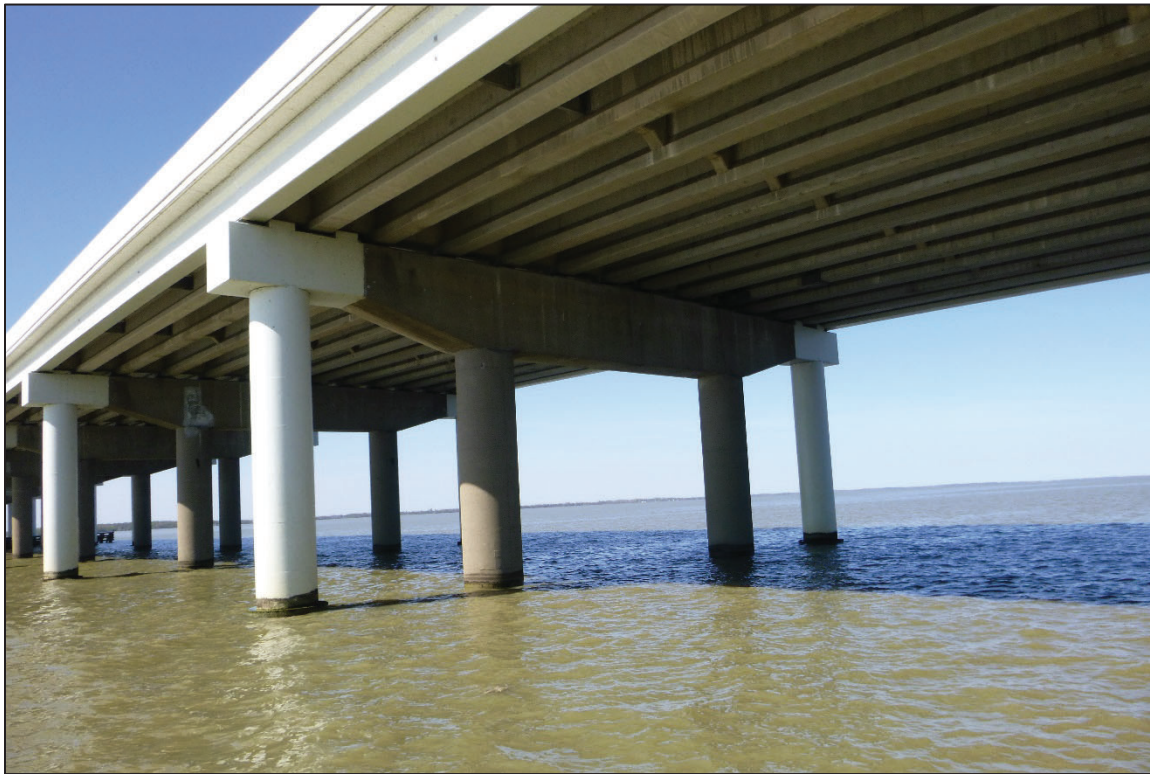
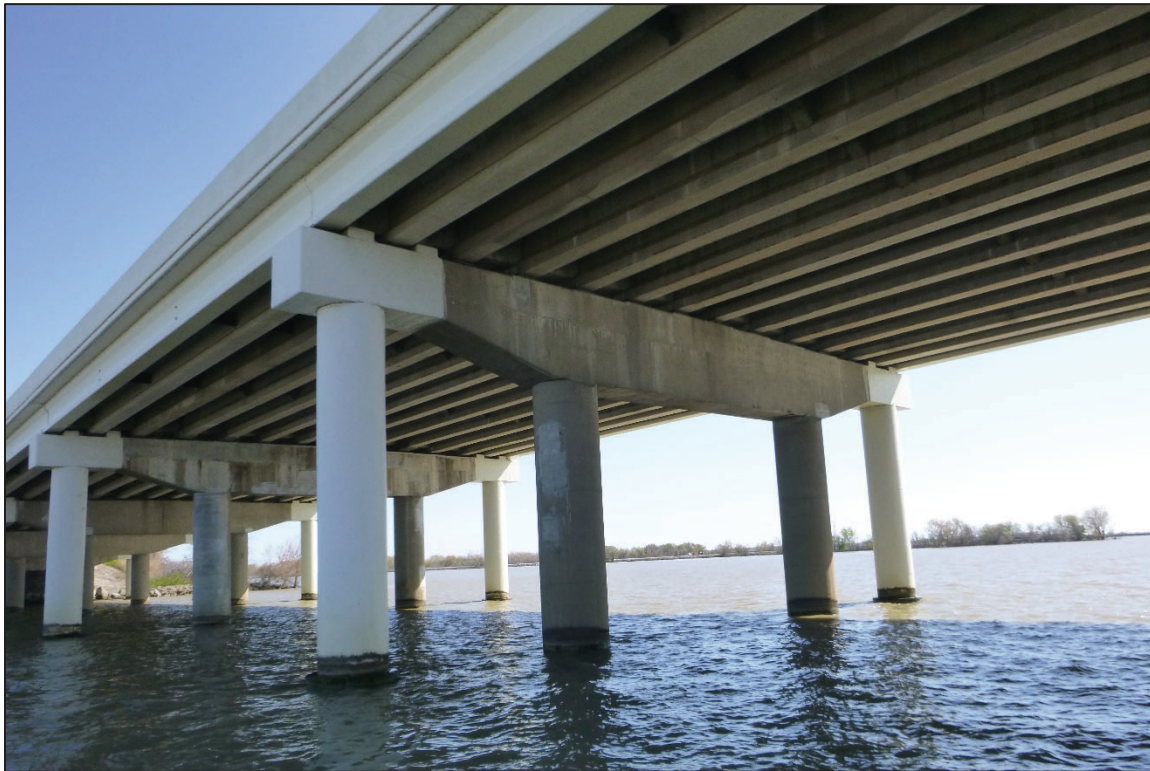
nodules up to 1 in. diameter with pitting up to 1/8 in. A scour hole 4 ft deep by 4 ft diameter was found on the downstream nose. Refer to Figure 24 in Exhibit 1 for detailed inspection notes of Pier 5. Refer to Photographs 17 and 18 in Exhibit 2 for views of Bent 5.

Photograph No. 17: View of the North Face of Bent 5, Looking Southwest.

Photograph No. 18: View of the South Face of Bent 5, Looking Northeast.

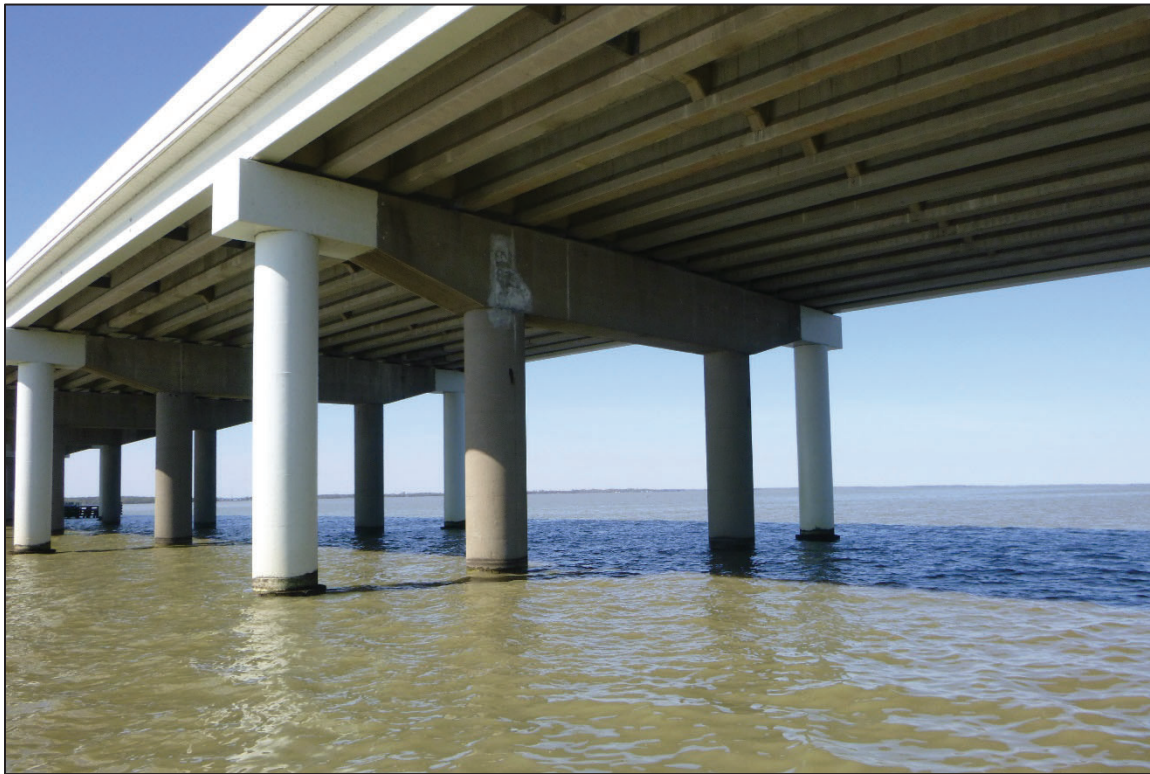
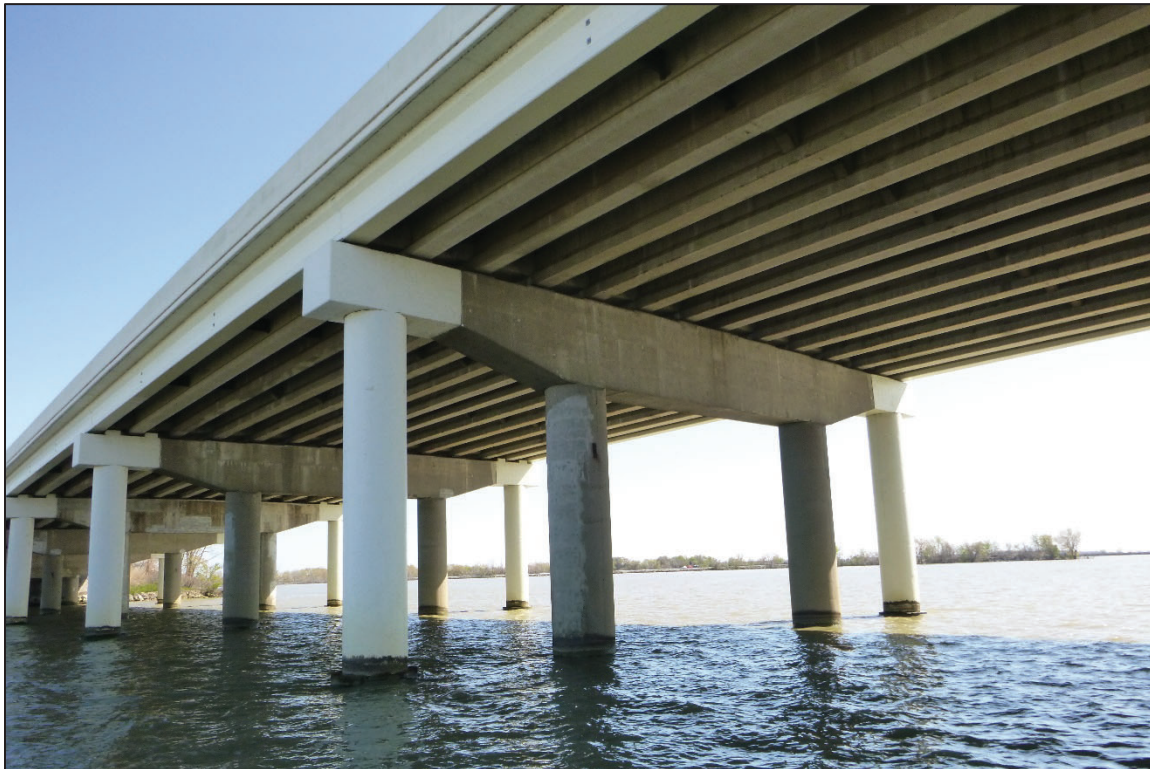
The channel bottom material around Bent 6 consisted of hard clay with no probe rod penetration. The typical steel caisson on typical Columns B and C exhibited moderate corrosion and rust nodules up to 1 in. diameter with pitting up to 1/8 in. Timber debris consisting of logs up to 18 in. diameter by 10 ft long was found on South face of Column D. Refer to Figure 25 in Exhibit 1 for detailed inspection notes of Bent 6. Refer to Photographs 19 and 20 in Exhibit 2 for views of Bent 6.

Photograph No. 19: View of the North Face of Bent 6, Looking Southwest.

Photograph No. 20: View of the South Face of Bent 6, Looking Northeast.

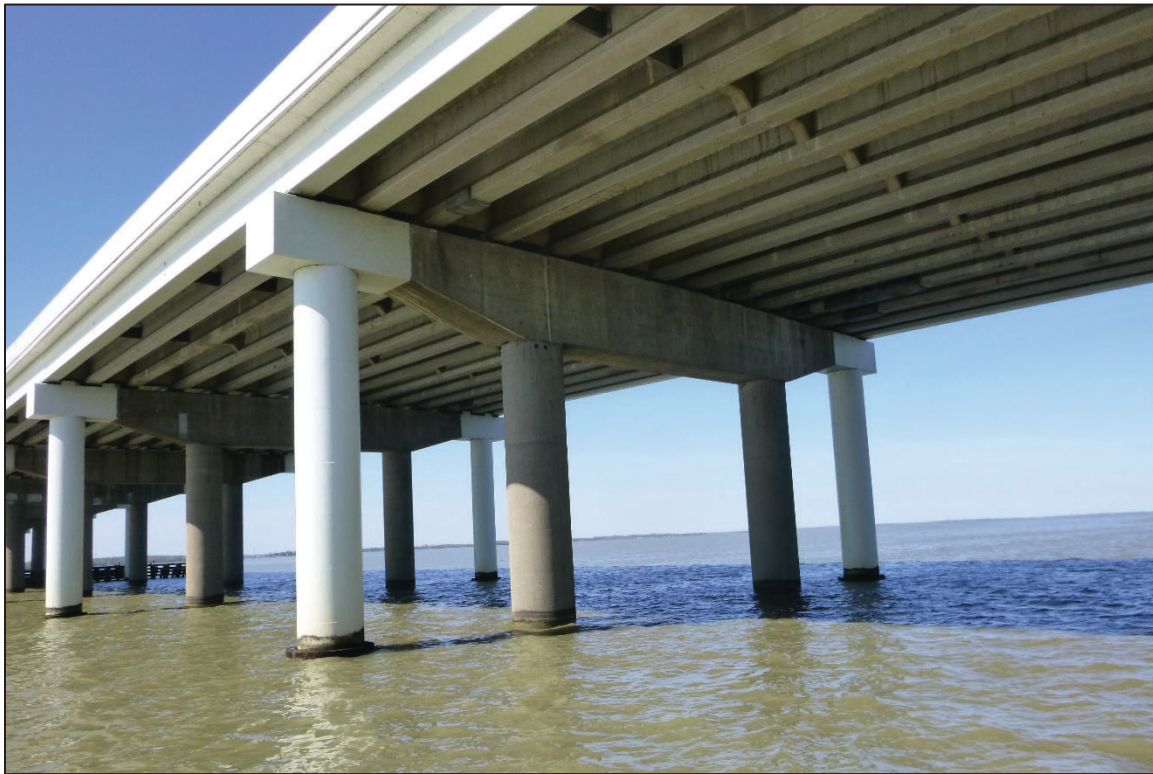
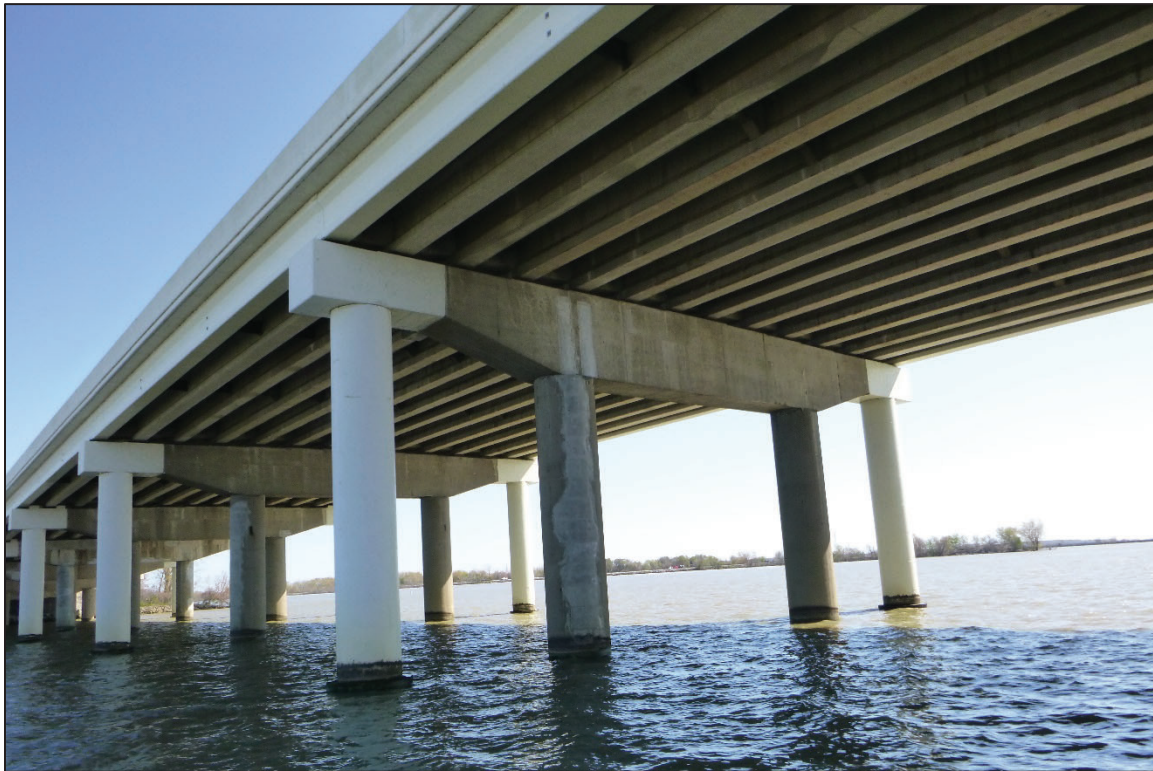
The channel bottom material around Bent 7 consisted of hard clay with no probe rod penetration. The typical steel caisson on typical Columns B and C exhibited moderate corrosion and rust nodules up to 1 in. diameter with pitting up to 1/8 in. A scour hole 4 ft deep by 4 ft diameter was found on the downstream nose. Refer to Figure 26 in Exhibit 1 for detailed inspection notes of Bent 7. Refer to Photographs 21 and 22 in Exhibit 2 for views of Bent 7.

Photograph No. 21: View of the North Face of Bent 7, Looking Southwest.

Photograph No. 22: View of the South Face of Bent 7, Looking Northeast.
