UNDERWATER BRIDGE INSPECTION REPORT

STRUCTURE NO. 6200788 (OTT-2-2839)
SR 2 OVER SANDUSKY BAY
OTTAWA COUNTY, OH
DISTRICT 2

May 2020

COLLINS
ENGINEERS INC.

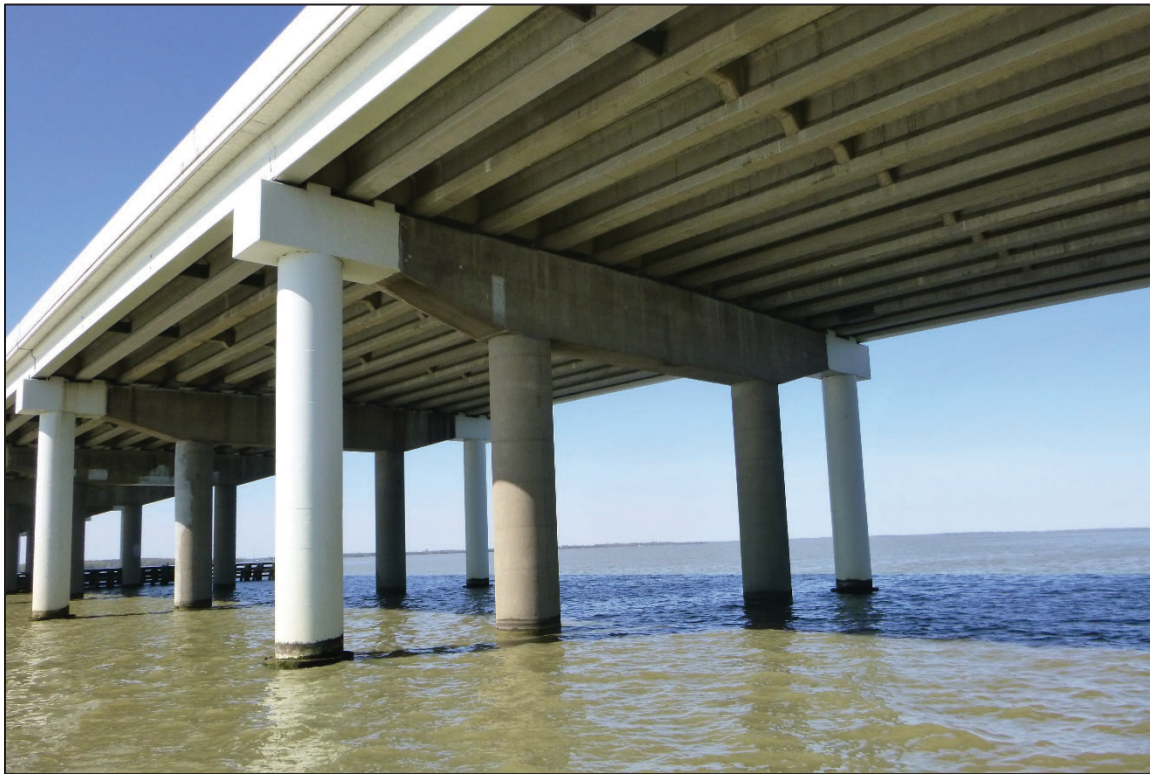
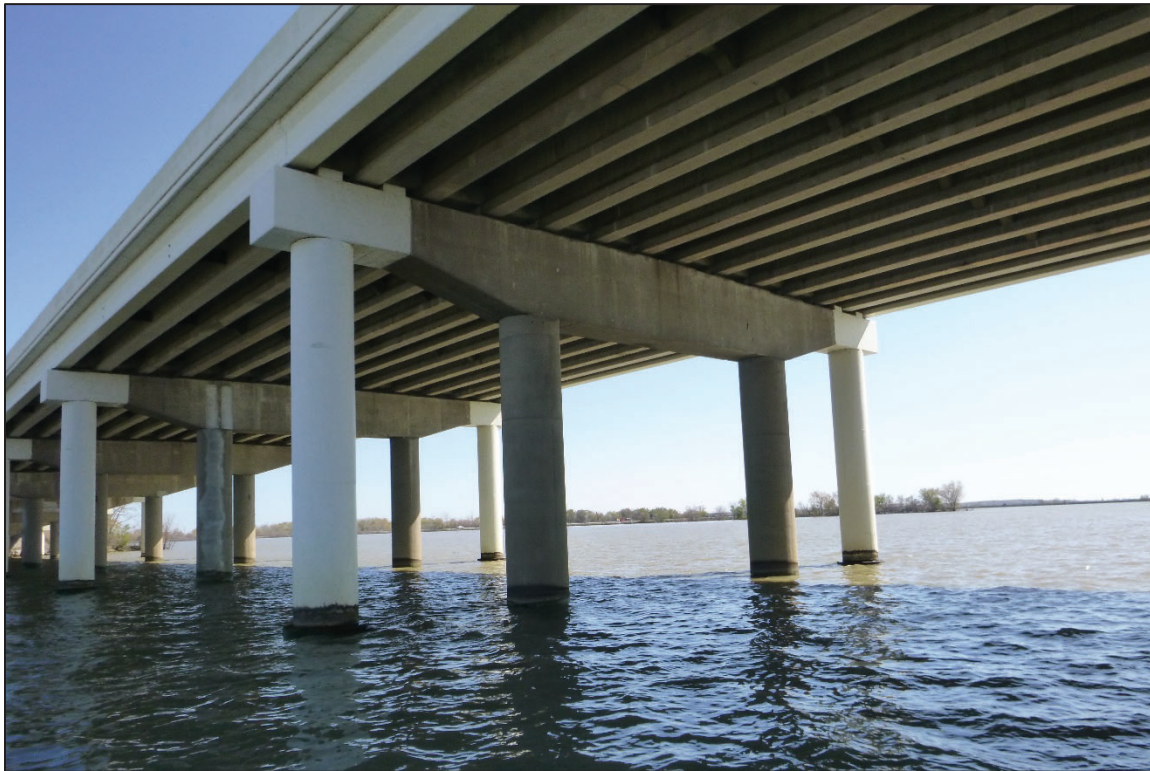
The channel bottom material around Bent 8 consisted of hard clay with no probe rod penetration. The typical steel caisson on typical Columns B and C exhibited moderate corrosion and rust nodules up to 1 in. diameter with pitting up to 1/8 in. Refer to Figure 27 in Exhibit 1 for detailed inspection notes of Bent 8. Refer to Photographs 23 and 24 in Exhibit 2 for views of Bent 8.

Photograph No. 23: View of the North Face of Bent 8, Looking Southwest.

Photograph No. 24: View of the South Face of Bent 8, Looking Northeast.

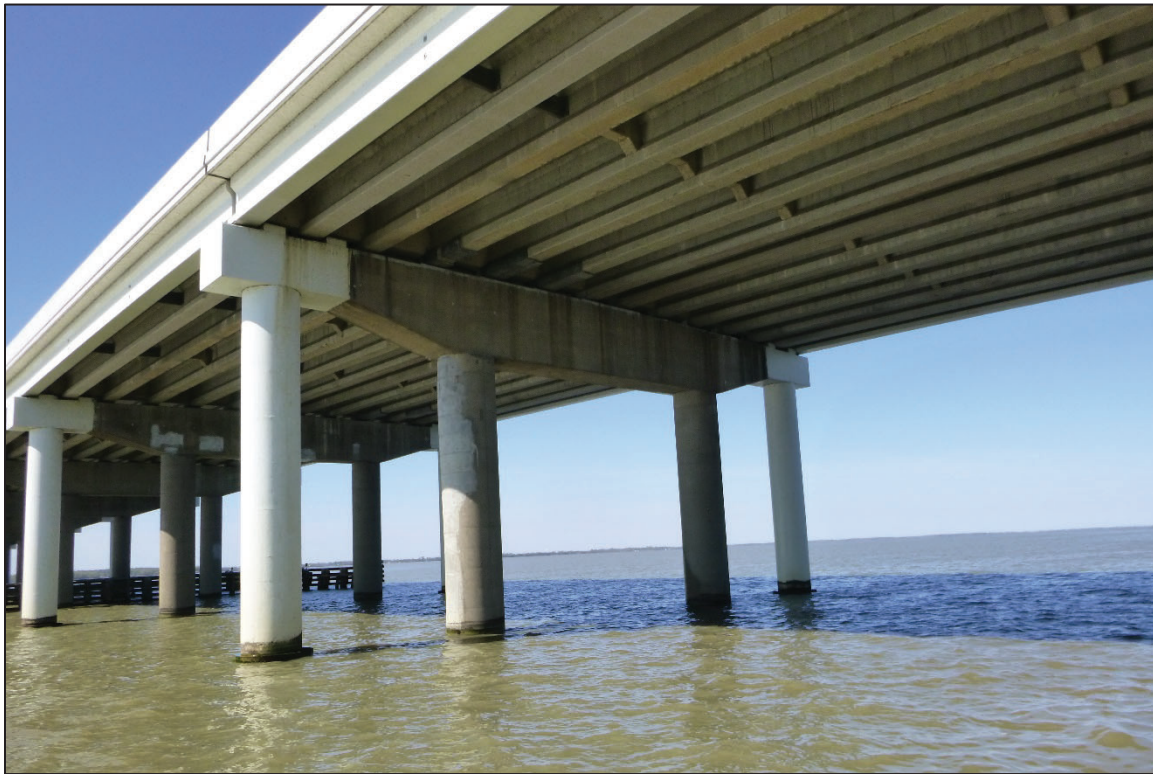
The channel bottom material around Bent 9 consisted of riprap and sand infill with no probe rod penetration. The typical steel caisson on typical Columns B and C exhibited moderate corrosion and rust nodules up to 1 in. diameter with pitting up to 1/8 in. A spall 18 in. diameter by 2 in. deep with one exposed rebar exhibiting light surface corrosion was found on Column B, 1 ft above the waterline on the Northwest face. Refer to Figure 28 in Exhibit 1 for detailed inspection notes of Bent 9. Refer to Photographs 25 and 26 in Exhibit 2 for views of Bent 9.

Photograph No. 25: View of the North Face of Bent 9, Looking Southwest.

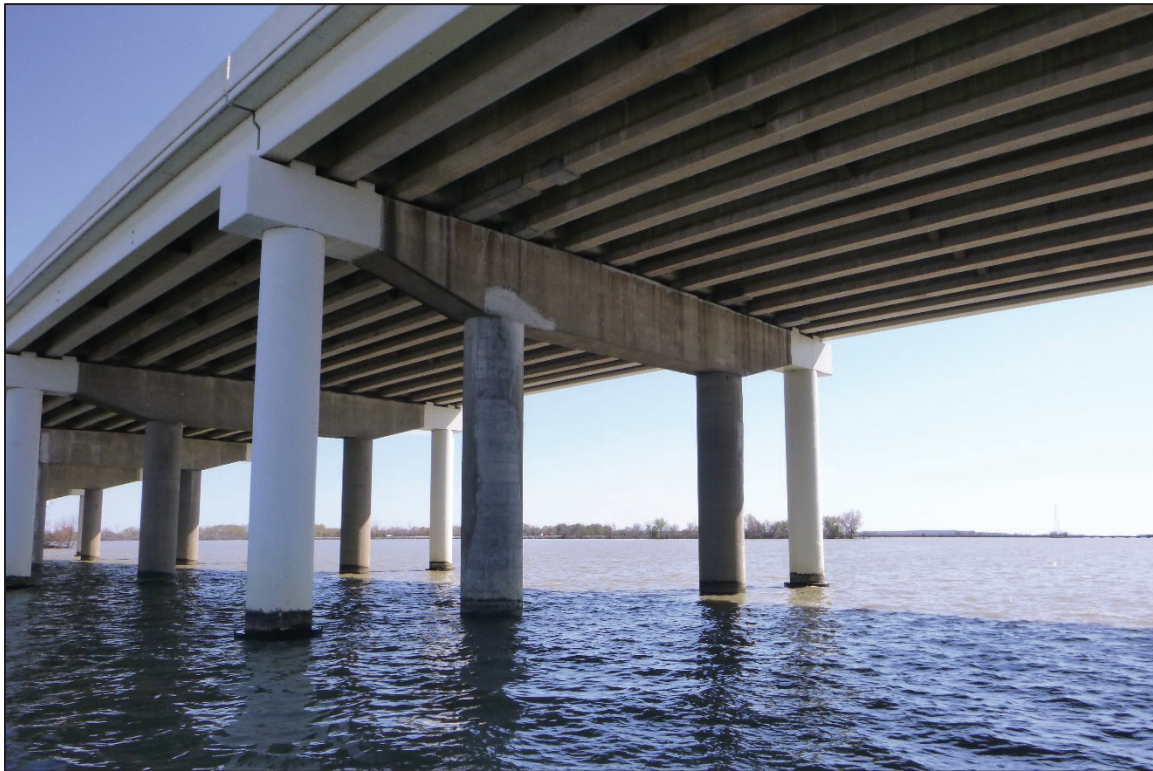
Photograph No. 26: View of the South Face of Bent 9, Looking Northeast.

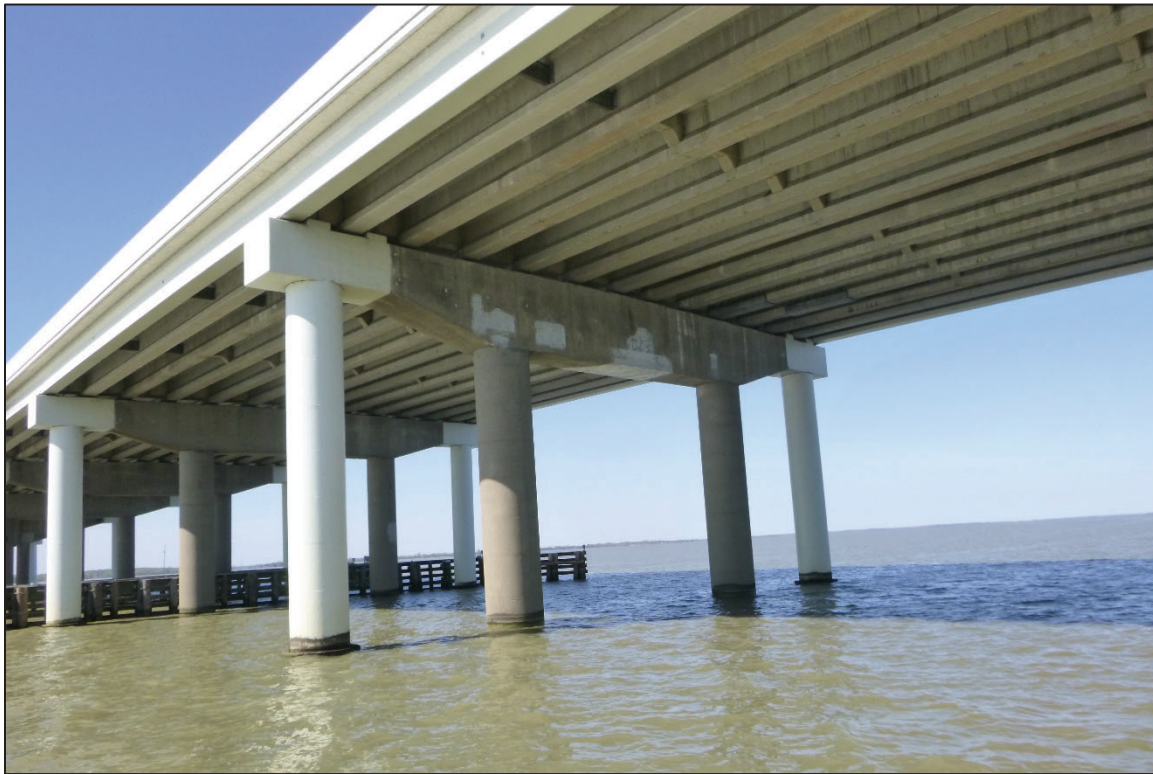
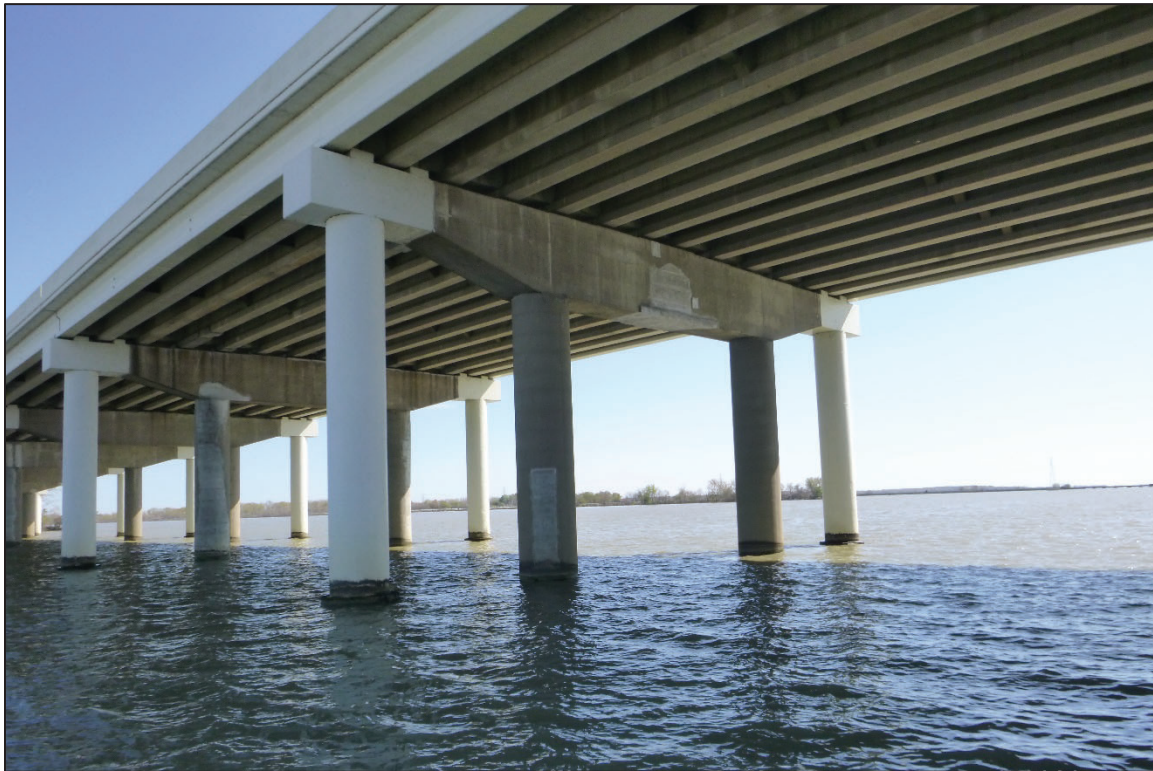
The channel bottom material around Bent 10 consisted of riprap and sand infill with no probe rod penetration. The typical steel caisson on typical Columns B and C exhibited moderate corrosion and rust nodules up to 1 in. diameter with pitting up to 1/8 in. Refer to Figure 29 in Exhibit 1 for detailed inspection notes of Bent 10. Refer to Photographs 27 and 28 in Exhibit 2 for views of Bent 10.

Photograph No. 27: View of the North Face of Bent 10, Looking Southwest.

Photograph No. 28: View of the South Face of Bent 10, Looking Northeast.

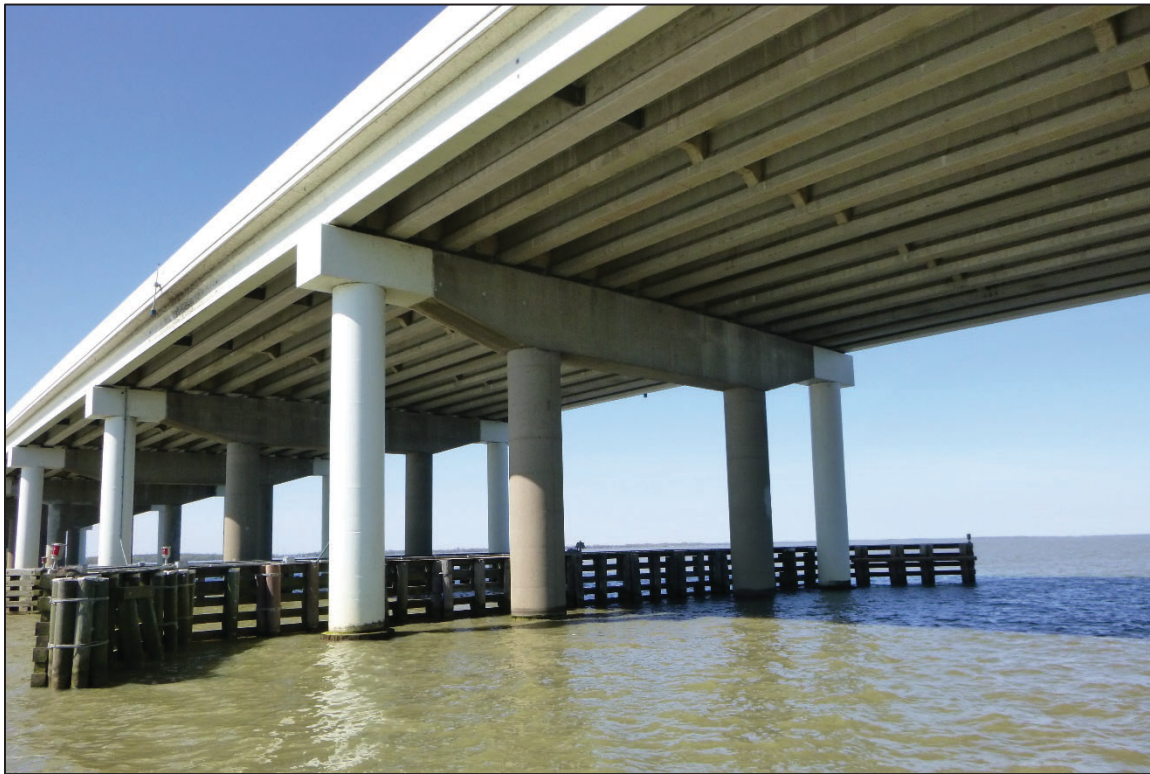
Photograph No. 29: View of the North Face of Bent 11, Looking Southwest.

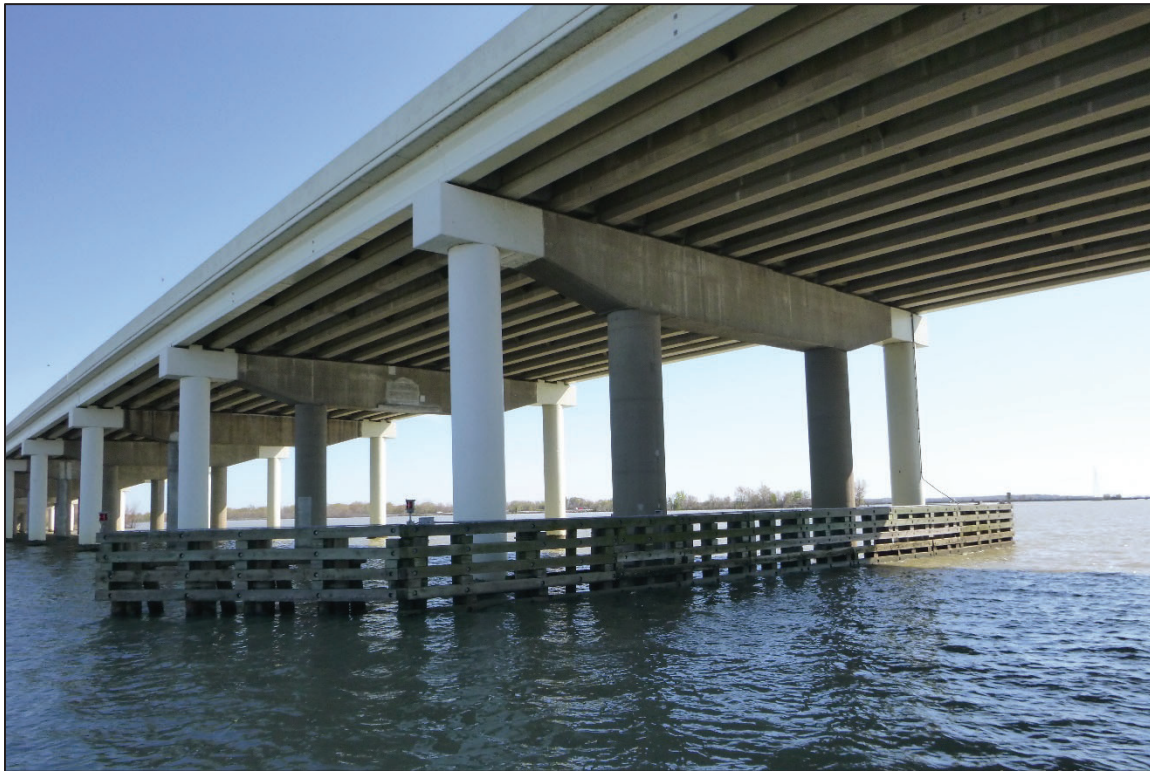
Photograph No. 30: View of the South Face of Bent 11, Looking Northeast.

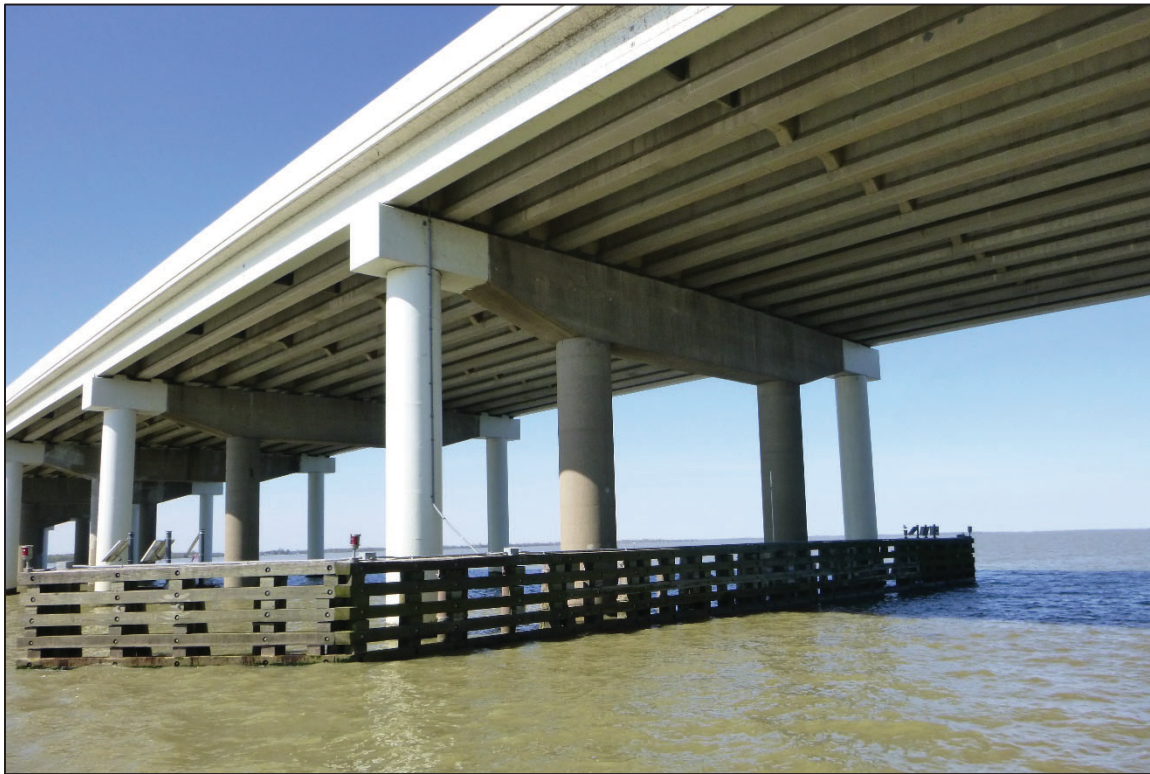
Photograph No. 31: View of the North Face of Bent 12, Looking Southwest.

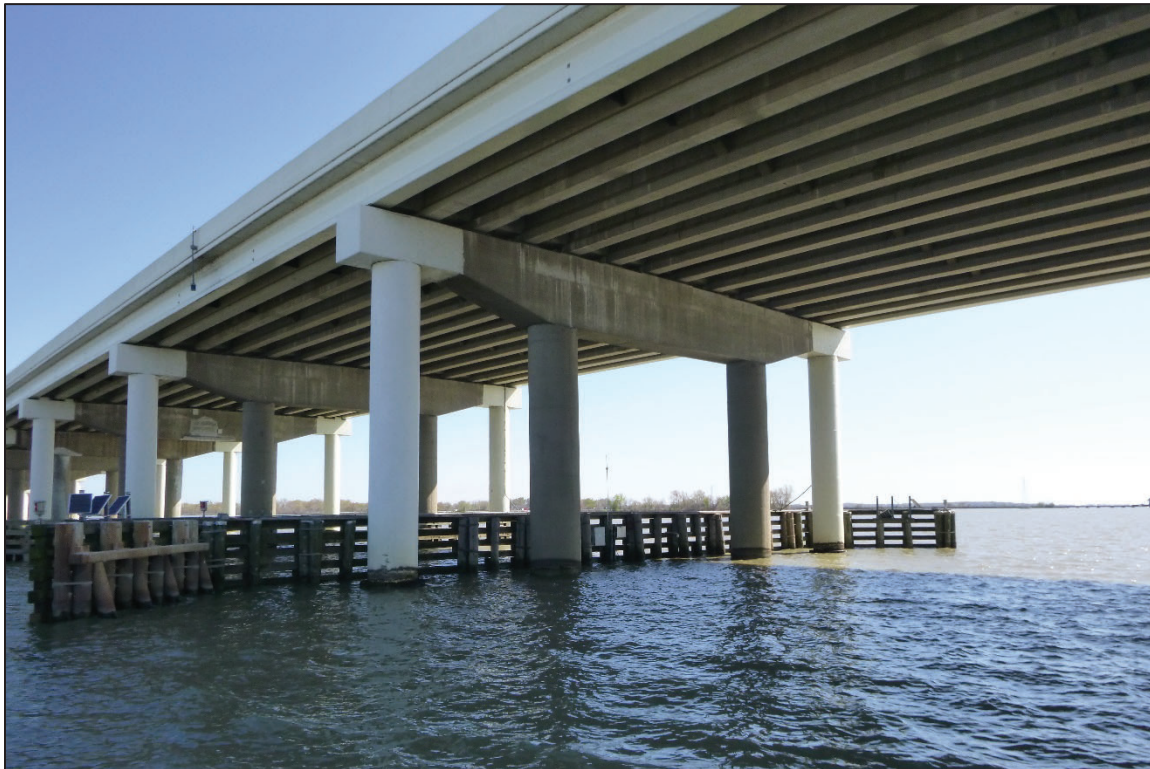
Photograph No. 32: View of the South Face of Bent 12, Looking Northeast.

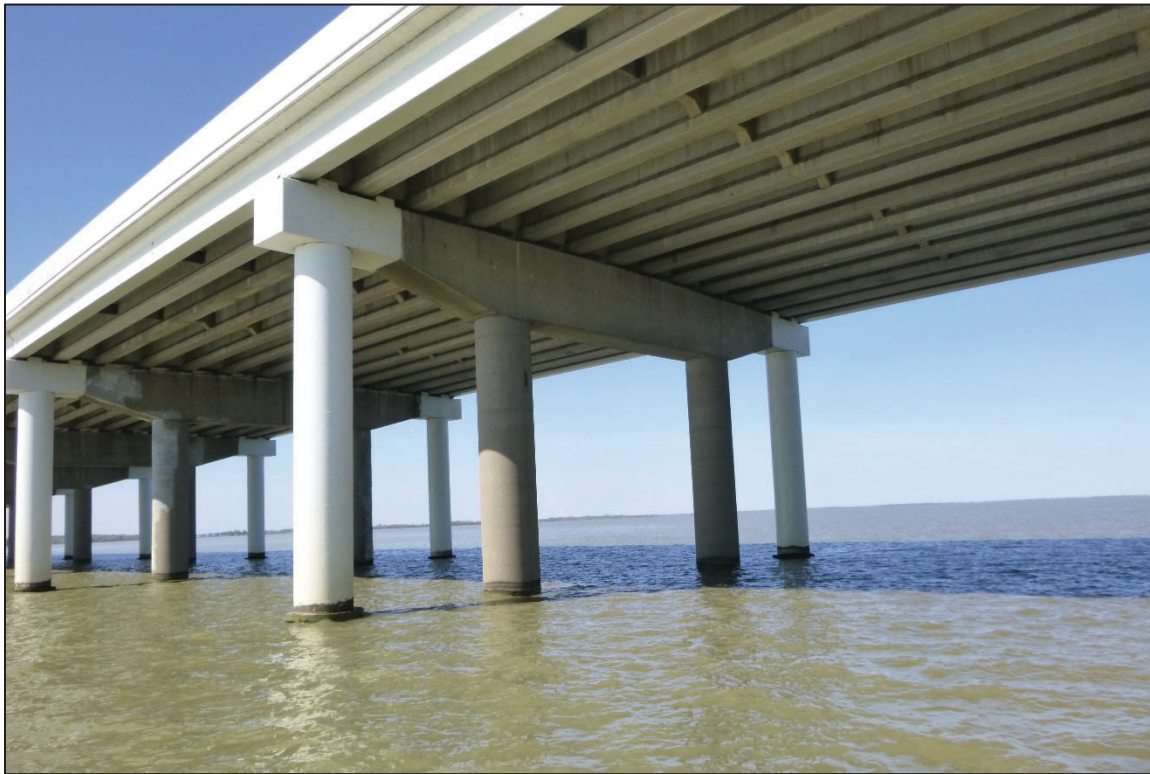
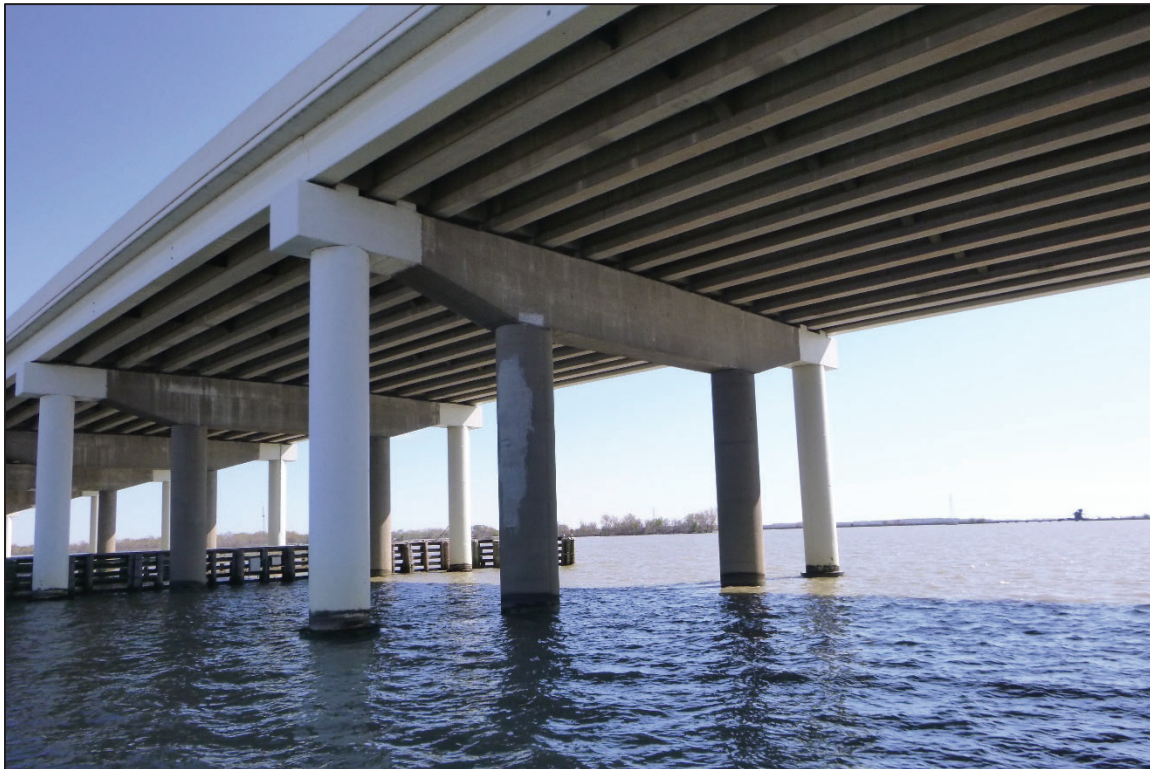
The channel bottom material around Bent 13 consisted of riprap and sand infill with no probe rod penetration. The typical steel caisson on typical Columns B and C exhibited moderate corrosion and rust nodules up to 1 in. diameter with pitting up to 1/8 in. Refer to Figure 32 in Exhibit 1 for detailed inspection notes of Bent 13. Refer to Photographs 33 and 34 in Exhibit 2 for views of Bent 13.

Photograph No. 33: View of the North Face of Bent 13, Looking Southwest.

Photograph No. 34: View of the South Face of Bent 13, Looking Northeast.

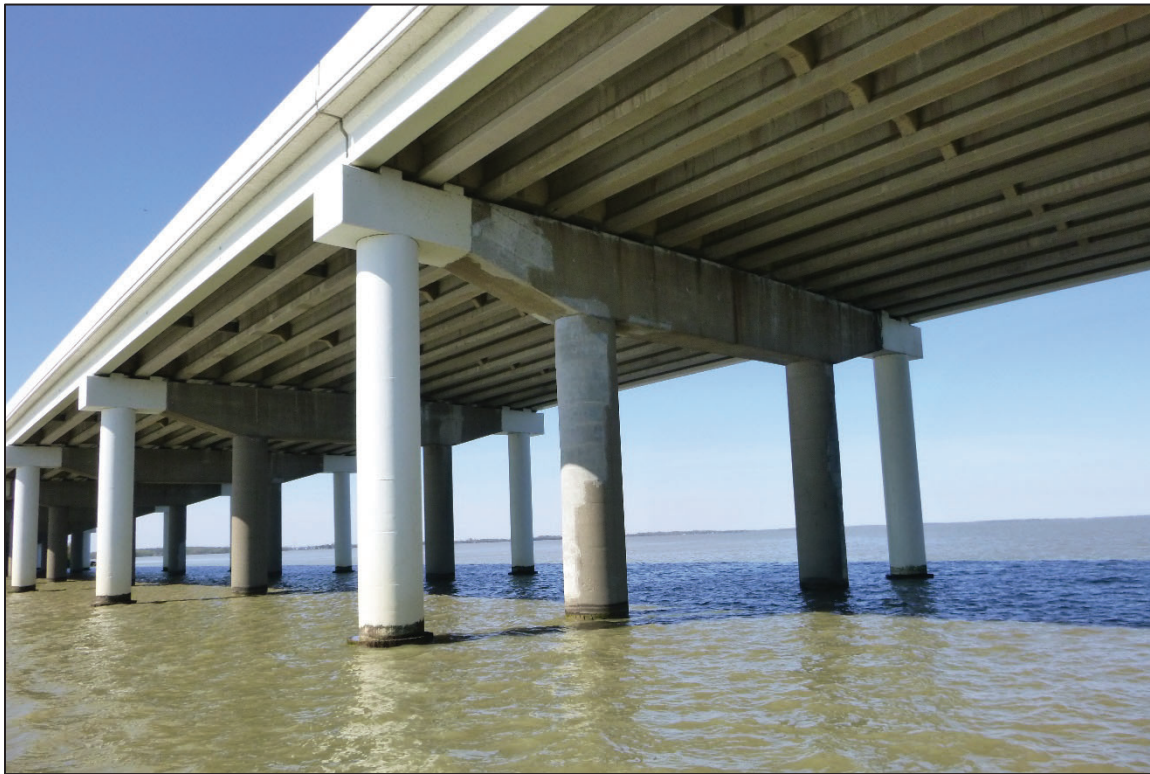
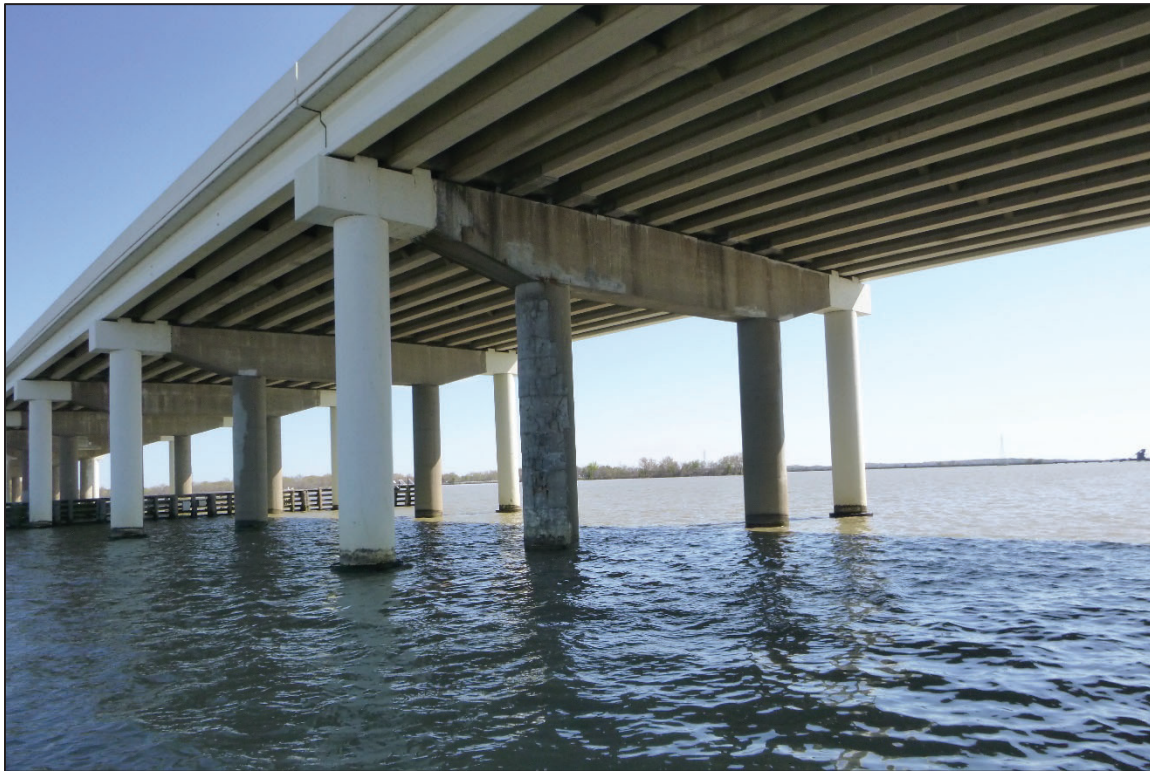
The channel bottom material around Bent 14 consisted of riprap and sand infill with no probe rod penetration. The typical steel caisson on typical Columns B and C exhibited moderate corrosion and rust nodules up to 1 in. diameter with pitting up to 1/8 in. Refer to Figure 33 in Exhibit 1 for detailed inspection notes of Bent 14. Refer to Photographs 35 and 36 in Exhibit 2 for views of Bent 14.

Photograph No. 35: View of the North Face of Bent 14, Looking Southwest.

Photograph No. 36: View of the South Face of Bent 14, Looking Northeast.

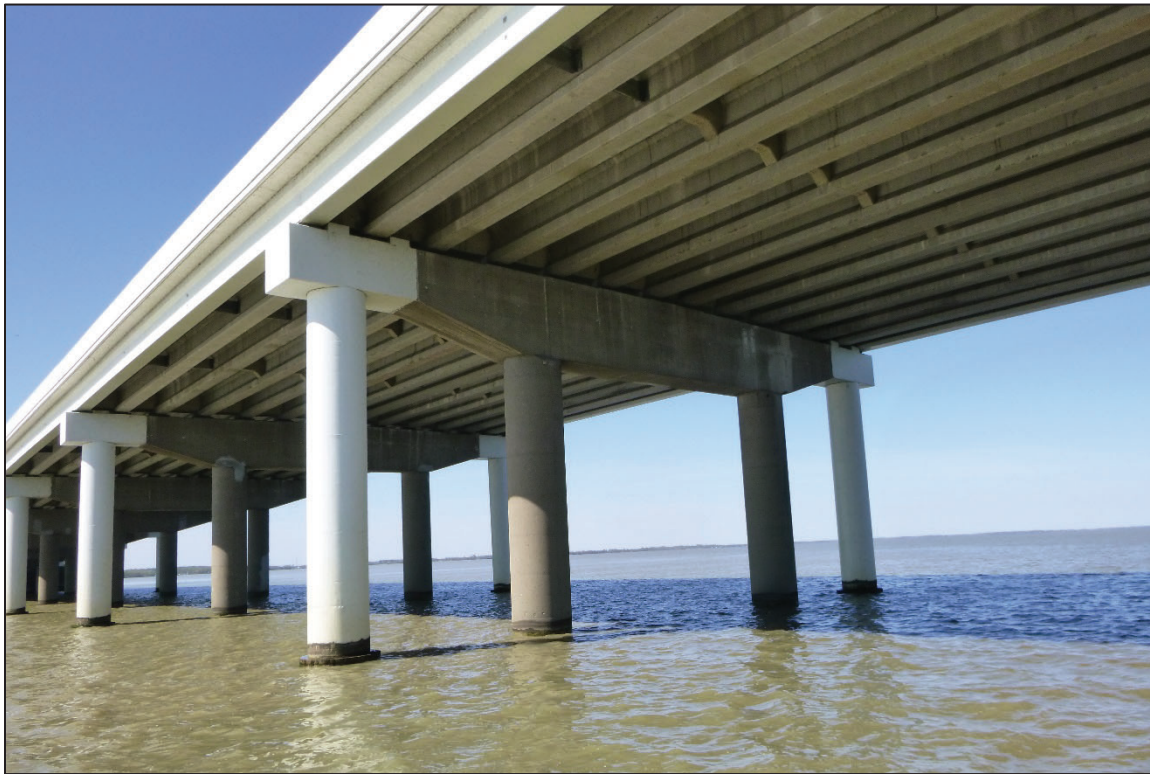
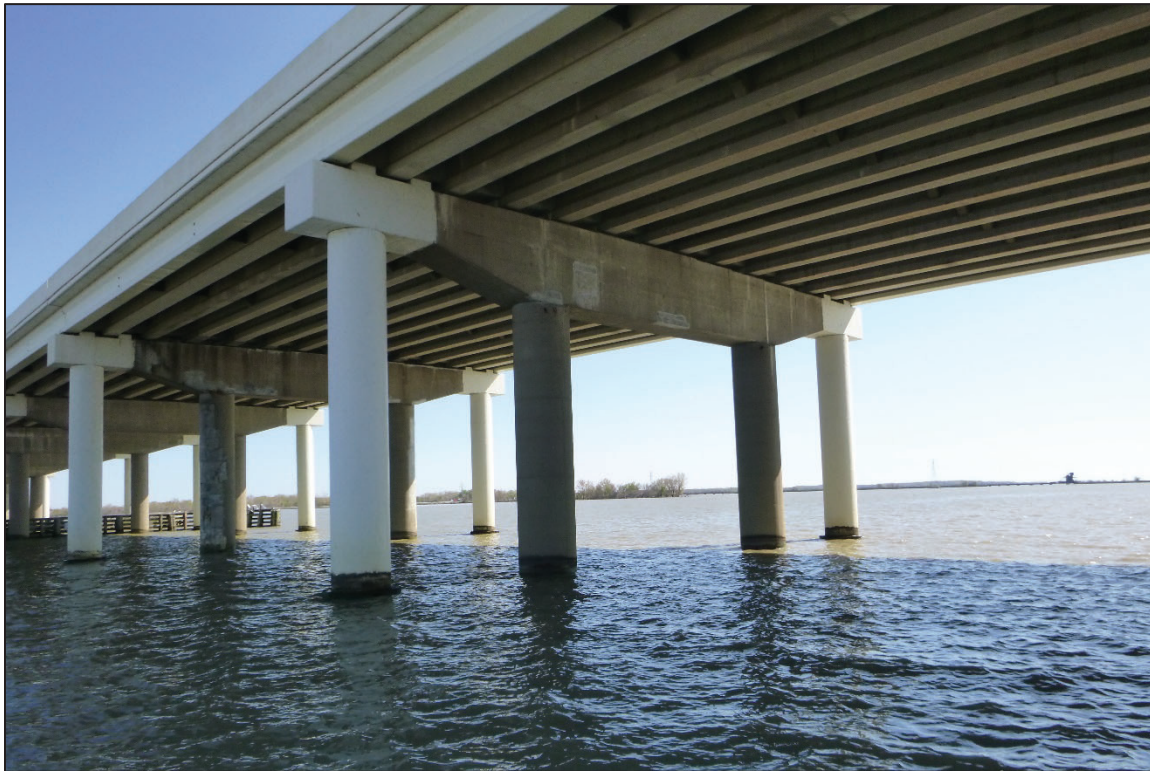
The channel bottom material around Bent 15 consisted of riprap and sand infill with no probe rod penetration. The typical steel caisson on typical Columns B and C exhibited moderate corrosion and rust nodules up to 1 in. diameter with pitting up to 1/8 in. Refer to Figure 34 in Exhibit 1 for detailed inspection notes of Bent 15. Refer to Photographs 37 and 38 in Exhibit 2 for views of Bent 15.

Photograph No. 37: View of the North Face of Bent 15, Looking Southwest.

Photograph No. 38: View of the South Face of Bent 15, Looking Northeast.

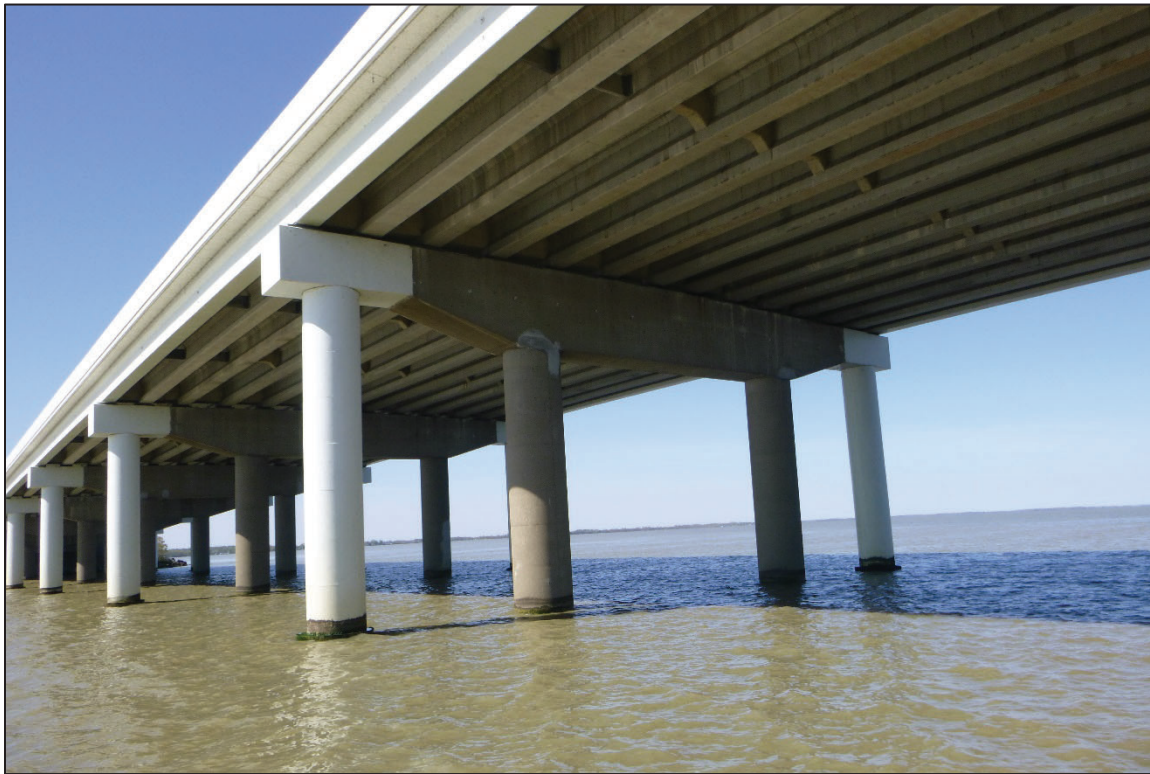
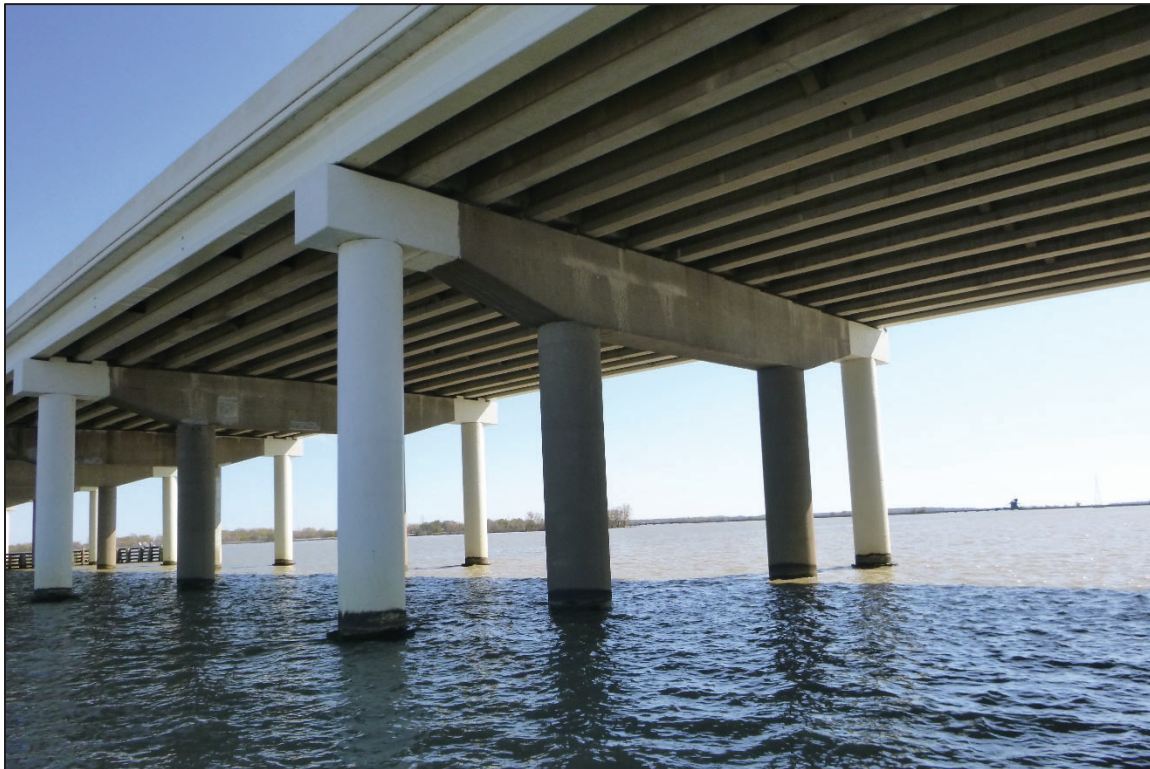
The channel bottom material around Bent 16 consisted of riprap and sand infill with no probe rod penetration. The typical steel caisson on typical Columns B and C exhibited moderate corrosion and rust nodules up to 1 in. diameter with pitting up to 1/8 in. A 2 ft vertical concrete jacket was found around Columns B and C beginning at 10.5 ft below waterline and in good condition of concrete. Refer to Figure 35 in Exhibit 1 for detailed inspection notes of Bent 16. Refer to Photographs 39 and 40 in Exhibit 2 for views of Bent 16.

Photograph No. 39: View of the North Face of Bent 16, Looking Southwest.

Photograph No. 40: View of the South Face of Bent 16, Looking Northeast.

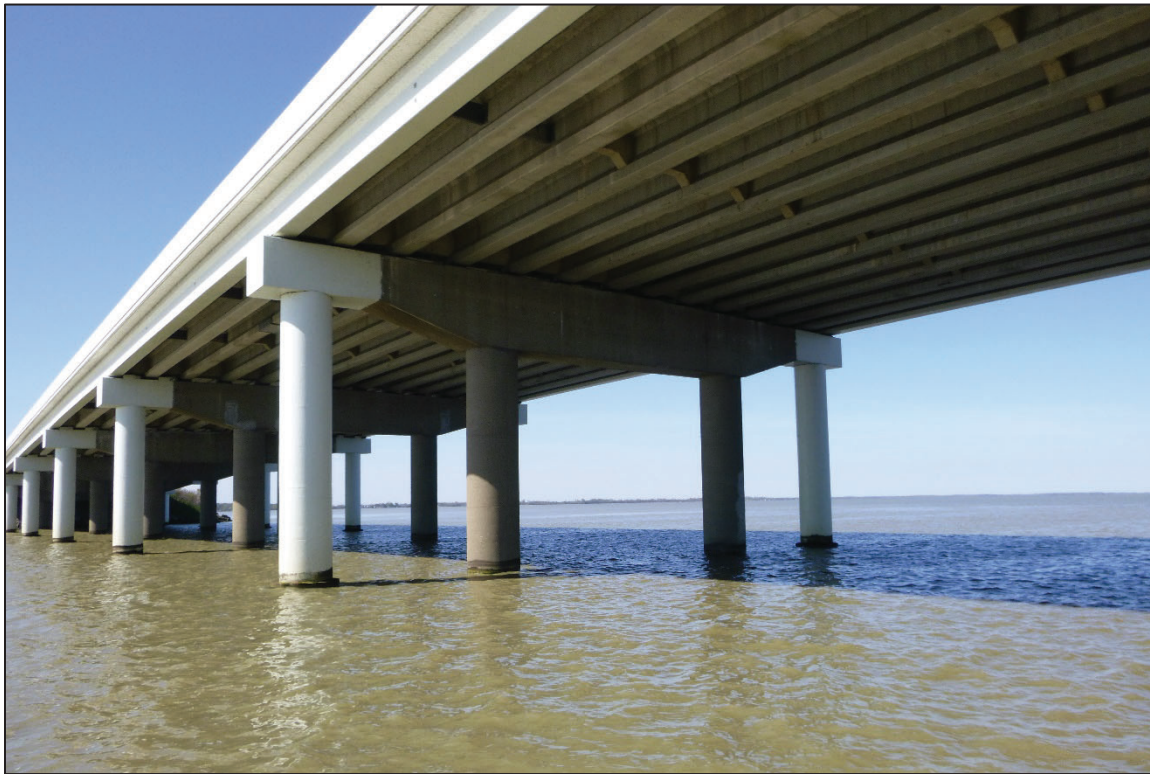
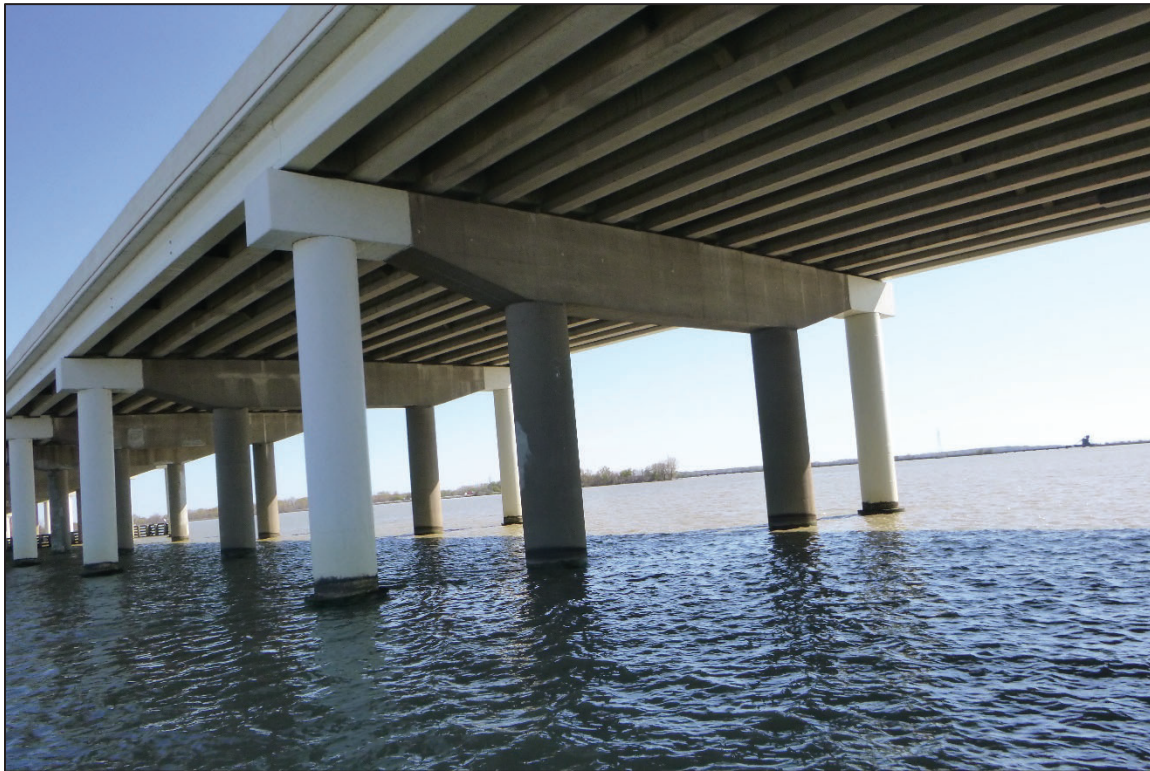
The channel bottom material around Bent 17 consisted of riprap and sand infill with no probe rod penetration. The typical steel caisson on typical Columns B and C exhibited moderate corrosion and rust nodules up to 1 in. diameter with pitting up to 1/8 in. Timber debris consisting of logs up to 10 ft long by 6 in. diameter was found on the South face of Column B. Refer to Figure 36 in Exhibit 1 for detailed inspection notes of Bent 17. Refer to Photographs 41 and 42 in Exhibit 2 for views of Bent 17.

Photograph No. 41: View of the North Face of Bent 17, Looking Southwest.

Photograph No. 42: View of the South Face of Bent 17, Looking Northeast.

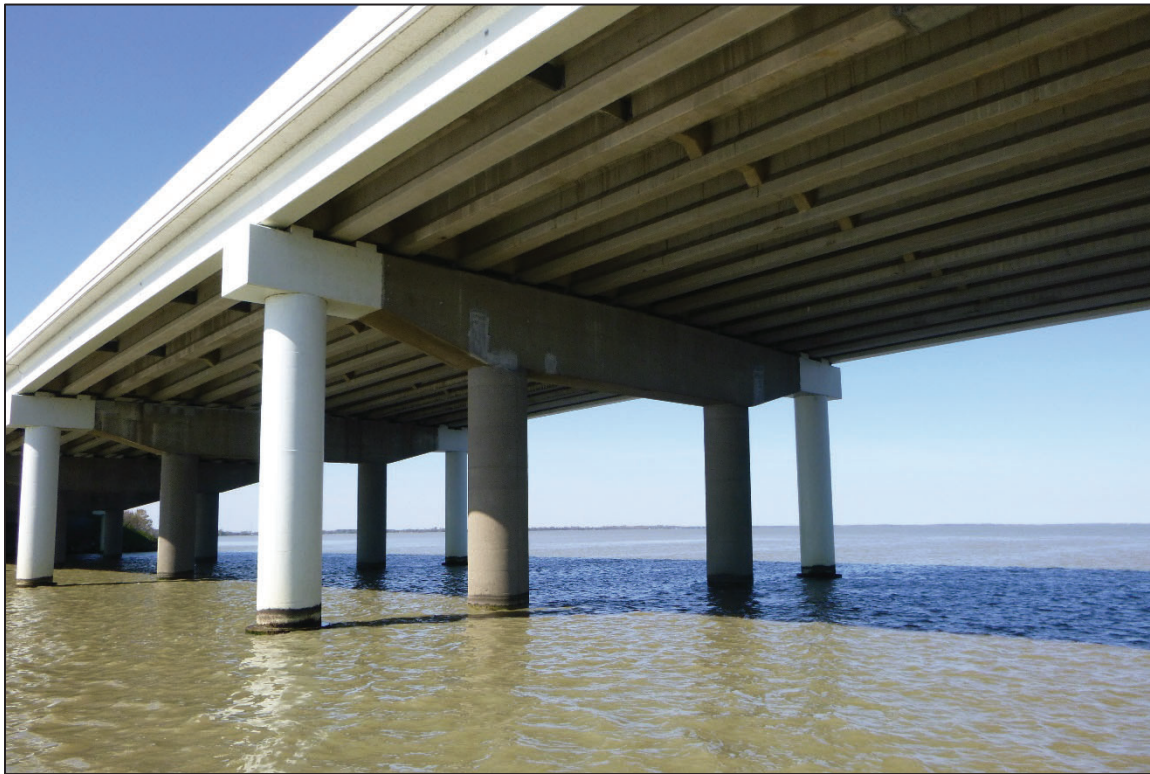
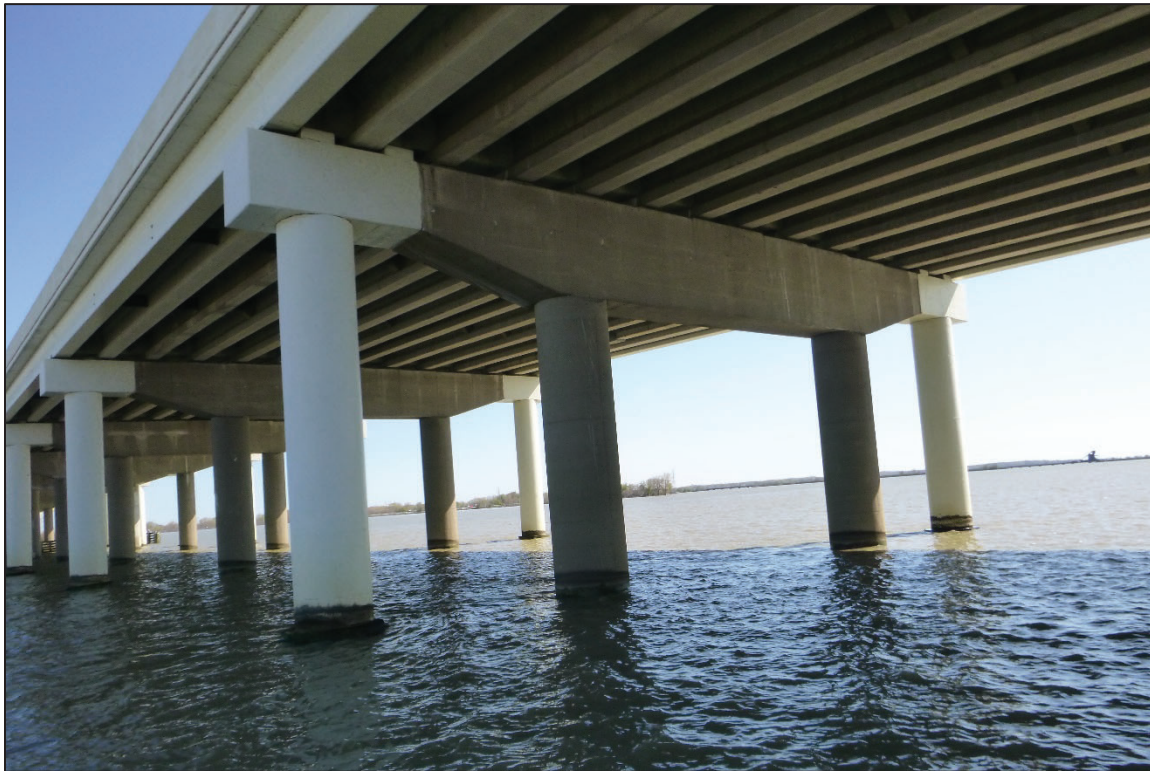
The channel bottom material around Bent 18 consisted of riprap and sand infill with no probe rod penetration. The typical steel caisson on typical Columns B and C exhibited moderate corrosion and rust nodules up to 1 in. diameter with pitting up to 1/8 in. Refer to Figure 37 in Exhibit 1 for detailed inspection notes of Bent 18. Refer to Photographs 43 and 44 in Exhibit 2 for views of Bent 18.

Photograph No. 43: View of the North Face of Bent 18, Looking Southwest.

Photograph No. 44: View of the South Face of Bent 18, Looking Northeast.

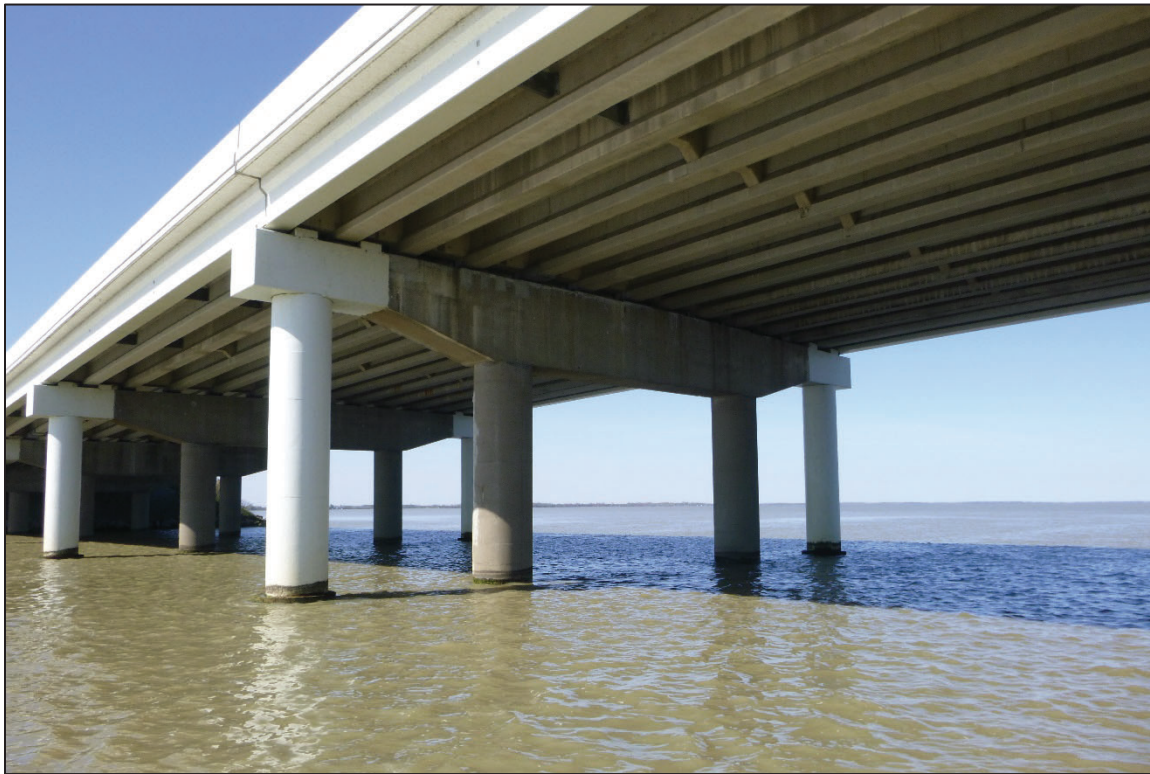
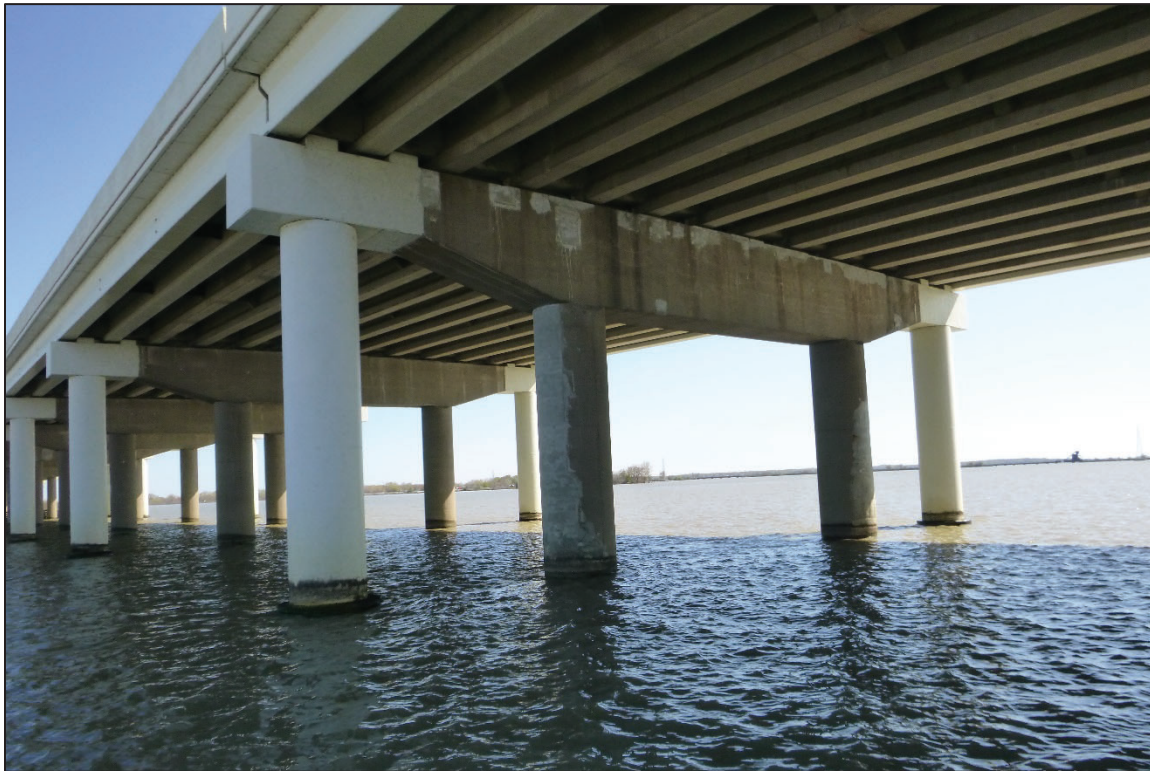
The channel bottom material around Bent 19 consisted of riprap and sand infill with no probe rod penetration. The typical steel caisson on typical Columns B and C exhibited moderate corrosion and rust nodules up to 1 in. diameter with pitting up to 1/8 in. Refer to Figure 38 in Exhibit 1 for detailed inspection notes of Bent 19. Refer to Photographs 45 and 46 in Exhibit 2 for views of Bent 19.

Photograph No. 45: View of the North Face of Bent 19, Looking Southwest.

Photograph No. 46: View of the South Face of Bent 19, Looking Northeast.
