UNDERWATER BRIDGE INSPECTION REPORT

STRUCTURE NO. 6200788 (OTT-2-2839)
SR 2 OVER SANDUSKY BAY
OTTAWA COUNTY, OH
DISTRICT 2

May 2020

COLLINS
ENGINEERS INC.

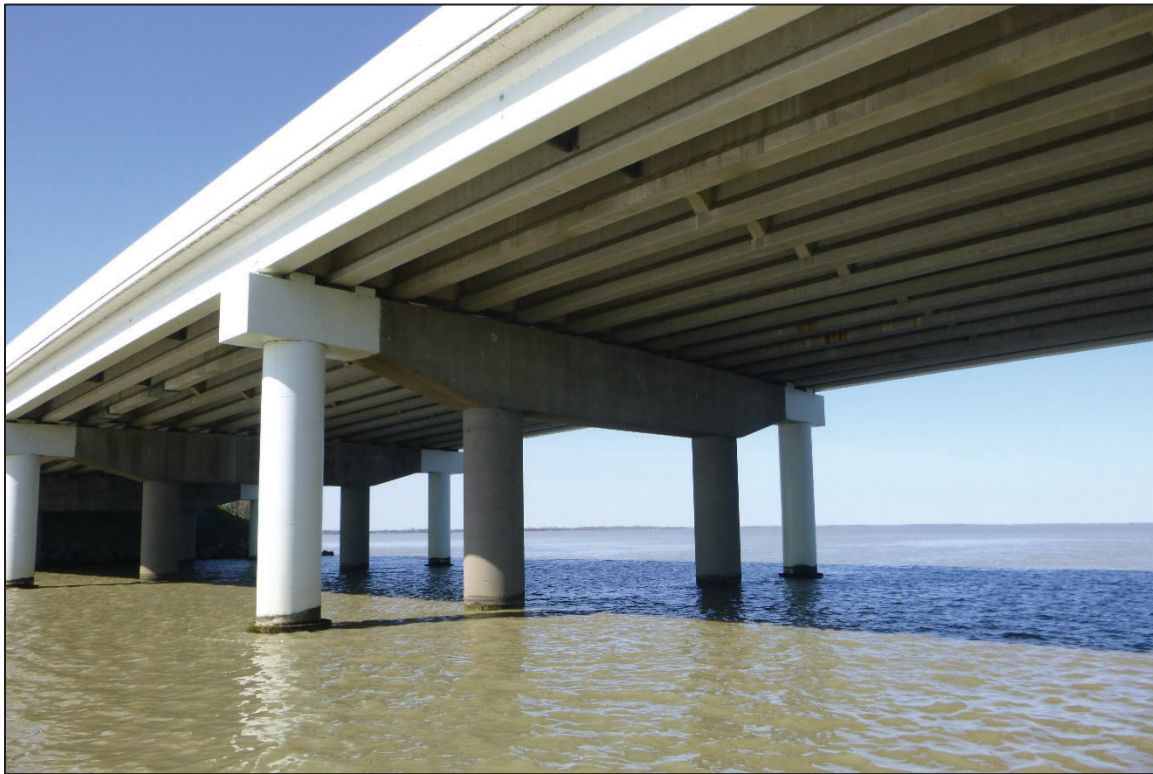
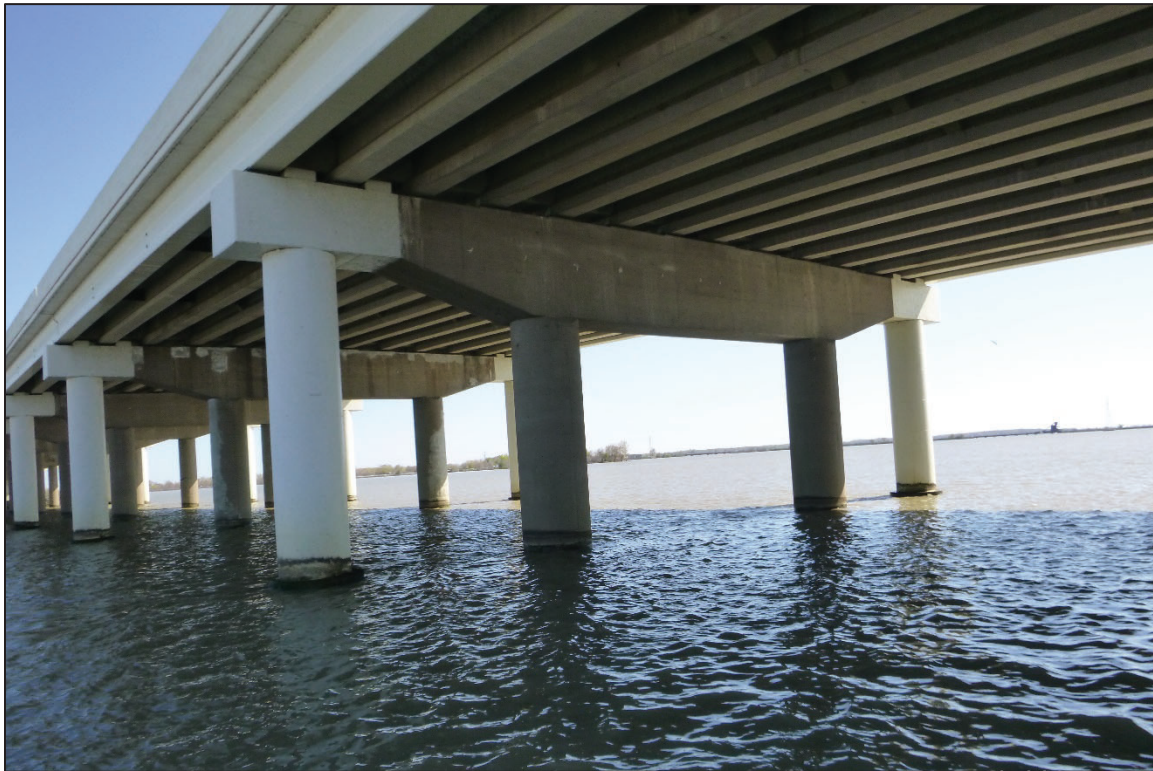
The channel bottom material around Bent 20 consisted of riprap and sand infill with no probe rod penetration. The typical steel caisson on typical Columns B and C exhibited moderate corrosion and rust nodules up to 1 in. diameter with pitting up to 1/8 in. Refer to Figure 39 in Exhibit 1 for detailed inspection notes of Bent 20. Refer to Photographs 47 and 48 in Exhibit 2 for views of Bent 20.

Photograph No. 47: View of the North Face of Bent 20, Looking Southwest.

Photograph No. 48: View of the South Face of Bent 20, Looking Northeast.

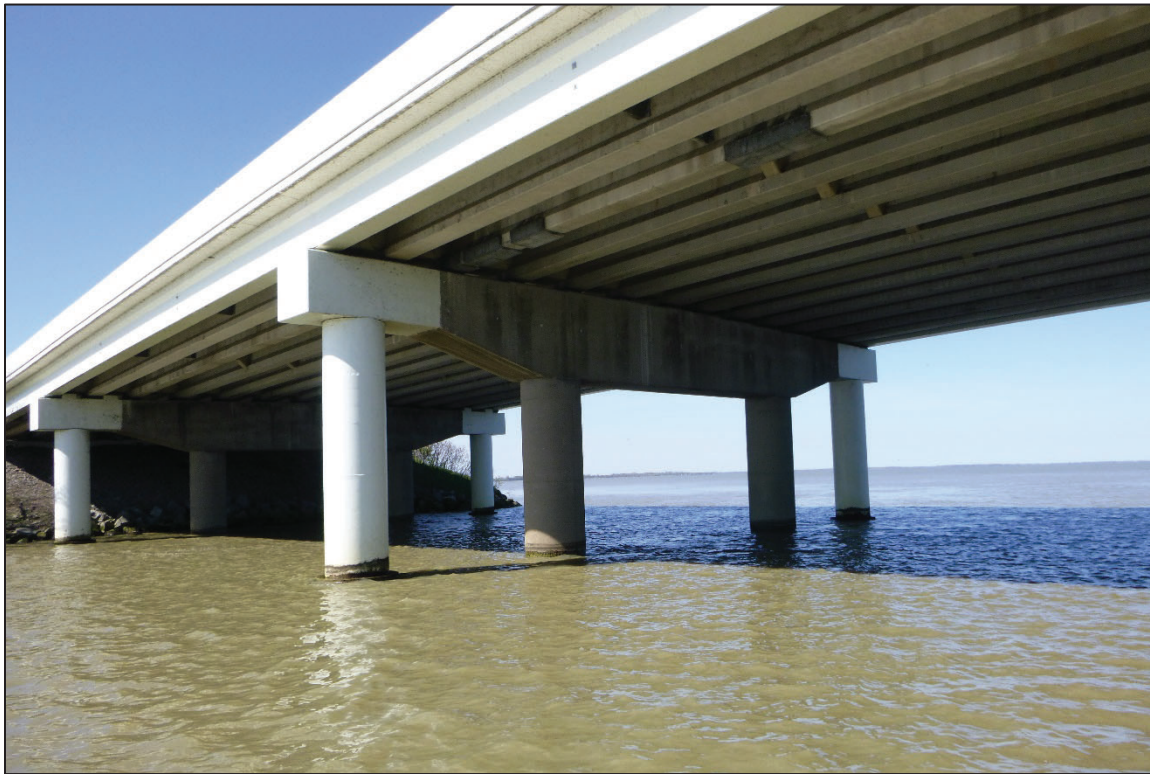
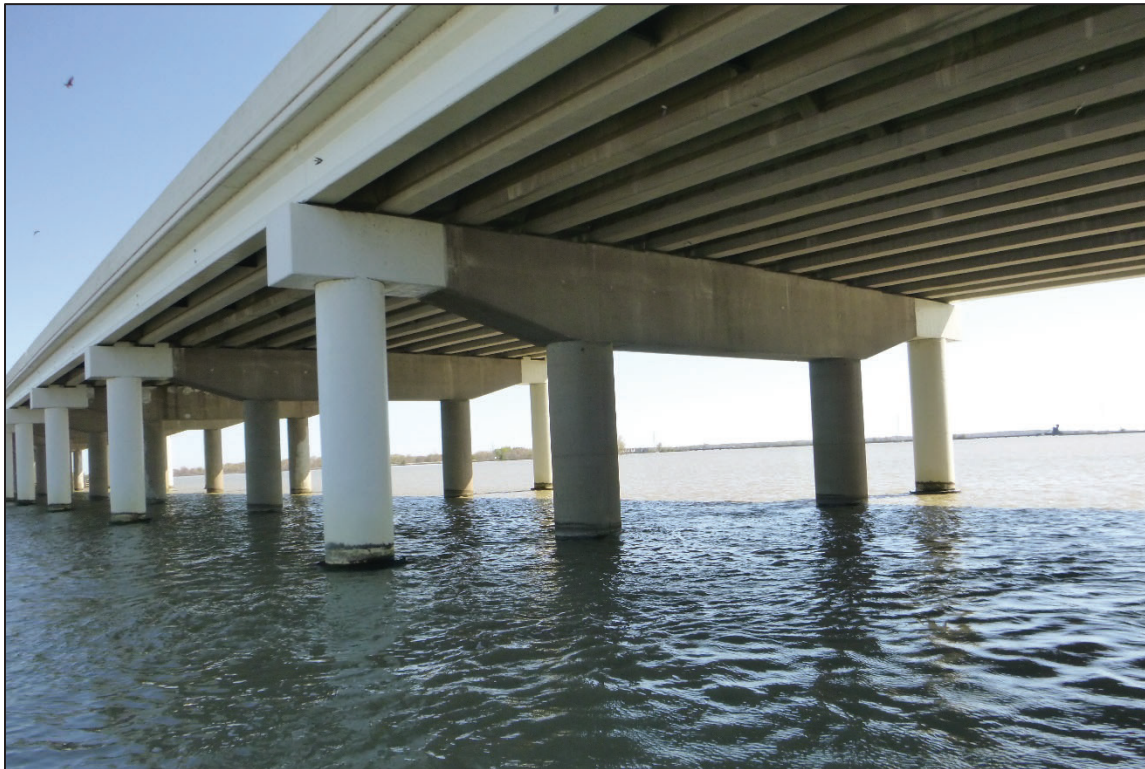
The channel bottom material around Bent 21 consisted of riprap and sand infill with no probe rod penetration. The typical steel caisson on typical Columns B and C exhibited moderate corrosion and rust nodules up to 1 in. diameter with pitting up to 1/8 in. Refer to Figure 40 in Exhibit 1 for detailed inspection notes of Bent 21. Refer to Photographs 49 and 50 in Exhibit 2 for views of Bent 21.

Photograph No. 49: View of the North Face of Bent 21, Looking Southwest.

Photograph No. 50: View of the South Face of Bent 21, Looking Northeast.

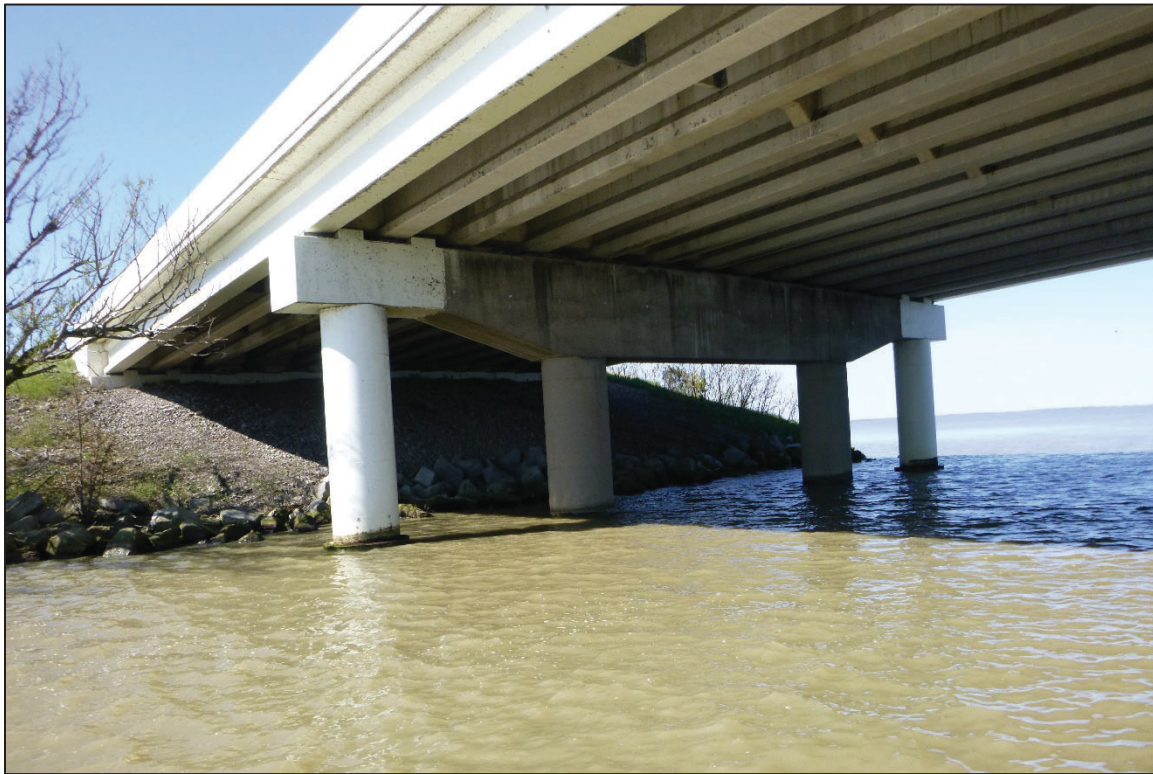
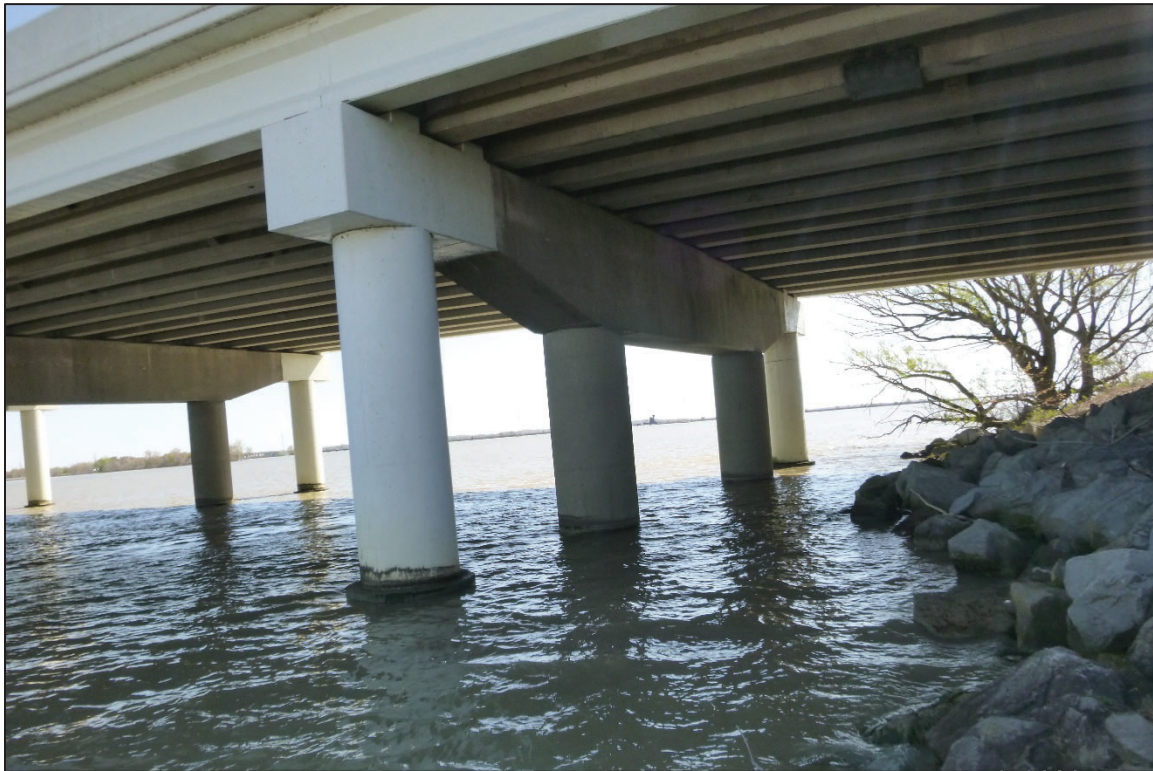
The channel bottom material around Bent 22 consisted of riprap and sand infill with no probe rod penetration. The typical steel caisson on typical Columns B and C exhibited moderate corrosion and rust nodules up to 1 in. diameter with pitting up to 1/8 in. Refer to Figure 41 in Exhibit 1 for detailed inspection notes of Bent 22. Refer to Photographs 51 and 52 in Exhibit 2 for views of Bent 22.

Photograph No. 51: View of the North Face of Bent 22, Looking Southwest.

Photograph No. 52: View of the South Face of Bent 22, Looking Northeast.

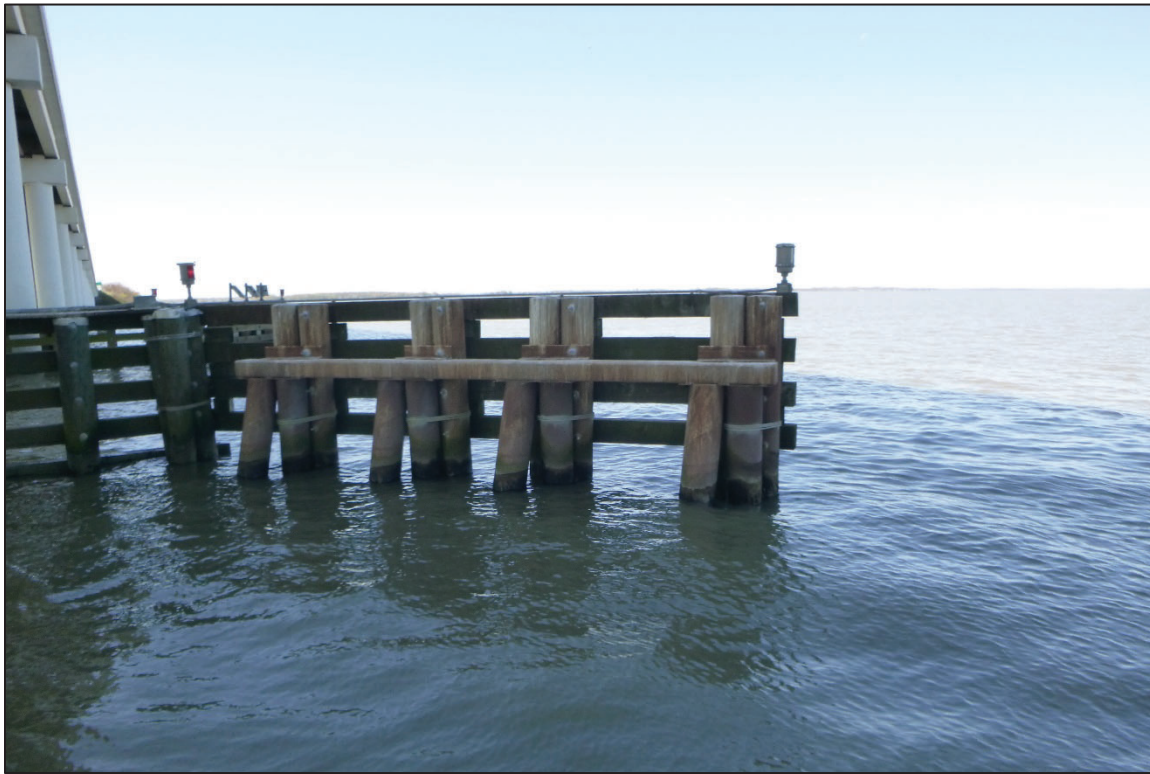
Photograph No. 55: View of the Steel Upstream Fender System, Looking Southwest.

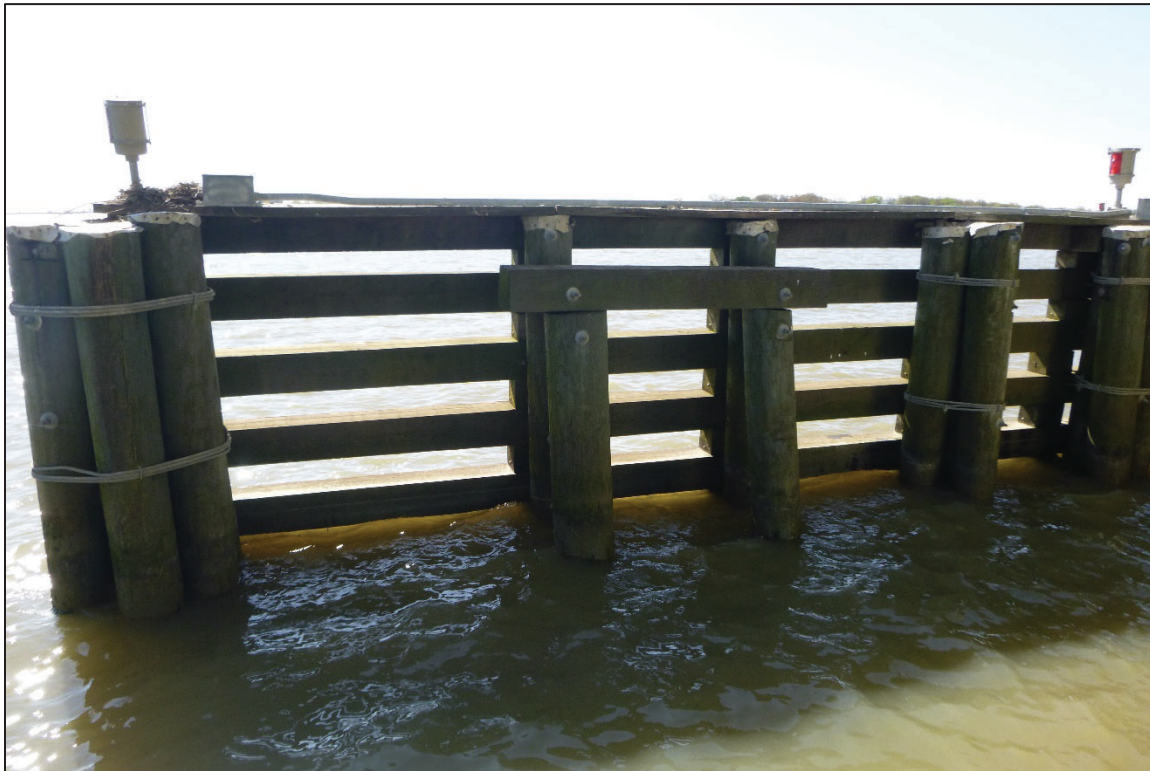
Photograph No. 56: View of the Timber Downstream Fender System, Looking Southeast.

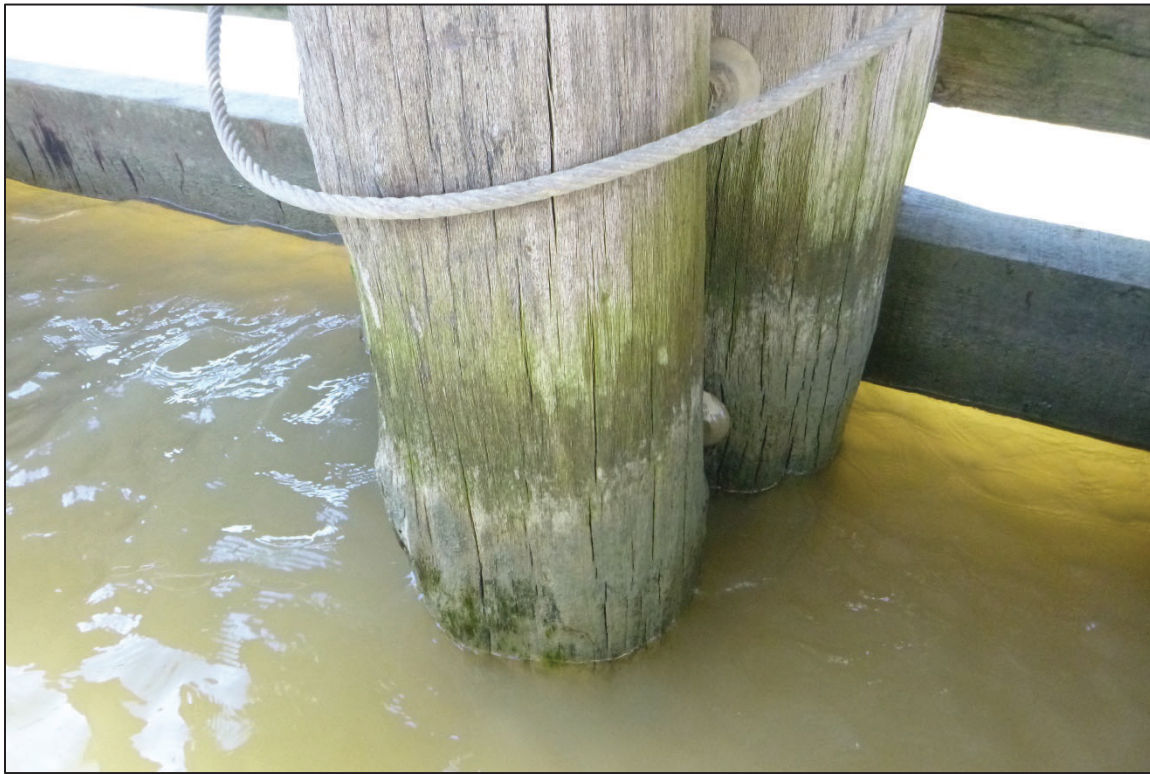
Photograph No. 57: View of the Typical Timber Pile of the Fender System, Looking Southeast.

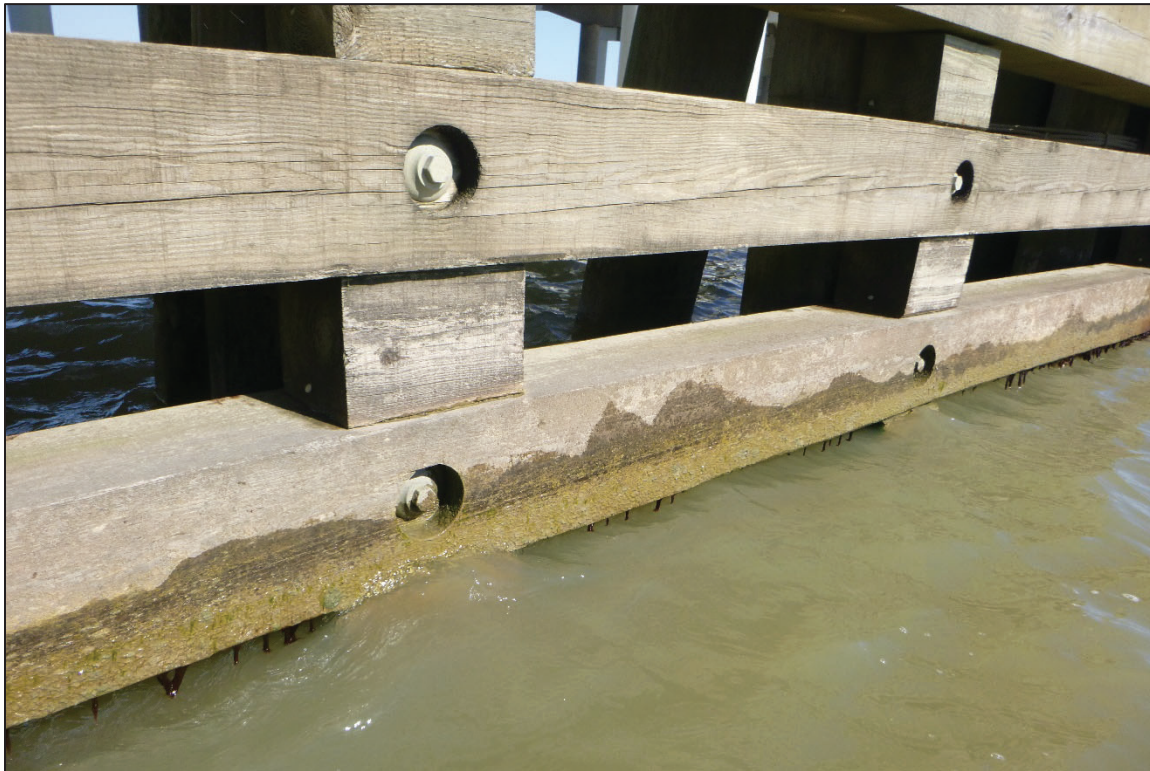
Photograph No. 58: View of the Typical Fender of the Fender System, Looking Northeast.
