# UNDERWATER BRIDGE INSPECTION REPORT

STRUCTURE NO. 6200885 (OTT-19-0323)  
SR 19 OVER PORTAGE RIVER  
OTTAWA COUNTY, OH  
DISTRICT 2

May 2020

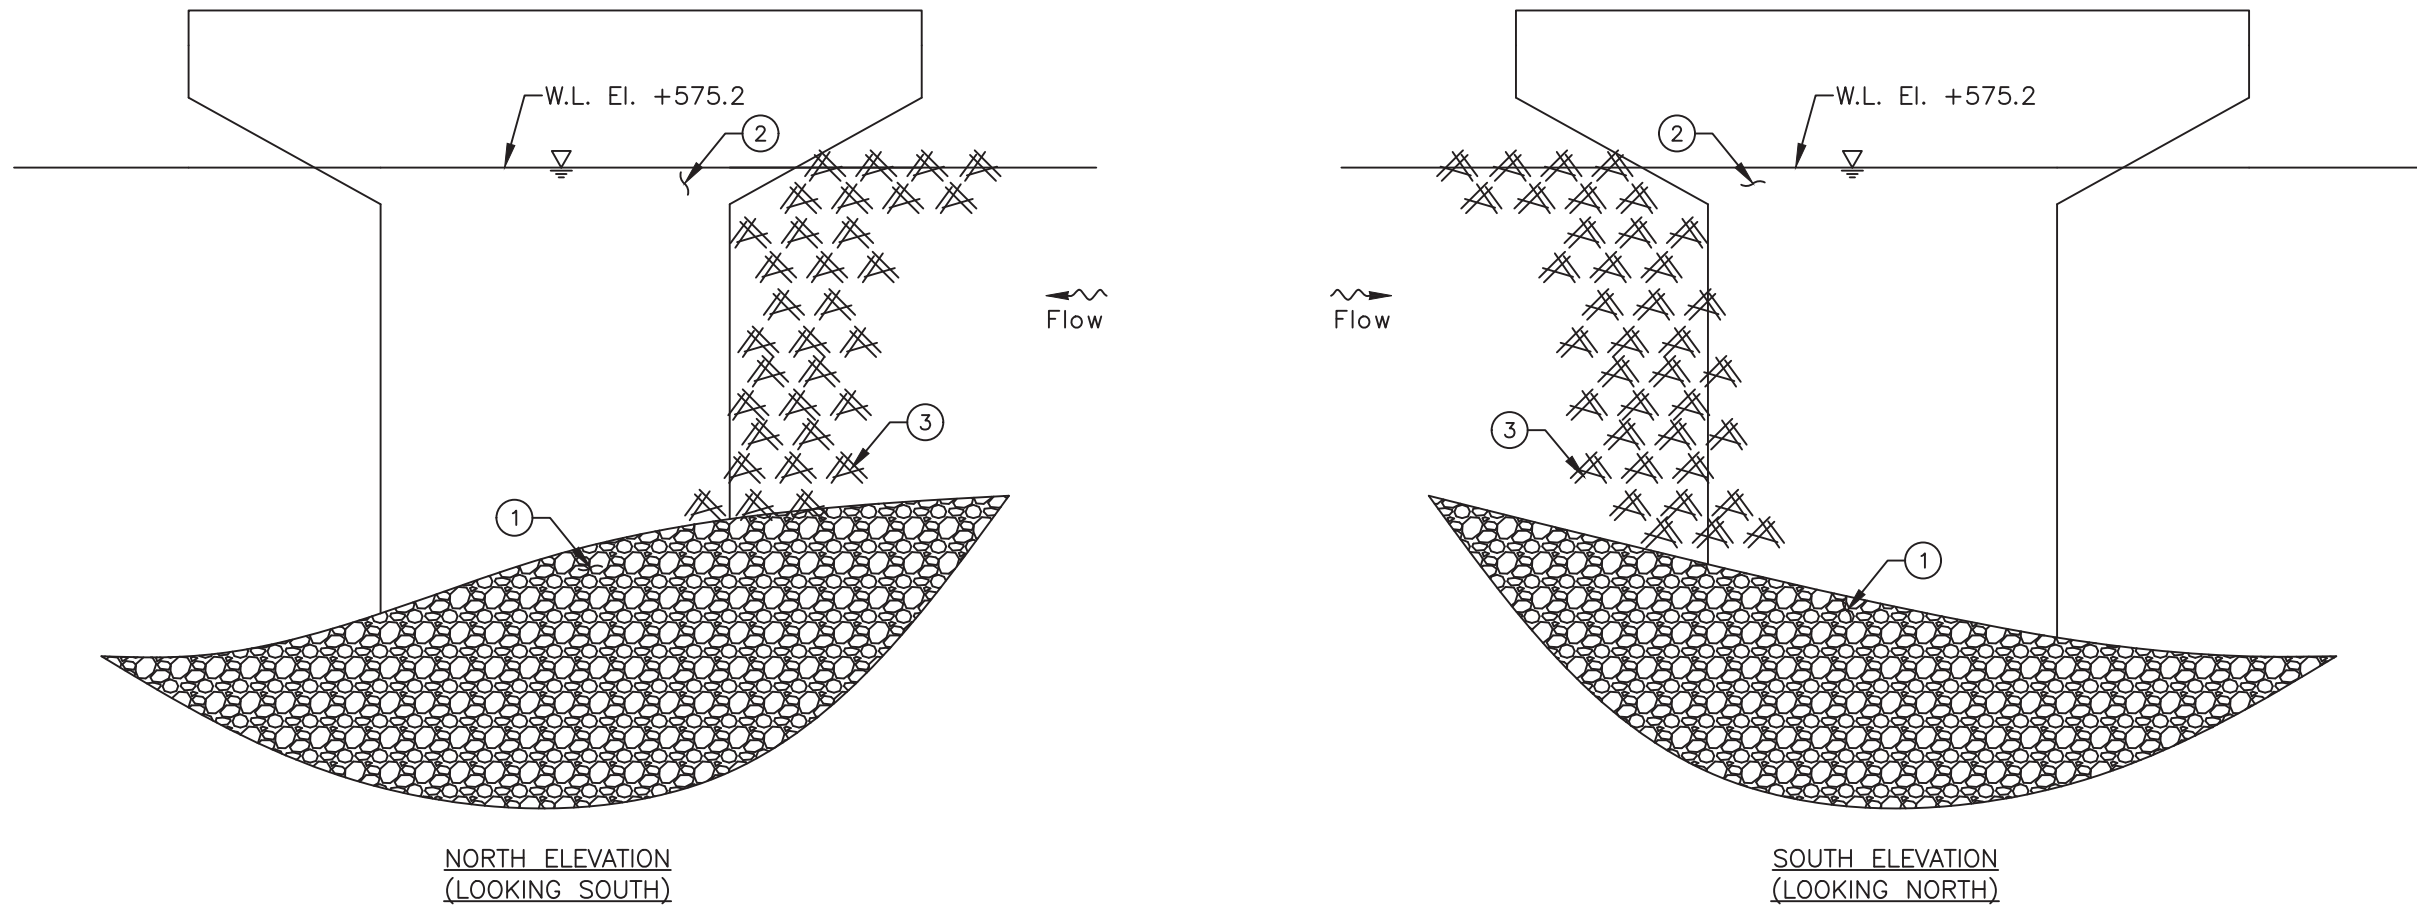
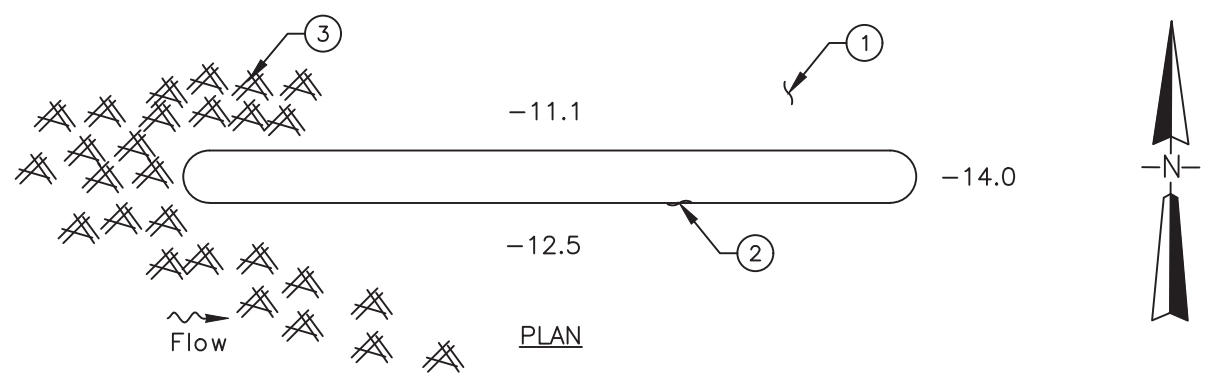
- Heavy timber debris consisting of logs up to 2 ft diameter were observed extending up to a 50 ft radius from the upstream nose from channel bottom to 1 ft above the waterline.

- ① The channel bottom material consisted of timber and silt overlay with approximately 6 in. probe rod penetration.
- ② The submerged portions of the pier were sound and smooth with no defects observed.
- ③ Heavy timber debris consisting of logs up to 2 ft diameter were observed extending up to a 50 ft radius from the upstream nose from channel bottom to 1 ft above the waterline.

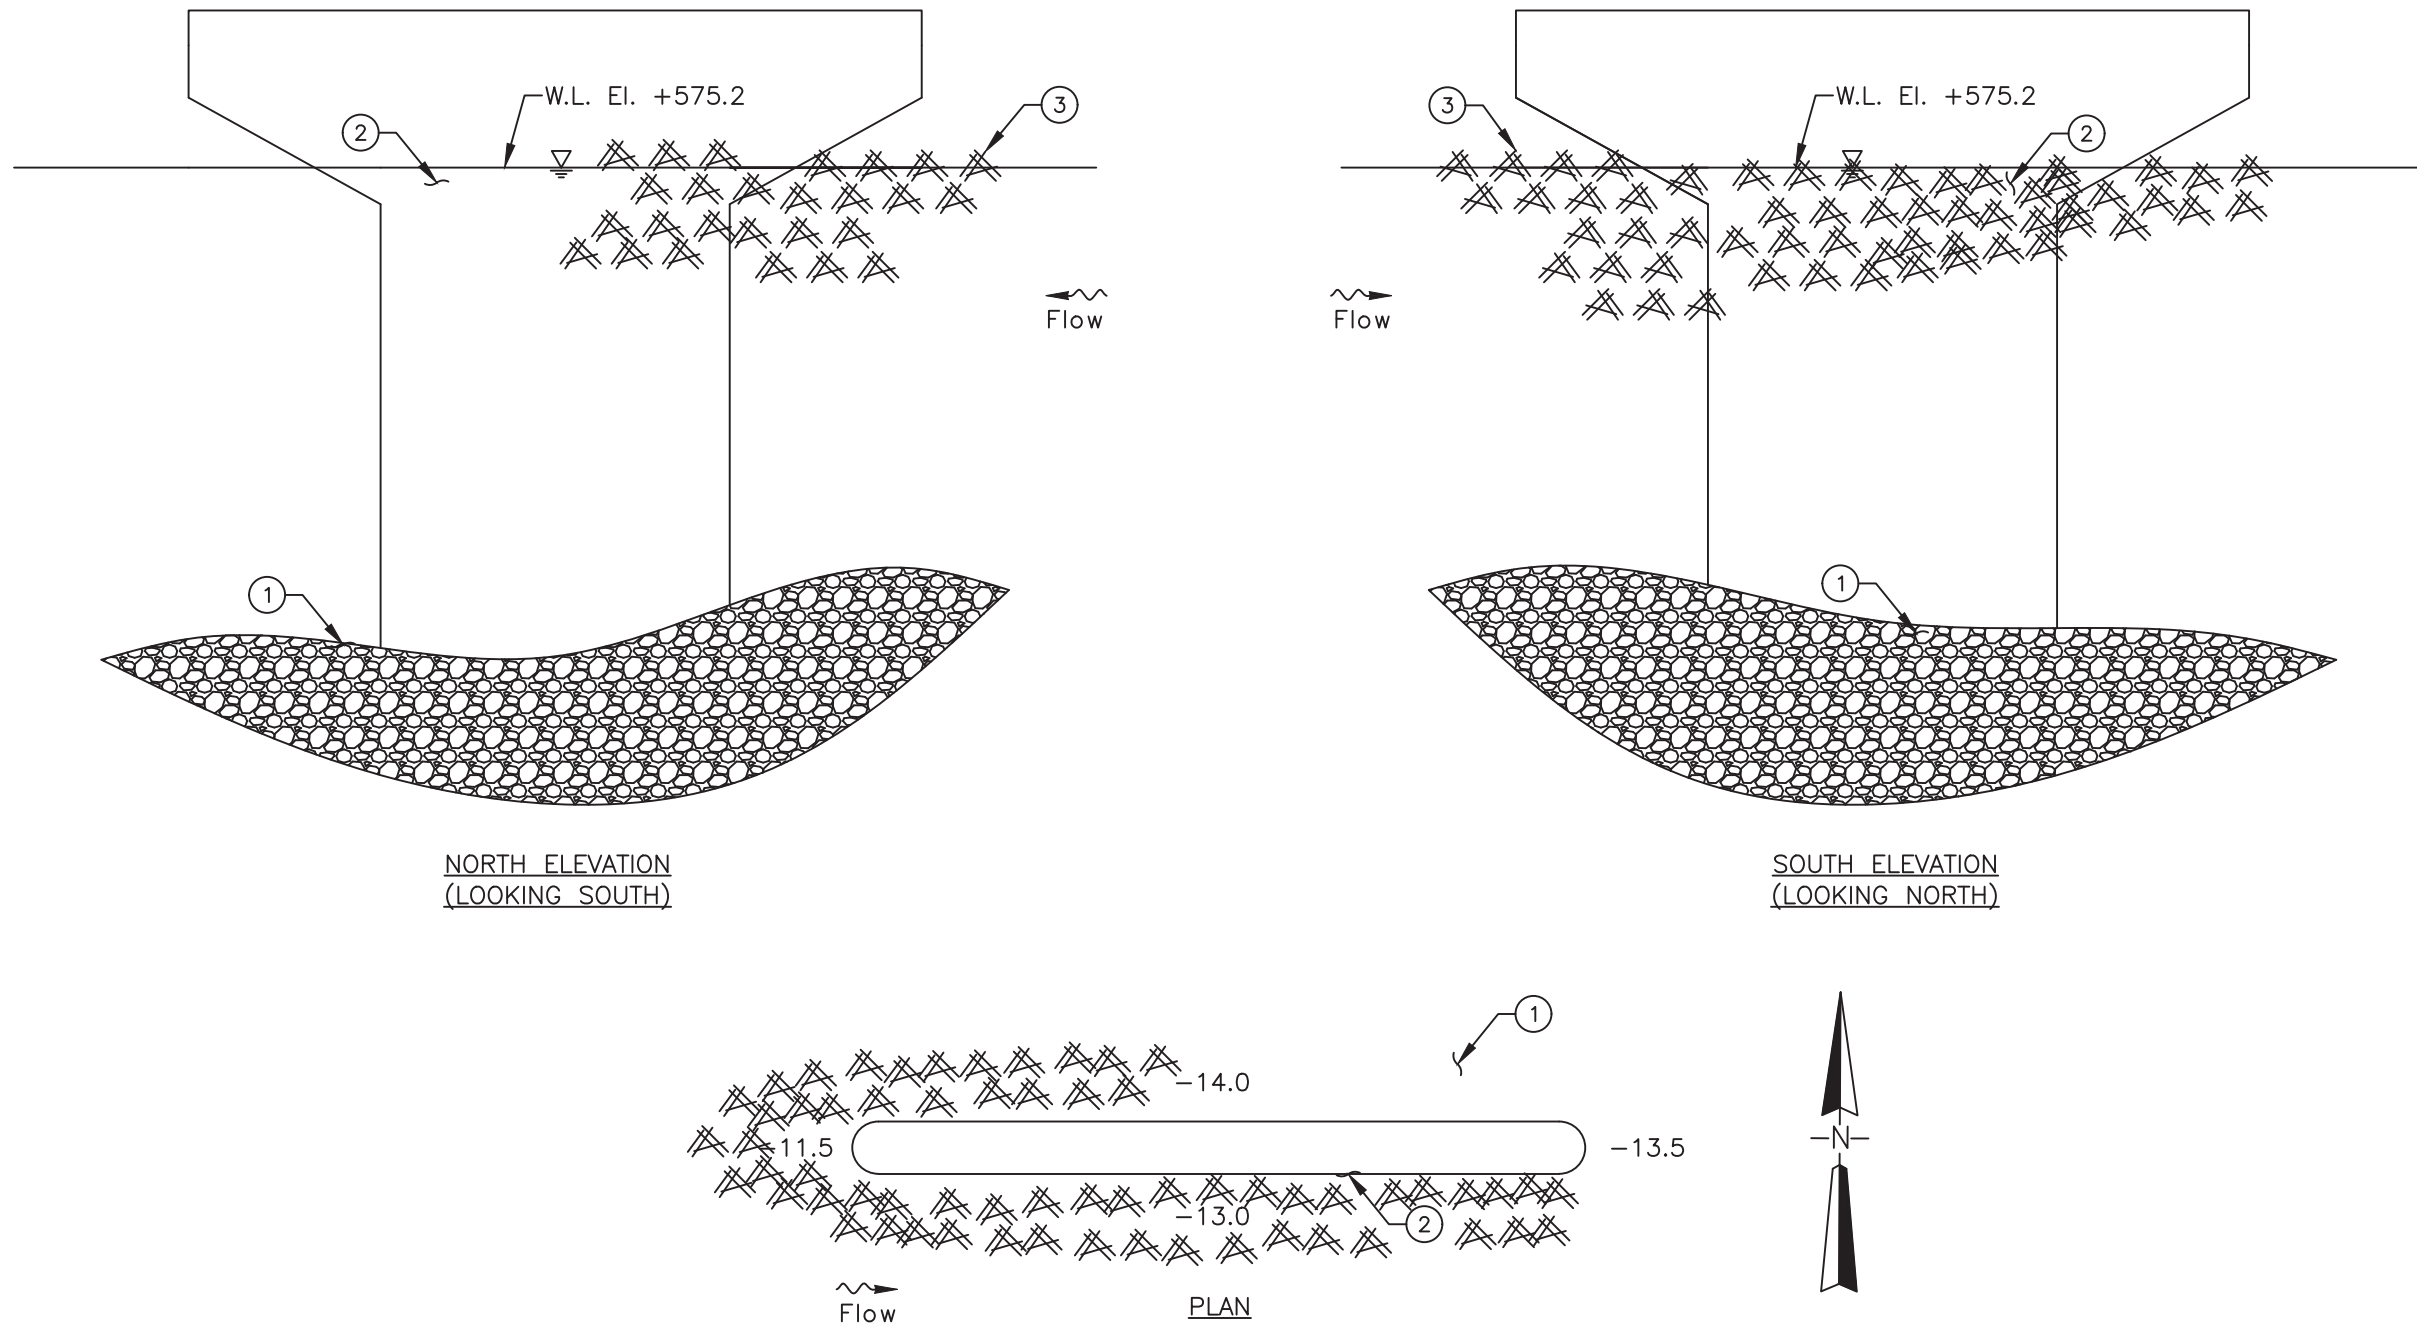
- Heavy timber debris consisting of logs up to 2 ft diameter were observed extending up to a 20 ft radius from the upstream nose from channel bottom to 1 ft above the waterline.

- ① The channel bottom material consisted of timber and silt overlay with approximately 6 in. probe rod penetration.
- ② The submerged portions of the pier were sound and smooth with no defects observed.
- ③ Heavy timber debris consisting of logs up to 2 ft diameter were observed extending up to a 20 ft radius from the upstream nose from channel bottom to 1 ft above the waterline.

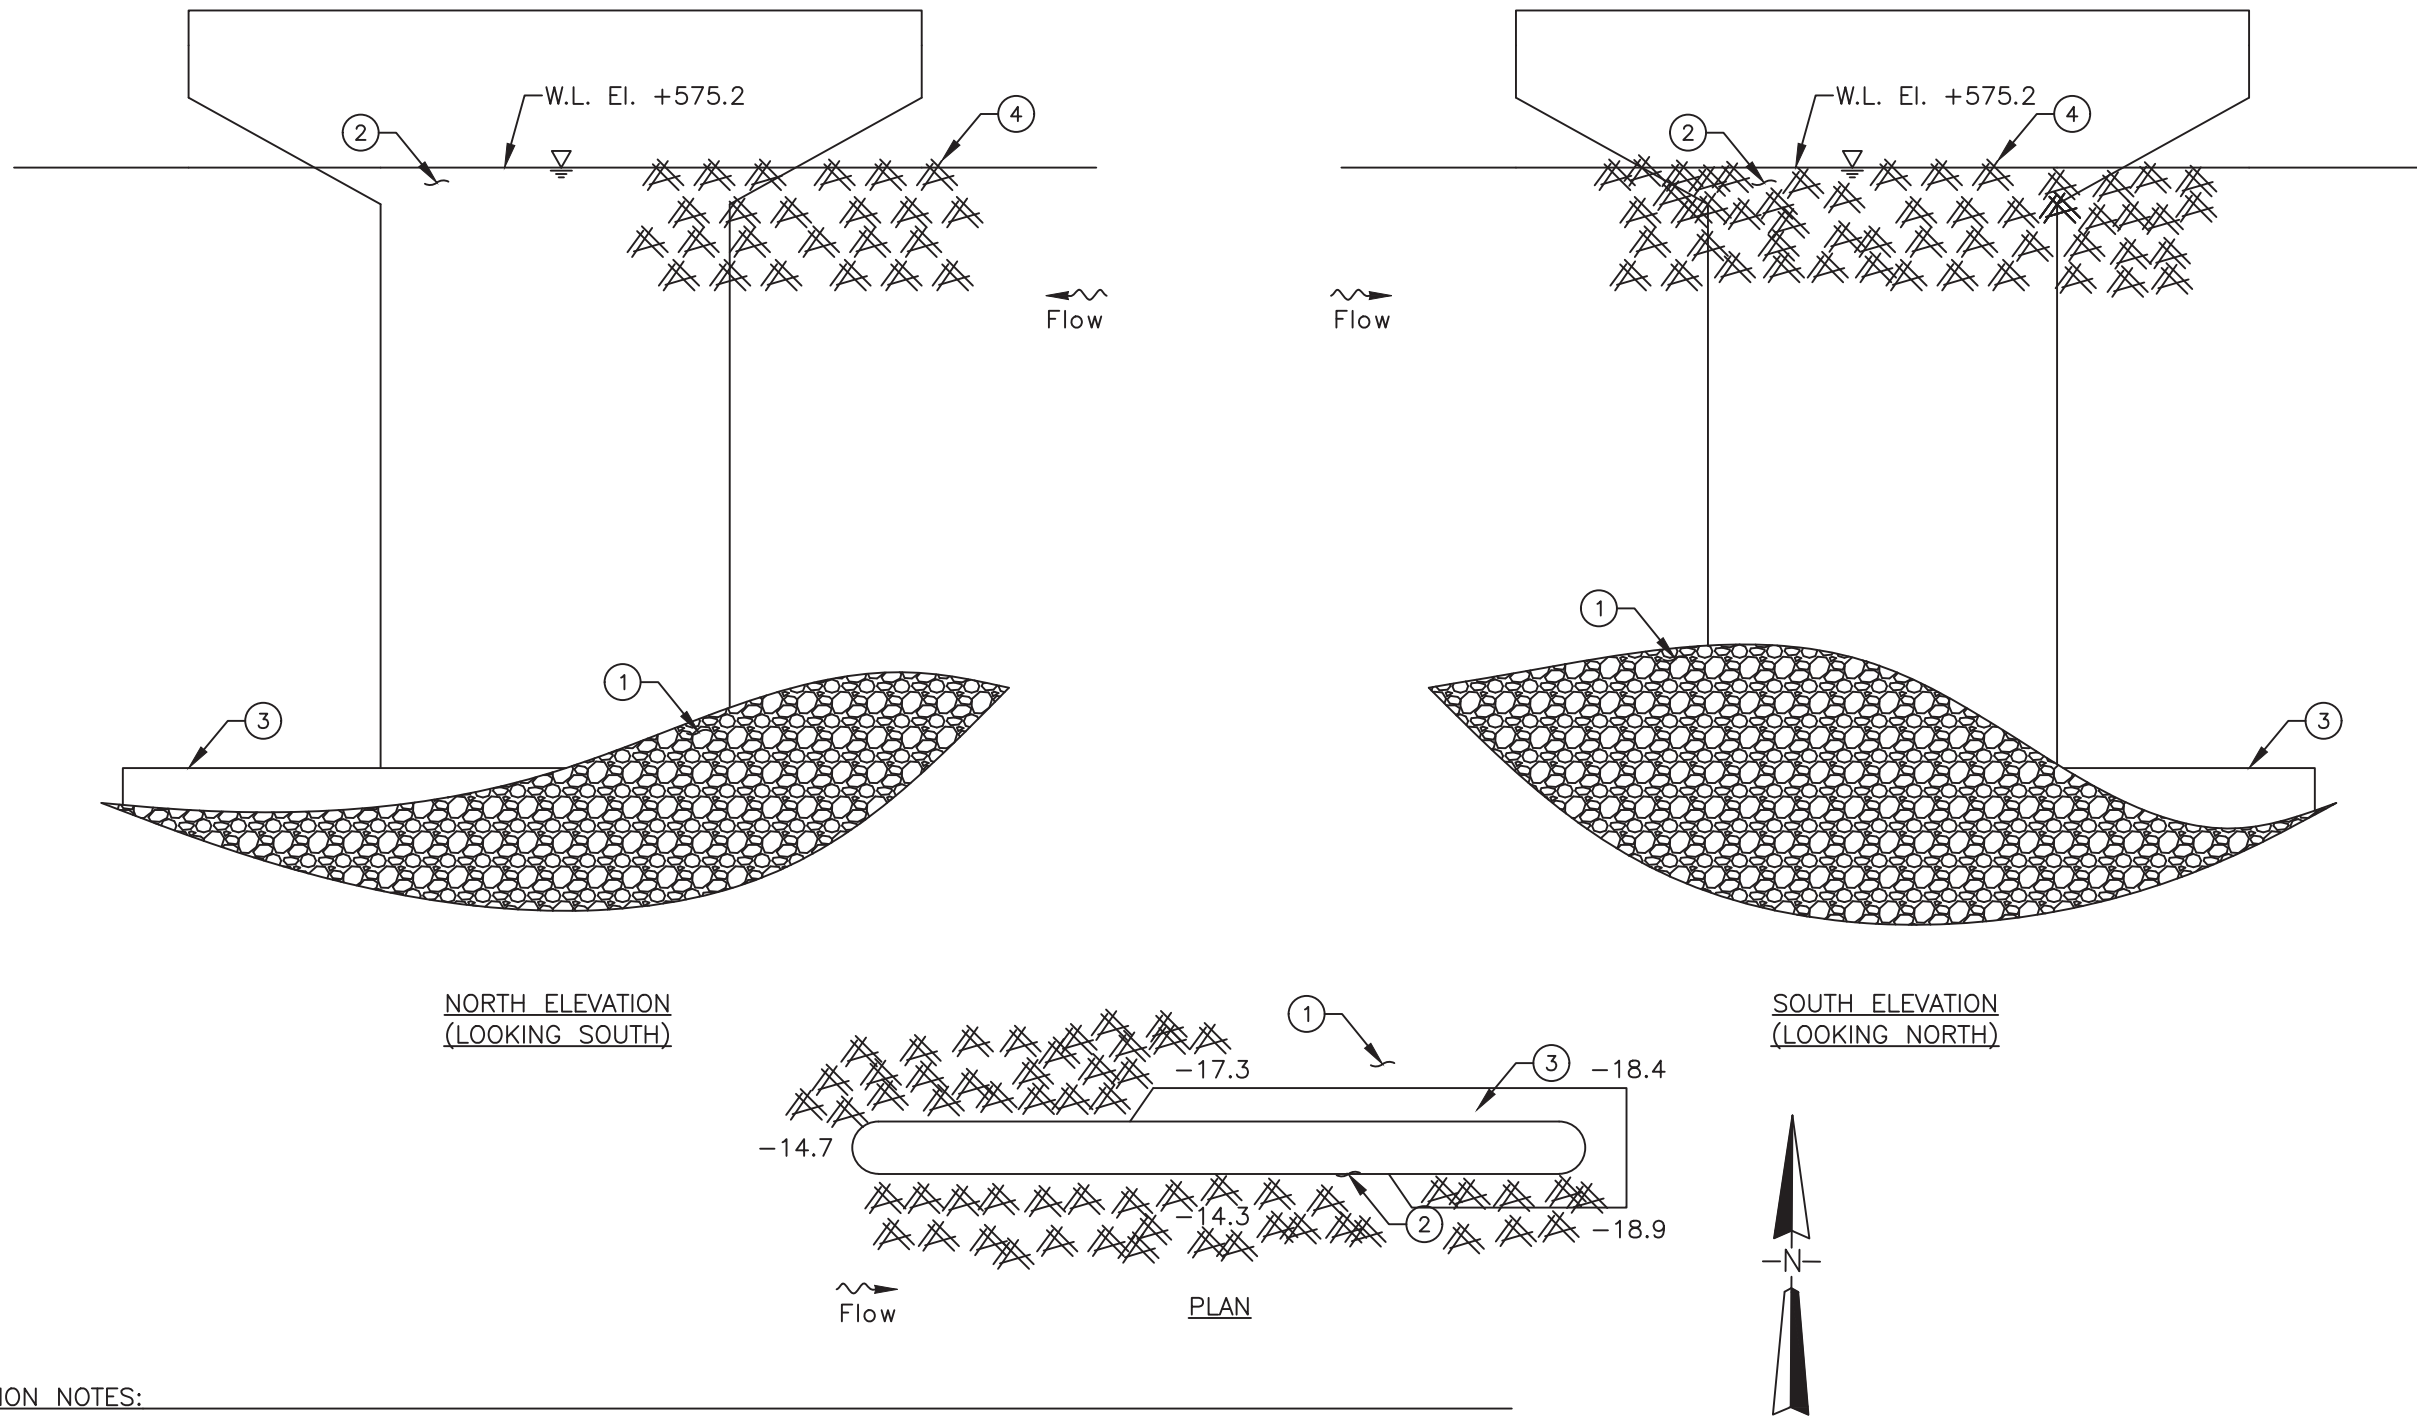
- The top of footing was observed at 17.2 ft below the waterline extending from the midpoint along the north face around the downstream nose to the downstream quarter point of the south face with a maximum vertical exposure of 1.7 ft at the southeast corner.

- ① The channel bottom material consisted of timber and silt overlay with approximately 6 in. probe rod penetration.
- ② The submerged portions of the pier were sound and smooth with no defects observed.
- ③ The top of footing was observed at 17.2 ft below the waterline extending from the midpoint along the north face around the downstream nose to the downstream quarter point of the south face with a maximum vertical exposure of 1.7 ft at the southeast corner.
- ④ Heavy timber debris consisting of logs up to 2 ft diameter were observed extending up to a 30 ft radius from the upstream nose from channel bottom to 1 ft above the waterline.

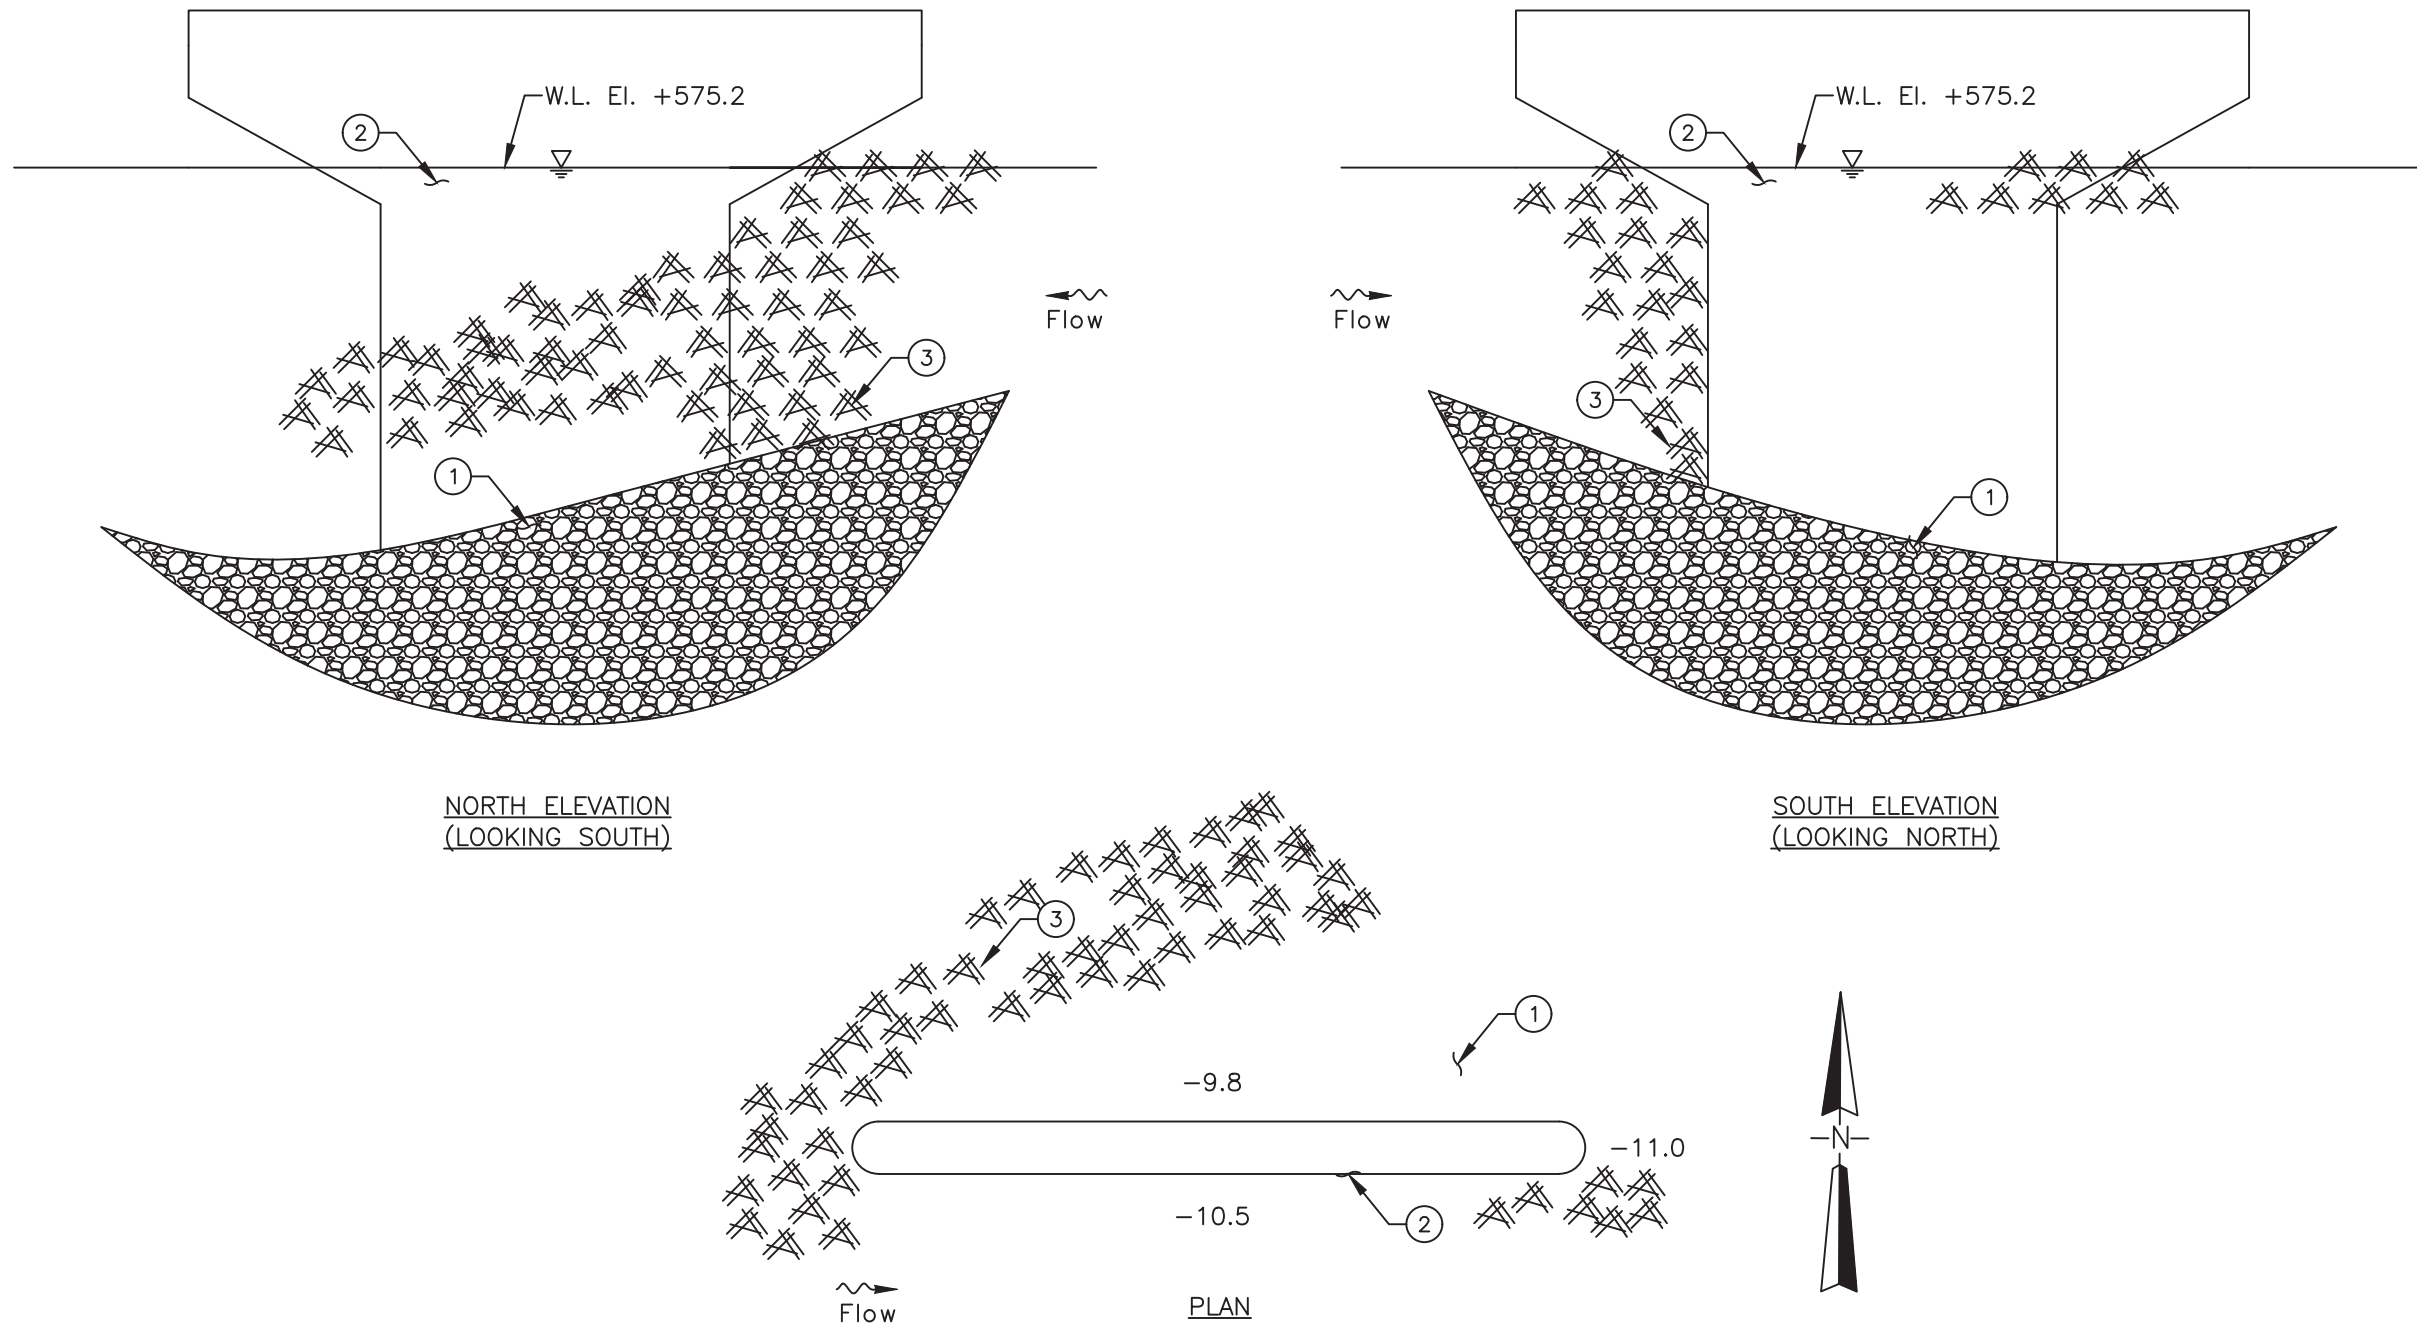
- INSPECTION NOTES:**
- ① The channel bottom material consisted of timber and silt overlay with approximately 6 in. probe rod penetration.
  - ② The submerged portions of the pier were sound and smooth with no defects observed.
  - ③ Heavy timber debris consisting of logs up to 2 ft diameter were observed extending up to a 40 ft radius from the upstream nose from channel bottom to 2 ft above the waterline.

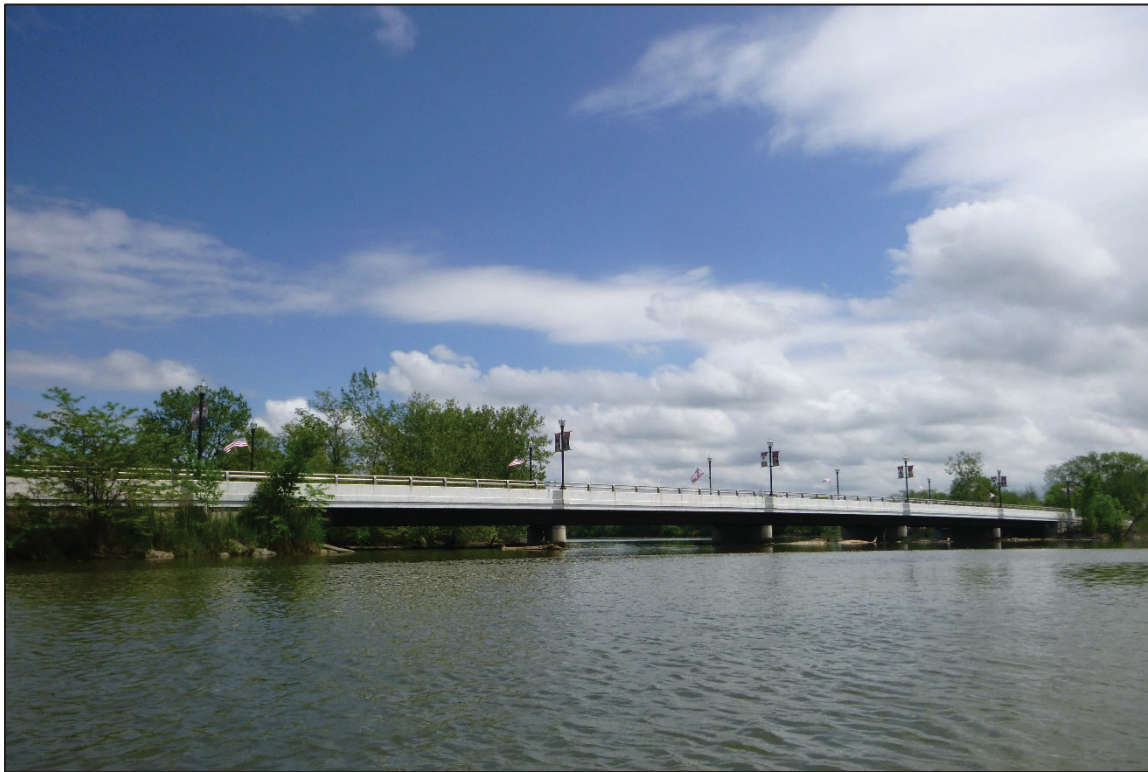
Photograph No. 1: Overall View of Structure No. 6200885 (OTT-19-0323), Looking Southeast.

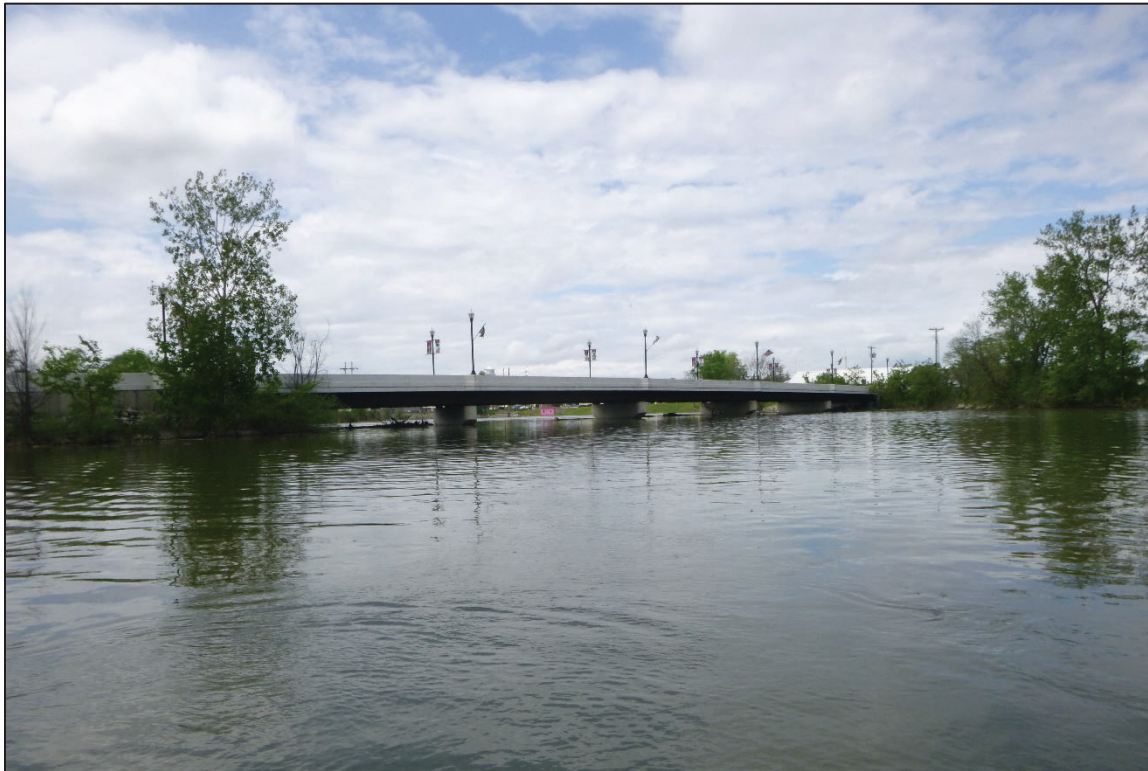
Photograph No. 2: Overall View of Structure No. 6200885 (OTT-19-0323), Looking Northwest.
