# UNDERWATER BRIDGE INSPECTION REPORT

STRUCTURE NO. 8706751 (WOO-475-0386L)  
I-475 SB OVER MAUMEE RIVER  
WOOD COUNTY, OH  
DISTRICT 2

April 2020

**COLLINS**  
**ENGINEERS** INC.

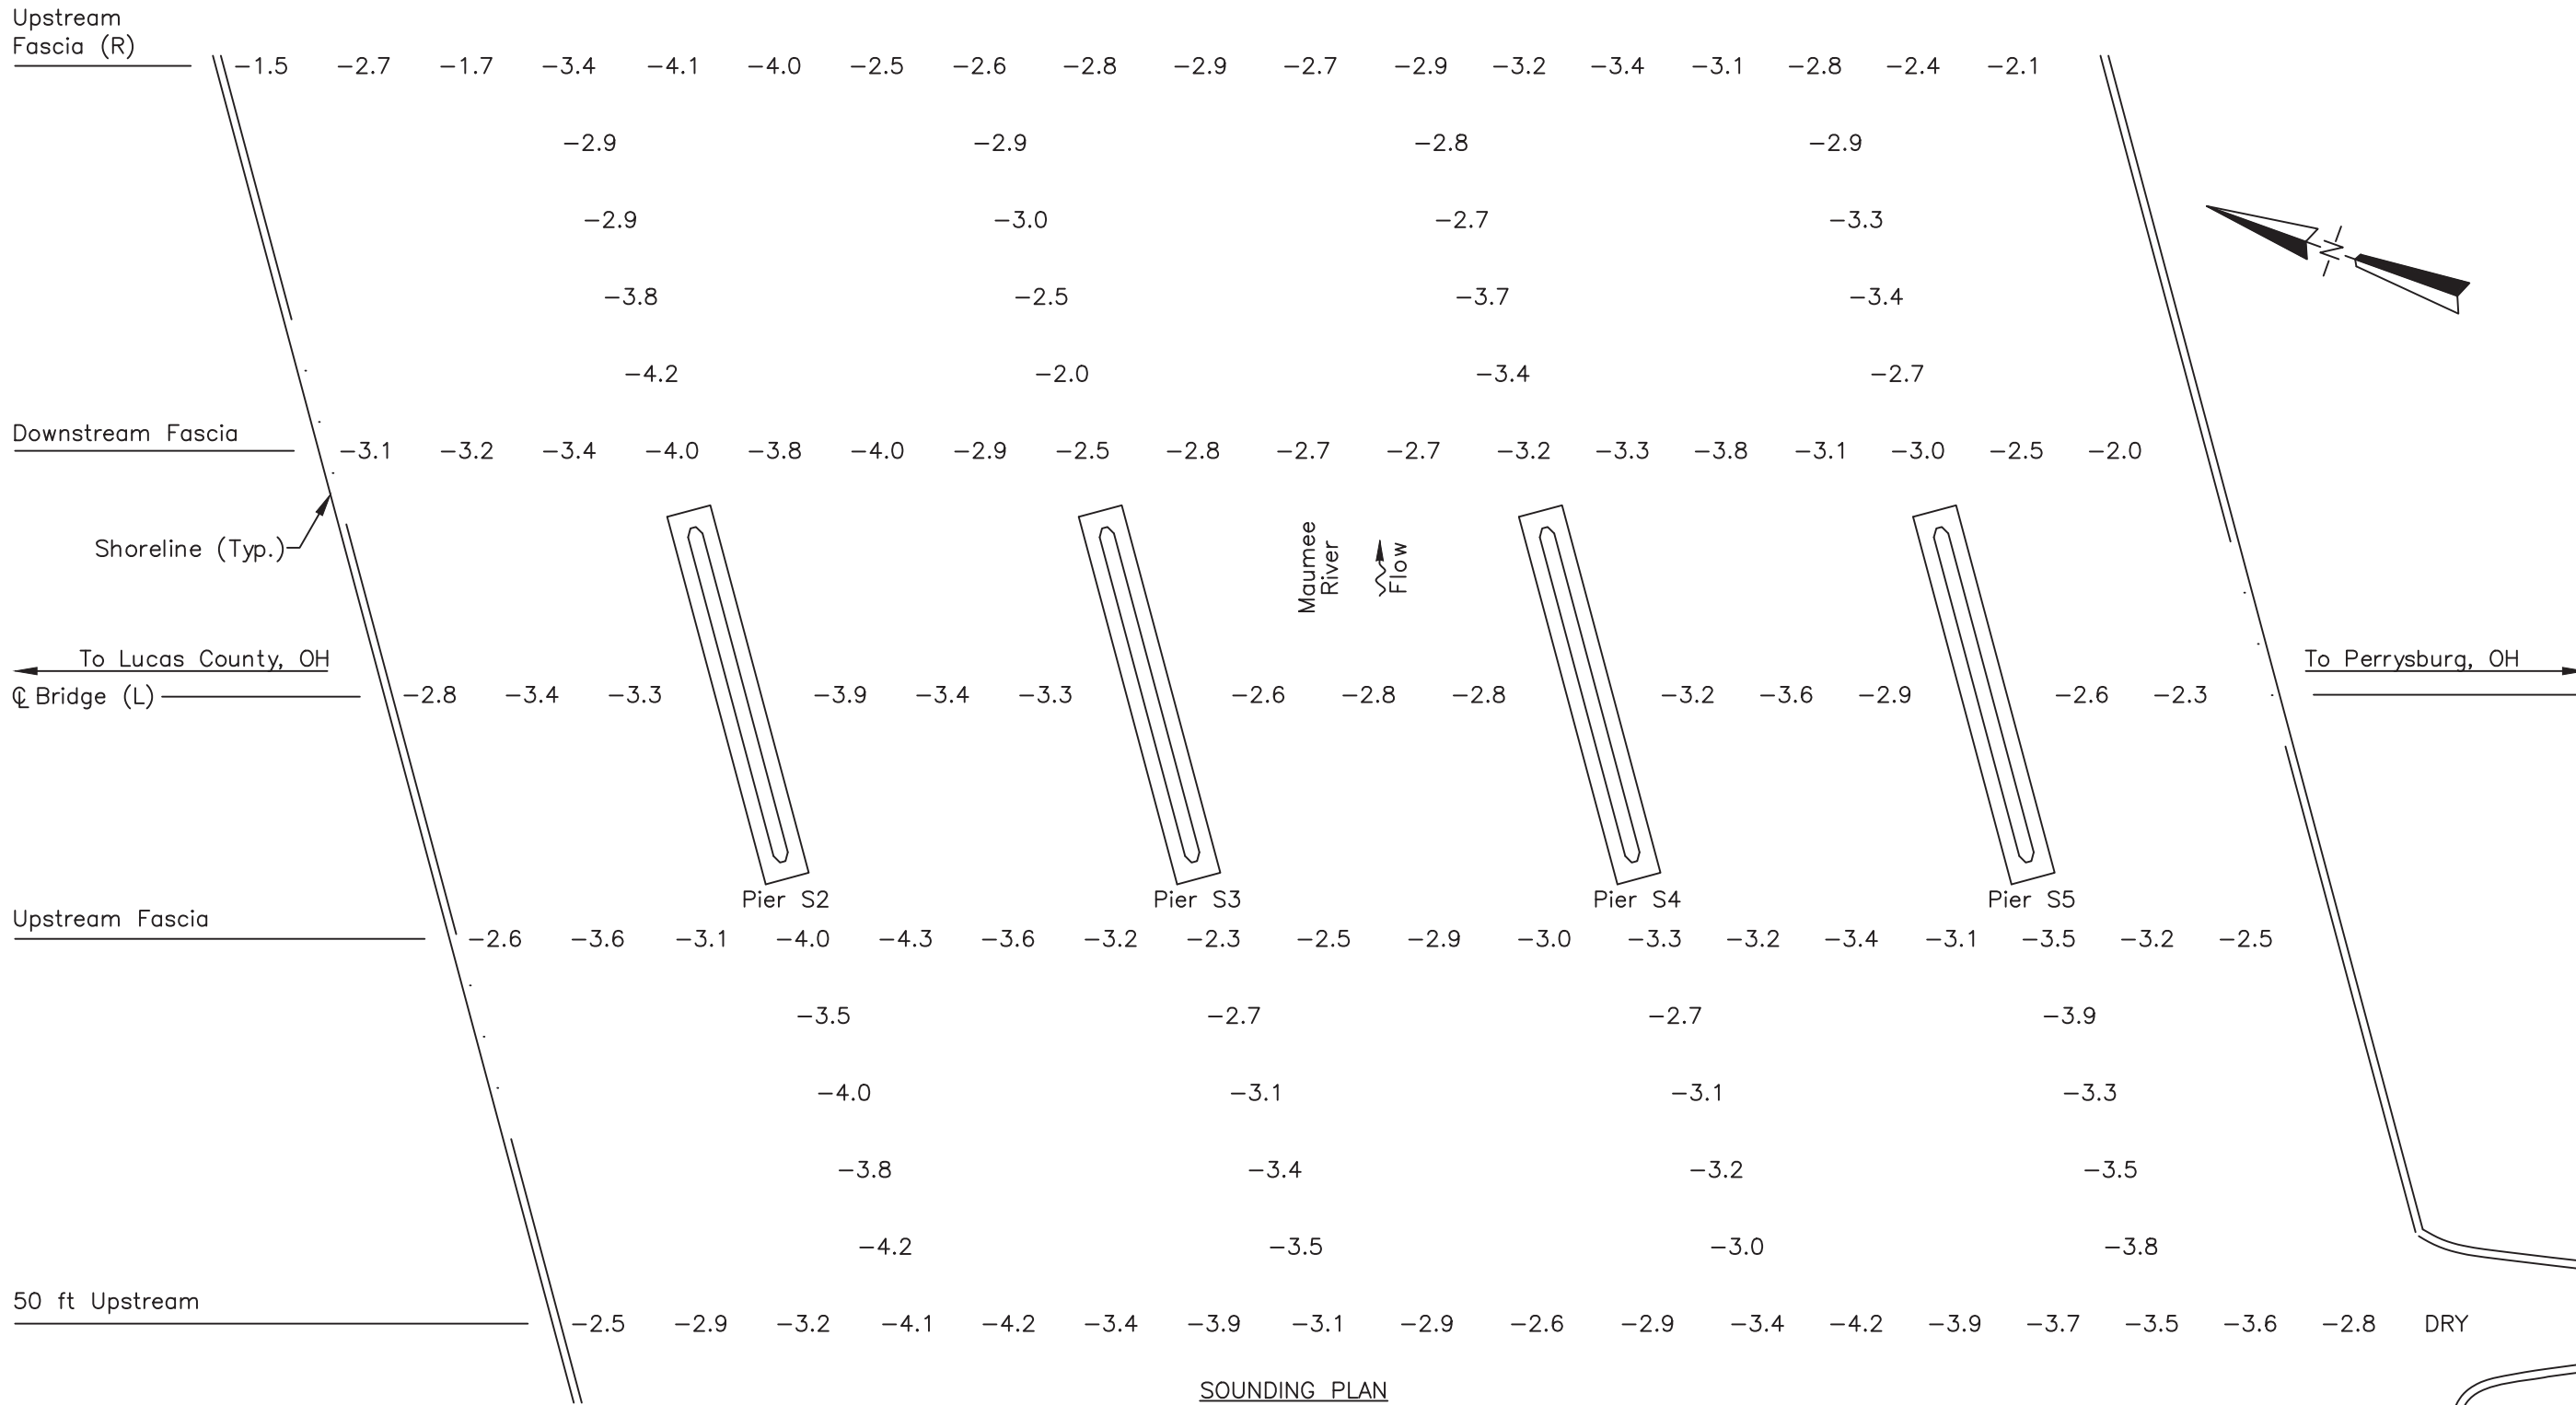
SOUNDING PLAN

Channel bottom soundings were performed utilizing a telescoping survey rod and digital fathometer. Soundings were collected at quarter points along the bridge centerline as well as at quarter points along the upstream and downstream fascias and 50 ft fascias. Additional soundings were collected adjacent to Piers 2 through 5 and at 10 foot intervals in-line with the piers, upstream and downstream, and the waterline was referenced to a known elevation on the bridge. A sounding plan was developed using the soundings and approximate location of the shorelines. Refer to Figures 2 through 7 in Exhibit 1 for the sounding plan and channel cross sections that show the channel limits and water depths around the structure.

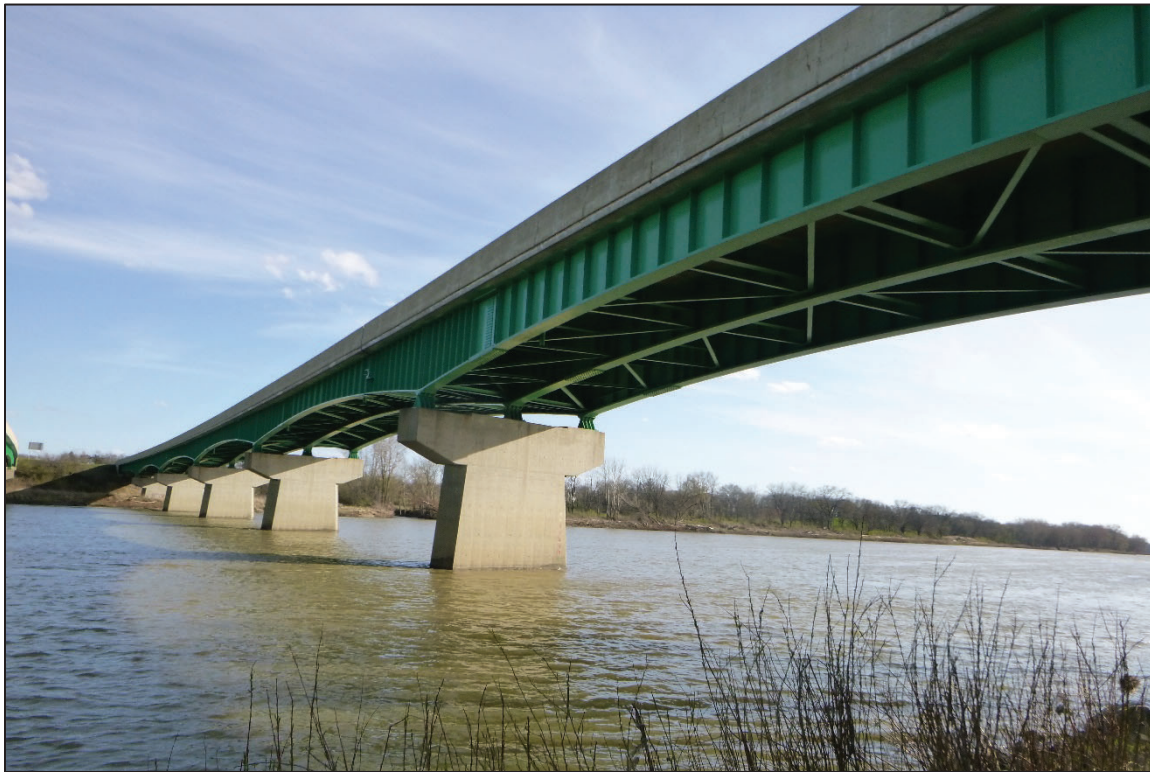
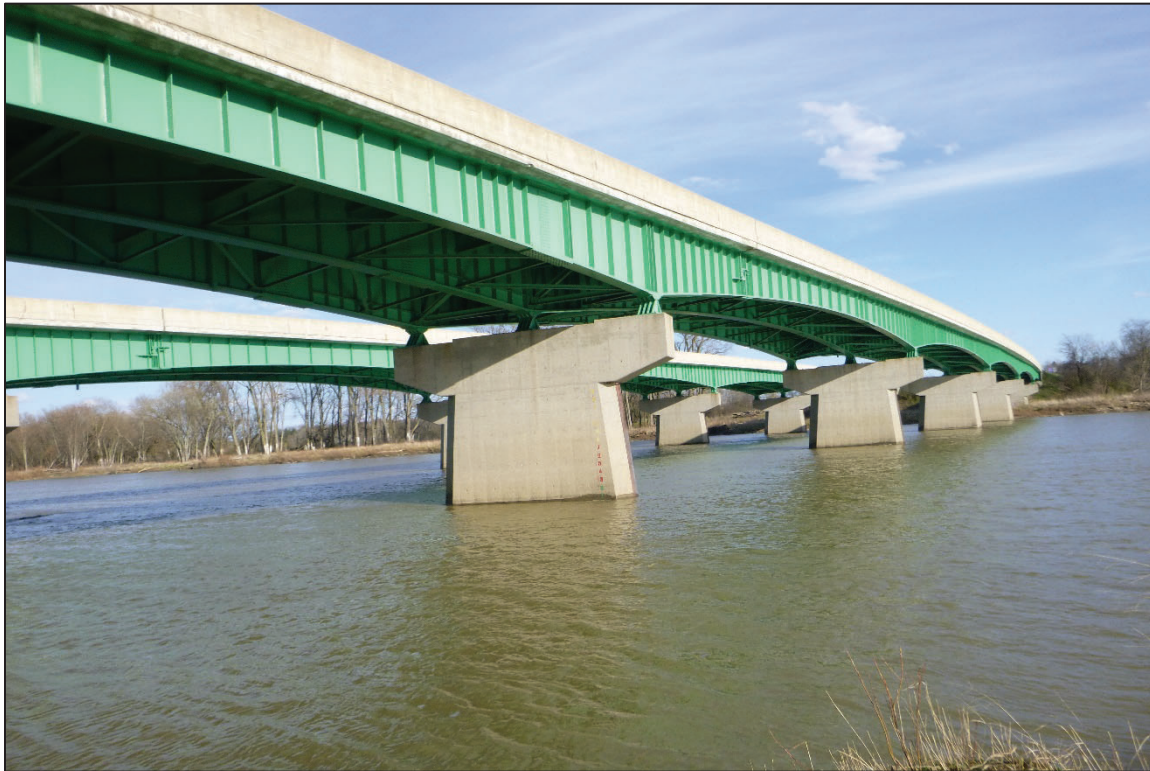
Structure No. 8706751 (WOO-475-0386L) spans 929.7 ft, carrying I-475 SB over Maumee River and is approximately 60 ft wide. The bridge superstructure is constructed of seven steel girder spans. The roadway orientation of the longitudinal axis of the bridge is north to south. The substructure units are labeled as Abutments 1 and 2 and Piers 1 through 6. Existing record drawings were not available at the time of the inspection. Refer to Figure 1 in Exhibit 1 for a Location Map of the bridge. Refer to Photographs 1 and 2 in Exhibit 2 for overall views of the bridge.

Photograph No. 1: Overall View of Structure No. 8706751 (WOO-475-0386L), Looking Southwest.

Photograph No. 2: Overall View of Structure No. 8706751 (WOO-475-0386L), Looking Southeast.

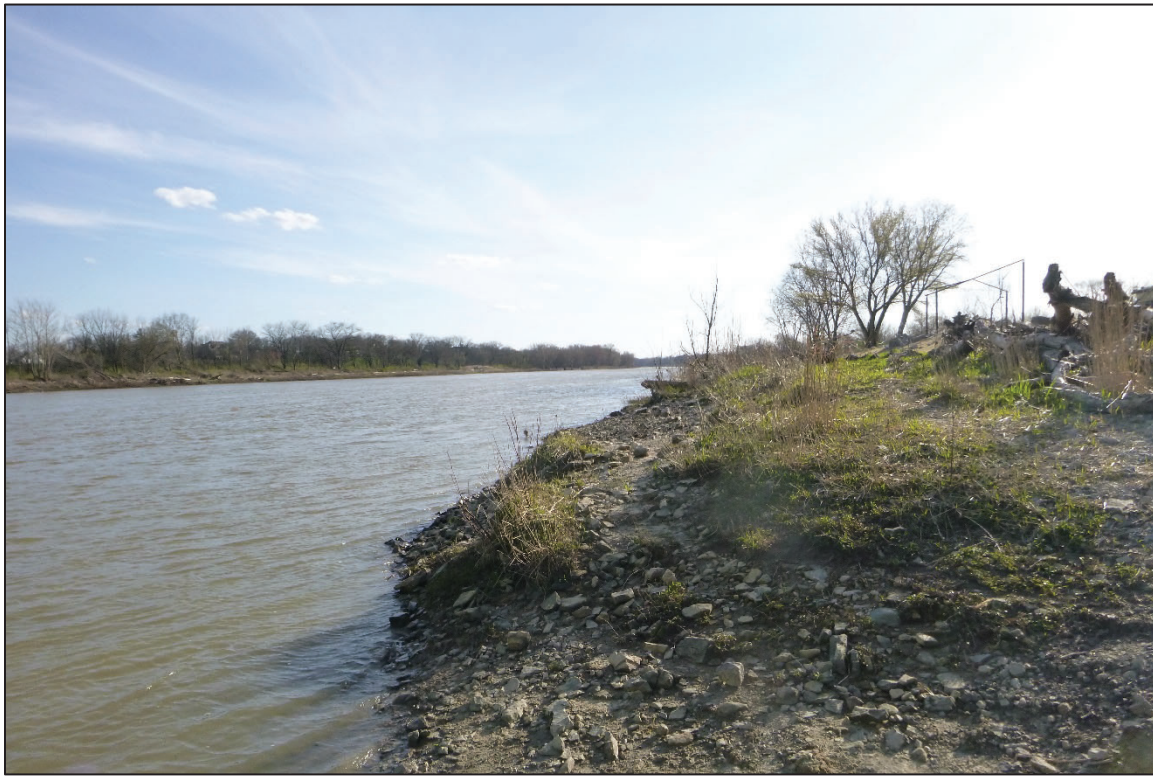
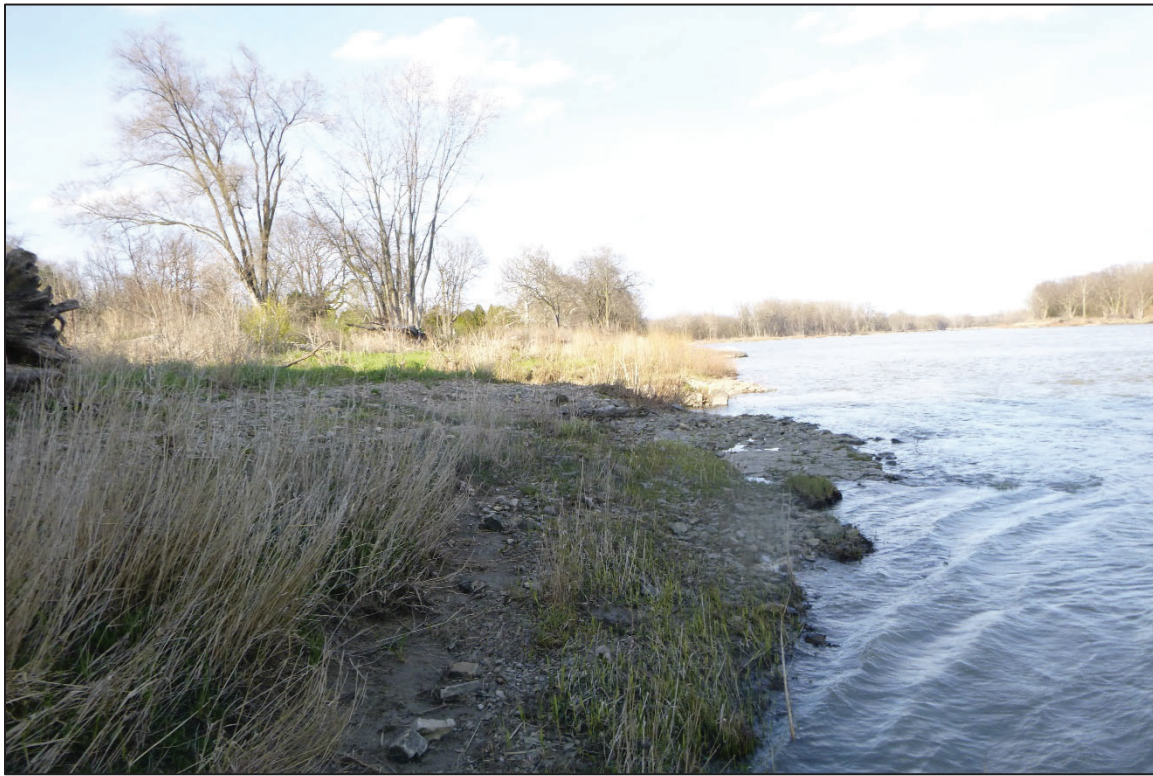
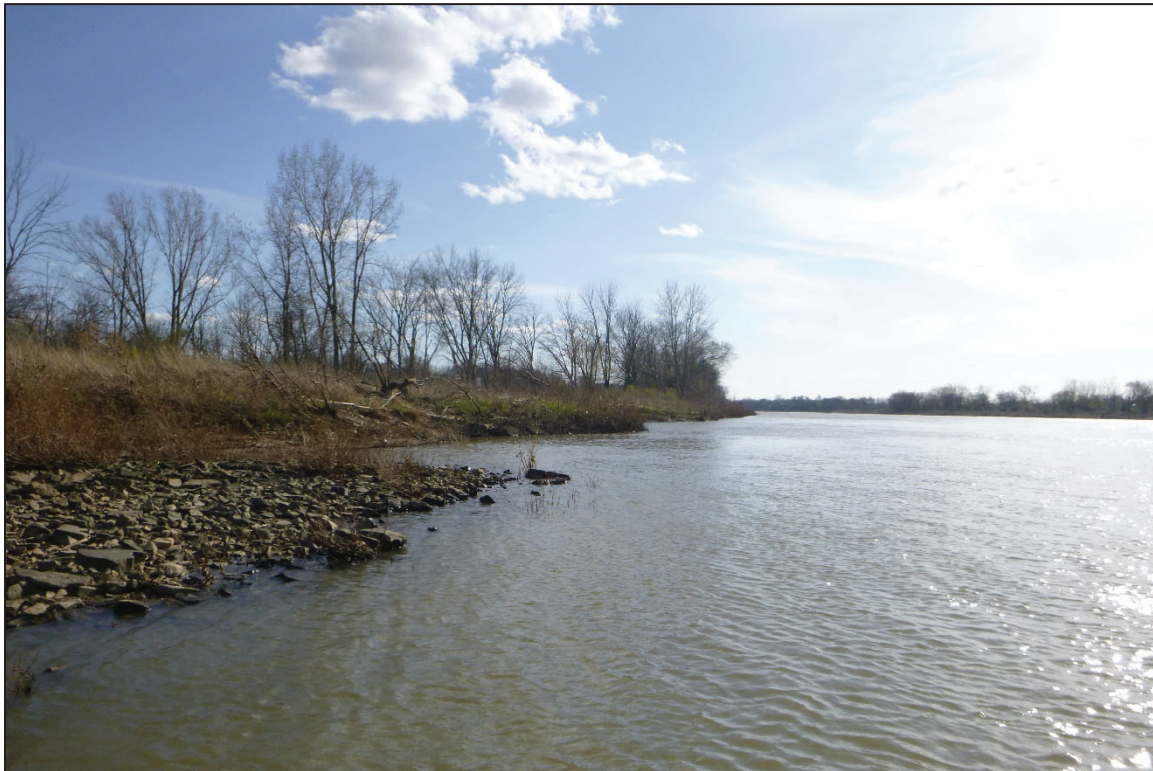
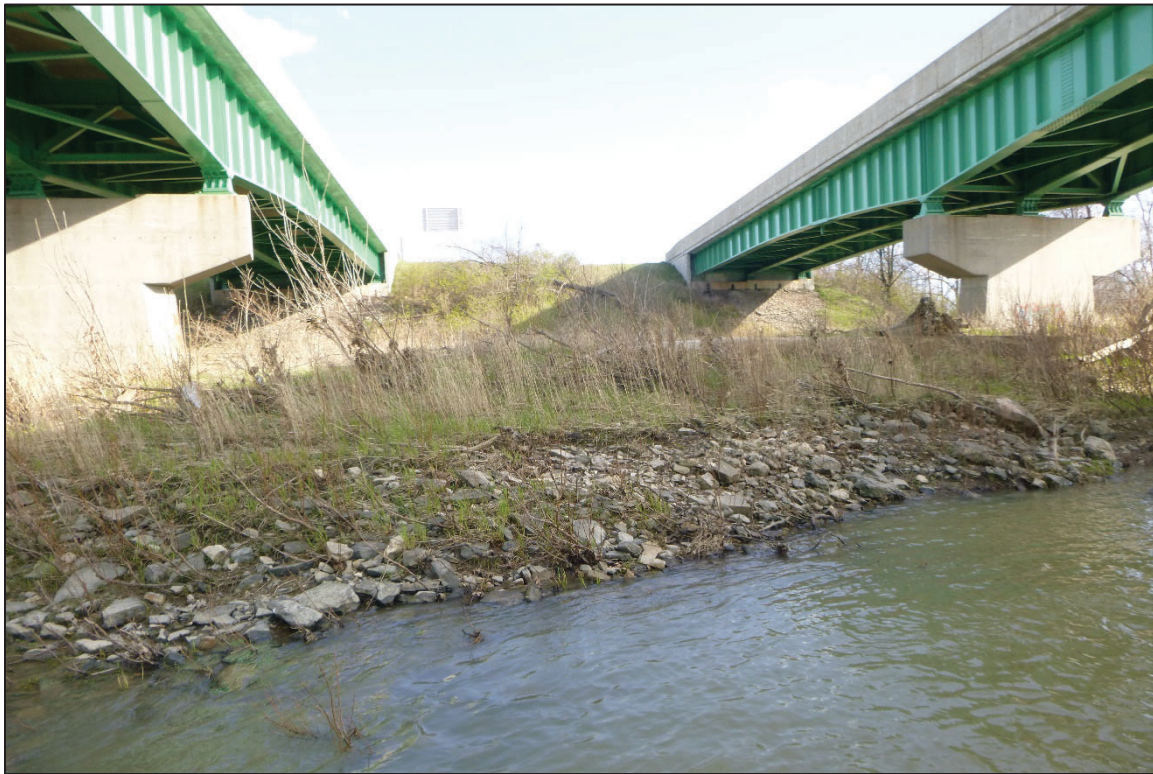
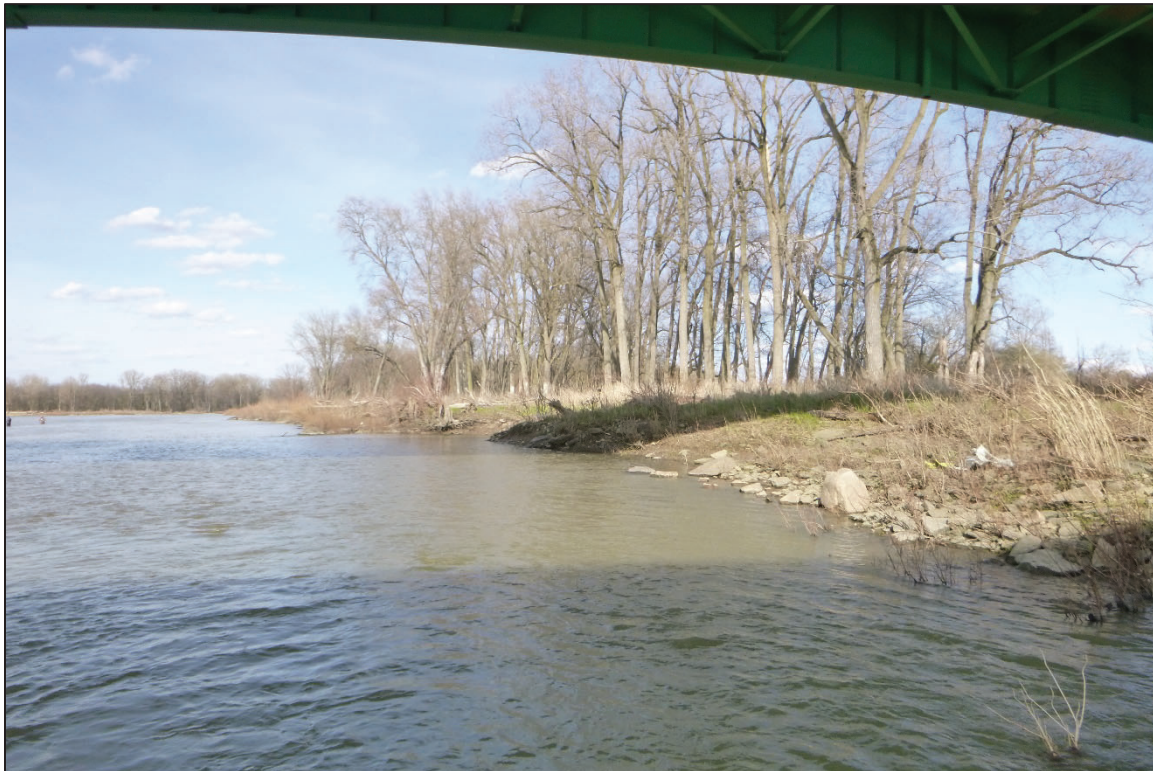
| <b>Shoreline Conditions:</b> | The north and south shorelines consisted of well-vegetated, gentle slopes with no erosion. | | |

At the time of the inspection, the waterline of 8706751 (WOO-475-0386L) was located approximately 9.5 ft below the gauge painted on the north face of Pier 5, which corresponds to a waterline elevation of 580.5 ft. During the inspection, the waterway was flowing at approximately 1.5 ft per second. The bridge pier skew was consistent with the channel alignment and does not require attention at this time. The north and south shorelines consisted of well-vegetated, gentle slopes with no erosion. Refer to Photographs 3 through 8 in Exhibit 2 for views of the shorelines near the structure.

Photograph No. 3: View of the North Embankment Upstream of the Structure, Looking West.

Photograph No. 4: View of the North Embankment at the Structure, Looking North.

Photograph No. 5: View of the North Embankment Downstream of the Structure, Looking East.

Photograph No. 6: View of the South Embankment Upstream of the Structure, Looking West.

Photograph No. 7: View of the South Embankment at the Structure, Looking South.

Photograph No. 8: View of the South Embankment Downstream of the Structure, Looking East.
