UNDERWATER BRIDGE INSPECTION REPORT

STRUCTURE NO. 8706786 (WOO-475-0386R)
I-475 NB OVER MAUMEE RIVER
WOOD COUNTY, OH
DISTRICT 2

April 2020

COLLINS
ENGINEERS INC.

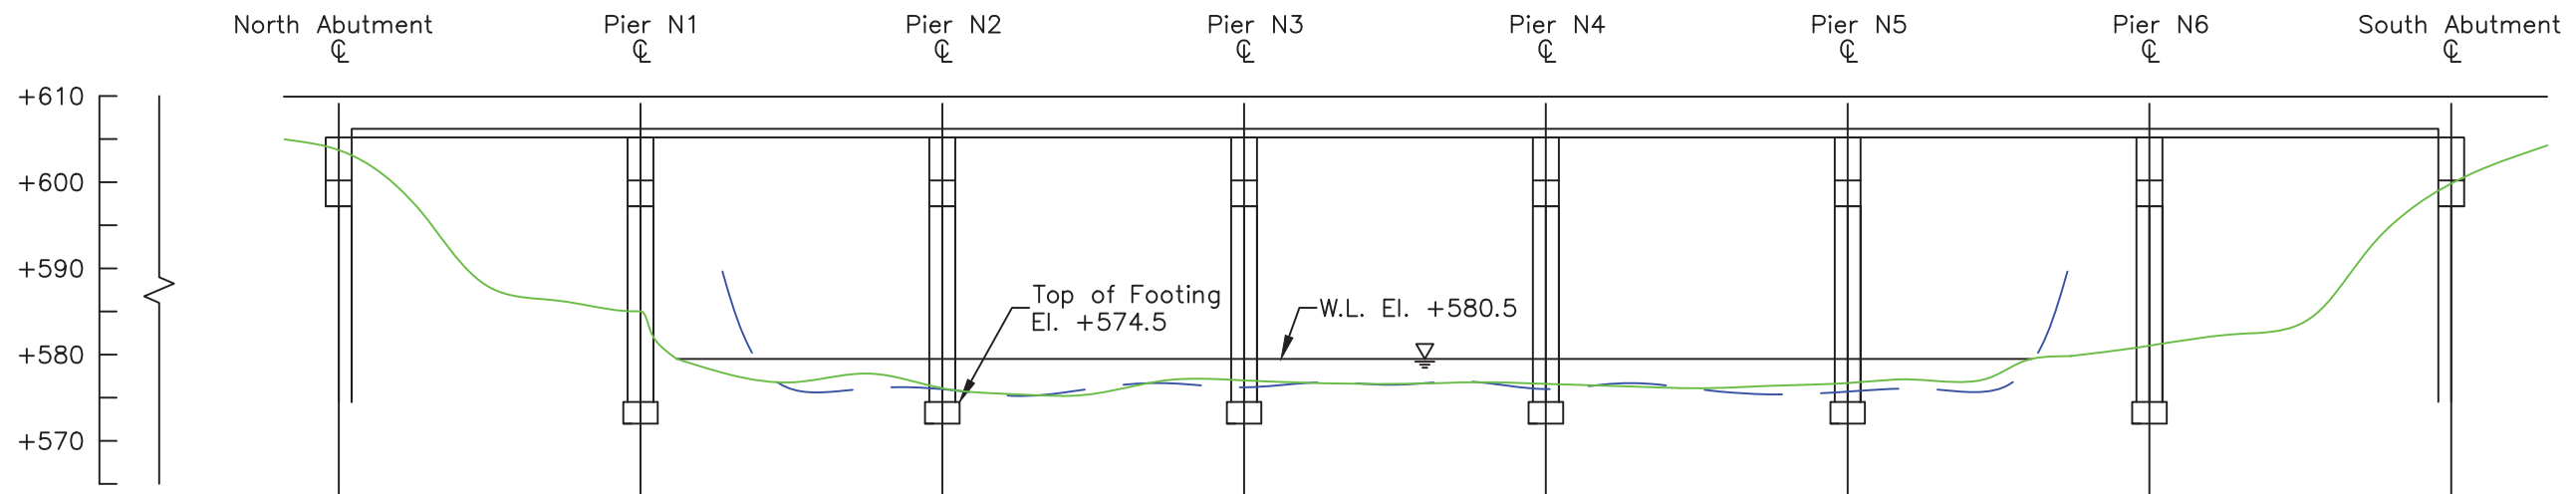
CHANNEL CROSS SECTION
 UPSTREAM FASCIA
 (LOOKING DOWNSTREAM)

UPSTREAM FASCIA LOOKING DOWNSTREAM	
Location	Y(ft)*
A1	7.2
1/4	15.3
1/2	23.5
3/4	24.7
PN1	25.9
1/4	30.2
1/2	34.5
3/4	34.8
PN2	35.1
1/4	35.1
1/2	35.2
3/4	35.2
PN3	35.3

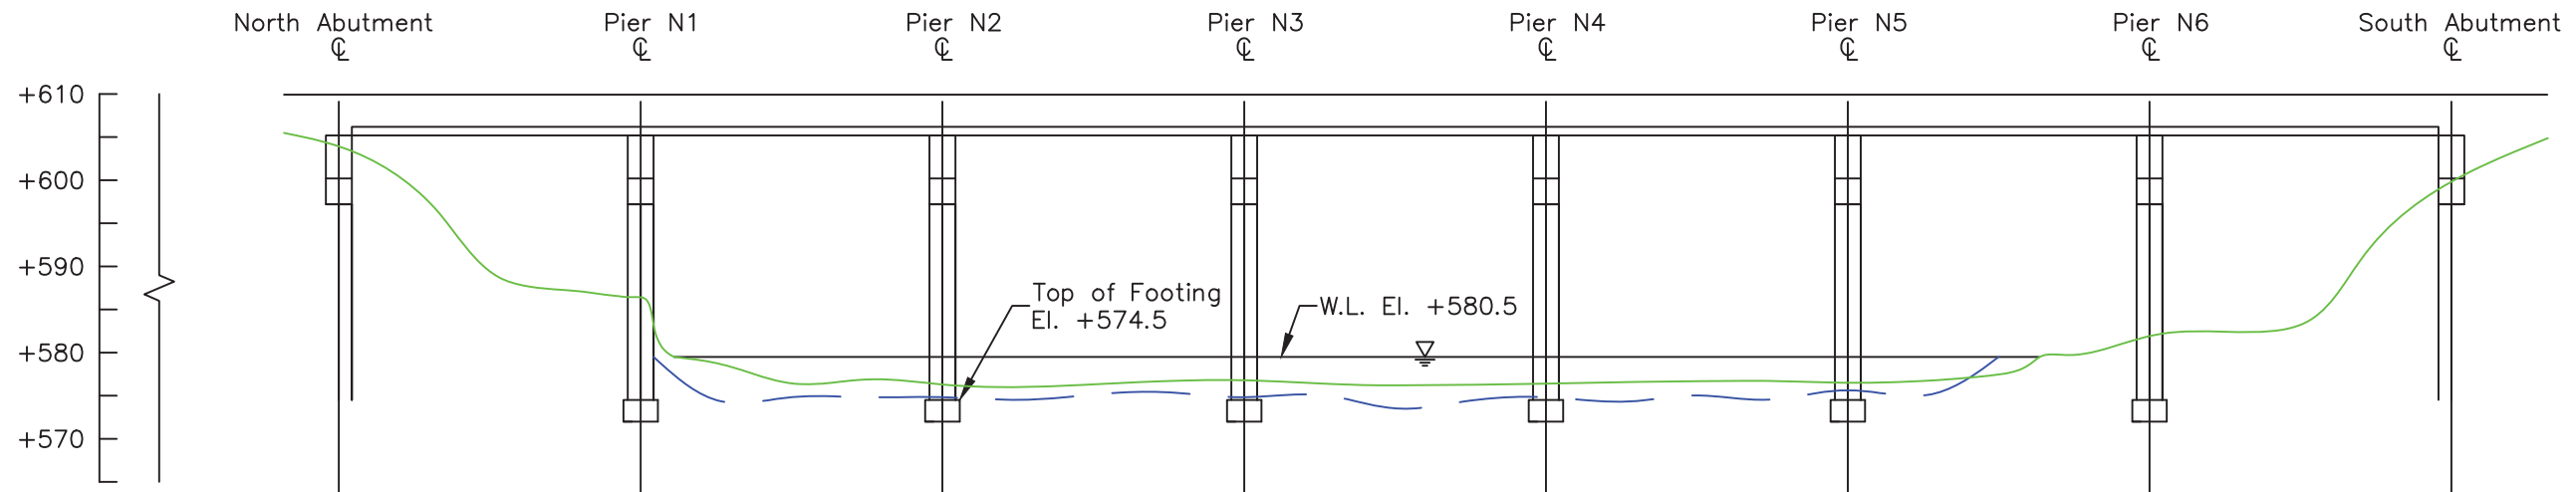
CHANNEL CROSS SECTION
 DOWNSTREAM FASCIA
 (LOOKING DOWNSTREAM)

DOWNSTREAM FASCIA LOOKING DOWNSTREAM	
Location	Y(ft)*
A1	7.0
1/4	14.6
1/2	22.2
3/4	23.8
PN1	24.5
1/4	29.0
1/2	33.5
3/4	33.9
PN2	34.3
1/4	34.3
1/2	34.4
3/4	34.5
PN3	34.6

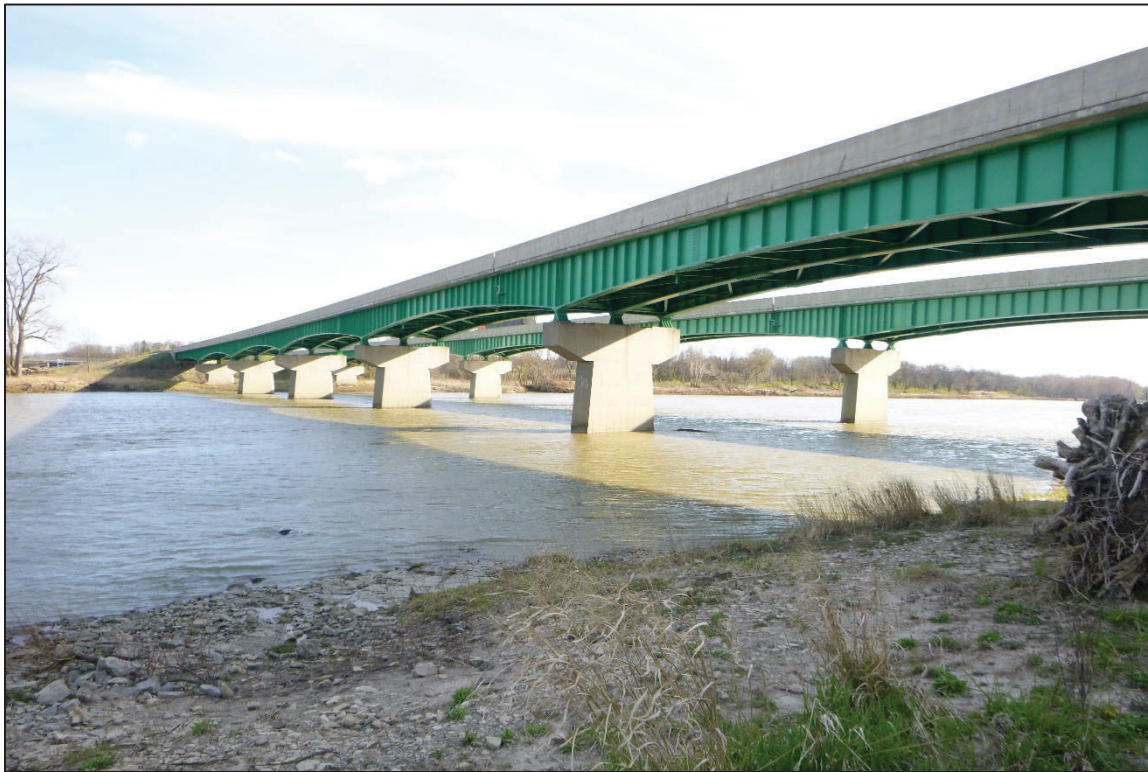
Photograph No. 1: Overall View of Structure No. 8706786 (WOO-475-0386R), Looking Southwest.

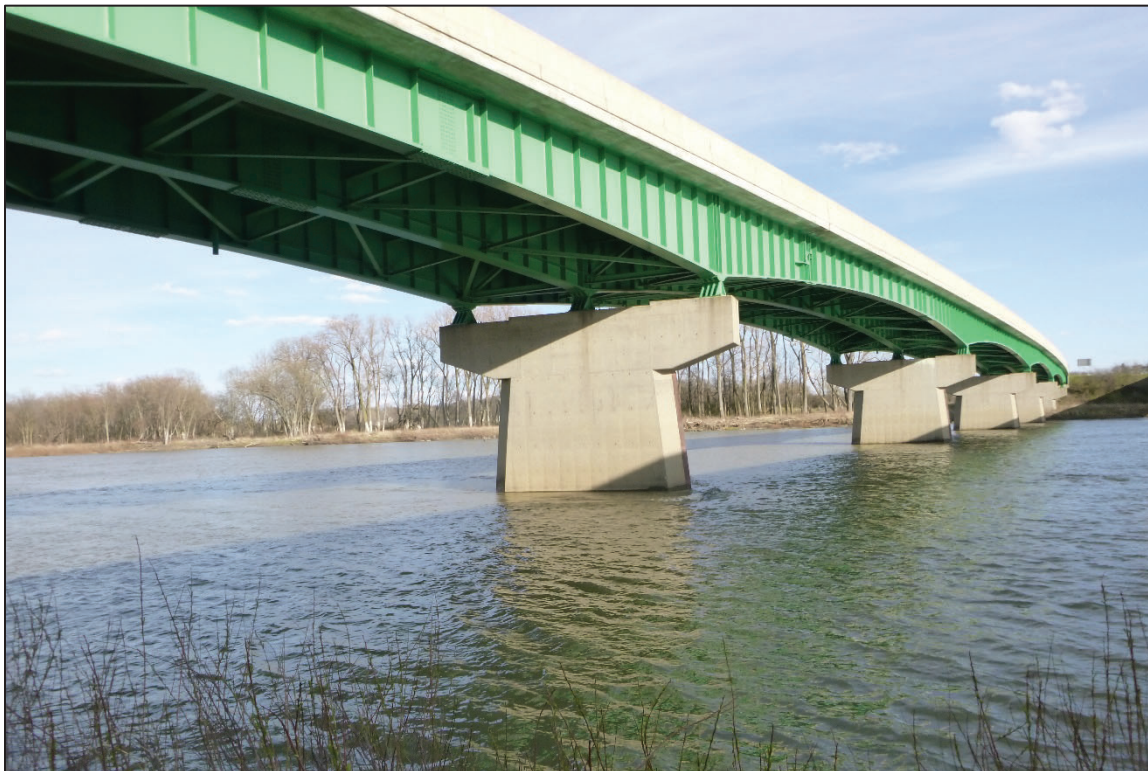
Photograph No. 2: Overall View of Structure No. 8706786 (WOO-475-0386R), Looking Southeast.

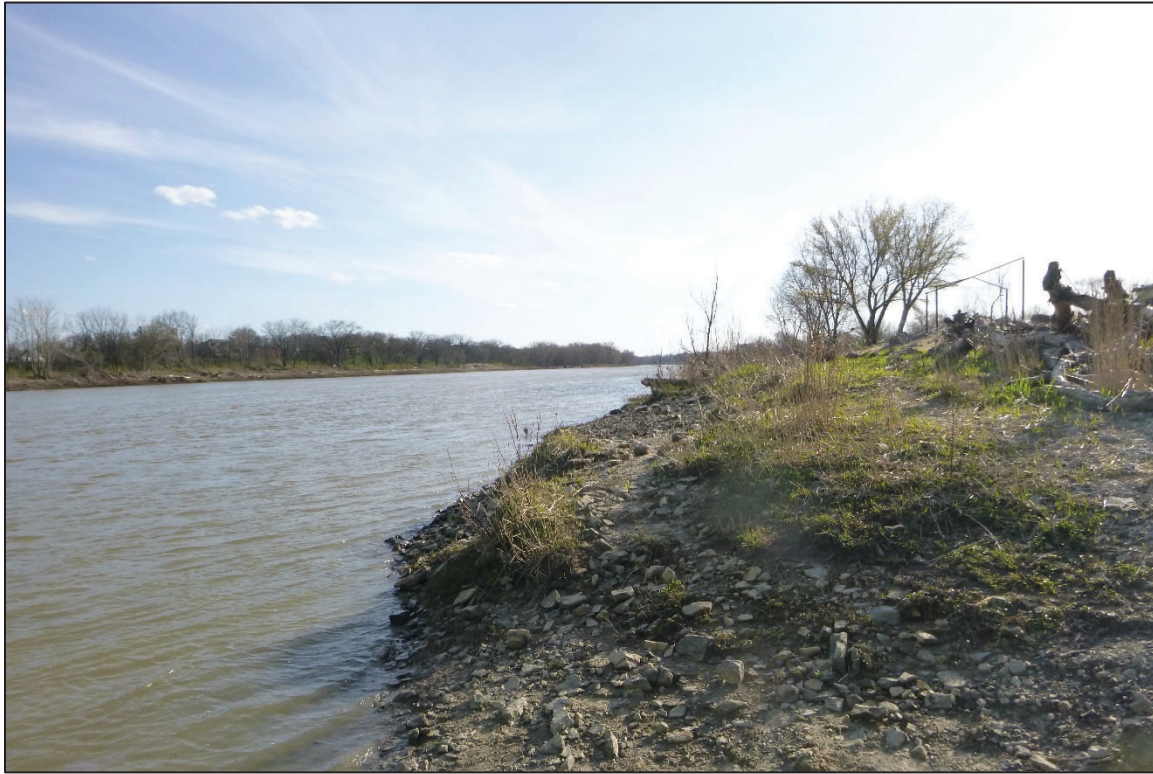
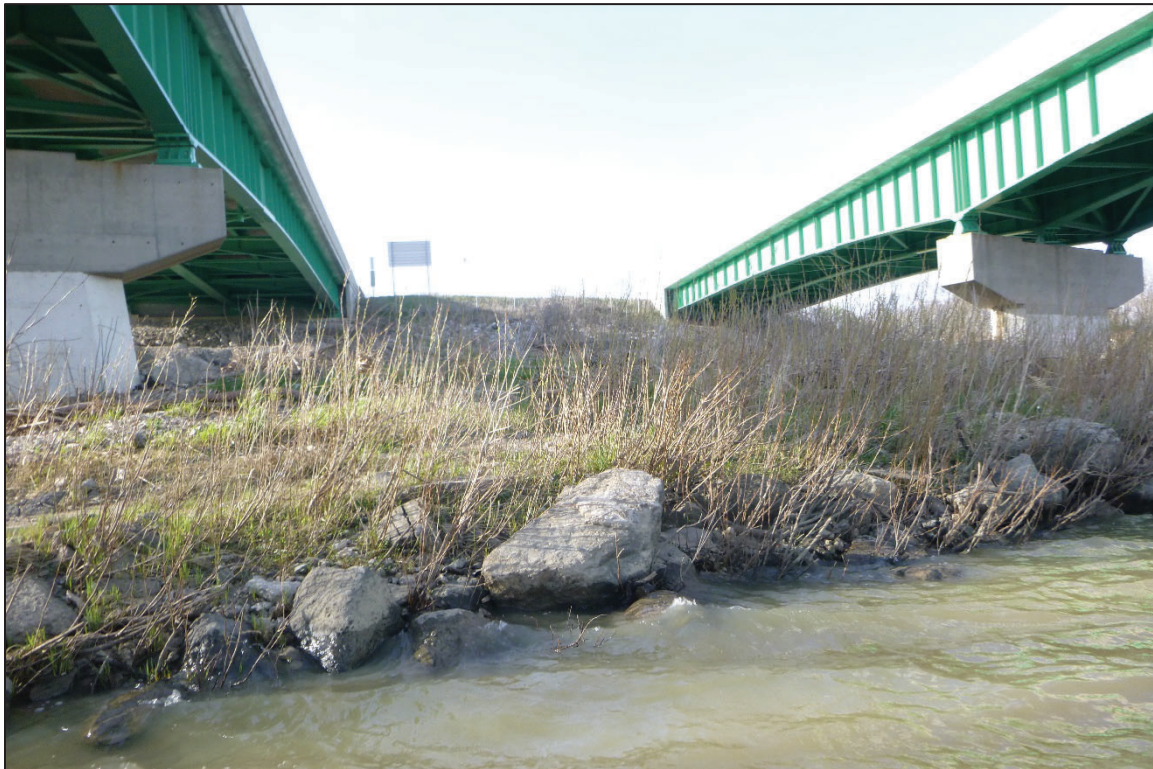
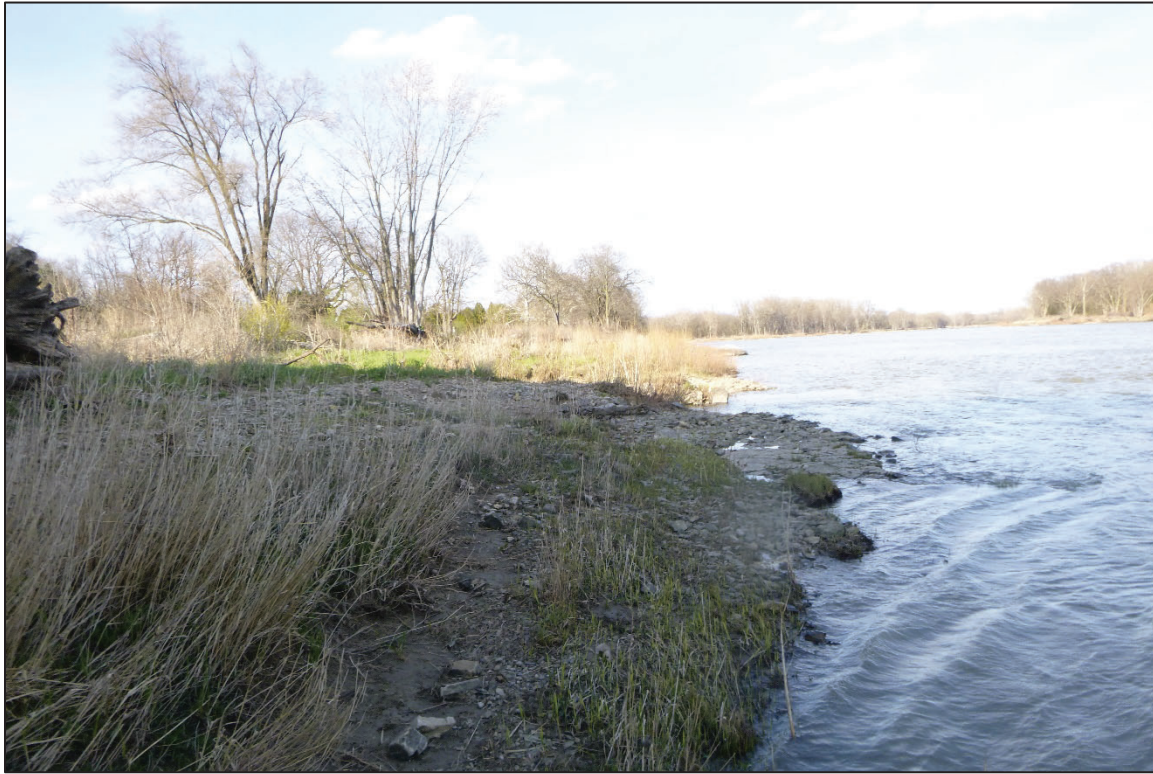
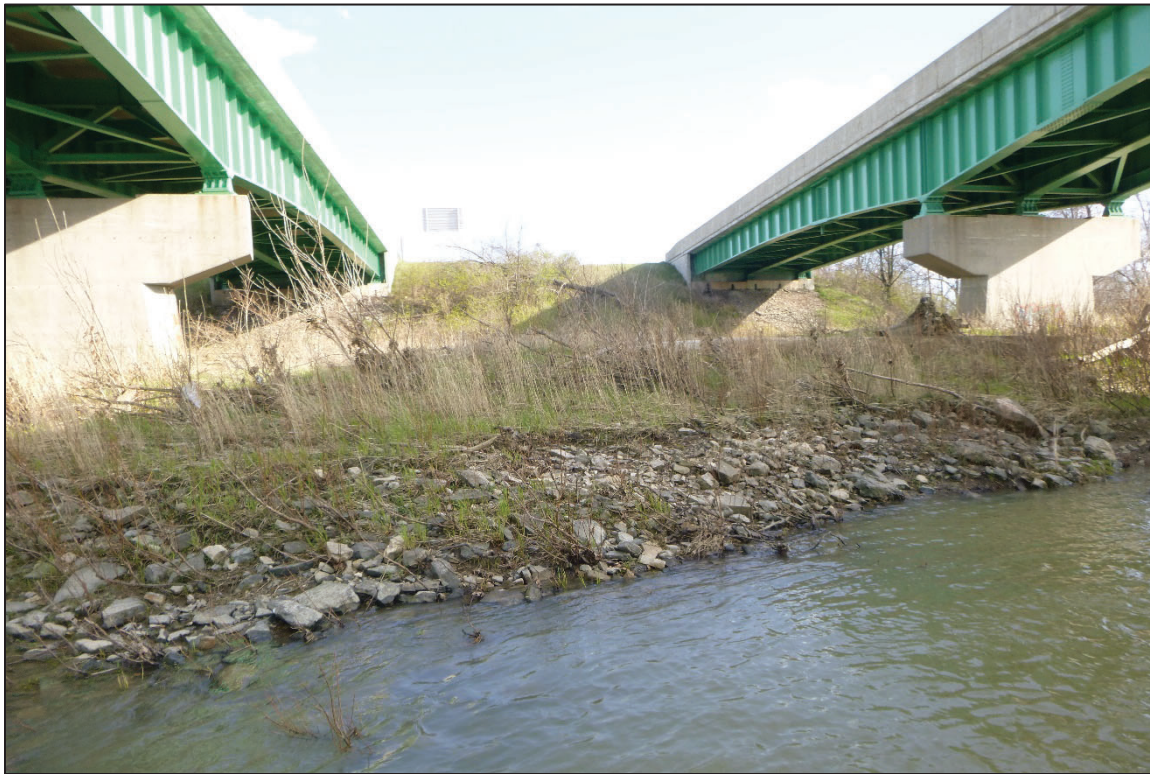
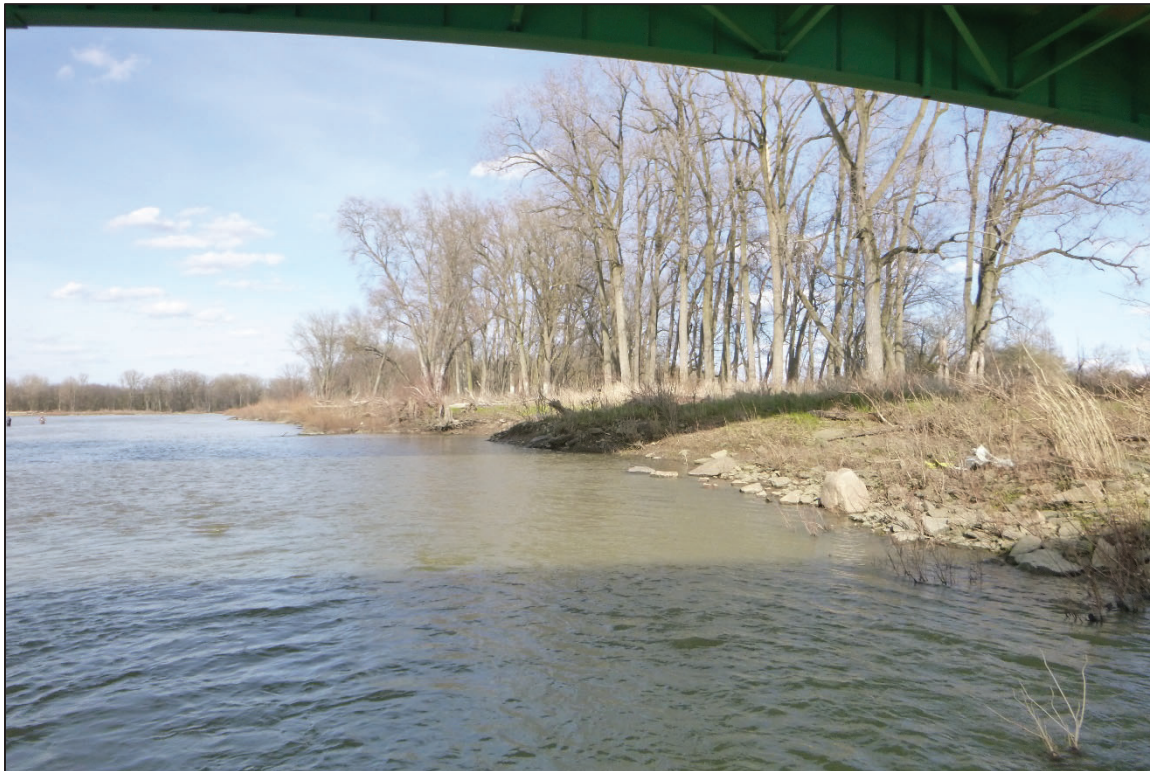
Shoreline Conditions:	The north and south shorelines consisted of well-vegetated, gentle slopes with no erosion.

Photograph No. 3: View of the North Embankment Upstream of the Structure, Looking West.

Photograph No. 4: View of the North Embankment at the Structure, Looking North.

Photograph No. 5: View of the North Embankment Downstream of the Structure, Looking East.

Photograph No. 6: View of the South Embankment Upstream of the Structure, Looking West.

Photograph No. 7: View of the South Embankment at the Structure, Looking South.

Photograph No. 8: View of the South Embankment Downstream of the Structure, Looking East.
