FRAMING PLAN

| MISCELLANEOUS STEEL REPAIR DETAILS | | |

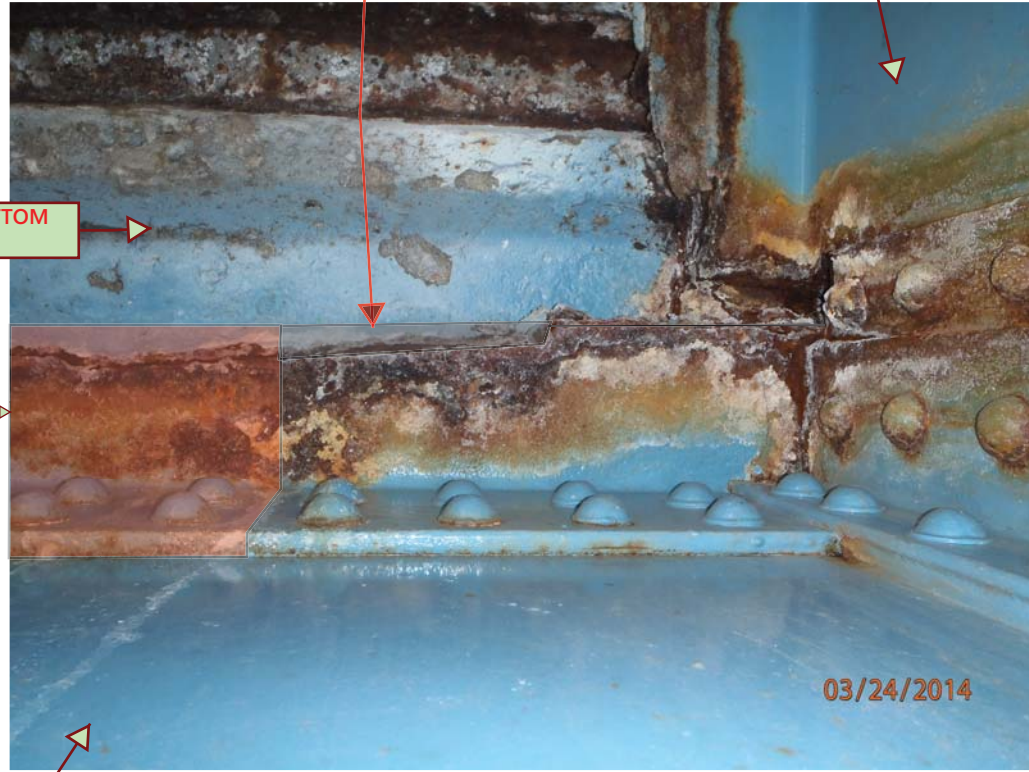
SECTION A-A

EXISTING FLANGE LOSS IN THIS AREA MAY BE SEVERE DUE TO APPARENT PREVIOUS FLAME CUTTING. ALL BOLTS (THROUGH NEW HOLES) ARE TO BE INSTALLED AS SHOWN. IF EXISTING FLANGE ANGLE IS NOT PRESENT UNDER AN INSTALLED BOLT (LESS THAN 30% OF IN THE AREA UNDER THE BOLT HEAD), IT MAY BE SNUG TIGHT AND THE FINAL TURN OF NUT ROTATION WILL NOT BE PERFORMED. CAULK GAPS LEFT BY MISSING TOP FLANGE ANGLE AFTER INSTALLATION OF SPLICE PLATES

REPAIR TYPE 201A: Top Flange Angle Repair with modified top flange splice

FIELD DRILL 15/16" DIA. HOLES IN EX. FLANGE ANGLES FOR 7/8" DIA. BOLTS AND WASHERS AS SHOWN. A TOTAL OF 28 HOLES ARE TO BE DRILLED AS PART OF REPAIR TYPE 201A

REPLACE EX RIVET WITH 7/8" BOLT AND WASHER

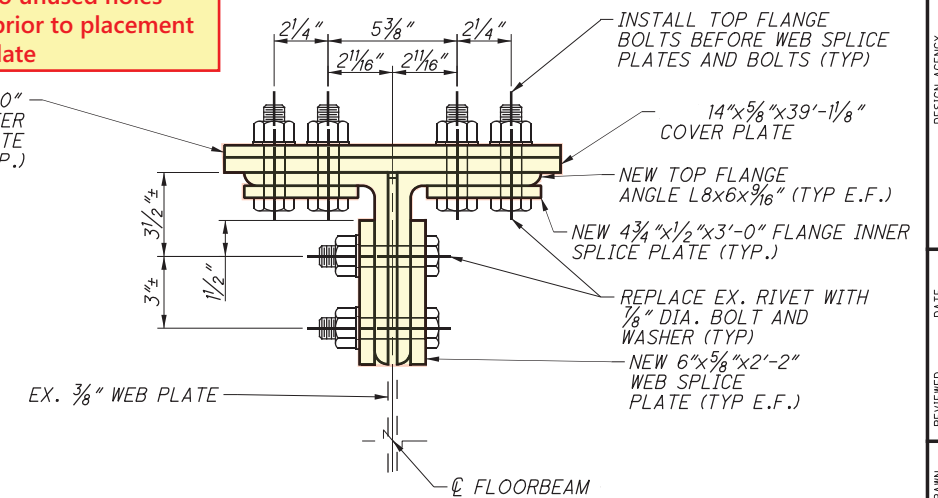
## REPAIR TYPE 203TF

NOTE: THIS REPAIR IS COMPRISED OF A TOP FLANGE ANGLE BEING REPLACED FROM THE END OF A FLOORBEAM TO A POINT UNDER THE TOP FLANGE COVER PLATE. ALL OTHER PLANNED REPAIRS AT AFFECTED FLOORBEAMS (INCLUDING TOP FLANGE COVERPLATE, IF PREVIOUSLY PLANNED) SHALL STILL BE PERFORMED PER THE ORIGINAL CONTRACT DRAWINGS.

**REPAIR TYPE 203TF: Top Flange Angle Repair**  
**Added per 2/7/14 & 3/24/14 Inspections**

Replace top flange angles for the length shown. Existing floorbeam stiffeners and stringer connections to be disassembled as required (but not replaced)

**IF APPLICABLE:** Modify originally planned Repair Type 202 top flange coverplate to allow for top flange splice as shown.

Provide web and flange splice plates and connectivity as shown.

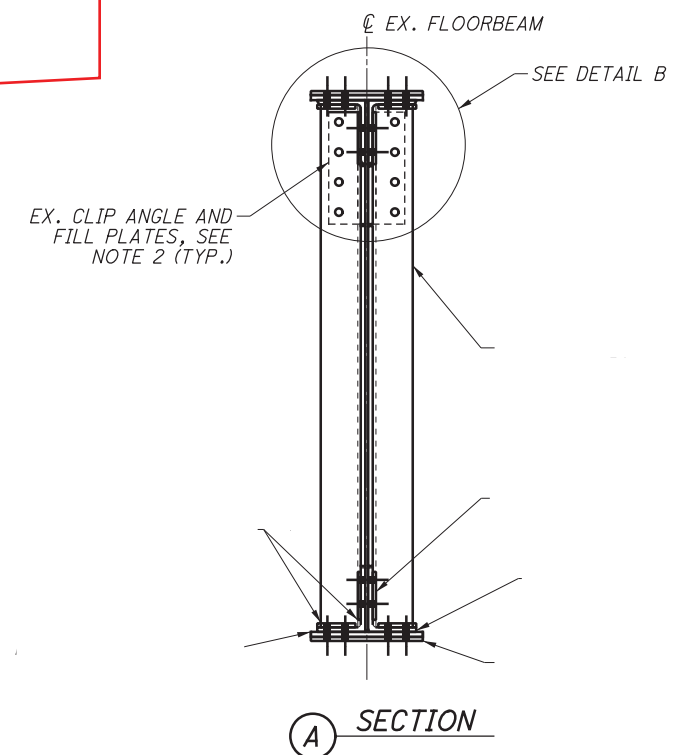
NOTE: BOTTOM FLANGE ANGLES AND COVERPLATE ARE NOT REPLACED AS PART OF THIS REPAIR

REPLACE EX. CRIMPED STIFFENER WITH  
NEW L5x3x  $\frac{3}{8}$ " x 5'-5 $\frac{3}{8}$ " STIFFENER  
AND NEW 3"x $\frac{9}{16}$ "x4'-2" FILL PLATE  
(REFER TO REPAIR TYPE 205  
FOR ADDITIONAL DETAILS)

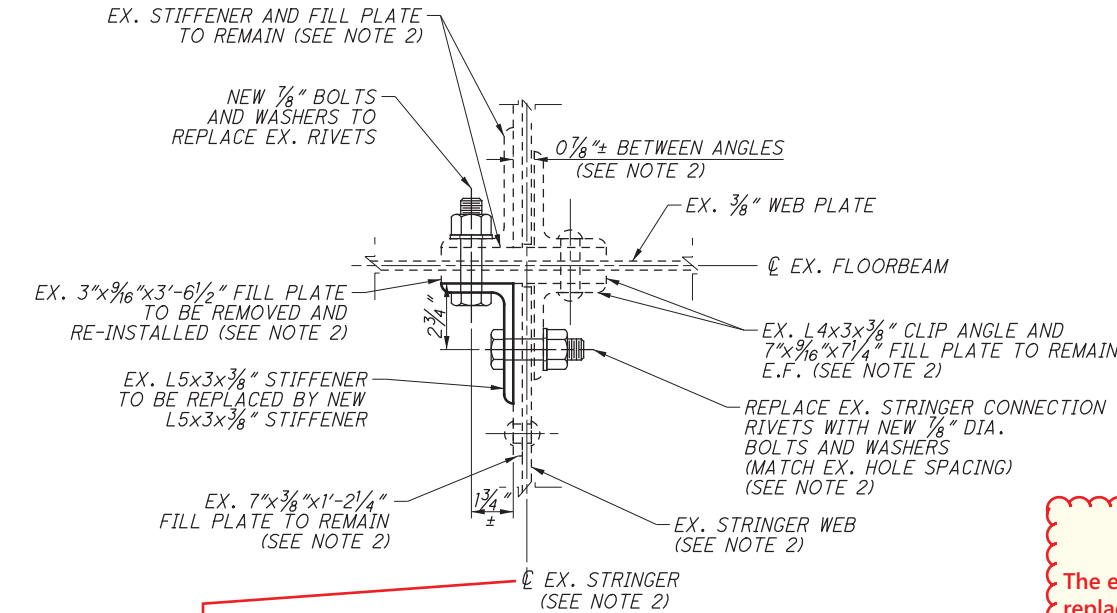
A SECTION

On the tower strut face, there is no stringer but it appears that the clip angles and fill plates were added. If present, these should not be replaced. Only a stiffener should be present on the tower strut face.

Existing clip angle not present in existing steel details. This angle and associated fill plates are not to be replaced on the tower strut face of the floorbeam webs

The existing floorbeam stiffeners adjacent to the tower strut should be replaced with stiffeners and fill plates as part of the suspension span Stage 6 deck and joint replacement. This repair is necessary because the existing condition and modified stiffener arrangement will not work with the proposed modular joint support details. Existing clip angles on the stringer face of the floorbeams may be reused. Clip angles on the tower strut face of the floorbeams shall not be replaced.

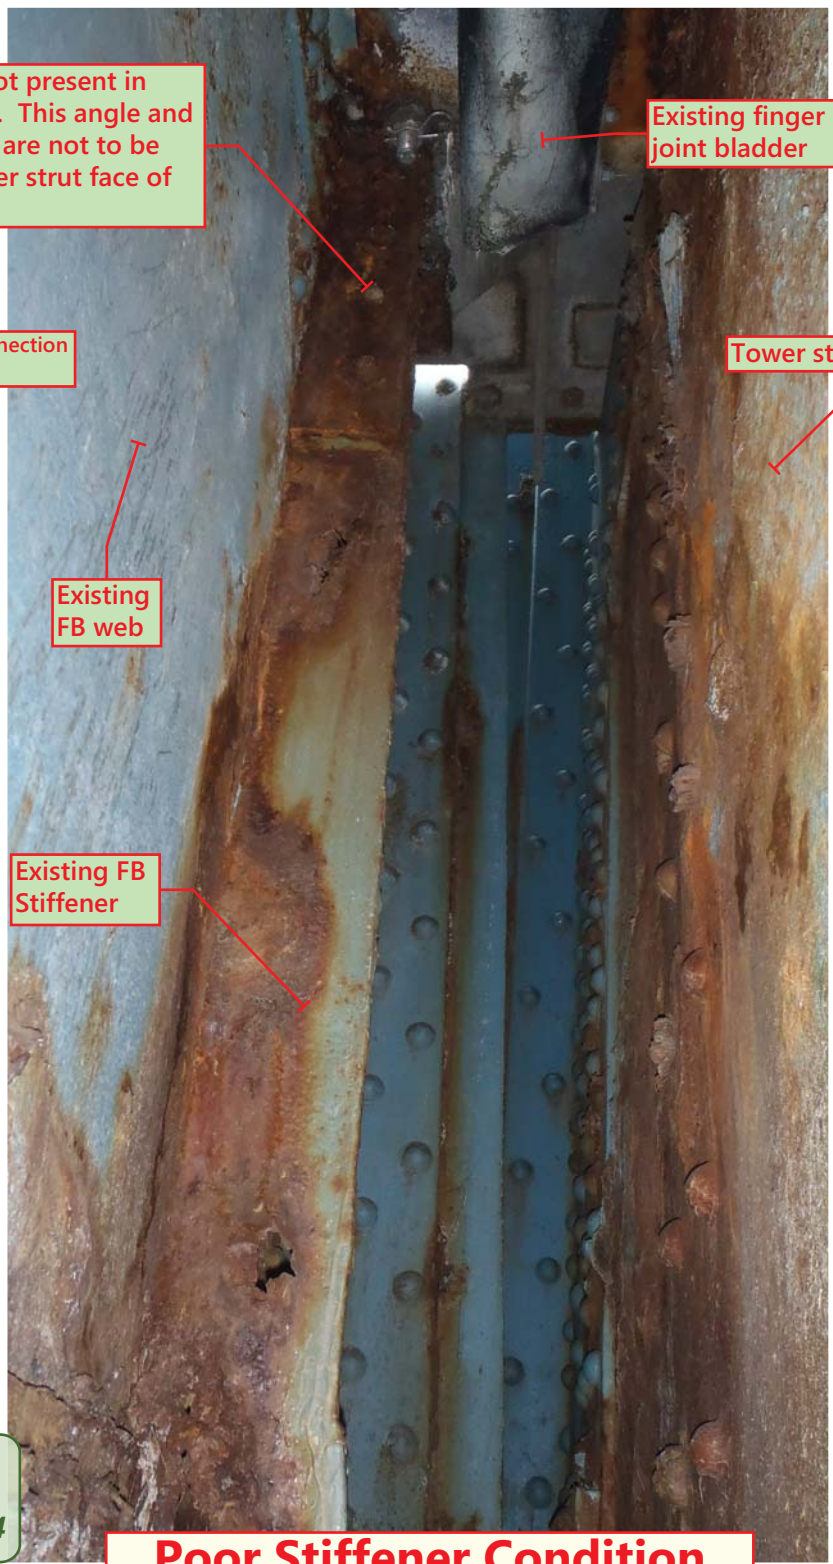
## Poor Stiffener Condition

Existing FB Stiffener

## REPAIR TYPE 205: Details of Floorbeam Stiffener replacement at Tower Face of Joint Floorbeams

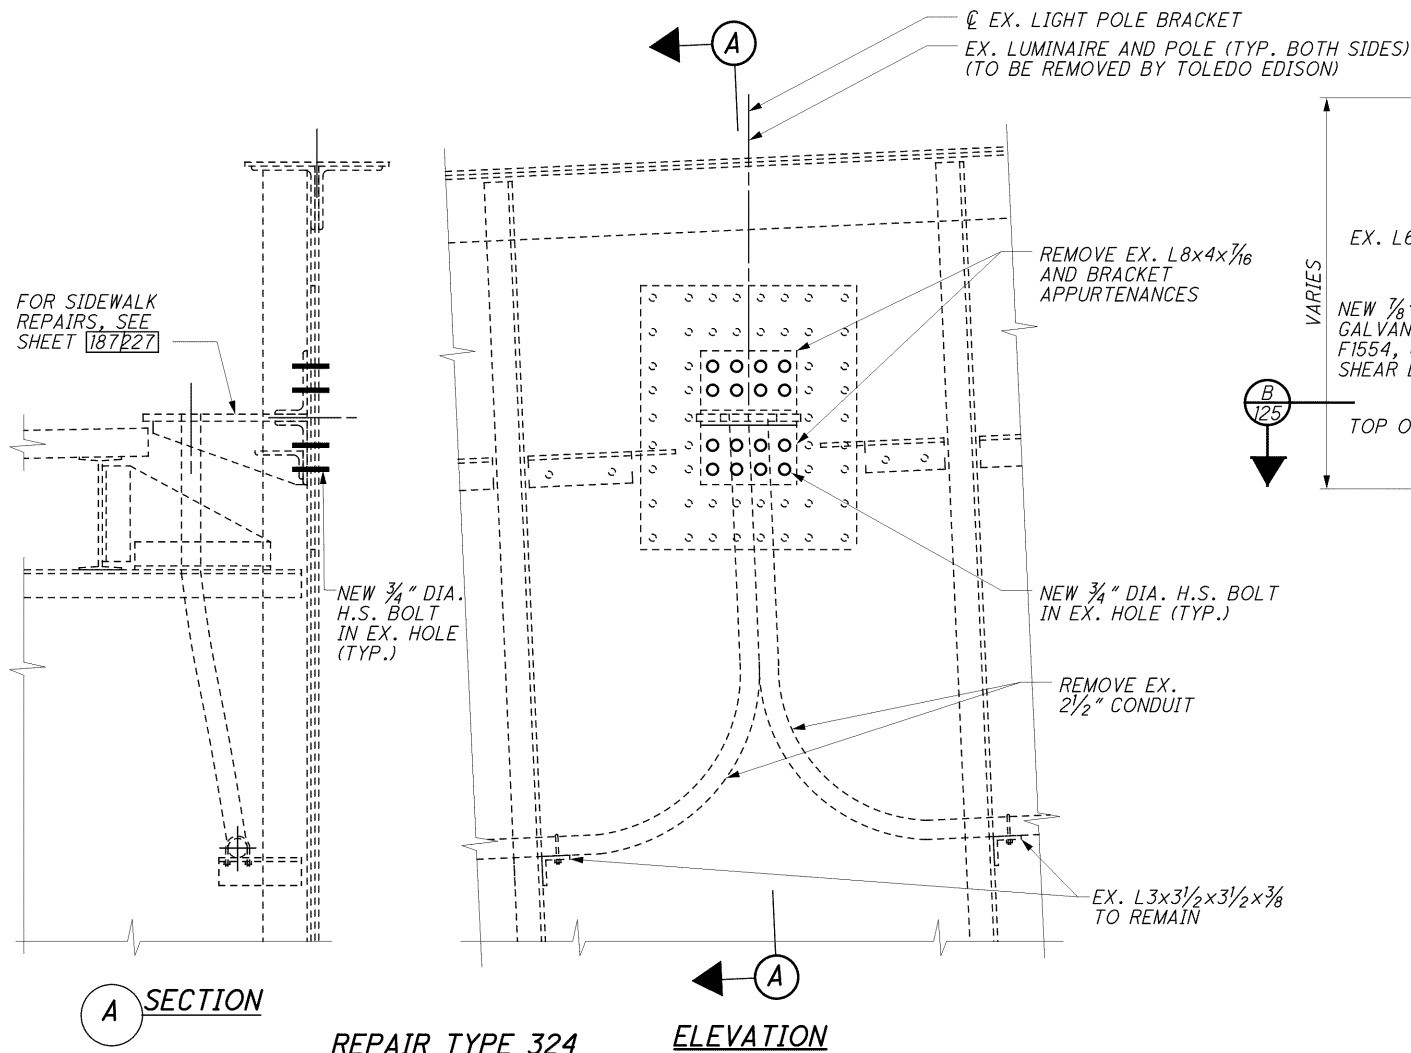
**REPAIR TYPE 324**  
LIGHT POLE BRACKET RETROFIT  
AT SUSPENDED SPANS  
(19 LOCATIONS)

REPLACE 16 EX. H.S. BOLTS IN STIFFENING GIRDER WEB  
WITH NEW ASTM A325 3/4"  $\phi$  H.S. BOLTS AFTER BRACKETS ARE REMOVED.

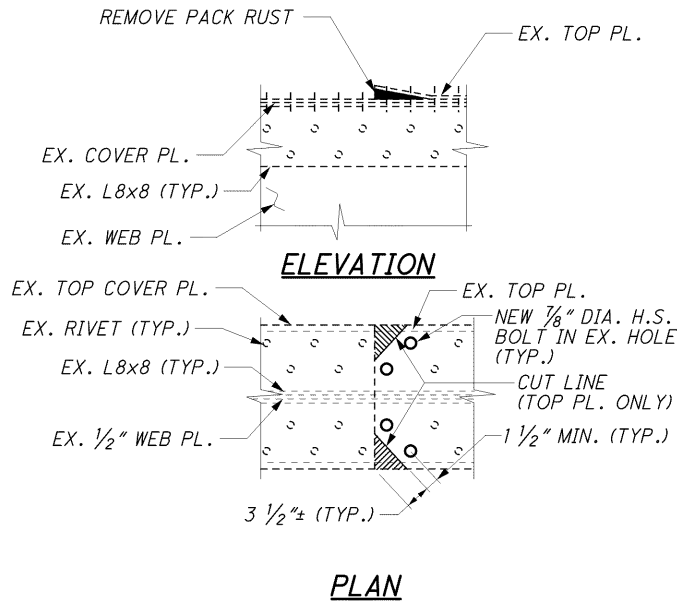
**REPAIR TYPE 322**  
(TOP FLANGE REPAIRS SHOWN,  
BOTTOM FLANGE REPAIRS SIMILAR)  
FOR REPAIR LOCATIONS, SEE SHEETS 78227 AND 83227.

REMOVE 4 EXISTING RIVETS. REMOVE PACK RUST, CLEAN SURFACES,  
APPLY EPOXY PRE-PRIMER AND APPLY EPOXY-TYPE REPAIR MATERIAL  
TO CAVITIES. INSTALL 4 NEW BOLTS IN EXISTING HOLES AS INDICATED.
