2017 LUC-00280-0283\_L (SB SOUTH APPROACH) ROUTINE  
INSPECTION REPORT  
BRIDGE INSPECTION REPORT

Structure File Number: 4805836

Inventory Bridge Number: LUC 00280 02.830 L

IR-280 over NSRR, RAMP Z, FRONT ST

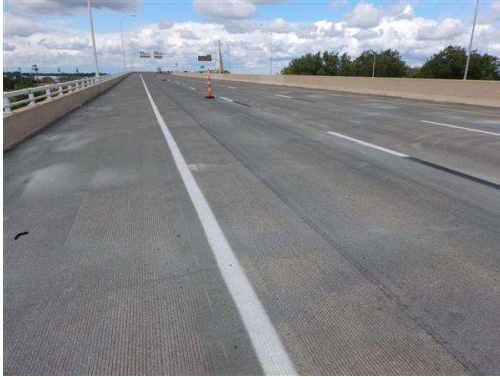
Photo 1

Southbound South Approach looking  
North

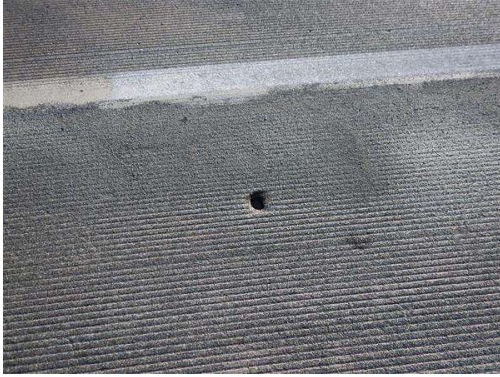
A depression of 0.25" was observed at multiple locations on the deck. See Photo 6. Holes were observed in West lane between Spans 18 SB and 19SB. See Photo 7.

Photo 7 Hole in the deck between Spans 18SB and 19SB

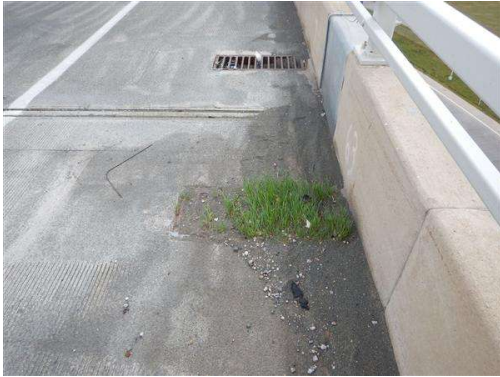
A majority of the scuppers on the deck appeared to be partially or fully filled with debris and not serving their intended function. Some of the scuppers had vegetation growing. See Photo 13.

Photo 13 Fully filled scupper with vegetation growing at Pier 20SB

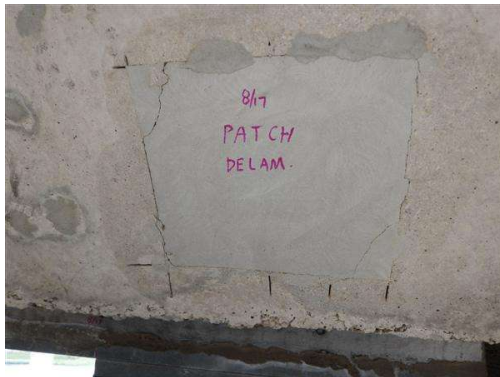
Along the exterior web and bottom flange/slab, several delaminated and spalled patches were noted along the length of the bridge. Some of the concrete spalls had exposed reinforcement. See Photos 9 through 14.

Photo 9 Delaminated concrete patch in the web at Pier 17SB looking West

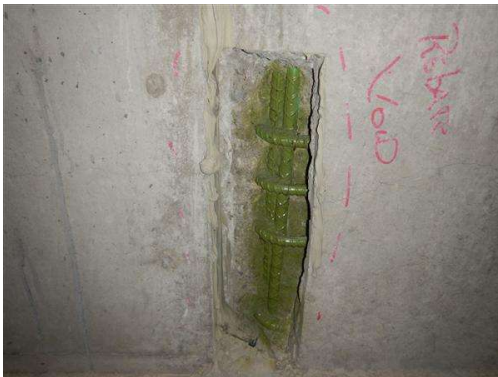
Voids were present in the segment construction joints, both interior and exterior, varying size and depth. Some of the voids were observed to be up to 11" deep. See Photo 20. In the Span 21SB, a 5" deep void with exposed reinforcement was observed. See Photo 21. Spalls and delaminated areas were noted throughout the interior and exterior of the segments in the pier segment closure pours and the future exterior stressing blocks located at the top of the webs and along the floor slab. See photos 22 and 23. In the Span 15SB, a spall was observed on the edge of a future floor slab PT block. See Photo 24.

Photo 21 5" deep concrete void with exposed reinforcement in Span 21SB looking West

Voids were present in the segment construction joints, varying size and depth. Some of the voids were observed to be up to 11" deep. See Photo 20 in the Superstructure section. In the Span 21SB, a 5" deep void with exposed reinforcement was observed. See Photo 21 in the Superstructure section. Spalls and delaminated areas were noted throughout the interior of the segments in the pier segment closure pours and the future exterior stressing blocks located at the top of the webs and along the floor slab. See Photos 22 and 23 in the Superstructure section. In the Span 15SB, a spall was noted on the edge of future floor slab future PT block. See Photo 24 in the Superstructure section.

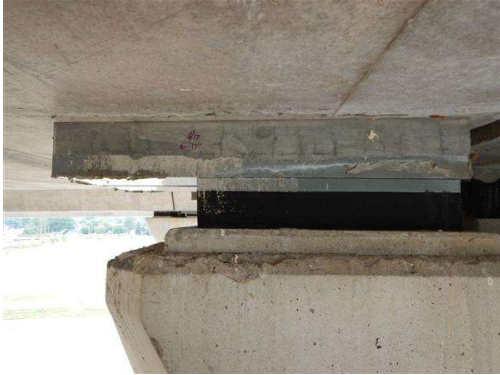
| Photo 31 | West bearing shifted 17" South at Pier 20SB |
