STATE OF OHIO DEPARTMENT OF TRANSPORTATION  
BRIDGE INSPECTION REPORT

Inventory Bridge Number: LUC 00280 02.830 R

IR-280 over NSRR,RAMP Z FRONT ST.

Inspection Date: 09/17/2017

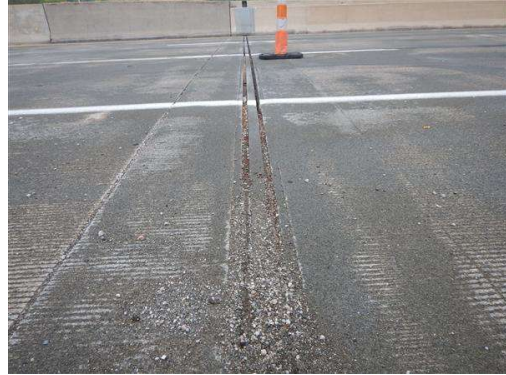
All the joints were either partially or fully filled with debris over the full width of the roadway with vegetation growing along the joints in certain locations. See Photos 19 and 20.

| Photo 20 | Expansion joint at Abutment 1NB looking West |
