2017 LUC-00280-0346 (SB/NB MAIN SPAN) ROUTINE  
INSPECTION REPORT  
BRIDGE INSPECTION REPORT

Inventory Bridge Number: LUC 00280 03.460

IR-280 over MAUMEE RIVER AND NSRR

Inspection Date: 09/15/2017

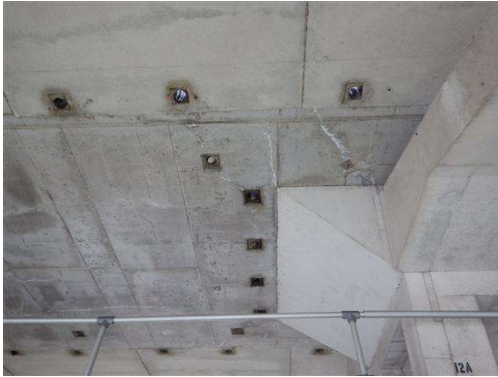
The bottom of the deck slab is rated in the superstructure inspection section of this report and subsequent photos for these defects are also located in that section. Numerous transverse closure pour joints in the top flange/deck displayed areas of cracking, some with efflorescence, over the length of the bridge. See Photo 1.

Photo 1 Transverse cracks with efflorescence in the bottom of the deck slab in Span 28NB

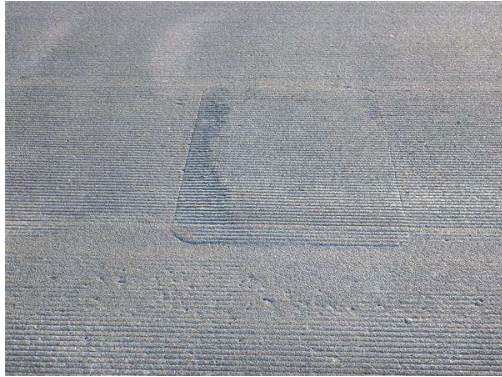
Additional delaminated or unsound patches with moderate cracking were noted in the shoulder and travel lane areas of the deck. See Photos 7 through 9.

Photo 7 Concrete patch (4'x2') in the traffic lane in Span 28SB

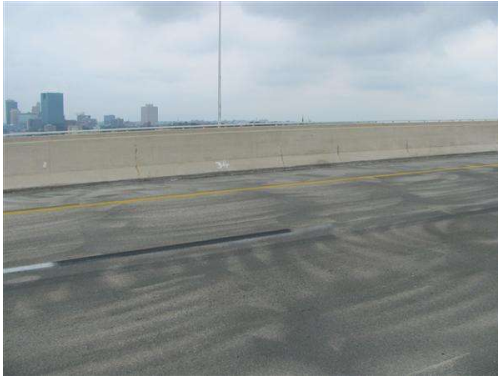
Typical areas of hairline to moderate vertical and horizontal cracking were noted along the length of the concrete parapets on both sides of the roadway. See Photos 12 and 13. Numerous areas of cracking had efflorescence, rust stains and/or discoloration. See Photo 14.

Photo 13 Vertical cracks in the West parapet in the Span 28NB looking West

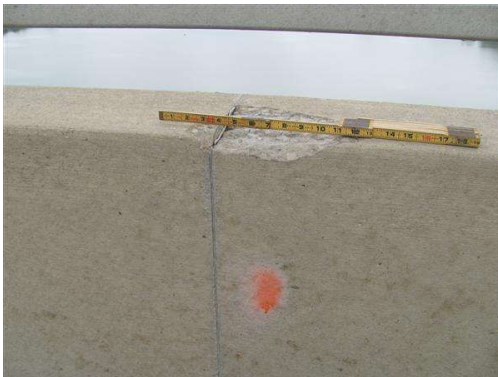
A few areas of delaminated concrete and spalls were noted in Span 27NB. See Photo 15.

Photo 15 Spalls on the top of the East parapet in Span 27NB looking East

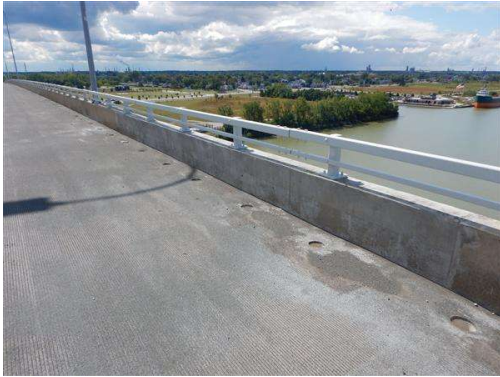
Typical areas of hairline to moderate vertical and horizontal cracking were noted along the length of the concrete parapets on both sides of the roadway. See Photos 17 and 18. In the Span 27SB, five (5) newly installed concrete barriers sections had

vertical cracks. See Photo 19. Collision damage on the East parapet in Span 27SB was observed. See Photo 20.

Photo 19 Vertical cracks in newly installed West parapet sections in Span 27SB

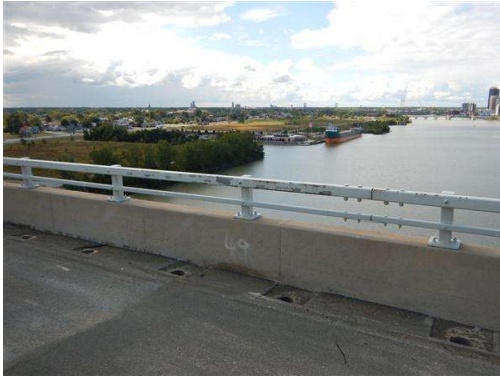
Several areas of deterioration and heavy rust on the steel railings along the length of the bridge. Minor paint damage was found at multiple locations. See Photos 24 and 25.

Photo 25 Coating damage/failure to the West steel railing in Span 27SB

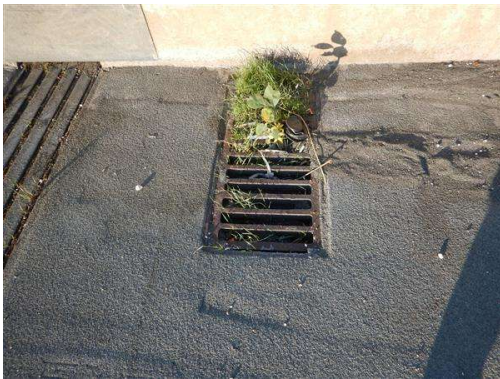
A majority of scuppers on the deck appeared to be partially or fully filled with debris and not serving their intended function. See Photo 27. In Span 27SB, nine (9) drains were missing PVC pipes. See Photo 28.

Photo 27 Scupper filled with debris and growing vegetation at Pier 29SB

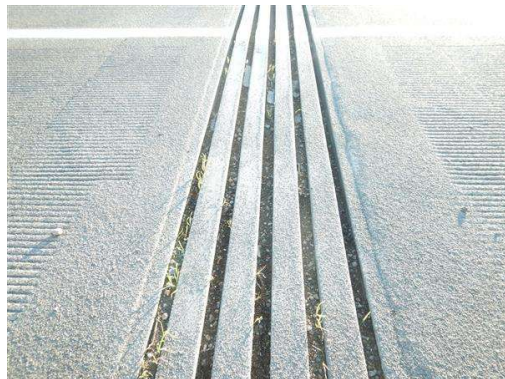
All the expansion joints were either partially or fully filled across the entire width of the roadway with vegetation growing along the joints in certain places. See Photo 30.

Photo 30 Expansion joint at Pier 29SB filled with debris and growing vegetation

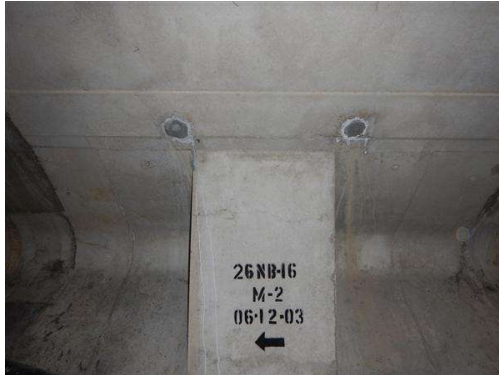
Photo 1 Leaching efflorescence from lift holes in Span 26NB

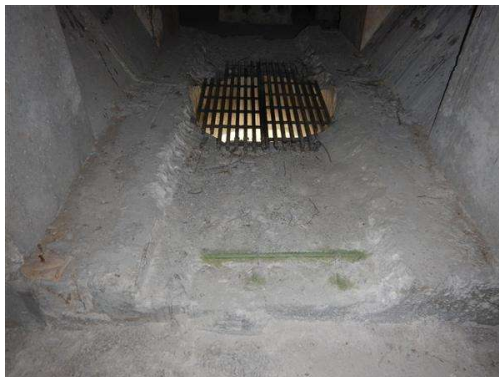
Photo 5 Exposed reinforcement on the bottom flange/slab in Span 29NB looking South

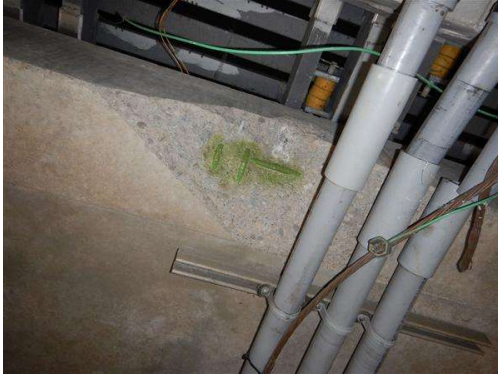
Photo 7 Spalls with exposed reinforcement at expansion joint at Pier 29NB looking South

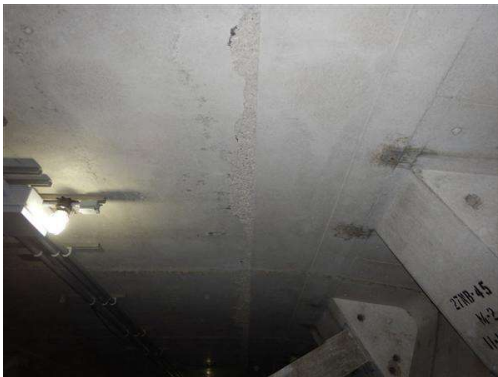
Photo 9 Typical spalls in the top flange/slab looking North

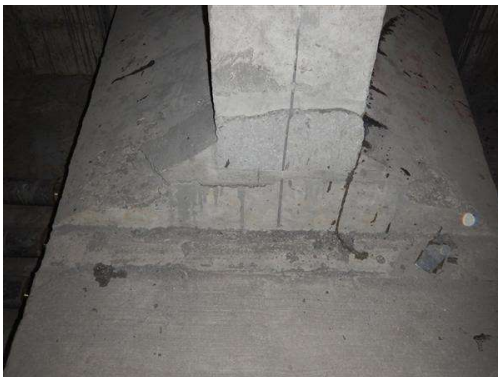
Photo 11 Spalls on the deviator wall at Pier 27NB looking West

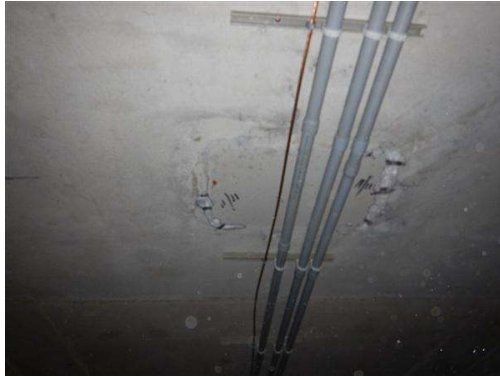
Photo 13 Construction access hole patch with cracks and leaching efflorescence in Span 27NB

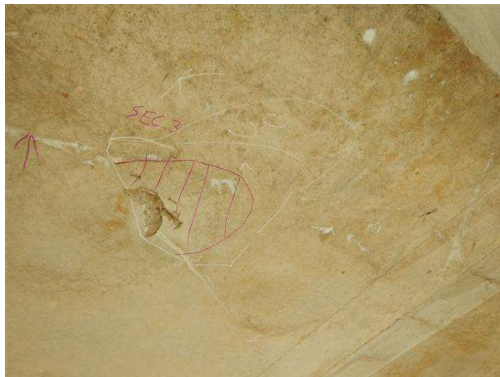
Photo 15 Delaminated concrete patch (12"x12") in the exterior bottom flange of Span 27NB

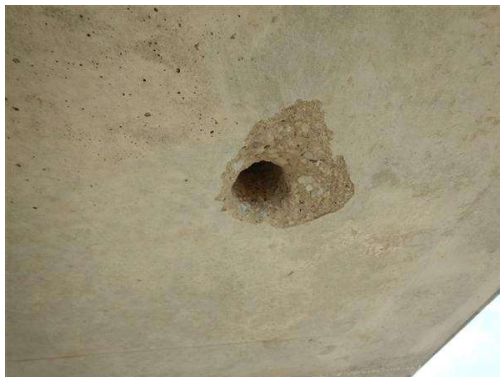
Photo 17 Spall (6"x6"x0.5") at the core hole in Segment 16 of Span 29NB

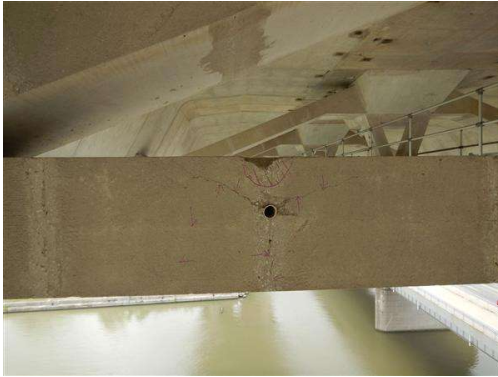
Photo 19 Spall and cracks in the lower right strut at Cable Stay Anchor 3B in Span 27NB

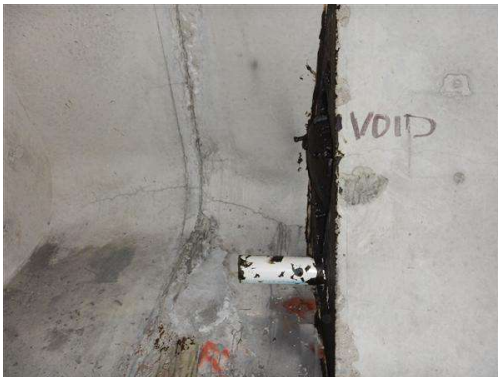
Photo 21 Typical interior, upper corner cracks along the length of the bridge looking East

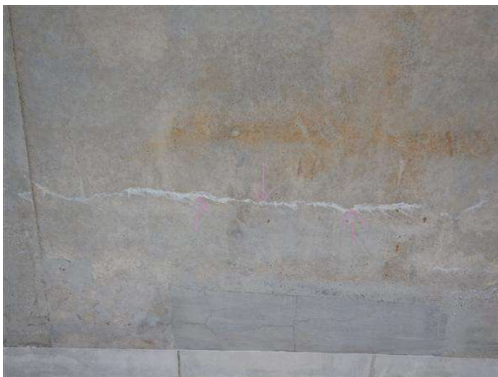
Photo 23 Longitudinal cracks with leaching efflorescence in the exterior bottom flange/slab in Span 27NB

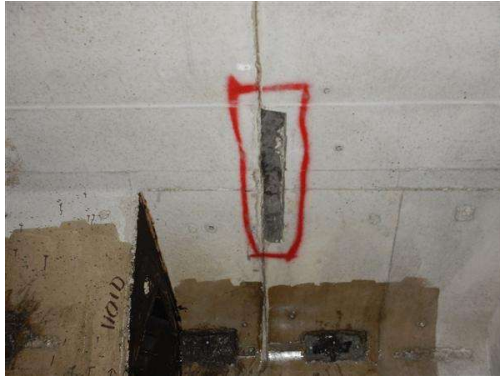
Photo 25 Concrete cutout (2.5" deep) in the top flange/slab at Pier 28NB looking West

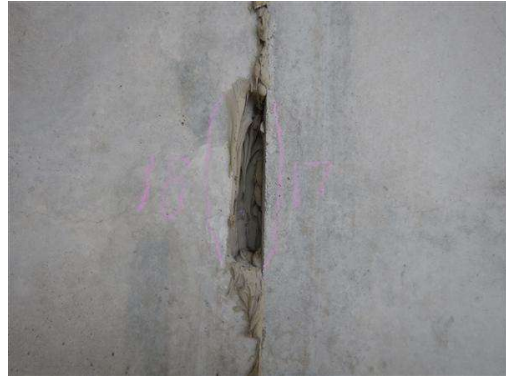
Photo 26 Void (4" deep) between Segments 17 and 18 of Span 28NB

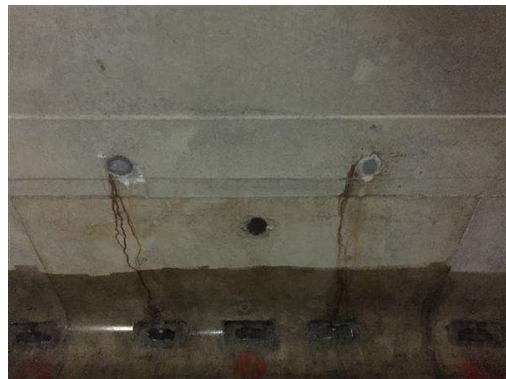
Photo 30 Leaching efflorescence from lift holes in Span 27SB

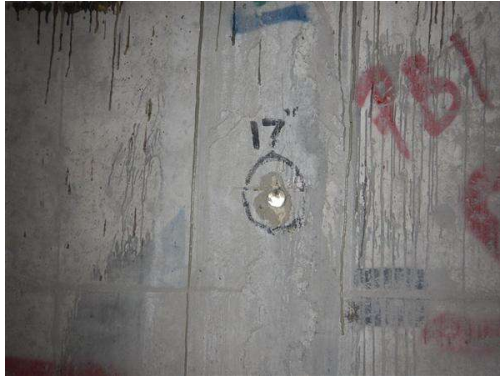
Photo 31 Unfilled hole in web of Span 28SB

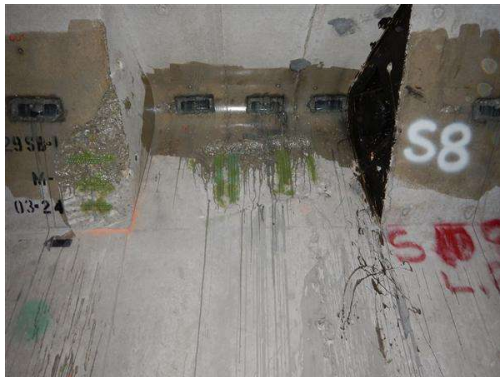
Photo 33 Typical spall with exposed reinforcement in the exterior PT block and web along the length of the bridge

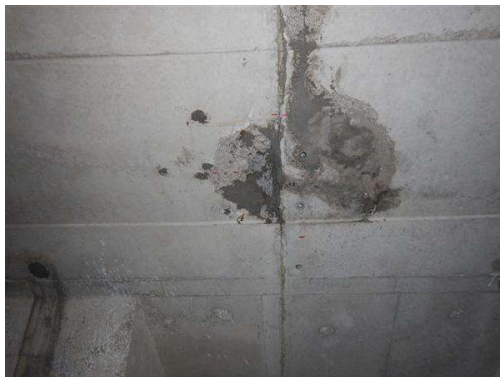
Photo 35 Delaminated/unsound patch and spalls in the top flange/slab in Span 28SB

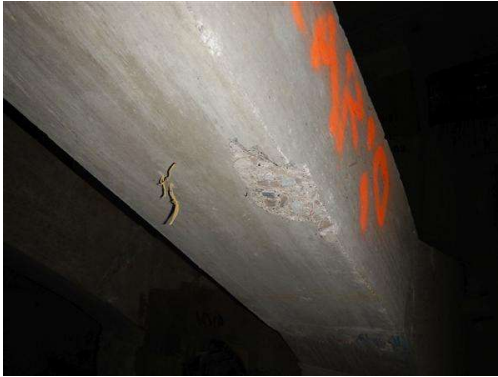
Photo 37 Typical spall in the strut legs along the length of the bridge

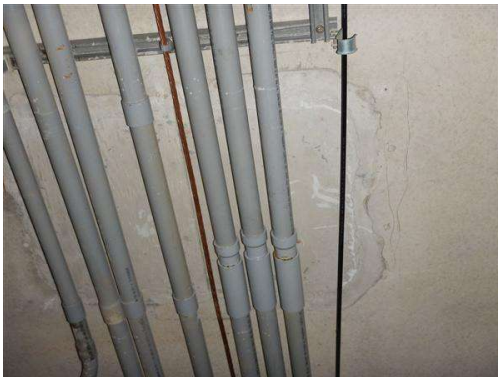
Photo 39 Construction access hole patch with cracks and efflorescence in Span 27SB

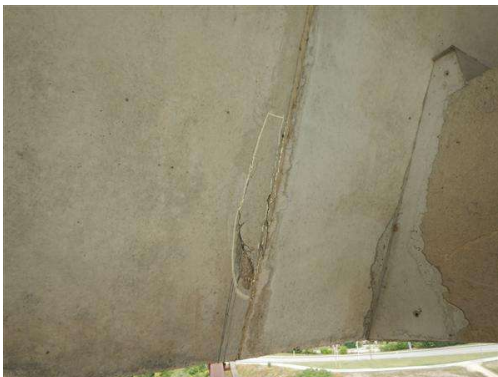
Photo 41 Spall (27"x5"x0.5") in the exterior East web of Span 28SB looking West

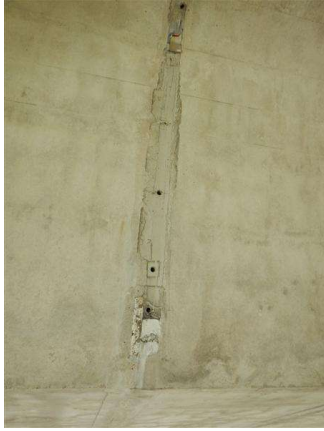
Photo 43 Multiple holes in closure pour between Segments 22 and 23 of Span 28SB

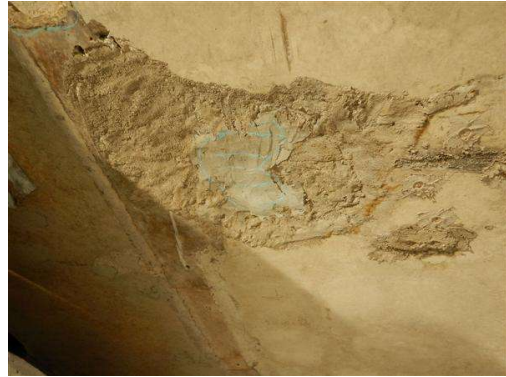
Photo 44 Delaminated concrete patch (14"x10") in the exterior bottom flange/slab of Span 26SB

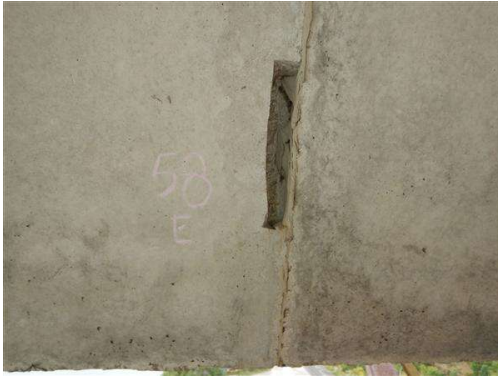
Photo 49 Cutout (3" deep) in the exterior East web between Segments 57 and 58, in Span 28SB looking West

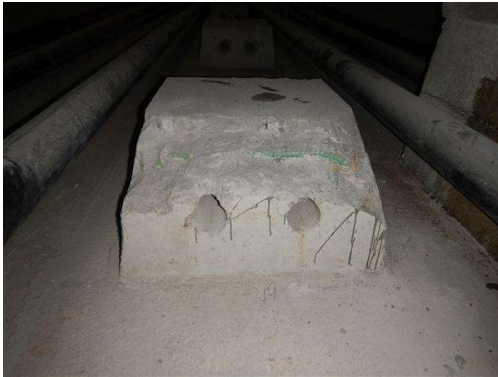
Photo 51 Typical spall with exposed reinforcement in the temporary PT blocks on bottom flange/slab along the length of the bridge

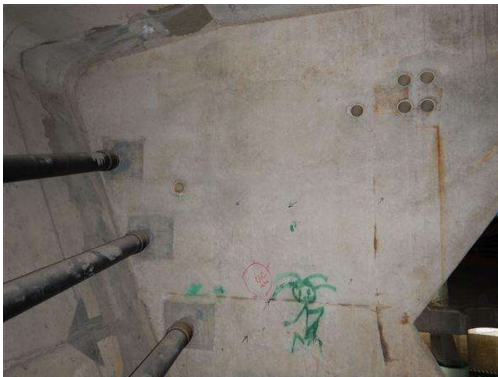
Photo 53 Map cracking on the vertical face of diaphragm at Pier 26NB

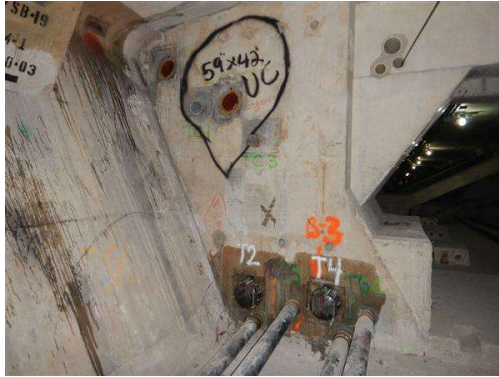
Photo 55 Delaminated concrete area in the vertical face of the diaphragm in Span 27SB

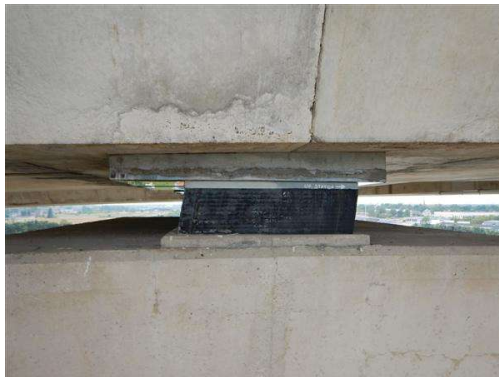
Photo 57 East bearing at Pier 27NB rotated 10° to the North

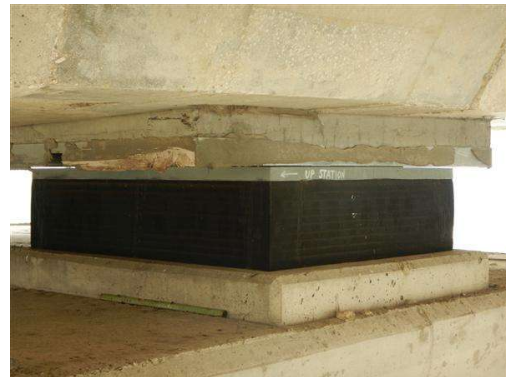
Photo 58 Gap between load plate and sole plate on West bearing at Pier 29NB

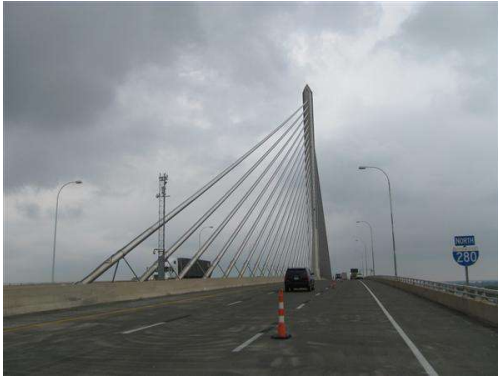
Interstate 280 North sign was observed to be faded and two 10.2 mile markers were missing. See Photo 1.

Photo 1 Faded I-280 North sign

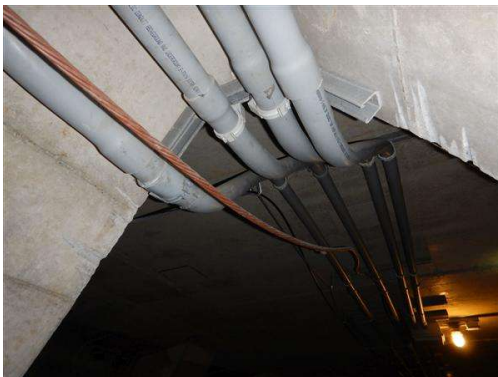
An electrical conduit was separated and clamps were broken in Span 26NB. See Photo 4. The ground wire was not attached to the brackets in Span 26NB. See Photo 5. Electrical conduits were separated and wires exposed in Span 29NB. See Photos 6 and 7.

Photo 5 Ground wire not attached to the brackets in Span 26NB

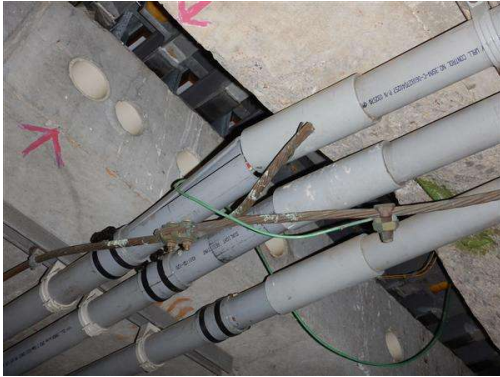
Photo 7 Separated electrical conduit at Pier 29NB

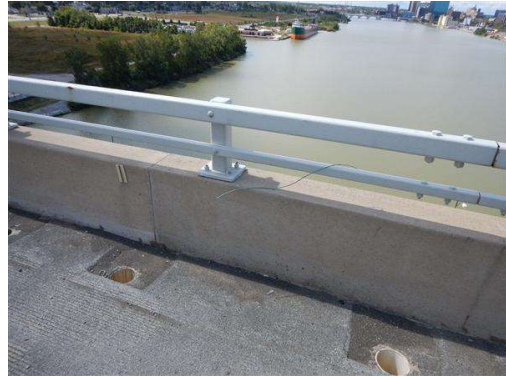
Light reflectors were either missing or broken on both the parapets along the length of the bridge. In the span 27SB, the grounding wire connected the light pole was disconnected. See Photo 8.

Photo 8 Disconnected grounding wire in Span 27SB

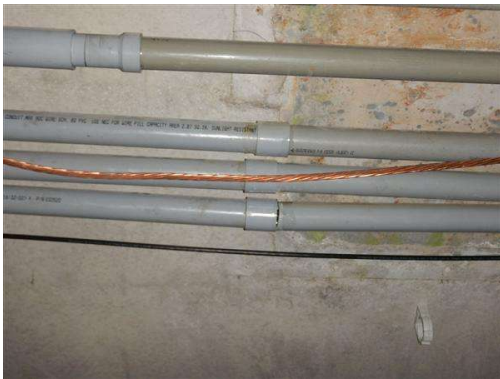
Electrical conduit was pulled apart in Span 27SB. See Photo 9. Electrical conduit clamp was broken in Span 26SB. See Photo 10.

Photo 9 Separated electrical conduit in Span 27SB

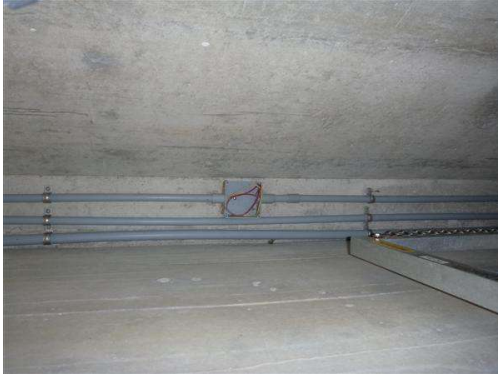
Photo 13 Missing junction box cover in the liftway

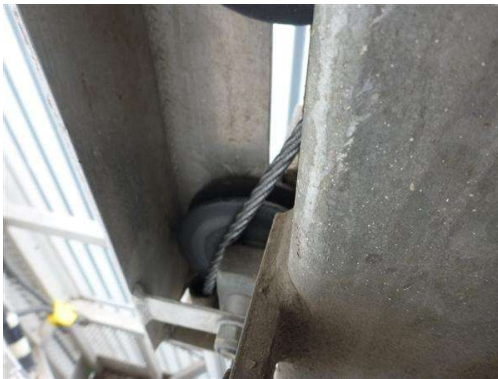
One of the wire ropes on the southeast lift had come off its sheave and was dragging across the trunnion support. This condition did not appear to interfere with the operation of the lifting mechanism, but will increase wear on this rope significantly. See Photo 15.

Photo 15 Southeast lift wire rope off sheave

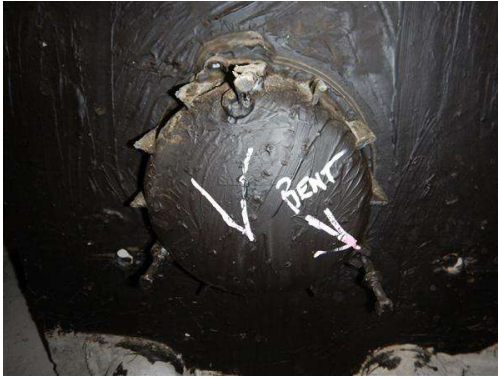
Photo 1 Void in the PT anchor cap at Pier 27NB

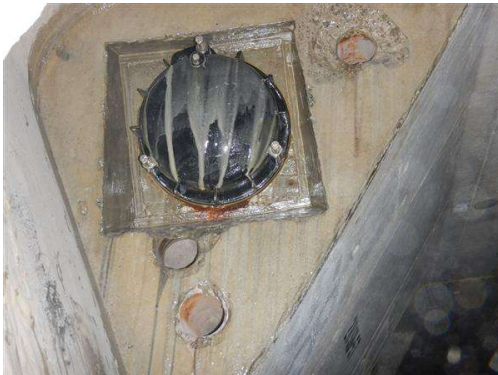
Photo 3 Rusted PT base plate in Span 28SB

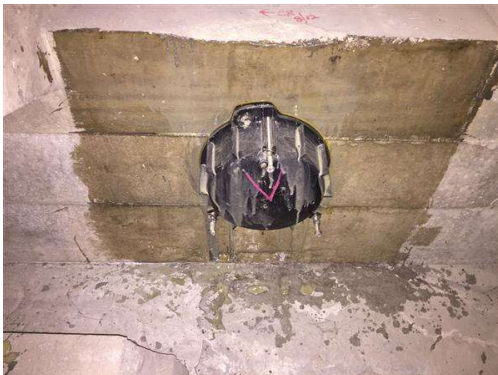
Photo 5 Voids in the PT anchor cap at Pier 27SB

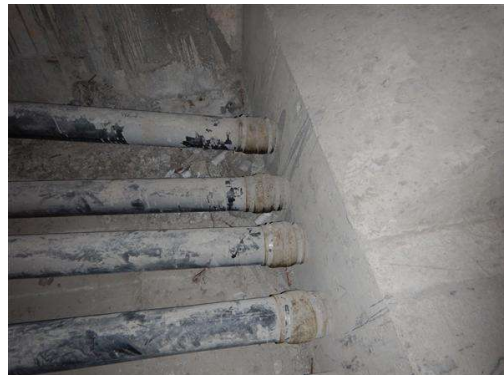
Photo 6 Soft PT tendon sleeves at Pier 26NB

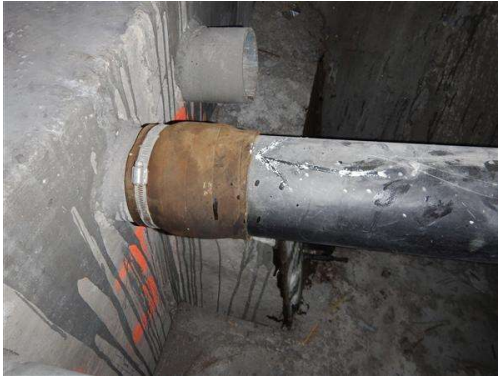
Photo 7 Missing PT clamp at Pier 27NB looking West

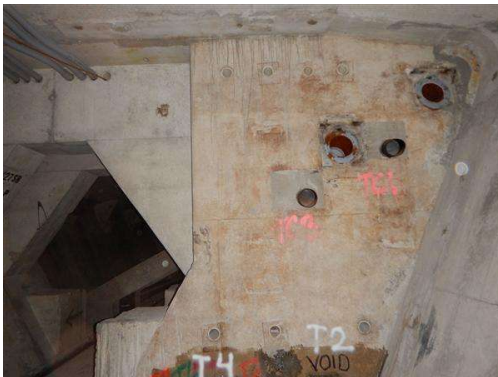
Photo 9 Typical rust on future PT ducts on the diaphragms

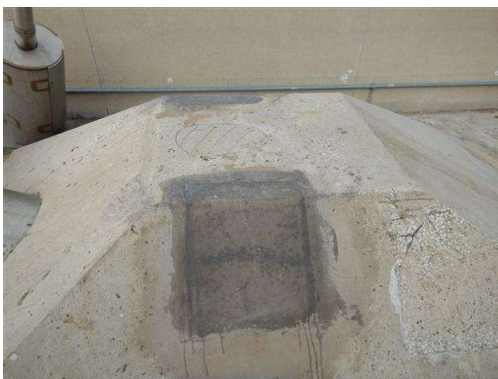
Photo 11 Delaminated/unsound concrete patch on the top face of deck Stay Cable Anchor 20A

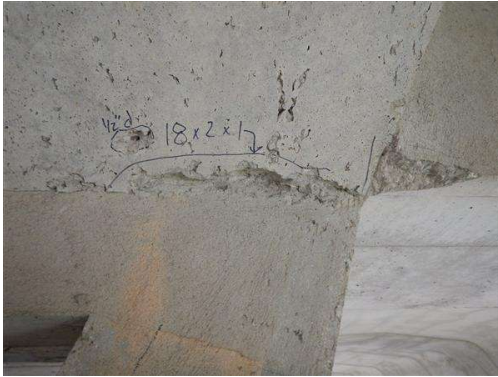
Photo 13 Spall (18"x2"x1") on South face (East side) of deck Stay Cable Anchor 18A

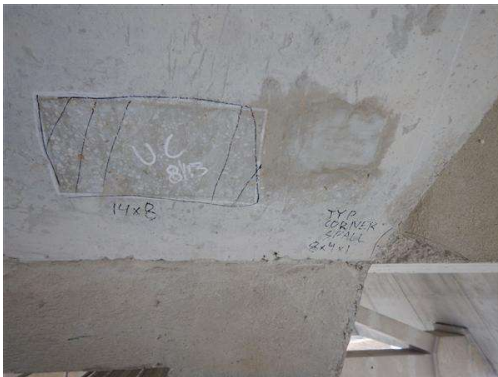
Photo 15 Delaminated/unsound concrete patch on the bottom (North face) of Stay Cable Anchor 8A

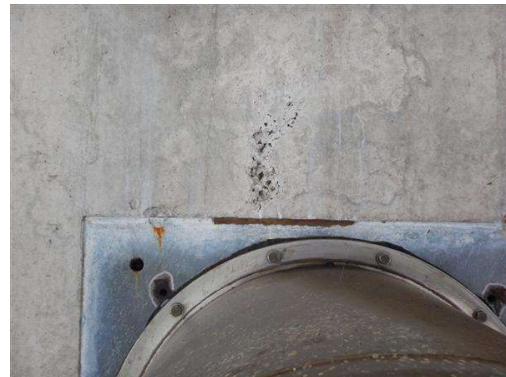
Photo 16 Honeycombed concrete on the top (North face) of deck Stay Cable Anchor 4A

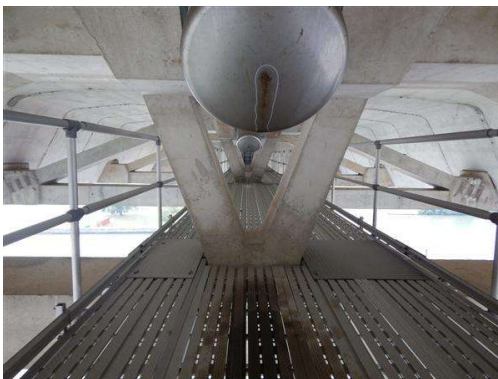
Photo 17 Leaching rust stains from stainless steel sheath at the bottom of deck Stay Cable Anchor 2A

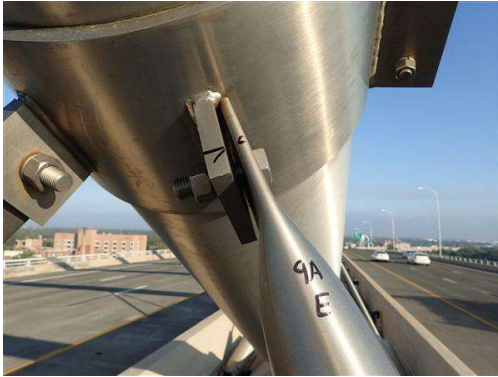
Photo 19 Gap (0.25") between cable clamp and East damper support leg at Cable Stay 9A

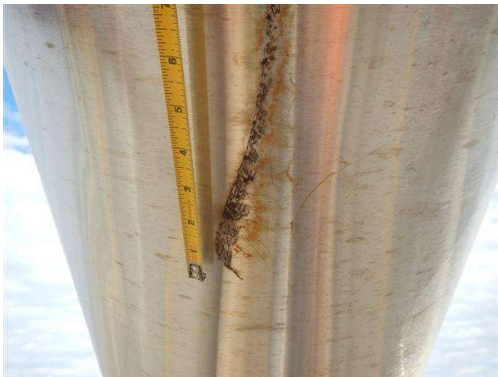
Photo 21 Gouge (8"x0.75") with light surface corrosion along the bottom side of the main sheath approximately 50' from the deck anchorage on Cable Stay 16A

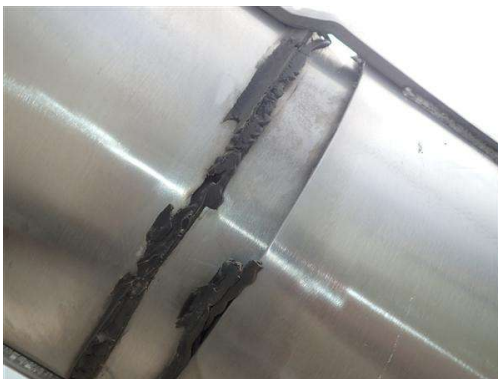
Photo 23 Full perimeter 2" gap in caulk at the top splice of Cable Stay 5B upper sleeve

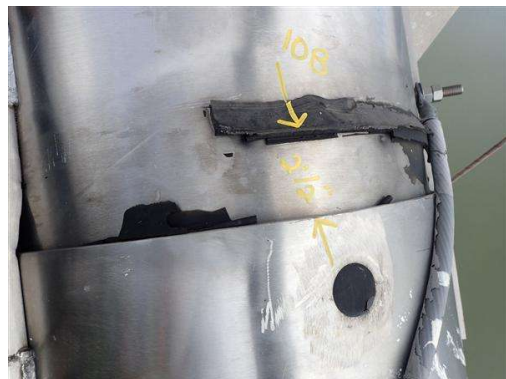
Photo 24 2.5" gap between sealant and top splice of Cable Stay 10B upper sleeve

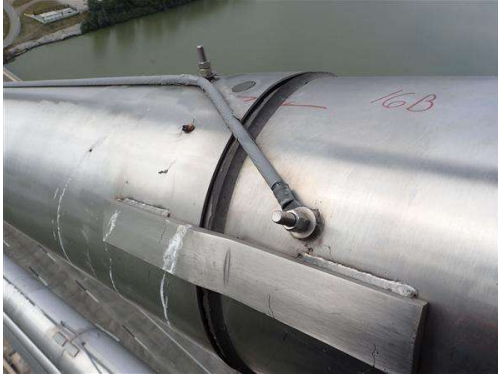
Photo 25 0.75" gap between the original caulk and the end of the upper sleeve. Full circumference gap between upper sleeve and cradle sheath on Cable Stay 16B upper sleeve

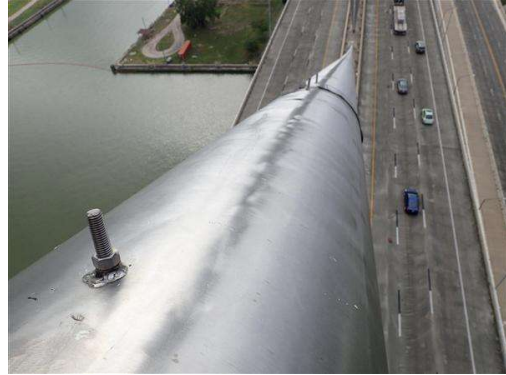
Photo 26 No ground wire present on Cable Stay 9B upper sleeve

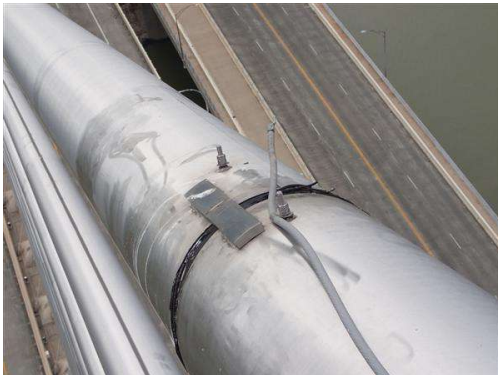
disconnected from the lower bolt at the top sleeve at the cable 20B. See Photo 27.

Photo 27 Ground cable disconnected from the lower bolt on the main sheath Cable Stay 20B upper sleeve

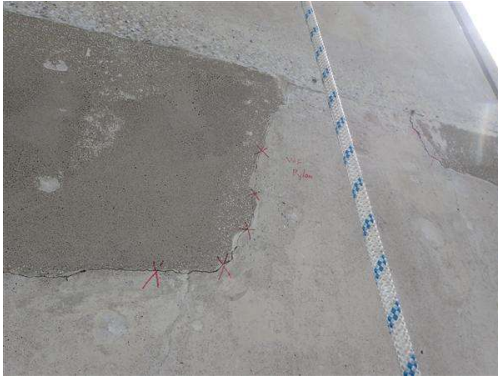
Photo 29 Two (2) patches with 0.0625" wide gaps along the bottom edge on the Upper Pylon West face near Cable Stay 20

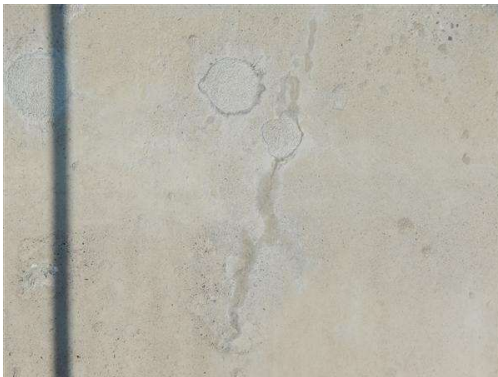
Photo 31 Multiple round patches up to 2" diameter with full perimeter cracking up to .03125" in width with discoloration on the Upper Pylon East face near Cable Stay 9
